April 2025 - Reactive Tree Felling Works Programme

Recent reactive inspections have identified the need for 26 individual tree felling work operations to take place. This work will now be issued to the Council’s Arborist Contractor KPS, for completion over the spring and summer period.

Dated 25.04.2025

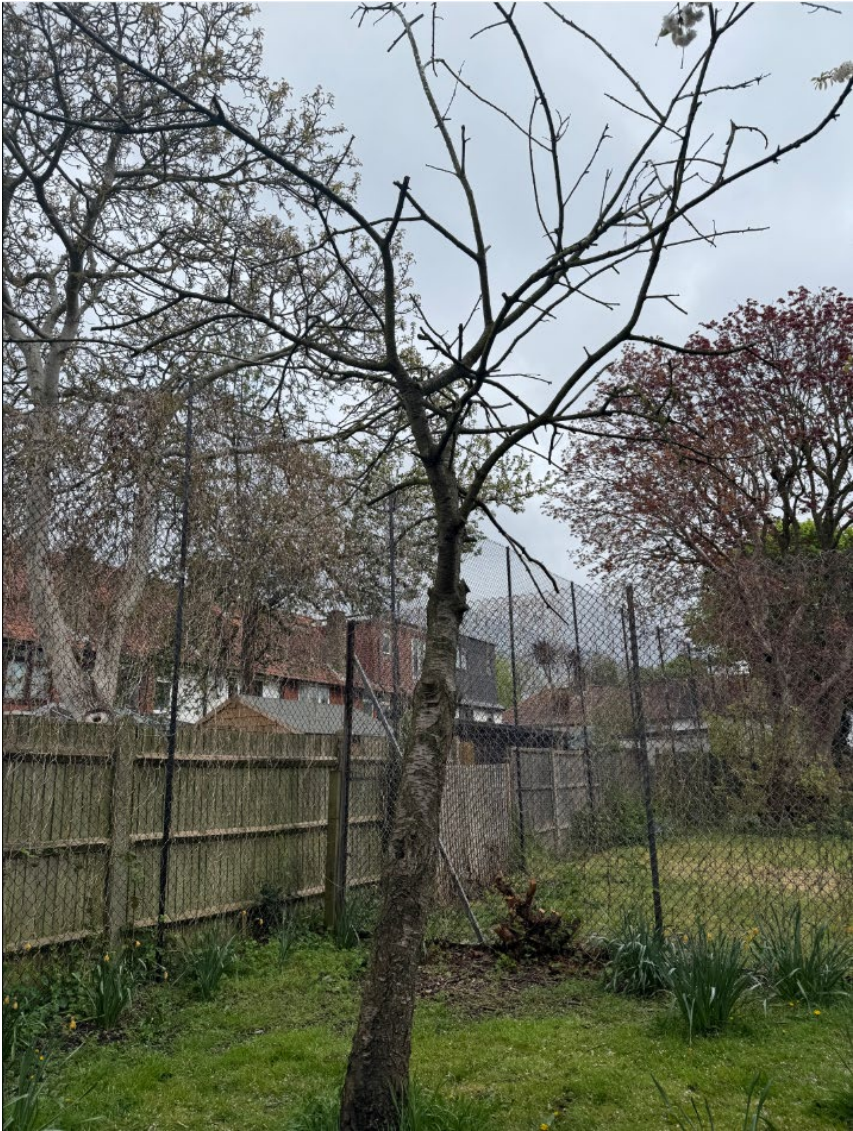
Ward	Barnes
Road	Barnes Avenue
Location	Castelnau Recreational ground- ///offer.oval.neck
Species	Wild Cherry (<i>Prunus avium</i>)
Height	7.0m
Physiological Condition	Poor
Structural Condition	Poor
Inspection findings/reason for exemption	This tree is moribund with over 90% of the crown being dead. Removal is required to prevent natural failure, manage risk, and facilitate replanting

Image shows moribund tree in park scene

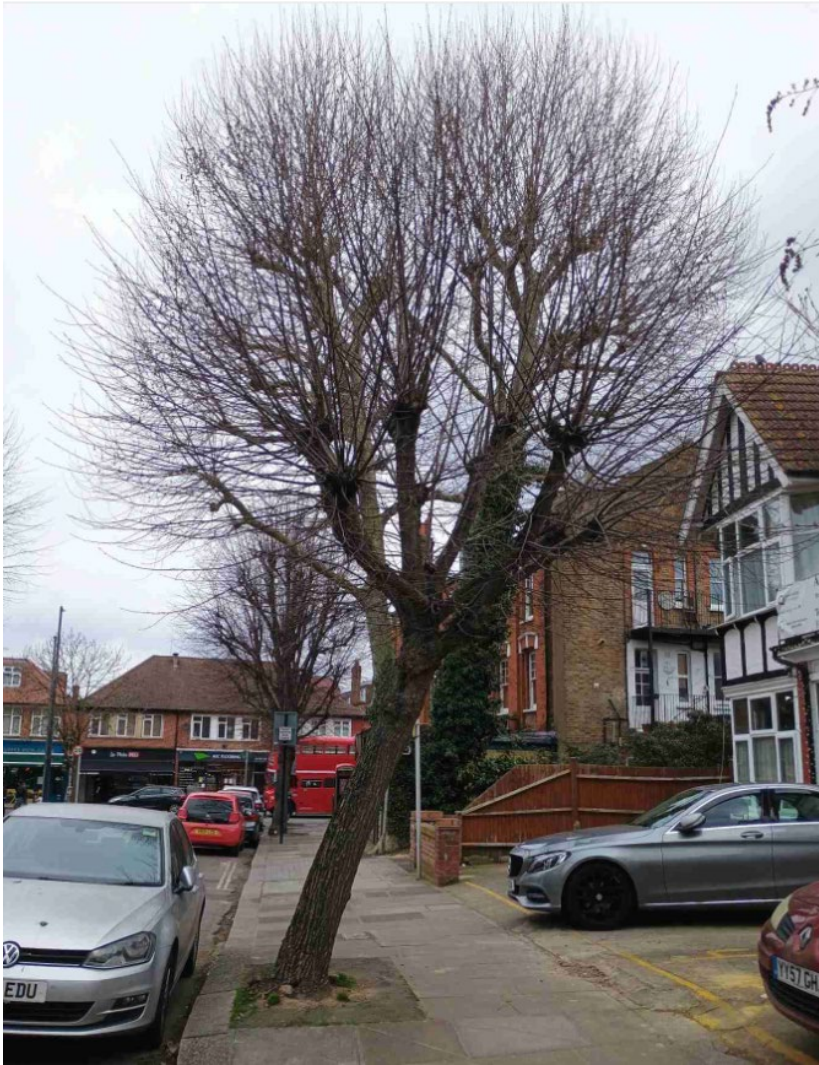
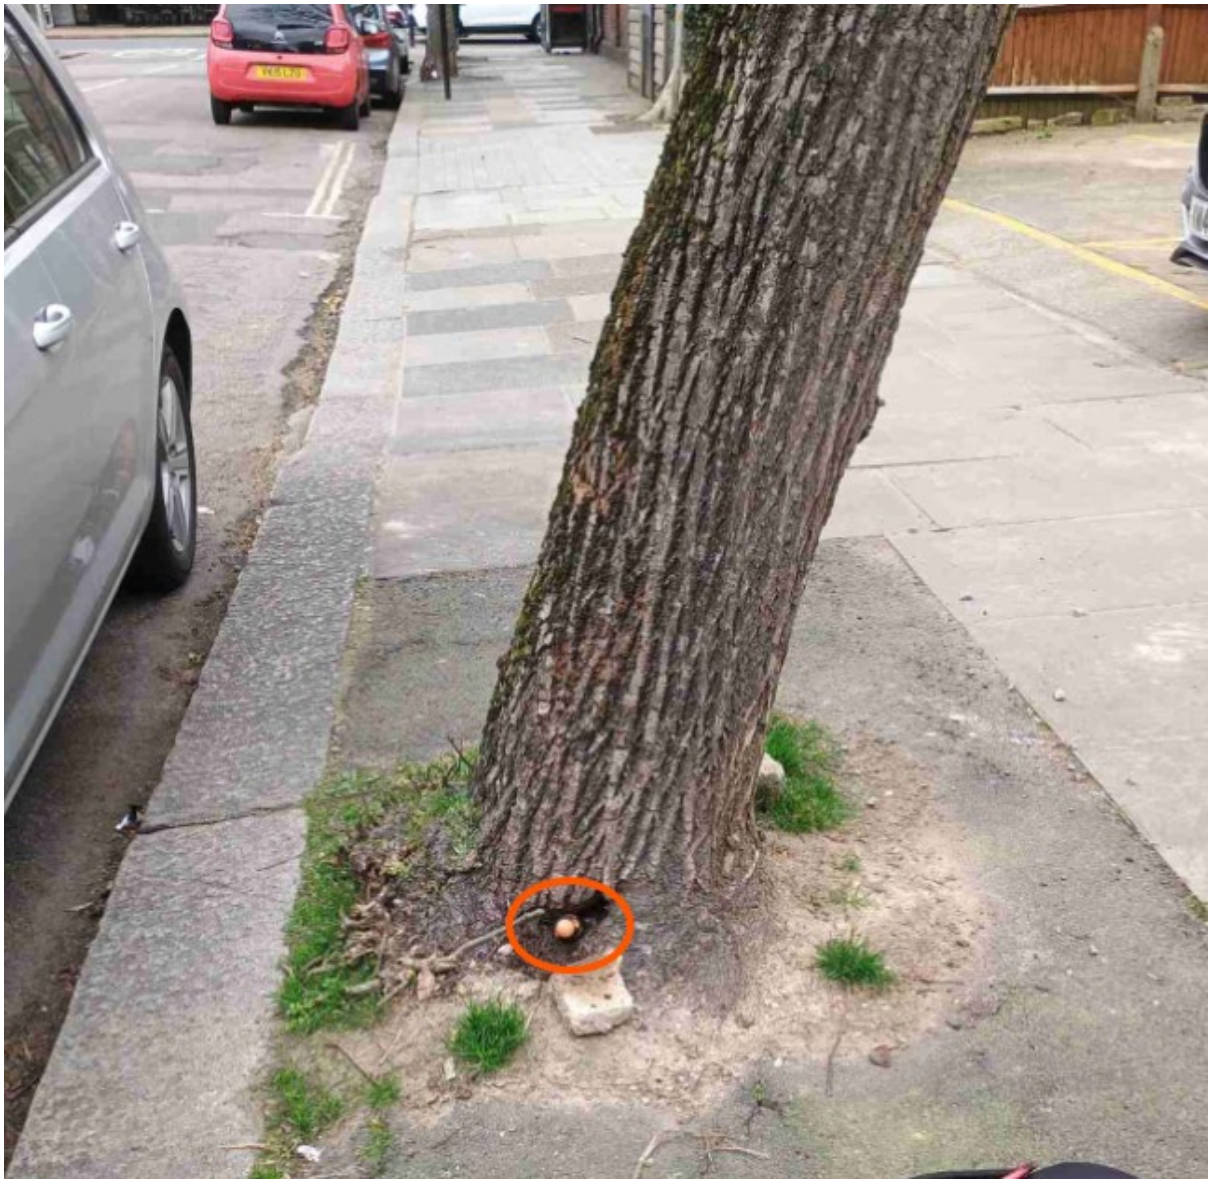
Ward	East Sheen
Road	Palewell Park
Location	Outside 3
Species	Common Lime (<i>Tilia x europaea</i>)
Height	7.0m
Physiological Condition	Fair
Structural Condition	Poor
Inspection findings/reason for exemption	Investigation with a probe and resonance testing with a sounding mallet has revealed an unacceptable degree of decay beyond the visible cavity at the base of the trunk. Removal is required to prevent natural failure, manage risk, and facilitate replanting.

Image shows tree in street scene.

Images show cavity with probe circled at base of trunk.

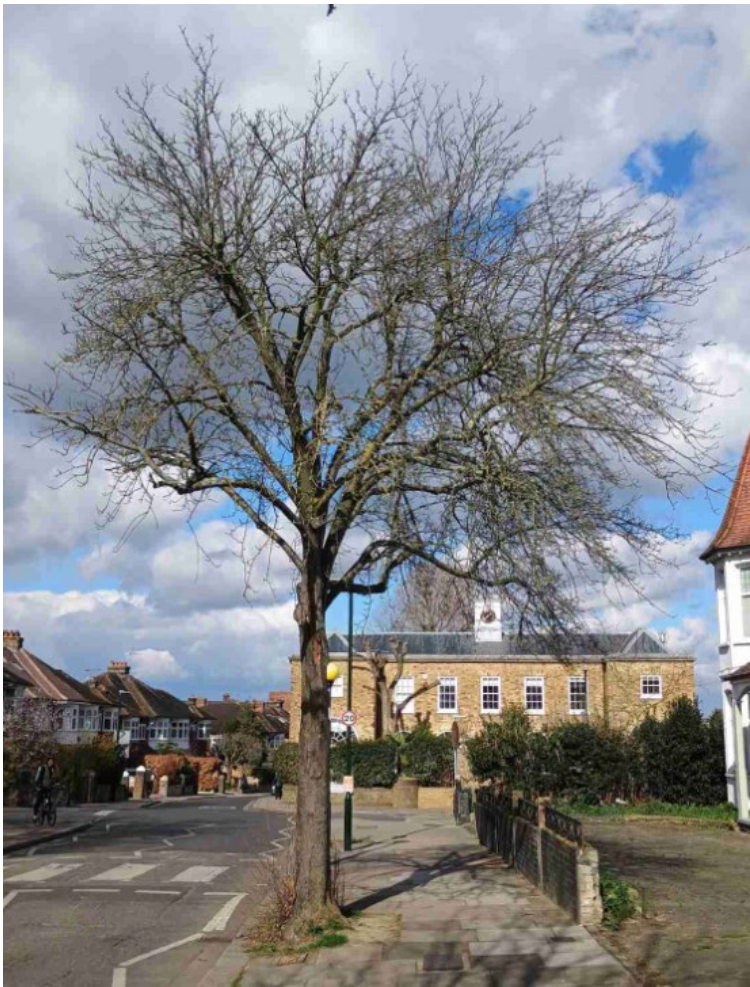
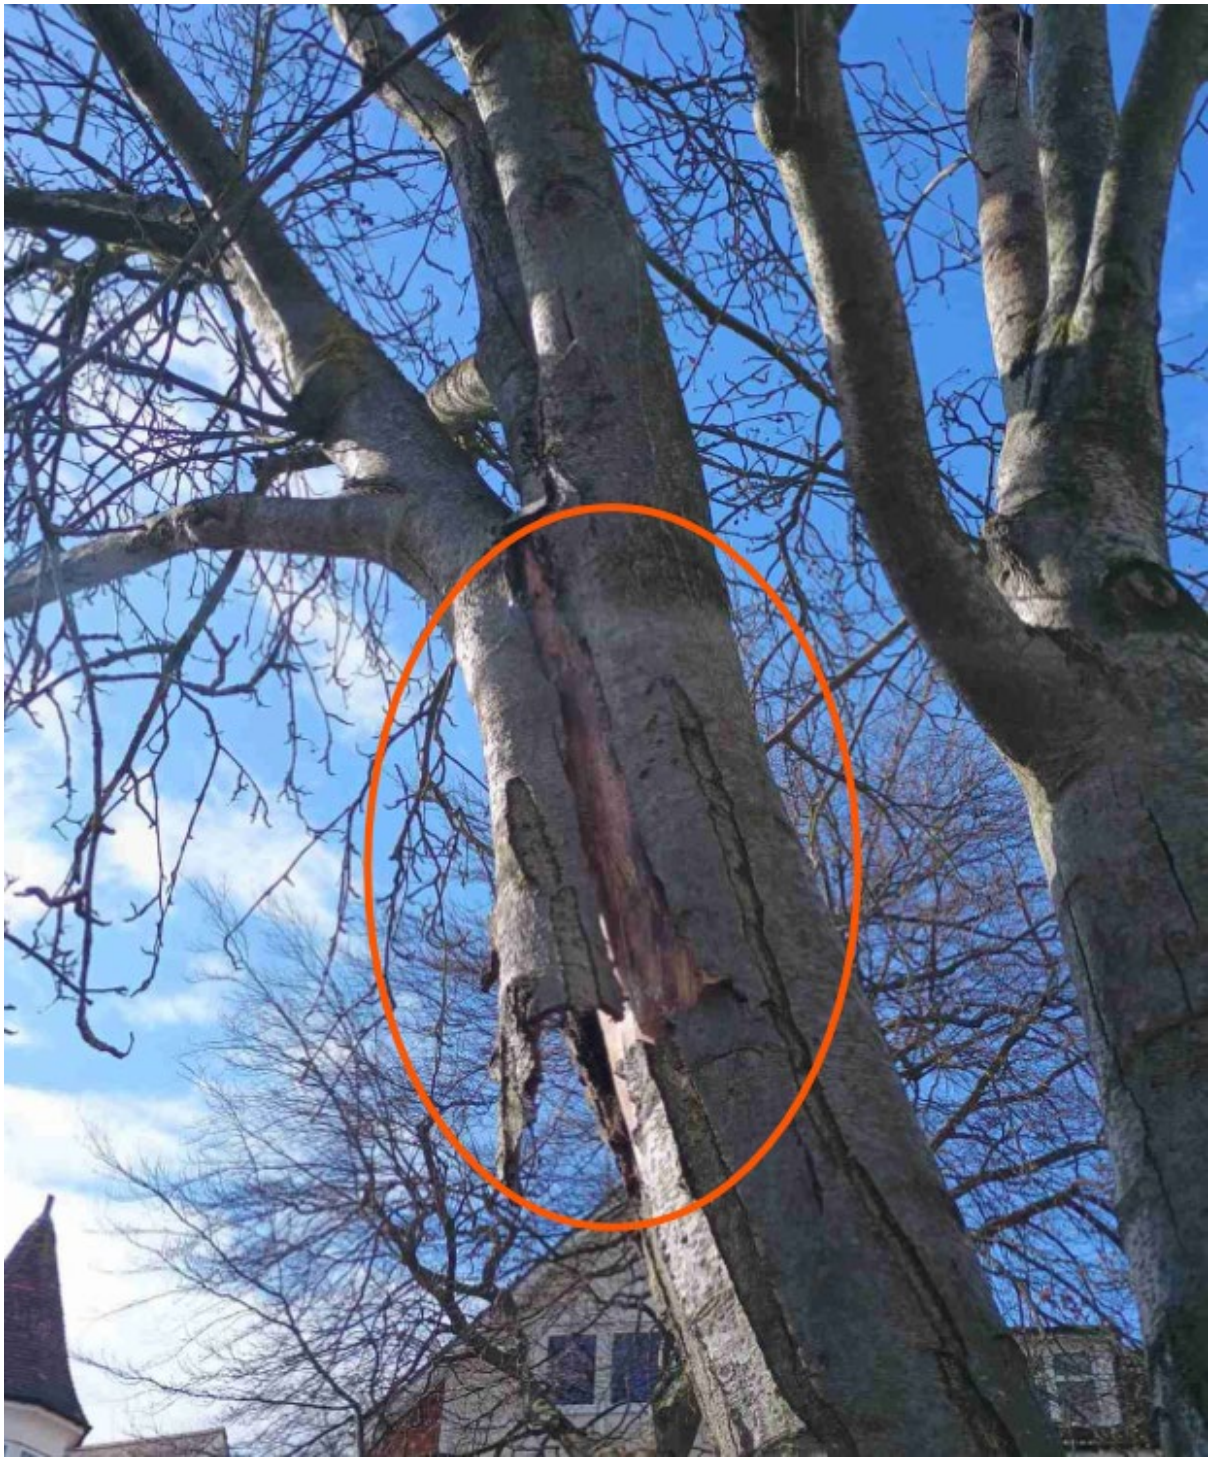
Ward	East Sheen
Road	Sheen Lane
Location	Outside 175 edge of building
Species	Whitebeam (<i>Sorbus aria</i>)
Height	9.0m
Physiological Condition	Dead
Structural Condition	Dead
Inspection findings/reason for exemption	This tree is Dead; removal is required to prevent natural failure and facilitate replanting.

Images show dead tree in street scene.

Images show delaminated bark on trunk circled.

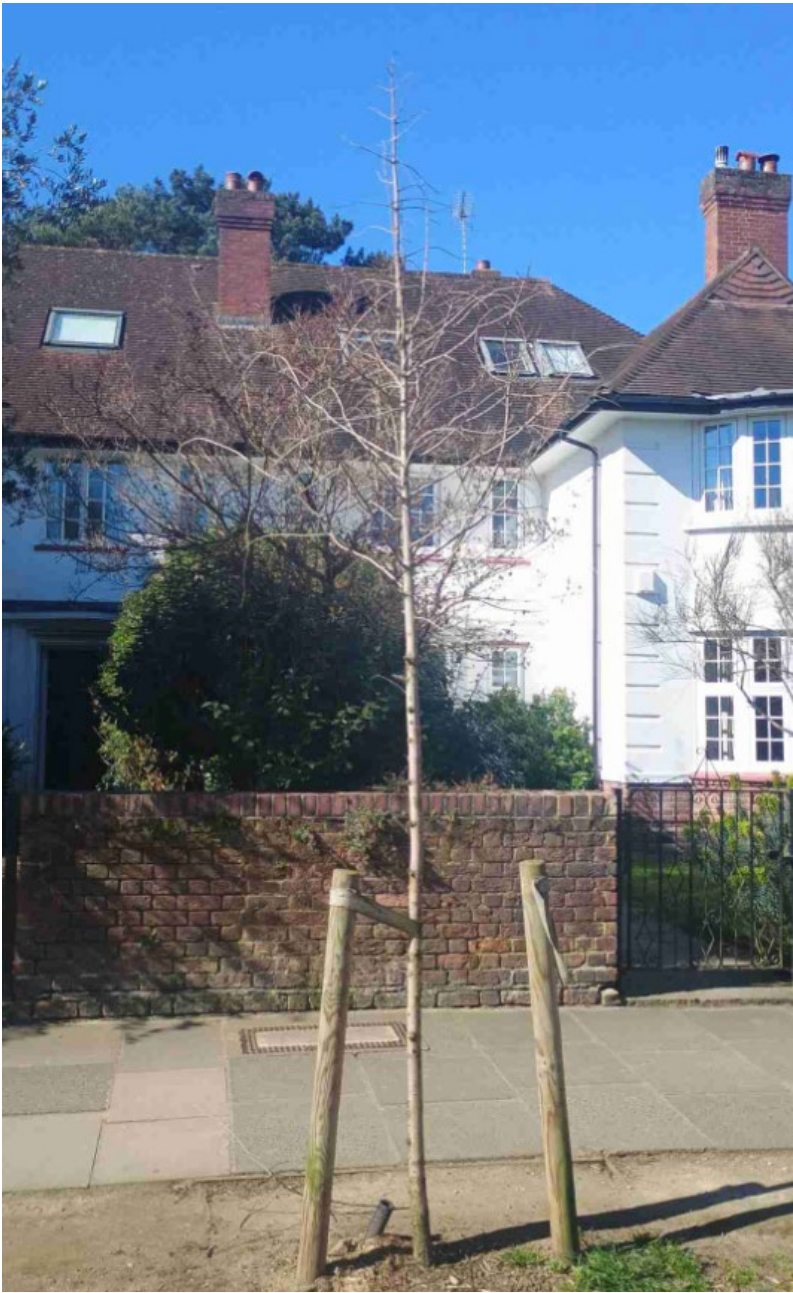
Ward	East Sheen
Road	Sheen Lane
Location	Outside 260/258
Species	Tulip tree (<i>Liriodendron tulipifera Aureomargin</i>)
Height	2.5m
Physiological Condition	Dead
Structural Condition	Dead
Inspection findings/reason for exemption	This tree is dead; removal is required to prevent natural failure, manage risk, and facilitate replanting

Image shows dead tree in street scene.

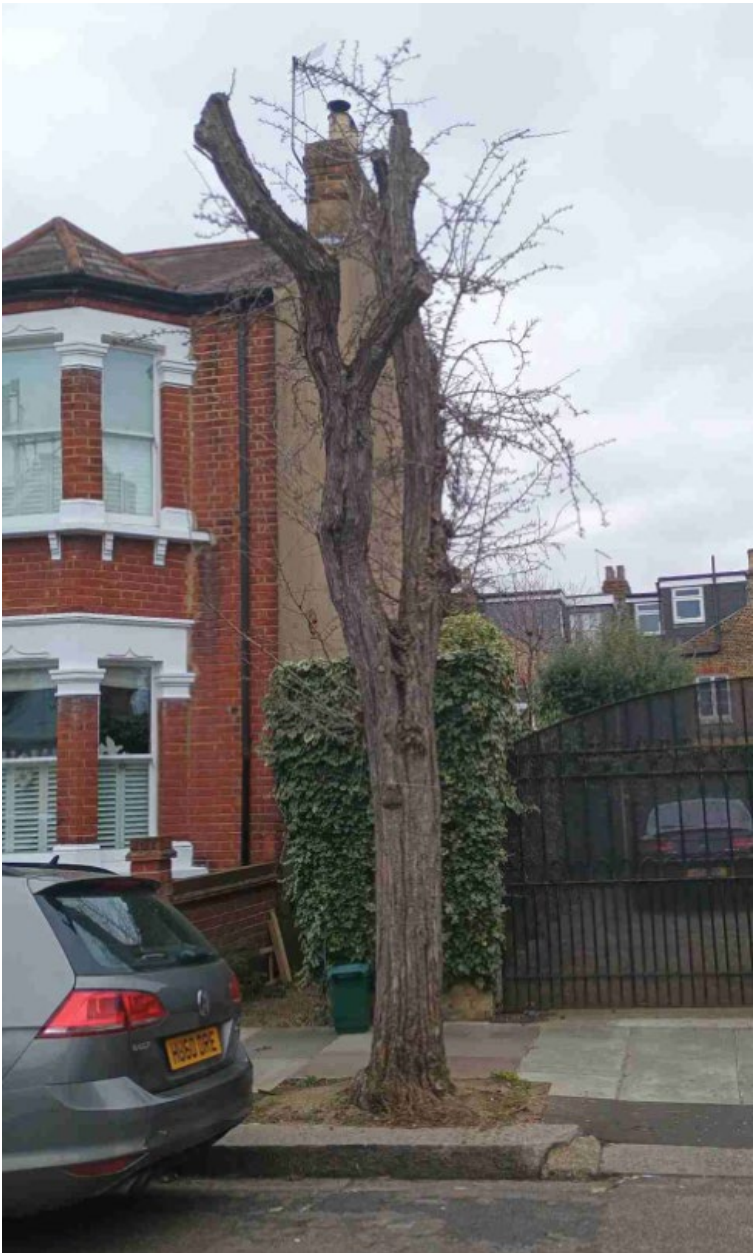
Ward	East Sheen
Road	Paynesfield Avenue
Location	Adjacent to 156 Upper Richmond Road West gates at rear of property
Species	Hawthorne (<i>Crataegus monogyna</i>)
Height	7.0m
Physiological Condition	Poor
Structural Condition	Poor
Inspection findings/reason for exemption	This tree is moribund; removal is required to prevent natural failure and facilitate replanting

Image shows moribund tree in street scene.

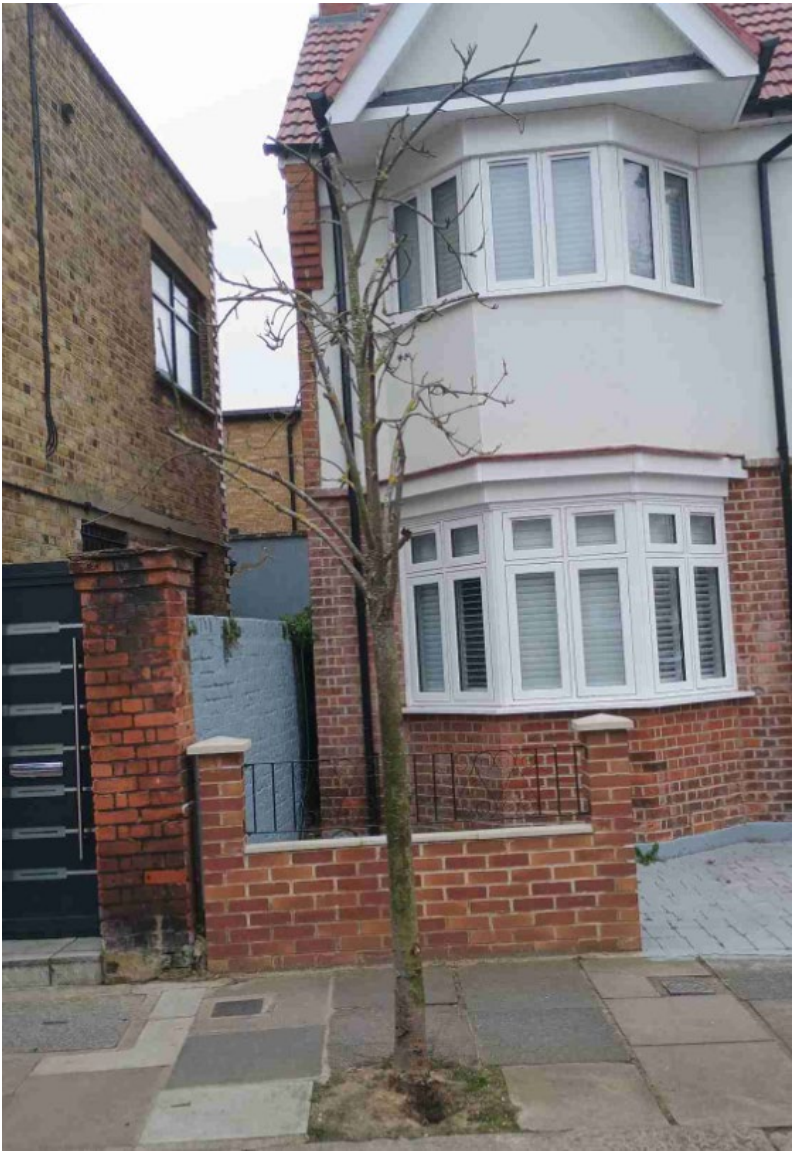
Ward	East Sheen
Road	Milton Road
Location	Outside 10
Species	Rowan (<i>Sorbus aucuparia</i>)
Height	4.5m
Physiological Condition	Dead
Structural Condition	Dead
Inspection findings/reason for exemption	This tree is dead; removal is required to prevent natural failure, manage risk, and facilitate replanting

Image shows dead tree in street scene.

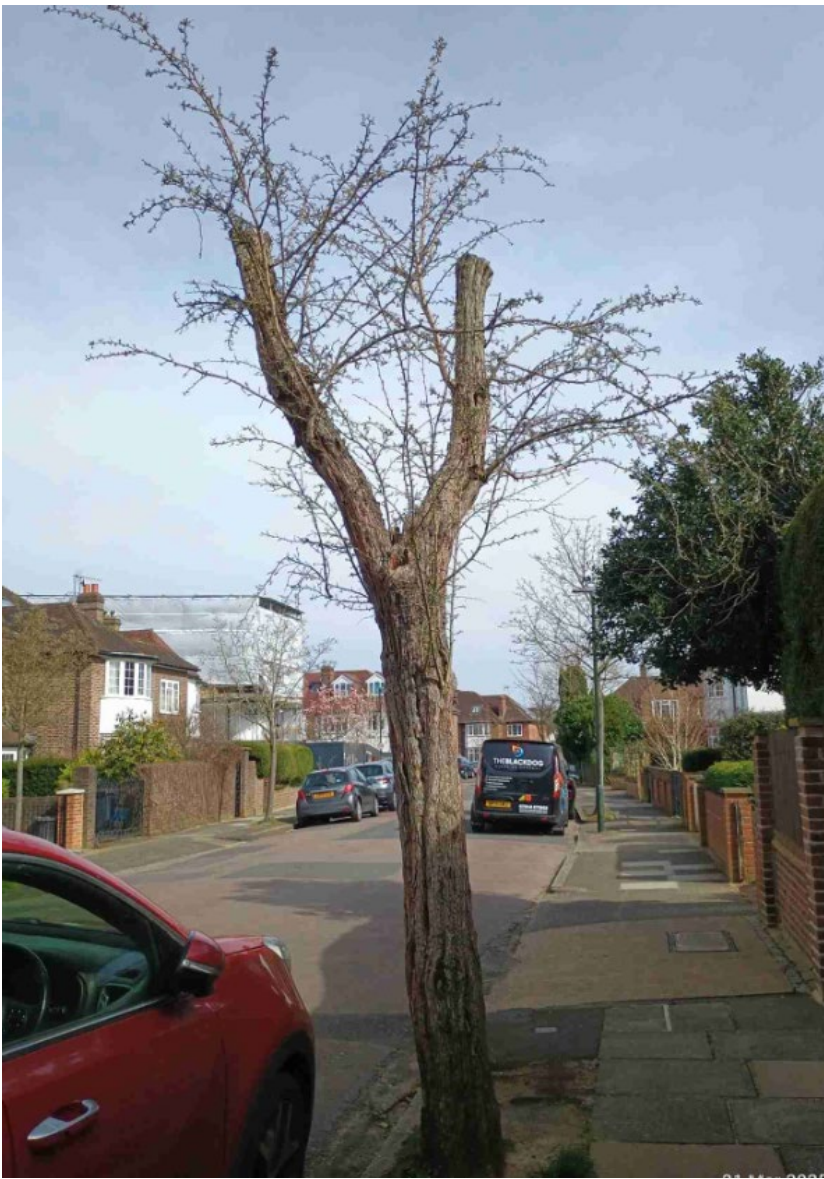
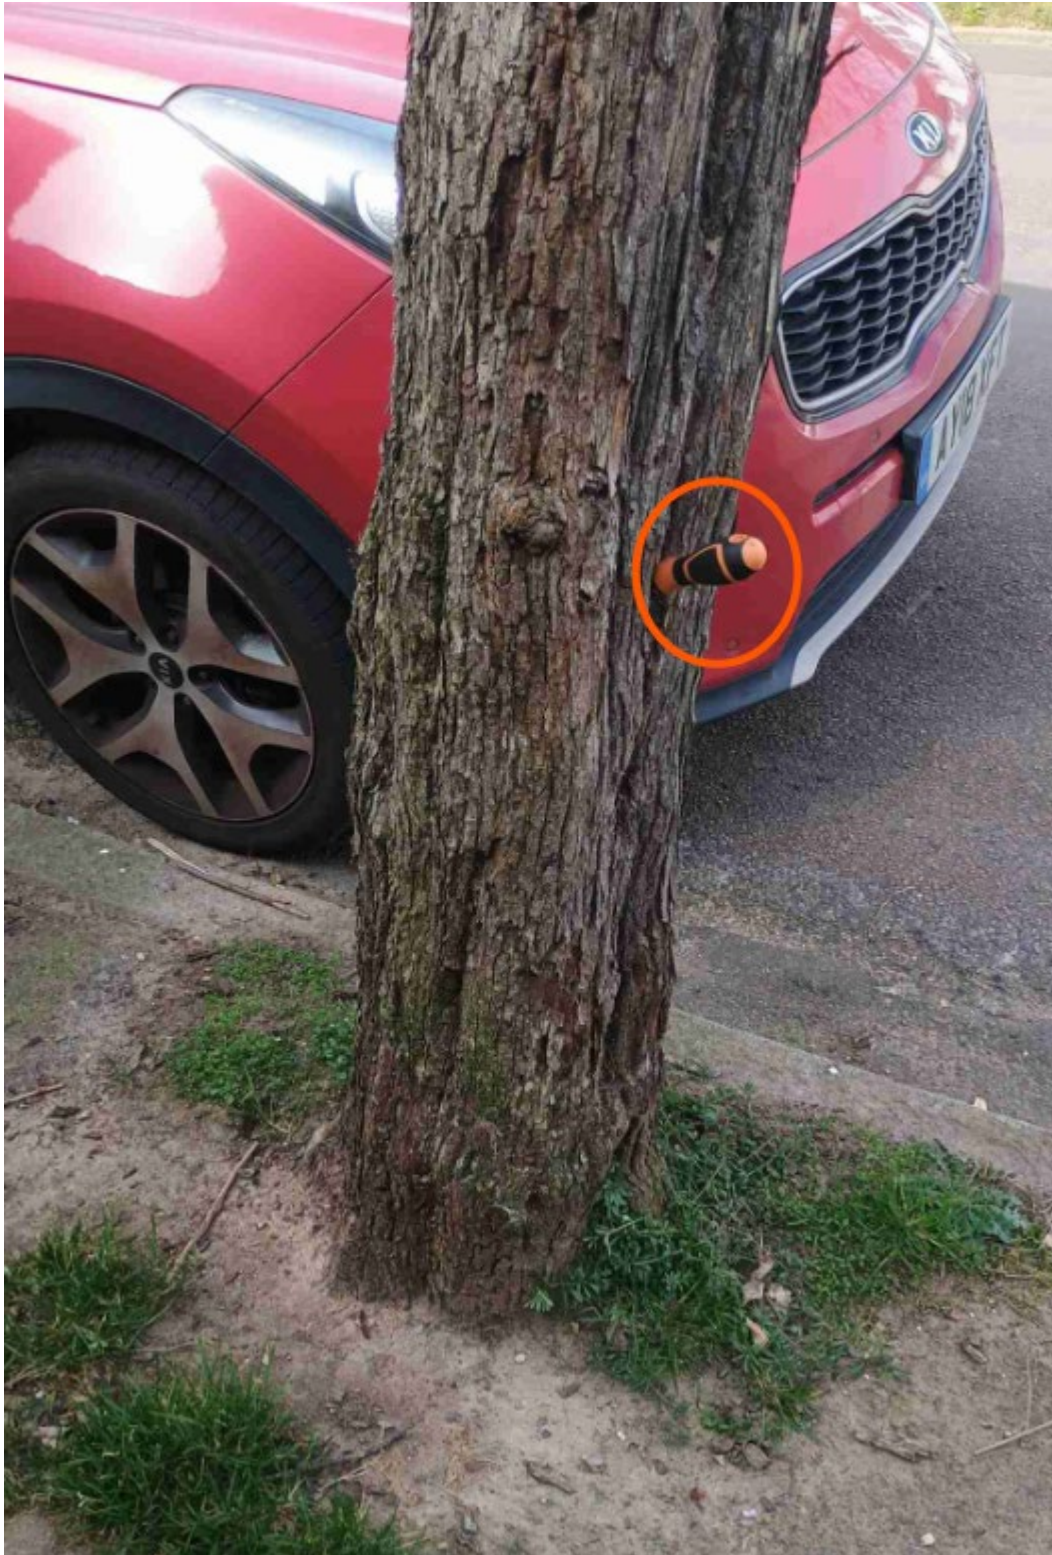
Ward	East Sheen
Road	Clare Lawn Avenue
Location	Opposite 1
Species	Hawthorn (<i>Crataegus monogyna</i>)
Height	5.0m
Physiological Condition	Poor
Structural Condition	Poor
Inspection findings/reason for exemption	A resonance test with a sounding hammer and a probe revealed an unacceptable degree of decay in the trunk of this tree. Removal is required to prevent natural failure, manage risk, and facilitate replanting

Image shows tree in street scene.

Image shows probe highlighting decay on stem circled.

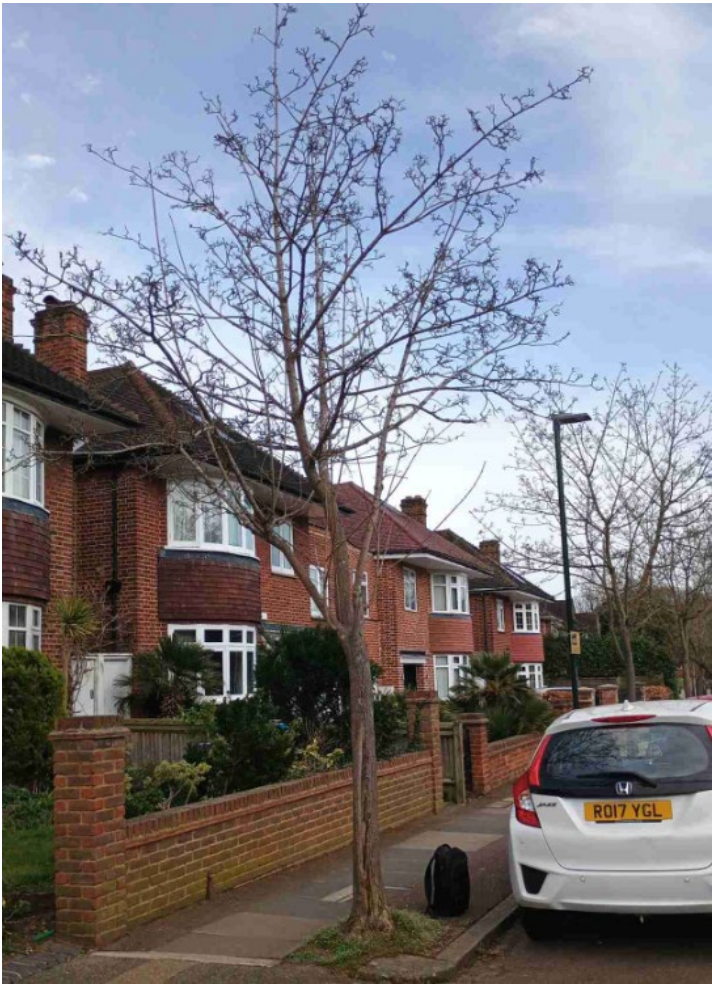
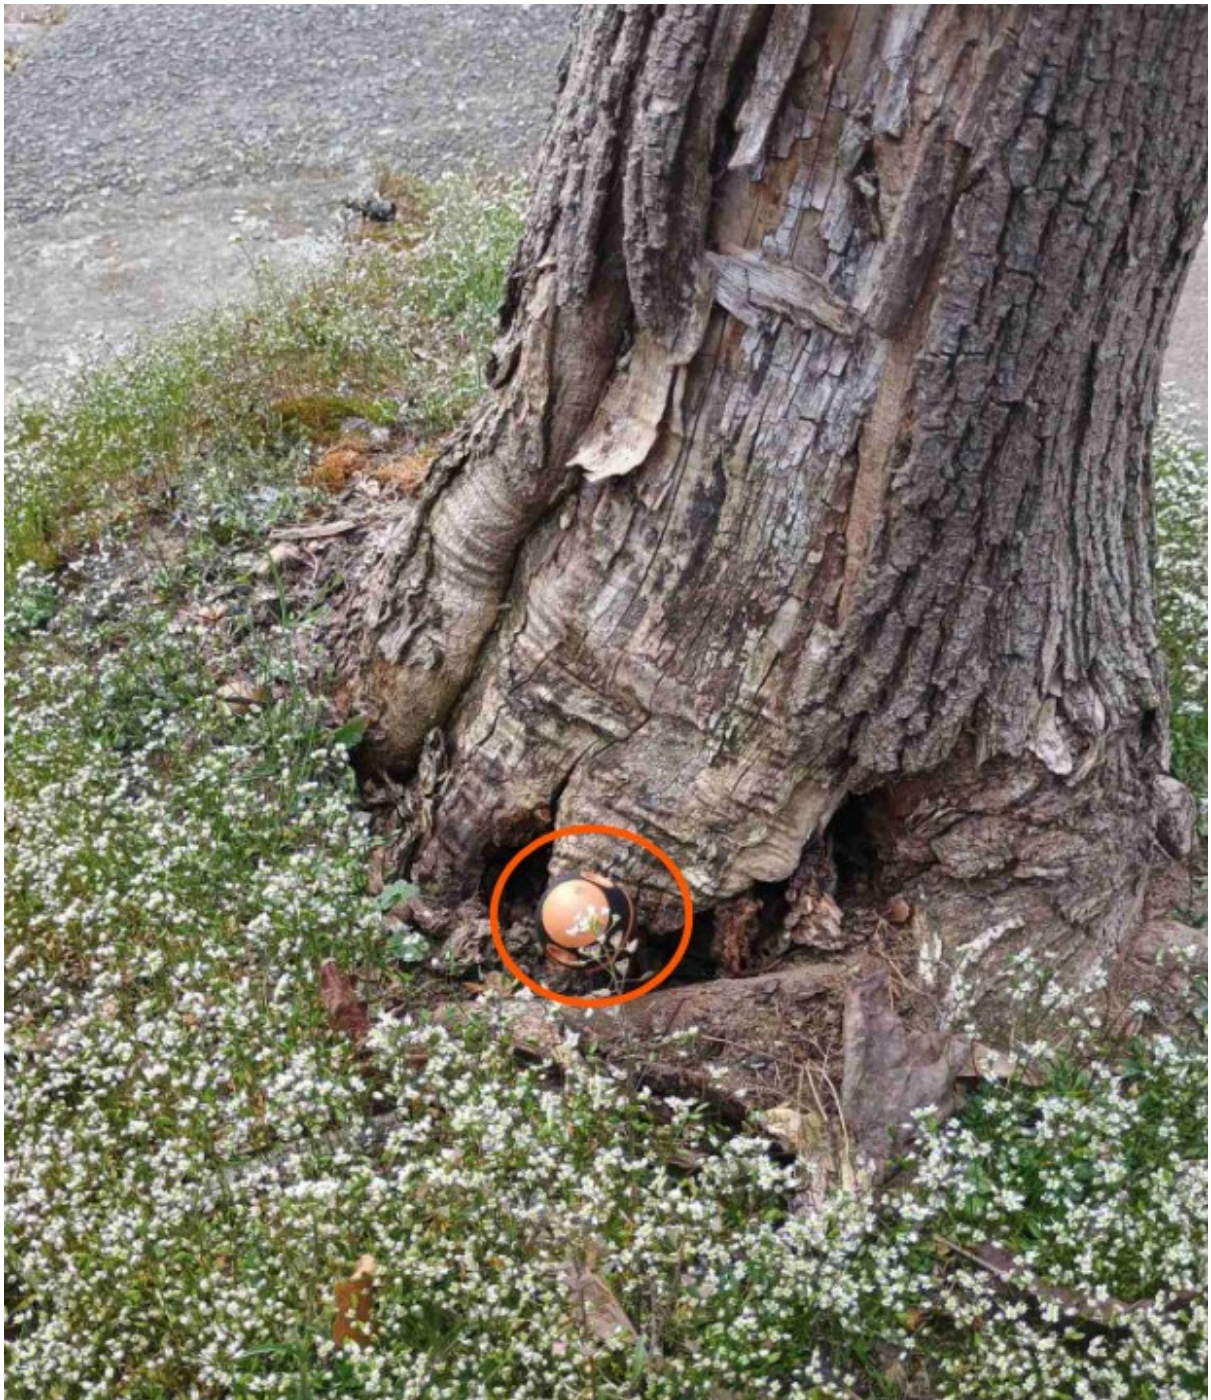
Ward	East Sheen
Road	Clare Lawn Avenue
Location	Outside 19
Species	Norway Maple (<i>Acer platanoides</i>)
Height	7.0m
Physiological Condition	Fair
Structural Condition	Poor
Inspection findings/reason for exemption	Investigation with a probe and a resonance test with a sounding hammer has revealed an unacceptable amount of decay beyond the visible cavities at the base of the trunk. Removal is required to prevent natural failure, manage risk, and facilitate replanting.

Image shows tree in street scene.

Image shows cavity with probe circled.

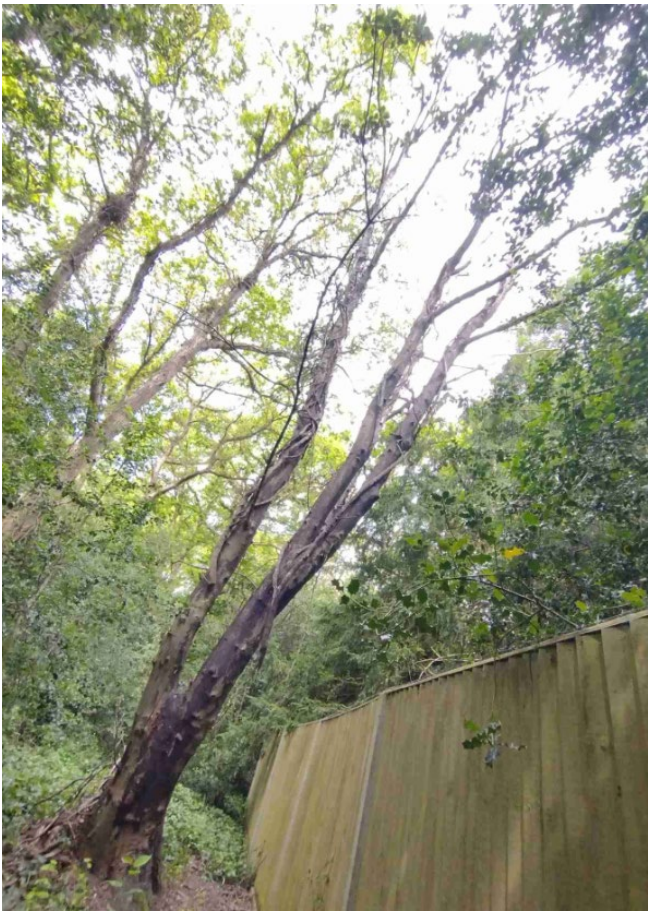
Ward	East Sheen
Road	Longfield Drive
Location	Sheen common- ///price.sand.trains
Species	Sycamore (<i>Acer pseudoplatanus</i>)
Height	17.0m
Physiological Condition	Dead
Structural Condition	Dead
Inspection findings/reason for exemption	This tree has been affected by the fungal pathogen 'sooty bark disease' (<i>Cryptostroma corticale</i>). This fungus disrupts the tree's vascular system, preventing the effective transport of water and nutrients, and leads to the cracking and peeling of bark, exposing masses of black fungal spores and tree death. The establishment of this disease also affects the structural integrity of the affected tree, causing branches to become brittle and predisposed to collapse. Removal is required to prevent natural failure, manage risk and prevent further release of spores which pose a respiratory risk to humans.

Image shows dead tree in woodland scene.

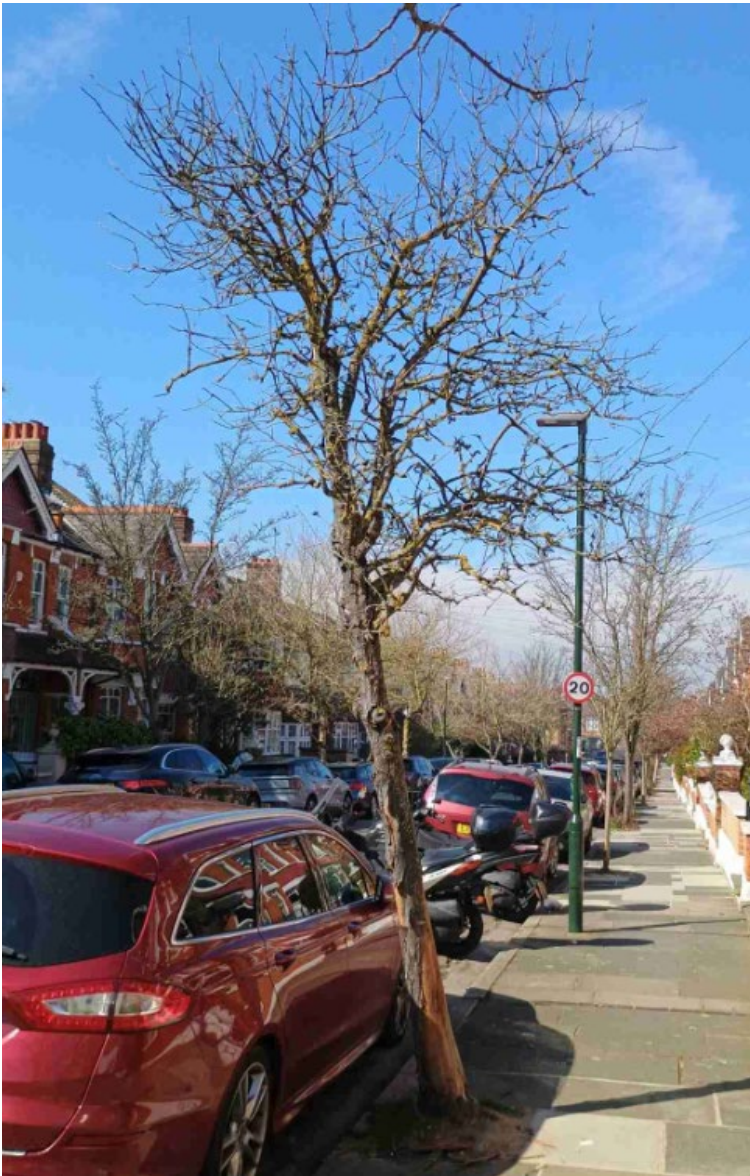
Ward	East Sheen
Road	Palmerston Road
Location	Outside 46
Species	Field Maple (<i>Acer campestre</i>)
Height	7.5m
Physiological Condition	Dead
Structural Condition	Dead
Inspection findings/reason for exemption	This tree is dead; removal is required to prevent natural failure, manage risk, and facilitate replanting

Image shows dead tree in street scene.

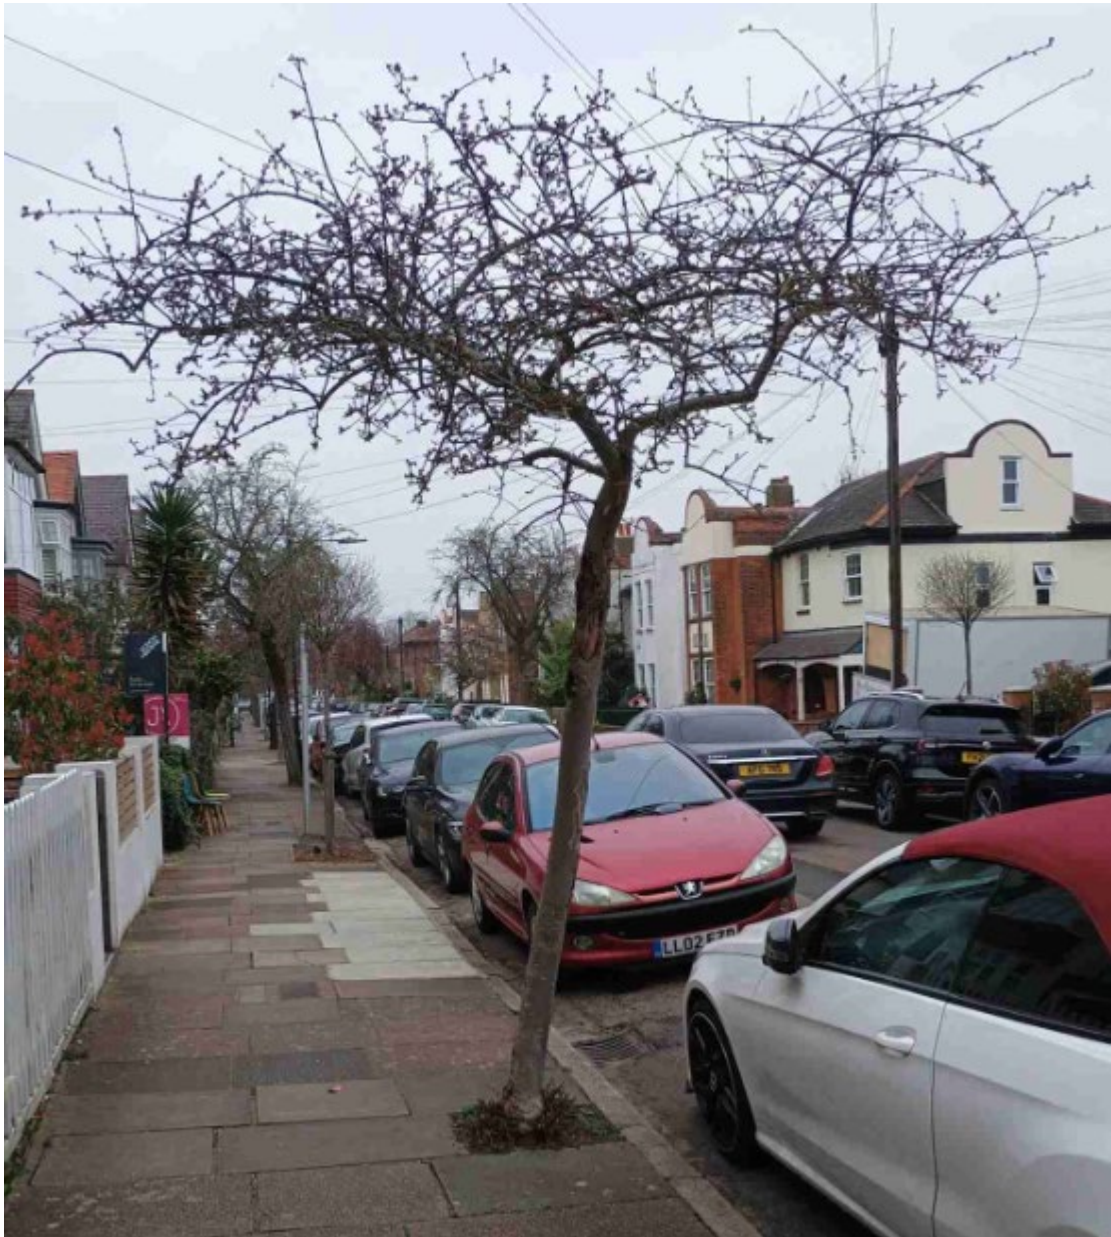
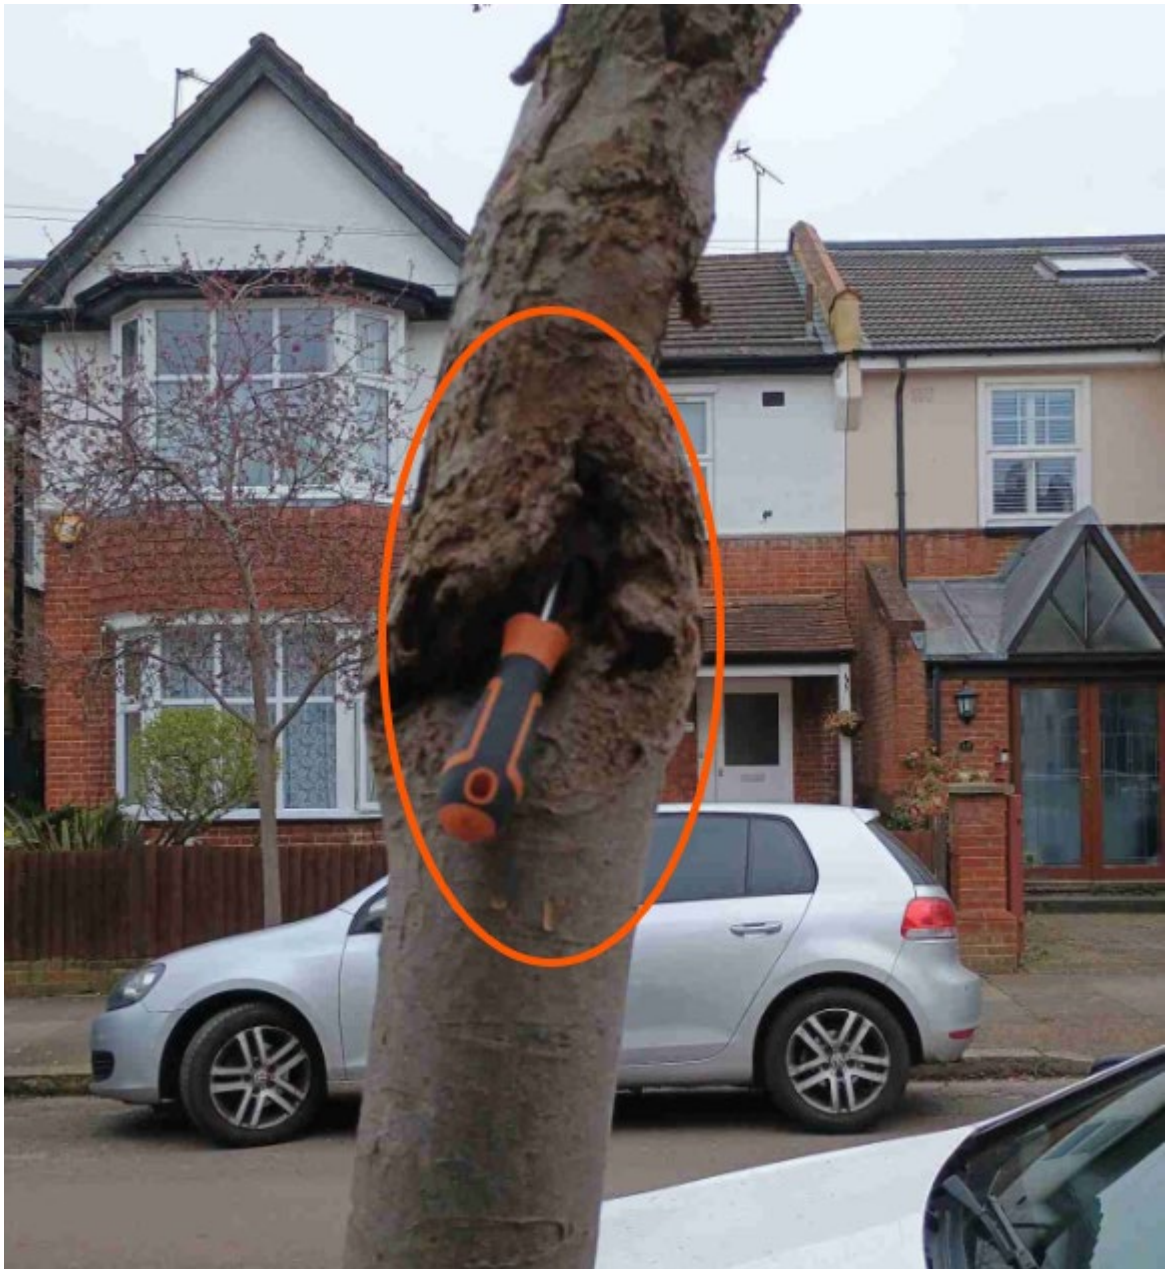
Ward	East Sheen
Road	Leinster Avenue
Location	Outside 36
Species	Crab apple (<i>Malus sylvestris</i>)
Height	4.5m
Physiological Condition	Fair
Structural Condition	Poor
Inspection findings/reason for exemption	A resonance test with a sounding hammer and a probe revealed an unacceptable degree of decay in the trunk of this tree removal is required to prevent natural failure, manage risk, and facilitate replanting

Image shows tree in street scene.

Image shows probe and decay on stem circled.

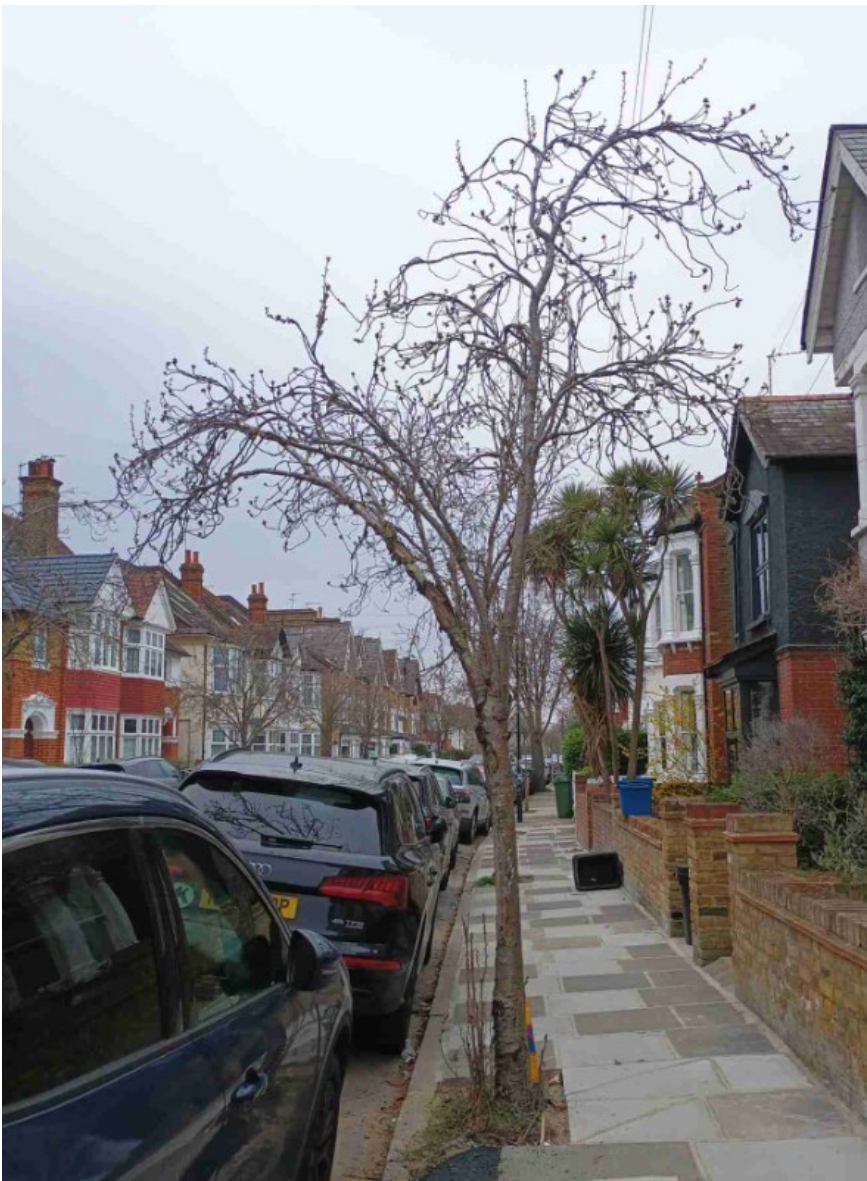
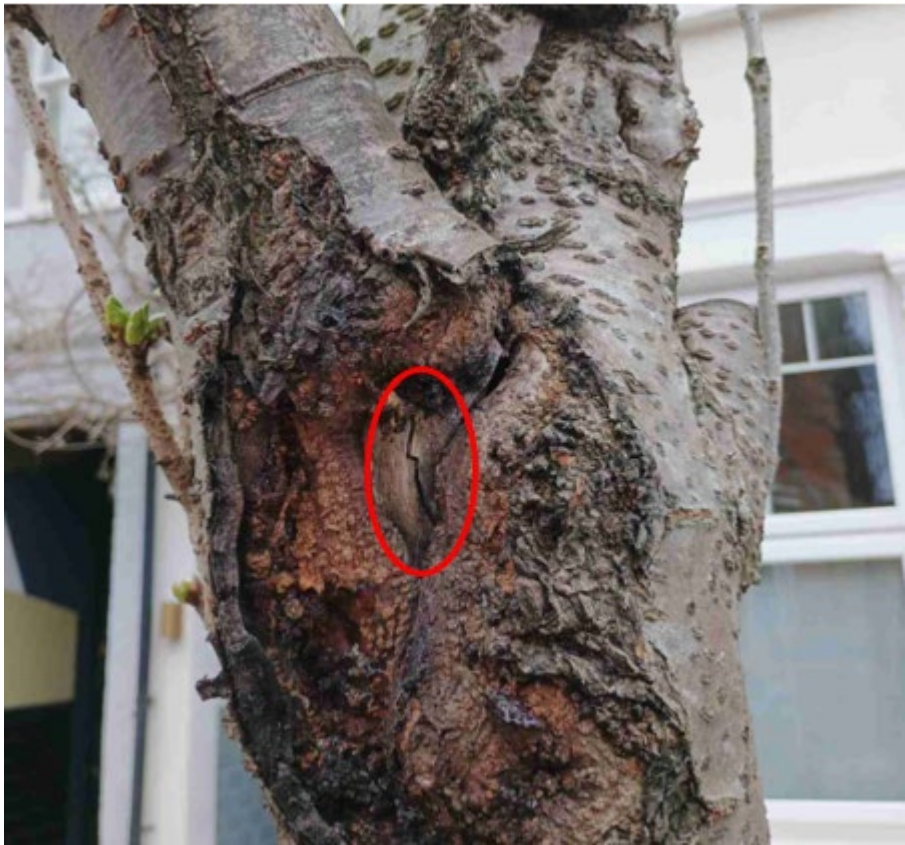
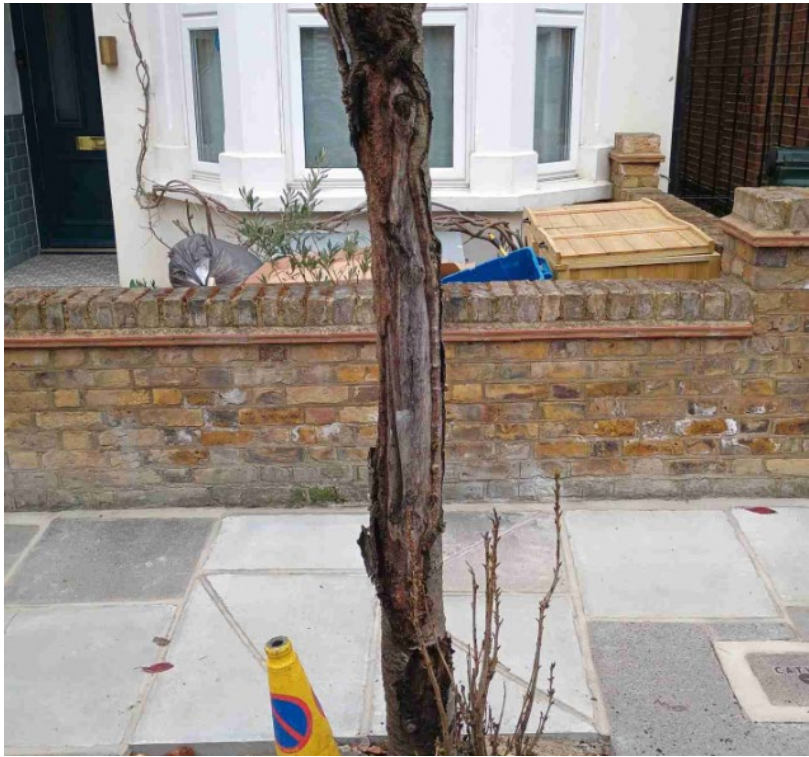
Ward	East Sheen
Road	Elm Road
Location	Outside 16
Species	Cherry 'Amanogawa' (<i>Prunus serrulata</i> 'Amanogawa')
Height	5.0m
Physiological Condition	Dead
Structural Condition	Dead
Inspection findings/reason for exemption	This tree has sustained significant bark damage from a historic vehicle strike, leading to heartwood cracking at the primary union of the trunk. Removal is required to prevent natural failure, manage risk, and facilitate replanting.

Image shows tree in street scene.

Image shows cracking to the heartwood circled on the union.

Image shows bark damage on trunk.
