April 2025 - Reactive Tree Felling Works Programme

Recent reactive inspections have identified the need for 26 individual tree felling work operations to take place. This work will now be issued to the Council’s Arborist Contractor KPS, for completion over the spring and summer period.

Dated 25.04.2025

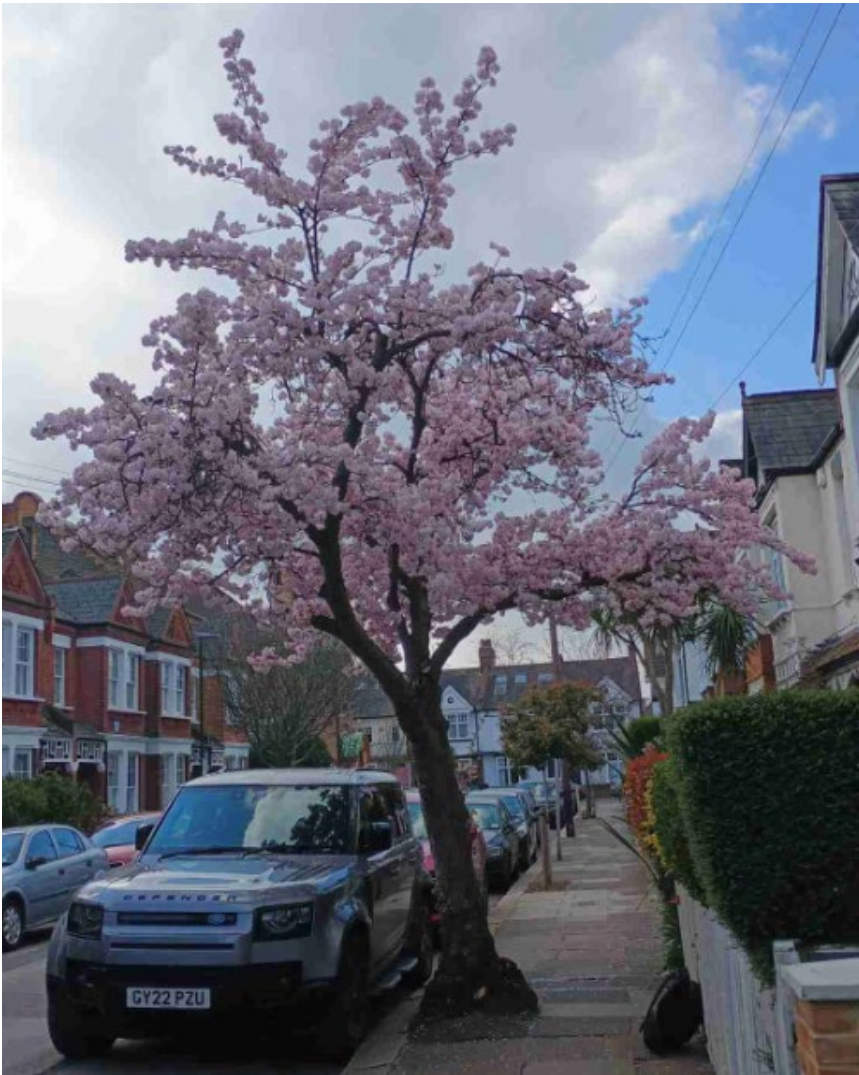
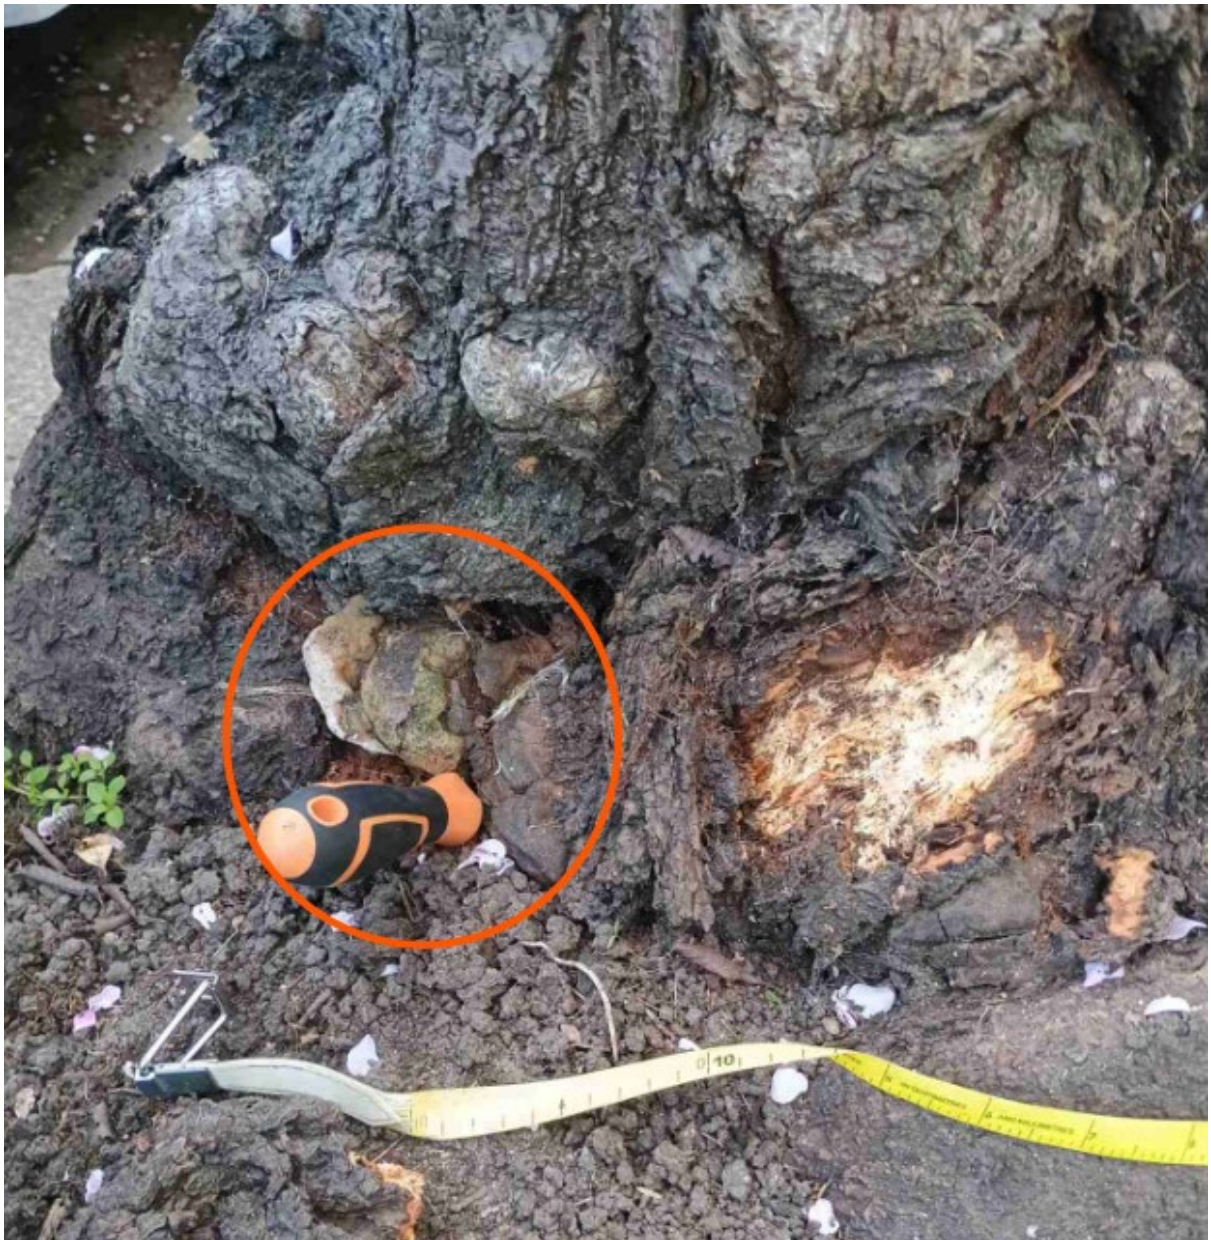
Ward	East Sheen
Road	Howgate Road
Location	Outside 22
Species	Sargent's cherry (<i>Prunus sargentii</i>)
Height	6.5m
Physiological Condition	Fair
Structural Condition	Poor
Inspection findings/reason for exemption	<p>A fungal fruiting body of the decay fungi <i>Ganoderma sp.</i> is present at the base of the trunk. Colonisation by this fungus causes a white rot of the stem and root system that can cause entire trees to collapse through fracture or windthrow. A resonance test with a sounding hammer and a probe revealed an unacceptable degree of decay in the trunk of this tree.</p> <p>Removal is required to prevent natural failure, manage risk, and facilitate replanting.</p>

Image shows tree in street scene.

Image shows fungal fruiting bodies and probe circled.

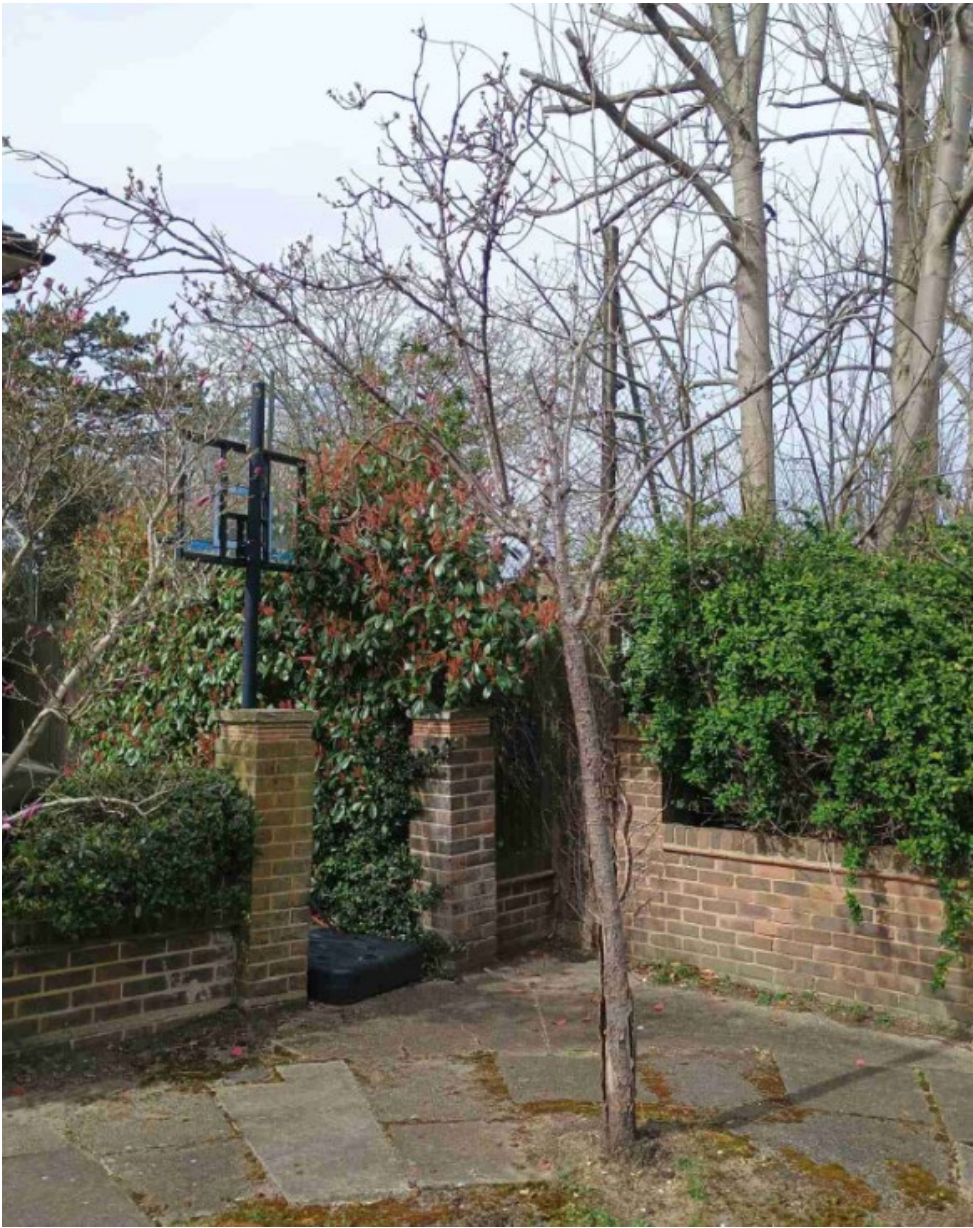
Ward	East Sheen
Road	Stonehill Close
Location	Outside 4/4A
Species	Sargent’s cherry (<i>Prunus sargentii</i>)
Height	4.0m
Physiological Condition	Poor
Structural Condition	Fair
Inspection findings/reason for exemption	This tree is moribund; removal is required to prevent natural failure, manage risk, and facilitate replanting

Image shows moribund tree in street scene.

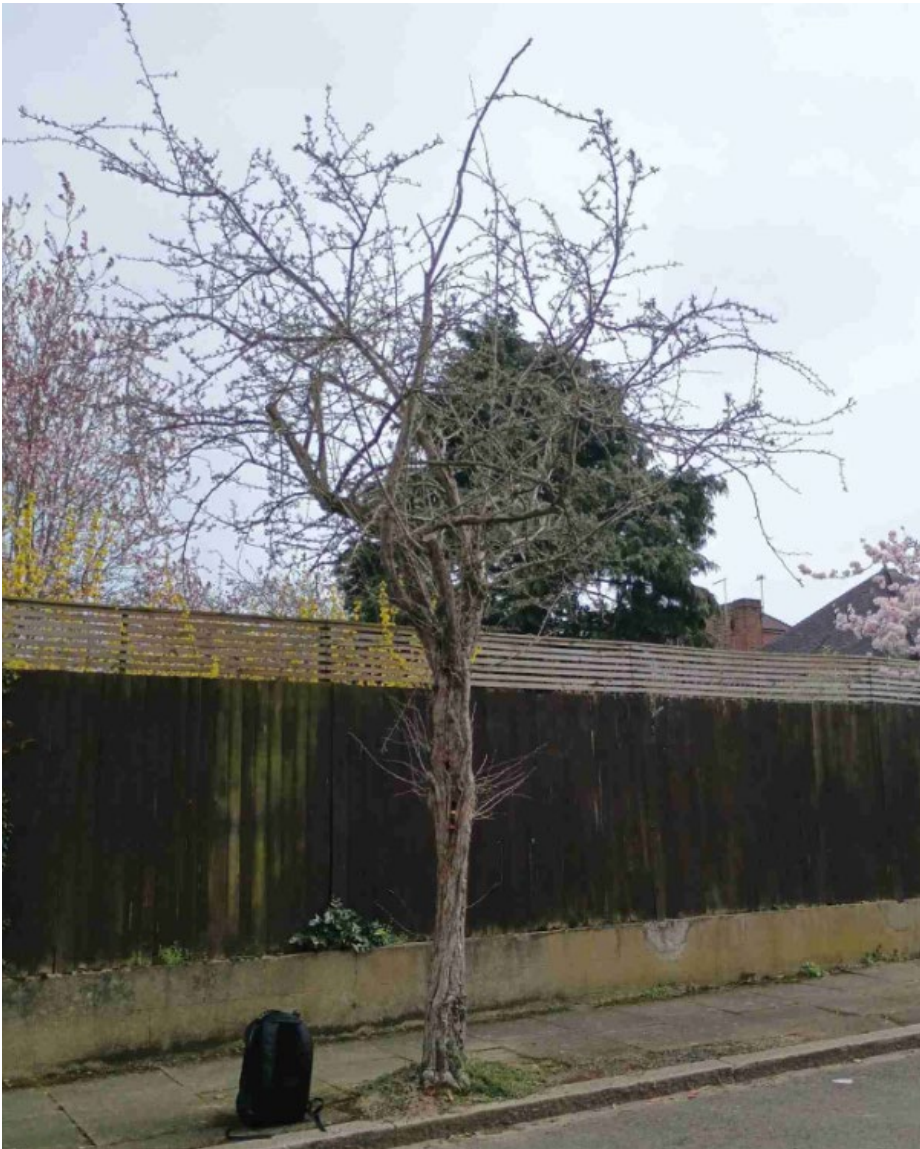
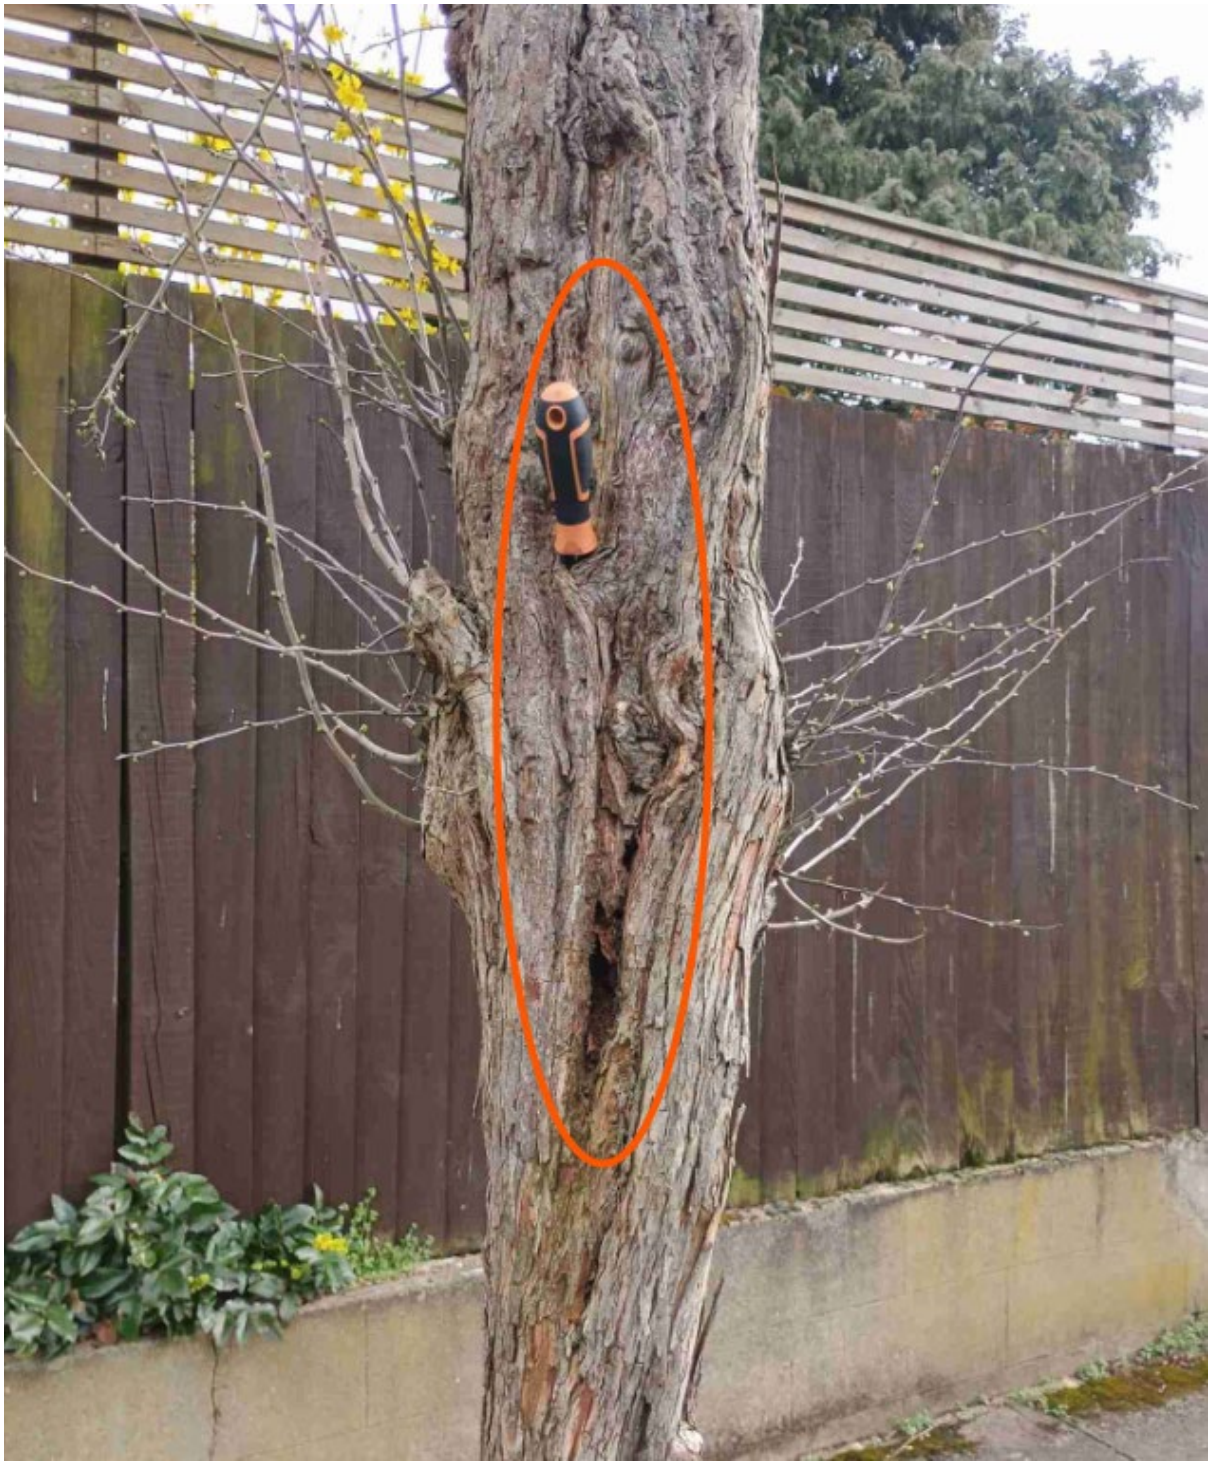
Ward	East Sheen
Road	Stonehill Close
Location	Opposite 1/2
Species	Hawthorn (<i>Crataegus monogyna</i>)
Height	5.0m
Physiological Condition	Fair
Structural Condition	Poor
Inspection findings/reason for exemption	A resonance test with a sounding hammer and a probe revealed an unacceptable degree of decay in the trunk of this tree. Removal is required to prevent natural failure, manage risk, and facilitate replanting

Image shows tree in street scene.

Image shows probe and decay on stem circled.

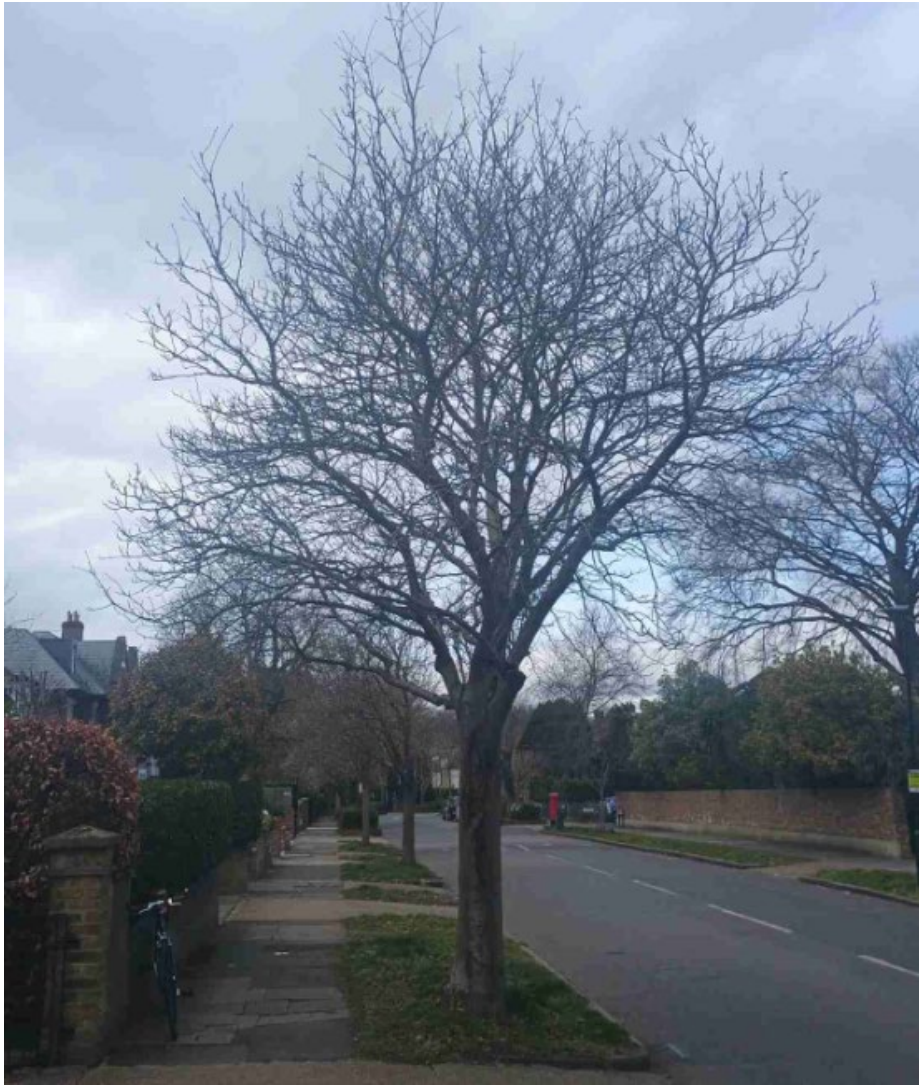
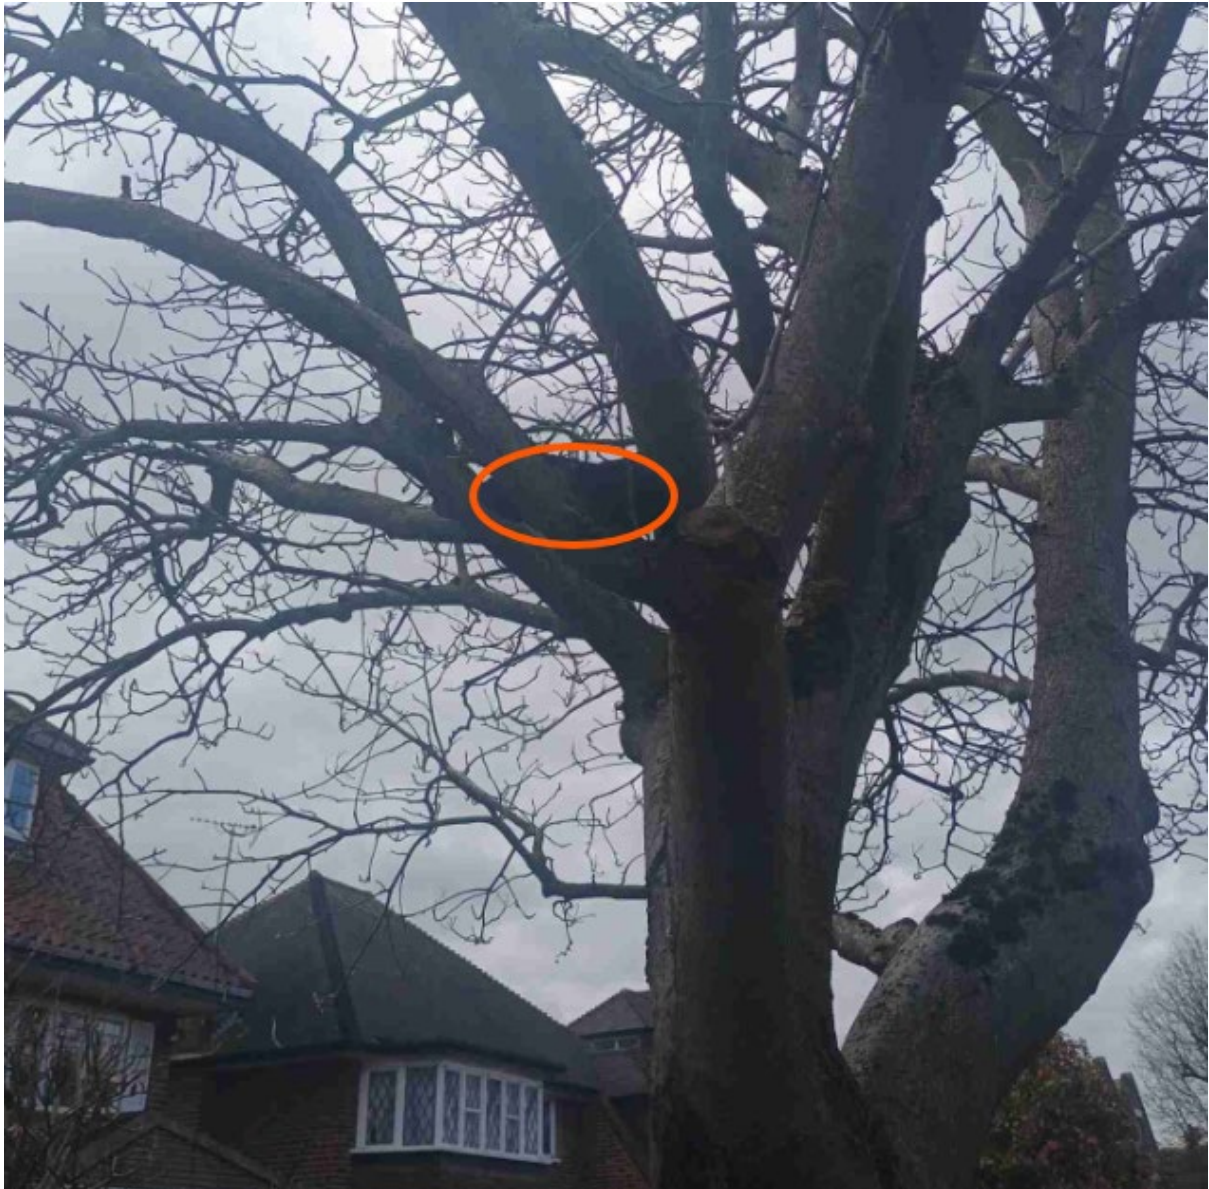
Ward	East Sheen
Road	Christchurch Road
Location	Outside 91/93
Species	Swedish whitebeam (<i>Sorbus x intermedia</i>)
Height	8.0m
Physiological Condition	Poor
Structural Condition	Poor
Inspection findings/reason for exemption	A fungal fruiting body of the species <i>Inonotus hispidus</i> is present in the lower crown. This fungus causes simultaneous white rot, which can lead to the snapping of tree parts. The tree is moribund, correlating with the presence of the pathogen. Removal is required to prevent natural failure, manage risk, and facilitate replanting.

Image shows tree in street scene.

Image shows fungal fruiting bodies circled.

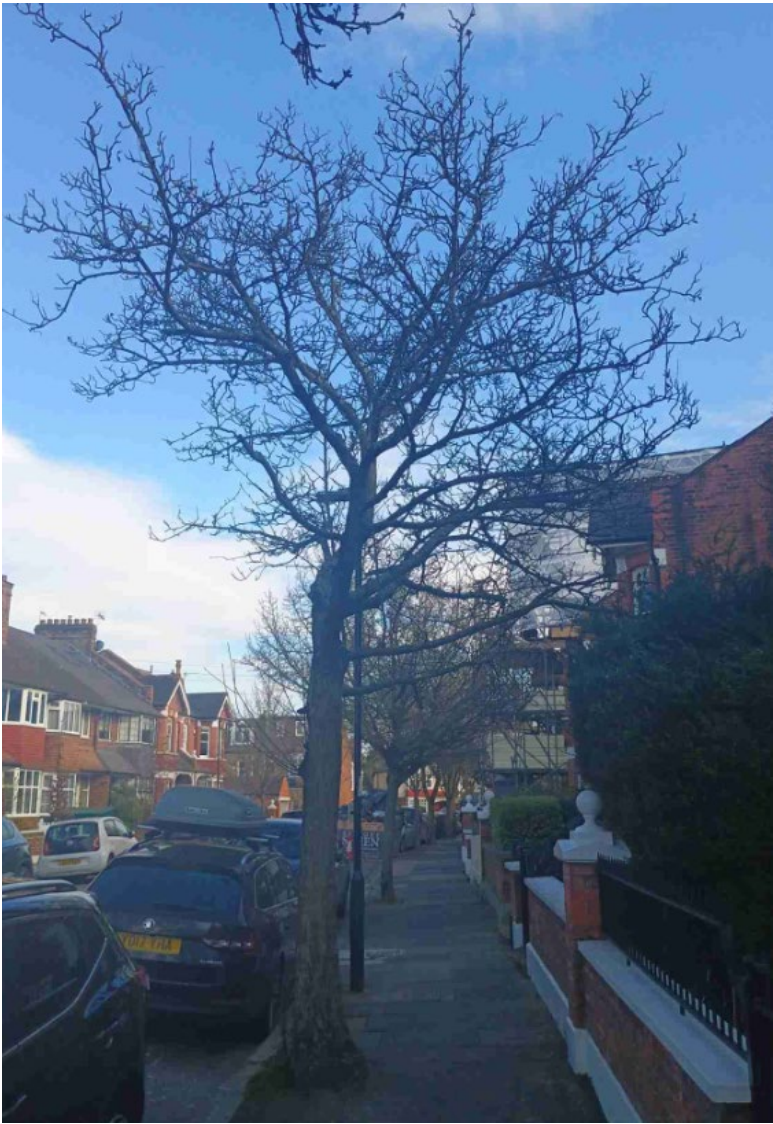
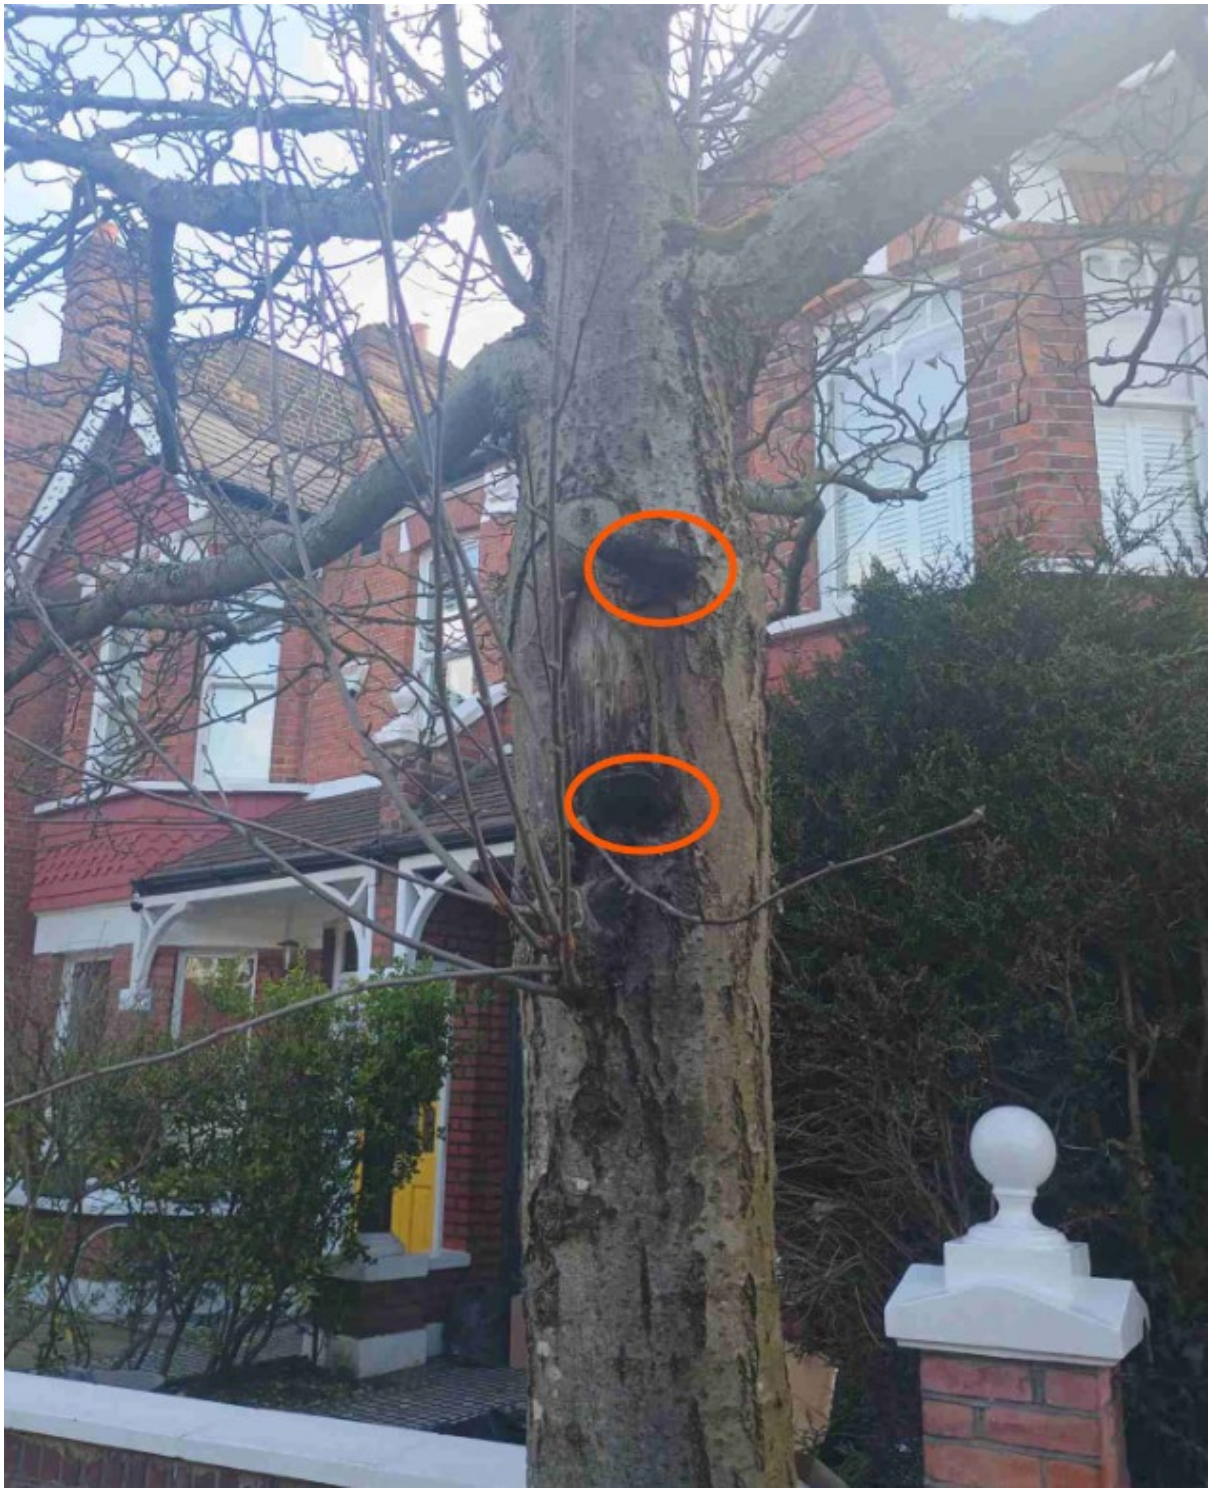
Ward	East Sheen
Road	Palmerston Road
Location	Outside 61/63
Species	Swedish whitebeam (<i>Sorbus x intermedia</i>)
Height	8.0m
Physiological Condition	Fair
Structural Condition	Poor
Inspection findings/reason for exemption	A fungal fruiting body of the species <i>Inonotus hispidus</i> is present in the lower crown. This fungus causes simultaneous white rot, which can lead to the snapping of tree parts. Removal is required to prevent natural failure, manage risk, and facilitate replanting.

Image shows tree in street scene.

Image shows fungal fruiting bodies circled.

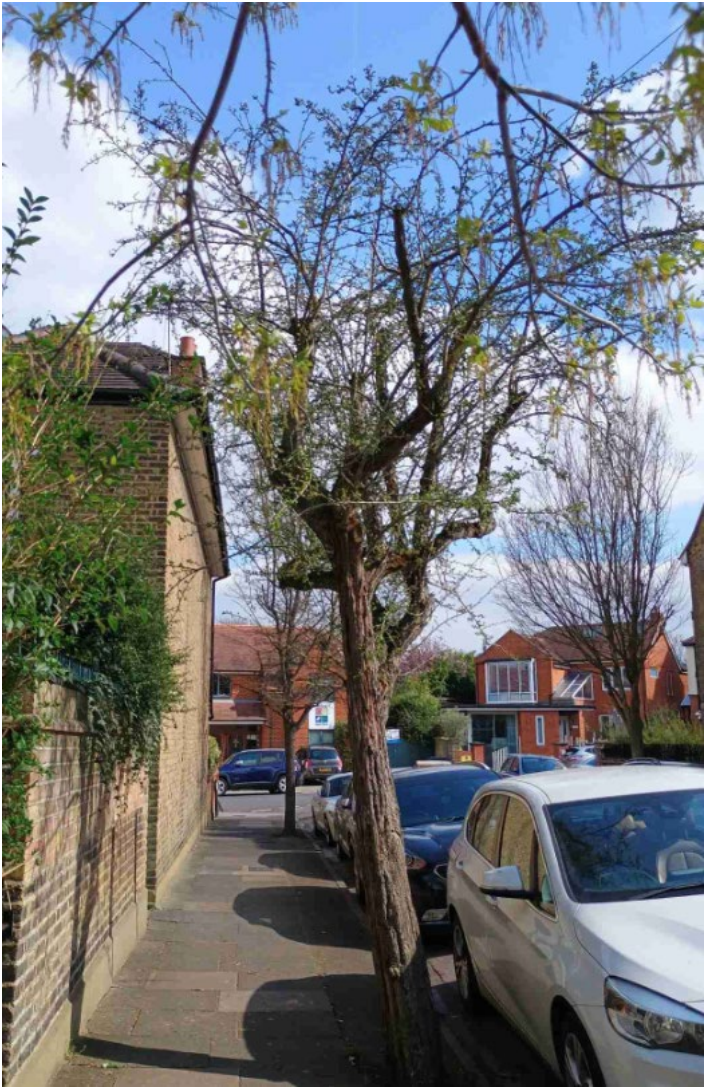
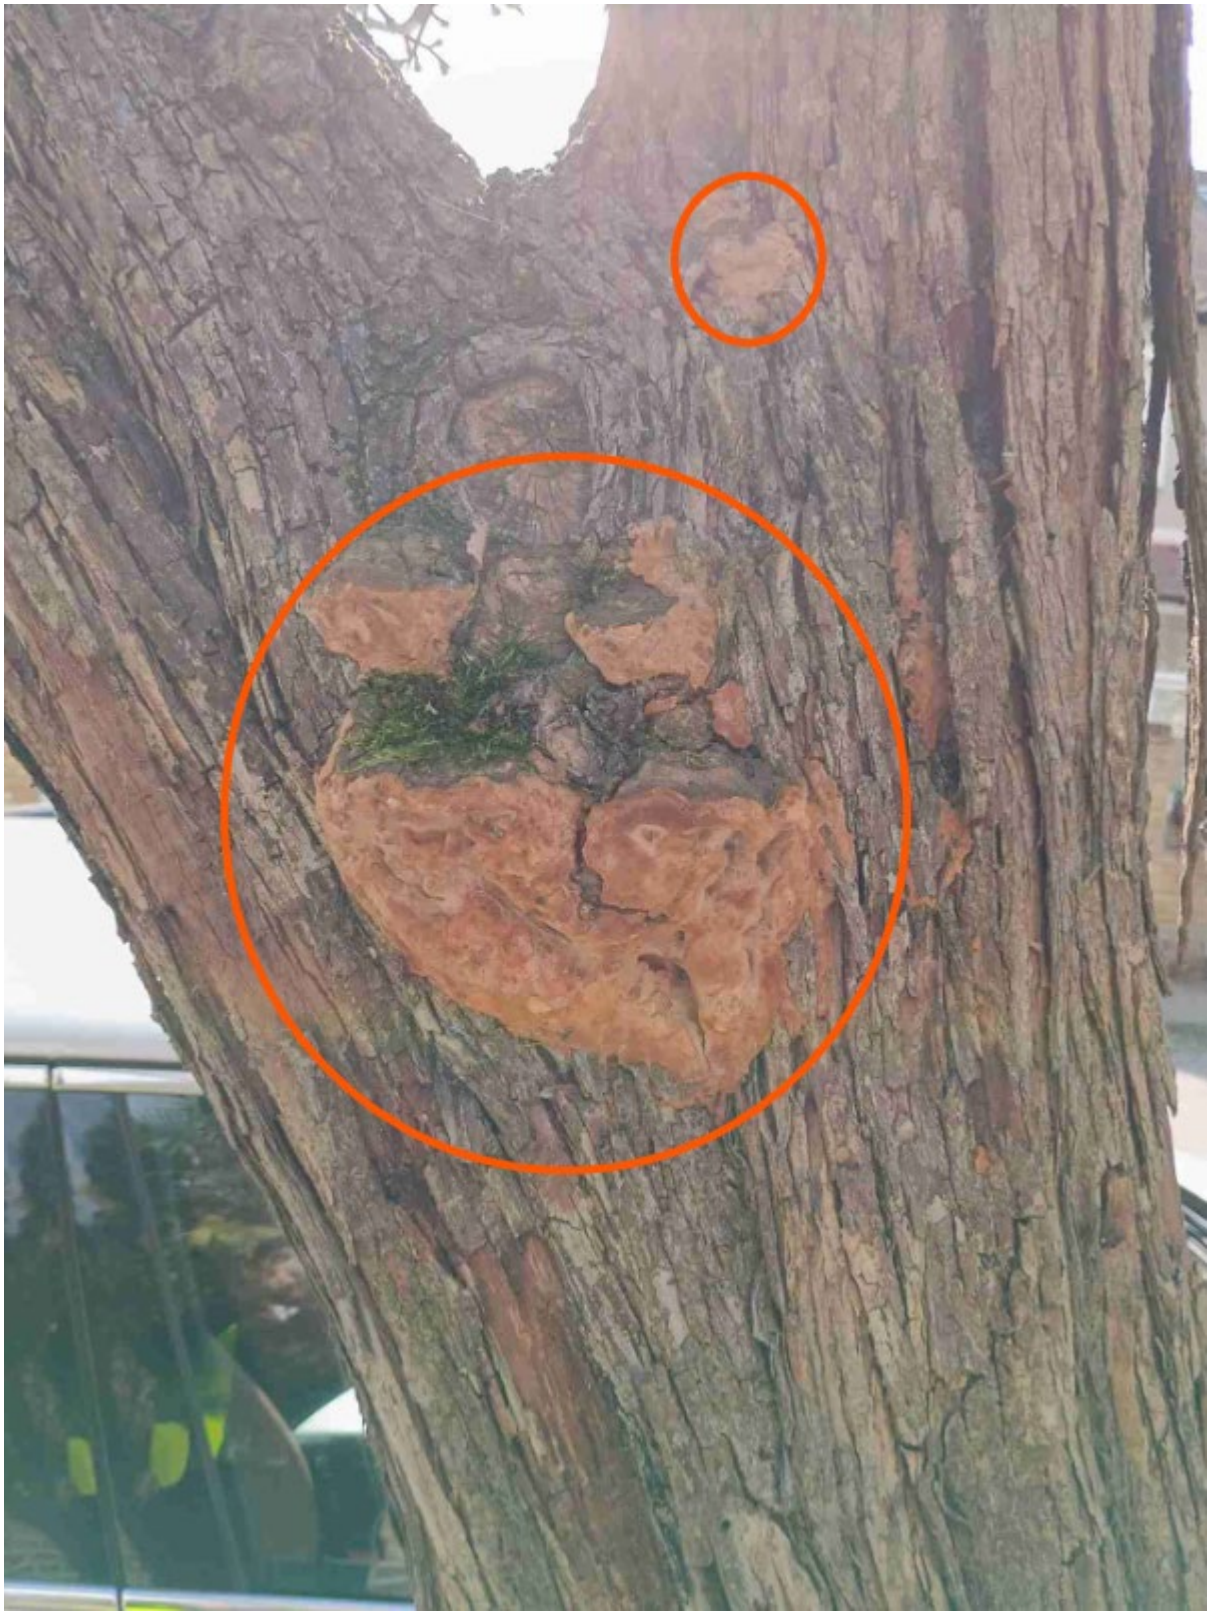
Ward	East Sheen
Road	Medcroft Gardens
Location	Adjacent to 10 Temple Sheen Road rear garden
Species	Hawthorn (<i>Crataegus monogyna</i>)
Height	6.5m
Physiological Condition	Fair
Structural Condition	Poor
Inspection findings/reason for exemption	Fungal fruiting bodies of the decay fungus <i>Phylloporia ribis</i> are present on the trunk of this tree. Colonization by this fungus causes a white rot of the roots and butt, which can lead to structural failure of the tree. Crown dieback correlates with the presence of this parasite. Removal is required to prevent natural failure, manage risk, and facilitate replanting.

Image shows tree in street scene.

Image shows fungal fruiting bodies circled.

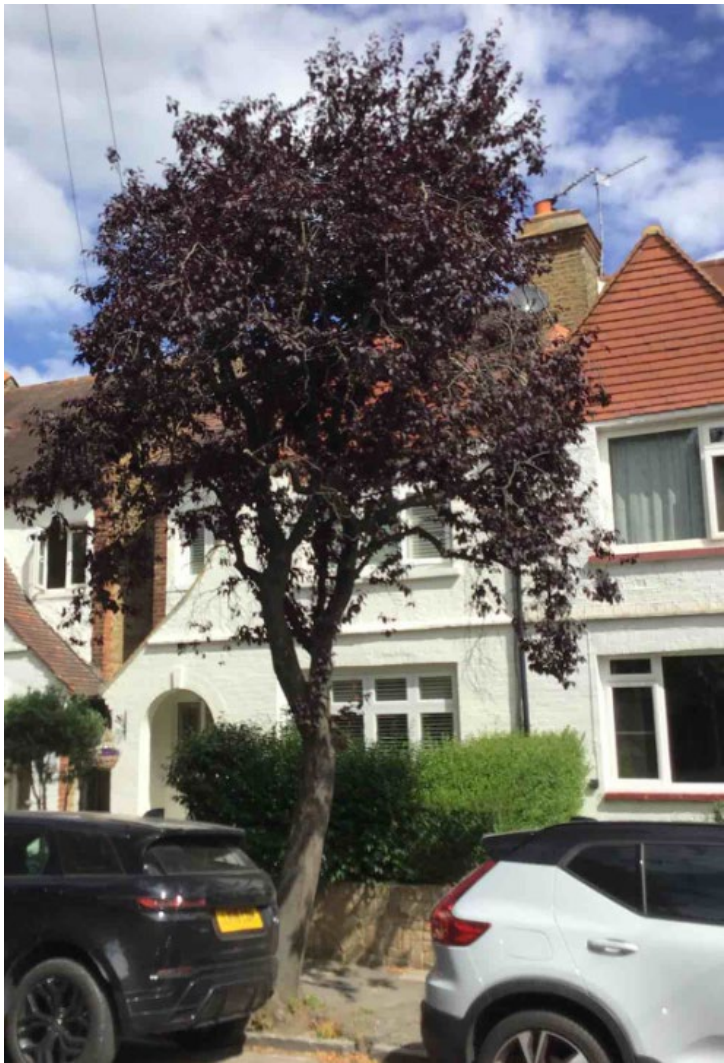
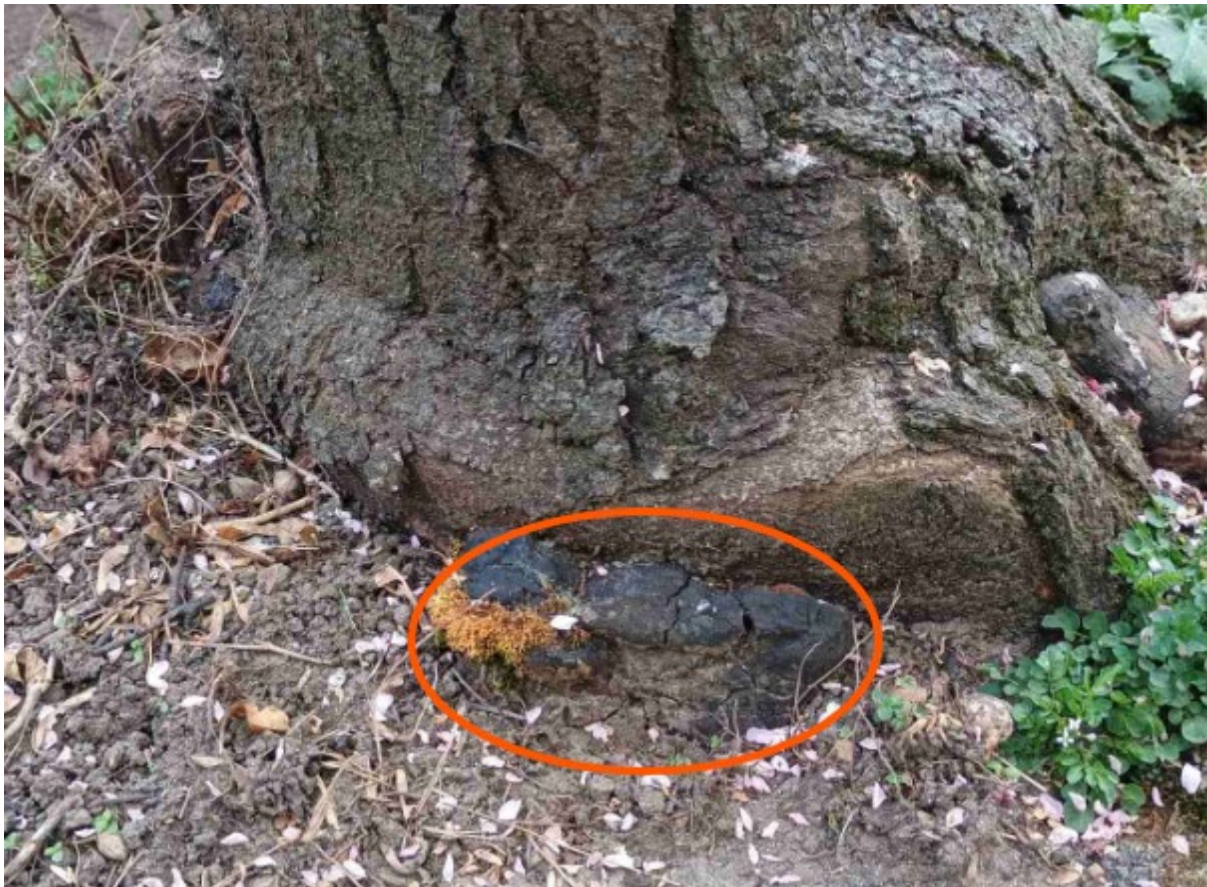
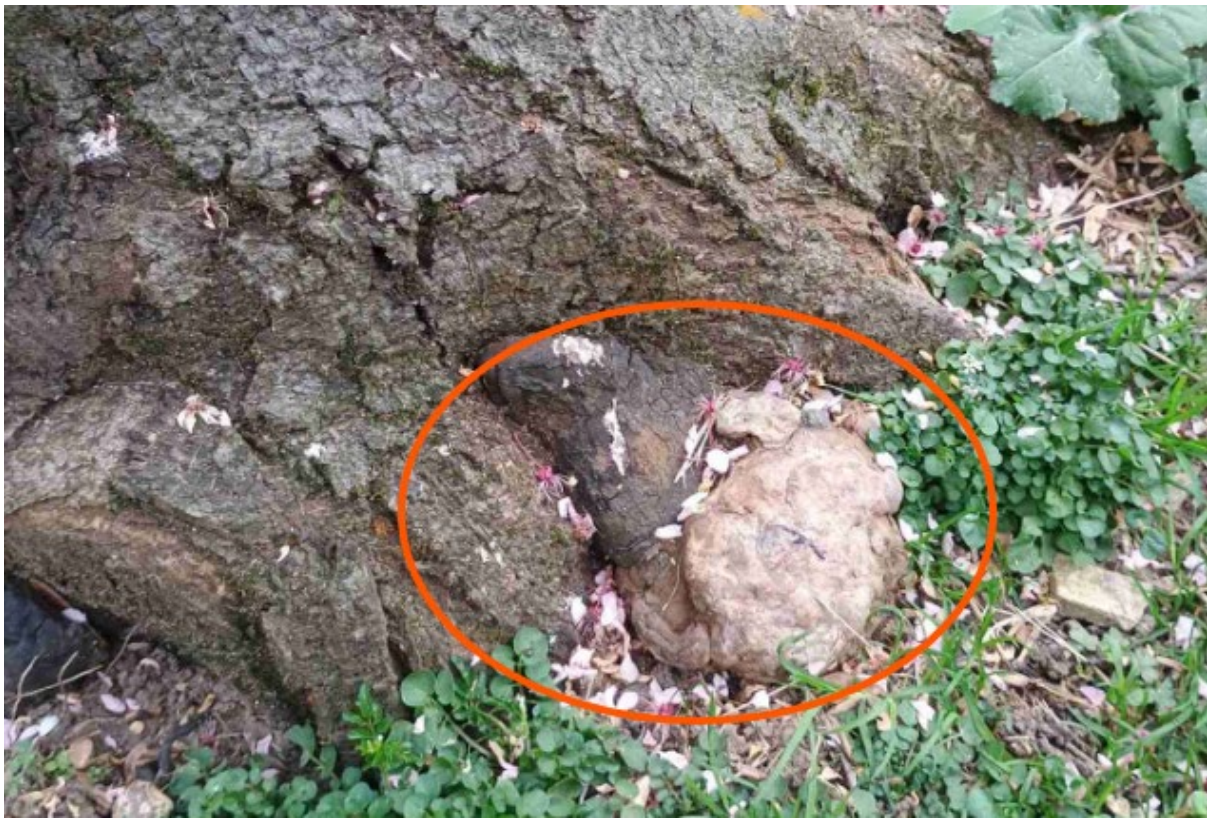
Ward	East Sheen
Road	Medcroft Gardens
Location	Outside 6
Species	Cherry plum (<i>Prunus cerasifera</i>)
Height	9.0m
Physiological Condition	Fair
Structural Condition	Poor
Inspection findings/reason for exemption	A fungal fruiting body of the decay fungi <i>Ganoderma sp.</i> is present at the base of the trunk. Colonisation by this fungus causes a white rot of the stem and root system that can cause entire trees to collapse through fracture or windthrow. A resonance test revealed an unacceptable degree of decay in the trunk of this tree. Removal is required to prevent natural failure, manage risk, and facilitate replanting.

Image shows tree in street scene.

Image shows fungal fruiting body circled.

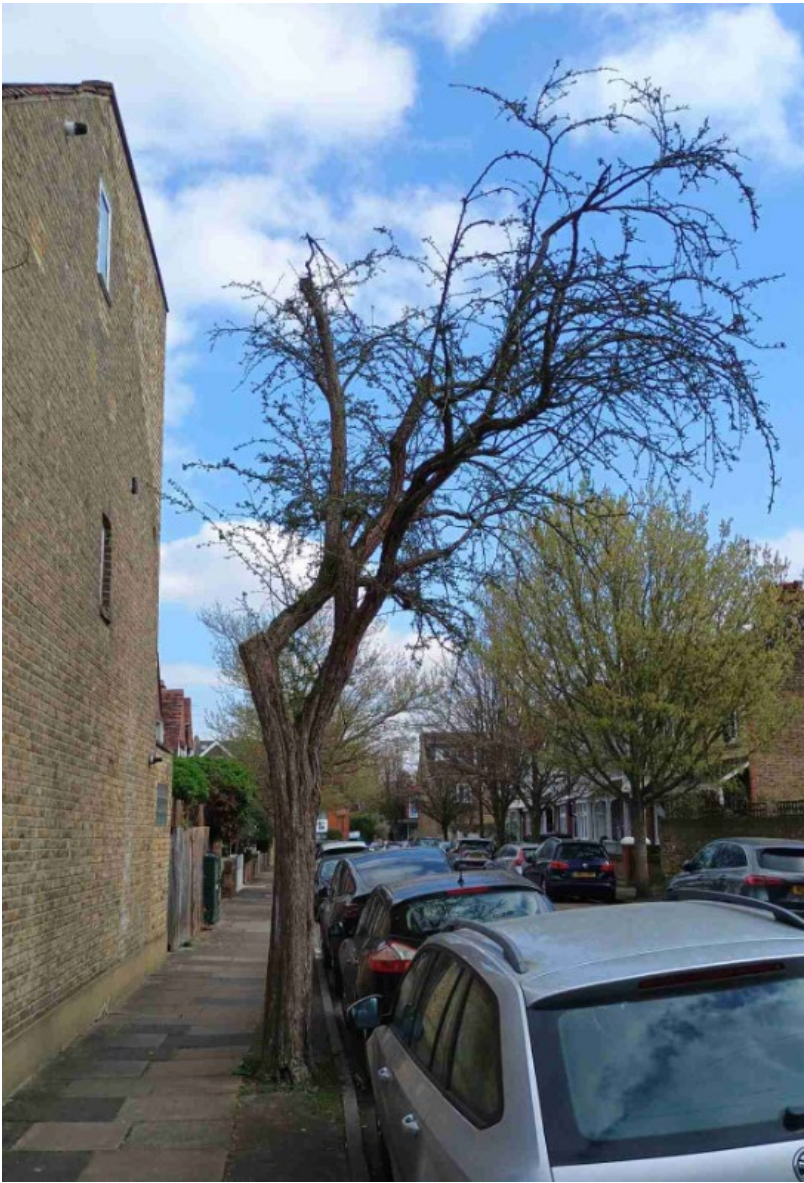
Ward	East Sheen
Road	Medcroft Gardens
Location	Outside 48 Coval Road front edge of building
Species	Hawthorn (<i>Crataegus monogyna</i>)
Height	10.0m
Physiological Condition	Poor
Structural Condition	Fair
Inspection findings/reason for exemption	This tree is moribund; removal is required to prevent natural failure, manage risk, and facilitate replanting.

Image shows moribund tree in street scene.

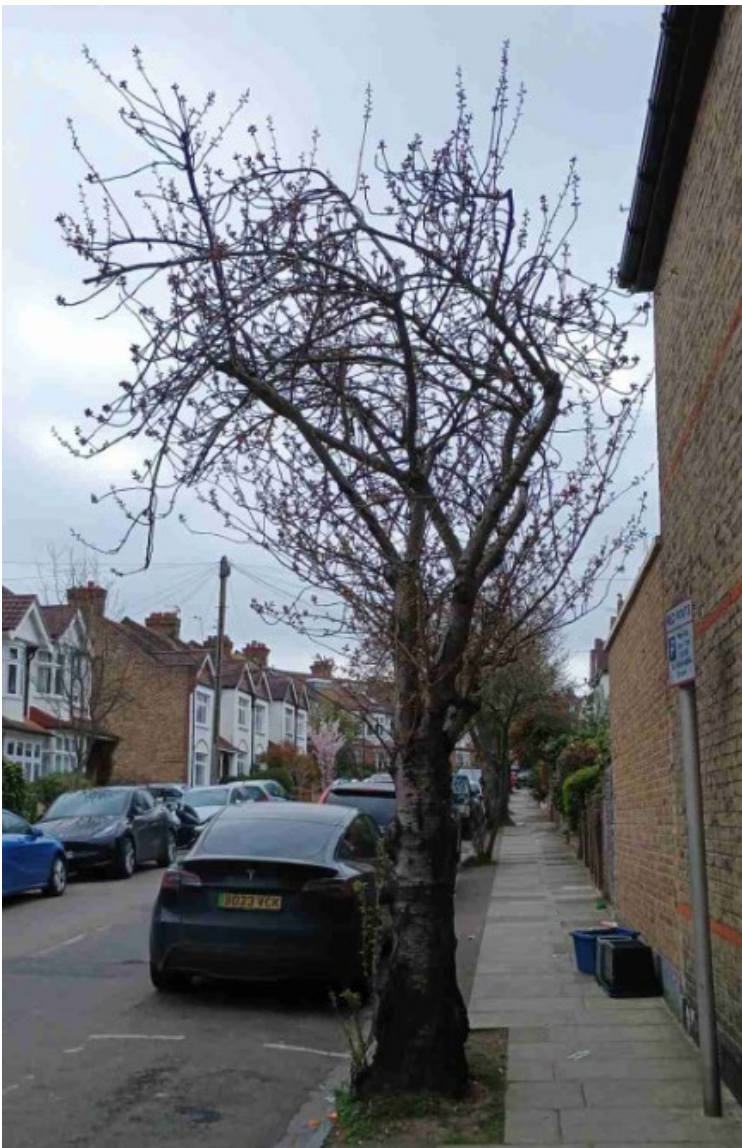
Ward	East Sheen
Road	Coval Road
Location	Outside 499 Upper Richmond Road West
Species	Wild cherry (<i>Prunus avium</i>)
Height	6.0m
Physiological Condition	Fair
Structural Condition	Poor
Inspection findings/reason for exemption	A resonance test with a sounding hammer has revealed an unacceptable amount of decay in the lower trunk of this tree. Removal is required to prevent natural failure, manage risk, and facilitate replanting.

Image shows tree in street scene.
