April 2025 - Reactive Tree Felling Works Programme

Recent reactive inspections have identified the need for 26 individual tree felling work operations to take place. This work will now be issued to the Council’s Arborist Contractor KPS, for completion over the spring and summer period.

Dated 25.04.2025

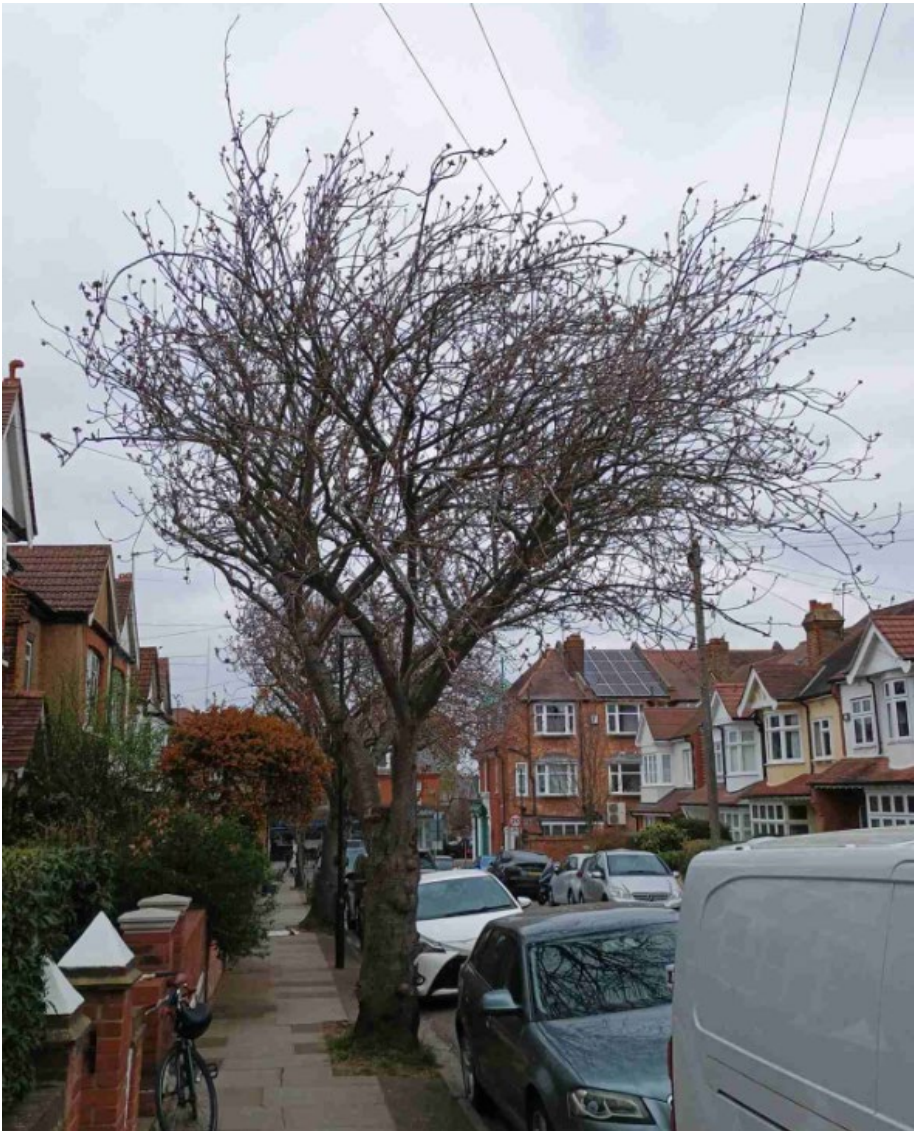
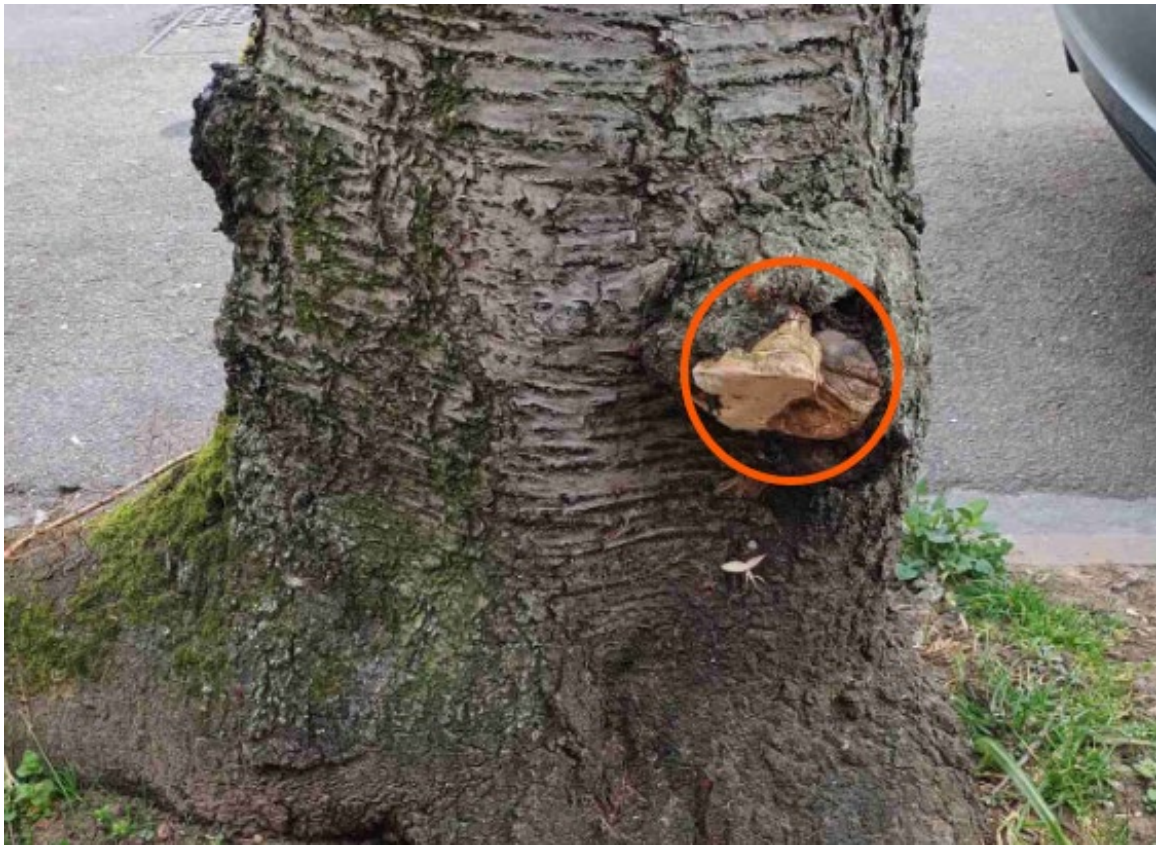
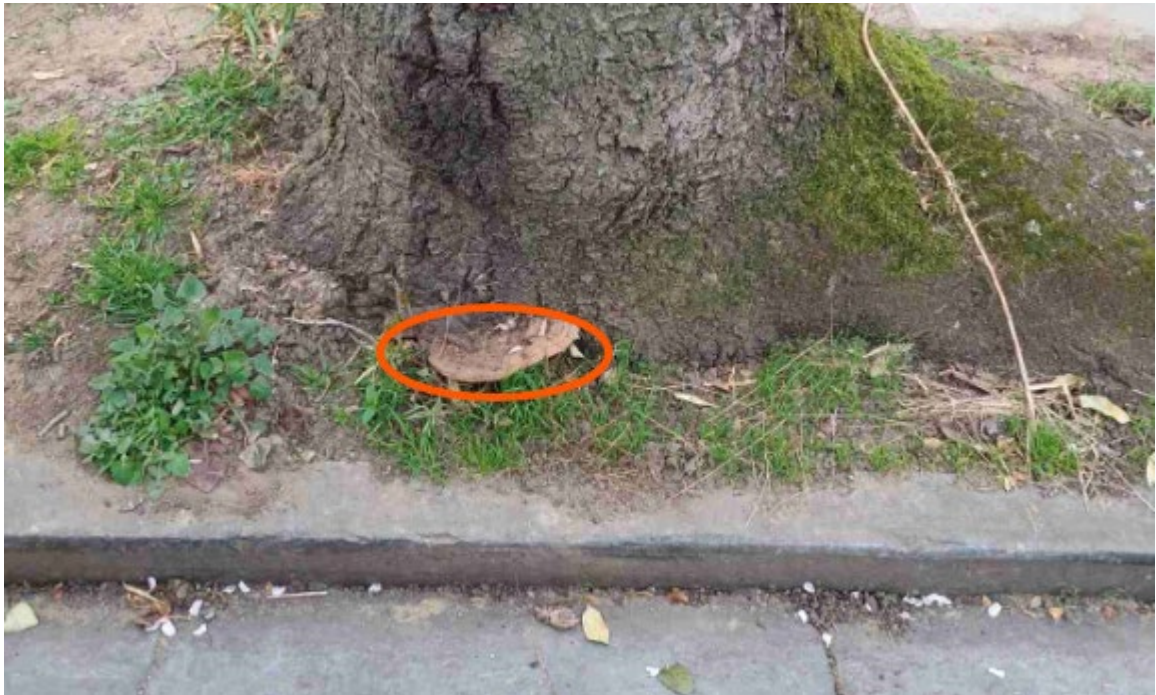
Ward	East Sheen
Road	Coval Road
Location	Outside 51
Species	Wild cherry (<i>Prunus avium</i>)
Height	9.0m
Physiological Condition	Fair
Structural Condition	Poor
Inspection findings/reason for exemption	A fungal fruiting body of the decay fungi <i>Ganoderma sp.</i> is present on the lower trunk. Colonisation by this fungus causes a white rot of the stem and root system that can cause entire trees to collapse through fracture or windthrow. A resonance test revealed an unacceptable degree of decay in the trunk of this tree. Removal is required to prevent natural failure, manage risk, and facilitate replanting.

Image shows tree in street scene.

Image shows fungal fruiting body circled.

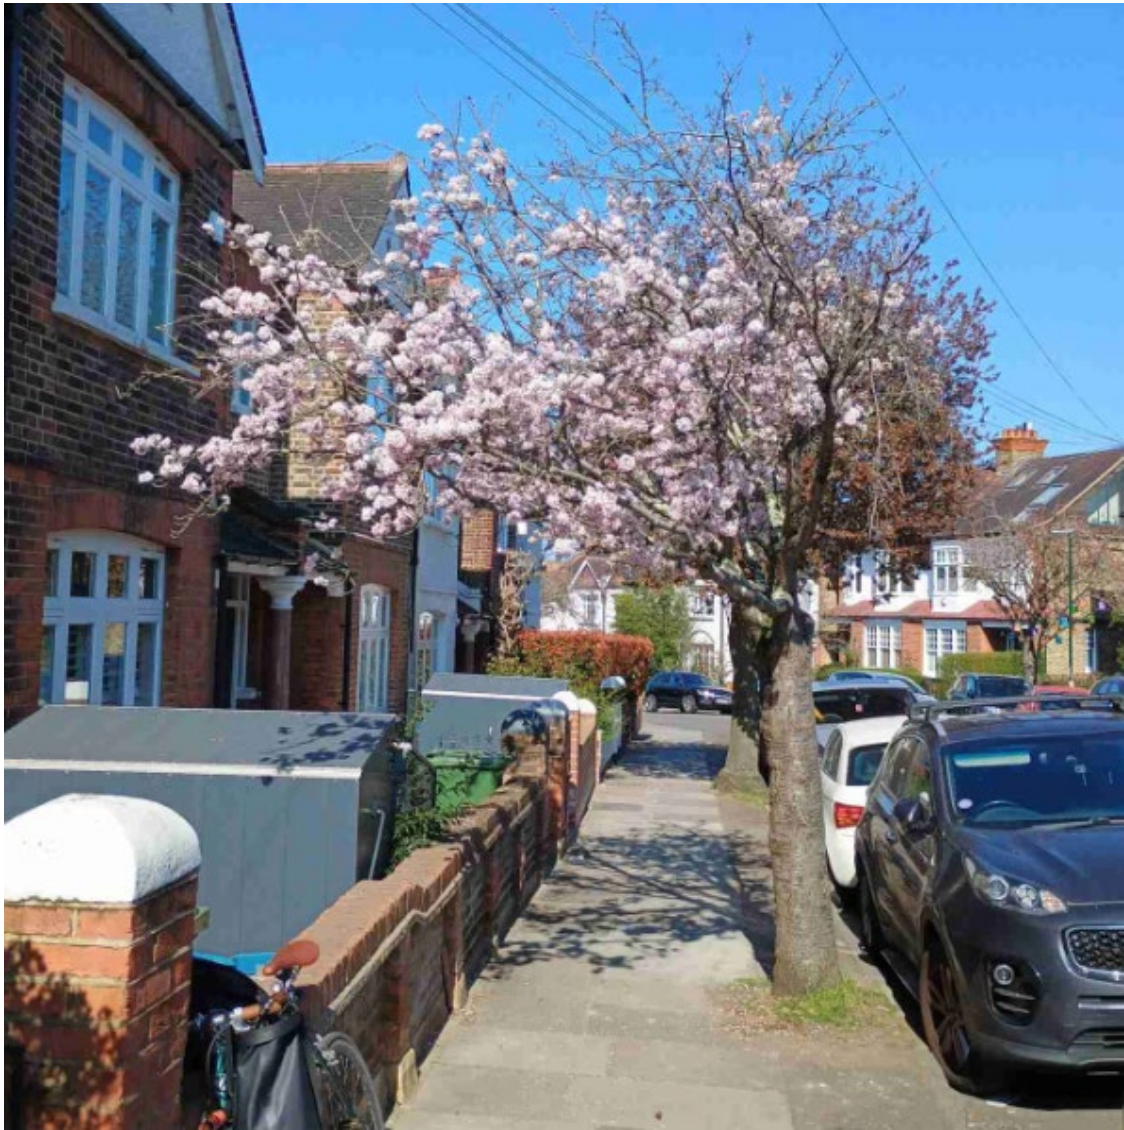
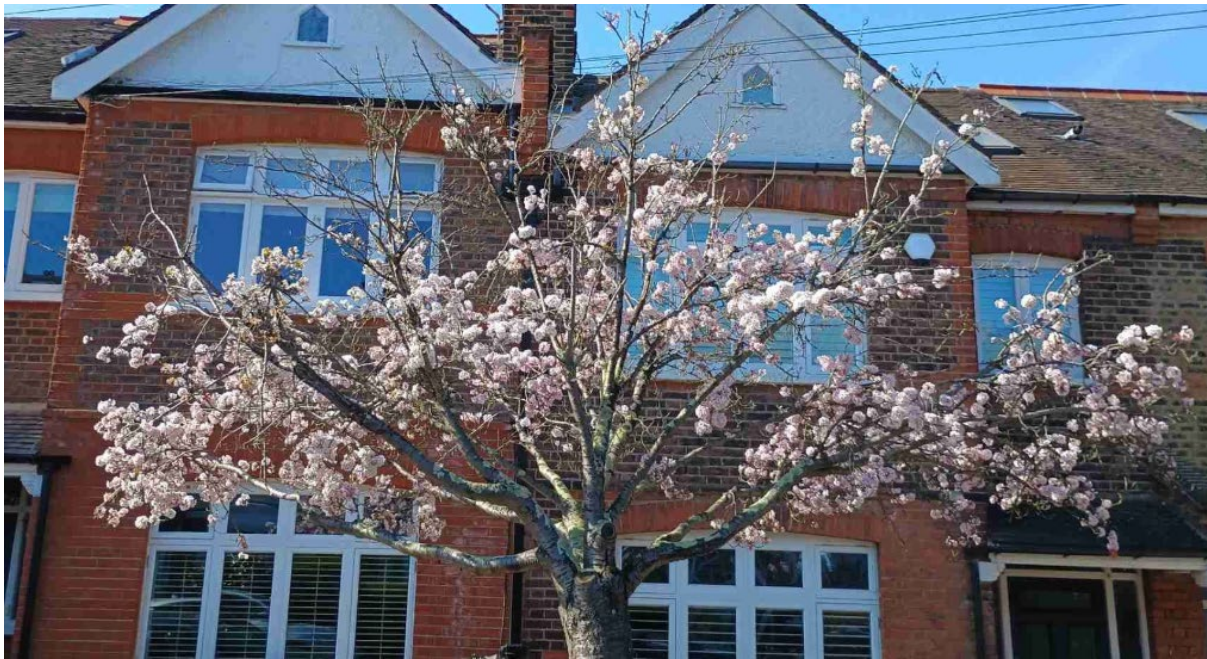
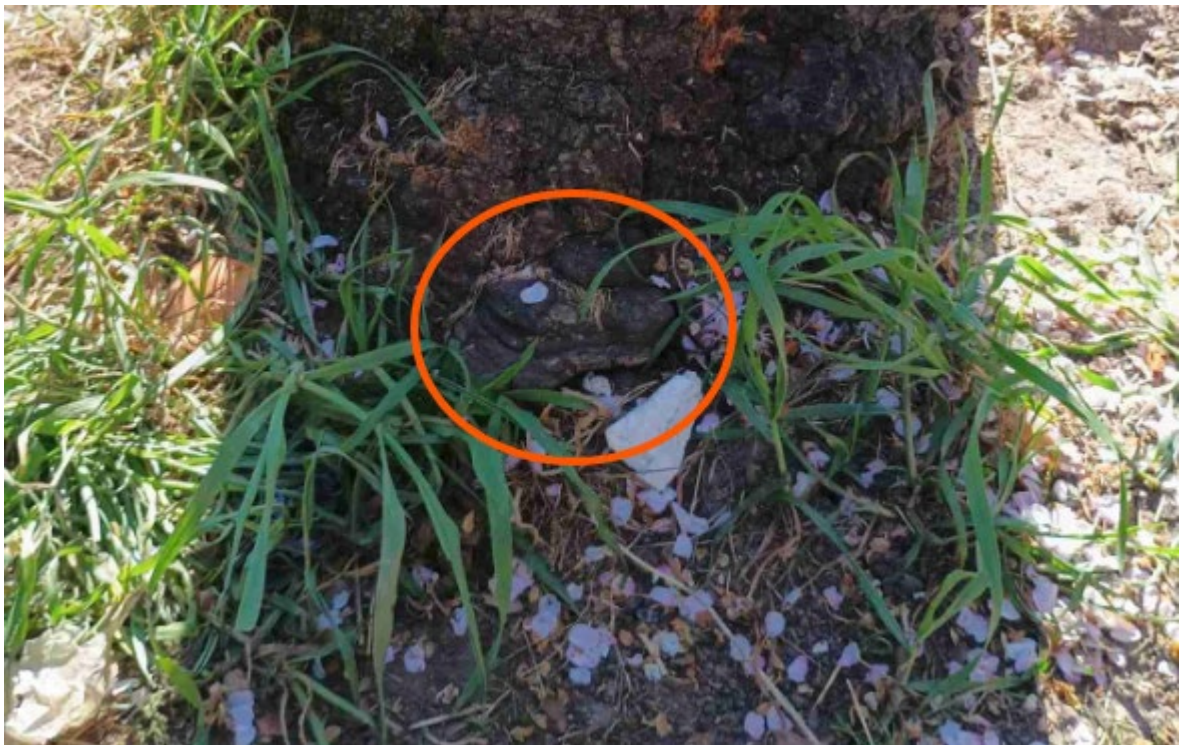
Ward	East Sheen
Road	Coval Road
Location	Outside 27/29
Species	Sargent's cherry (<i>Prunus sargentii</i>)
Height	6.0m
Physiological Condition	Poor
Structural Condition	Poor
Inspection findings/reason for exemption	A fungal fruiting body of the decay fungi <i>Ganoderma sp.</i> is present on the lower trunk. Colonisation by this fungus causes a white rot of the stem and root system that can cause entire trees to collapse through fracture or windthrow. Dieback is visible in the upper crown and a resonance test revealed an unacceptable degree of decay in the trunk of this tree. Removal is required to prevent natural failure, manage risk, and facilitate replanting.

Image shows tree in street scene.

Image shows dieback in upper crown.

Image shows fungal fruiting body circled.

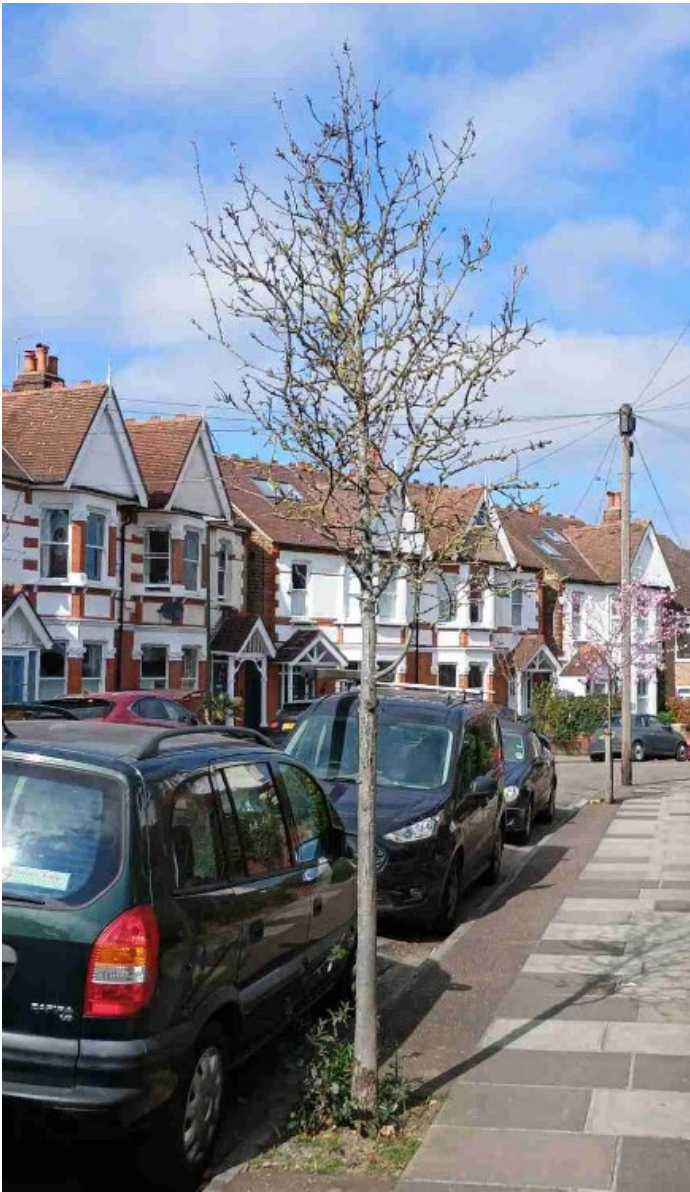
Ward	East Sheen
Road	Coval Road
Location	Outside 4
Species	Apple (<i>Malus sp.</i>)
Height	5.0m
Physiological Condition	Dead
Structural Condition	Dead
Inspection findings/reason for exemption	This tree is Dead; removal is required to prevent natural failure, manage risk, and facilitate replanting.

Image shows dead tree in street scene.

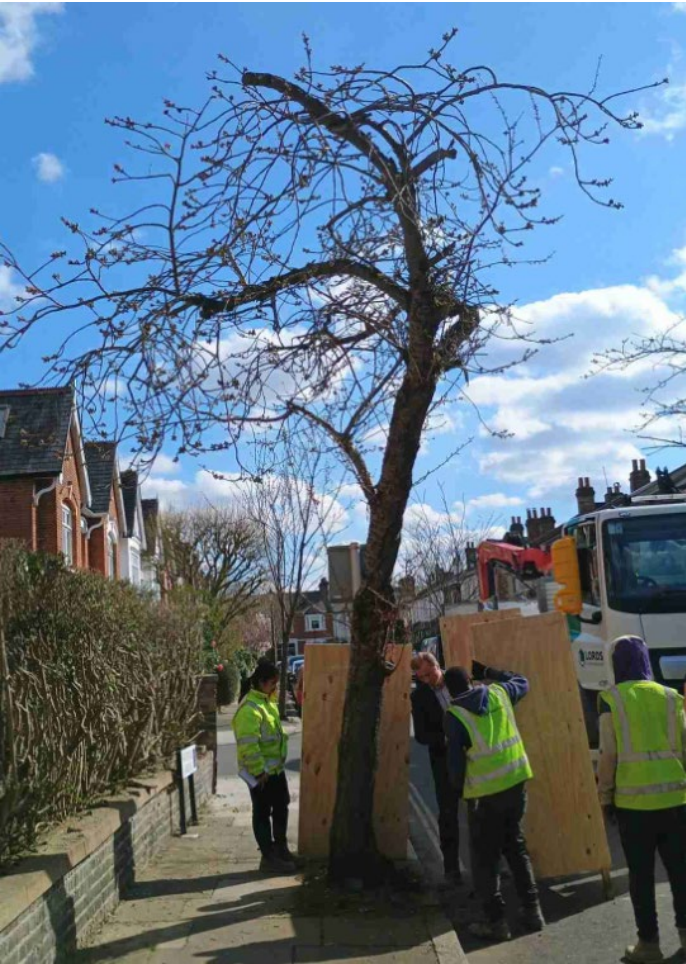
Ward	Kew
Road	Haverfield Gardens
Location	Outside 19/21
Species	Cherry (<i>Prunus sp.</i>)
Height	6.0m
Physiological Condition	Good
Structural Condition	Poor
Inspection findings/reason for exemption	This tree has been struck by a vehicle, sustaining damage in the upper crown. The tree has excessive movement indicating that the root structure has been damaged as a result of the incident. Removal is required to prevent natural failure and facilitate replanting.

Image shows tree in street scene.

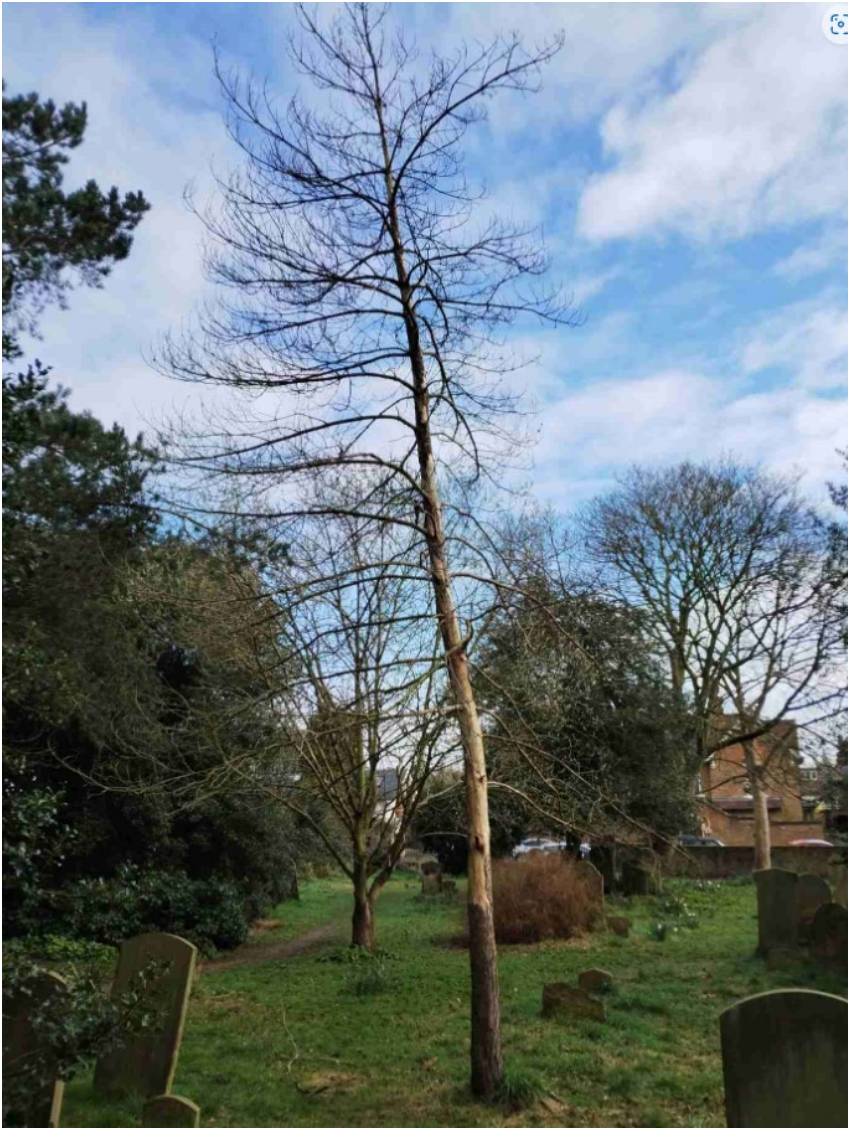
Ward	Twickenham Riverside
Road	Oak lane
Location	Oak Lane Cemetery- ///lease.dices.hooks
Species	Pine (<i>Pinus</i> sp.)
Height	10.0m
Physiological Condition	Dead
Structural Condition	Dead
Inspection findings/reason for exemption	This tree is dead; removal is required to prevent natural failure, manage risk, and facilitate replanting

Image shows dead tree in cemetery scene.
