February 2024 - Reactive Tree Works Programme

Dated 22.02.2024.

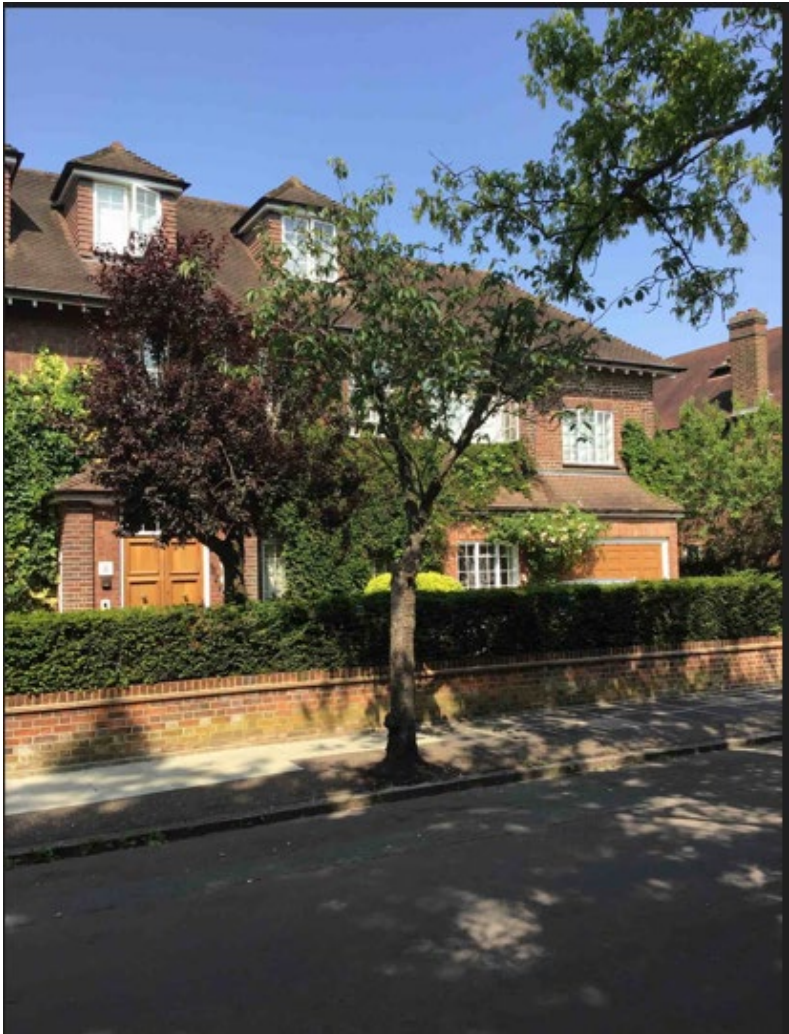
Ward	East Sheen
Road	Park Gate Gardens
Location	Outside 45 front doors.
Species	Cherry (<i>Prunus sp.</i>)
Height	5.5m
Physiological Condition	Poor
Structural Condition	Poor
Inspection findings	A fungal fruiting body of the decay pathogen <i>Ganoderma</i> sp. is present at the stem base. Colonisation by this fungus causes a white rot of the stem and root system that can cause entire trees to collapse through fracture or windthrow. A resonance test revealed an unacceptable degree of decay in the trunk of this tree, removal is required to prevent natural failure and facilitate replanting.

Image shows tree in street scene.

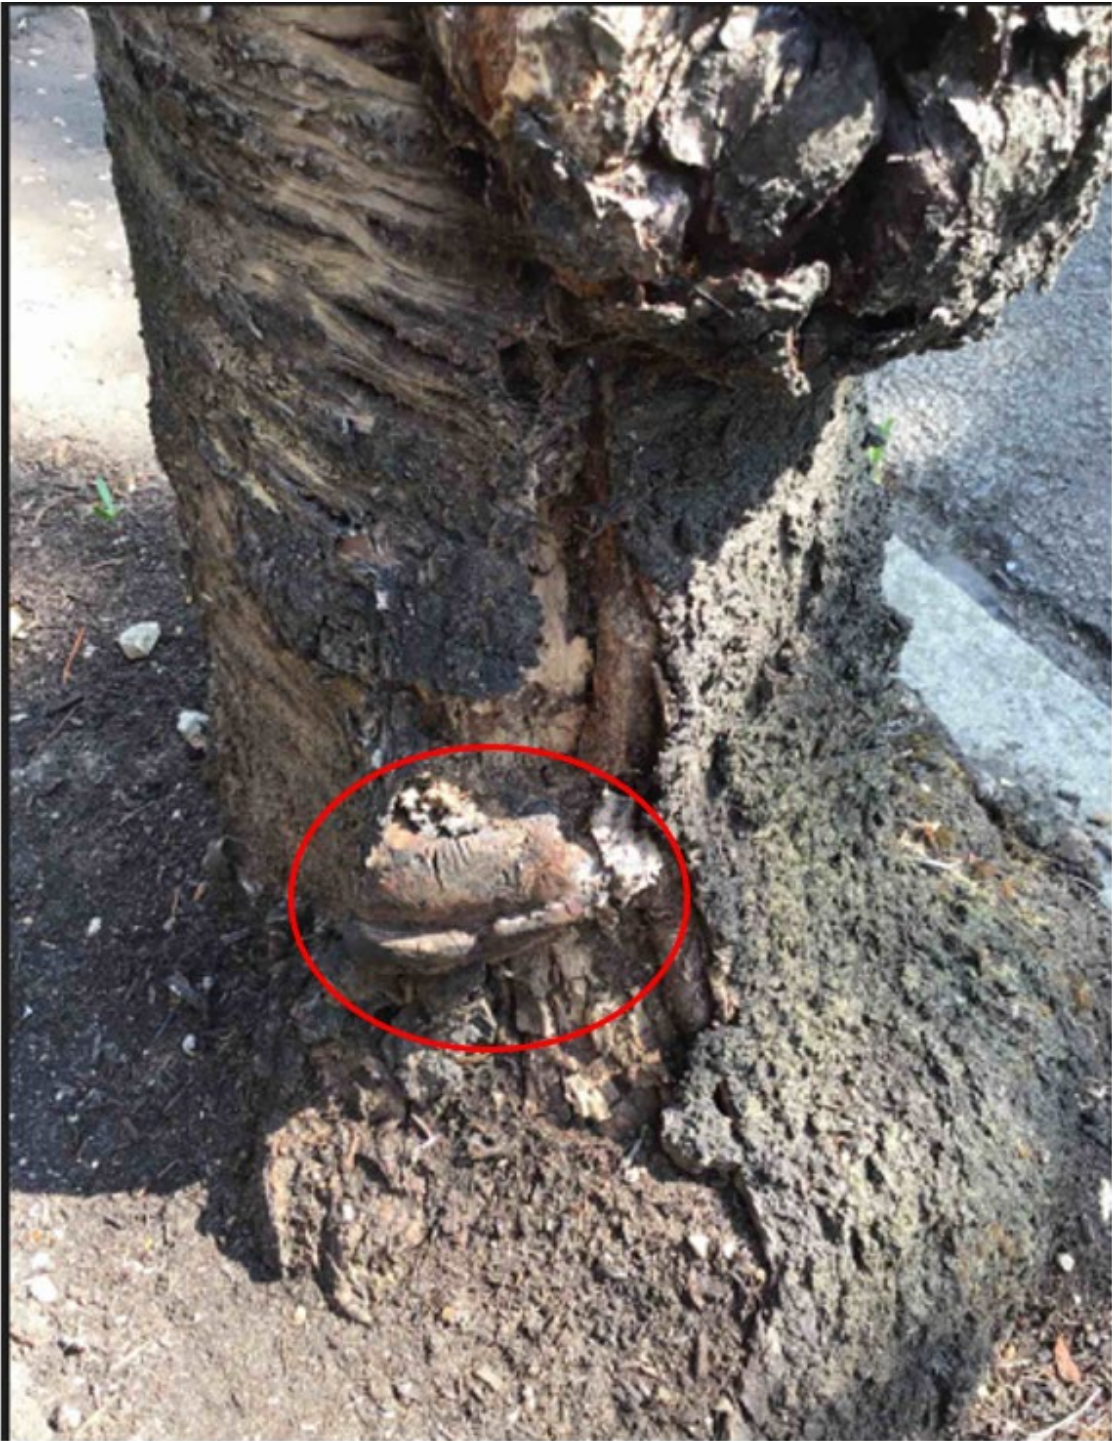
Image shows fruiting body on lower stem circled.

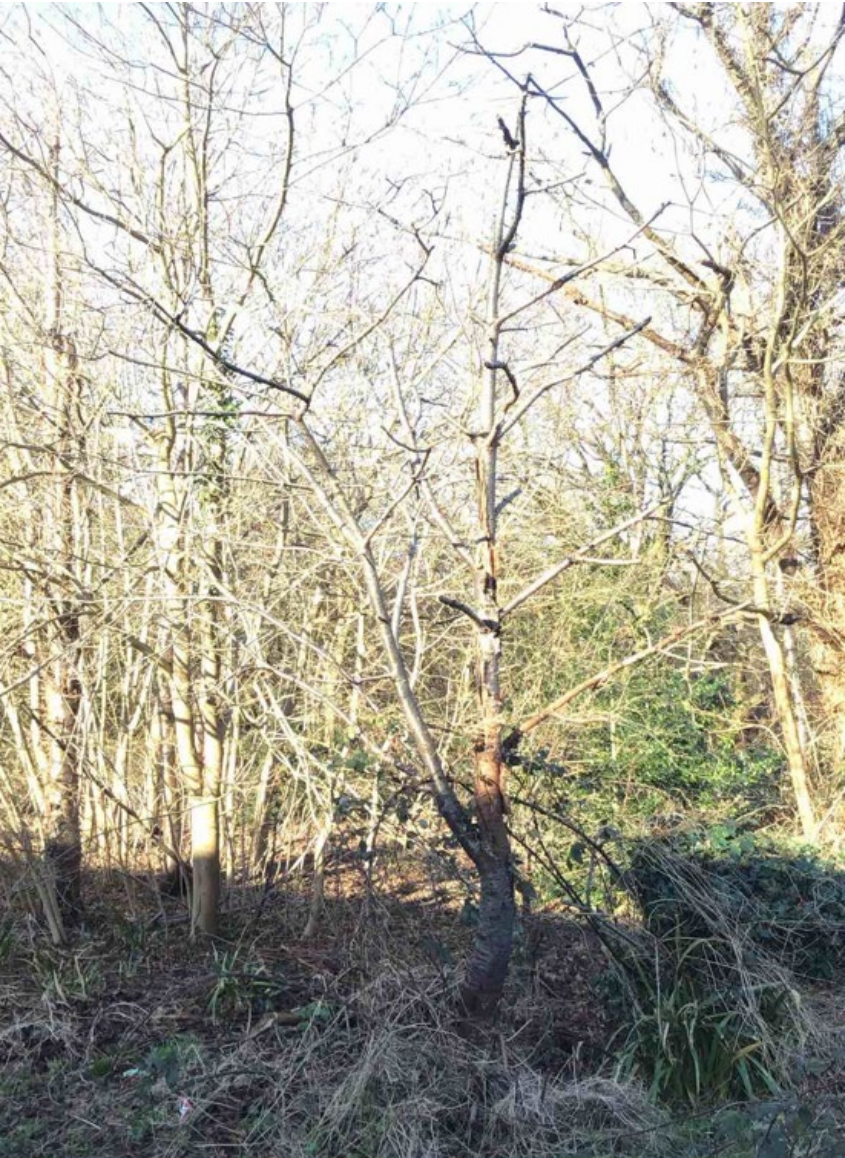
Ward	Ham, Petersham and Richmond Riverside
Road	Sandy Lane
Location	The Copse- ///logs.resort.fear
Species	Wild Cherry (<i>Prunus avium</i>)
Height	6.0m
Physiological Condition	Dead
Structural Condition	Dead
Inspection findings	This tree is dead; removal is required to prevent natural failure and manage risk.

Image shows dead tree in park scene

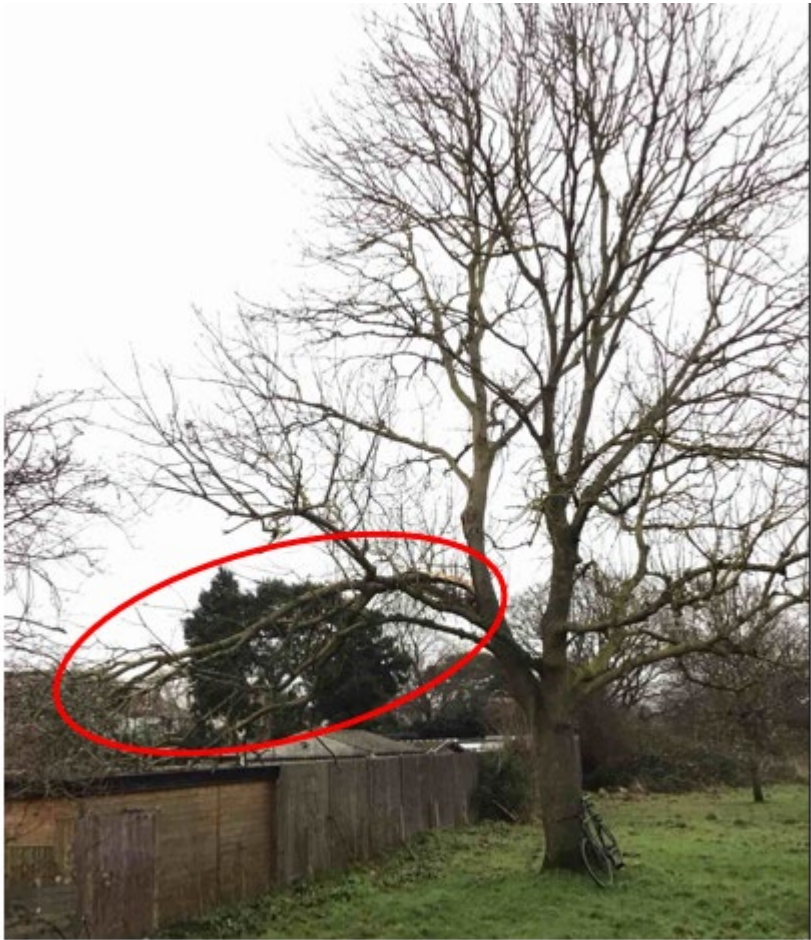
Ward	Hampton
Road	Broad Lane
Location	Hatherop Park- ///sits.lifted.relate
Species	Common Ash (<i>Prunus sp.</i>)
Height	14.5m
Physiological Condition	Poor
Structural Condition	Poor
Inspection findings	A fungal fruiting body of the species Shaggy Polypore (<i>Inonotus hispidus</i>) is present on the main stems in the crown of the tree, this fungus causes a simultaneous white rot which can cause snapping of tree parts in this particular species. A main stem on this tree has failed in the recent storms, and with multiple brackets spread throughout the remaining crown, removal is required to prevent further natural failure and manage risk.

Images show tree in park scene with failed limb circled.

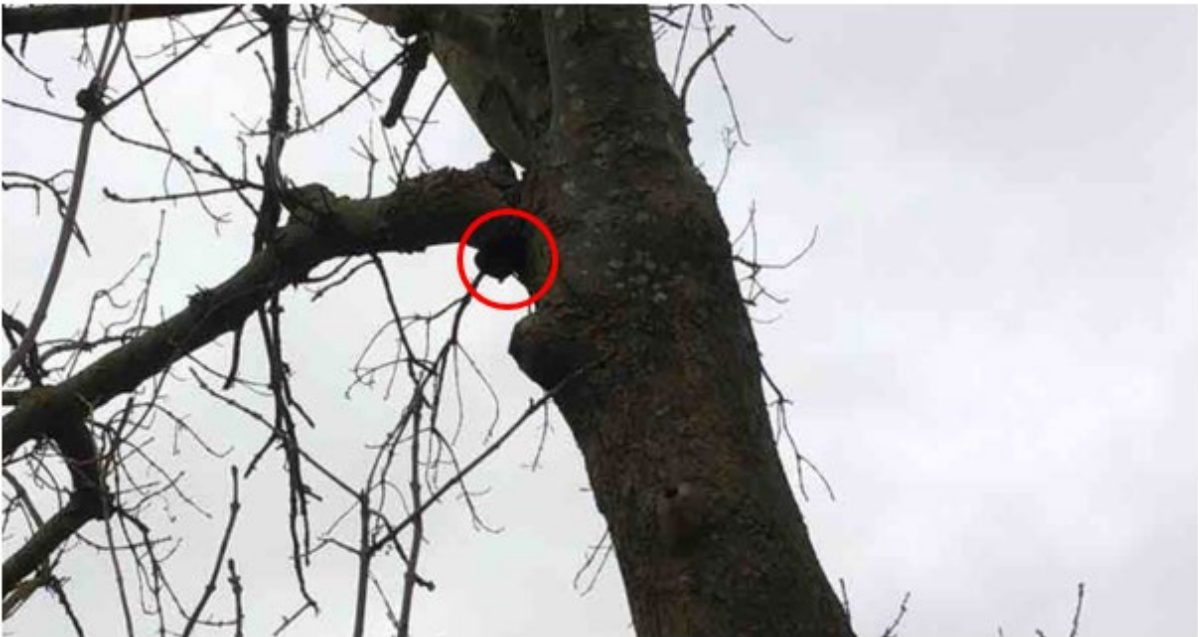
Images shows tree with fruiting body circled on main stem.

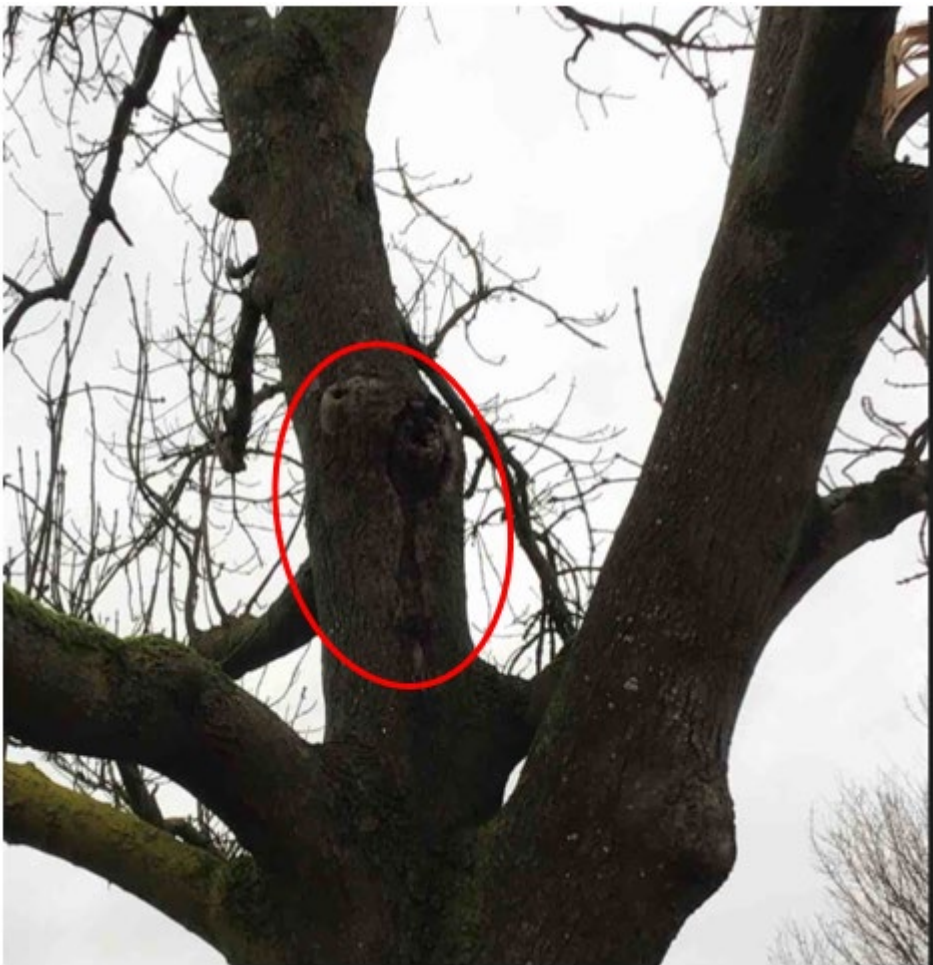
Images shows main stem with cavities with decay and with fruiting body circled.

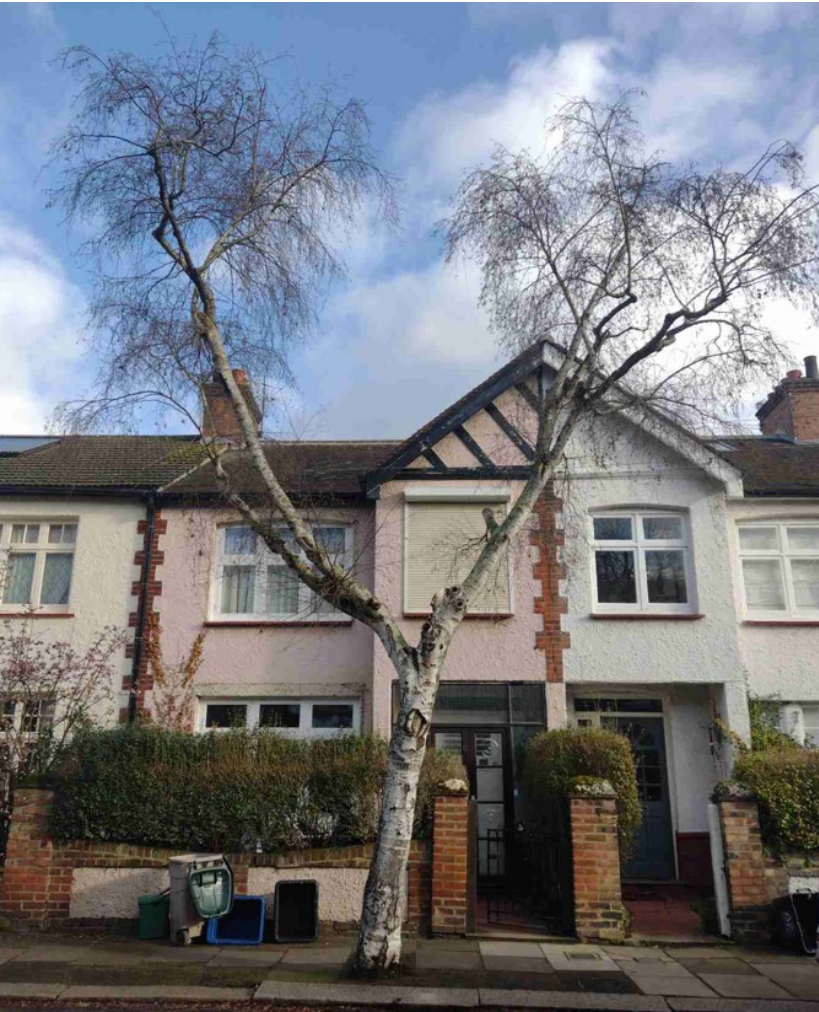
Ward	Kew
Road	Defoe Avenue
Location	Outside 6
Species	Silver Birch (<i>Betula pendula</i>)
Height	8.5m
Physiological Condition	Poor
Structural Condition	Poor
Inspection findings	Presence of Birch Polypore indicates the tree is under physiological stress and in decline. The decay caused from these fungi has caused a decay column to establish around the crown break. A resonance test has revealed areas of an unacceptable amount of decay beyond the visible cavities. Removal is required to prevent natural failure and facilitate replanting.

Image shows tree in street scene

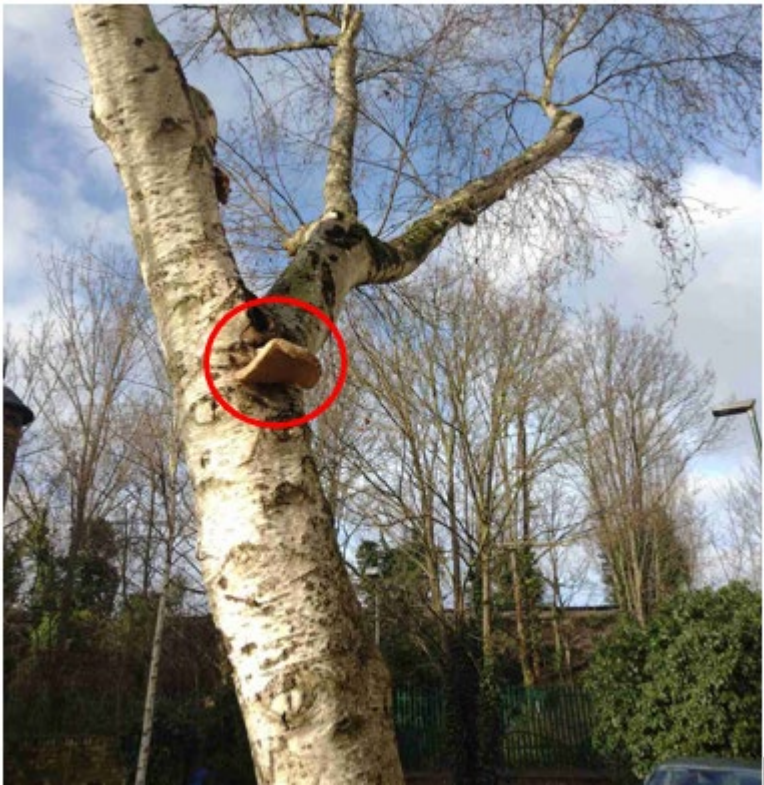
Image shows fruiting body on stem circled.

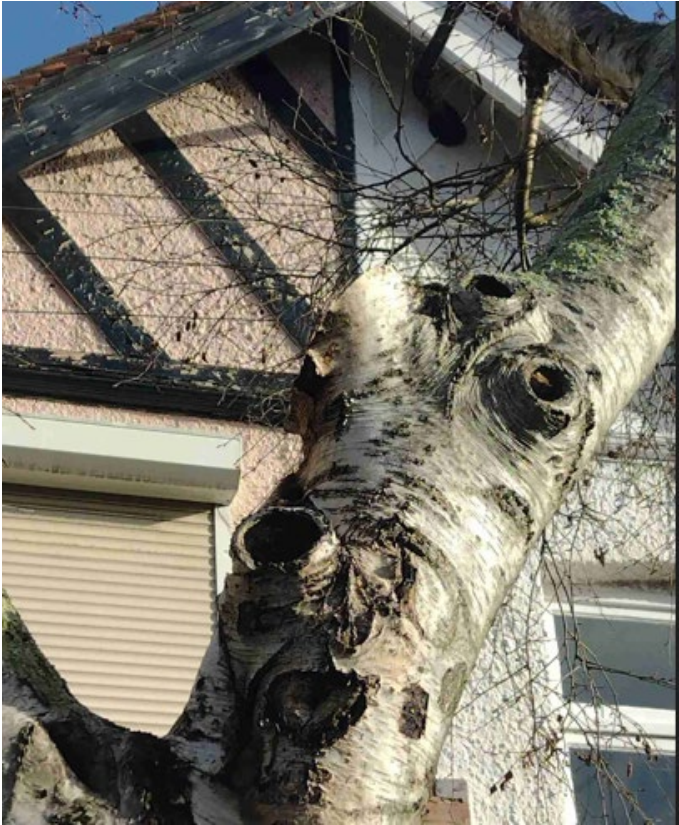
Image shows cavities on stem.

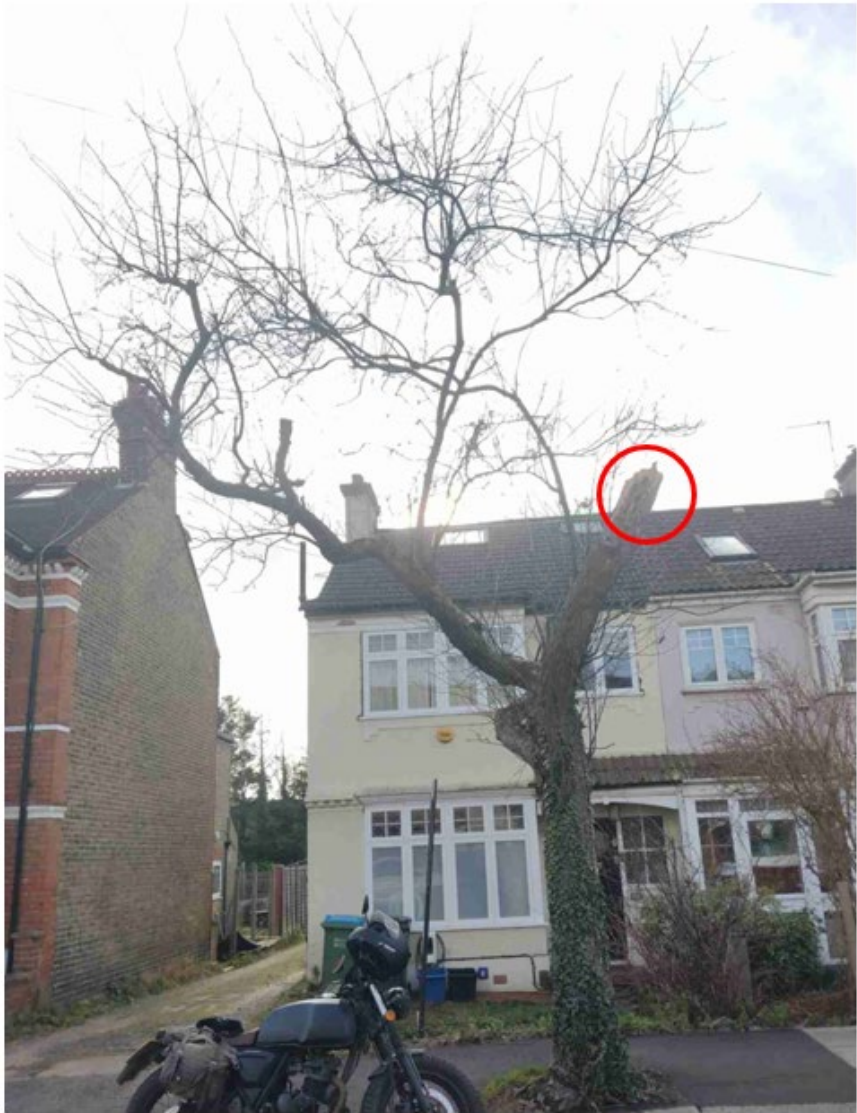
Ward	Mortlake and Barnes Common
Road	Kingsway
Location	Outside 129
Species	Apple (<i>malus sp.</i>)
Height	11.0m
Physiological Condition	Poor
Structural Condition	Poor
Inspection findings	This tree has had major stem failure in recent storms with cavities present on the remaining stem with an unacceptable amount of decay. Removal is required to prevent further natural failure, manage risk, and facilitate replanting

Image shows tree in street scene with wound from failed stem circled.

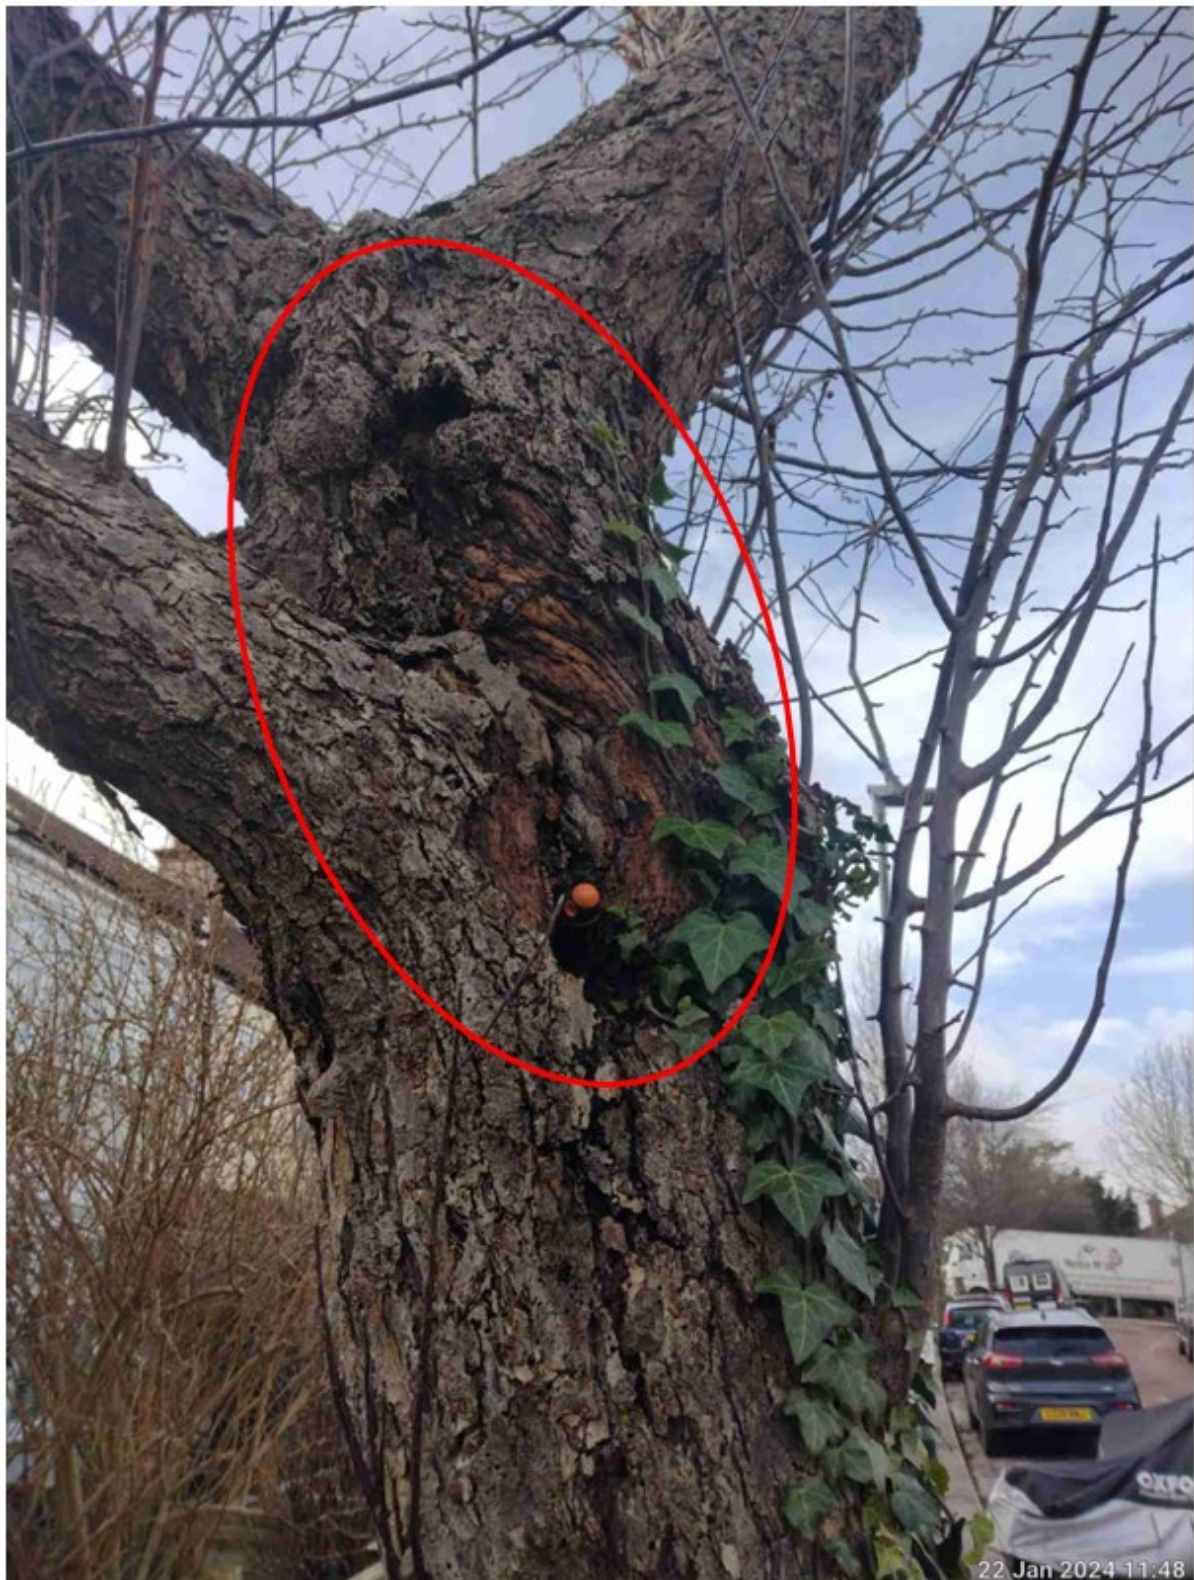
Image shows cavities on lower stem circled.

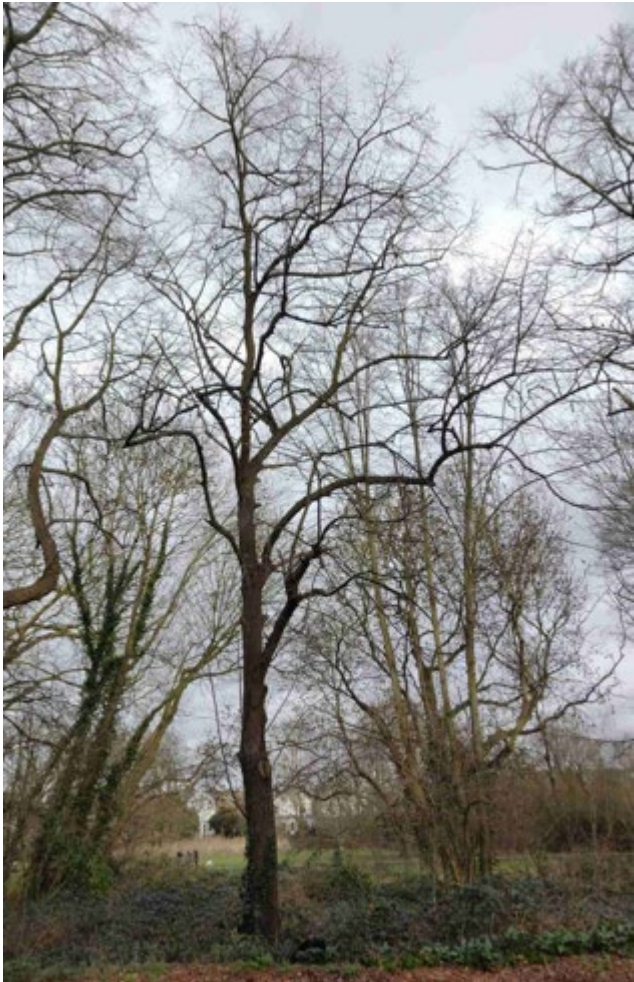
Ward	Mortlake and Barnes Common
Road	Mill Hill Road
Location	Barnes common What3Words ///dance.woven.marked
Species	Lime (<i>Tilia sp.</i>)
Height	18.0m
Physiological Condition	Poor
Structural Condition	Poor
Inspection findings	Cavities indicating root and lower stem decay are present at the base of this tree. Investigation with a probe and a resonance test has revealed areas of decay beyond the visible cavities. Removal is required to prevent further natural failure and manage risk, leaving the base of trunk as a 3 meter high monolith for habitat.

Image shows tree in park scene adjacent to road.

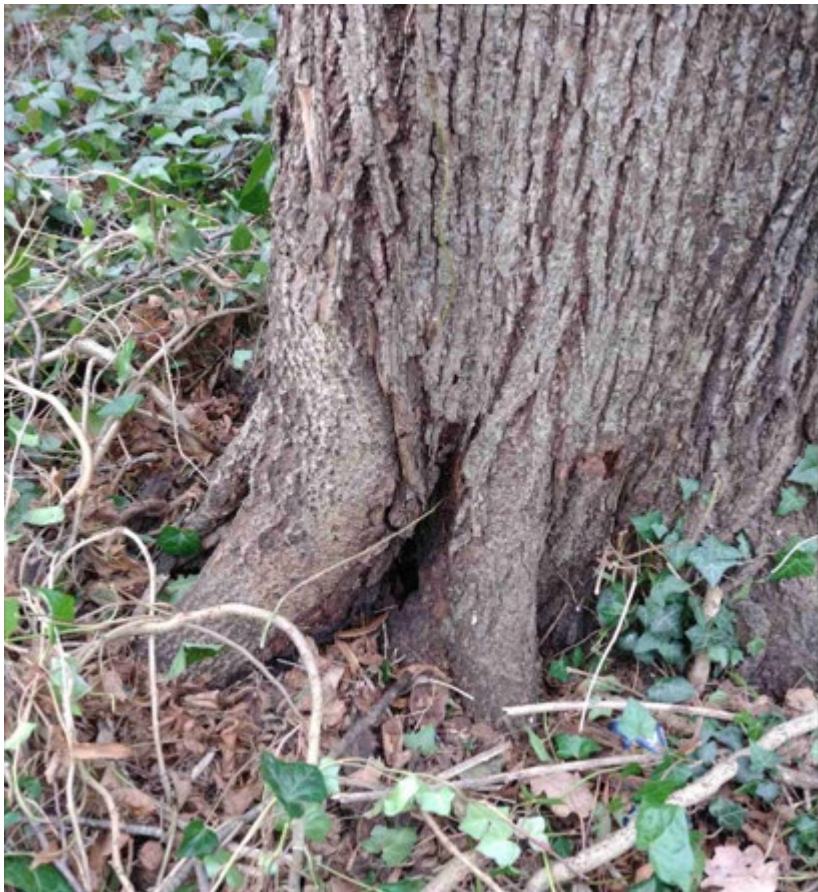
Image shows cavity at base of tree.

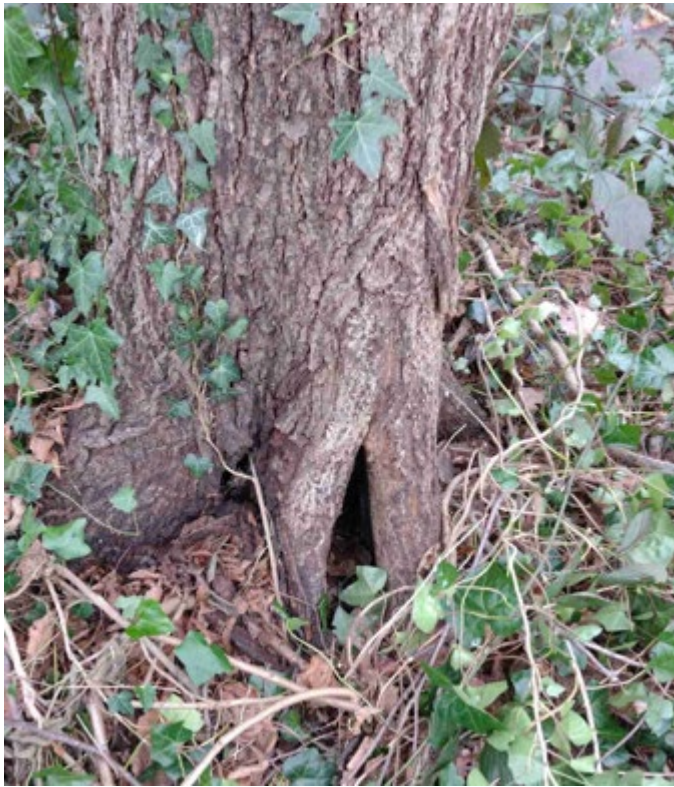
Image shows cavity at base of tree.

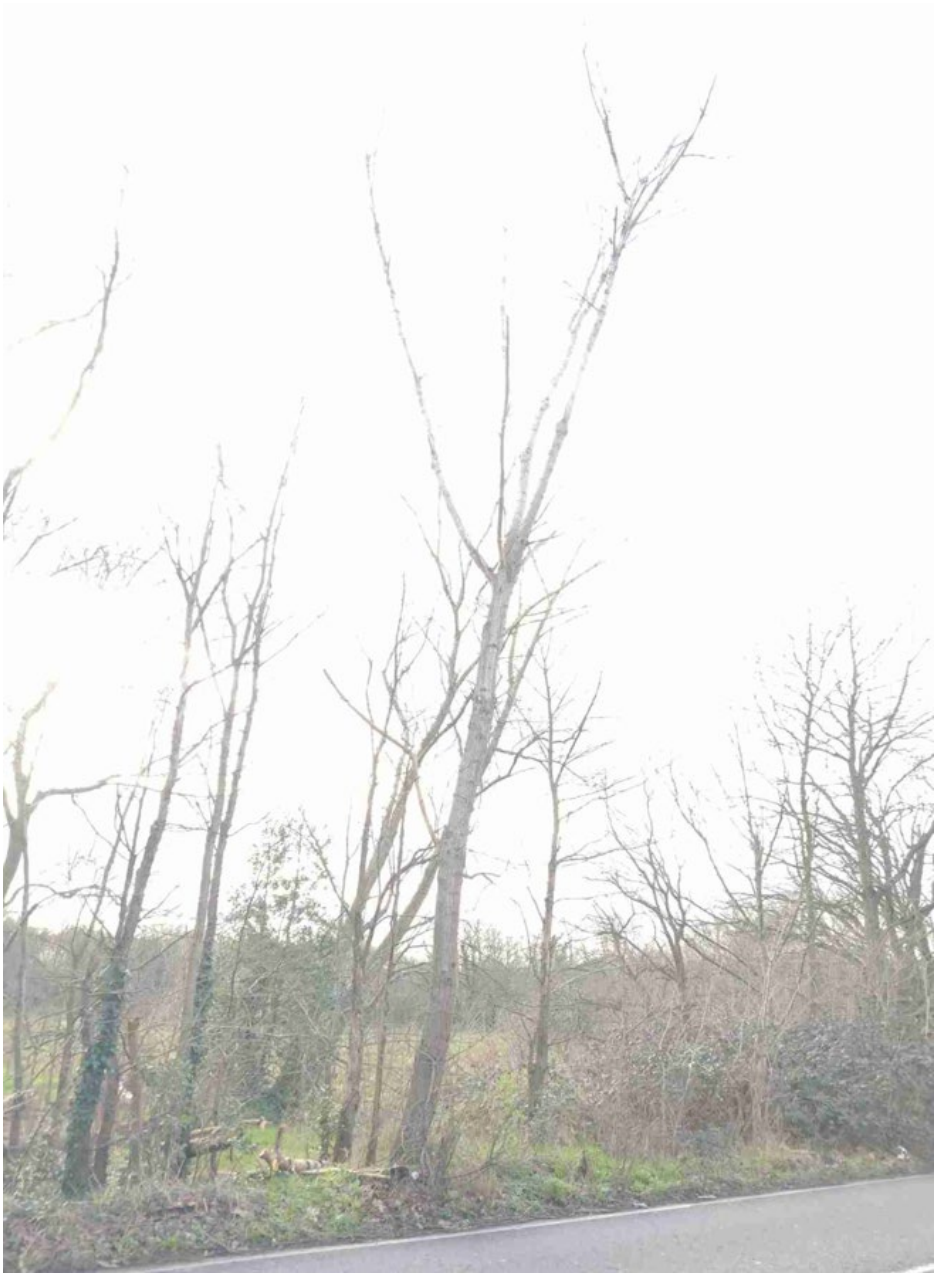
Ward	Mortlake and Barnes Common
Road	Mill Hill Road
Location	Barnes Common What3Words-///comic.saints.blame
Species	1 x Poplar (<i>Populus sp.</i>) 3 x Elm (<i>Ulmus sp.</i>)
Height	Between 15.0m and 8.0m
Physiological Condition	Dead
Structural Condition	Dead
Inspection findings	These trees are dead. Removal is required to prevent natural failure and manage risk.

Image shows trees in park scene adjacent to road.

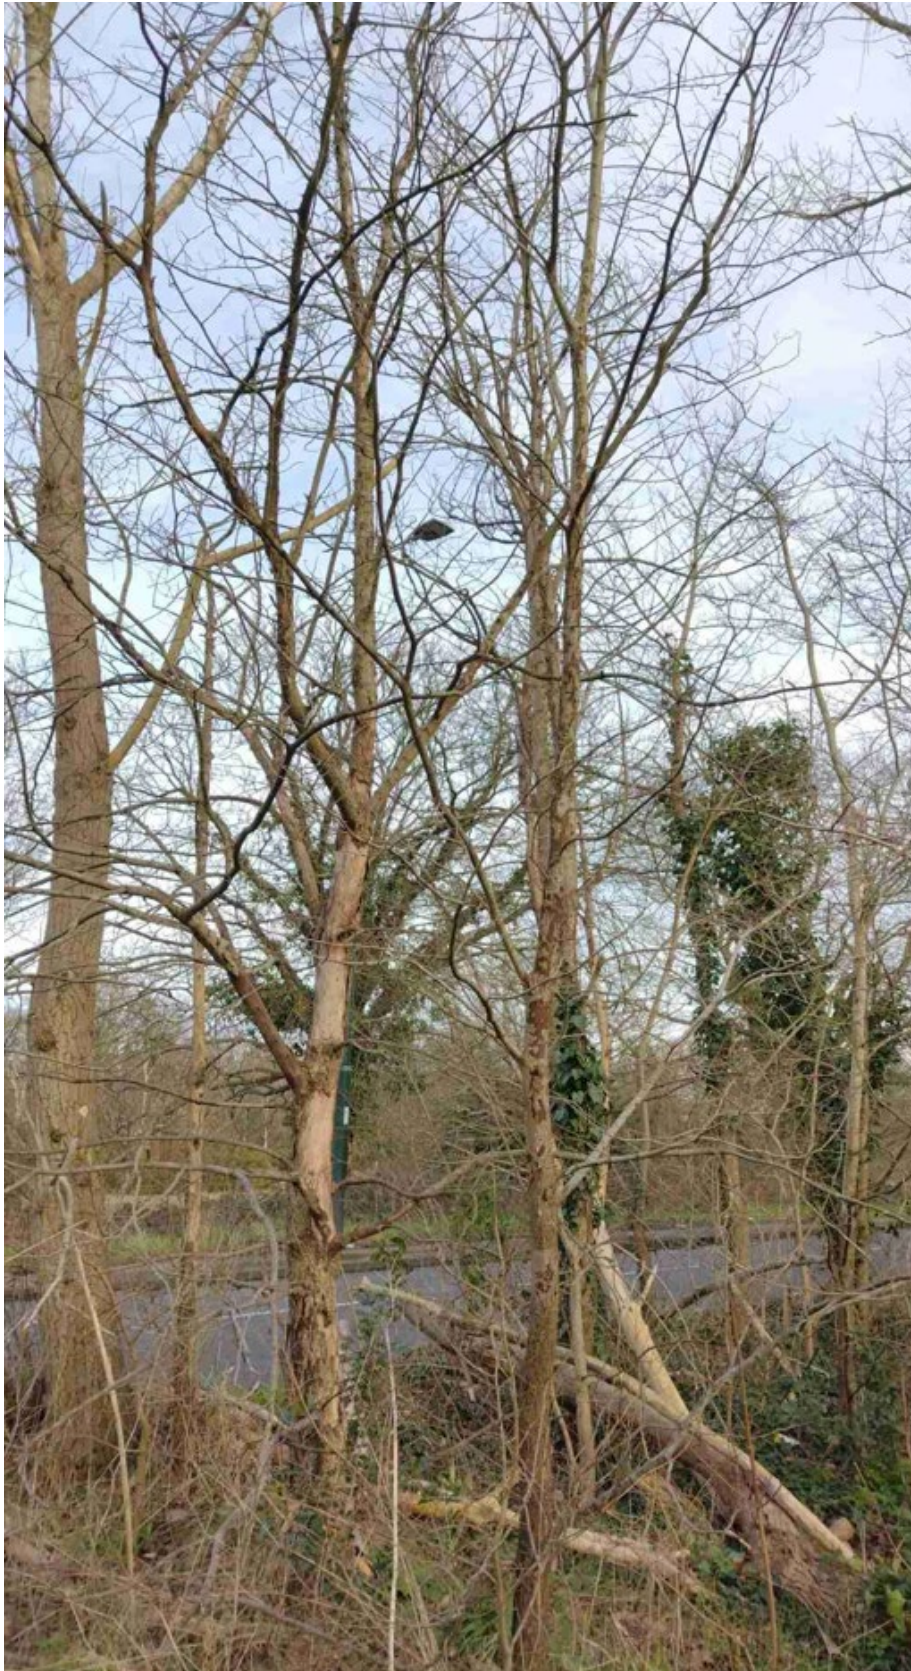
Image shows 3 dead Elm trees in park scene.

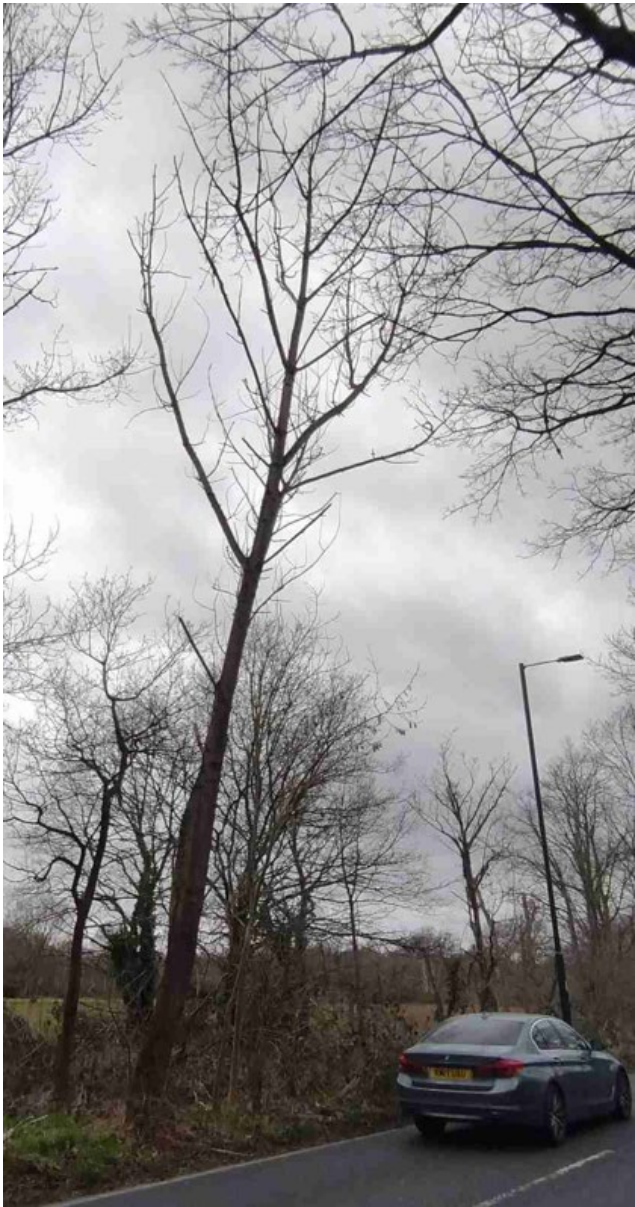
Ward	Mortlake and Barnes Common
Road	Mill Hill Road
Location	Barnes Common What3Words-///sector.trail.tanks
Species	Poplar (<i>Populus sp.</i>)
Height	15.5m
Physiological Condition	Dead
Structural Condition	Dead
Inspection findings	This tree is dead; removal is required to prevent natural failure and manage of risk

Image shows tree in park scene adjacent to road.

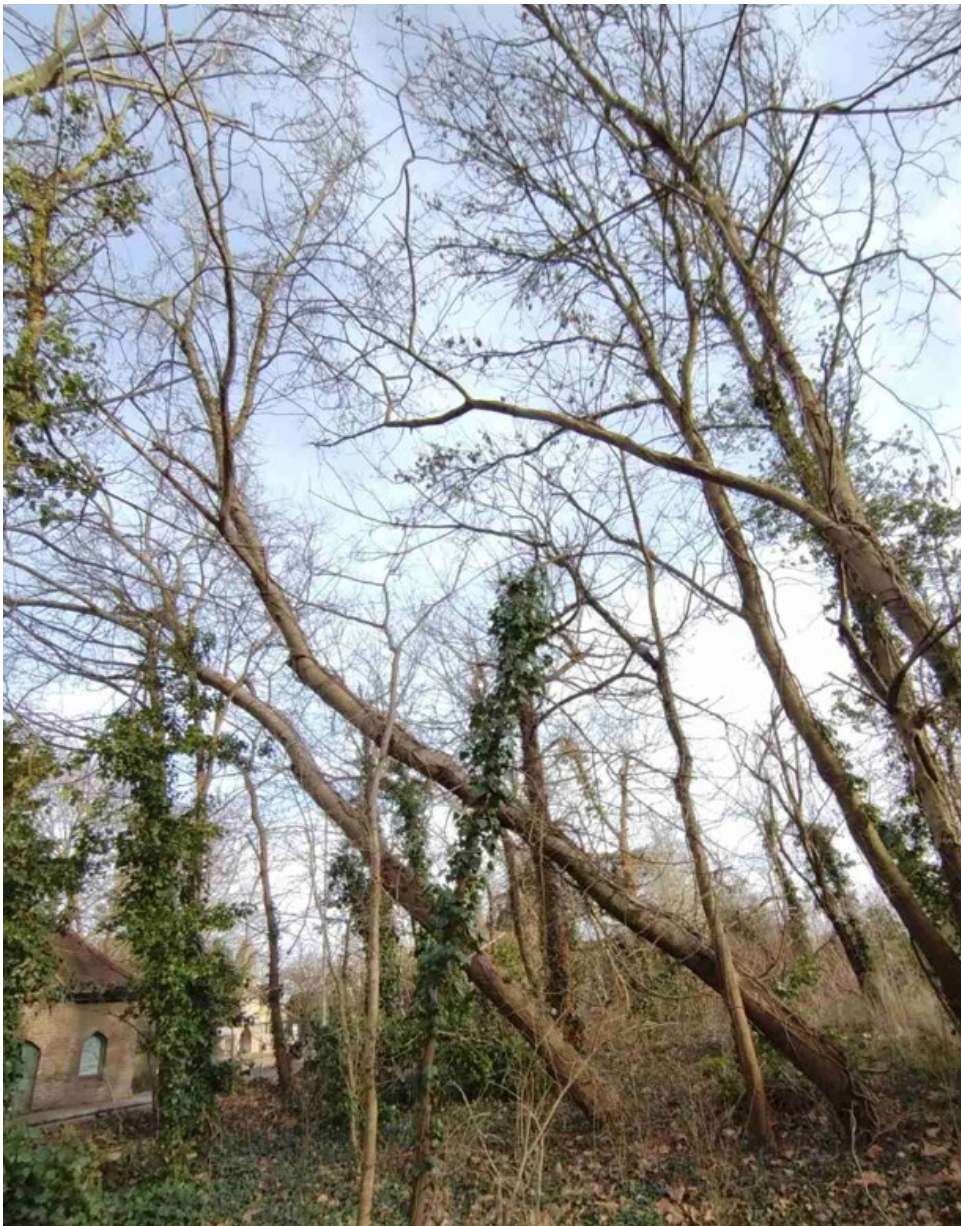
Ward	Mortlake and Barnes Common
Road	Mill Hill Road
Location	Barnes common What3Words ///desk.data.energy
Species	2 x Poplar (<i>Populus sp.</i>)
Height	15.m
Physiological Condition	Fair
Structural Condition	Poor
Inspection findings	These tree's root structures are failing which is causing progressive leans to stems. Removal is required to prevent natural failure and manage of risk

Image shows dead trees in park scene.

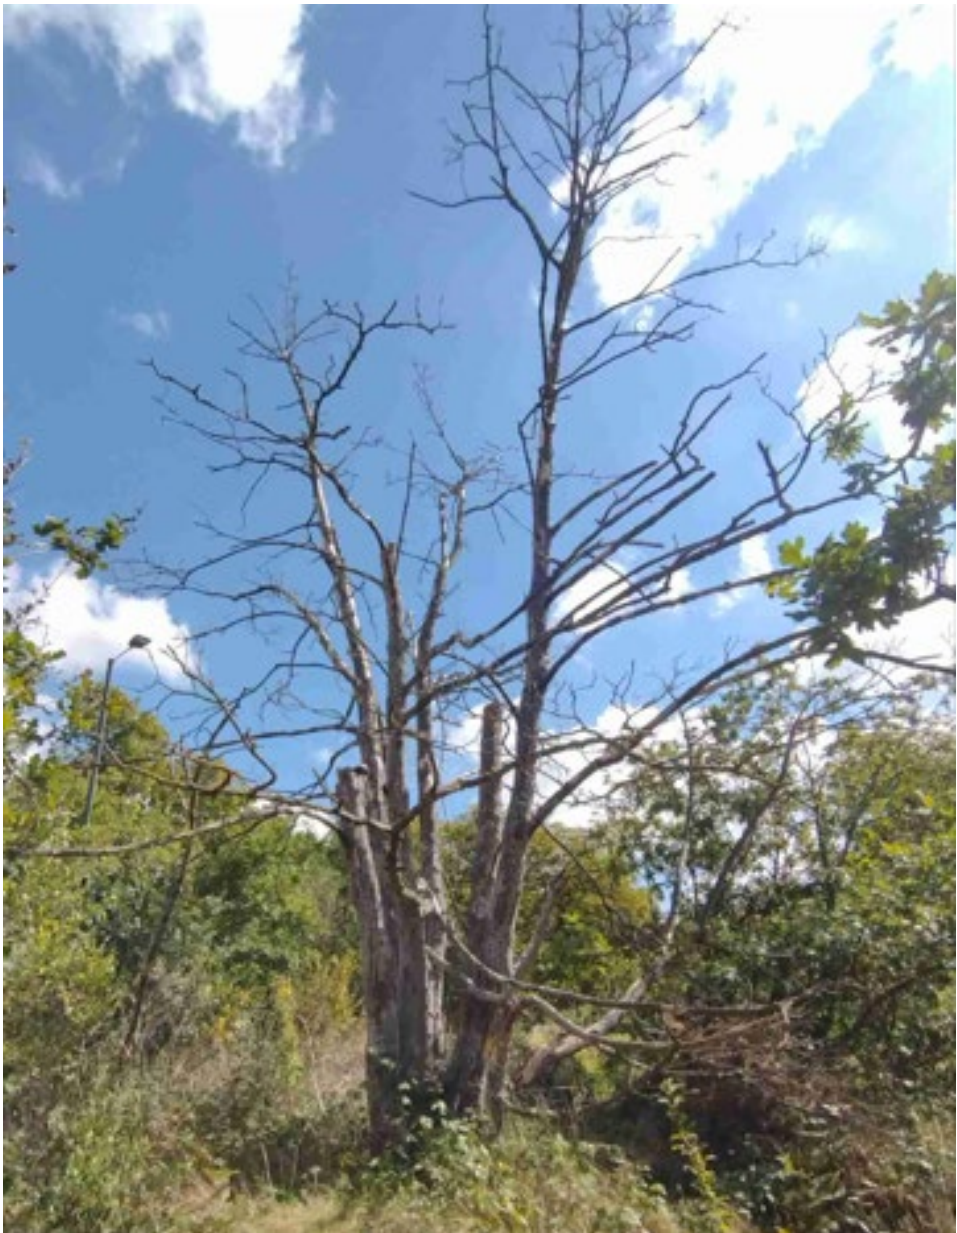
Ward	Mortlake and Barnes Common
Road	Mill Hill Road
Location	Barnes common - What3Words///frogs.hulk.fades
Species	Sycamore (<i>Acer pseudoplatanus</i>)
Height	11.0m
Physiological Condition	Dead
Structural Condition	Dead
Inspection findings	This tree is dead; removal is required to prevent natural failure and manage risk. Leaving the base of trunk as a 3 meter high monolith for habitat.

Image shows dead tree in park scene.

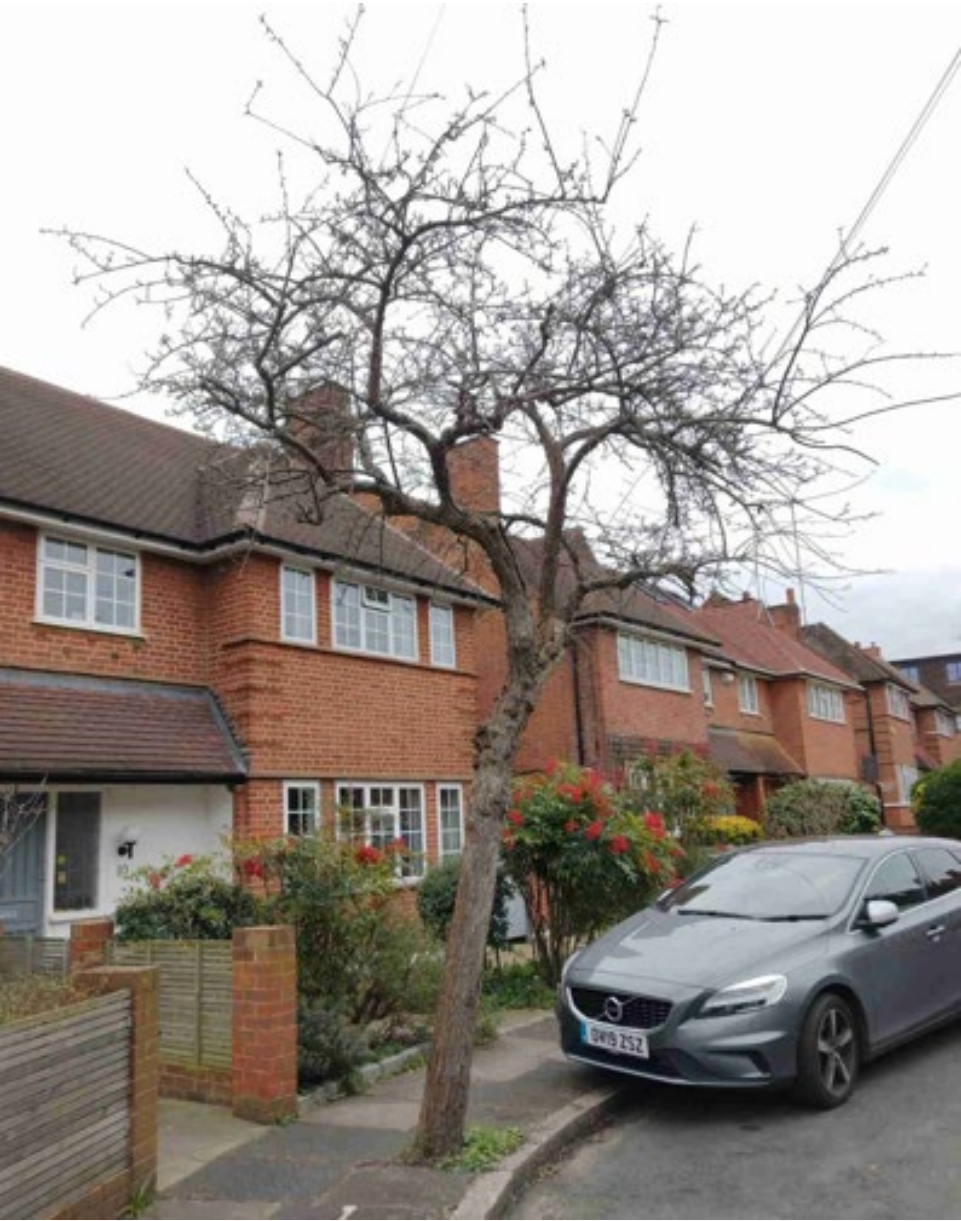
Ward	North Richmond
Road	Burdenshott Avenue
Location	Outside 10/12
Species	Apple (Malus sp.)
Height	5.0m
Physiological Condition	Dead
Structural Condition	Dead
Inspection findings	This tree is dead; removal is required to prevent natural failure and facilitate replanting

Image shows dead tree in street scene.

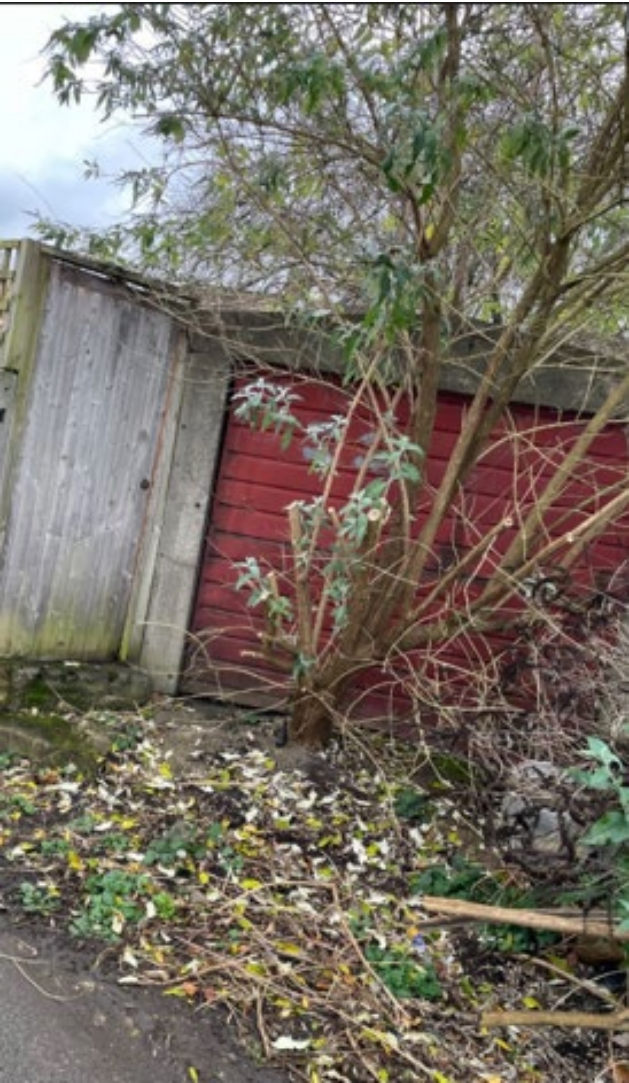
Ward	Whitton
Road	Warren Road
Location	Rear of 40 warren road at entrance to Garage ///cage.buzz.roses
Species	Butterfly Bush (<i>Buddleia davidii</i>)
Height	4.0m
Physiological Condition	Good
Structural Condition	Good
Inspection findings	This tree is growing in an inappropriate place and blocking access to a privately own garage. Removal is required to access garage

Images shows tree in street scene blocking access to garage.

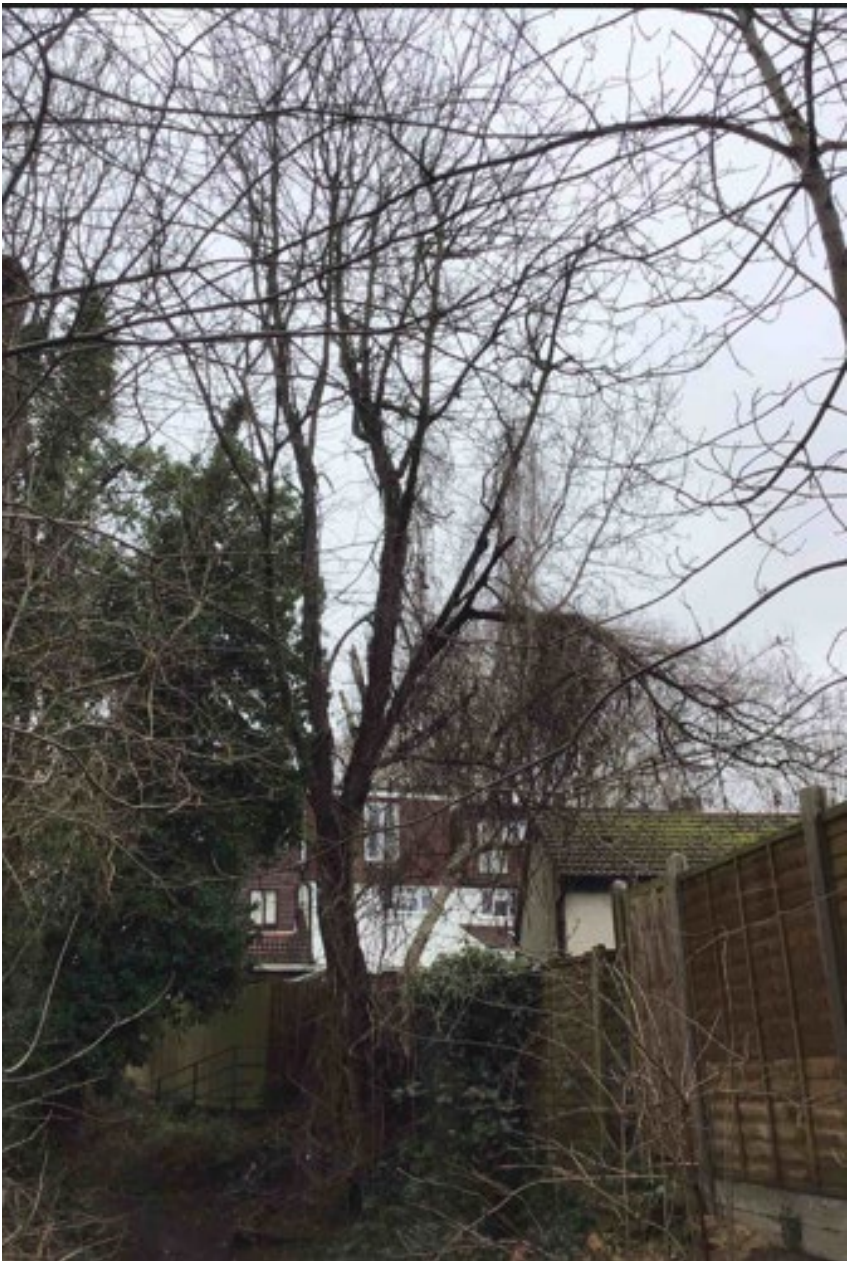
Ward	Whitton
Road	Hospital Bridge Road
Location	Crane Park- On boundary fence to park directly behind 275 Fulwell Park Avenue- ///faces.pokers.card
Species	Sycamore (<i>Acer pseudoplatanus</i>)
Height	21.0m
Physiological Condition	Good
Structural Condition	Good
Inspection findings	This tree is growing in an inappropriate location and presents an unacceptable risk of damage to private property.

Images shows dead in park scene.
