February 2024 - Reactive Tree Works Programme

Dated 22.02.2024.

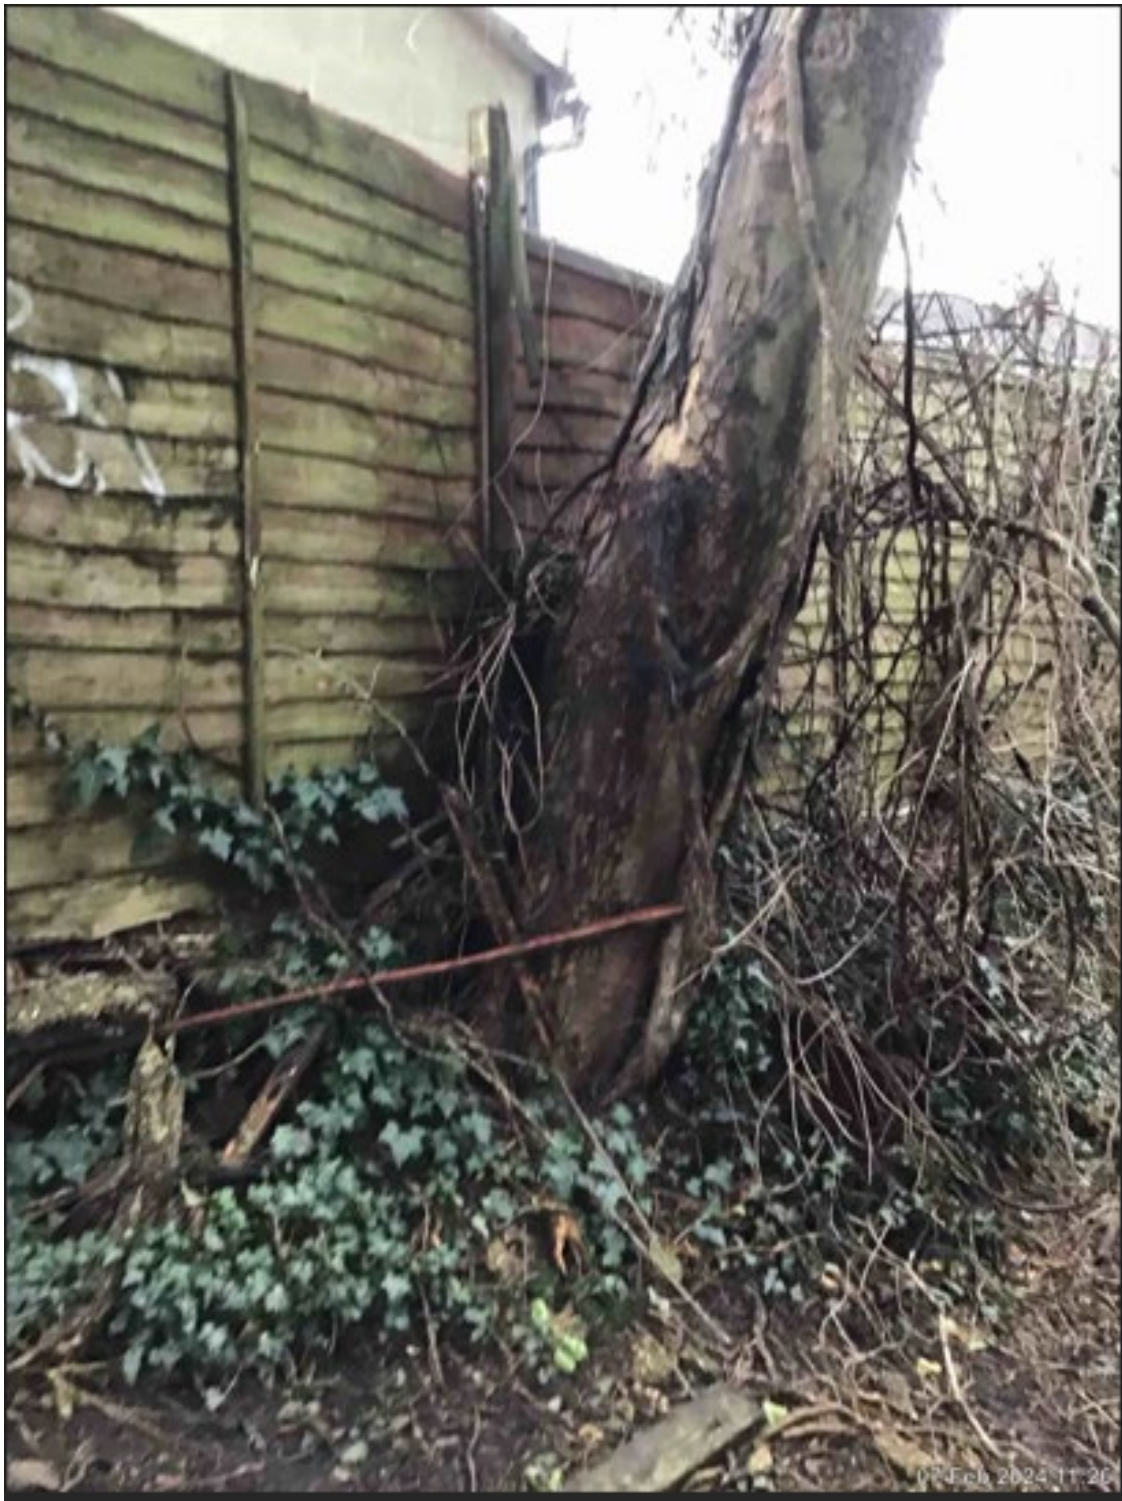
Ward	Whitton
Road	Hospital Bridge Road
Location	Crane Park- On boundary fence to park directly behind 275 Fulwell Park Avenue- ///faces.pokers.card
Species	Sycamore (<i>Acer pseudoplatanus</i>)
Height	21.0m
Physiological Condition	Good
Structural Condition	Good
Inspection findings	This tree is growing in an inappropriate location and presents an unacceptable risk of damage to private property.

Images shows base of trunk and its proximity to privately owned fence.
