Ham, Petersham and Richmond Riverside - 2022 Ward Works and Tree Removals Programme

Introduction

Dated 27.01.2022

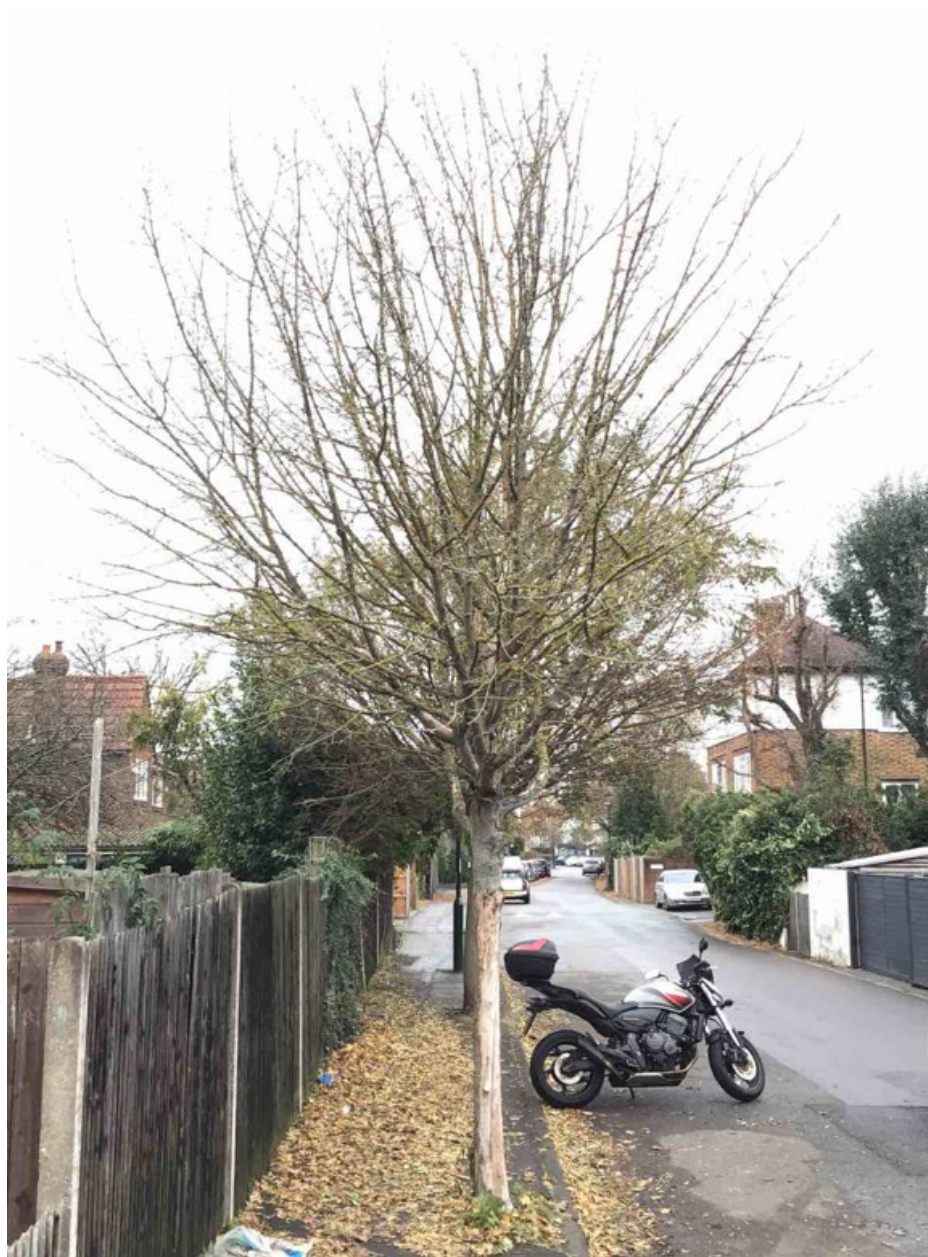
Tree number	8
Road	Back Lane
Location	Adjacent to 2 Mead Road main building
Species	Filed Maple (<i>Acer campestre</i>)
Height	6.0 meters
Physiological condition	Dead
Structural condition	Poor
Inspection findings	This tree is dead

Image shows dead tree

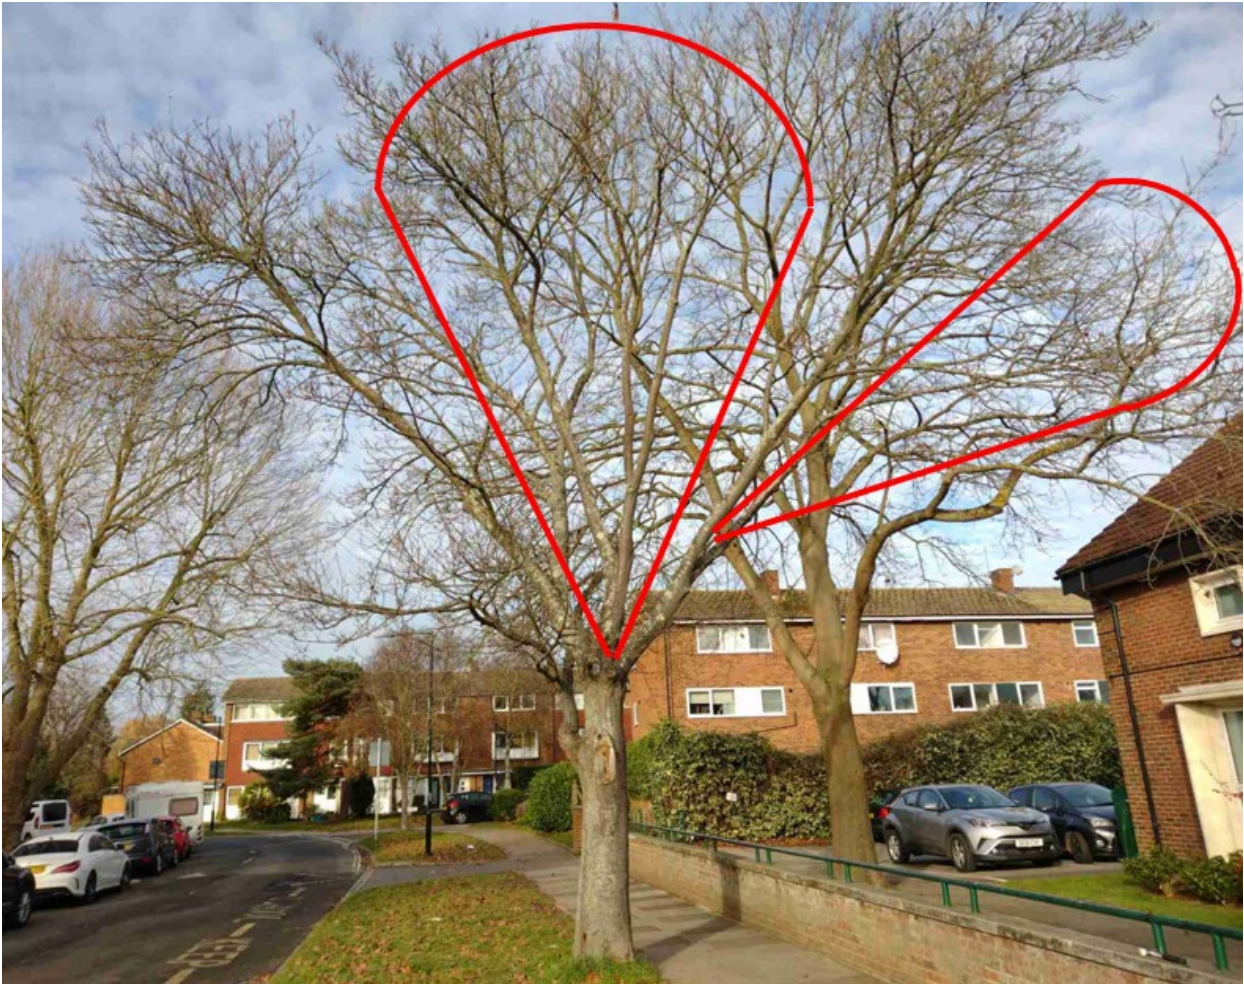
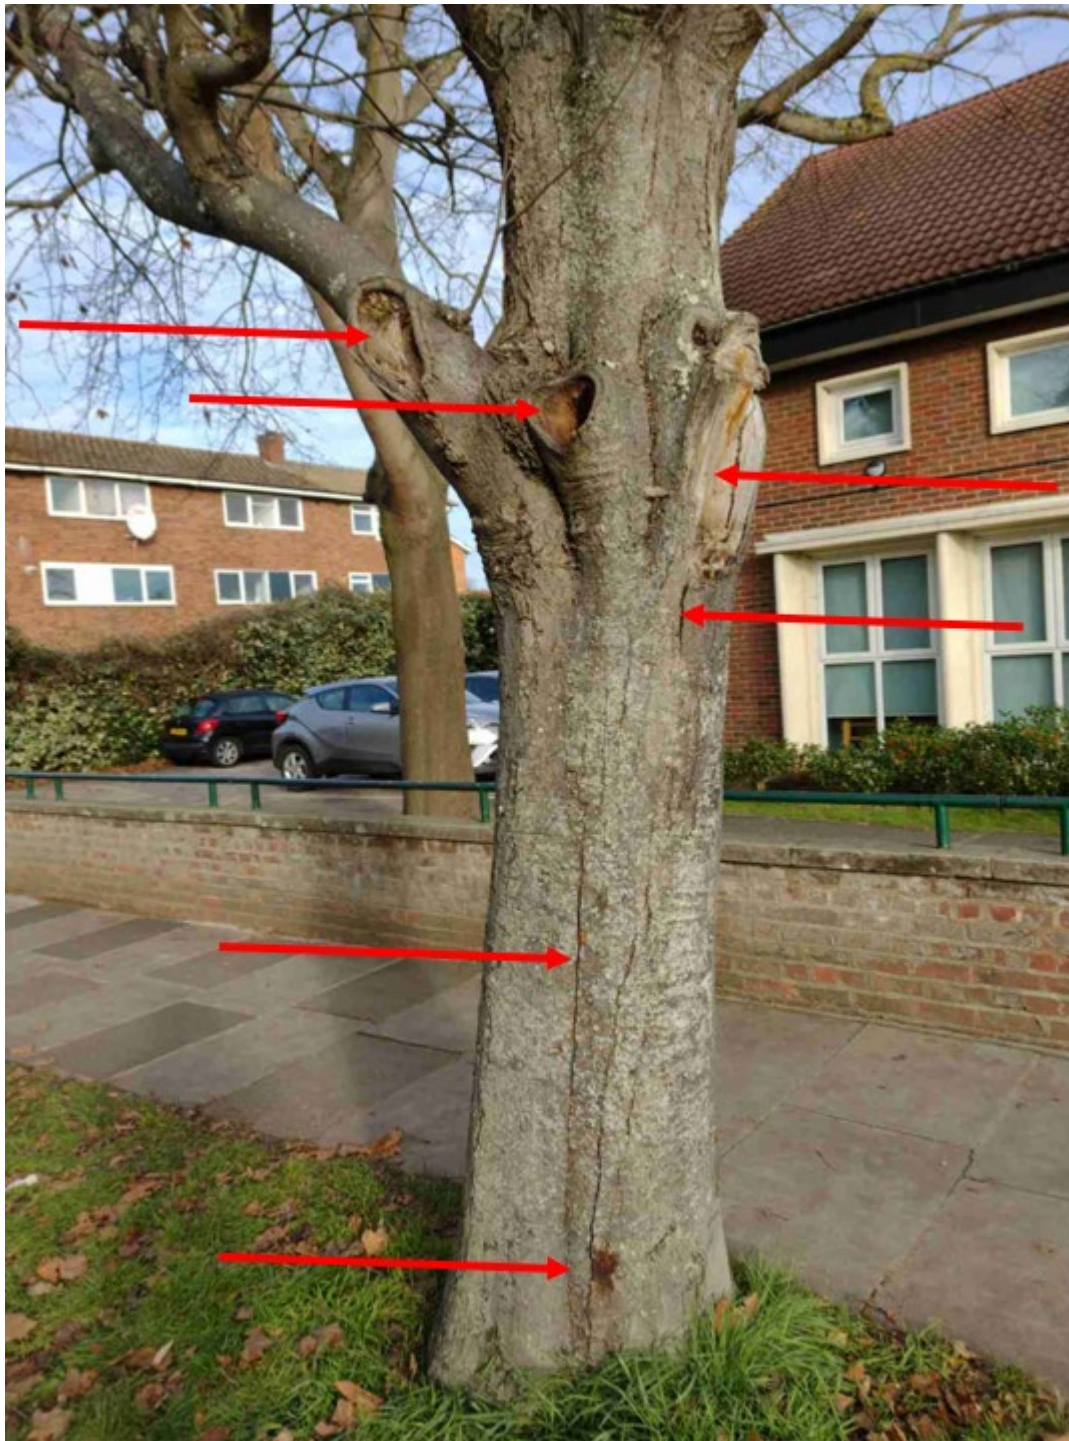
Tree number	39
Road	Broughton Avenue
Location	Opposite 2 Simpson Road outside Meadlands Primary School
Species	Hybrid Whitebeam (<i>Sorbus x thuringiaca</i>)
Height	9 meters
Physiological condition	Poor
Structural condition	Poor
Inspection findings	The tree is in a state of terminal decline. There are wounds with cavity formation indicating decay in the main stem at the crown break of this tree. Significant portions of the canopy of this tree are dead or dying back and the bark on the main stem is cracked and necrotic, indicating physiological dysfunction. The condition of the tree is poor and removal is necessary to address an unacceptable risk of collapse.

First image shows tree in situ with dead and dying sections of the canopy highlighted. Second image shows trunk with cavity formation, bark cracks and stem bleeding.

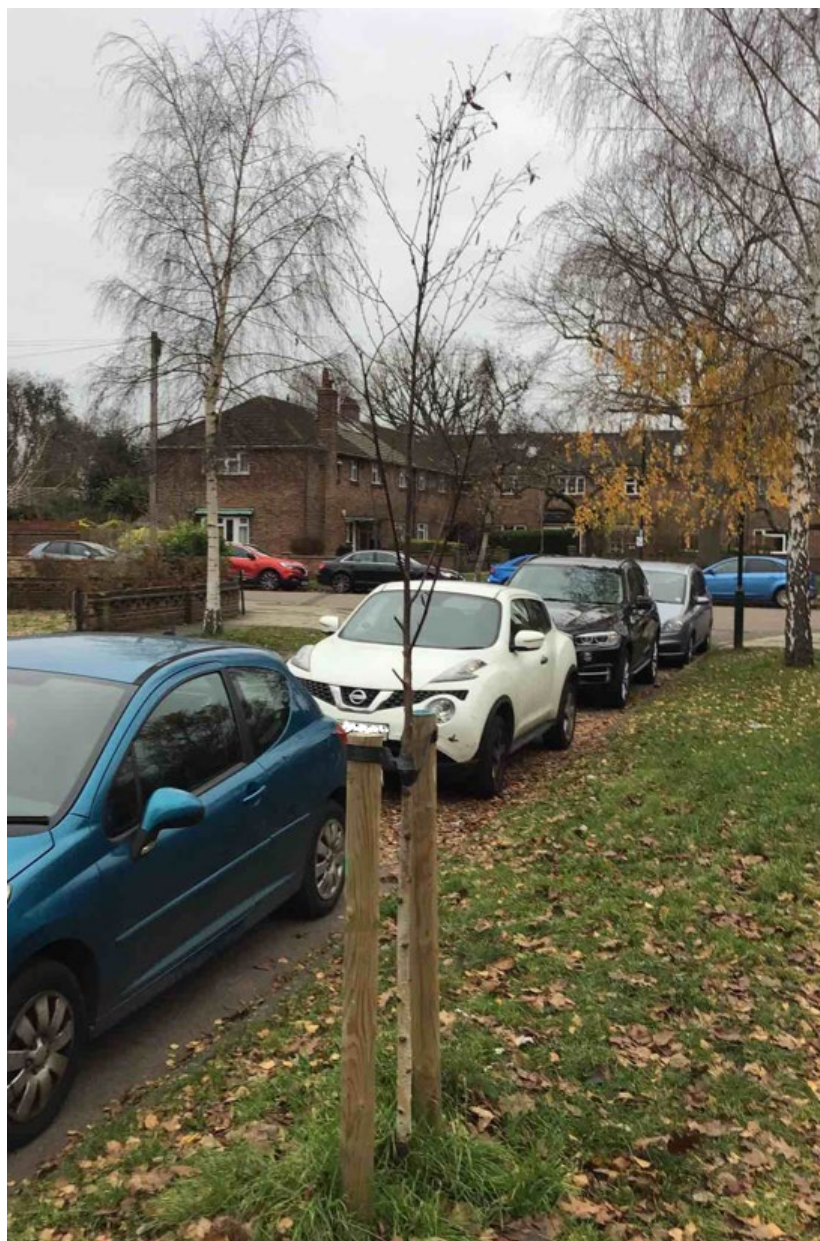
Tree number	8
Road	Buckingham Road
Location	Outside 96
Species	Birch (<i>Betula sp.</i>)
Height	2.5 meters
Physiological condition	Dead
Structural condition	Dead
Inspection findings	This tree is dead

Image shows dead tree in situ

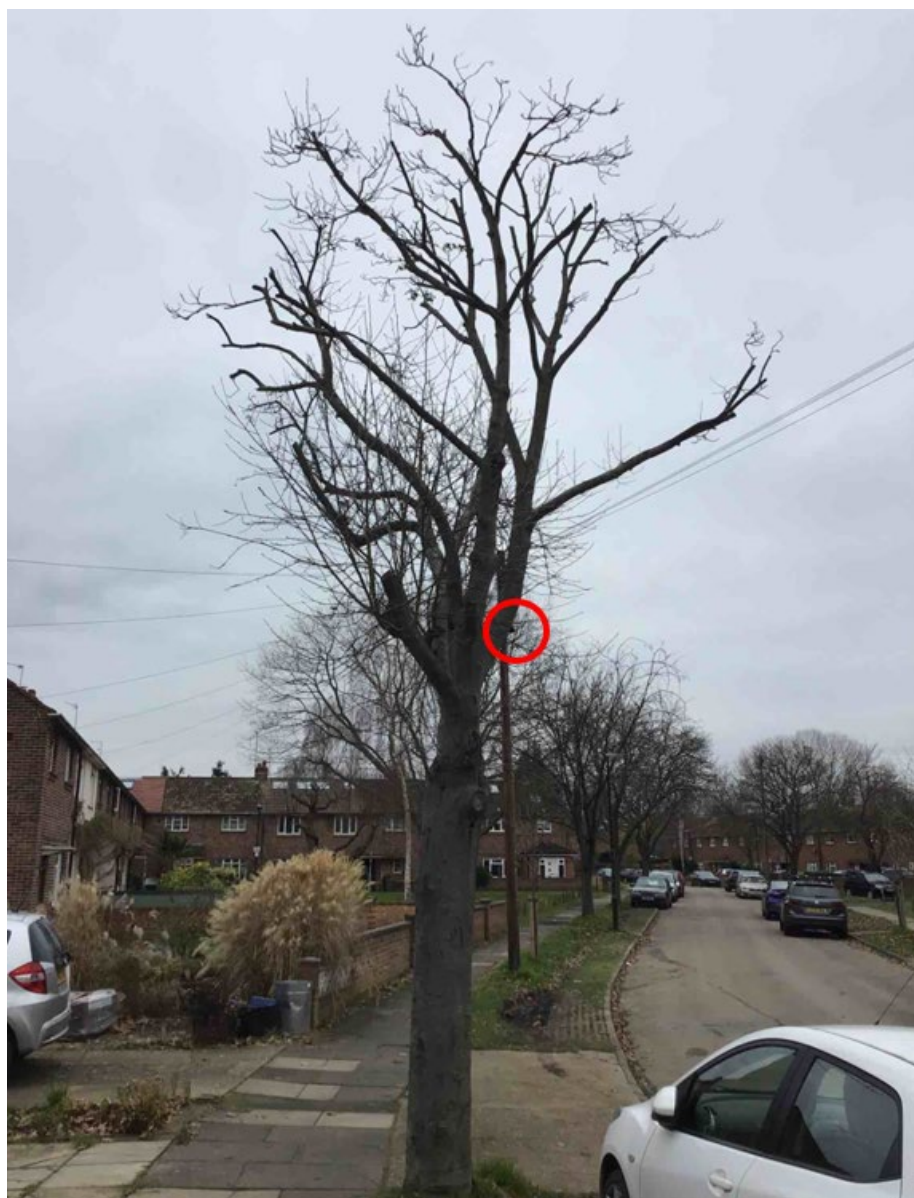
Tree number	18
Road	Buckingham Road
Location	Outside 96
Species	Swedish Whitebeam (<i>Sorbus intermedia</i>)
Height	7.0 meters
Physiological condition	Poor
Structural condition	Poor
Inspection findings	A fungal fruiting body of the species Shaggy Polypore (<i>Inonotus hispidus</i>) is present on the main stem or trunk. This fungus causes a simultaneous white rot which can cause snapping of tree parts in this species. The crown of this tree has died back extensively indication serious physiological dysfunction. This tree is in terminal decline and requires removal before natural failure occurs.

Image shows extensive crown die back and location of *Inonotus* fruiting body

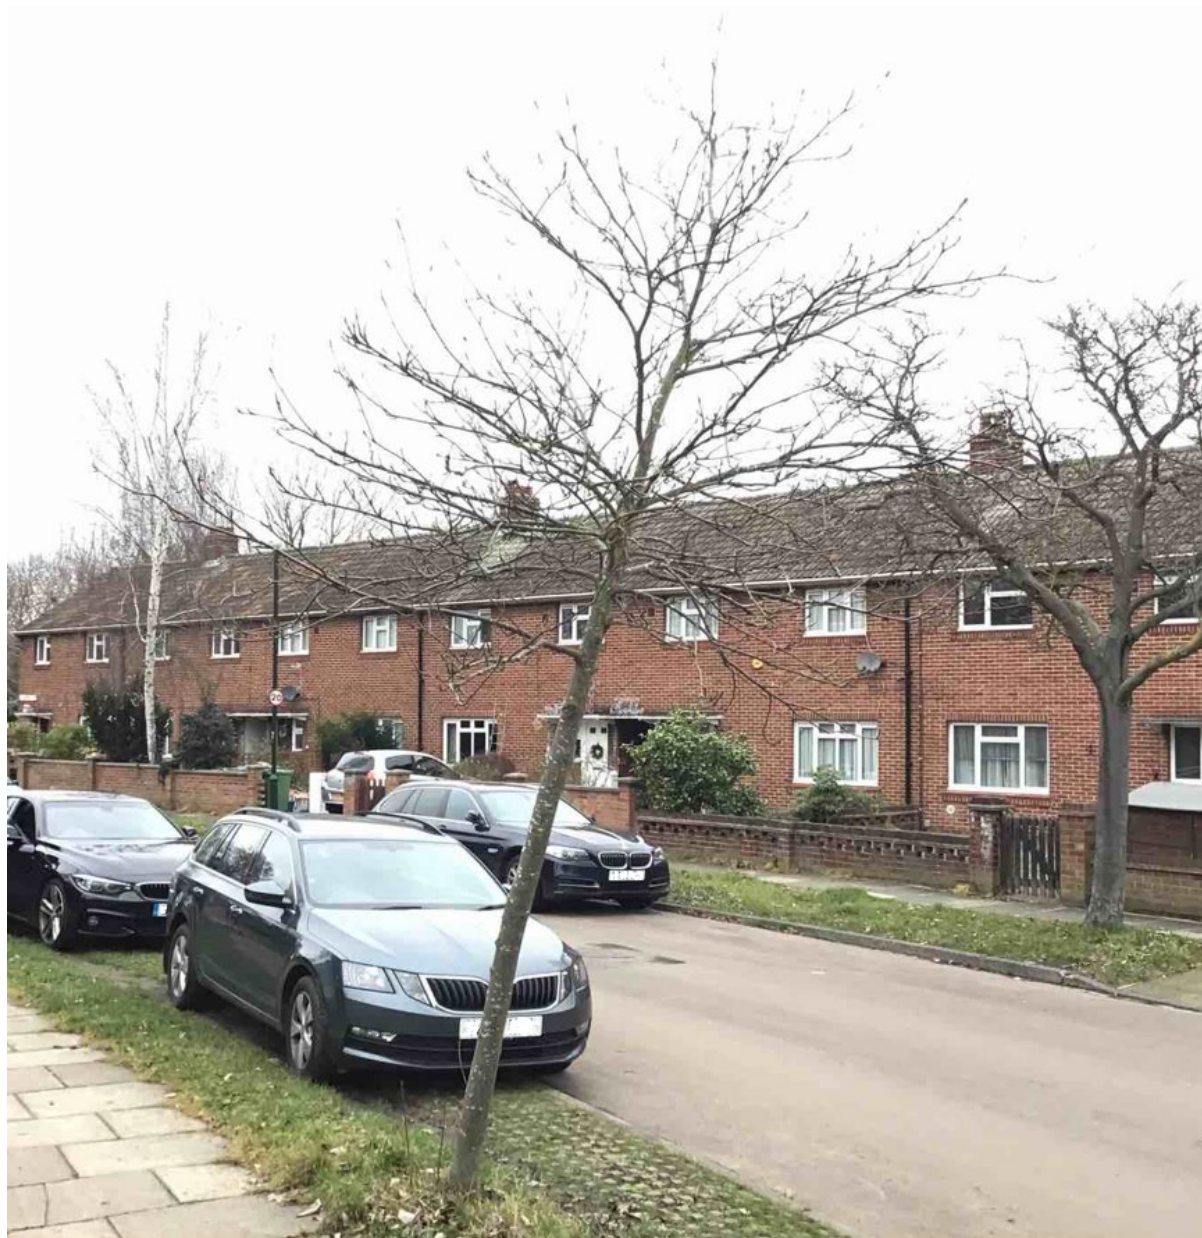
Tree number	13
Road	Buckingham Road
Location	Opposite 84/86
Species	Swedish Whitebeam (<i>Sorbus intermedia</i>)
Height	4.5 meters
Physiological condition	Good
Structural condition	Poor
Inspection findings	This tree is moving in such a way that indicates that the rooting structure is compromised. The tree is liable to failure and removal is required.

Image shows tree in situ with lean from insecure rooting

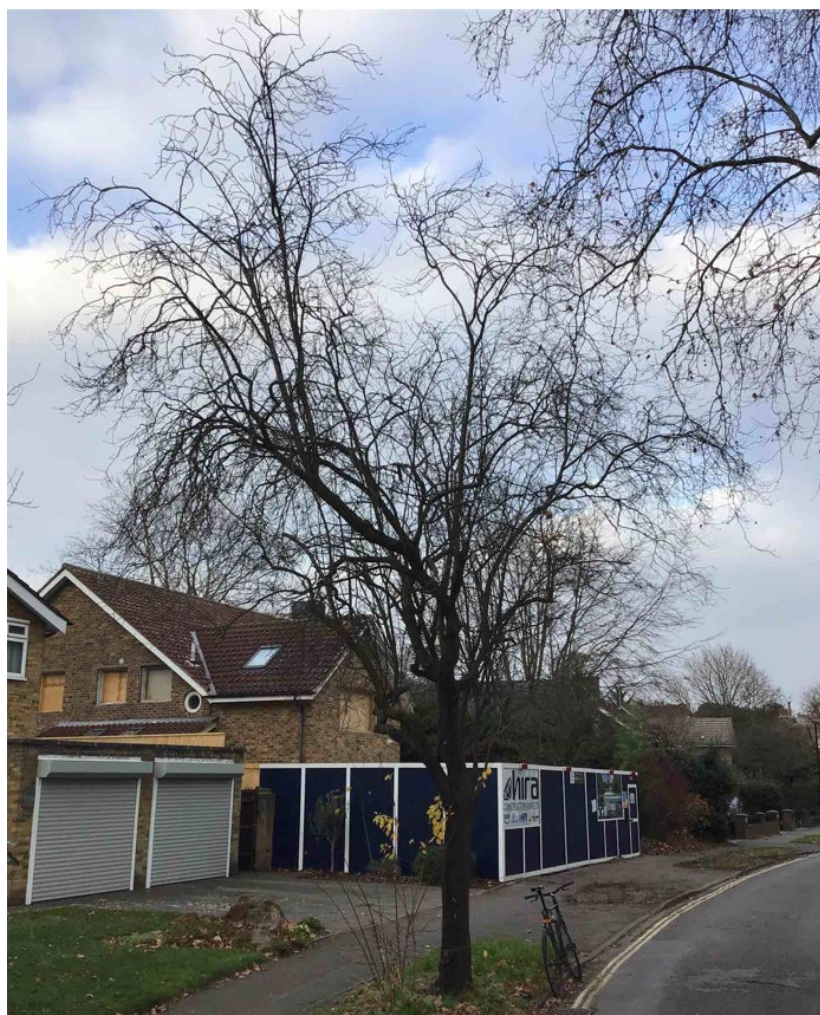
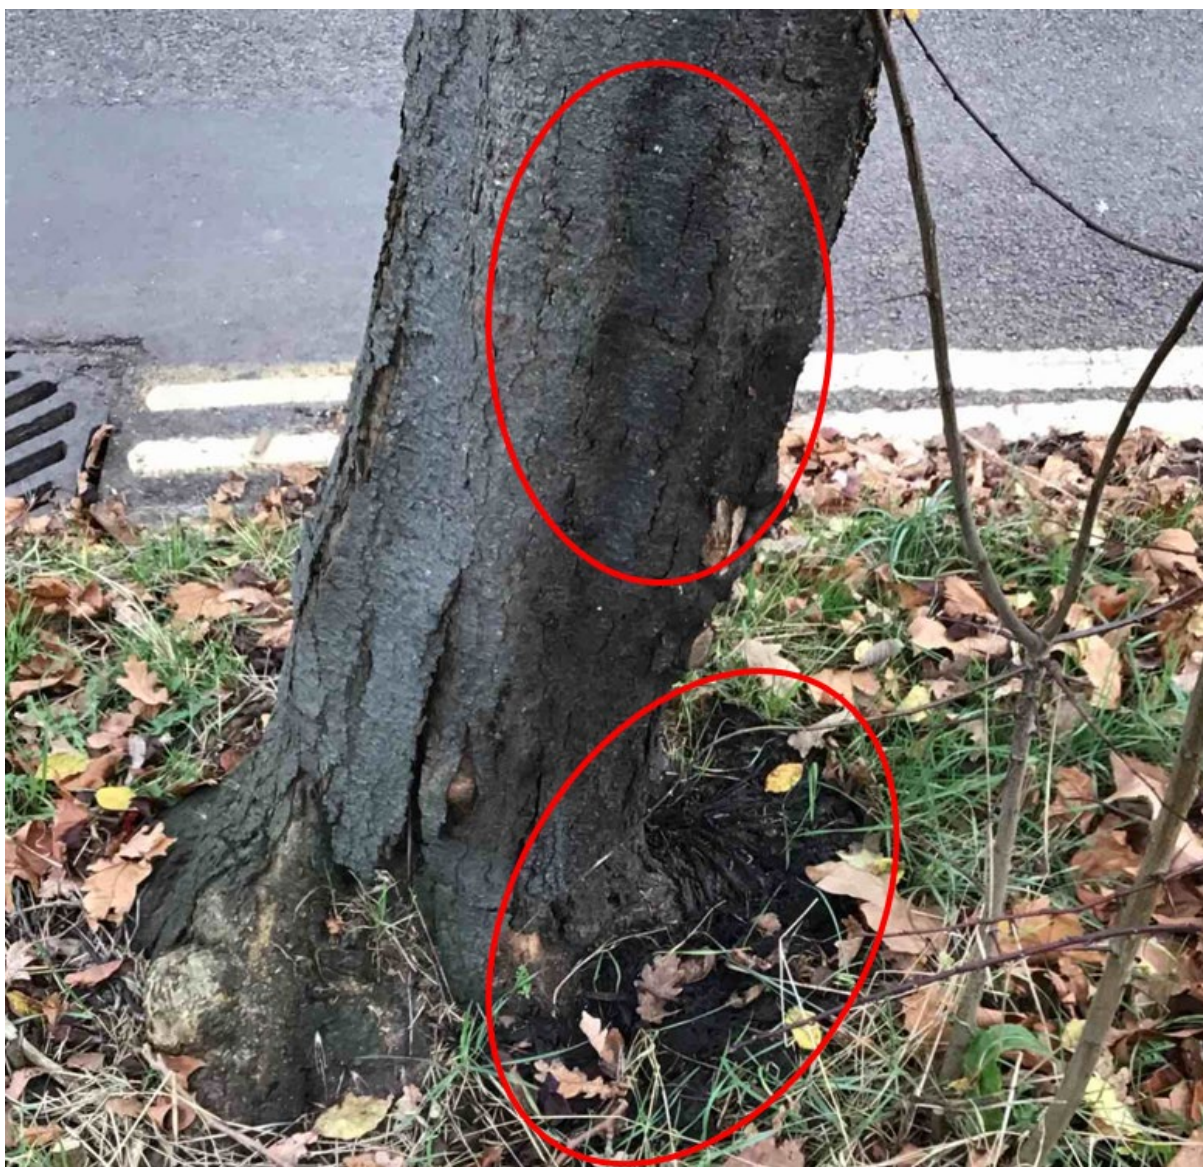
Tree number	5
Road	Cedar Heights
Location	Outside 10
Species	Purple Plum (<i>Prunus cerasifera</i>)
Height	9.0 Meters
Physiological Condition	Good
Structural Condition	Poor
Inspection findings	Fungal fruiting bodies of the decay pathogen <i>Armillaria</i> sp. are present at the base of this tree in conjunction with stem bleeding. Colonisation by this fungus causes a white rot of the roots and butt that can cause entire tree failure.

First image shows tree in situ, second image shows decaying fungal fruiting bodies at the base and trunk bleeding

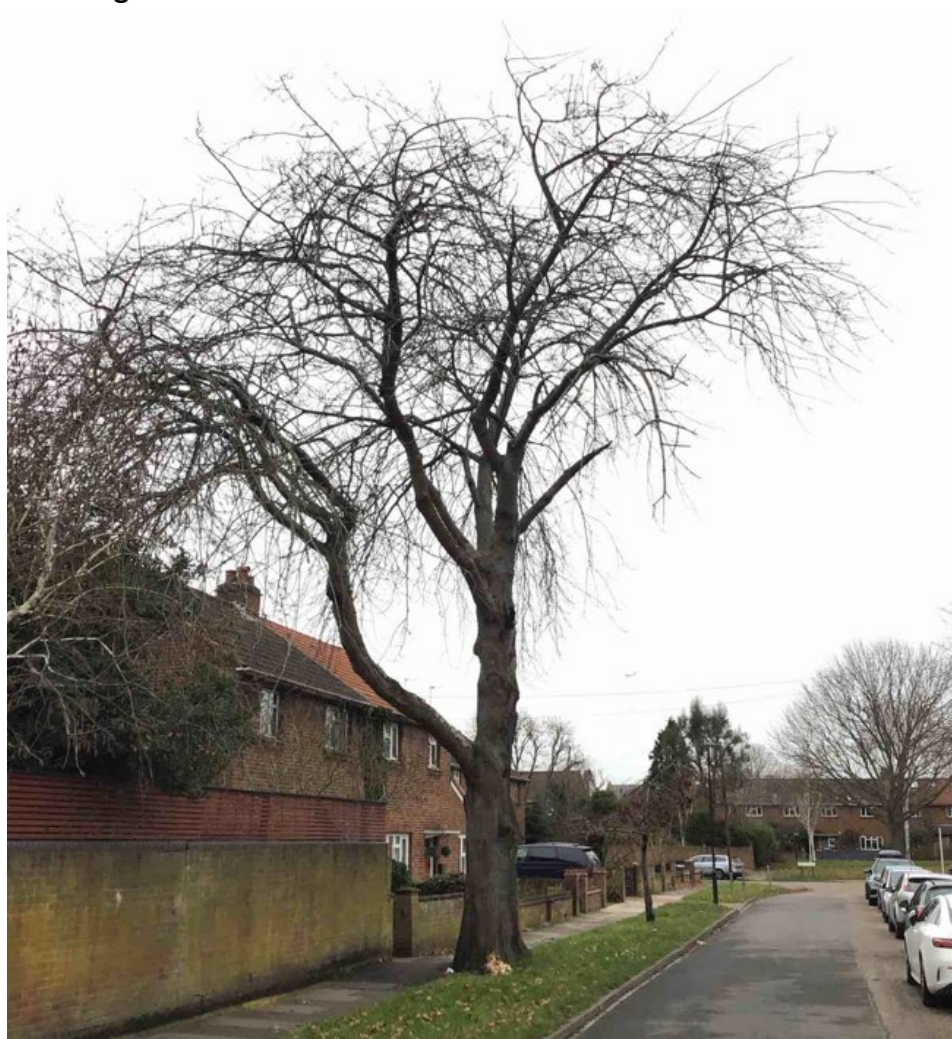
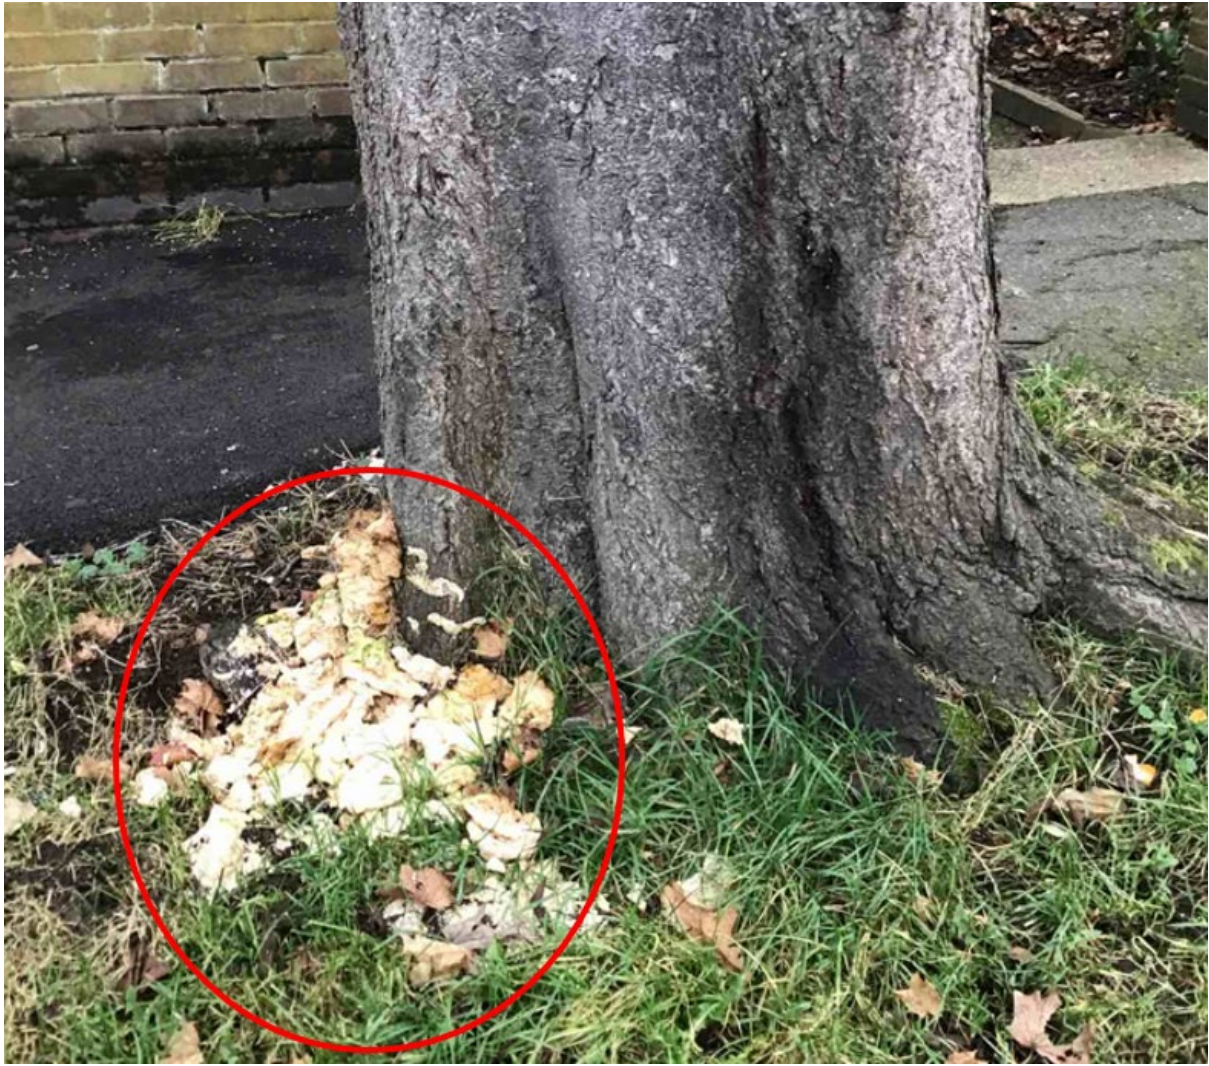
Tree number	8
Road	Clifford Road
Location	Outside 1
Species	Wild Cherry (<i>Prunus avium</i>)
Height	15.0 meters
Physiological condition	Poor
Structural condition	Poor
Inspection findings	Fungal fruiting bodies of the wood decay fungus <i>Laetiporus sulphureus</i> are present on the trunk of this tree. This fungus causes a brown rot which can rapidly reduce wood strength and cause branch or whole tree failure through brittle fracture. This tree is in a state of physiological decline and contains weak branches that are liable to collapse. A resonance test revealed an unacceptable degree of decay in the trunk of this tree, removal is required to prevent natural failure and manage risk.

First image shows tree with canopy decline, broken branch, and remnants of fungal fruiting bodies at base. Second image shows detail of fruiting body remnants.

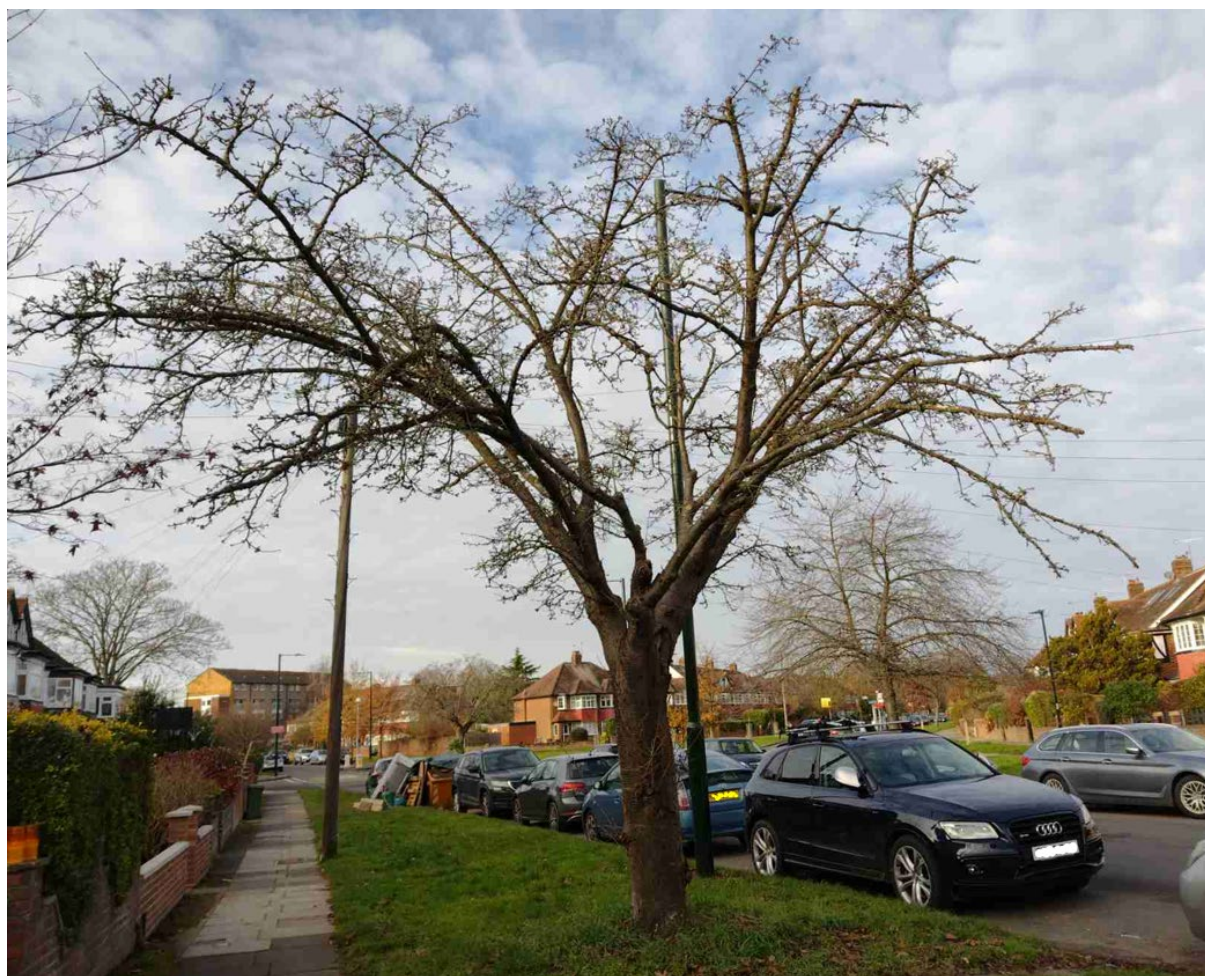
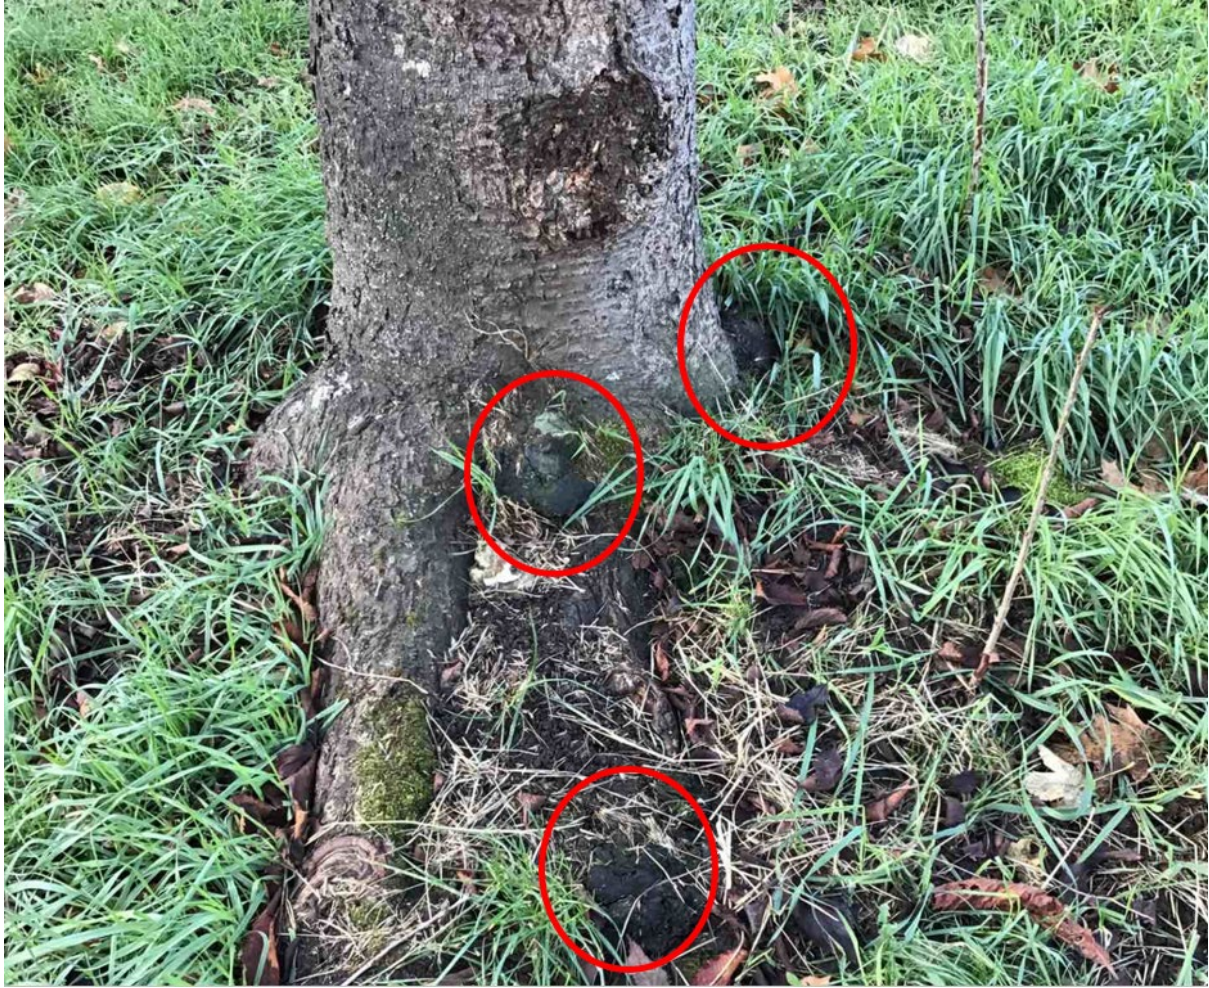
Tree number	16
Road	Dukes Avenue
Location	Outside 155
Species	Wild Cherry (<i>Prunus avium</i>)
Height	7.0 Meters
Physiological Condition	Fair
Structural Condition	Poor
Inspection findings	A fungal fruiting body of the decay pathogen <i>Ganoderma</i> sp. is present at the stem base. Colonisation by this fungus causes a white rot of the stem and root system that can cause entire trees to collapse through fracture or windthrow. Cavities indicating decay are present in the trunk of this tree at the main crown break.

First image shows tree in situ, second image shows fungal fruiting bodies circled with dysfunction visible on the bark on the trunk

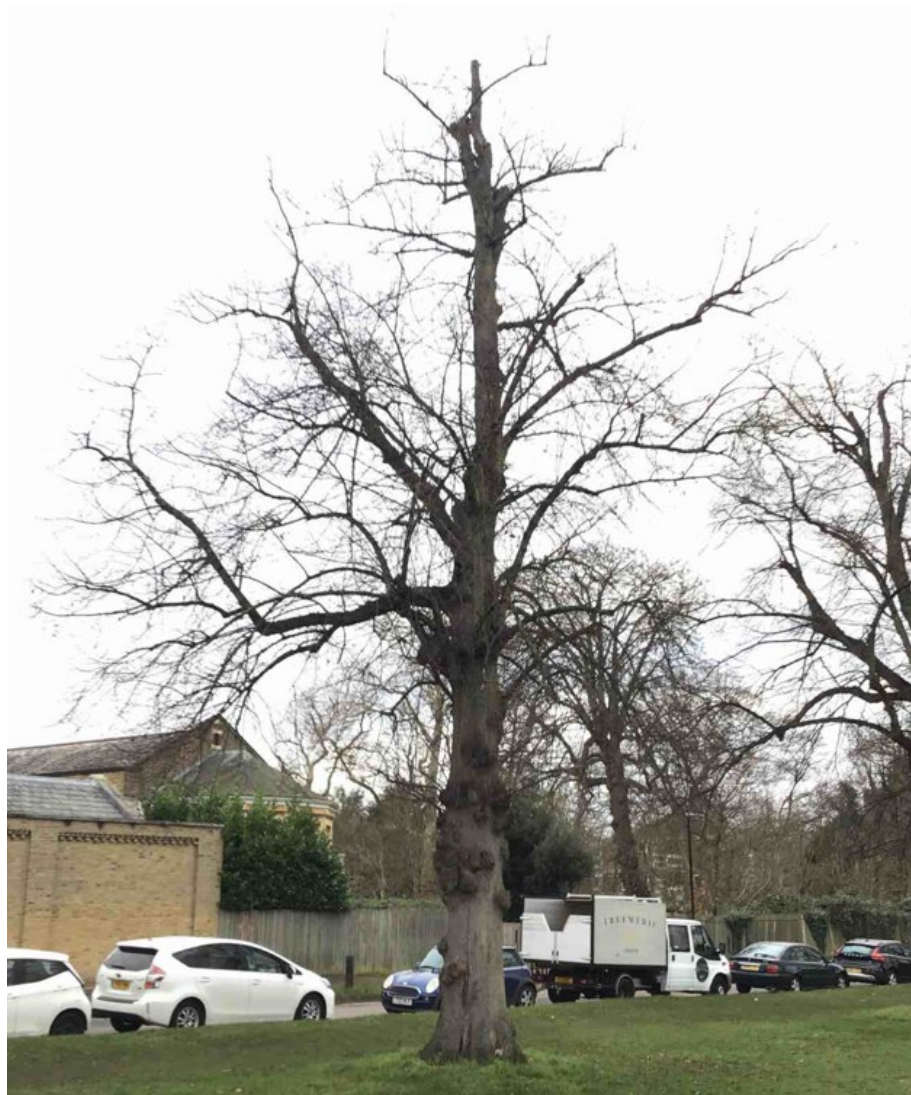
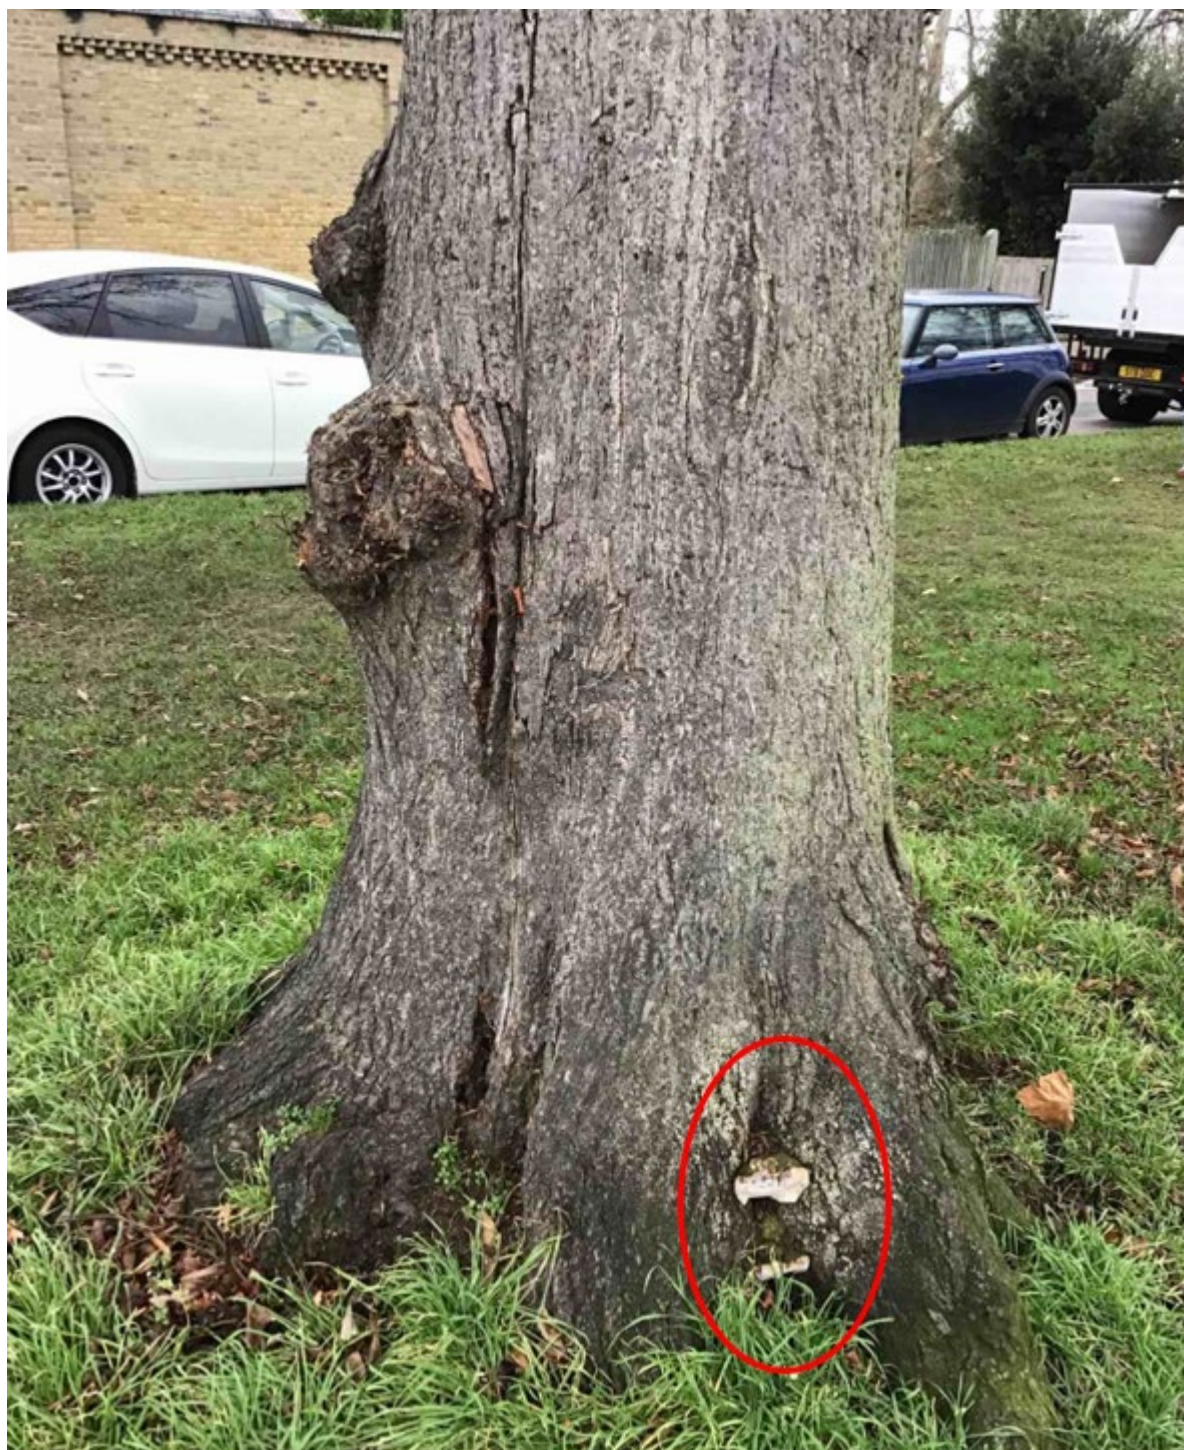
Tree number	14
Road	Ham Common
Location	King George's Field, opposite The Cassel Hospital
Species	Lime (<i>Tilia</i> sp.)
Height	15.0 Meters
Physiological Condition	Good
Structural Condition	Poor
Inspection findings	A fungal fruiting body of the decay pathogen <i>Ganoderma</i> sp. is present at the stem base. Colonisation by this fungus causes a white rot of the stem and root system that can cause entire trees to collapse through fracture or windthrow. A resonance test revealed an unacceptable degree of decay in the trunk of this tree, removal is required to prevent natural failure and manage risk.

First image shows tree in situ, second image shows fungal fruiting bodies circled.

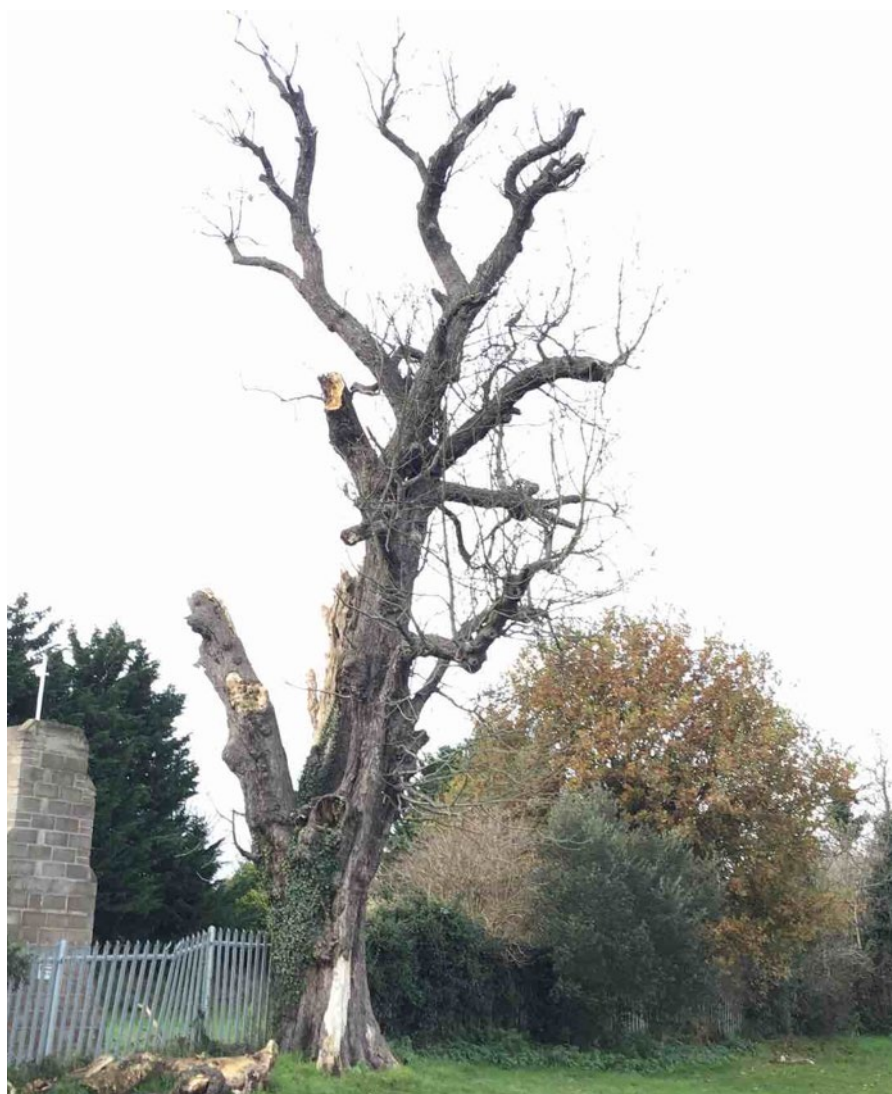
Tree number	13
Road	Ham Street
Location	King George's Field – adjacent to rifle range
Species	Horse Chestnut (<i>Aesculus hippocastanum</i>)
Height	16.0 Meters
Physiological Condition	Dead
Structural Condition	Poor
Inspection findings	This tree is dead and contains weak branches that are liable to collapse

Images shows dead tree

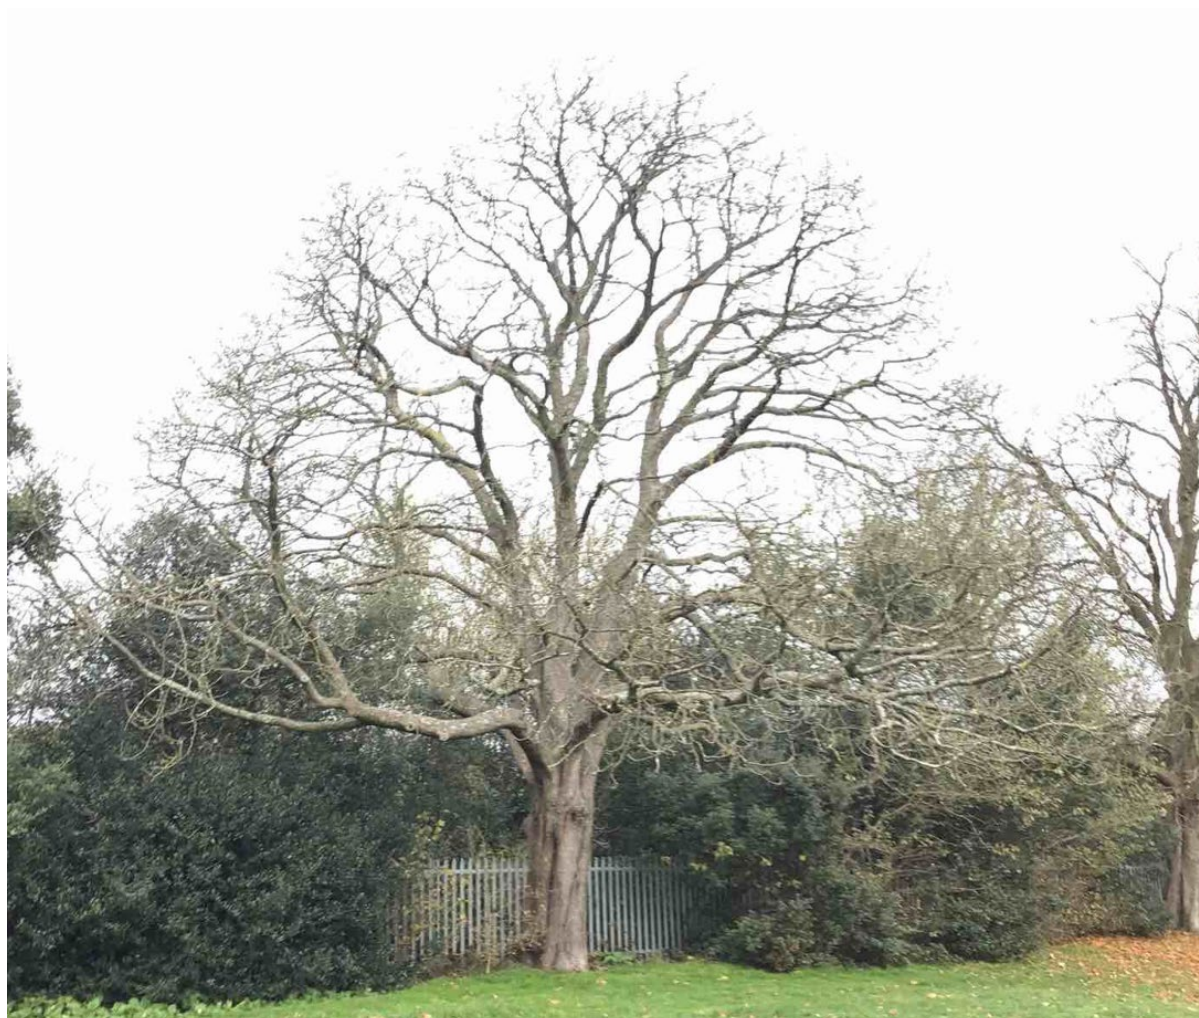
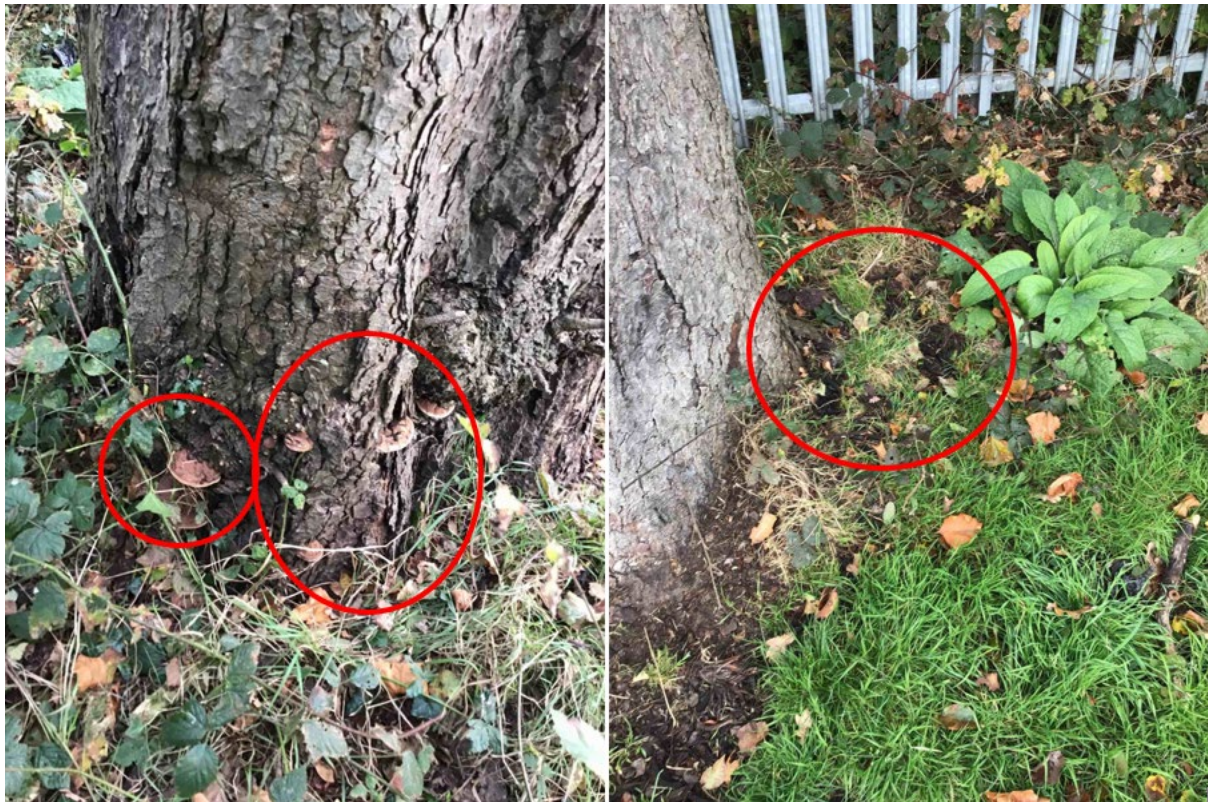
Tree number	12
Road	Ham Street
Location	King George's Field – north boundary
Species	Horse Chestnut (<i>Aesculus hippocastanum</i>)
Height	15.5 Meters
Physiological Condition	Fair
Structural Condition	Poor
Inspection findings	Fungal fruiting bodies of the decay pathogen <i>Armillaria</i> sp. are present at the base of this tree. Colonisation by this fungus causes a white rot of the roots and butt that can cause entire tree failure. A fungal fruiting body of the decay pathogen <i>Ganoderma</i> sp. is present at the stem base. Colonisation by this fungus causes a white rot of the stem and root system that can cause entire trees to collapse through fracture or windthrow. A resonance test revealed an unacceptable degree of decay in the trunk of this tree, removal is required to prevent natural failure and manage risk.

First images show tree in situ, second image (left) shows Ganoderma fruiting bodies on the trunk and third image (right) shows remnants of armillaria fruiting bodies adjacent to the base.
