Ham, Petersham and Richmond Riverside - 2022 Ward Works and Tree Removals Programme

Introduction

Dated 27.01.2022

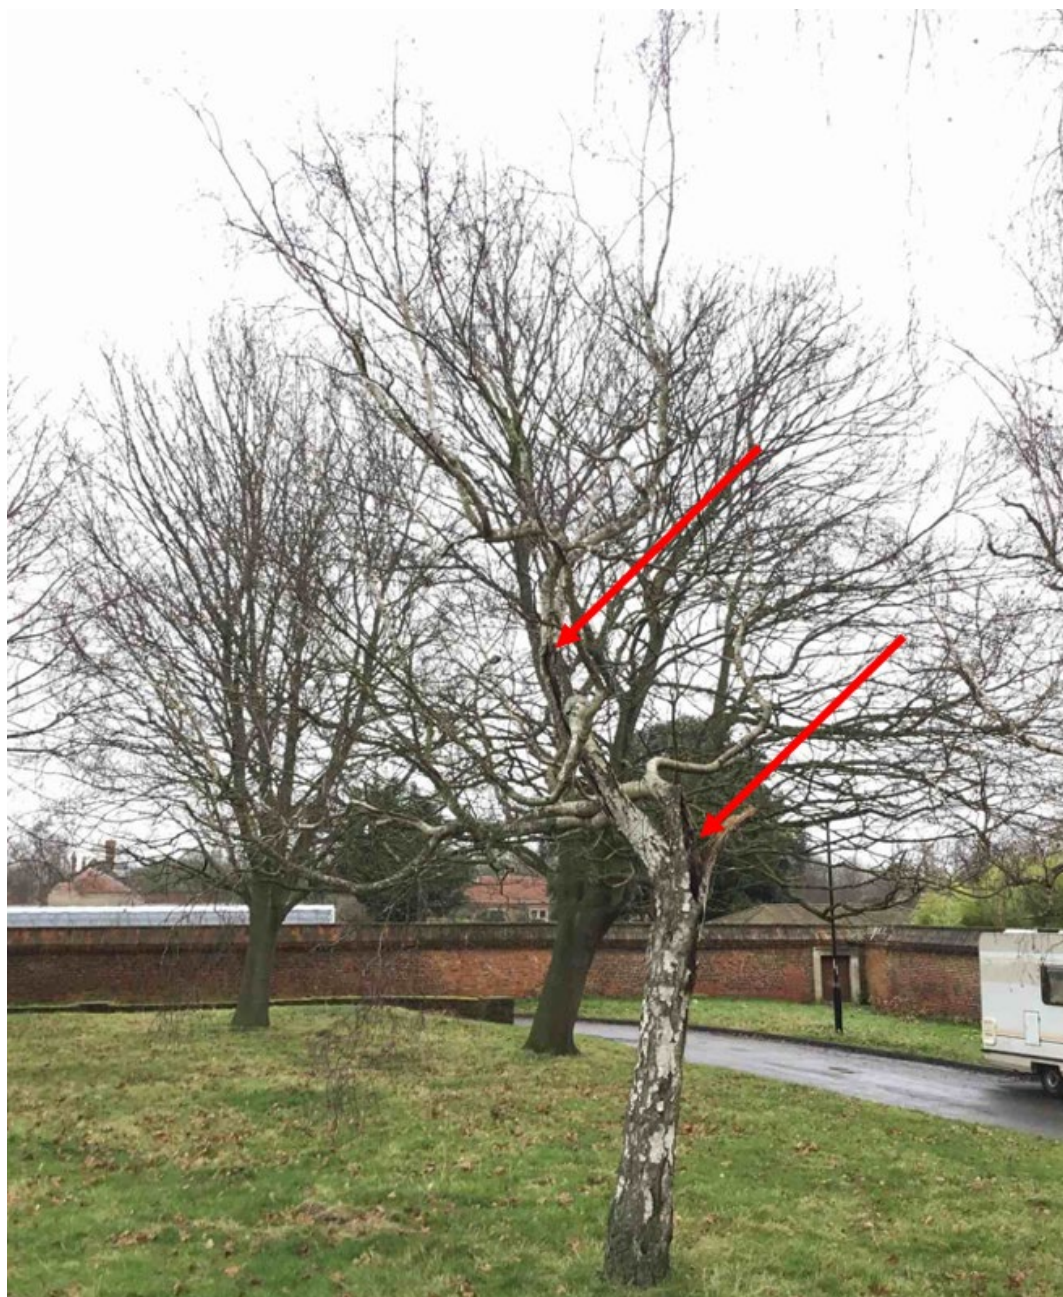
Tree number	-
Road	Ham Street
Location	King George's Field – adjacent to rifle range
Species	Silver Birch (<i>Betula pendula</i>)
Height	7.0 Meters
Physiological Condition	Good
Structural Condition	Poor
Inspection findings	The main stem has failed, there is a cavity at the failure site, a cavity in the largest remaining branch and the remaining crown is liable to collapse.

Images shows tree in situ with cavities indicated by arrows

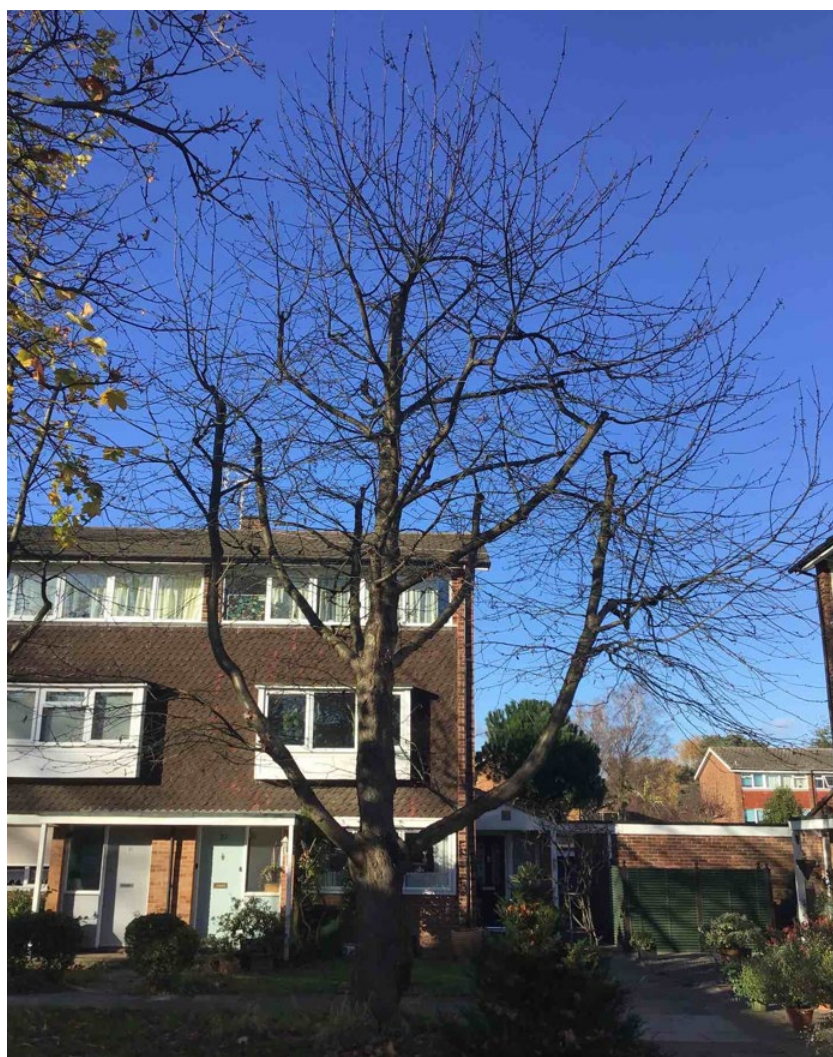
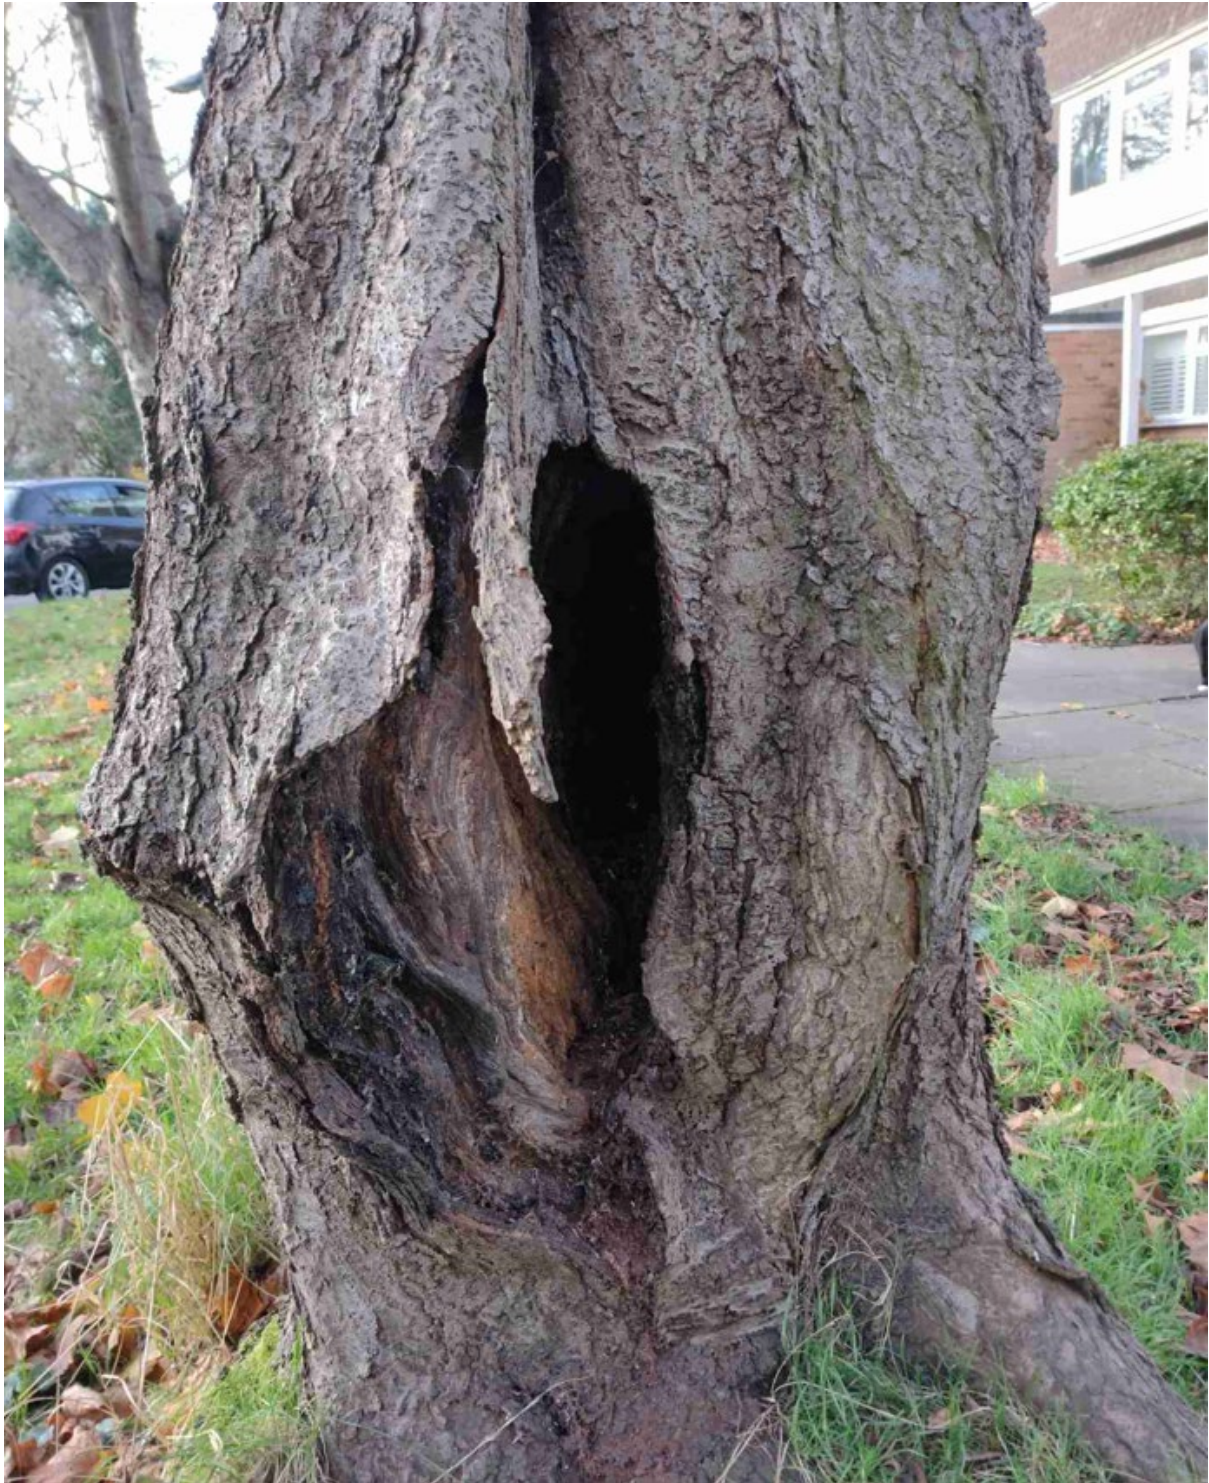
Tree number	2
Road	Hardwicke Road
Location	On grass area by Junction to Simpson Road- Need Map
Species	Wild Cherry (<i>Prunus avium</i>)
Height	12.5 meters
Physiological Condition	Fair
Structural Condition	Poor
Inspection findings	A cavity indicating lower stem decay is present at the base of this tree. A resonance test revealed an unacceptable degree of decay in the trunk of this tree, removal is required to prevent natural failure and manage risk.

First image shows tree in situ, second image shows cavity at base

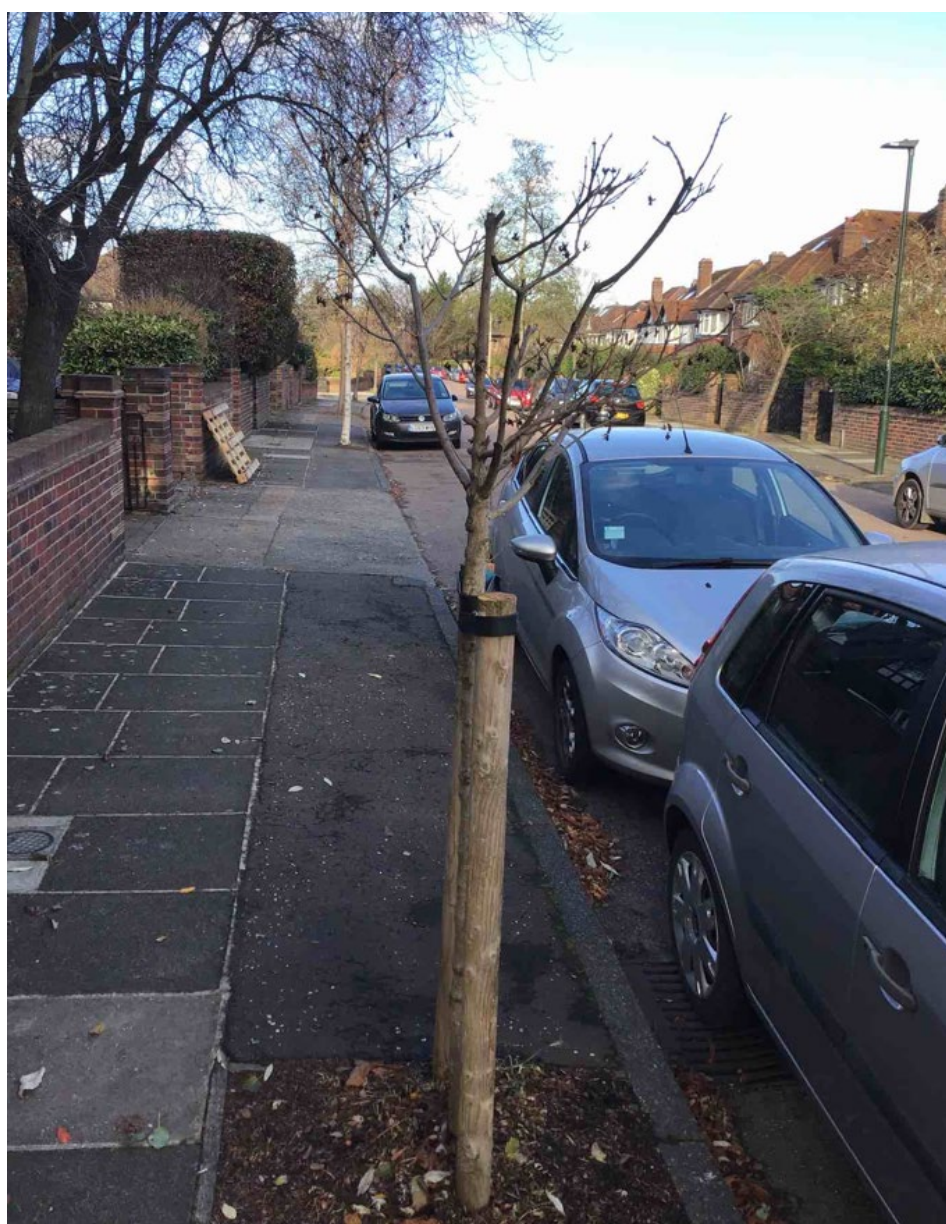
Tree number	-
Road	Lauderdale Drive
Location	Outside 16
Species	Privet (<i>Ligustrum</i> sp.)
Height	2.0 meters
Physiological Condition	Good
Structural Condition	Poor
Inspection findings	This tree has been disfigured by unauthorised cutting

Image shows tree with tops cut off

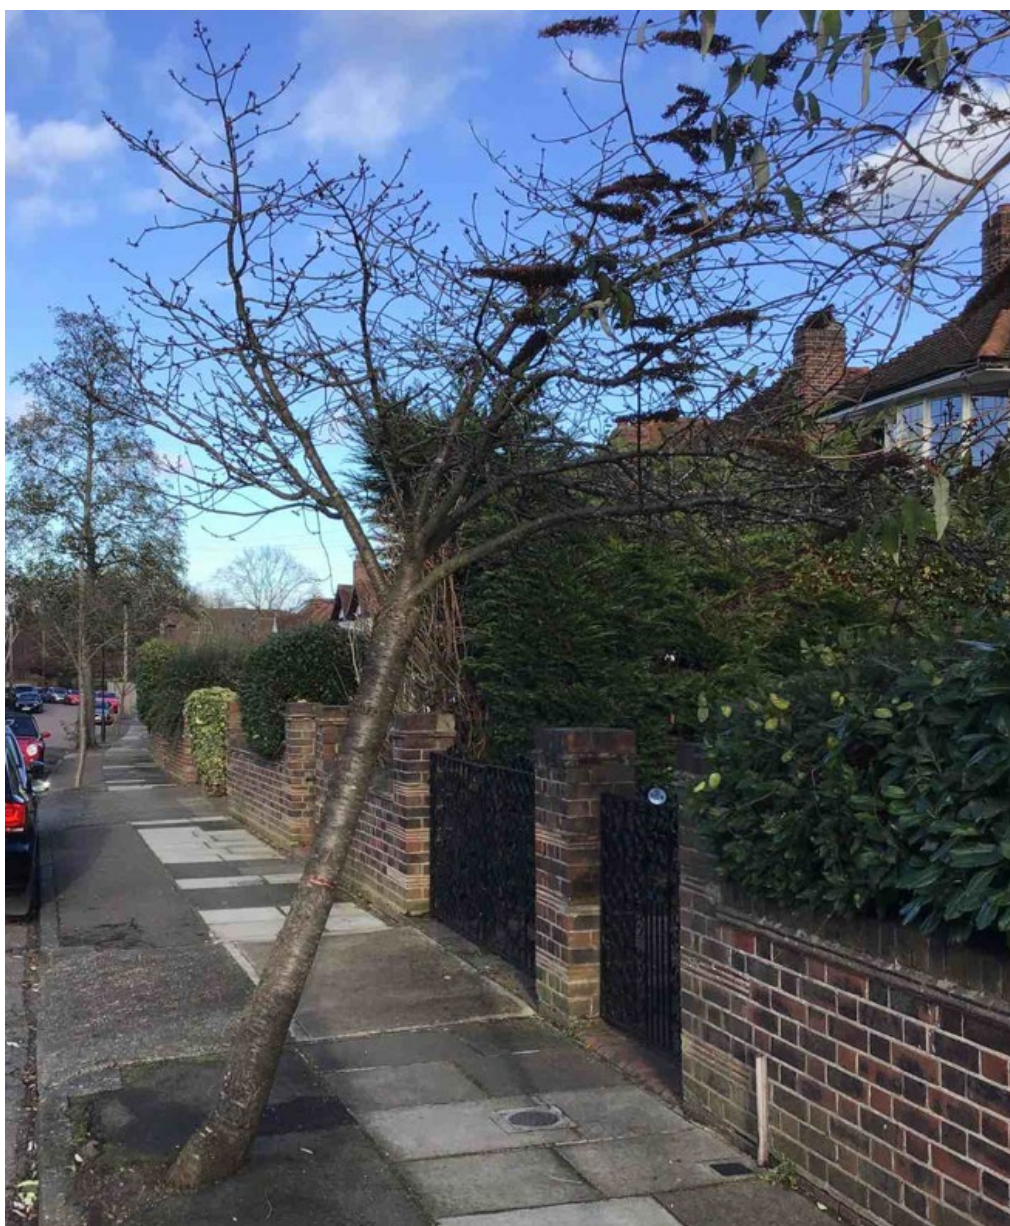
Tree number	7
Road	Lauderdale Drive
Location	Outside 23
Species	Wild Cherry (<i>Prunus avium</i>)
Height	3.5 Meters
Physiological Condition	Good
Structural Condition	Poor
Inspection findings	This tree is causing an unacceptable degree of obstruction of the footway

Image shows tree is situ and restricted footway

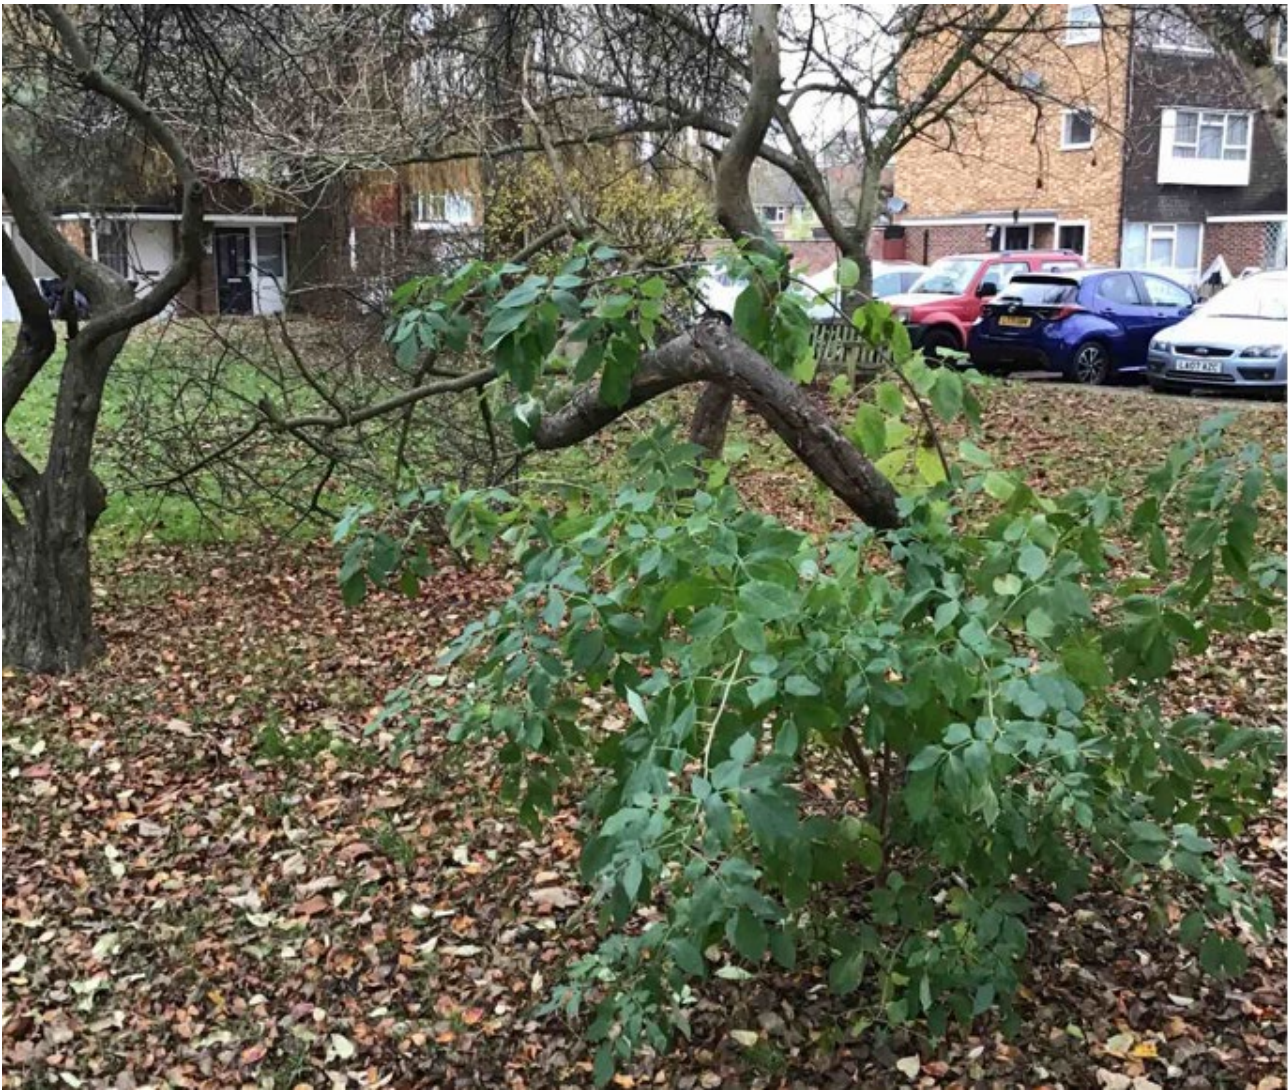
Tree number	7
Road	Mariner Gardens
Location	Outside 35
Species	Cherry (<i>Prunus sp.</i>)
Height	2.0 Meters
Physiological Condition	Not assesses
Structural Condition	Poor
Inspection findings	The trunk of this tree has failed, and the tree has collapsed. Removal is required to facilitate replanting.

Image shows collapsed tree

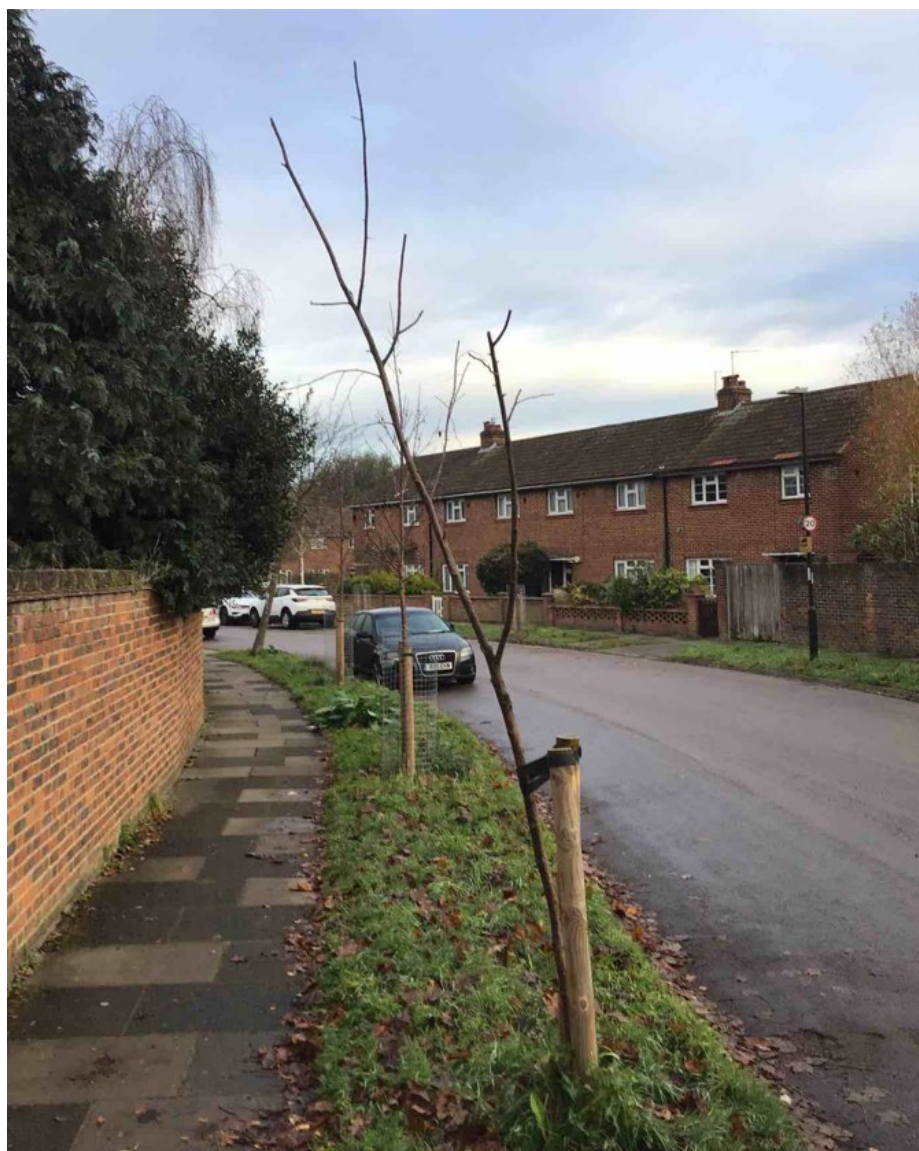
Tree number	-
Road	Meadlands Drive
Location	Adjacent to 58 Sandy Lane main building
Species	Birch (<i>Betula sp.</i>)
Height	3.0 Meters
Physiological Condition	Dead
Structural Condition	Poor
Inspection findings	This tree is dead. Removal is required to prevent natural failure and facilitate replanting.

Image shows dead tree

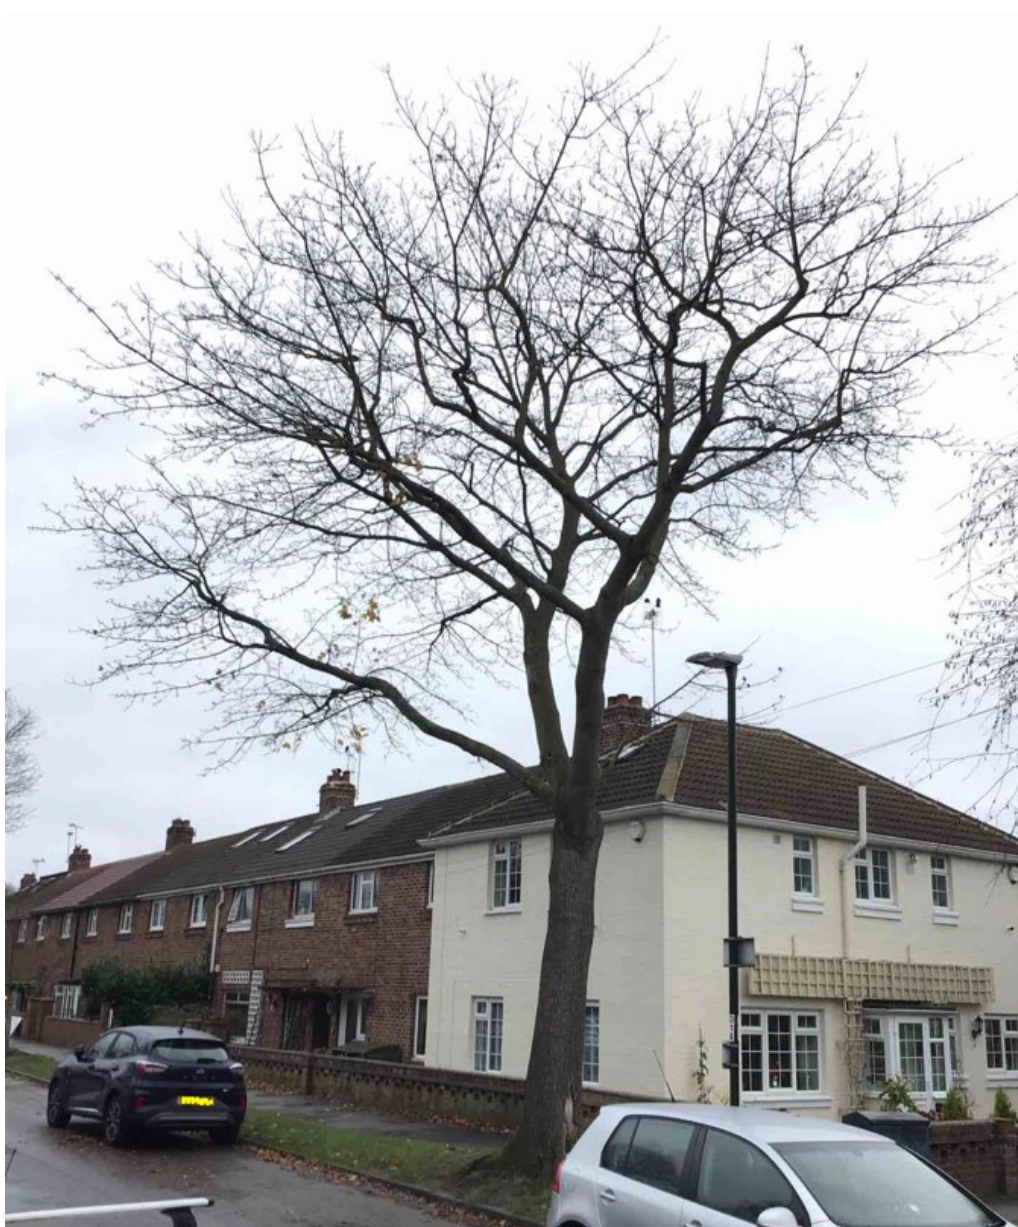
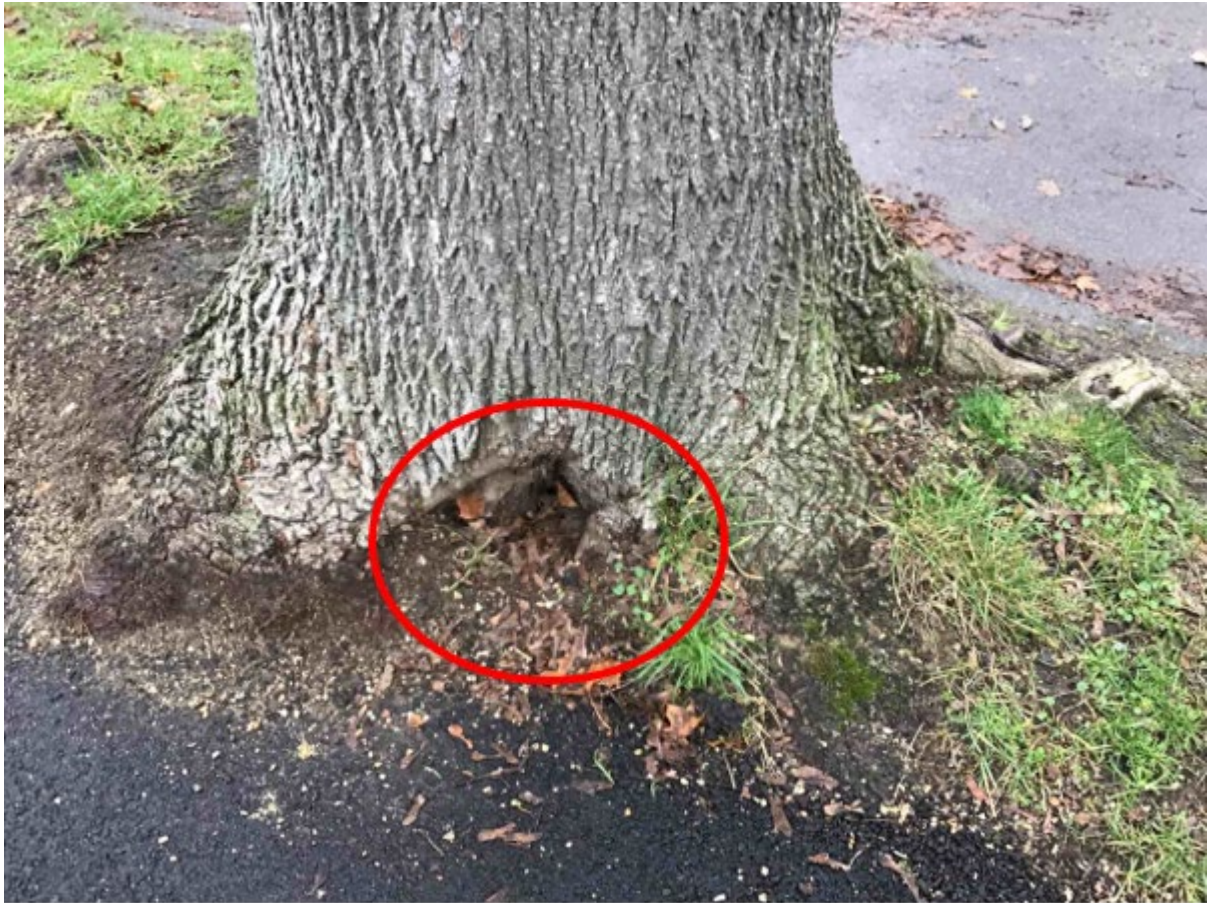
Tree number	25
Road	Meadlands Drive
Location	Outside 66
Species	Norway Maple (<i>Acer platanoides</i>)
Height	13.5 Meters
Physiological Condition	Poor
Structural Condition	Poor
Inspection findings	Cavities indicating root and lower stem decay are present at the base of this tree. Investigation with a probe revealed an unacceptable degree of decay present. Removal is required to prevent natural failure and manage risk.

First image shows tree in situ, second image shows basal cavity to south circled, cavity is also present on the north side of the base.

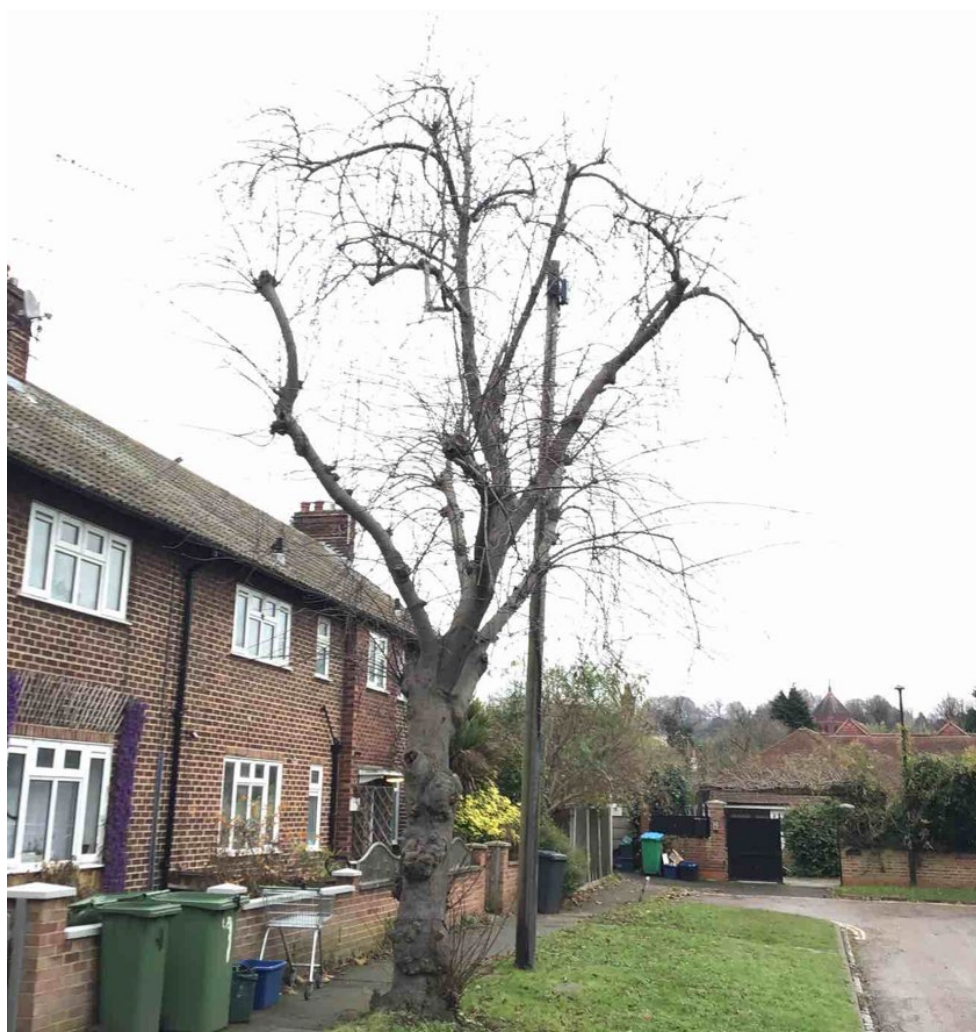
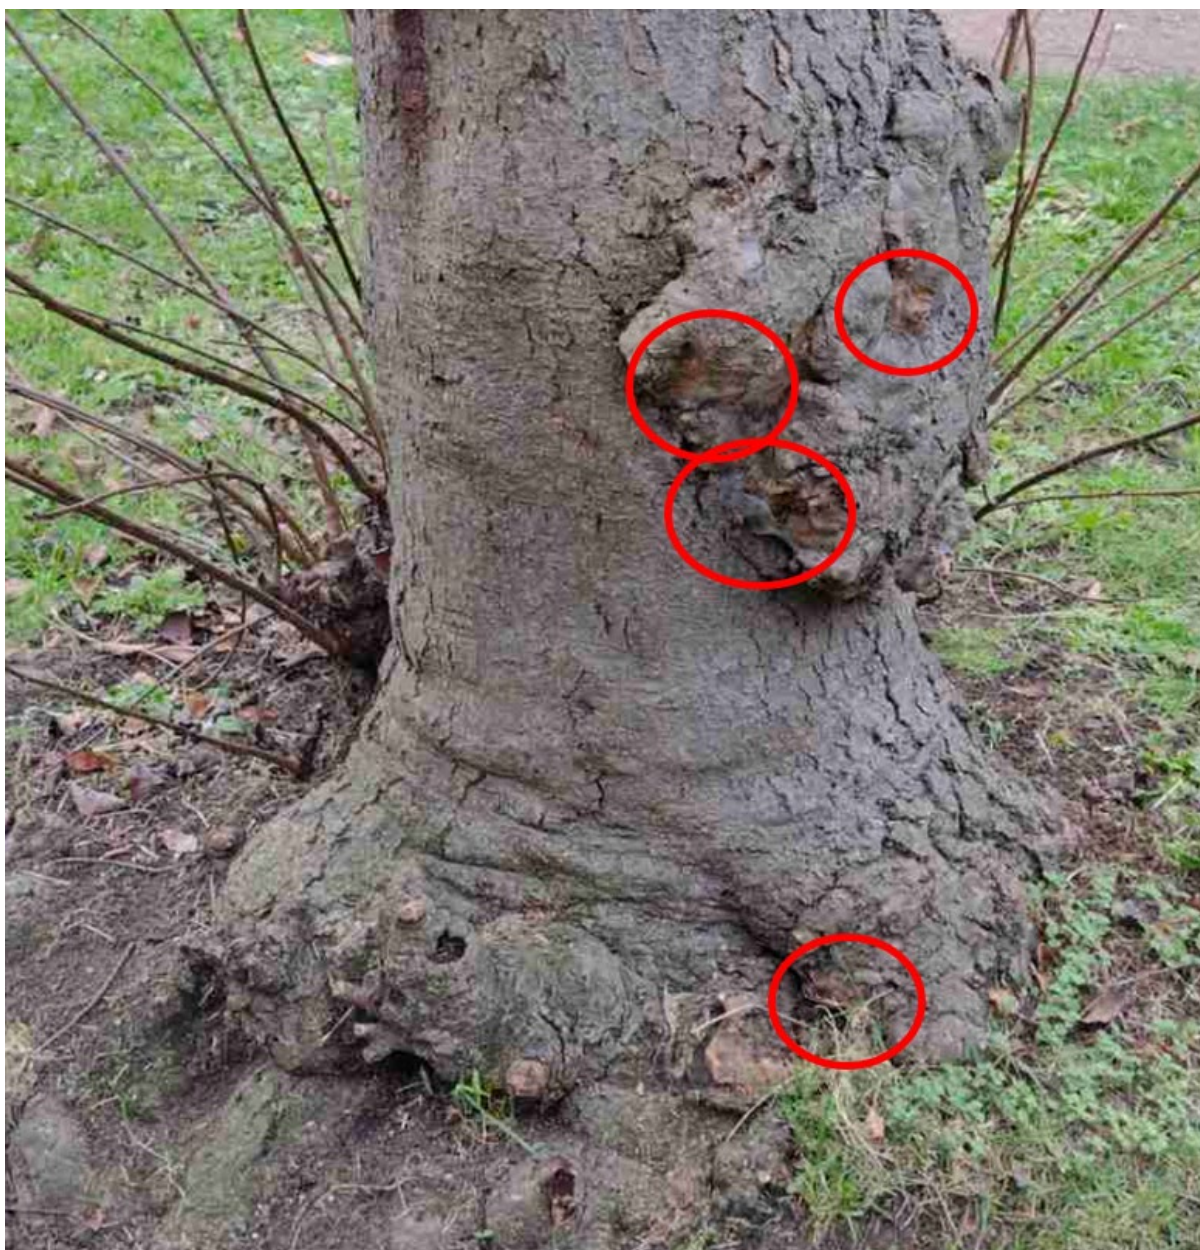
Tree number	1
Road	Petersham Close
Location	Outside 7&3
Species	Bird Cherry (<i>Prunus padus</i>)
Height	9.0 Meters
Physiological Condition	Good
Structural Condition	Poor
Inspection findings	A fungal fruiting body of the decay pathogen <i>Ganoderma</i> sp. is present at the stem base. Colonisation by this fungus causes a white rot of the stem and root system that can cause entire trees to collapse through fracture or windthrow. A resonance test revealed an unacceptable degree of decay in the trunk of this tree, removal is required to prevent natural failure and manage risk.

First image shows tree in situ, second image shows fungal fruiting bodies near base

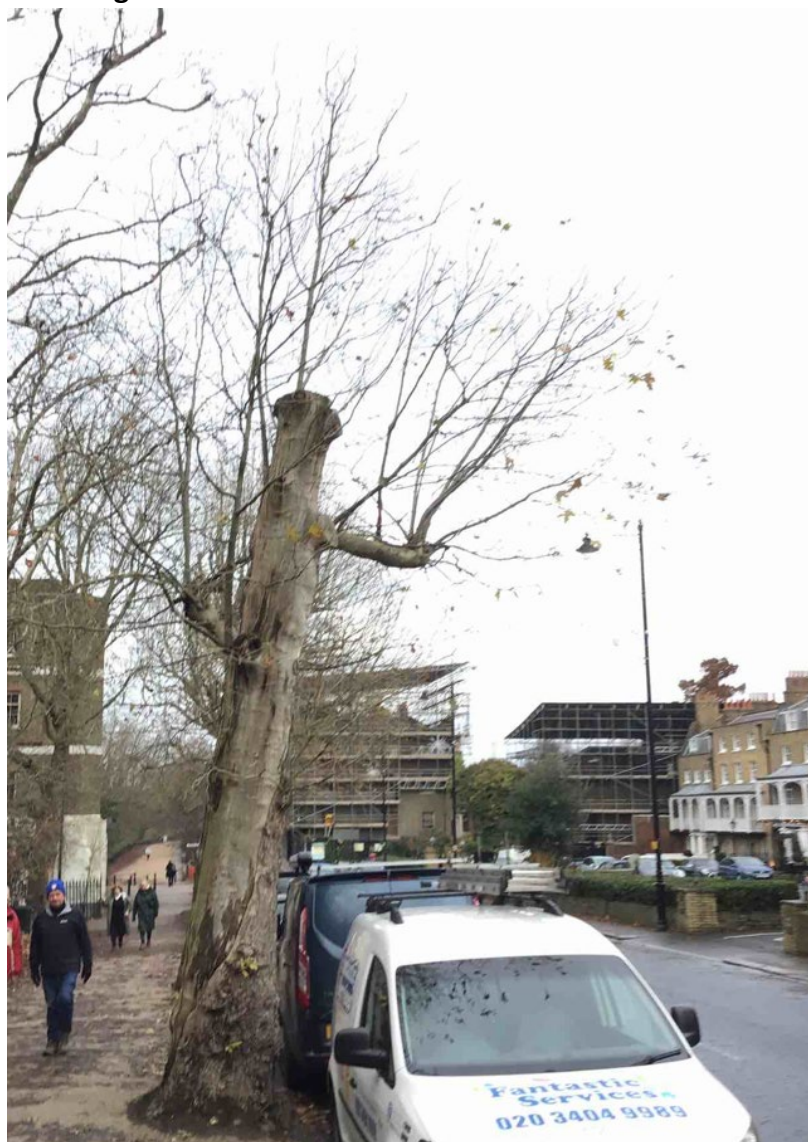
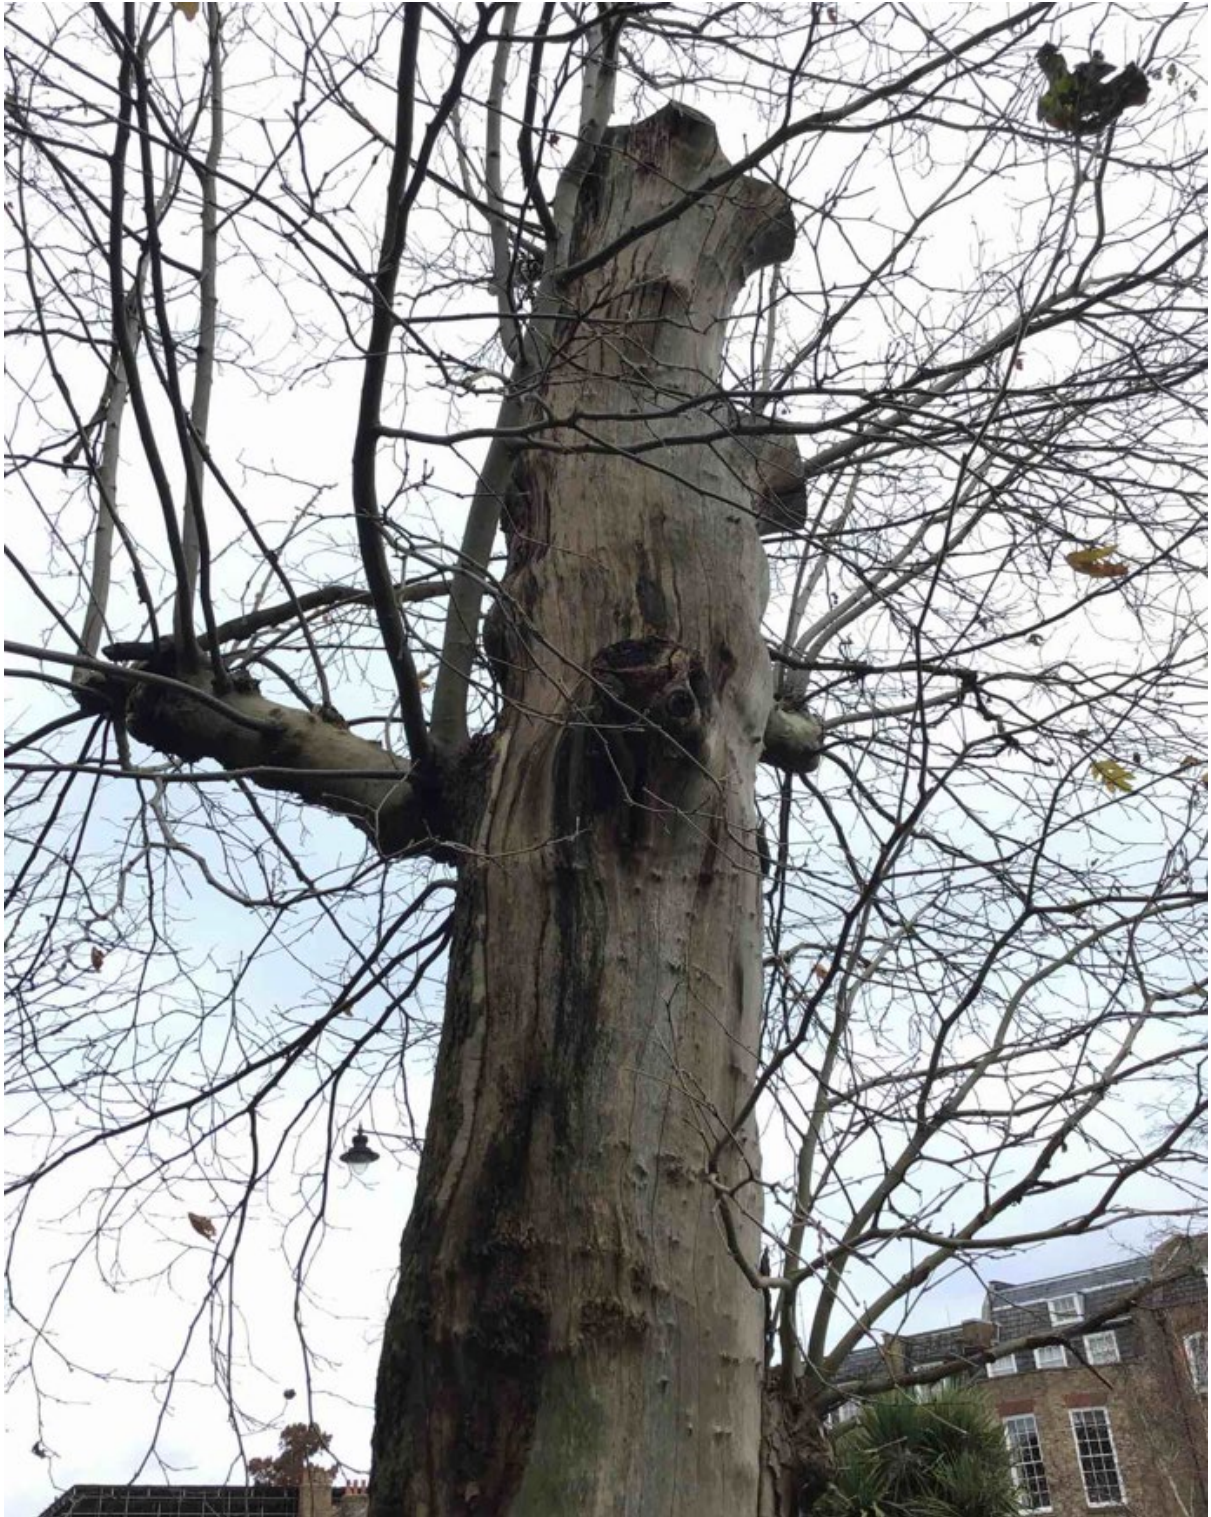
Tree number	3
Road	Richmond Hill
Location	Opposite entrance to Harbour Hotel and Lamppost 030
Species	Oriental Plane (<i>Platanus orientalis</i>)
Height	8.5 Meters
Physiological Condition	Poor
Structural Condition	Poor
Inspection findings	This tree has cracked, peeling bark indicating dysfunction of the trees vascular system; the decline of the trees vascular system correlates with dieback within the crown of this declining specimen. Removal is required to prevent natural failure and facilitate replanting.

First image shows tree in situ, second image shows extent of bark die back

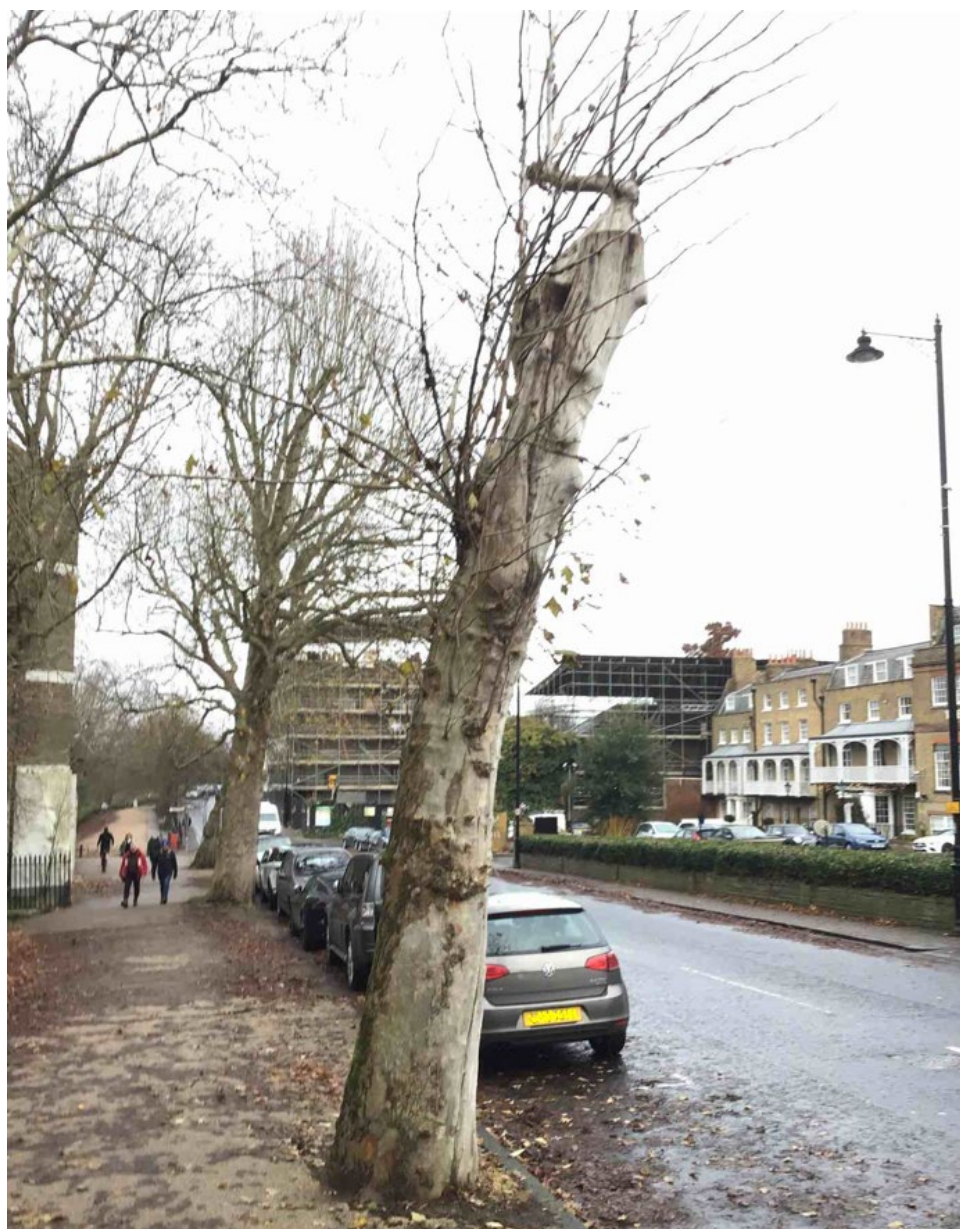
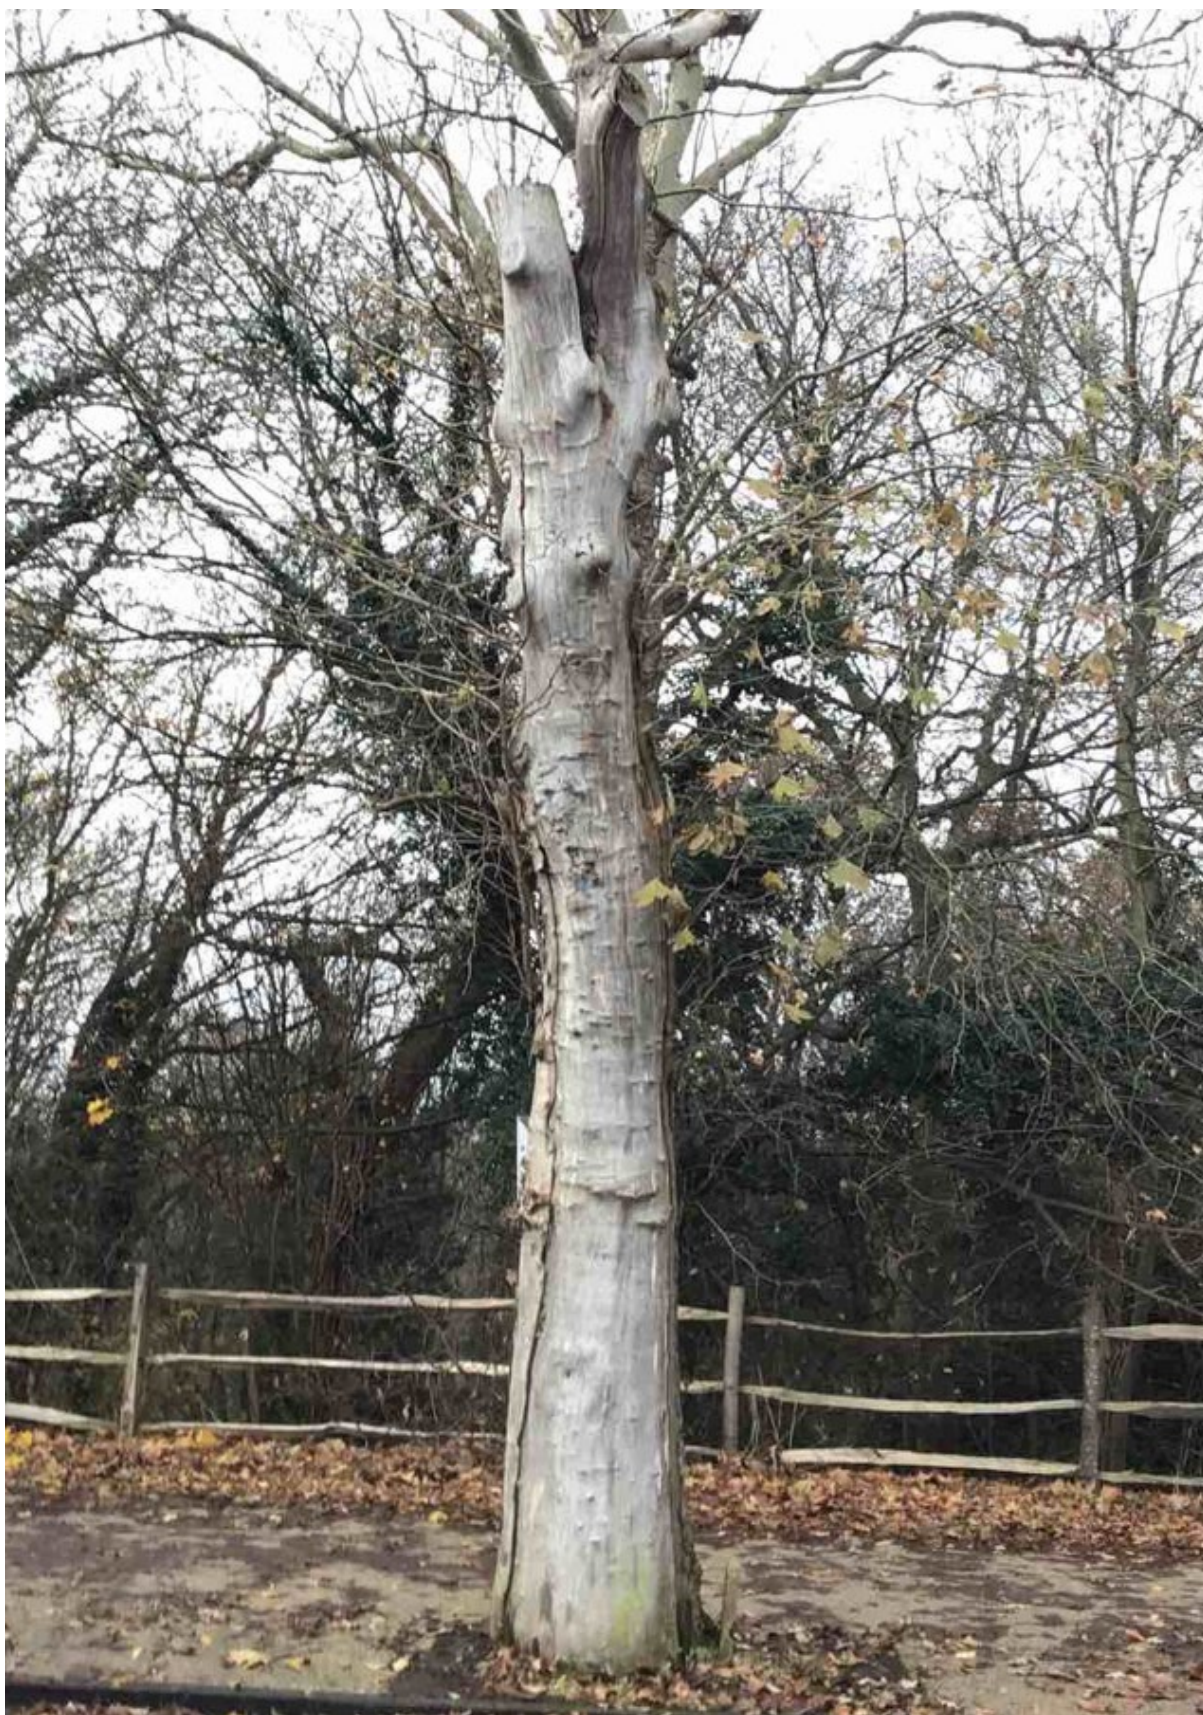
Tree number	4
Road	Richmond Hill
Location	Opposite The Richmond Hill Hotel and Harbour Hotel
Species	Oriental Plane (<i>Platanus orientalis</i>)
Height	9.0 Meters
Physiological Condition	Poor
Structural Condition	Poor
Inspection findings	This tree has cracked, peeling bark indicating dysfunction of the trees vascular system; the decline of the trees vascular system correlates with dieback within the crown of this declining specimen. Removal is required to prevent natural failure and facilitate replanting.

First image shows tree in situ, second image shows extent of bark die back
