Ham, Petersham and Richmond Riverside - 2022 Ward Works and Tree Removals Programme

Introduction

Dated 27.01.2022

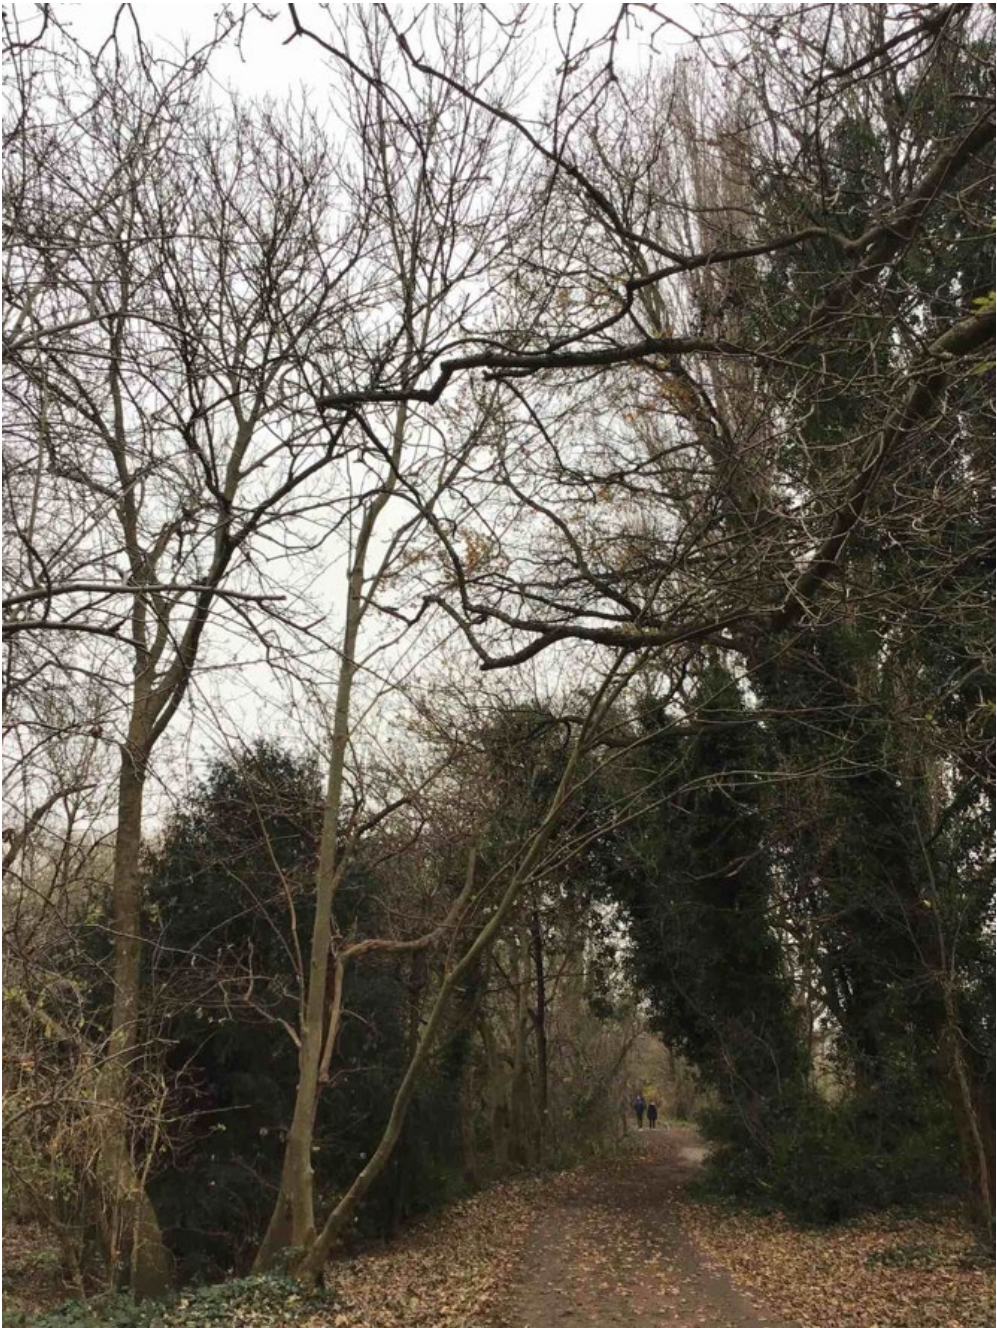
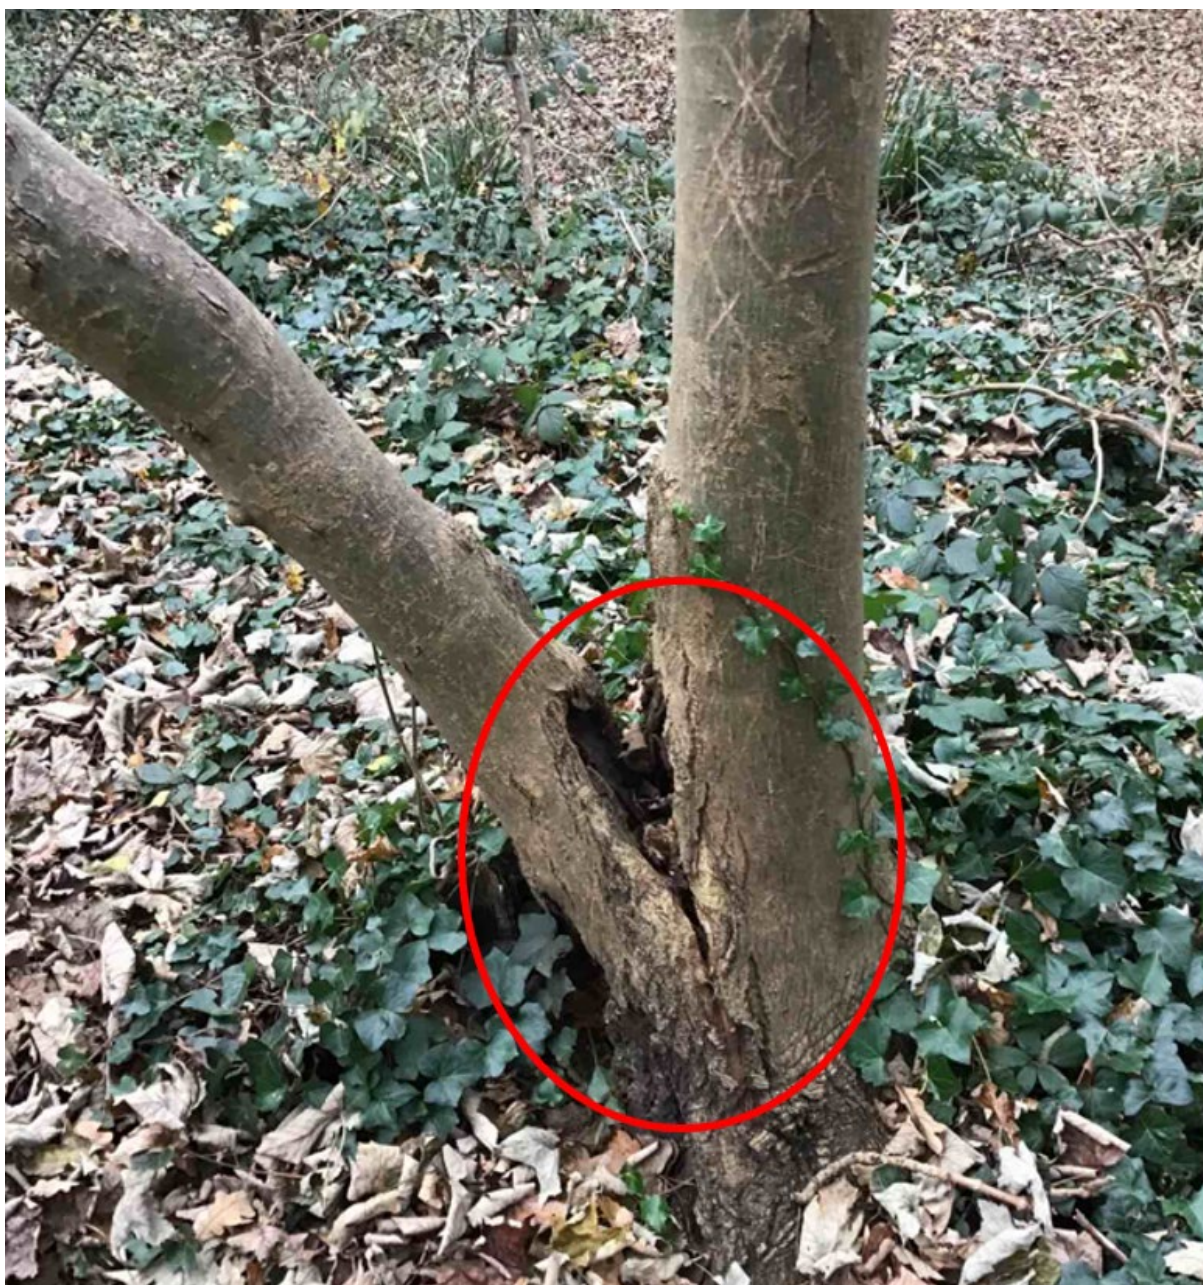
Tree number	12
Road	River Lane
Location	Thames towpath
Species	Ash (<i>Fraxinus excelsior</i>)
Height	15.0 Meters
Physiological Condition	Good
Structural Condition	Poor
Inspection findings	This tree has a weak union at the base which has partially failed and is liable to further collapse.

First image shows tree in situ, second image shows weak union circled

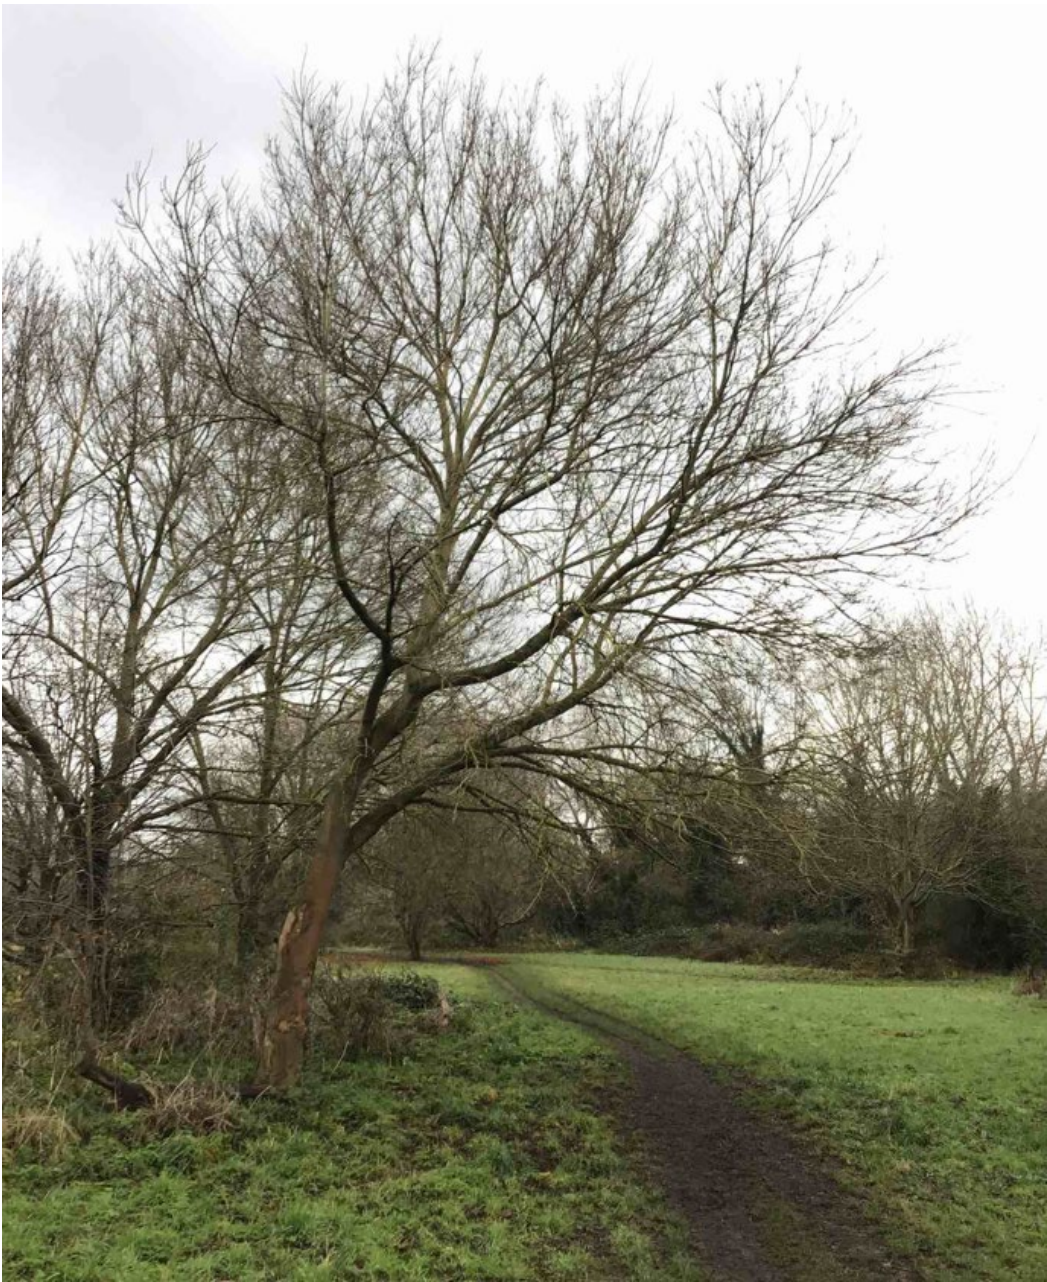
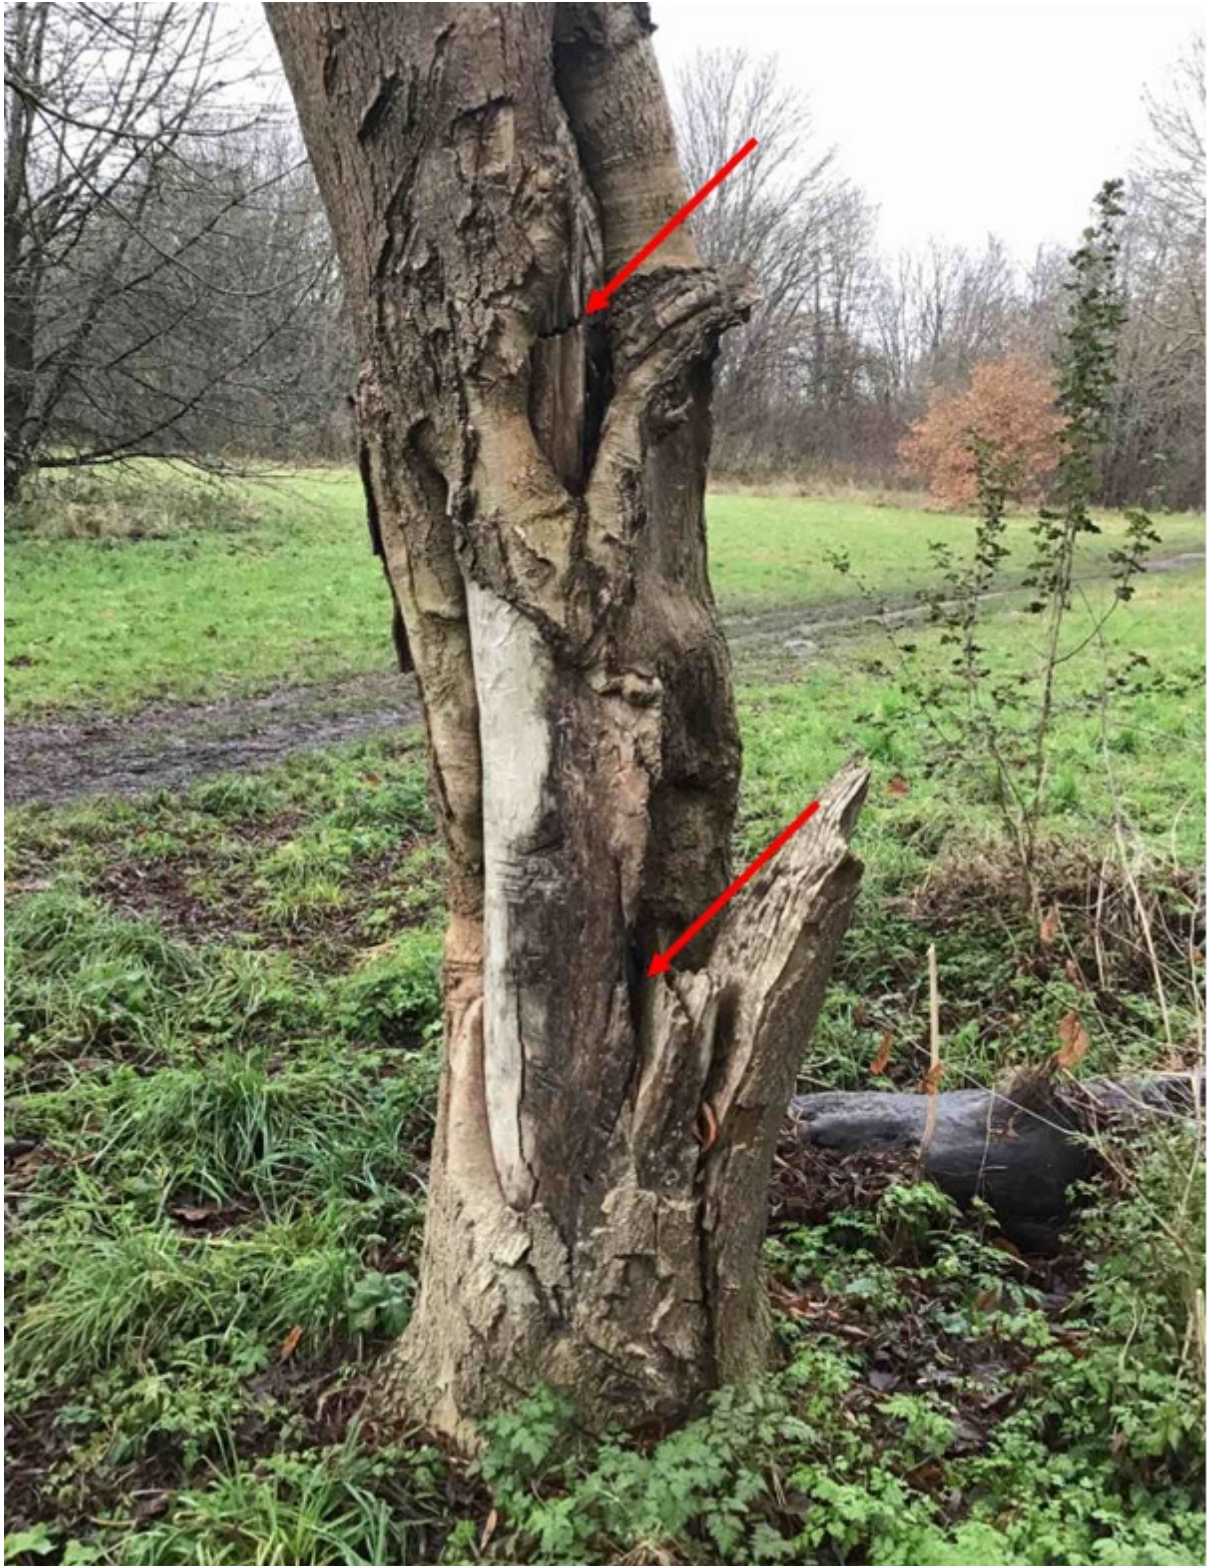
Tree number	4
Site	Ham Common
Location	Between Richmond Lock footpath and southern playground
Species	Ash (<i>Fraxinus excelsior</i>)
Height	12.5 Meters
Physiological Condition	Good
Structural Condition	Poor
Inspection findings	This tree has partially failed and is liable to further collapse. Removal is required to prevent natural failure.

First image shows tree in situ, second image shows wounding and points of likely further failure

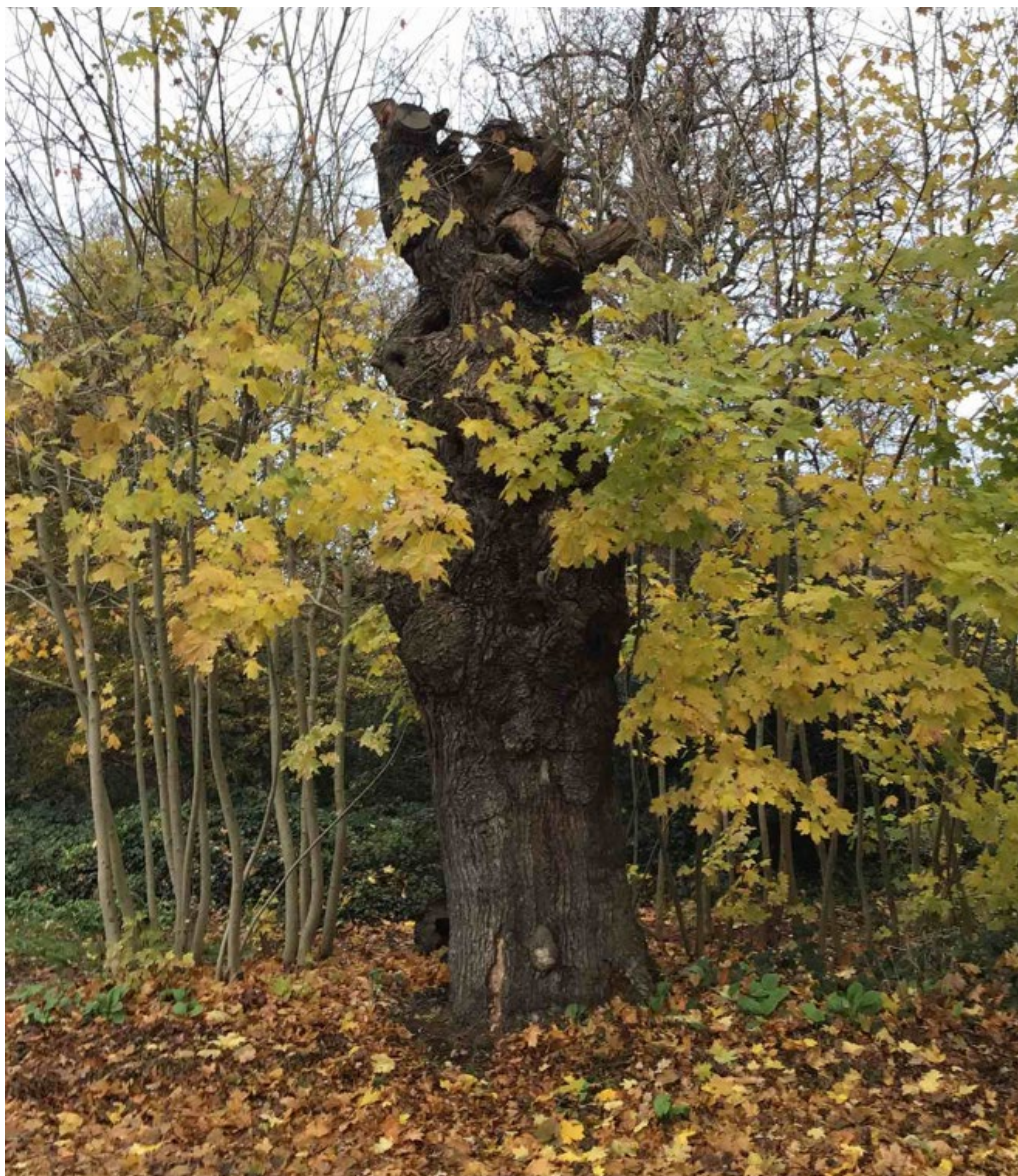
Tree number	19
Road	Sandy Lane
Location	Opposite Side Garden to 22 Meadlands Drive- Need Map
Species	Oak (<i>Quercus robur</i>)
Height	6.5m
Physiological Condition	Dead
Structural Condition	Vandalised
Inspection findings	This tree is dead and is now unstable. The wood is to be retained onsite as habitat.

Image shows tree in situ

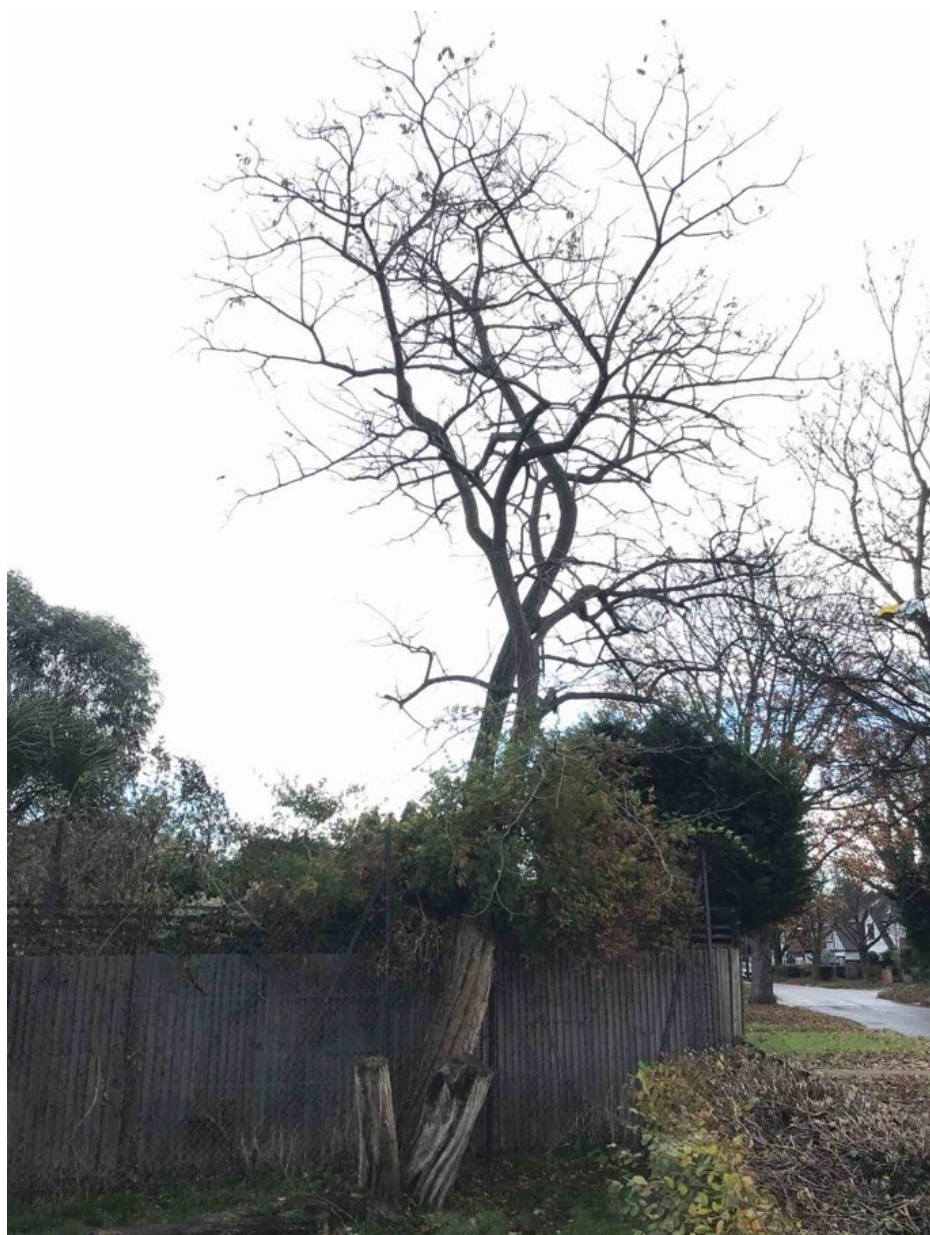
Tree number	19
Road	Sandy Lane
Location	Side of 62
Species	Black Locust (<i>Robinia pseudoacacia</i>)
Height	12.0m
Physiological Condition	Good
Structural Condition	Poor
Inspection findings	This tree has a progressive lean and will cause direct damage to the fence. Last remaining stem of bunch planting or coppice and therefore liable to collapse.

Image shows tree in situ and stumps from removal of other stems

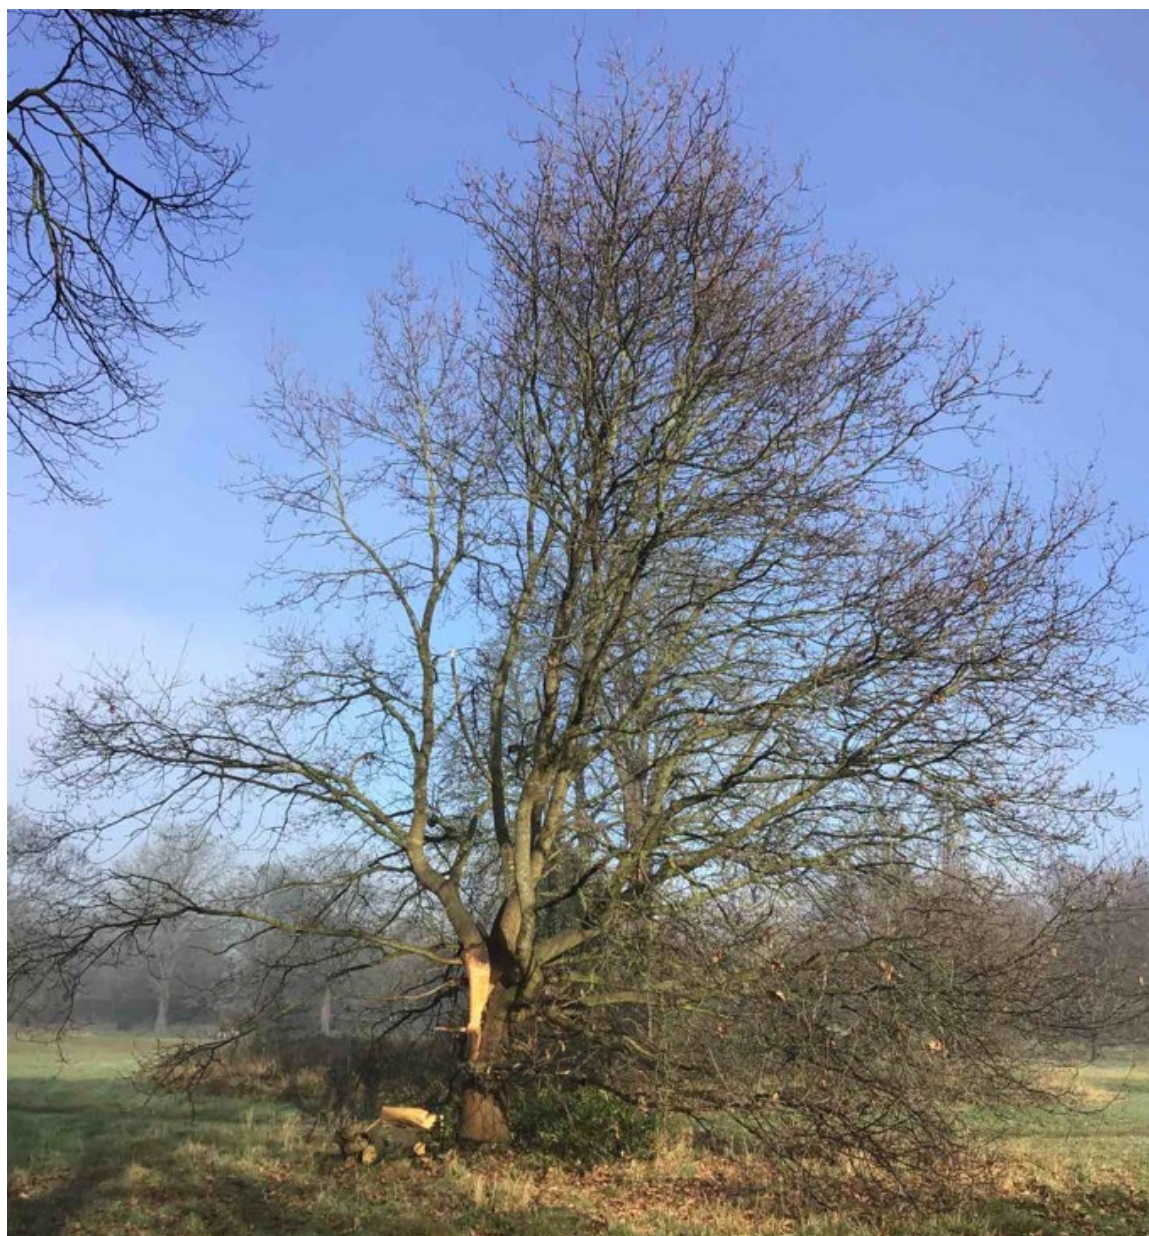
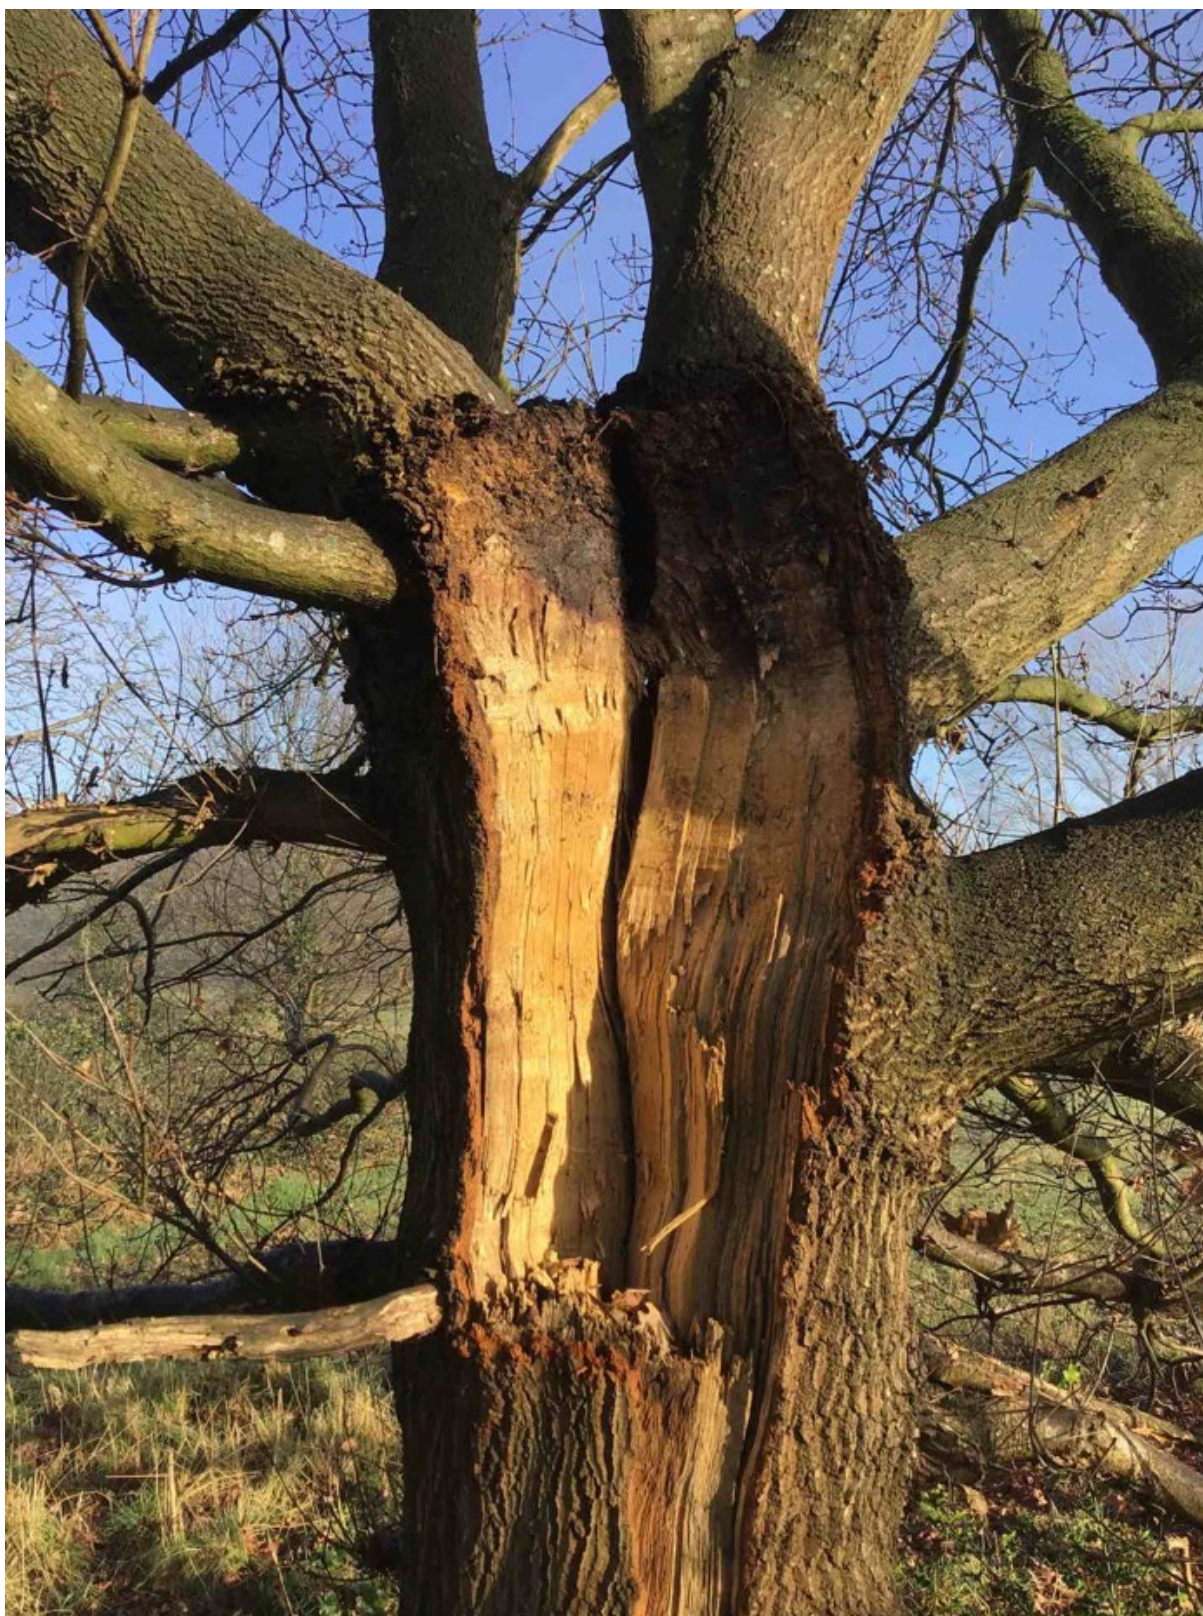
Tree number	19
Road	Sandy Lane
Location	The Copse, near Ham Avenue lane
Species	Oak (<i>Quercus robur</i>)
Height	14.5m
Physiological Condition	Good
Structural Condition	Poor
Inspection findings	This tree has partially failed, and the trunk is cracked leaving the remainder of the crown liable to collapse. Removal of the crown will allow the tree to be retained as a pollard or standing deadwood.

First image shows tree in situ, second image shows crack in trunk from main union

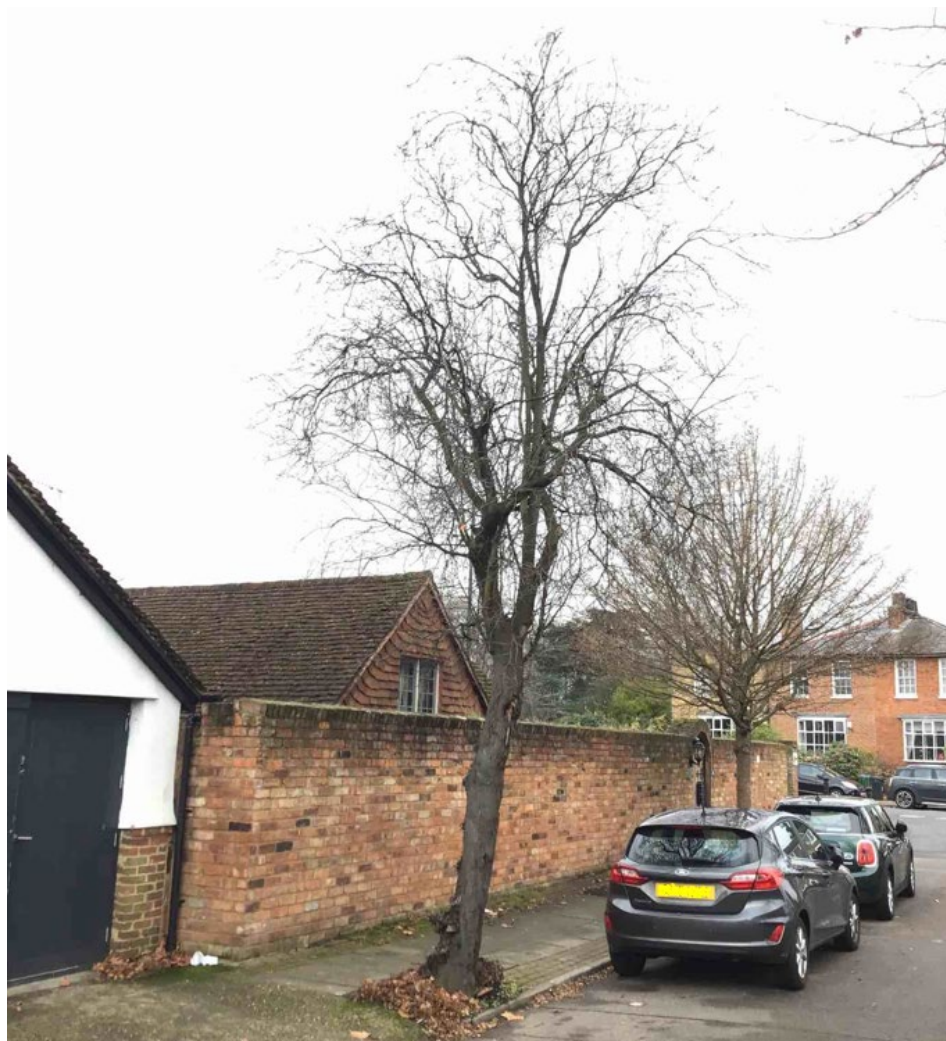
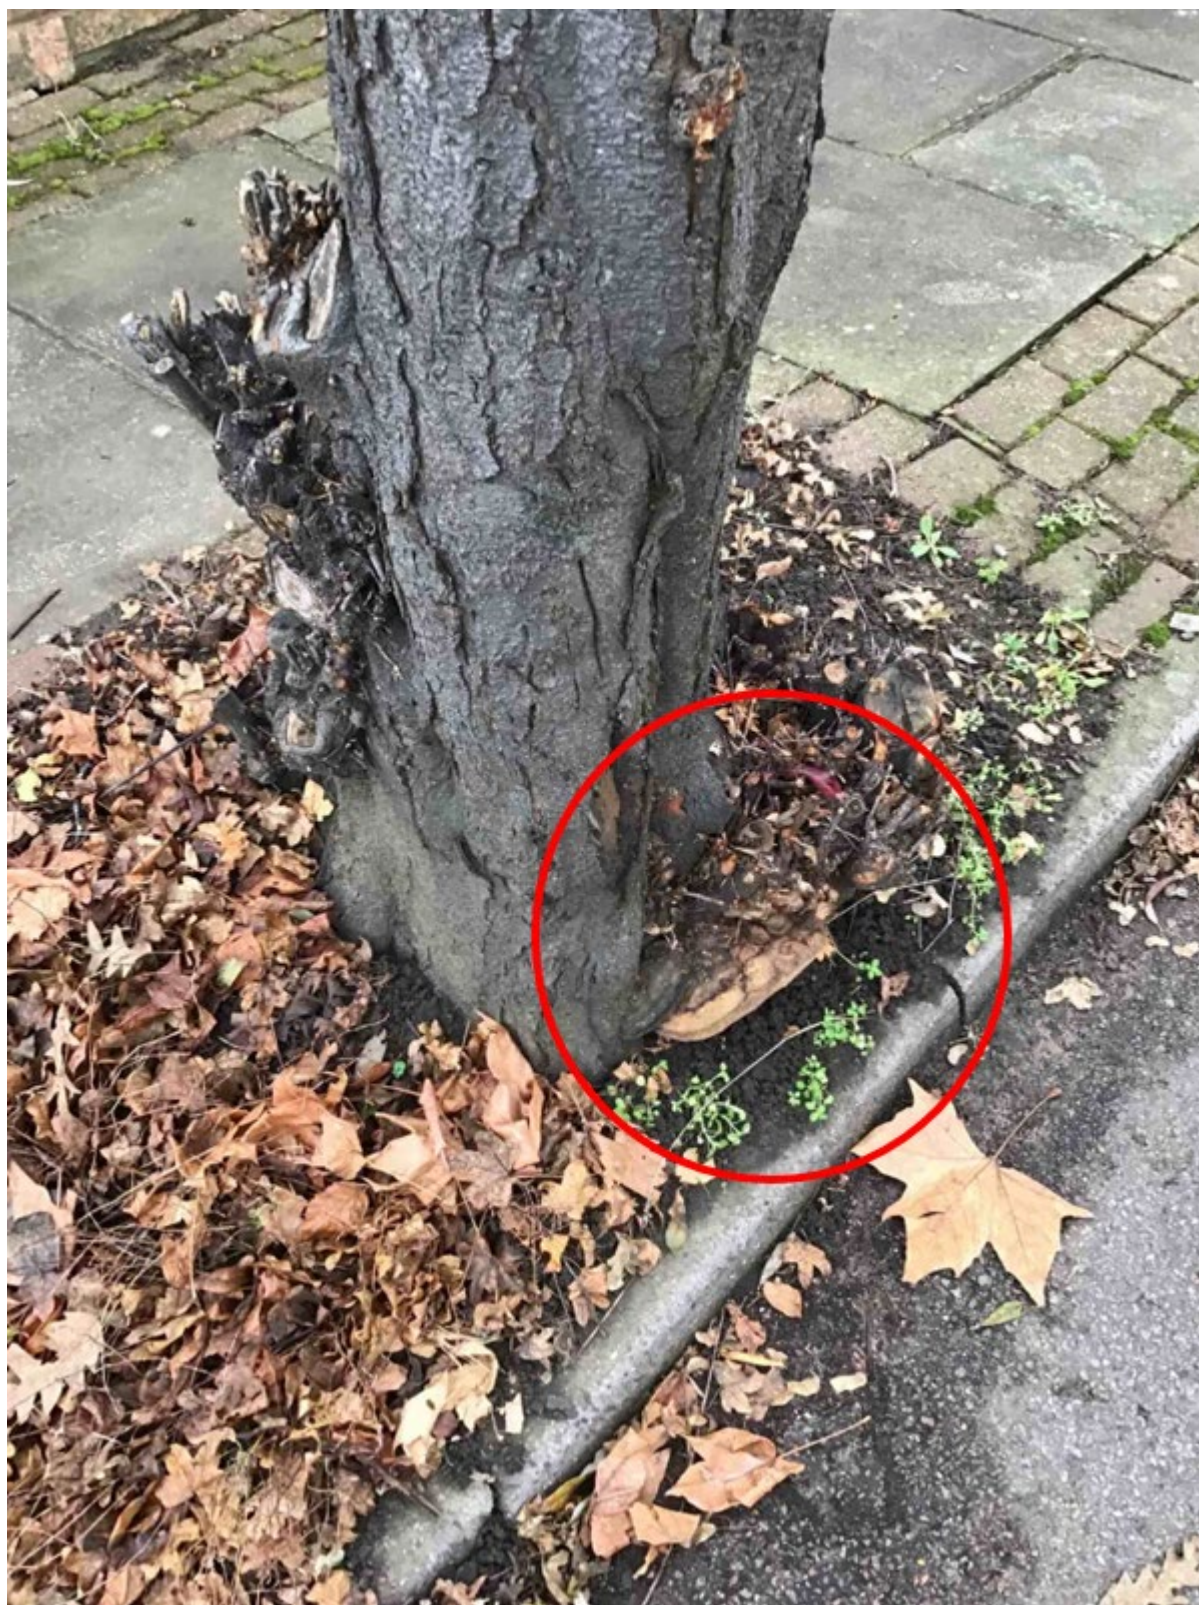
Tree number	9
Road	Sudbrook Gardens
Location	Opposite 1, main building
Species	Purple Plum (<i>Prunus cerasifera</i>)
Height	7.5m
Physiological Condition	Good
Structural Condition	Poor
Inspection findings	Fungal fruiting bodies of the decay pathogen <i>Ganoderma</i> sp. are present at the stem base. Colonisation by this fungus causes a white rot of the stem and root system that can cause entire trees to collapse through fracture or windthrow. A resonance test revealed an unacceptable degree of decay in the trunk of this tree, removal is required to prevent natural failure and manage risk.

First image shows tree in situ, second shows fungal fruiting bodies at base circled
