## **Hampton – 2022/2023 Ward Works and Tree Removals Programme**

### Introduction

Dated 24.02.2022

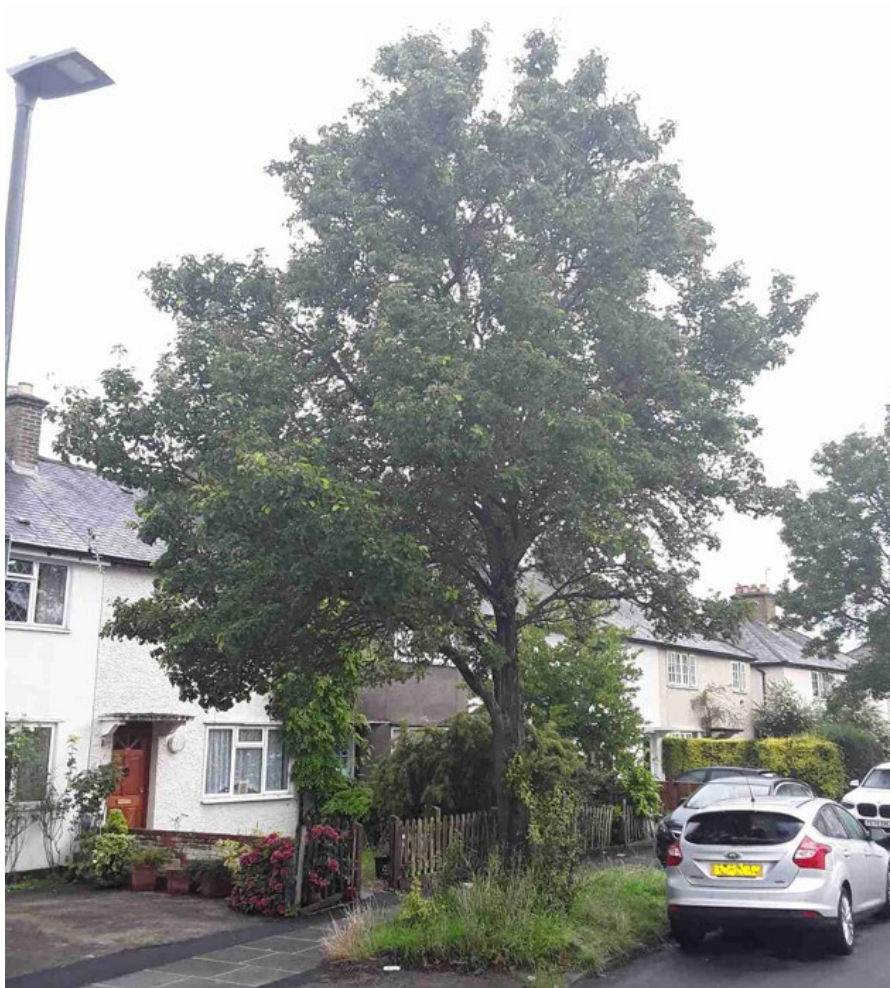
## Site 1. Bloxham Crescent

| Inspection findings | A fungal fruiting body of the decay pathogen <i>Ganoderma</i> sp. is present at the stem base. Colonisation by this fungus causes a white rot of the stem and root system that can cause entire trees to collapse through fracture or windthrow. Frass and insect activity indicating decay are present at the base of the tree. The tree presents an unacceptable risk and removal is required to mitigate this risk. |

**Images show multiple points of branch fracture, wounding and a split in the main stem or trunk**

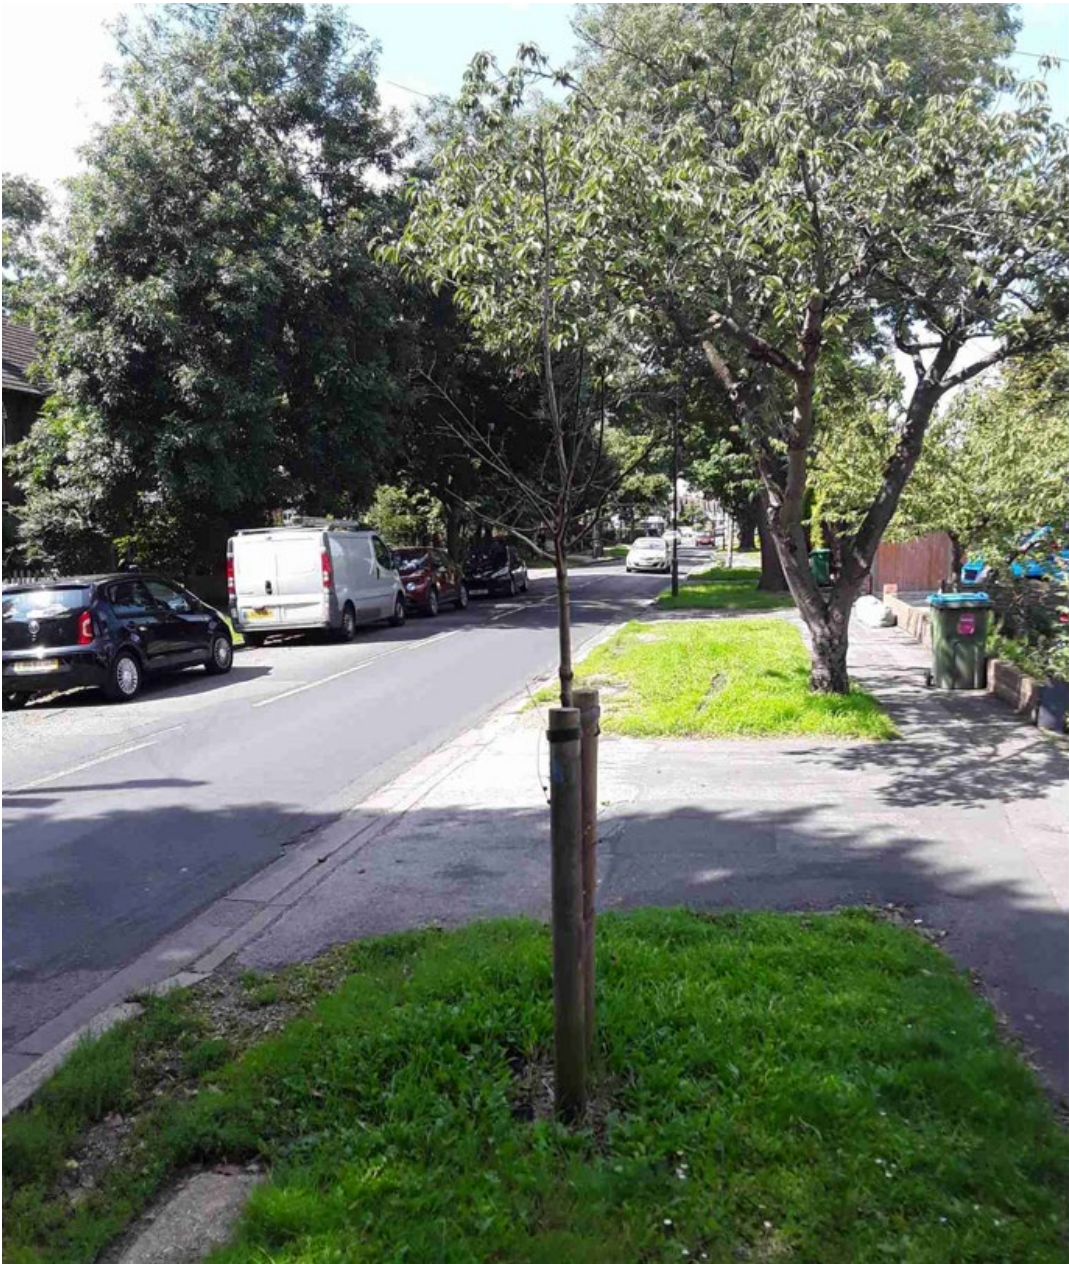
| Location | Outside 60 |

| Inspection findings | This tree is dead and removal is required to prevent natural failure and facilitate replanting. |

**Images show dead tree.**

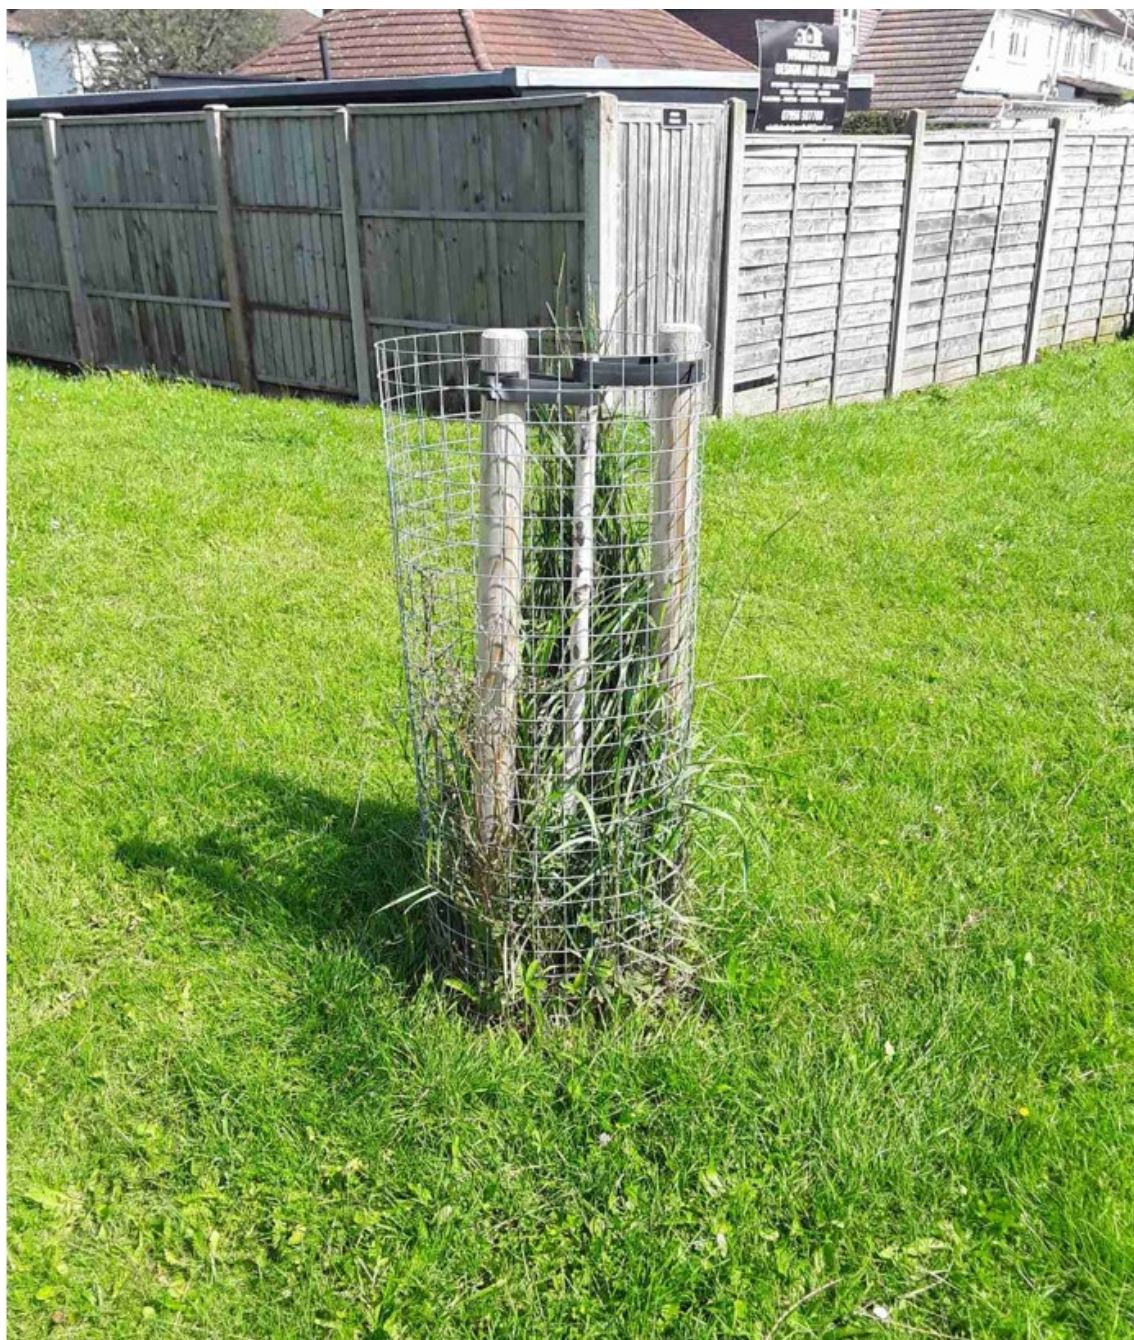
| Location | Hatherop Park – play area |

| Inspection findings | This tree is dead and removal is required to prevent natural failure and facilitate replanting. |

**Images show dead tree.**

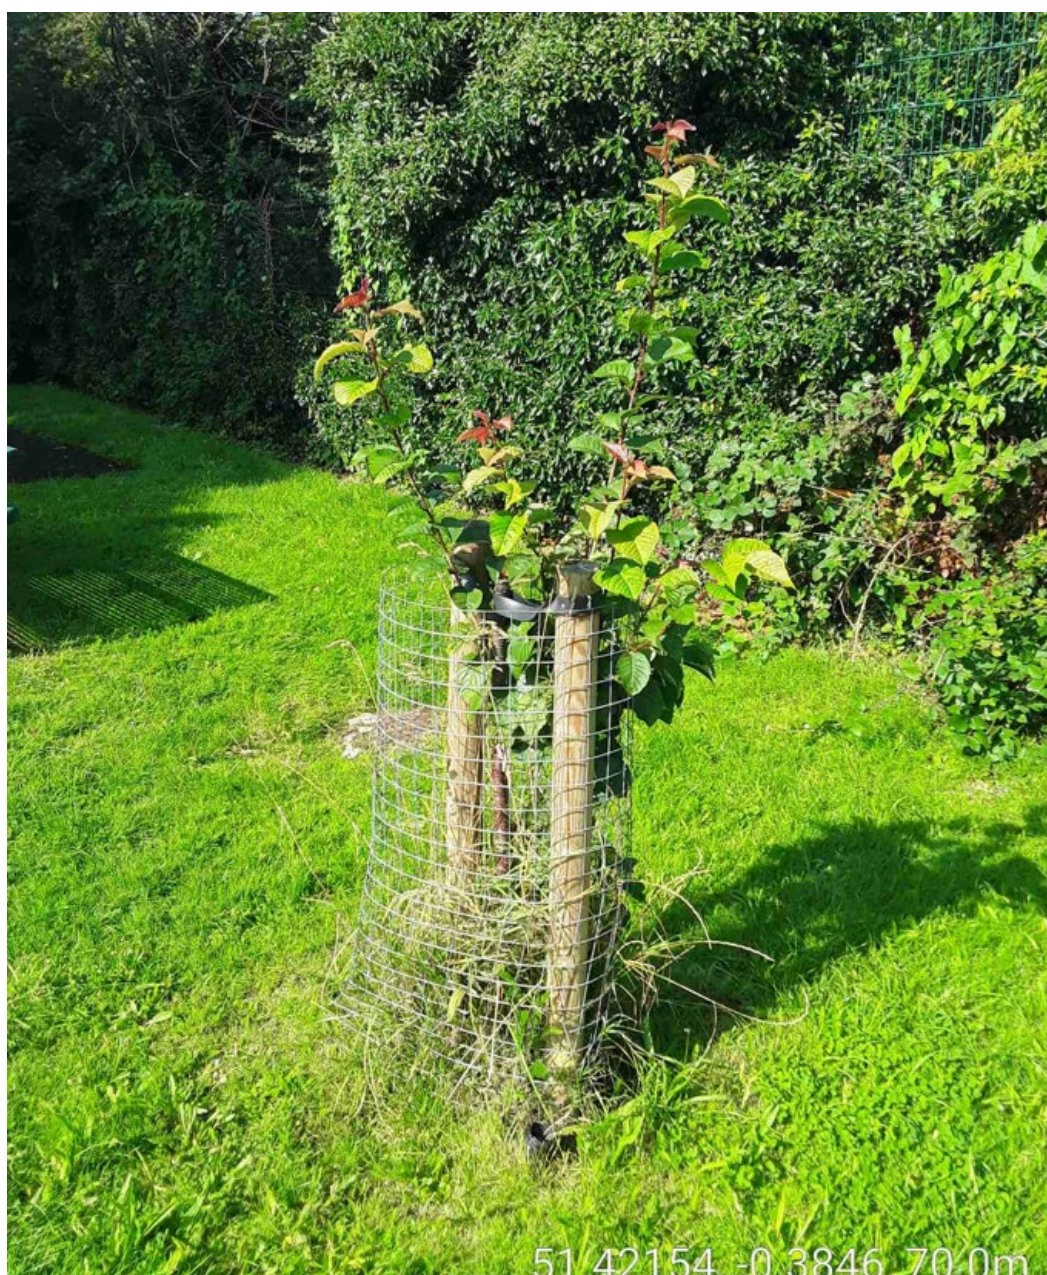
| Location | Hatherop Park – play area |

| Inspection findings | This tree is has been vandalised and is no longer capable of producing the desired canopy and associated benefits and removal is required to and facilitate replanting. |

**Images show vandalised tree.**

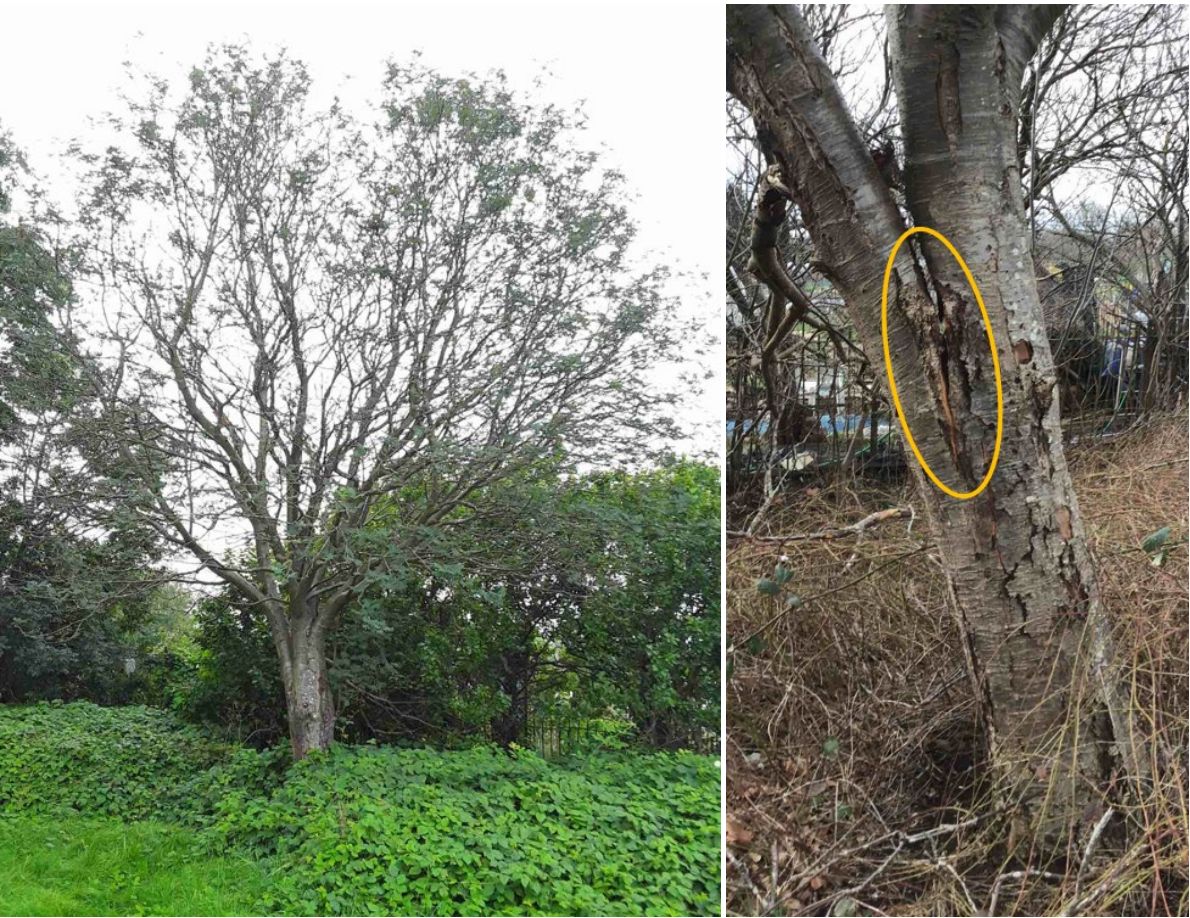
| Tree number | 8 |

| Inspection findings | This tree has sparse foliage indicating poor physiological condition. The main union of this tree is weak and a crack has developed below it that is prone to unpredictable failure. The tree poses an unacceptable risk and removal is required. |

Left images show subject tree with sparse foliage indicating declining physiological condition. Right image shows wide mouthed bark included union with crack in trunk below, circled.

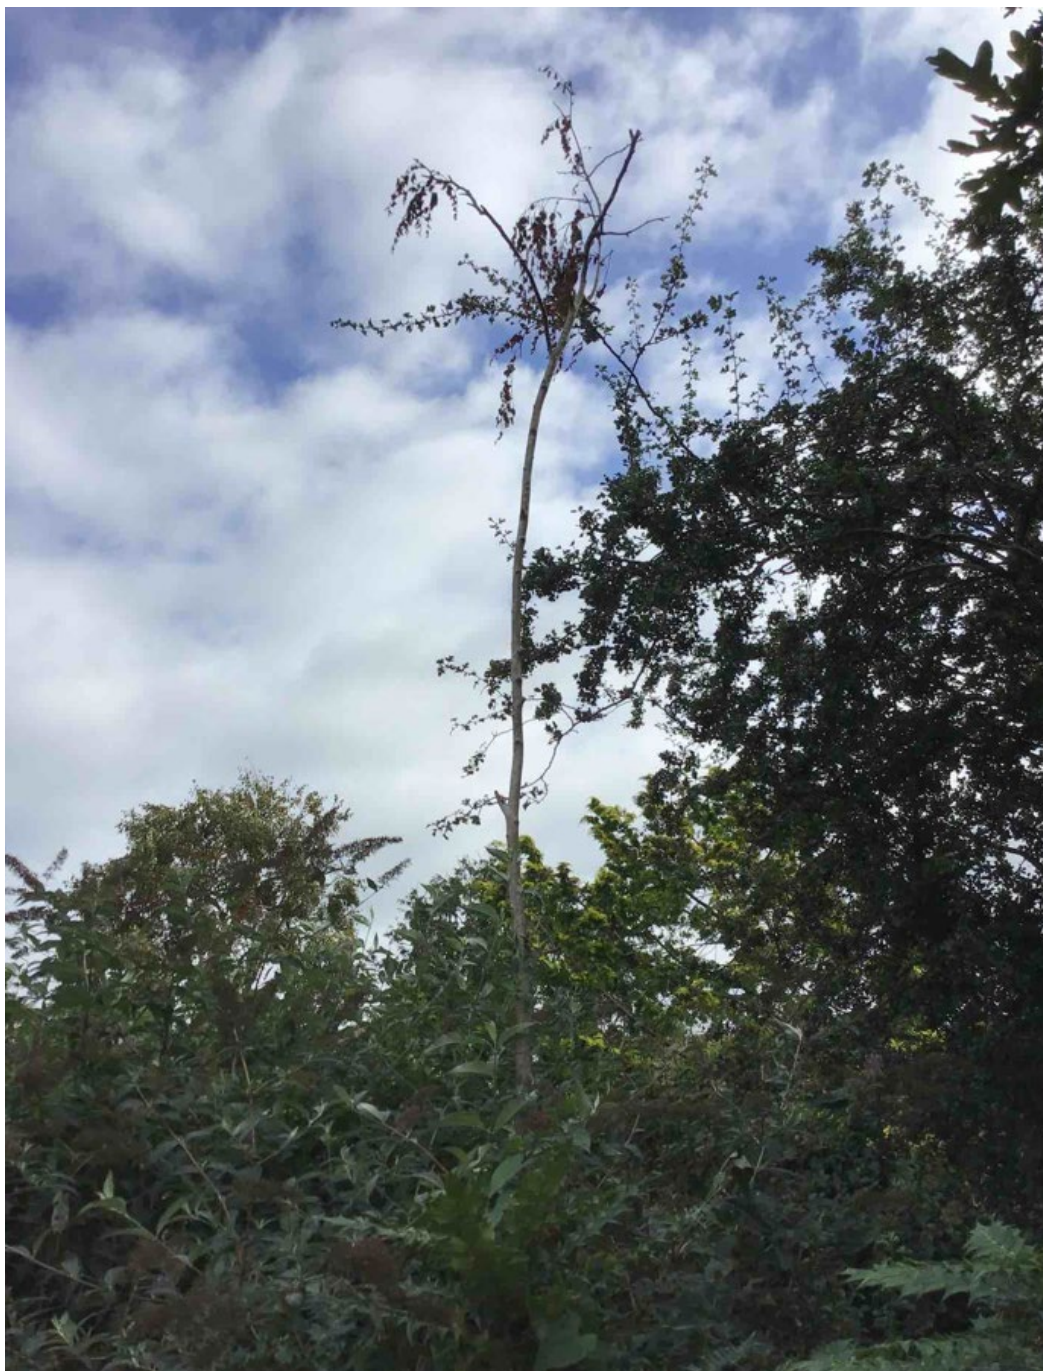
| Tree number | 19 |

| Inspection findings | This tree is dead and removal is required to prevent natural failure and facilitate replanting. |

**Images show dead tree.**

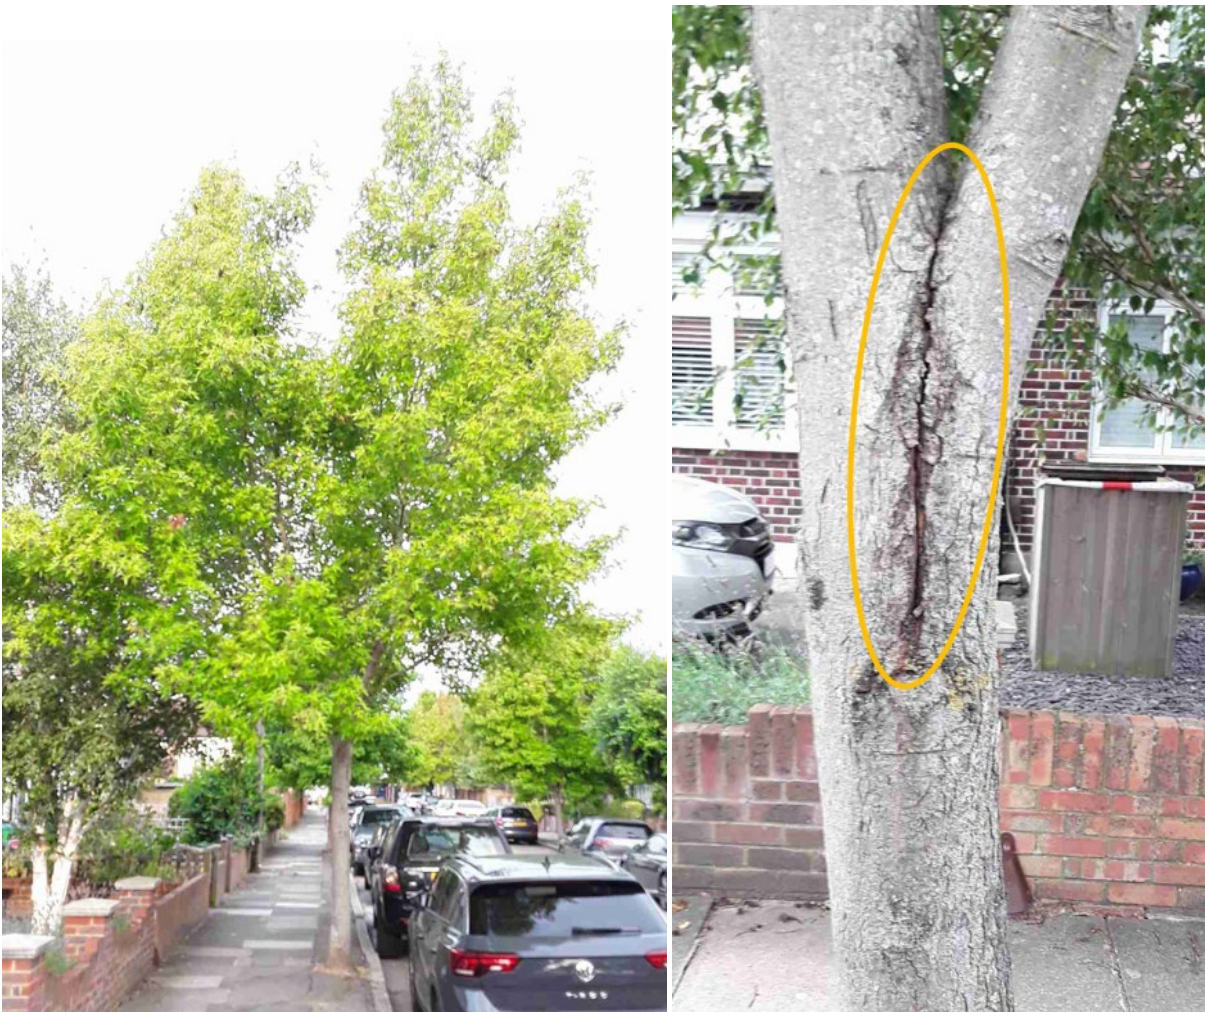
Site 3. Cambridge Road

| Inspection findings | The main union of this tree is weak and liable to collapse. Removal is required to mitigate the risk. |

Left image shows subject tree in situ. Right image shows bark included union affecting main trunk.

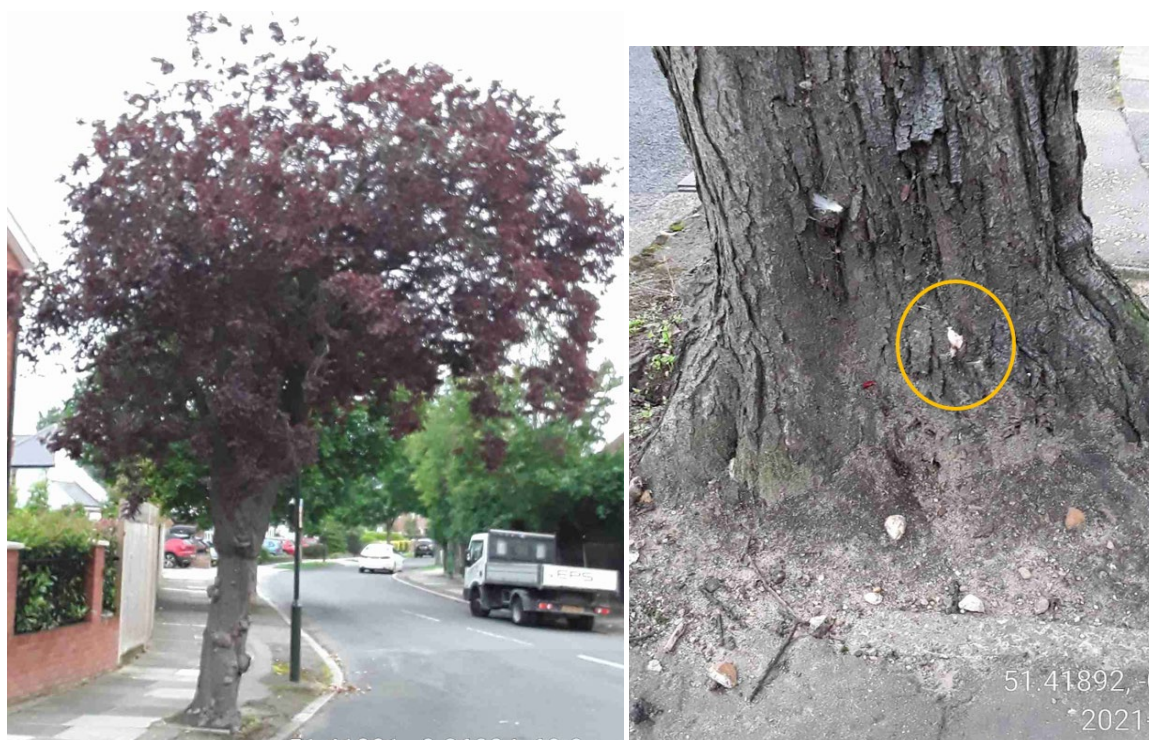
## Site 4. Cardinals Walk

| Inspection findings | A fungal fruiting body of the decay pathogen <i>Ganoderma</i> sp. is present at the stem base. Colonisation by this fungus causes a white rot of the stem and root system that can cause entire trees to collapse through fracture or windthrow. A resonance test revealed an unacceptable degree of decay in the trunk of this tree, removal is required to prevent natural failure and manage risk. |

**Left image shows subject tree in situ. Right image shows nascent fungal fruiting body circled.**

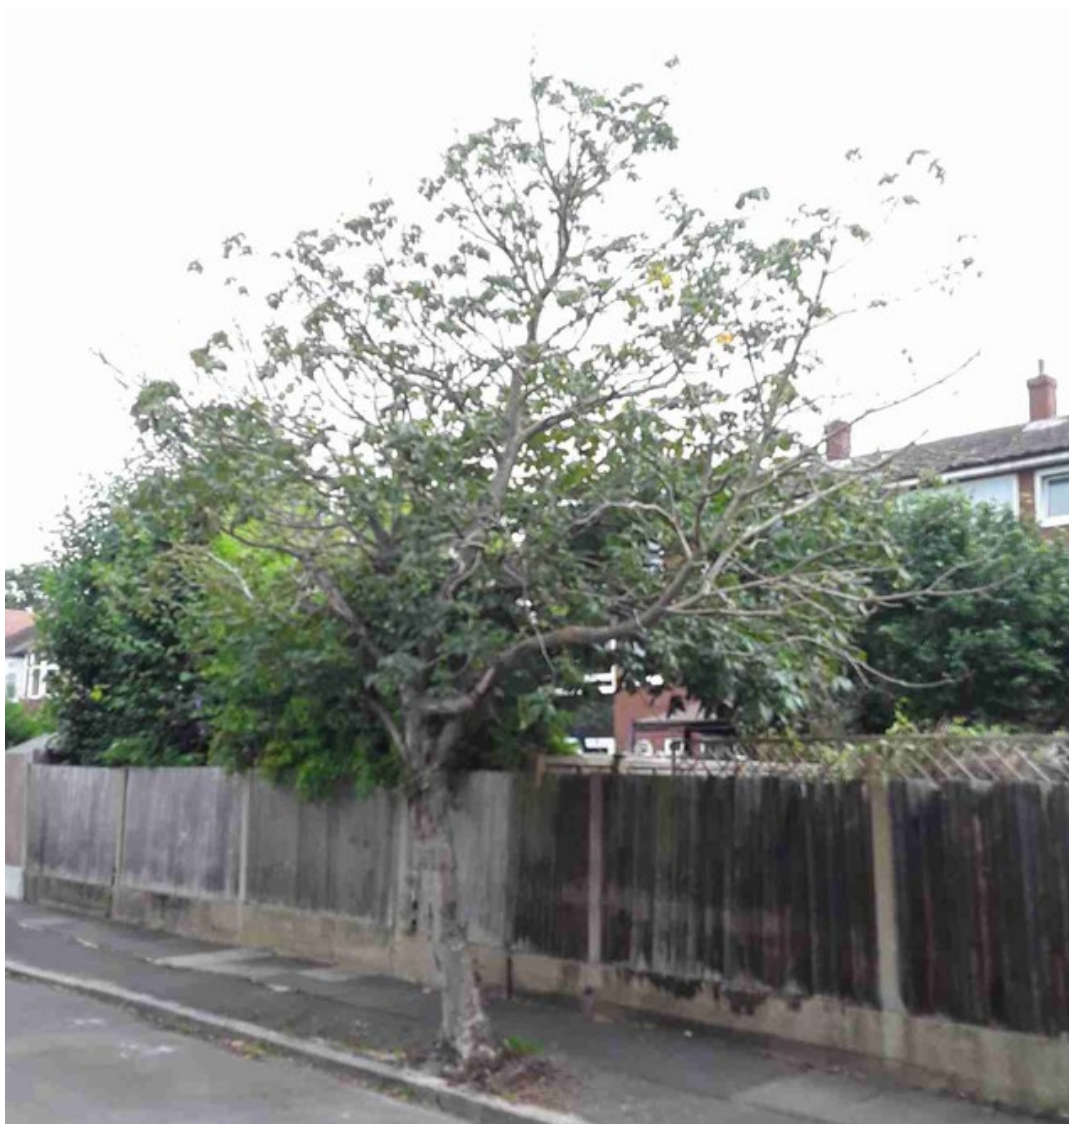
## Site 5. Chestnut Avenue

| Inspection findings | This tree is in a state of physiological decline and contains weak branches that are liable to collapse. |

**Image shows tree with sparse canopy and dead branches**

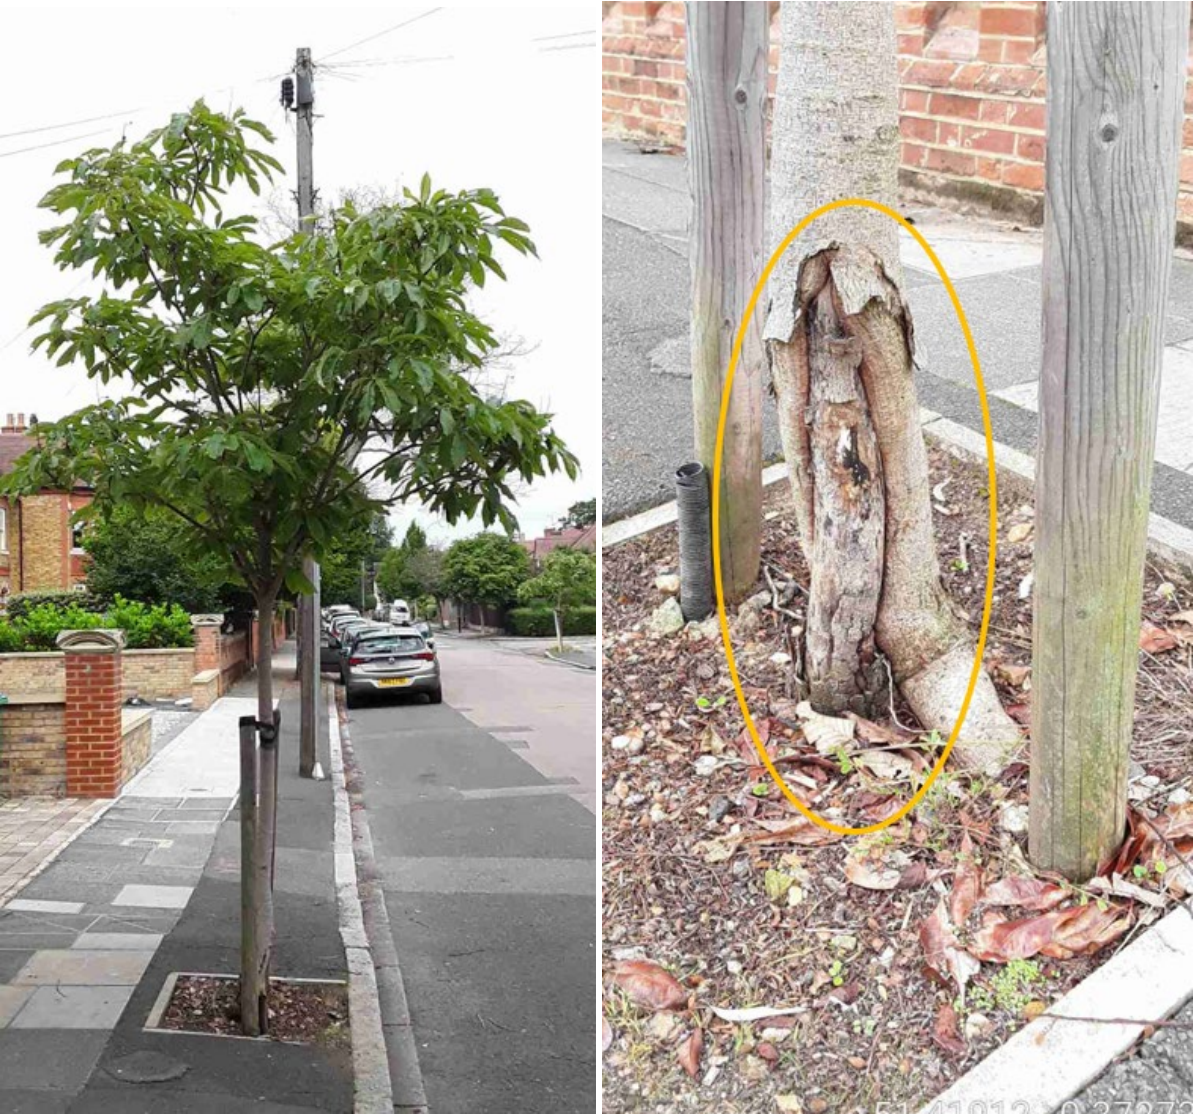
| Location | Outside Catterall House |

| Inspection findings | Tree main stem or trunk and roots are extensively damaged; tree is moving in such a way that indicates that the structure is compromised presenting increased risk of failure |

Left image shows subject tree in situ. Right image shows damage to base

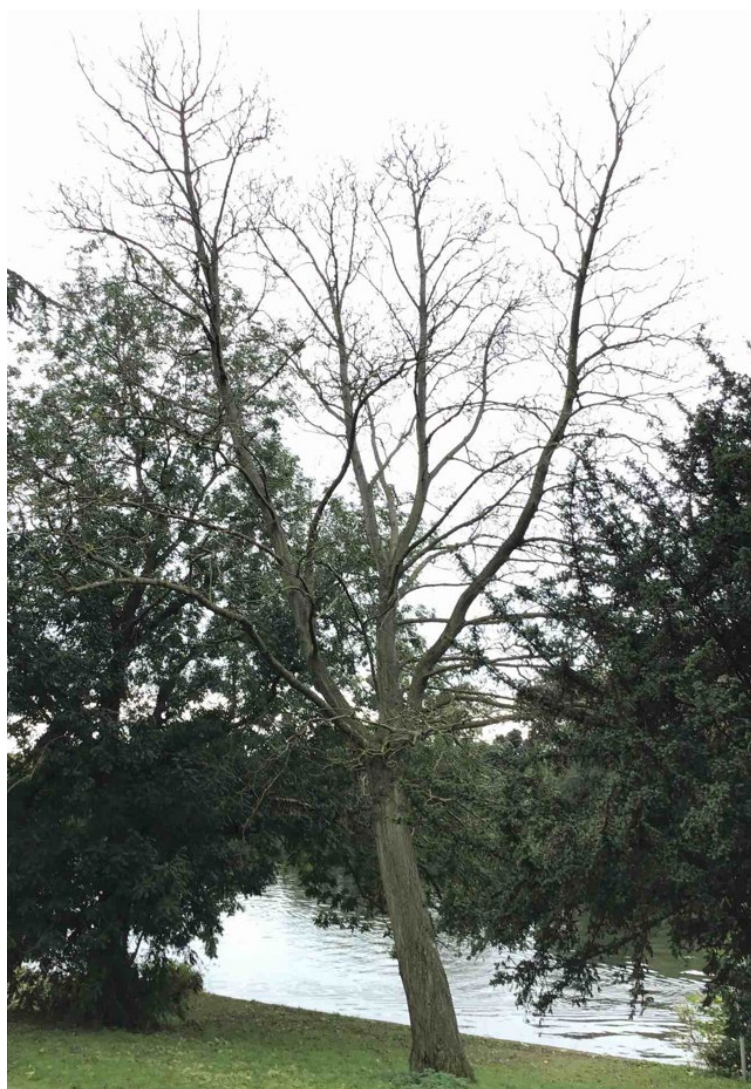
| Tree number | 12 |

| Inspection findings | This tree is dead and requires removal to facilitate replanting and prevent natural failure. |

**Image shows dead tree**

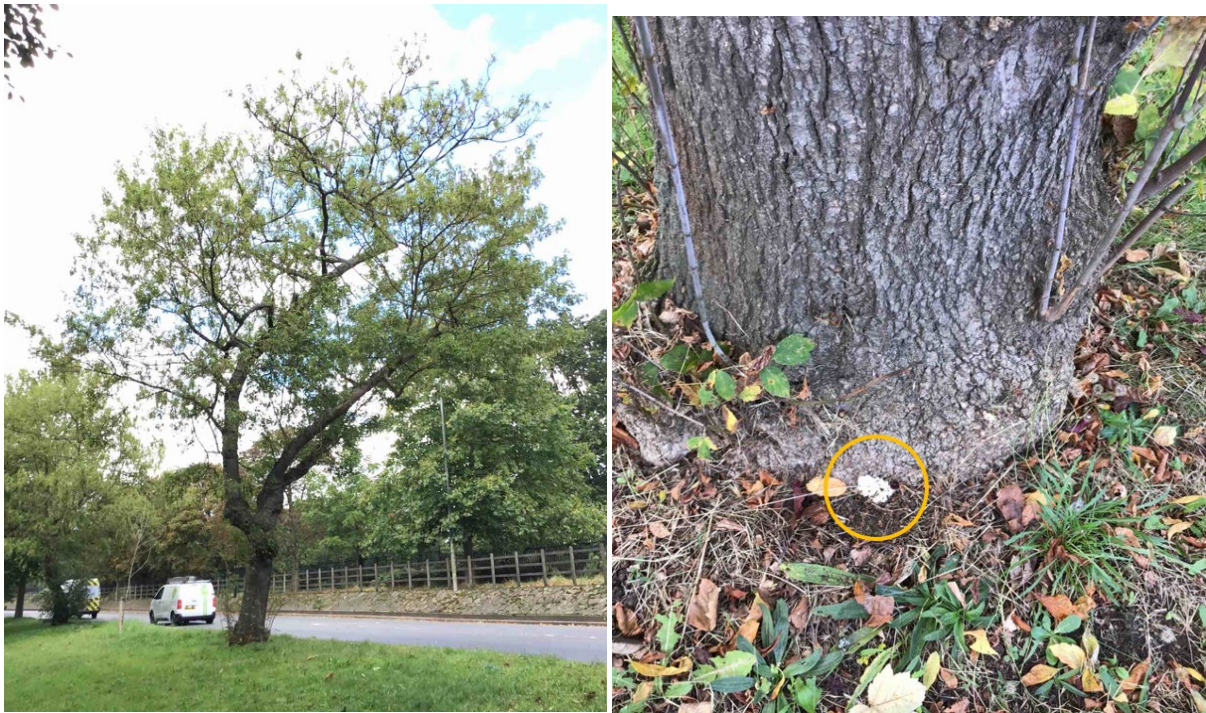
| Inspection findings | A fruiting body of the decay fungus <i>Rigidoporus</i> is present at the base of this tree. This fungus causes a brown rot that does not stimulate the tree to produce adaptive growth which can cause entire trees to collapse through fracture or windthrow. Crown dieback could correlate with the degradation of the trees structural or supporting root system. |

Left image shows low crown density with die back and deadwood. Right image shows larger one of two *Rigidoporus* fruiting body remnants

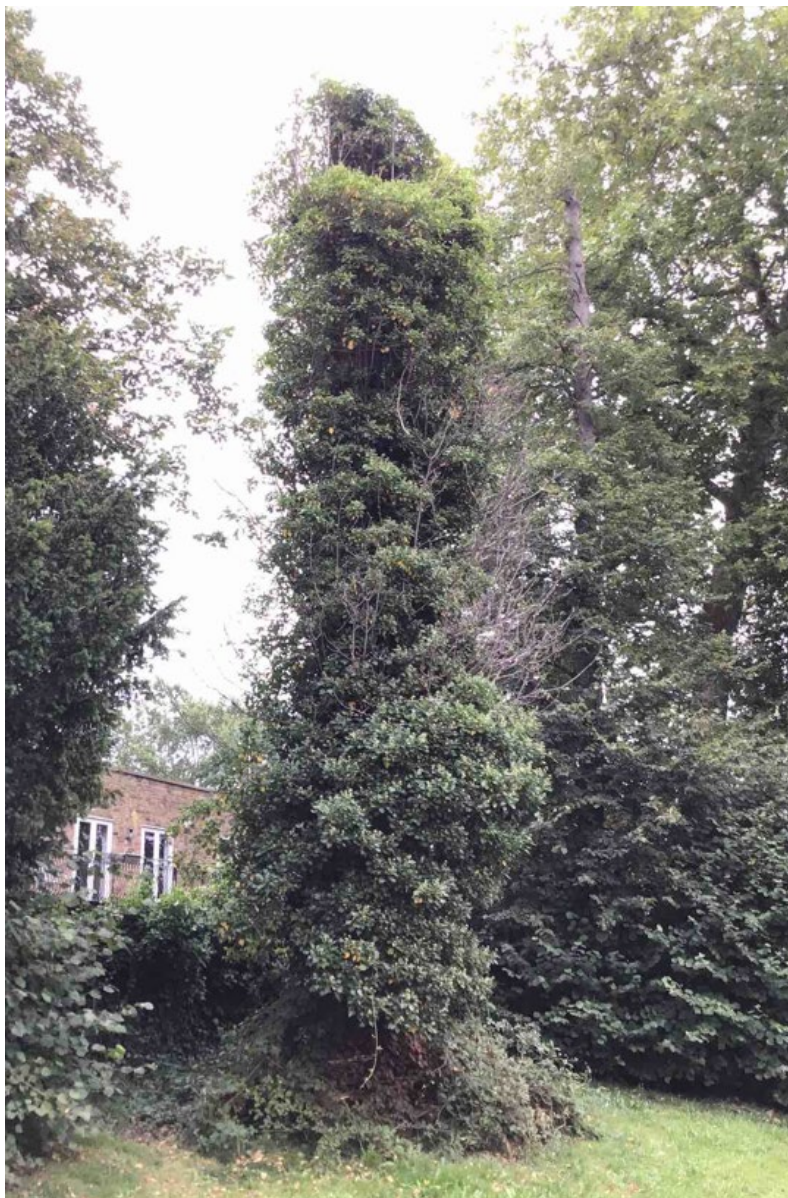
| Tree number | 18 |

| Inspection findings | This tree is dead and requires removal to facilitate replanting and prevent natural failure. |

**Images show dead tree**

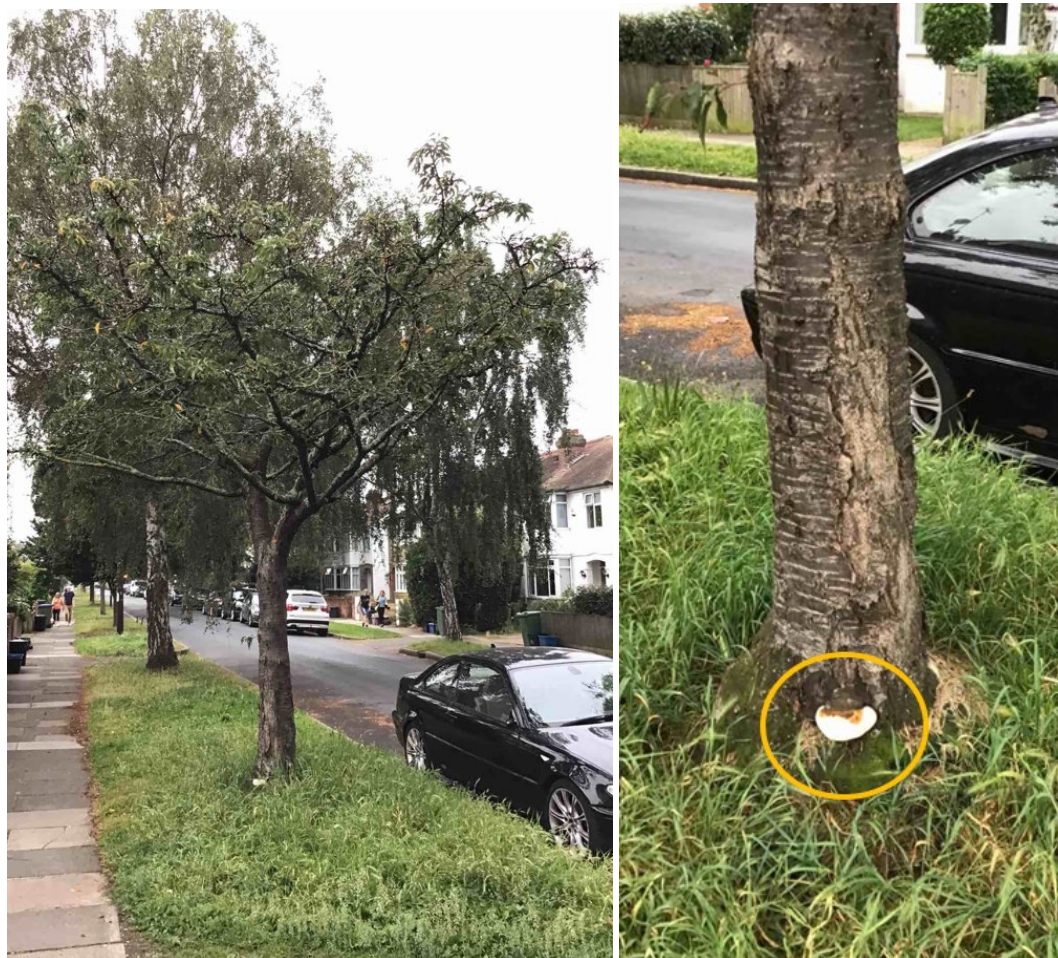
| Inspection findings | A fungal fruiting body of the decay pathogen <i>Ganoderma</i> sp. is present at the stem base. Colonisation by this fungus causes a white rot of the stem and root system that can cause entire trees to collapse through fracture or windthrow. A resonance test revealed an unacceptable degree of decay in the trunk of this tree which correlates with the crown die back and pathogen present. Removal is required to prevent natural failure and manage risk. |

**Left image shows subject tree in situ. Right image shows fungal fruiting body circled**

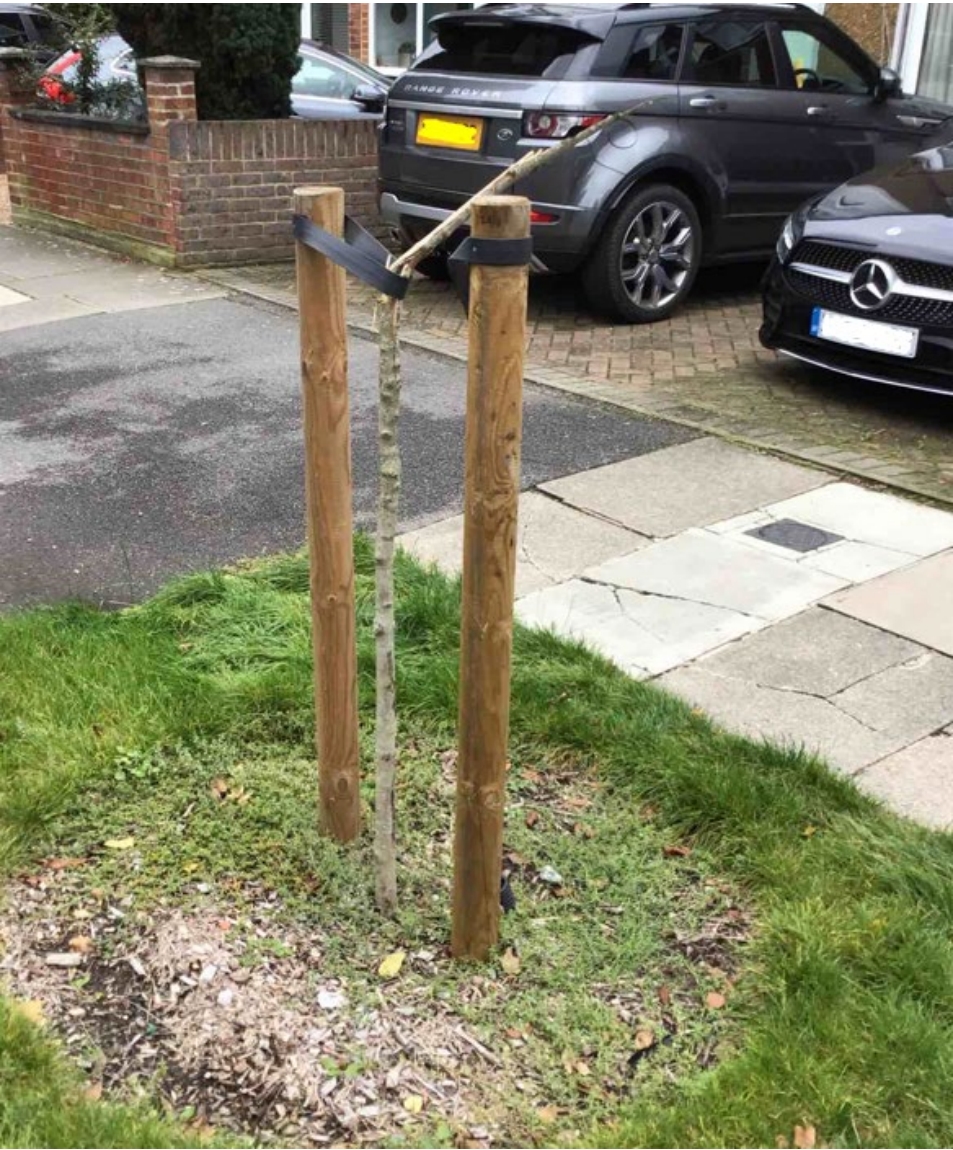
| Tree number | 39 |

| Inspection findings | This tree has been vandalised and requires replacement. |

Image shows vandalised tree

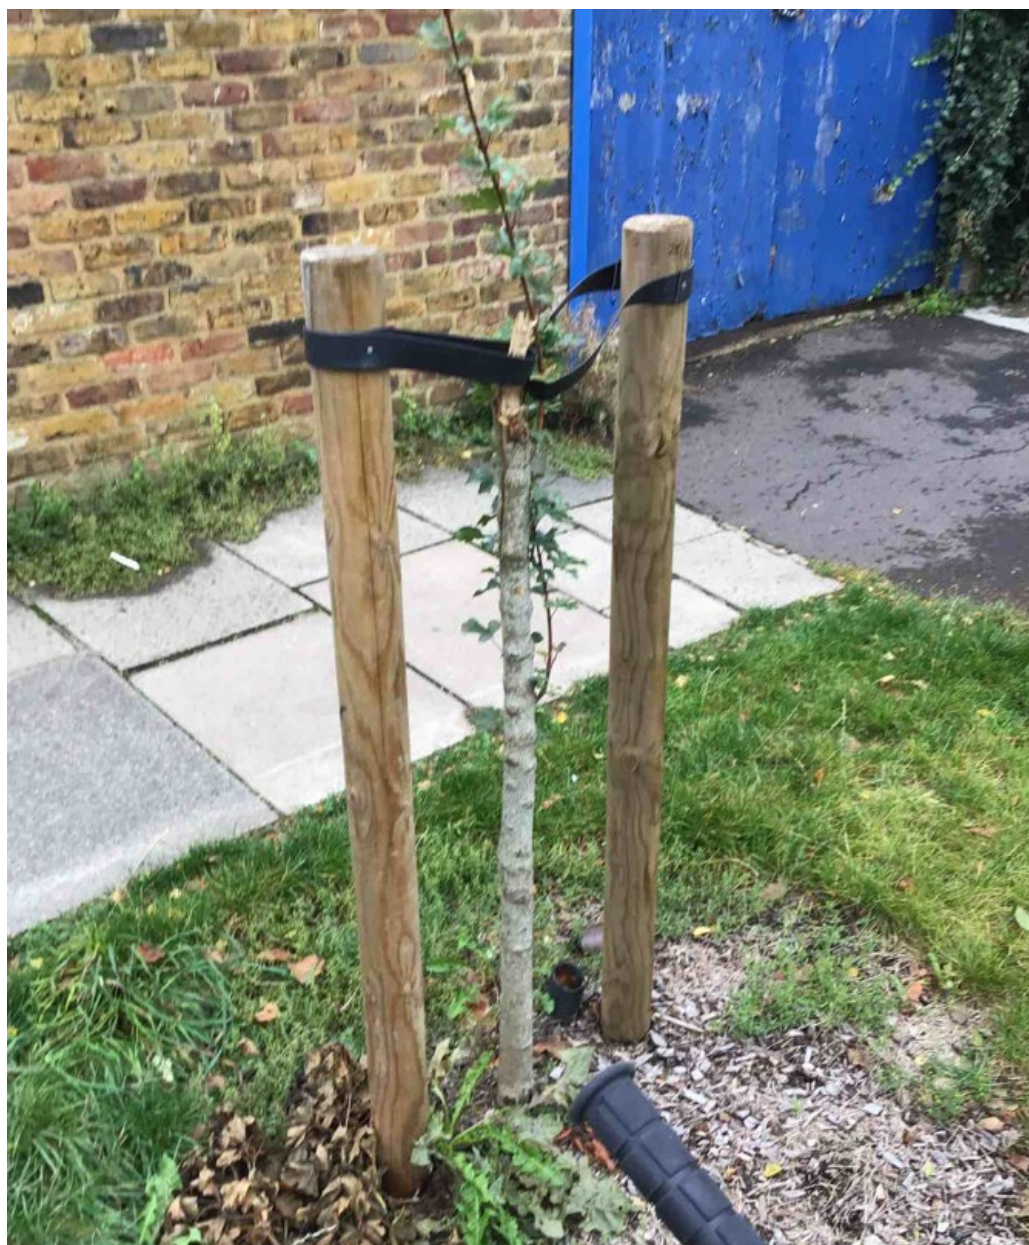
| Location | Opposite 73 |

| Inspection findings | This tree has been vandalised and requires replacement. |

**Image shows declining tree**

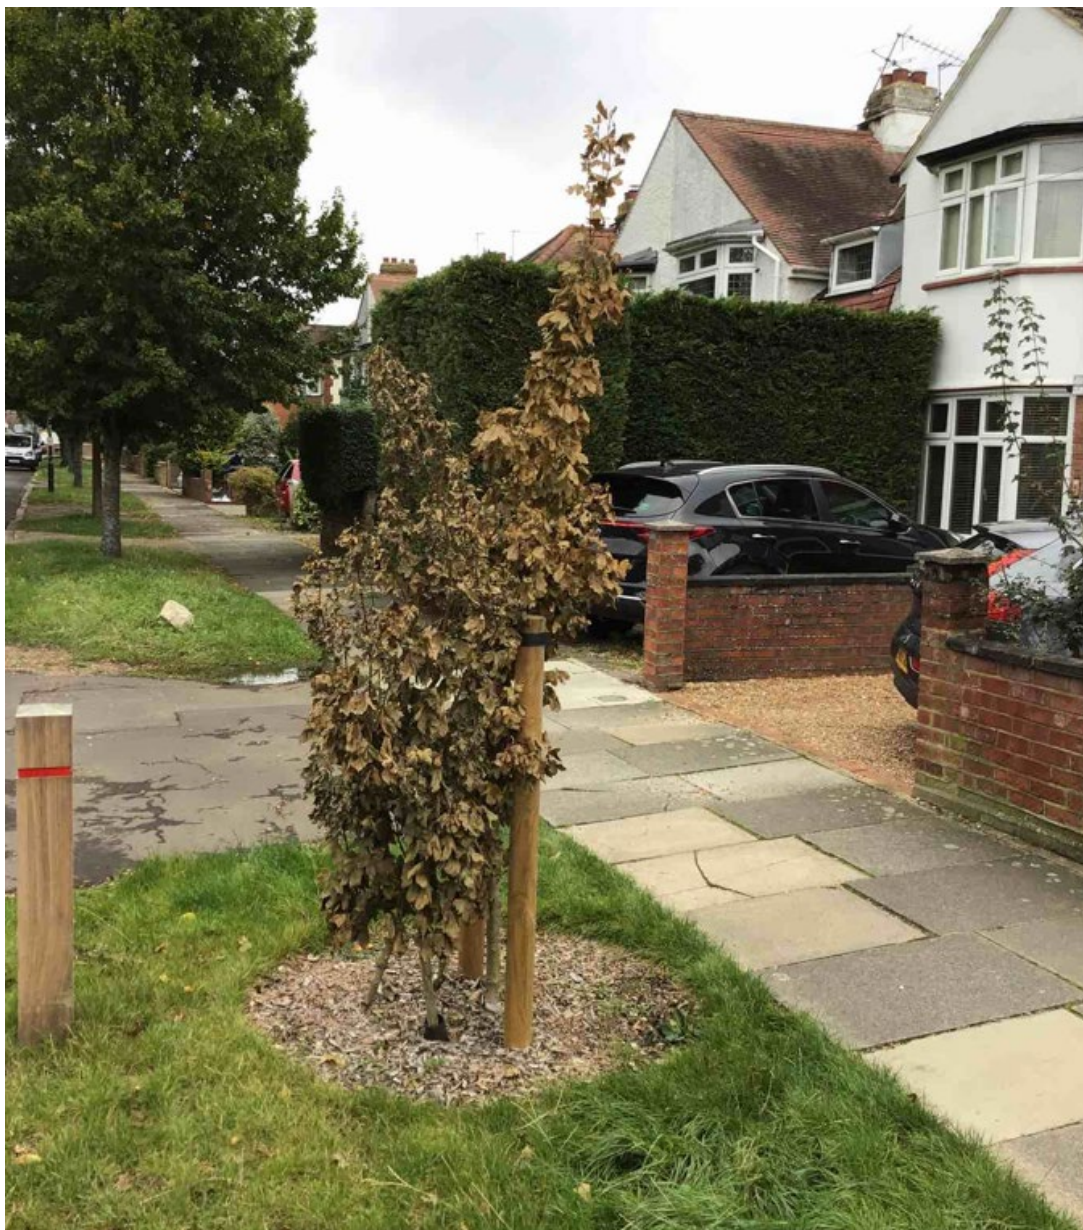
| Location | Outside 44 |

| Inspection findings | This tree has been vandalised and requires replacement. |

***Image shows vandalised tree***

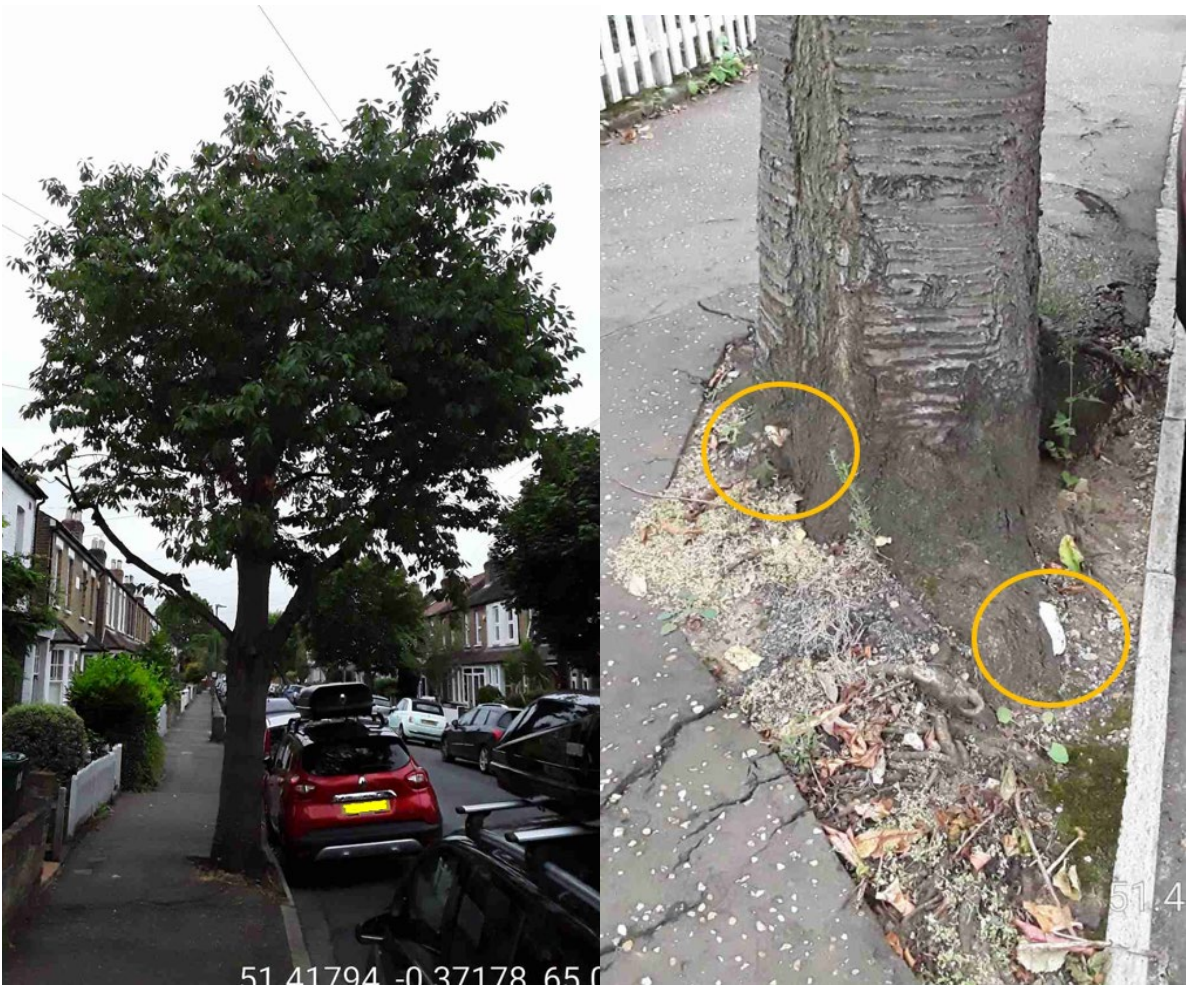
| Inspection findings | A fungal fruiting body of the decay pathogen <i>Ganoderma</i> sp. is present at the stem base. Colonisation by this fungus causes a white rot of the stem and root system that can cause entire trees to collapse through fracture or windthrow. A resonance test revealed an unacceptable degree of decay in the trunk of this tree, removal is required to prevent natural failure and manage risk. |

Left image shows subject tree. Right image shows nascent fruiting bodies at base.
