## **Hampton – 2022/2023 Ward Works and Tree Removals Programme**

### Introduction

Dated 24.02.2022

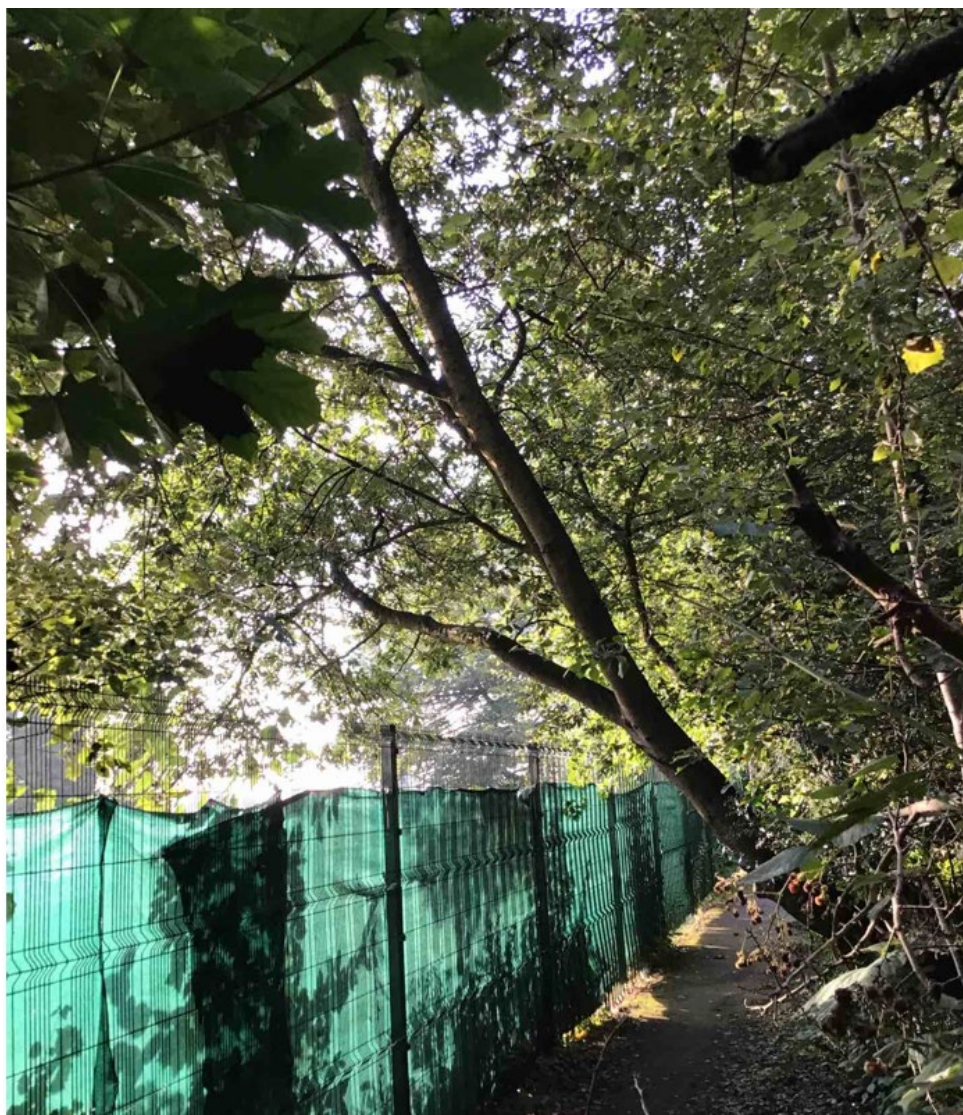
## Site 9. Oldfield Road

| Inspection findings | This tree is causing an unreasonable obstruction of the footpath |

**Image shows healthy tree in context with the footpath**

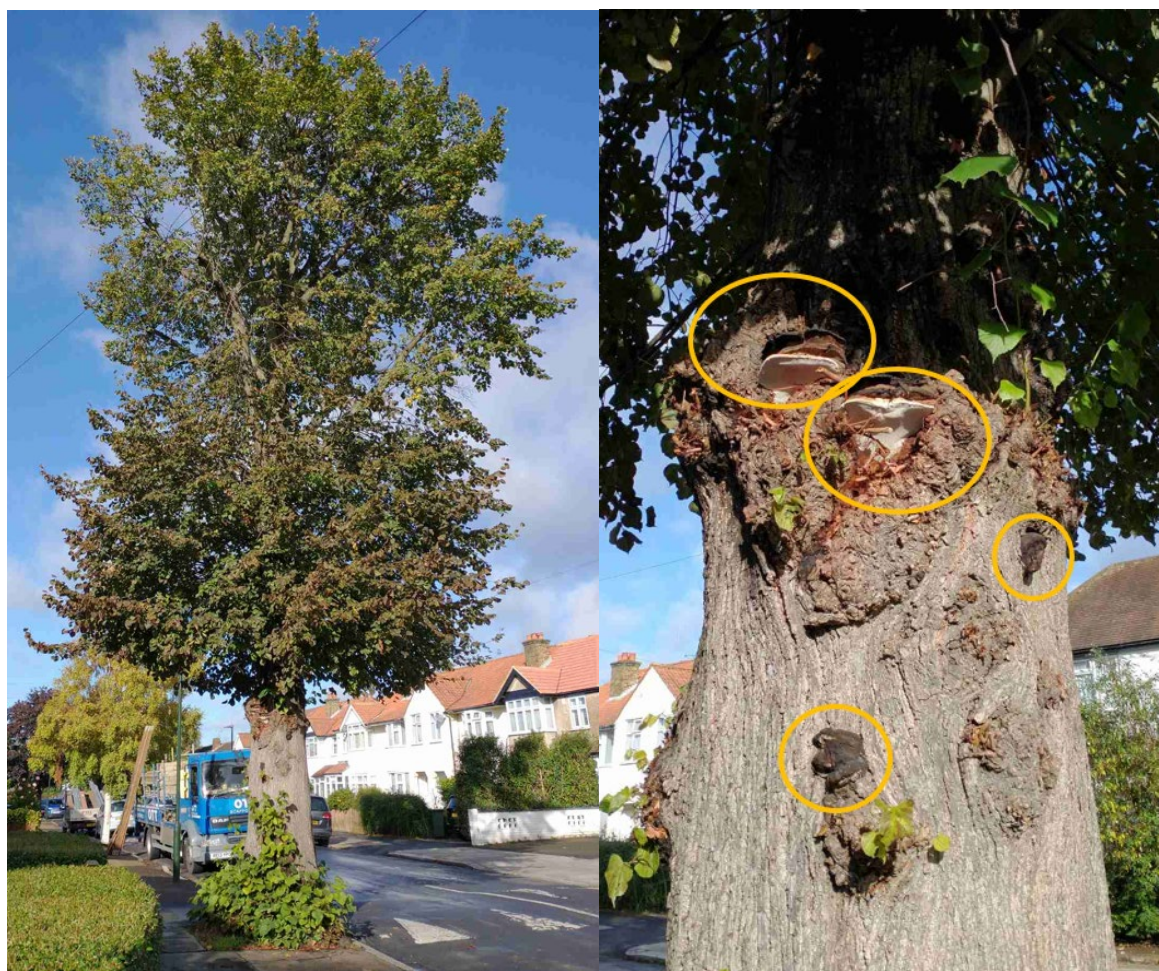
| Inspection findings | <p>Fruiting bodies of the decay pathogen <i>Ganoderma</i> sp. is present on the main trunk. Colonisation by this fungus causes a white rot of the stem and root system that can cause entire trees to collapse through fracture or windthrow.</p> <p>A resonance test has indicated an unacceptable degree of decay in the base and trunk of the tree; this decay correlates with the location of the fruiting bodies.</p> |

**Left images show apparent healthy tree. Right image shows fungal fruiting bodies . Investigations revealed an unacceptable degree of decay**

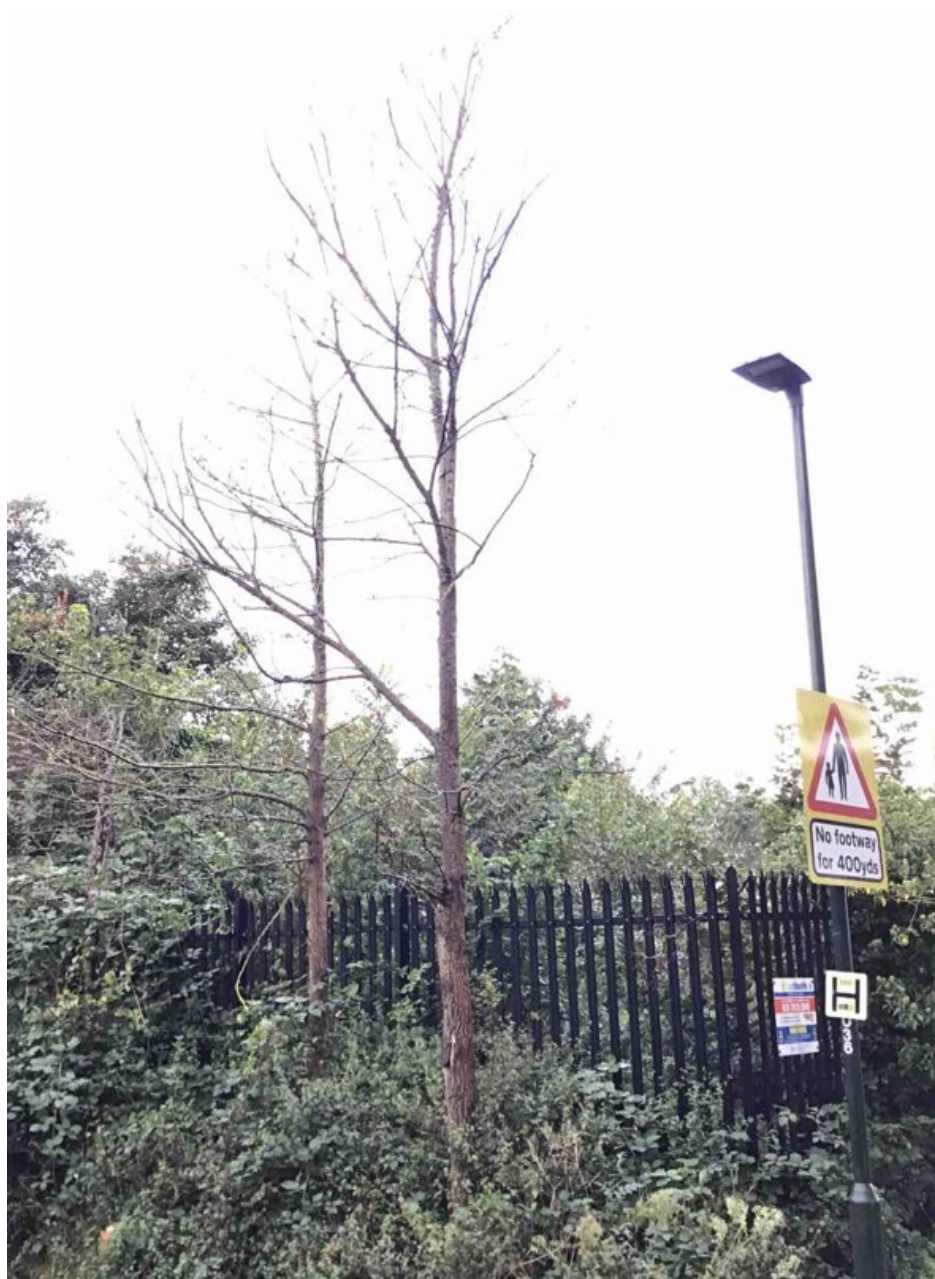
| Inspection findings | This tree is dead and requires removal to facilitate replanting and prevent natural failure. |

**Image shows dead tree, symptoms consistent with Dutch Elm Disease.**

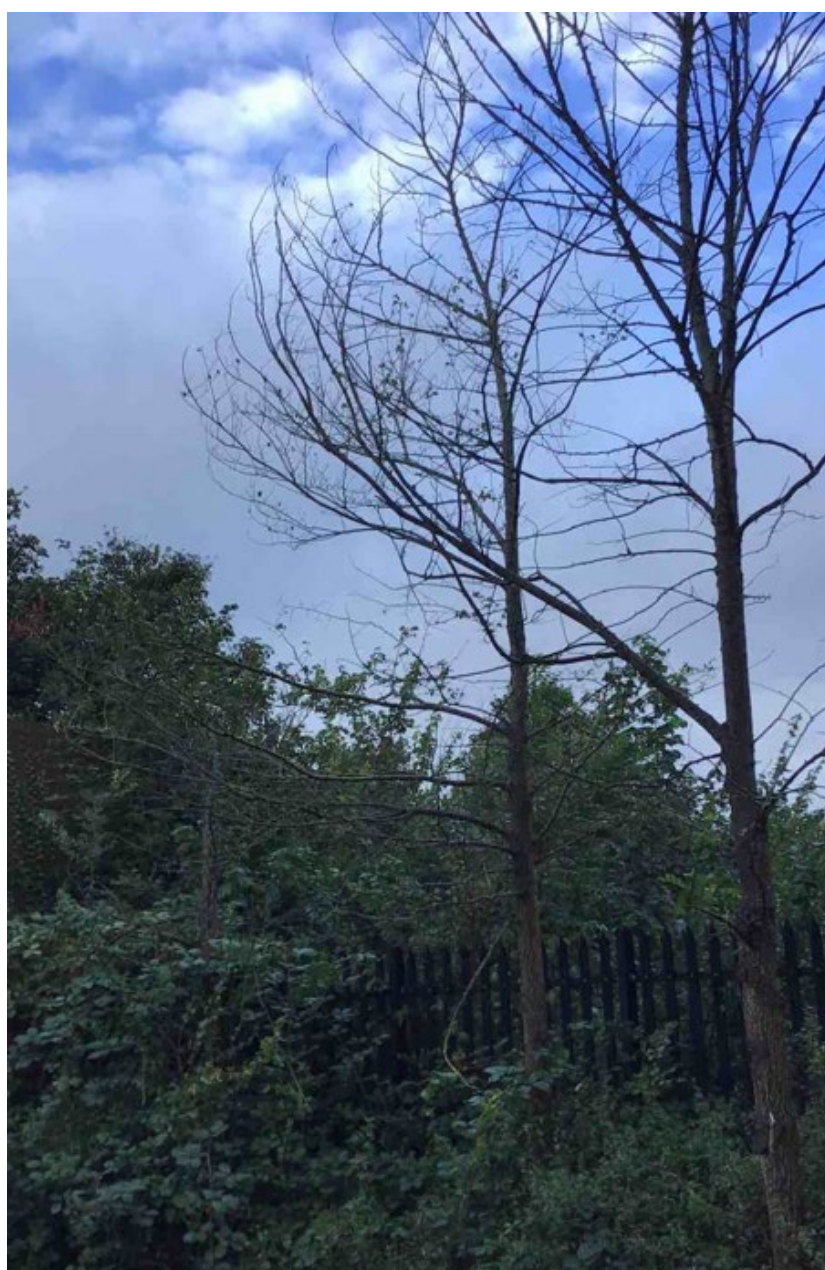
| Inspection findings | This tree is dead and requires removal to facilitate replanting and prevent natural failure. |

**Image shows dead tree, symptoms consistent with Dutch Elm Disease.**

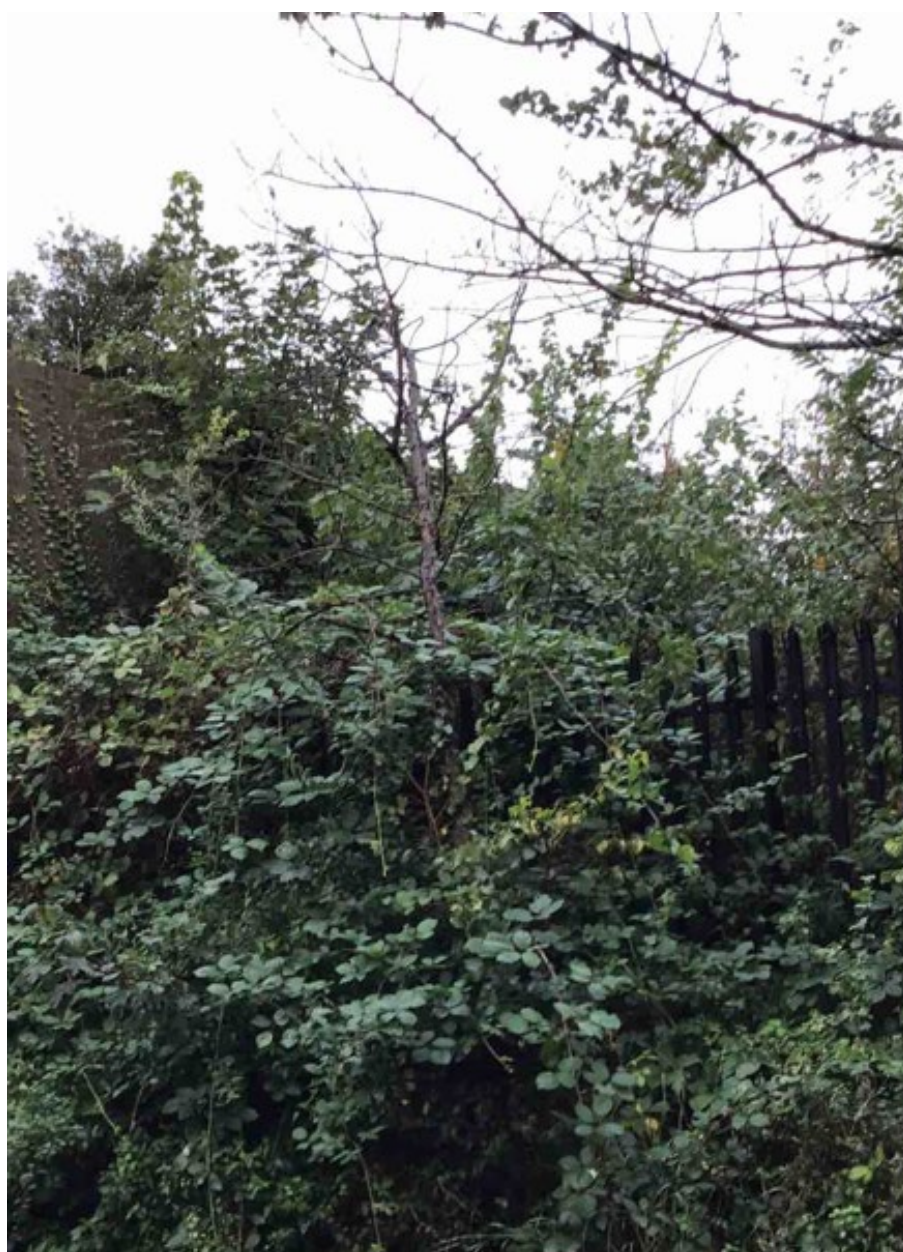
| Inspection findings | This tree is dead and requires removal to facilitate replanting and prevent natural failure. |

**Image shows dead tree, symptoms consistent with Dutch Elm Disease.**

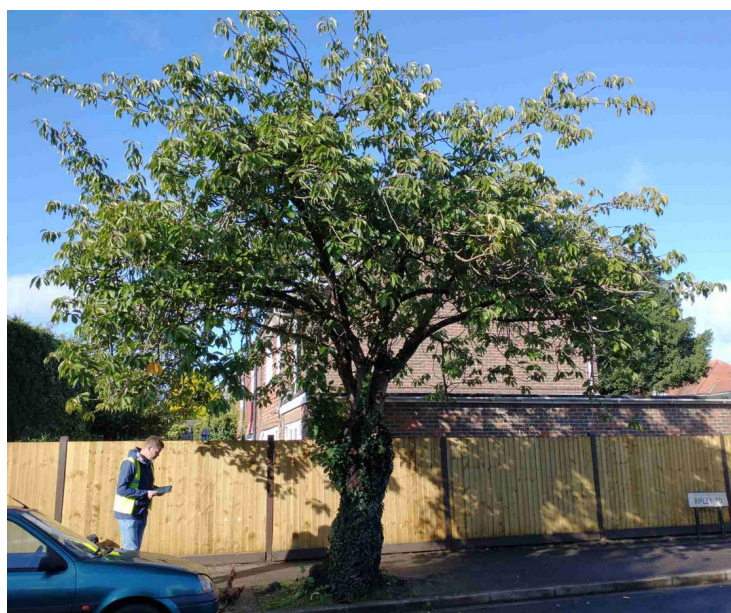
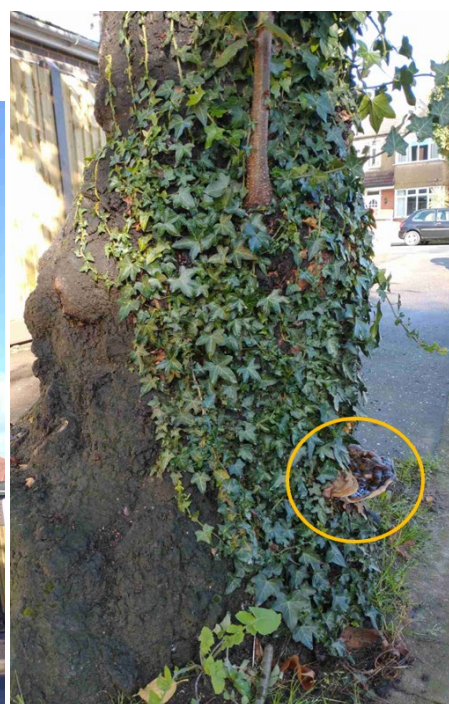
| Inspection findings | A fungal fruiting body of the decay pathogen <i>Ganoderma</i> sp. is present at the stem base. Colonisation by this fungus causes a white rot of the stem and root system that can cause entire trees to collapse through fracture or windthrow. A resonance test revealed an unacceptable degree of decay in the trunk of this tree, removal is required to prevent natural failure and manage risk. |

**Left image shows apparent healthy tree, however investigations at the base and fungal fruiting bodies (right image) indicate an unacceptable degree of decay**

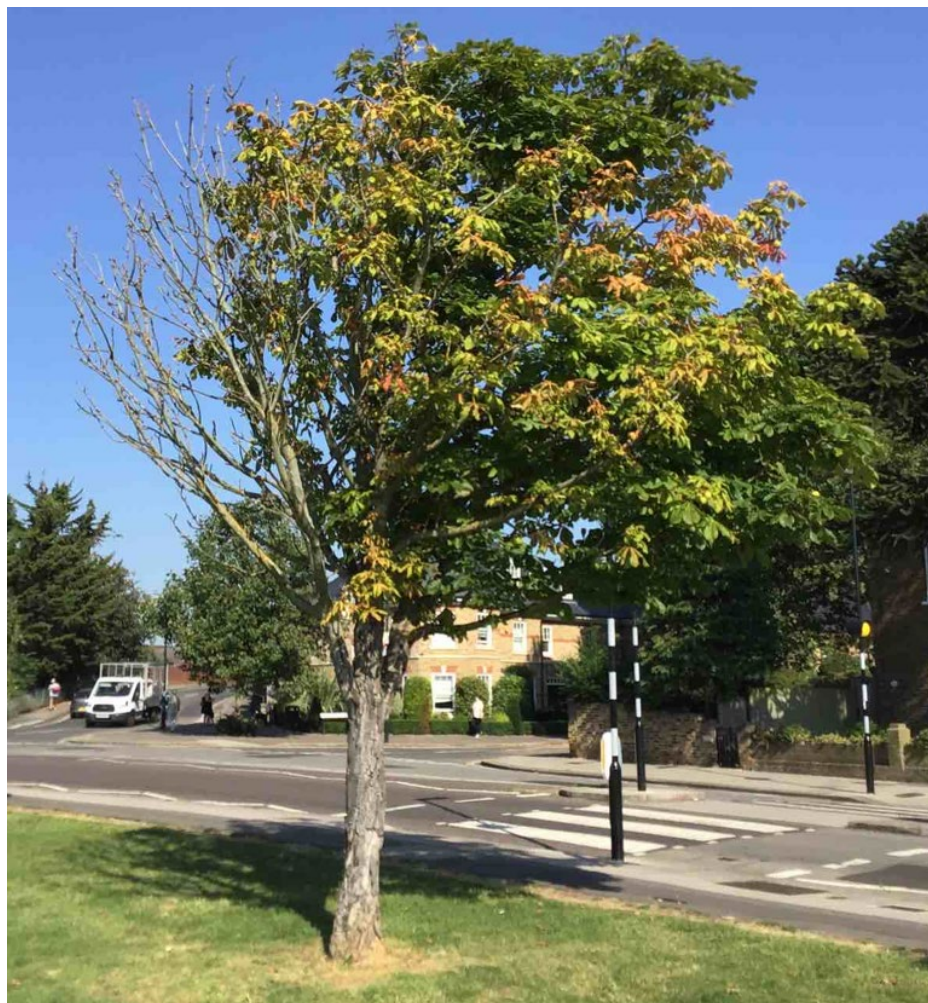
| Inspection findings | Bark lesions and necrosis consistent with the pathogen <i>Pseudomonas syringae</i> is present on the stem of this tree; the decline of the trees vascular system correlates with dieback within the crown which contains weak branches that are liable to collapse. This disease has poor prognosis for young trees and removal is required. |

**Images shows die back of the crown with dead branches and discolouration of the foliage**

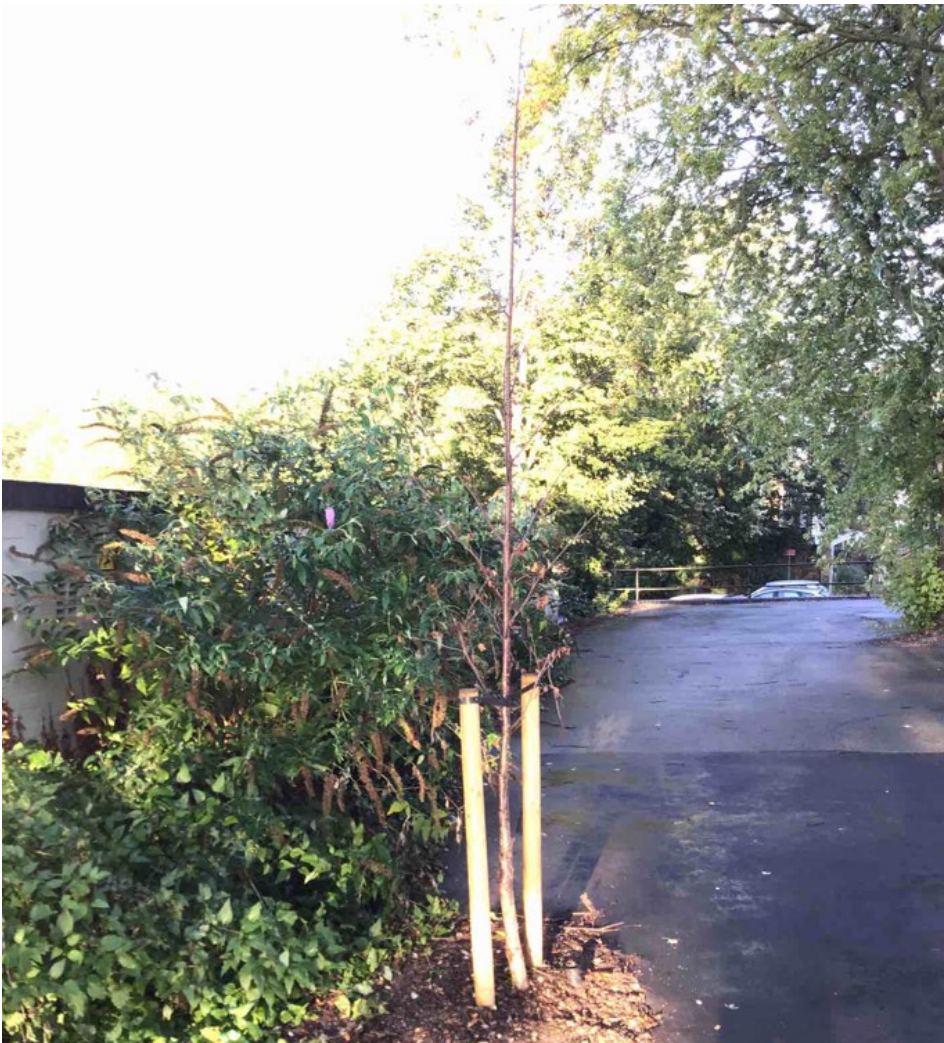
| Tree number | 7 |

| Inspection findings | This tree is dead and requires removal to facilitate replanting and prevent natural failure. |

Image shows dead tree

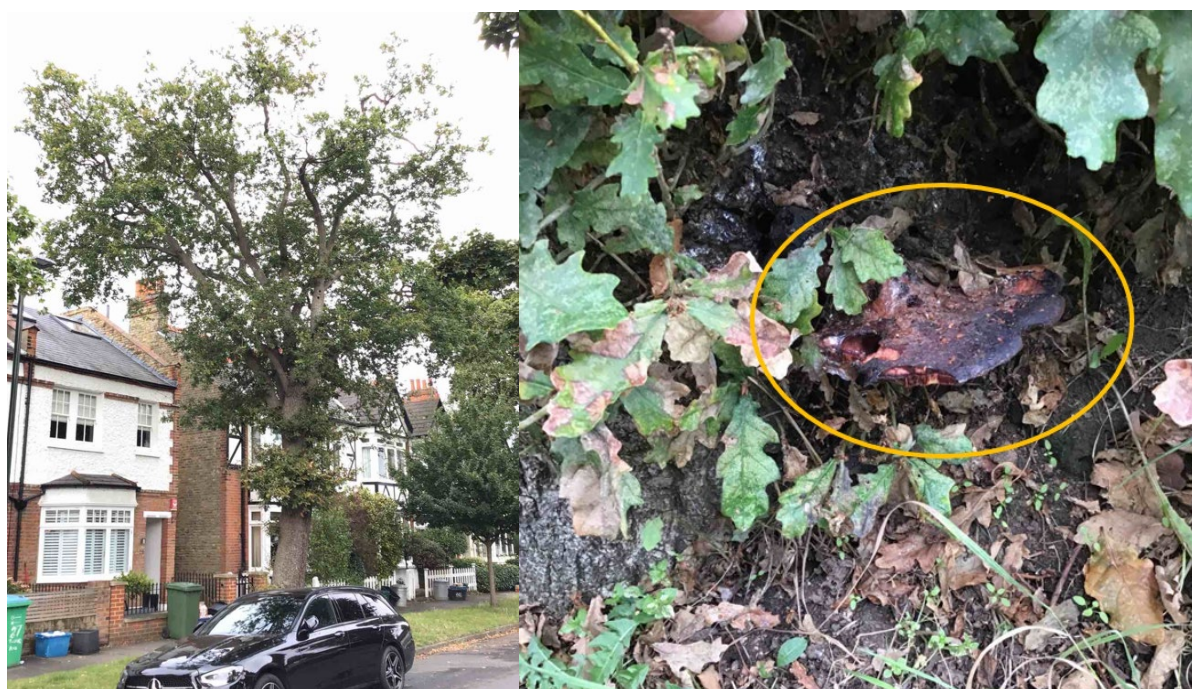
| Inspection findings | Remnants of a fruiting body of the decay fungus <i>Fistulina hepatica</i> were found at the base of this tree. This fungus causes brown rot and soft rot, and the presence of long-standing decay can cause entire tree failure. A resonance test has indicated root and lower stem or trunk decay; crown dieback could correlate with the degradation of the trees structural or supporting root system. This tree is in a state of physiological decline and contains weak branches that are liable to collapse. |

Left images show tree with sparse canopy indicating poor physiological condition. Right image shows fungal fruiting body. Investigations revealed an unacceptable degree of decay in the base and trunk of this tree

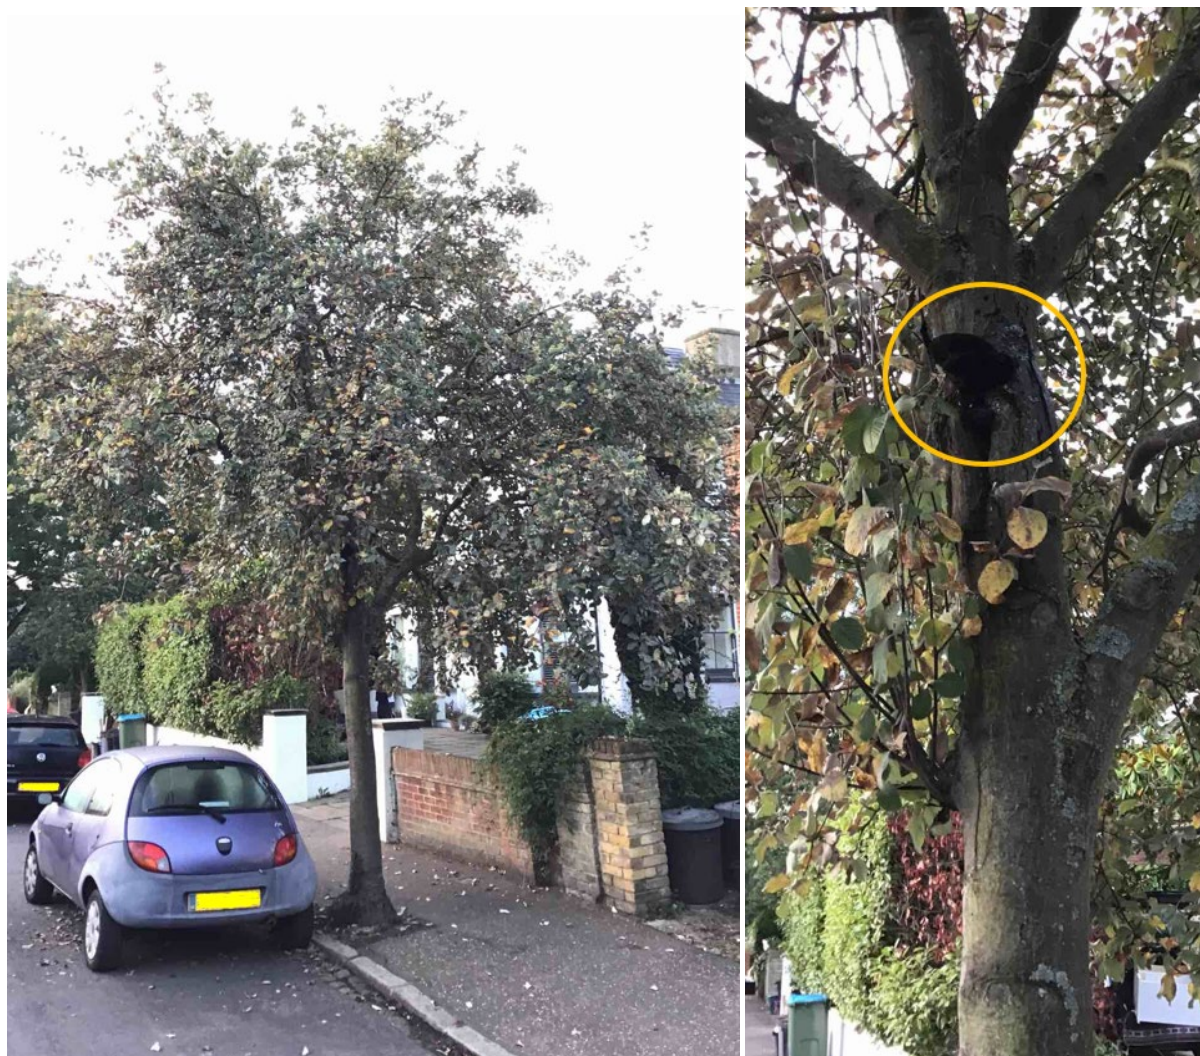
| Tree number | 14 |

| Inspection findings | A fungal fruiting body of the species Shaggy Polypore ( <i>Inonotus hispidus</i> ) is present on the main stem or trunk, this fungus causes a simultaneous white rot which can cause snapping of tree parts in this species |

**Left image shows tree in situ. Right image shows fruiting body on main stem circled**

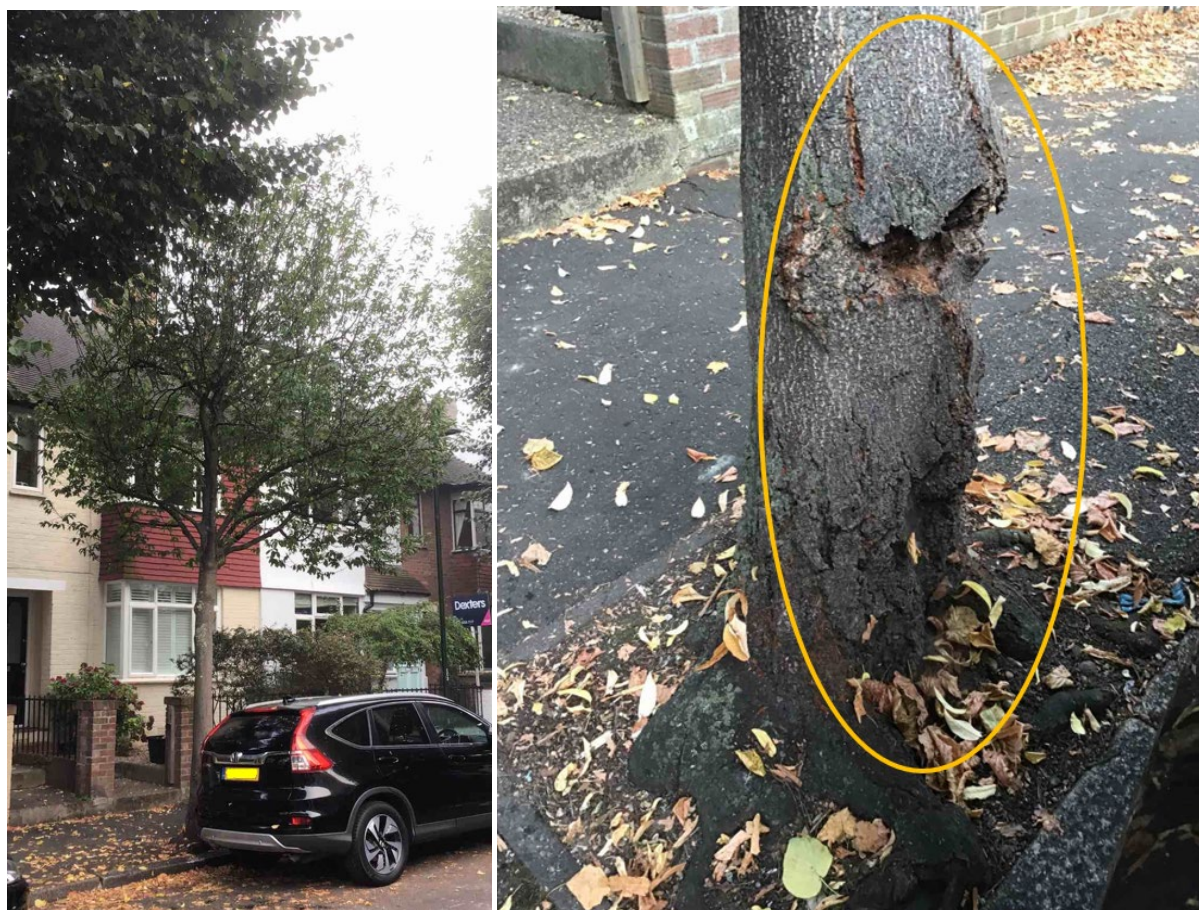
| Tree number | 6 |

| Inspection findings | A cavity indicating decay is present at the base of this tree. Investigation with a probe revealed an unacceptable degree of decay. |

**Left image shows apparent healthy tree. Right image shows location of decay**

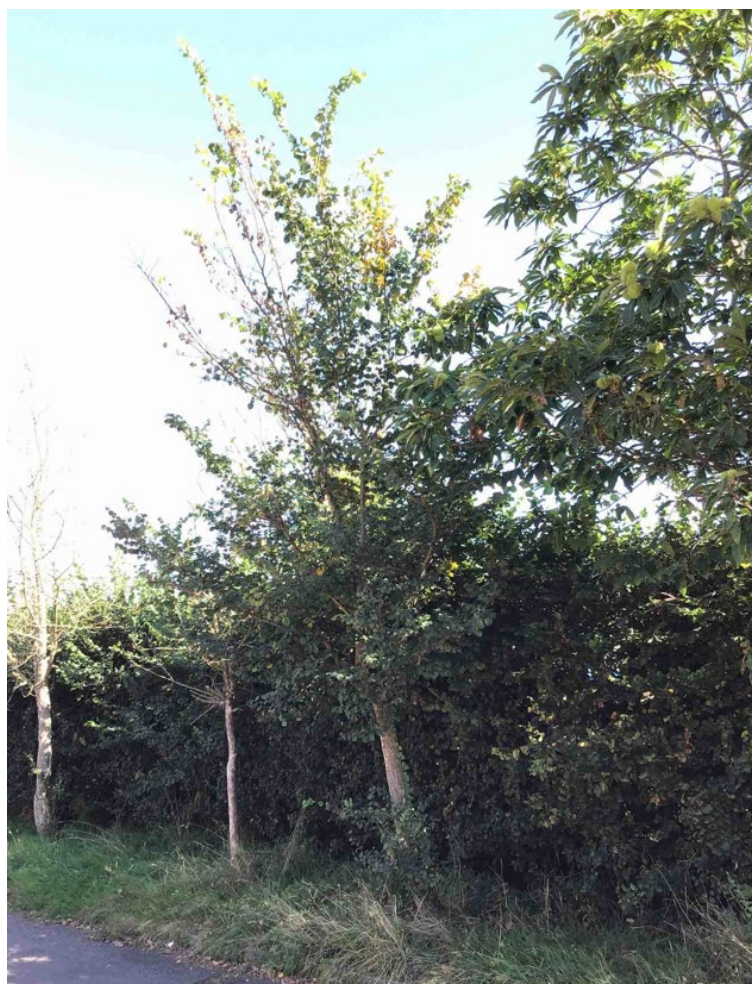
| Tree number | 25 |

| Inspection findings | Leaf browning on this tree is consistent with Dutch Elm Disease which is invariably fatal. |

**Image shows leaf browning in the upper canopy consistent with Dutch Elm Disease**

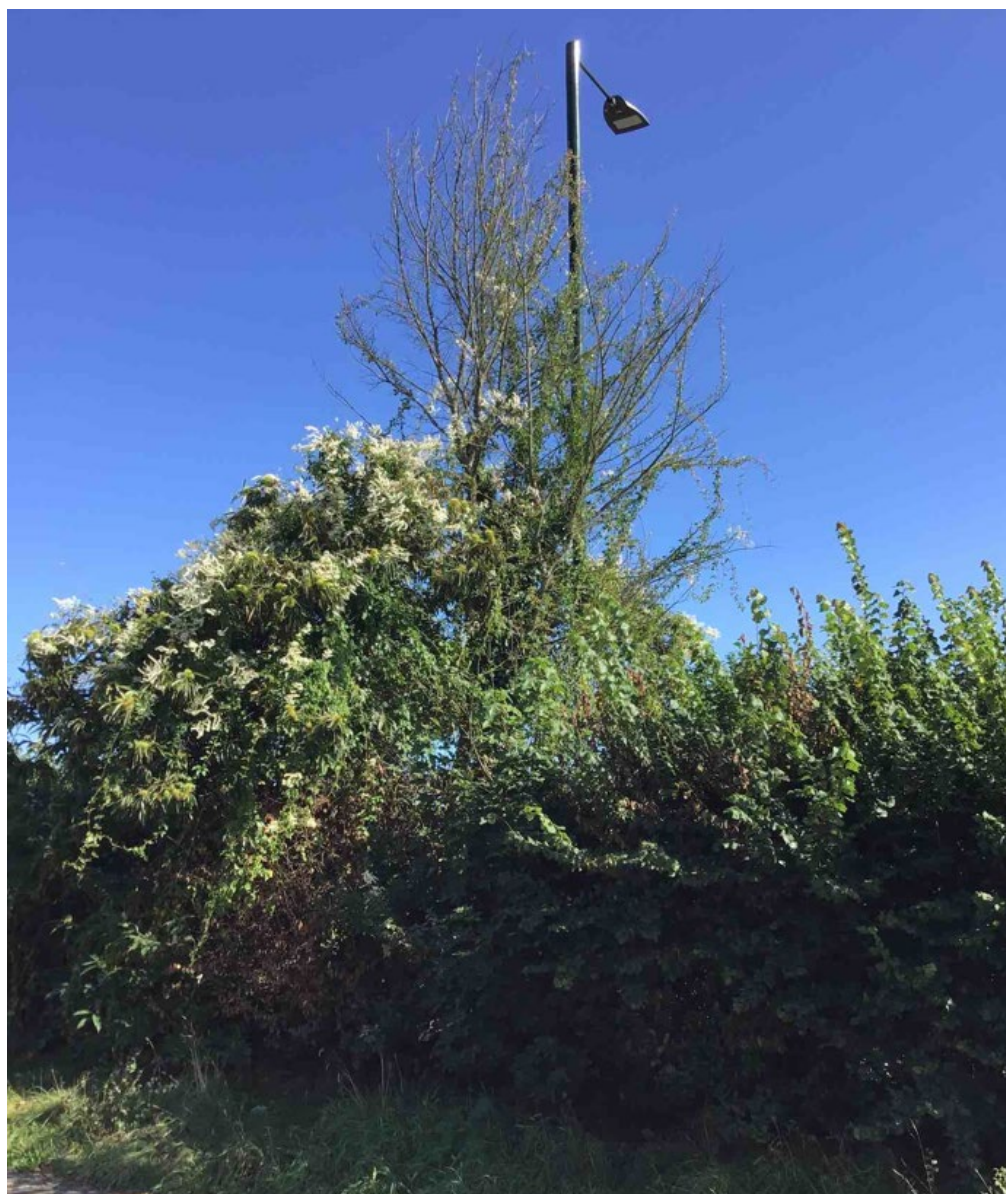
| Location | Opposite 5-6 |

| Inspection findings | This tree is dead and requires removal to facilitate replanting and prevent natural failure. |

**Image shows dead tree, symptoms are consistent with Dutch Elm Disease**
