Teddington - 2021 Ward Works and Tree Removals Programme

A recent survey of trees in the Teddington ward has taken place; this was conducted by a competent specialist Arboriculturist as part of the scheduled 4 yearly detailed inspection regime that has been devised for all Council highway and parks trees.

Dated 09.03.2021

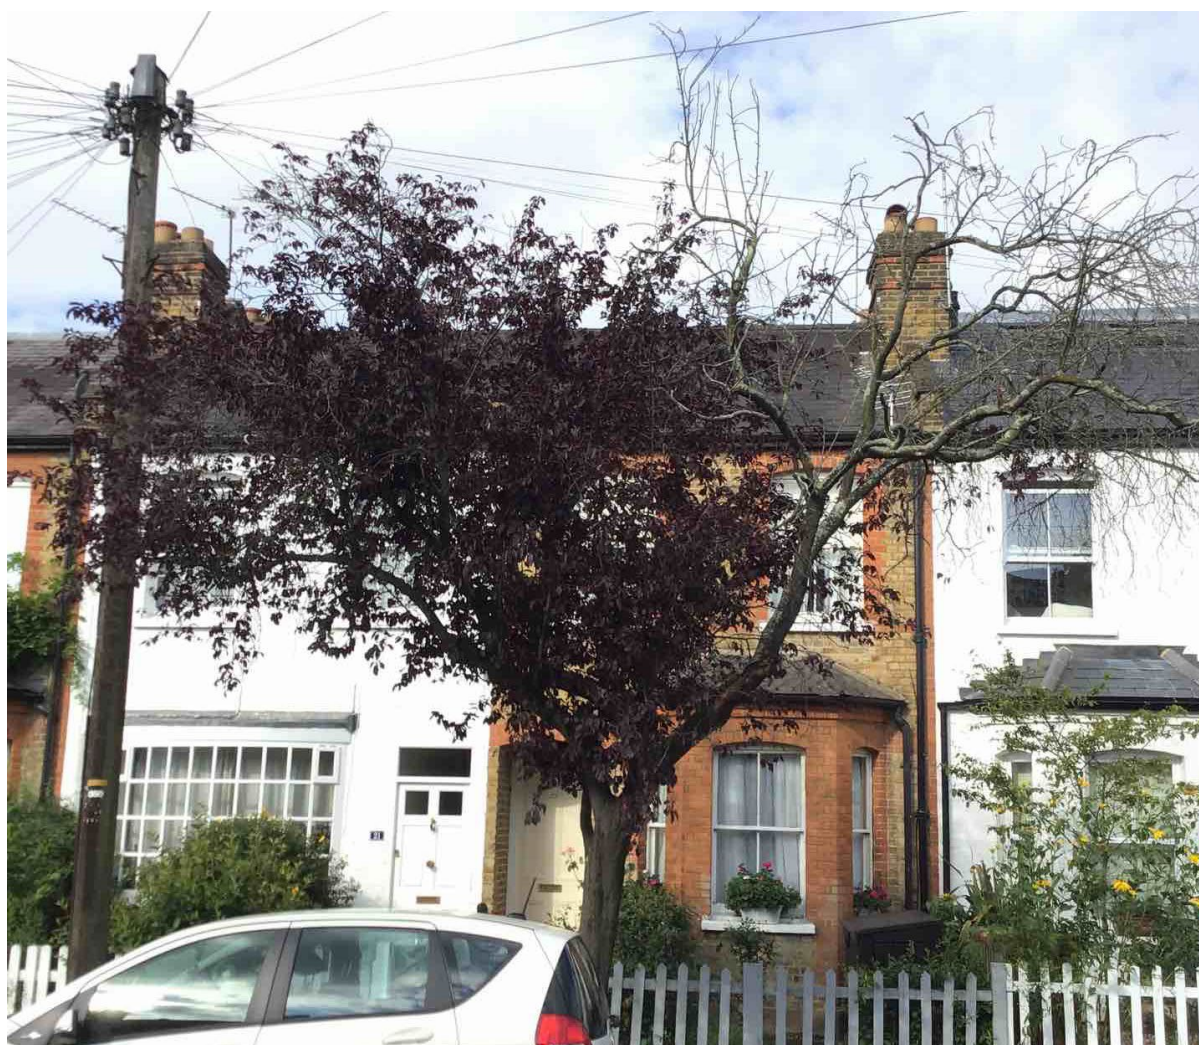
Tree number	9
Park	Arlington Road
Location	Outside 23
Species	Purple leaf plum (<i>Prunus cerasifera</i>)
Height	7.00
Physiological condition	Poor
Structural condition	Fair
Inspection findings	Ganoderma spp decay pathogen fruiting body at base and half of crown is already dead including a major scaffold limb. Remaining crown beginning to die back and presents no real scope for remedial reduction as this (given species tendencies) is likely to kill the remaining tree

Image shows half of tree devoid of live growth and leaving no viable remedial pruning options

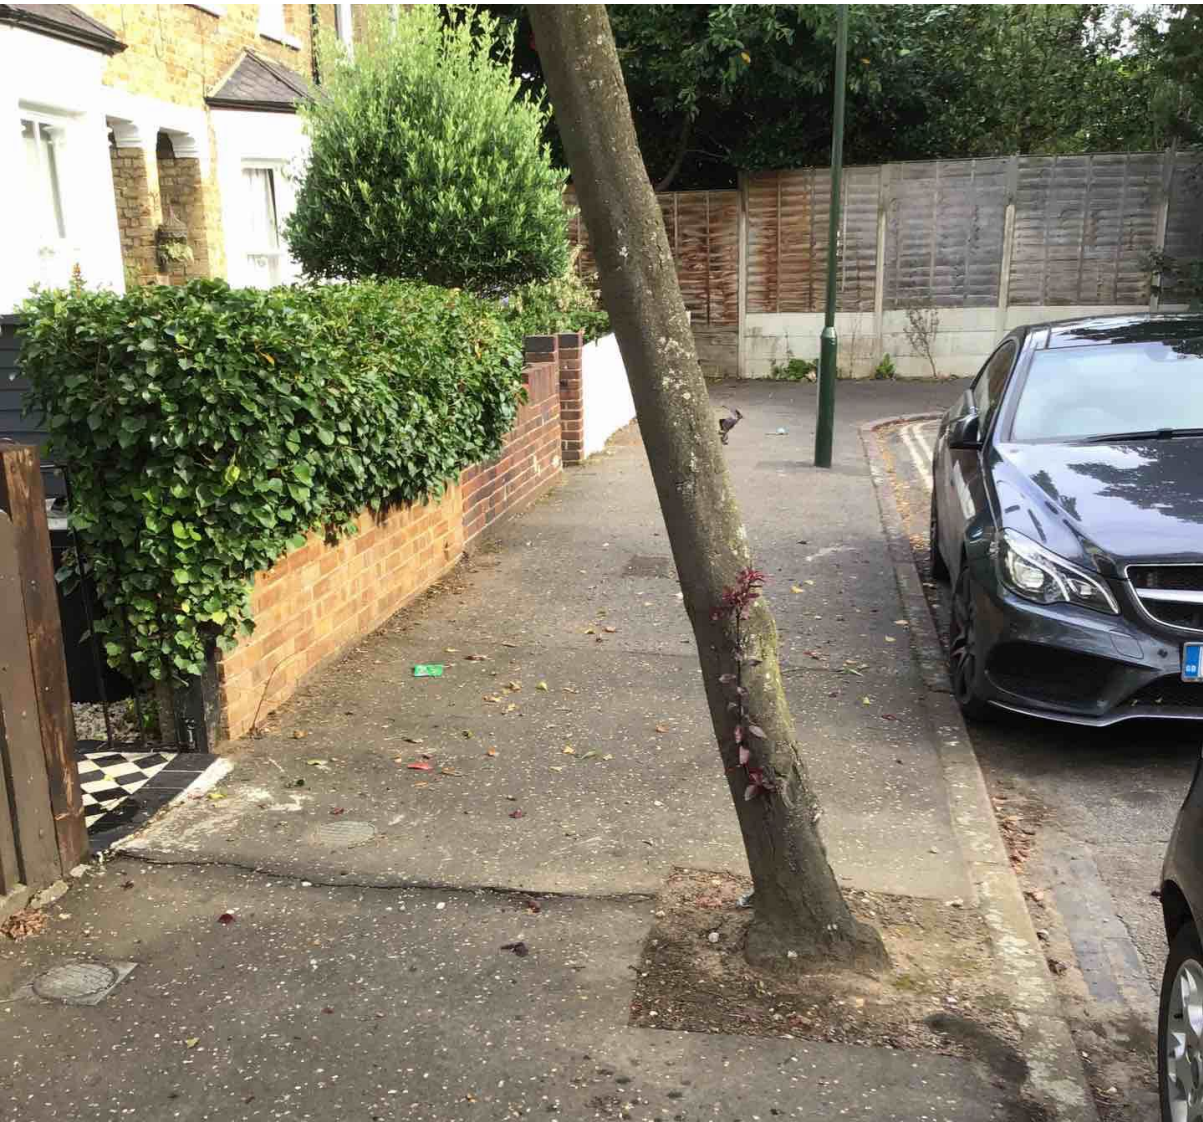
Tree number	6
Park	Arlington Road
Location	Outside 69-71
Species	Purple leaf plum (<i>Prunus cerasifera</i>)
Height	6.50
Physiological condition	Fair
Structural condition	Poor
Inspection findings	Ganoderma species fungal bodies at base, tree crown is uniformly thinning out with reduced leaf size and density. There is a moderate lean in the main stem which obstructs free passage on pathway. Although relatively young its issues cannot be satisfactorily be remedial via pruning

Image shows lean in stem towards properties and minimum required pavement clearances not possible at present

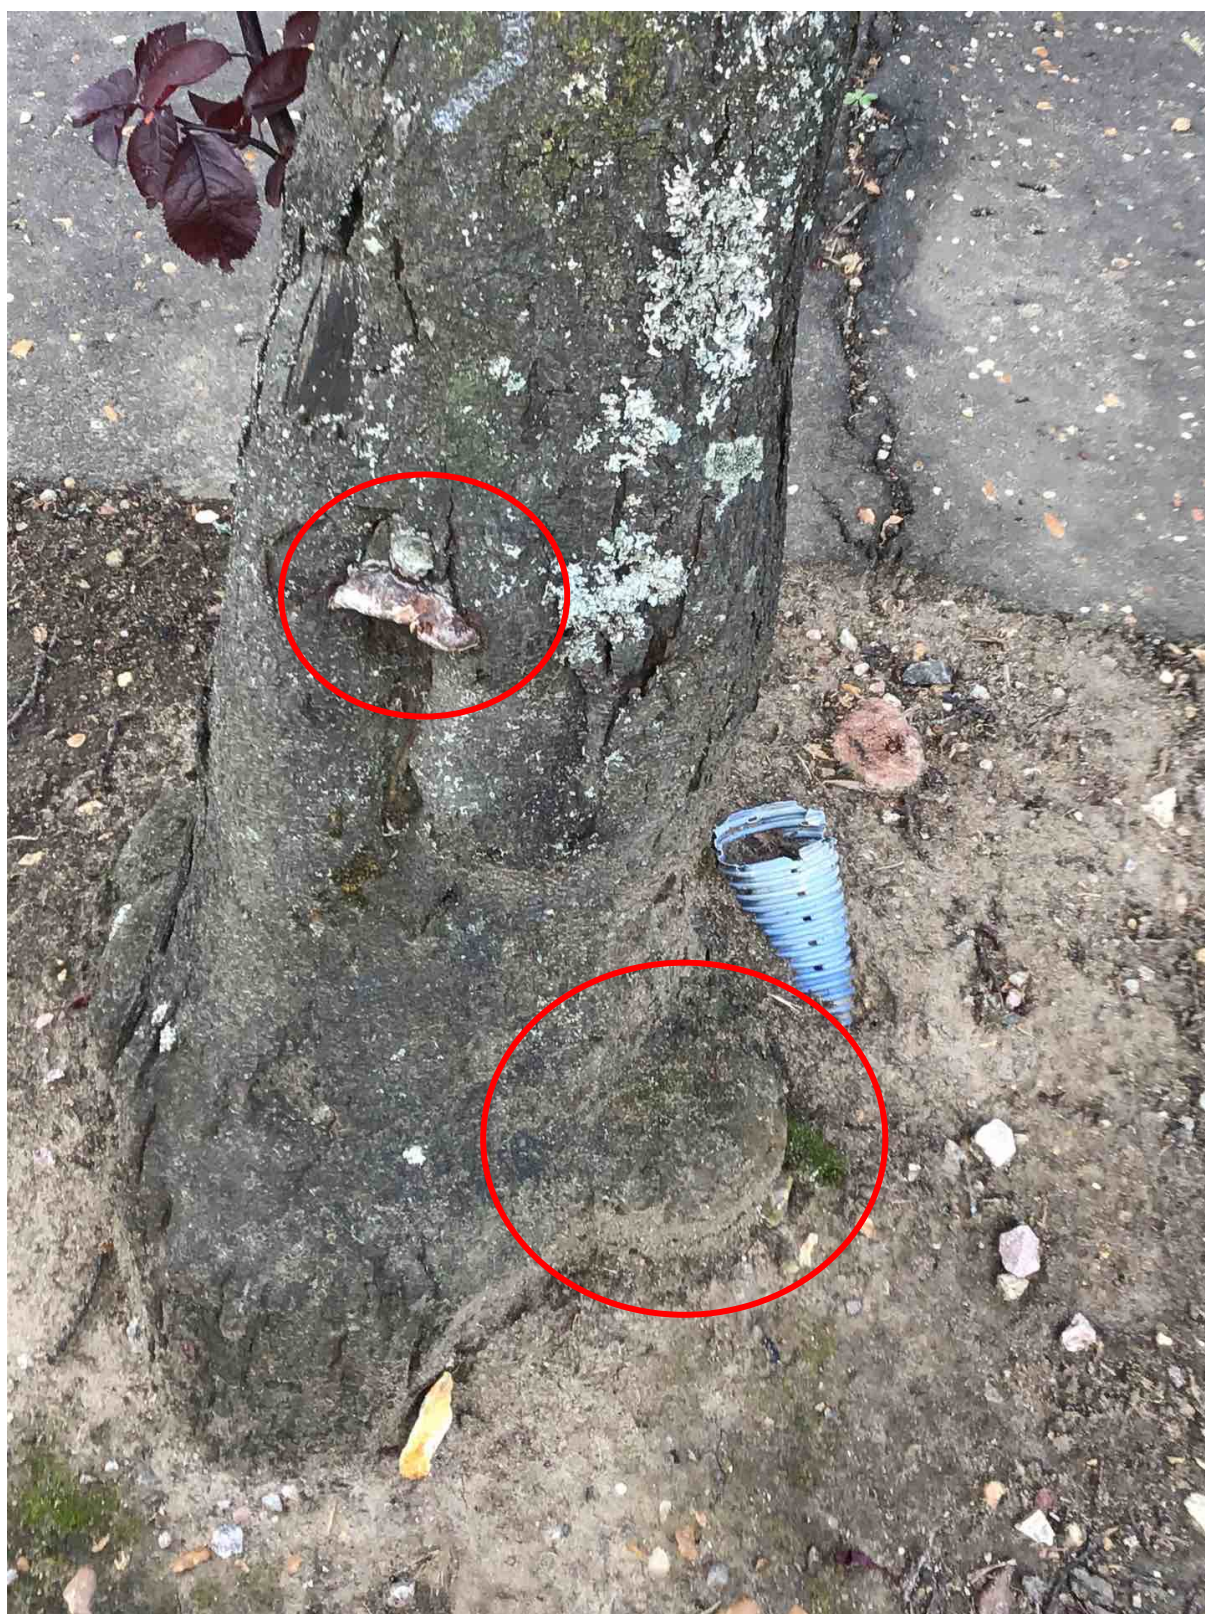
Image shows fruiting bodies of the decay pathogen Ganoderma spp at 2 separate basal locations

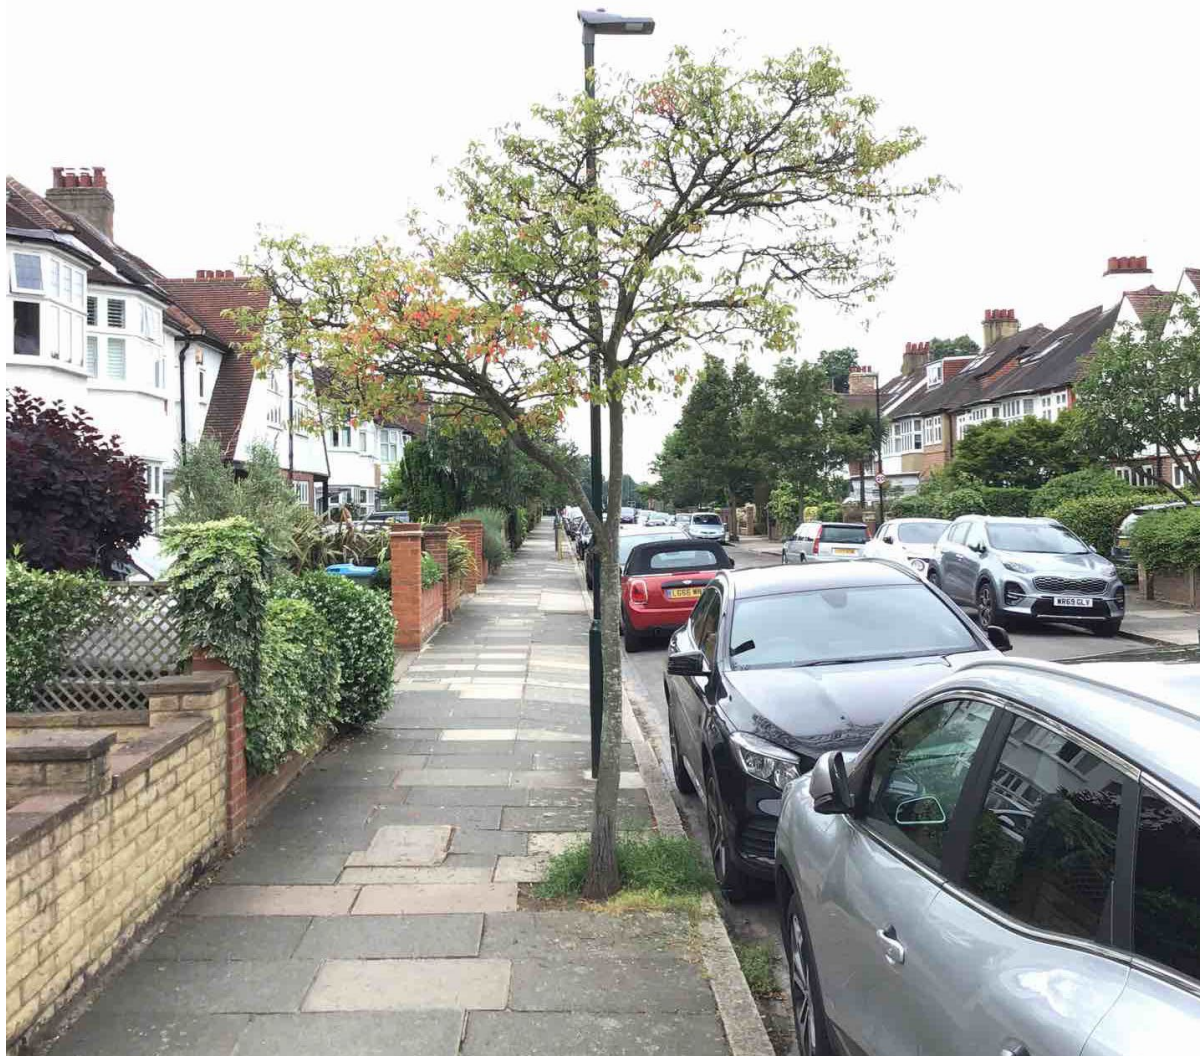
Tree number	8
Road	Avenue Gardens
Location	Outside 5-7
Species	Serviceberry (<i>Amalanchier</i> sp.)
Height	3.5 meters
Physiological condition	Fair
Structural condition	Poor
Inspection findings	Tree has poorly established root system and is loose in ground, reduced leaf size and crown density, apical growth dieback. ie. physiologically declining

Image shows reduced crown density and limited but uniform dieback. Tree is also structurally compromised through poor root establishment

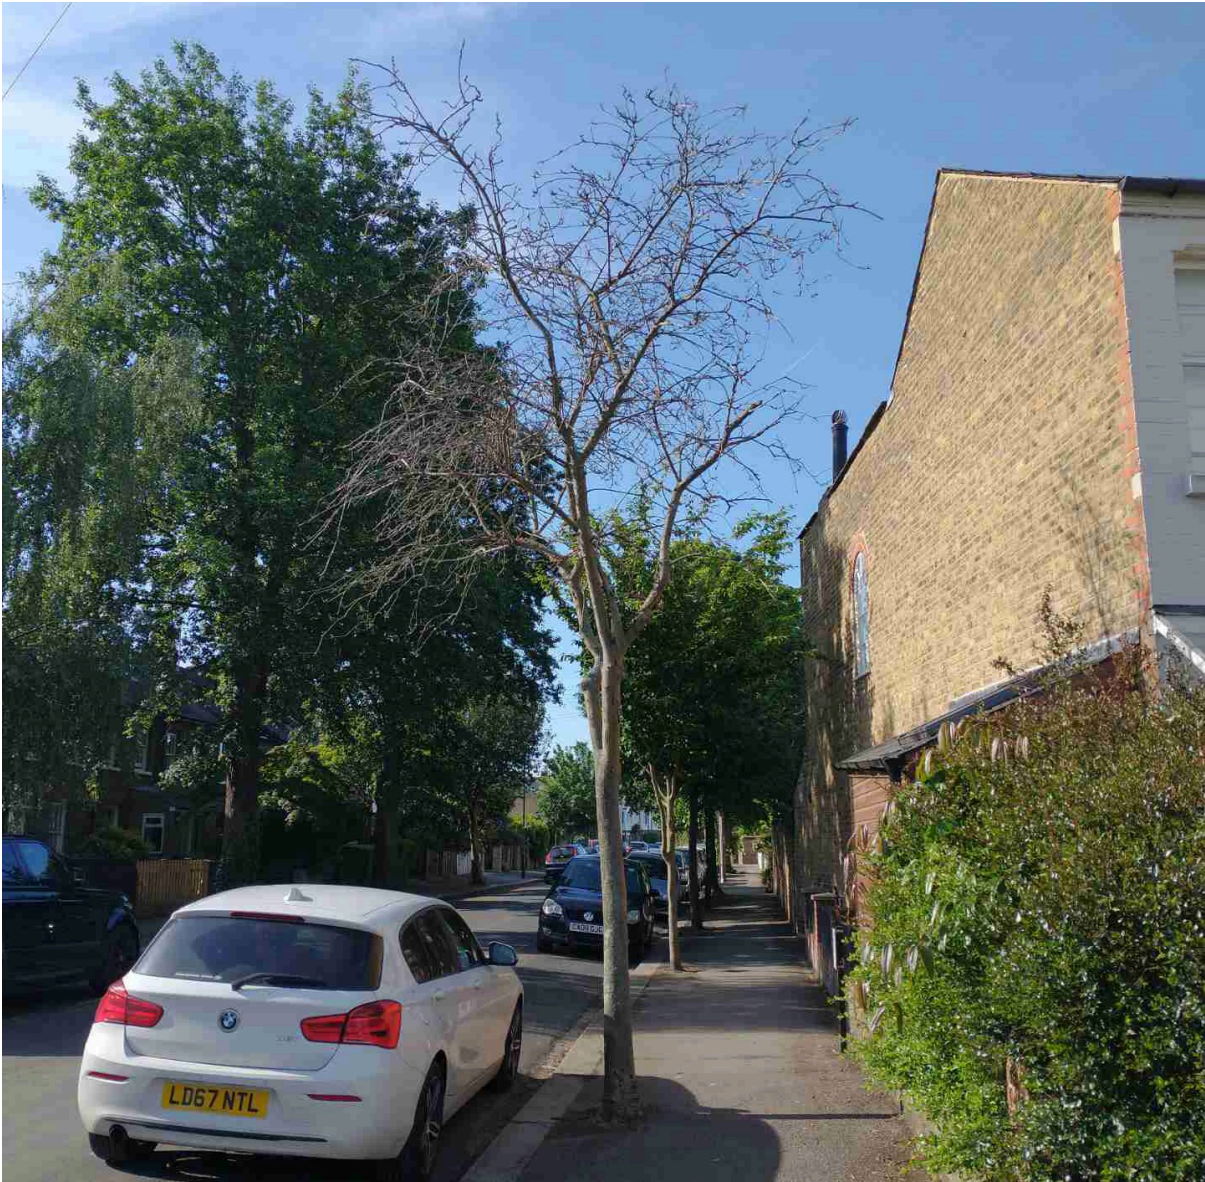
Tree number	15
Road	Blackmores Grove
Location	Opposite 5
Species	Mountain Ash (<i>Sorbus aucuparia</i>)
Height	6.00
Physiological condition	Dead
Structural condition	Dead
Inspection findings	This tree is dead and removal is required to prevent natural failure and facilitate replanting.

Images show dead tree during peak growing season

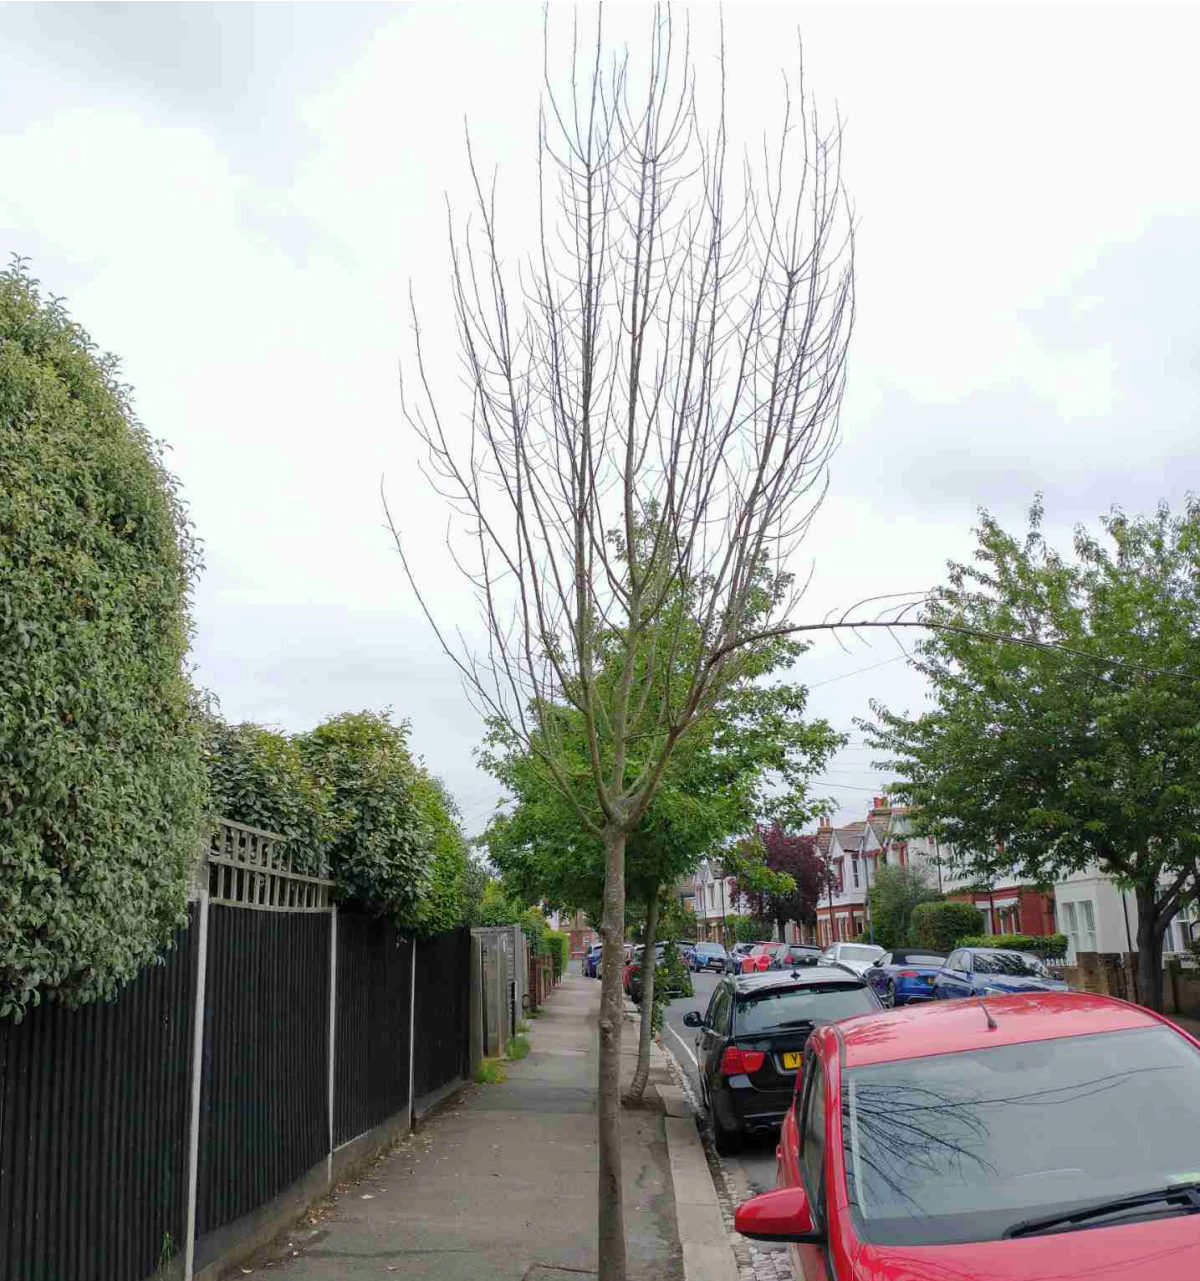
Tree number	28
Road	Blackmores Grove
Location	Adjacent to 59 Station Road
Species	Unknown
Height	5.00
Physiological condition	Dead
Structural condition	Dead
Inspection findings	This tree is dead and removal is required to prevent natural failure and facilitate replanting.

Image shows young dead tree on footpath during peak growing season

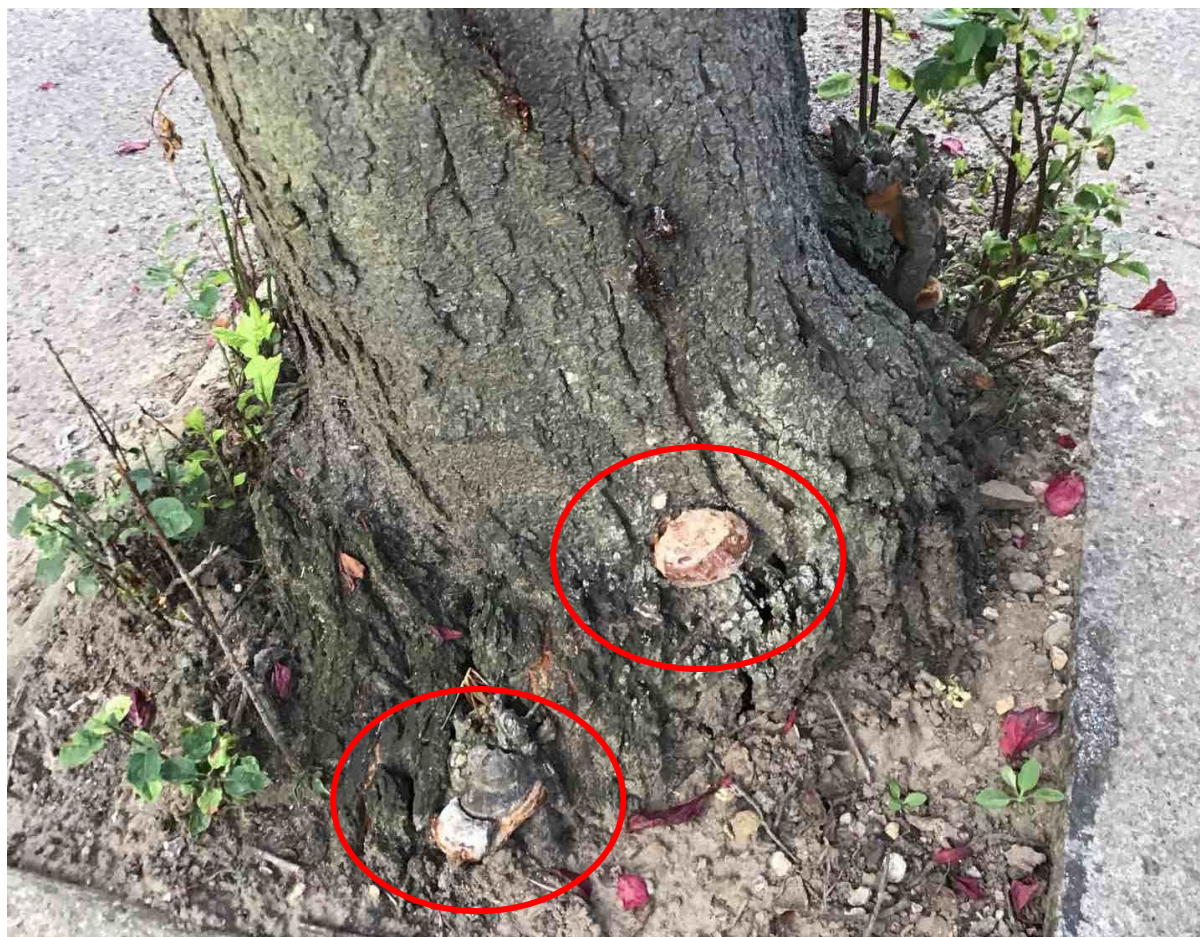
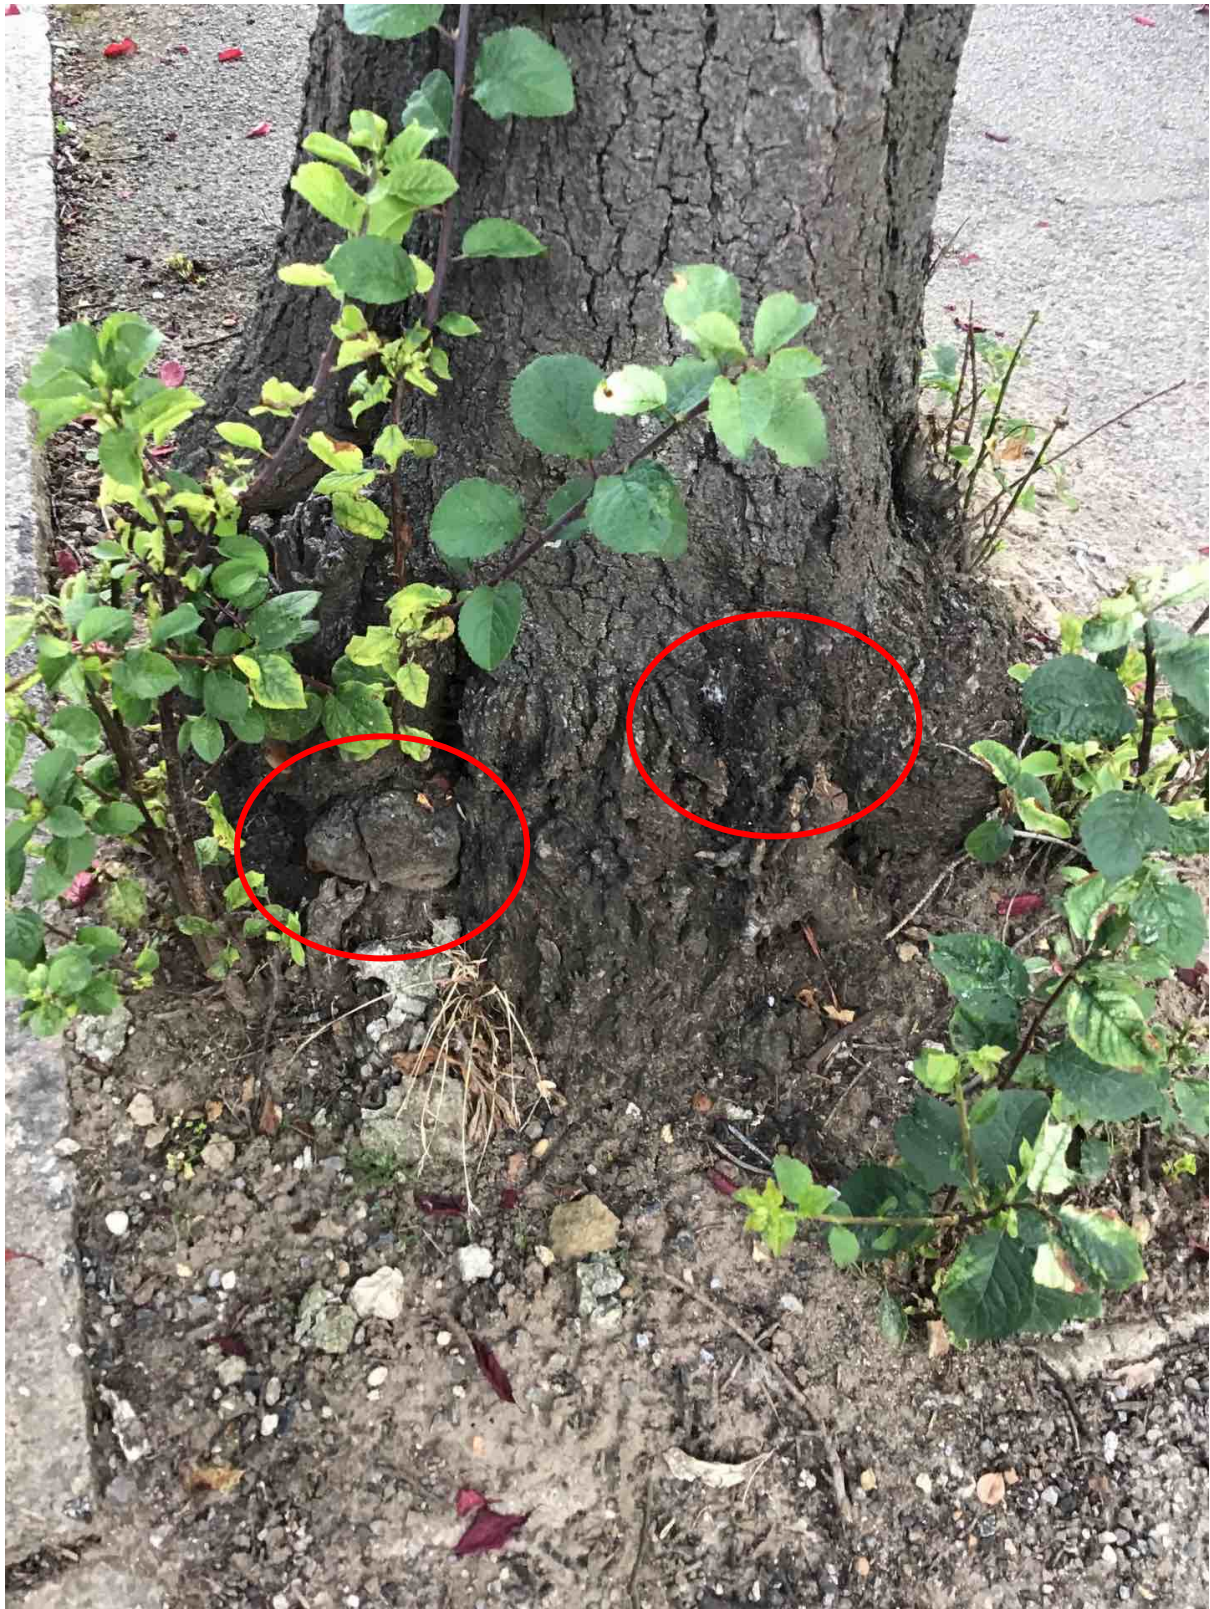
Tree number	24
Road	Blackmores Grove
Location	Outside 61
Species	Purple leaf plum (<i>Prunus cerasifera</i>)
Height	6.50
Physiological condition	Good
Structural condition	Poor
Inspection findings	Proliferation of Gannoderma fruiting bodies around base. Resonance tests indicated advancing decay. Structurally compromised. No scope for adequate sail reduction given spp

Images show both young and mature *Gannoderma* spp fruiting bodies around base. Clear indications of internal decay

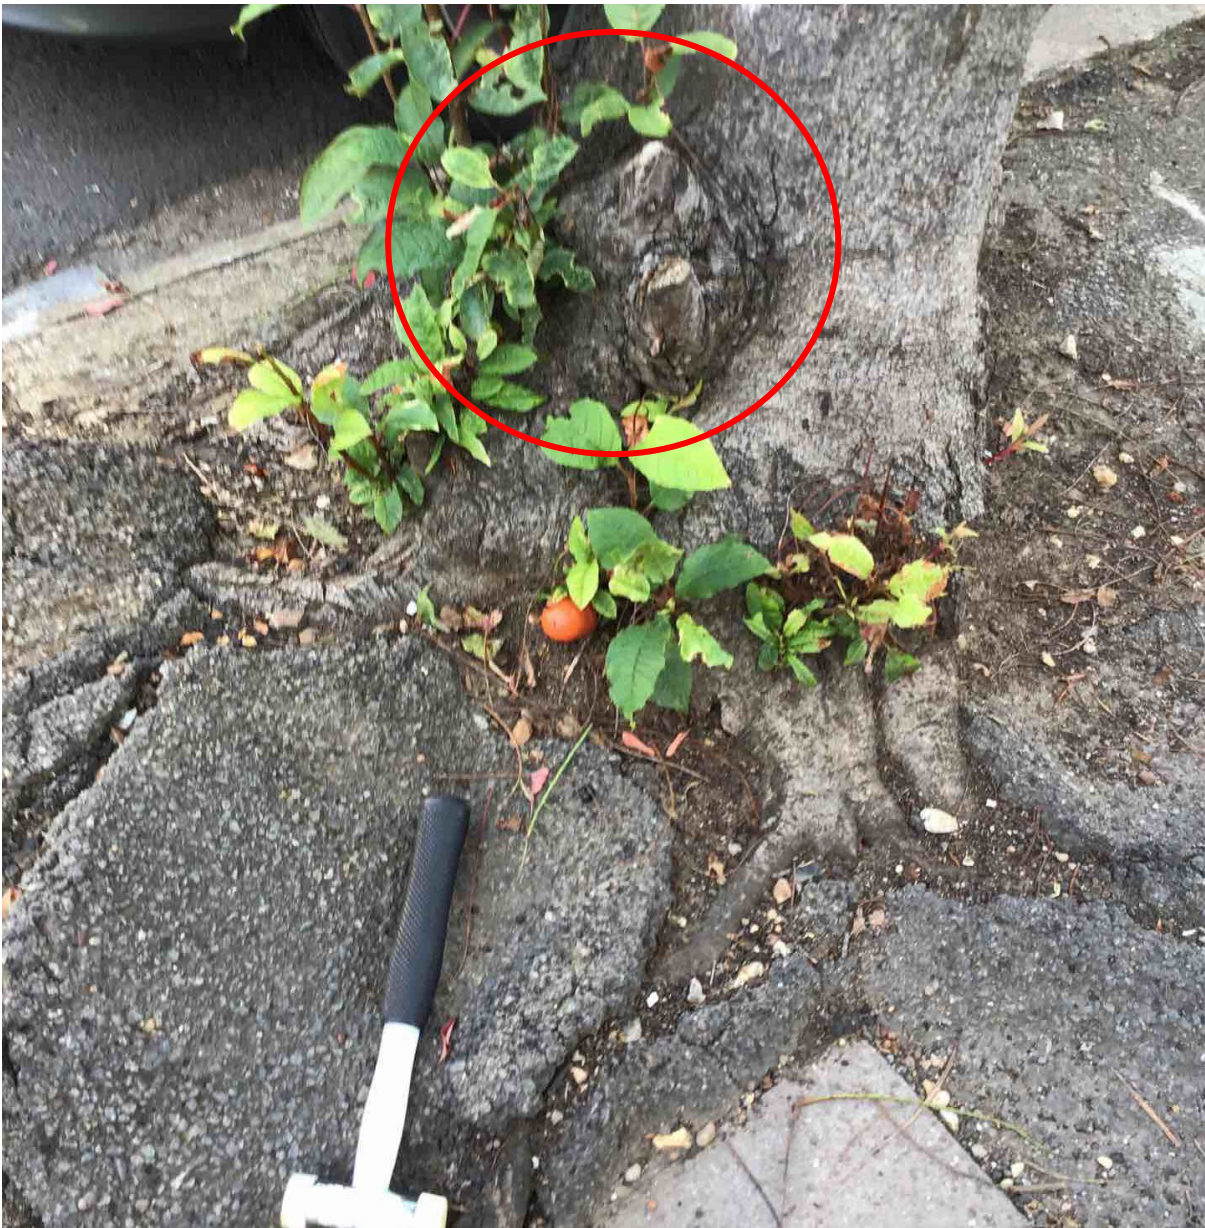
Tree number	32
Road	Bushy Park Road
Location	Outside 41
Species	Bird cherry (<i>Prunus padus</i>)
Height	2.5
Physiological condition	Good
Structural condition	Poor
Inspection findings	Ganoderma spp brackets present at base and presenting an extensive basal cavity with limited holding wood opposing stem lean. Higher the acceptable risk of failure

Image shows area of extensive internal basal decay. While not clearly visible externally, probing and resonance tests have found the structural integrity is compromised with a raised risk of failure

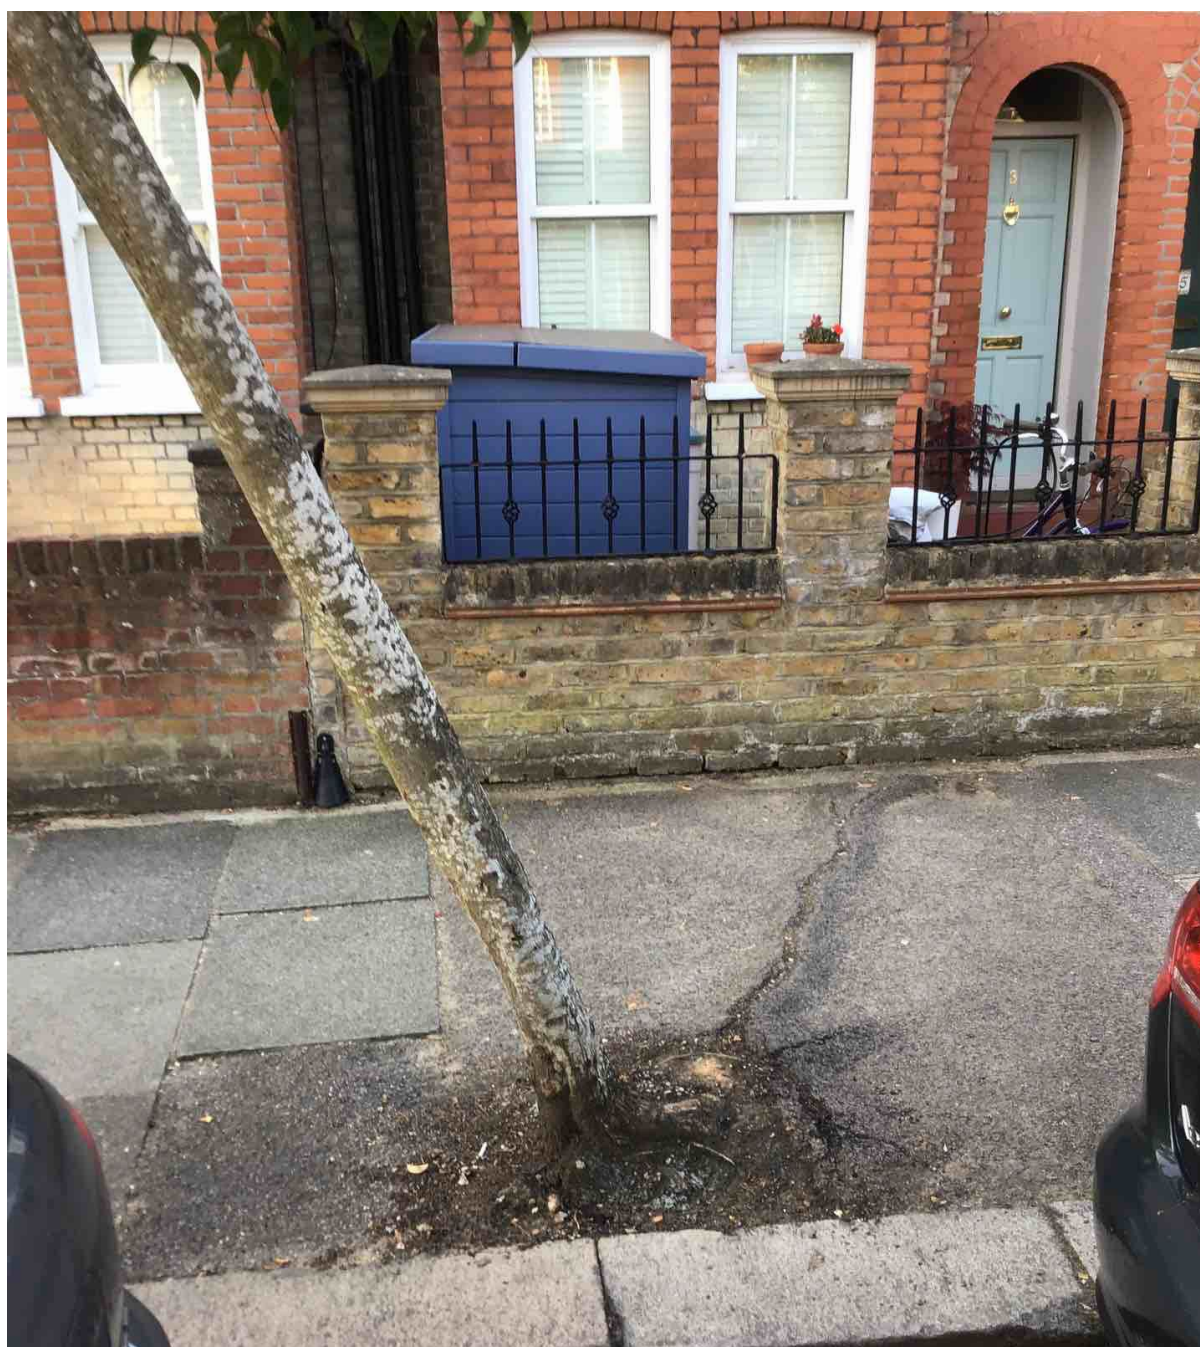
Tree number	24
Road	Bushy Park Road
Location	Outside 1-3
Species	Japanese Privet (<i>Ligustrum japonicum</i>)
Height	5.5
Physiological condition	Good
Structural condition	Poor
Inspection findings	Tree doesn't have established rooting system and is leaning over with potential for failure over path and / or road.

Image shows acute lean in stem arising from poor root establishment / stability

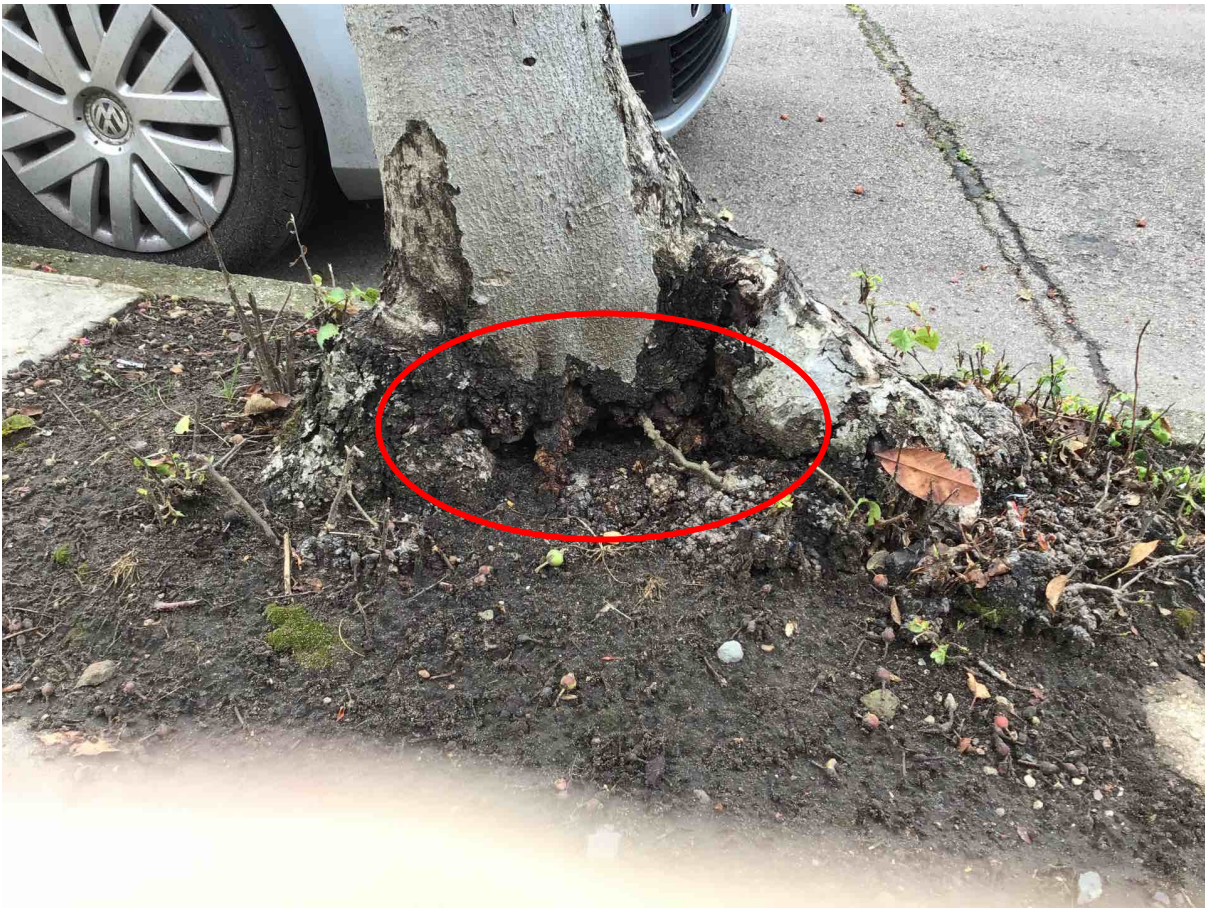
Tree number	7
Road	Cambridge Crescent
Location	Outside 89
Species	Crab apple (<i>Malus spp</i>)
Height	6.50
Physiological condition	Fair
Structural condition	Poor
Inspection findings	Ganoderma and extensive basal cavity. Bole decayed out beneath root collar, failure potential as no significant amount of quality holding wood remaining

Image shows extensive basal cavity/hollowing with *Ganoderma spp* pathogen fruiting bodies within

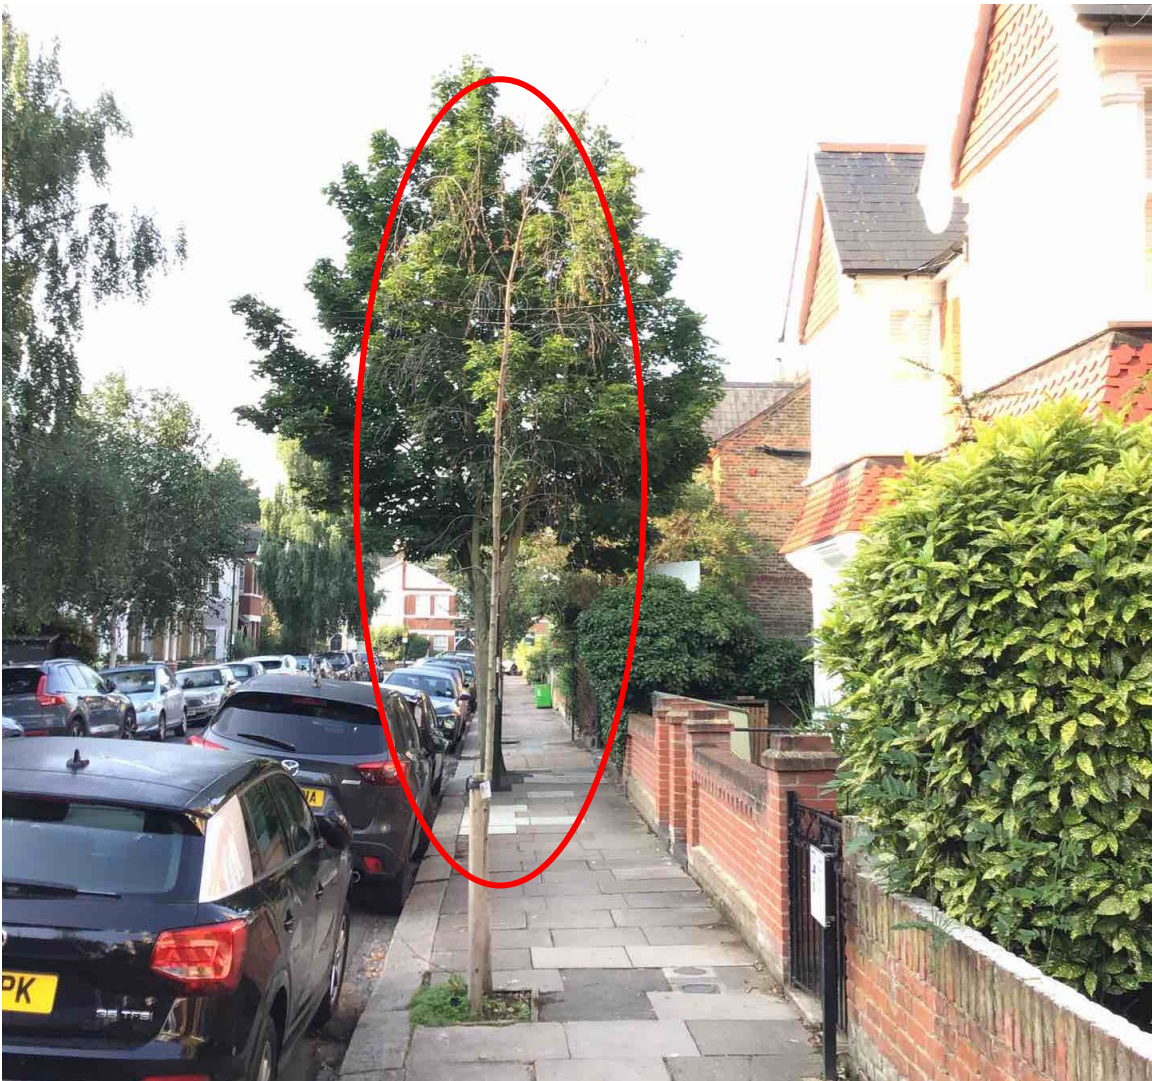
Tree number	4
Road	Cedar Road
Location	Outside 10-12
Species	Norway Maple (<i>Acer platanoides</i>)
Height	5.00
Physiological condition	Dead
Structural condition	Dead
Inspection findings	This tree is dead and removal is required to prevent natural failure and facilitate replanting.

Image shows dead young transplant which failed to come out of dormancy

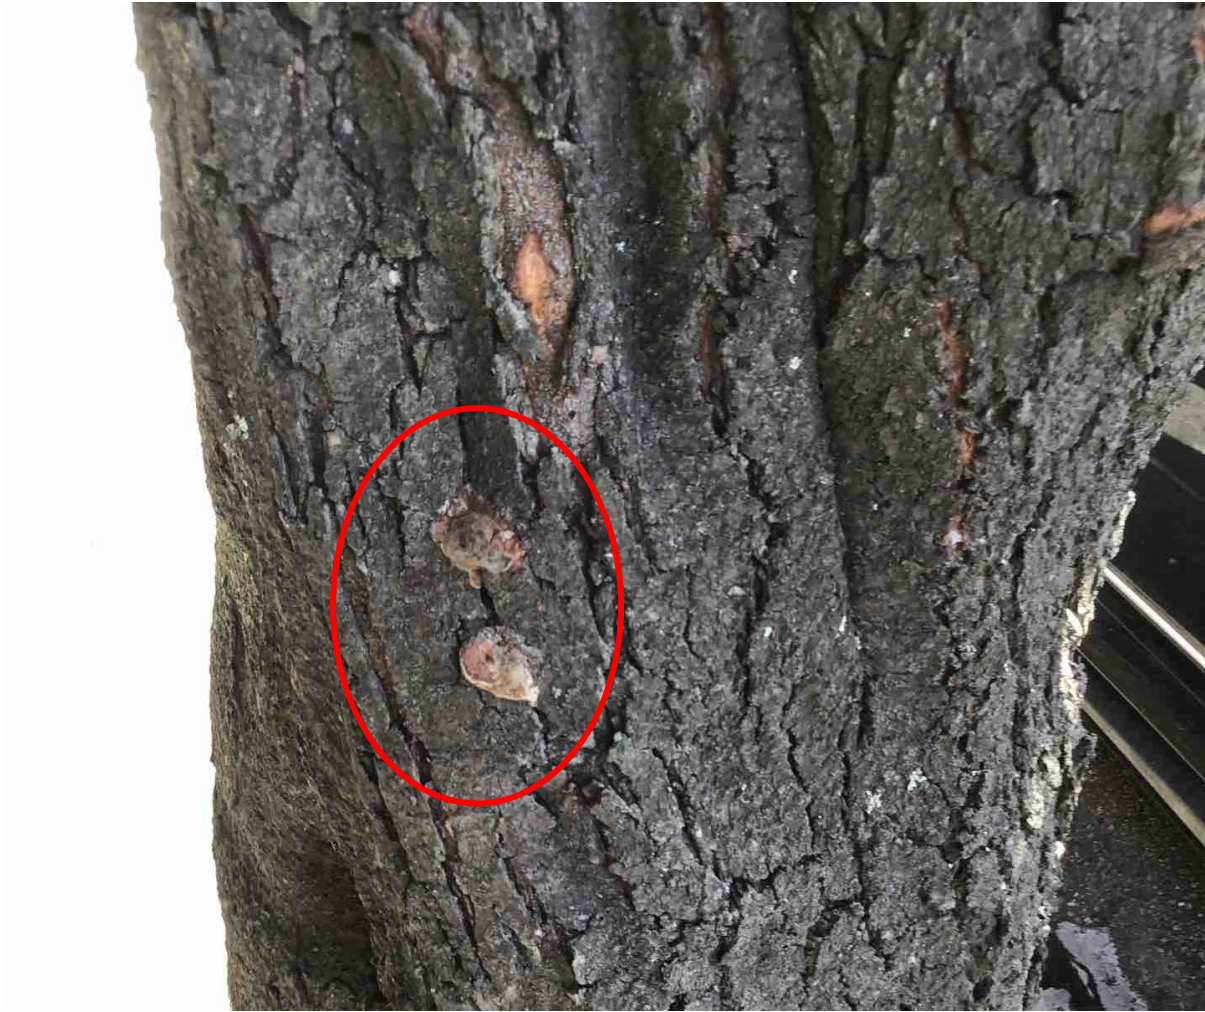
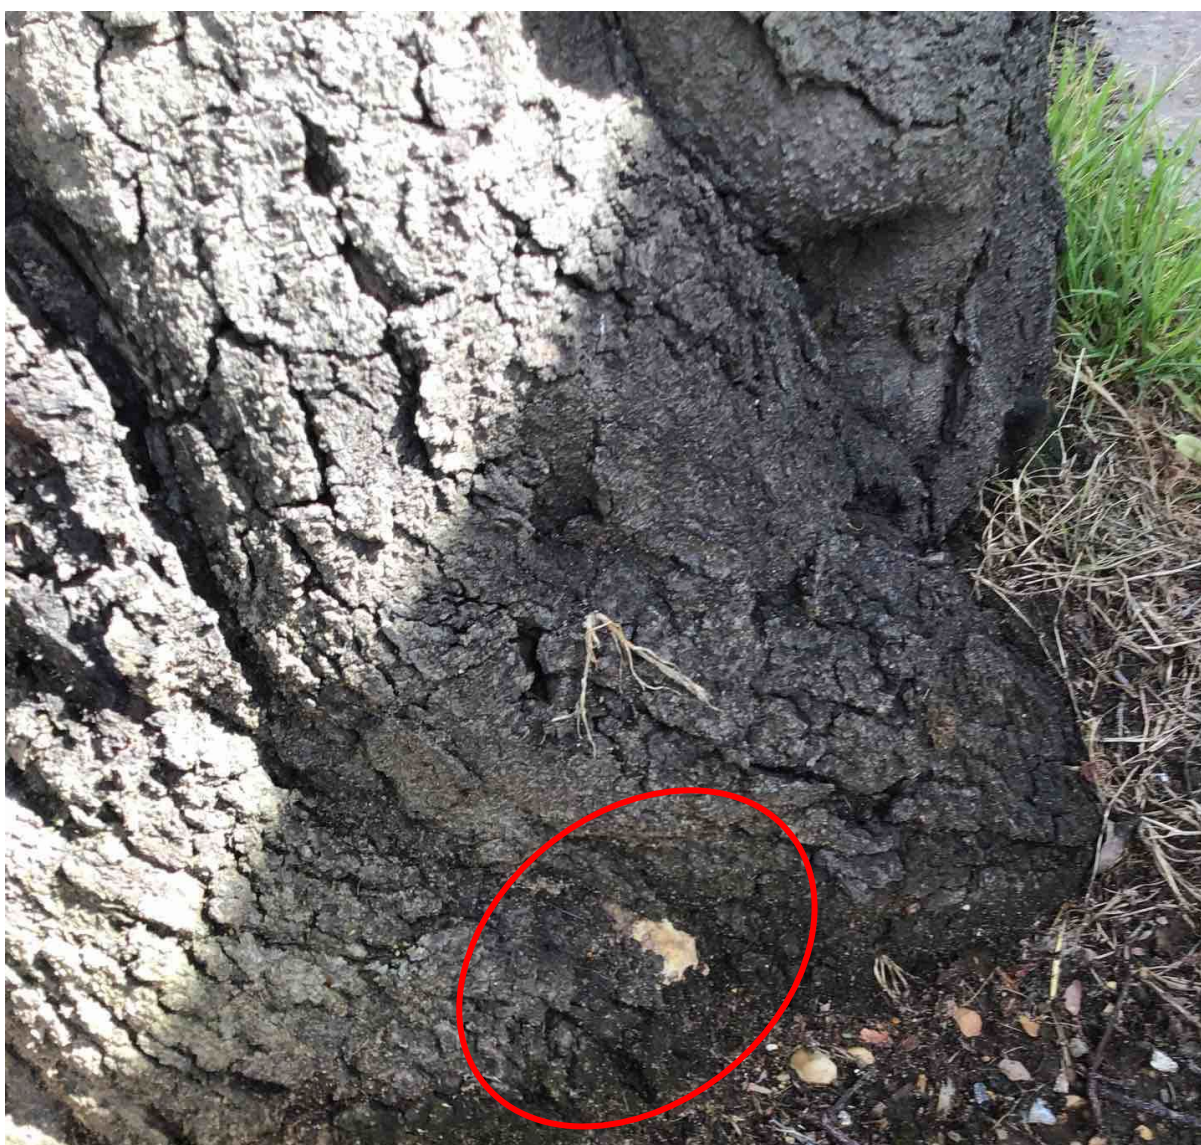
Tree number	18
Road	Claremont Road
Location	Outside 2A
Species	Purple leaf plum (<i>Prunus cerasifera</i>)
Height	7.5
Physiological condition	Fair
Structural condition	Poor
Inspection findings	Phellinus pomaceus brackets at base of stem and around upper stem, with internal decay defects in base of stem when using sounding hammer. Poor structural integrity and showing partial crown dieback. This decay fungus has a high incidence of failure in this tree species

Images show two of several areas on the stem with decay pathogen fruiting bodies. Colonisation of this species often leads to failure of trees in part or whole

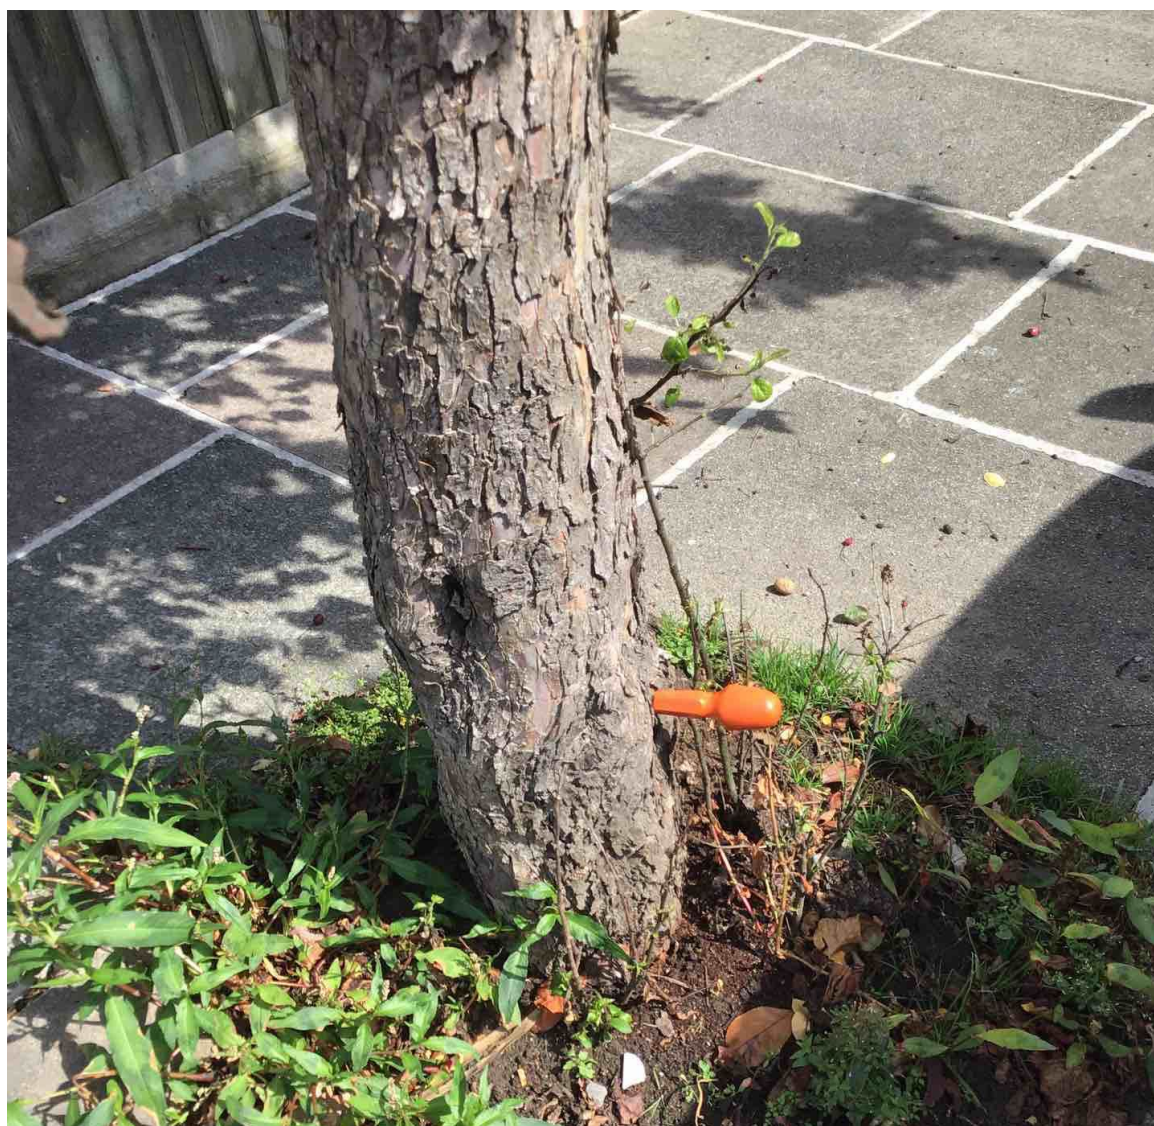
Tree number	22
Road	Claremont Road
Location	Outside 21-23
Species	Crab Apple (<i>Malus spp</i>)
Height	7.50
Physiological condition	Fair
Structural condition	Poor
Inspection findings	Ganoderma species fungal brackets at base, advanced stem decay; resonating as hollowed out. Apical die off, tree has a limited useful life expectancy remaining. Assessing officer also reports excessive movement in stem

Image shows area of hollowed stem with 20cm+ screwdriver probed. Quality of wood in this area is degraded and compromised in terms of structural stability
