Teddington - 2021 Ward Works and Tree Removals Programme

A recent survey of trees in the Teddington ward has taken place; this was conducted by a competent specialist Arboriculturist as part of the scheduled 4 yearly detailed inspection regime that has been devised for all Council highway and parks trees.

Dated 09.03.2021

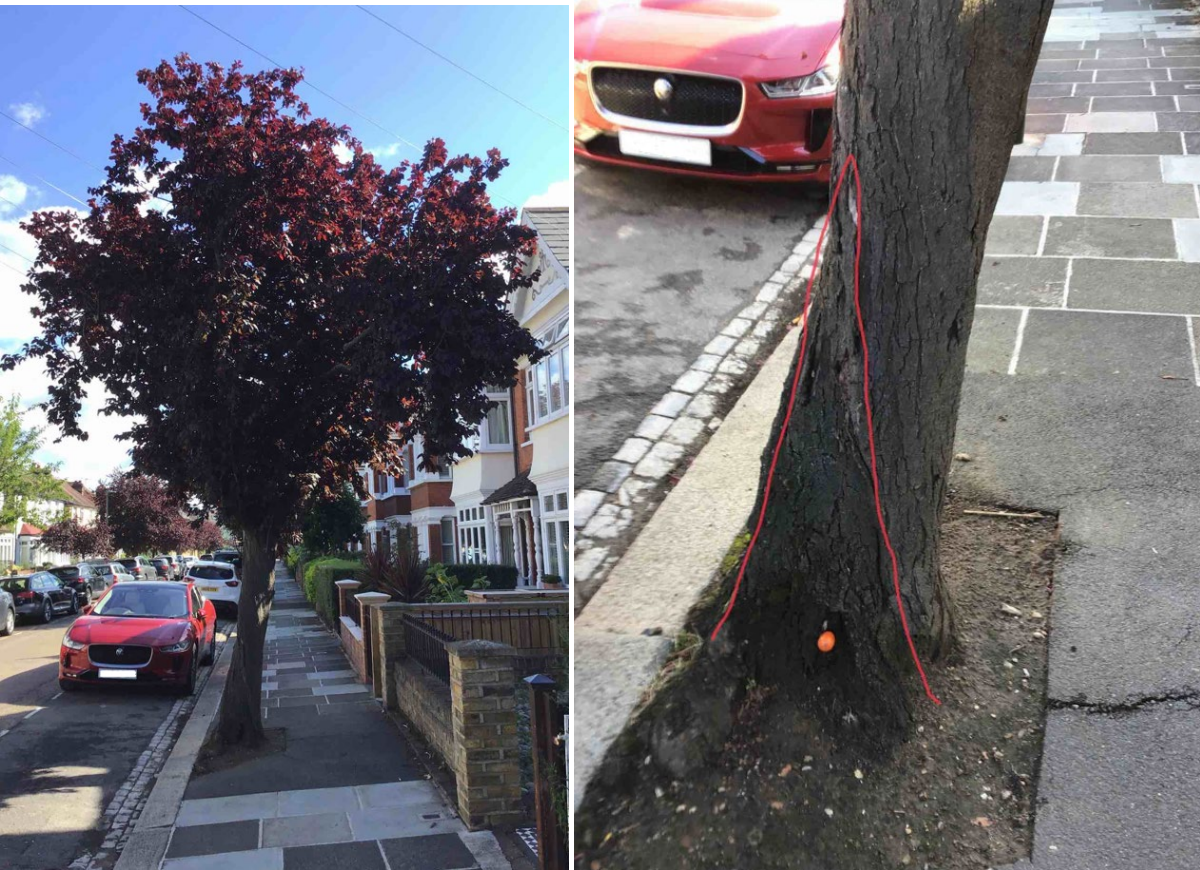
Tree number	8
Road	Claremont Road
Location	Outside 30
Species	Purple leaf plum (<i>Prunus cerasifera</i>)
Height	7.00
Physiological condition	Fair
Structural condition	Poor
Inspection findings	Strip of necrotic wood up stem from base, extensive decay progressing into stem. A resonance test revealed an unacceptable degree of decay in the trunk of this tree, removal is required to prevent natural failure and manage risk.

Images shows tree in situ and area of decay indicated by resonance testing

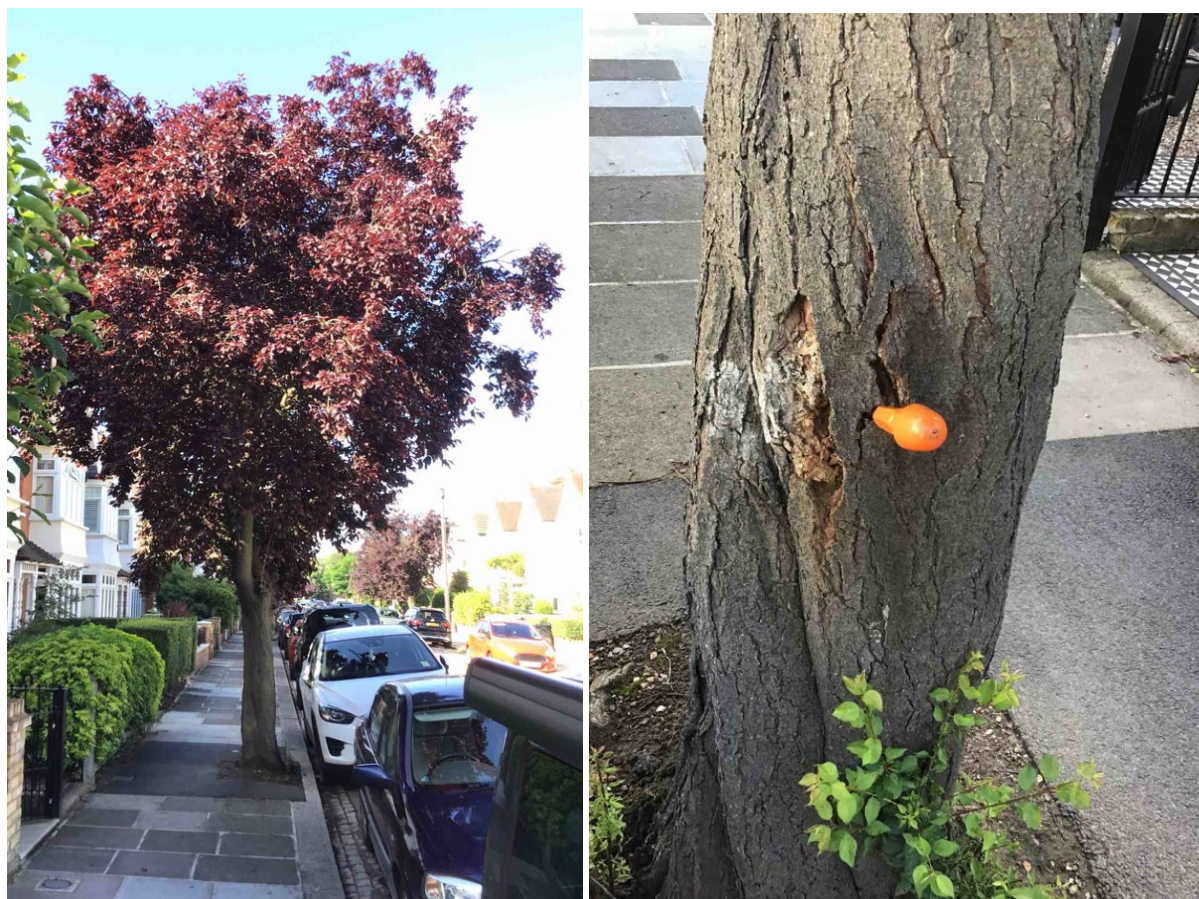
Tree number	7
Road	Claremont Road
Location	Outside 36
Species	Purple leaf plum (<i>Prunus cerasifera</i>)
Height	7.5m
Physiological condition	Fair
Structural condition	Poor
Inspection findings	Fungal fruiting bodies of the wood decay fungus <i>Laetiporus sulphureus</i> are present on the trunk of this tree. This fungus causes a brown rot which can rapidly reduce wood strength and cause branch or whole tree failure through brittle fracture.

Images shows tree in situ and probe inserted into decayed wood adjacent to remnants of fungal fruiting body.

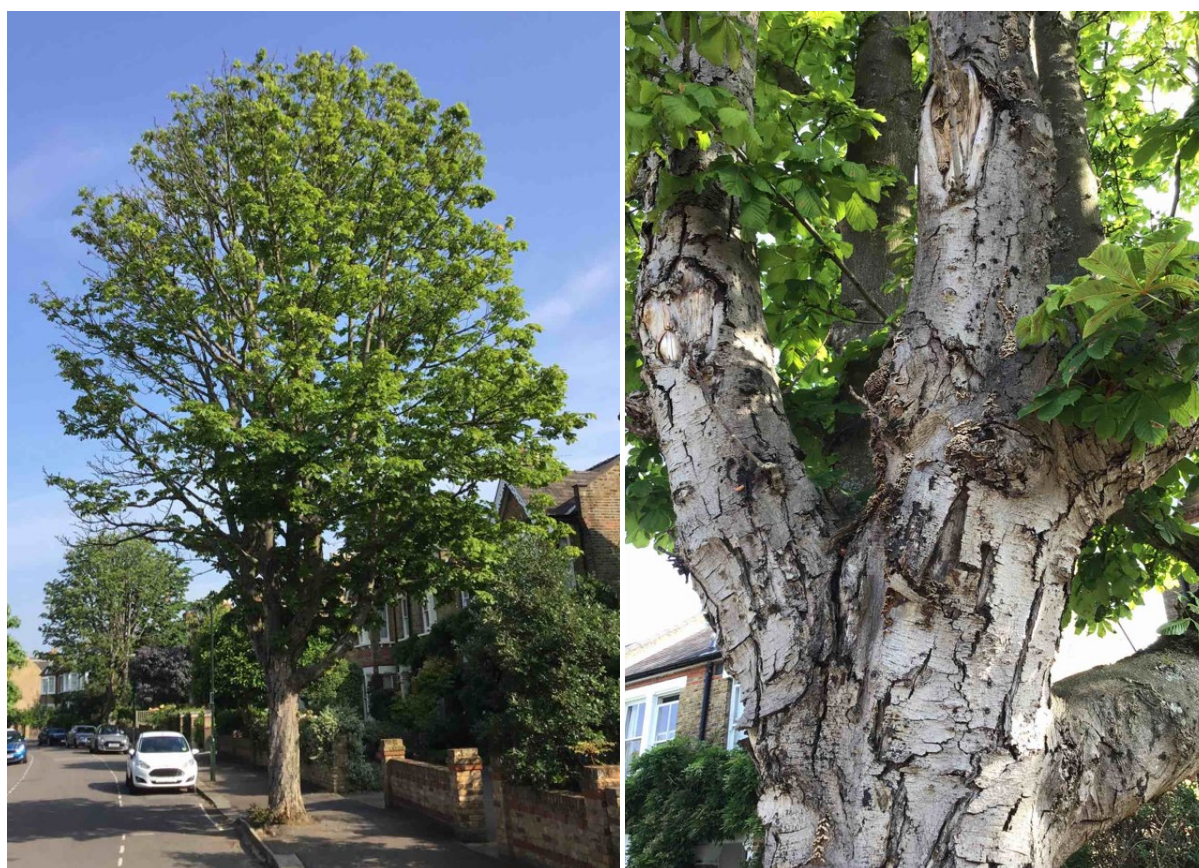
Tree number	25
Road	Clarence Road
Location	Outside 59
Species	Horse Chestnut (<i>Aesculus hippocastanum</i>)
Height	14.5m
Physiological condition	Poor
Structural condition	Poor
Inspection findings	This tree has stem bleeding, necrotic bark and crown die back which is consistent with the pathogen <i>Pseudomonas syringae</i> . The extent of infection has permanently damaged this trees adaptive capacities and it now presents an unacceptable risk and requires removal.

Left image shows tree with sparse canopy on the road side, right image shows main crown break with stem bleeding, necrotic bark and saprotrophic fungi colonising dead tissue.

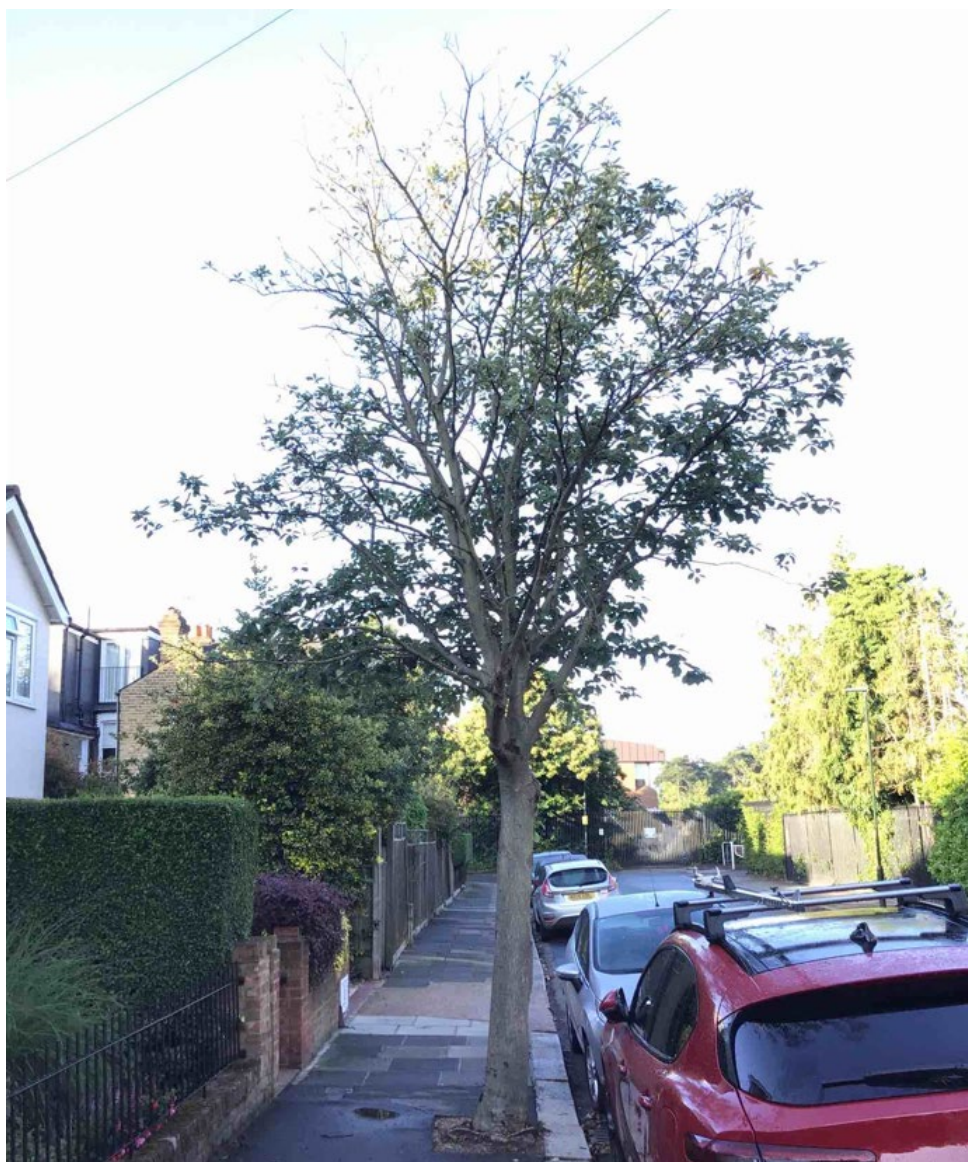
Tree number	18
Road	Coleshill Road
Location	Outside 41-43
Species	Swedish Whitebeam (<i>Sorbus intermedia</i>)
Height	8.0m
Physiological condition	Poor
Structural condition	Fair
Inspection findings	This tree is in a state of physiological decline and contains weak branches that are liable to collapse.

Image shows tree with sparse canopy

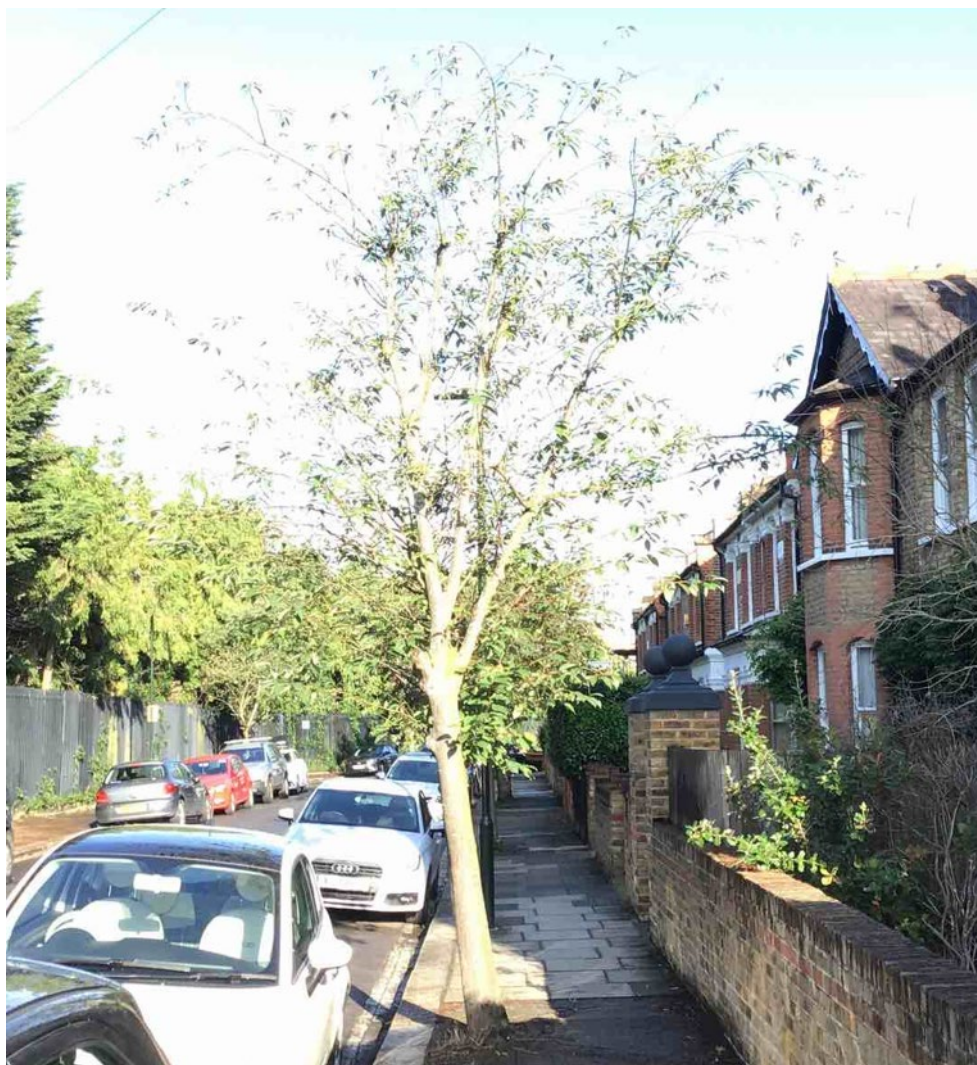
Tree number	24
Road	Coleshill Road
Location	Outside 77
Species	Bird Cherry (<i>Prunus padus</i>)
Height	6.0m
Physiological condition	Poor
Structural condition	Poor
Inspection findings	An emerging fungal fruiting body displaying characteristics of decay pathogen <i>Ganoderma</i> sp. is present at the stem base. Colonisation by this fungus causes a white rot of the stem and root system that can cause entire trees to collapse through fracture or windthrow. The tree is declining, significant dieback is present and this correlates with the pathogen present.

Image shows tree with sparse canopy

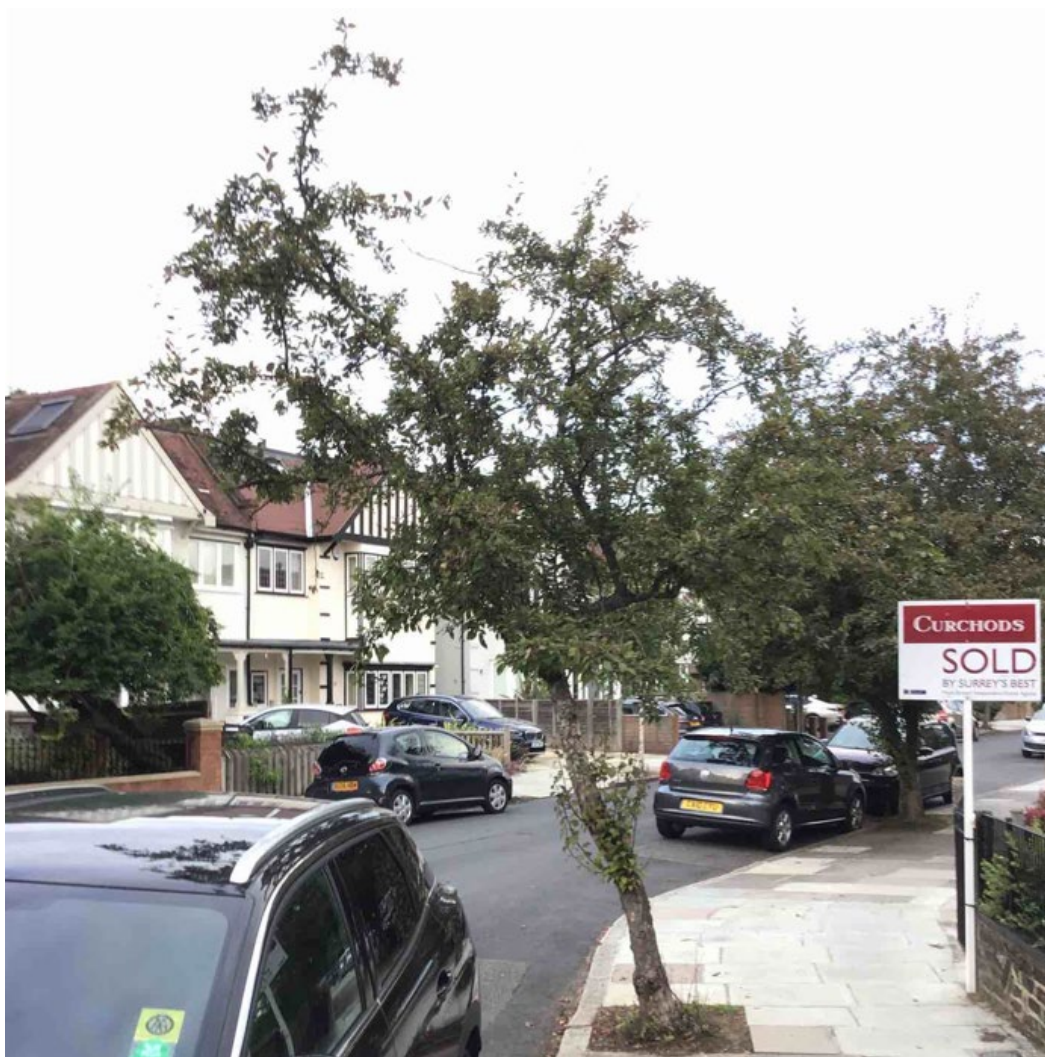
Tree number	14
Road	Elmfield Avenue
Location	Outside 38
Species	Apple (<i>Malus</i> sp.)
Height	5.0m
Physiological condition	Fair
Structural condition	Poor
Inspection findings	Tree main trunk and roots are decayed; tree is moving in such a way that indicates that the structure is compromised presenting increased risk of failure. Crown dieback could correlate with the degradation of the trees structural or supporting root system.

Image shows tree with sparse canopy and lean towards road

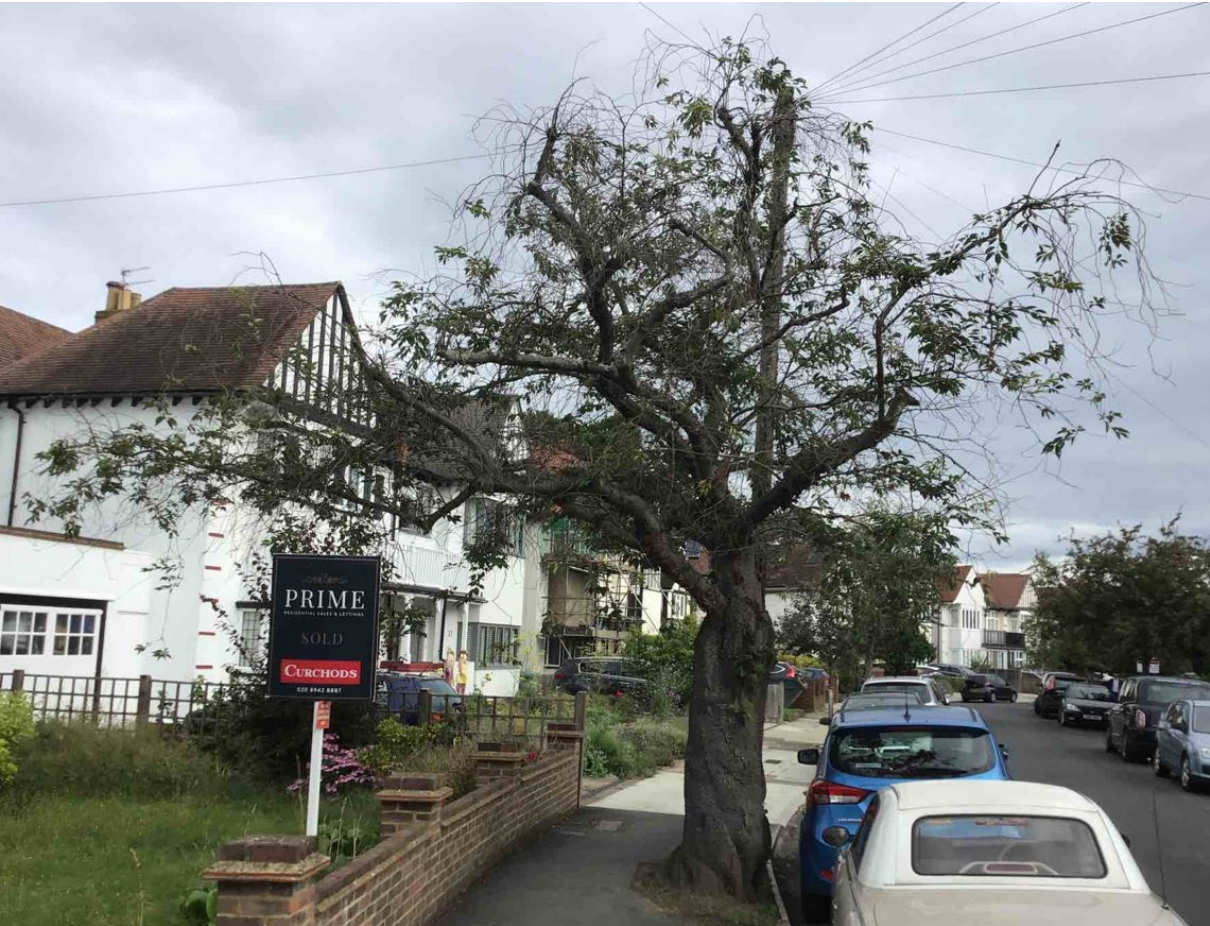
Tree number	28
Road	Elmfield Avenue
Location	Outside 27
Species	Cherry (<i>Prunus</i> sp.)
Height	7.5m
Physiological condition	Poor
Structural condition	Poor
Inspection findings	This tree is in a state of physiological decline and contains weak branches that are liable to collapse.

Image shows tree with extensive die back of canopy

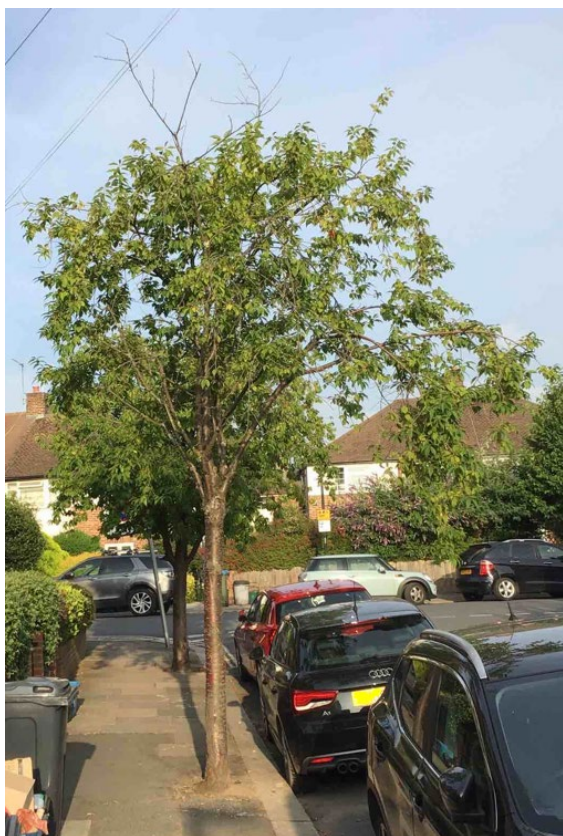
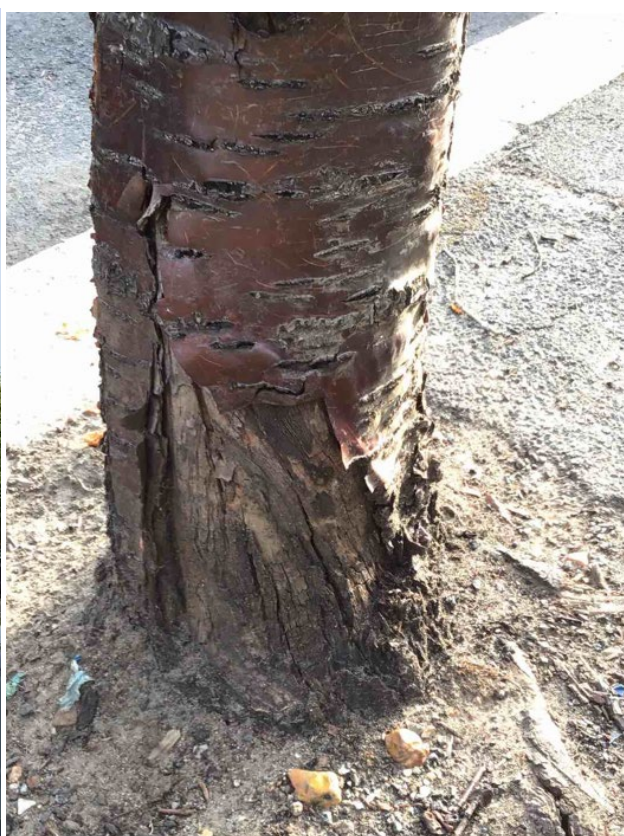
Tree number	4
Road	Gomer Gardens
Location	Outside 4/6
Species	Cherry (<i>Prunus</i> sp.)
Height	5.5m
Physiological condition	Poor
Structural condition	Poor
Inspection findings	Tree trunk and roots are extensively decayed/damaged; tree is moving in such a way that indicates that the structure is compromised presenting increased risk of failure. Crown dieback could correlate with the degradation of the trees structural or supporting root system.

Left image shows tree with die back of canopy. Right image shows basal damage.

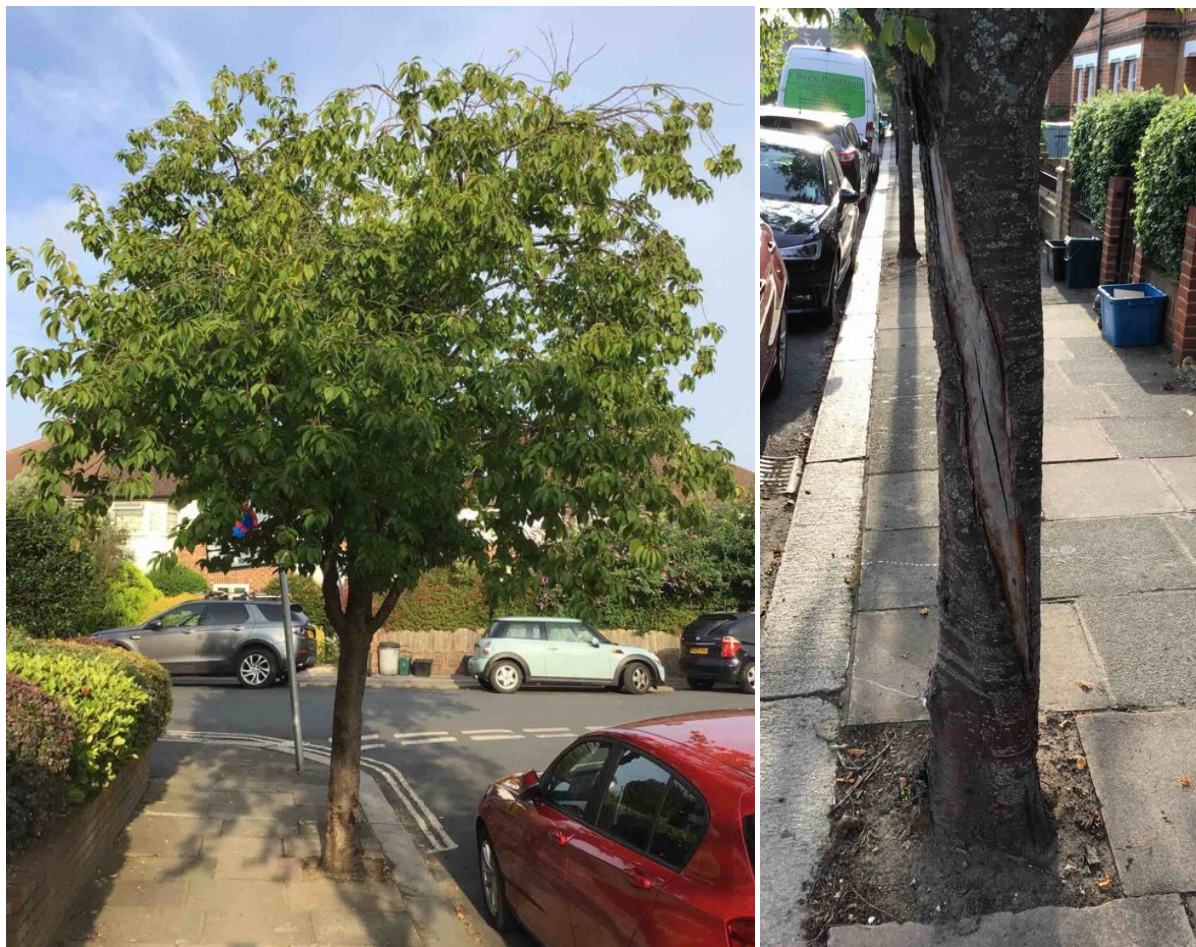
Tree number	5
Road	Gomer Gardens
Location	Outside 2
Species	Cherry (<i>Prunus</i> sp.)
Height	5.5m
Physiological condition	Poor
Structural condition	Poor
Inspection findings	The trunk and base of this tree contain cavities and splits. A resonance test revealed an unacceptable degree of decay in the trunk of this tree; this decay correlates with crown dieback and decline. Removal is required to prevent natural failure and manage risk.

Left image shows tree with die back of canopy. Right image shows split in trunk.

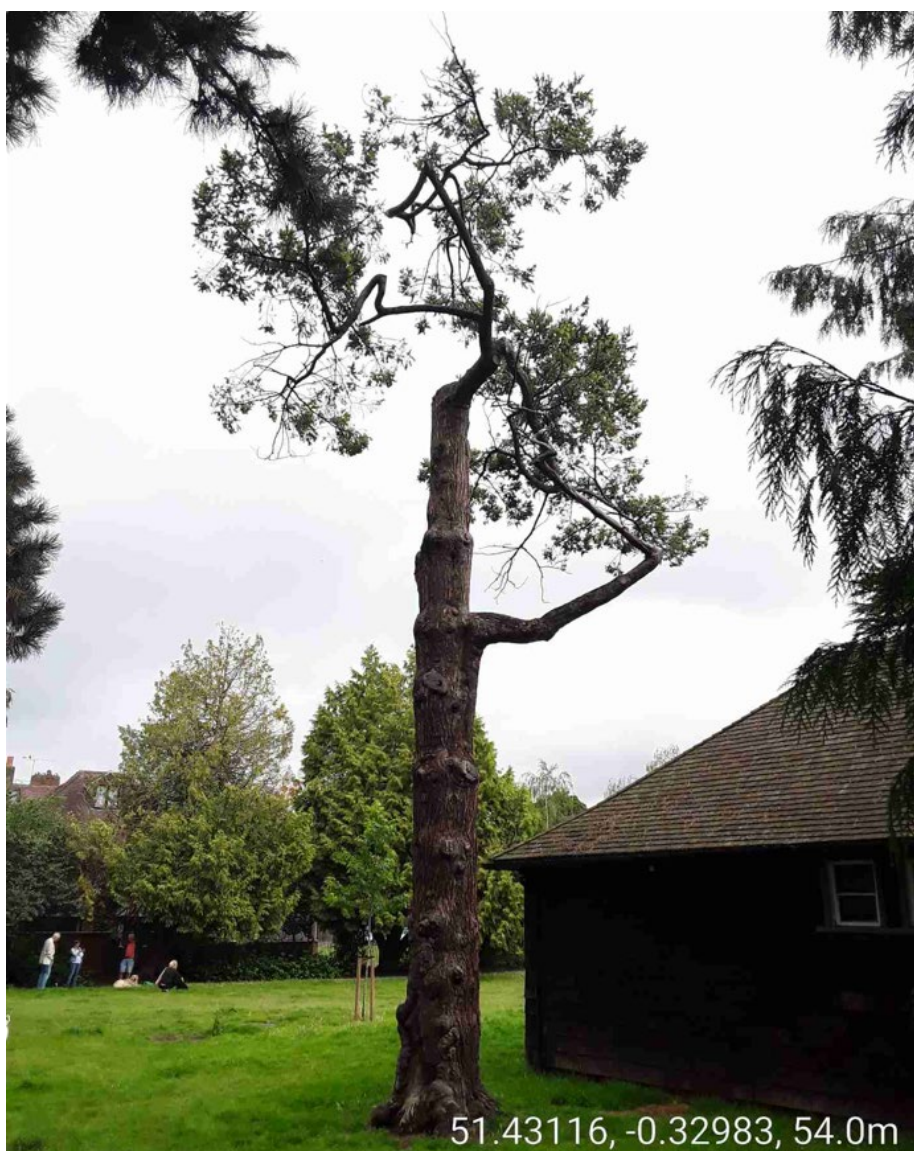
Tree number	4
Road	Grove Gardens
Location	Grove Gardens – need map
Species	Spruce (<i>Picea</i> sp.)
Height	11.0m
Physiological condition	Poor
Structural condition	Poor
Inspection findings	A cavity indicating root and lower stem decay is present at the base of this tree; this decay correlates with crown dieback and decline.

Image shows tree with die back of canopy and basal decay

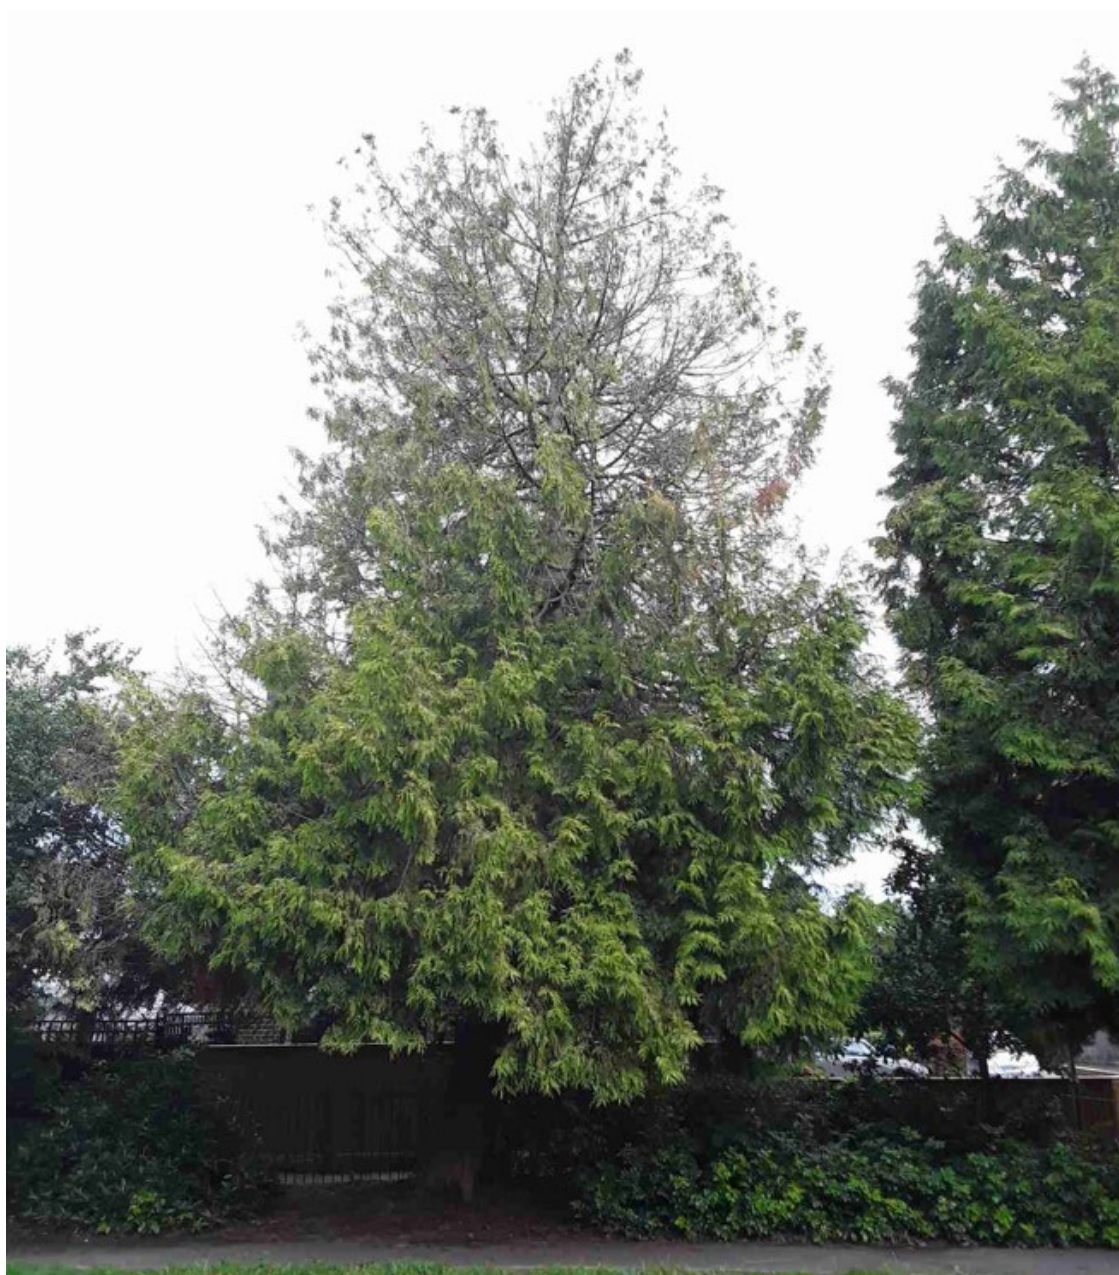
Tree number	21
Road	Grove Gardens
Location	Grove Gardens – need map
Species	Lawsons Cypress (<i>Chamaecyparis lawsoniana</i>)
Height	12.5m
Physiological condition	Poor
Structural condition	Good
Inspection findings	This tree is dying/deadwood is ubiquitous

Left image shows tree with die back of canopy. Right image shows split in trunk.

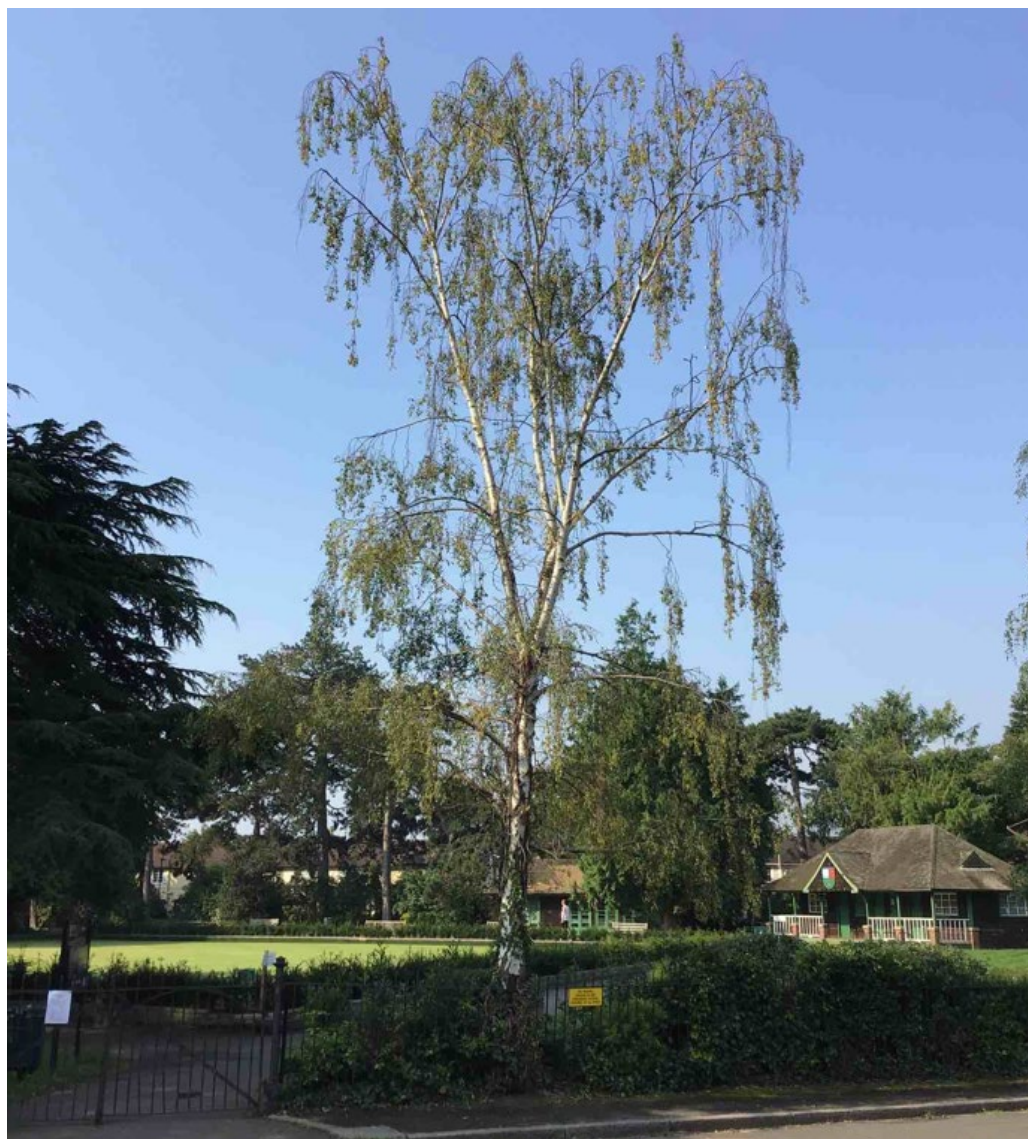
Tree number	26
Road	Grove Gardens
Location	Grove Gardens – need map
Species	Silver Birch (<i>Betula pendula</i>)
Height	13.5m
Physiological condition	Poor
Structural condition	Poor
Inspection findings	There is a cavity indicating decay at the base of this tree. A resonance test confirmed an unacceptable degree of decay in the trunk of this tree; this decay correlates with crown dieback and decline. Removal is required to prevent natural failure and manage risk.

Image shows tree with sparse foliage.

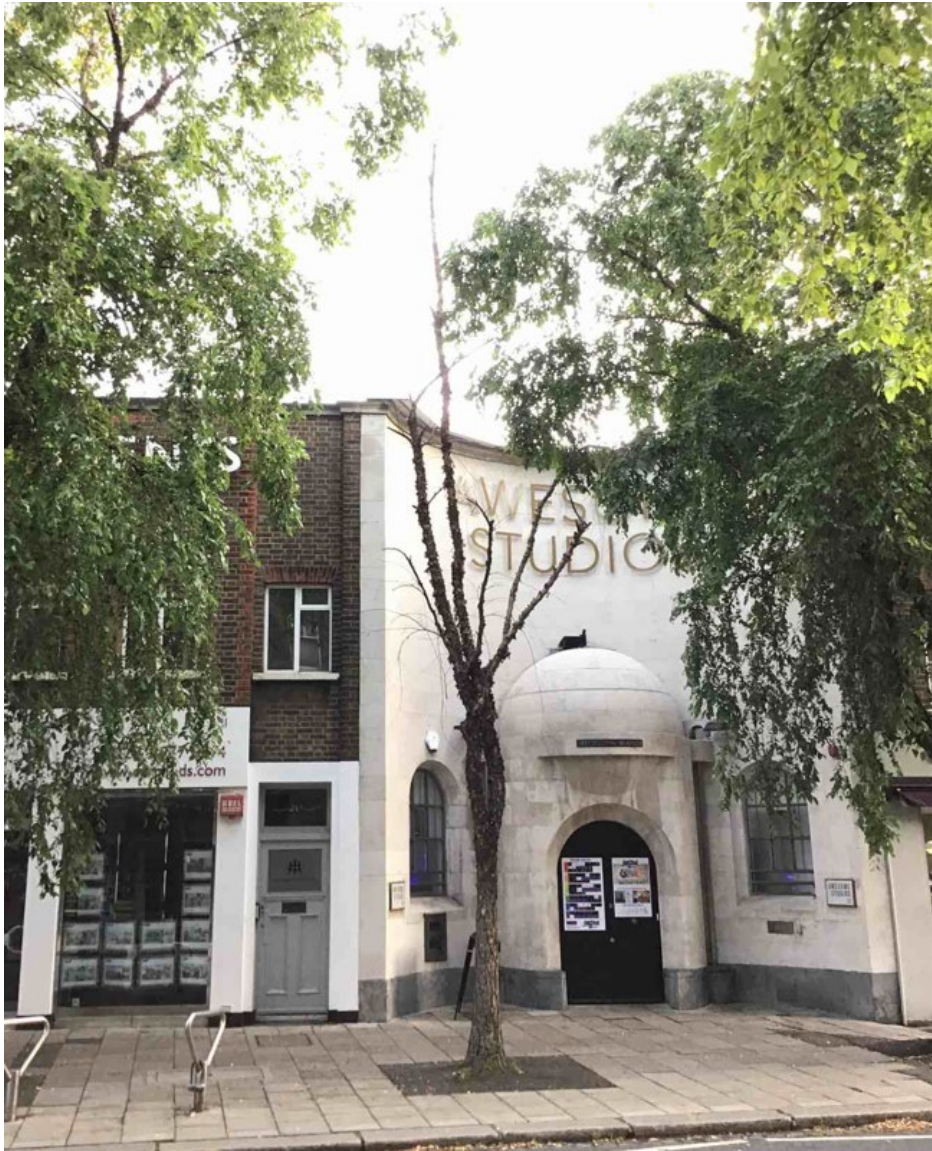
Tree number	20
Road	High Street
Location	Outside 2
Species	Cherry (<i>Betula papyifera</i>)
Height	11.0m
Physiological condition	Dead
Structural condition	Dead
Inspection findings	This tree is dead and removal is required to prevent natural failure and manage risk.

Image shows dead tree.

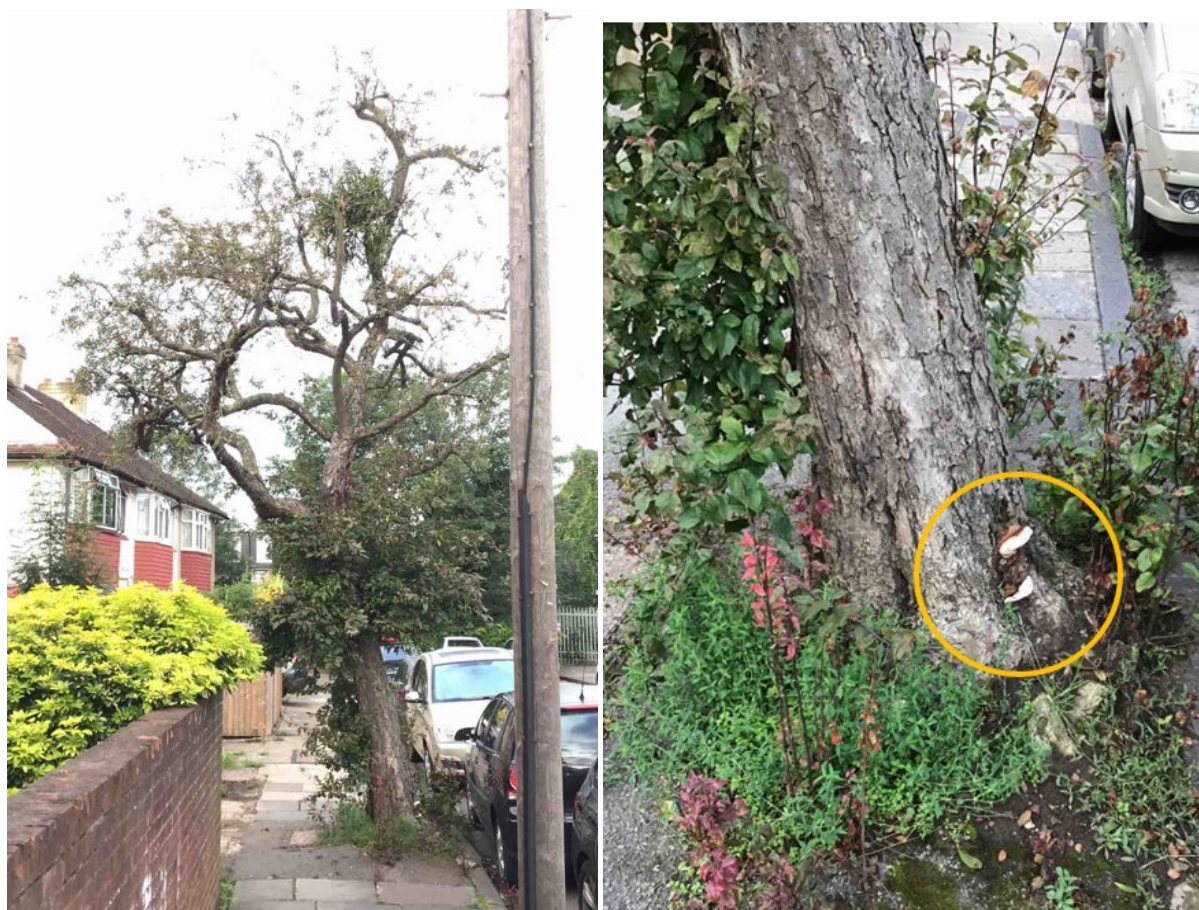
Tree number	3
Road	Linden Grove
Location	Opposite 6
Species	Apple (<i>Malus</i> sp.)
Height	6.5m
Physiological condition	Poor
Structural condition	Poor
Inspection findings	Fungal fruiting bodies of the decay pathogen <i>Ganoderma</i> sp. are present at the stem base and the trunk. Colonisation by this fungus causes a white rot of the stem and root system that can cause entire trees to collapse through fracture or windthrow. Tree is declining, significant deadwood and dieback is present and this correlates with the pathogen present.

Left image shows tree with die back of canopy. Right image shows fungal fruiting bodies at base.

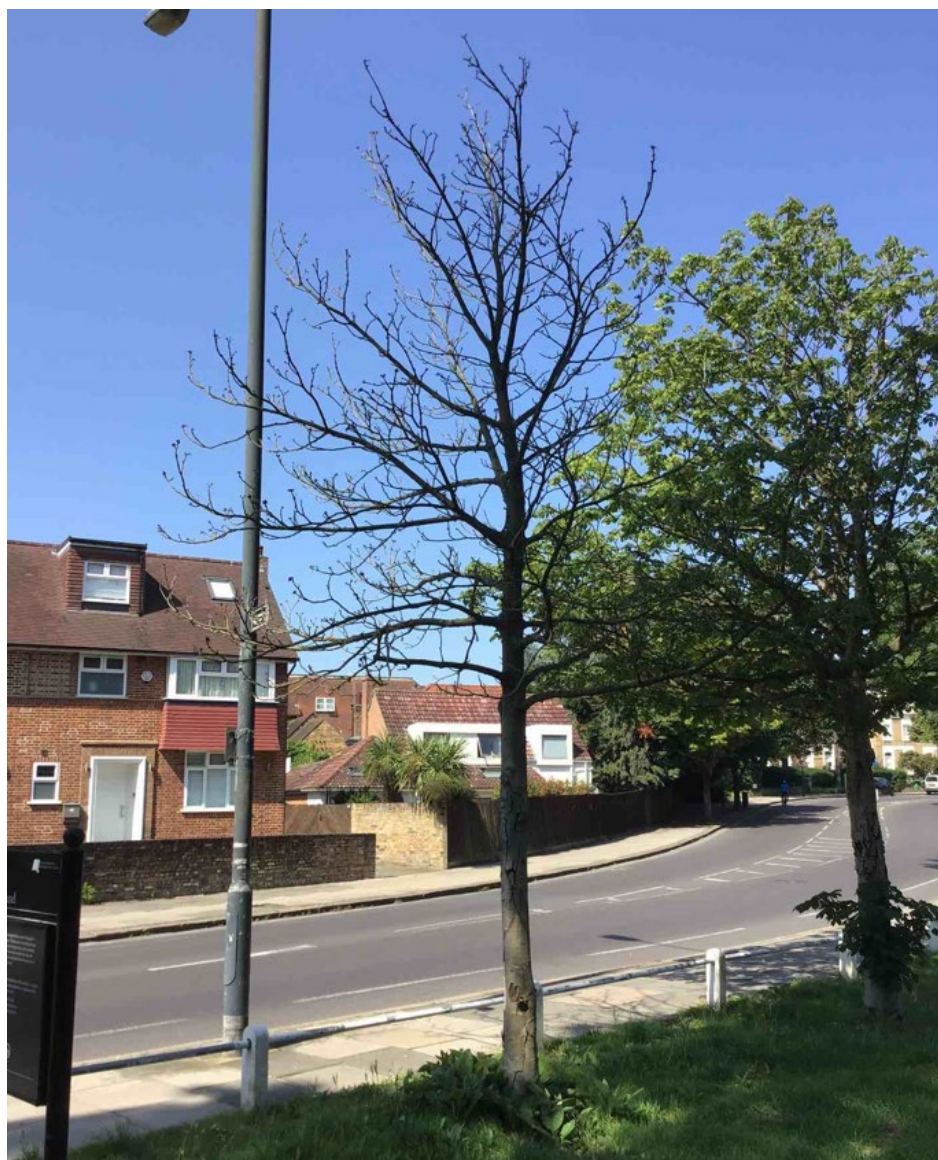
Tree number	11
Road	Manor Road
Location	Manor Road Recreation Ground – need map
Species	Horse Chestnut (<i>Aesculus hippocastanum</i>)
Height	7.0m
Physiological condition	Dead
Structural condition	Dead
Inspection findings	This tree is dead and removal is required to prevent natural failure and facilitate replanting.

Image shows dead tree.

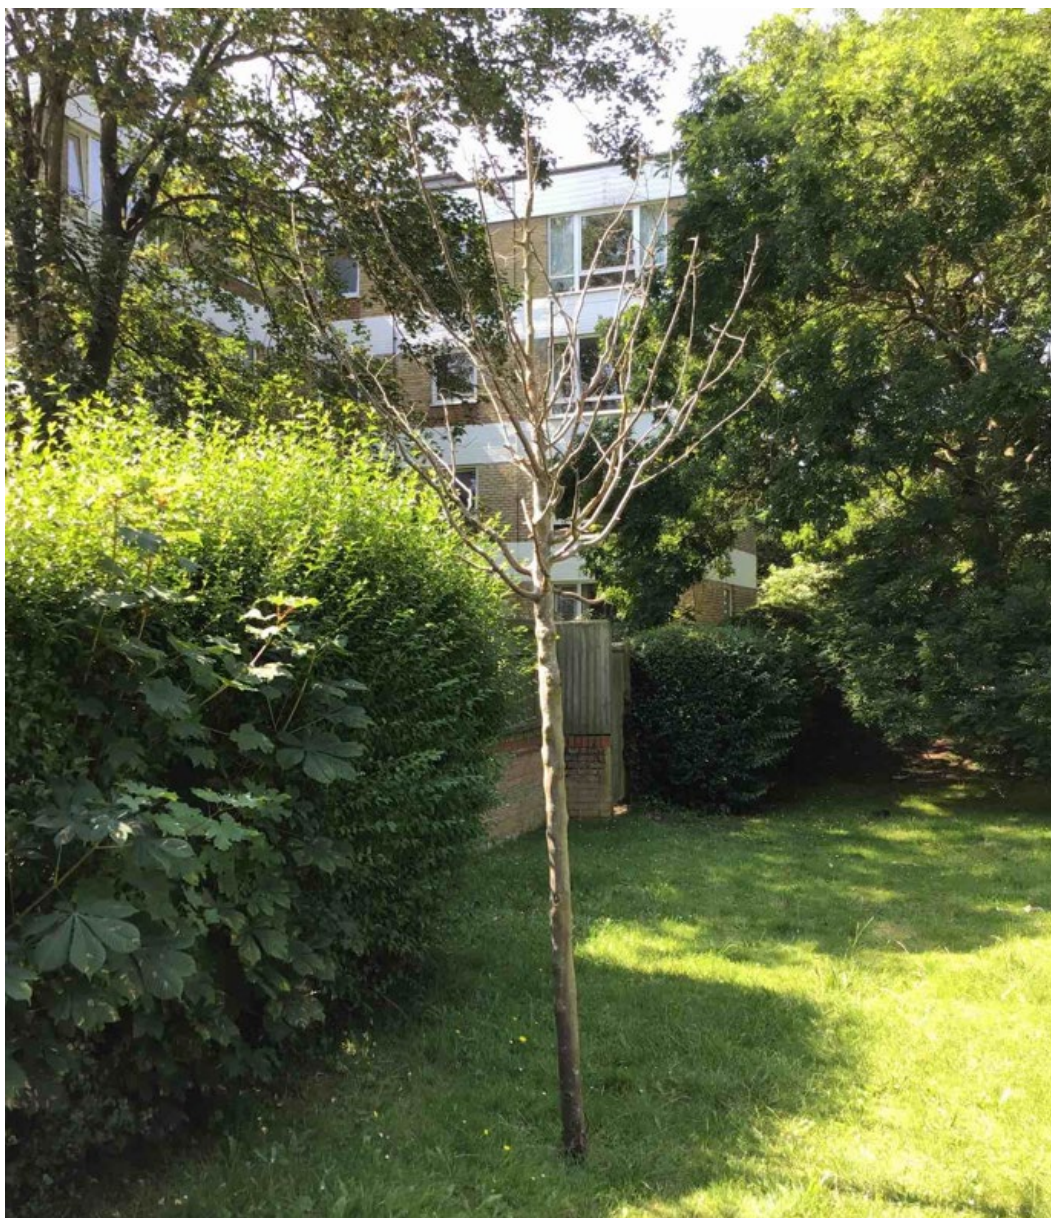
Tree number	26
Road	Manor Road
Location	Manor Road Recreation Ground – need map
Species	Hornbeam (<i>Carpinus betulus</i>)
Height	3.5m
Physiological condition	Dead
Structural condition	Dead
Inspection findings	This tree is dead and removal is required to prevent natural failure and facilitate replanting.

Image shows dead tree.

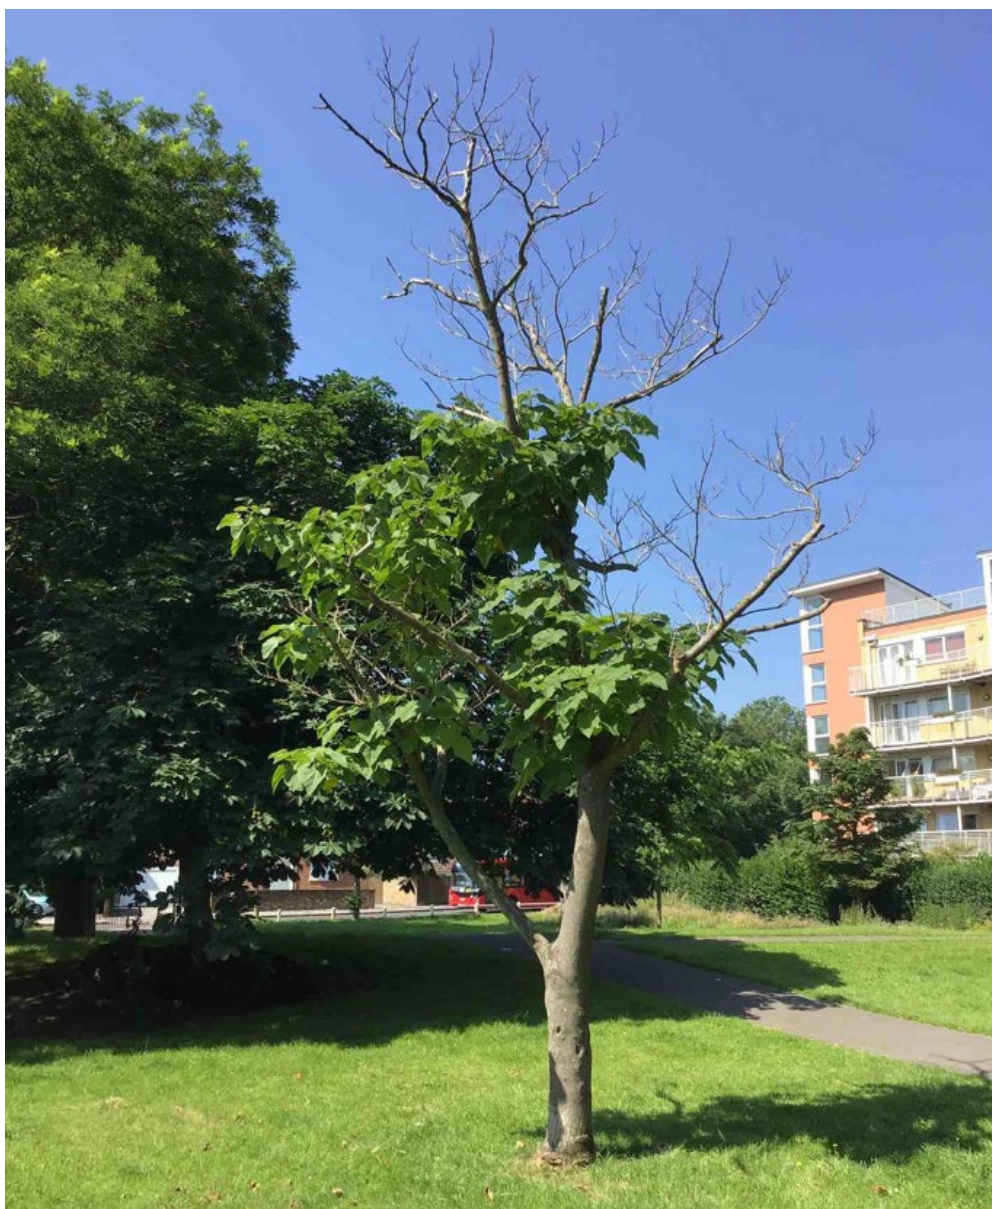
Tree number	27
Road	Manor Road
Location	Manor Road Recreation Ground – need map
Species	Foxglove Tree (<i>Paulonia tomentosa</i>)
Height	7.5m
Physiological condition	Poor
Structural condition	Poor
Inspection findings	This tree is dying/deadwood is ubiquitous

Image shows tree with extensive die back of canopy.

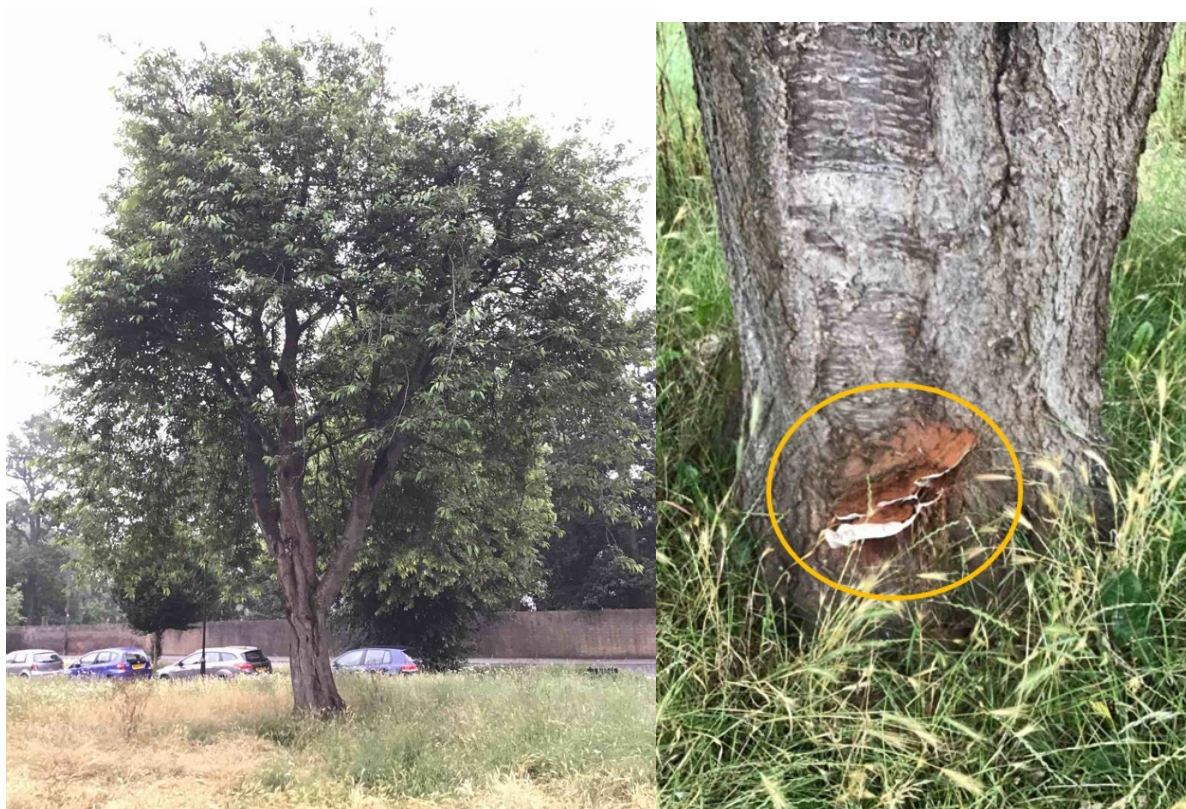
Tree number	2
Road	Shaef Way
Location	On Grass Area Outside 30
Species	Wild Cherry (<i>Prunus avium</i>)
Height	12.5m
Physiological condition	Good
Structural condition	Poor
Inspection findings	A fungal fruiting body of the decay pathogen <i>Ganoderma</i> sp. is present at the stem base. Colonisation by this fungus causes a white rot of the stem and root system that can cause entire trees to collapse through fracture or windthrow. Fungal fruiting bodies of the wood decay fungus <i>Laetiporus sulphureus</i> are present on the trunk of this tree. This fungus causes a brown rot which can rapidly reduce wood strength and cause branch or whole tree failure through brittle fracture.

Left image shows tree in apparent good vitality. Right image shows fungal fruiting bodies at base.
