Teddington - 2021 Ward Works and Tree Removals Programme

A recent survey of trees in the Teddington ward has taken place; this was conducted by a competent specialist Arboriculturist as part of the scheduled 4 yearly detailed inspection regime that has been devised for all Council highway and parks trees.

Dated 09.03.2021

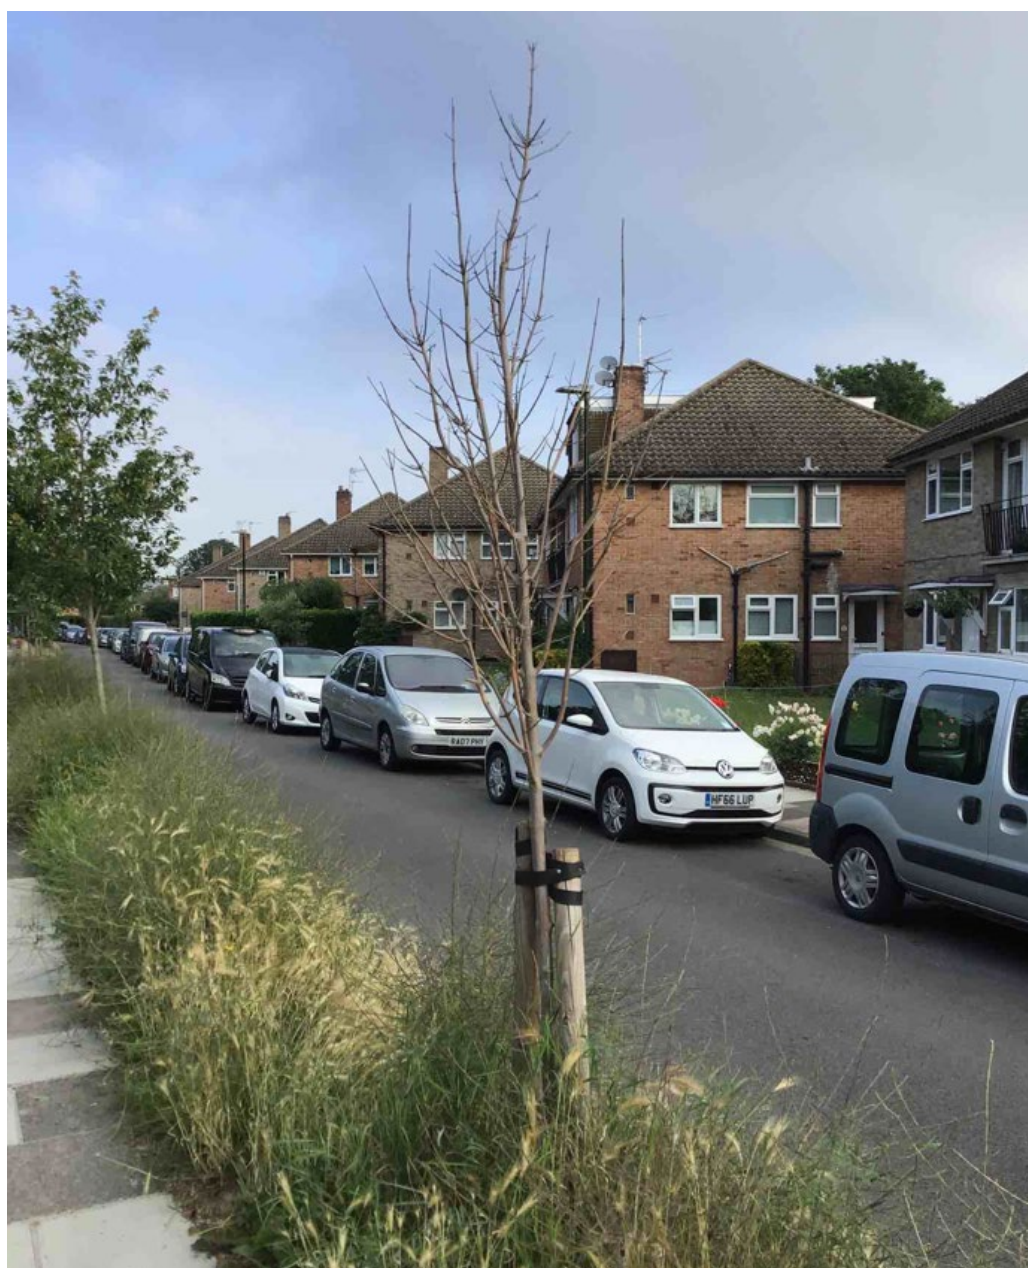
Tree number	11
Road	Shaef Way
Location	On Grass Verge Opposite 62
Species	Unknown dead
Height	3.5m
Physiological condition	Dead
Structural condition	Dead
Inspection findings	This tree is dead and removal is required to prevent natural failure and facilitate replanting.

Image shows dead tree.

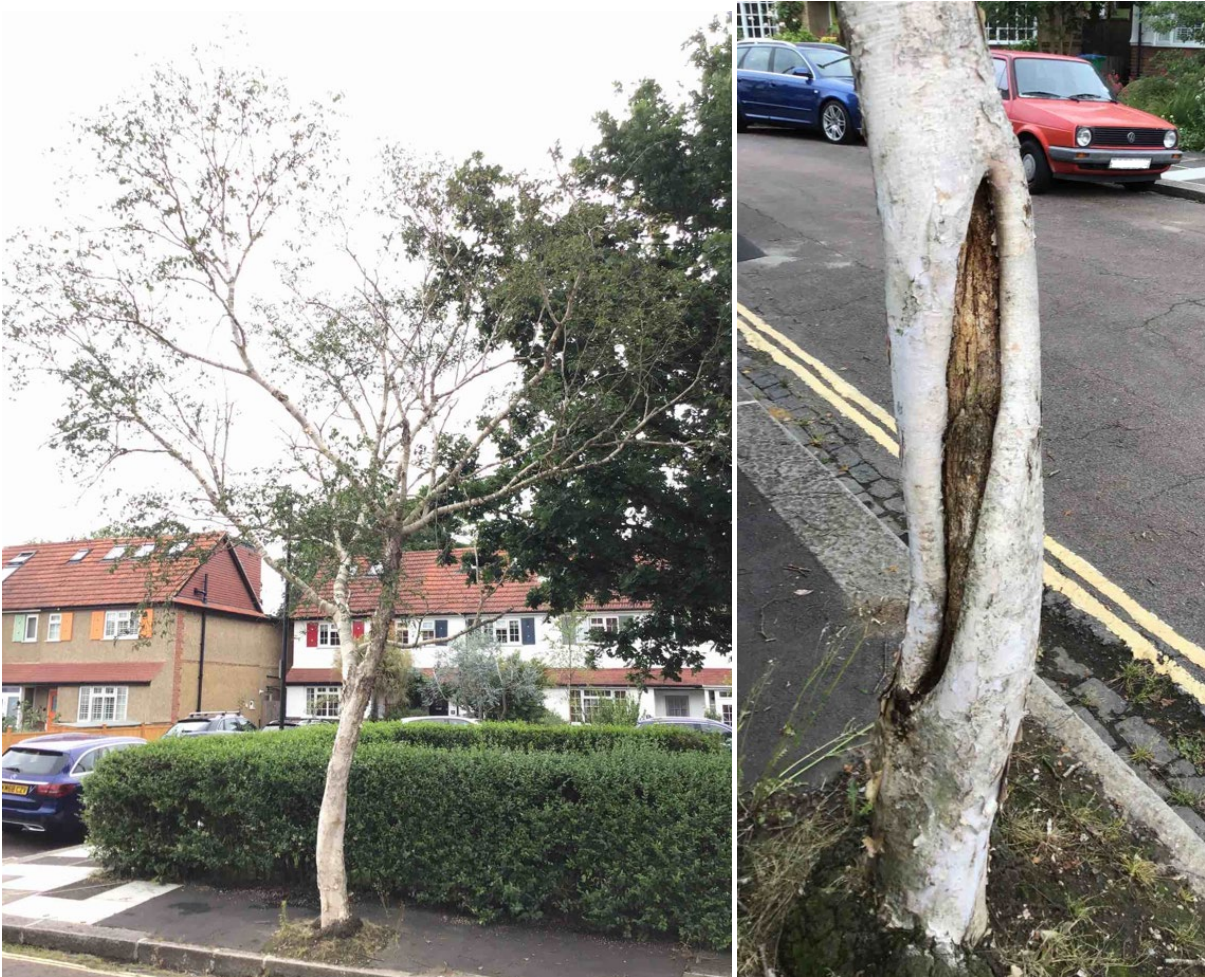
Tree number	4
Road	St Marys Avenue
Location	Opposite 12
Species	Silver Birch (<i>Betula pendula</i>)
Height	7.5m
Physiological condition	Poor
Structural condition	Poor
Inspection findings	Cavities indicating decay are present in the trunk of this tree. This tree is in a state of physiological decline with sparse foliage and ubiquitous deadwood.

Left image shows tree with die back of canopy. Right image shows split in trunk.

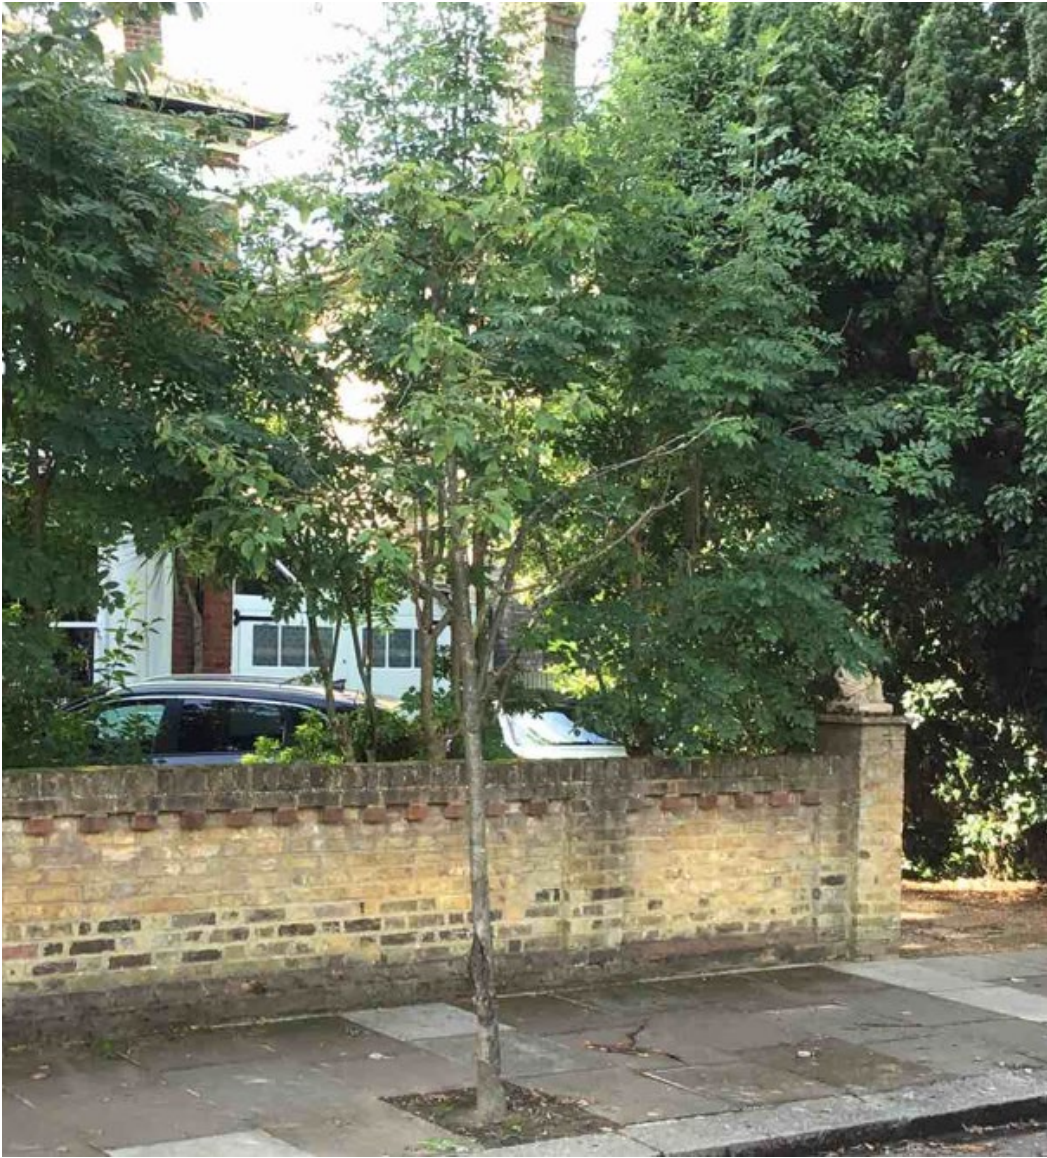
Tree number	19
Road	Teddington Park Road
Location	Outside 104
Species	Cherry (<i>Prunus</i> sp.)
Height	3.5m
Physiological condition	Poor
Structural condition	Poor
Inspection findings	This tree is in a state of physiological decline with sparse foliage and ubiquitous deadwood.

Image shows tree with die back of canopy.

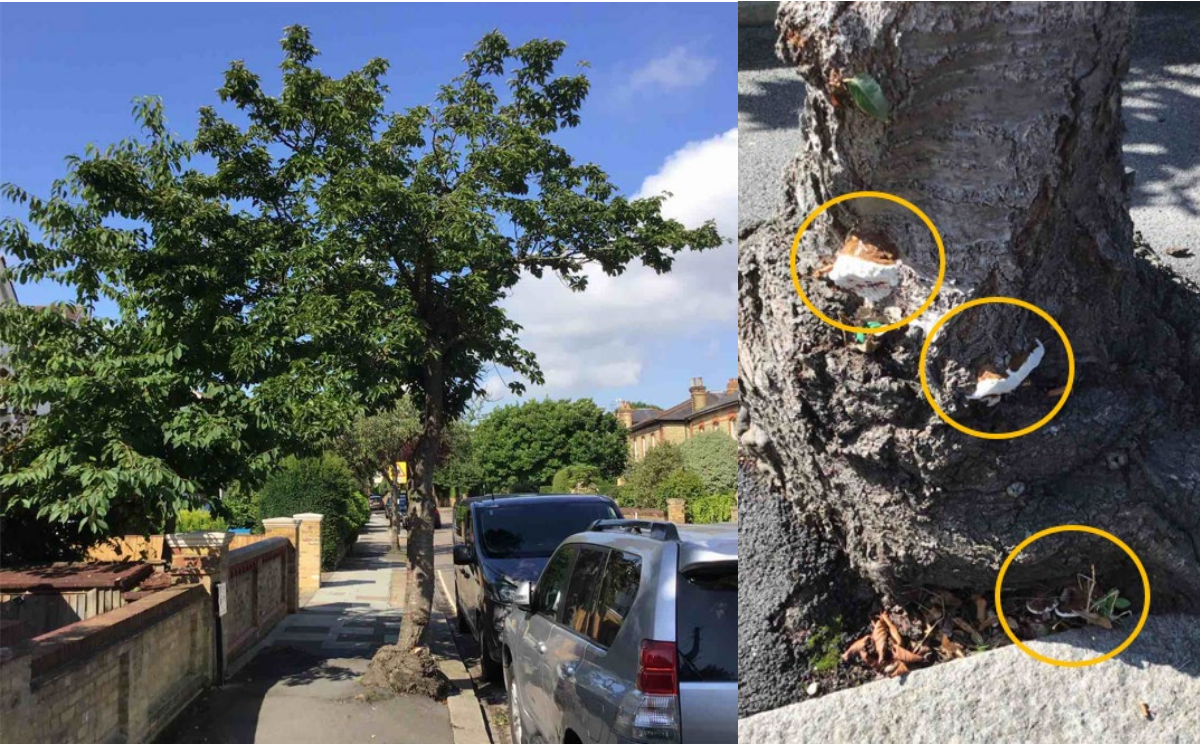
Tree number	20
Road	Teddington Park Road
Location	Outside 94/96
Species	Cherry (<i>Prunus</i> sp.)
Height	5.5m
Physiological condition	Fair
Structural condition	Poor
Inspection findings	A fungal fruiting body of the decay pathogen <i>Ganoderma</i> sp. is present at the stem base. Colonisation by this fungus causes a white rot of the stem and root system that can cause entire trees to collapse through fracture or windthrow.

Left image shows tree with mainly healthy canopy. Right image highlights fructifications.

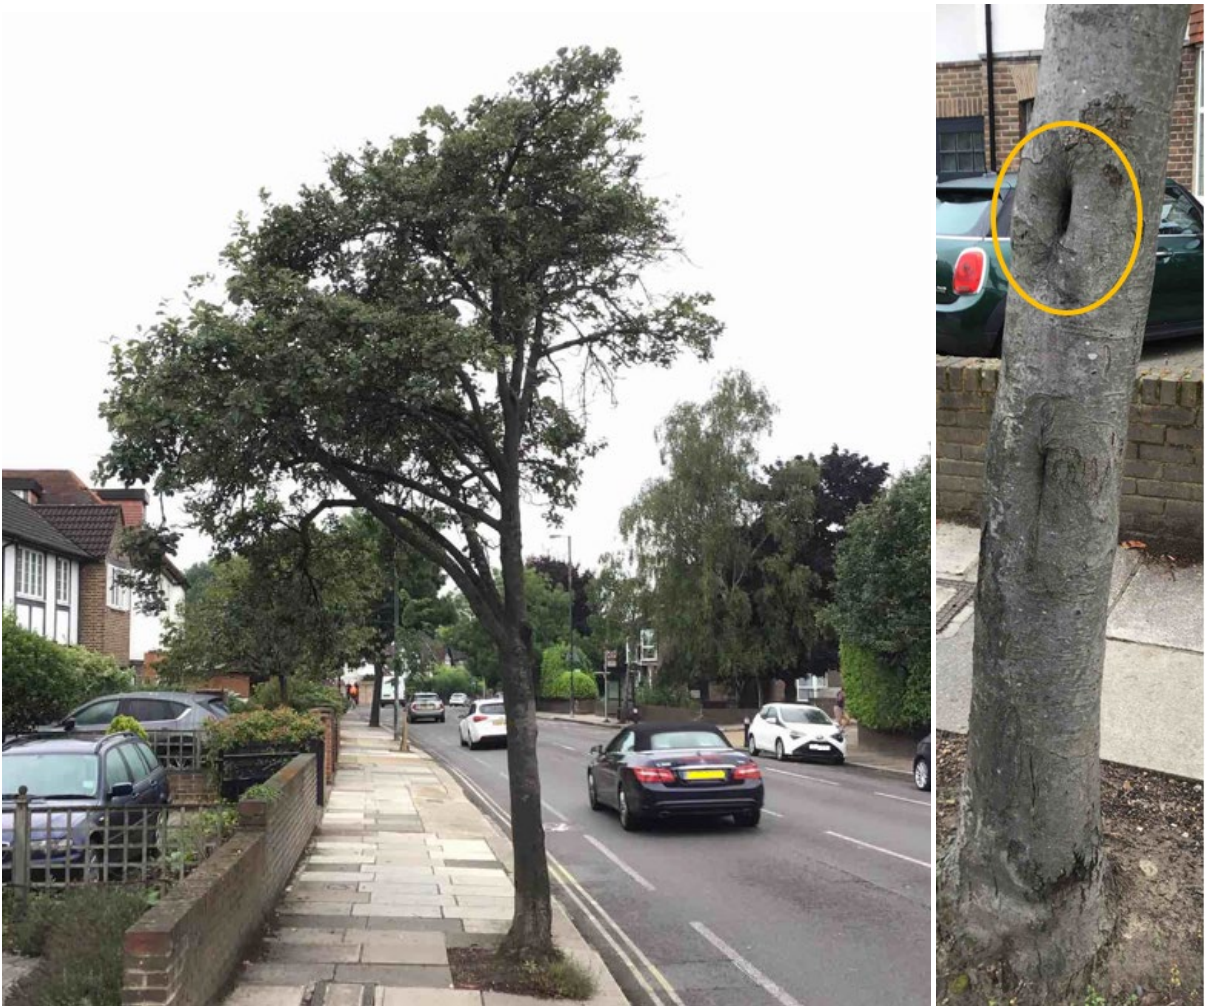
Tree number	16
Road	Twickenham Road
Location	Outside 79
Species	Whitebeam (<i>Sorbus aria</i>)
Height	6.5m
Physiological condition	Fair
Structural condition	Poor
Inspection findings	The trunk of this tree contains cavities and splits. Fungal fruiting bodies of the decay pathogen <i>Kretzschmaria deusta</i> are present in the cavity. This fungus causes a white rot that can cause whole tree failure through a ceramic like fracture. Removal is required to prevent natural failure and manage risk.

Left image shows tree with die back of canopy. Right image shows split in trunk.

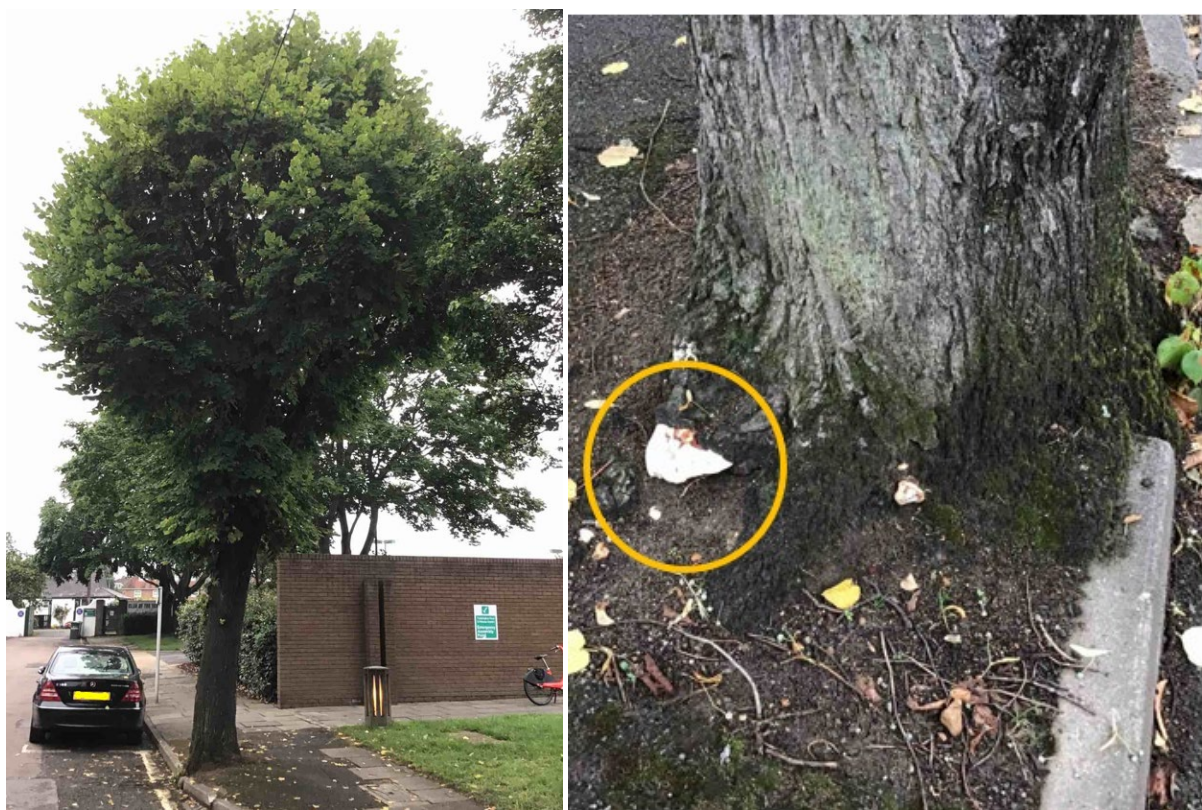
Tree number	9
Road	Vicarage Road
Location	Opposite 17
Species	Lime (<i>Tilia</i> sp.)
Height	9.0m
Physiological condition	Good
Structural condition	Poor
Inspection findings	A fungal fruiting body of the decay pathogen <i>Ganoderma</i> sp. is present at the stem base. Colonisation by this fungus causes a white rot of the stem and root system that can cause entire trees to collapse through fracture or windthrow.

Left image shows tree with healthy canopy. Right image shows fungal fruiting body at base.

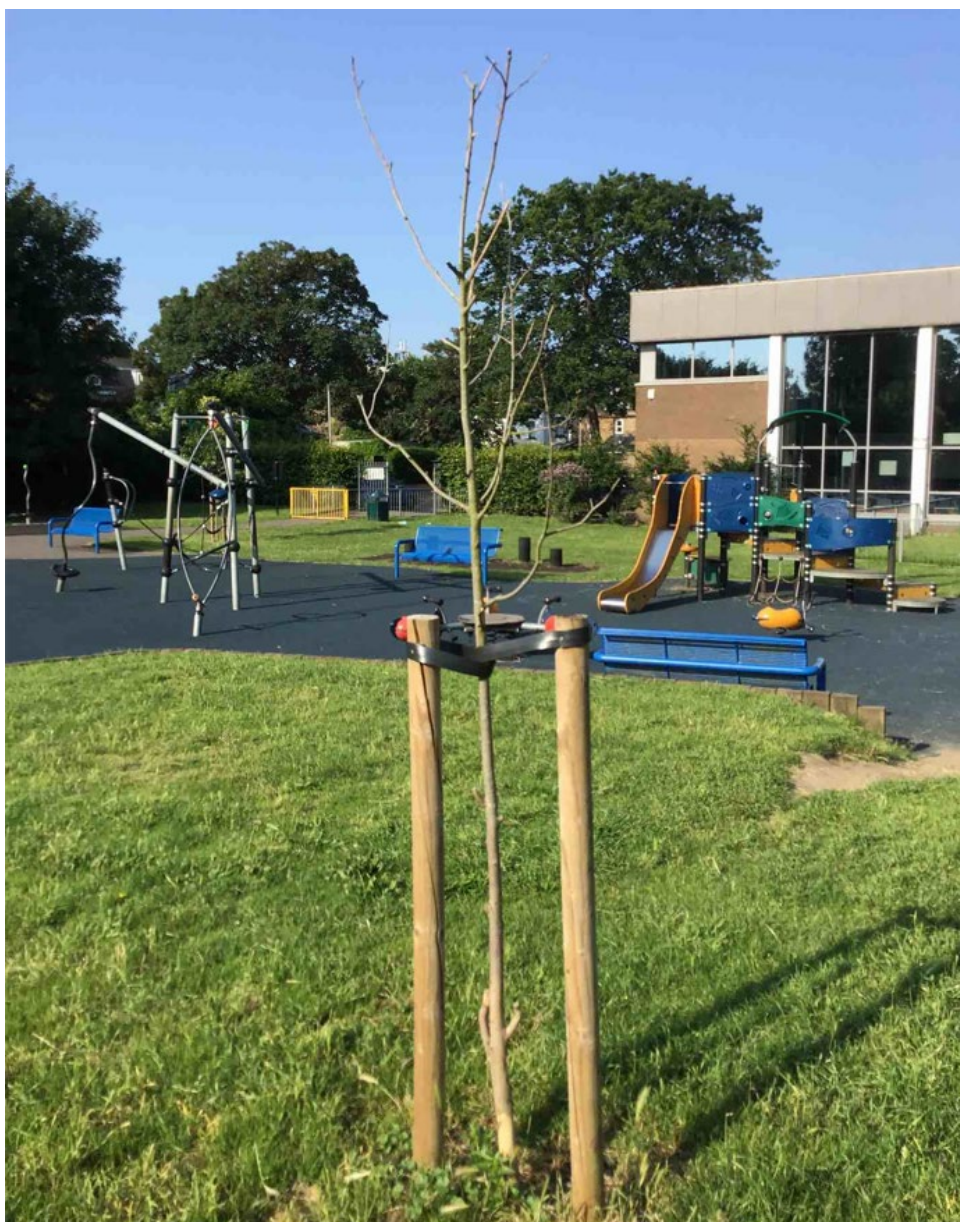
Tree number	-
Road	Vicarage Road
Location	Wade Lane Ground Play Area- Need Map
Species	Silver Birch (<i>Betula pendula</i>)
Height	2.0m
Physiological condition	Dead
Structural condition	Dead
Inspection findings	This tree is dead and removal is required to prevent natural failure and facilitate replanting.

Image shows dead tree.

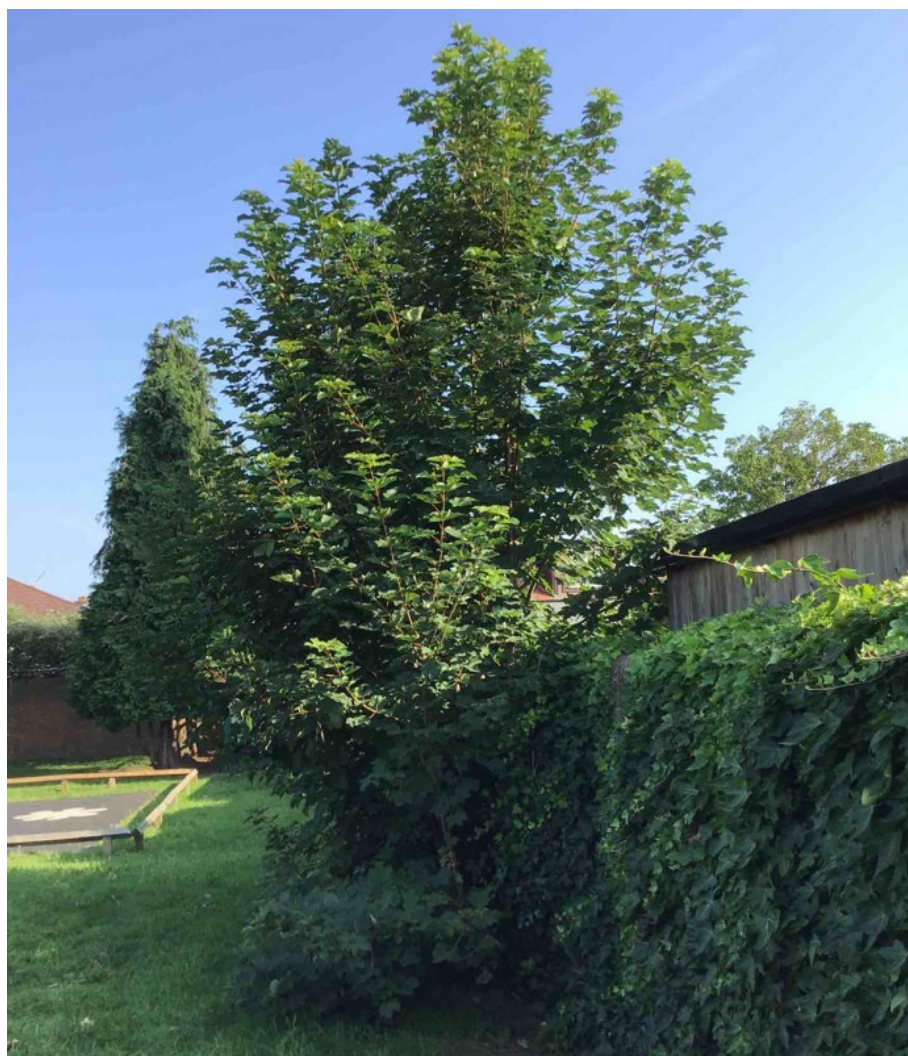
Tree number	-
Road	Vicarage Road
Location	Wade Lane Ground Play Area- Need Map
Species	Sycamore (<i>Acer pseudoplatanus</i>)
Height	5.5m
Physiological condition	Good
Structural condition	Poor
Inspection findings	This tree is regrowing from a stump and is in an unsuitable location.

Left image shows tree with die back of canopy. Right image shows split in trunk.

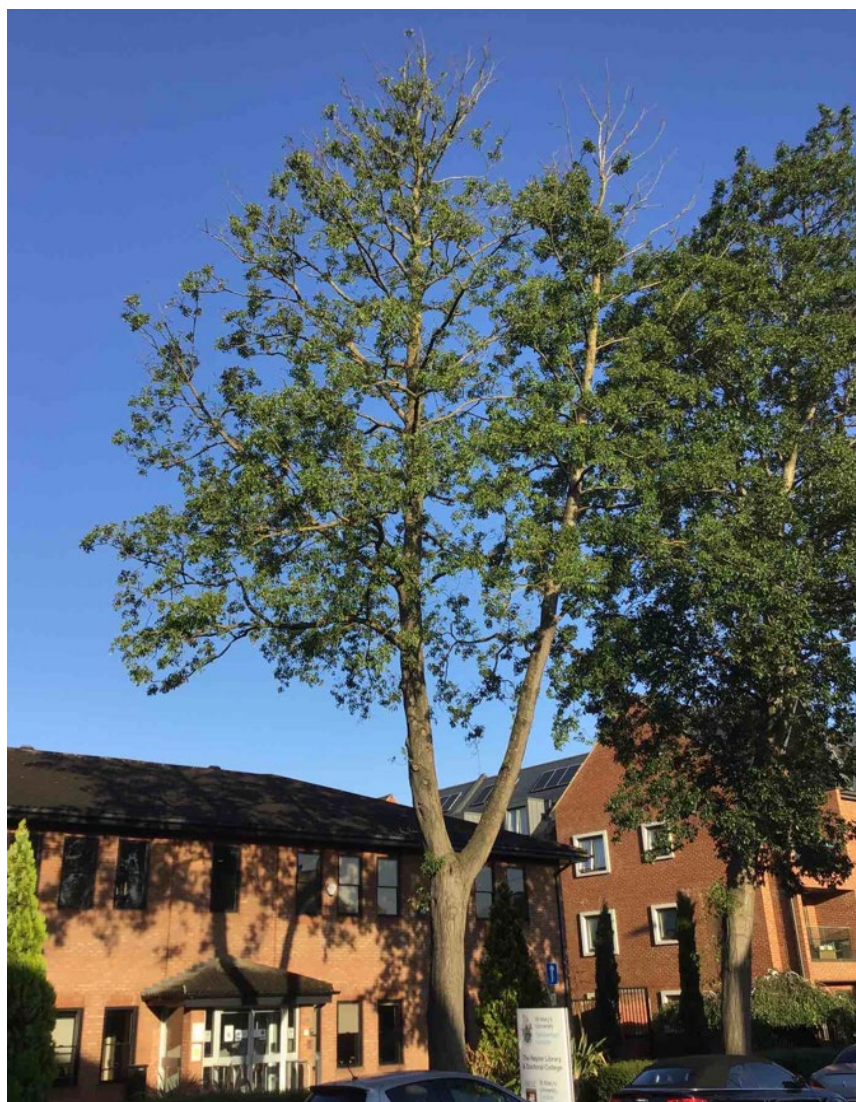
Tree number	15
Road	Waldegrave Road
Location	Outside 99 The Naylor Library on South East side of front entrance
Species	Italian Alder (<i>Alnus cordata</i>)
Height	19.0m
Physiological condition	Poor
Structural condition	Fair
Inspection findings	This tree is in a state of physiological decline and crown dieback is likely to correlate with the degradation of the trees structural or supporting root system.

Image shows tree with die back of canopy.

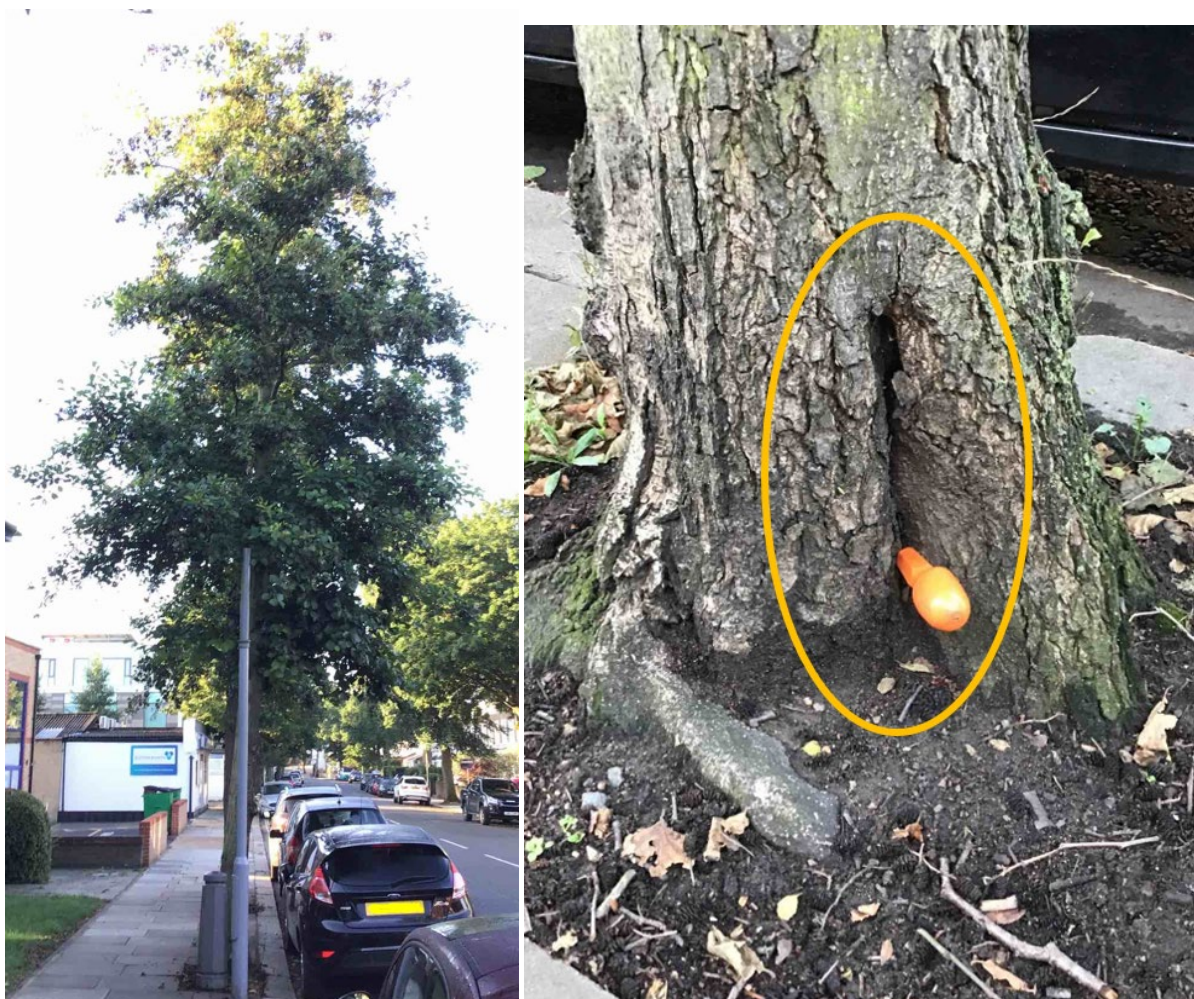
Tree number	25
Road	Waldegrave Road
Location	Opposite 12
Species	Italian Alder (<i>Alnus cordata</i>)
Height	11.0m
Physiological condition	Fair
Structural condition	Poor
Inspection findings	Cavities indicating decay are present in the trunk of this tree. A resonance test revealed an unacceptable degree of decay in the trunk of this tree, removal is required to prevent natural failure and manage risk.

Left image shows tree with tip die back of canopy. Right image shows cavity in base with probe inserted.
