October 2024 - Reactive Tree Works Programme

Introduction

The following pages provide the locations of each tree that is to be removed, in addition photographs and descriptions of the inspection findings have been provided.

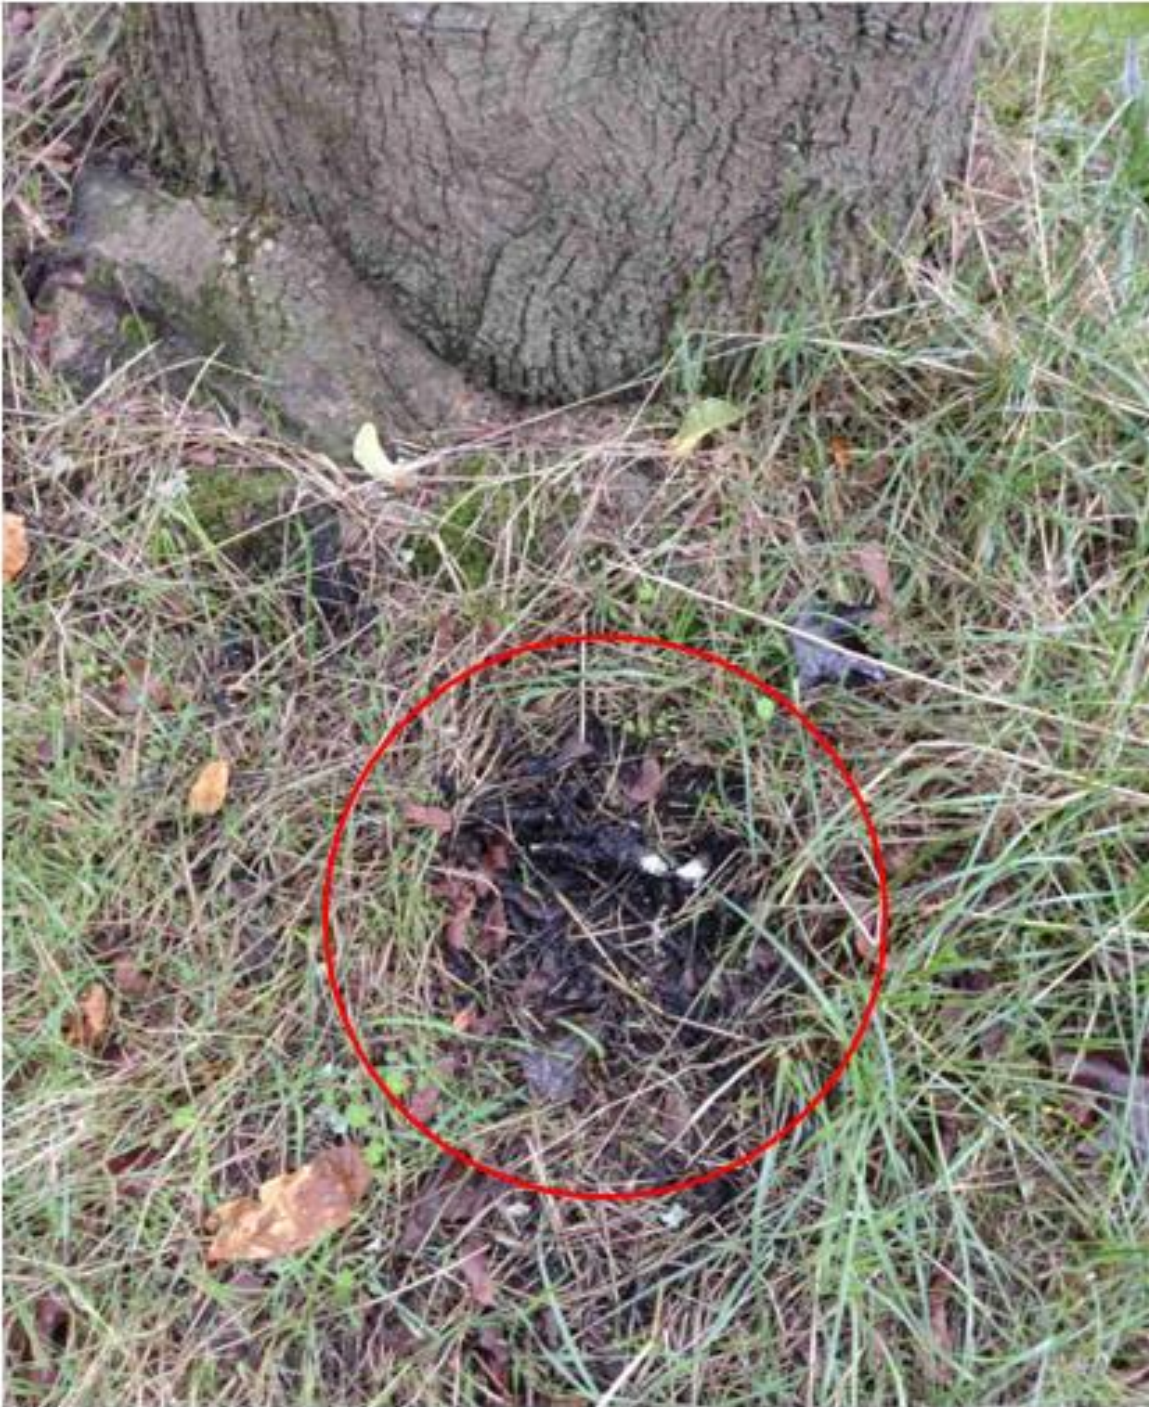
Image shows suspected Armillaria sp. fruiting bodies circled at base of trunk.

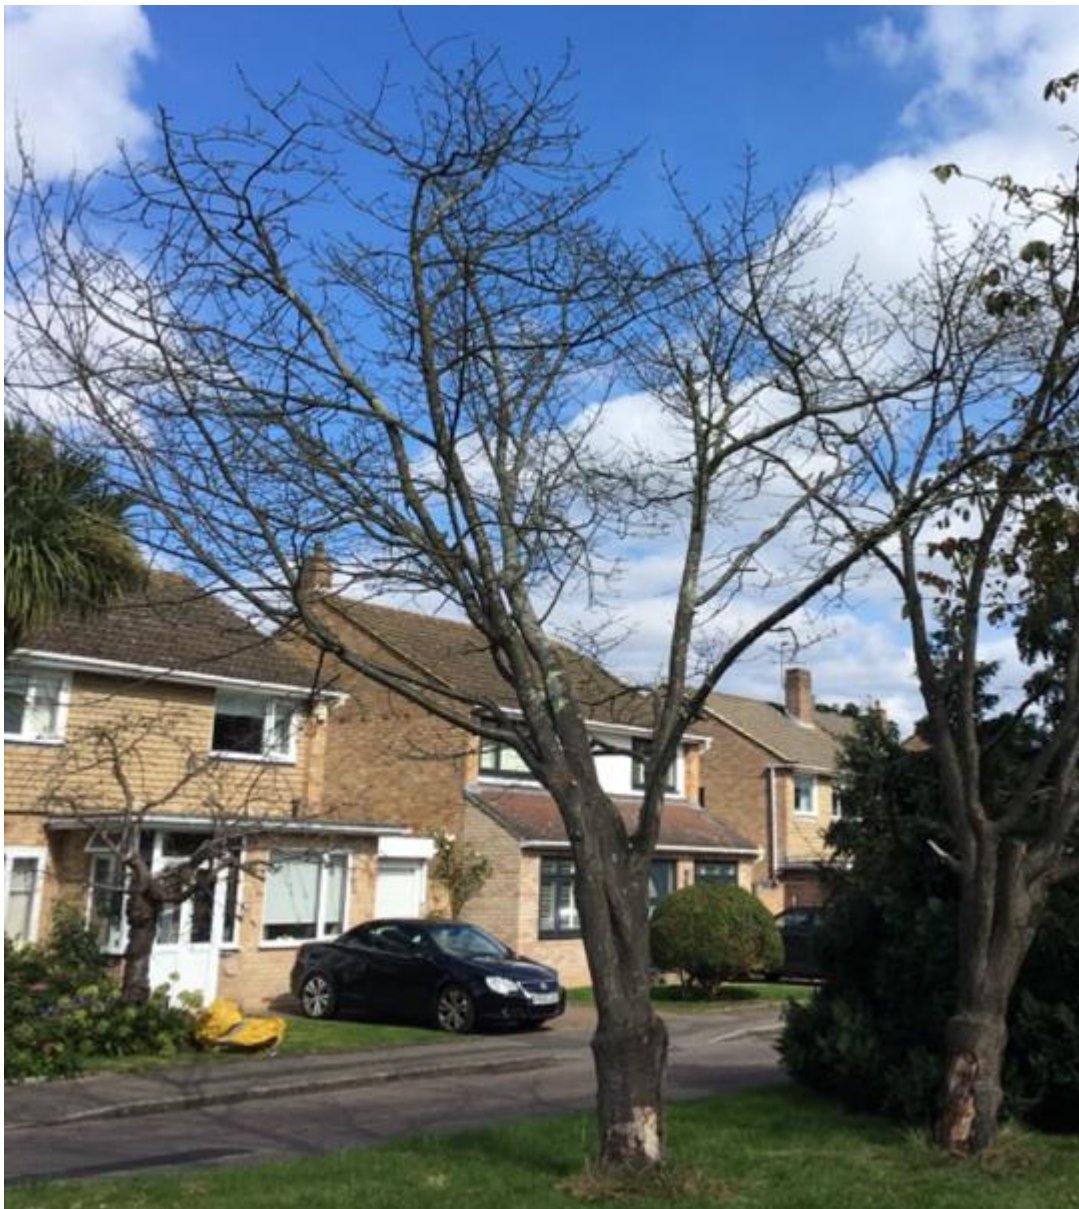
Ward	Hampton North
Road	Albury Close
Location	On Grass Island opposite 71
Species	Cherry (<i>Prunus sp.</i>)
Height	6.5m
Physiological Condition	Dead
Structural Condition	Dead
Inspection findings/reason for exemption	This tree is dead; removal is required to prevent natural failure, manage risk, and facilitate replanting.

Image shows dead tree in street scene.

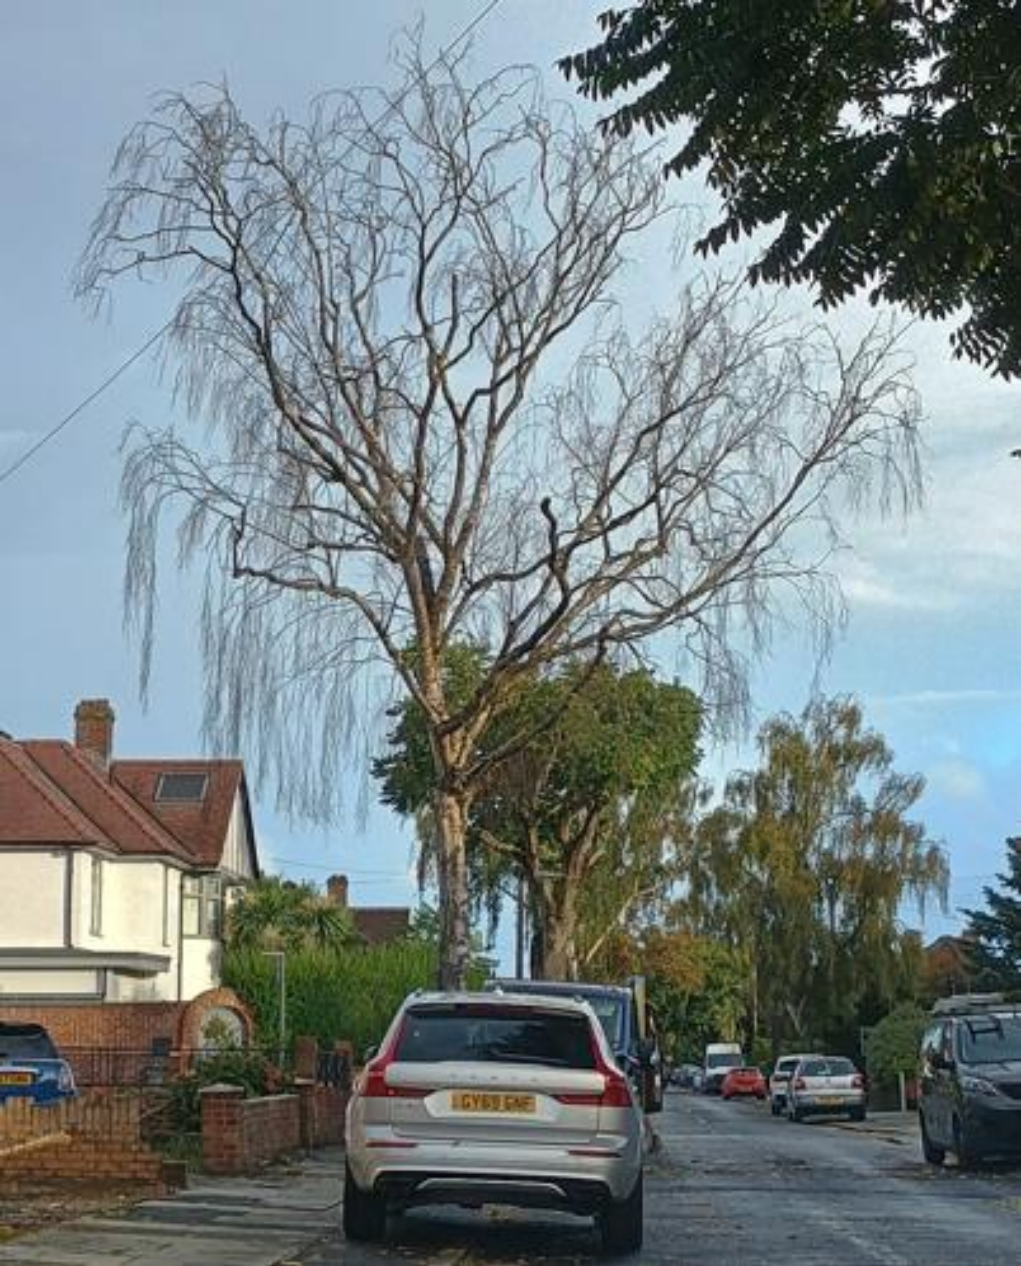
Ward	Heathfield
Road	Waverley Avenue
Location	Outside 194/196
Species	Silver Birch (<i>Betula pendula</i>)
Height	15.0m
Physiological Condition	Dead
Structural Condition	Dead
Inspection findings/reason for exemption	This tree is dead; removal is required to prevent natural failure, manage risk and facilitate replanting.

Images shows dead tree in street scene.

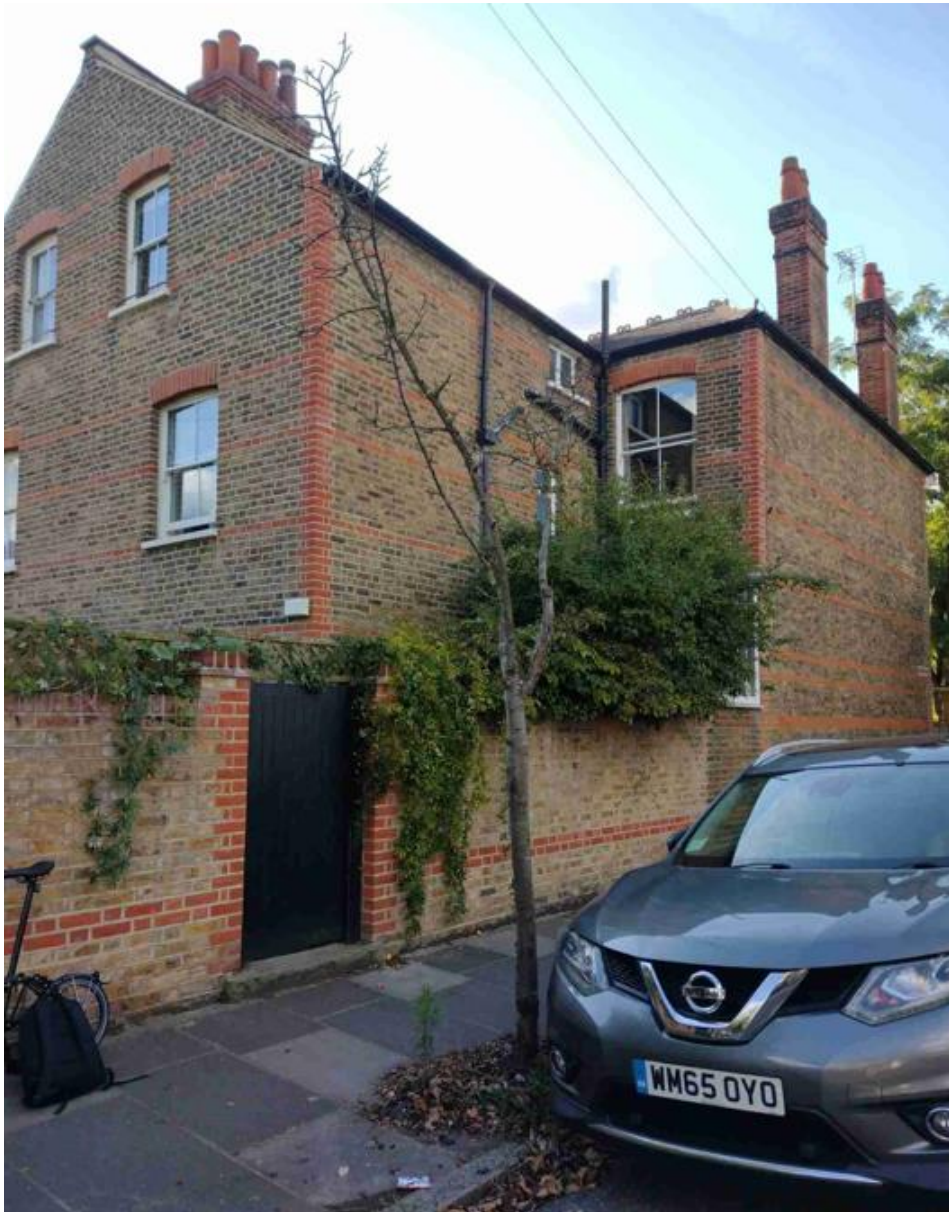
Ward	Kew
Road	Bushwood Road
Location	Adjacent to 46 Kew Green rear gardens
Species	Cherry (<i>Prunus sp.</i>)
Height	4.5m
Physiological Condition	Dead
Structural Condition	Dead
Inspection findings/reason for exemption	This tree is dead; removal is required to prevent natural failure, manage risk, and facilitate replanting

Image shows Dead tree in street scene.

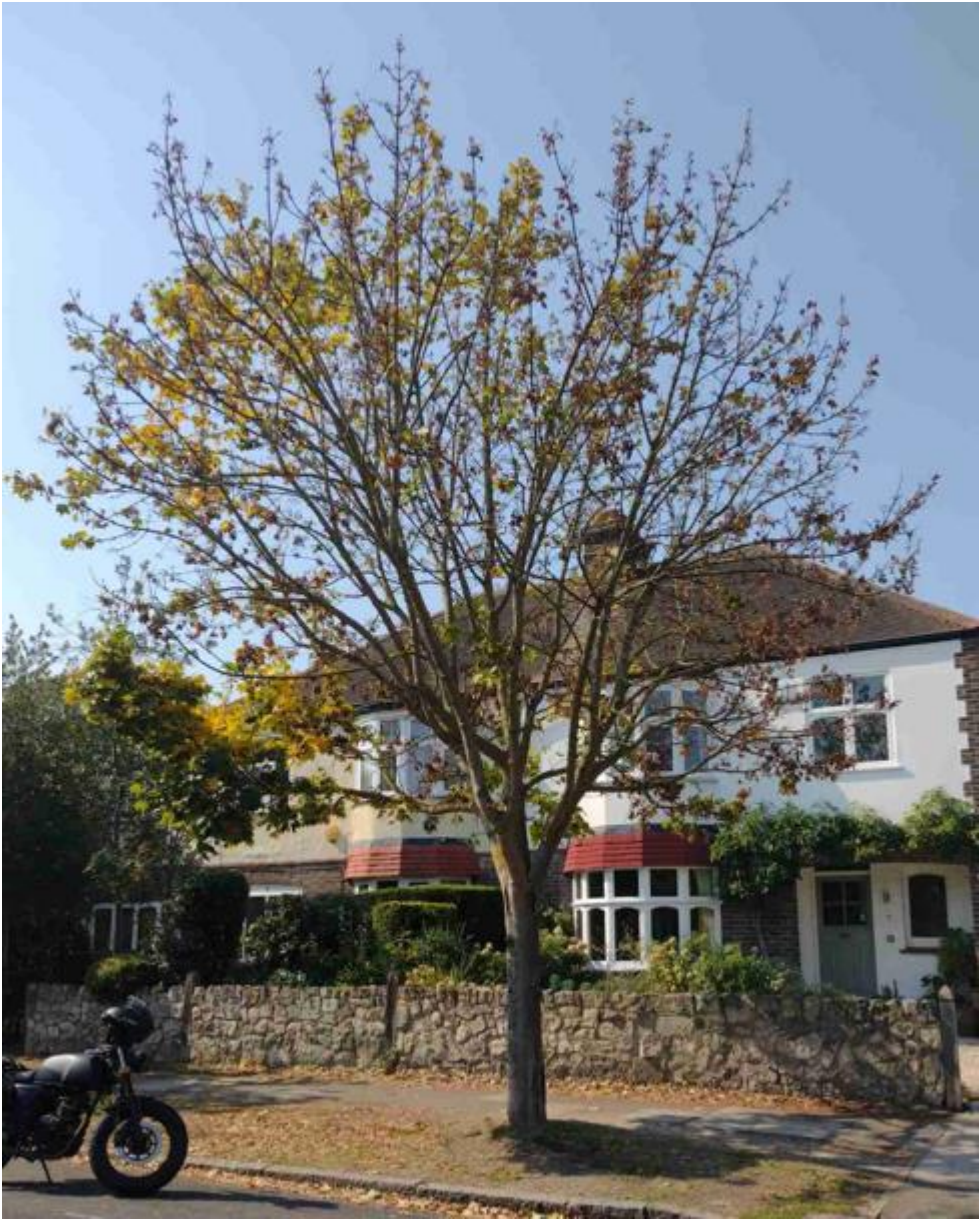
Ward	Kew
Road	Pensford Avenue
Location	Outside 7
Species	Norway Maple (<i>Acer platanoides</i>)
Height	8.5m
Physiological Condition	Poor
Structural Condition	Fair
Inspection findings/reason for exemption	This tree is in moribund state with over 80% of the crown being dead. Removal is required to prevent natural failure, manage risk, and facilitate replanting.

Image shows moribund tree in street scene.

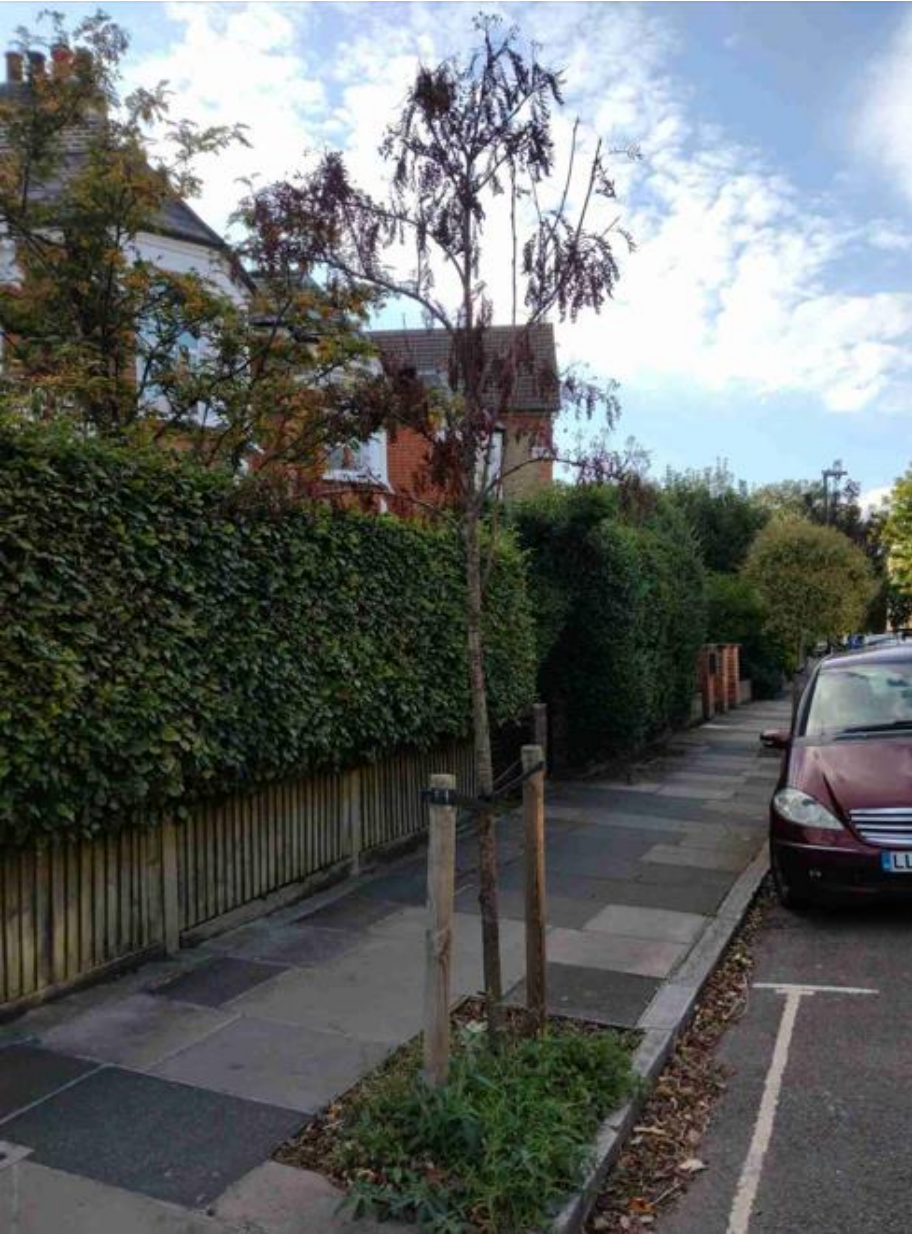
Ward	North Richmond
Road	Pagoda Avenue
Location	Outside 12
Species	Rowan (<i>Sorbus aucuparia</i>)
Height	5.0m
Physiological Condition	Dead
Structural Condition	Dead
Inspection findings/reason for exemption	This tree is dead; removal is required to prevent natural failure and facilitate replanting

Image shows moribund tree in street scene.

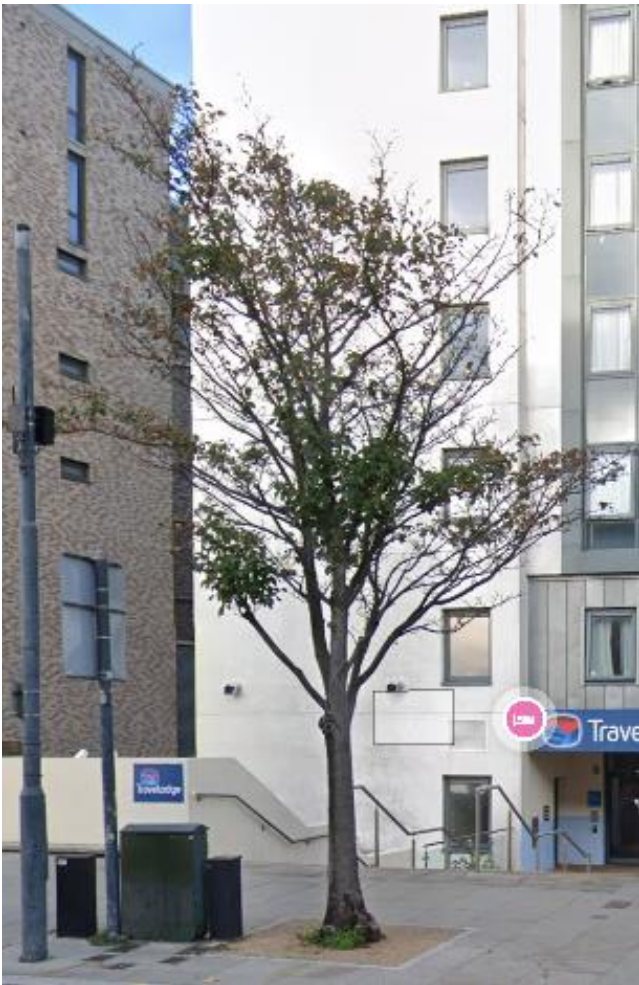
Ward	Twickenham Riverside
Road	London Road
Location	Outside 70 Regal House- ///shakes.punchy.hours
Species	Crab Apple (Malus sp.)
Height	8.0m
Physiological Condition	Poor
Structural Condition	Poor
Inspection findings/reason for exemption	An emerging fungal fruiting body displaying characteristics of decay pathogen <i>Ganoderma</i> sp. is present at the stem base. Colonisation by this fungus causes a white rot of the stem and root system that can cause entire trees to collapse through fracture or windthrow. Crown dieback correlates with the fruiting body at the base of stem. Removal is required to prevent natural failure, manage risk, and facilitate replanting

Images show tree in street scene
