November 2022 - Reactive Tree Works Programme

The following pages provide the locations, descriptions of the inspection findings, and photographs of each tree that is to be removed.

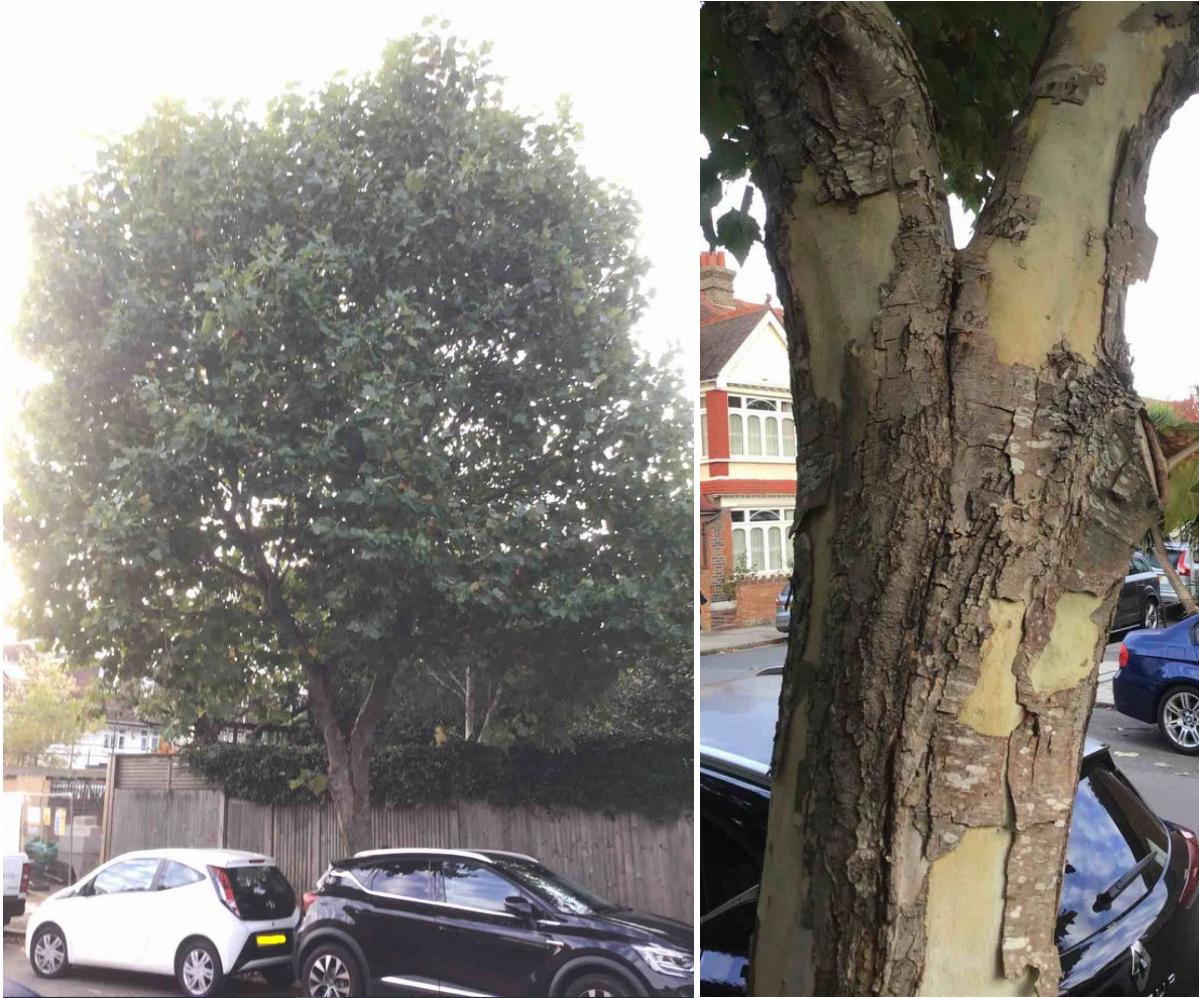
Ward	East Sheen
Road	Park Avenue
Location	Adjacent to 2 Park Drive rear garden
Species	London Plane (<i>Platanus acerfolia</i>)
Height	12.0m
Physiological Condition	Good
Structural Condition	Poor
Inspection findings	This tree has a wide-mouthed bark included union indicated by cracks at the main union which are a weak point for failure to occur from.

Left images shows tree in situ, right image shows main union with split descending trunk

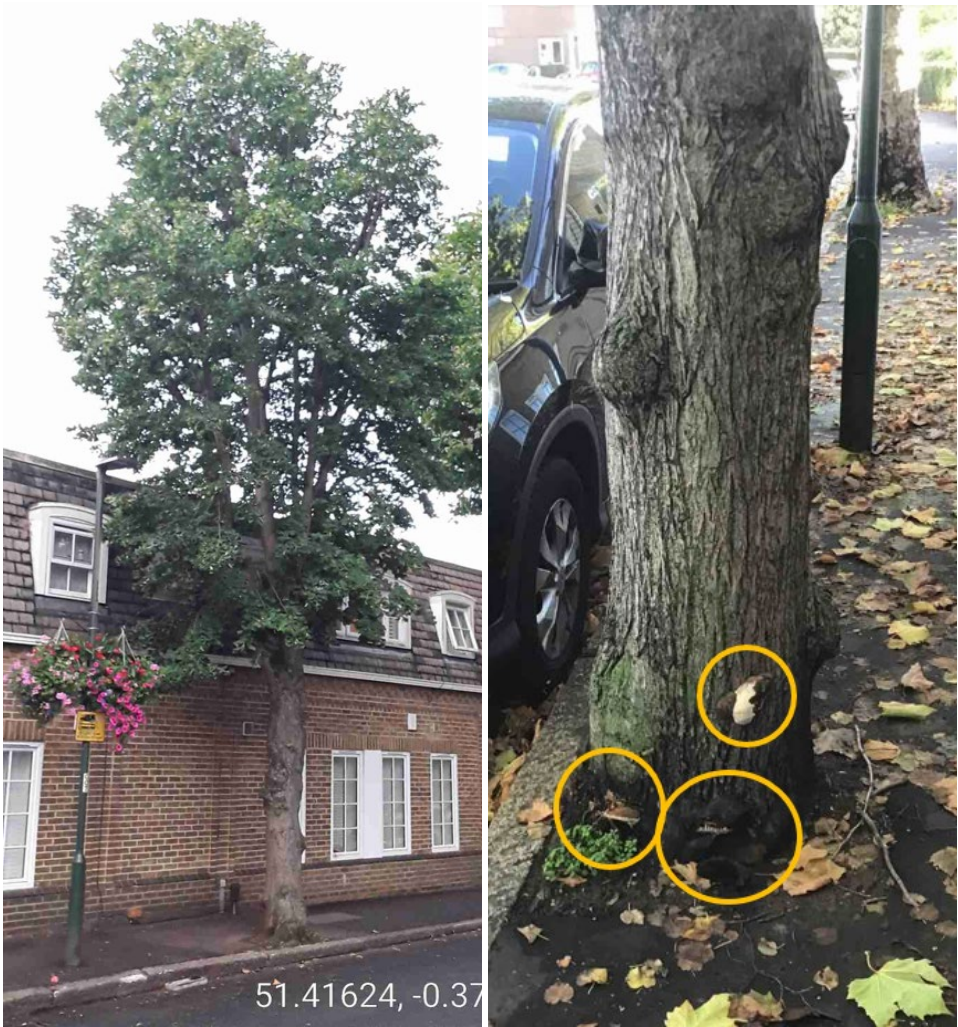
Ward	Hampton
Road	Ashley Road
Location	Adjacent to lamp post 007
Species	Lime (<i>Tilia</i> sp.)
Height	10.0m
Physiological Condition	Good
Structural Condition	Poor
Inspection findings	Fungal fruiting bodies of the decay pathogen <i>Ganoderma</i> sp. are present at the base. Colonisation by this fungus causes a white rot of the stem and roots that can cause entire trees to collapse. A detailed investigation of this tree using sonic tomography revealed an unacceptable degree of decay. Removal is required to prevent failure and facilitate replanting

Images show tree in street scene and base with fungal fructifications circled

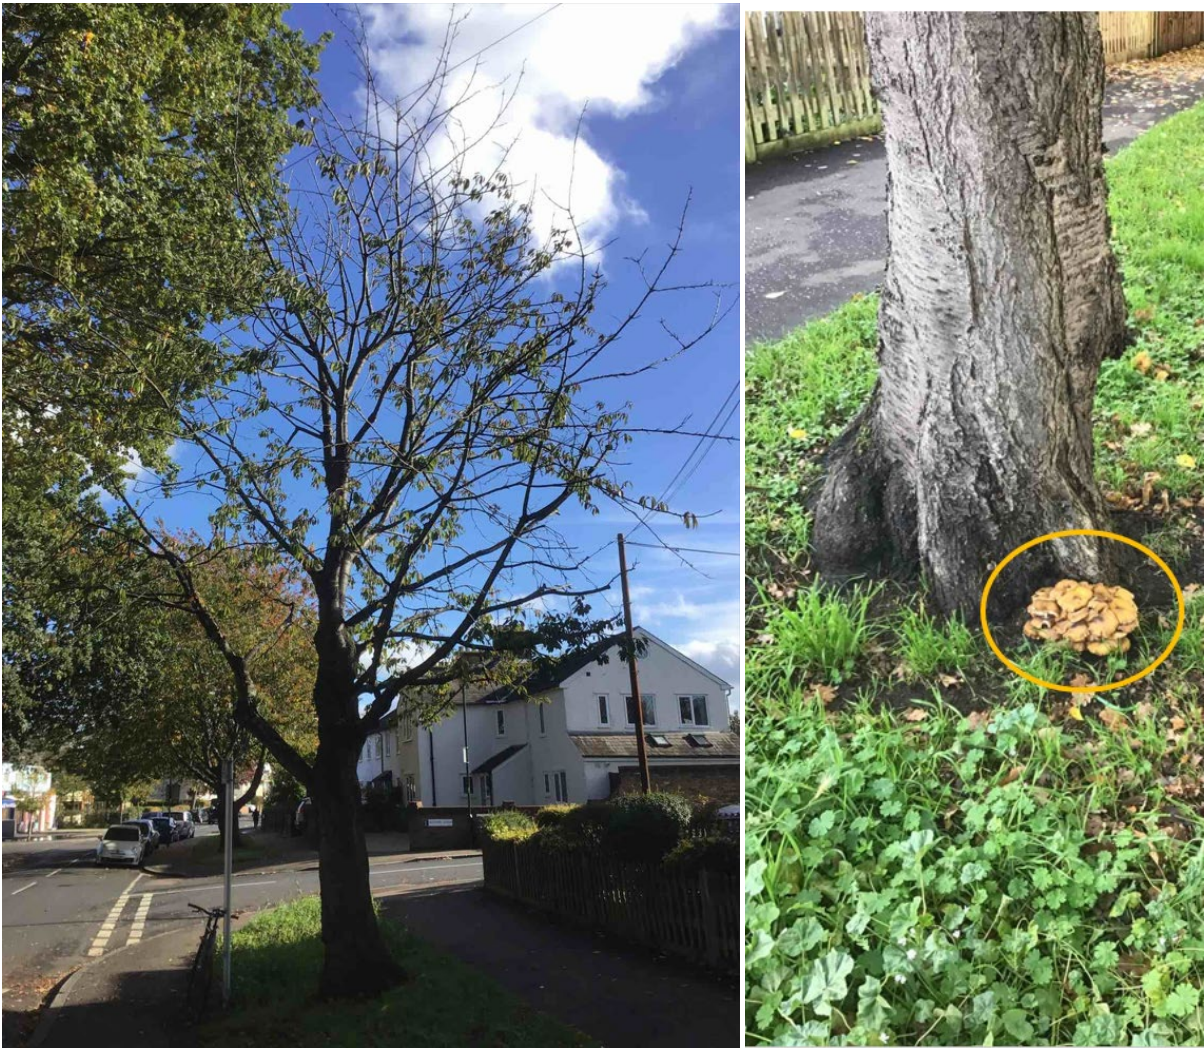
Ward	Hampton
Road	Priory Road
Location	Outside 135
Species	Wild Cherry (<i>Prunus avium</i>)
Height	12.5m
Physiological Condition	Poor
Structural Condition	Poor
Inspection findings	Th Fungal fruiting bodies of the decay pathogen <i>Armillaria</i> sp. are present at the base of this tree. Colonisation by this fungus causes a white rot of the roots and butt that can cause entire tree failure. Crown dieback could correlate with the degradation of the trees structural or supporting root system. Removal is required to prevent natural failure and facilitate replanting

Images show tree in street scene with sparse canopy indicating poor physiological condition and base with fungal fructifications circled

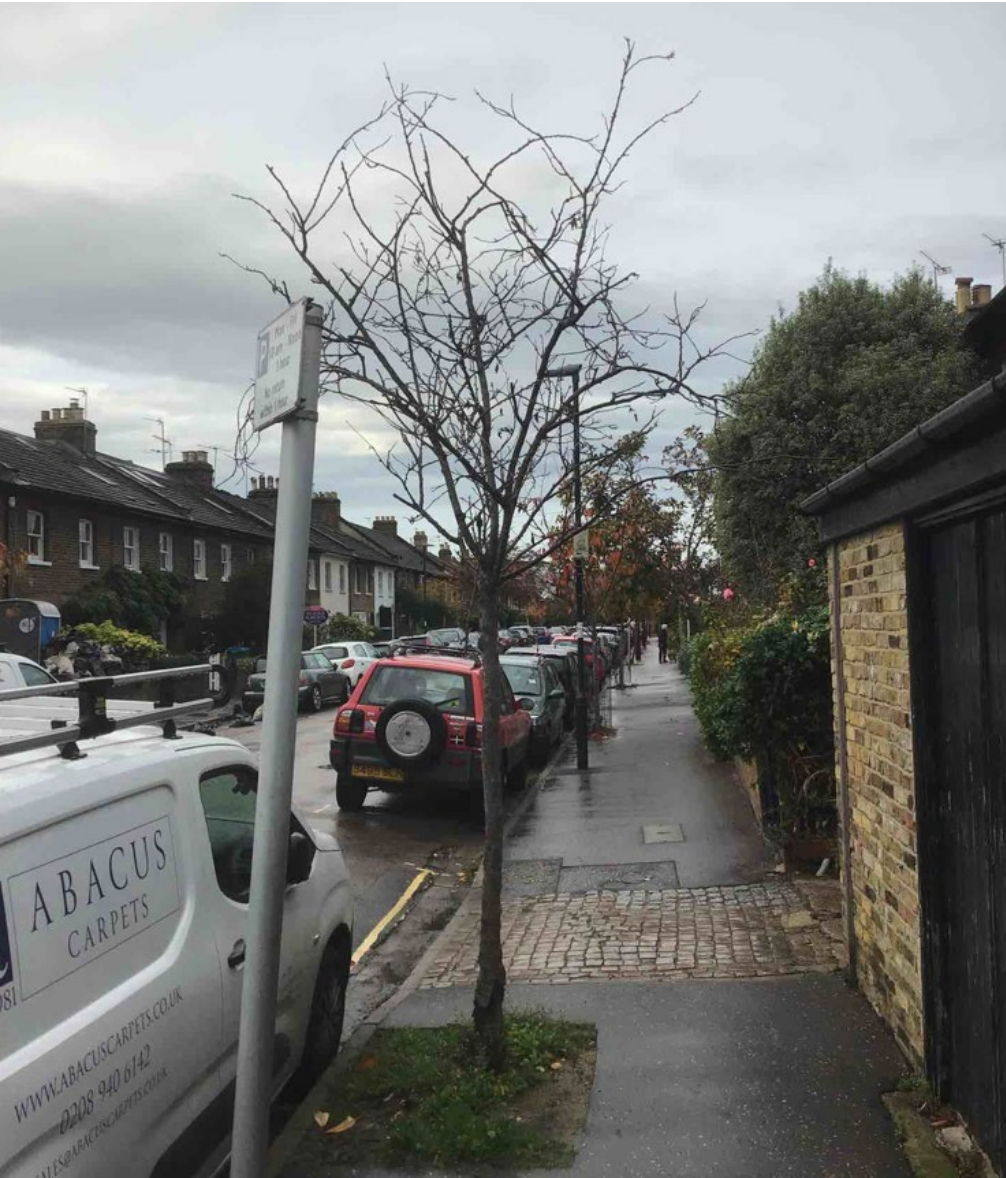
Ward	Kew
Road	Alexandra Road
Location	Adjacent to 234 Sandycoombe Road shed at rear of property
Species	Cherry (<i>Prunus sp.</i>)
Height	4.0m
Physiological Condition	Dead
Structural Condition	Dead
Inspection findings	This tree is dead; removal is required to prevent natural failure and facilitate replanting

Image shows dead tree

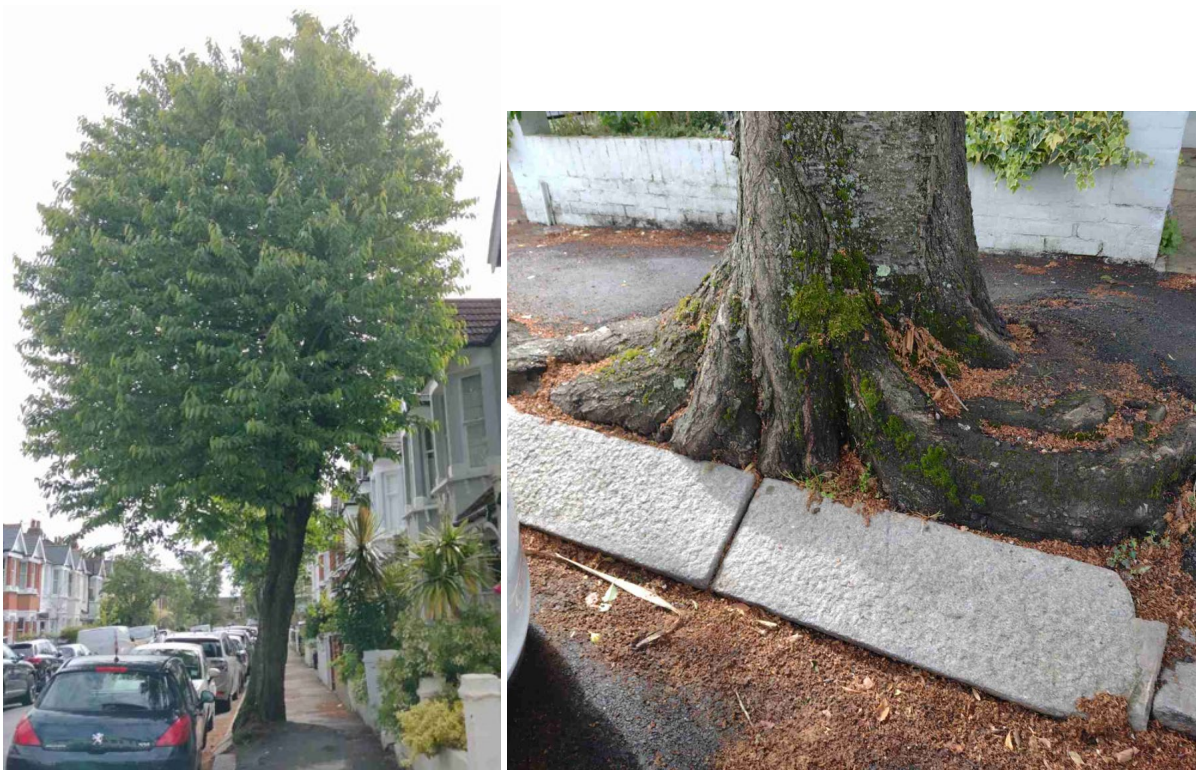
Ward	Mortlake and Barnes Common
Road	Grosvenor Avenue
Location	Outside 22
Species	Wild Cherry (<i>Prunus avium</i>)
Height	12.5m
Physiological Condition	Good
Structural Condition	Good
Inspection findings	This tree is causing an unacceptable degree of disruption to the footway. An effective engineering solution could not be found by highways; removal and replanting is required to make the highway acceptable.

Left image shows tree in street scene, right image shows base and rooting disruption to pavement and kerb

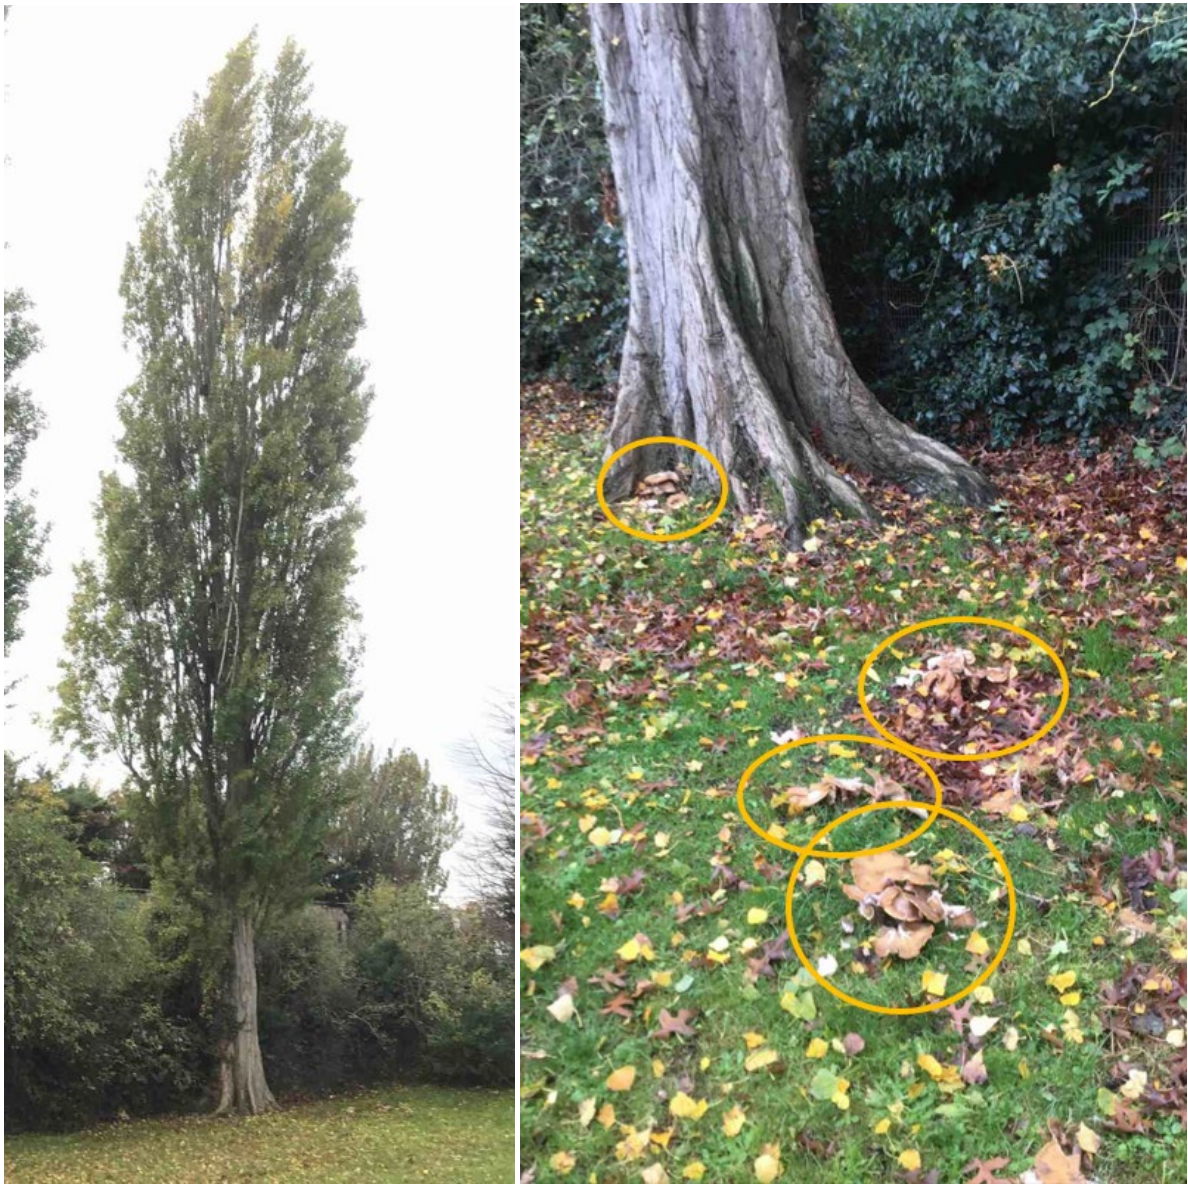
Ward	Mortlake and Barnes Common
Road	Vine Road
Location	Vine Road recreation ground
Species	Lombardy Poplar (<i>Populus nigra</i> var. <i>italica</i>)
Height	31.0m
Physiological Condition	Poor
Structural Condition	Good
Inspection findings	Fungal fruiting bodies of the decay pathogen <i>Armillaria</i> sp. are present at the base of this tree. Colonisation by this fungus causes a white rot of the roots and butt that can cause entire tree failure. Removal is required to prevent natural failure and facilitate replanting

Images show tree in situ and fungal fructifications circled

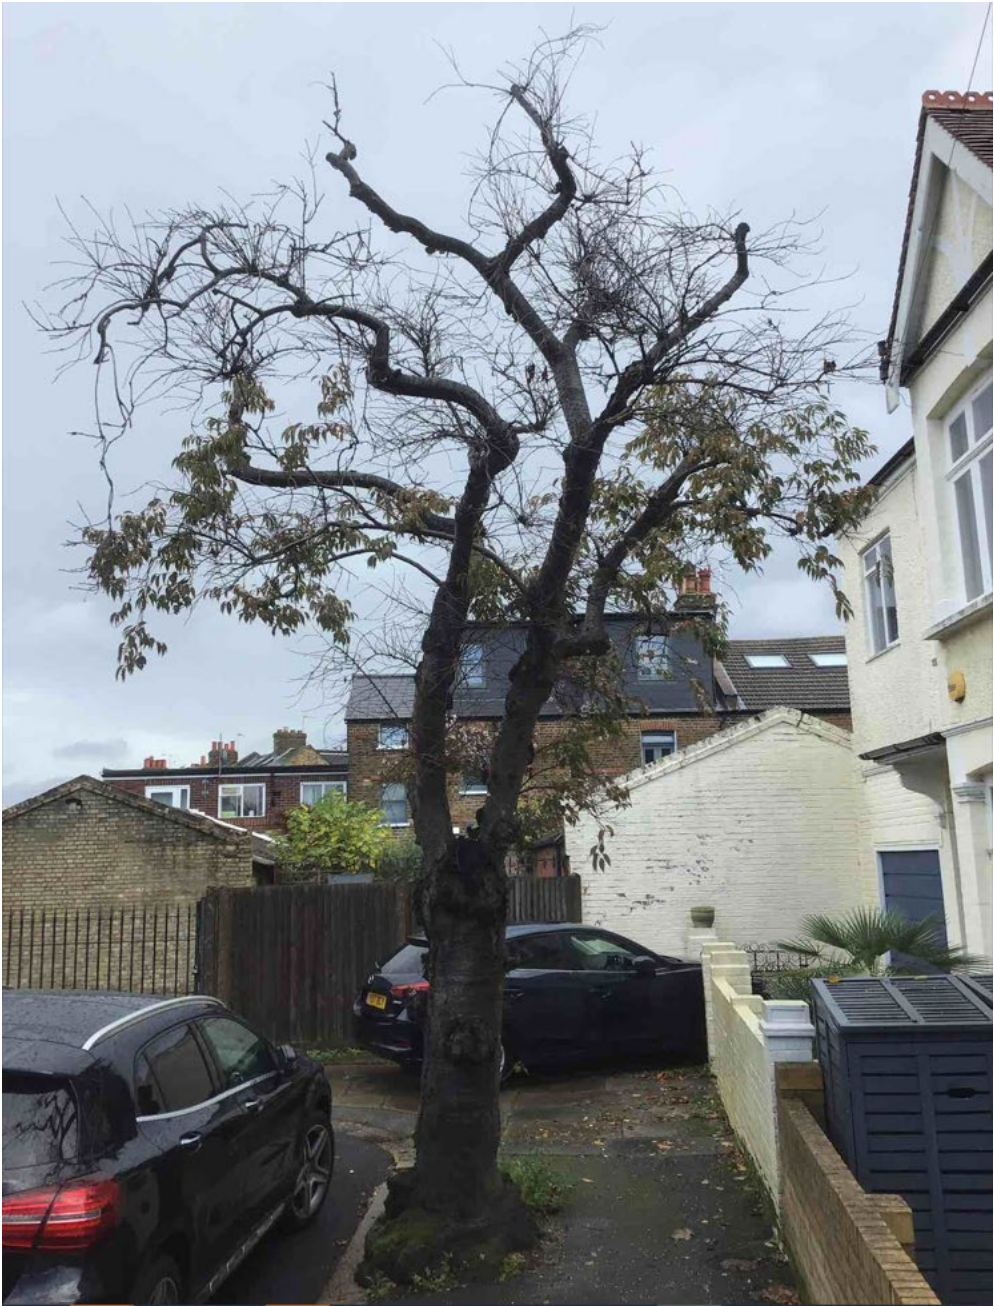
Ward	Mortlake and Barnes Common
Road	Grosvenor Avenue
Location	Outside 22
Species	Sargent's Cherry (<i>Prunus sargentii</i>)
Height	5.5m
Physiological Condition	Poor
Structural Condition	Poor
Inspection findings	This tree is moribund; removal is required to prevent natural failure and facilitate replanting

Image shows moribund tree

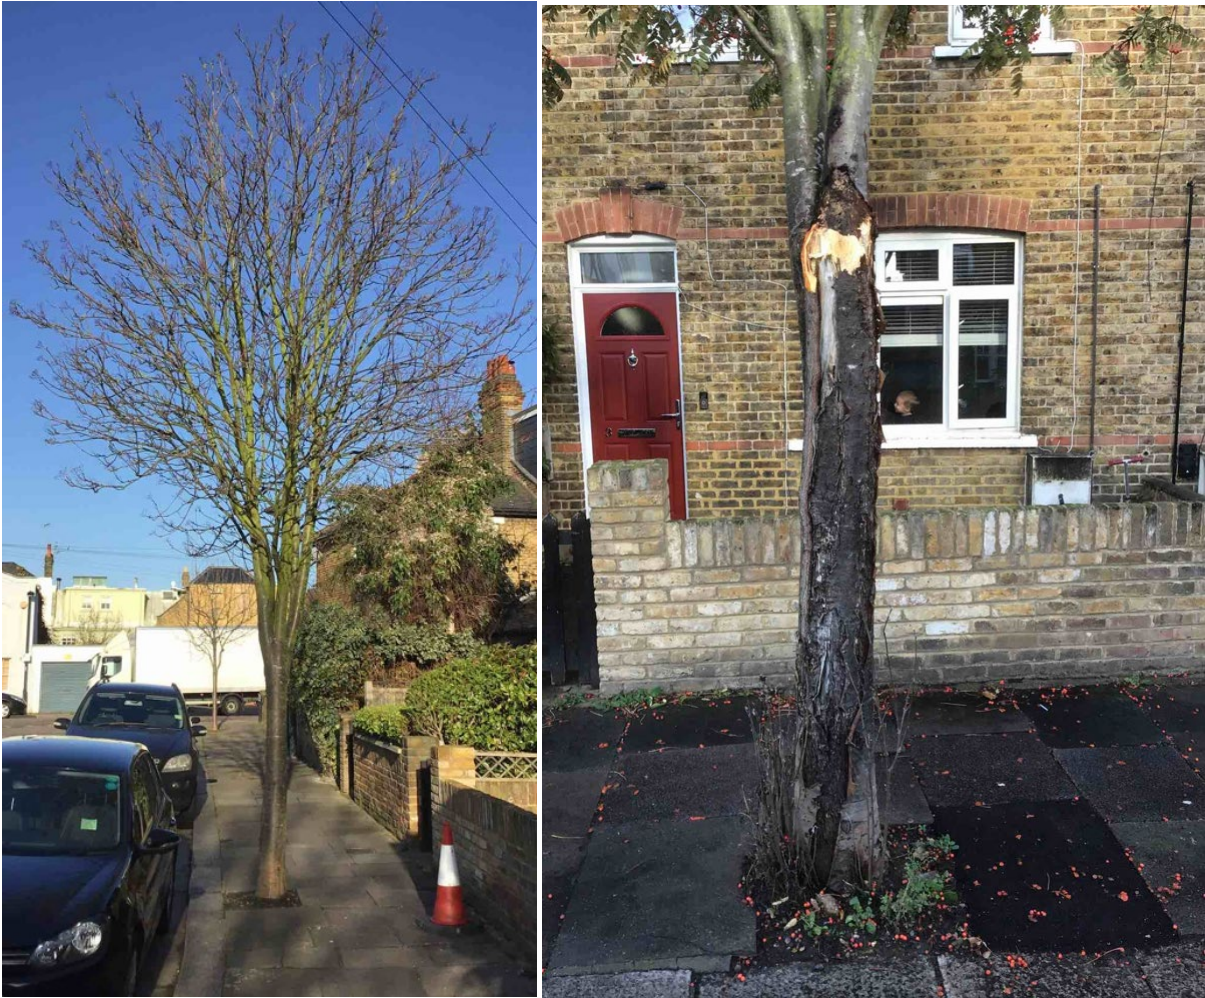
Ward	Mortlake and Barnes Common
Road	Limes Avenue
Location	Outside 3
Species	Rowan (<i>Sorbus aucuparia</i>)
Height	7.5m
Physiological Condition	Poor
Structural Condition	Poor
Inspection findings	This tree has cracked, peeling bark indicating necrosis and dysfunction of the trees vascular system. Partial failure has occurred at the main union and there are cracks which are a weak point for further failure to occur from; removal is required to prevent natural failure and facilitate replanting

Image shows tree in situ and after failure with large area of necrosis on main stem

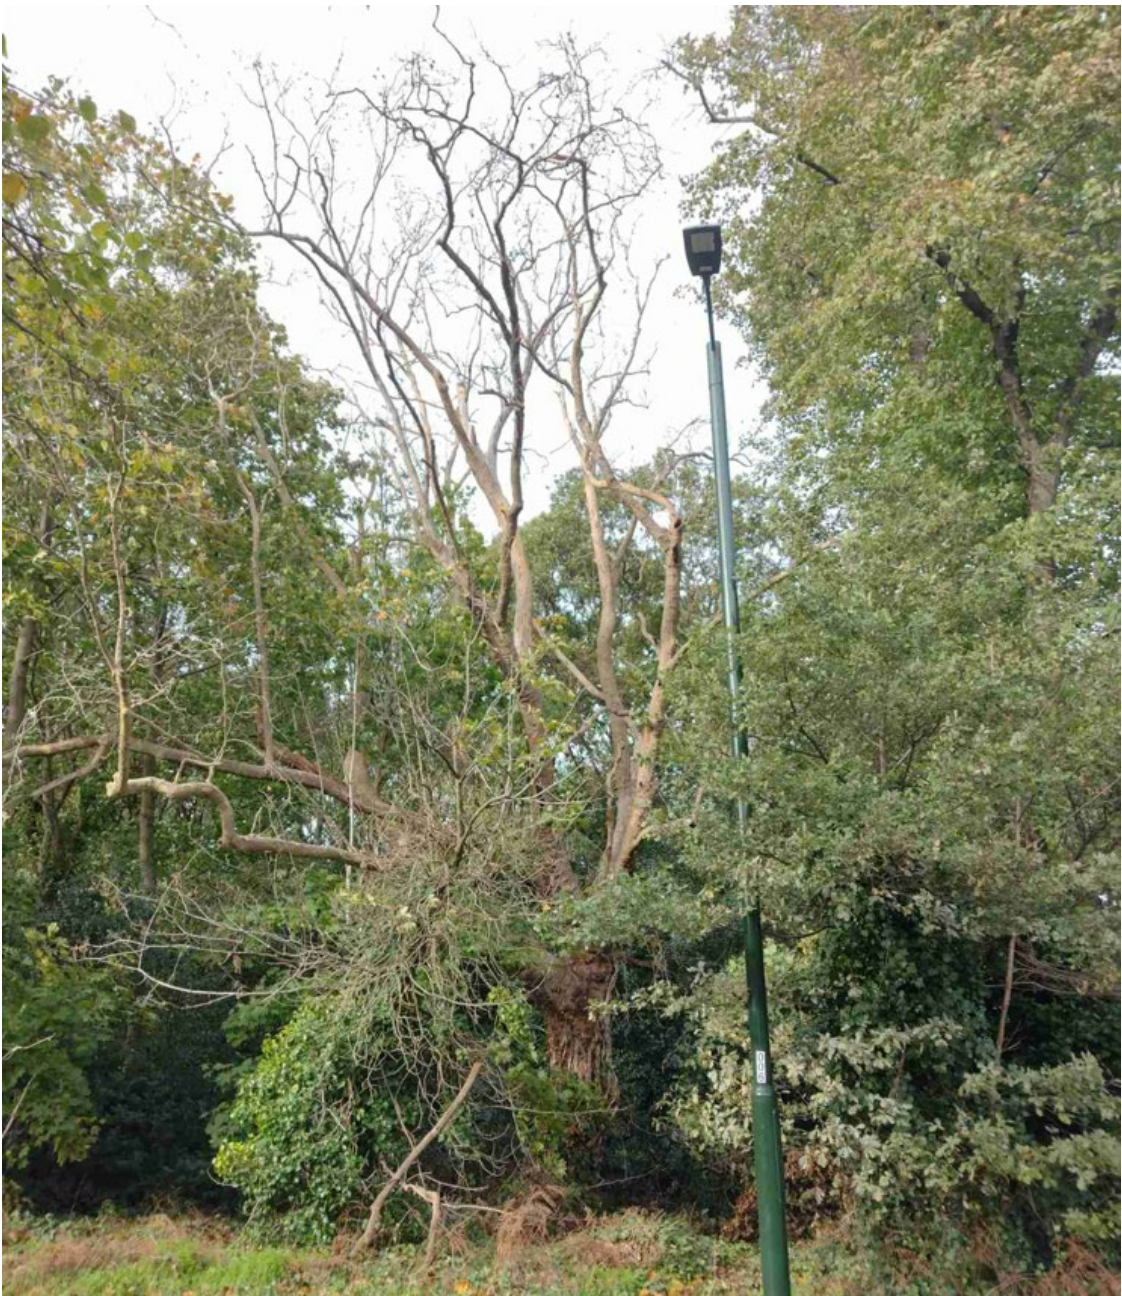
Ward	Mortlake and Barnes Common
Road	Queens Ride
Location	W3W///knots.ruby.cones
Species	London Plane (<i>Platanus x acerfolia</i>)
Height	18.0m
Physiological Condition	Dead
Structural Condition	Dead
Inspection findings	This tree is dead; removal is required to prevent natural failure and facilitate replanting

Image shows dead tree

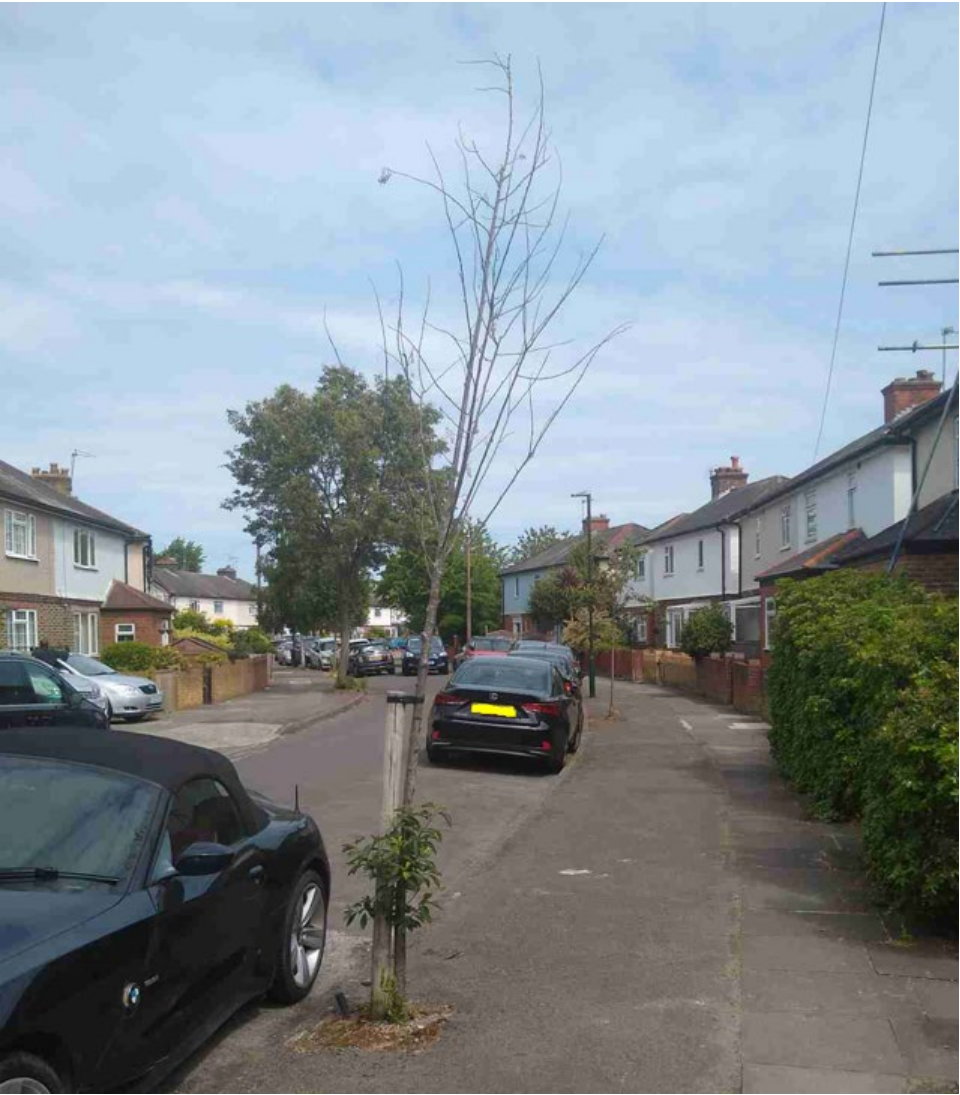
Ward	North Richmond
Road	Lambert Avenue
Location	Outside 87/89
Species	Cherry (<i>Prunus sp.</i>)
Height	4.0m
Physiological Condition	Dead
Structural Condition	Dead
Inspection findings	This tree is dead; removal is required to prevent natural failure and facilitate replanting

Image shows dead tree

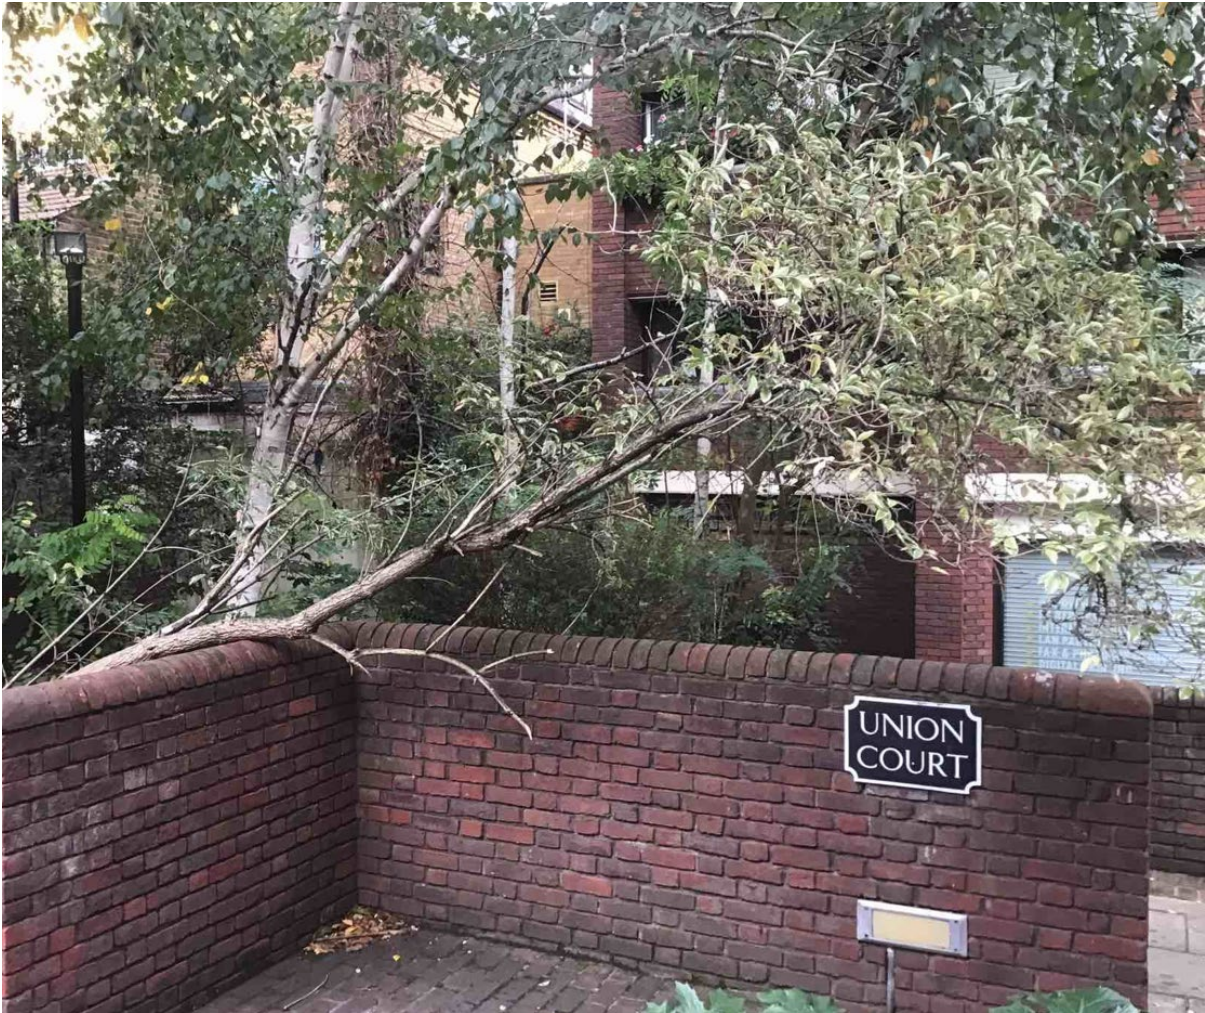
Ward	South Richmond
Road	Towers Place
Location	Outside Union Court
Species	Elder (<i>Sambucus nigra</i>)
Height	5.5m
Physiological Condition	Poor
Structural Condition	Poor
Inspection findings	This tree has partially failed at the base; removal is required to prevent further failure and facilitate replanting

Image shows tree fallen onto wall

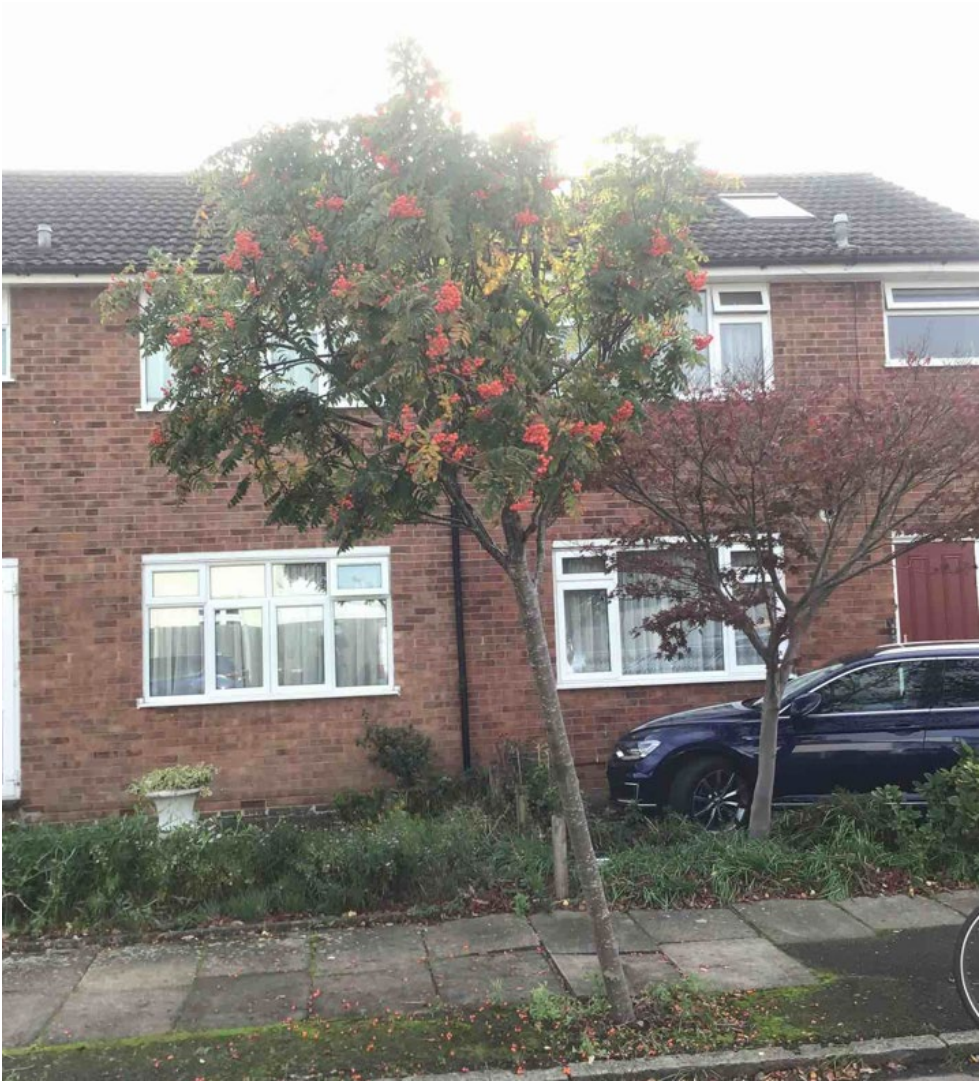
Ward	St Margarets and North Twickenham
Road	Heatham Park
Location	Outside 21/23
Species	Rowan (<i>Sorbus aucuparia</i>)
Height	5.5m
Physiological Condition	Good
Structural Condition	poor
Inspection findings	Tree main stem or trunk and roots are extensively decayed or damaged; tree is moving in such a way that indicates that the structure is compromised presenting increased risk of failure. Removal is required to prevent natural failure and facilitate replanting

Image shows dead tree

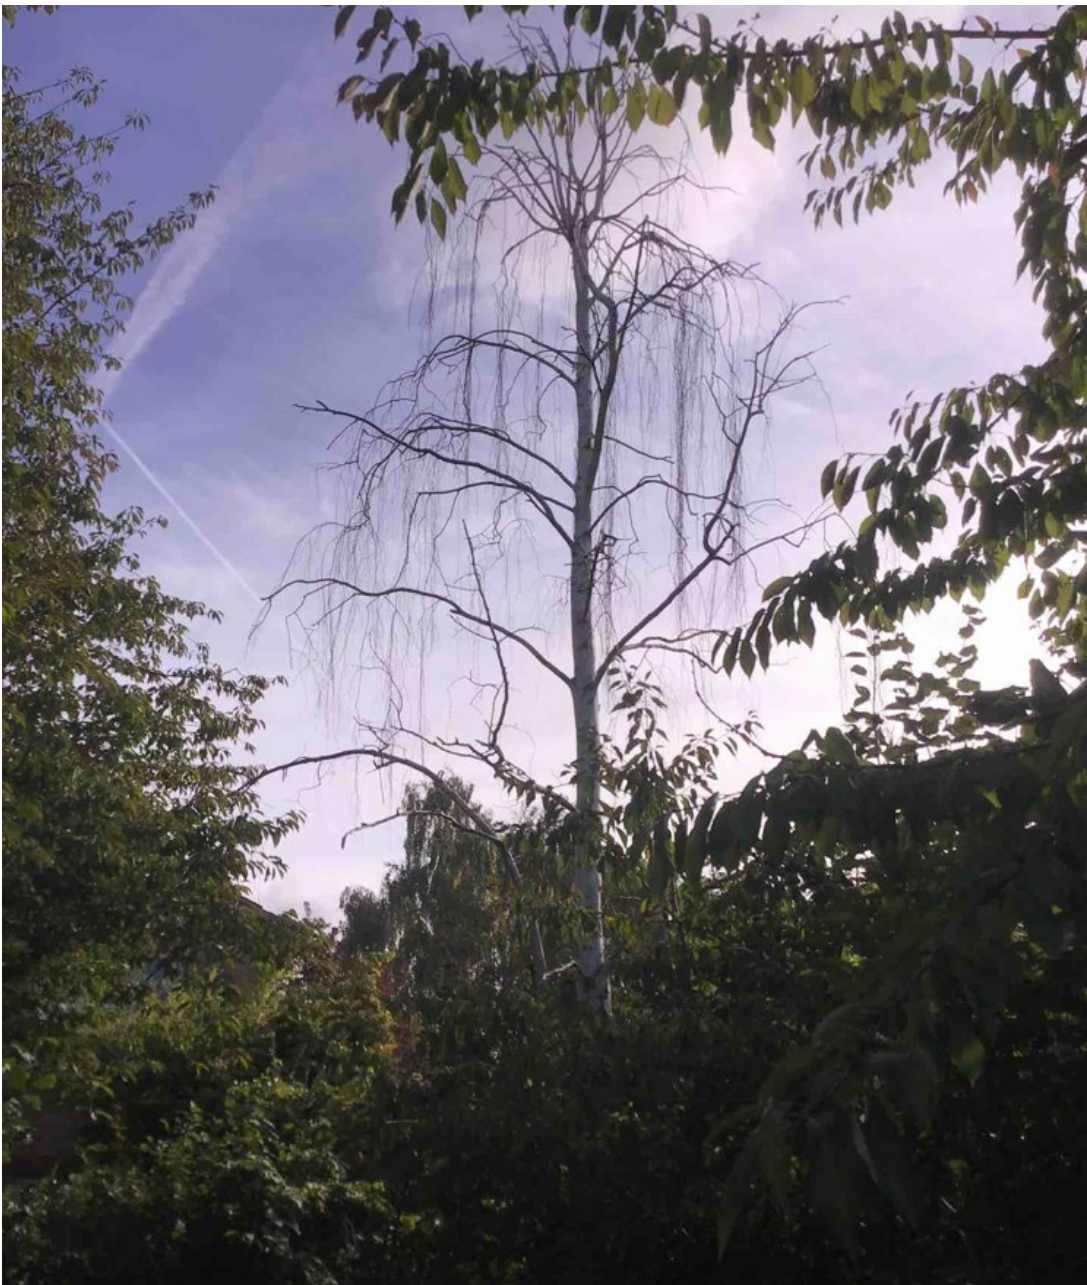
Ward	St Margarets and North Twickenham
Road	Grimwood Road
Location	Grimwood Road Recreation Ground
Species	Silver Birch (<i>Betula pendula</i>)
Height	10.0m
Physiological Condition	Dead
Structural Condition	Dead
Inspection findings	This tree is dead and removal is required to prevent natural failure and facilitate replanting

Image shows dead

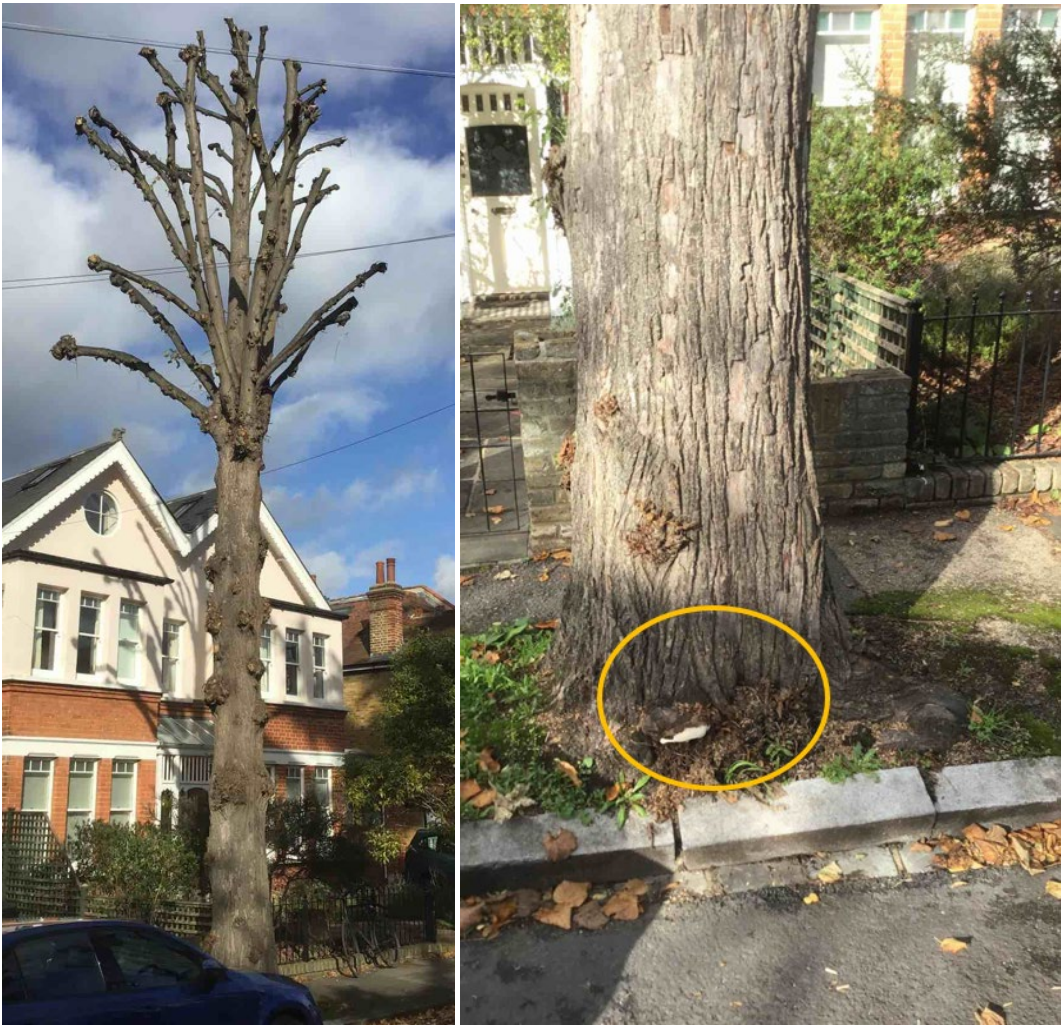
Ward	Teddington
Road	Teddington Park
Location	Outside 53/55
Species	Common Lime (<i>Tilia x europea</i>)
Height	15.0m
Physiological Condition	Good
Structural Condition	Poor
Inspection findings	A fungal fruiting body of the decay pathogen <i>Ganoderma</i> sp. is present at the stem base. Colonisation by this fungus causes a white rot of the stem and root system that can cause entire trees to collapse through fracture or windthrow. A detailed investigation of this tree using sonic tomography revealed an unacceptable degree of decay; removal is required to prevent natural failure and facilitate replanting

Images show tree in situ and base with fungal fructification and area of decay circled

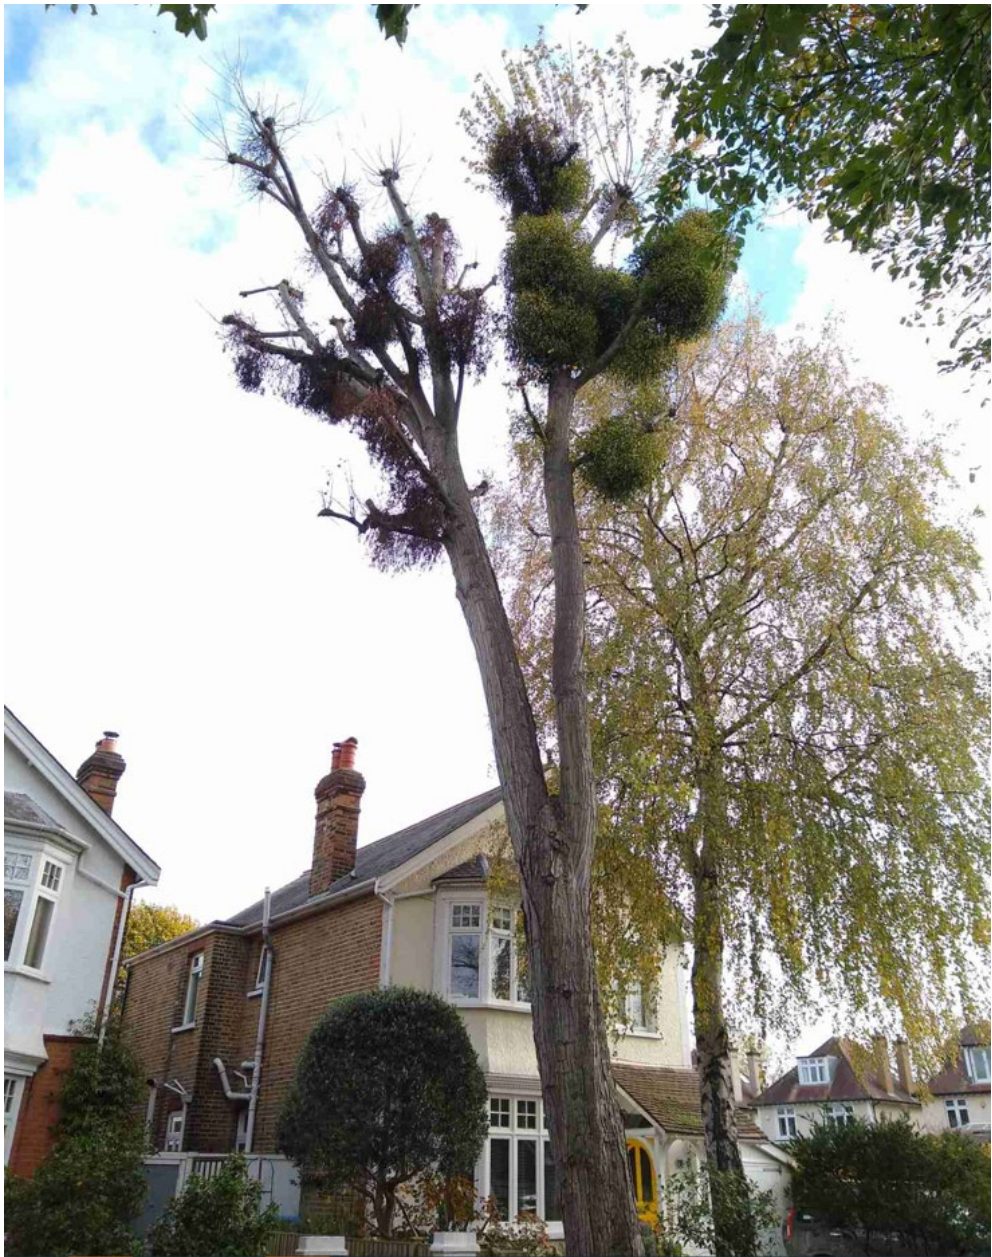
Ward	Teddington
Road	Udney Park Road
Location	Outside 85-87
Species	Sugar Maple (<i>Acer saccharinum</i>)
Height	21.0m
Physiological Condition	Poor
Structural Condition	Good
Inspection findings	Tree crown is displaying symptoms of physiological decline and is moribund; removal is required to prevent natural failure and facilitate replanting

Image shows moribund tree

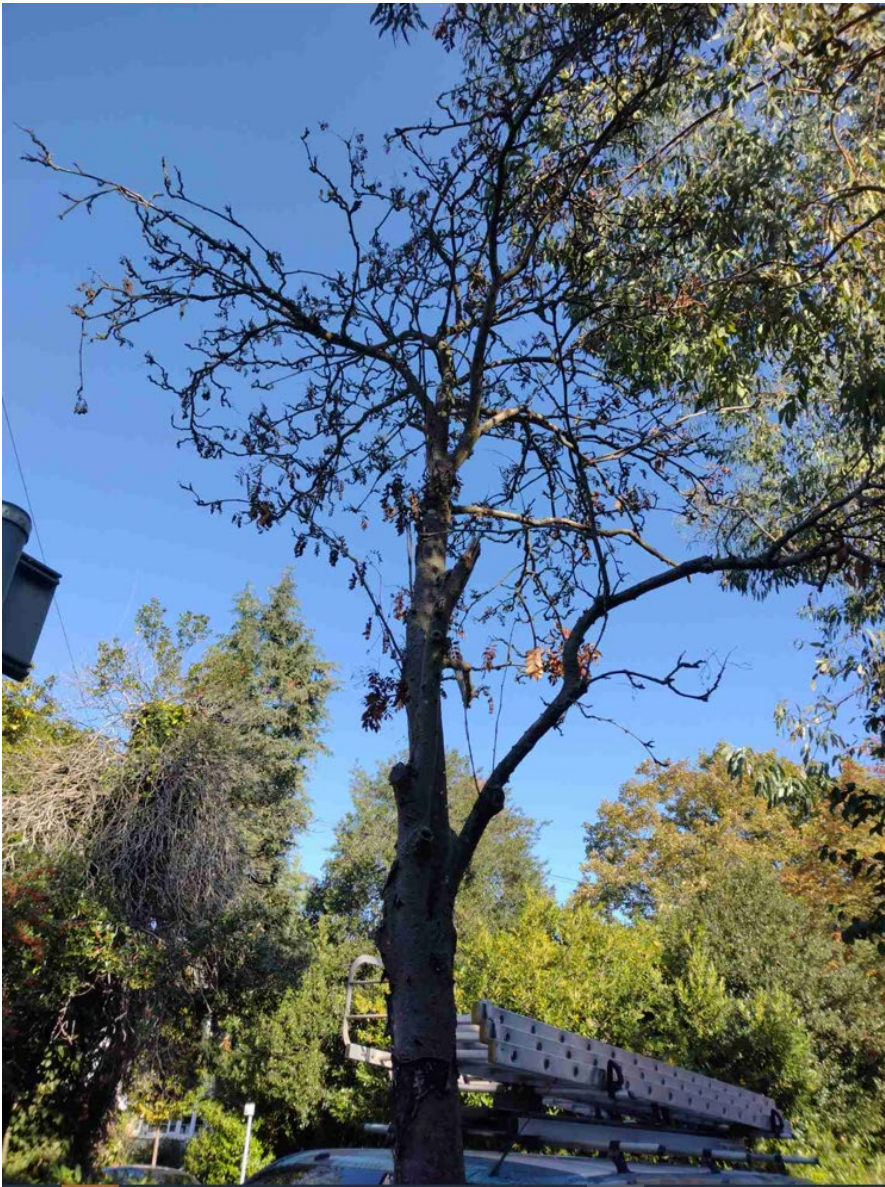
Ward	Twickenham Riverside
Road	Park House Gardens
Location	Side of 50/52
Species	Swedish Whitebeam (<i>Sorbus intermedia</i>)
Height	5.5m
Physiological Condition	Dead
Structural Condition	Dead
Inspection findings	This tree is dead; removal is required to prevent natural failure and facilitate replanting

Image shows dead tree

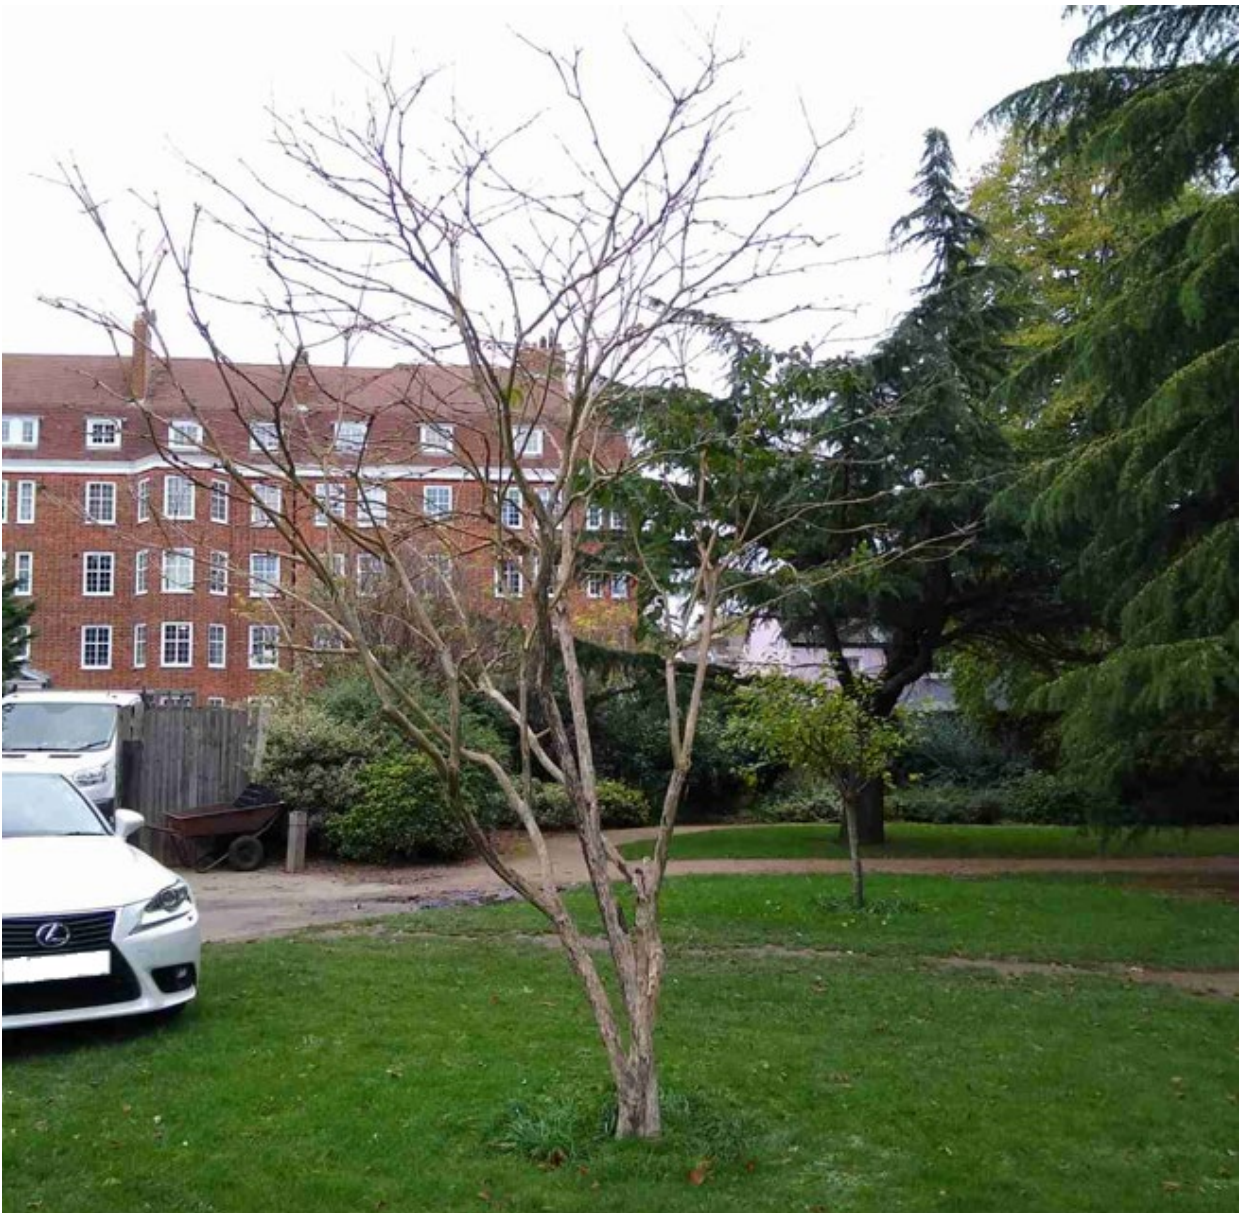
Ward	Twickenham Riverside
Road	York House Gardens
Location	York House Gardens – What3Words ///table.supply.tribes
Species	Katsura (<i>Cercidiphyllum japonicum</i>)
Height	4.0m
Physiological Condition	Dead
Structural Condition	Dead
Inspection findings	This tree is dead; removal is required to prevent natural failure and facilitate replanting

Image shows dead tree
