November 2022 - Reactive Tree Works Programme

The following pages provide the locations, descriptions of the inspection findings, and photographs of each tree that is to be removed.

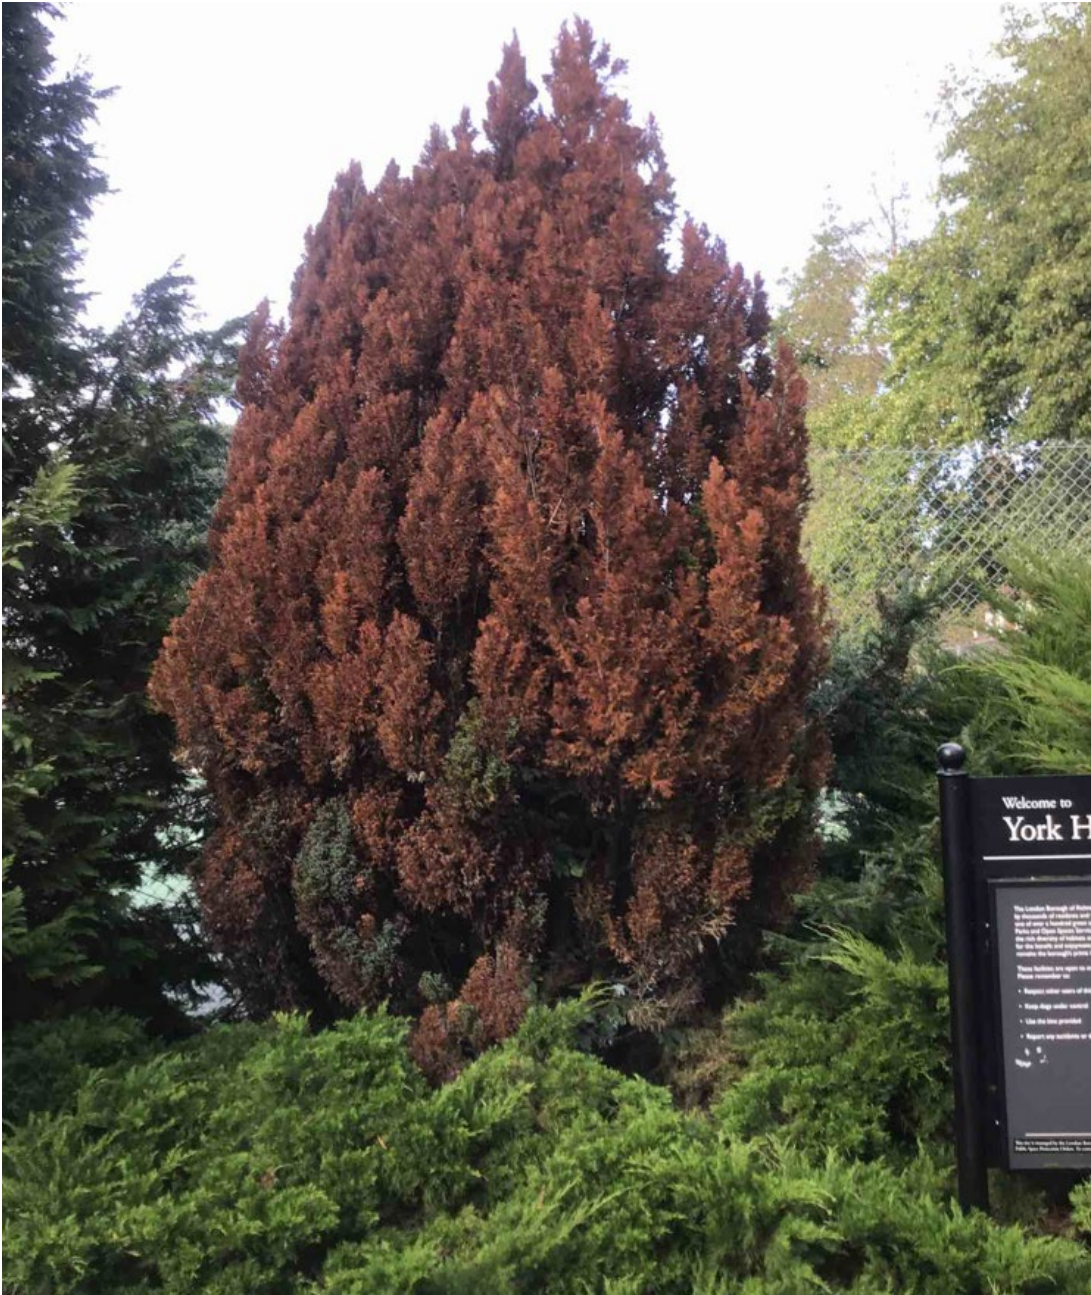
Ward	Twickenham Riverside
Road	York House Gardens
Location	York House Gardens- ///What3Word- friend.poker.votes
Species	Juniper (<i>Juniperis sp.</i>)
Height	4.0m
Physiological Condition	Poor
Structural Condition	Poor
Inspection findings	This tree is moribund; removal is required to prevent natural failure and facilitate replanting

Image shows moribund tree
