July 2025 - Reactive Tree Works Programme

Introduction

A survey of trees in the North Richmond ward is currently being undertaken; this is being conducted by specialist arboricultural officers as part of the scheduled 4 yearly detailed inspection regime that has been devised for all Council highway and parks trees.

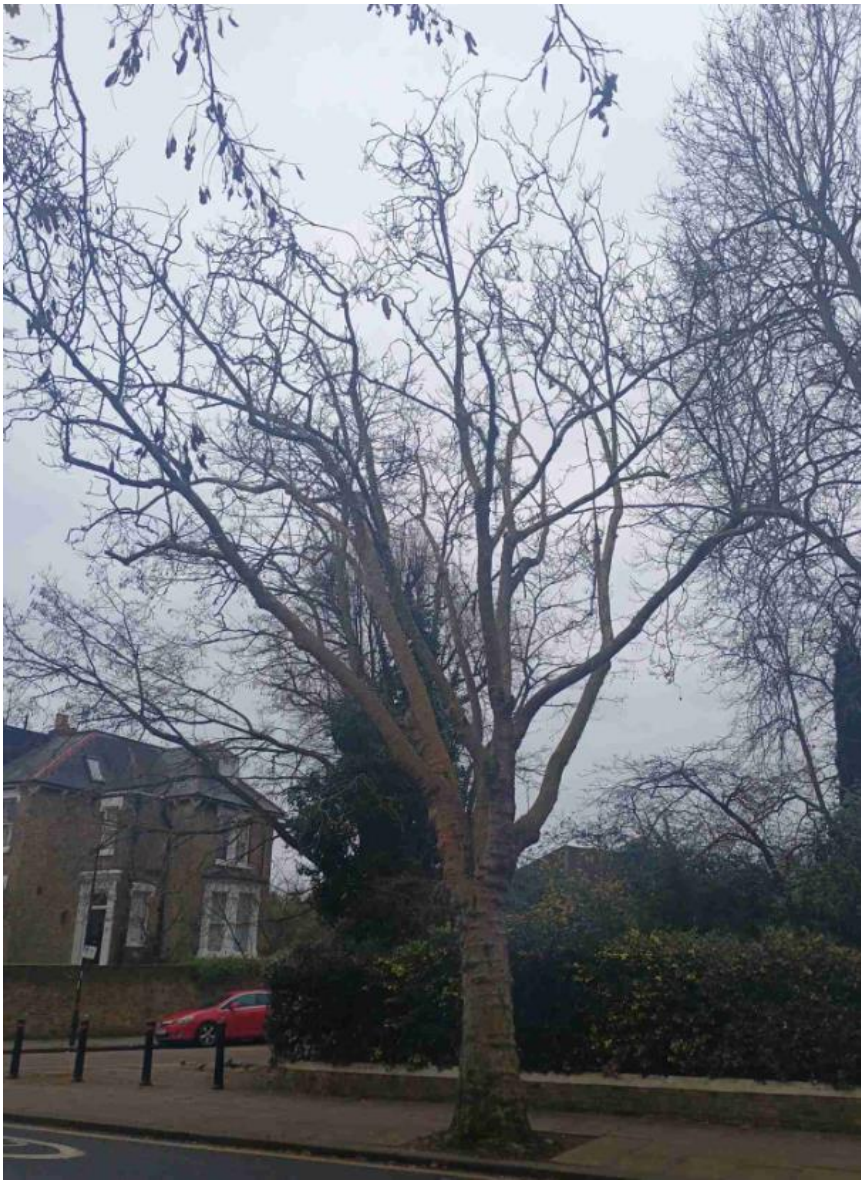
Ward	Barnes
Road	Lonsdale Road
Location	Opposite 46
Species	London Plane (<i>Platanus x hispanica</i>)
Height	17.0m
Physiological Condition	Poor
Structural Condition	Fair
Inspection findings/reason for exemption	This tree is moribund; removal is required to prevent natural failure, manage risk, and facilitate replanting.

Image shows moribund tree in street scene.

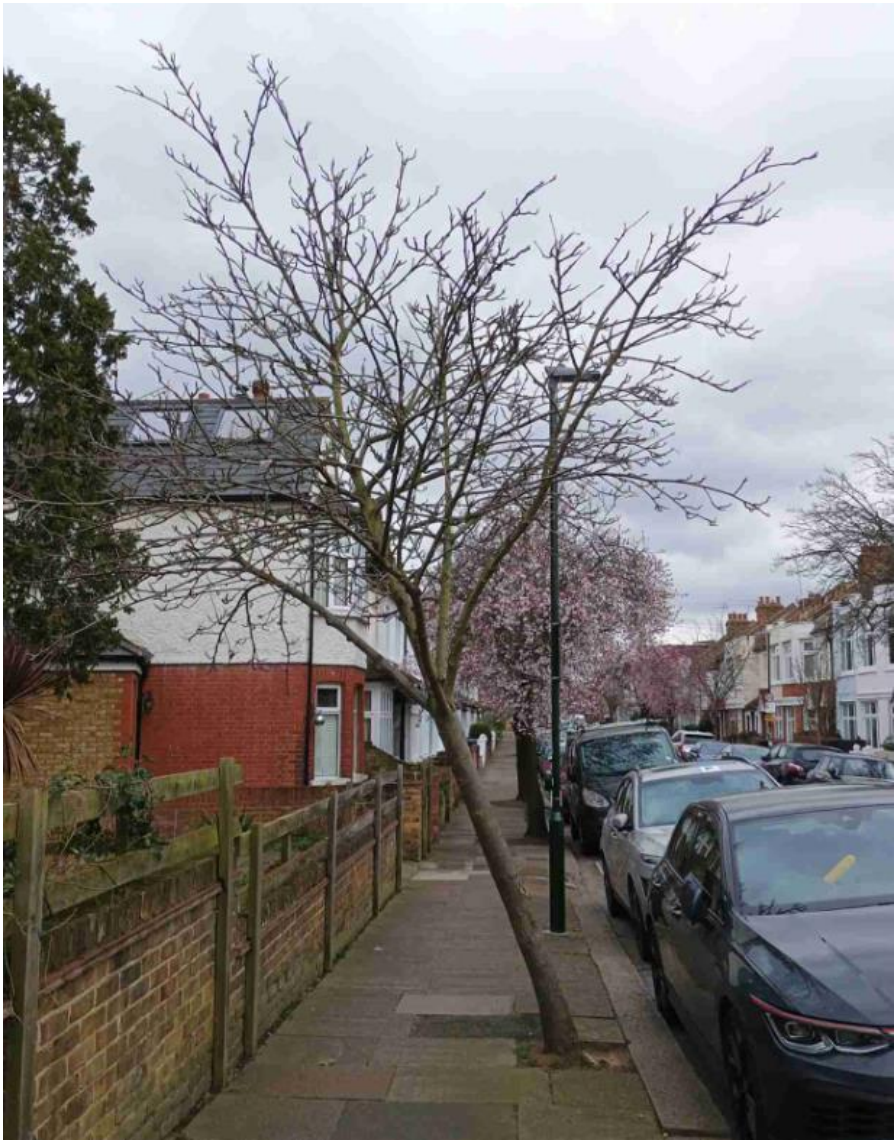
Ward	East Sheen
Road	Church Avenue
Location	Adjacent to Firmston House
Species	Whitebeam (<i>Sorbus aria</i>)
Height	5.5m
Physiological Condition	Good
Structural Condition	Fair
Inspection findings/reason for exemption	This tree is excessively leaning across the footway causing an unreasonable obstruction. Removal is required to manage the unacceptable risk of pedestrian injury and facilitate replanting.

Image shows leaning tree street scene.

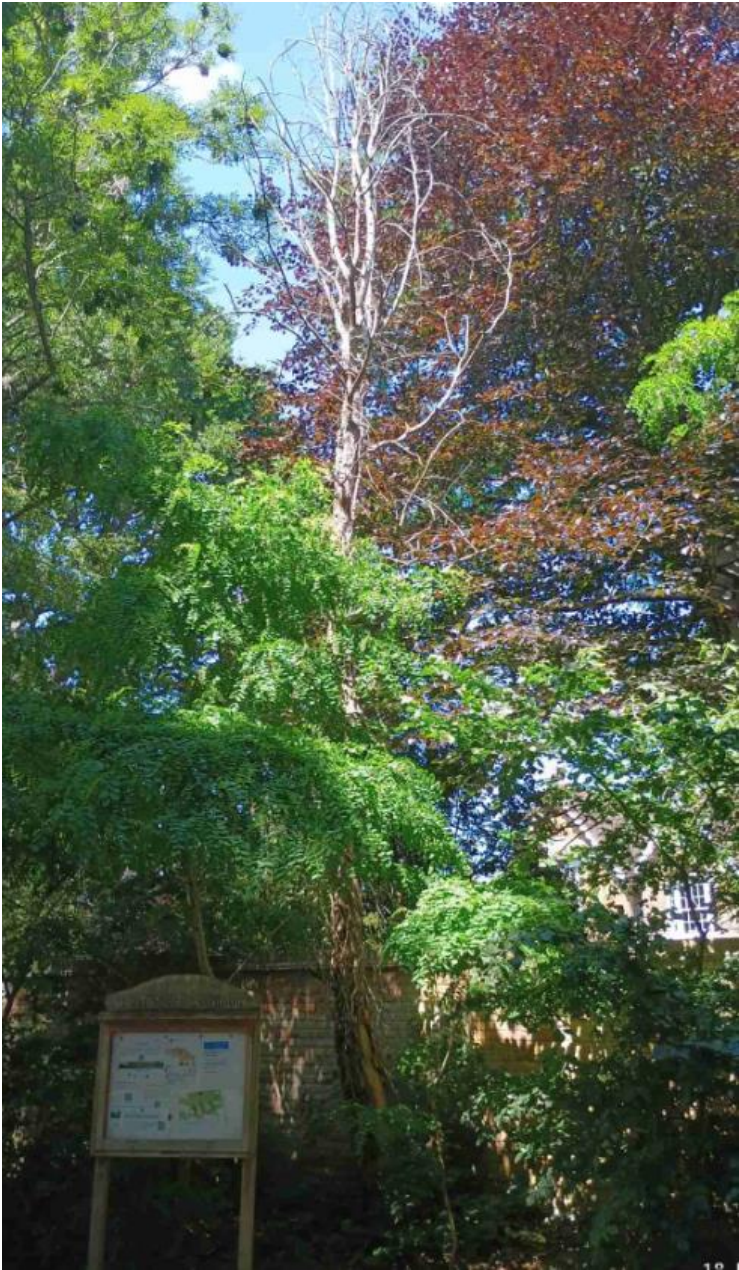
Ward	East Sheen
Road	Fife Road
Location	Sheen common ///damp.fluid.wacky
Species	Lime (Tilia sp.)
Height	12.0m
Physiological Condition	Dead
Structural Condition	Dead
Inspection findings/reason for exemption	This tree is dead; removal is required to prevent natural failure, manage risk, and facilitate replanting

Image shows dead tree in park scene.

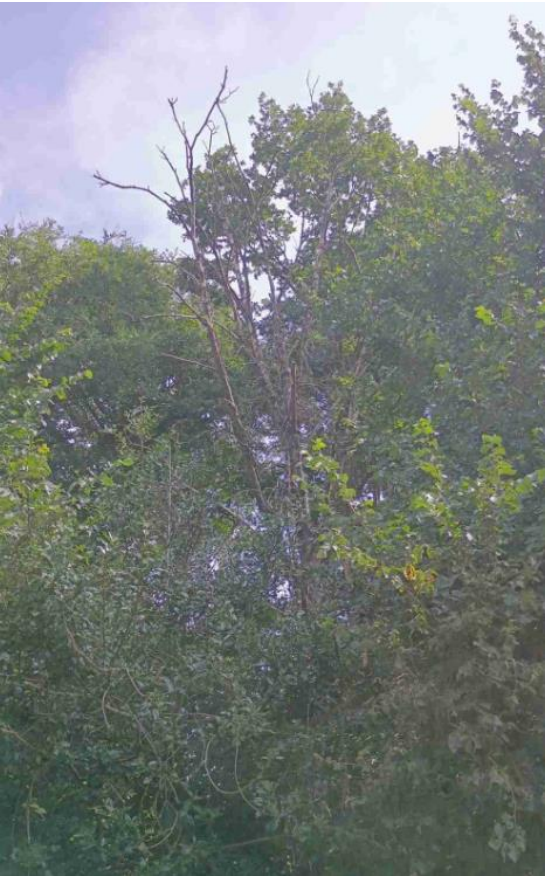
Ward	Ham, Petersham and Richmond Riverside
Road	Ham Farm Road
Location	Ham Common Woods- ///pillow.glow.kicked
Species	Sycamore (<i>Acer pseudoplatanus</i>)
Height	14.0m
Physiological Condition	Dead
Structural Condition	Dead
Inspection findings/reason for exemption	This tree has died due to a fungal pathogen called 'sooty bark disease' (<i>Cryptostroma corticale</i>). This fungus disrupts the tree's vascular system, preventing the effective transport of water and nutrients, and leads to the cracking and peeling of bark, exposing masses of black fungal spores and tree death. The establishment of this disease also affects the structural integrity of the affected tree, causing branches to become brittle and predisposed to collapse. Removal is required to prevent natural failure, manage risk and prevent further release of spores which pose a respiratory risk to humans.

Image shows dead tree in woodland scene.

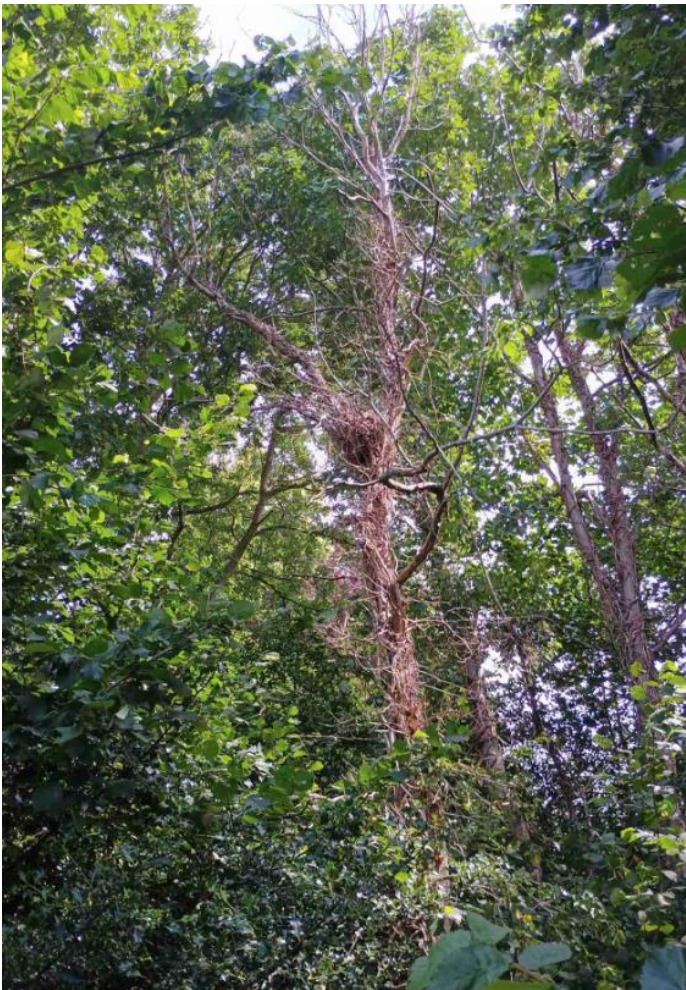
Ward	Ham, Petersham and Richmond Riverside
Road	Ham Farm Road
Location	Ham Common Woods- /// sizes.tags.crew
Species	Sycamore (<i>Acer pseudoplatanus</i>)
Height	10.0m
Physiological Condition	Dead
Structural Condition	Dead
Inspection findings/reason for exemption	This tree has died due to a fungal pathogen called ‘sooty bark disease’ (<i>Cryptostroma corticale</i>). This fungus disrupts the tree’s vascular system, preventing the effective transport of water and nutrients, and leads to the cracking and peeling of bark, exposing masses of black fungal spores and tree death. The establishment of this disease also affects the structural integrity of the affected tree, causing branches to become brittle and predisposed to collapse. Removal is required to prevent natural failure, manage risk and prevent further release of spores which pose a respiratory risk to humans.

Image shows dead tree in woodland scene.

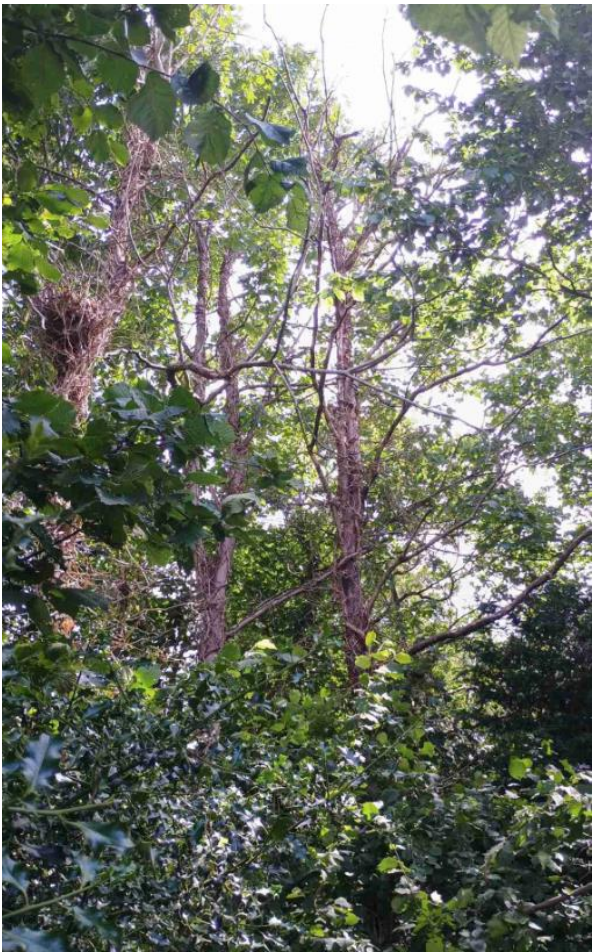
Ward	Ham, Petersham and Richmond Riverside
Road	Ham Farm Road
Location	Ham Common Woods- /// ruler.jukebox.aura
Species	Sycamore (<i>Acer pseudoplatanus</i>)
Height	10.0m
Physiological Condition	Dead
Structural Condition	Dead
Inspection findings/reason for exemption	This tree has died due to a fungal pathogen called ‘sooty bark disease’ (<i>Cryptostroma corticale</i>). This fungus disrupts the tree’s vascular system, preventing the effective transport of water and nutrients, and leads to the cracking and peeling of bark, exposing masses of black fungal spores and tree death. The establishment of this disease also affects the structural integrity of the affected tree, causing branches to become brittle and predisposed to collapse. Removal is required to prevent natural failure, manage risk and prevent further release of spores which pose a respiratory risk to humans.

Image shows dead tree in woodland scene.

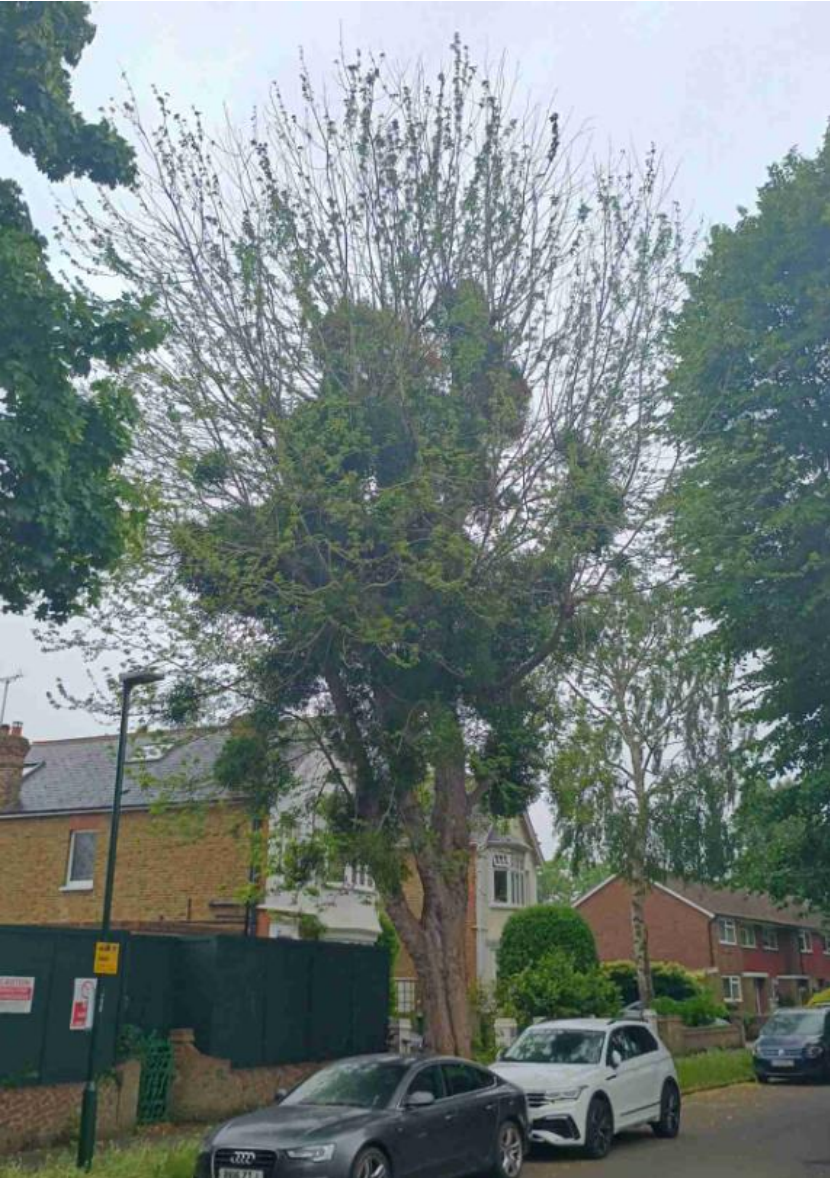
Ward	Teddington
Road	Udney Park Road
Location	Outside 83
Species	Silver maple (<i>Acer saccharinum</i>)
Height	20.0m
Physiological Condition	Poor
Structural Condition	Fair
Inspection findings/reason for exemption	This tree is moribund with over 70% of the crown being dead; removal is required to prevent natural failure, manage risk and facilitate replanting

Image shows moribund tree in street scene

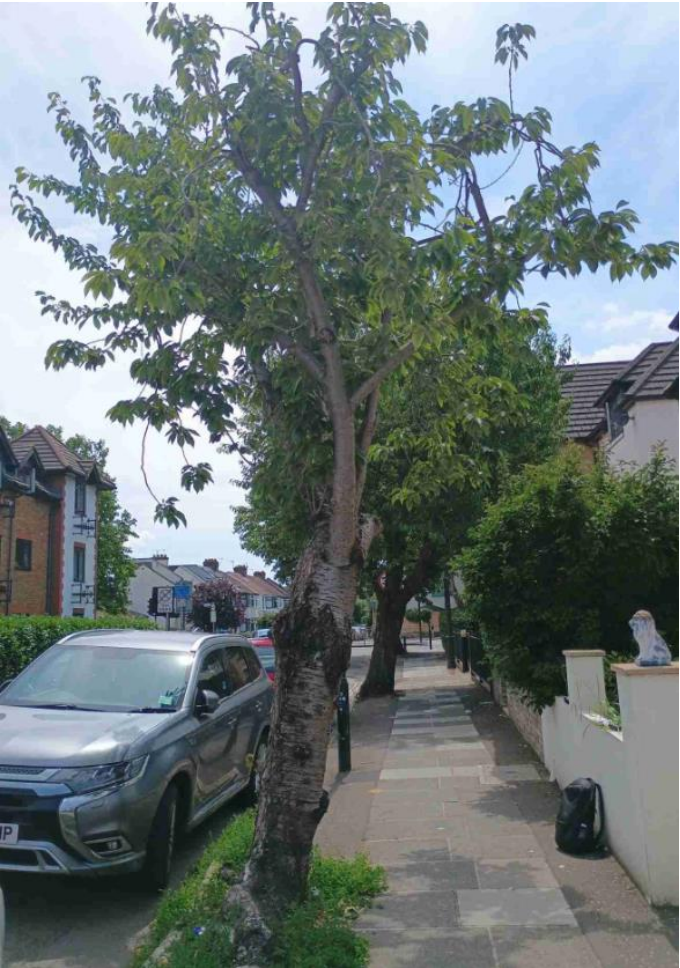
Ward	Kew
Road	Marksbury Avenue
Location	Opposite 3
Species	Cherry (<i>Prunus sp.</i>)
Height	7.5m
Physiological Condition	Fair
Structural Condition	Poor
Inspection findings/reason for exemption	Investigation with a probe and a resonance test with a sounding hammer has revealed an unacceptable amount of decay beyond the visible cavities at the base of the trunk. Removal is required to prevent natural failure, manage risk, and facilitate replanting.

Image shows tree in street scene.

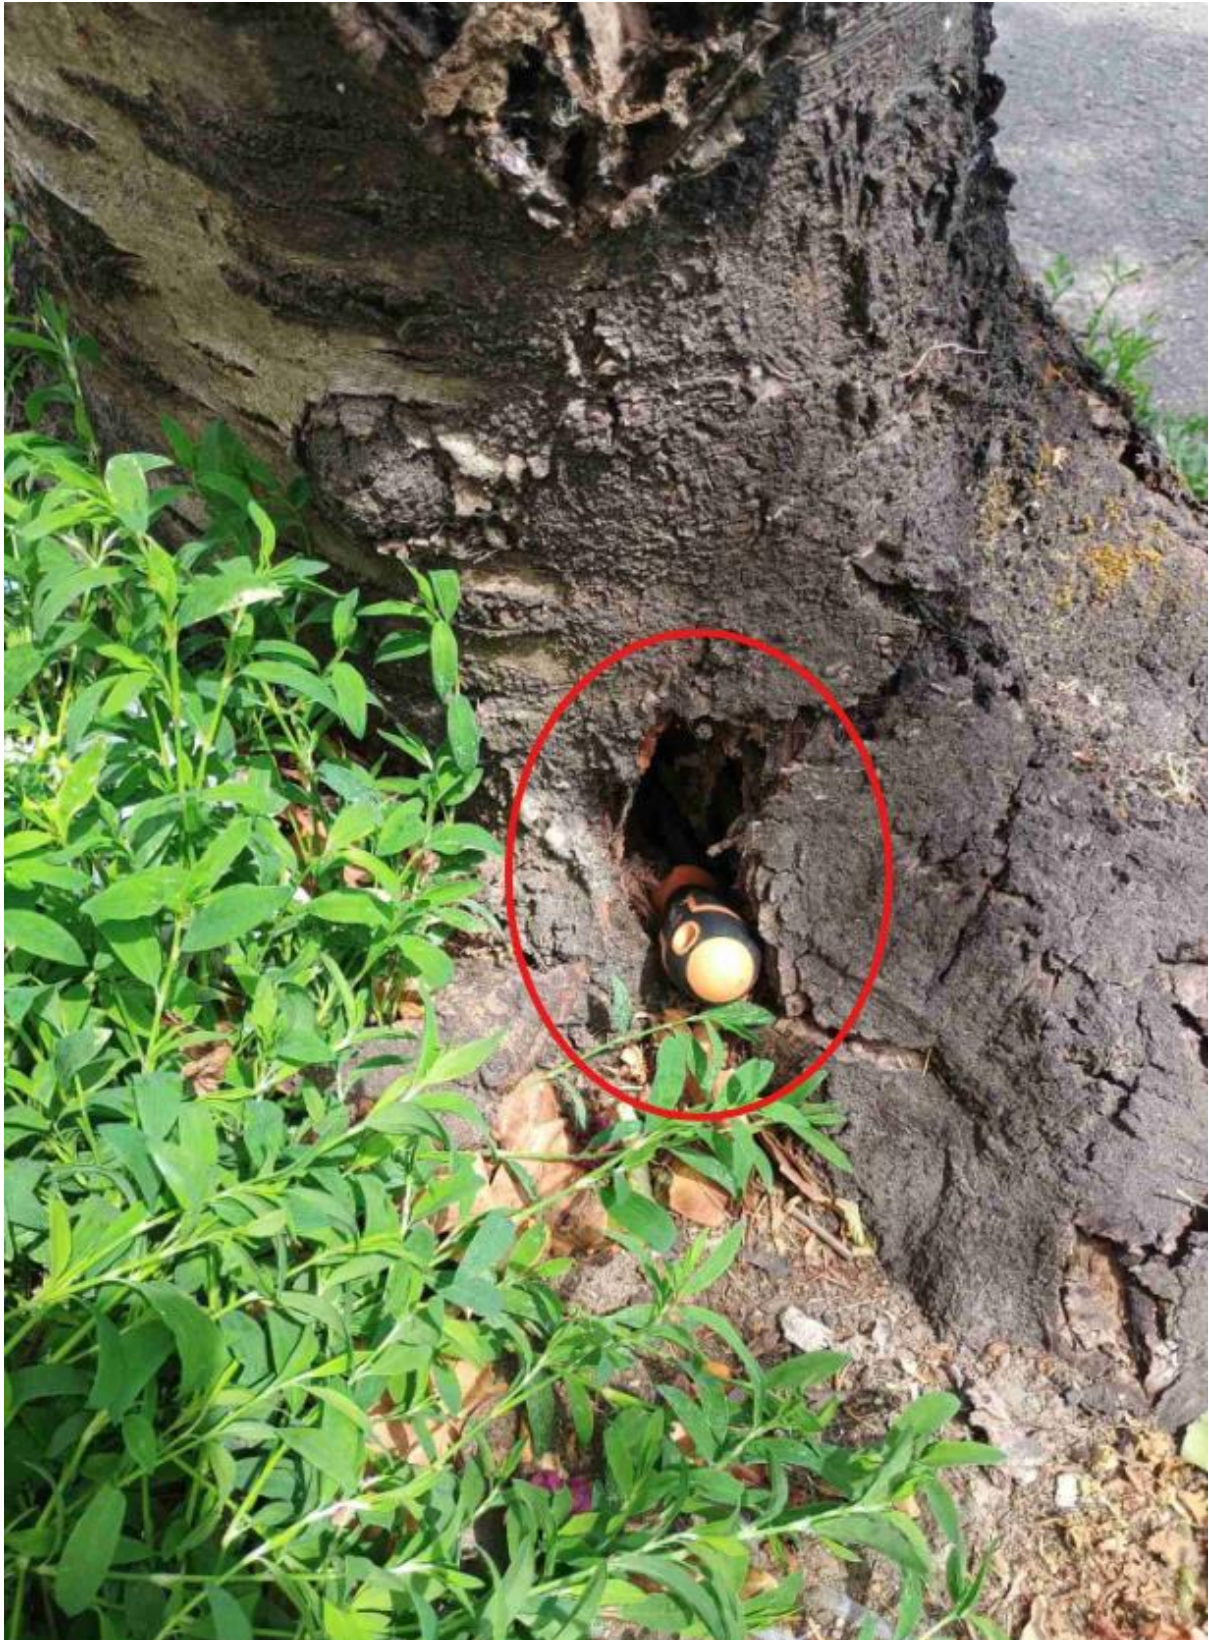
Image shows prob in cavity at base of trunk circled.

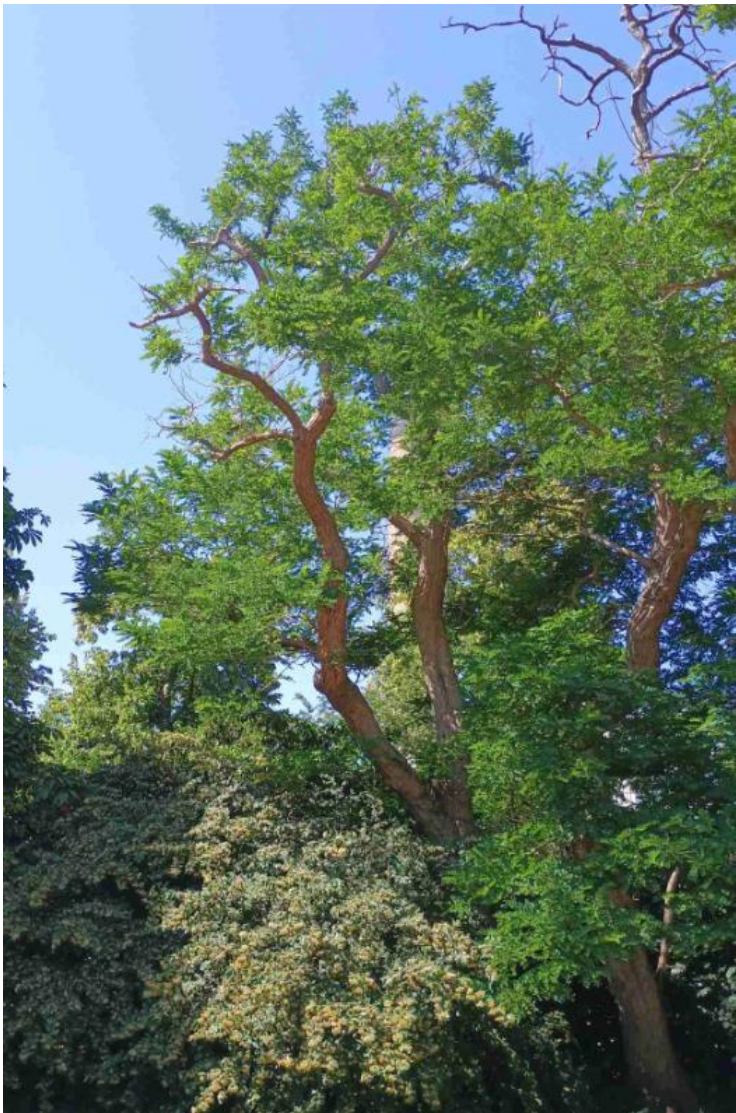
Ward	Mortlake and Barnes Common
Road	Sheen Lane
Location	Mortlake Green- ///farmer.deflection.double
Species	Black locust (<i>Robinia pseudoacacia</i>)
Height	12.5m
Physiological Condition	Fair
Structural Condition	Poor
Inspection findings/reason for exemption	Investigation with a probe and a resonance test with a sounding hammer has revealed an unacceptable amount of decay beyond the visible cavities at the base of the trunk. Removal is required to prevent natural failure, manage risk, and facilitate replanting.

Image shows tree in park scene.

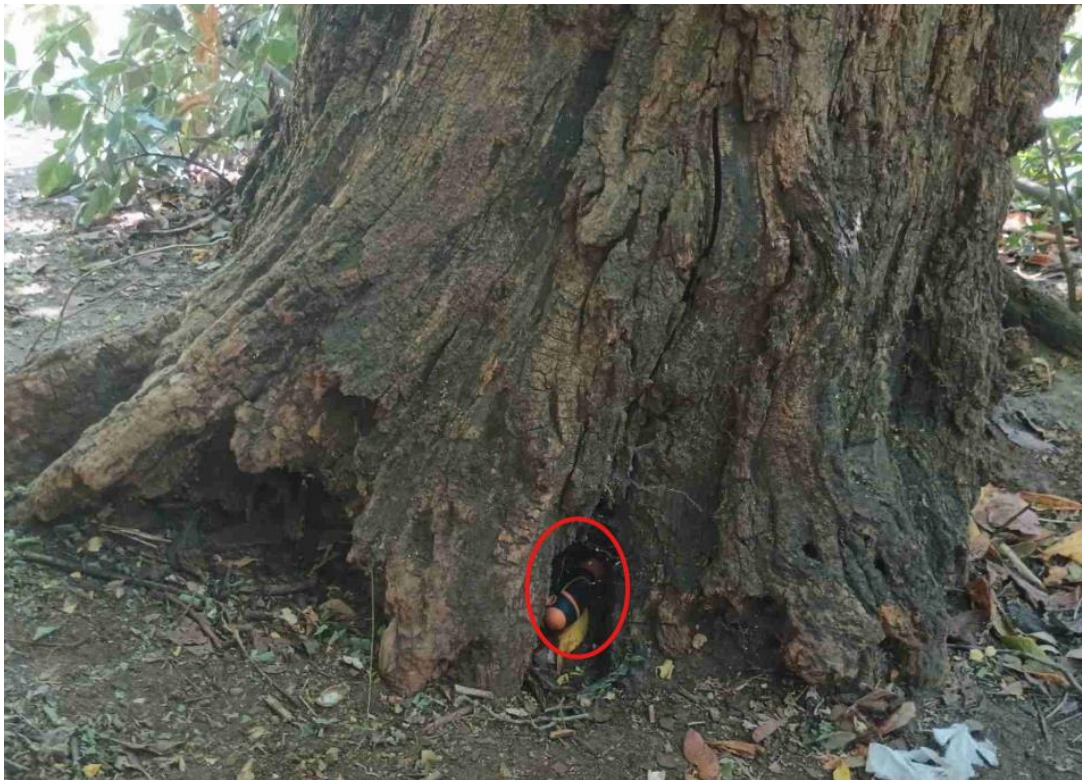
Image shows prob in cavity at base of trunk circled.

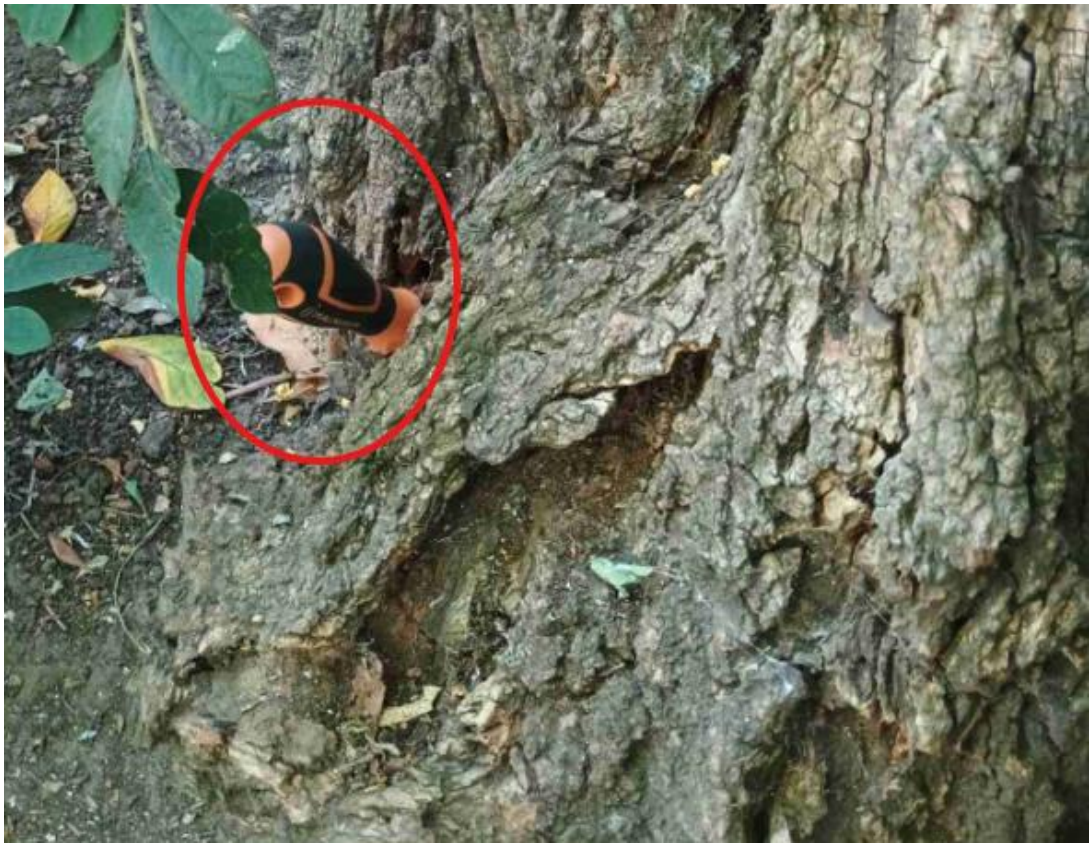
Image shows prob in cavity at base of trunk circled.

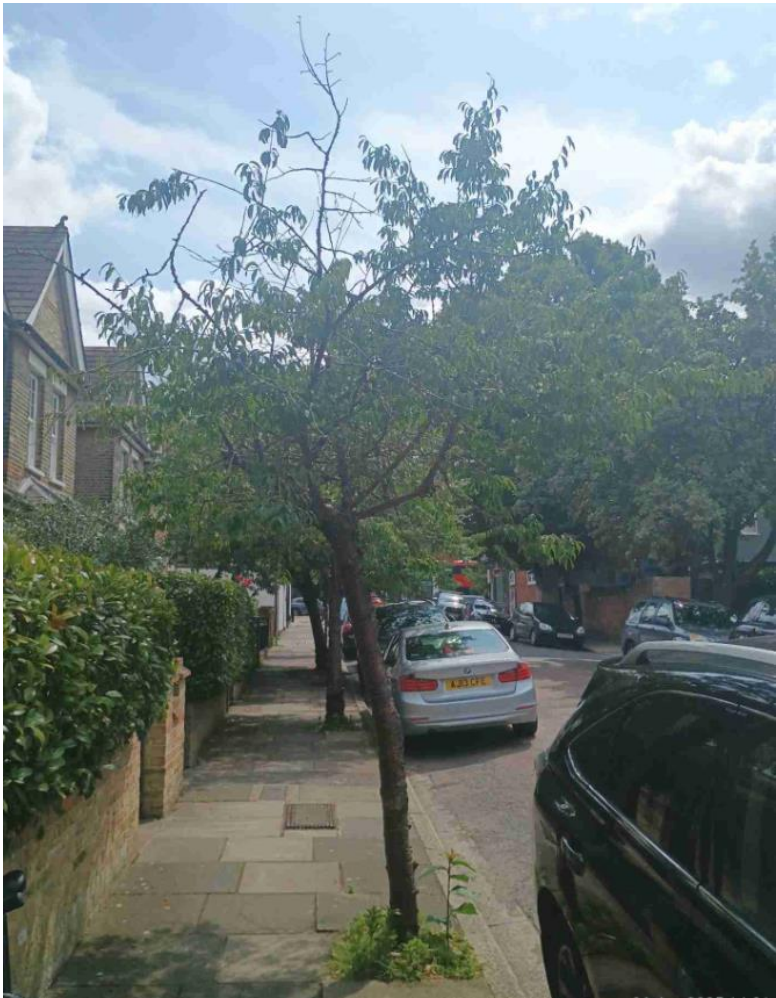
Ward	North Richmond
Road	Carlton Road
Location	Outside 8
Species	Tibetan cherry (<i>Prunus serrula</i>)
Height	5.0m
Physiological Condition	Poor
Structural Condition	Poor
Inspection findings/reason for exemption	A fungal fruiting body of the decay fungus <i>Ganoderma sp.</i> is present on the trunk above a historic bark wound caused by a vehicle strike. Colonisation by this fungus results in white rot affecting the stem and root system, which can lead to structural failure through fracture or windthrow. Crown dieback is evident and correlates with the presence of the decay fungi. Removal is required to prevent natural failure, manage risk, and facilitate replanting.

Image shows tree in street scene.

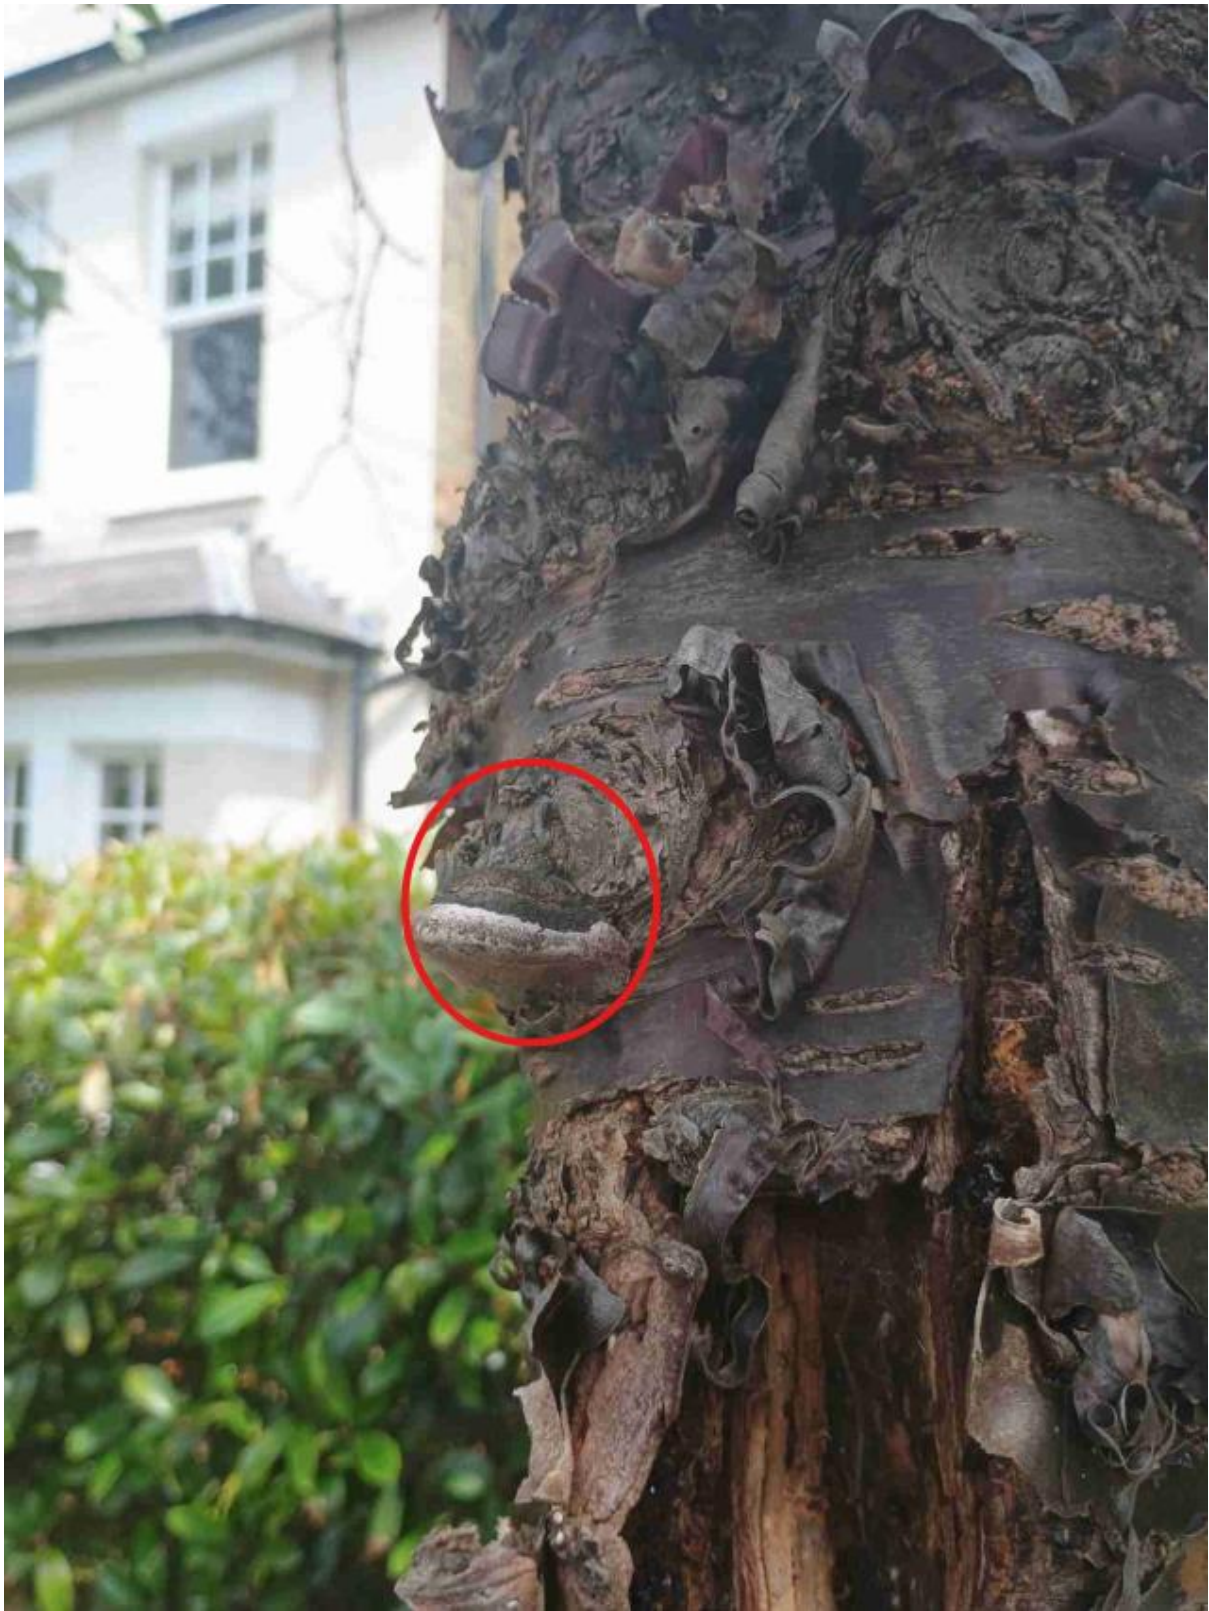
Image shows fungal fruiting bodies circled in red.

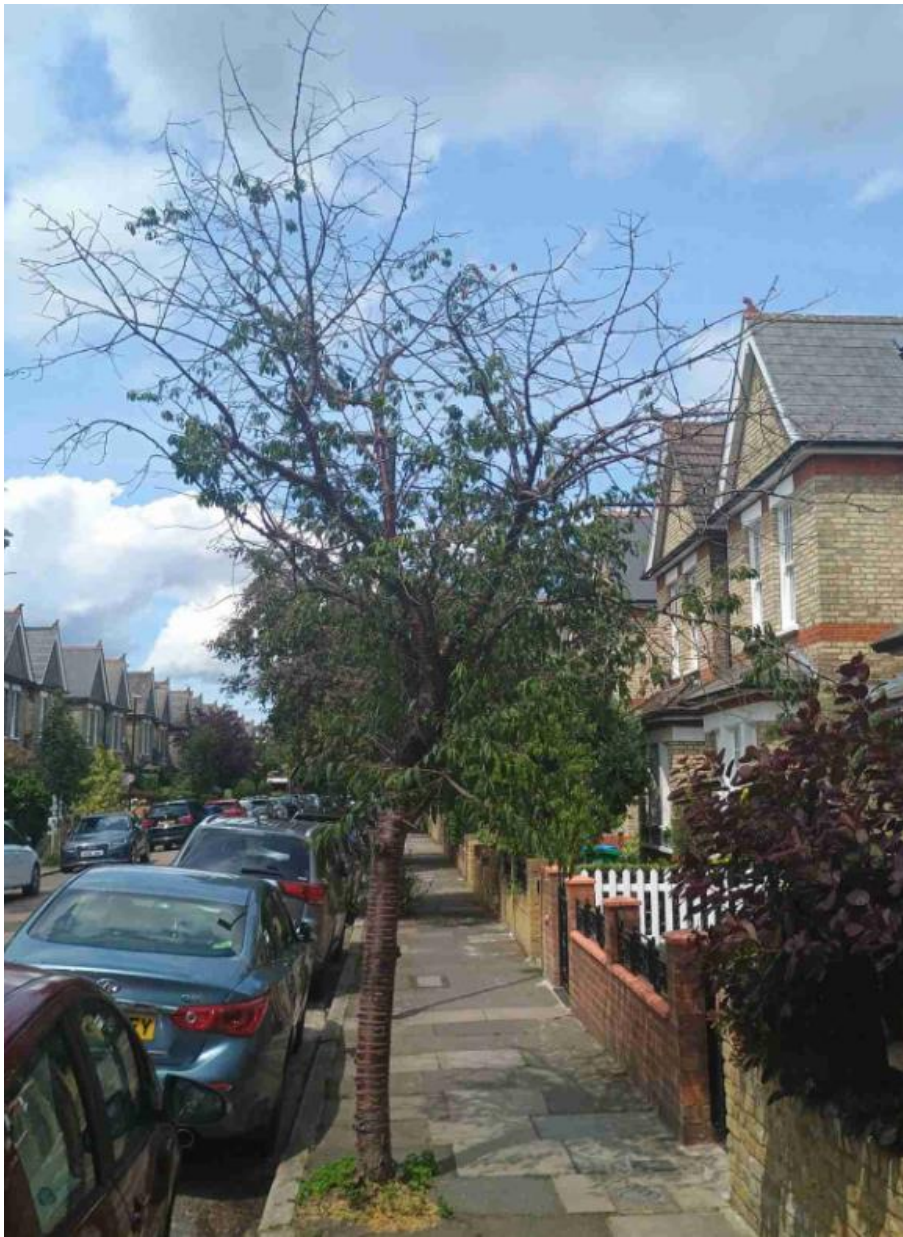
Ward	North Richmond
Road	Carlton Road
Location	Outside 12/14
Species	Tibetan cherry (<i>Prunus serrula</i>)
Height	6.0m
Physiological Condition	Poor
Structural Condition	Fair
Inspection findings/reason for exemption	This tree is moribund with over 50% of the crown being dead; removal is required to prevent natural failure, manage risk, and facilitate replanting

Image shows moribund tree in street scene.

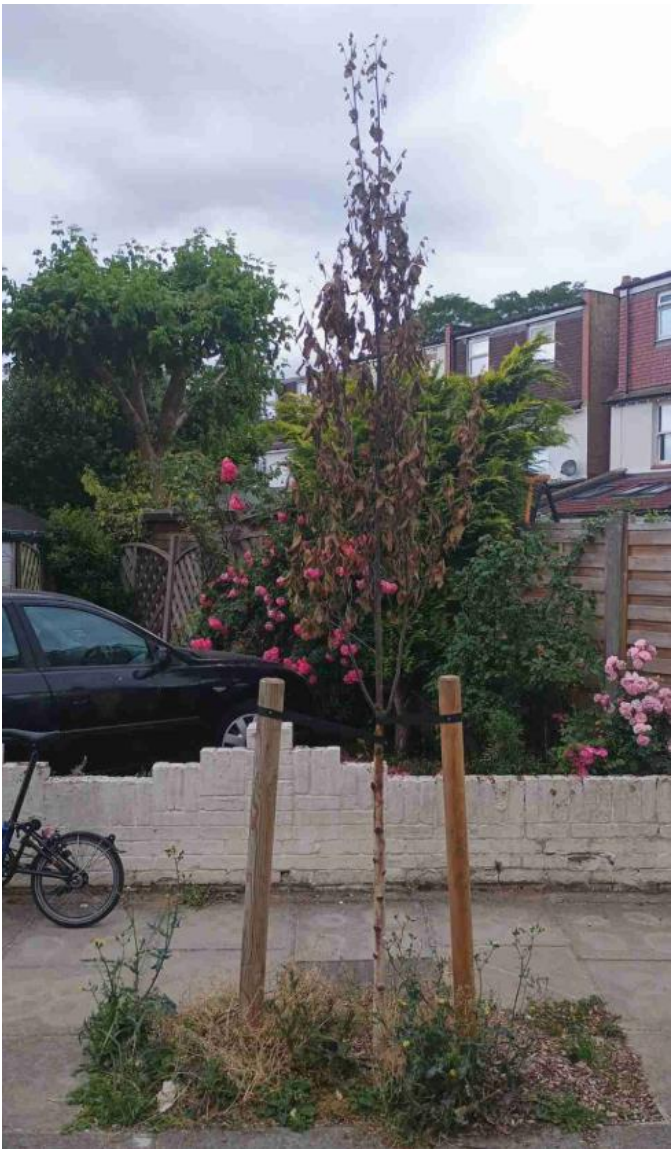
Ward	North Richmond
Road	Graemesdyke Avenue
Location	Outside 2
Species	Birch (<i>Betula sp.</i>)
Height	4.0m
Physiological Condition	Dead
Structural Condition	Dead
Inspection findings/reason for exemption	This tree is dead; removal is required to prevent natural failure, manage risk, and facilitate replanting

Image shows dead tree in street scene.

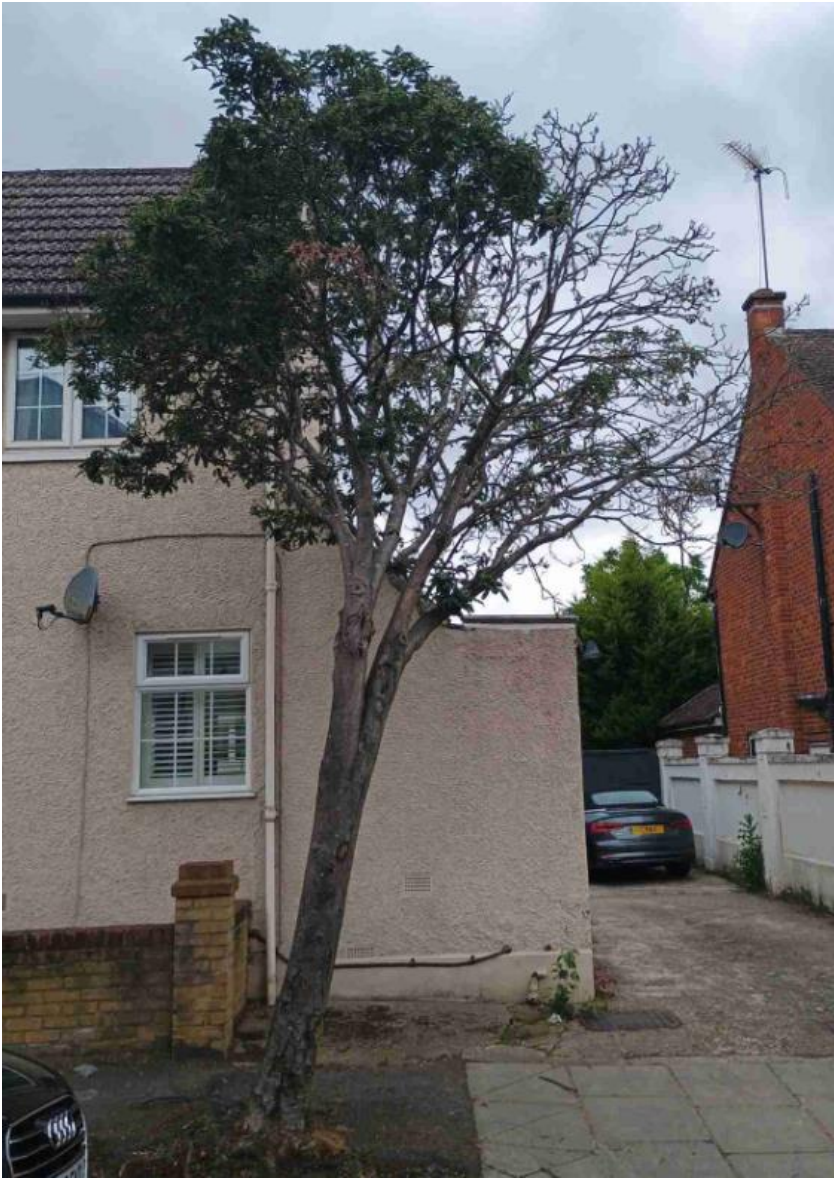
Ward	North Richmond
Road	Graemesdyke Avenue
Location	Outside 54
Species	Swedish whitebeam (<i>Sorbus x intermedia</i>)
Height	6.0m
Physiological Condition	Poor
Structural Condition	Fair
Inspection findings/reason for exemption	This tree is moribund with over 50% of the crown being dead; removal is required to prevent natural failure, manage risk, and facilitate replanting.

Image shows moribund tree in street scene.

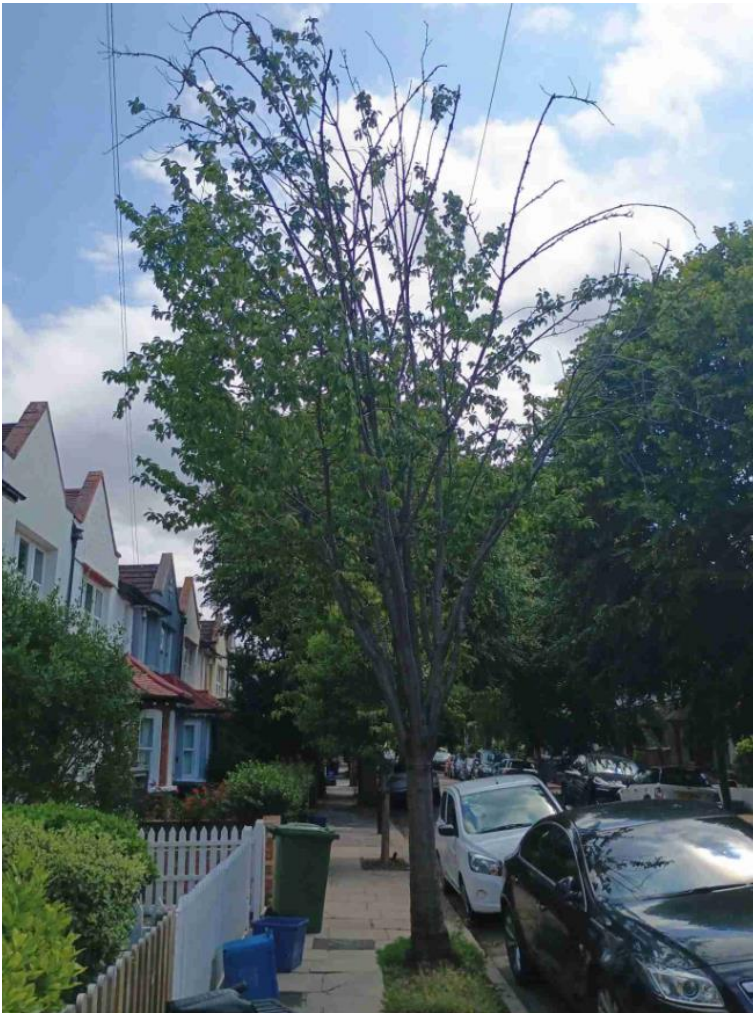
Ward	North Richmond
Road	Graemesdyke Avenue
Location	Outside 23
Species	Wild cherry (<i>Prunus avium</i>)
Height	9.0m
Physiological Condition	Poor
Structural Condition	Poor
Inspection findings/reason for exemption	A fungal fruiting body of the decay fungus <i>Ganoderma sp.</i> is present at the base of the trunk. Colonisation by this fungus results in white rot affecting the stem and root system, which can lead to structural failure through fracture or windthrow. Crown dieback is evident and correlates with the presence of the decay fungi. Removal is required to prevent natural failure, manage risk, and facilitate replanting.

Image shows moribund tree in street scene.

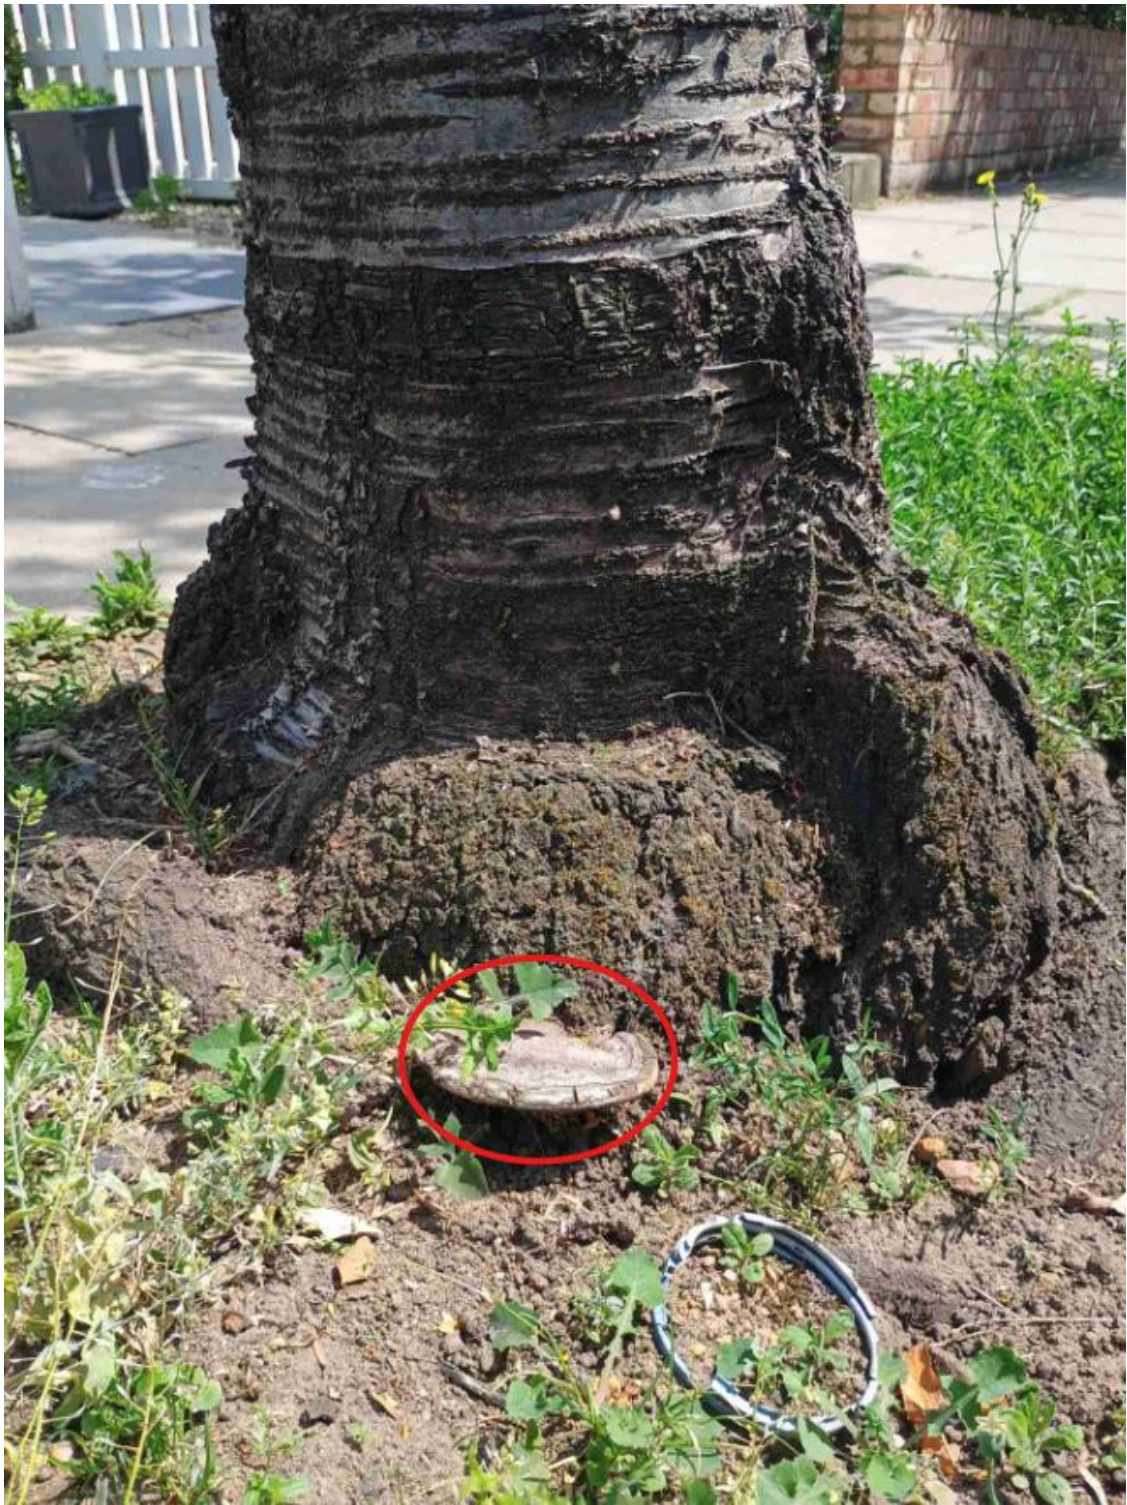
Image shows fungal fruiting body circled.

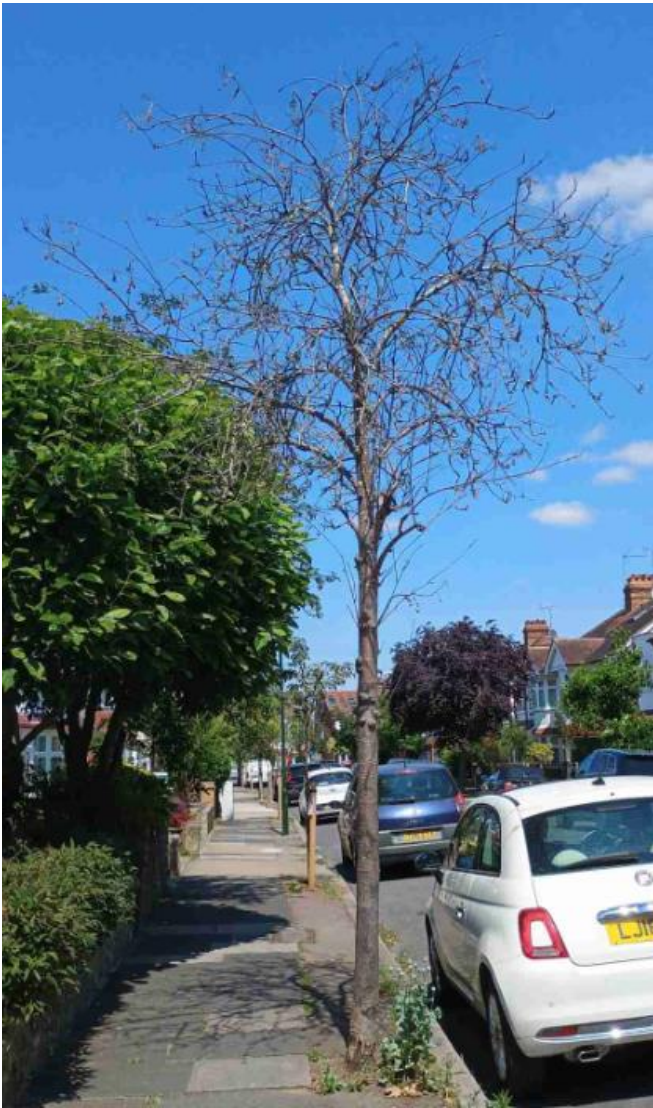
Ward	North Richmond
Road	Denehurst Gardens
Location	Outside 17
Species	Rowan (<i>Sorbus aucuparia</i>)
Height	6.5m
Physiological Condition	Dead
Structural Condition	Dead
Inspection findings/reason for exemption	This tree is dead; removal is required to prevent natural failure, manage risk, and facilitate replanting

Image shows dead tree in street scene.

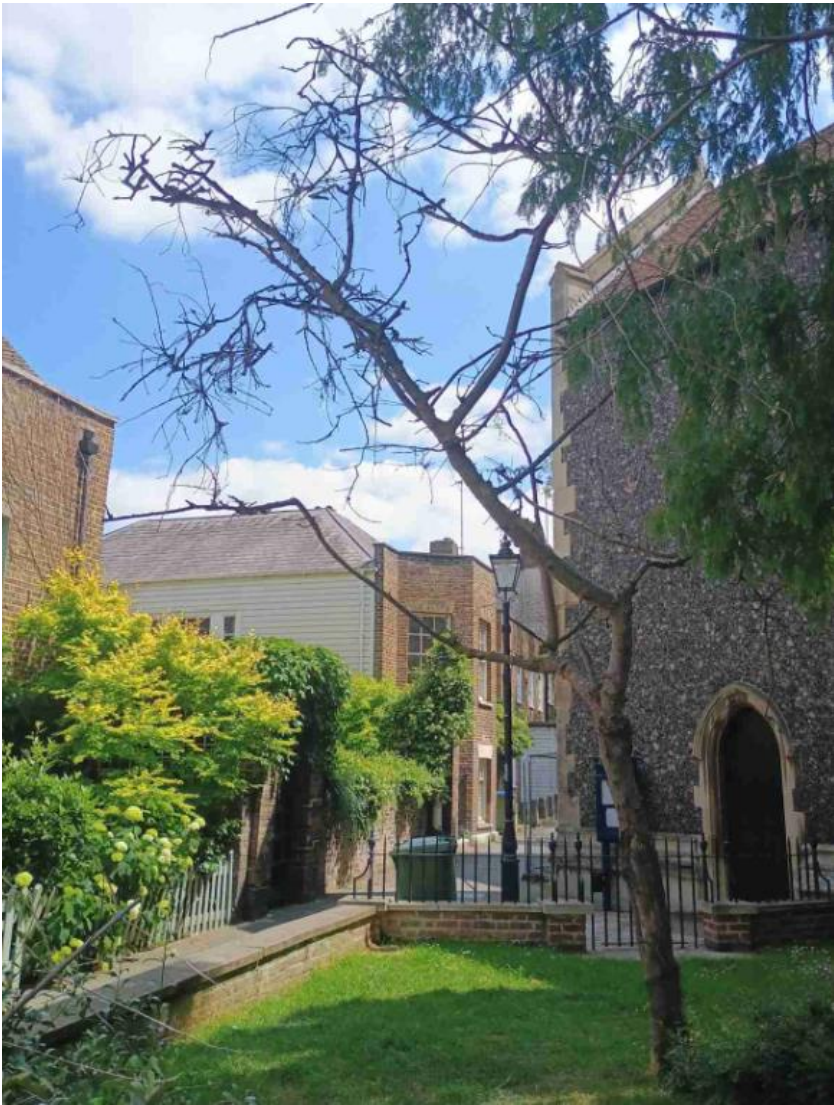
Ward	South Richmond
Road	Paradise Road
Location	St Mary Magdalene church ///like.cabin.quarrel
Species	Cherry (<i>Prunus</i> sp.)
Height	6.0m
Physiological Condition	Dead
Structural Condition	Dead
Inspection findings/reason for exemption	This tree is dead; removal is required to prevent natural failure, manage risk, and facilitate replanting

Image shows dead tree in church scene.
