July 2025 - Reactive Tree Works Programme

Introduction

A survey of trees in the North Richmond ward is currently being undertaken; this is being conducted by specialist arboricultural officers as part of the scheduled 4 yearly detailed inspection regime that has been devised for all Council highway and parks trees.

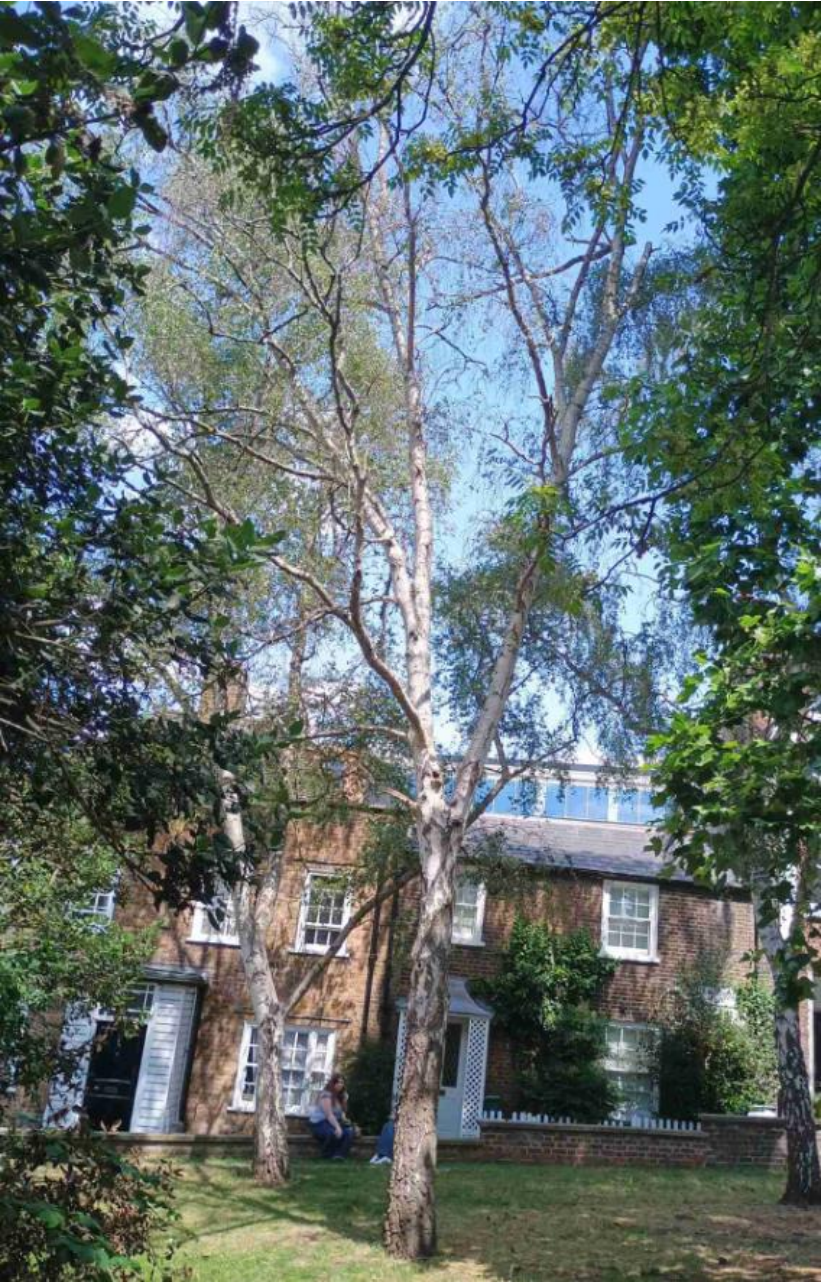
Ward	South Richmond
Road	Paradise Road
Location	St Mary Magdalene church ///defeat.fines.anyone
Species	Birch (<i>Betula</i> sp.)
Height	10.0m
Physiological Condition	Poor
Structural Condition	Fair
Inspection findings/reason for exemption	This tree is moribund; removal is required to prevent natural failure, manage risk, and facilitate replanting

Image shows moribund tree in church scene.

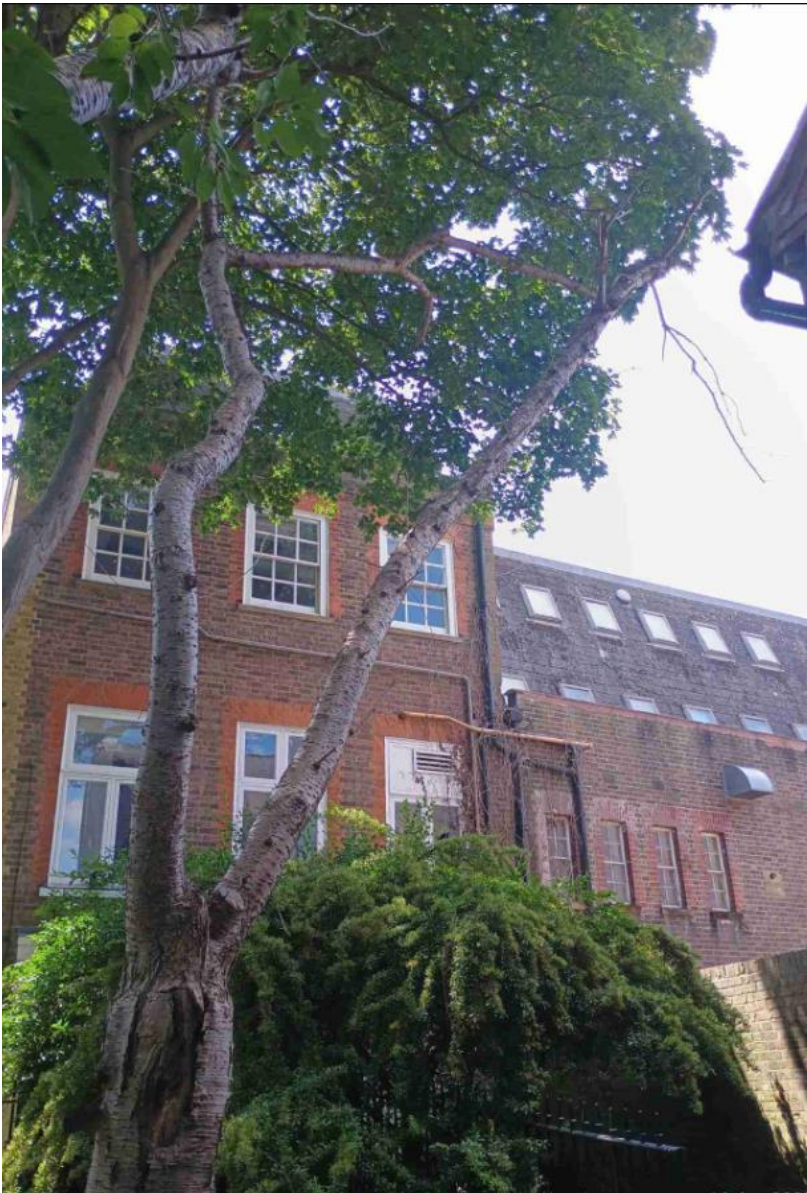
Ward	South Richmond
Road	Paradise Road
Location	St Mary Magdalene church /// mount.lift.shaky
Species	Cherry (<i>Prunus</i> sp.)
Height	6.0m
Physiological Condition	Dead
Structural Condition	Dead
Inspection findings/reason for exemption	This tree is dead; removal is required to prevent natural failure, manage risk, and facilitate replanting

Image shows dead tree in church scene.

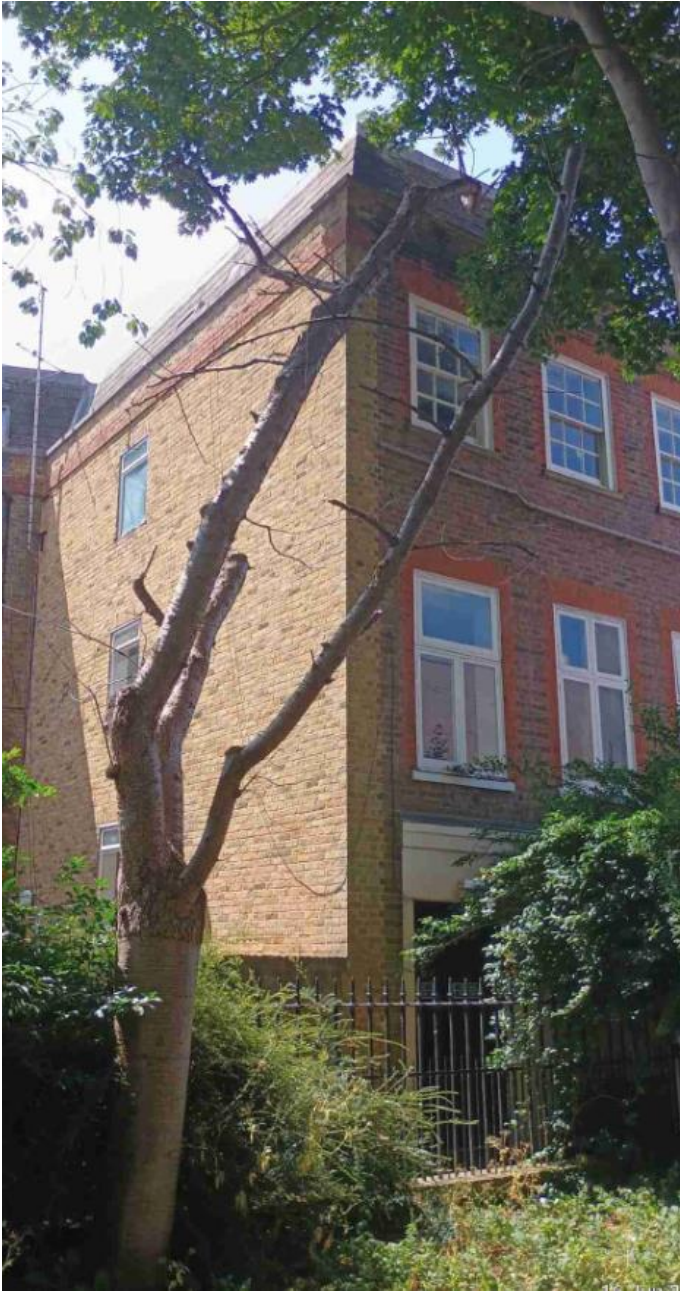
Ward	South Richmond
Road	Paradise Road
Location	St Mary Magdalene church /// orbit.income.grin
Species	Cherry (<i>Prunus</i> sp.)
Height	6.0m
Physiological Condition	Dead
Structural Condition	Dead
Inspection findings/reason for exemption	This tree is dead; removal is required to prevent natural failure, manage risk, and facilitate replanting

Image shows dead tree in church scene.

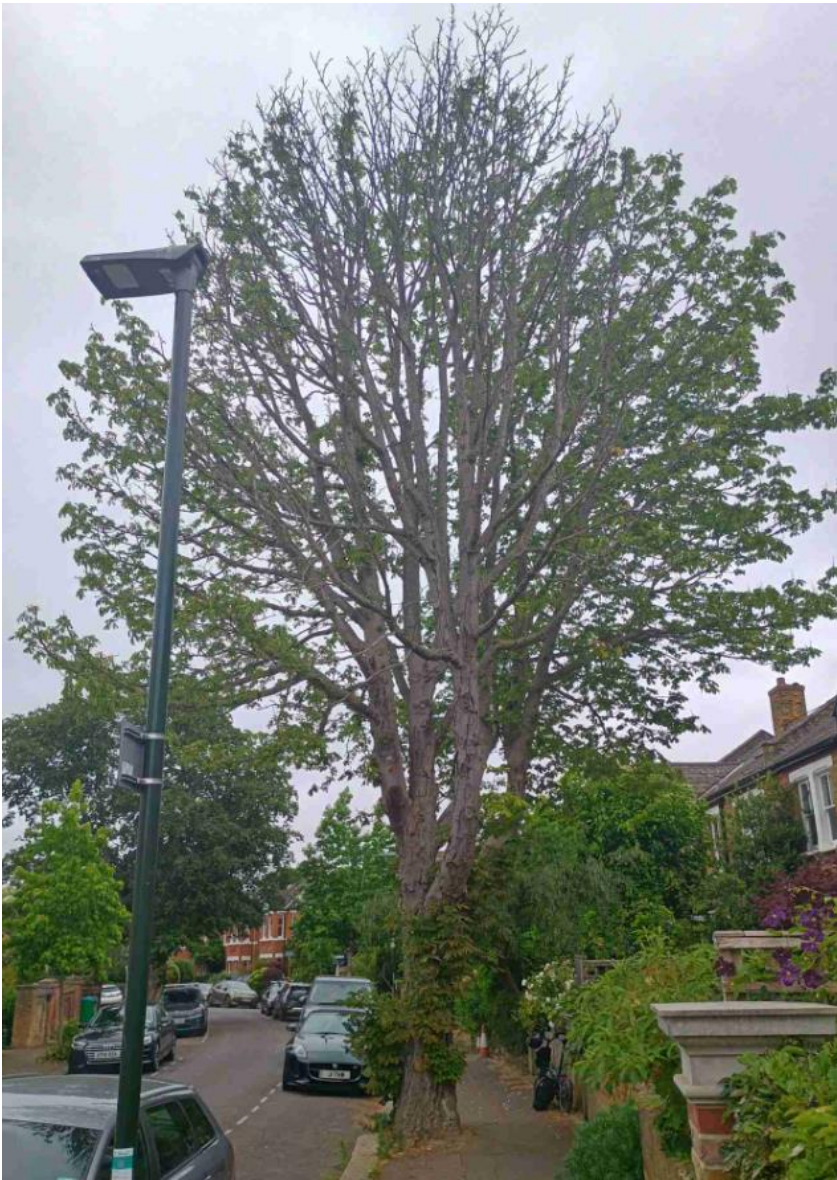
Ward	Teddington
Road	Clarence Road
Location	Outside 51
Species	Horse chestnut (<i>Aesculus hippocastanum</i>)
Height	16.0m
Physiological Condition	Poor
Structural Condition	Fair
Inspection findings/reason for exemption	This tree is moribund with over 50% of the crown being dead; removal is required to prevent natural failure, manage risk and facilitate replanting

Image shows moribund tree in street scene.

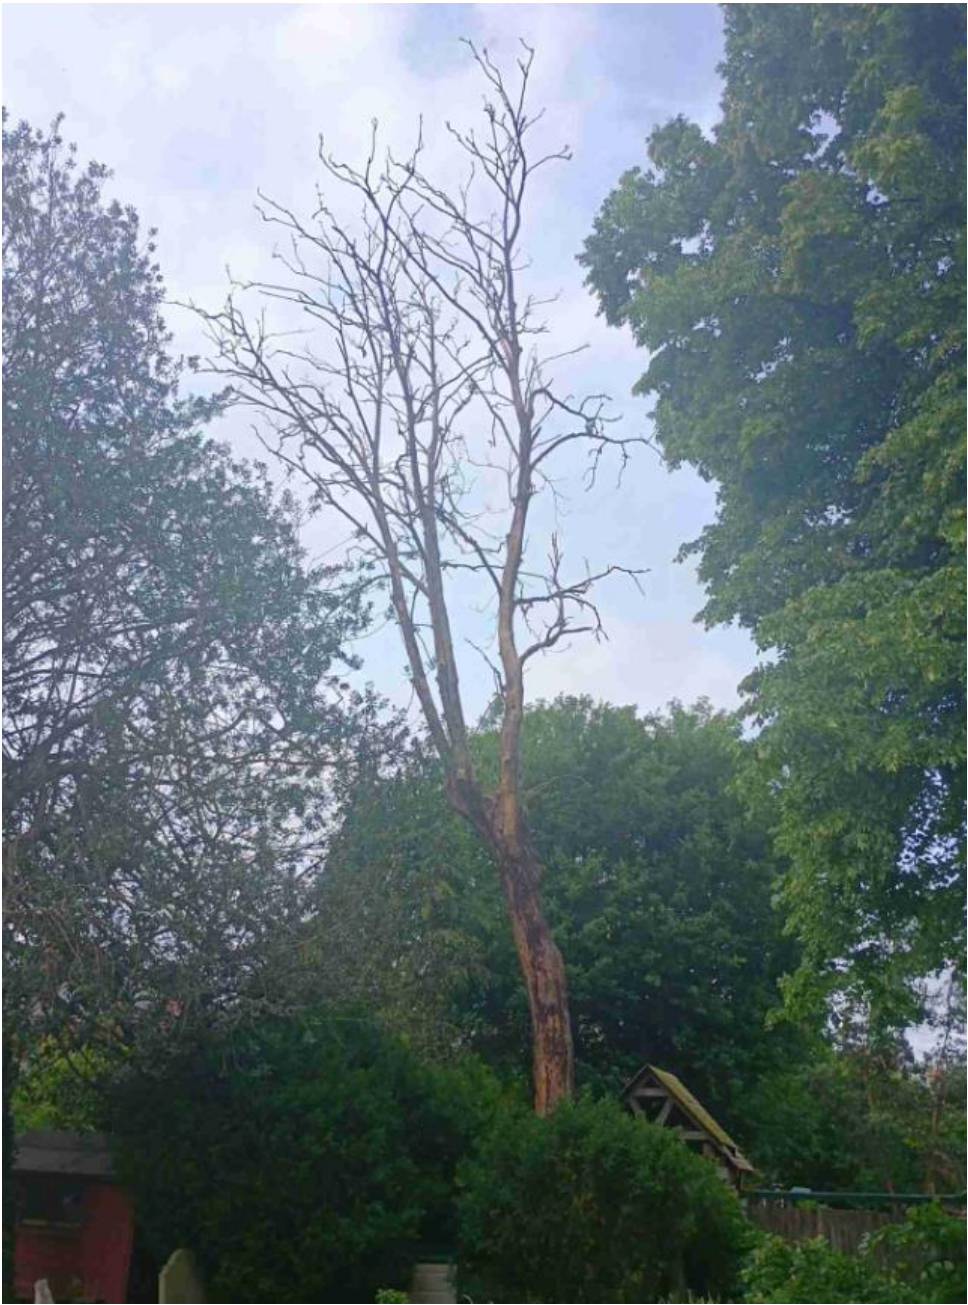
Ward	Teddington
Road	Ferry Road
Location	St. Marys Church- ///seats.salt.email
Species	Sycamore (<i>Acer pseudoplatanus</i>)
Height	17.0m
Physiological Condition	Dead
Structural Condition	Dead
Inspection findings/reason for exemption	This tree is dead; removal is required to prevent natural failure and manage risk.

Image shows dead tree in churchyard scene.

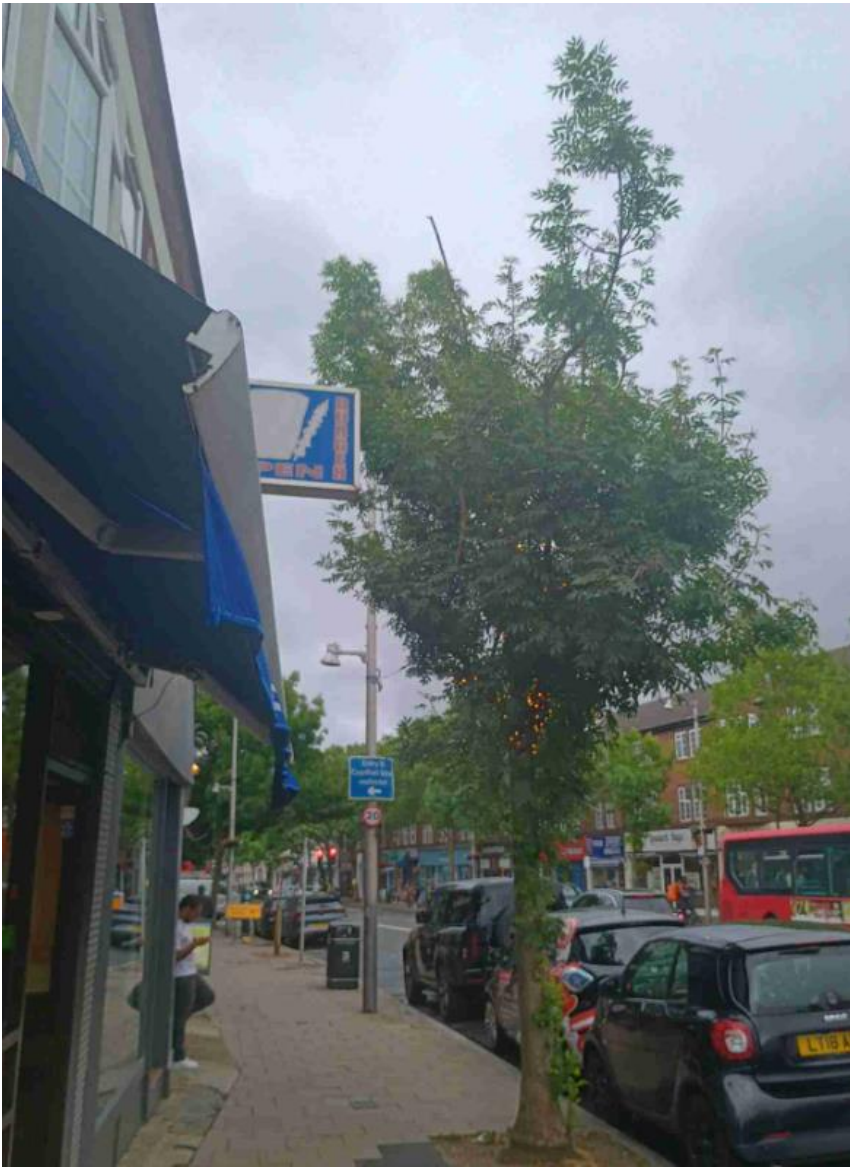
Ward	Twickenham Riverside
Road	Heath Road
Location	Outside 58
Species	Ash (<i>Fraxinus sp.</i>)
Height	7.5m
Physiological Condition	Poor
Structural Condition	Fair
Inspection findings/reason for exemption	This tree is moribund with over 40% of the crown being dead; removal is required to prevent natural failure, manage risk and facilitate replanting

Image shows moribund tree in street scene

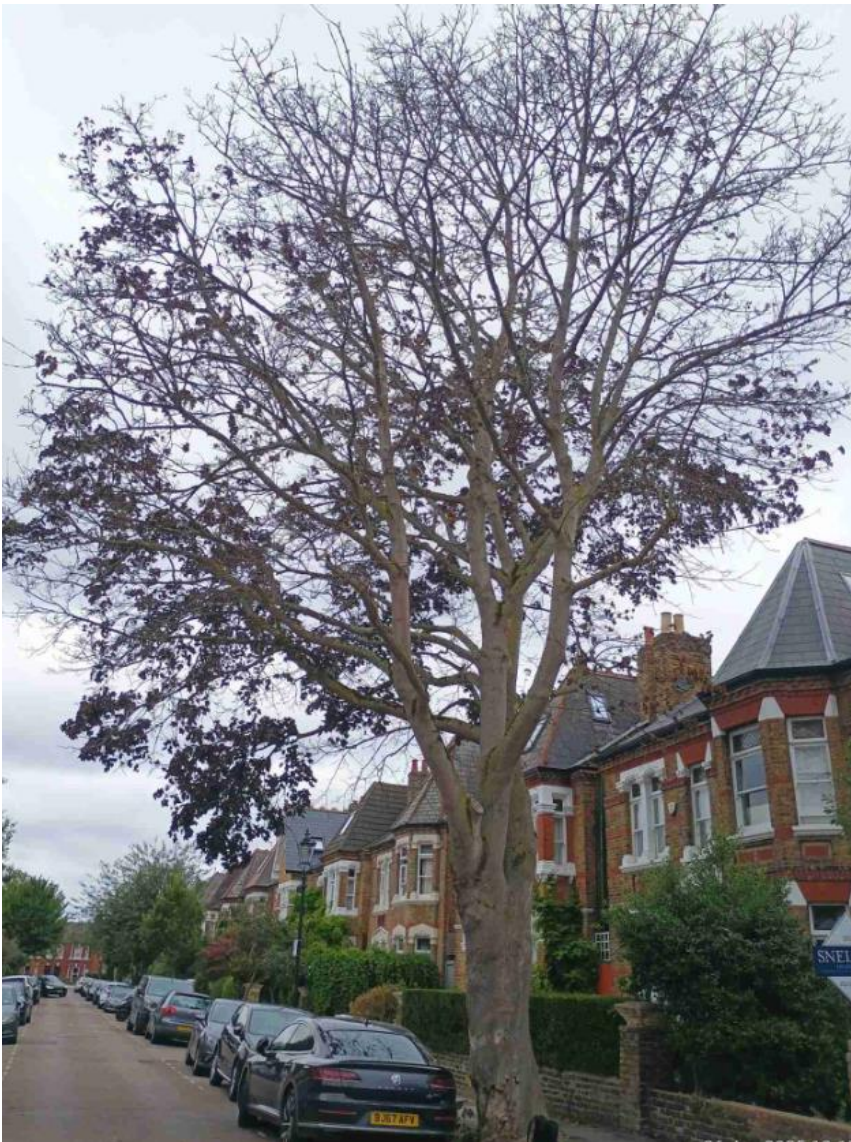
Ward	Twickenham Riverside
Road	Claremont Road
Location	Outside 19/21
Species	Norway maple (<i>Acer platanoides</i>)
Height	16.0m
Physiological Condition	Poor
Structural Condition	Fair
Inspection findings/reason for exemption	This tree is moribund with over 60% of the crown being dead; removal is required to prevent natural failure, manage risk and facilitate replanting

Image shows moribund tree in street scene

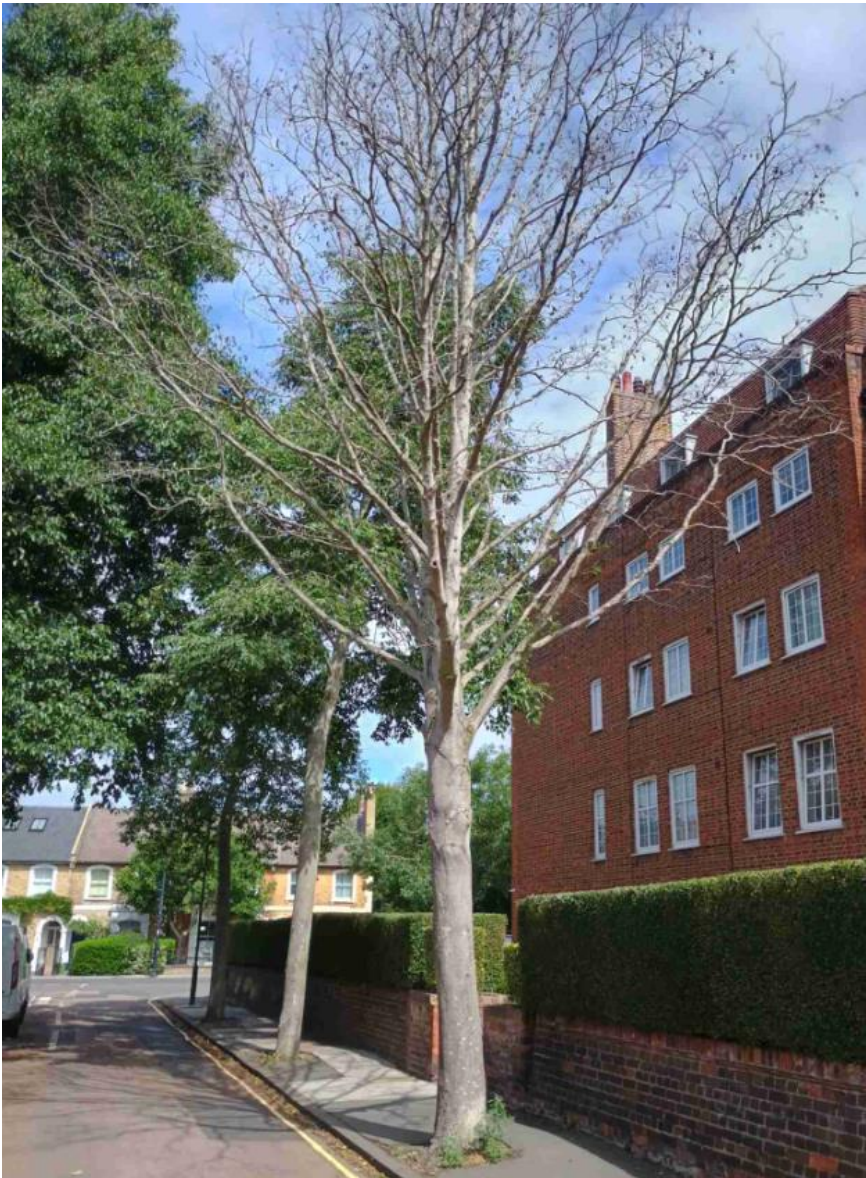
Ward	Twickenham Riverside
Road	Sion Road
Location	Outside Lebanon Court- /// frames.sports.direct
Species	Black alder (<i>Alnus glutinosa</i>)
Height	12.0m
Physiological Condition	Dead
Structural Condition	Dead
Inspection findings/reason for exemption	This tree is dead; removal is required to prevent natural failure, manage risk and facilitate replanting

Image shows dead tree in street scene

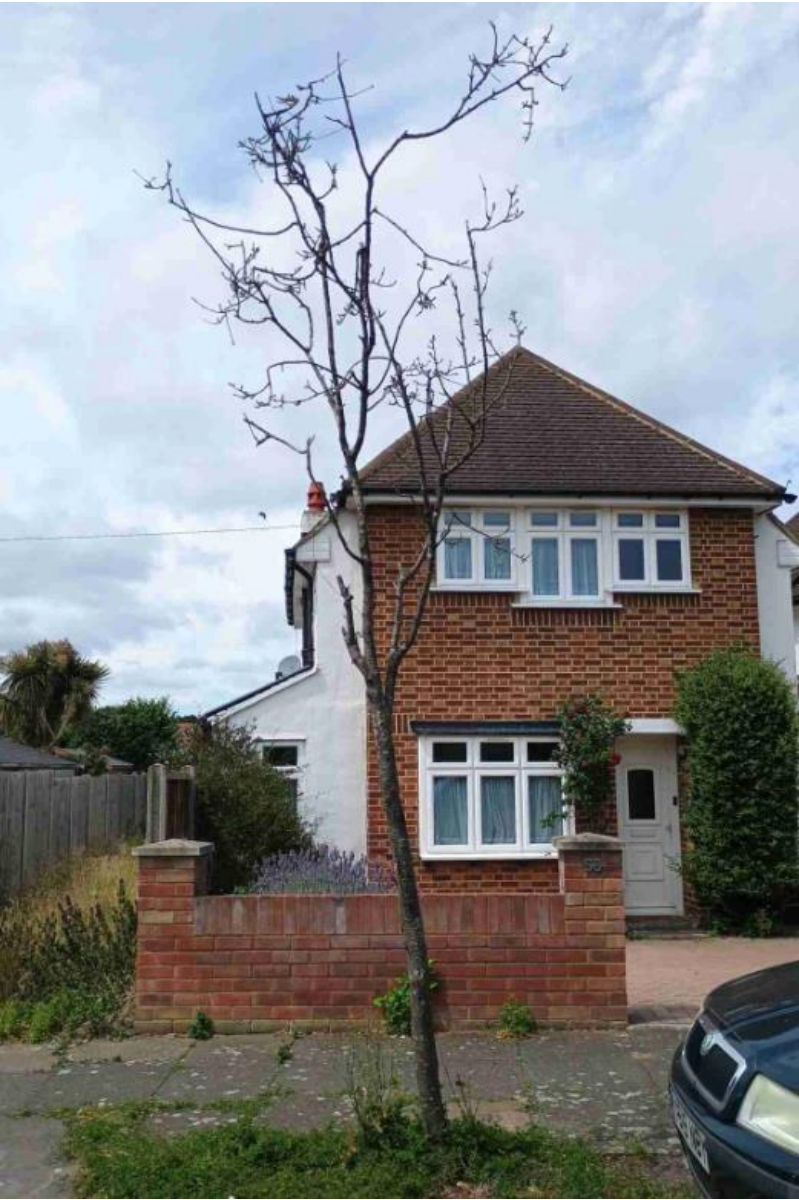
Ward	Whitton
Road	Hazel Close
Location	Outside 68
Species	Cherry (<i>Prunus sp.</i>)
Height	5.0m
Physiological Condition	Dead
Structural Condition	Dead
Inspection findings/reason for exemption	This tree is dead; removal is required to prevent natural failure, manage risk, and facilitate replanting

Image shows dead tree in street scene.

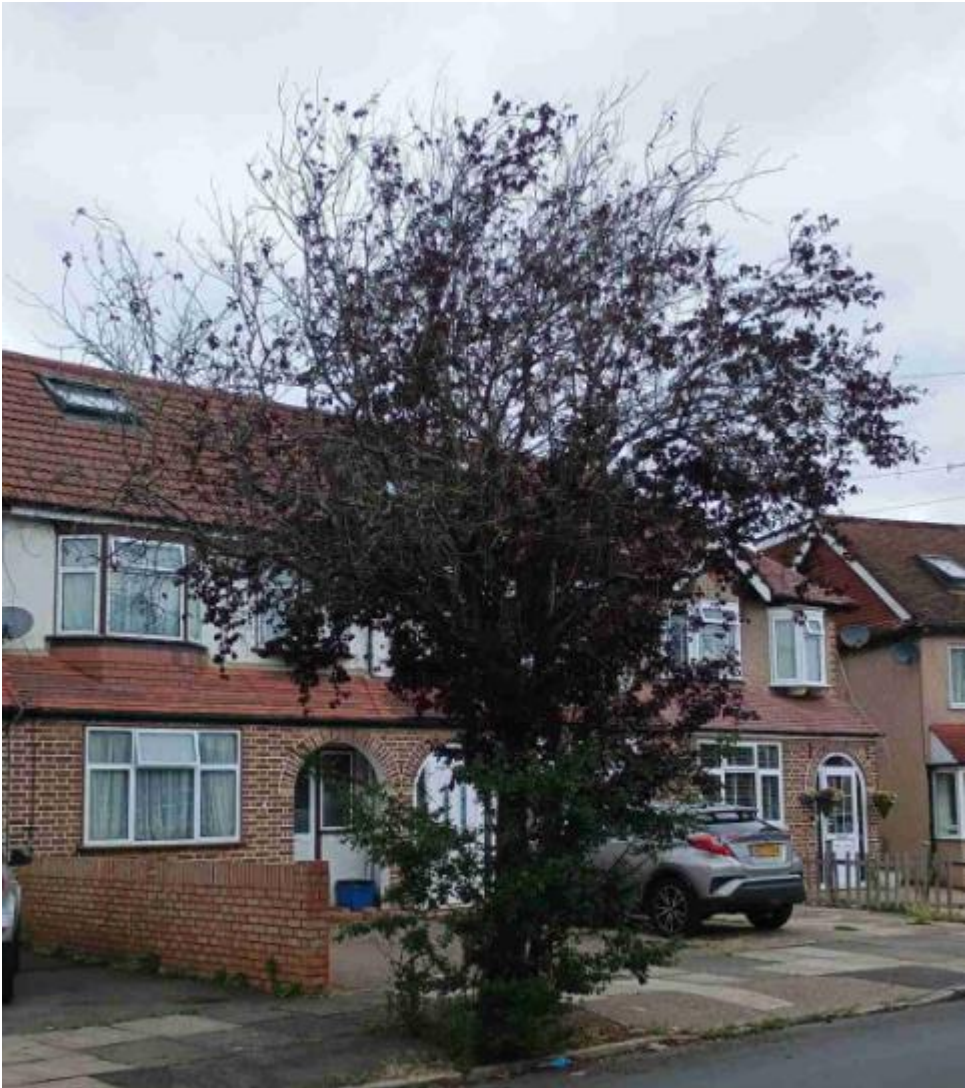
Ward	Whitton
Road	Grasmere Avenue
Location	Outside 42/44
Species	Cherry plum (<i>Prunus cerasifera</i>)
Height	6.5m
Physiological Condition	Poor
Structural Condition	Fair
Inspection findings/reason for exemption	Fruiting bodies of the cushion fungus (<i>Phellinus pomaceus</i>) are present on the main stem of this tree. This fungus causes a crumbly white rot, which commonly leads to stem failure in this species. Dieback in the crown correlates with the presence of the pathogen on the trunk. Removal is required to prevent natural failure, manage risk, and facilitate replanting

Image shows tree in street scene.

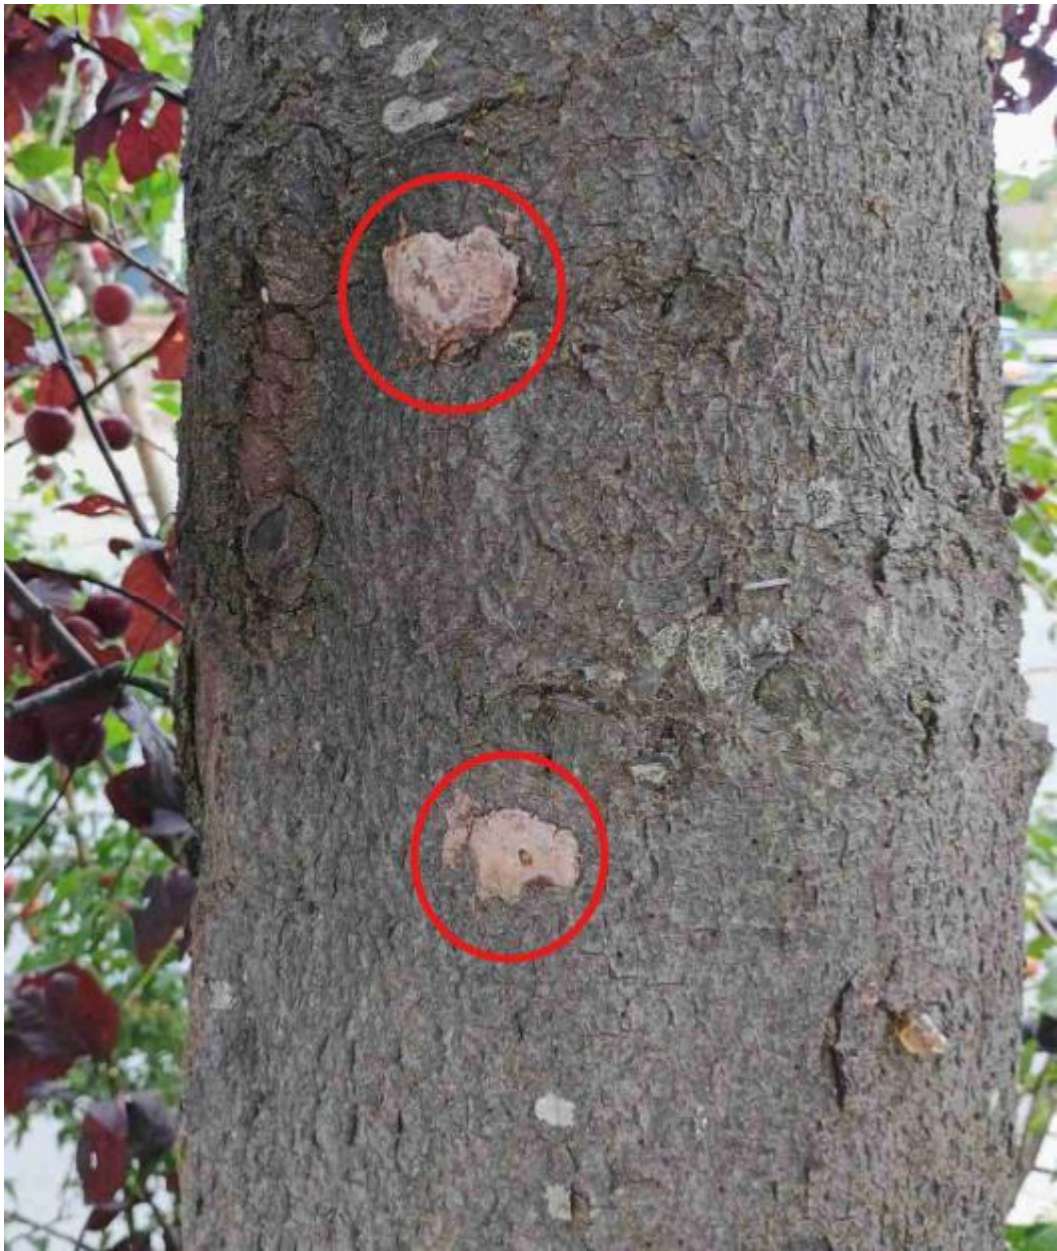
Image shows fruiting bodies circled on trunk.
