# June 2026 Highways Reactive Tree Works Programme

A survey of the Highway trees in the ward of Hampton North has been undertaken; this was conducted by specialist arboricultural officers as part of the scheduled 4 yearly detailed inspection regime that has been devised for all Council highway and parks trees.

Recent reactive inspections have identified the need for 33 individual tree work operations to take place. This work will now be issued to the Council’s arborist contractor KPS, for completion over the summer period.

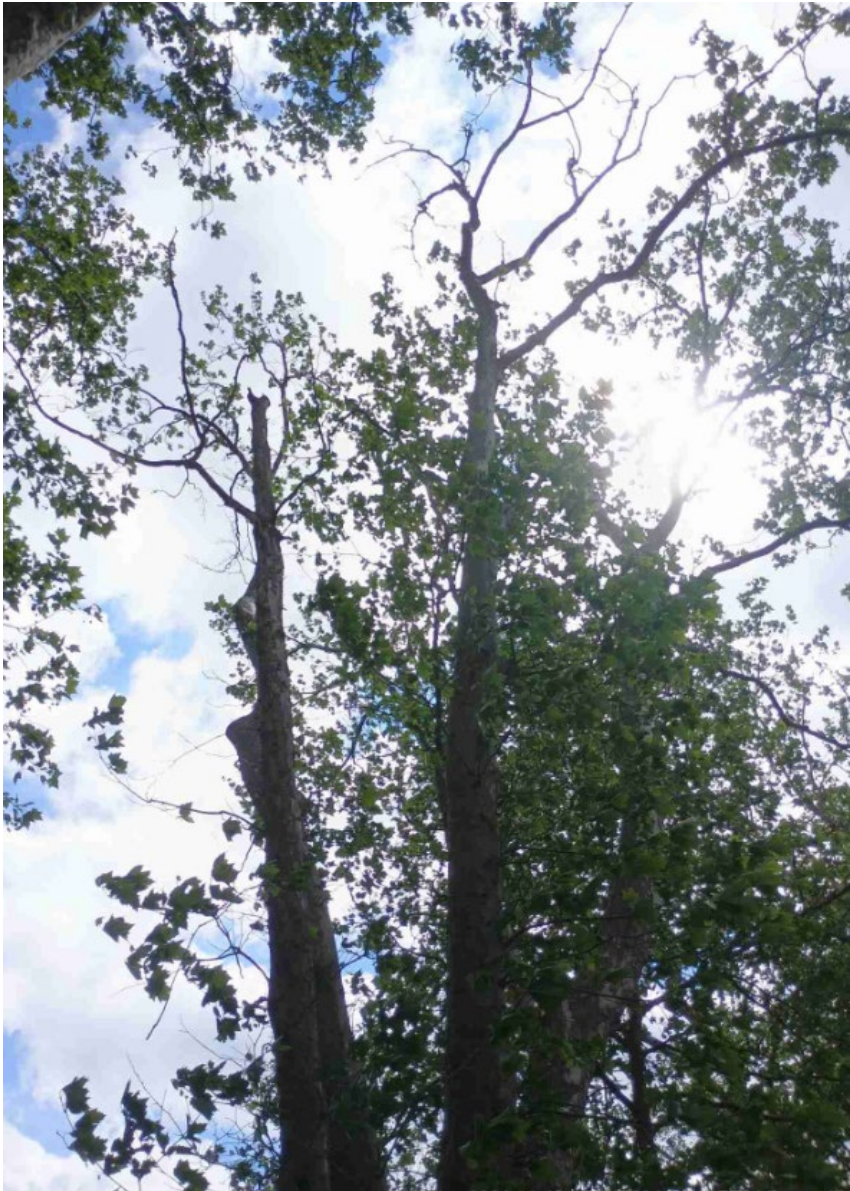
| Location | Opposite 41/42- ///smoke.royal.asleep |

| Inspection findings/reason for exemption | This tree is moribund; removal is required to prevent natural failure, manage risk, and facilitate replanting |

Image shows moribund tree in street scene

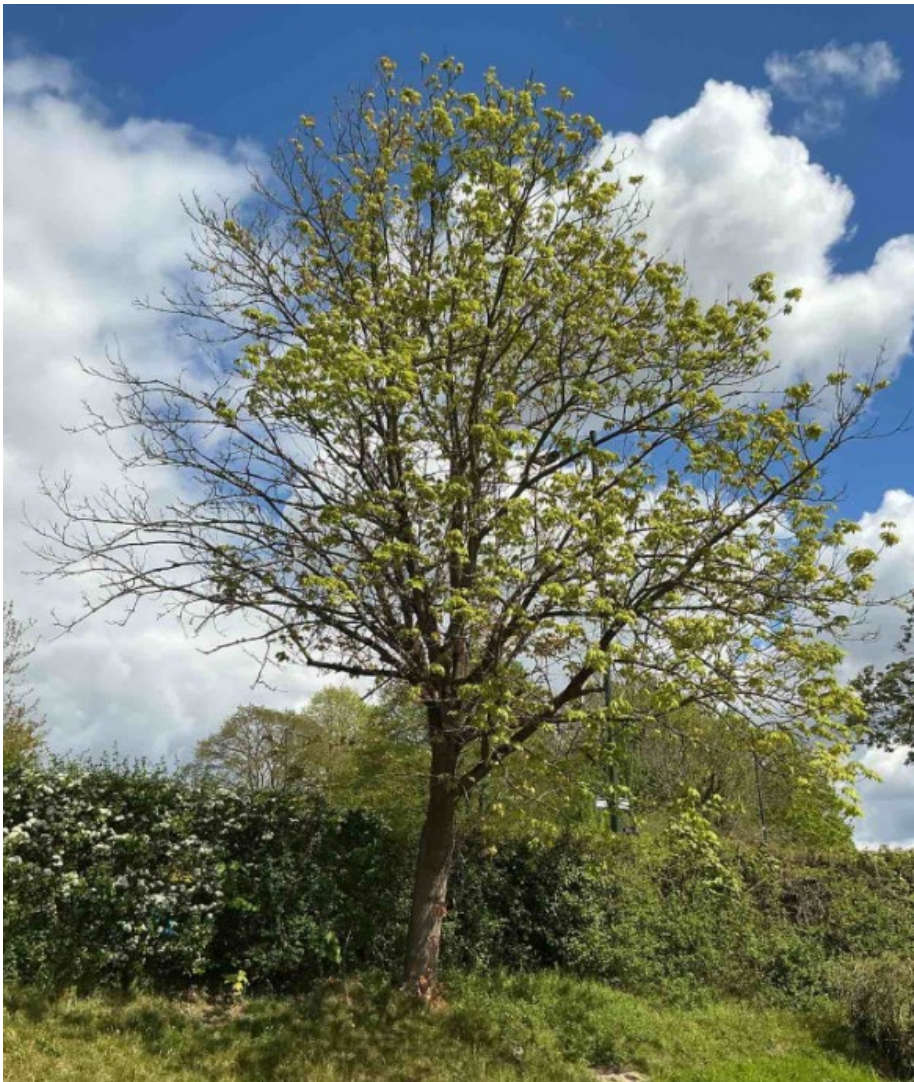
| Location | Opposite 1 side garden |

| Inspection findings/reason for exemption | This tree is moribund; removal is required to prevent natural failure, manage risk, and facilitate replanting |

Images show moribund tree in street scene.

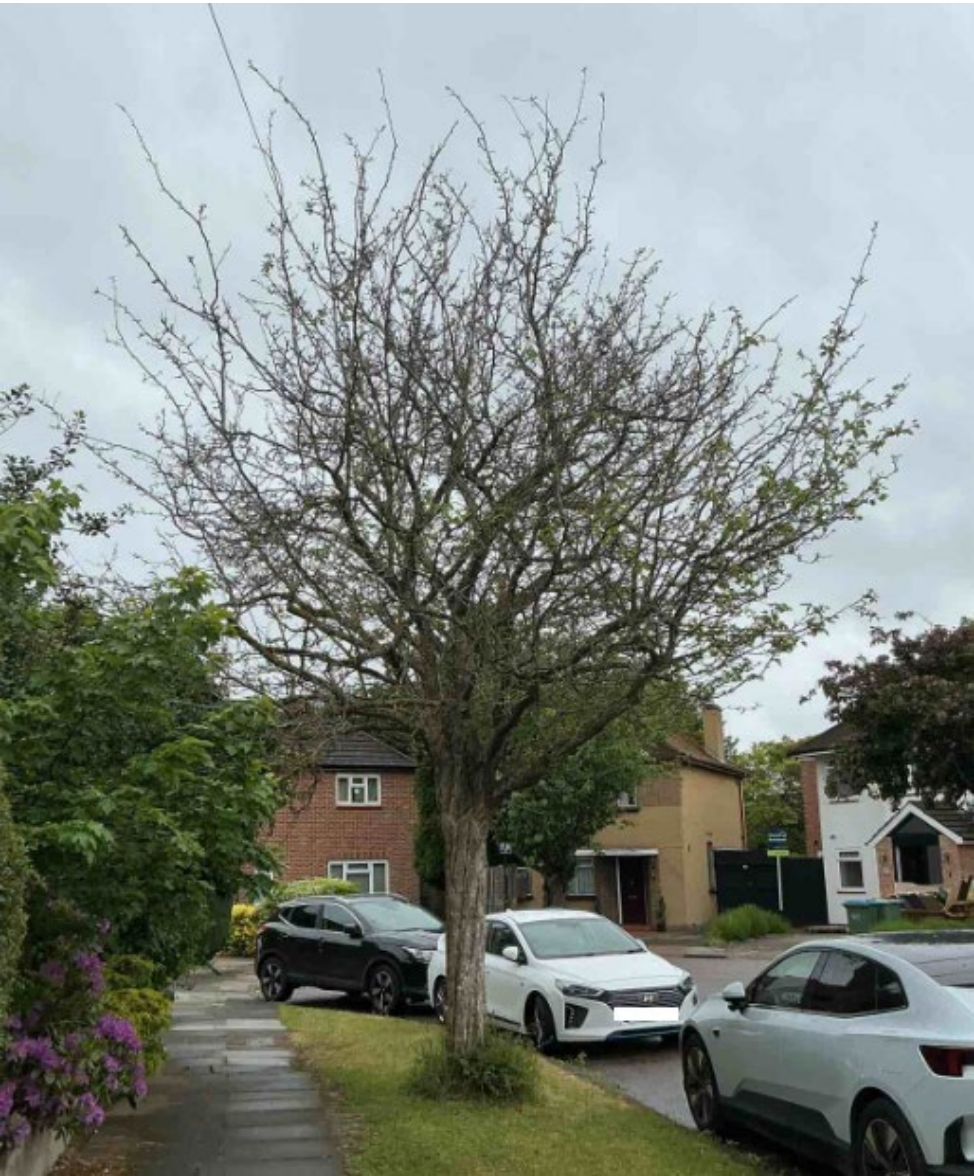
| Location | Outside 37-39 |

| Inspection findings/reason for exemption | This tree is moribund; removal is required to prevent natural failure, manage risk, and facilitate replanting |

Image shows moribund tree in street scene.

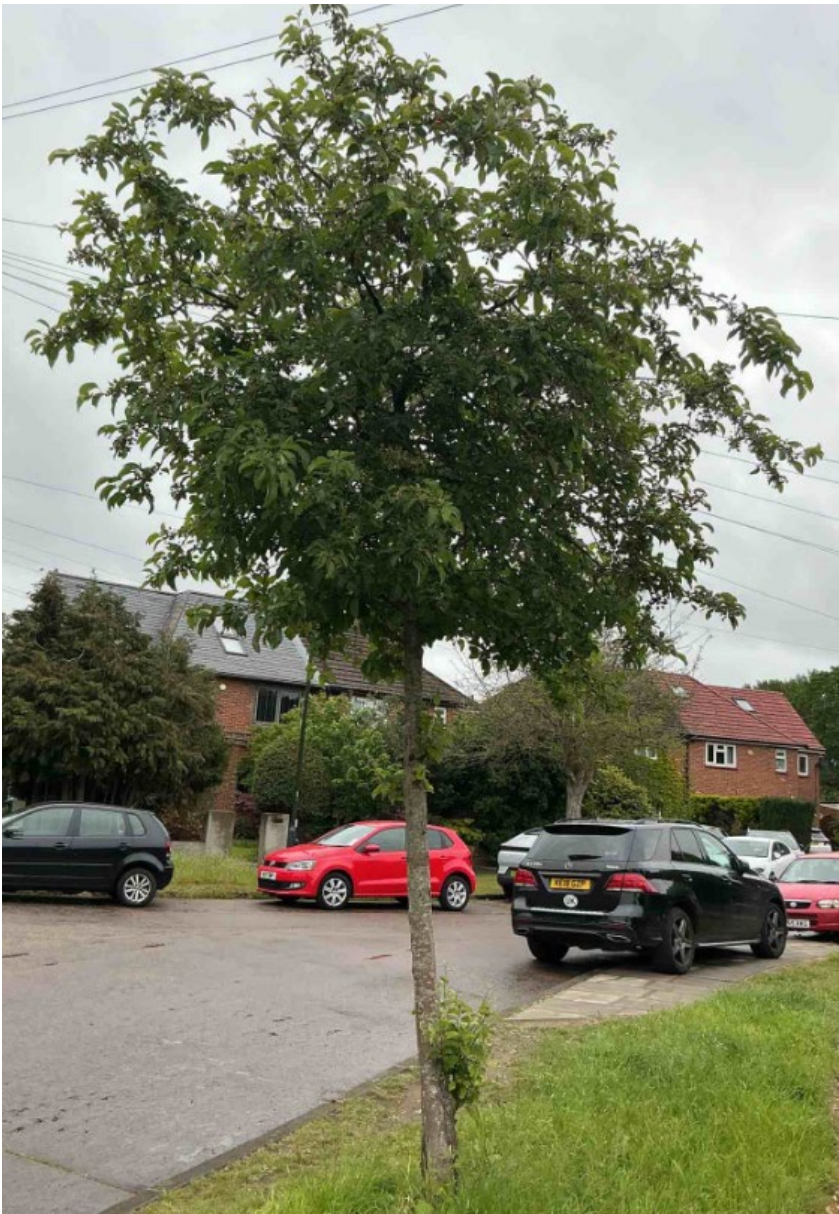
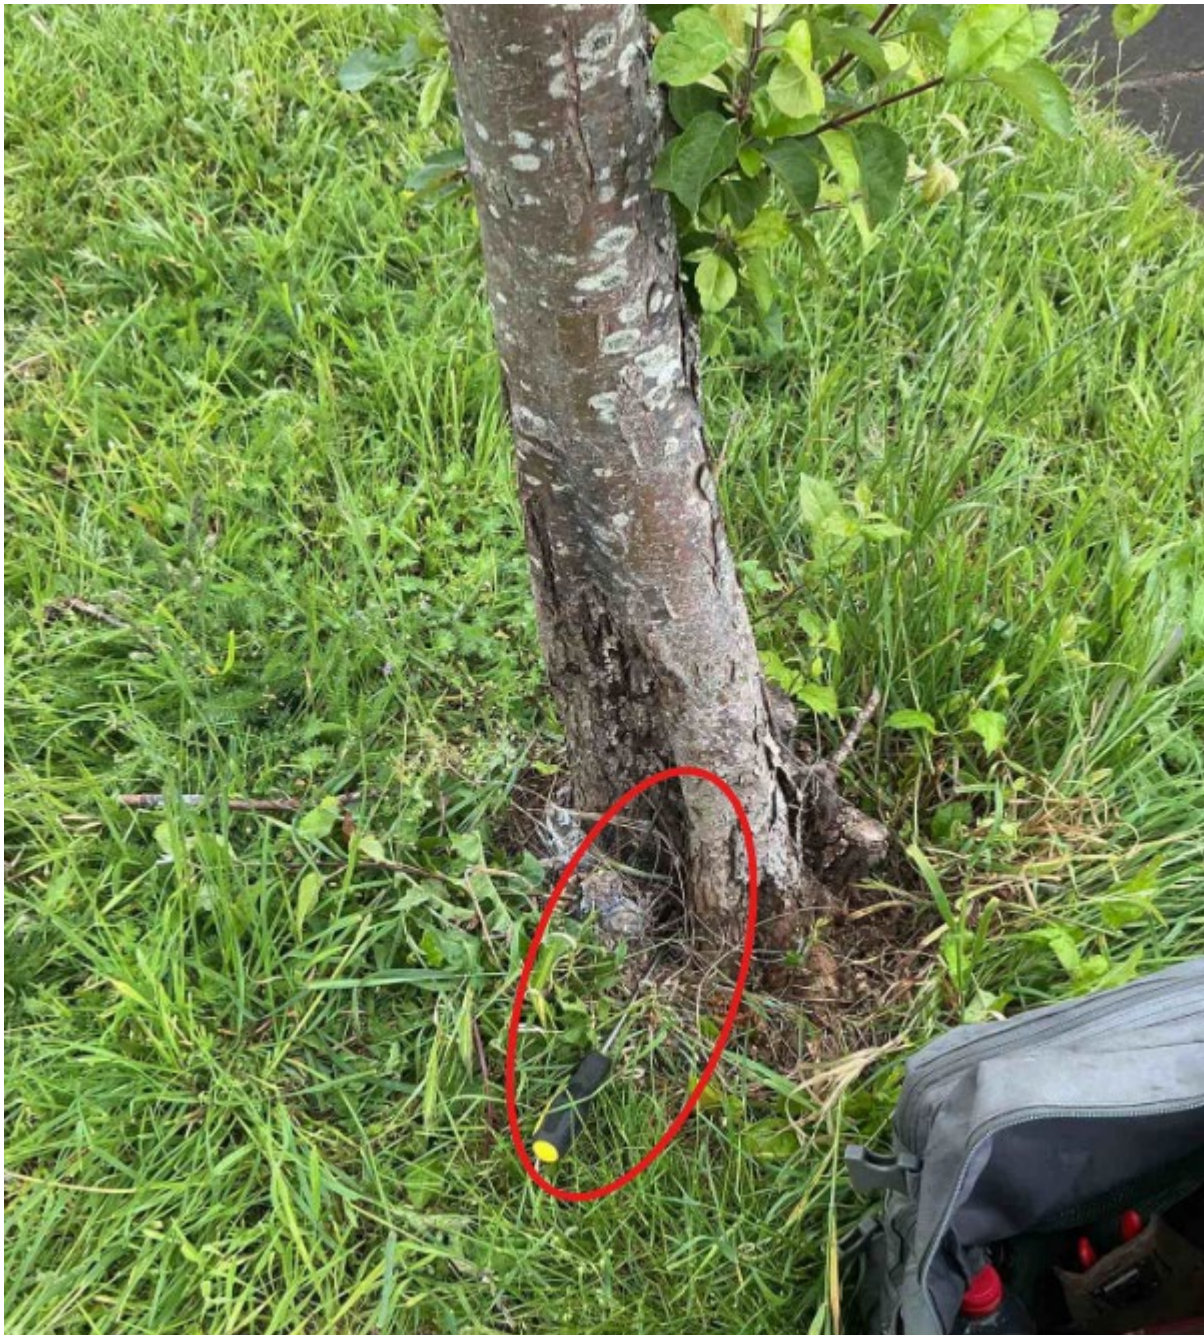
| Location | Outside 57 |

| Inspection findings/reason for exemption | Investigation with a probe has revealed an unacceptable amount of decay beyond the visible cavities at the base of the trunk. Removal is required to prevent natural failure, manage risk, and facilitate replanting. |

*Image shows probe and cavity circled.*

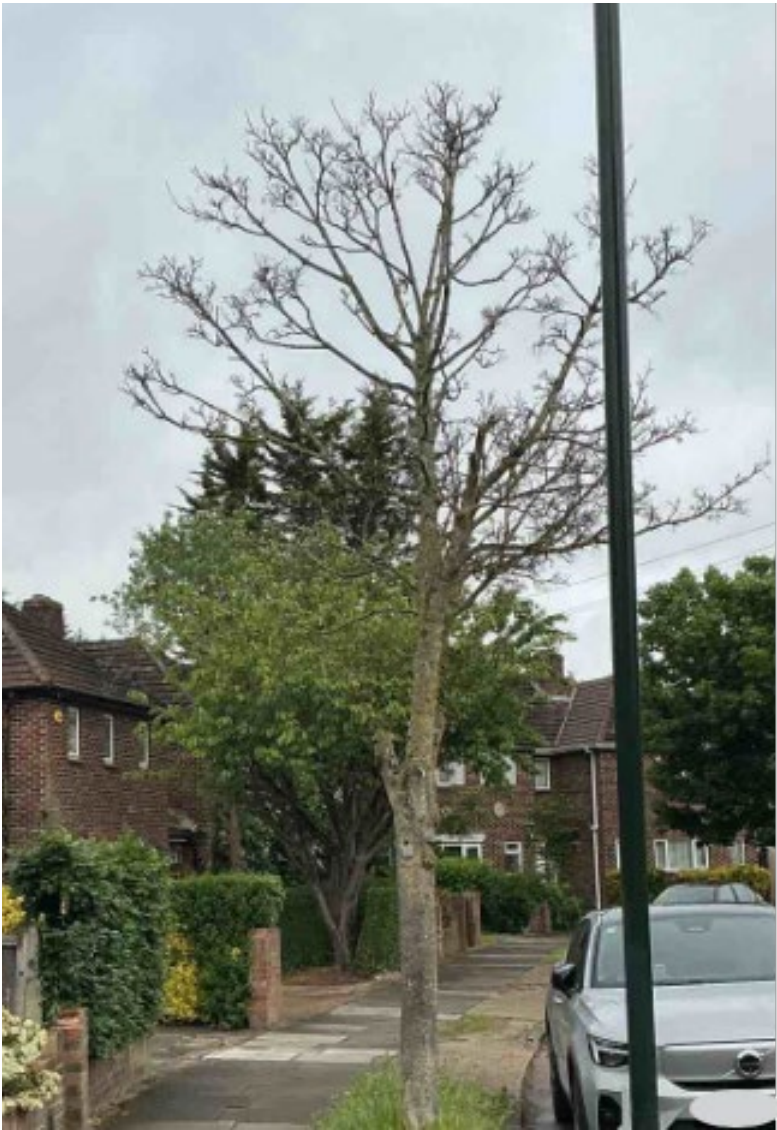
| Location | Outside 57 |

| Inspection findings/reason for exemption | This tree is moribund; removal is required to prevent natural failure, manage risk, and facilitate replanting. |

Image shows moribund tree in street scene.

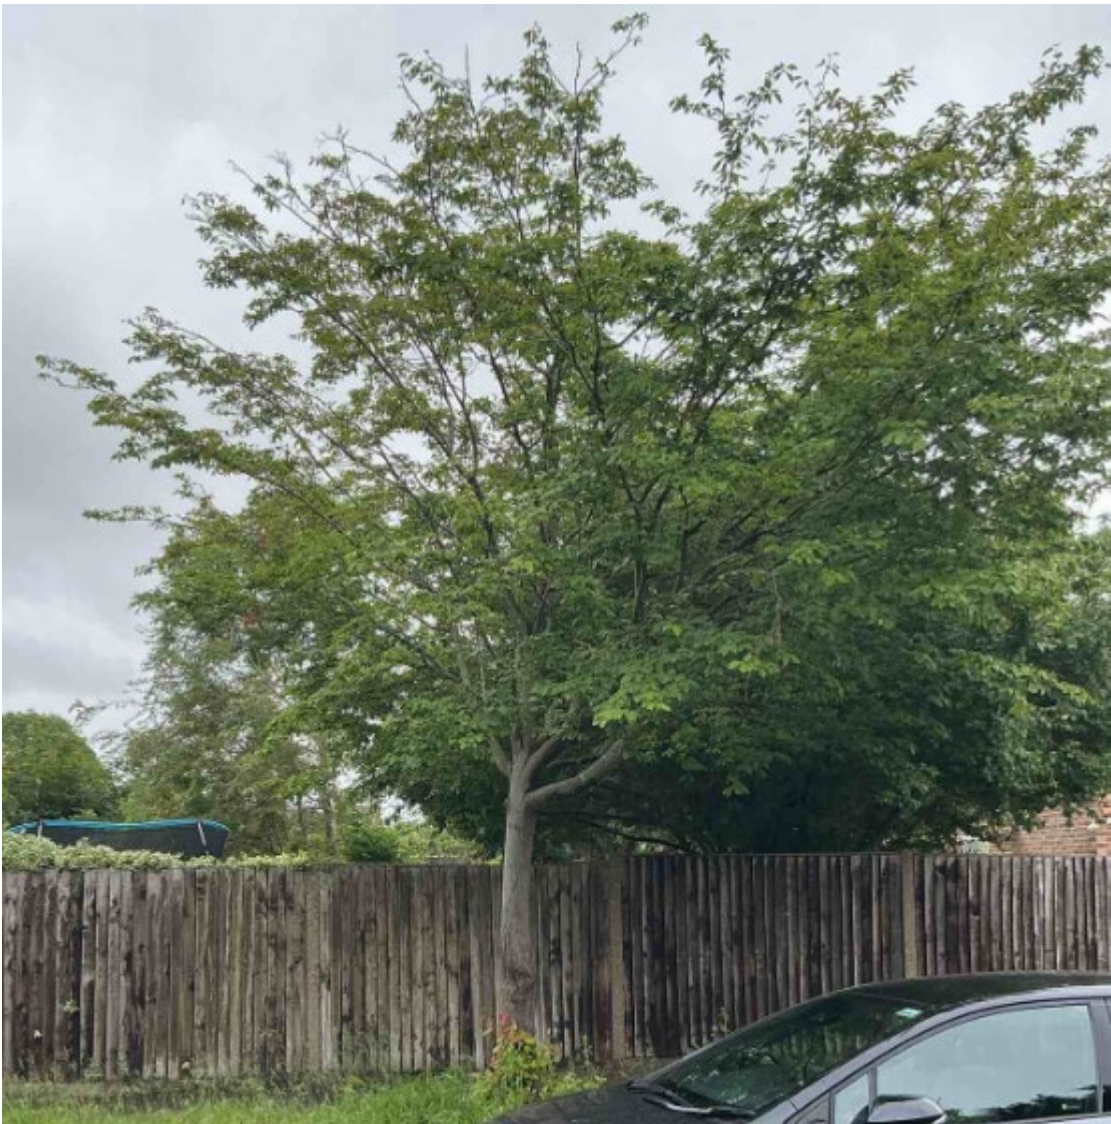
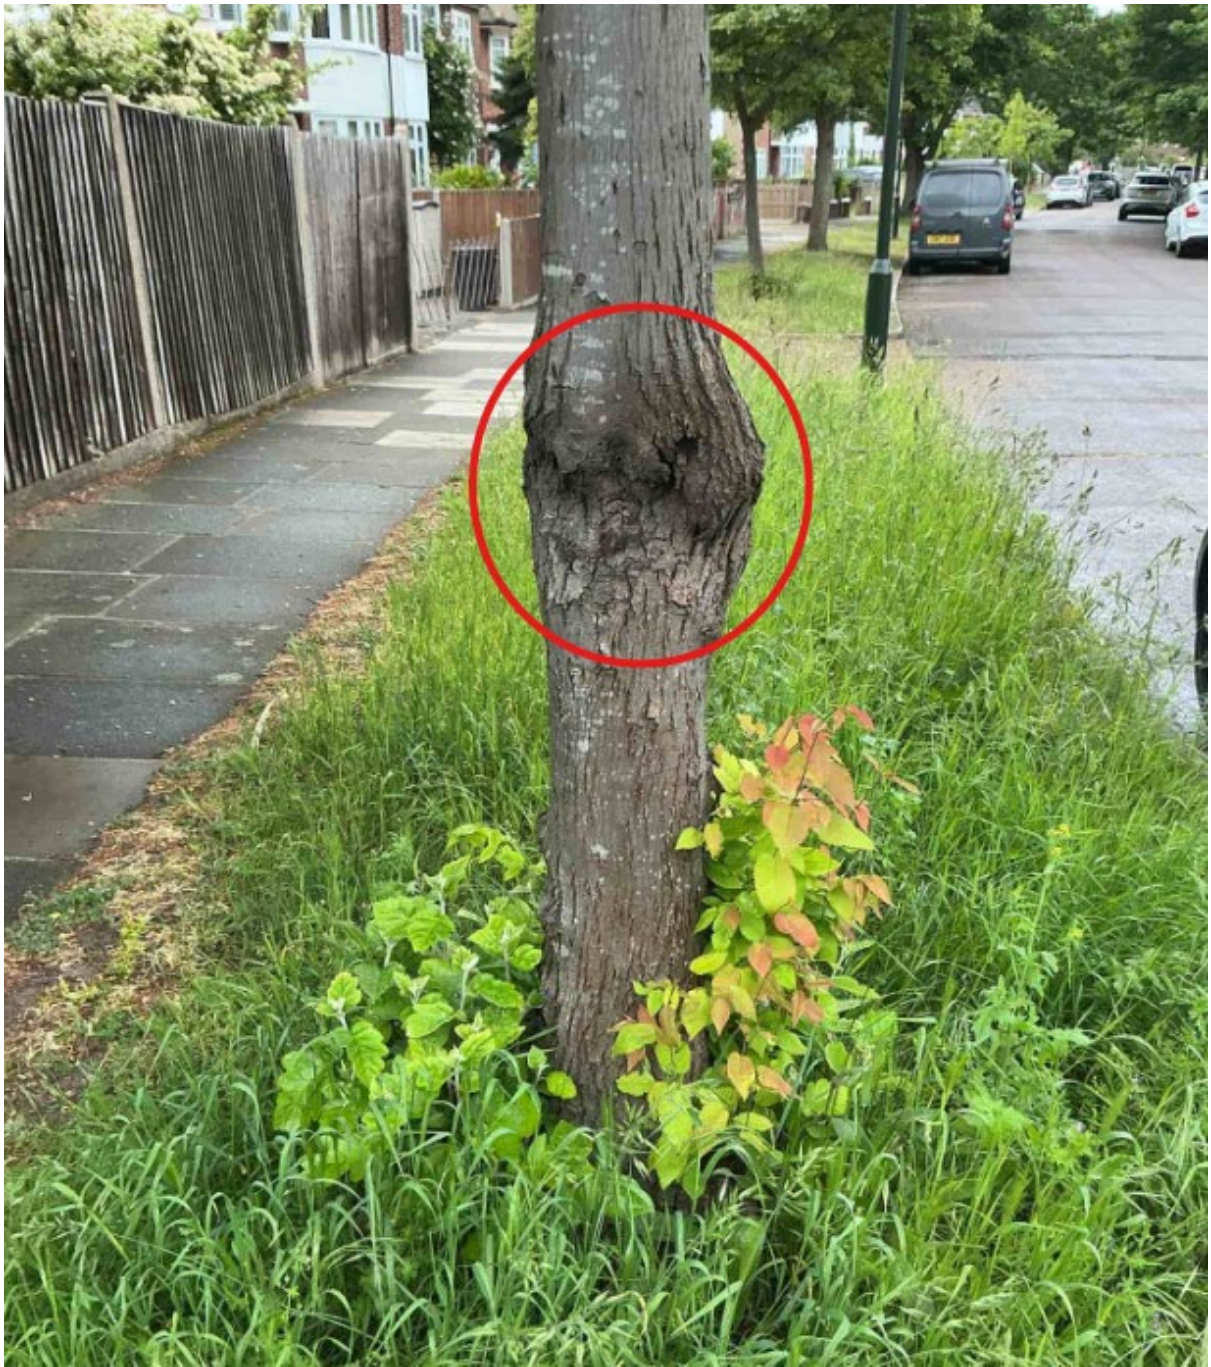
| Location | Adjacent to 261 Uxbridge Road rear garden |

| Inspection findings/reason for exemption | Investigation with a probe and resonance testing with a sounding mallet has revealed an unacceptable amount of decay beyond the visible cavity on the trunk. Removal is required to prevent natural failure, manage risk, and facilitate replanting. |

***Image shows cavity on trunk circled.***

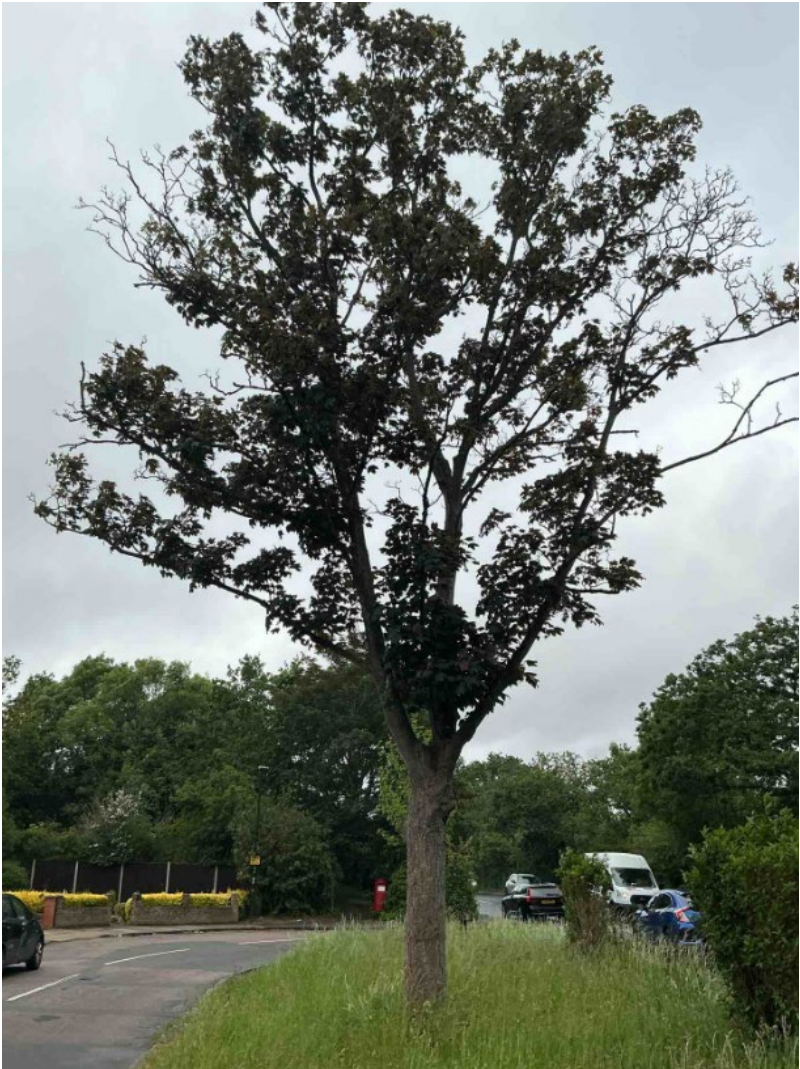
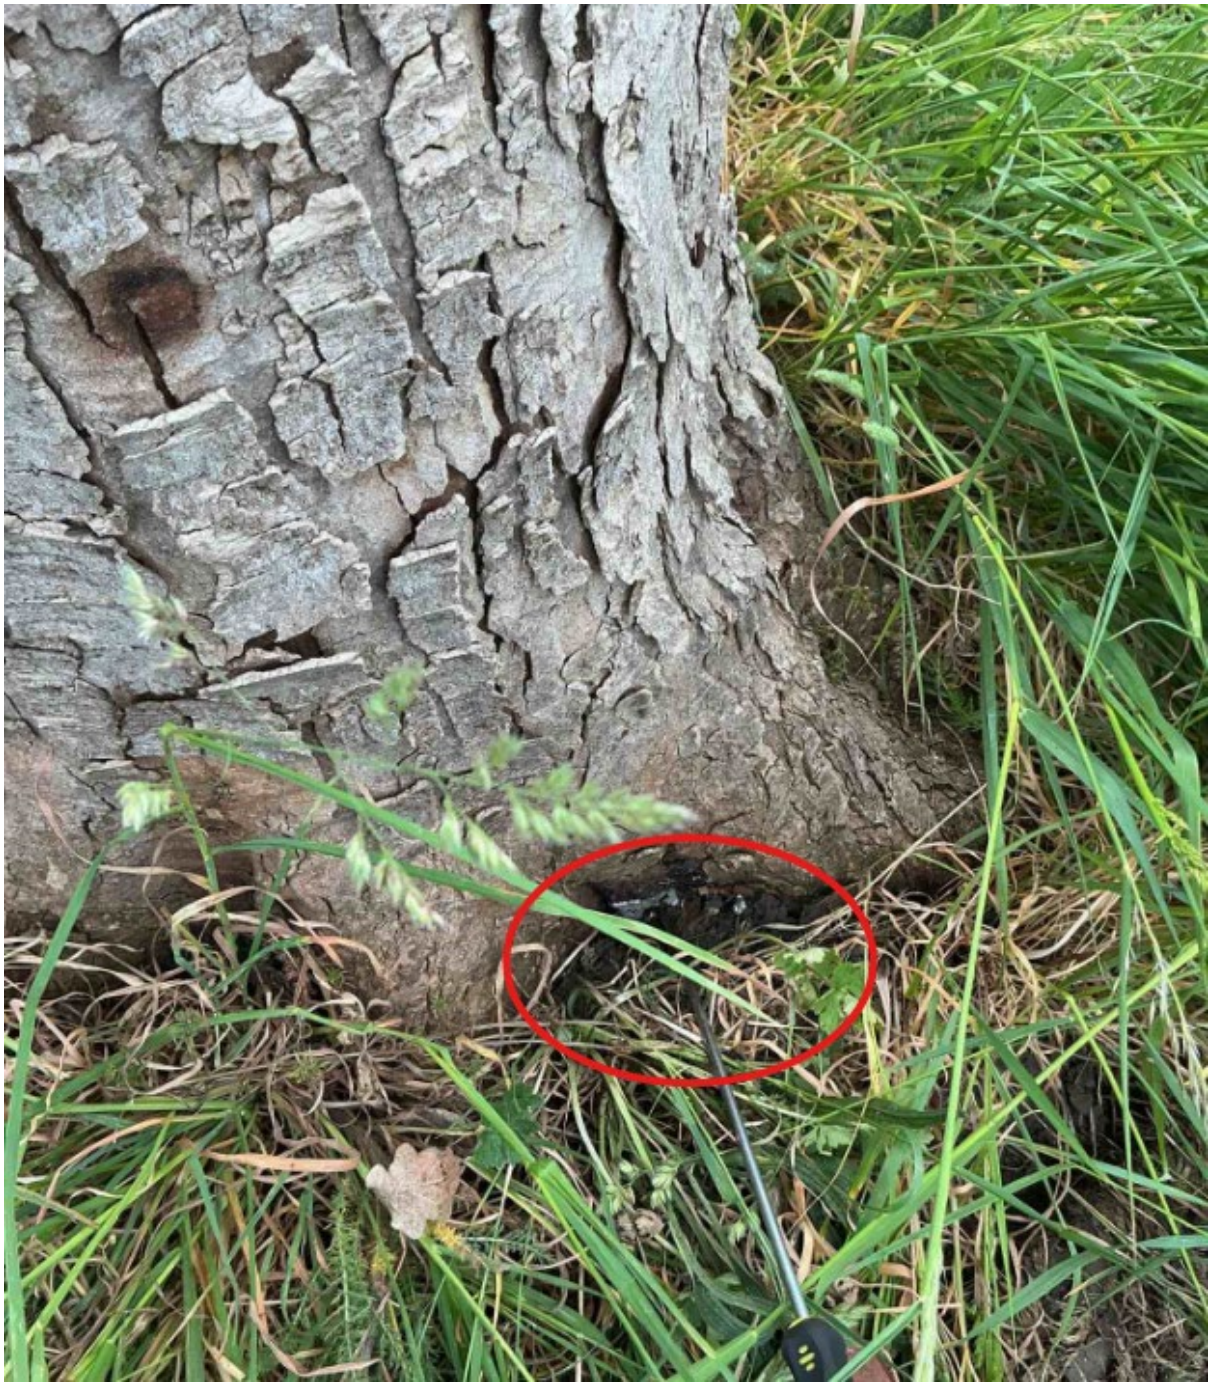
| Inspection findings/reason for exemption | Fungal fruiting bodies of the decay pathogen <i>Kretzschmaria deusta</i> are present on the base of this tree. This fungus causes a white rot that can cause whole tree failure through a ceramic like fracture of the base. Removal is required to prevent natural failure, manage risk, and facilitate replanting. |

***Image shows fungal fruiting body circled.***

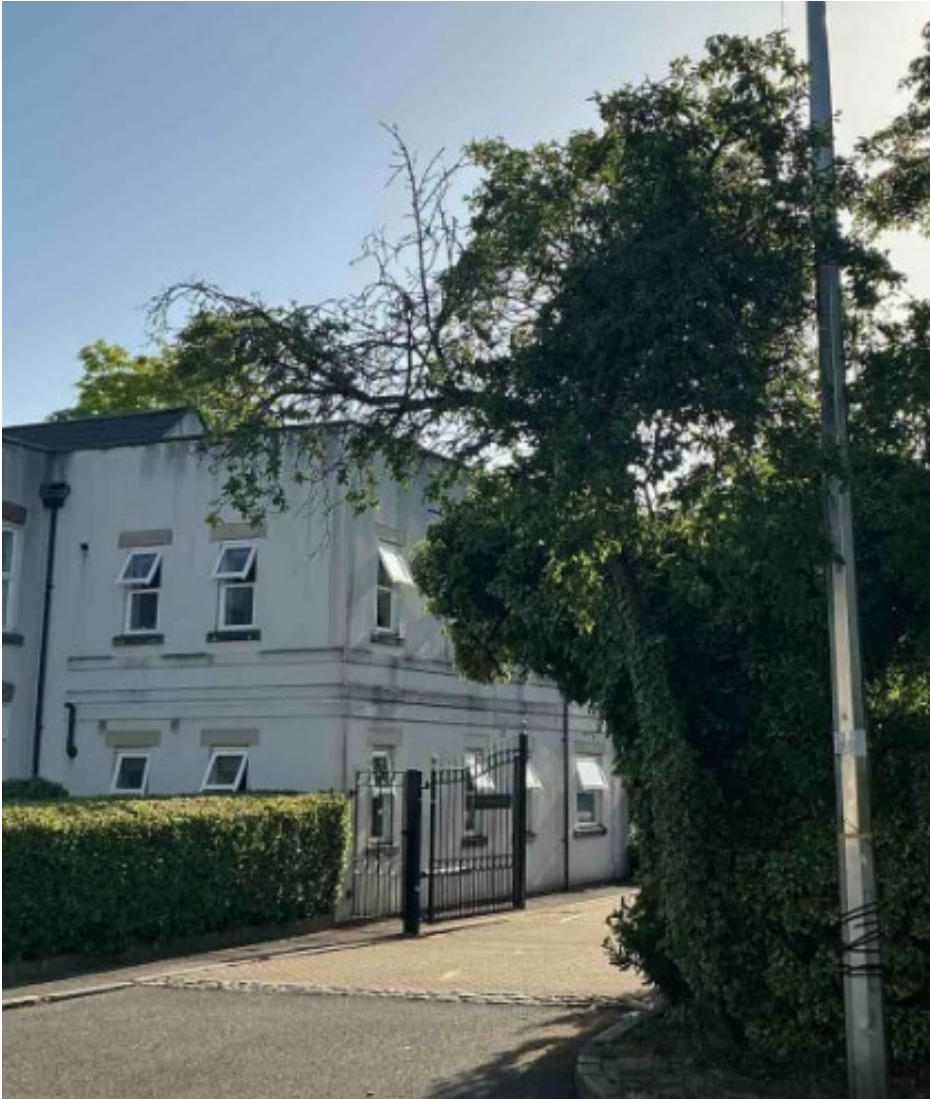
| Location | On grass area opposite 77A |

| Inspection findings/reason for exemption | This tree is moribund; removal is required to prevent natural failure, manage risk, and facilitate replanting. |

Image shows moribund tree in street scene.

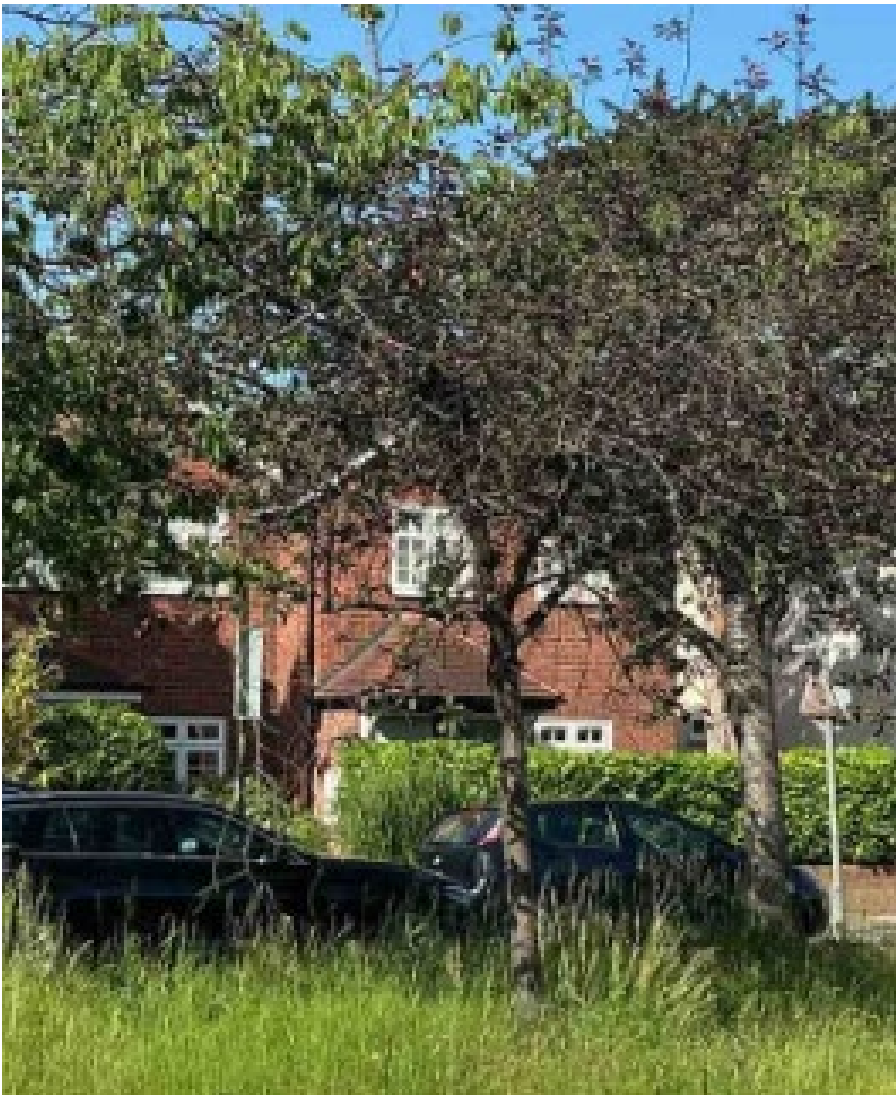
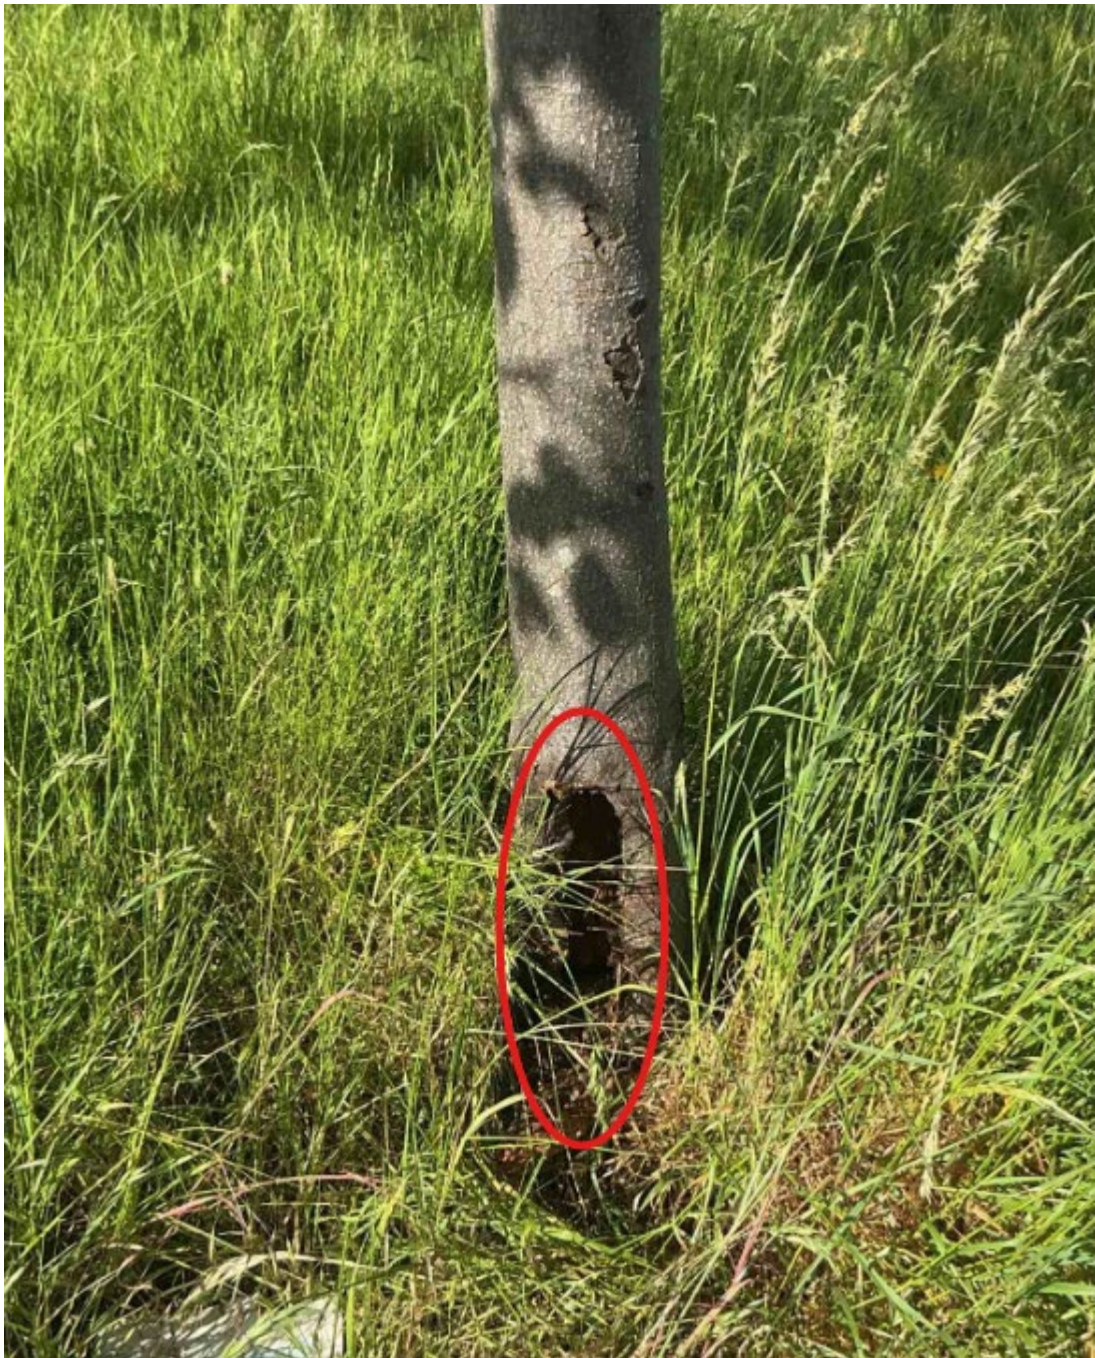
| Location | Opposite 52 |

| Inspection findings/reason for exemption | Investigation with a probe has revealed an unacceptable amount of decay beyond the visible cavities at the base of the trunk. Removal is required to prevent natural failure, manage risk, and facilitate replanting. |

***Image shows cavity at base of trunk circled.***

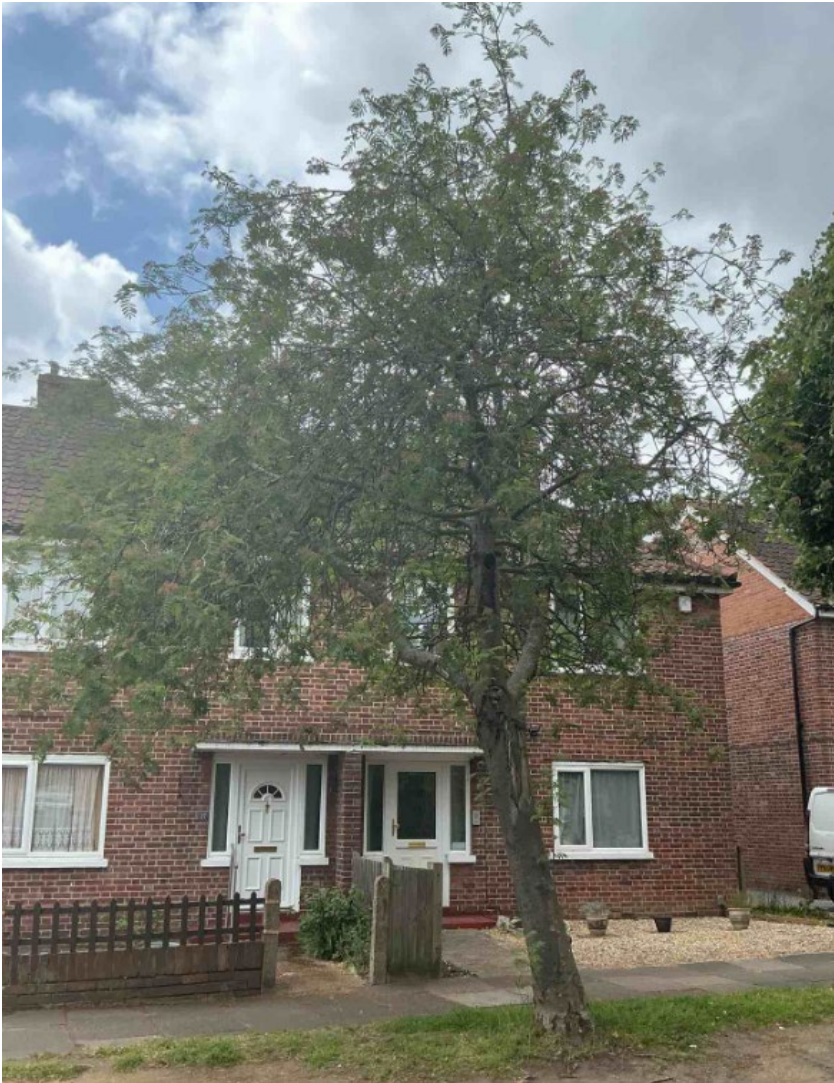
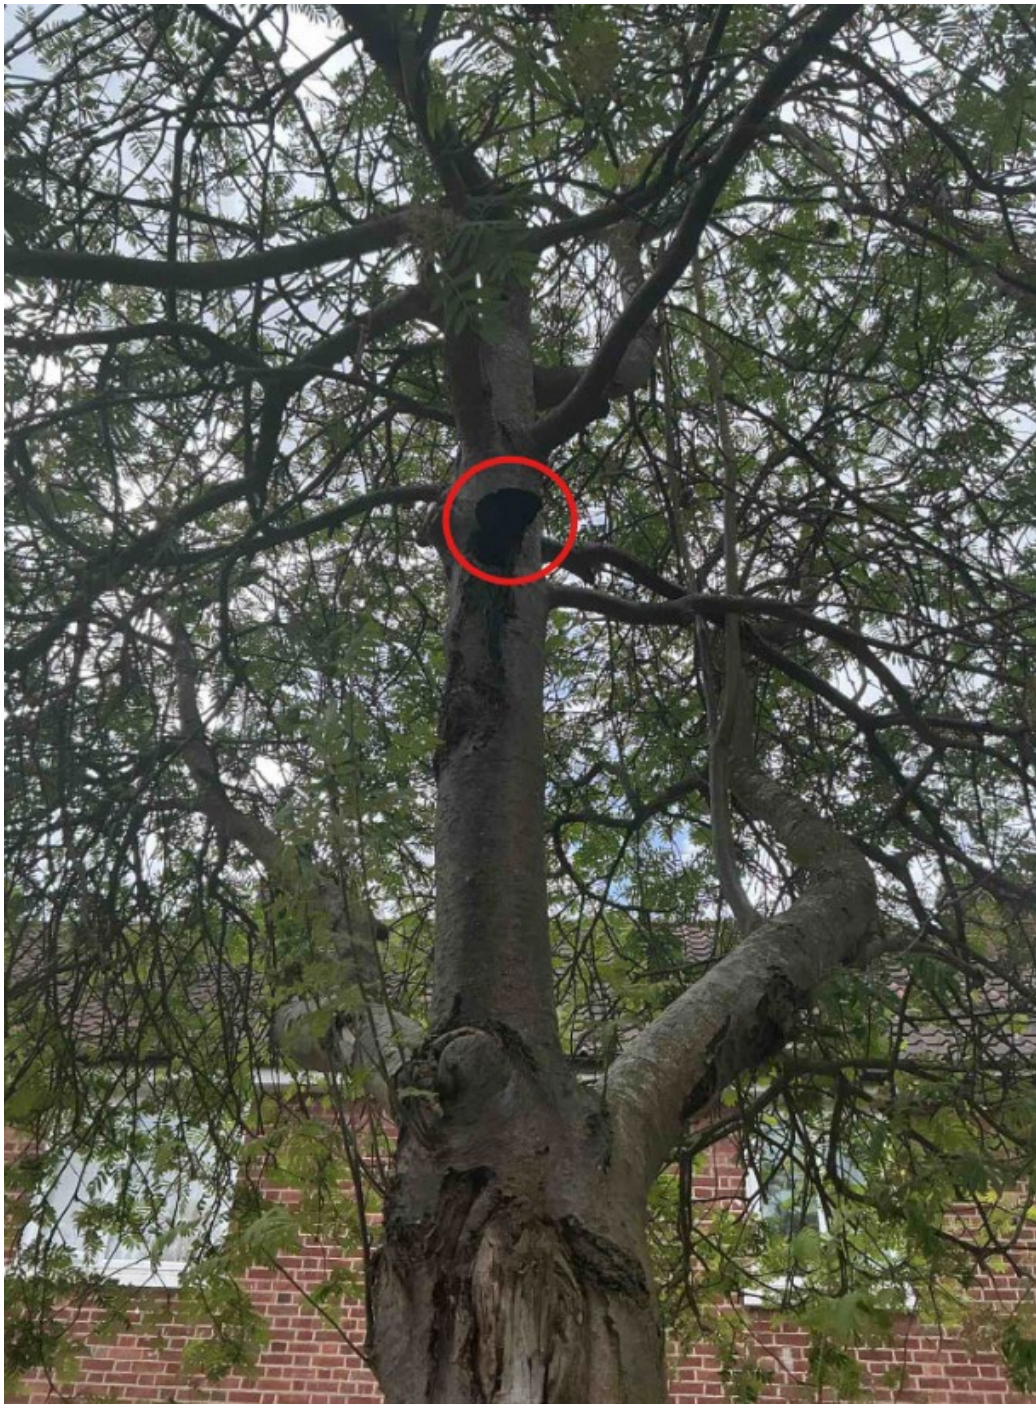
| Inspection findings/reason for exemption | A fungal fruiting body of the species Shaggy Polypore ( <i>Inonotus hispidus</i> ) is present on the main stem; this fungus causes a simultaneous white rot which can cause snapping of tree parts in this species. Removal is required to prevent natural failure, manage risk, and facilitate replanting. |

***Image shows fungal fruiting body circled.***

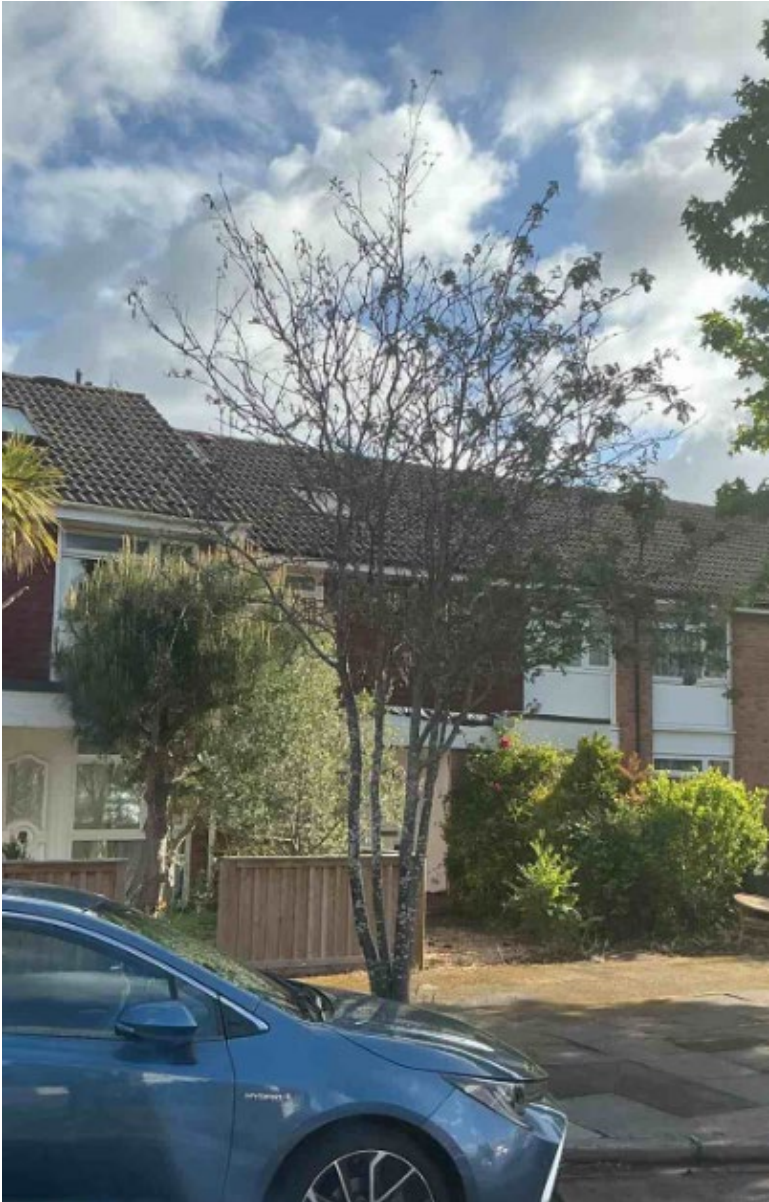
| Location | Outside 27/29 |

| Inspection findings/reason for exemption | This tree is moribund; removal is required to prevent natural failure, manage risk, and facilitate replanting. |

Image shows moribund tree in street scene.

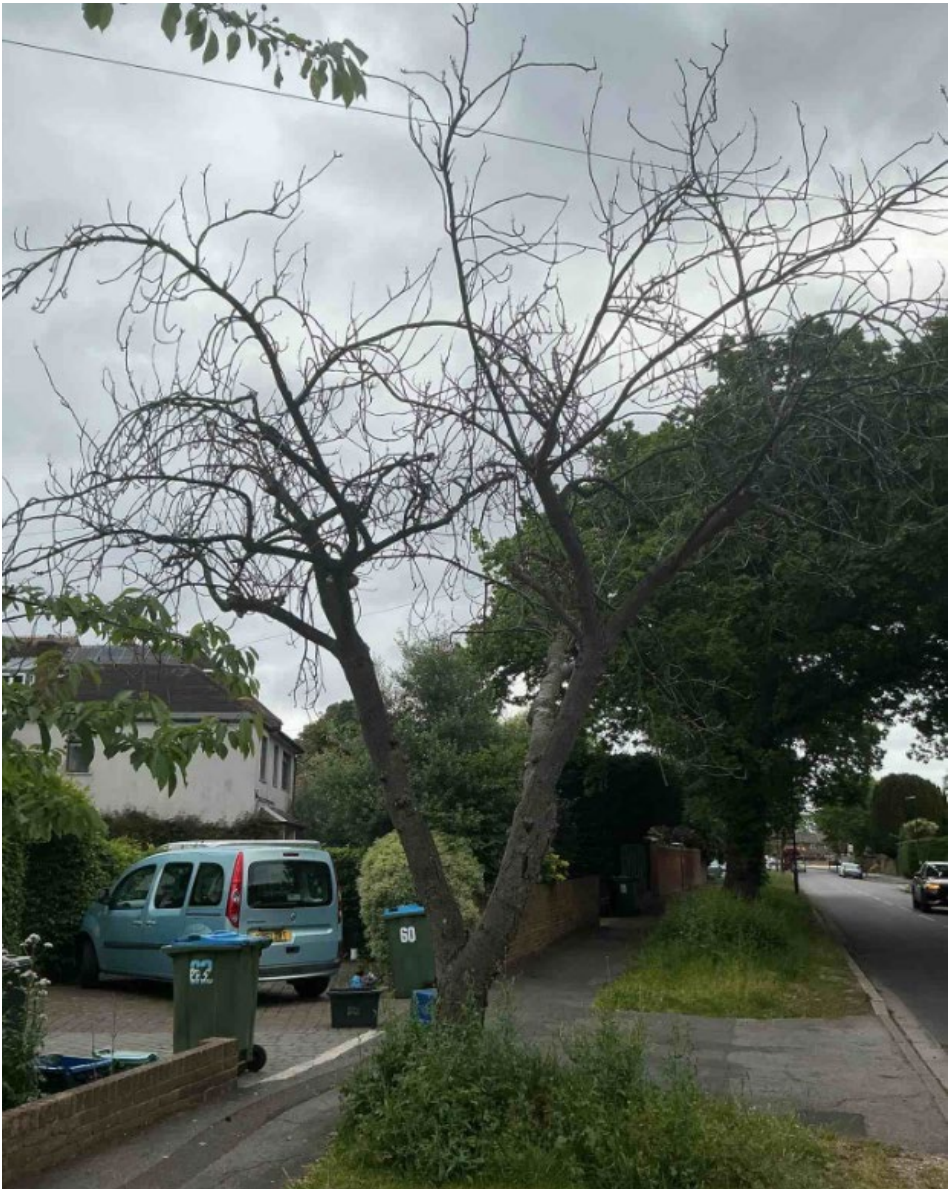
| Location | Outside 62 |

| Inspection findings/reason for exemption | This tree is dead; removal is required to prevent natural failure, manage risk, and facilitate replanting. |

Image shows dead tree in street scene.

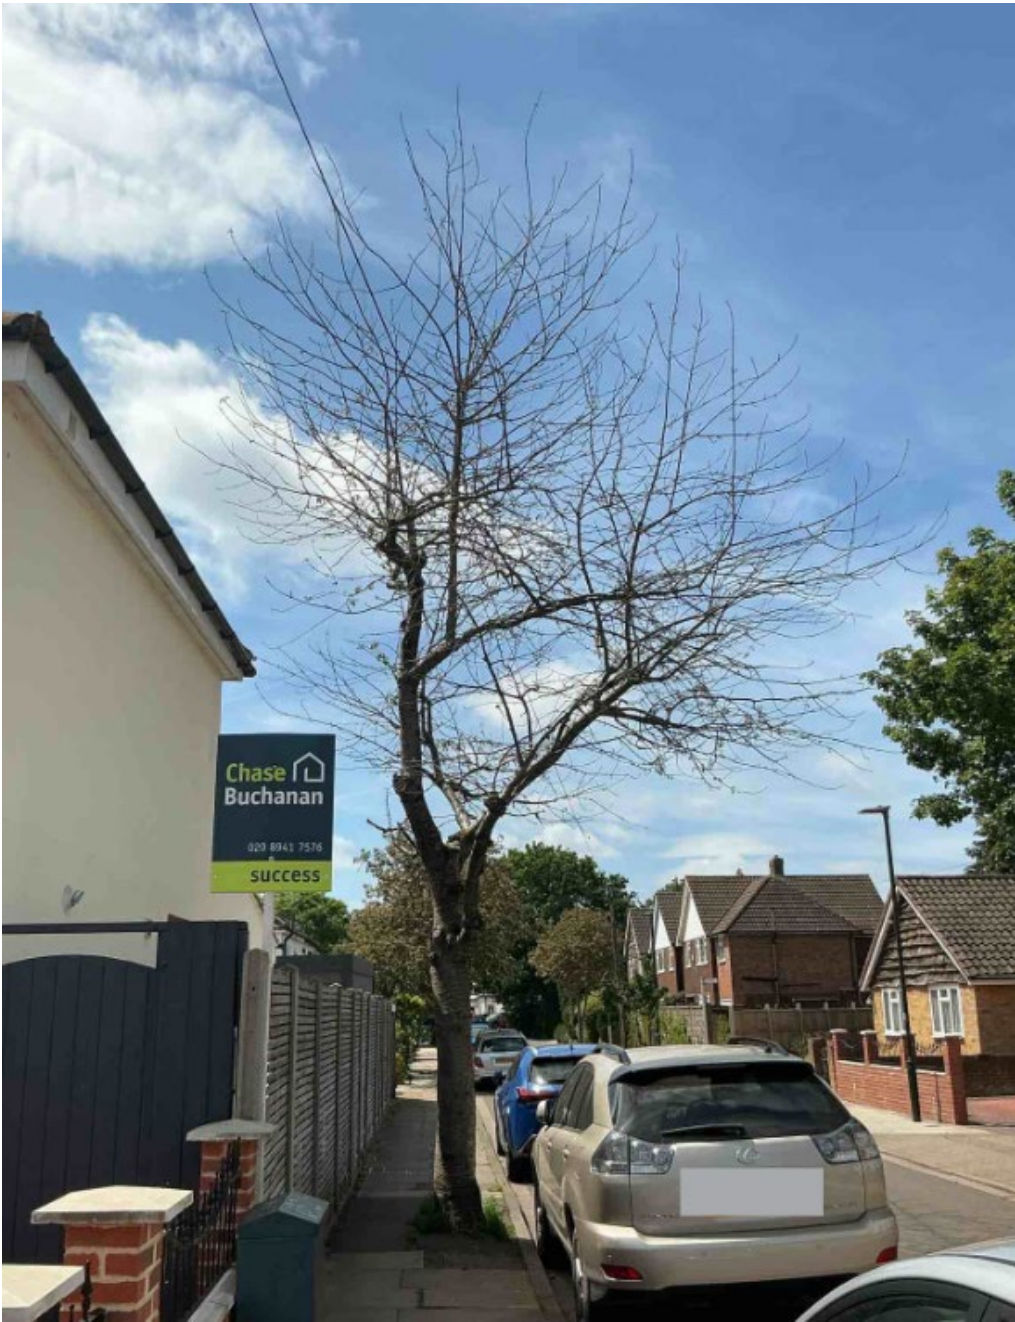
| Location | Outside 62 |

| Inspection findings/reason for exemption | This tree is dead; removal is required to prevent natural failure, manage risk, and facilitate replanting. |

Image shows dead tree in street scene.
