# June 2026 Highways Reactive Tree Works Programme

A survey of the Highway trees in the ward of Hampton North has been undertaken; this was conducted by specialist arboricultural officers as part of the scheduled 4 yearly detailed inspection regime that has been devised for all Council highway and parks trees.

Recent reactive inspections have identified the need for 33 individual tree work operations to take place. This work will now be issued to the Council’s arborist contractor KPS, for completion over the summer period.

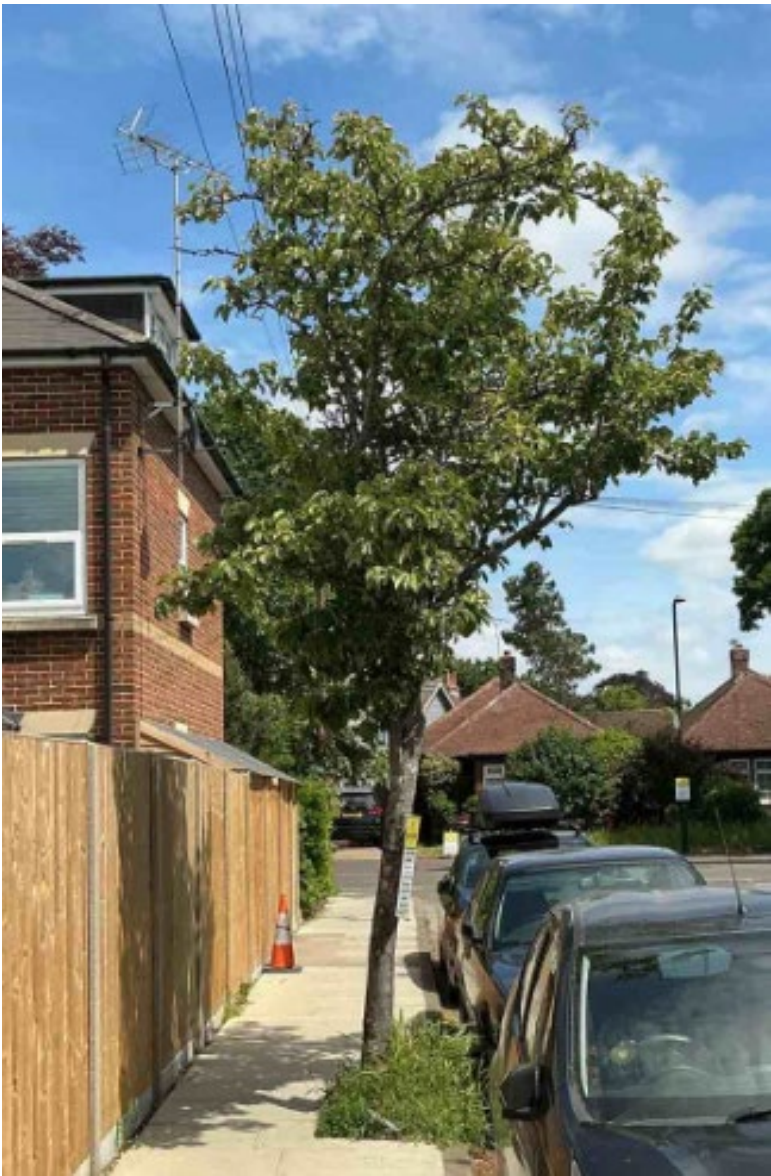
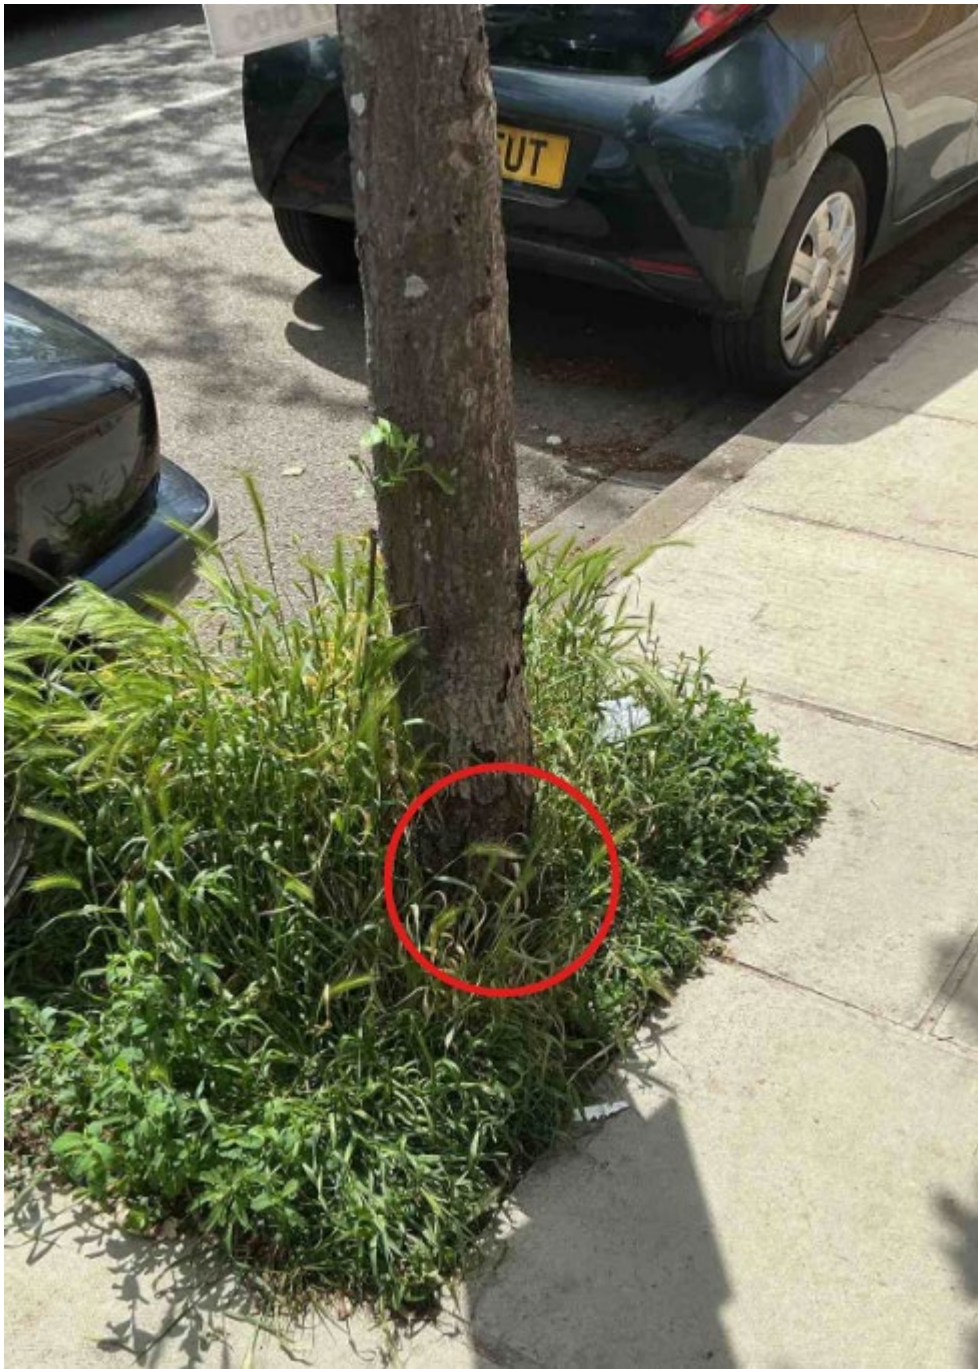
| Location | Adjacent to 49a Oak Avenue rear edge of building |

| Inspection findings/reason for exemption | Investigation with a probe has revealed an unacceptable amount of decay beyond the visible cavities at the base of the trunk. Removal is required to prevent natural failure, manage risk, and facilitate replanting. |

***Image shows cavity at base of trunk circled.***

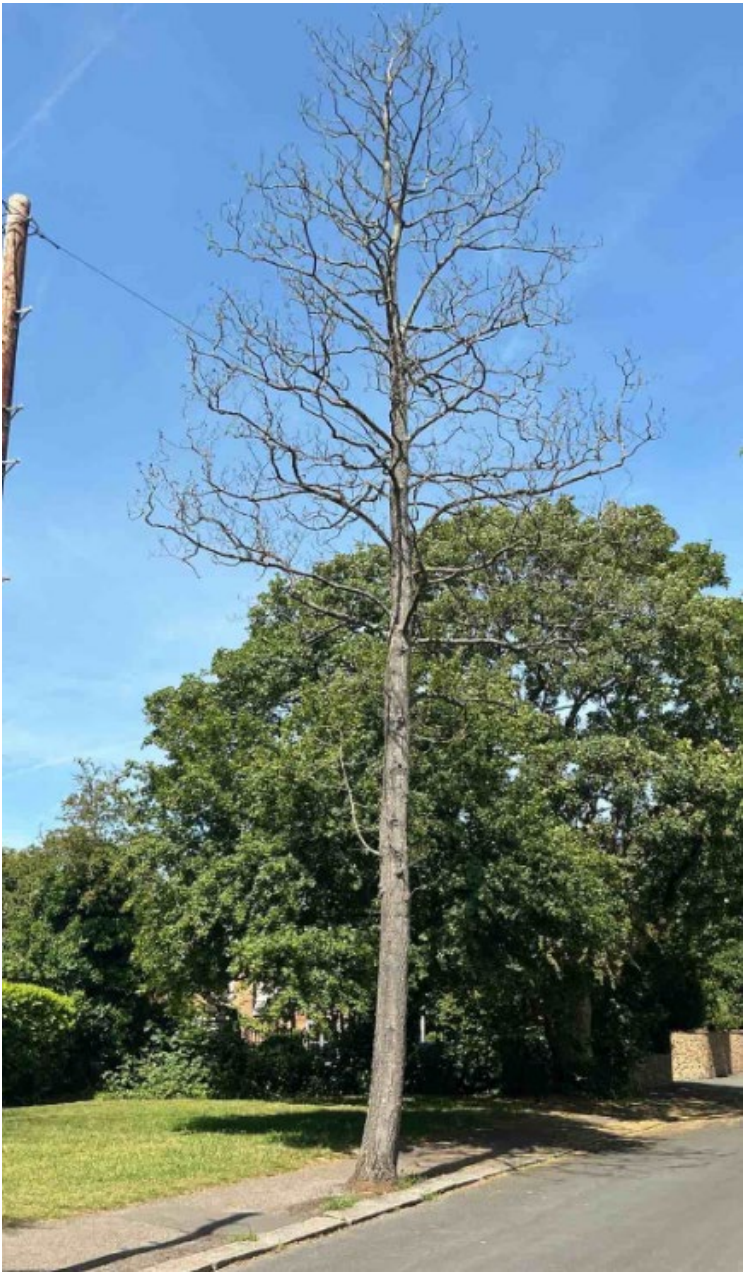
| Location | Opposite 10-12 |

| Inspection findings/reason for exemption | This tree is dead; removal is required to prevent natural failure, manage risk, and facilitate replanting. |

Image shows dead tree in street scene.

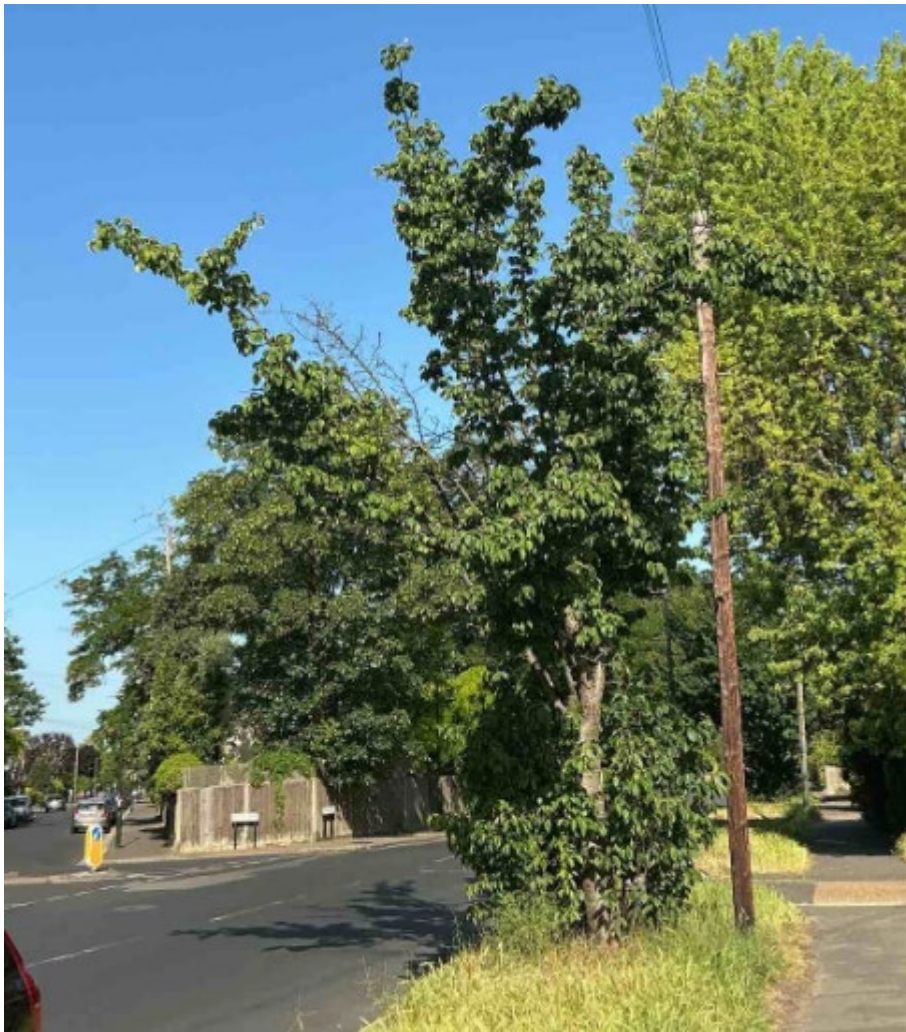
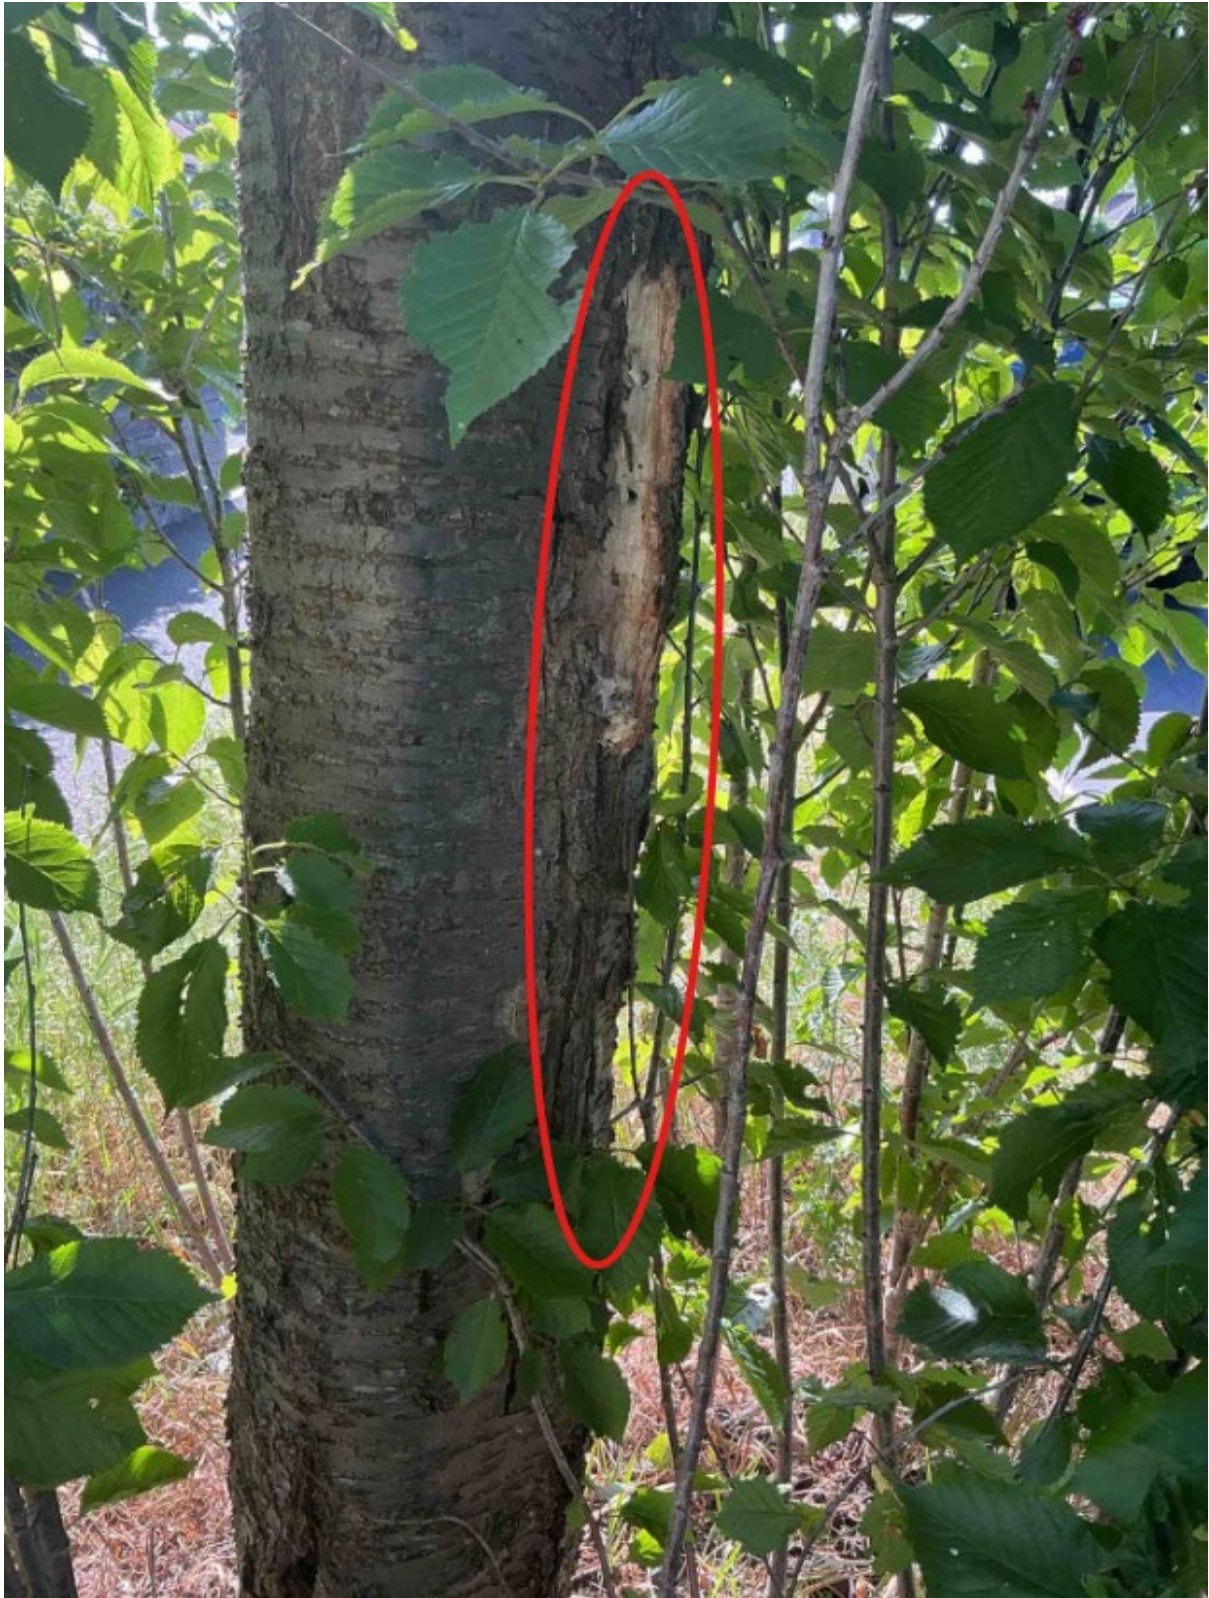
| Location | Outside 36 |

| Inspection findings/reason for exemption | Investigation with a probe has revealed an unacceptable amount of decay on the trunk. This correlates with crown dieback. Removal is required to prevent natural failure, manage risk, and facilitate replanting. |

***Image shows decay on trunk circled.***

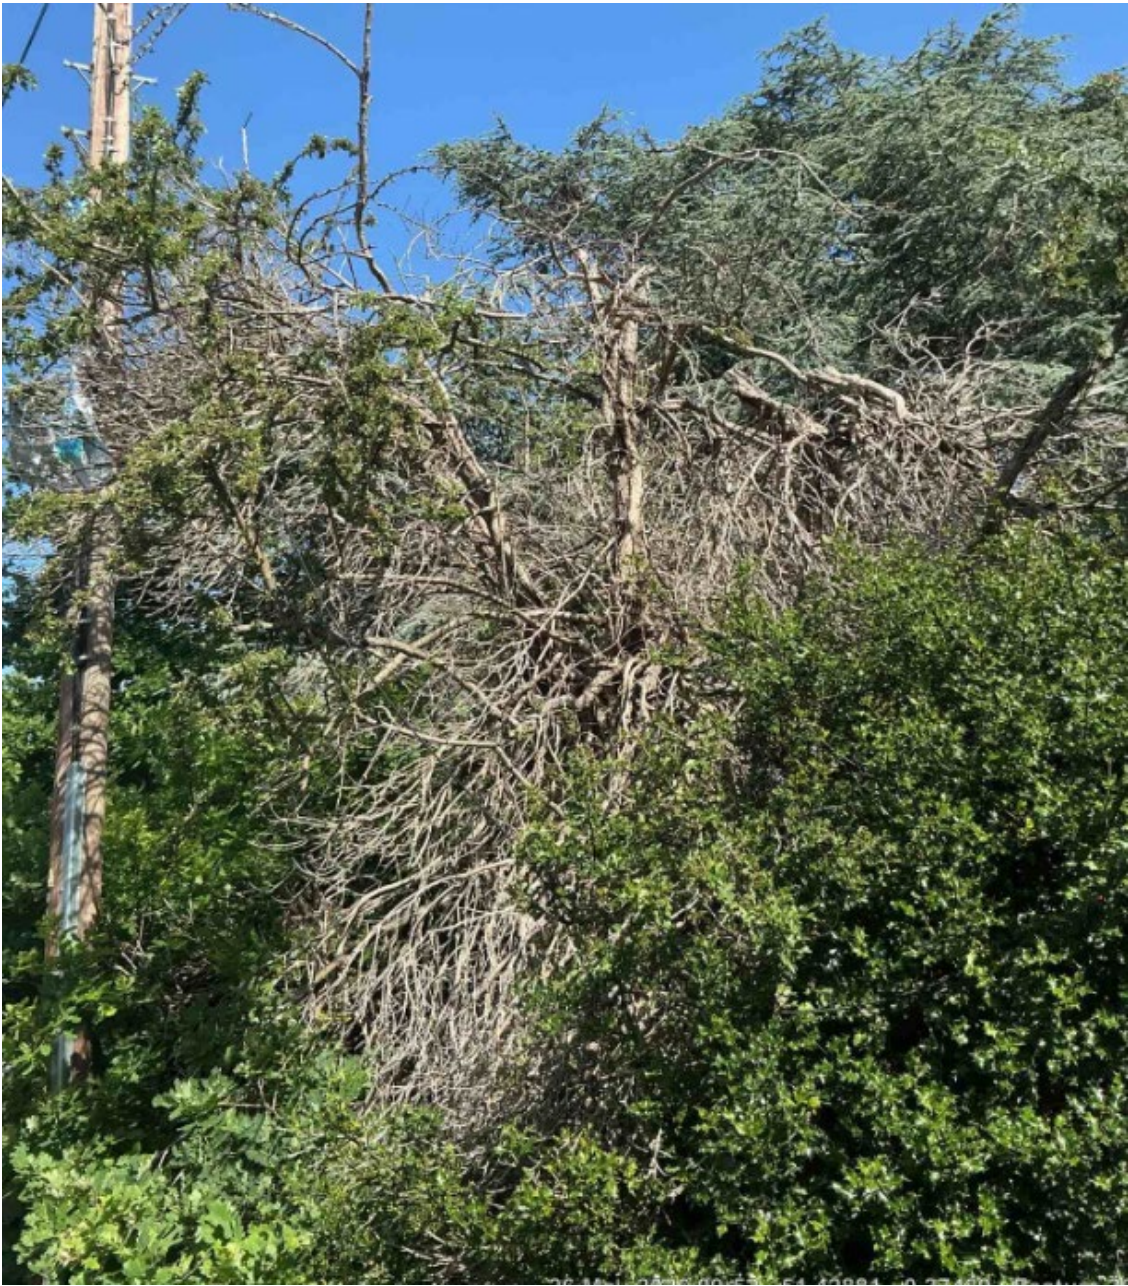
| Location | Opposite 121 |

| Inspection findings/reason for exemption | This tree is moribund; removal is required to prevent natural failure, manage risk, and facilitate replanting. |

Image shows moribund tree in street scene.

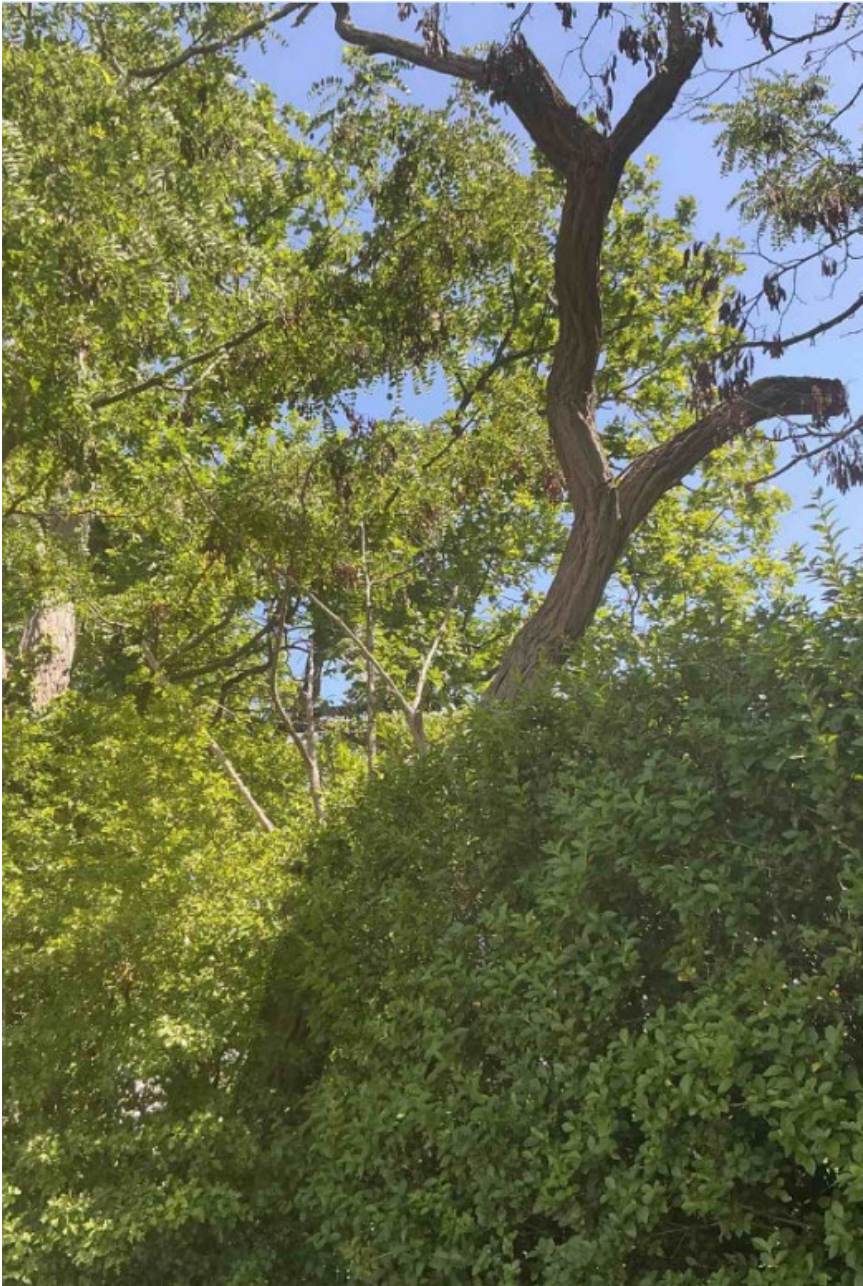
| Location | Outside school directly adjacent to footpath sign |

| Inspection findings/reason for exemption | This tree is dead; removal is required to prevent natural failure, manage risk, and facilitate replanting. |

Image shows dead tree in street scene.

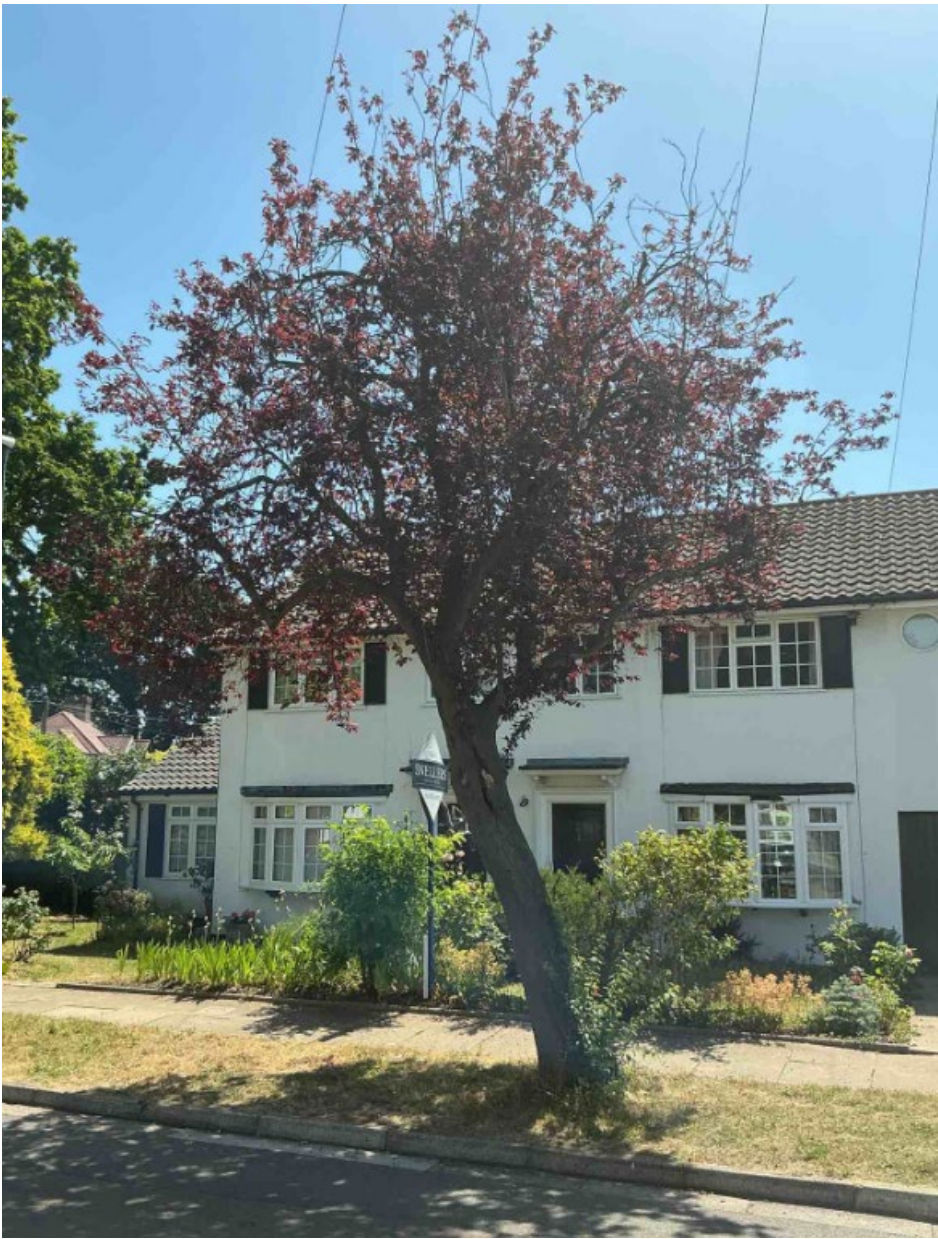
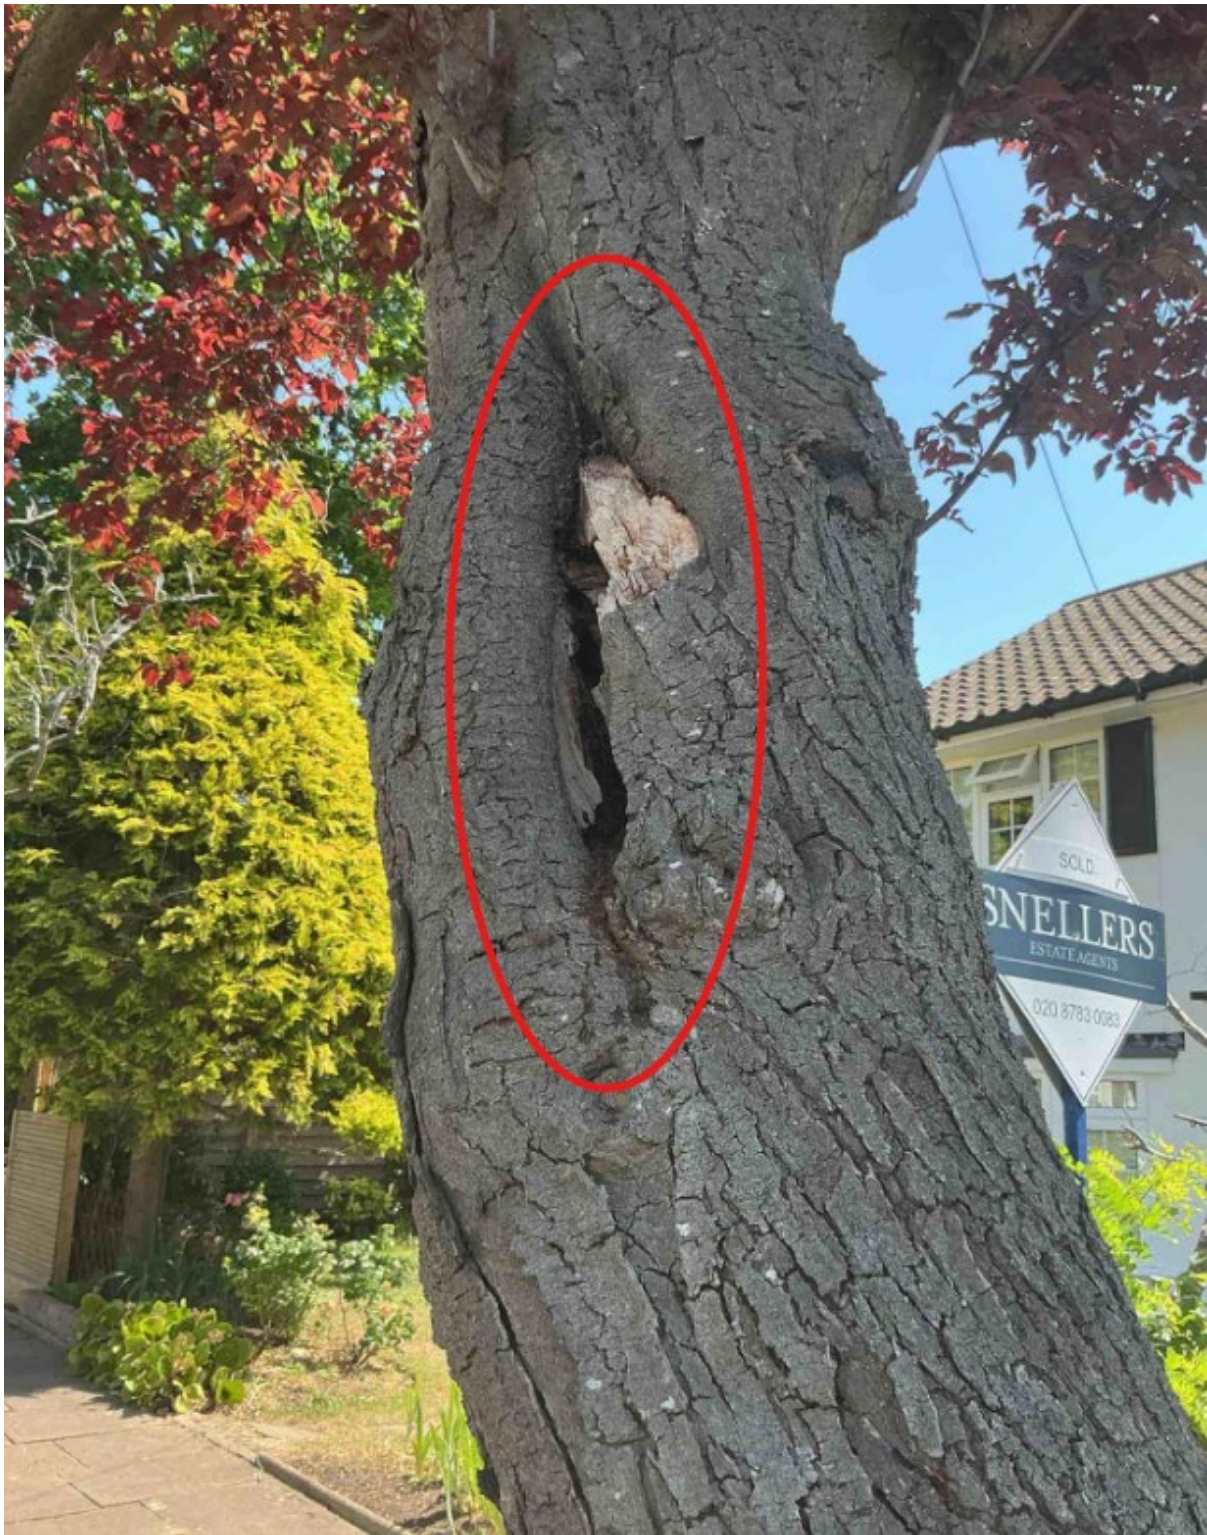
| Location | Outside 3 |

| Inspection findings/reason for exemption | Investigation with a probe and a resonance test with a sounding hammer has revealed an unacceptable amount of decay beyond the visible cavity on the trunk. Removal is required to prevent natural failure, manage risk, and facilitate replanting. |

***Image shows cavity on trunk circled.***

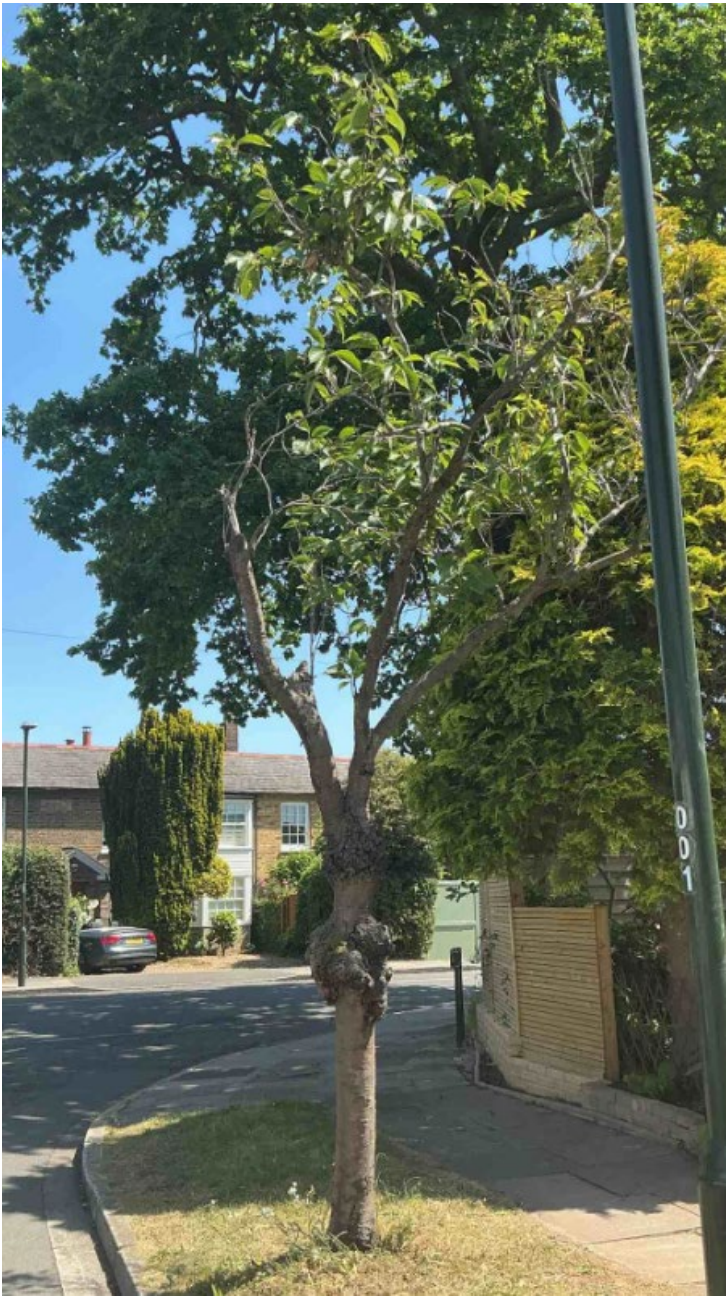
| Location | Outside 1 |

| Inspection findings/reason for exemption | This tree is moribund; removal is required to prevent natural failure, manage risk, and facilitate replanting. |

Image shows moribund tree in street scene.

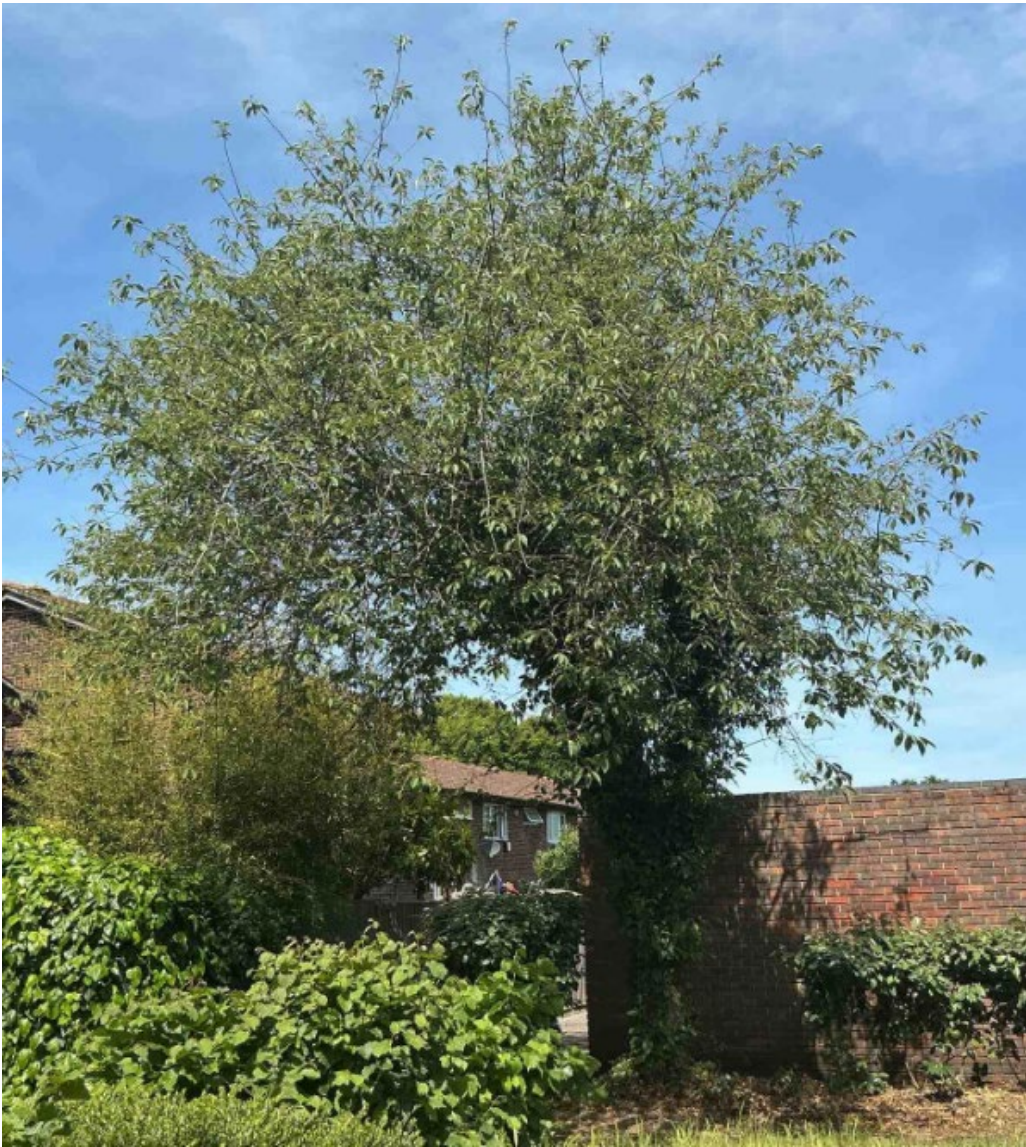
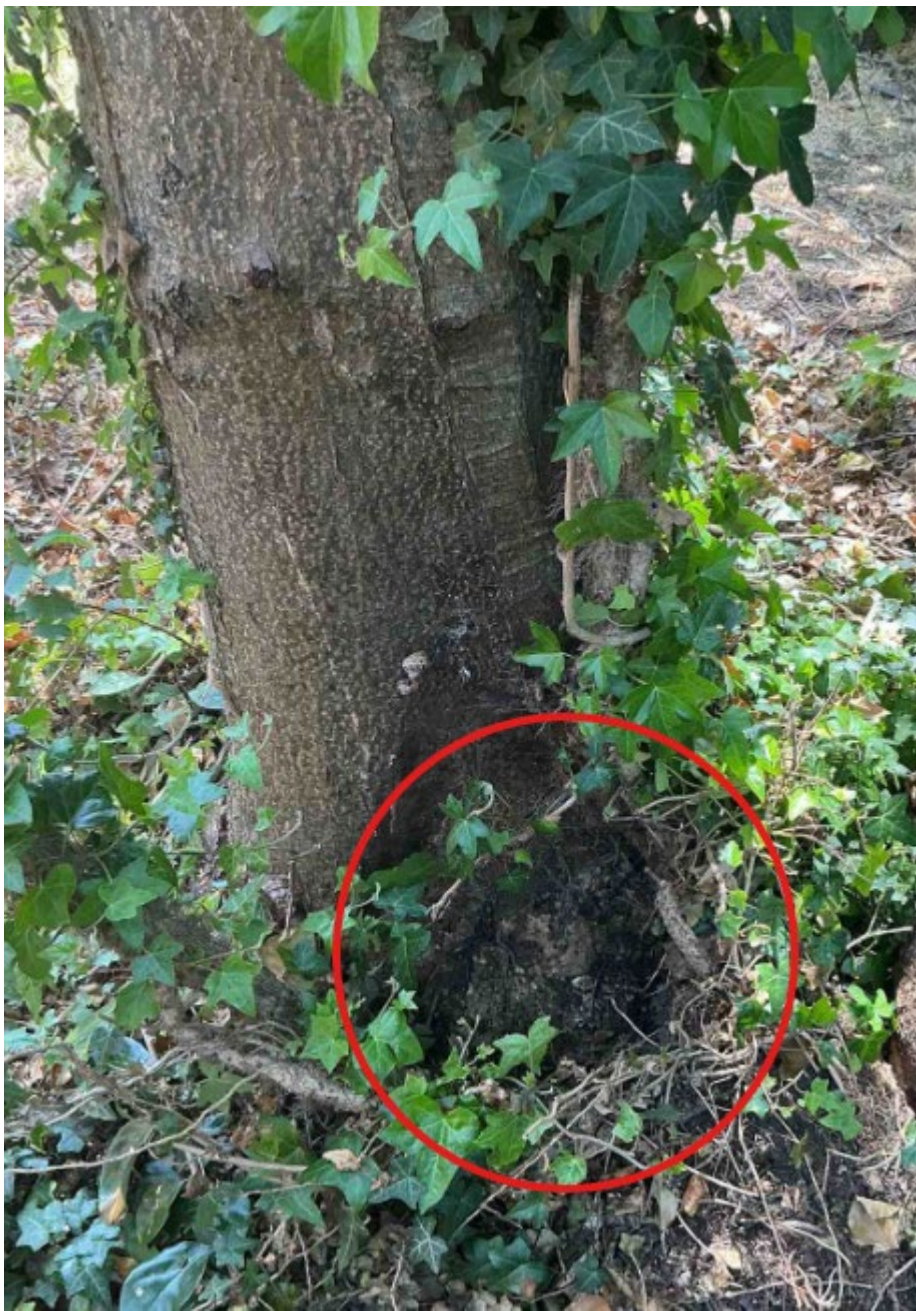
| Inspection findings/reason for exemption | Investigation with a probe and a resonance test with a sounding hammer has revealed an unacceptable amount of decay on a wound from a previous stem failure on the base of trunk.<br>Removal is required to prevent natural failure, manage risk, and facilitate replanting. |

***Image shows wound on base of trunk circled.***

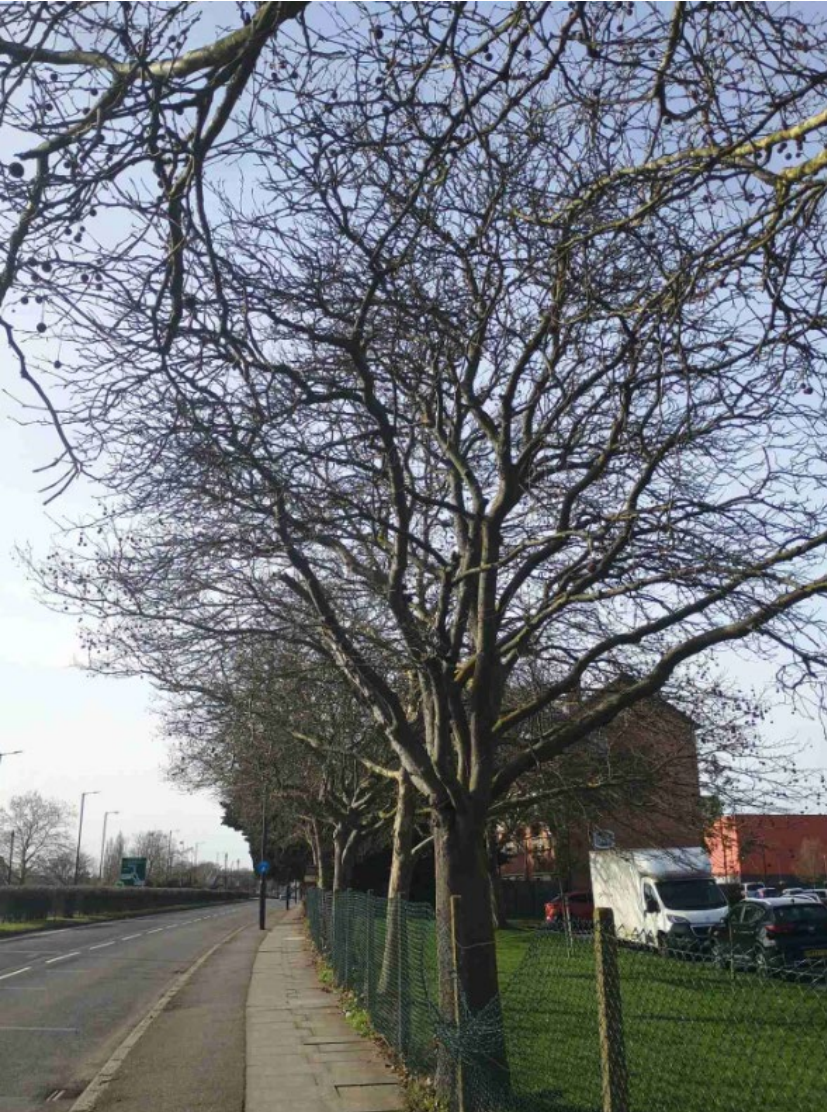
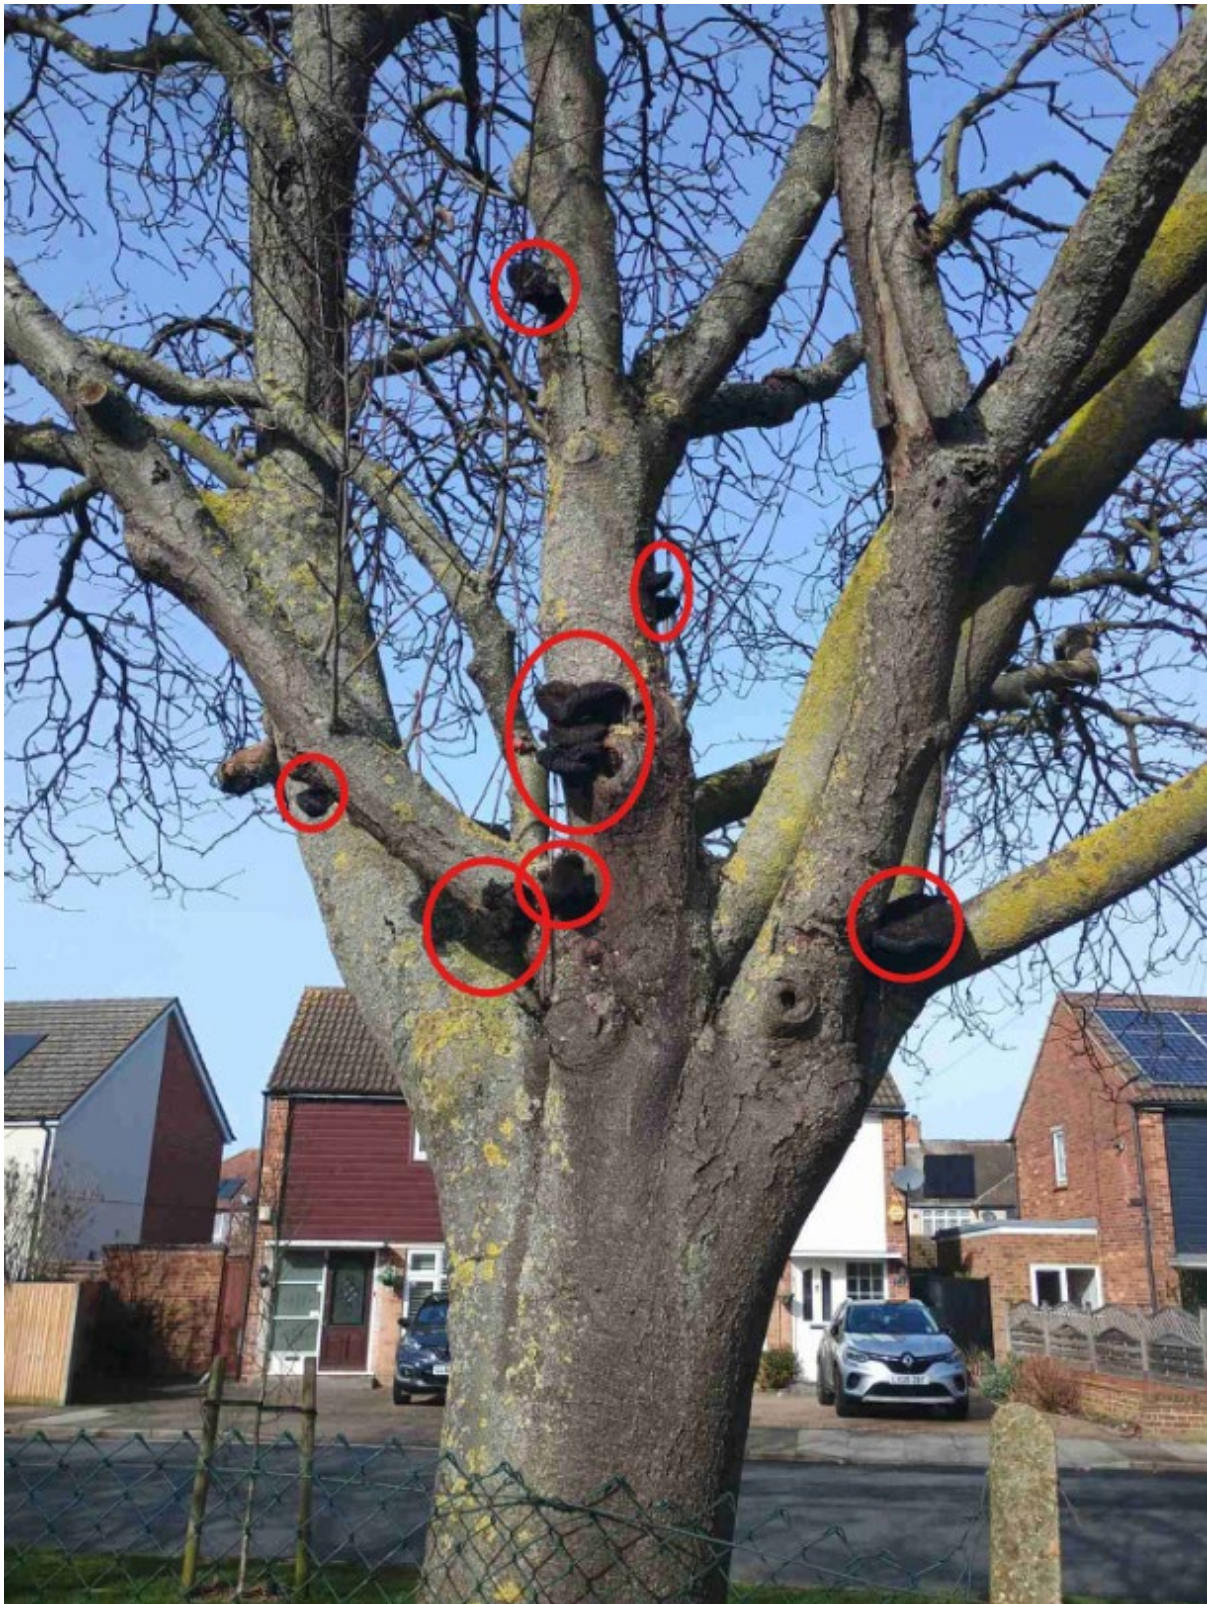
| Inspection findings/reason for exemption | A fungal fruiting body of the species Shaggy Polypore ( <i>Inonotus hispidus</i> ) is present on the branches in the lower crown; this fungus causes a simultaneous white rot which can cause snapping of tree parts in this species. Removal is required to prevent natural failure, manage risk, and facilitate replanting. |

***Image shows fungal fruiting bodies circled.***

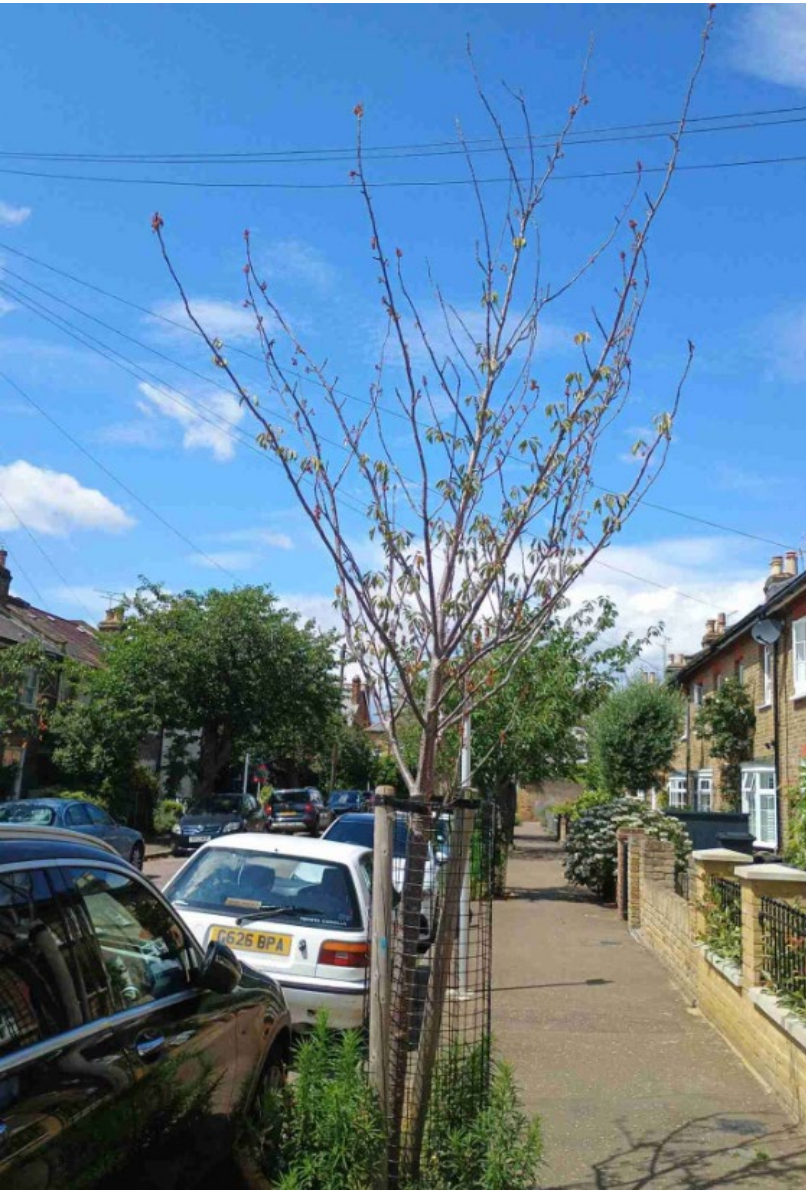
| Location | Outside 48/50 |

| Inspection findings/reason for exemption | This tree is moribund; removal is required to prevent natural failure, manage risk, and facilitate replanting |

Image shows moribund tree in street scene.

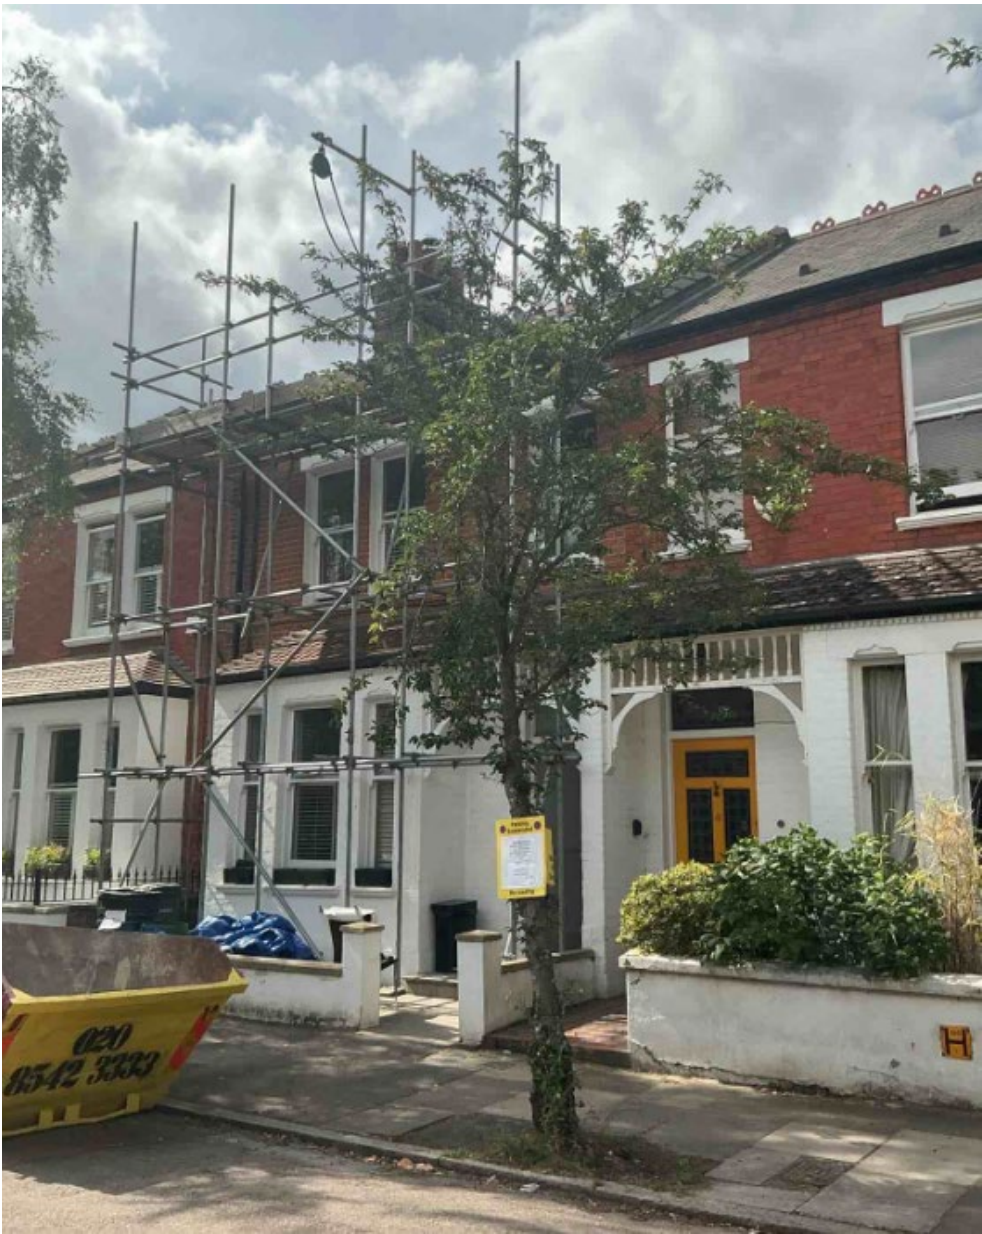
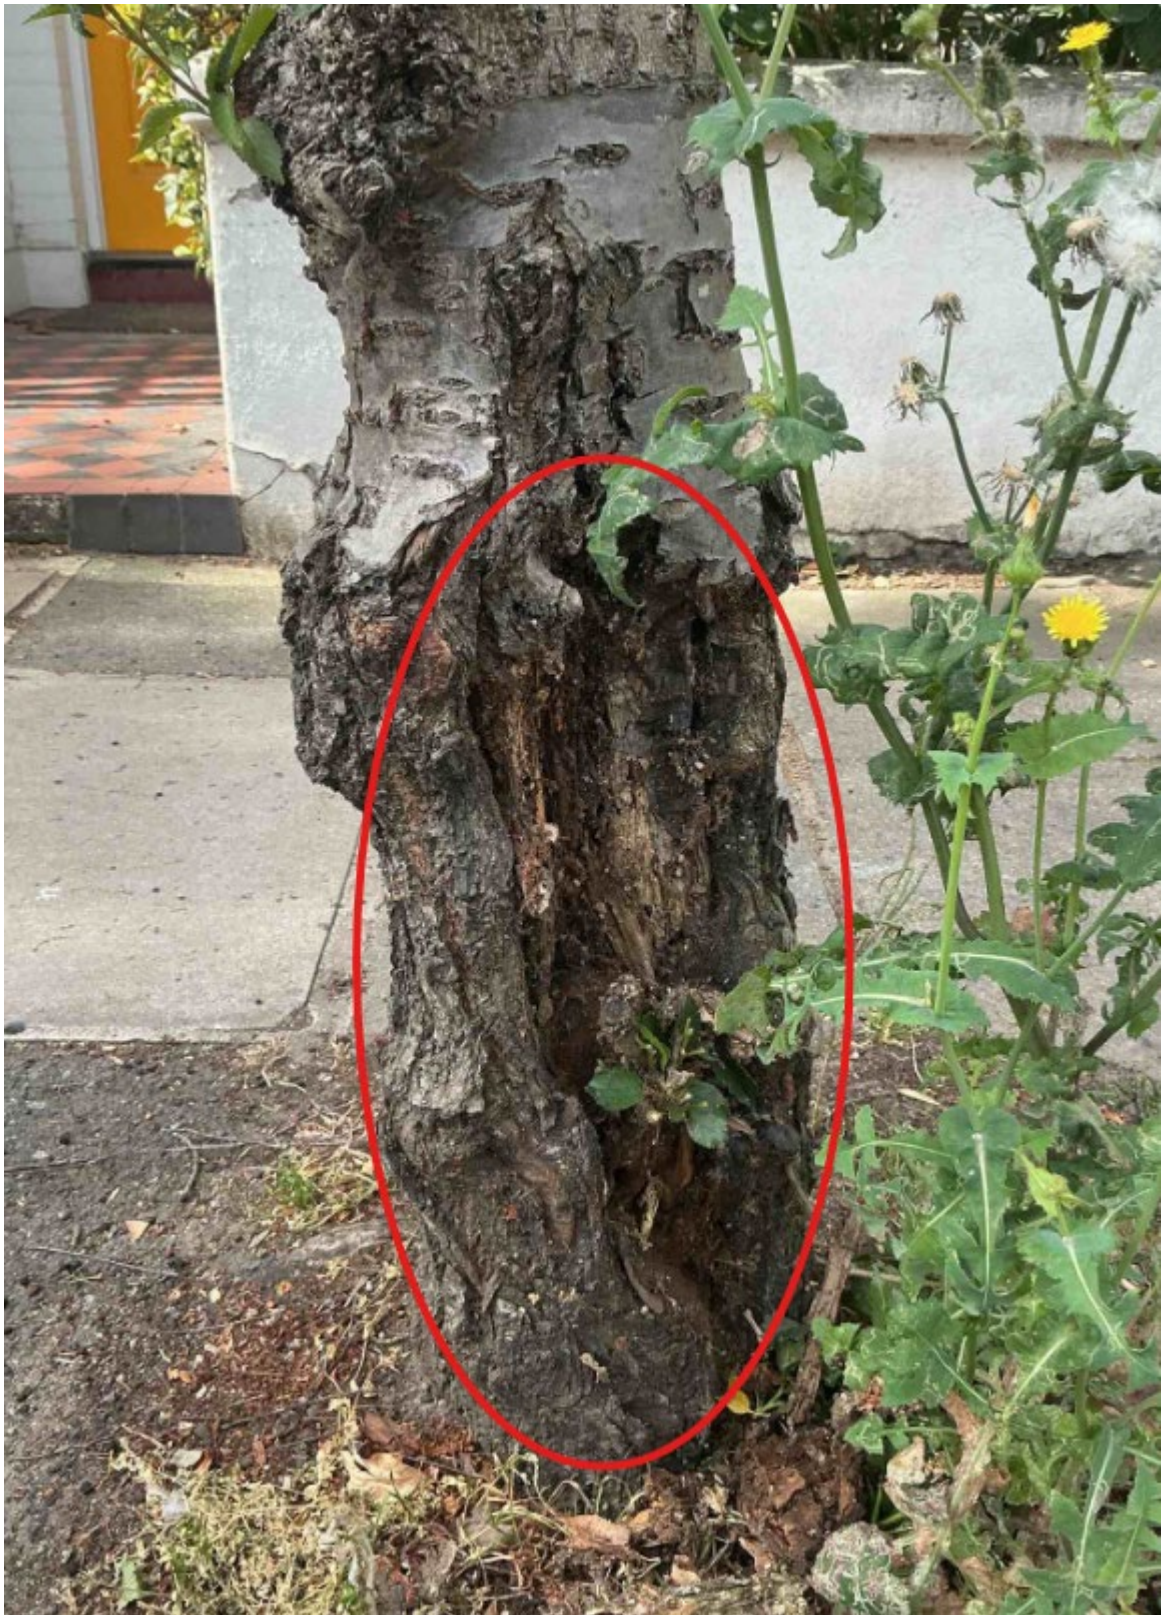
| Location | Outside 4 |

| Inspection findings/reason for exemption | Investigation with a probe has revealed an unacceptable amount of decay beyond the visible cavities at the base of the trunk. Removal is required to prevent natural failure, manage risk, and facilitate replanting. |

***Image shows cavity at base of trunk circled.***
