# June 2026 Highways Reactive Tree Works Programme

A survey of the Highway trees in the ward of Hampton North has been undertaken; this was conducted by specialist arboricultural officers as part of the scheduled 4 yearly detailed inspection regime that has been devised for all Council highway and parks trees.

Recent reactive inspections have identified the need for 33 individual tree work operations to take place. This work will now be issued to the Council’s arborist contractor KPS, for completion over the summer period.

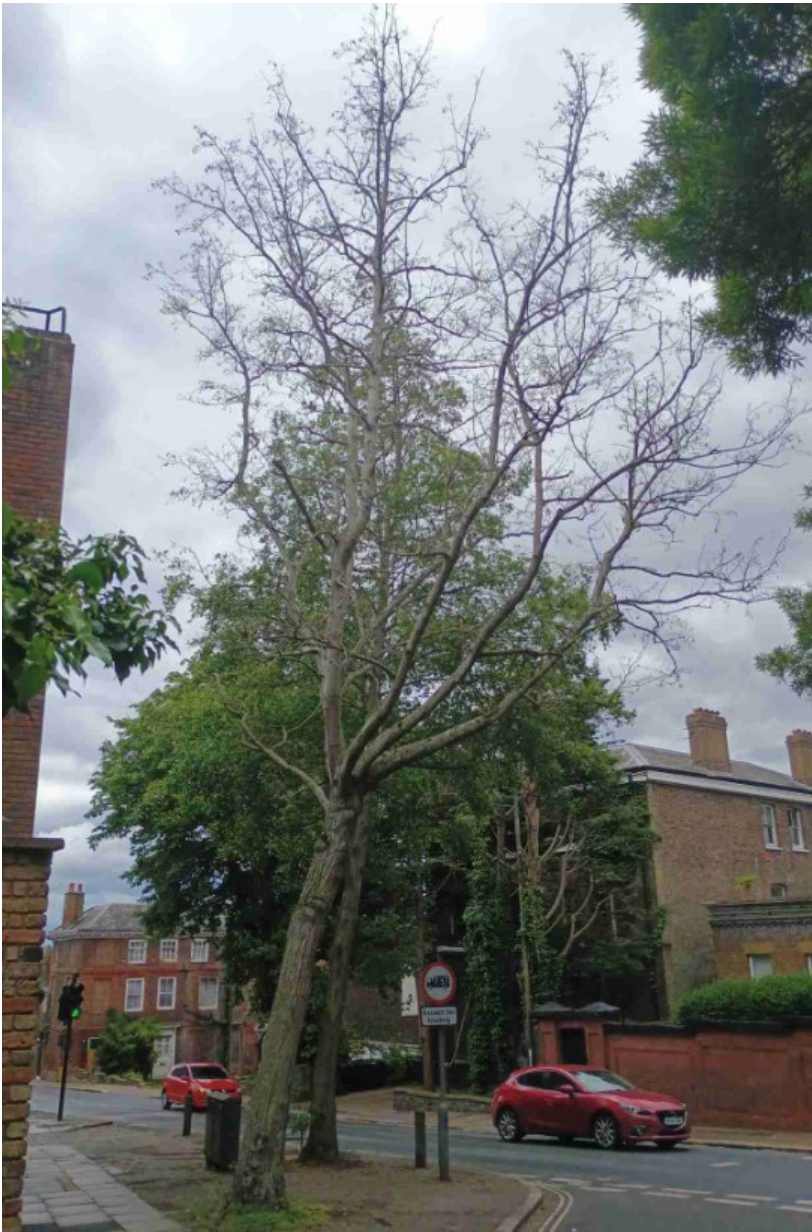
| Location | Outside 12 |

| Inspection findings/reason for exemption | This tree is dead; removal is required to prevent natural failure, manage risk, and facilitate replanting |

Image shows dead tree in street scene.

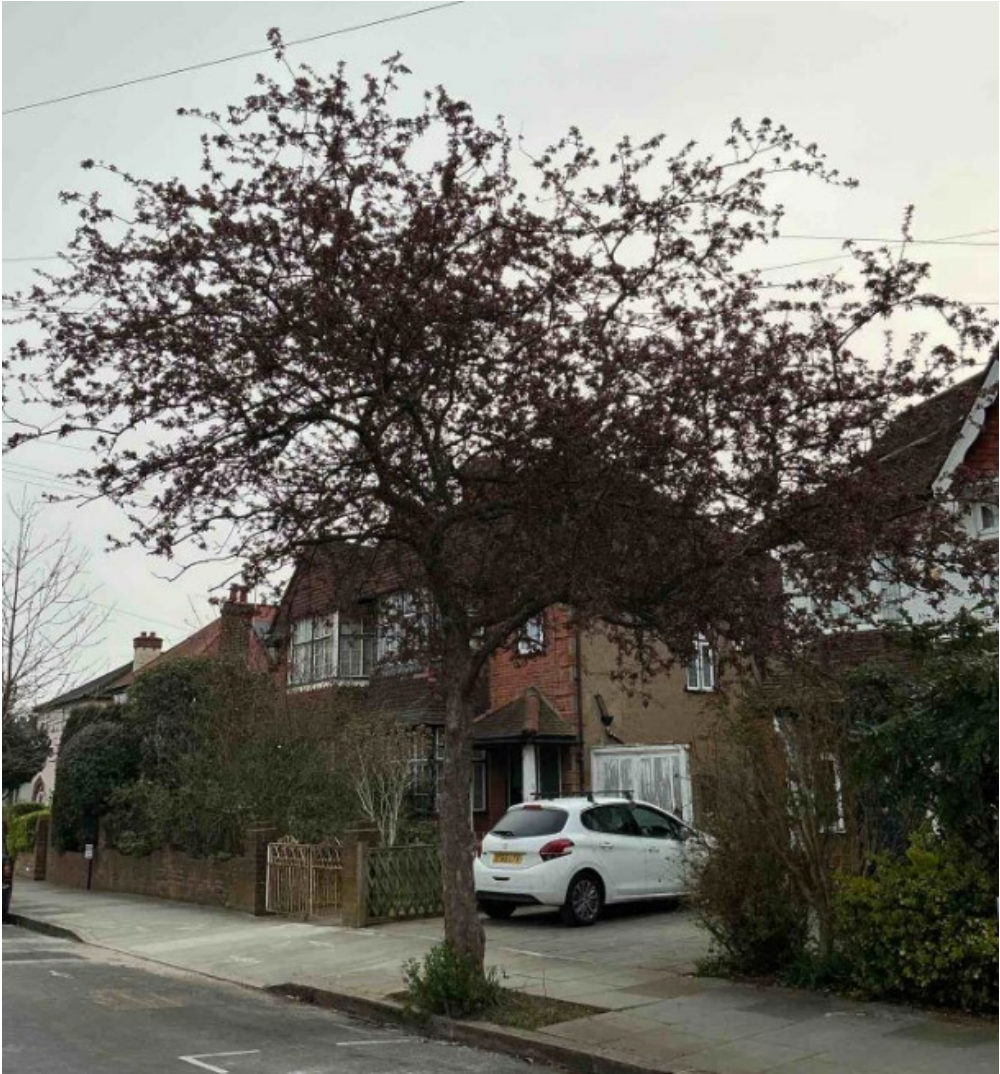
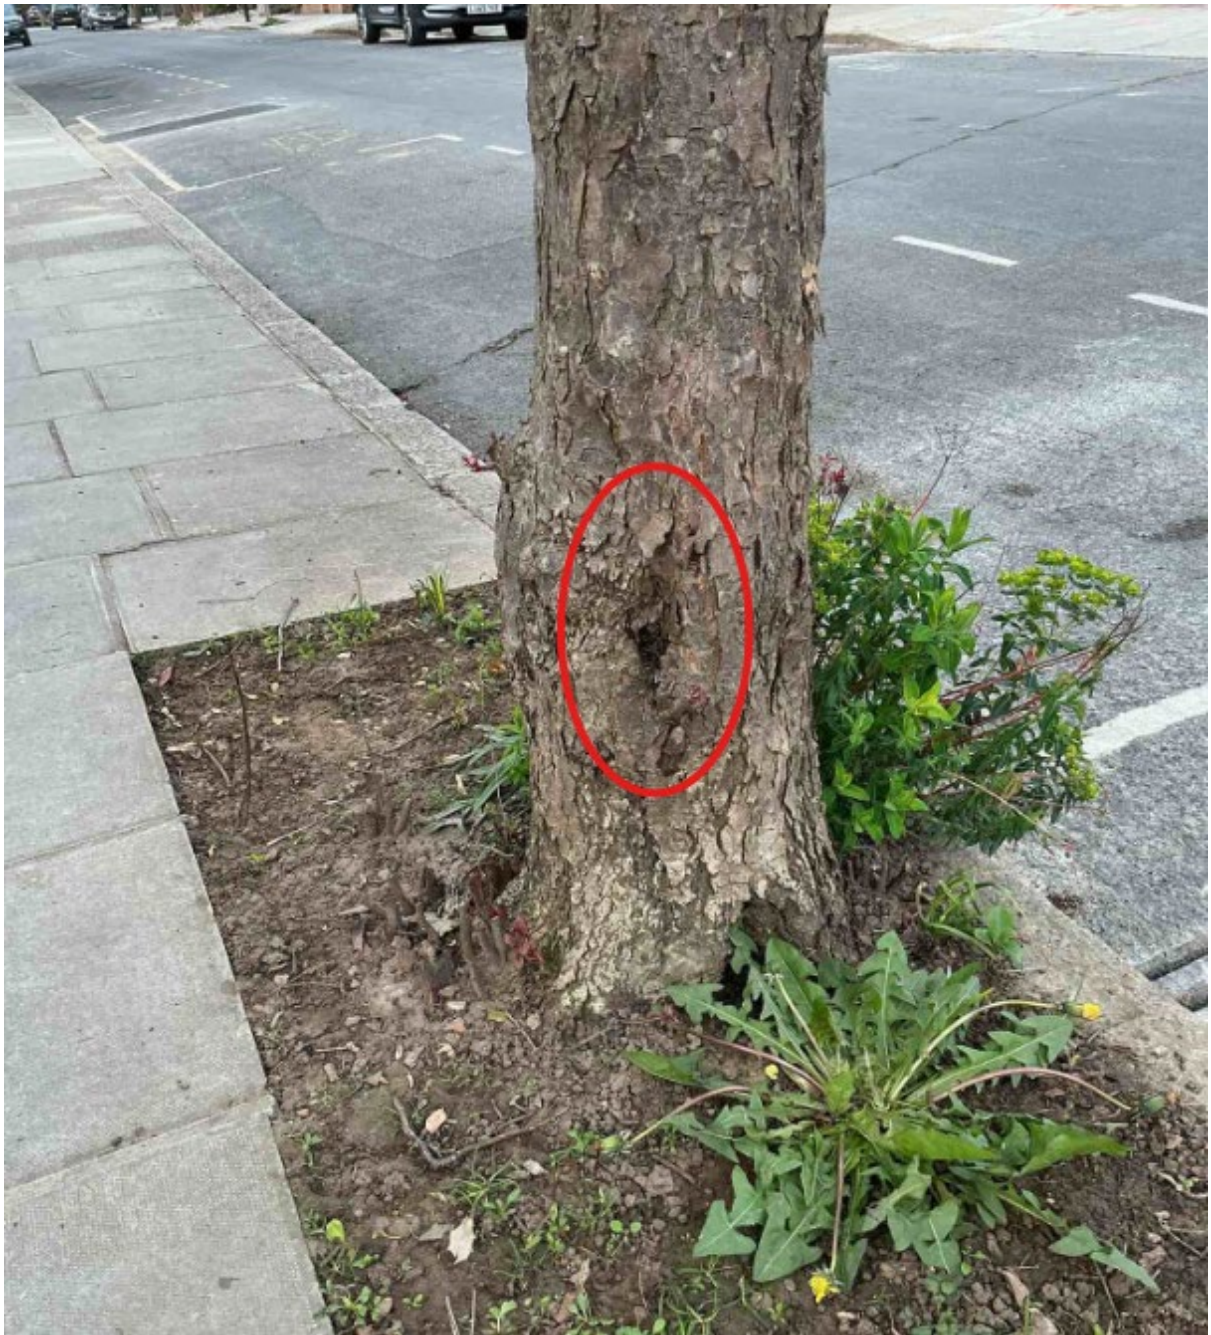
| Inspection findings/reason for exemption | Investigation with a probe and a resonance test with a sounding hammer has revealed an unacceptable amount of decay beyond the visible cavities at the base of the trunk. Removal is required to prevent natural failure, manage risk, and facilitate replanting. |

***Image shows cavity at base of trunk circled.***
