# January 2026 - Reactive Tree Works Programme

Dated 24/02/2026

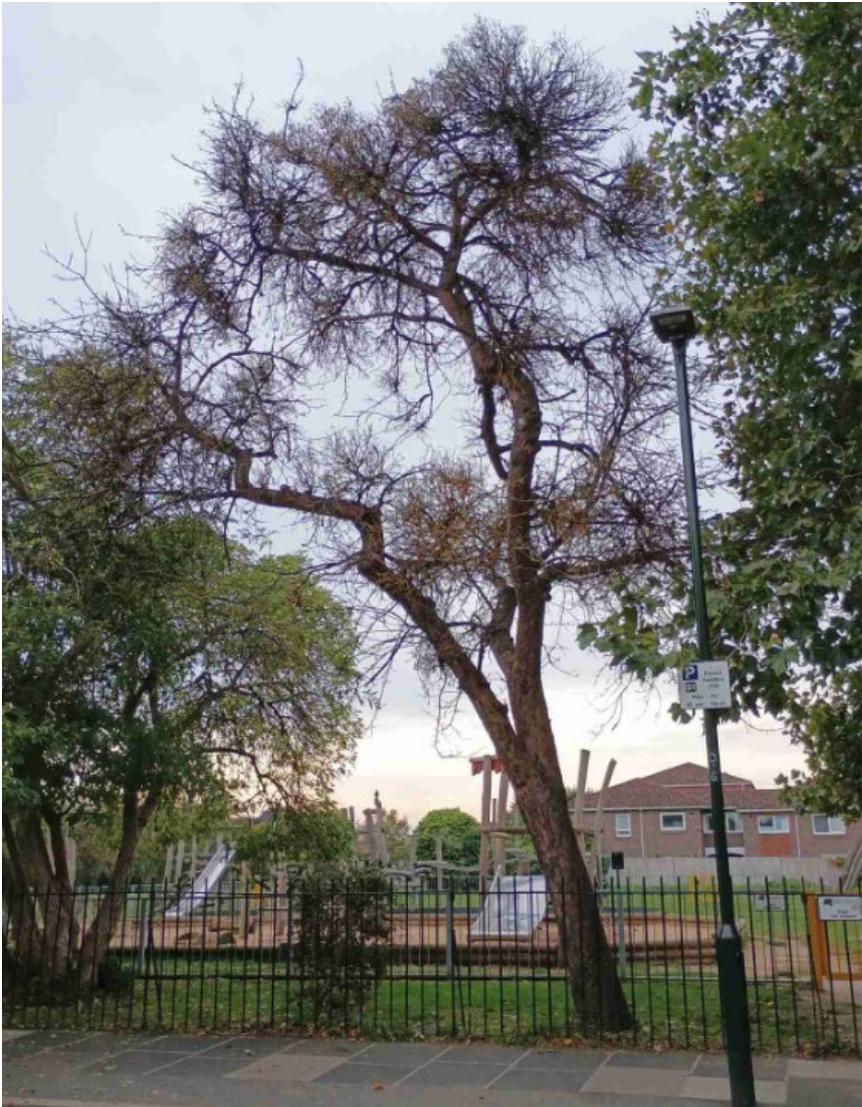
<b>Ward</b>	Barnes
<b>Road</b>	Suffolk Road
<b>Location</b>	Suffolk Road Recreation Ground- /// caller.amuse.chemistry
<b>Species</b>	Apple ( <i>Malus sp.</i> )
<b>Height</b>	9.0m
<b>Physiological Condition</b>	Dead
<b>Structural Condition</b>	Fair
<b>Inspection findings/reason for exemption</b>	This tree is dead; removal is required to prevent natural failure, manage risk, and facilitate replanting

**Image shows dead tree in park scene**

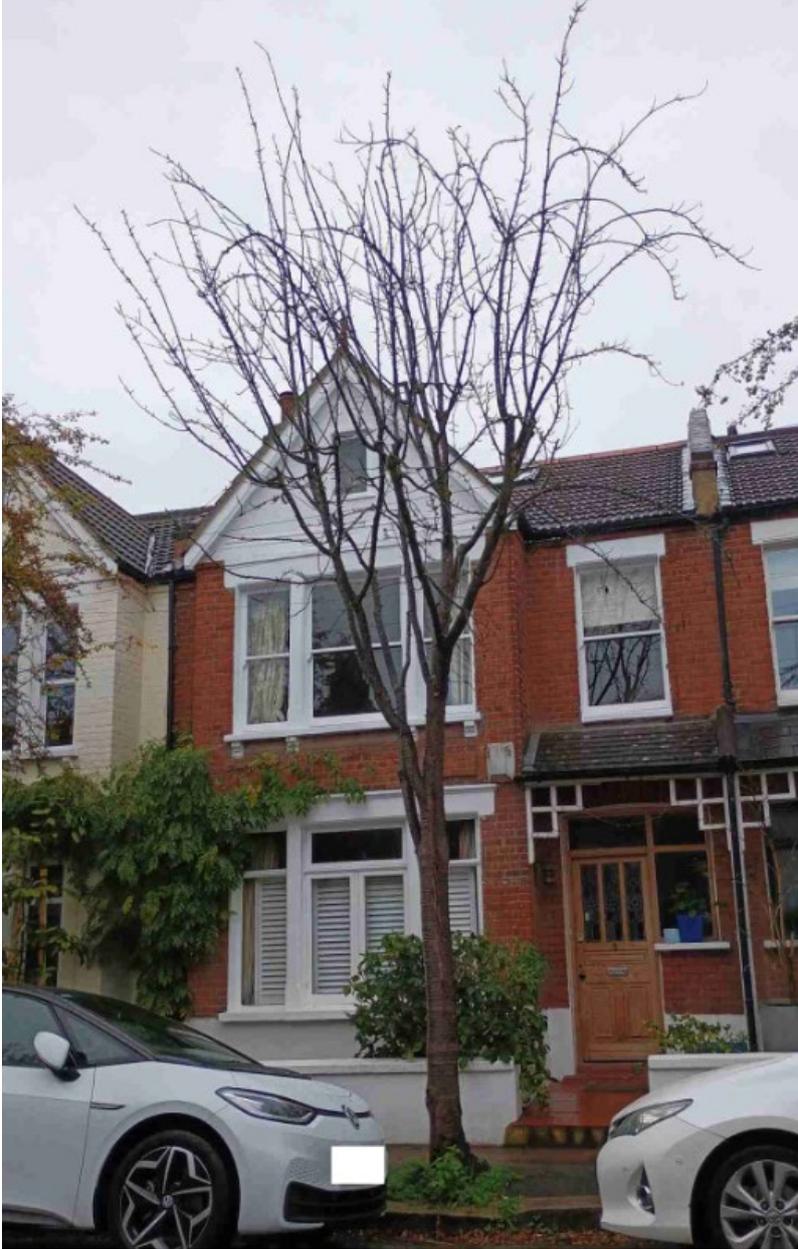
<b>Ward</b>	Barnes
<b>Road</b>	St Anns Road
<b>Location</b>	Outside 5
<b>Species</b>	Schmitt's cherry ( <i>Prunus x schmittii</i> )
<b>Height</b>	8.5m
<b>Physiological Condition</b>	Dead
<b>Structural Condition</b>	Fair
<b>Inspection findings/reason for exemption</b>	This tree is dead; removal is required to prevent natural failure, manage risk, and facilitate replanting

**Image shows dead tree in street scene**

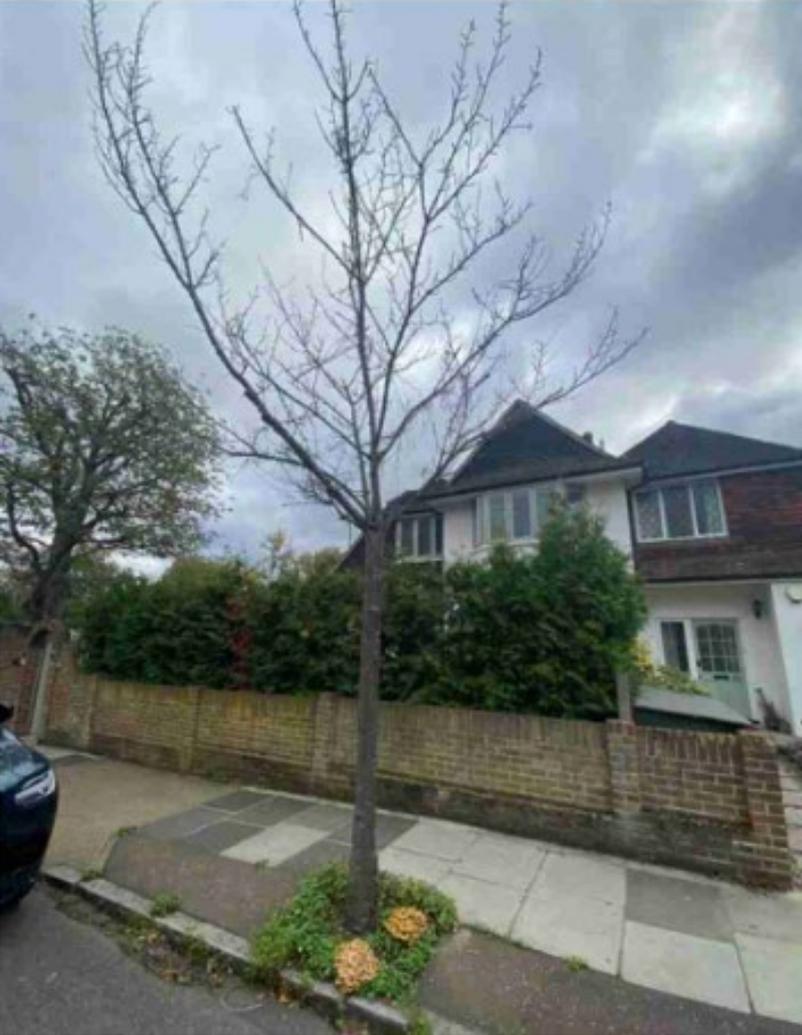
<b>Ward</b>	East Sheen
<b>Road</b>	Hertford Avenue
<b>Location</b>	Outside 24/26
<b>Species</b>	Wild cherry ( <i>Prunus avium</i> )
<b>Height</b>	6.5m
<b>Physiological Condition</b>	Fair
<b>Structural Condition</b>	Poor
<b>Inspection findings/reason for exemption</b>	Fungal fruiting bodies of the decay fungi <i>Armillaria sp.</i> are present at the base of this tree. Colonisation by this fungus causes a white rot of the roots and butt that can cause entire tree failure. Removal is required to prevent natural failure, manage risk, and facilitate replanting

Image shows tree in street scene

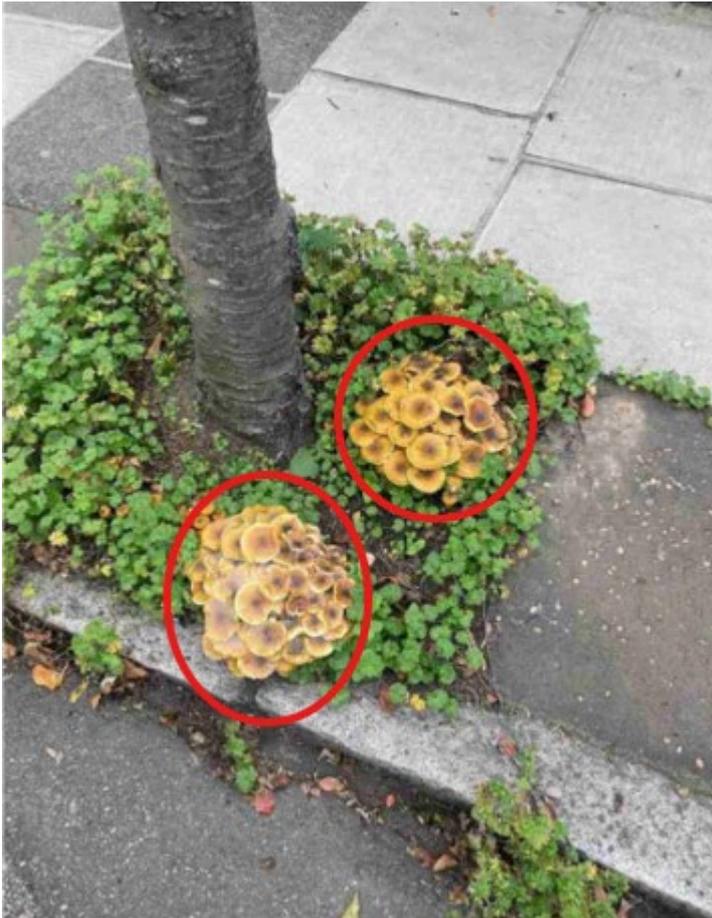
***Image shows fungal fruiting bodies circled at base of tree.***

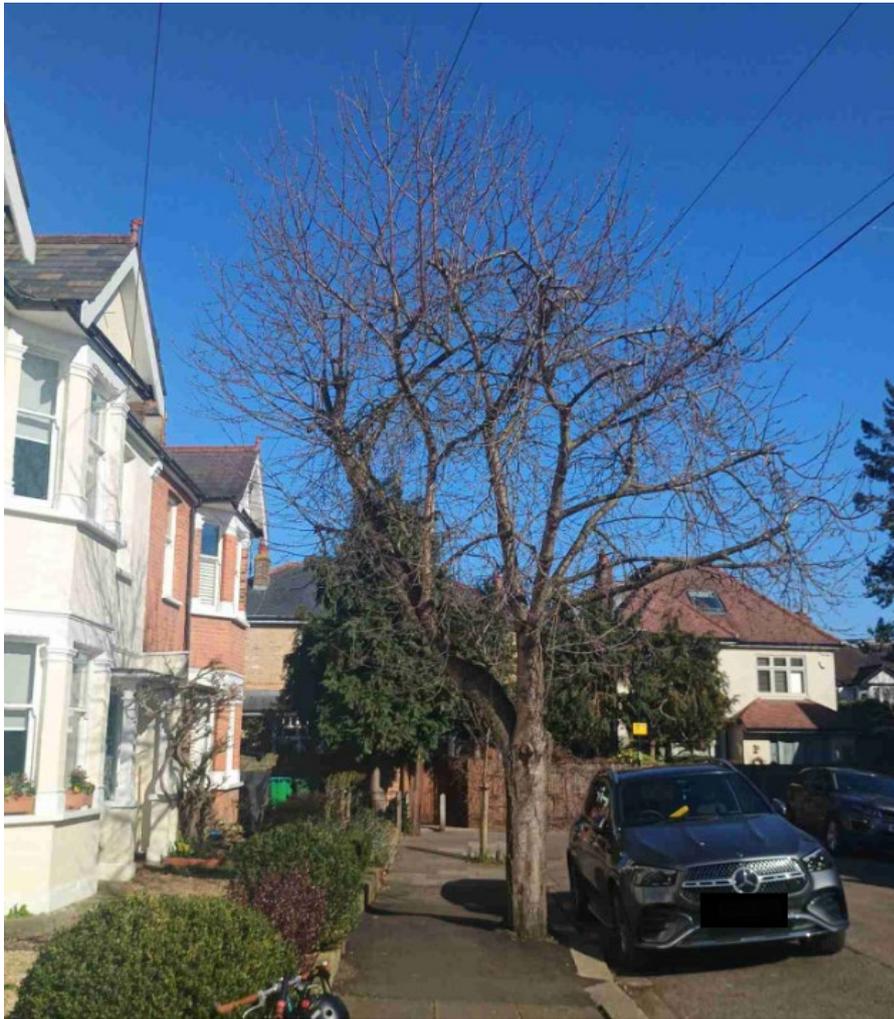
<b>Ward</b>	East Sheen
<b>Road</b>	Spencer Gardens
<b>Location</b>	Outside 21
<b>Species</b>	Wild cherry ( <i>Prunus avium</i> )
<b>Height</b>	6.5m
<b>Physiological Condition</b>	Good
<b>Structural Condition</b>	Good
<b>Inspection findings/reason for exemption</b>	This tree is being removed under 'Duty to Consult' as its roots have caused substantial damage to the footway & kerb causing a significant trip hazard and limiting accessibility for people with disabilities or mobility issues. Unfortunately, this cannot be remedied by pruning of roots, without seriously harming the trees health and stability, thereby rendering it unstable and a hazard to the public. There were no responses to the consultation and so the Council received no objections to the tree removal. Removal will facilitate replanting.

Image shows tree is street scene.

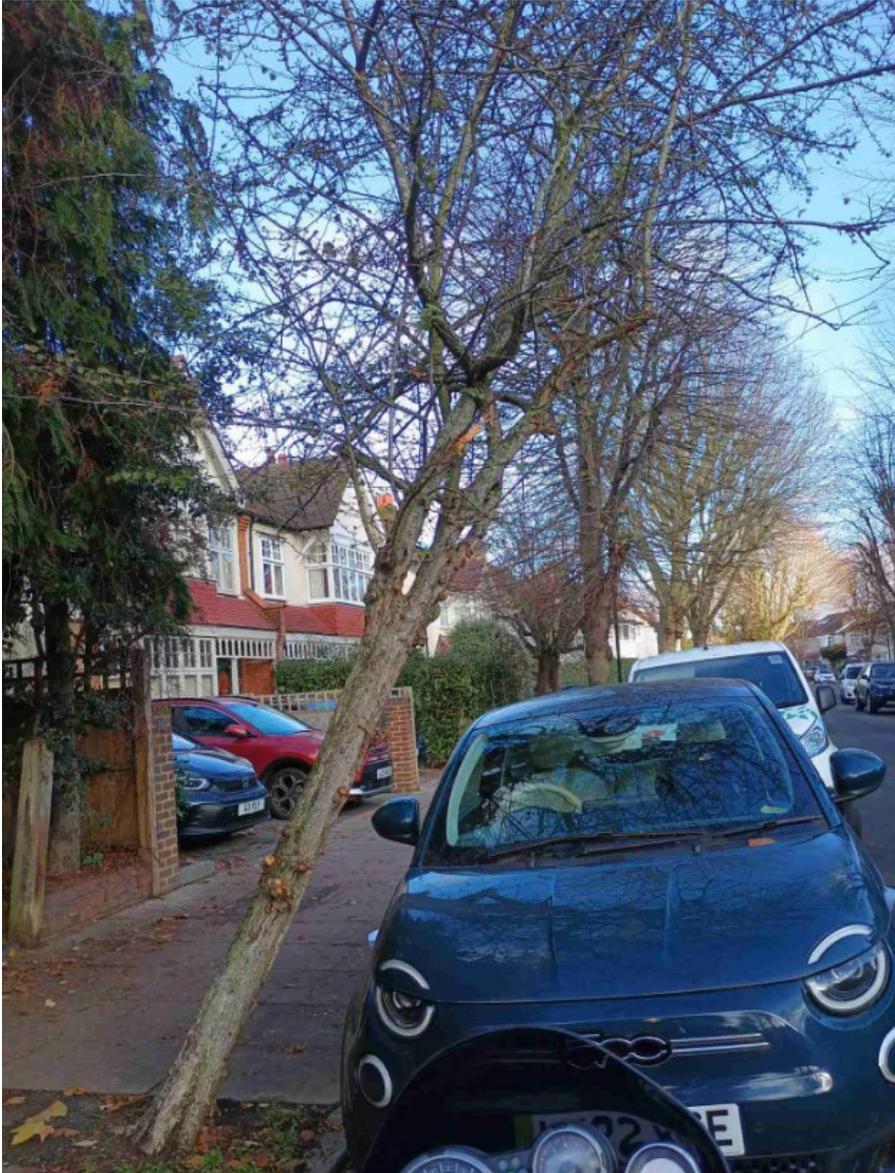
Ward	East Sheen
Road	Richmond Park Road
Location	Outside 84
Species	Common hawthorn ( <i>Crataegus monogyna</i> )
Height	7.5m
Physiological Condition	Fair
Structural Condition	Fair
Inspection findings/reason for exemption	This tree is leaning into the road, creating an unacceptable obstruction to highway users. Removal is required to eliminate the obstruction and facilitate replanting.

**Image shows tree is street scene.**

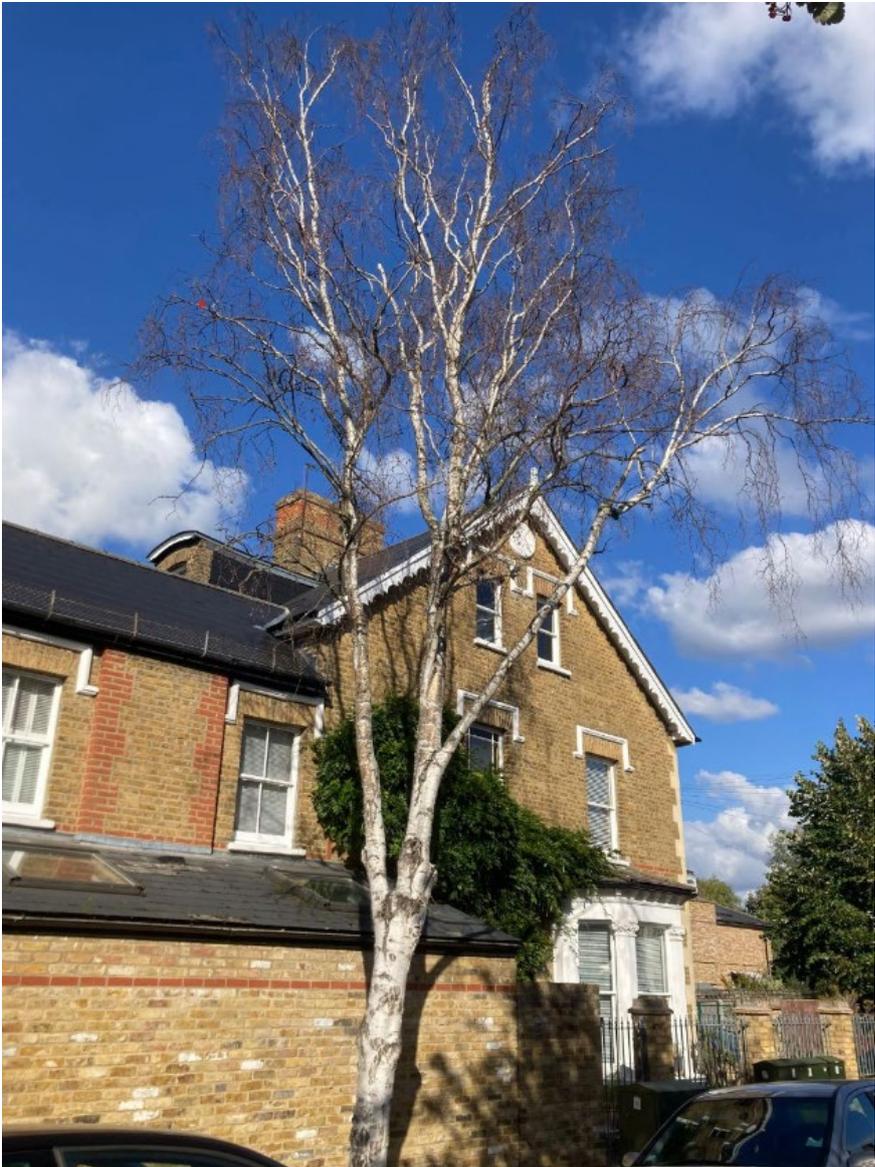
<b>Ward</b>	Fulwell and Hampton Hill
<b>Road</b>	Anlaby Road
<b>Location</b>	Outside 44
<b>Species</b>	Birch ( <i>Betula sp.</i> )
<b>Height</b>	9.0m
<b>Physiological Condition</b>	Dead
<b>Structural Condition</b>	Fair
<b>Inspection findings/reason for exemption</b>	This tree is dead; removal is required to prevent natural failure, manage risk, and facilitate replanting

**Image shows dead tree in street scene.**

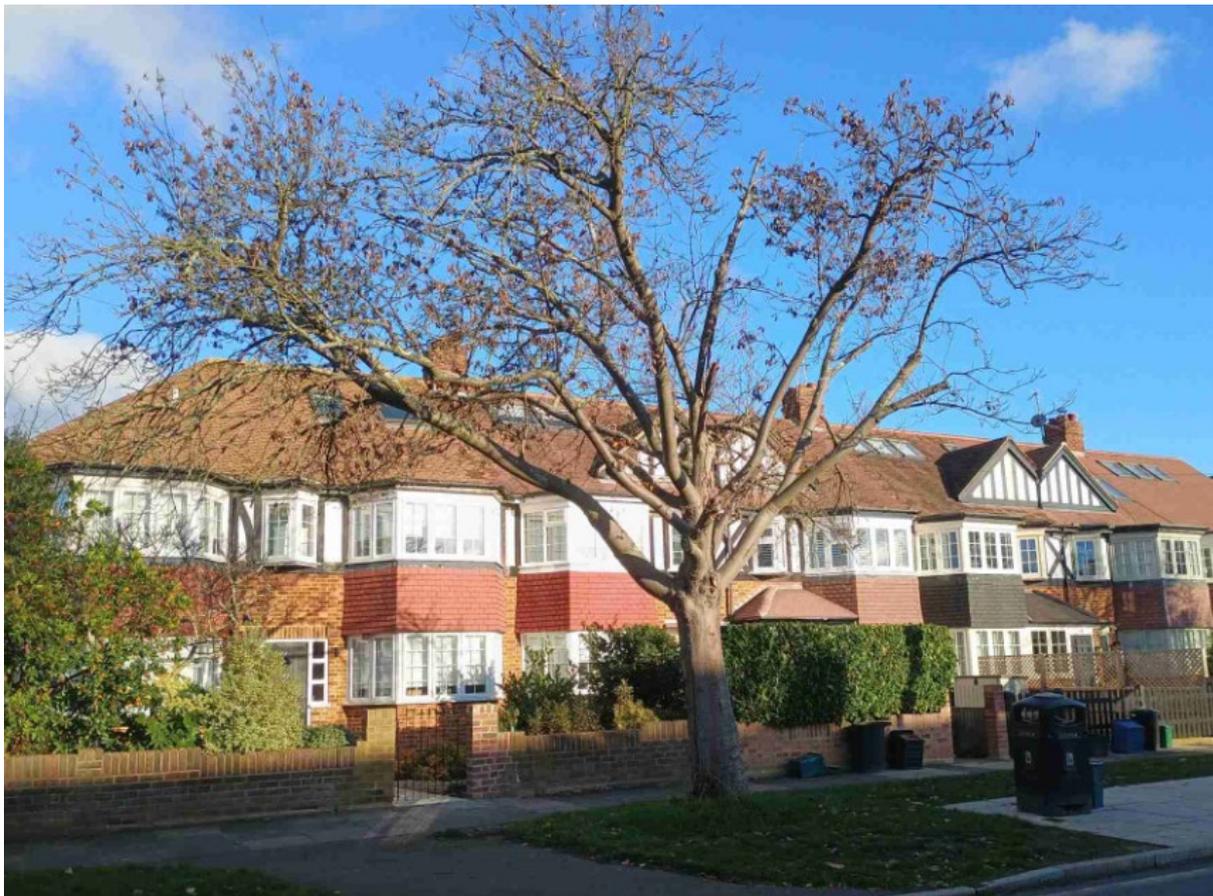
<b>Ward</b>	Ham, Petersham and Richmond Riverside
<b>Road</b>	Broughton Avenue
<b>Location</b>	Outside 32
<b>Species</b>	Bastard Service Tree ( <i>Sorbus x thuringiaca</i> )
<b>Height</b>	7.5m
<b>Physiological Condition</b>	Fair
<b>Structural Condition</b>	Poor
<b>Inspection findings/reason for exemption</b>	Fungal fruiting bodies of the decay fungi <i>Armillaria sp.</i> are present at the base of this tree. Colonisation by this fungus causes a white rot of the roots and butt that can cause entire tree failure. Crown dieback could correlate with the parasite present. Removal is required to prevent natural failure, manage risk, and facilitate replanting.

**Image shows tree in street scene.**

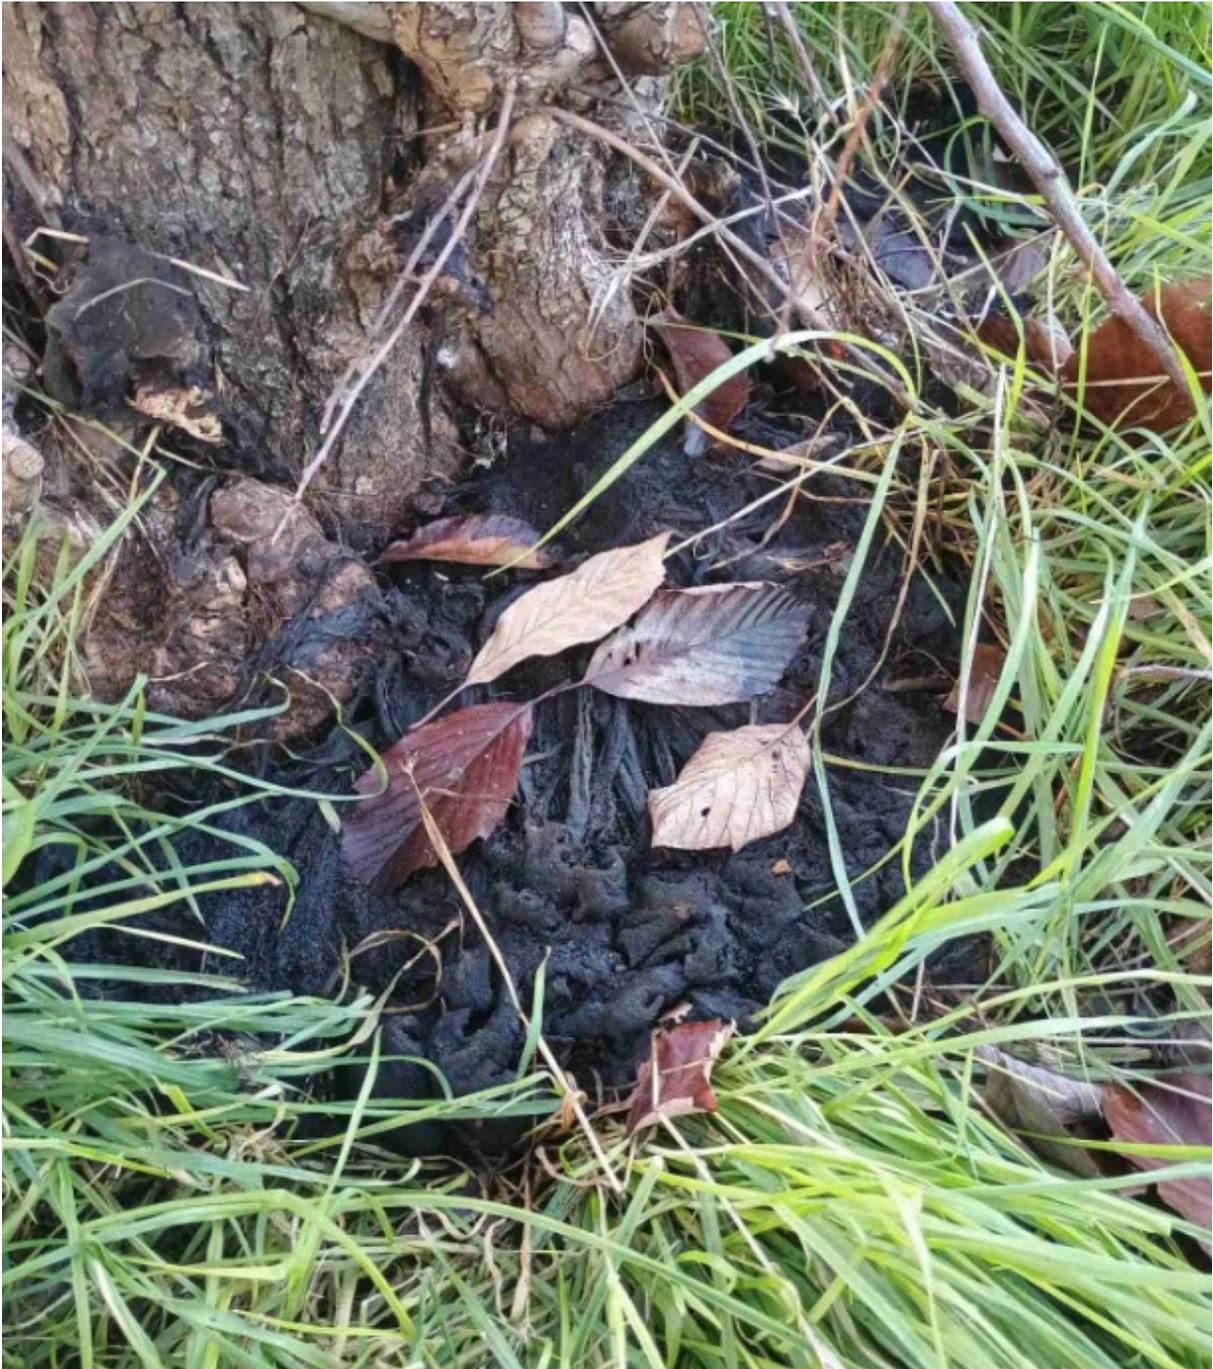
***Image shows fungal fruiting bodies at base of trunk.***

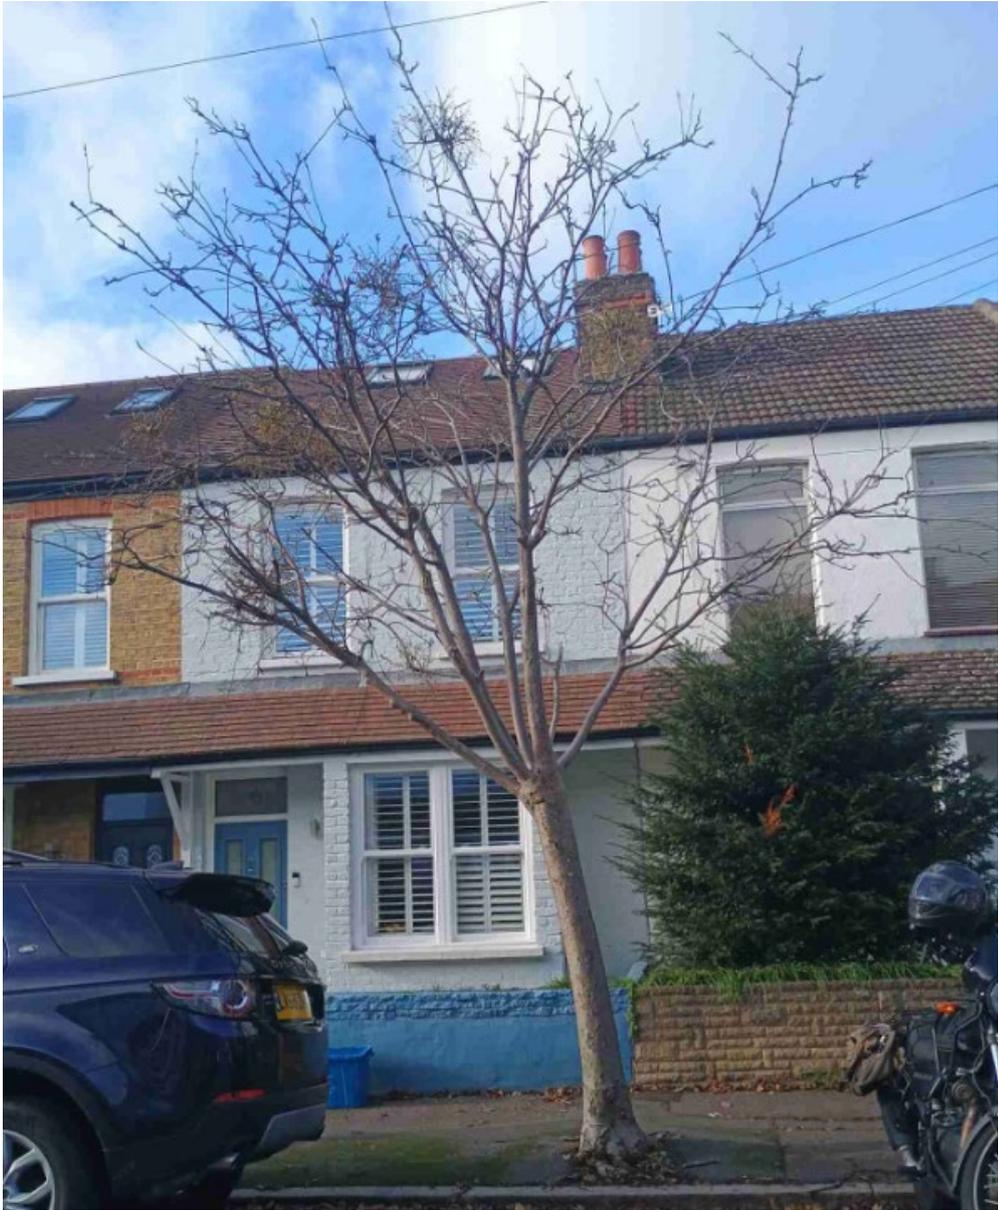
Ward	Hampton
Road	Malvern Road
Location	Outside 34-36
Species	Rowan ( <i>Sorbus aucuparia</i> )
Height	6.0m
Physiological Condition	Dead
Structural Condition	Fair
Inspection findings/reason for exemption	This tree is moribund; removal is required to prevent natural failure, manage risk, and facilitate replanting

**Image shows moribund tree in street scene.**

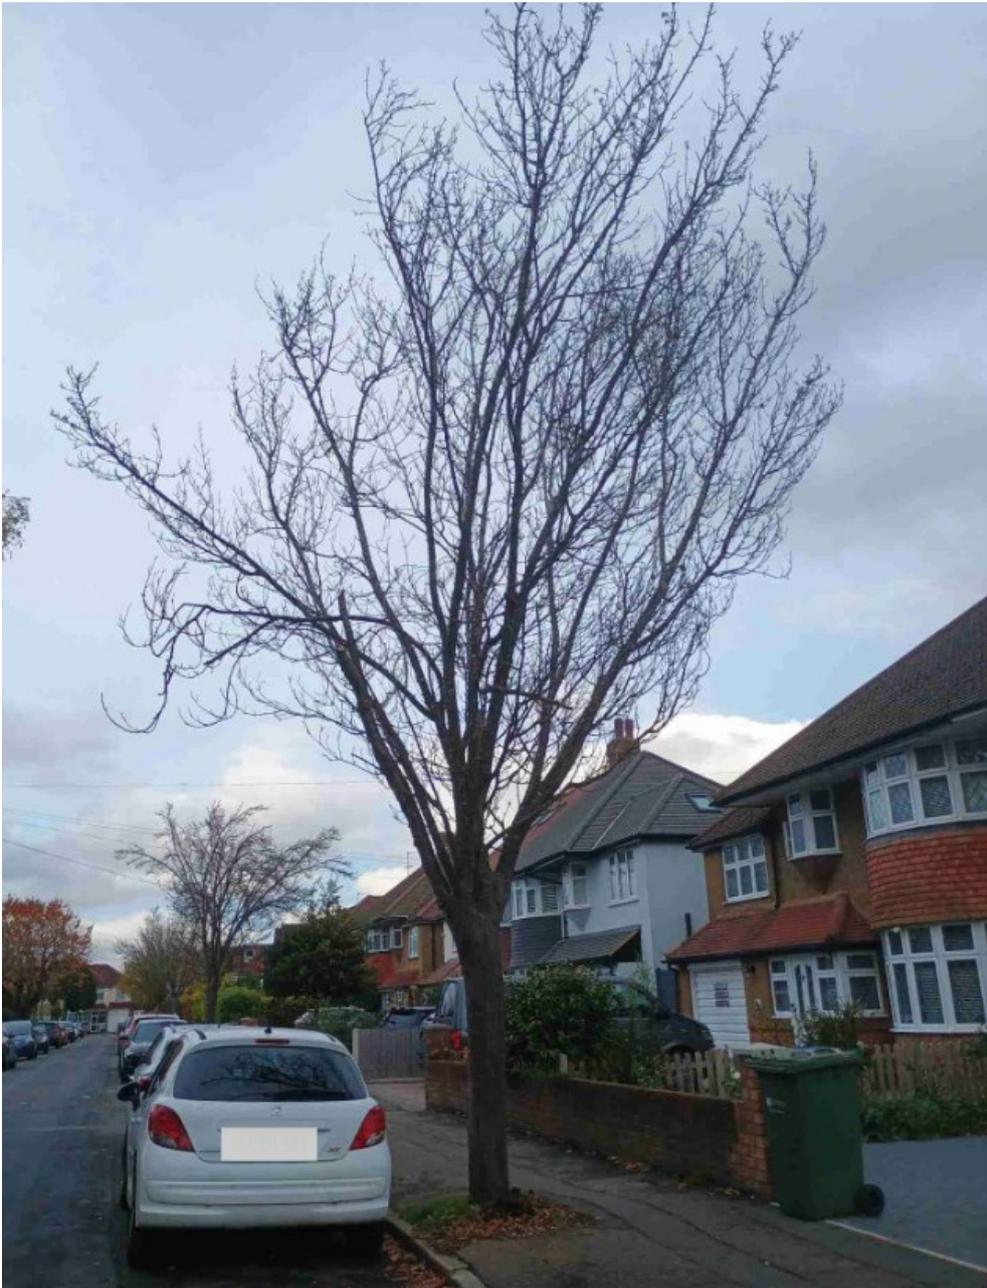
<b>Ward</b>	Hampton
<b>Road</b>	Ripley Road
<b>Location</b>	Outside 24
<b>Species</b>	Cherry ( <i>Prunus sp.</i> )
<b>Height</b>	9.0m
<b>Physiological Condition</b>	Dead
<b>Structural Condition</b>	Fair
<b>Inspection findings/reason for exemption</b>	This tree is dead; removal is required to prevent natural failure, manage risk, and facilitate replanting

**Images show dead tree in street scene.**

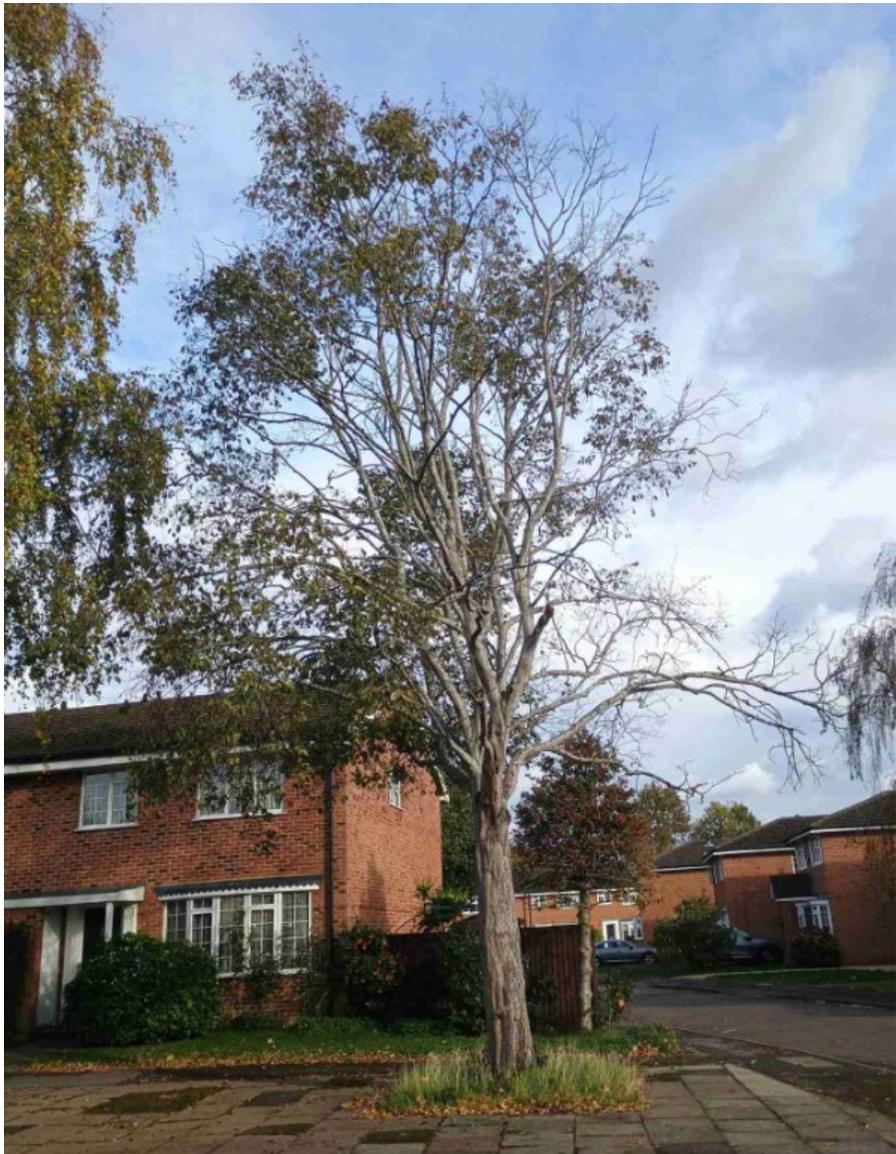
Ward	Hampton North
Road	Birchwood Grove
Location	Outside 2
Species	Black alder ( <i>Alnus glutinosa</i> )
Height	12.0m
Physiological Condition	Poor
Structural Condition	Fair
Inspection findings/reason for exemption	This tree is moribund; removal is required to prevent natural failure, manage risk, and facilitate replanting

**Image shows moribund tree in street scene.**

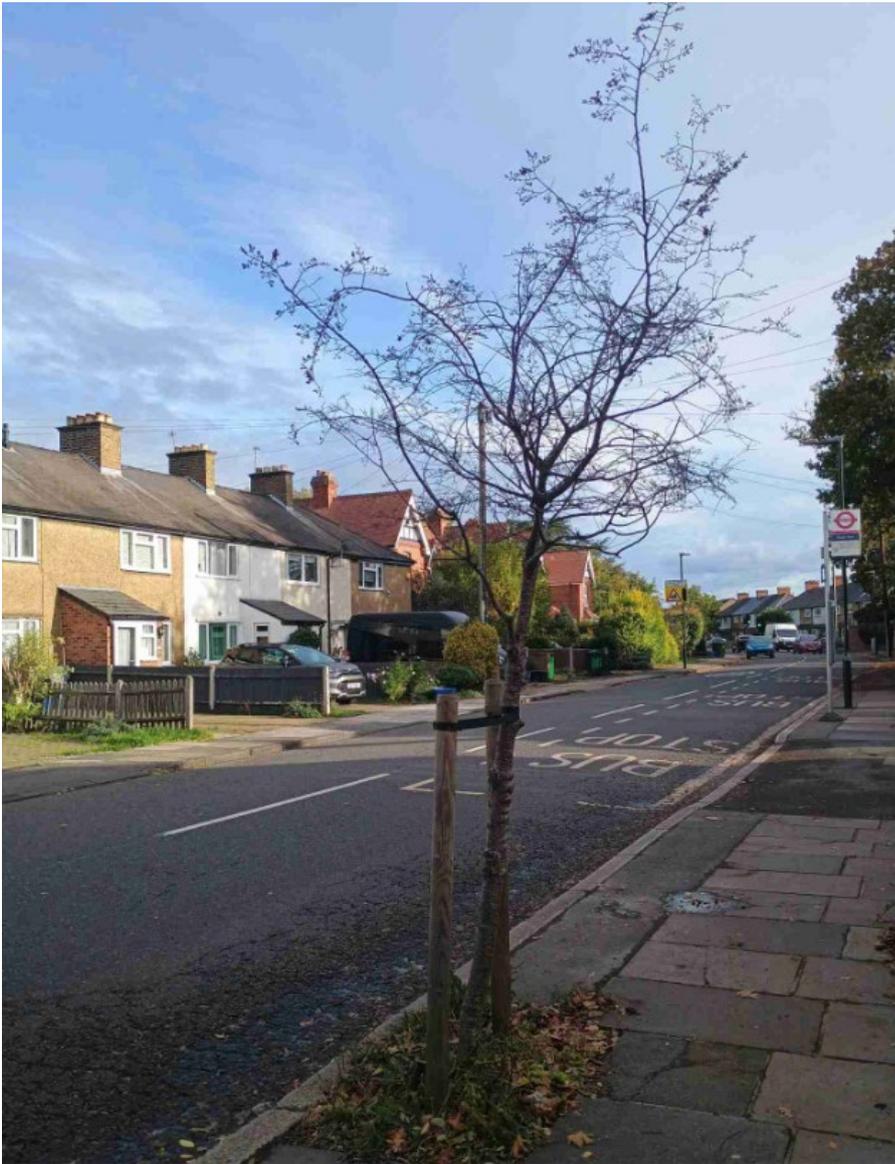
Ward	Hampton North
Road	Hanworth Road
Location	Outside 241
Species	Antarctic beech ( <i>Nothofagus antarctica</i> )
Height	3.0m
Physiological Condition	Dead
Structural Condition	Fair
Inspection findings/reason for exemption	This tree is dead; removal is required to prevent natural failure, manage risk, and facilitate replanting

Image shows dead tree in street scene.

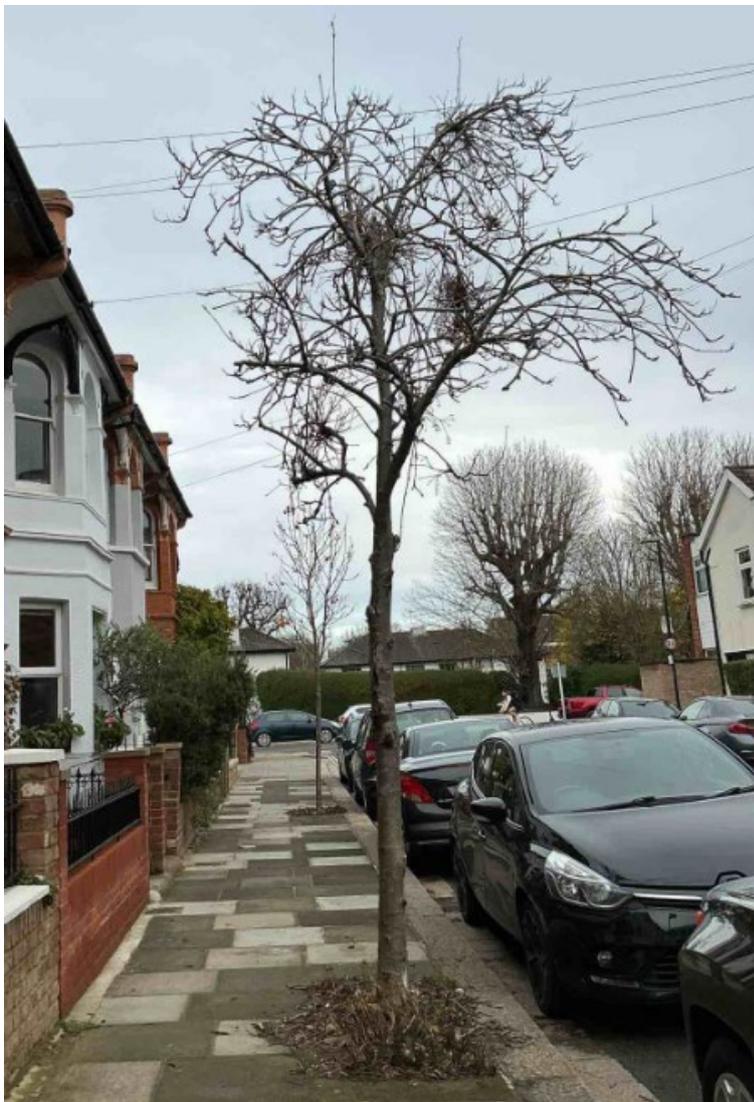
<b>Ward</b>	Hampton Wick and South Teddington
<b>Road</b>	Warwick Road
<b>Location</b>	Outside 4/5
<b>Species</b>	Rowan ( <i>Sorbus aucuparia</i> )
<b>Height</b>	3.0m
<b>Physiological Condition</b>	Dead
<b>Structural Condition</b>	Fair
<b>Inspection findings/reason for exemption</b>	This tree is dead; removal is required to prevent natural failure, manage risk, and facilitate replanting

**Image shows dead tree in street scene.**

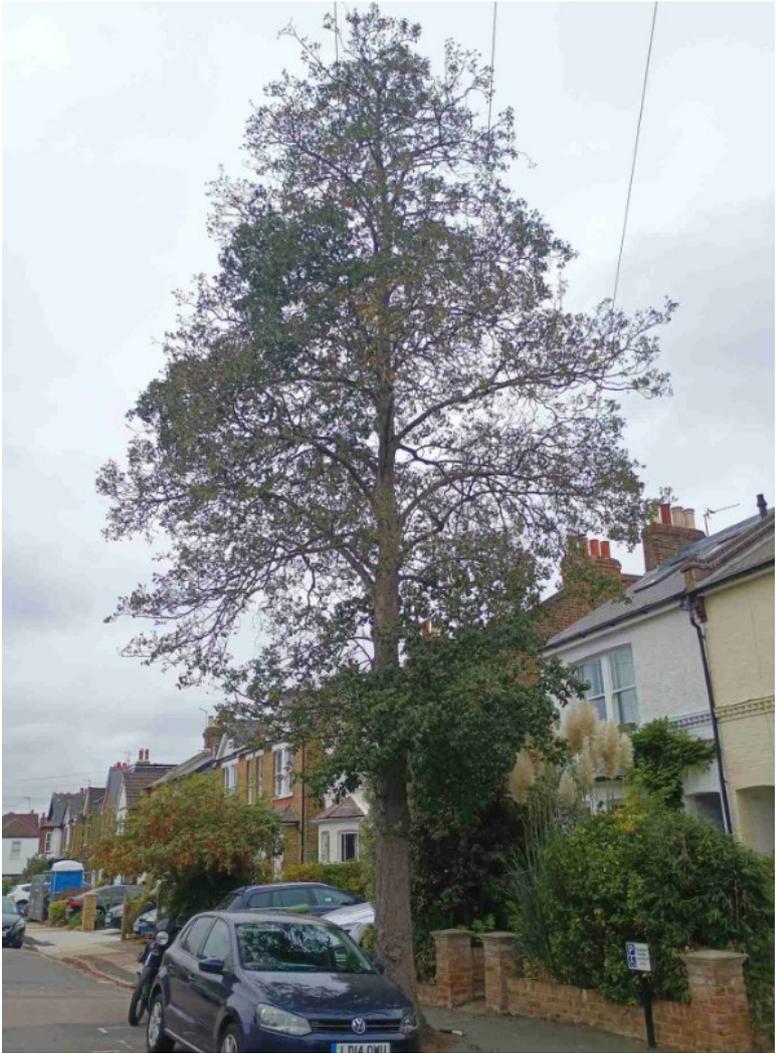
<b>Ward</b>	Hampton Wick and South Teddington
<b>Road</b>	St Winifreds Road
<b>Location</b>	Outside 25
<b>Species</b>	Italian alder ( <i>Alnus cordata</i> )
<b>Height</b>	16.0m
<b>Physiological Condition</b>	Poor
<b>Structural Condition</b>	Poor
<b>Inspection findings/reason for exemption</b>	A fungal fruiting body of the decay fungus <i>Ganoderma sp.</i> (resembling <i>Ganoderma resinaceum</i> or Lacquered bracket) is present on the trunk. Colonisation by this fungus results in white rot affecting the stem and root system, which can lead to structural failure through fracture or windthrow. Probe has identified trunk decay and crown dieback is evident and correlates with the presence of the decay fungi. Removal of the tree is recommended to prevent natural failure, manage risk, and facilitate replanting.

**Image shows moribund tree in street scene**

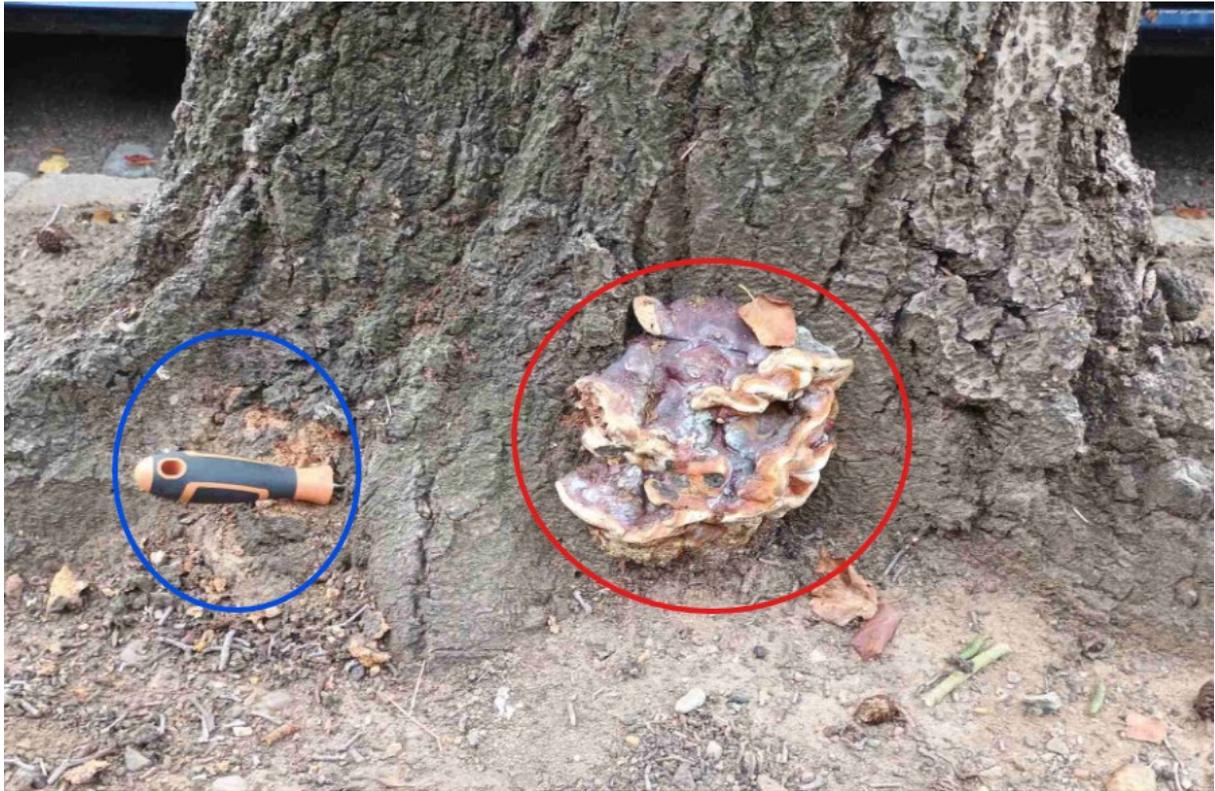
***Image shows probe and fungal fruiting body circled.***

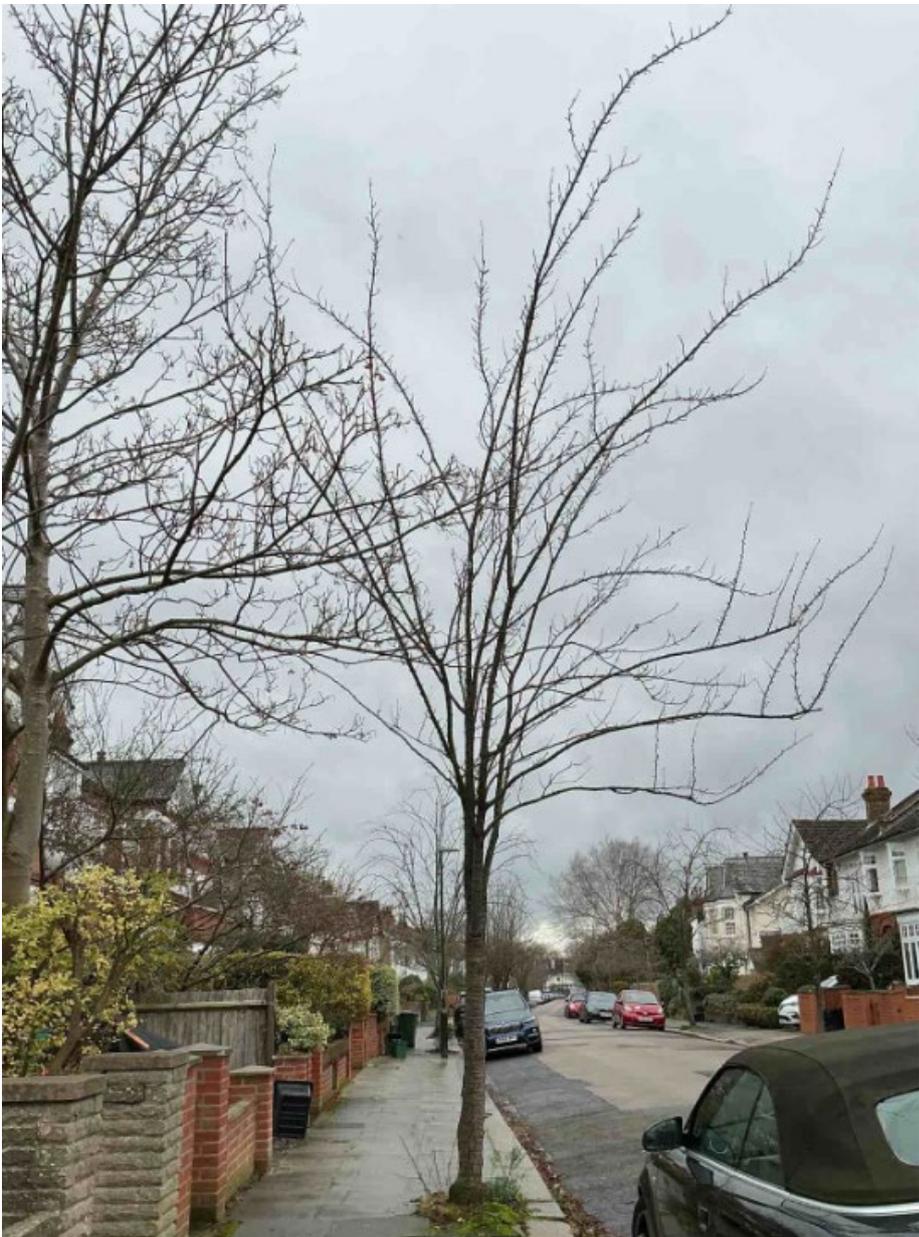
<b>Ward</b>	Hampton Wick and South Teddington
<b>Road</b>	King Edwards Grove
<b>Location</b>	Outside 56
<b>Species</b>	Hillier's cherry ( <i>Prunus x hillieri</i> 'Spire')
<b>Height</b>	7.0m
<b>Physiological Condition</b>	Fair
<b>Structural Condition</b>	Poor
<b>Inspection findings/reason for exemption</b>	This tree has bark delamination on the trunk, exposing longitudinal splits within the heartwood, indicating a loss of mechanical integrity. Removal is required to prevent natural failure, manage risk, and facilitate replanting

Image shows tree in street scene.

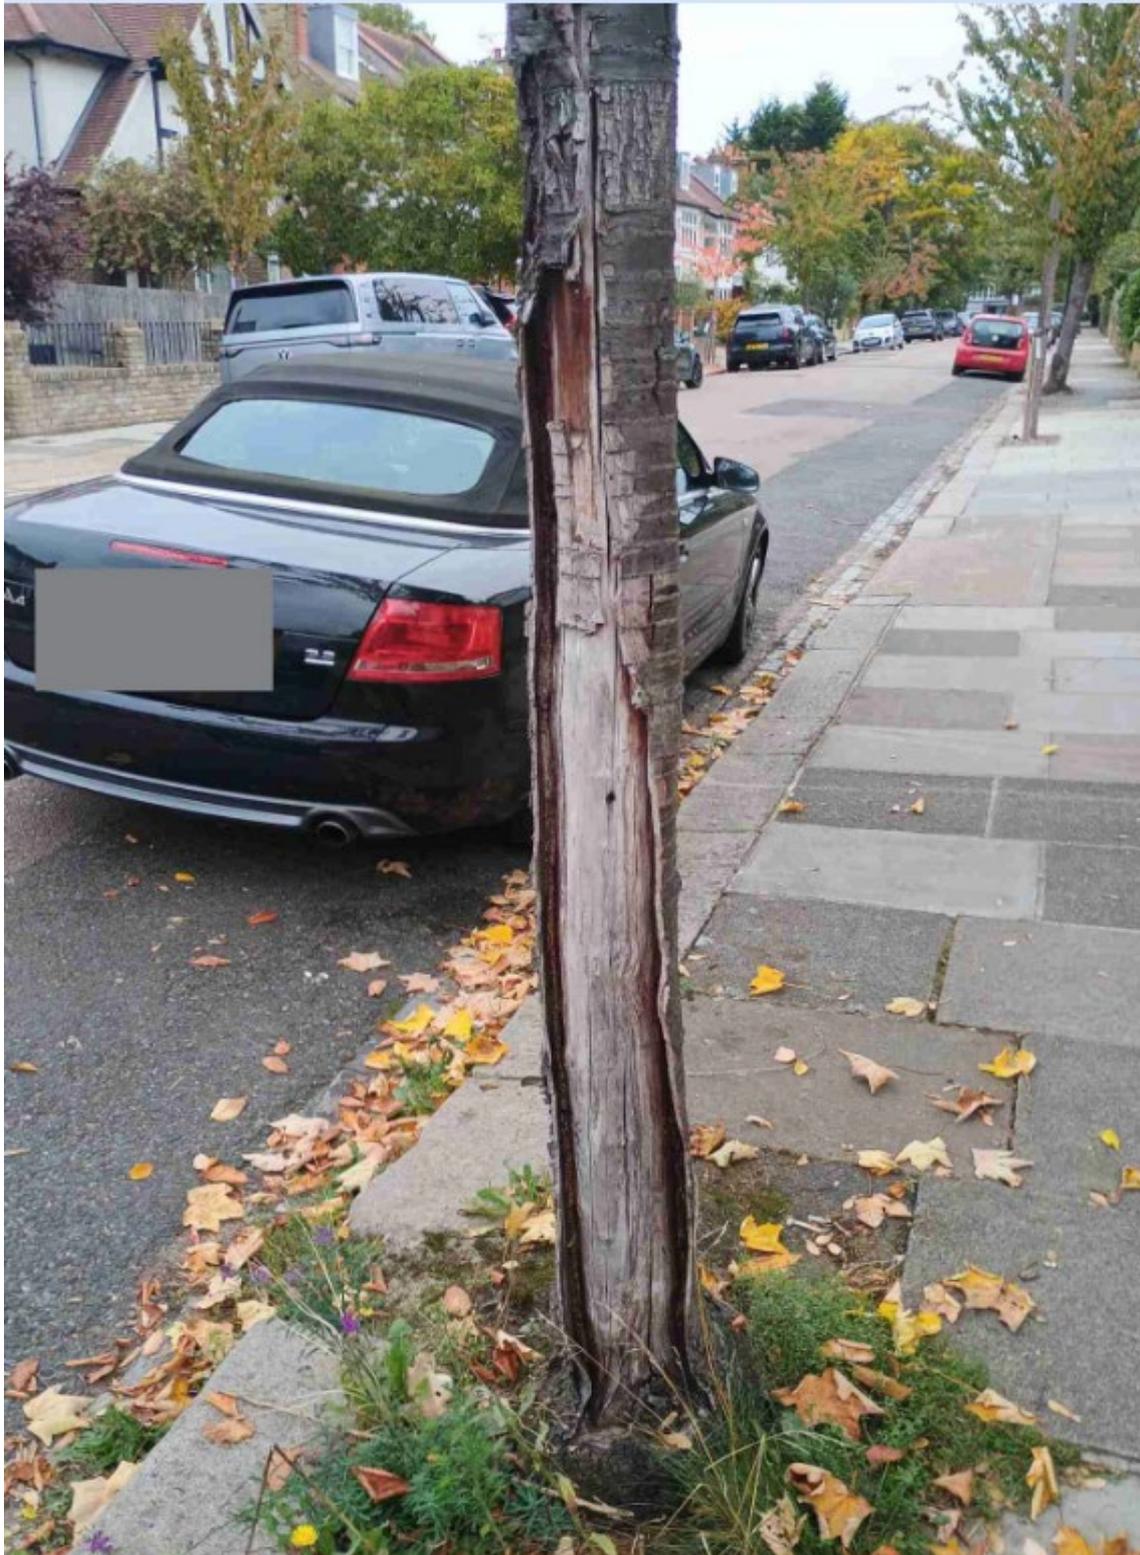
***Image shows bark delamination with splits in heartwood on trunk.***

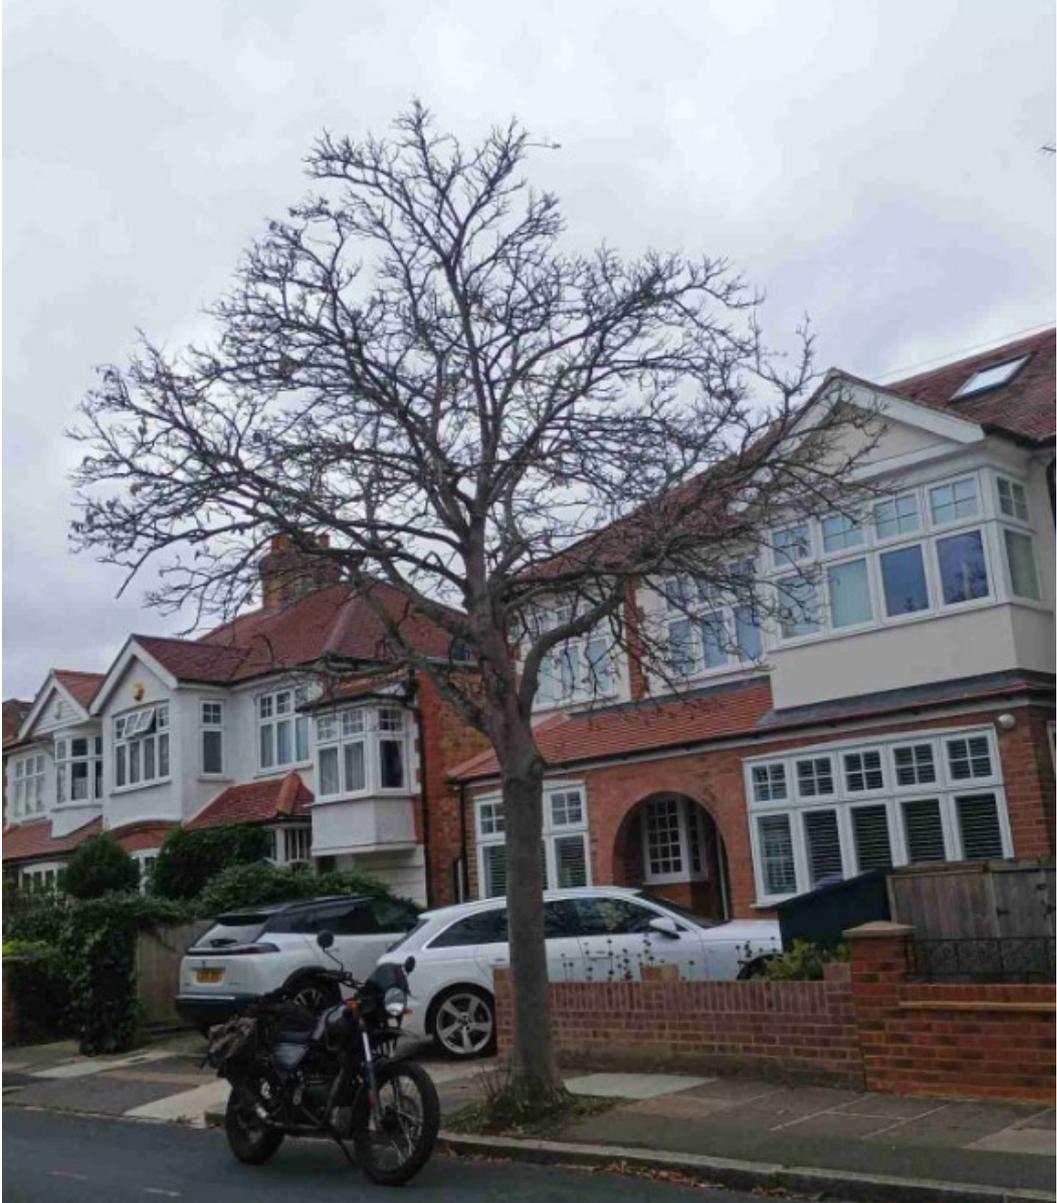
Ward	Kew
Road	Chelwood Gardens
Location	Outside 13
Species	Whitebeam ( <i>Sorbus aria</i> )
Height	7.0m
Physiological Condition	Dead
Structural Condition	Fair
Inspection findings/reason for exemption	This tree is dead; removal is required to prevent natural failure, manage risk, and facilitate replanting

Image shows dead tree in street scene.
