# January 2026 - Reactive Tree Works Programme

Dated 24/02/2026

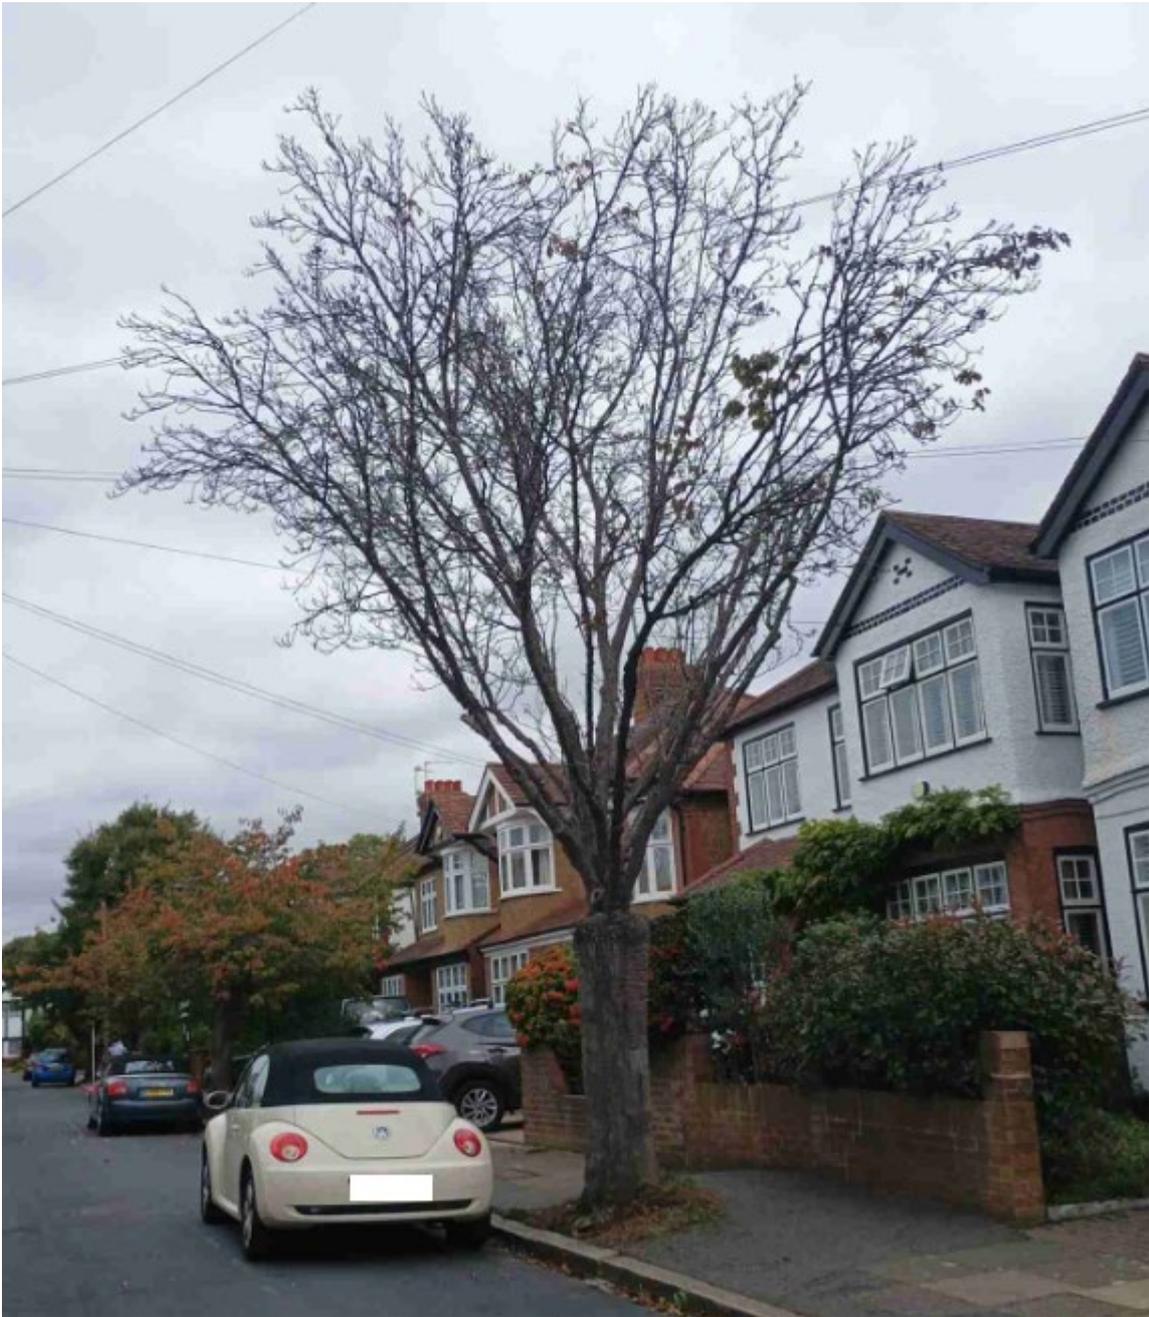
<b>Ward</b>	Kew
<b>Road</b>	Chelwood Gardens
<b>Location</b>	Outside 22
<b>Species</b>	Cherry ( <i>Prunus sp.</i> )
<b>Height</b>	8.5m
<b>Physiological Condition</b>	Dead
<b>Structural Condition</b>	Fair
<b>Inspection findings/reason for exemption</b>	This tree is dead; removal is required to prevent natural failure, manage risk, and facilitate replanting

**Image shows dead tree in street scene.**

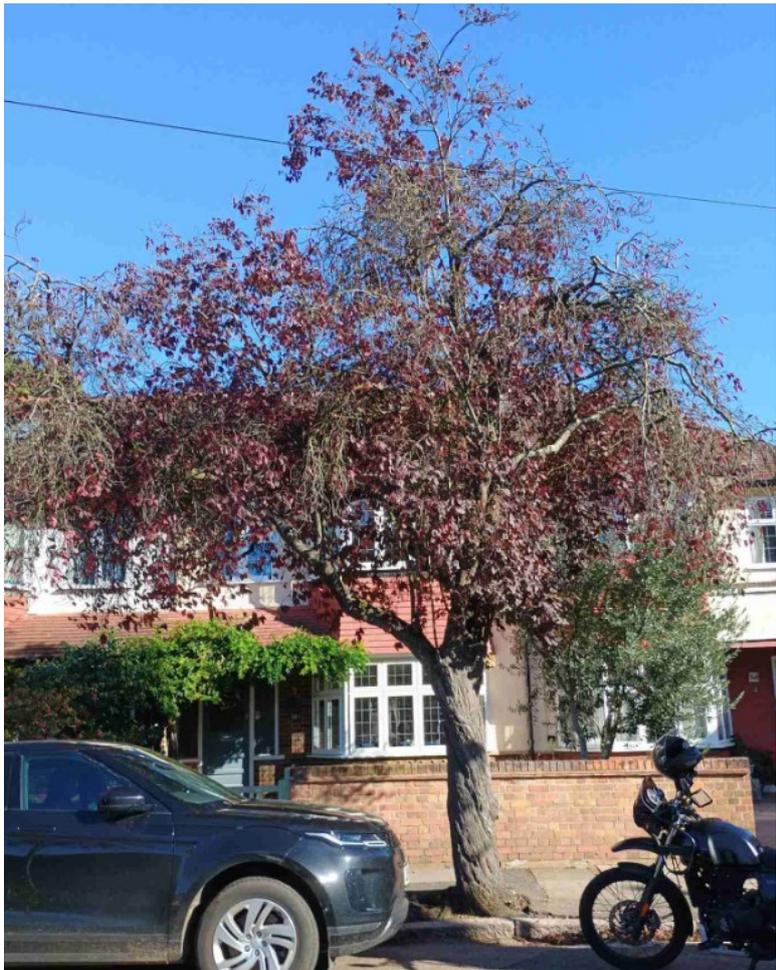
<b>Ward</b>	St Margarets and North Twickenham
<b>Road</b>	Kilmorey Gardens
<b>Location</b>	Outside 38
<b>Species</b>	Cherry Plum ( <i>Prunus cerasifera</i> )
<b>Height</b>	8.5m
<b>Physiological Condition</b>	Fair
<b>Structural Condition</b>	Poor
<b>Inspection findings/reason for exemption</b>	Fungal fruiting bodies of the wood-decay fungus <i>Laetiporus sulphureus</i> are present on the trunk of this tree. This fungus causes a brown rot that rapidly reduces wood strength, increasing the risk of branch or whole-tree failure through brittle fracture. The crown is displaying symptoms of physiological decline, which correlates with the presence of this pathogen. Removal is required to prevent natural failure, manage risk, and facilitate replanting.

**Image shows moribund tree in street scene.**

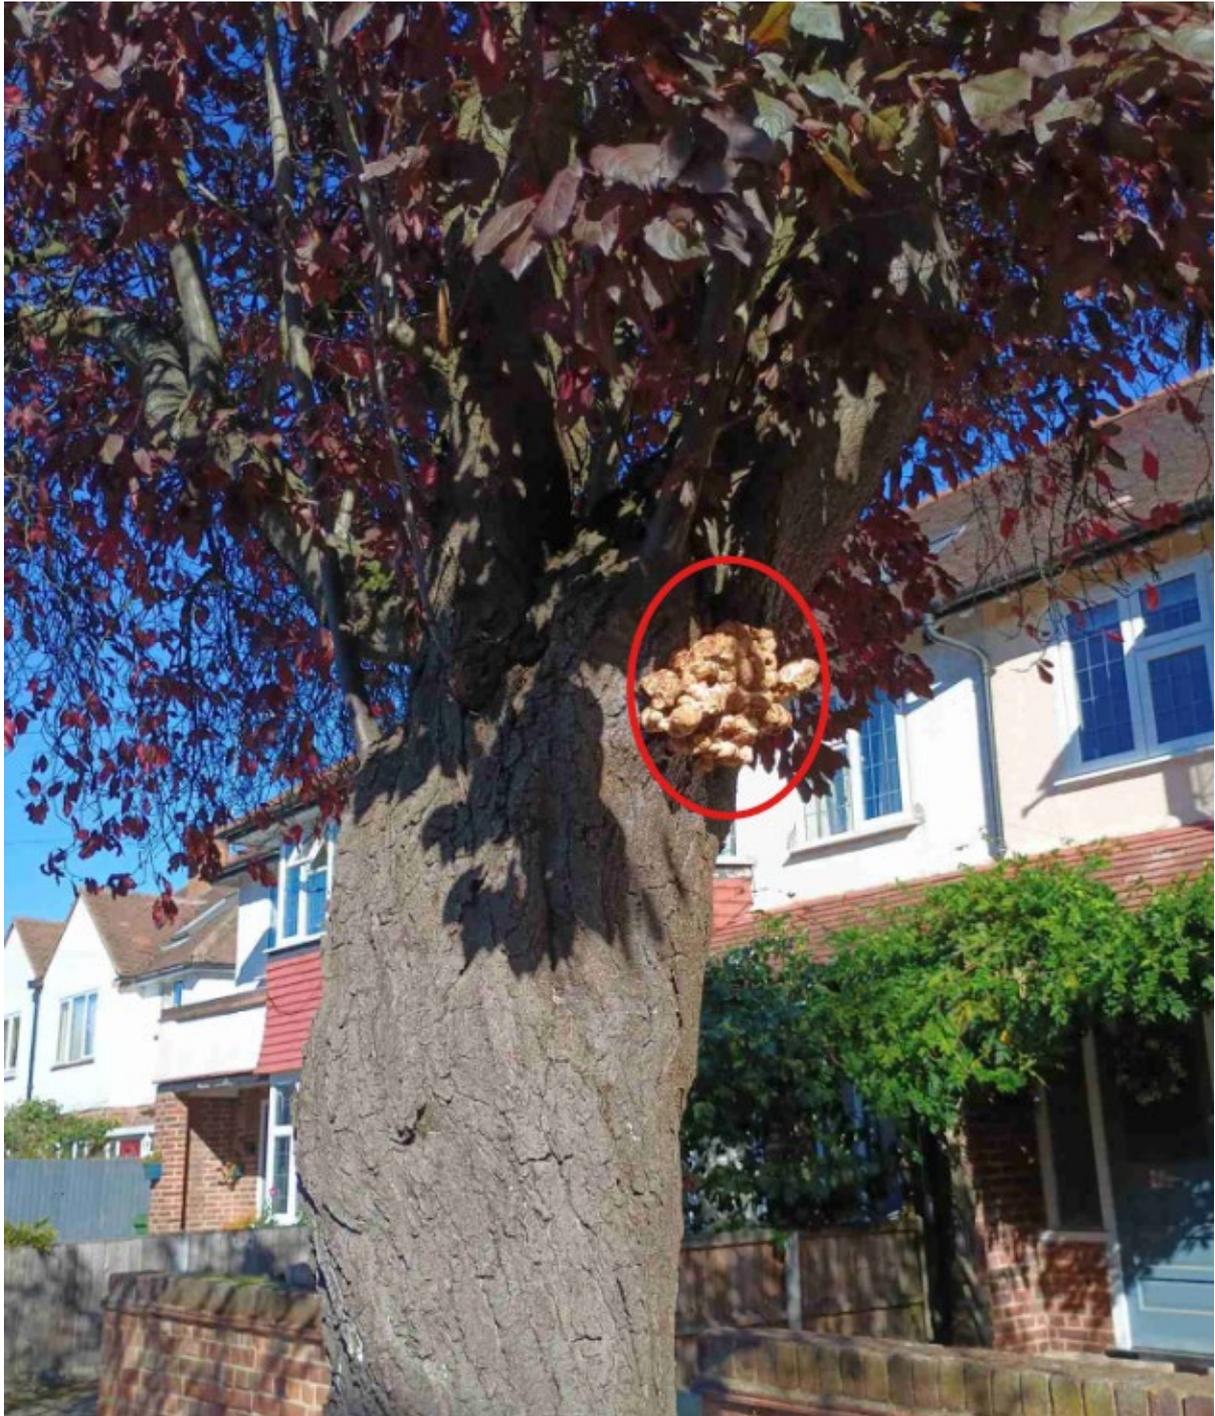
***Image shows fungal fruiting body circled.***

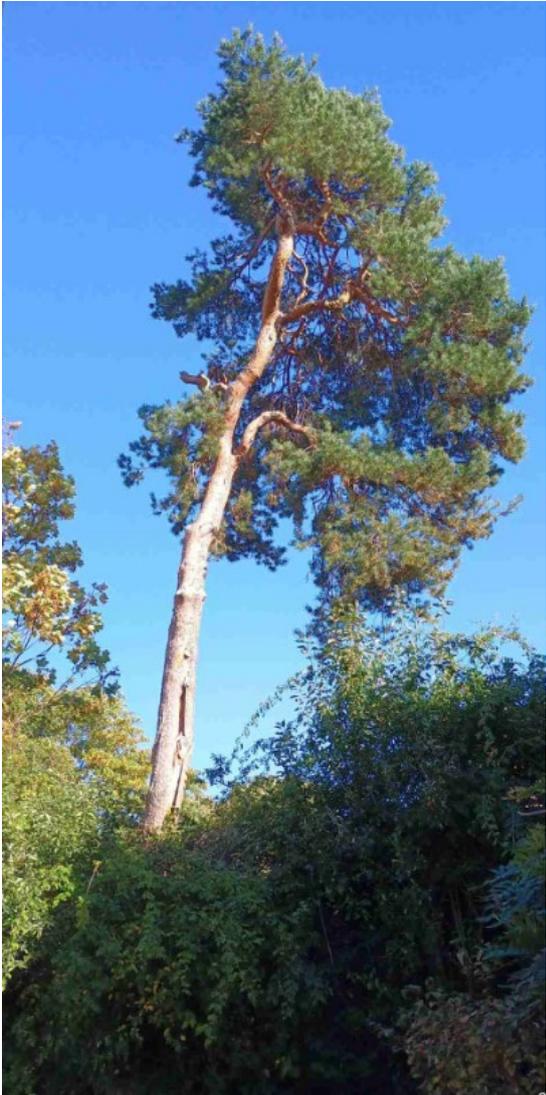
<b>Ward</b>	St Margarets and North Twickenham
<b>Road</b>	Grimwood Road
<b>Location</b>	Adjacent to 40 in shrub bed
<b>Species</b>	Scotch pine ( <i>Pinus sylvestris</i> )
<b>Height</b>	16.0m
<b>Physiological Condition</b>	Good
<b>Structural Condition</b>	Poor
<b>Inspection findings/reason for exemption</b>	Investigation with a probe and a resonance test with a sounding hammer has revealed an unacceptable amount of decay beyond the visible wound on the trunk. Removal is required to prevent natural failure, manage risk, and facilitate replanting.

**Image shows tree in street scene.**

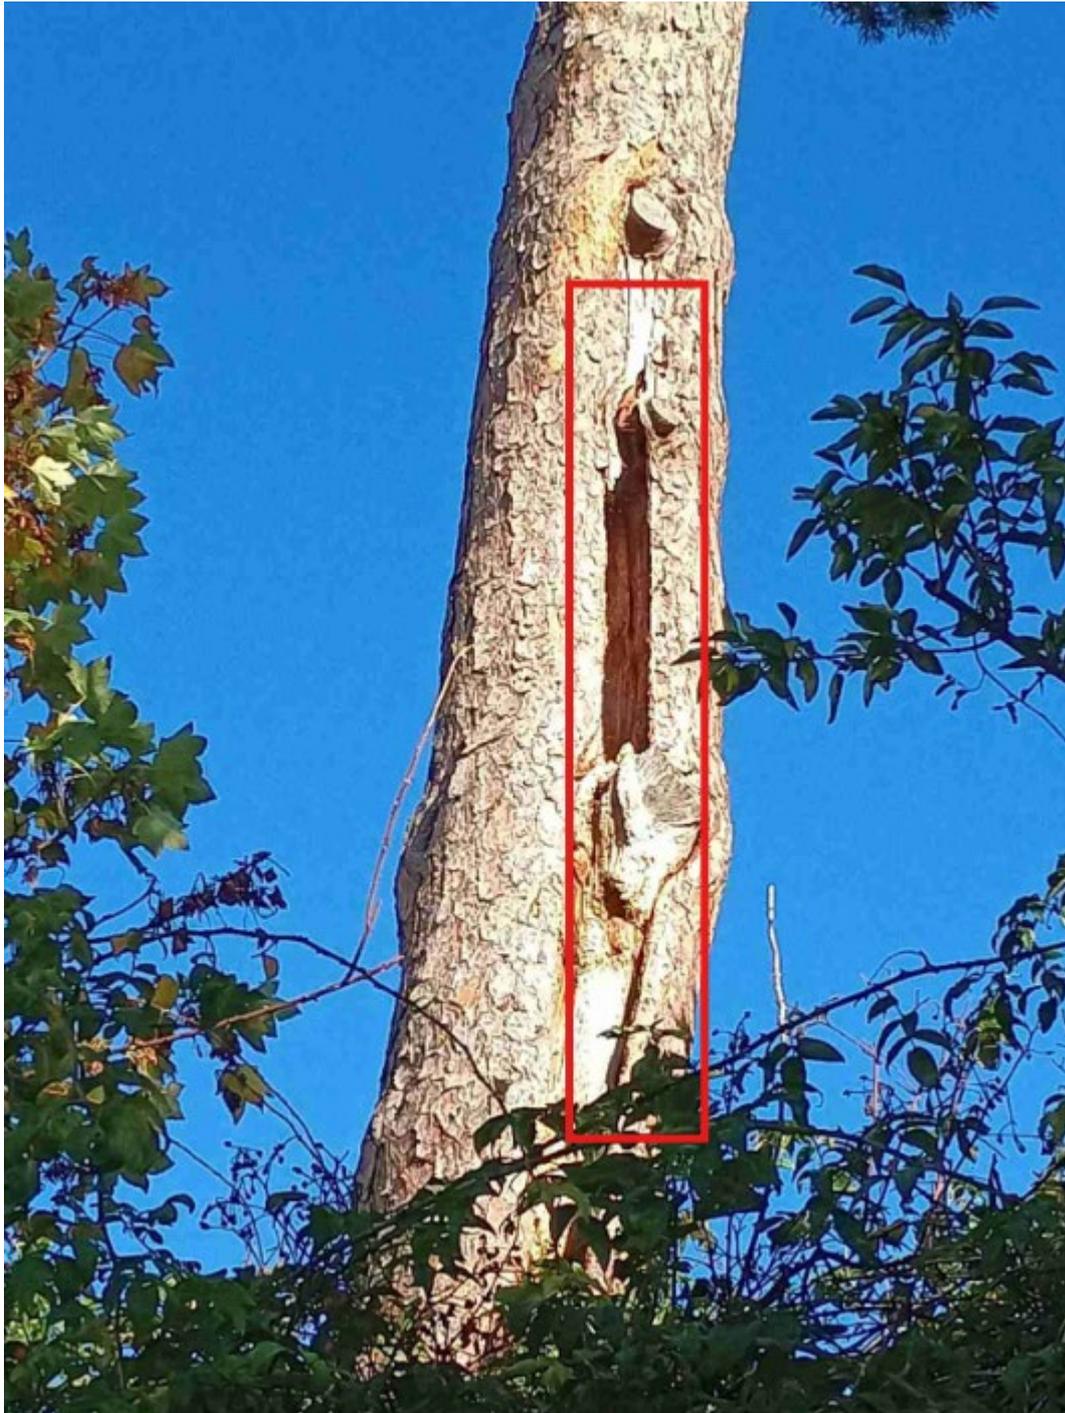
***Image shows wound on trunk highlighted.***

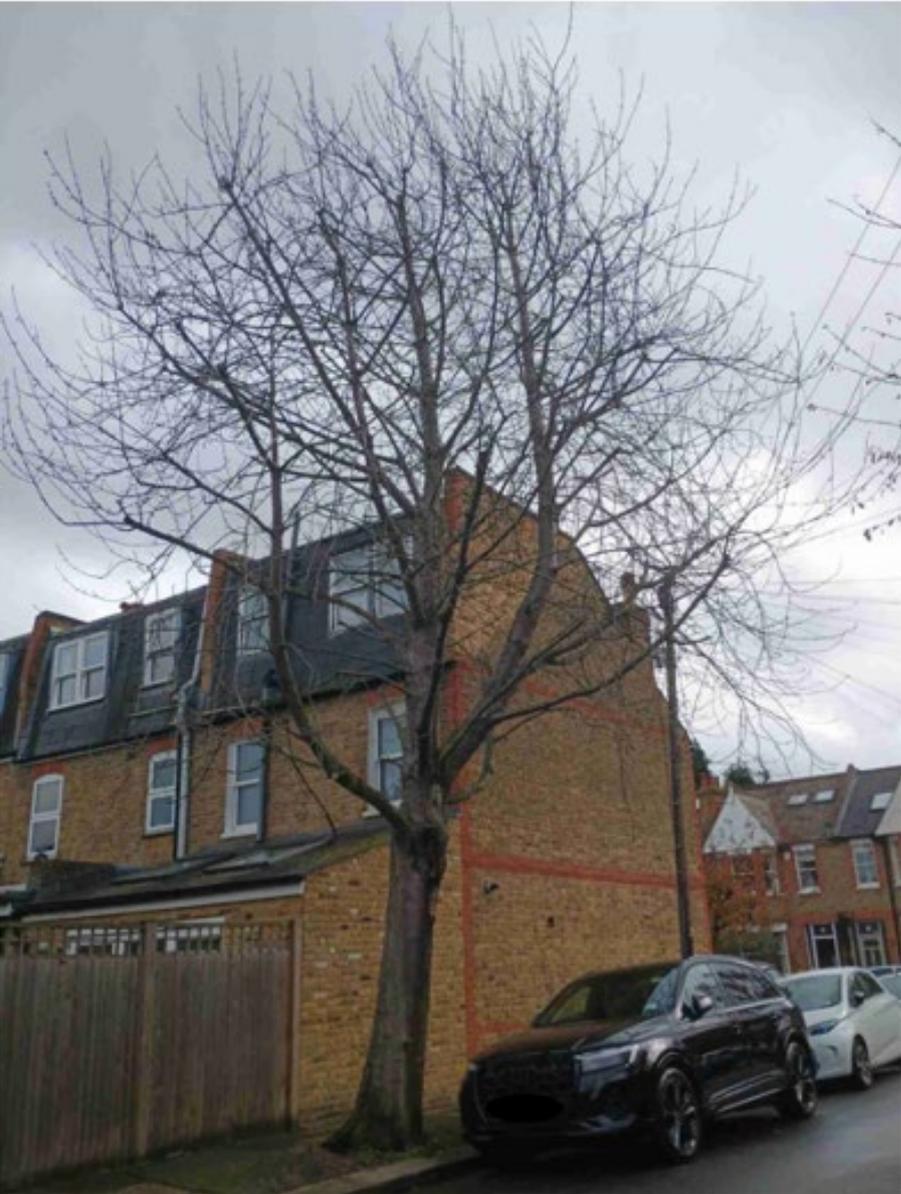
<b>Ward</b>	St Margarets and North Twickenham
<b>Road</b>	Ailsa Avenue
<b>Location</b>	Opposite 73
<b>Species</b>	Cherry ( <i>Prunus sp.</i> )
<b>Height</b>	13.0m
<b>Physiological Condition</b>	Fair
<b>Structural Condition</b>	Poor
<b>Inspection findings/reason for exemption</b>	Fungal fruiting bodies of the decay fungi <i>Armillaria sp.</i> are present at the base of this tree. Colonisation by this fungus causes a white rot of the roots and butt that can cause entire tree failure. Removal is required to prevent natural failure, manage risk, and facilitate replanting.

Image shows tree in street scene.

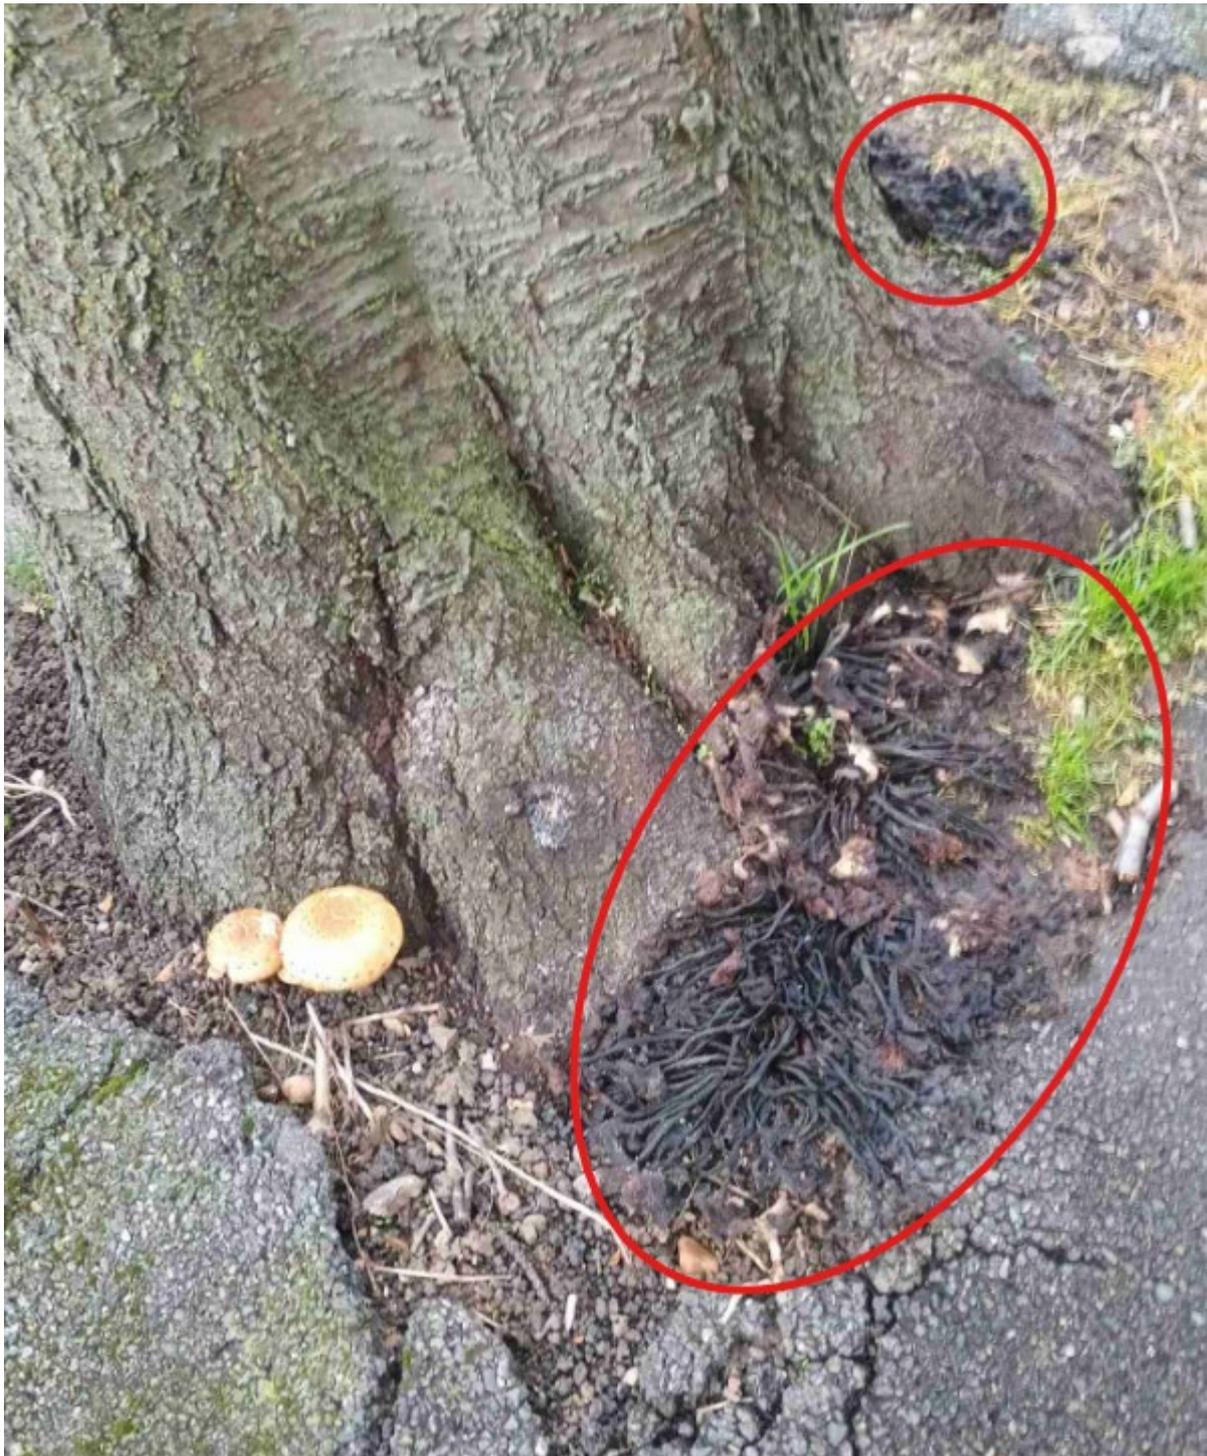
***Image shows fungal fruiting bodies circled.***

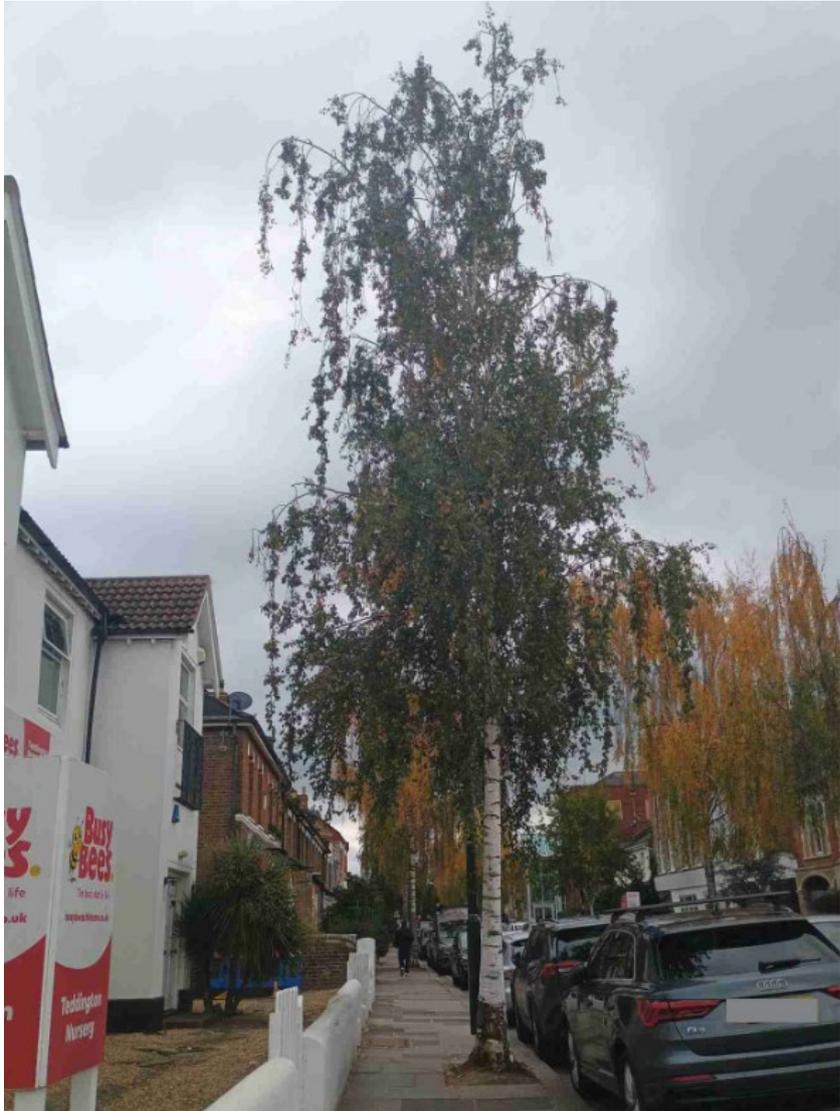
Ward	Teddington
Road	Church Road
Location	Outside 52
Species	Birch ( <i>Betula sp.</i> )
Height	12.0m
Physiological Condition	Good
Structural Condition	Poor
Inspection findings/reason for exemption	Investigation with a probe and a resonance test with a sounding hammer has revealed an unacceptable amount of decay beyond the visible cavities at the base of the trunk. Removal is required to prevent natural failure, manage risk, and facilitate replanting.

Image shows tree in street scene.

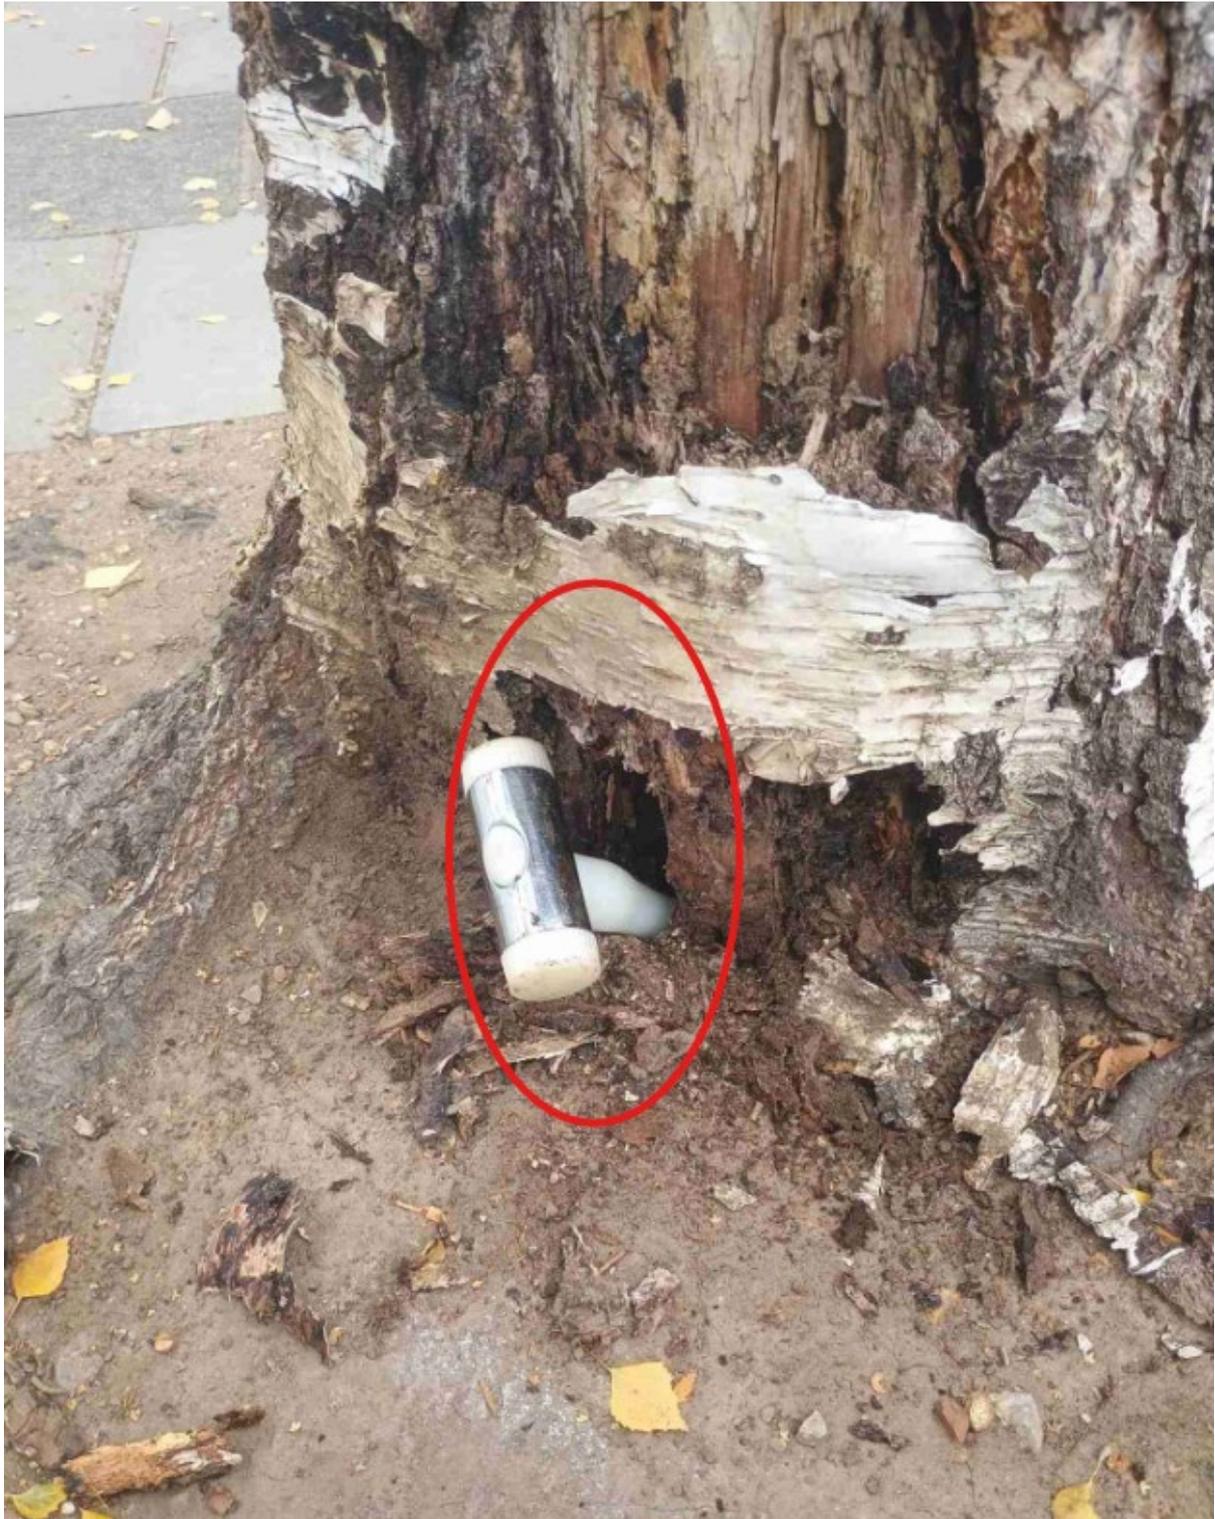
***Image shows cavity at base of trunk with prob circled.***

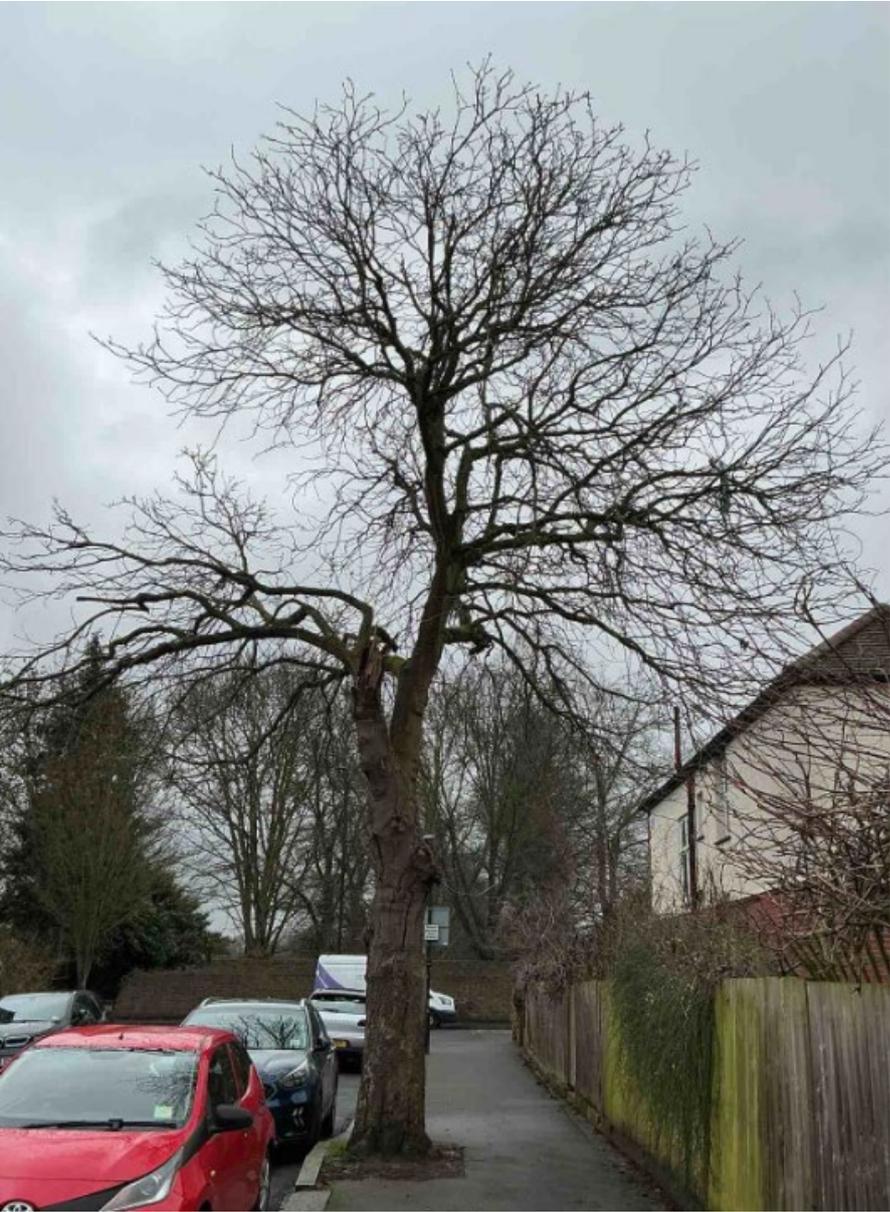
<b>Ward</b>	Teddington
<b>Road</b>	Avenue Road
<b>Location</b>	Adjacent to 153 Park Road rear garden
<b>Species</b>	Red horse-chestnut ( <i>Aesculus x carnea</i> )
<b>Height</b>	12.0m
<b>Physiological Condition</b>	Fair
<b>Structural Condition</b>	Poor
<b>Inspection findings/reason for exemption</b>	A fungal fruiting body of the species Dryad saddle ( <i>Ceriporus squamosus</i> ) is present on the trunk; this fungus causes a simultaneous white rot which can cause snapping of tree parts in this particular species. Removal is required to prevent natural failure, manage risk and facilitate replanting

**Image shows tree in street scene.**

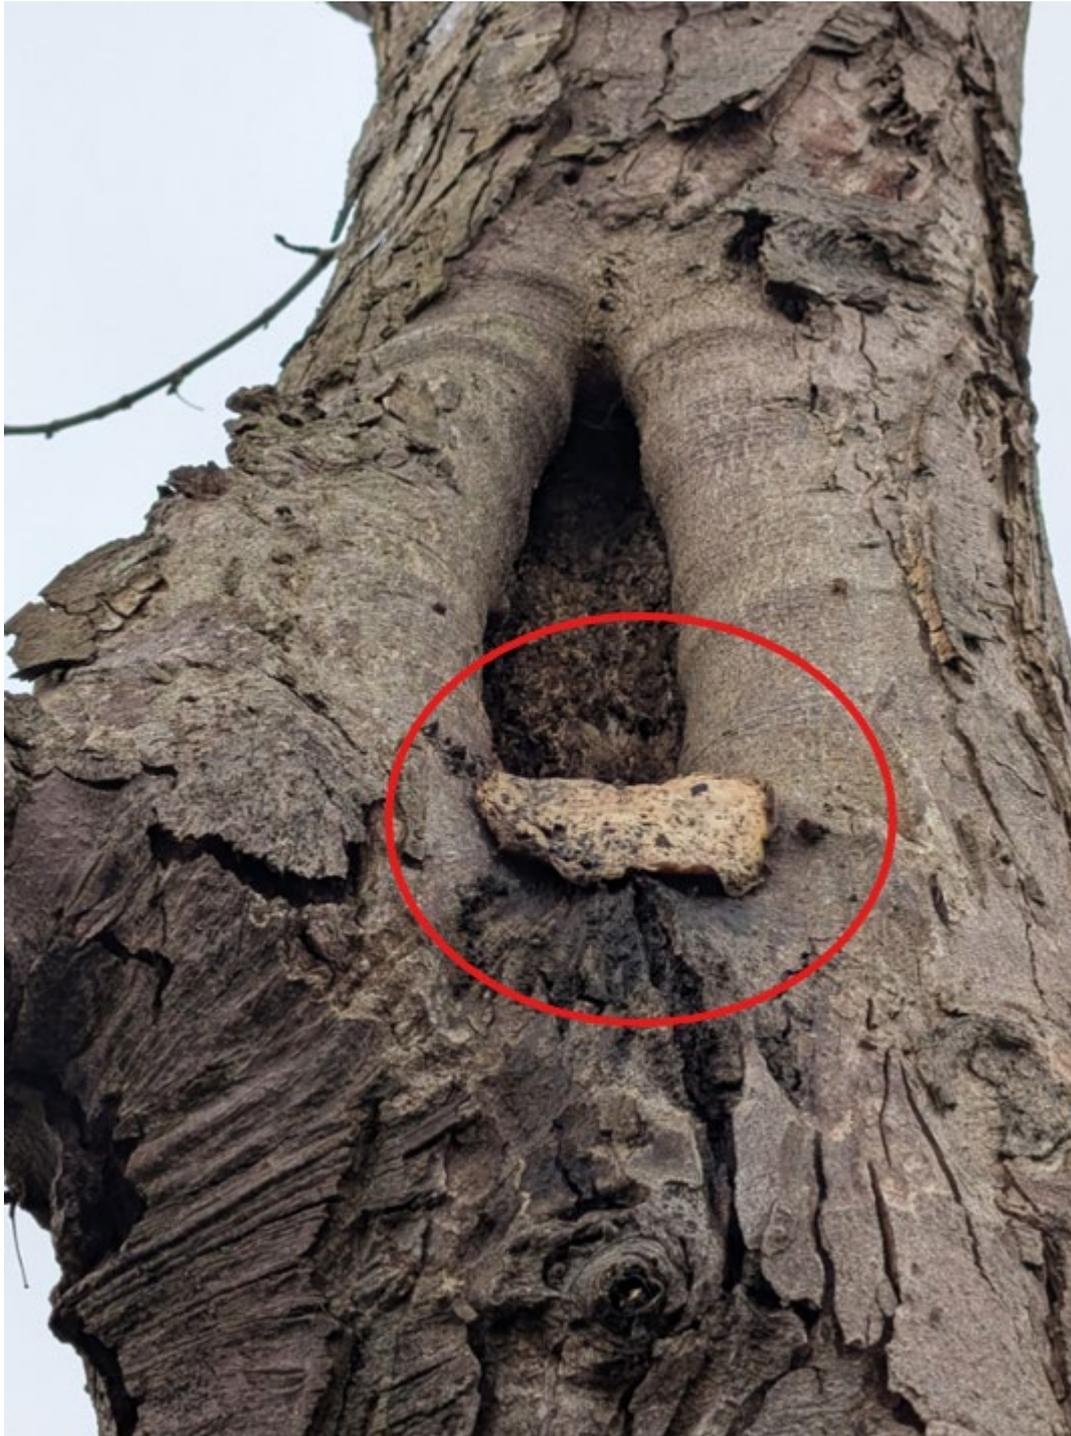
***Image shows fruiting body on stem circled.***

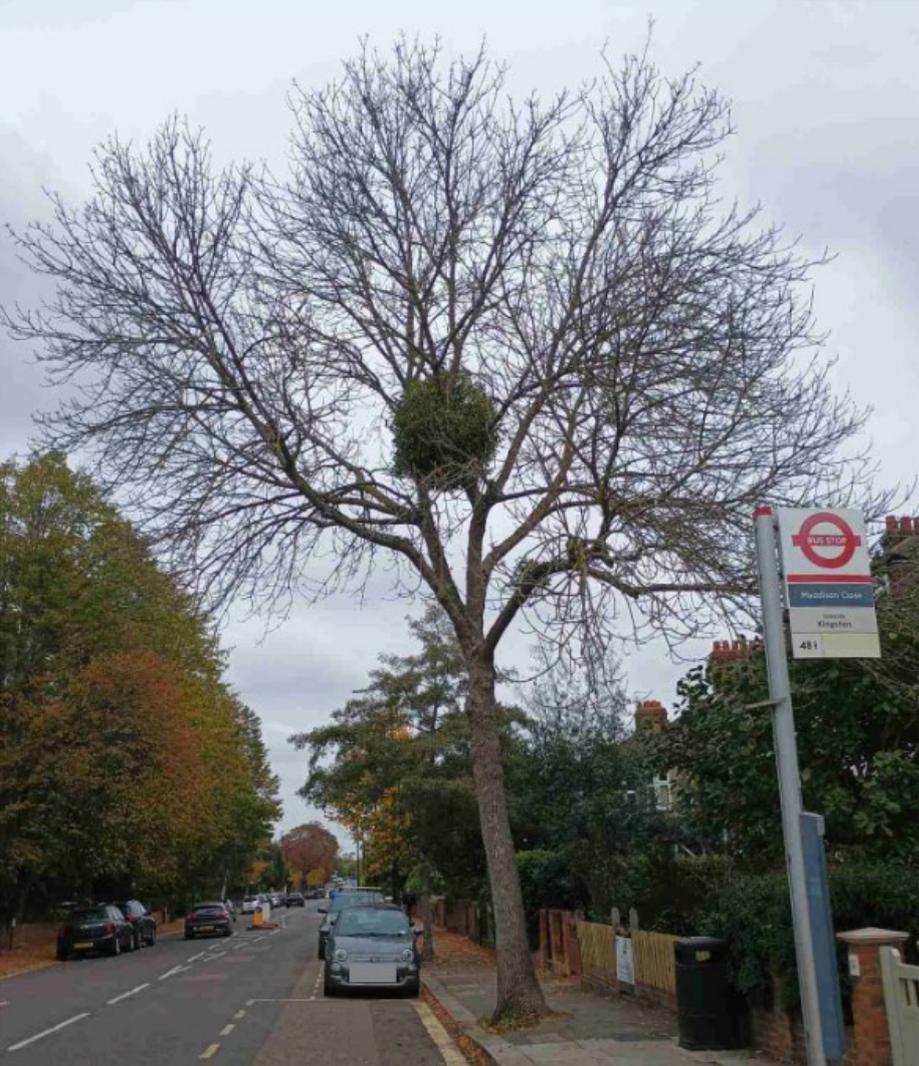
<b>Ward</b>	Teddington
<b>Road</b>	Park Road
<b>Location</b>	Outside 85
<b>Species</b>	Common Ash ( <i>Fraxinus sp.</i> )
<b>Height</b>	15.0m
<b>Physiological Condition</b>	Poor
<b>Structural Condition</b>	Poor
<b>Inspection findings/reason for exemption</b>	Fungal fruiting bodies of the decay fungi <i>Armillaria sp.</i> are present at the base of this tree. Colonisation by this fungus causes a white rot of the roots and butt that can cause entire tree failure. Crown dieback could correlate with the parasite present. Removal is required to prevent natural failure, manage risk, and facilitate replanting

**Image shows tree in street scene**

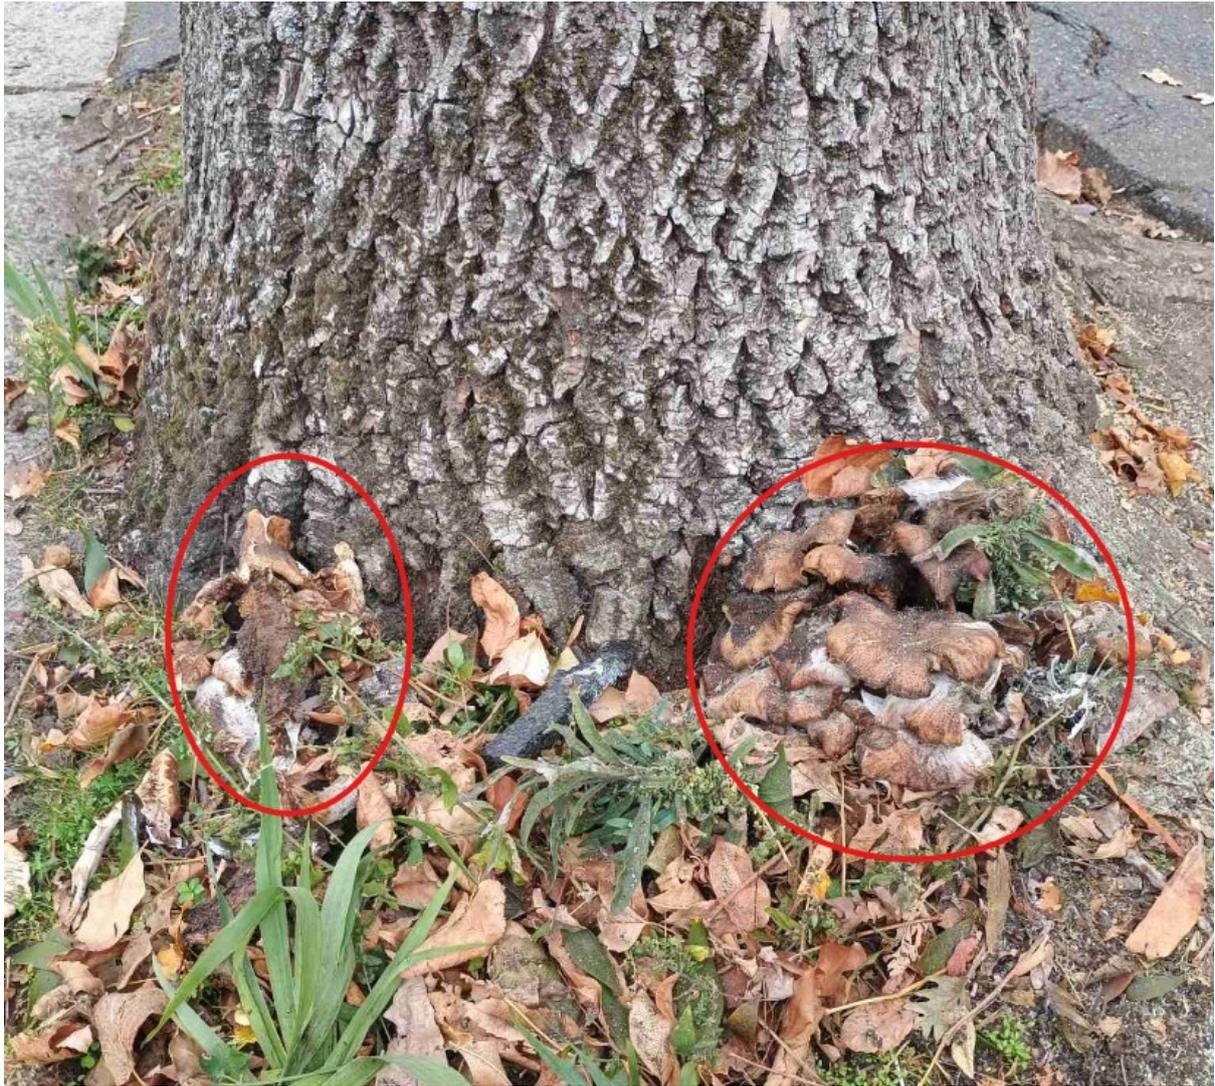
***Image shows fungal fruiting bodies circled at base of trunk.***

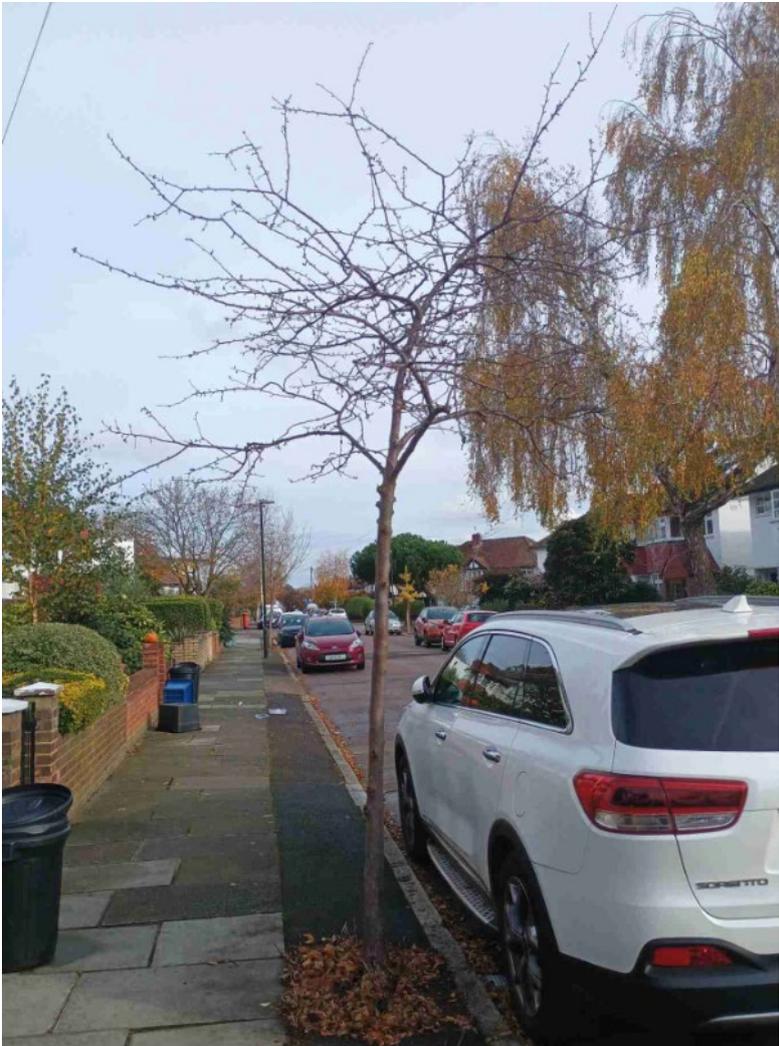
Ward	West Twickenham
Road	Rivermeads Avenue
Location	Outside 54/56
Species	Apple ( <i>Malus sp.</i> )
Height	4.5m
Physiological Condition	Dead
Structural Condition	Fair
Inspection findings/reason for exemption	This tree is dead; removal is required to prevent natural failure, manage risk, and facilitate replanting

**Image shows dead tree in street scene**

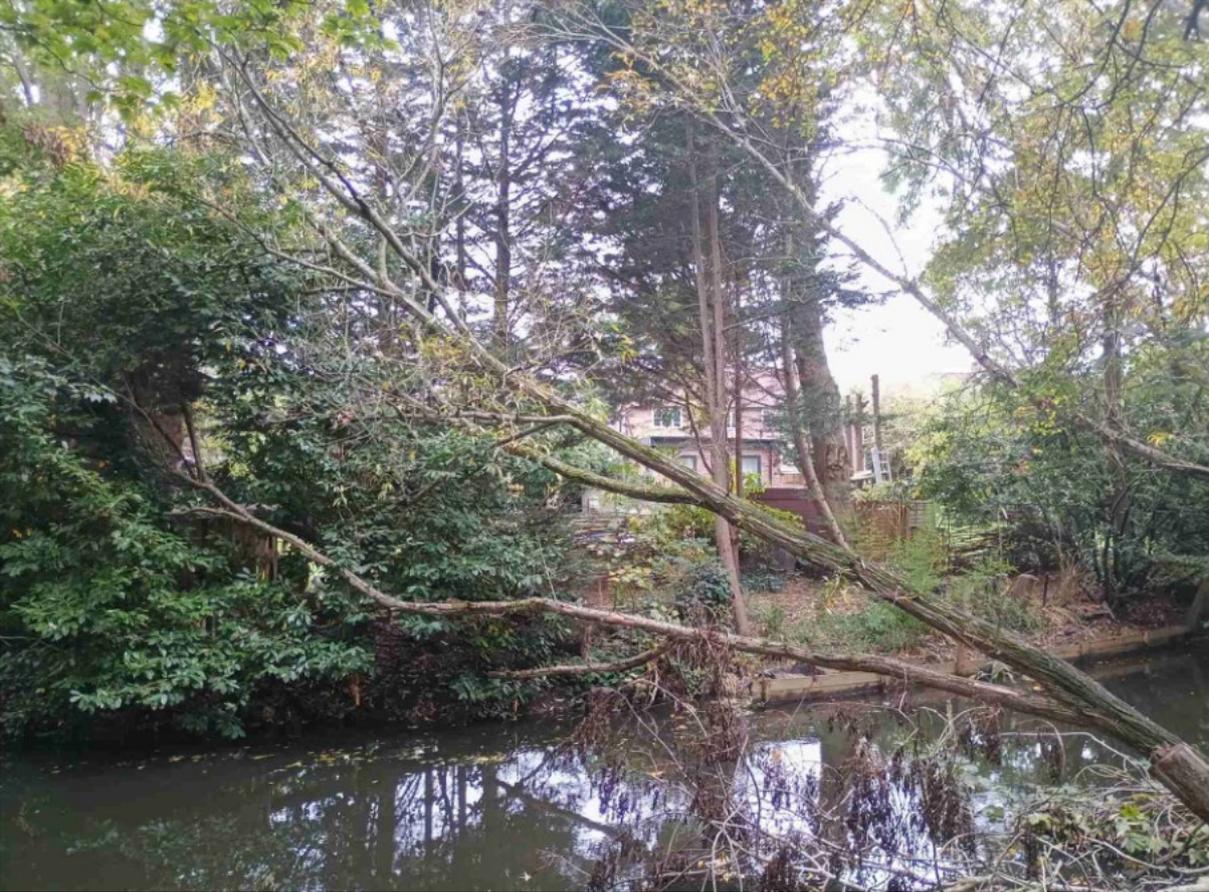
<b>Ward</b>	West Twickenham
<b>Road</b>	Hospital Bridge Road
<b>Location</b>	Crane park - ///armed.regime.librarian
<b>Species</b>	Willow ( <i>Salix sp.</i> )
<b>Height</b>	10.0m
<b>Physiological Condition</b>	Fair
<b>Structural Condition</b>	Poor
<b>Inspection findings/reason for exemption</b>	This tree has a progressive lean across the river and is now resting on a neighbouring tree. Removal is required to prevent further natural failure and manage risk,

**Image shows leaning tree in park scene**

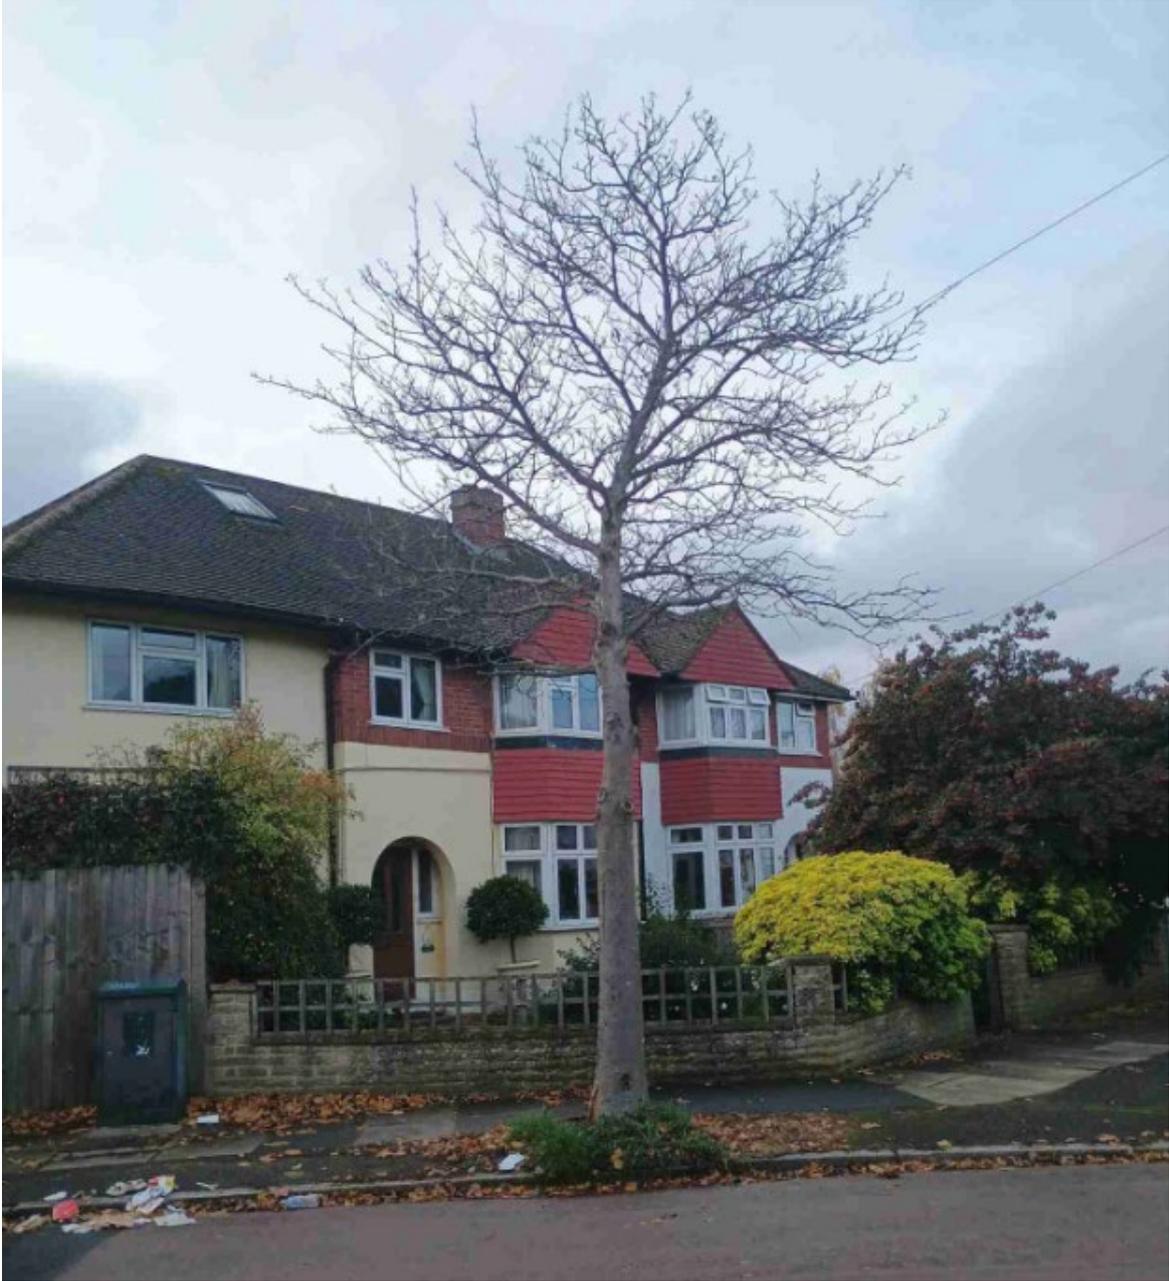
<b>Ward</b>	West Twickenham
<b>Road</b>	Court Close Avenue
<b>Location</b>	Outside 55 Rivermeads Avenue
<b>Species</b>	Whitebeam ( <i>Sorbus aria</i> )
<b>Height</b>	6.5m
<b>Physiological Condition</b>	Dead
<b>Structural Condition</b>	Fair
<b>Inspection findings/reason for exemption</b>	This tree is dead; removal is required to prevent natural failure and facilitate replanting

**Images show dead tree in street scene.**
