# September 2026 – Highways Reactive Tree Works Programme

Dated 18.9.2026

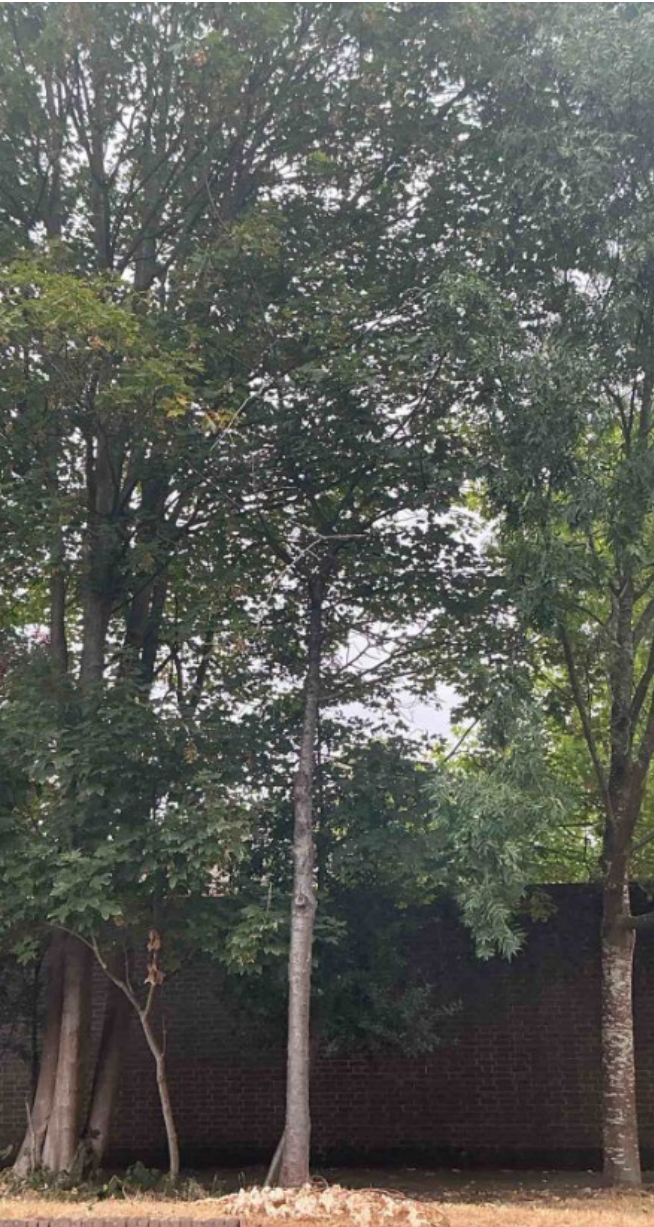
| Inspection findings/reason for exemption | This tree is dead; removal is required to prevent natural failure, manage risk, and facilitate replanting |

Image shows dead tree in street scene

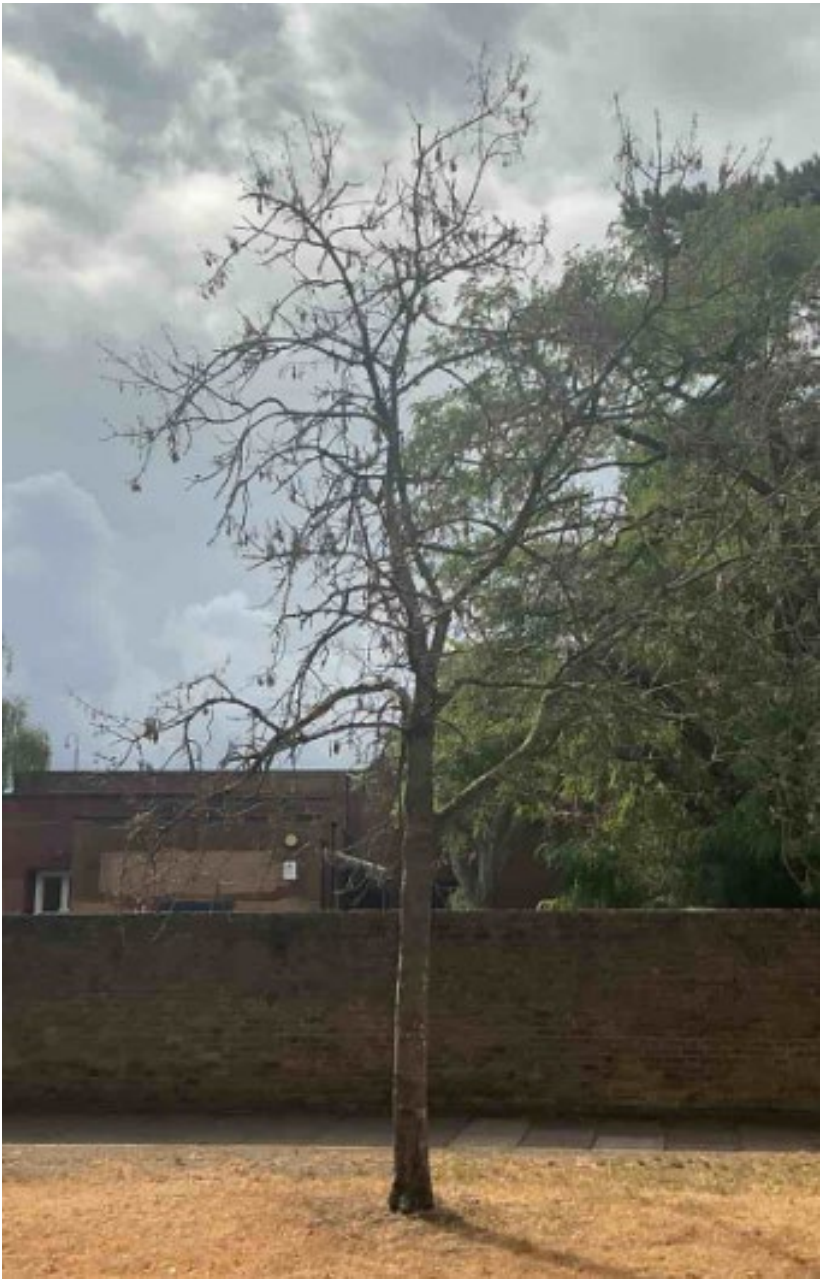
| Inspection findings/reason for exemption | This tree is dead; removal is required to prevent natural failure, manage risk, and facilitate replanting |

Image shows dead tree in street scene

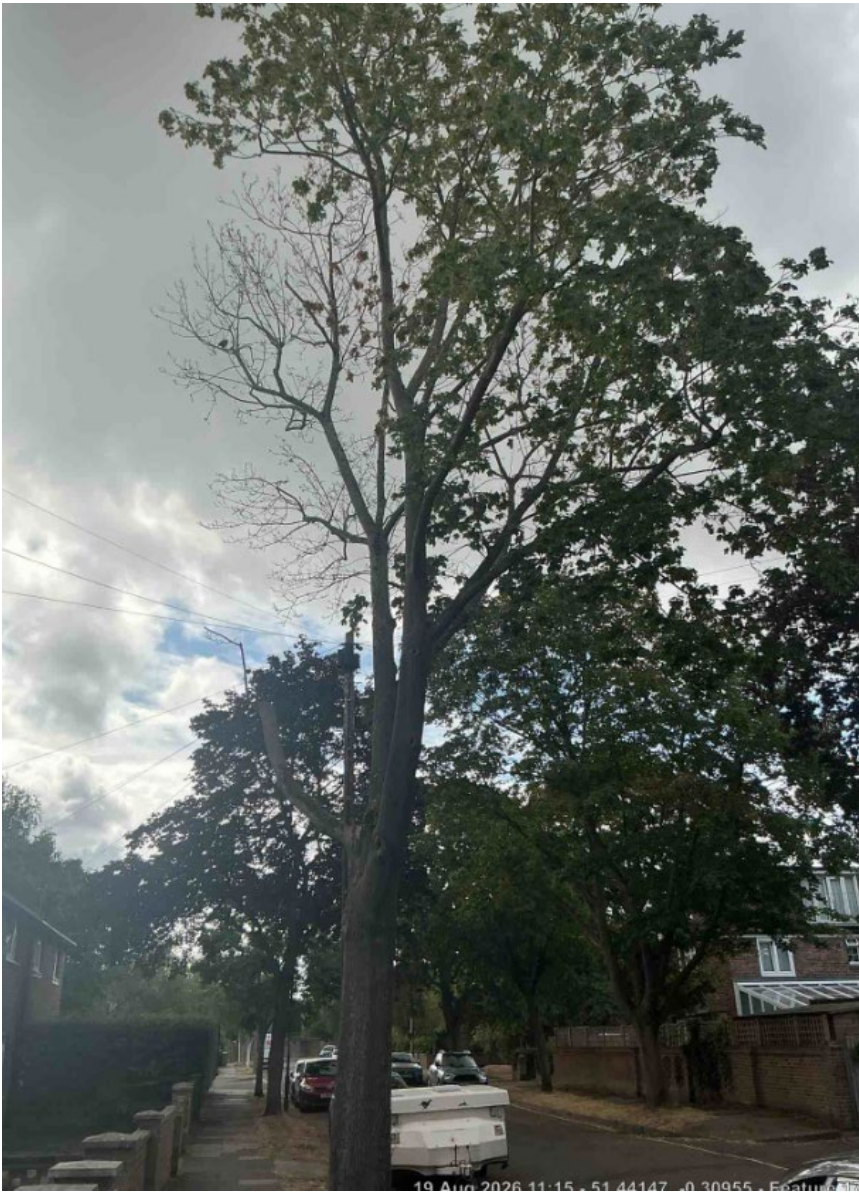
| Inspection findings/reason for exemption | This tree is moribund; removal is required to prevent natural failure, manage risk, and facilitate replanting |

Image shows moribund tree in street scene

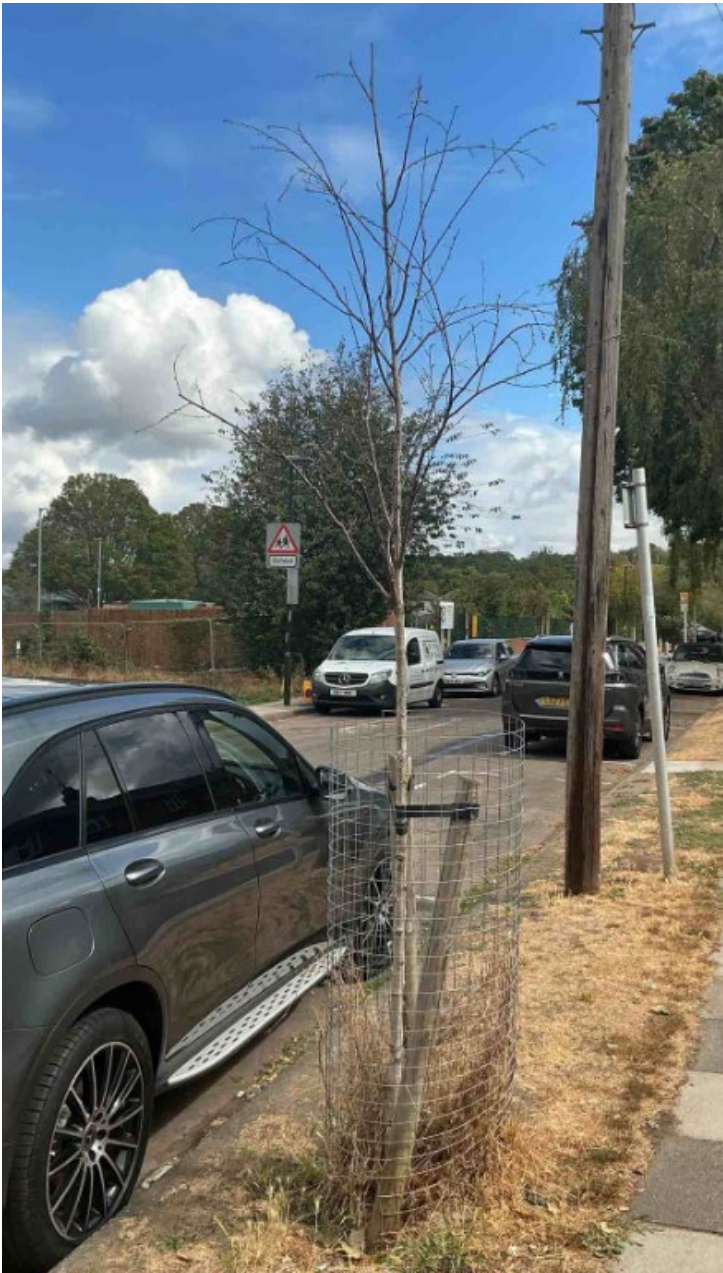
| Inspection findings/reason for exemption | This tree is dead; removal is required to prevent natural failure, manage risk, and facilitate replanting |

Image shows dead tree in street scene

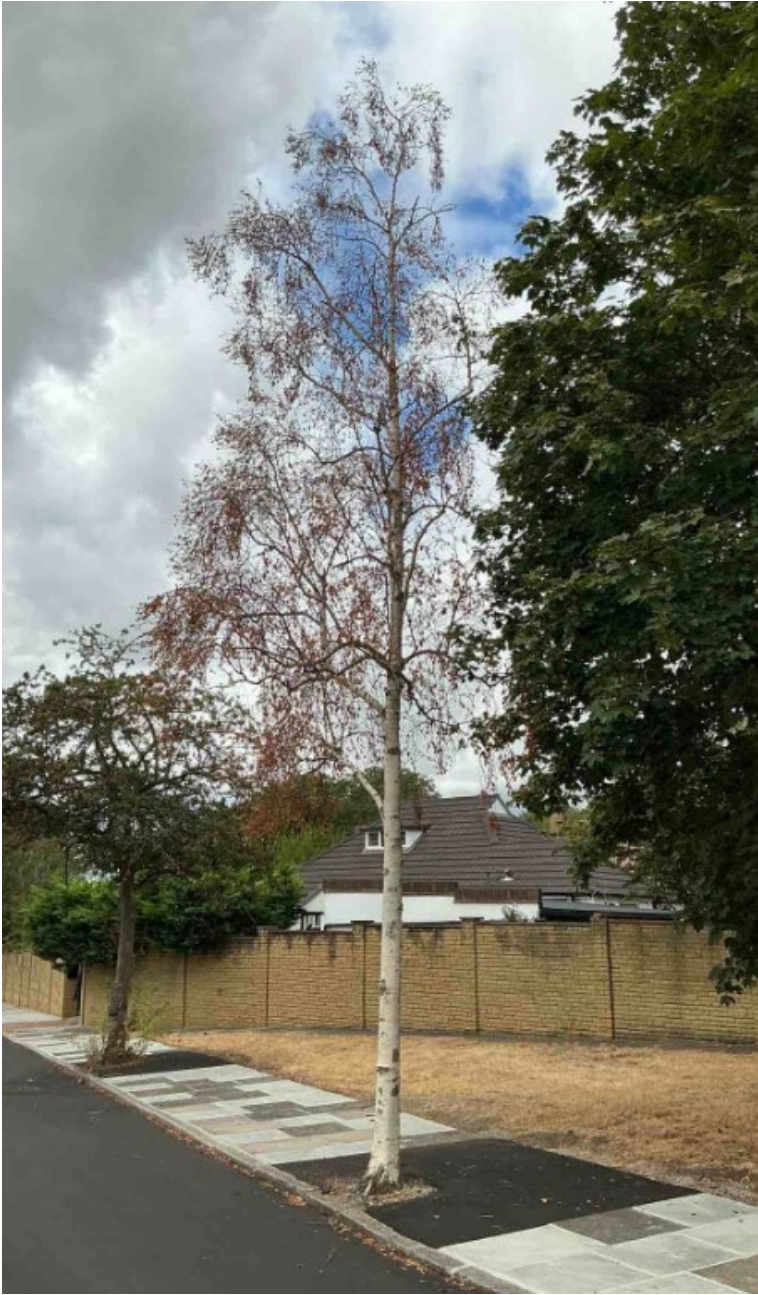
| Inspection findings/reason for exemption | This tree is dead; removal is required to prevent natural failure, manage risk, and facilitate replanting. |

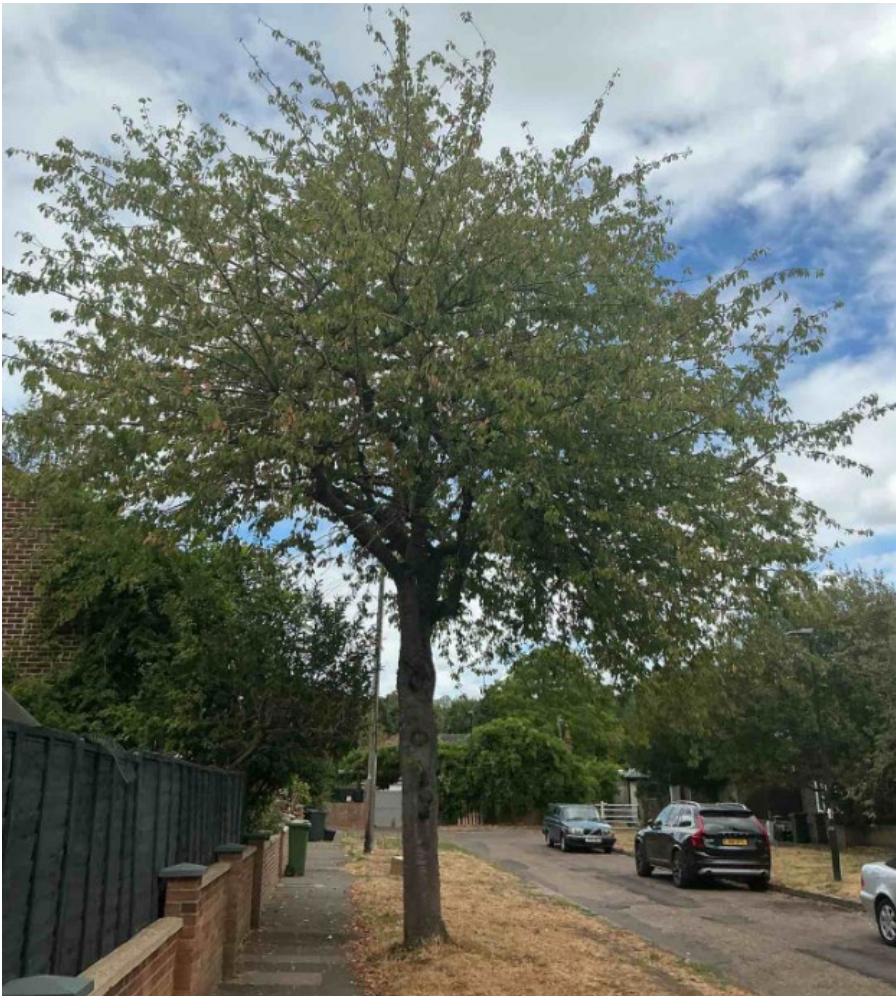
| Inspection findings/reason for exemption | A fungal fruiting body of the decay fungus <i>Ganoderma sp.</i> is present on the trunk. Colonisation by this fungus results in white rot affecting the stem and root system, which can lead to structural failure through fracture or windthrow A resonance test with a sounding hammer has revealed an unacceptable amount of decay around the bracket. Removal of the tree is recommended to prevent natural failure, manage risk, and facilitate replanting. |

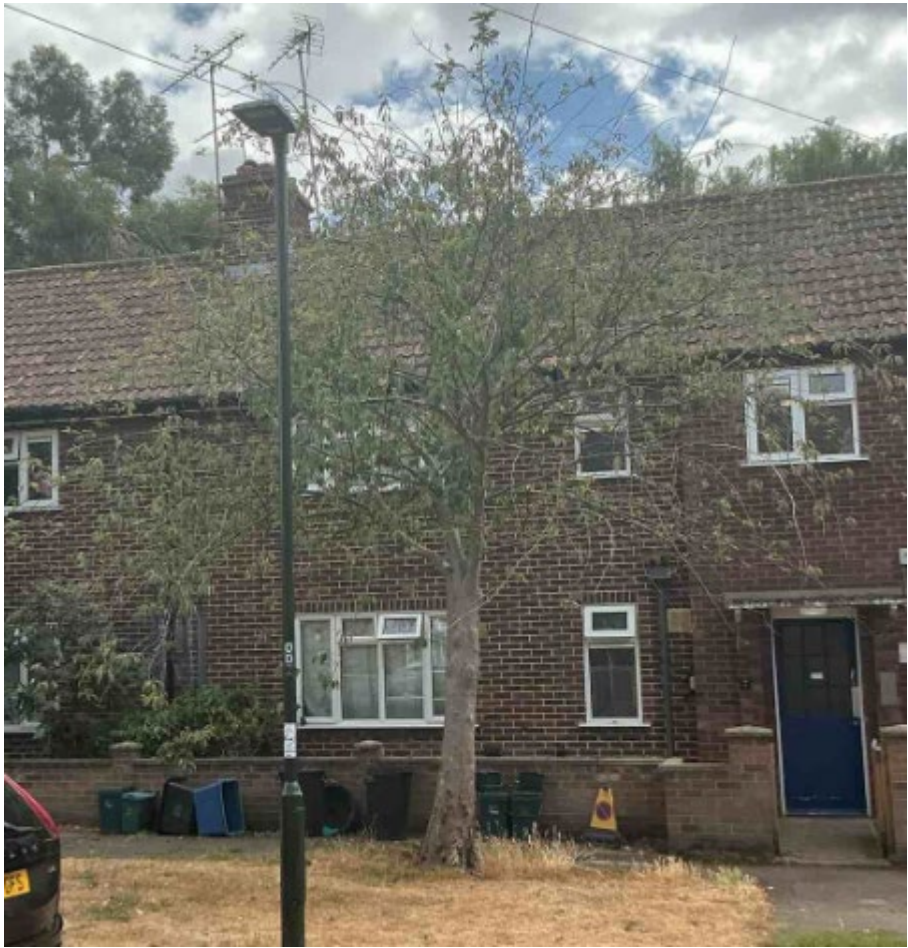
| Inspection findings/reason for exemption | A fungal fruiting body of the decay fungus <i>Ganoderma sp.</i> is present on the trunk. Colonisation by this fungus results in white rot affecting the stem and root system, which can lead to structural failure through fracture or windthrow. Crown dieback is evident and correlates with the presence of the decay fungi. Removal of the tree is recommended to prevent natural failure, manage risk, and facilitate replanting. |

Image shows moribund tree in street scene.

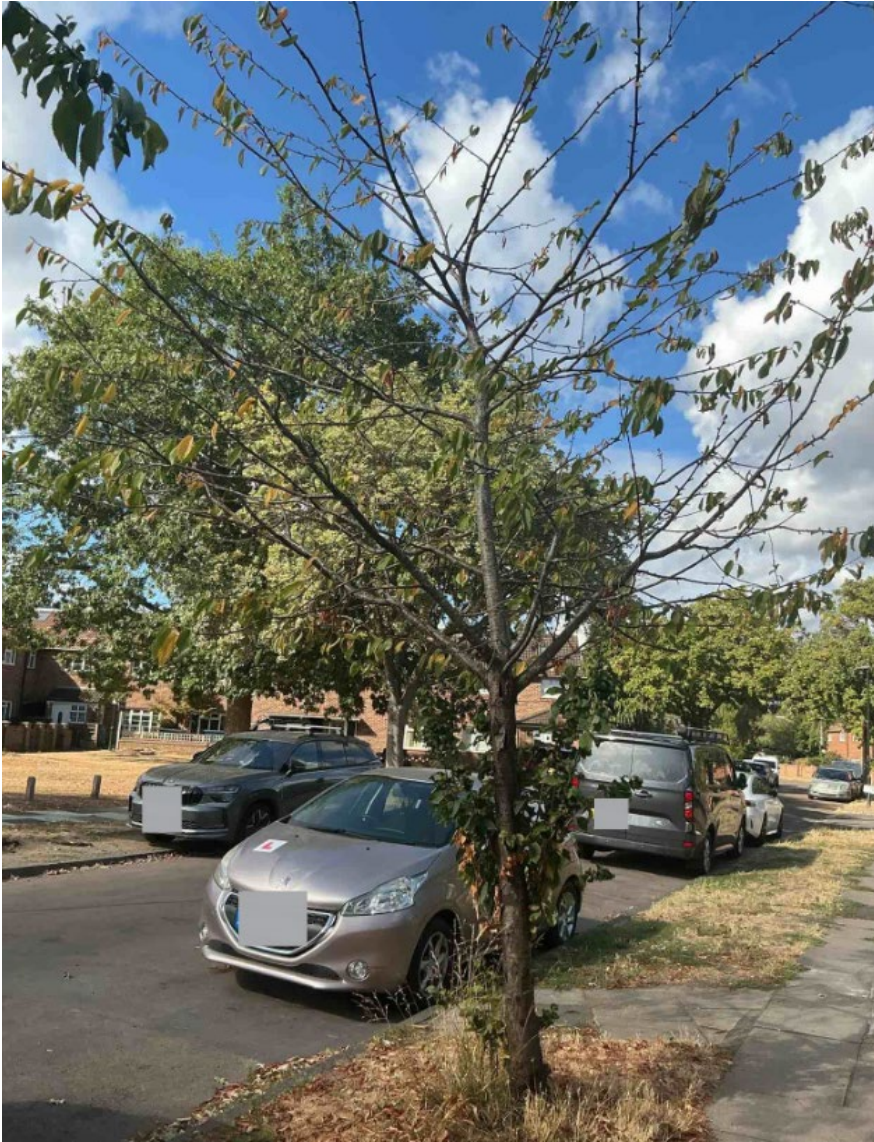
| Inspection findings/reason for exemption | This tree is moribund; removal is required to prevent natural failure, manage risk, and facilitate replanting. |

Image shows moribund tree in street scene.

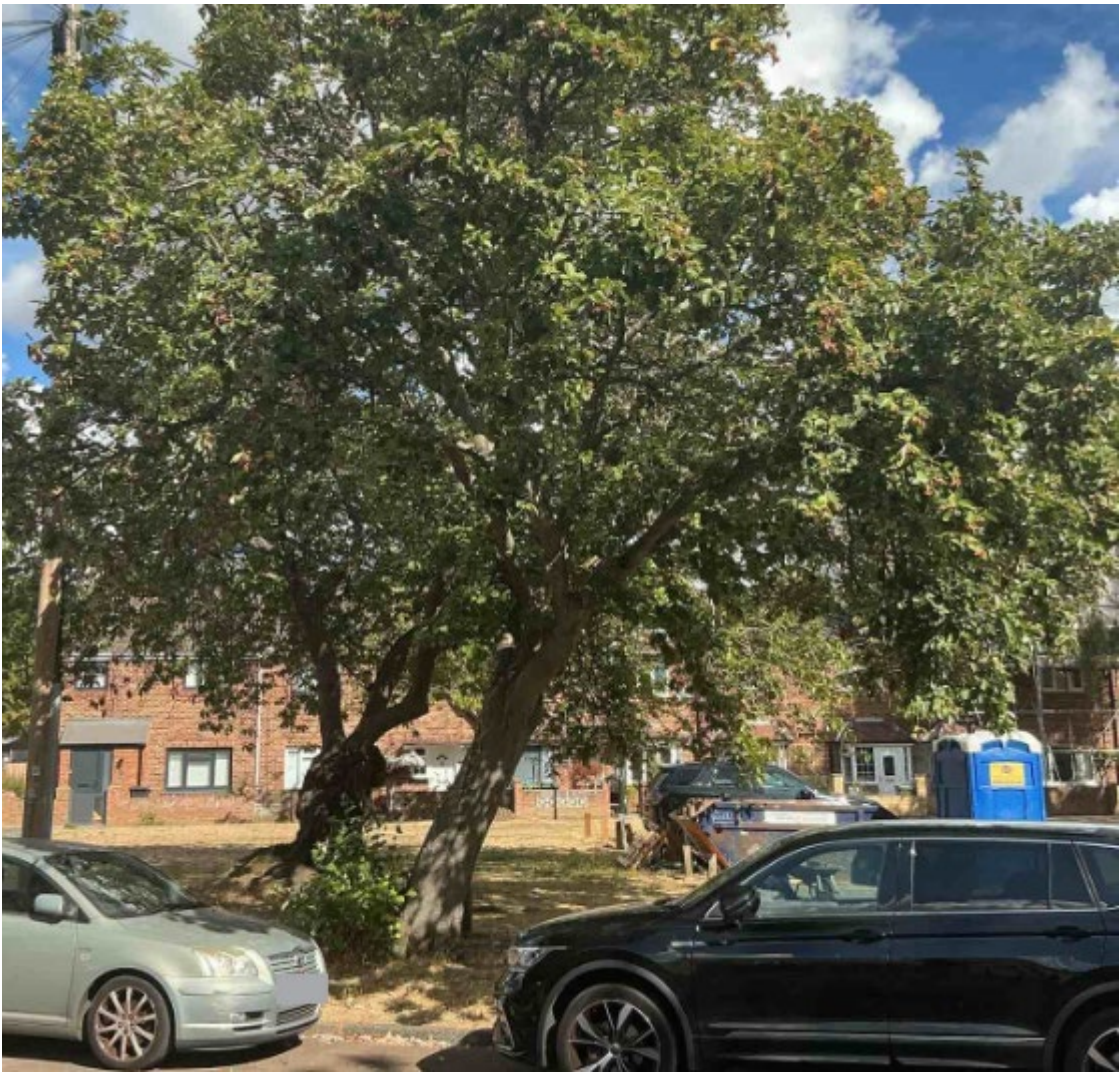
| Inspection findings/reason for exemption | A fungal fruiting body of the decay fungus Ganoderma sp. is present on the trunk. Colonisation by this fungus can result in white rot affecting the stem and root system, which can lead to structural failure through fracture or windthrow. A resonance test with a sounding hammer and probe has revealed an unacceptable amount of decay around the bracket. Removal of the tree is recommended to prevent natural failure, manage risk, and facilitate replanting. |

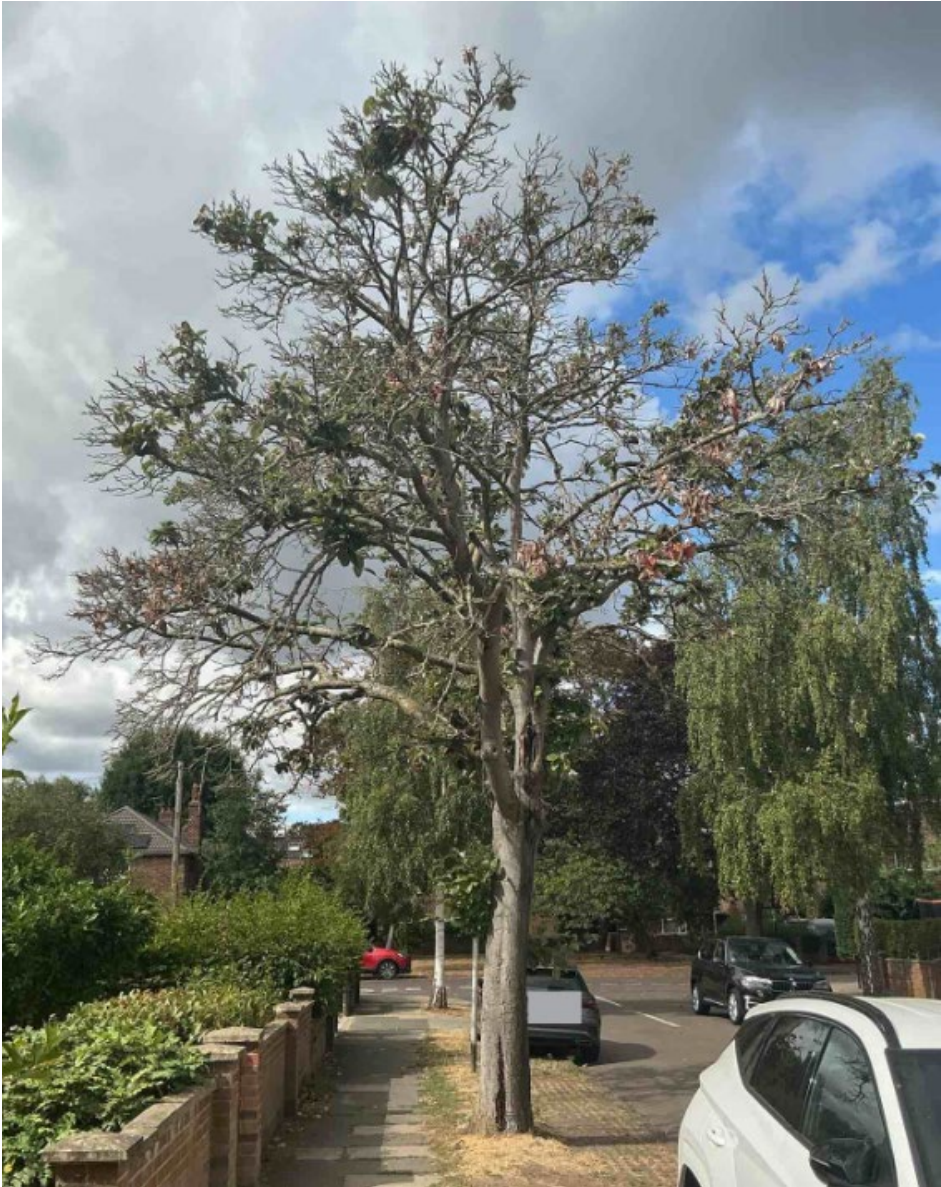
| Inspection findings/reason for exemption | This tree is moribund; removal is required to prevent natural failure, manage risk, and facilitate replanting. |

Image shows moribund tree in street scene.

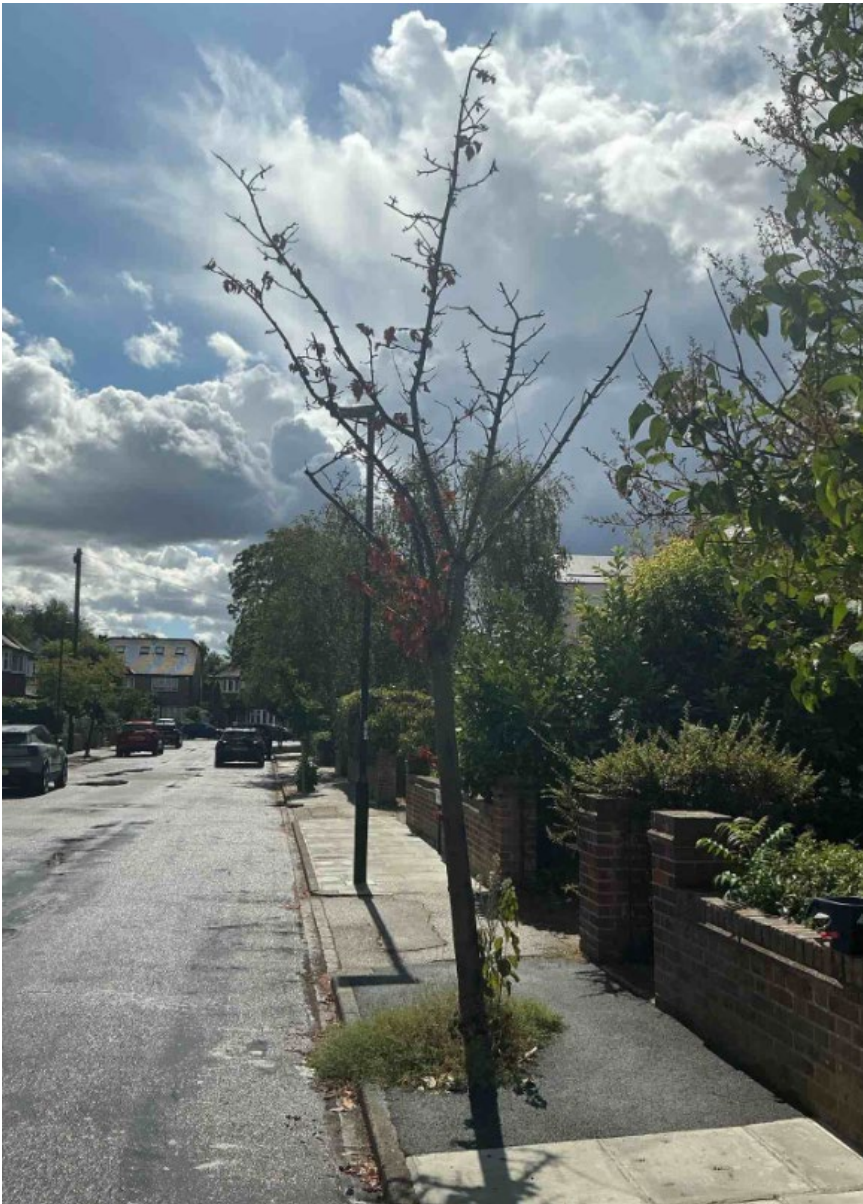
| Inspection findings/reason for exemption | This tree is moribund; removal is required to prevent natural failure, manage risk, and facilitate replanting. |

Image shows moribund tree in street scene.

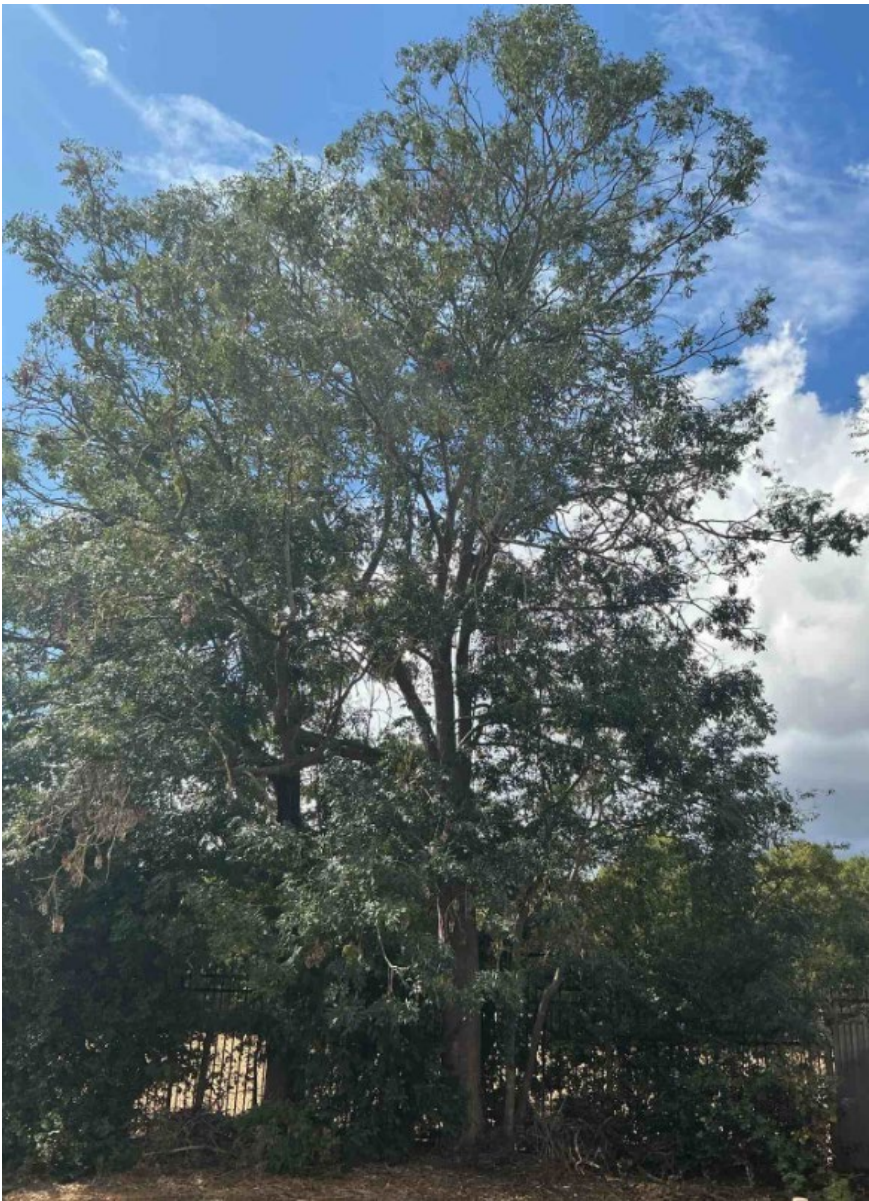
| Inspection findings/reason for exemption | A fungal fruiting body of the species Shaggy Polypore ( <i>Inonotus hispidus</i> ) is present on the main trunk; this fungus causes a simultaneous white rot which can cause snapping of tree parts in this particular species. Removal is required to prevent natural failure, manage risk, and facilitate replanting. |

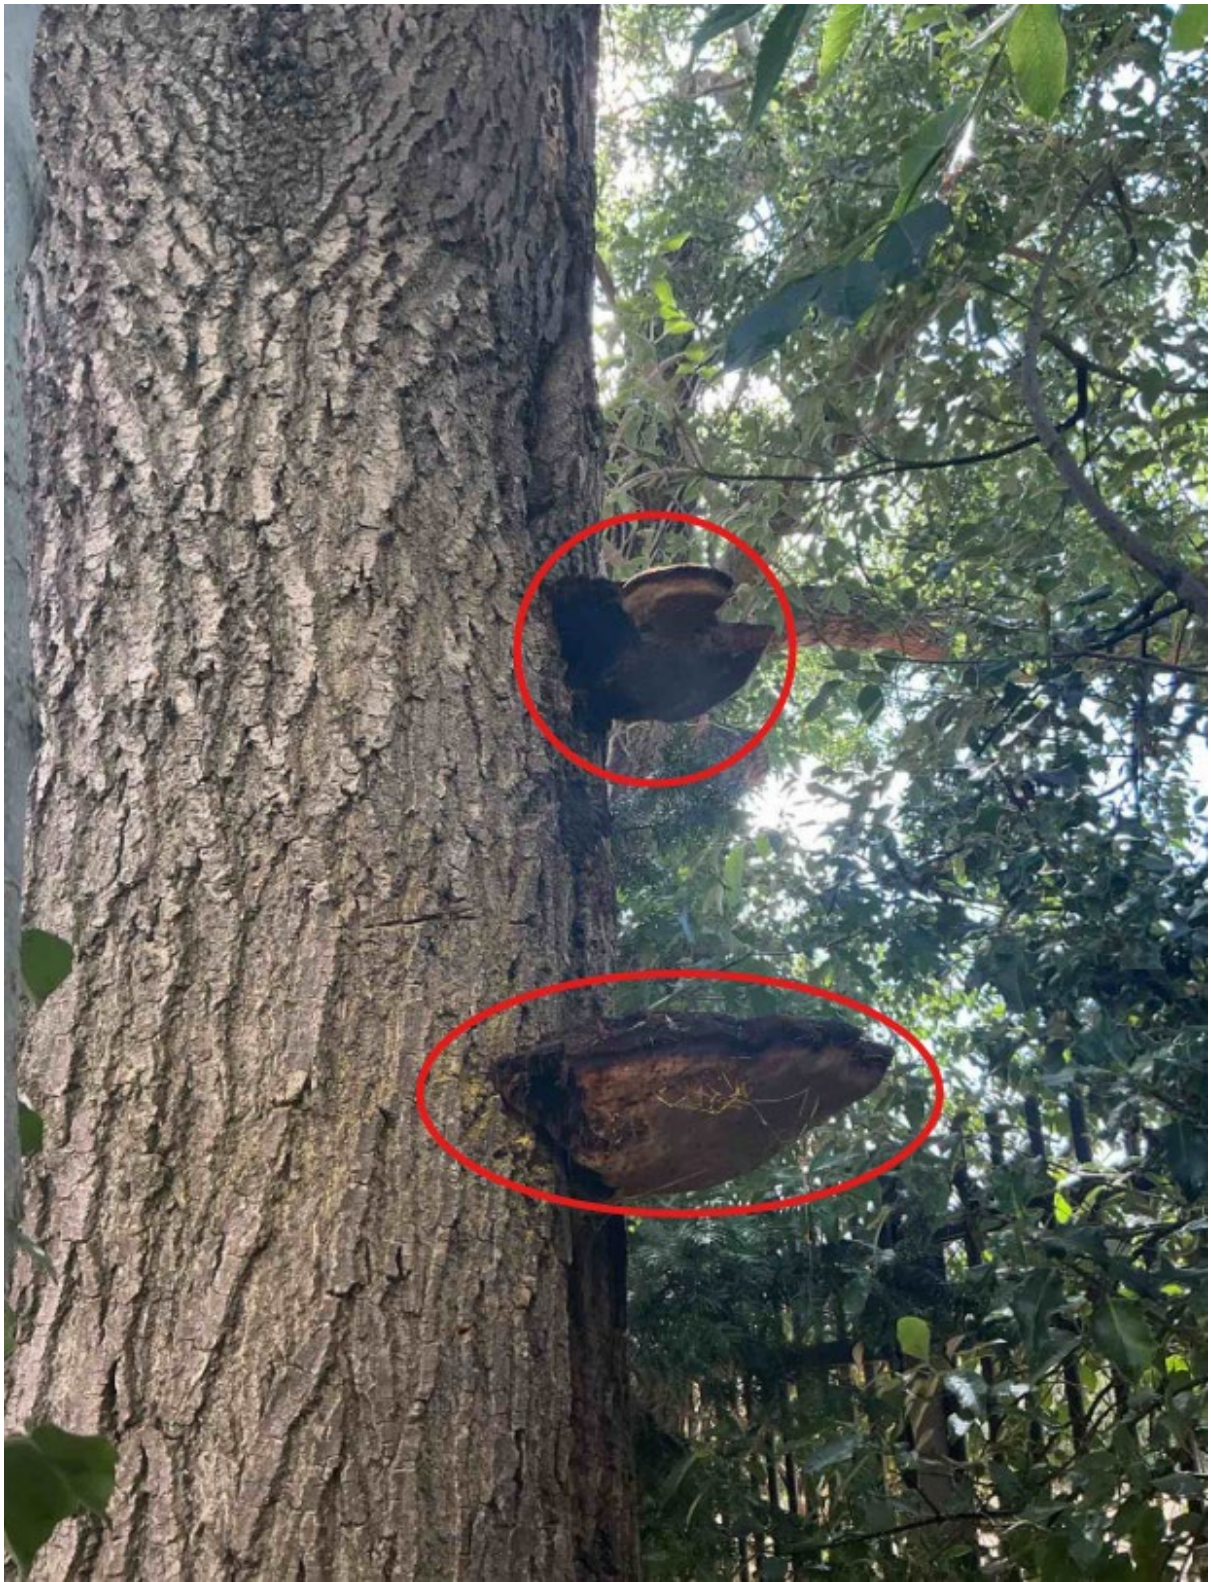
*Image shows fungal fruiting bodies circled.*

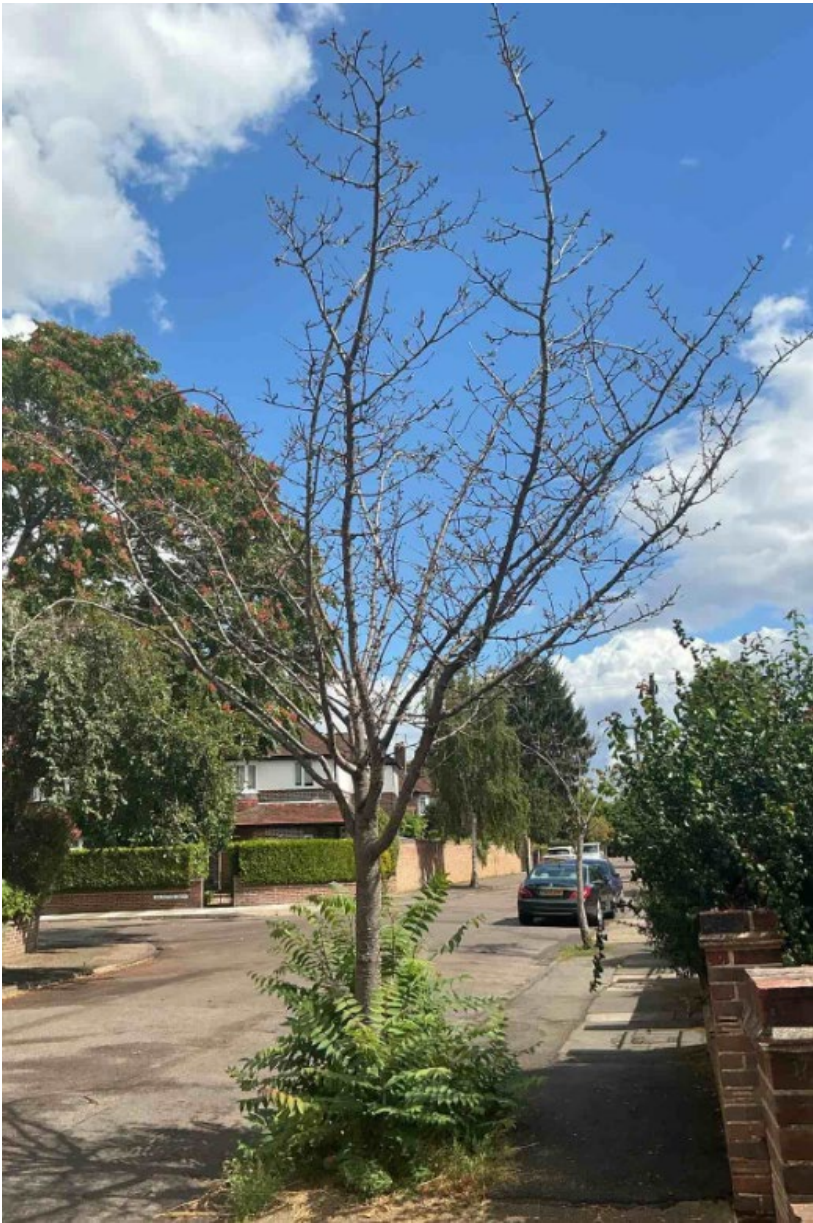
| Inspection findings/reason for exemption | This tree is dead; removal is required to prevent natural failure, manage risk, and facilitate replanting. |

Image shows dead tree in street scene.

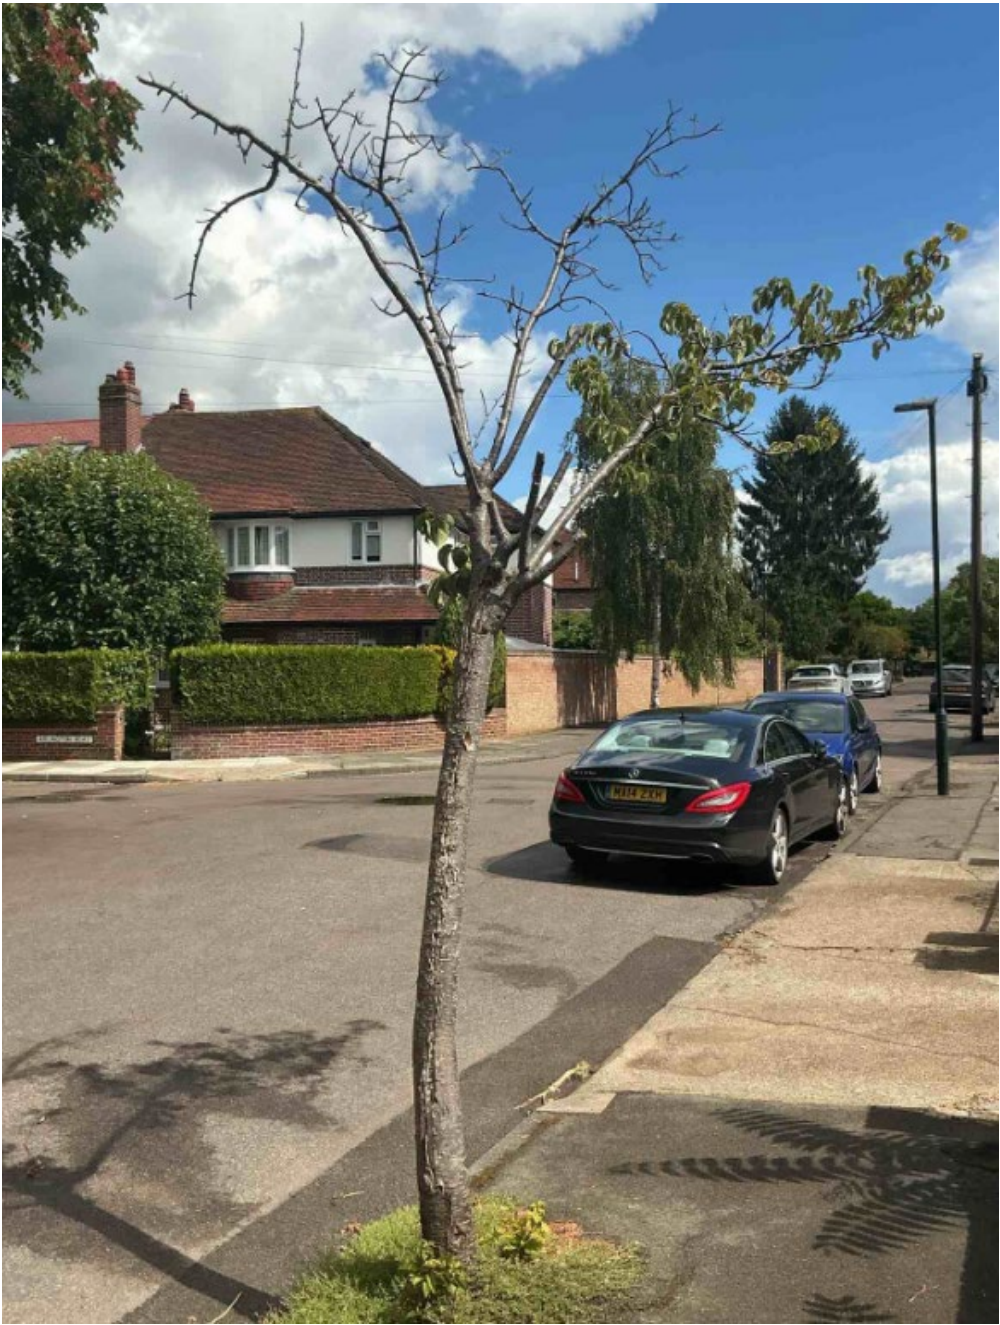
| Inspection findings/reason for exemption | This tree is moribund; removal is required to prevent natural failure, manage risk, and facilitate replanting. |

Image shows moribund tree in street scene.

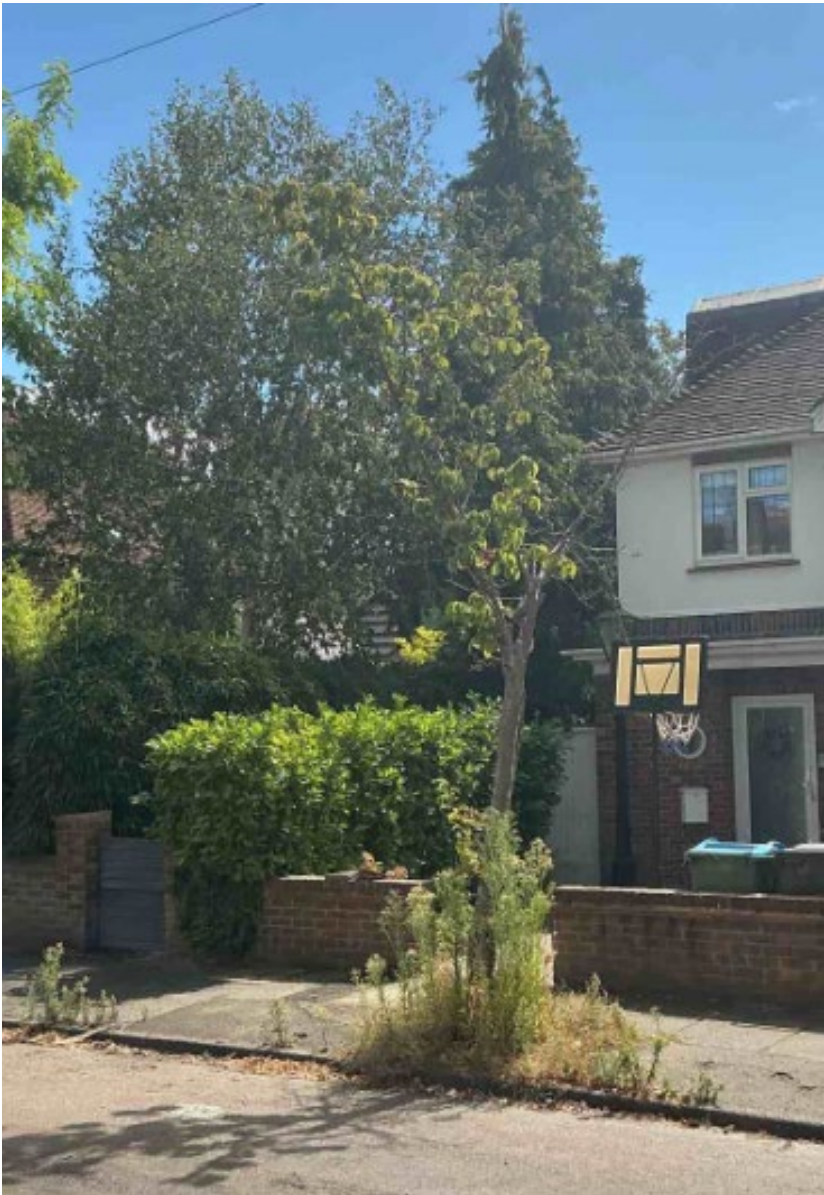
| Inspection findings/reason for exemption | This tree is moribund; removal is required to prevent natural failure, manage risk, and facilitate replanting. |

Image shows moribund tree in street scene.

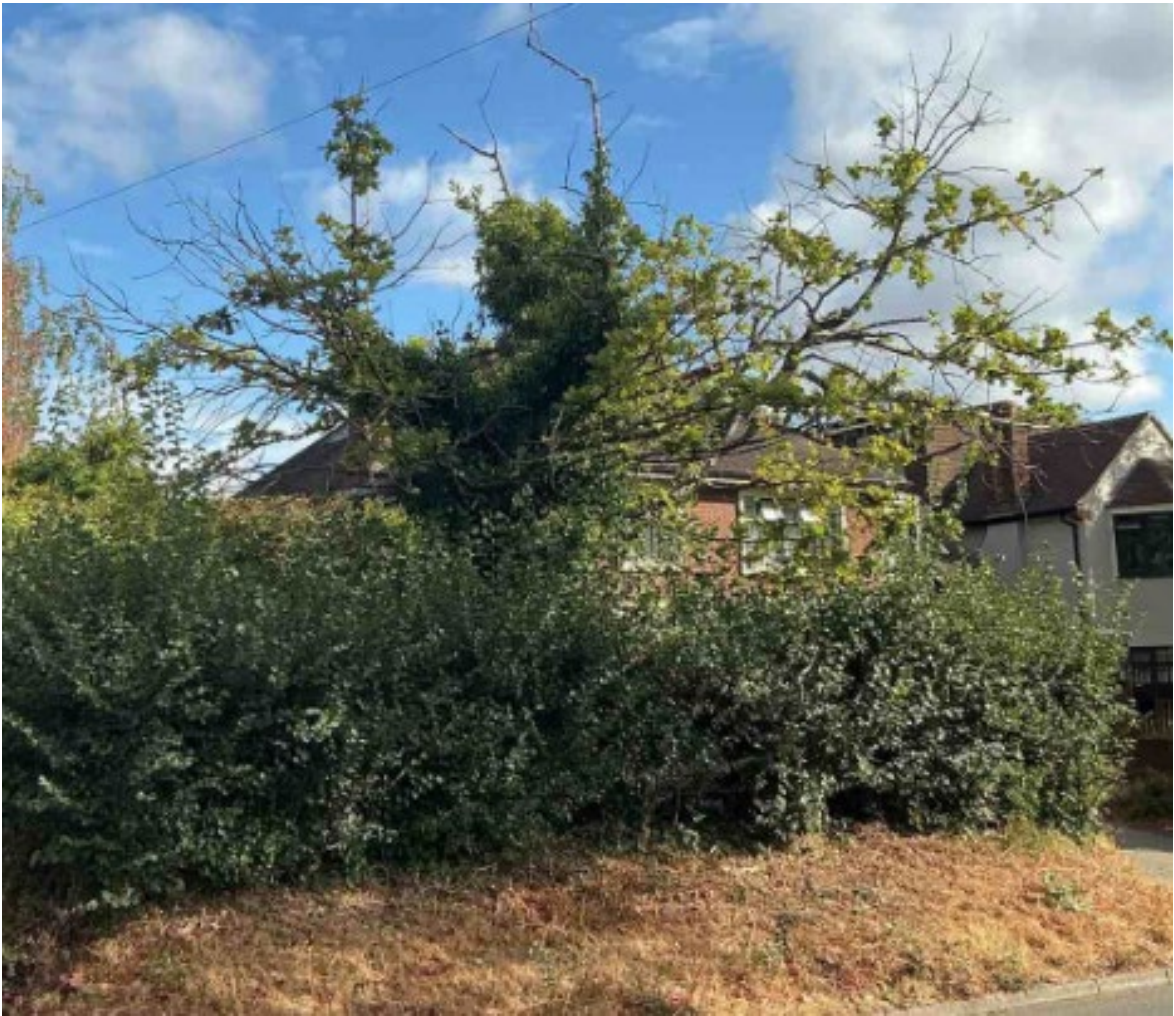
| Inspection findings/reason for exemption | This tree is moribund; removal is required to prevent natural failure, manage risk, and facilitate replanting. |

Image shows moribund tree in street scene.

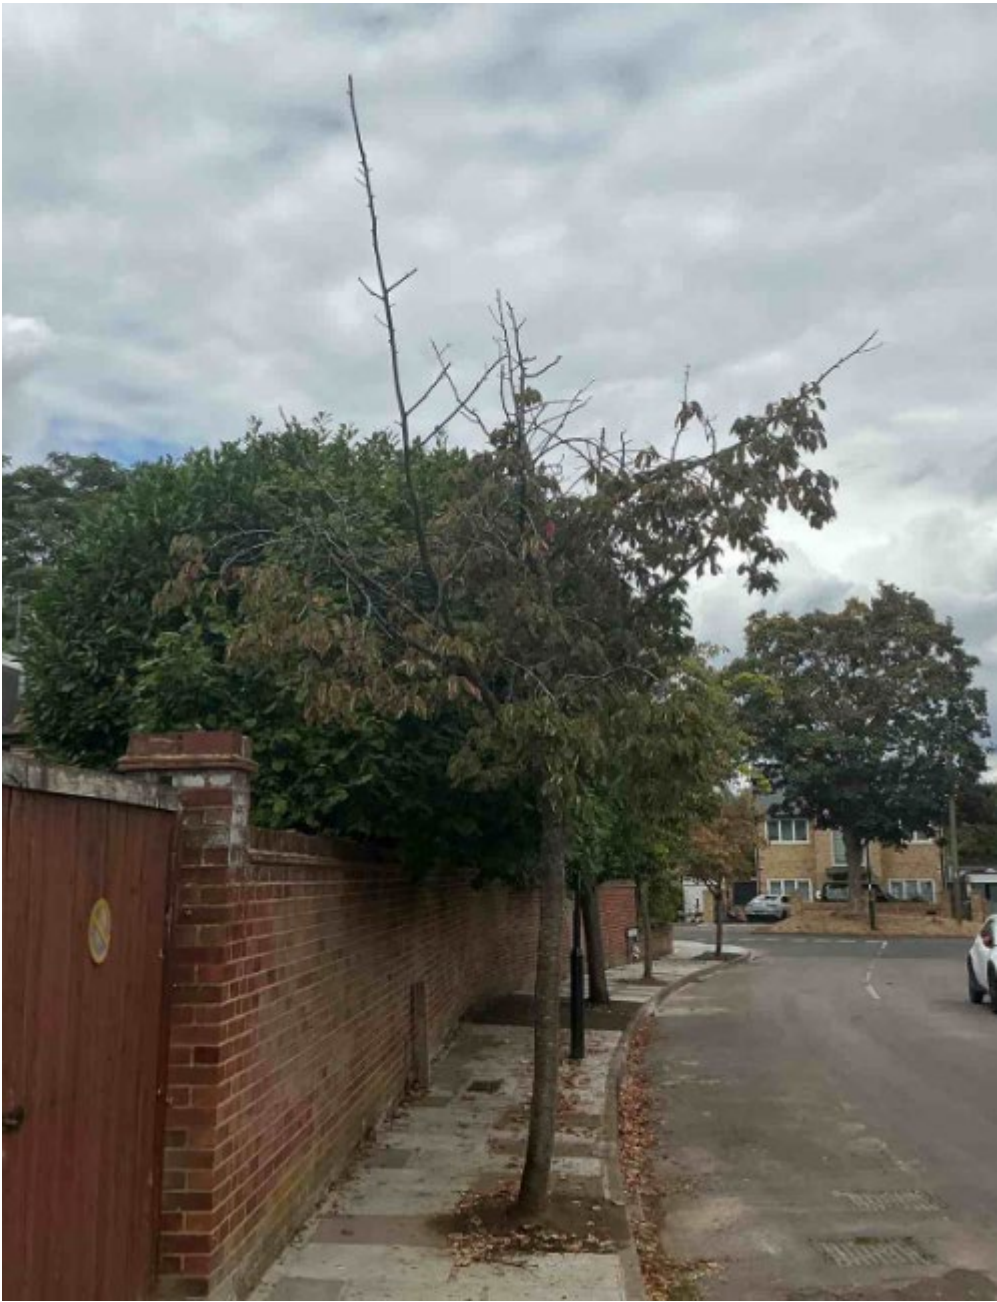
| Inspection findings/reason for exemption | This tree is moribund; removal is required to prevent natural failure, manage risk, and facilitate replanting. |

Image shows moribund tree in street scene.

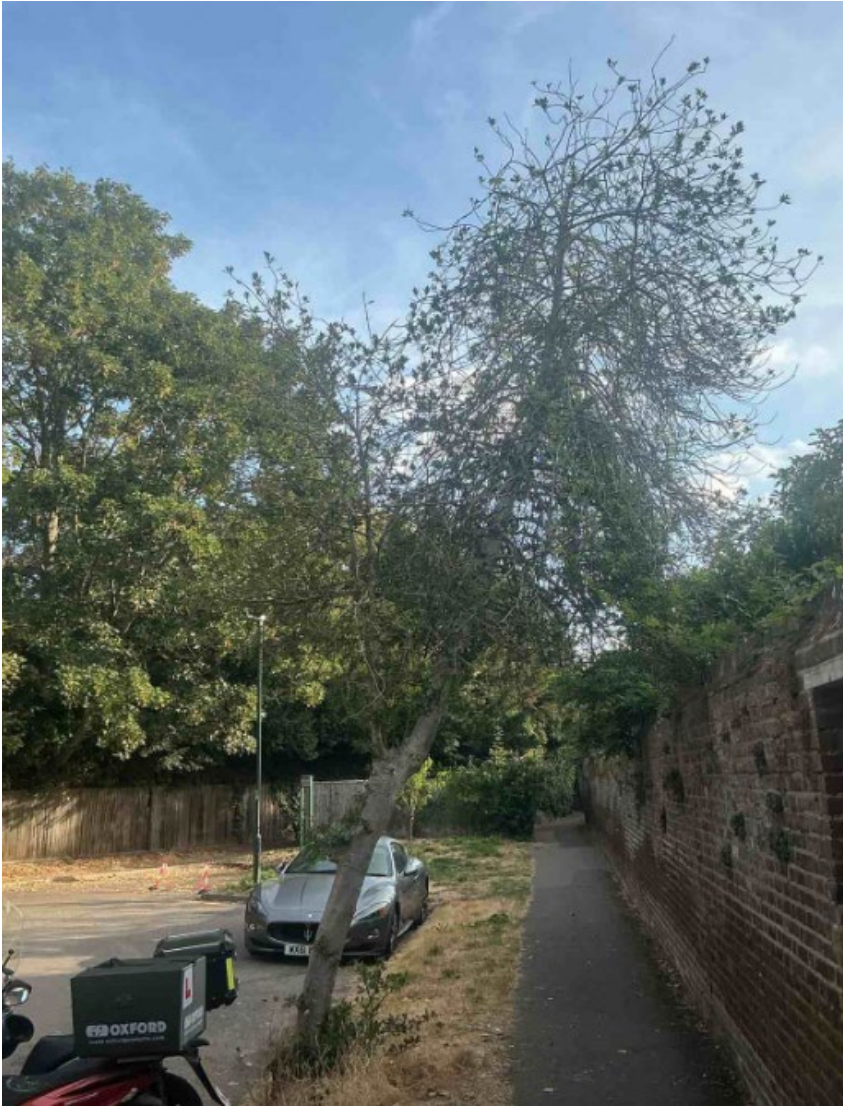
| Inspection findings/reason for exemption | This tree is moribund; removal is required to prevent natural failure, manage risk, and facilitate replanting. |

Image shows moribund tree in street scene.

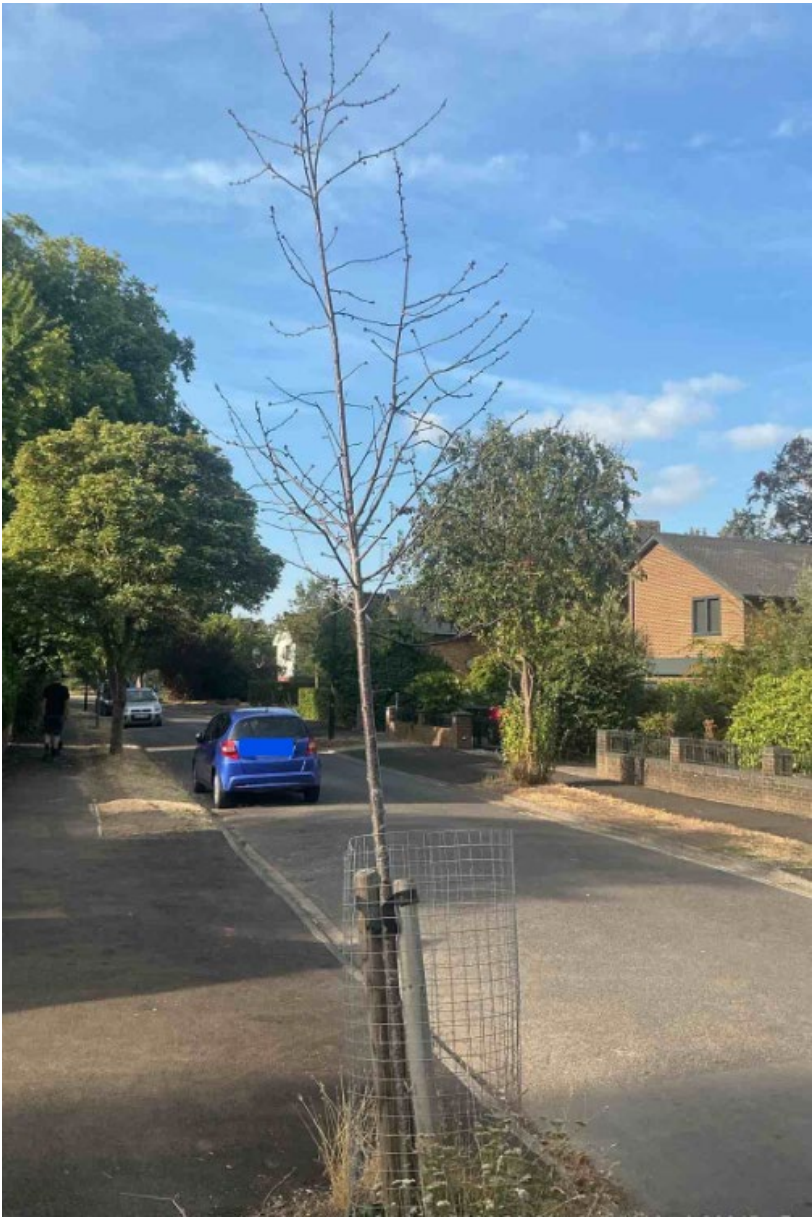
| Inspection findings/reason for exemption | This tree is dead; removal is required to prevent natural failure, manage risk, and facilitate replanting. |

Image shows dead tree in street scene.
