# September 2026 – Highways Reactive Tree Works Programme

Dated 18.9.2026

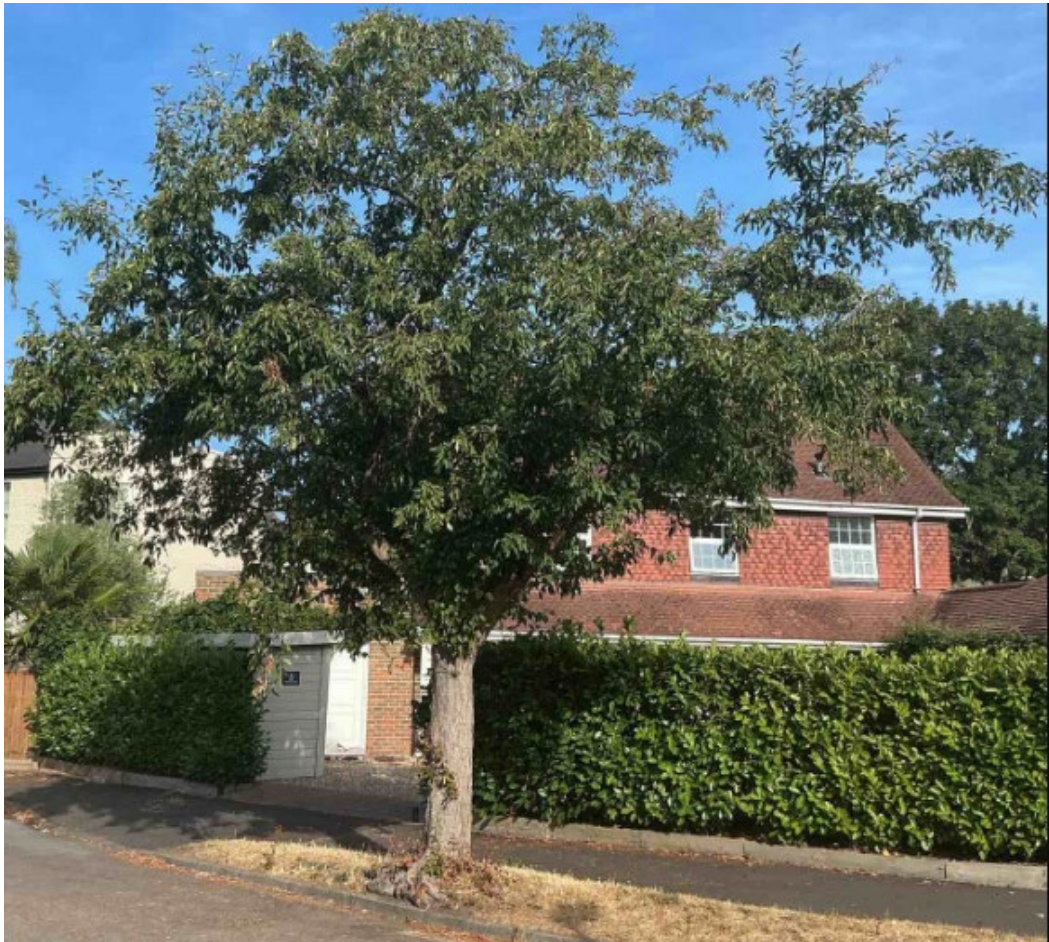
| Inspection findings/reason for exemption | A fungal fruiting body of the decay fungus <i>Ganoderma sp.</i> is present in cavity in primary union. Colonisation by this fungus results in white rot affecting the stem and root system, which can lead to structural failure through fracture or windthrow A resonance test with a sounding hammer and probe has revealed an unacceptable amount of decay around the bracket. Removal of the tree is recommended to prevent natural failure, manage risk, and facilitate replanting. |

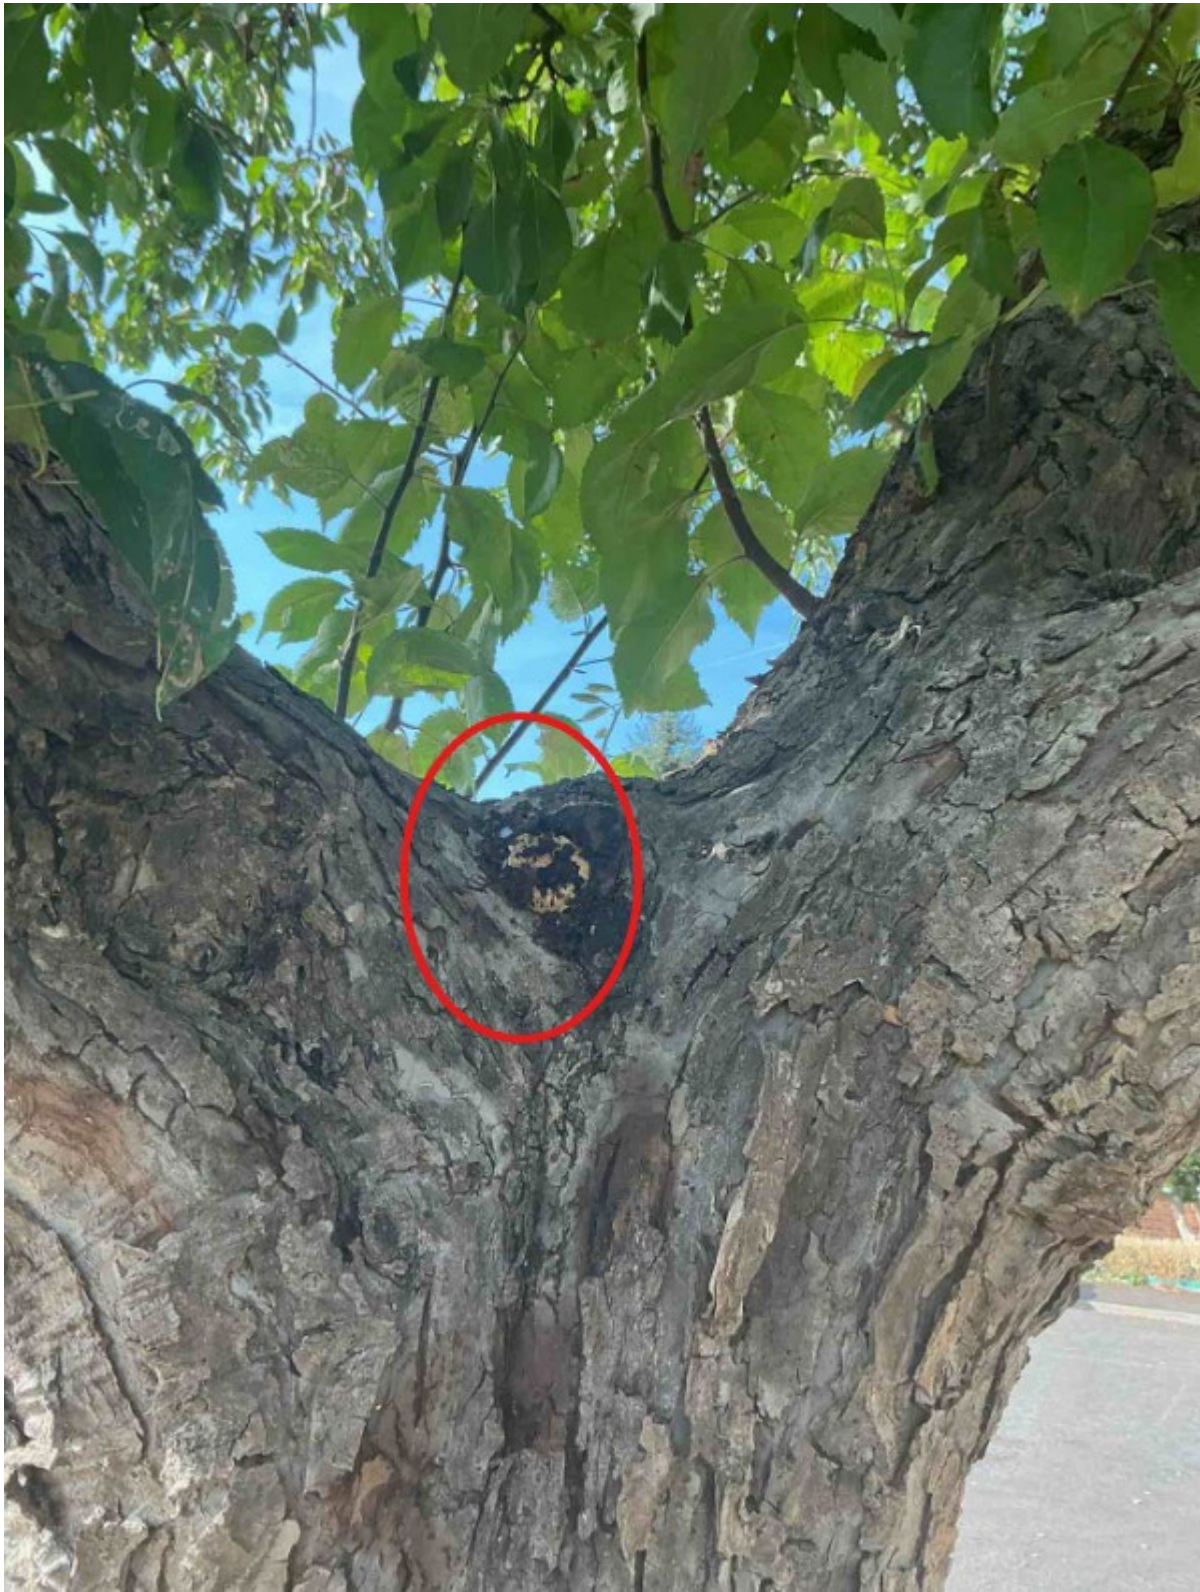
***Image shows fungal fruiting body circled.***

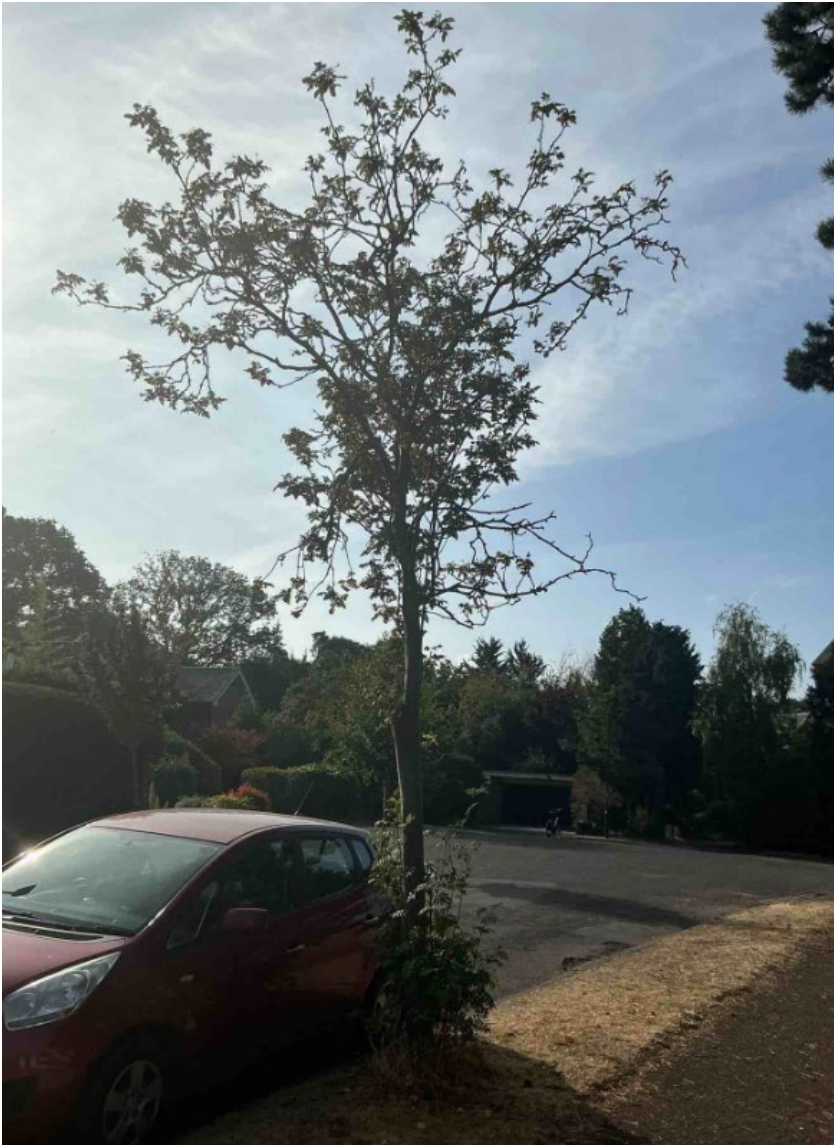
| Inspection findings/reason for exemption | Investigation with a probe and a resonance test with a sounding hammer has revealed an unacceptable amount of decay beyond the visible cavity on a historic tear wound on trunk. Removal is required to prevent natural failure, manage risk, and facilitate replanting. |

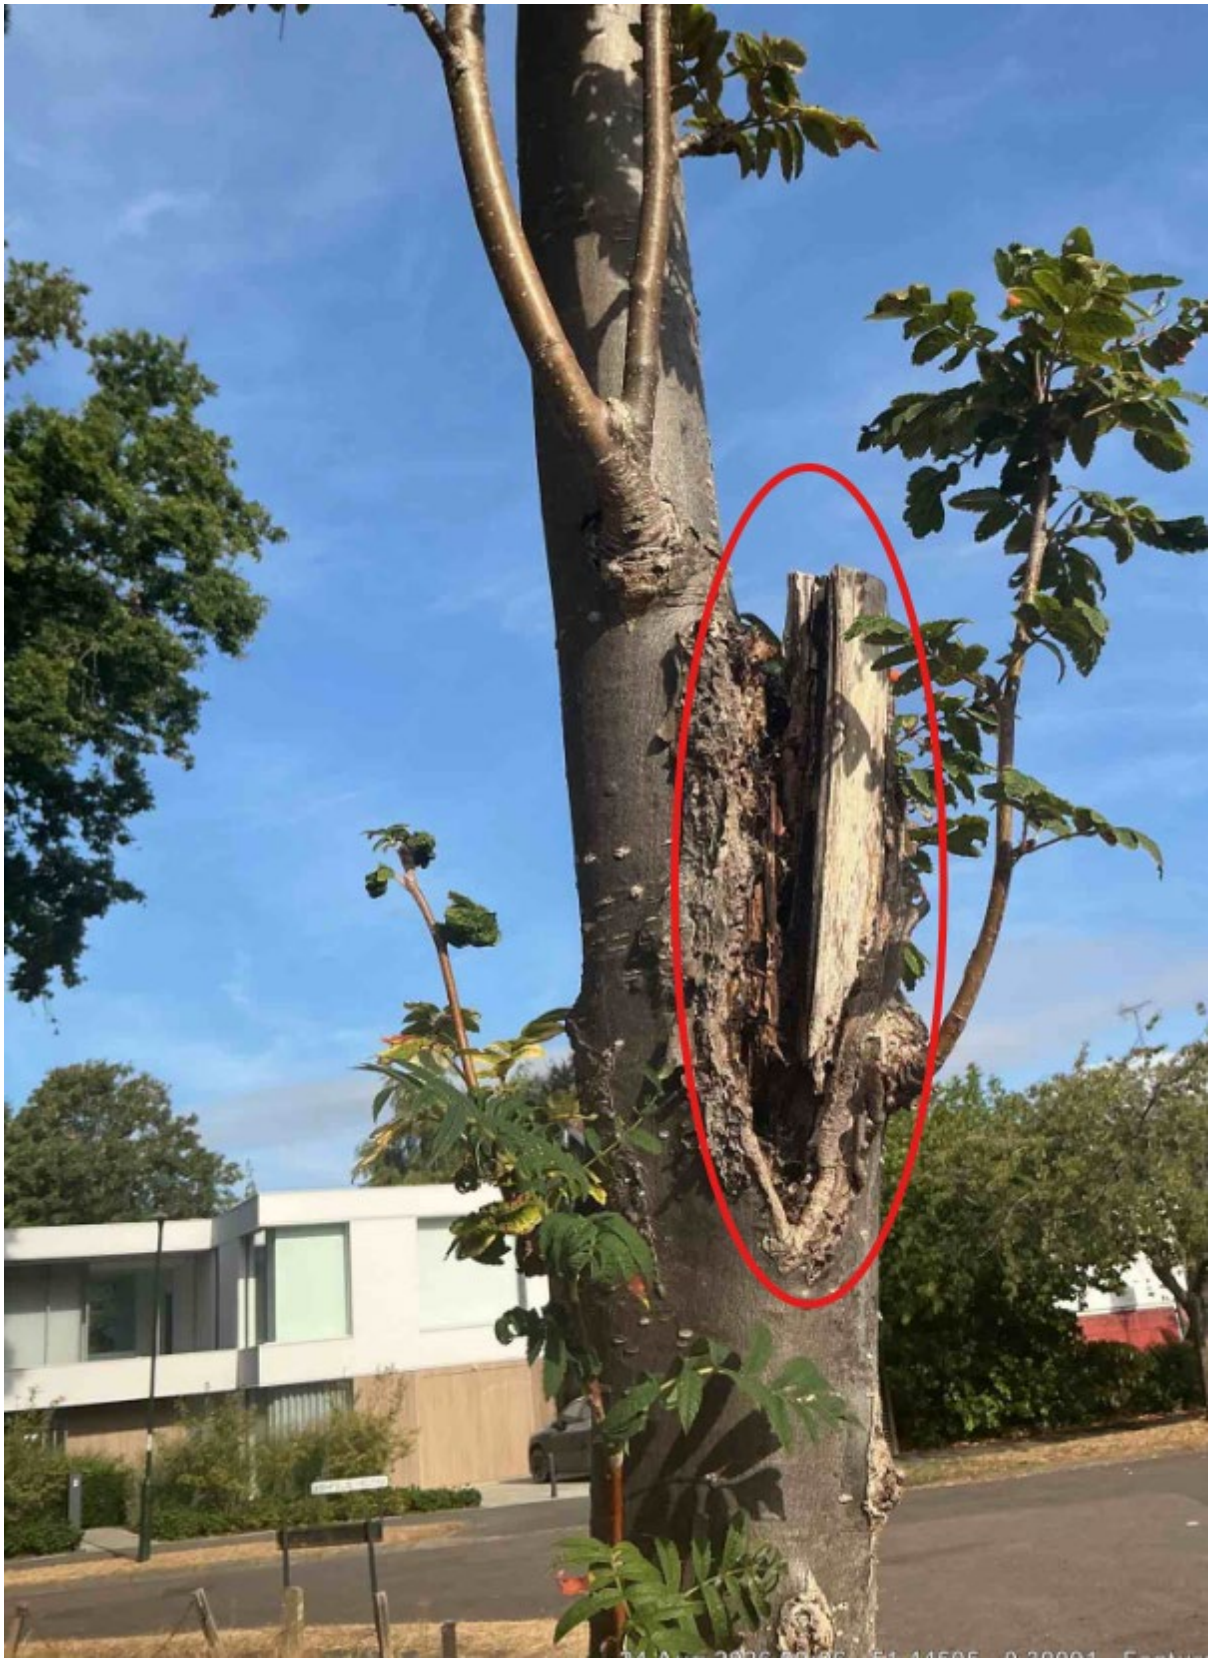
***Image shows cavity on historic tear wound.***

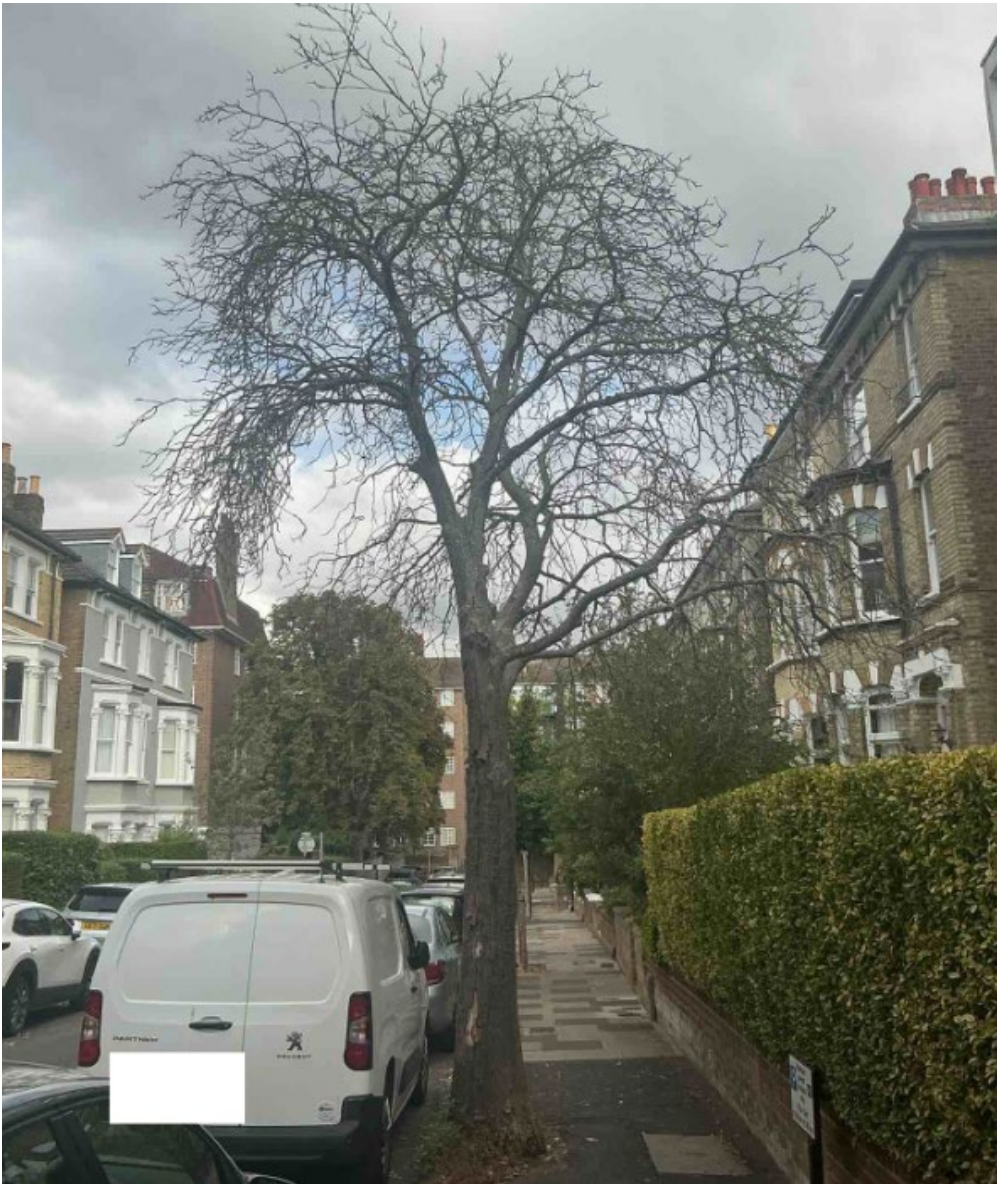
| Inspection findings/reason for exemption | This tree is dead; removal is required to prevent natural failure, manage risk, and facilitate replanting. |

Image shows dead tree in street scene.

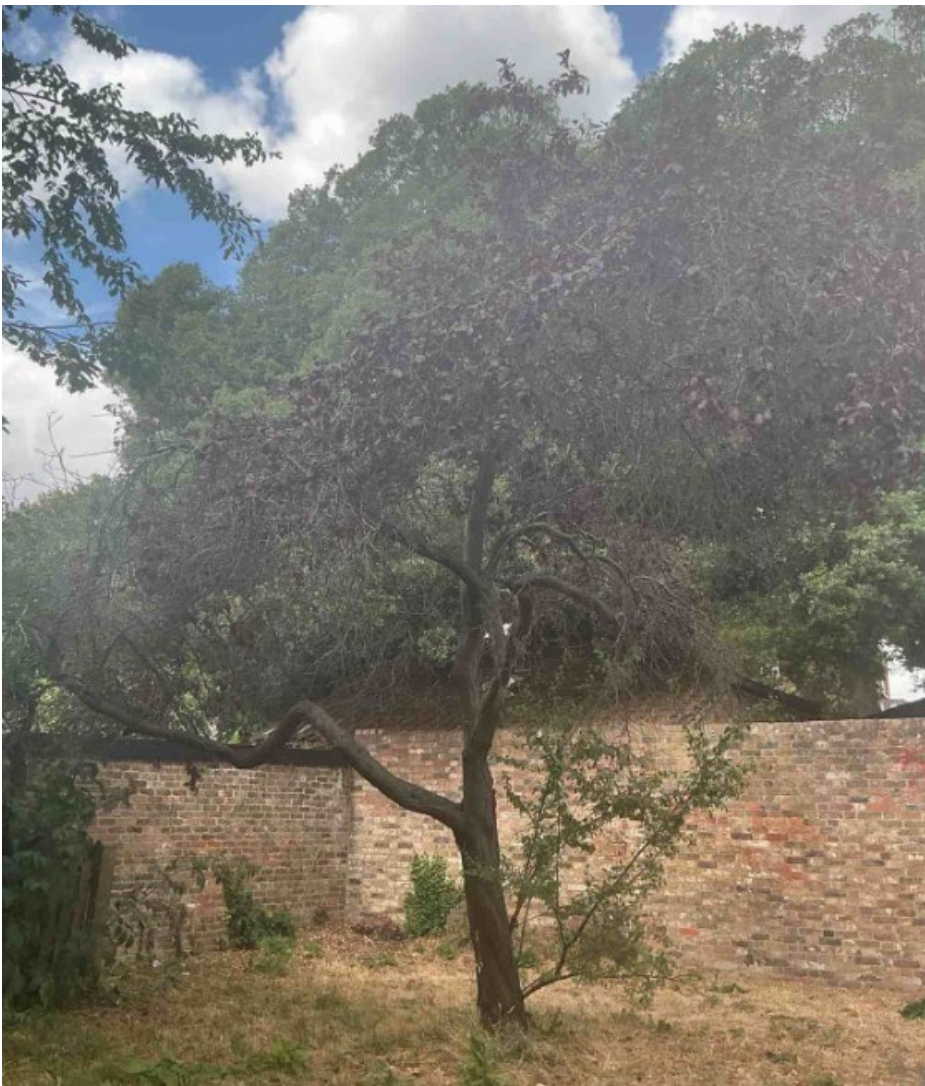
| Inspection findings/reason for exemption | Investigation with a probe and a resonance test with a sounding hammer has revealed an unacceptable amount of decay beyond the visible cavities at the base of the trunk. Removal is required to prevent natural failure, manage risk, and facilitate replanting. |

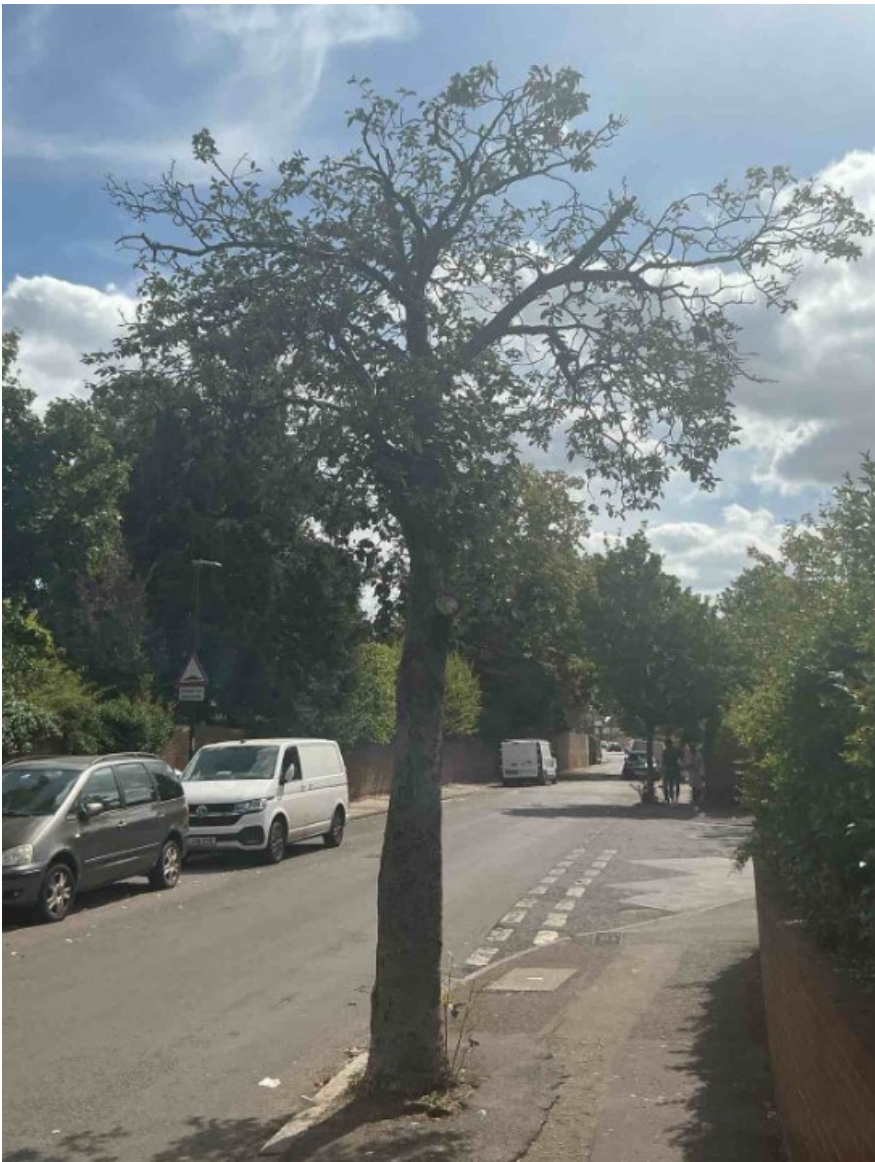
| Inspection findings/reason for exemption | A fungal fruiting body of the species Shaggy Polypore ( <i>Inonotus hispidus</i> ) is present on the trunk; this fungus causes a simultaneous white rot which can cause snapping of tree parts in this species |

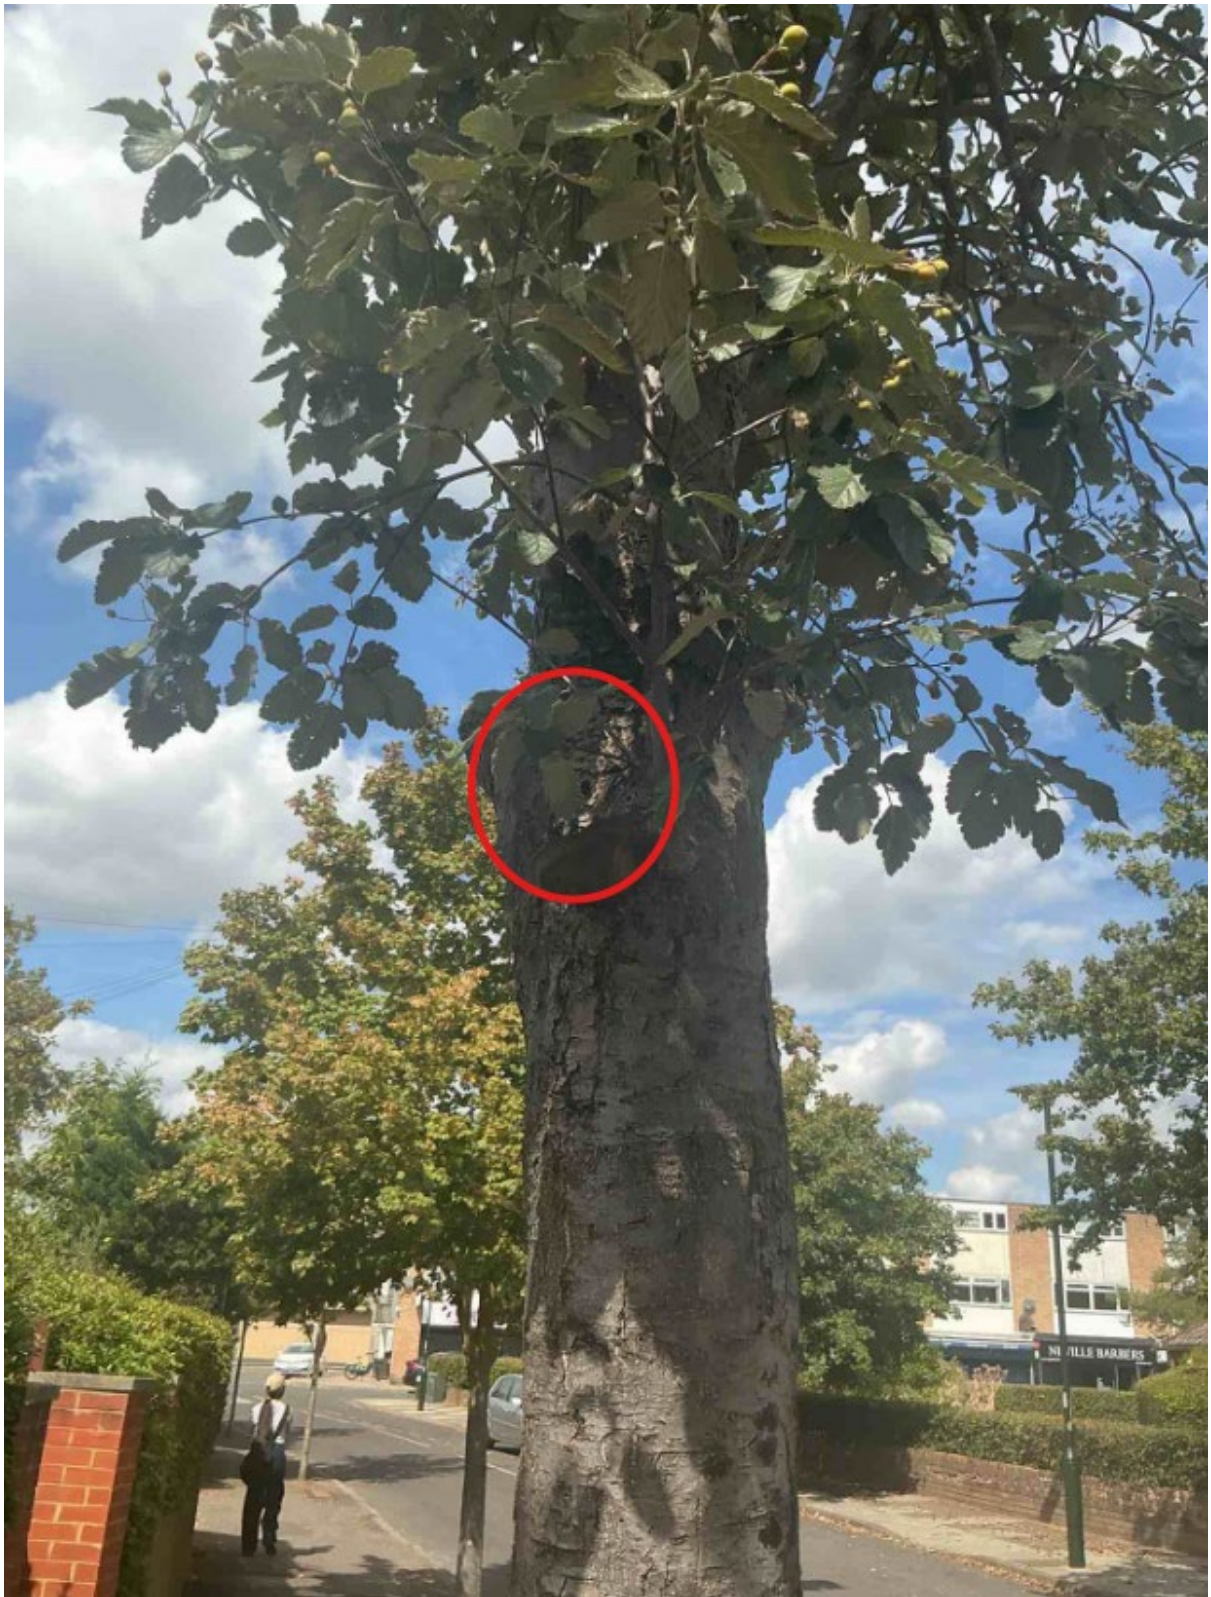
***Images show fungal fruiting body on truck.***

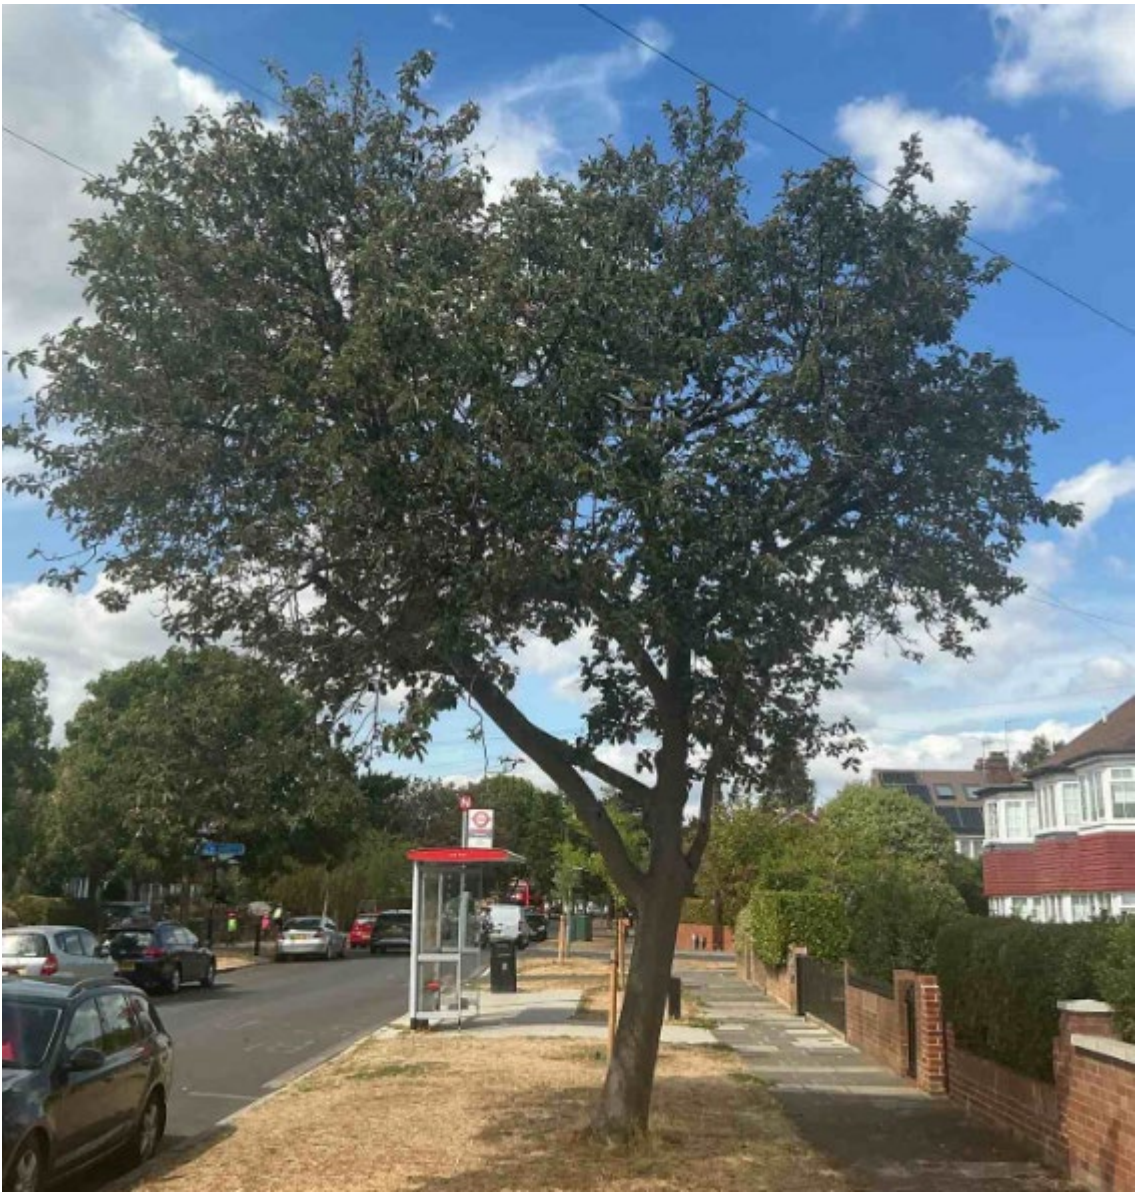
| Inspection findings/reason for exemption | Investigation with a probe and a resonance test with a sounding hammer has revealed an unacceptable amount of decay beyond the visible cavity on the trunk. Removal is required to prevent natural failure, manage risk, and facilitate replanting. |

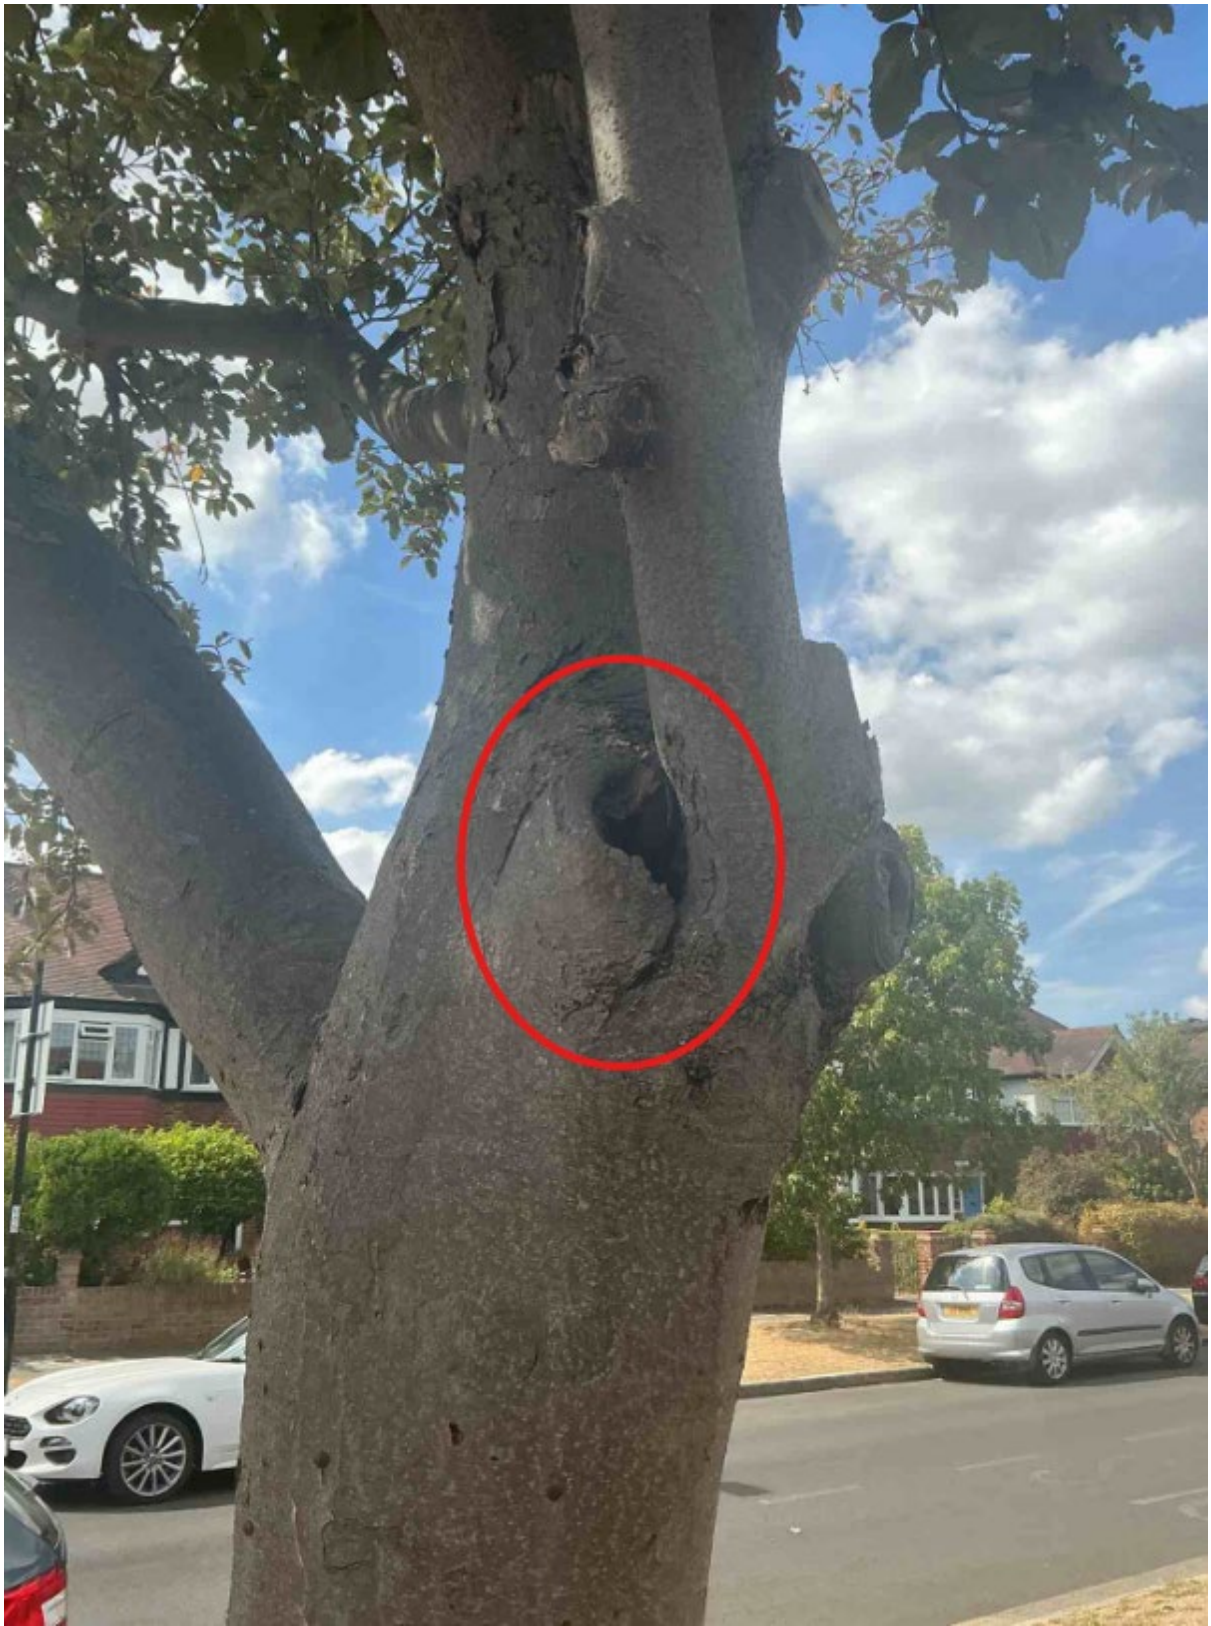
***Images show cavity on trunk circled.***

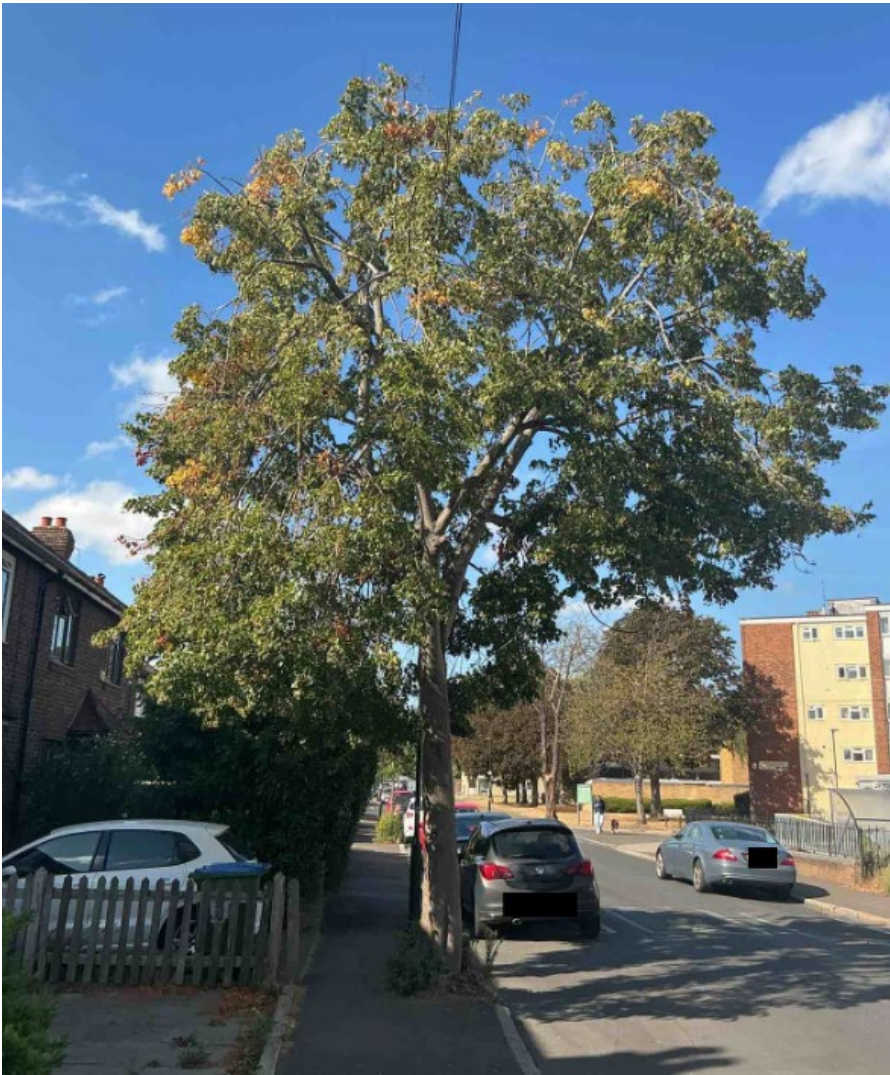
| Inspection findings/reason for exemption | A fungal fruiting body of the decay fungus <i>Ganoderma sp.</i> is present on the trunk. Colonisation by this fungus results in white rot affecting the stem and root system, which can lead to structural failure through fracture or windthrow A resonance test with a sounding hammer has revealed an unacceptable amount of decay around the bracket. Removal of the tree is recommended to prevent natural failure, manage risk, and facilitate replanting. |

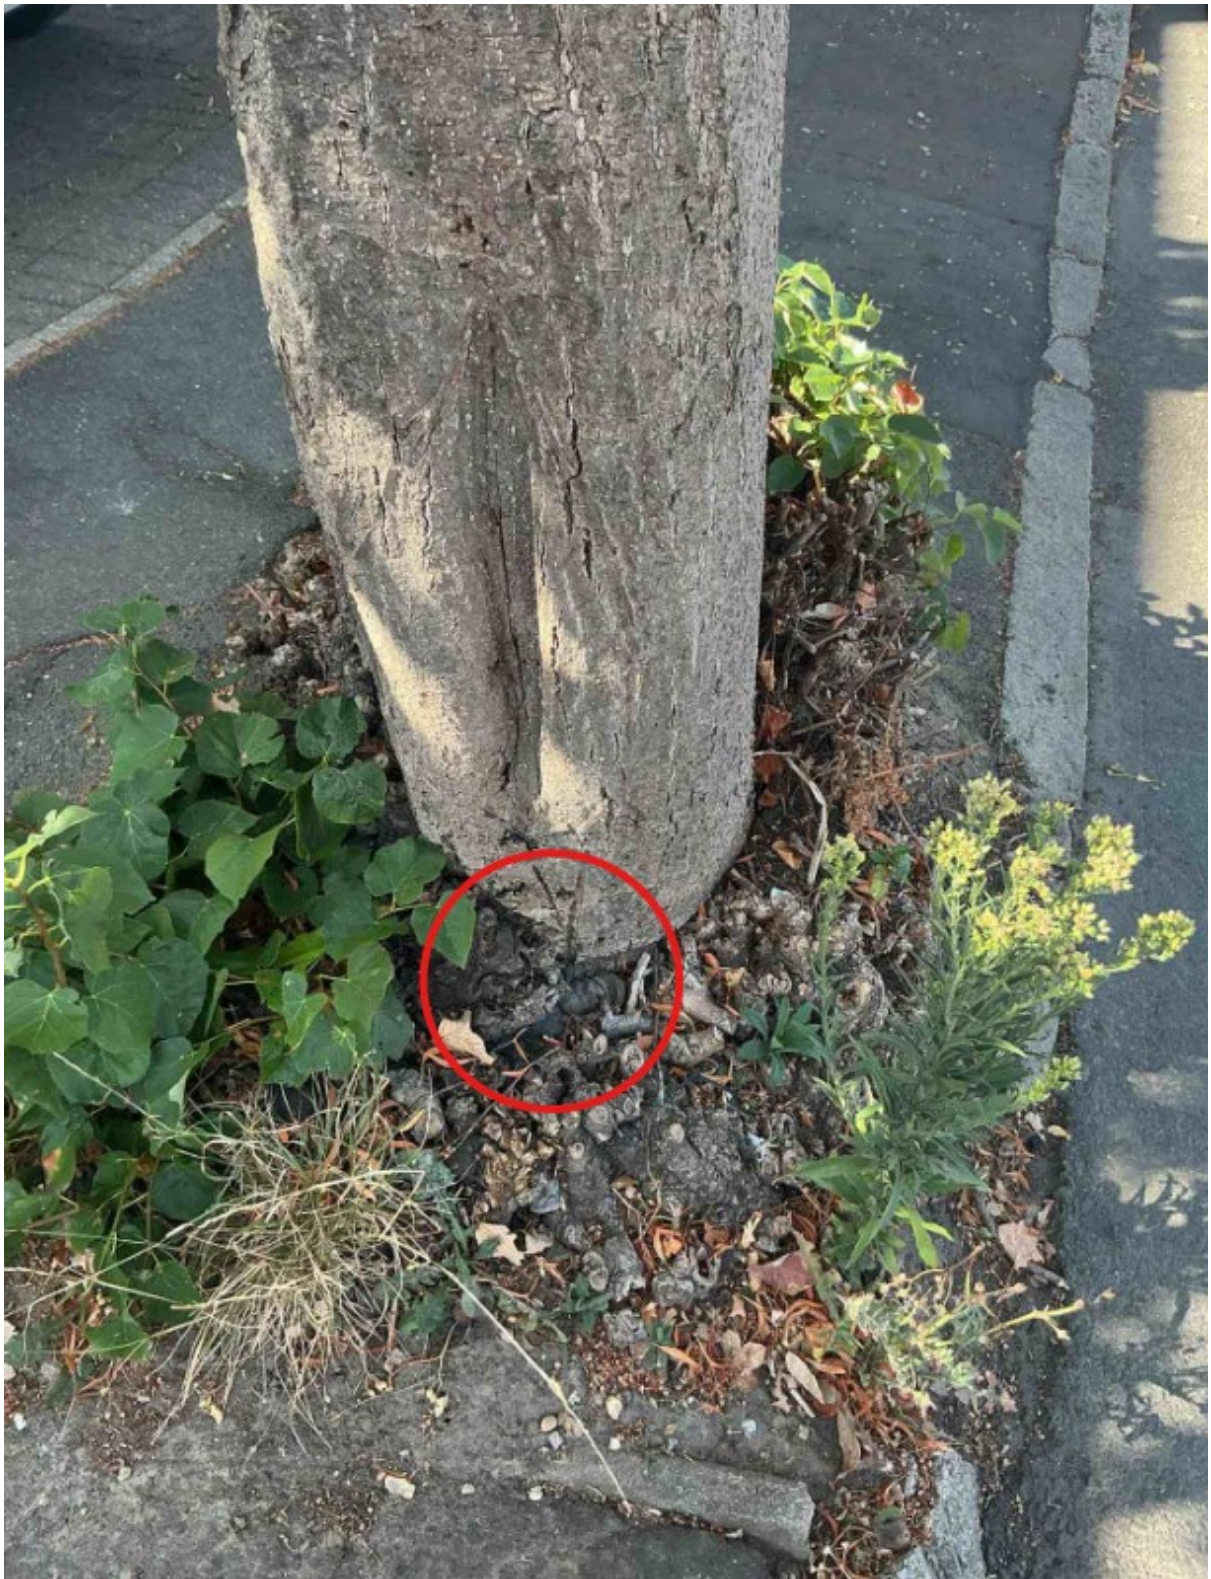
*Images show fungal fruiting body circled.*

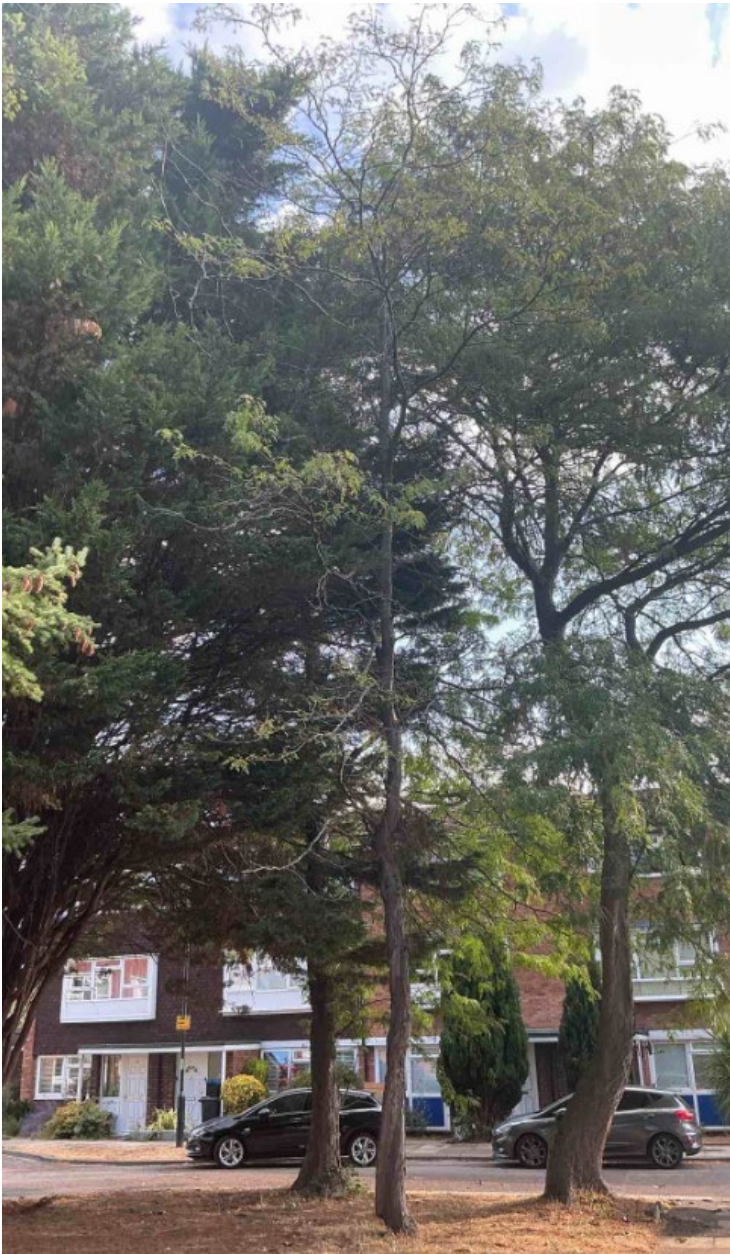
| Inspection findings/reason for exemption | This tree is moribund; removal is required to prevent natural failure, manage risk, and facilitate replanting. |

Images show moribund tree in street scene.

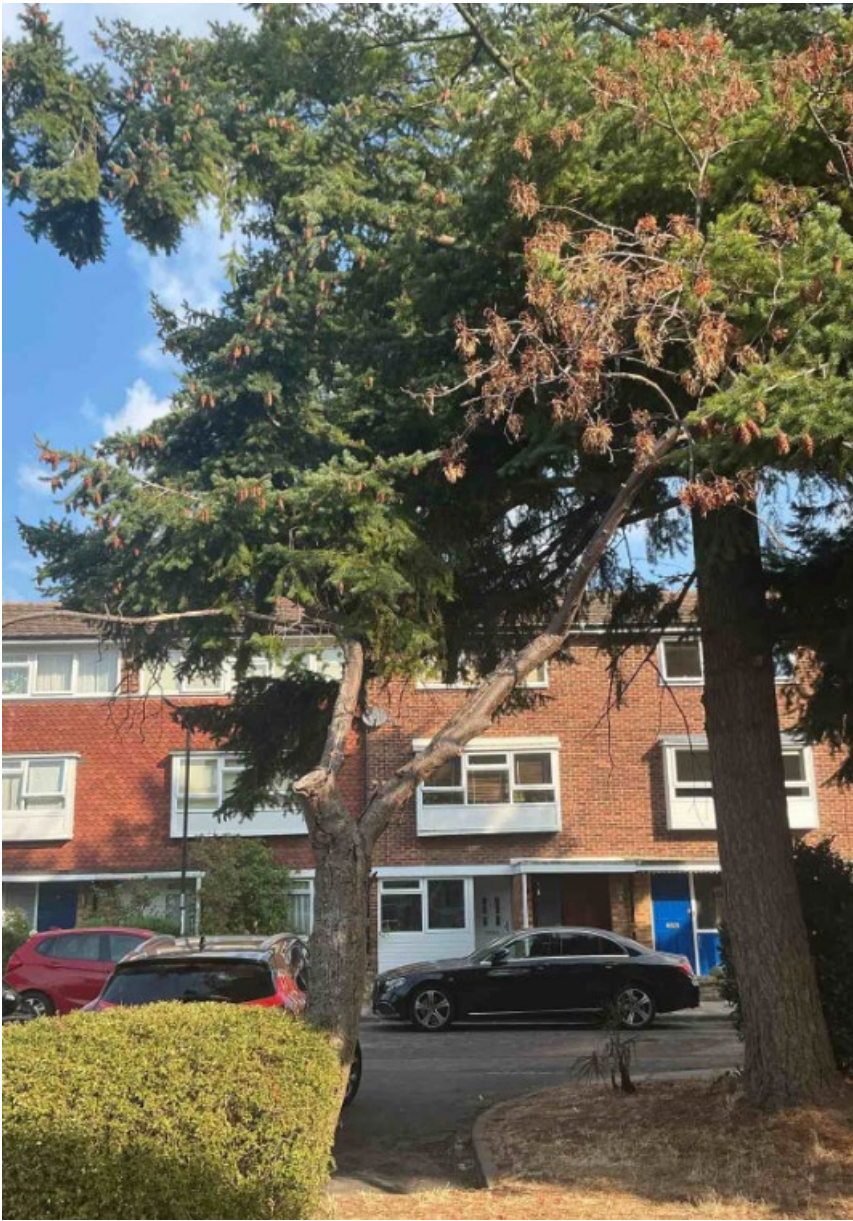
| Inspection findings/reason for exemption | This tree is dead; removal is required to prevent natural failure, manage risk, and facilitate replanting. |

Images show dead tree in street scene.

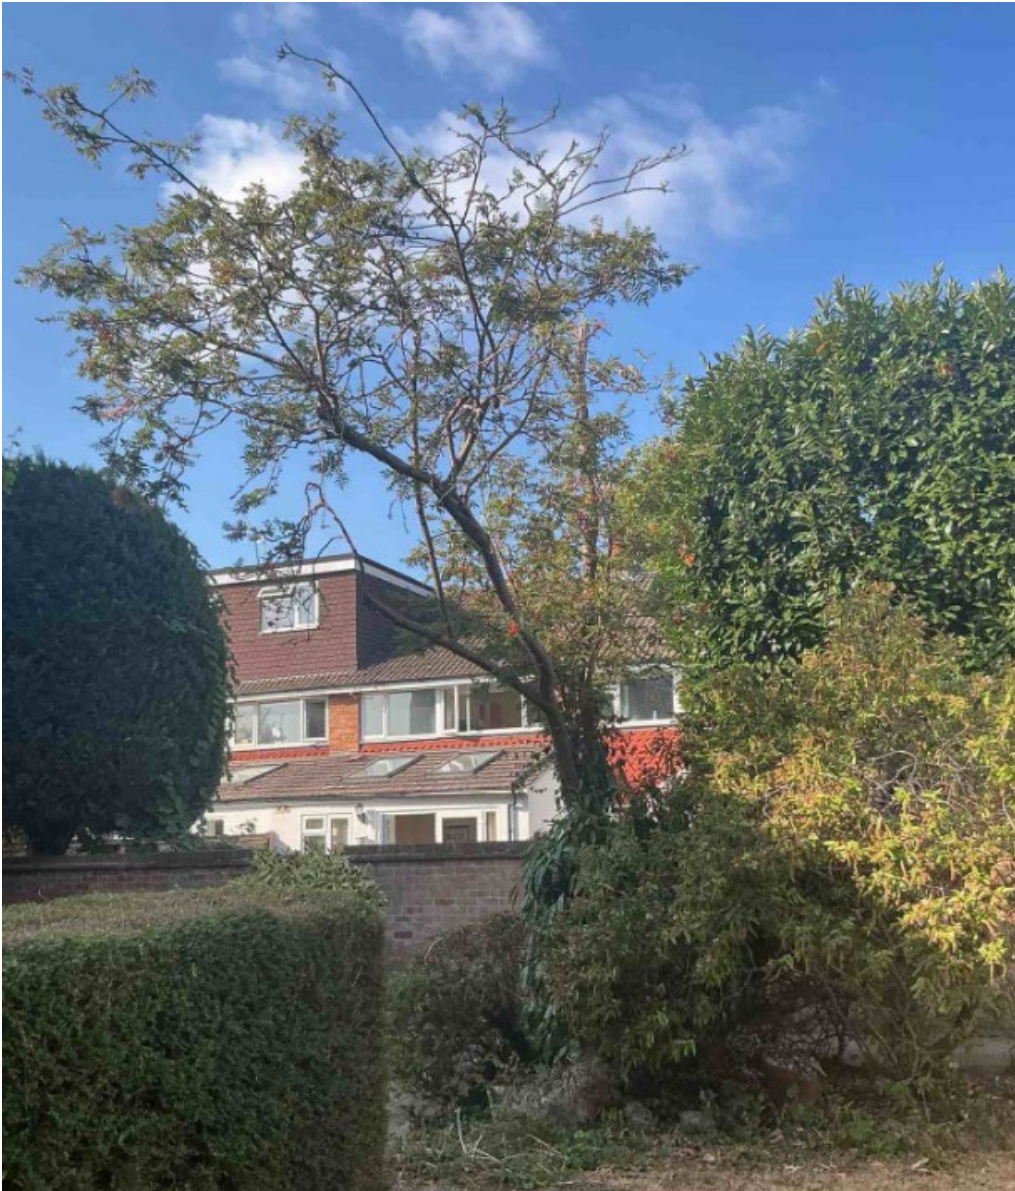
| Inspection findings/reason for exemption | Investigation with a probe and a resonance test with a sounding hammer has revealed an unacceptable amount of decay beyond the visible cavity at the base of the trunk. Removal is required to prevent natural failure, manage risk, and facilitate replanting. |

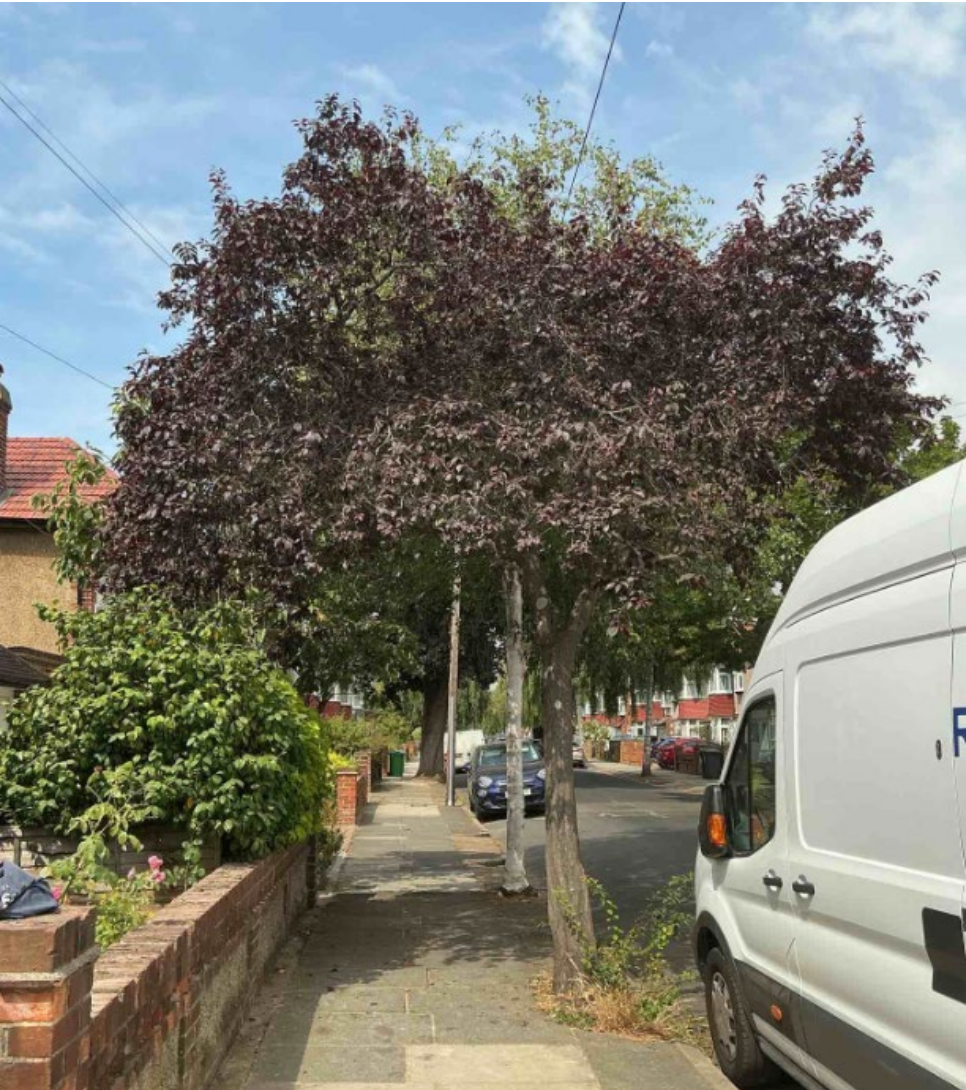
| Inspection findings/reason for exemption | Investigation with a probe and a resonance test with a sounding hammer has revealed an unacceptable amount of decay beyond the visible cavities at the base of the trunk. Removal is required to prevent natural failure, manage risk, and facilitate replanting. |
