# September 2026 – Highways Reactive Tree Works Programme

Dated 18.9.2026

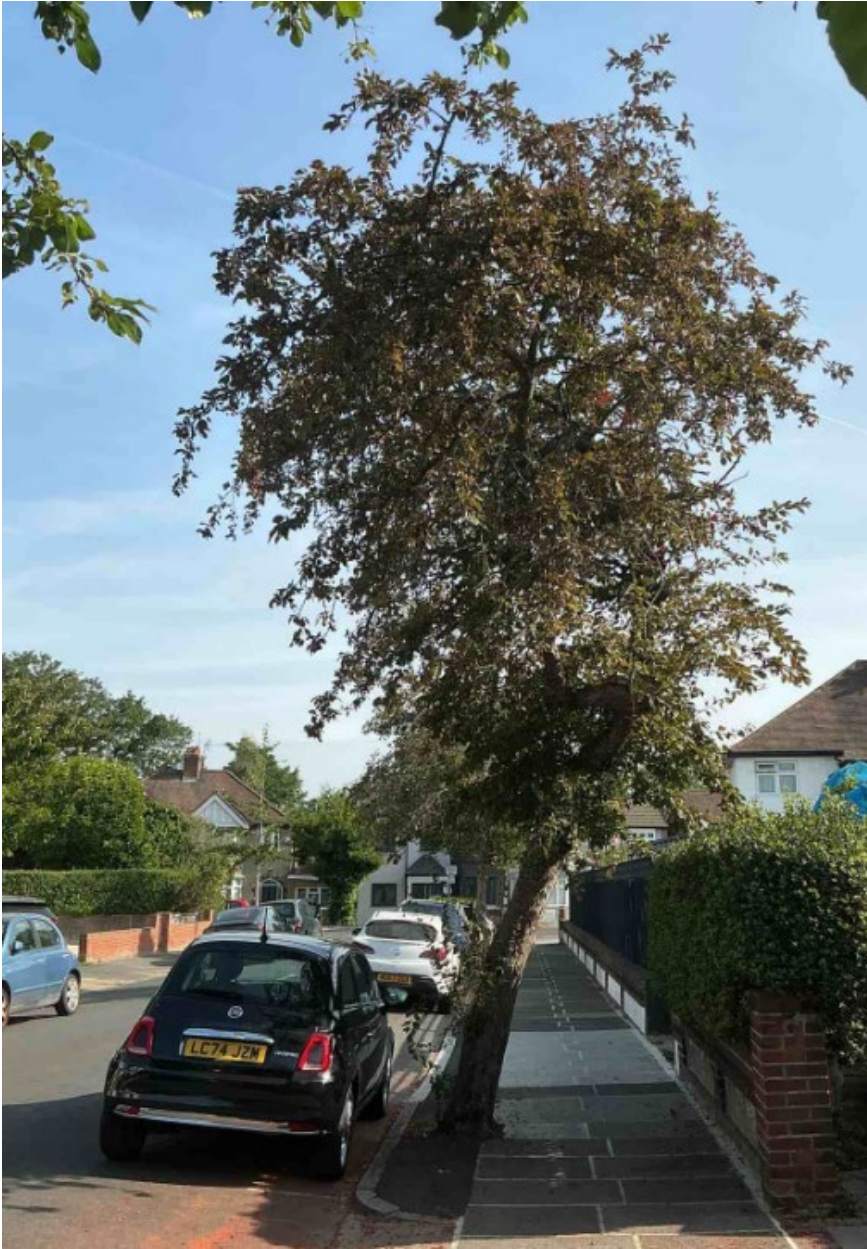
| Inspection findings/reason for exemption | A fungal fruiting body of the species Shaggy Polypore ( <i>Inonotus hispidus</i> ) is present on the trunk; this fungus causes a simultaneous white rot which can cause snapping of tree parts in this species; removal is required to prevent natural failure and facilitate replanting |

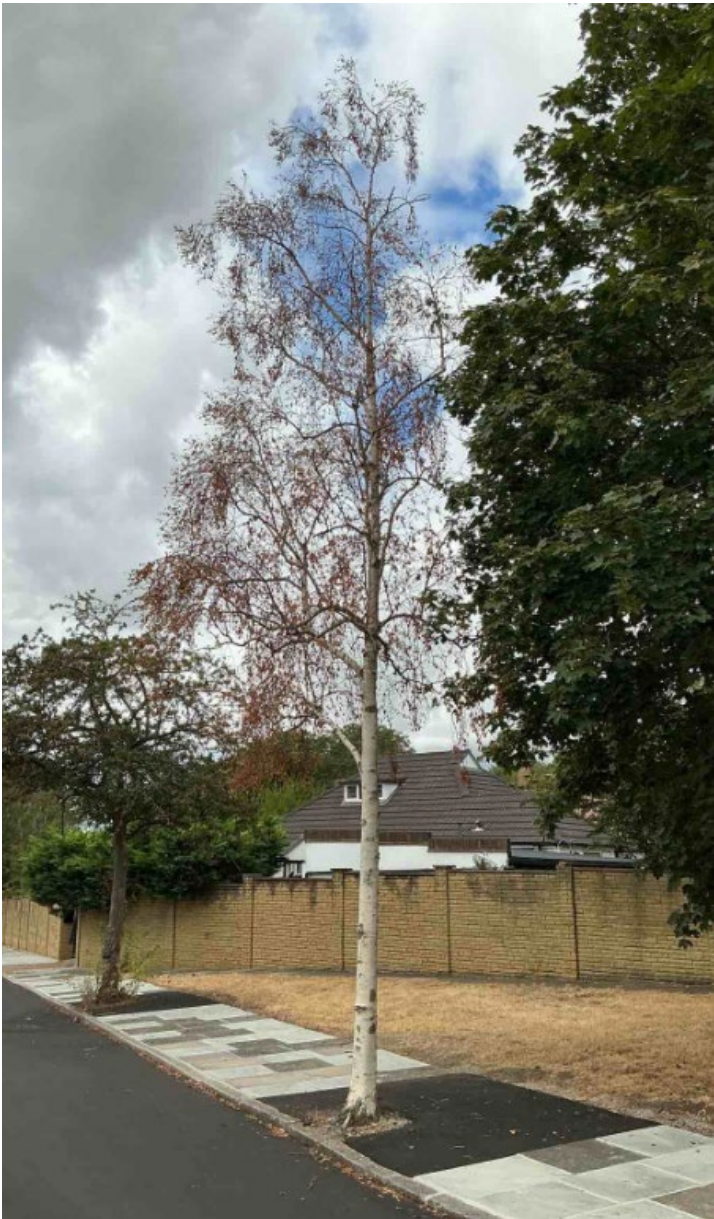
| Inspection findings/reason for exemption | This tree is dead; removal is required to prevent natural failure and facilitate replanting |

Image shows dead tree in street scene.

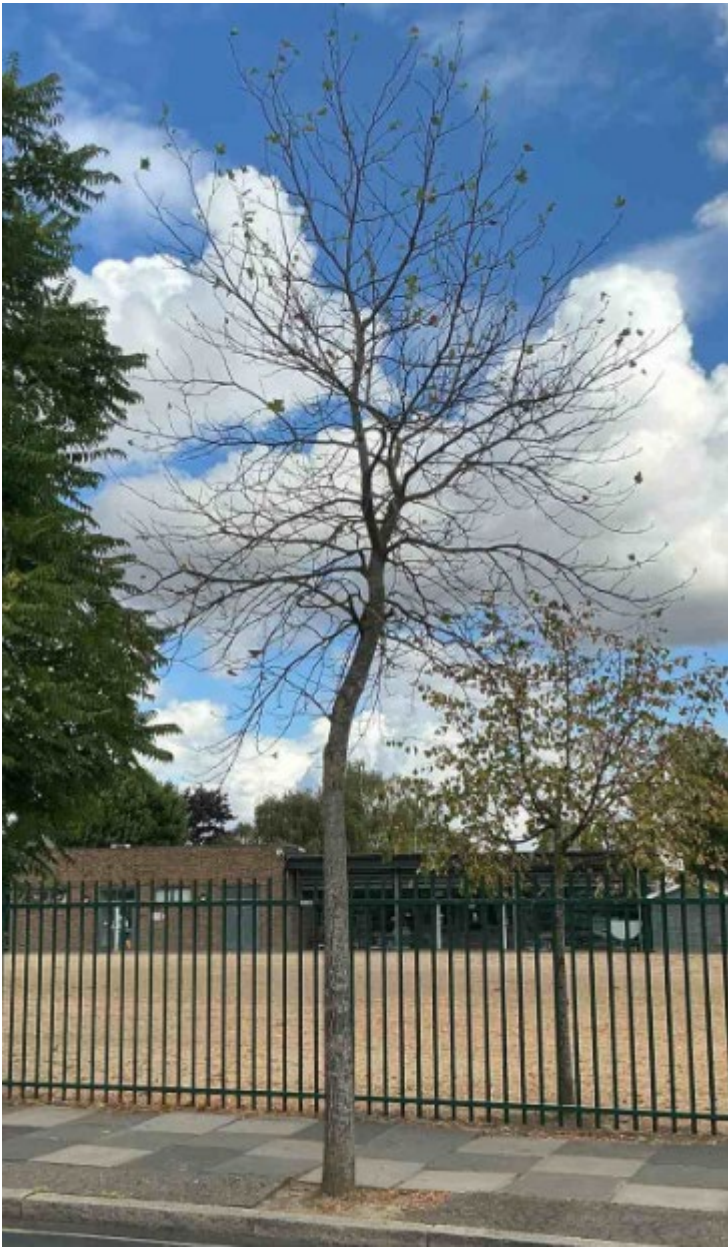
| Inspection findings/reason for exemption | This tree is moribund; removal is required to prevent natural failure and facilitate replanting |

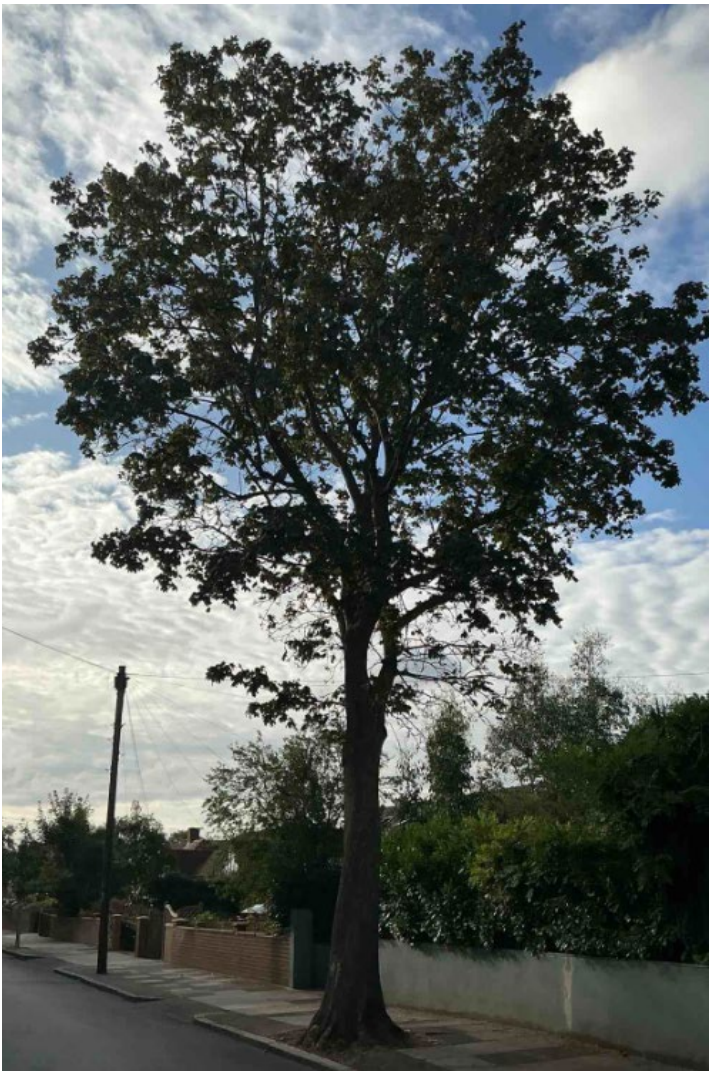
| Inspection findings/reason for exemption | A fungal fruiting body of the decay fungus <i>Ganoderma sp.</i> is present on the trunk. Colonisation by this fungus results in white rot affecting the stem and root system, which can lead to structural failure through fracture or windthrow A resonance test with a sounding hammer and probe has revealed an unacceptable amount of decay around the bracket. Removal of the tree is recommended to prevent natural failure, manage risk, and facilitate replanting. |

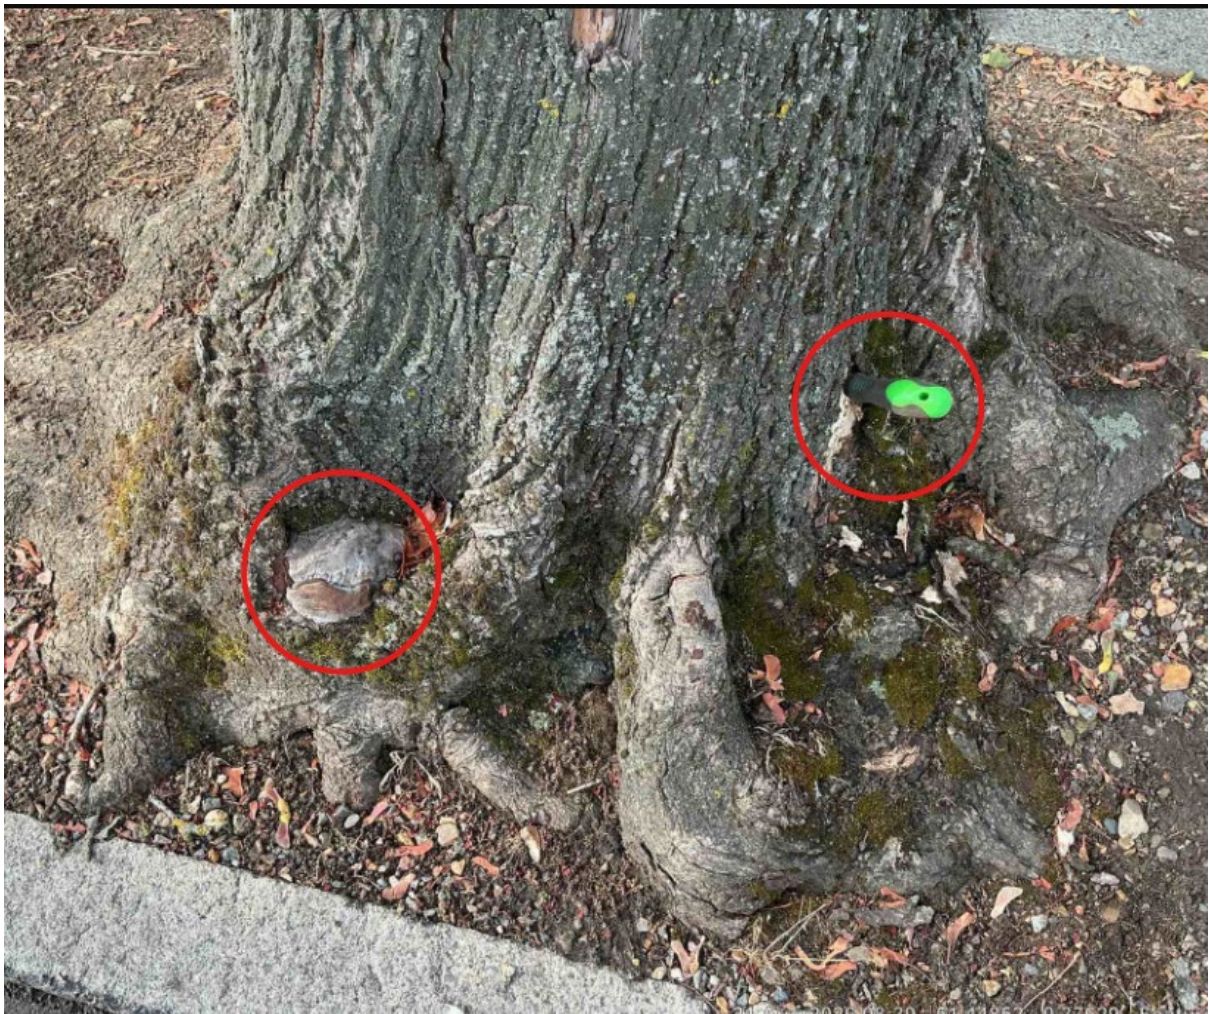
***Image shows fungal fruiting body and probe highlighting decay circled.***

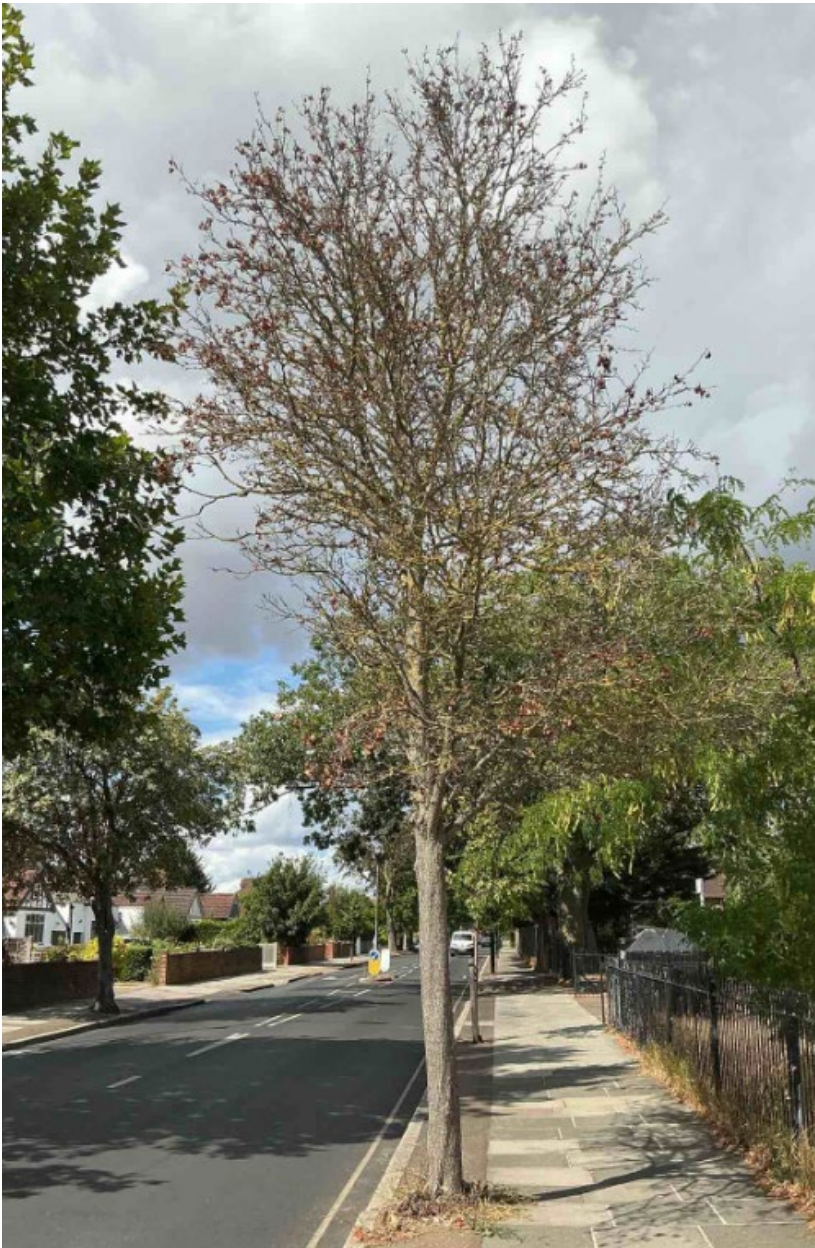
| Inspection findings/reason for exemption | This tree is dead; removal is required to prevent natural failure and facilitate replanting |

Image shows dead tree in street scene.

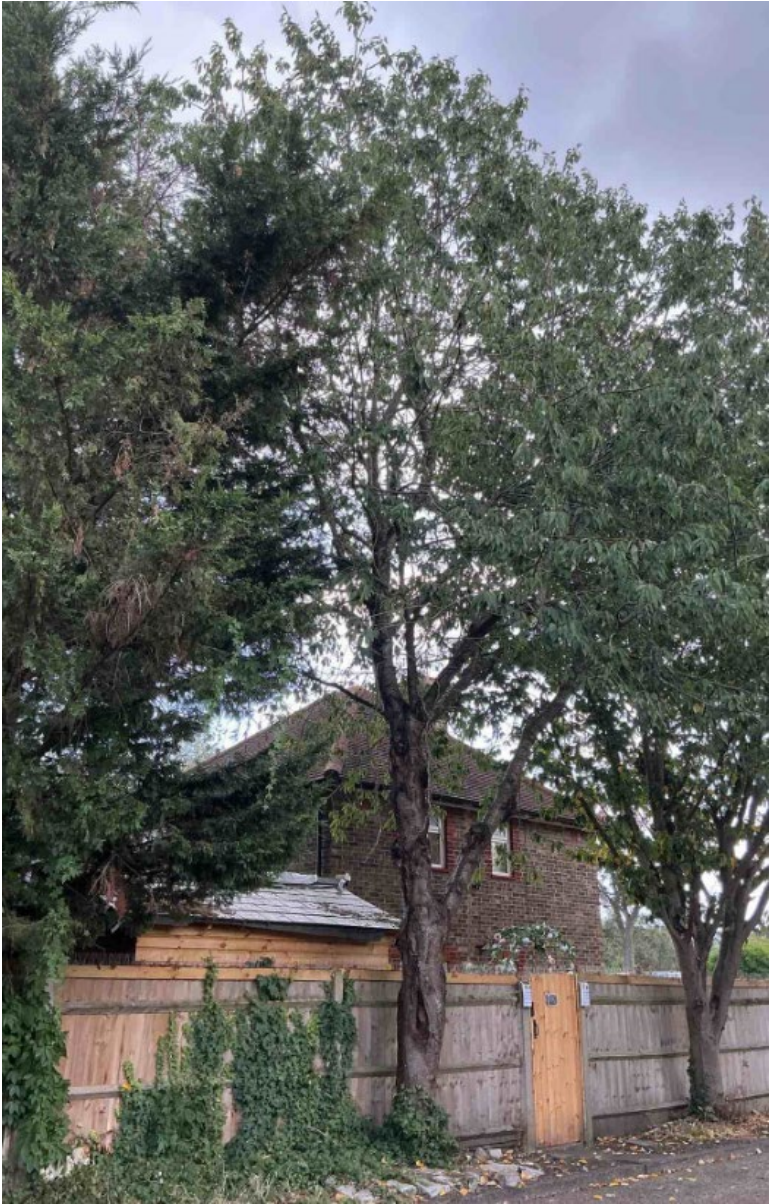
| Inspection findings/reason for exemption | Investigation with a probe and a resonance test with a sounding hammer has revealed an unacceptable amount of decay beyond the visible cavities at the base of the trunk. Removal is required to prevent natural failure, manage risk, and facilitate replanting. |

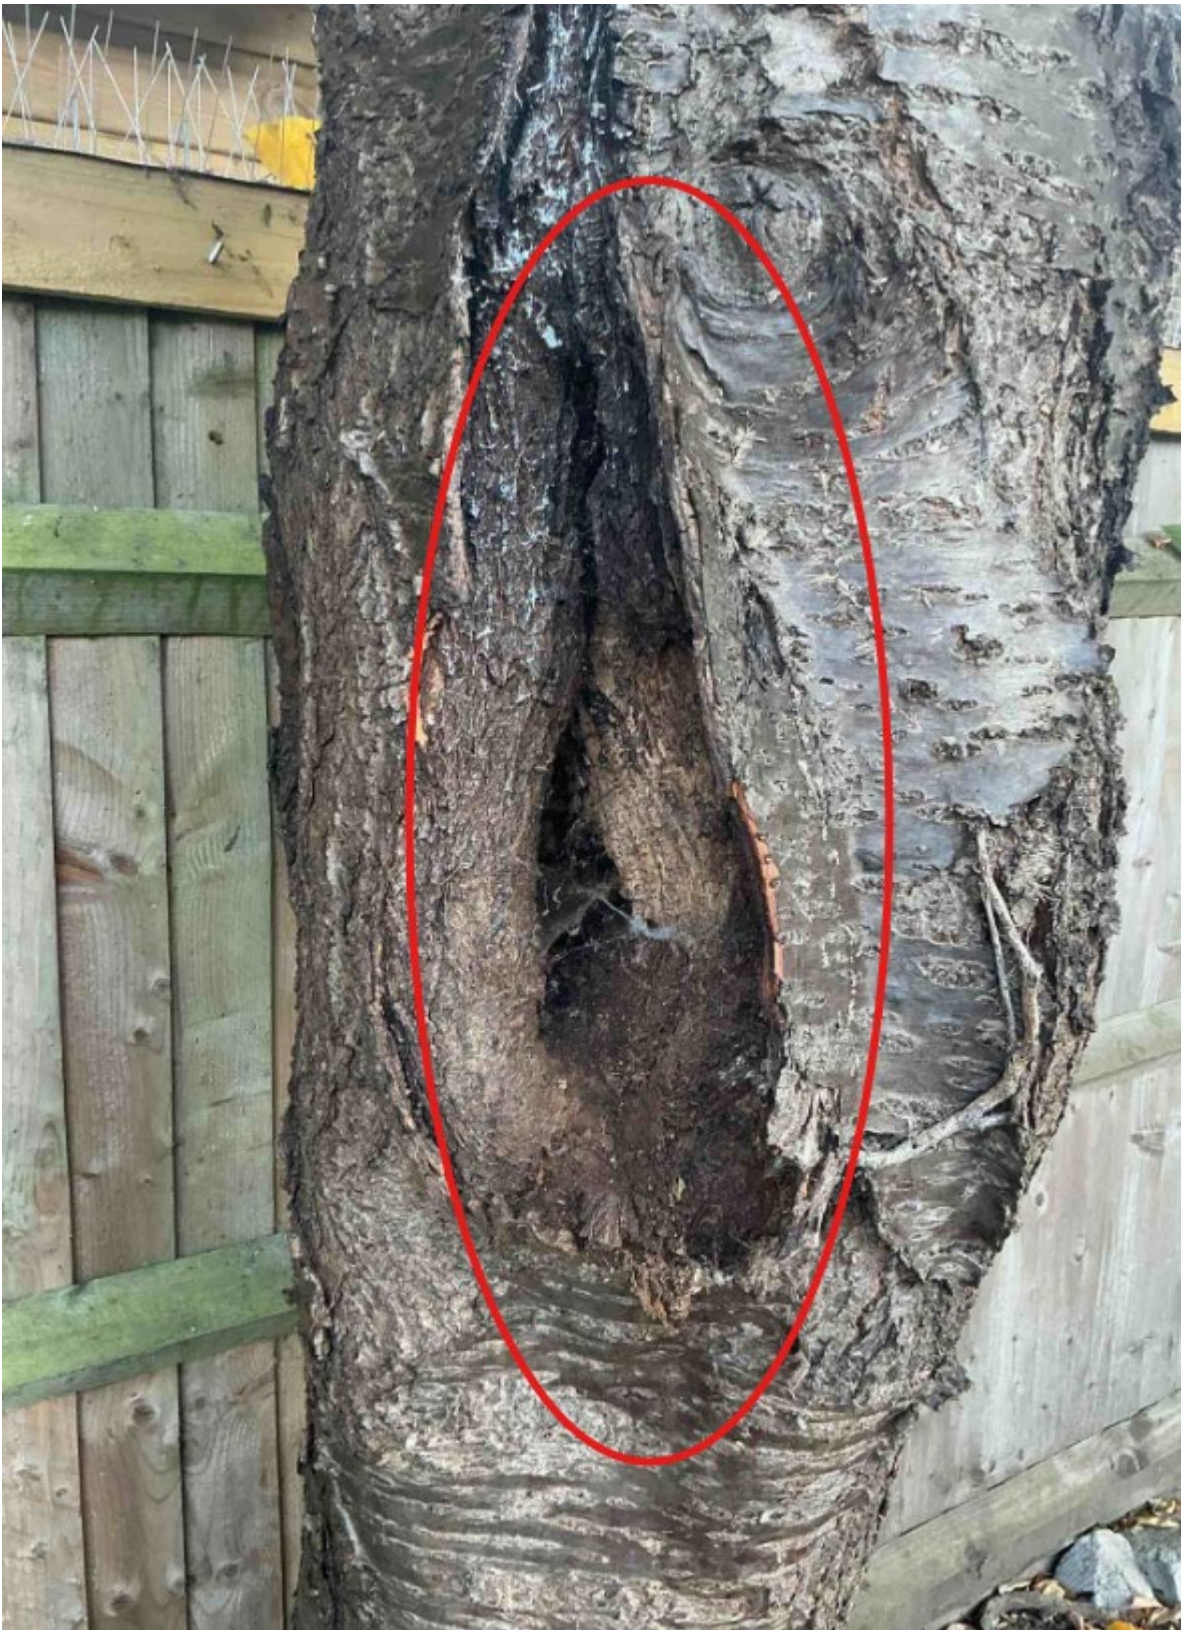
*Image shows cavity on trunk circled.*

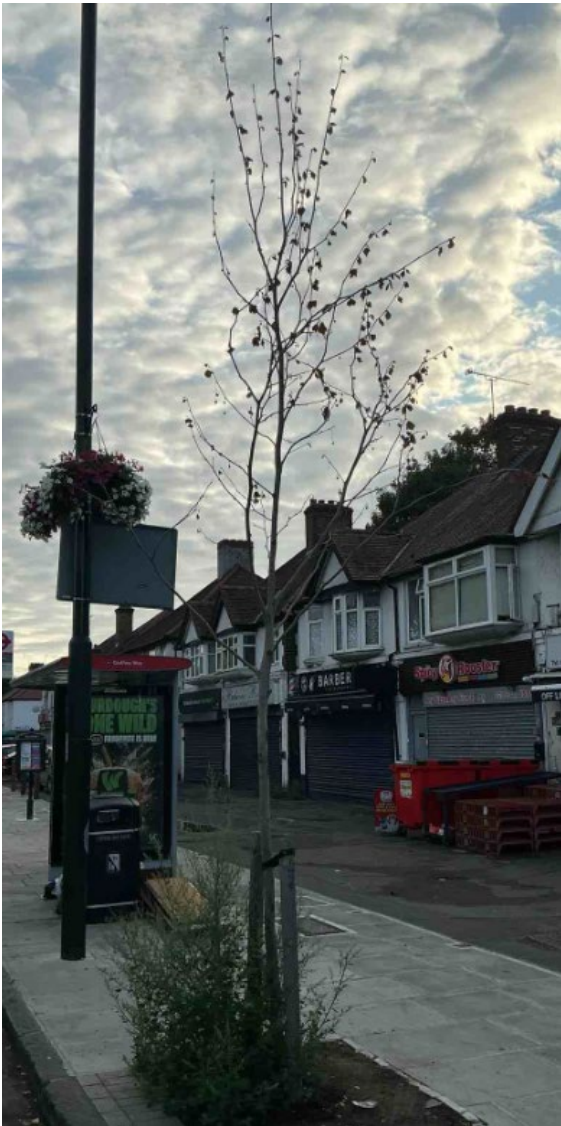
| Inspection findings/reason for exemption | This tree is dead; removal is required to prevent natural failure and facilitate replanting |

Image shows dead tree in street scene.

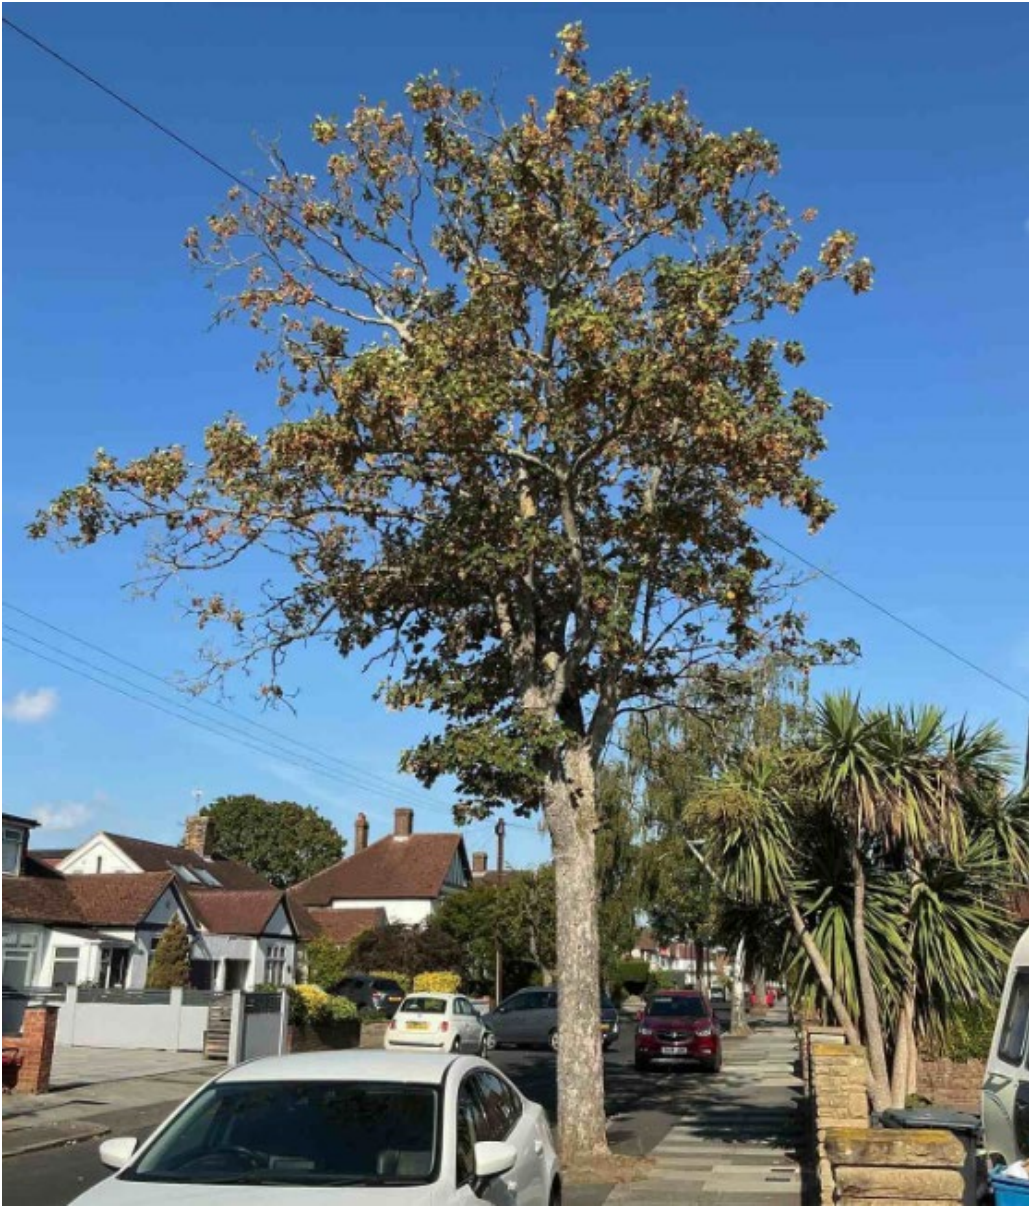
| Inspection findings/reason for exemption | Substantial wounding has occurred on the trunk of this tree and associated bark/vascular necrosis has taken place. Removal is required to prevent natural failure, manage risk, and facilitate replanting. |

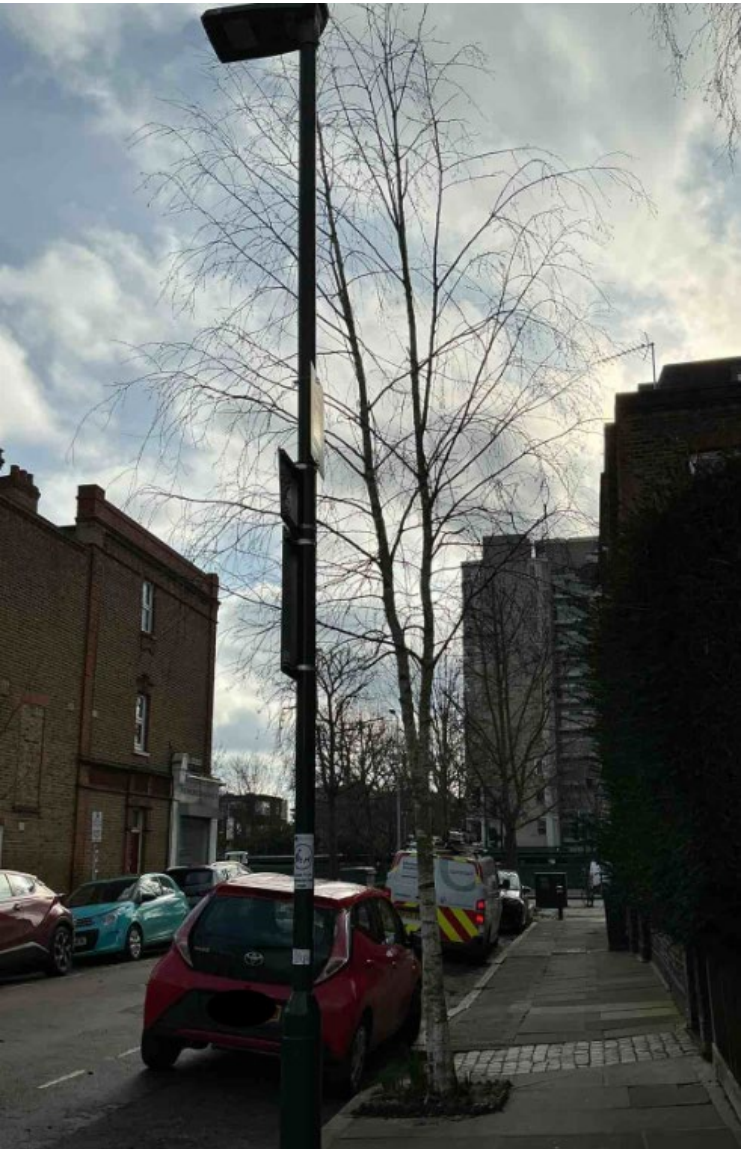
| Inspection findings/reason for exemption | This tree is dead; removal is required to prevent natural failure, manage risk, and facilitate replanting |

Image shows dead tree in street scene.

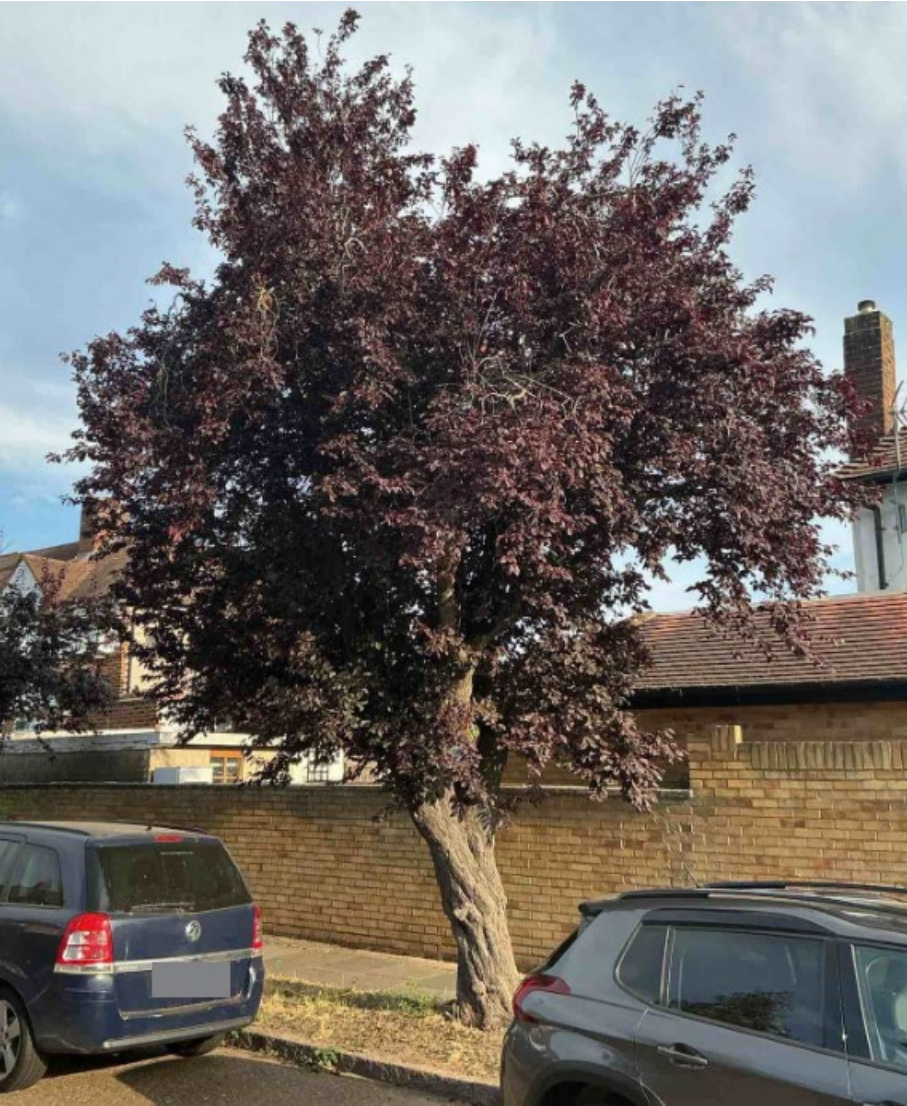
| Inspection findings/reason for exemption | This tree has fungal fruiting bodies of the cushion fungus ( <i>Phellinus pomaceus</i> ) present throughout the crown of this tree. This fungus causes a crumbly white rot that commonly causes this species of tree to snap. Removal is required to prevent natural failure, manage risk, and facilitate replanting |

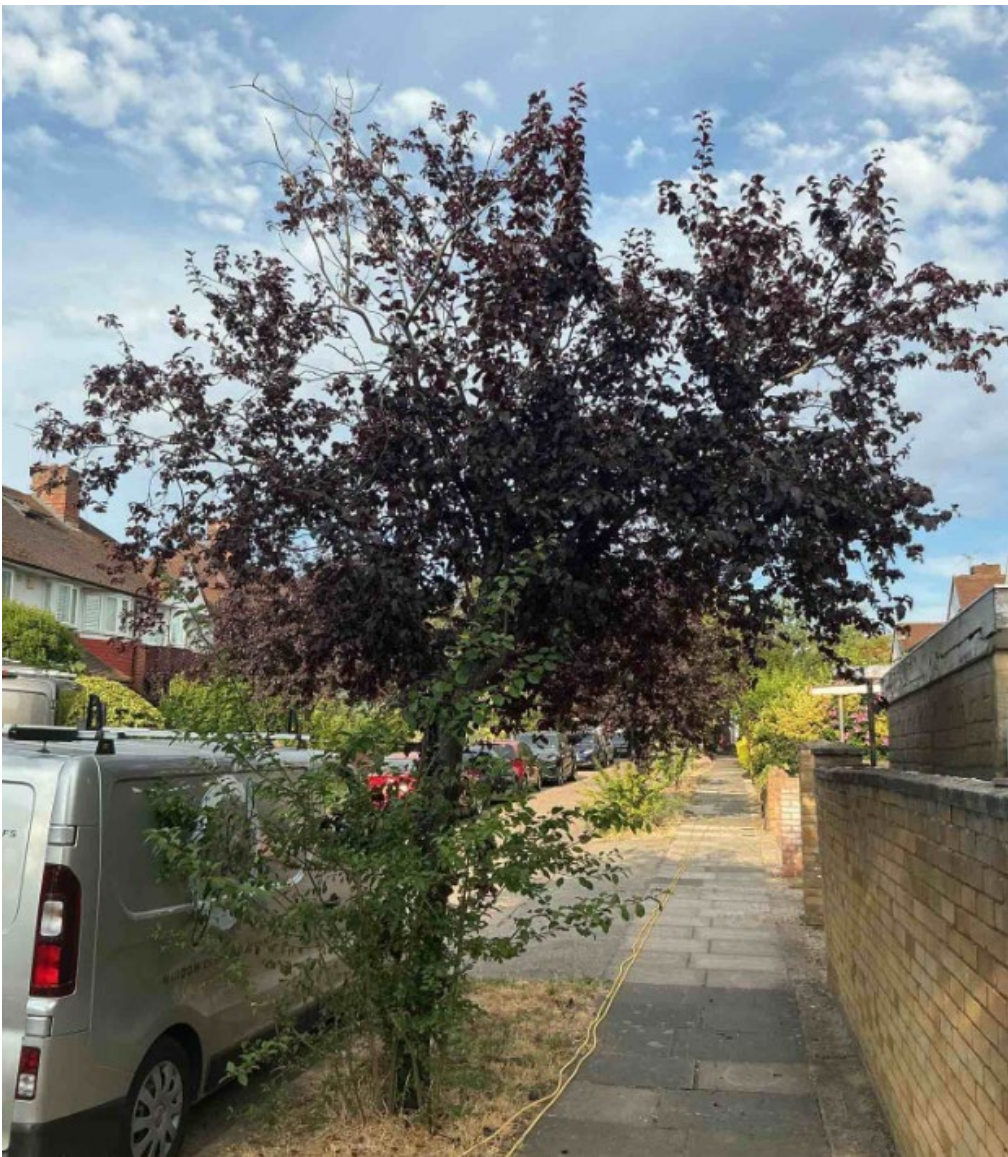
| Inspection findings/reason for exemption | This tree has substantial wounding at the base of the trunk, with vertical cracking on exposed heartwood evident within the wound. Removal is required to prevent natural failure, manage risk, and facilitate replanting |

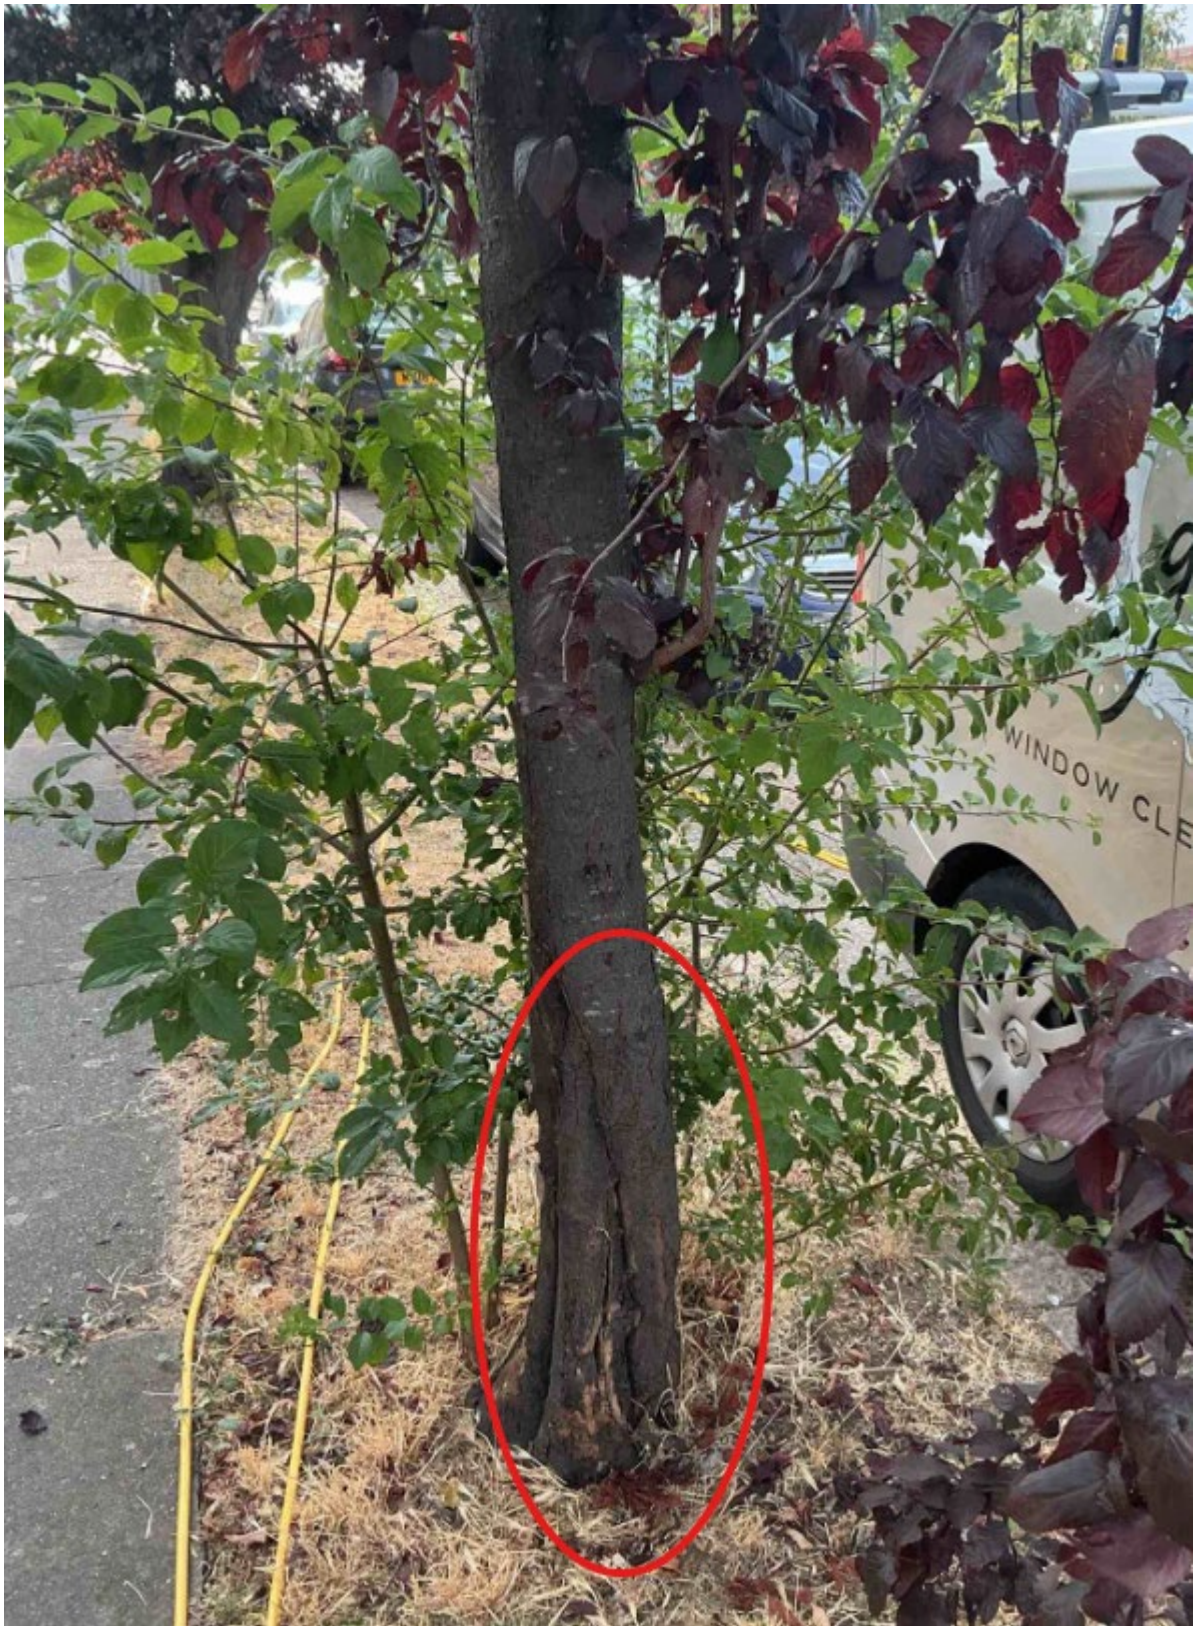
*Image shows wounding and cracking on trunk circled.*

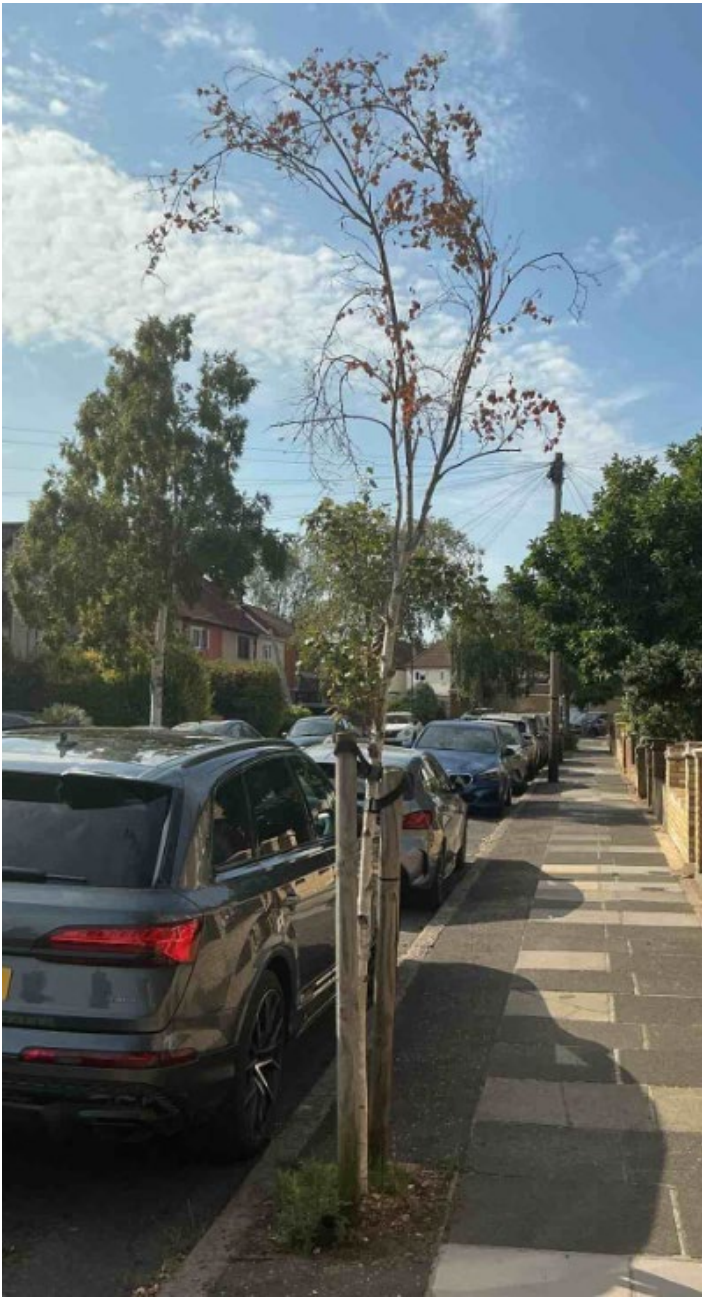
| Inspection findings/reason for exemption | This tree is moribund; removal is required to prevent natural failure, manage risk, and facilitate replanting |

Image moribund tree shows in street scene.

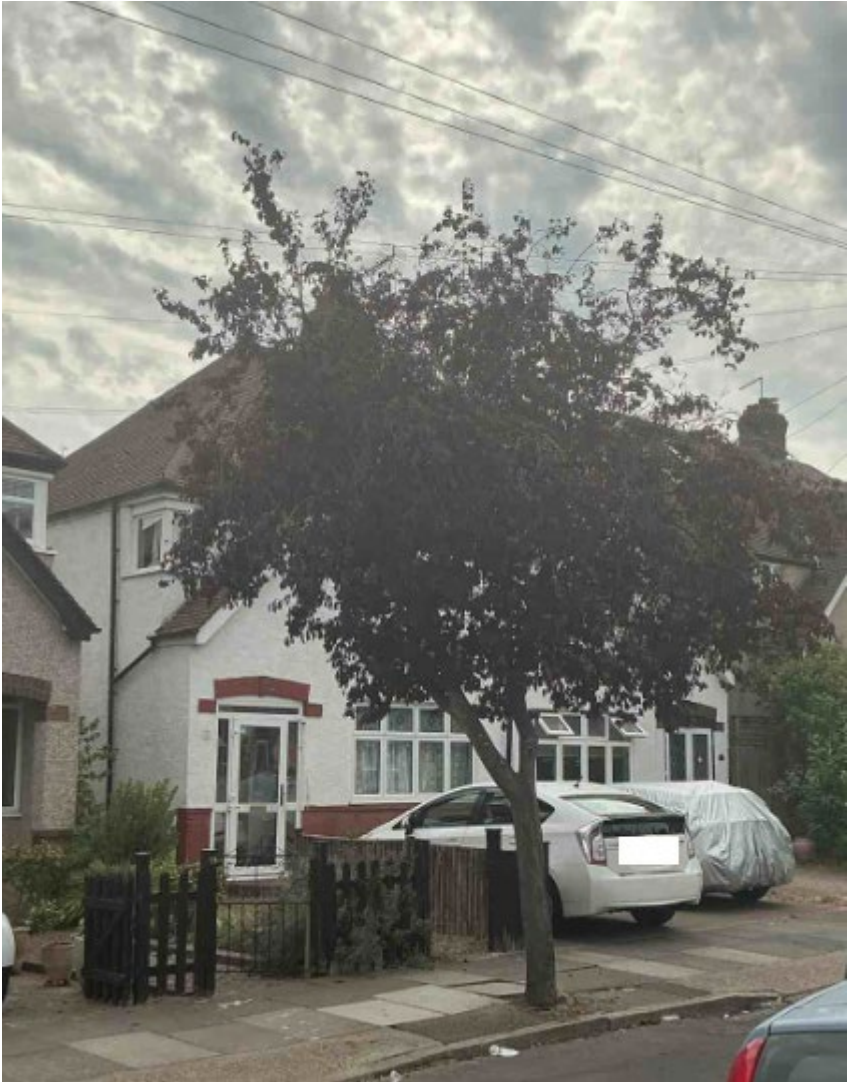
| Inspection findings/reason for exemption | This tree has fungal fruiting bodies of the cushion fungus ( <i>Phellinus pomaceus</i> ) present throughout the crown of this tree. This fungus causes a crumbly white rot that commonly causes this species of tree to snap. Removal is required to prevent natural failure, manage risk, and facilitate replanting |

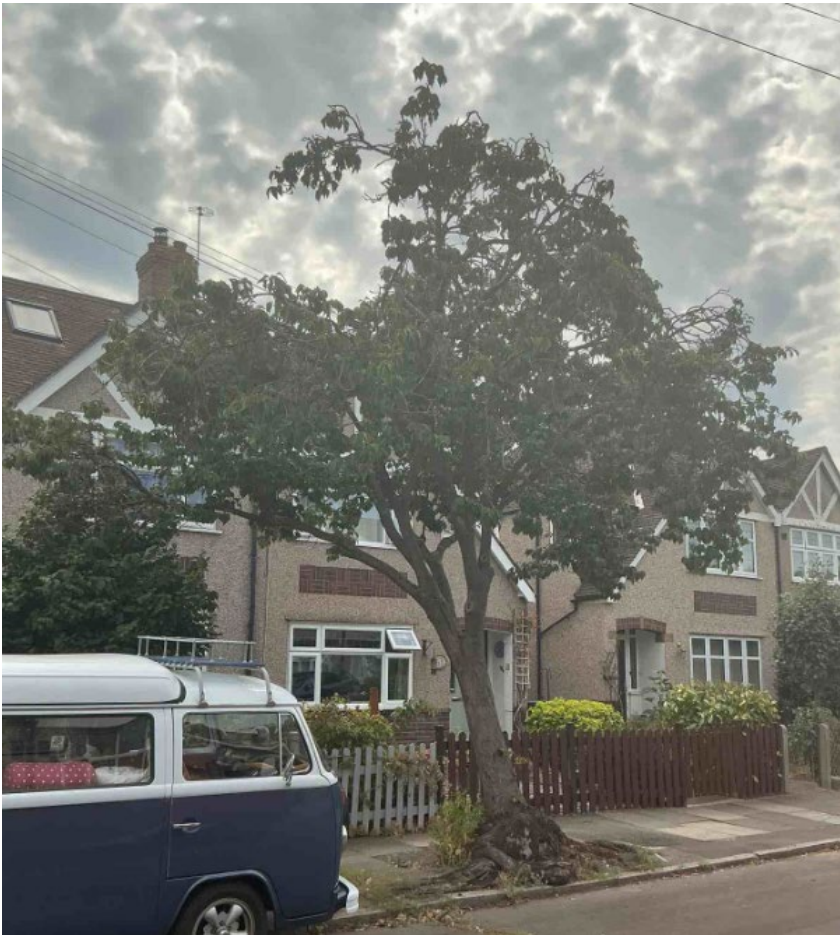
| Inspection findings/reason for exemption | A fungal fruiting body of the decay fungus <i>Ganoderma sp.</i> is present on the trunk. Colonisation by this fungus results in white rot affecting the stem and root system, which can lead to structural failure through fracture or windthrow A resonance test with a sounding hammer has revealed an unacceptable amount of decay around the bracket. Removal of the tree is recommended to prevent natural failure, manage risk, and facilitate replanting. |

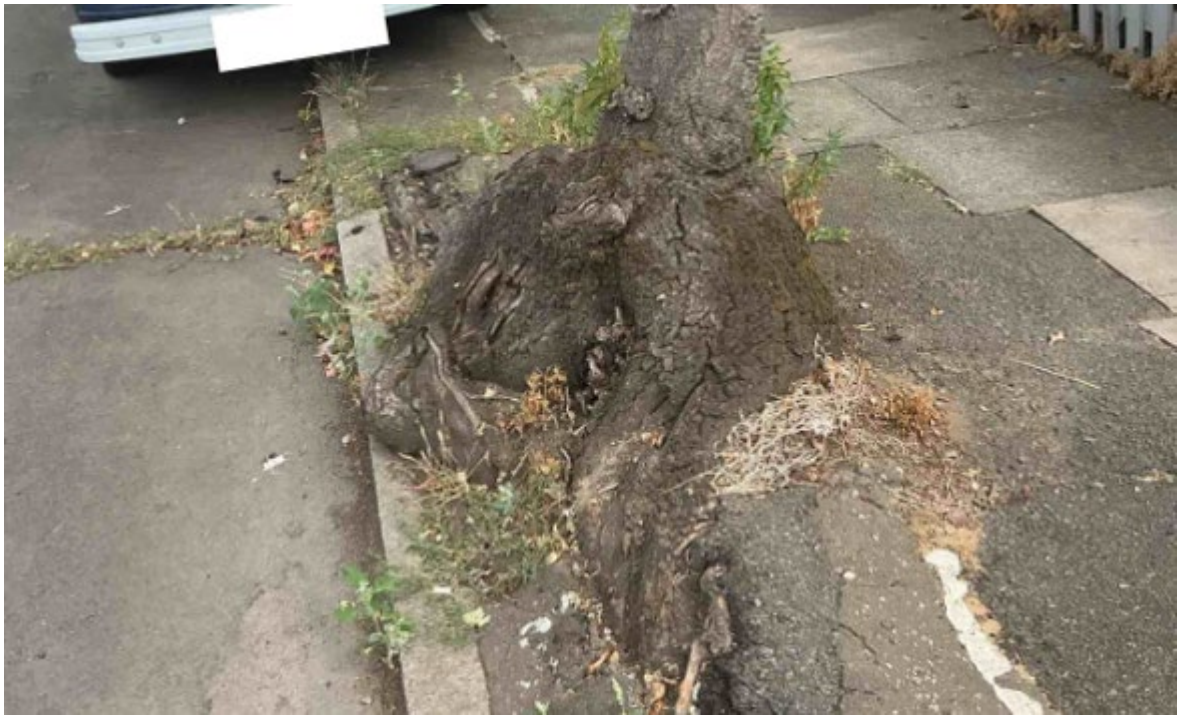
*Image shows wounding and cracking on trunk.*

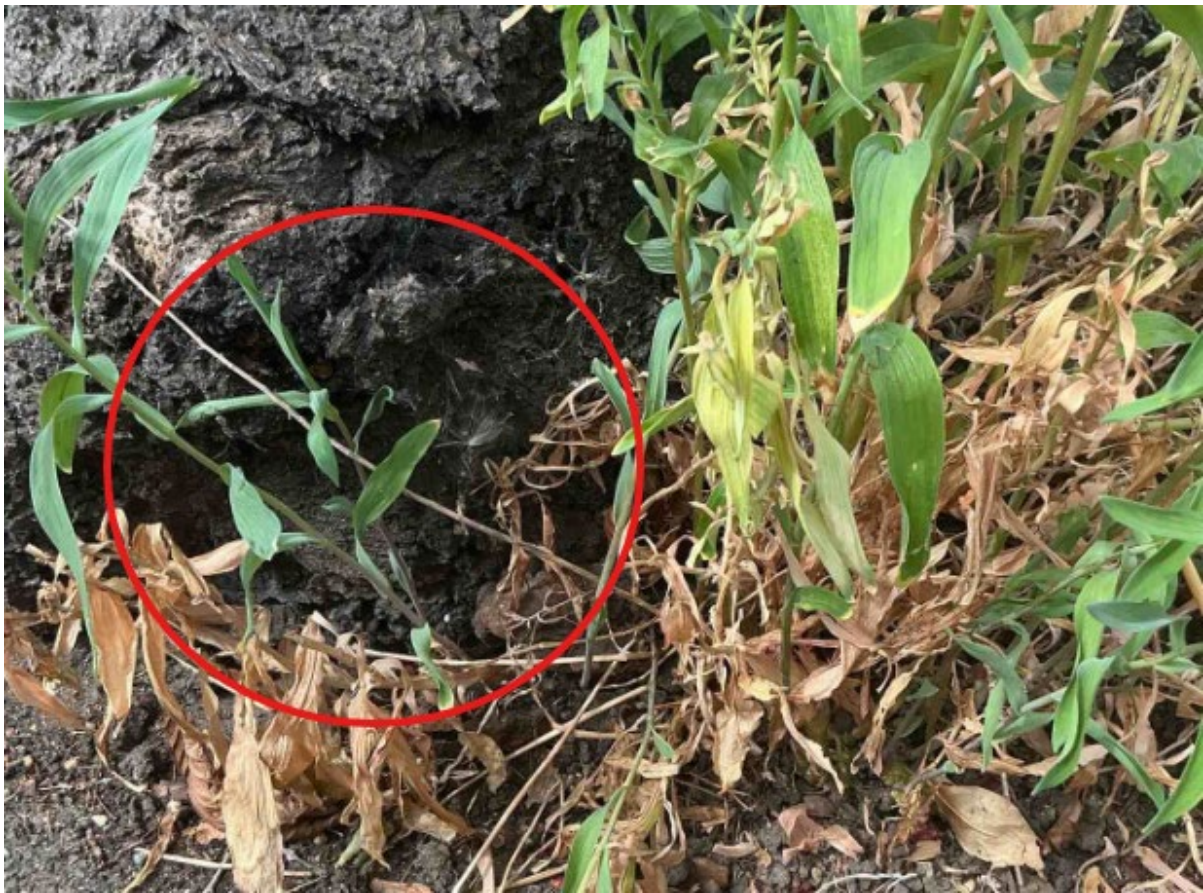
*Image shows fungal fruiting body circled.*

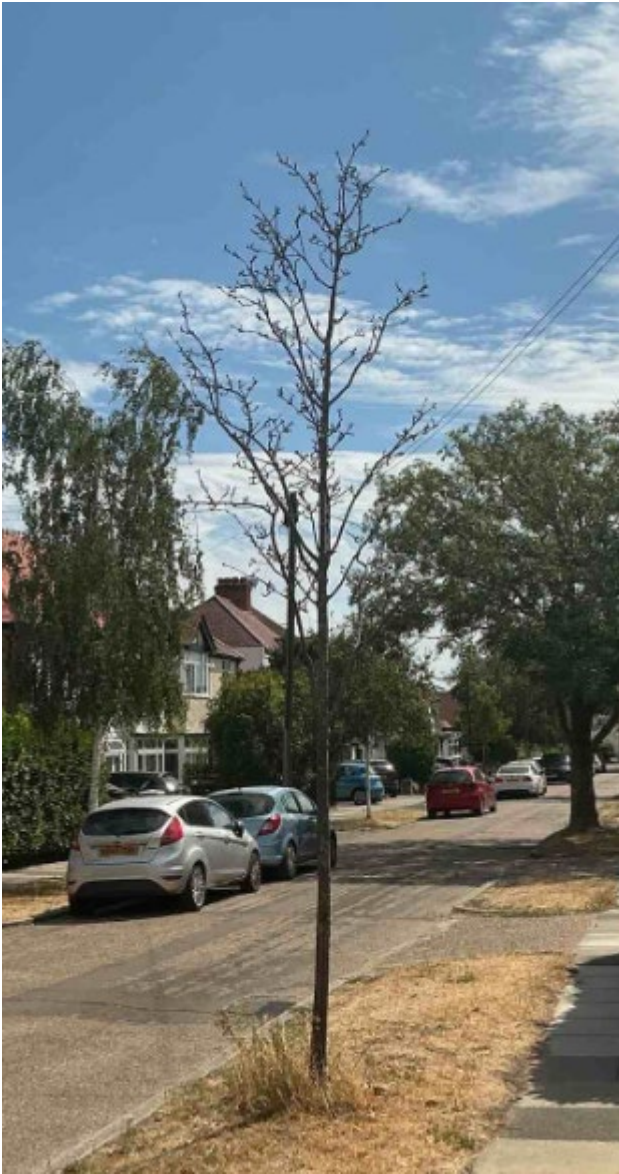
| Inspection findings/reason for exemption | This tree is dead; removal is required to prevent natural failure, manage risk, and facilitate replanting |

Image dead tree shows in street scene.

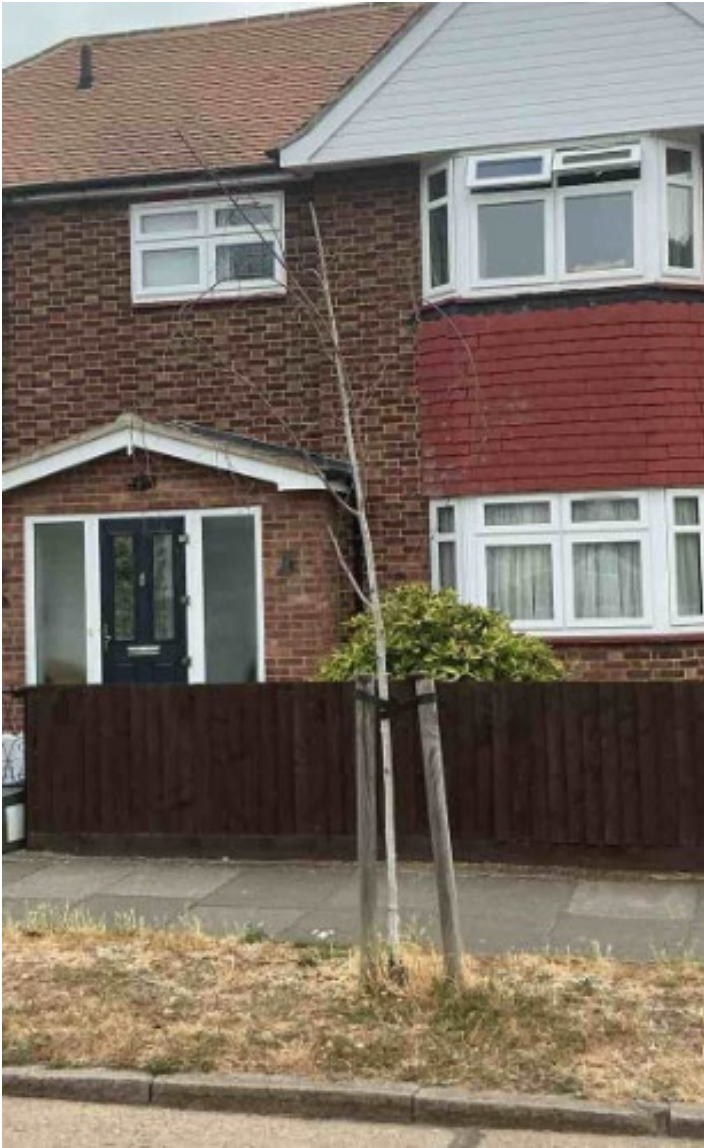
| Inspection findings/reason for exemption | This tree is dead; removal is required to prevent natural failure, manage risk, and facilitate replanting |

Image dead tree shows in street scene.
