# September 2026 – Highways Reactive Tree Works Programme

Dated 18.9.2026

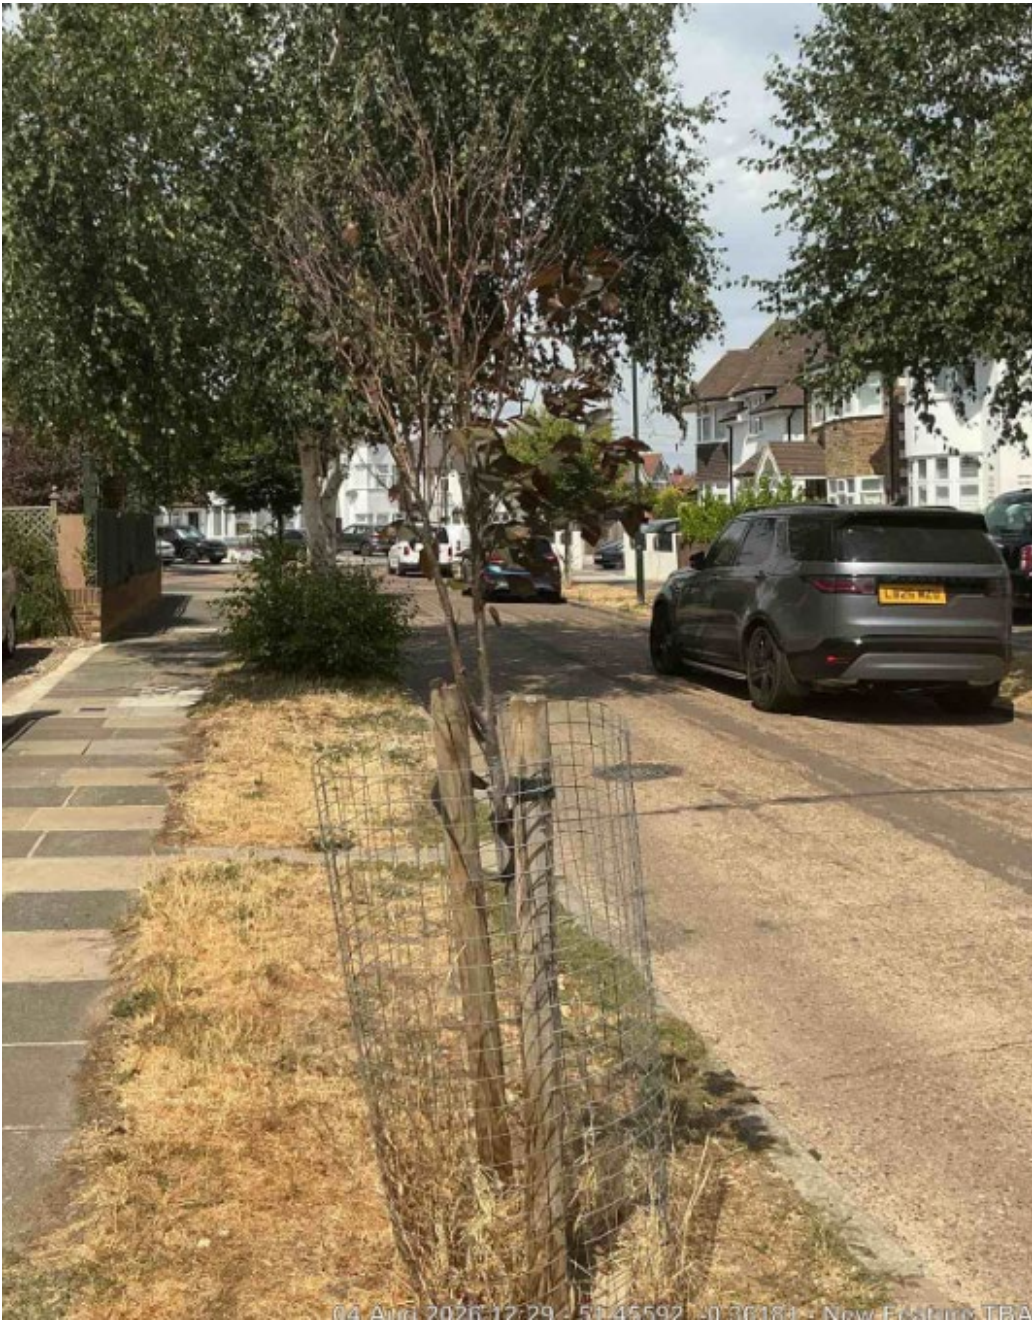
| Inspection findings/reason for exemption | This tree is dead; removal is required to prevent natural failure, manage risk, and facilitate replanting |

Image dead tree shows in street scene.

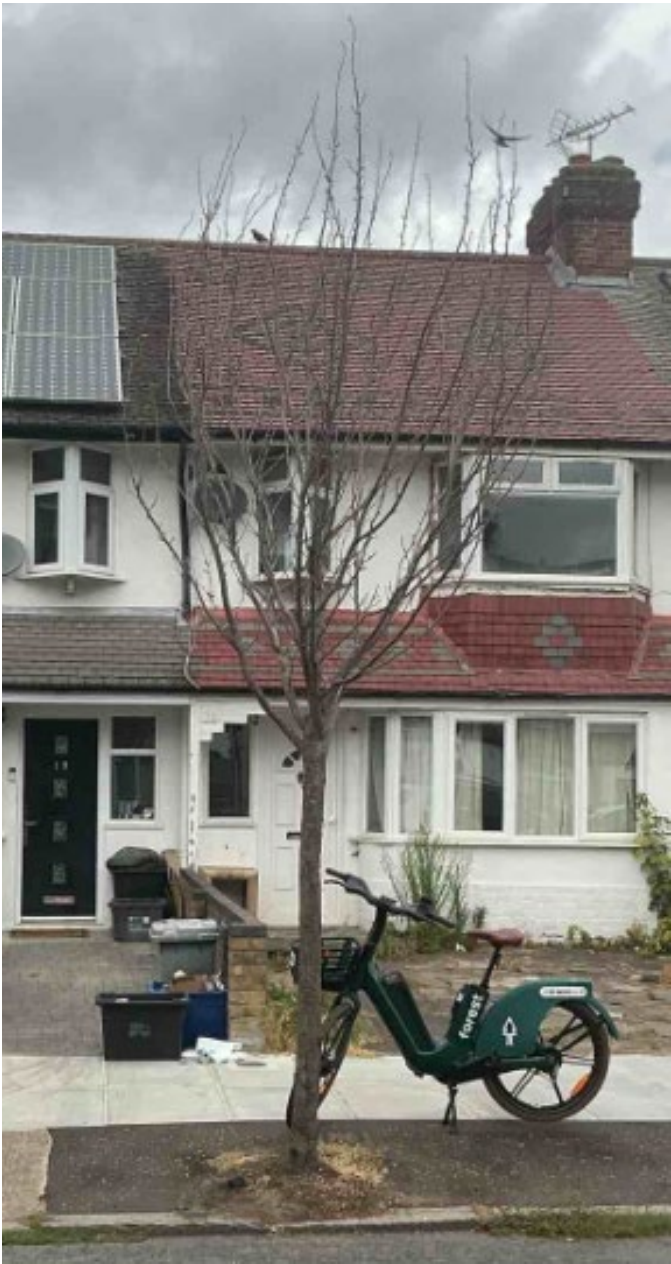
| Inspection findings/reason for exemption | This tree is dead; removal is required to prevent natural failure, manage risk, and facilitate replanting |

Image dead tree shows in street scene.

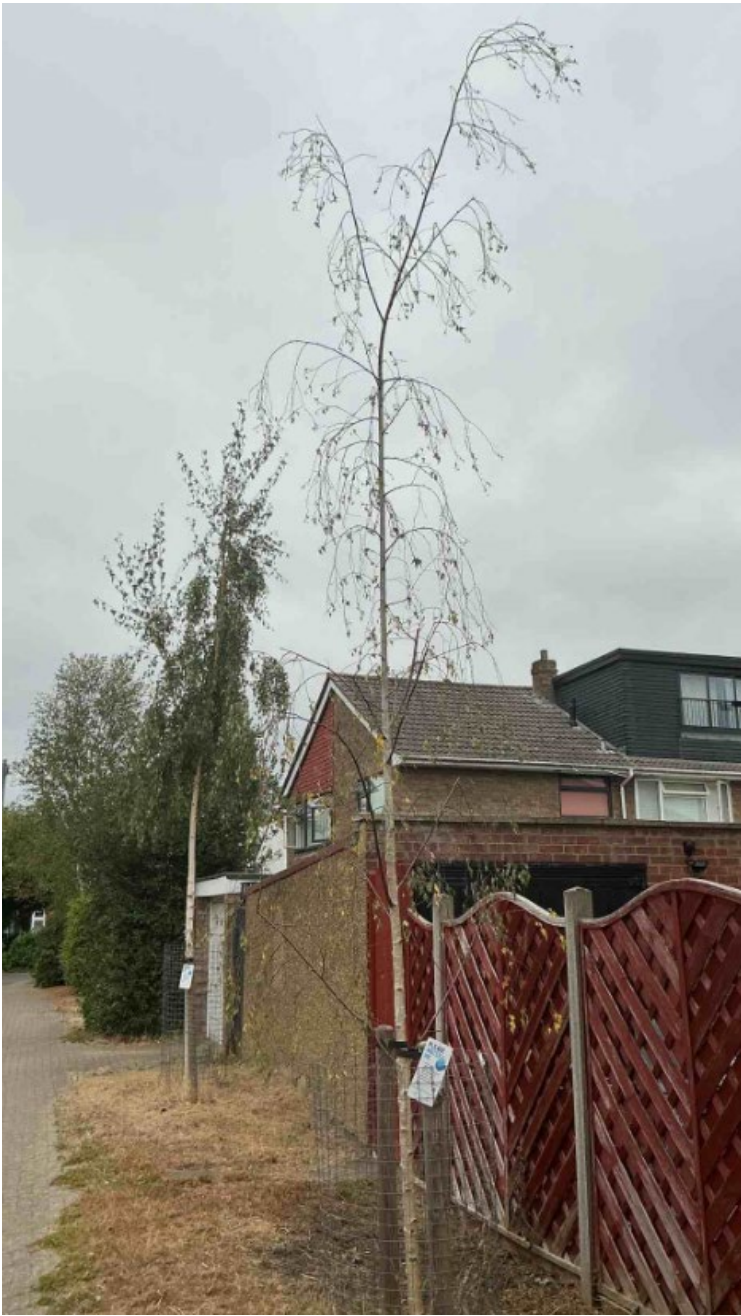
| Inspection findings/reason for exemption | This tree is moribund; removal is required to prevent natural failure, manage risk, and facilitate replanting |

Image moribund tree shows in street scene.

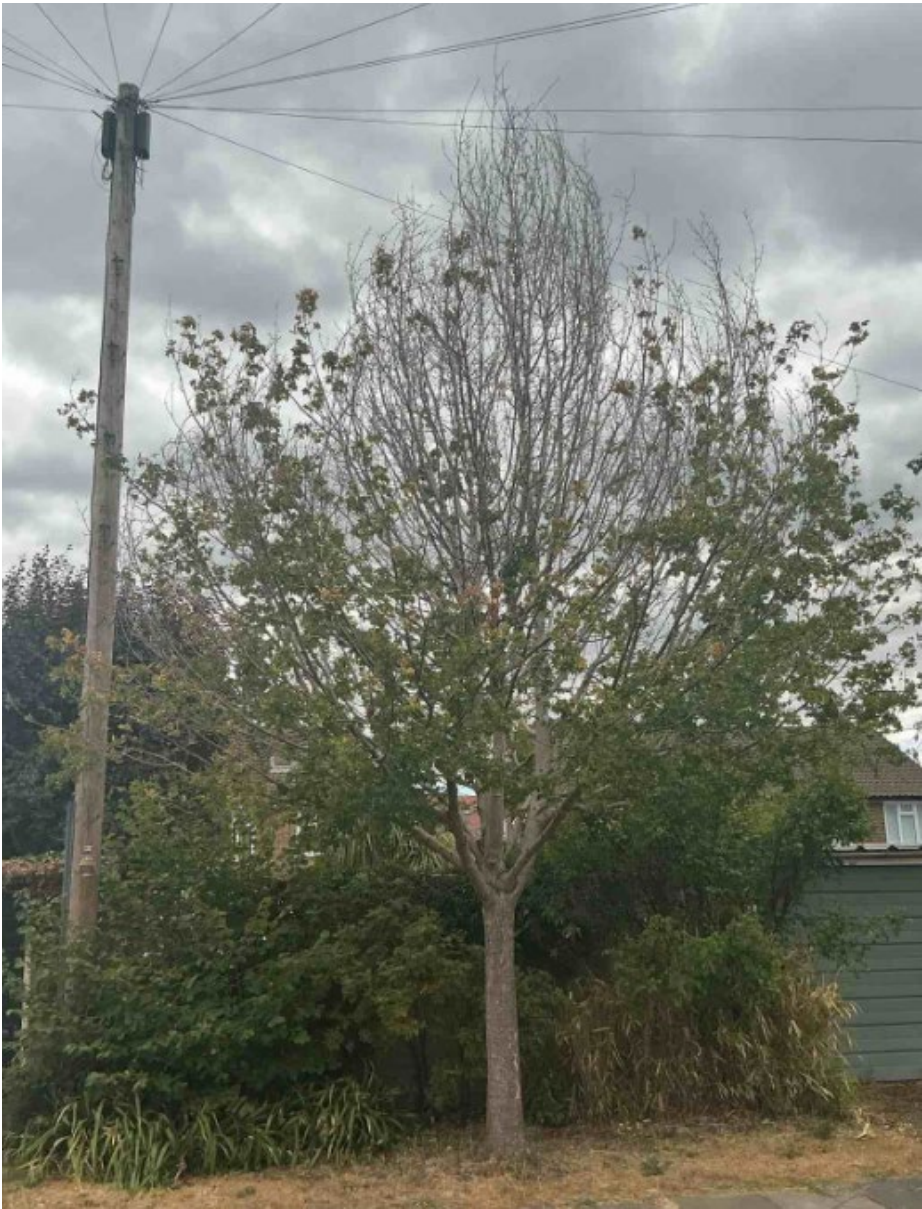
| Inspection findings/reason for exemption | This tree is moribund; removal is required to prevent natural failure, manage risk, and facilitate replanting |

Image shows moribund tree shows in street scene.

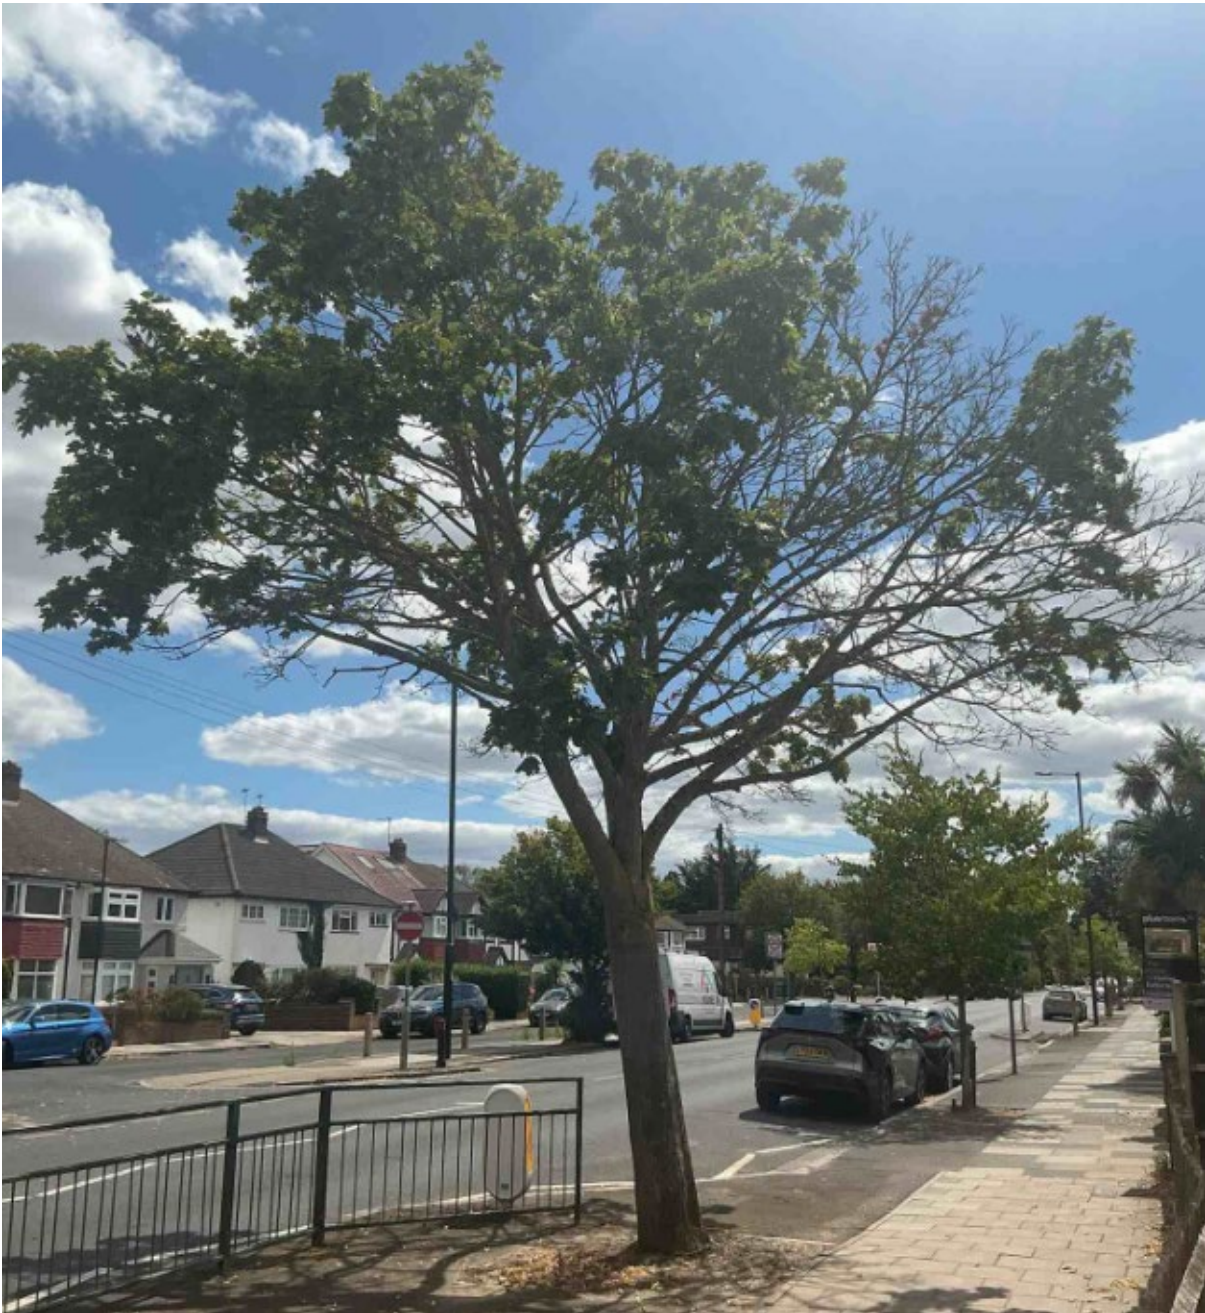
Image moribund tree shows in street scene.

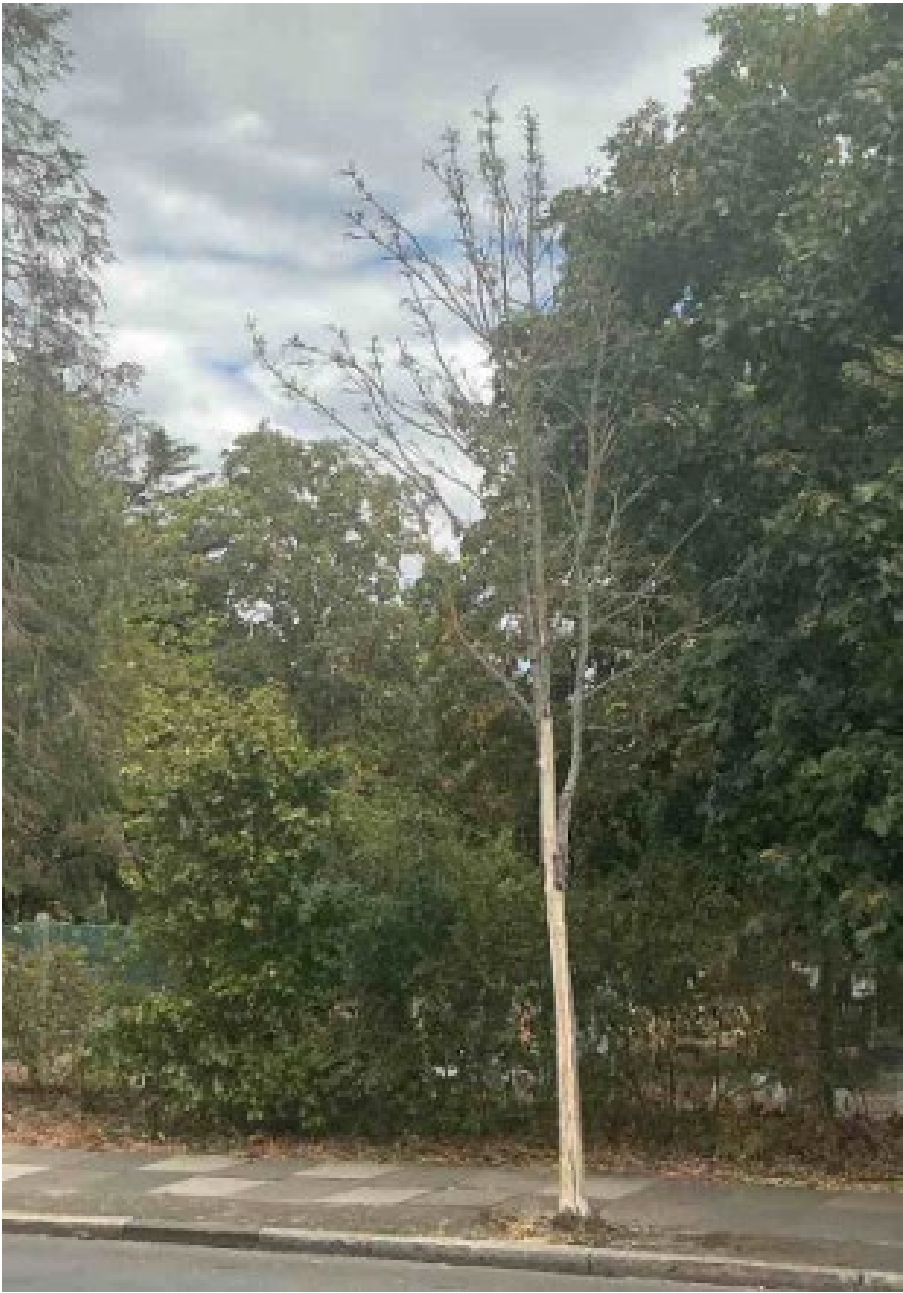
Image dead tree shows in street scene.

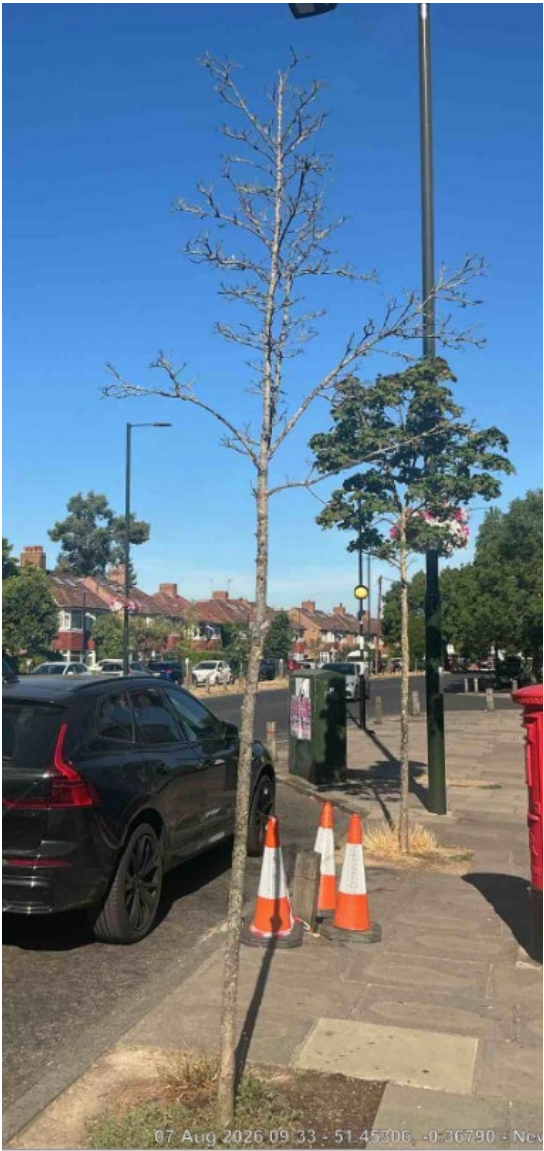
Image dead tree shows in street scene.

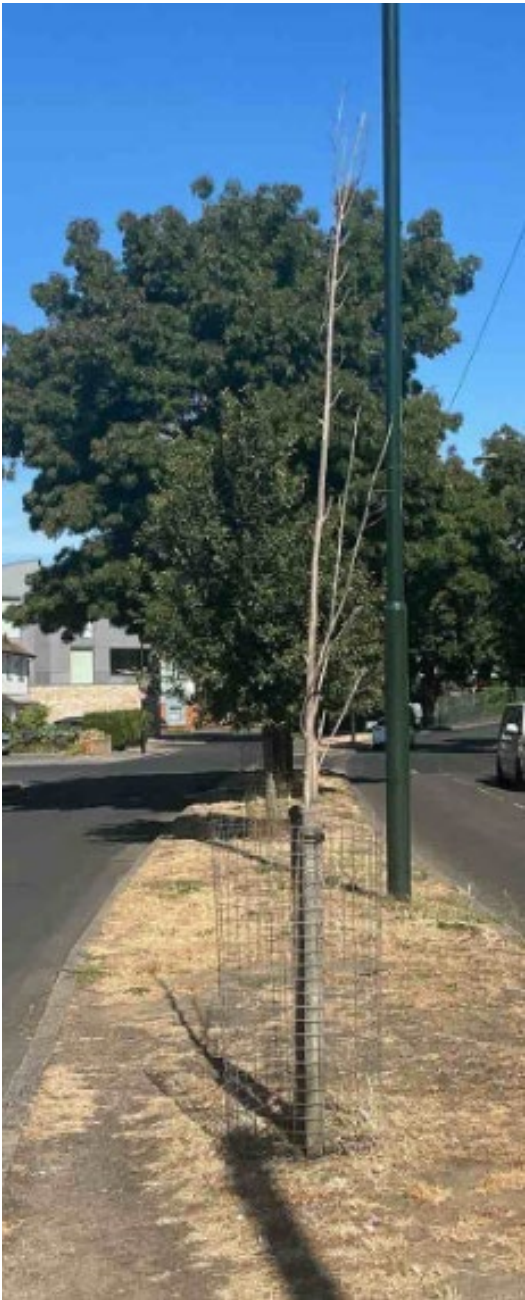
Image dead tree shows in street scene.

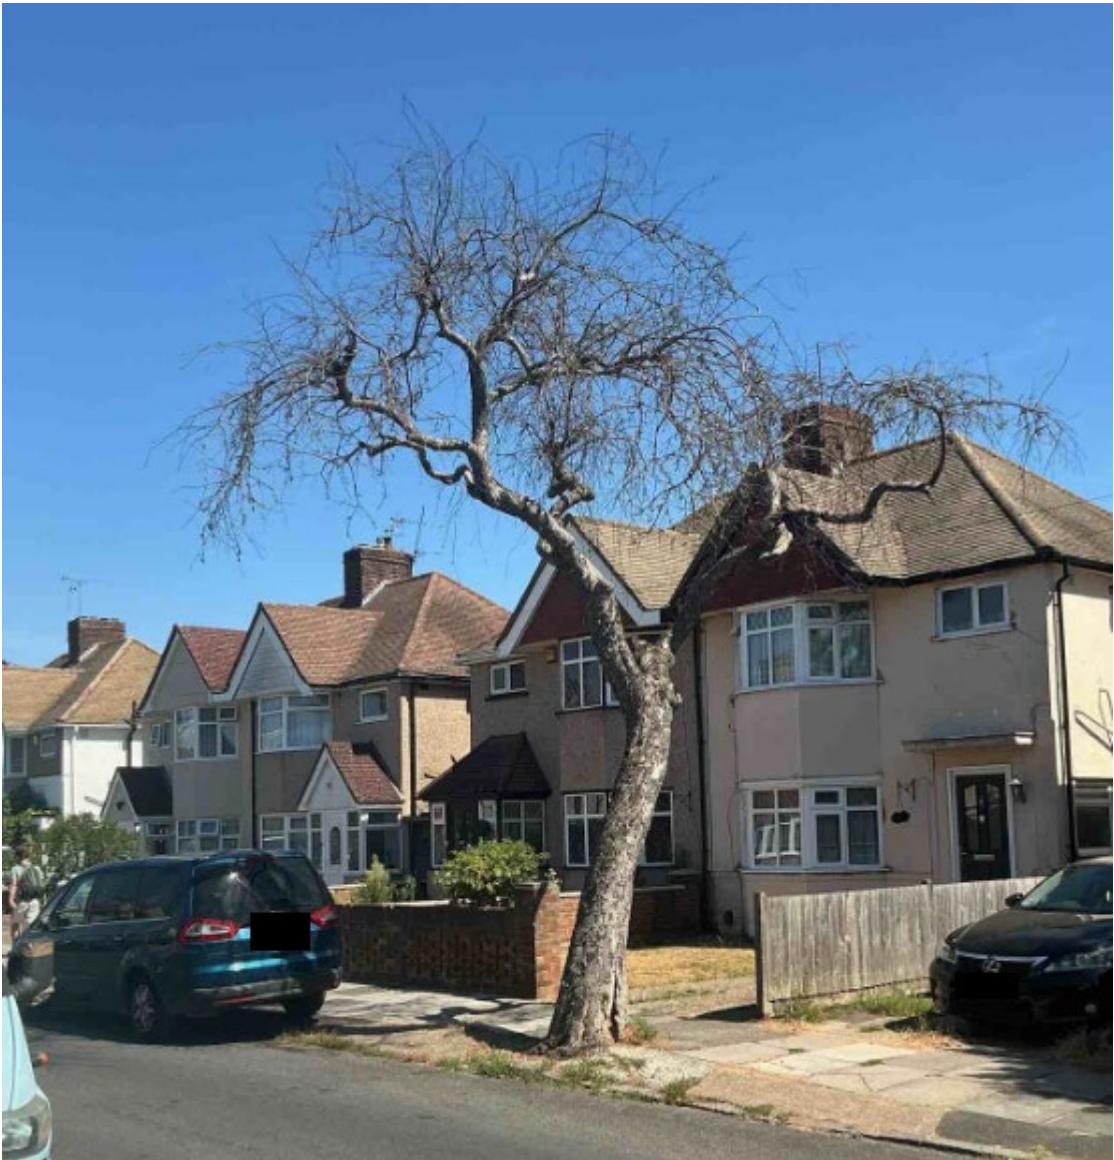
Image dead tree shows in street scene.

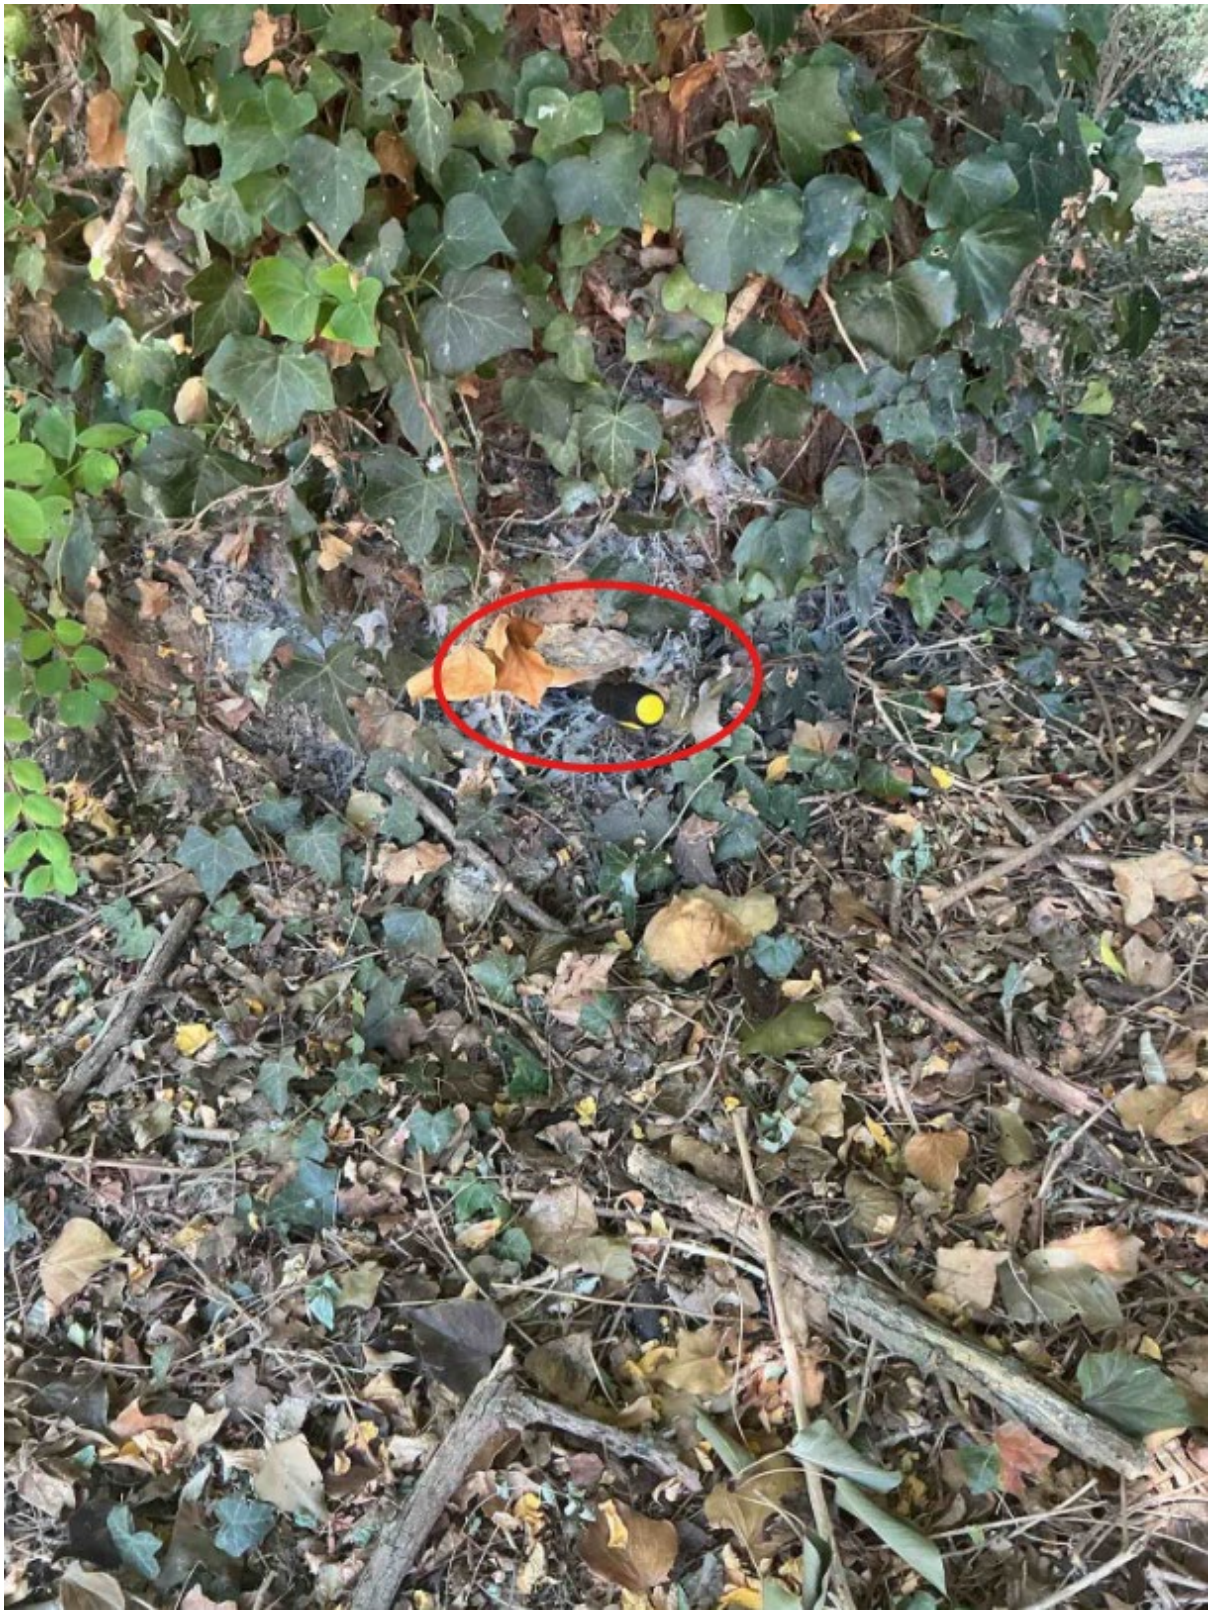
***Image shows fungal fruiting body and probe circled.***
