# October 2023 - Reactive Tree Works Programme

## Introduction

Dated 16.10.2023

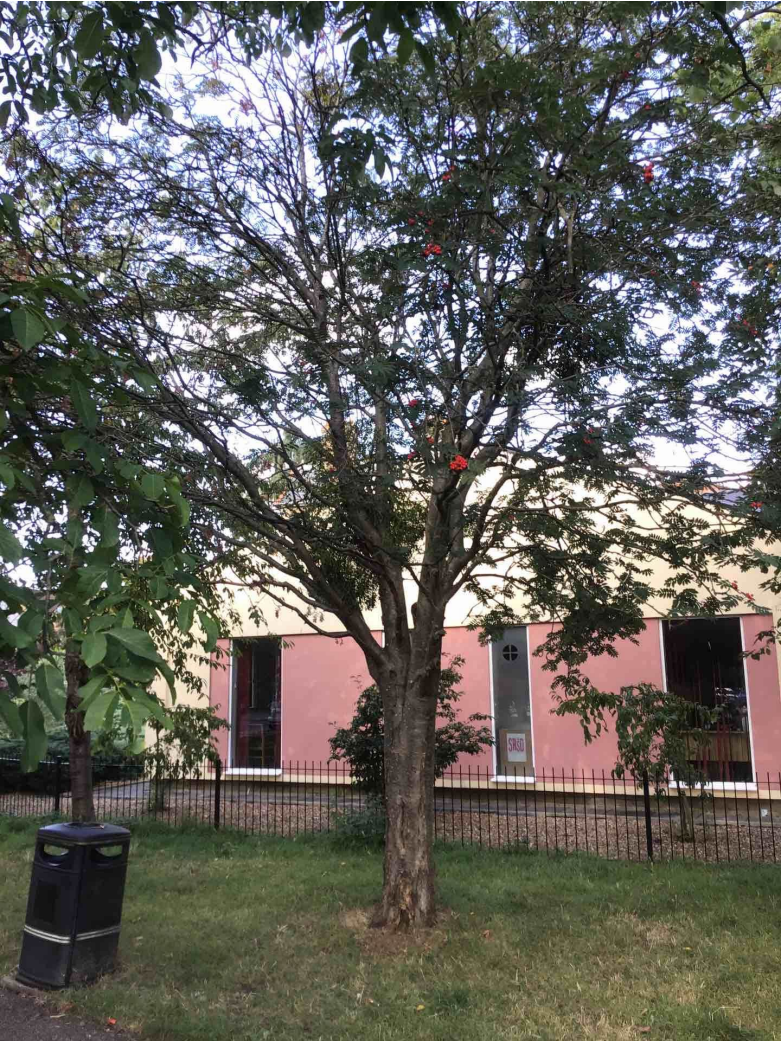
| Inspection findings | There is a cavity present at the base of the stem with an unacceptable level of decay. Crown dieback correlates with the degradation of the trees structure. Removal is required to prevent natural failure and facilitate replanting. |

Image shows tree in street scene

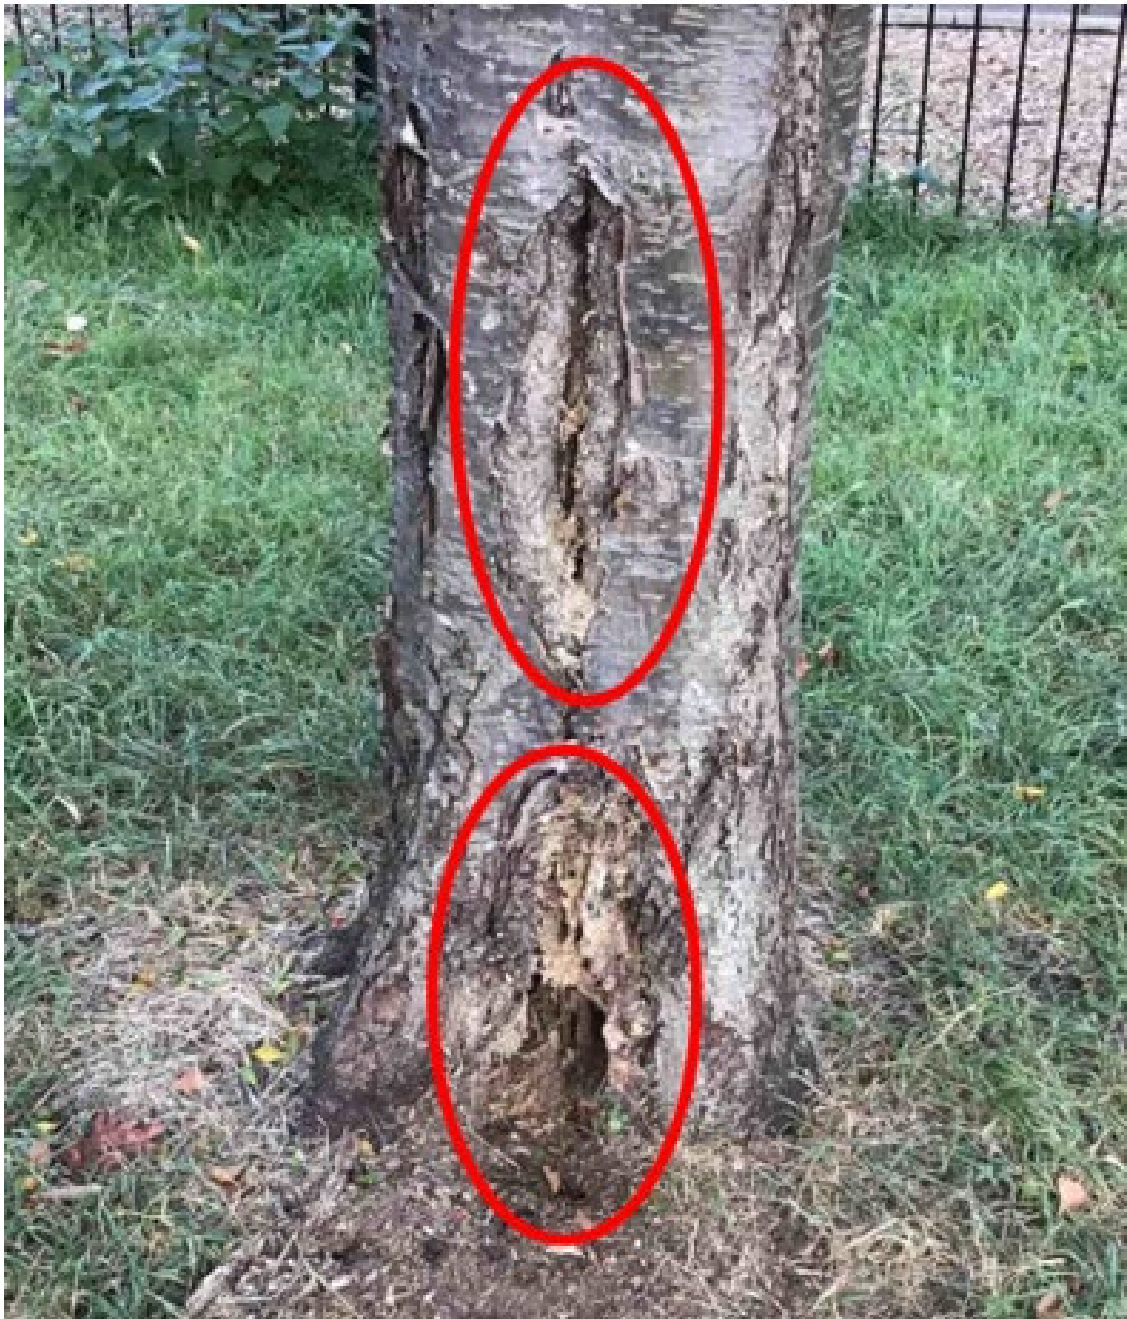
*Image shows cavities circled in red*

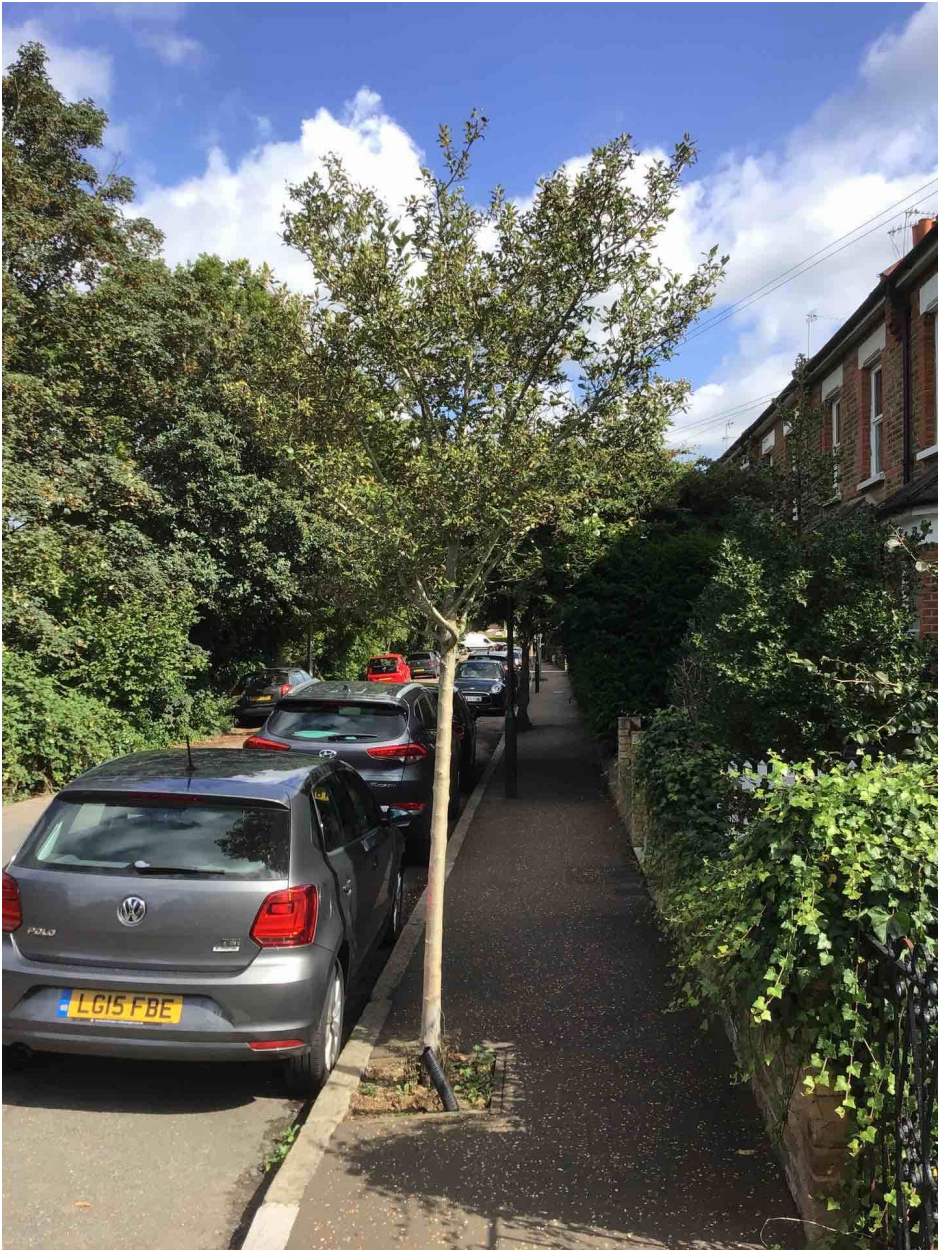
| Inspection findings | The tree is moving in such a way that indicates that the structure of the roots is compromised presenting increased risk of failure. Removal is required to prevent natural failure and facilitate replanting |

Image shows tree in street scene

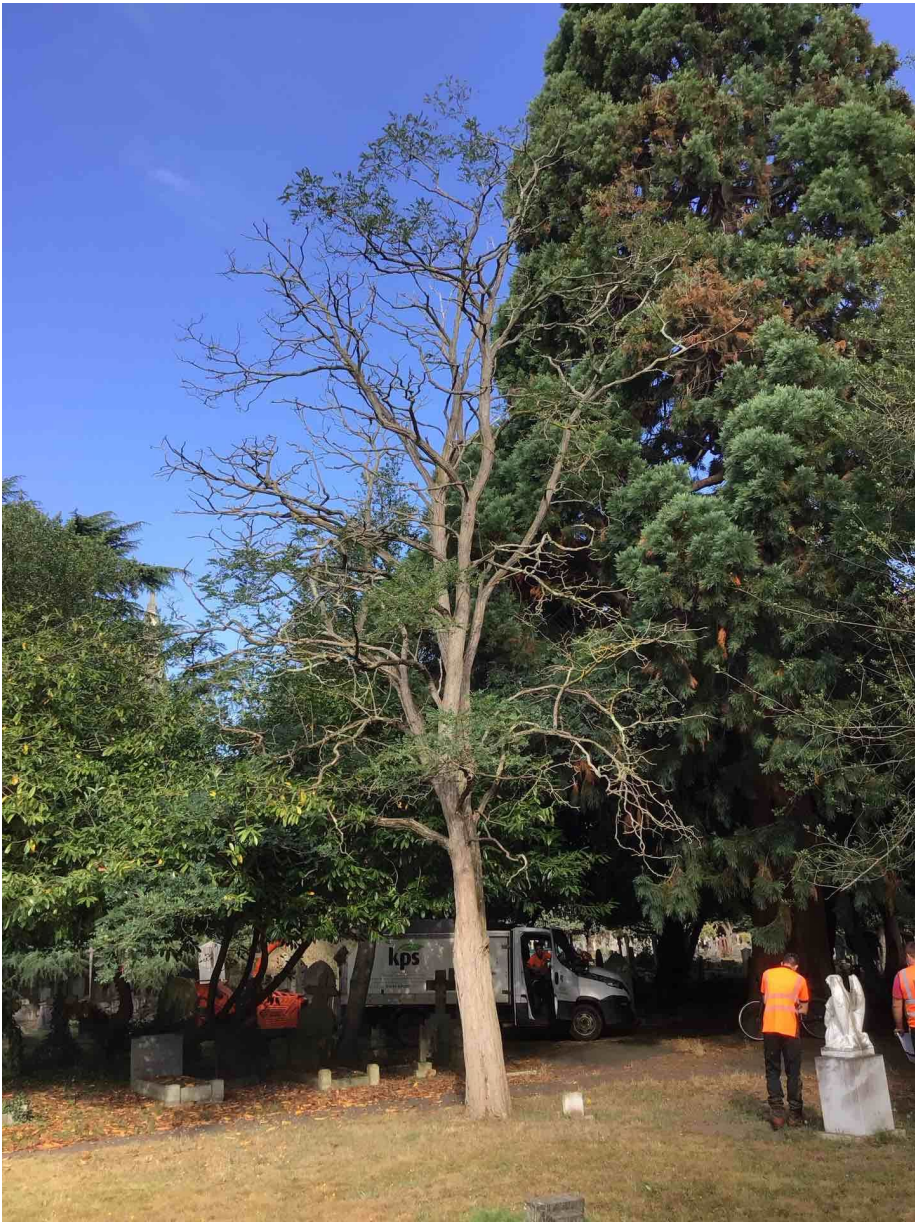
| Inspection findings | The tree is in moribund condition with over 90% of the crown being dead. Removal is required to prevent natural failure and facilitate replanting |

Image shows moribund tree in graveyard scene

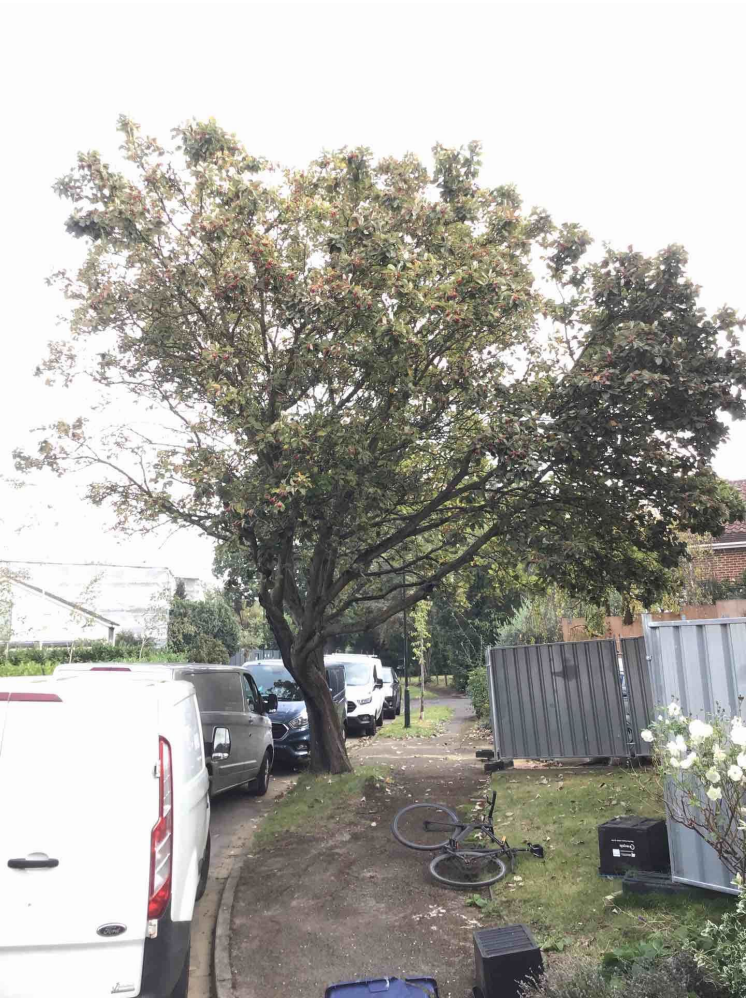
| Inspection findings | A fungal fruiting body of the species Shaggy Polypore ( <i>Inonotus hispidus</i> ) is present on the main stem or trunk and primary scaffold limb, this fungus causes a simultaneous white rot which can cause snapping of tree parts in this species. This has led to major failure. The onset of Crown dieback also correlates with the pathogen present. Removal is required to prevent further natural failure, manage risk, and facilitate replanting |

Image shows tree in street scene

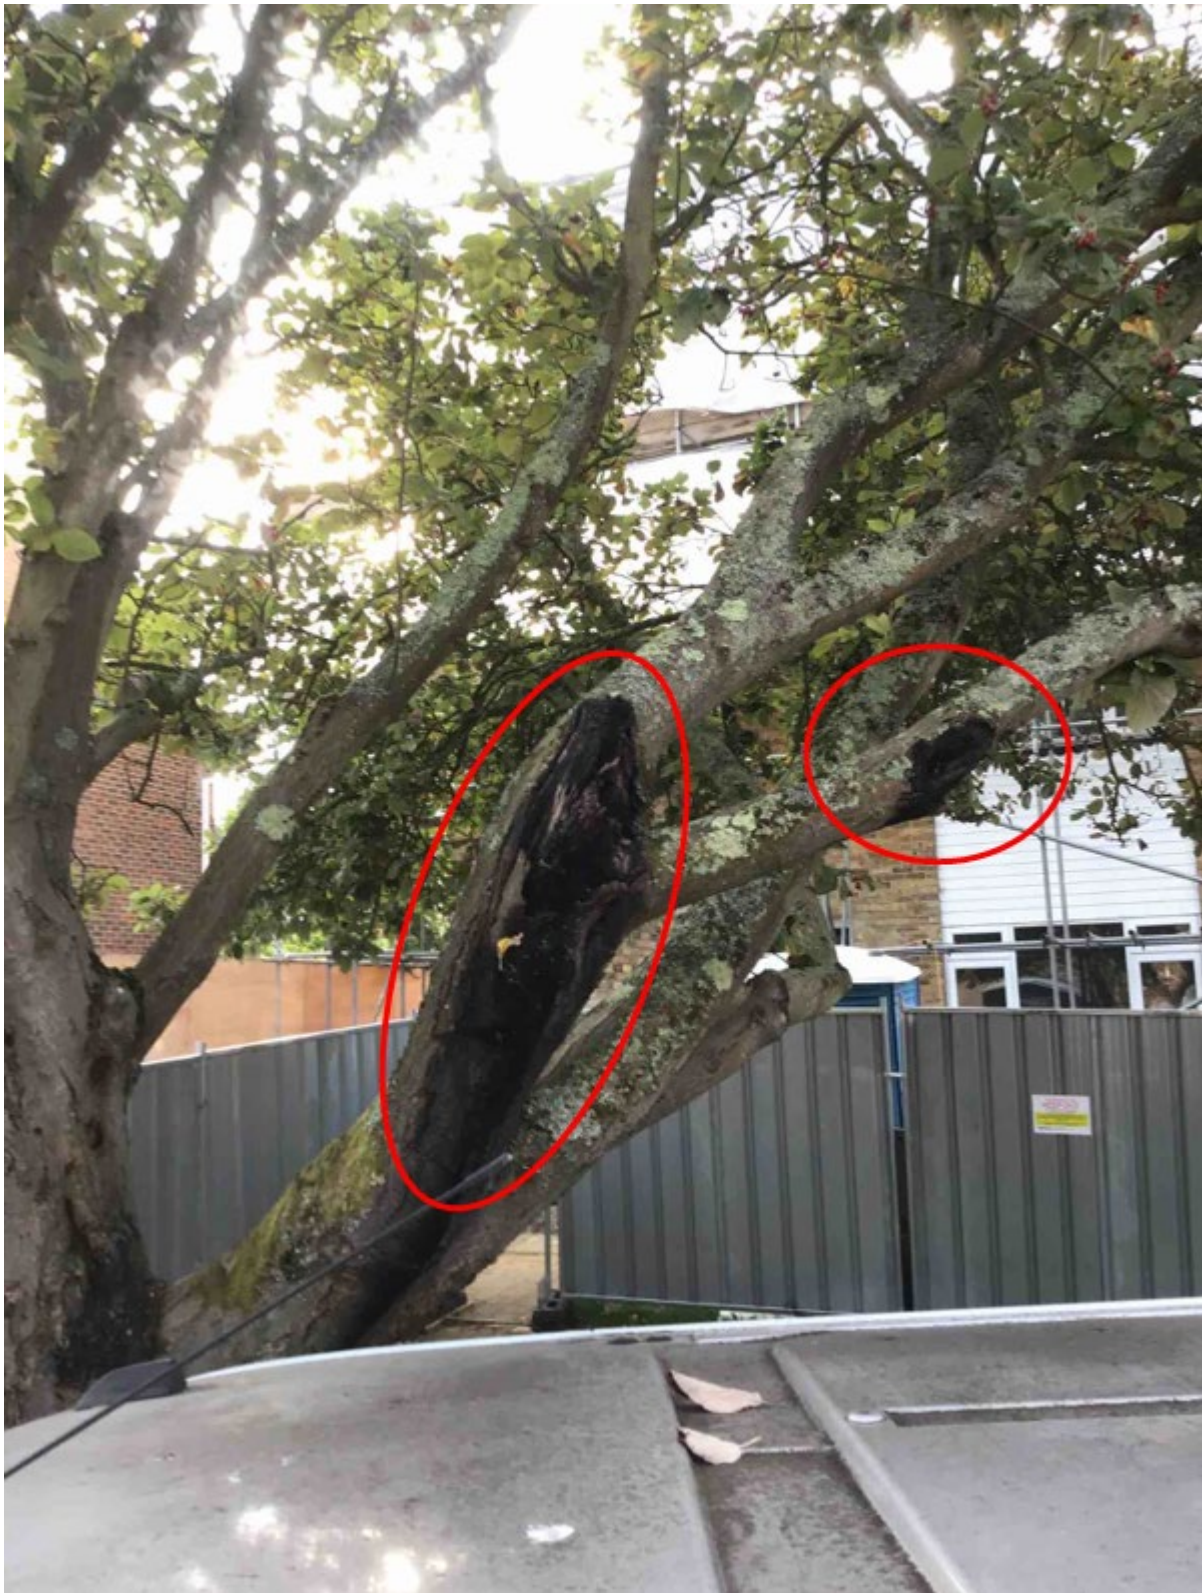
***Image shows cavities from historic branch failure circled in red***

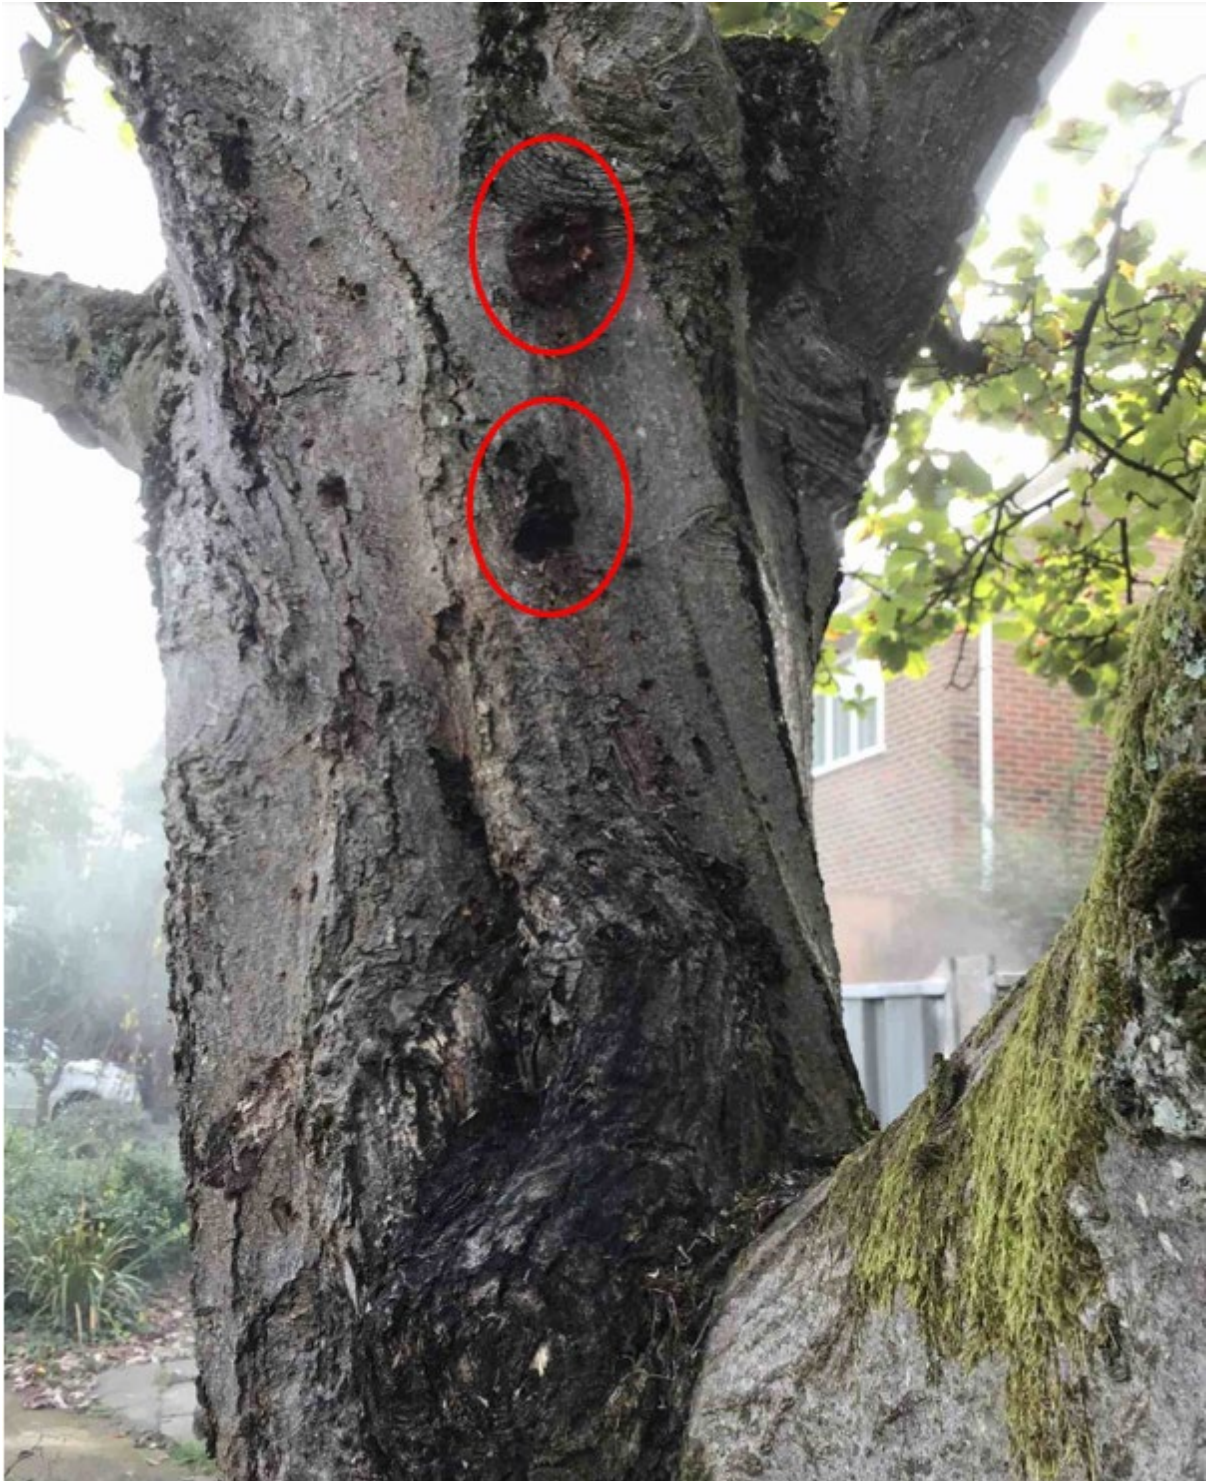
*Image shows emerging fungal fruiting bodies circled in red*

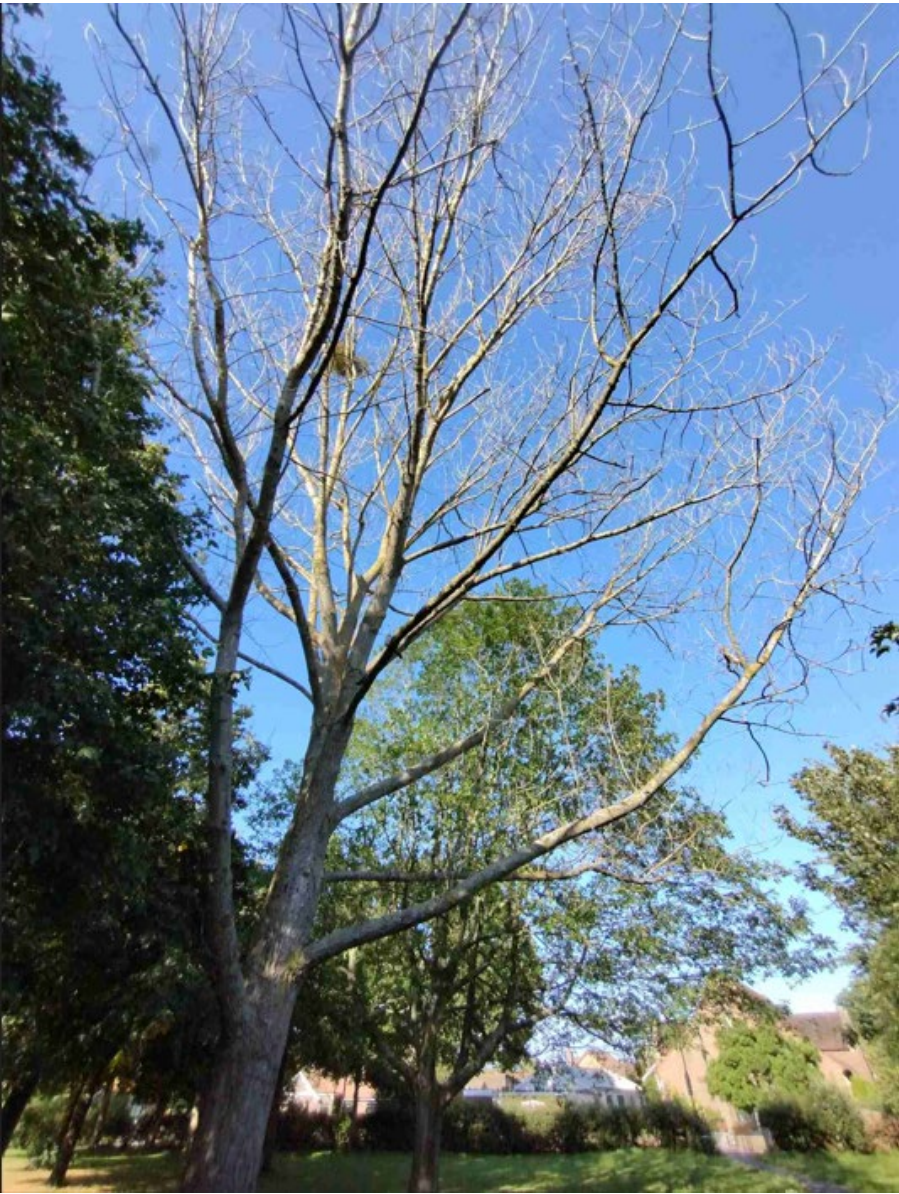
| Inspection findings | This tree is dead; removal is required to prevent natural failure and facilitate replanting |

Image shows dead tree in park scene

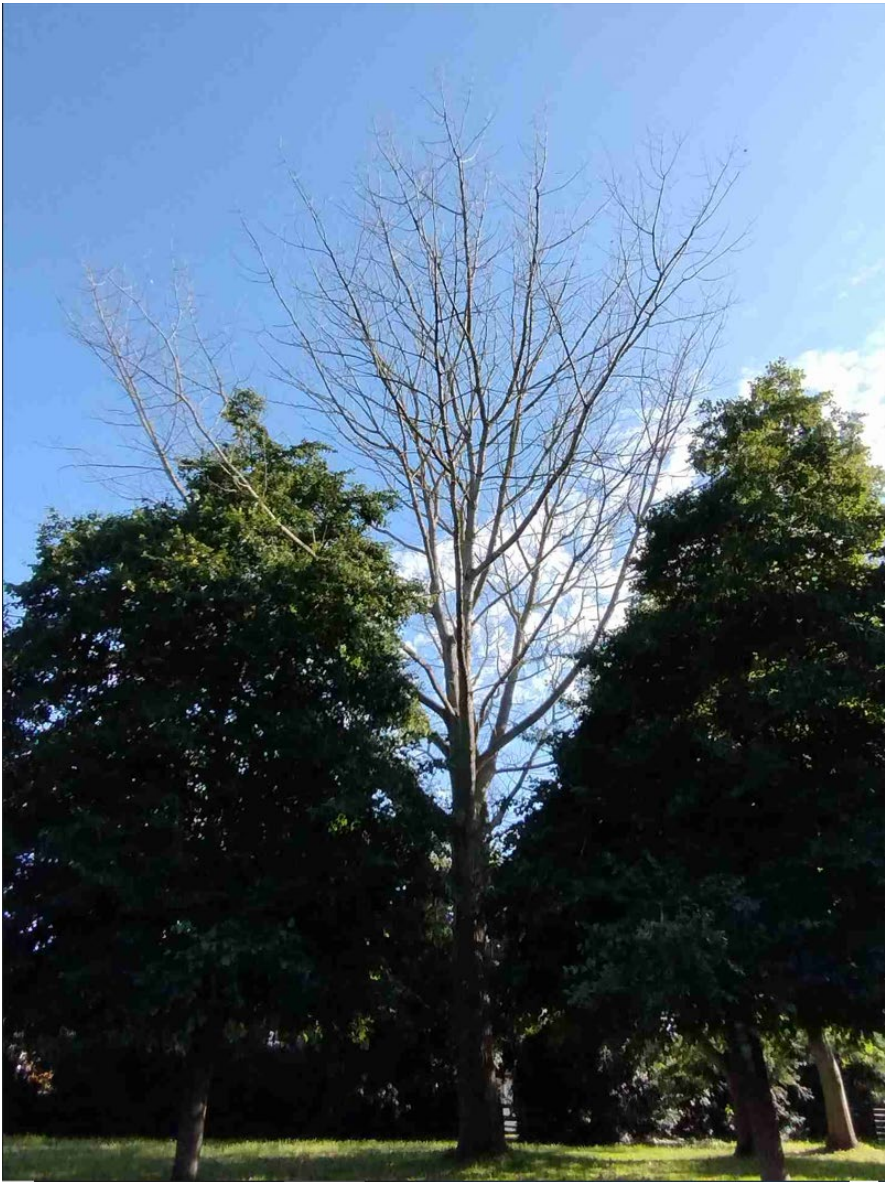
| Inspection findings | This tree is dead; removal is required to prevent natural failure and facilitate replanting |

Image shows dead tree in park scene

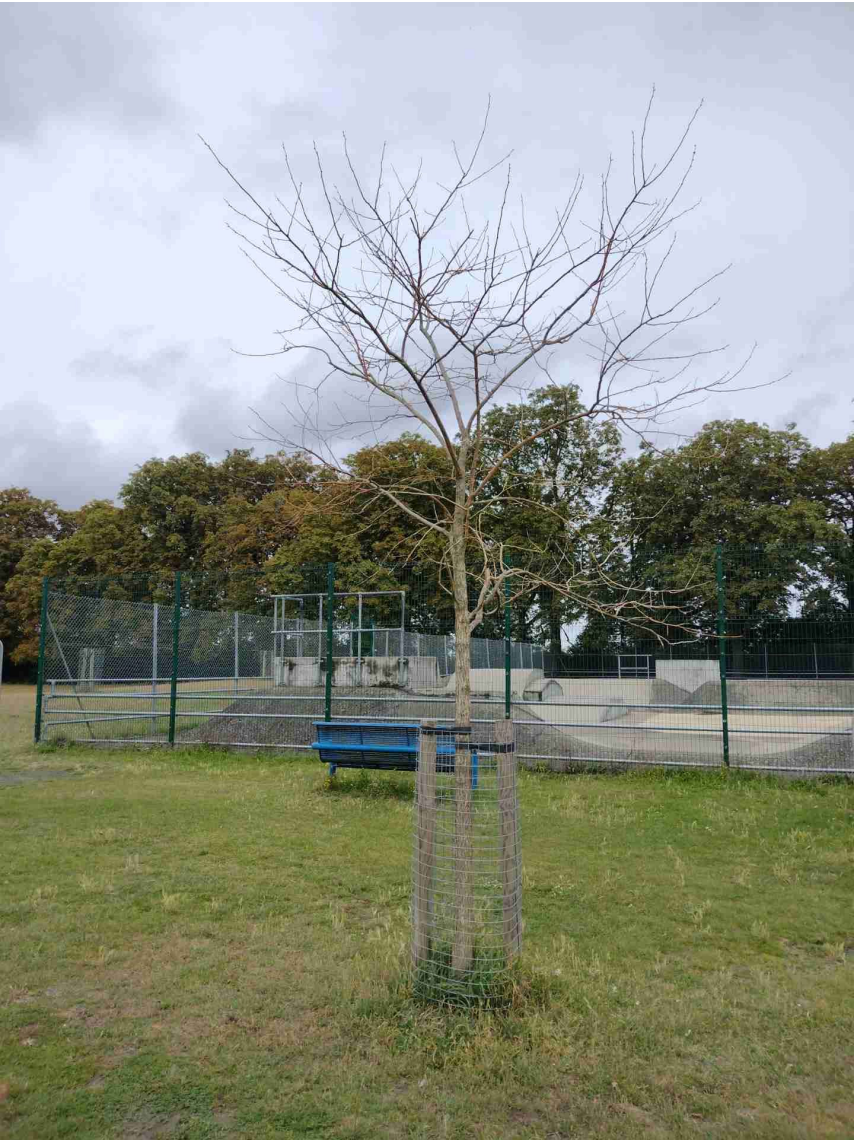
| Inspection findings | This tree is dead; removal is required to prevent natural failure and facilitate replanting |

Image shows dead tree in park scene

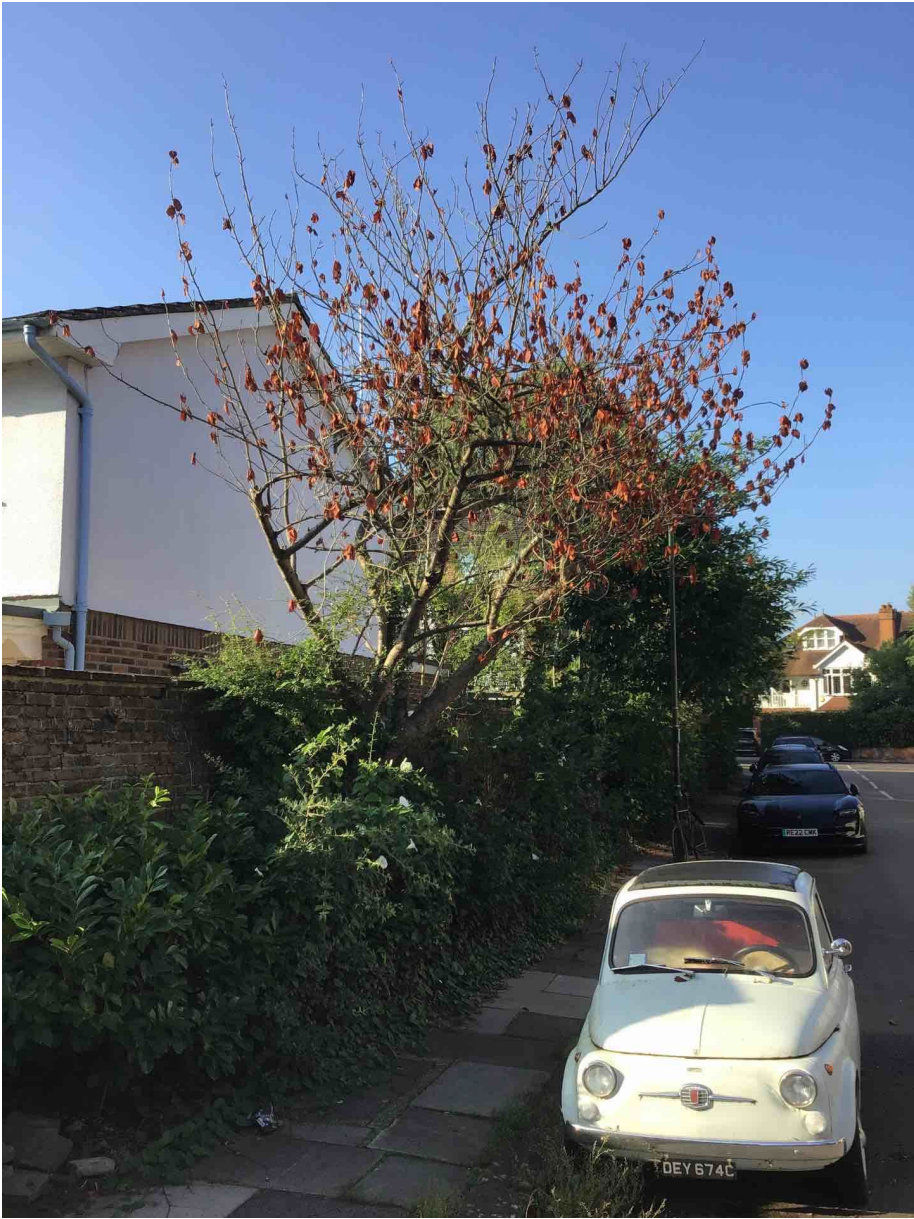
| Inspection findings | This tree is dead; removal is required to prevent natural failure and facilitate replanting |

Image shows dead tree in street scene

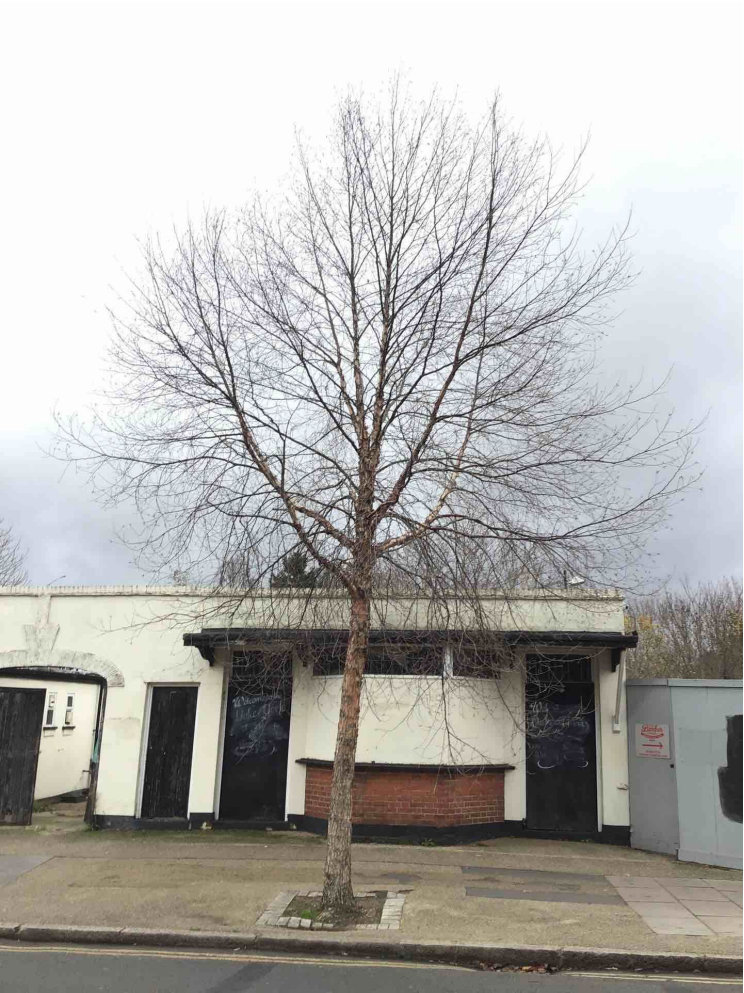
| Inspection findings | This tree removal and replanting was approved as part of planning permission 21/0156/FUL. The tree will be removed to facilitate development and replanted at a nearby location. |

Image shows dead tree in street scene

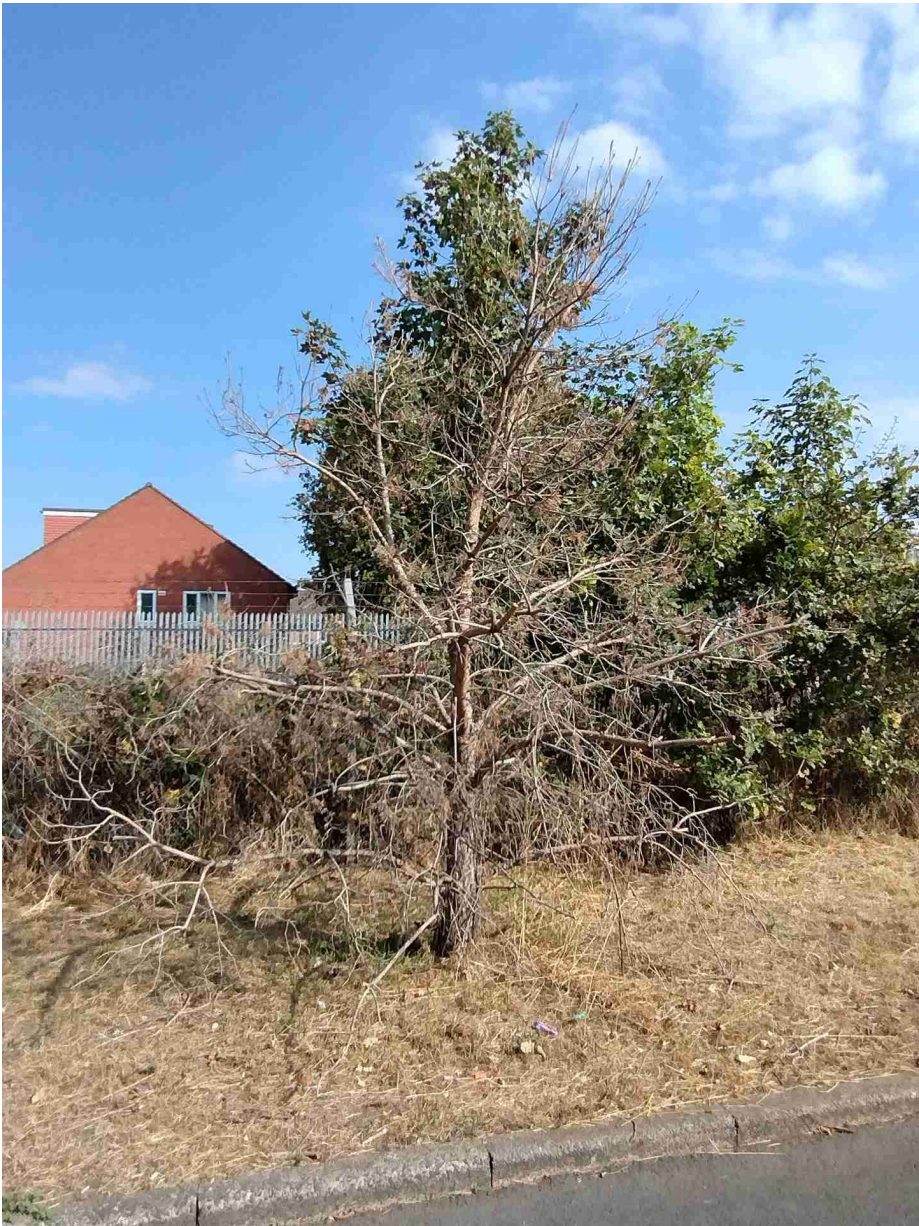
| Inspection findings | This tree is dead; removal is required to prevent natural failure and facilitate replanting |

Images shows dead tree in street scene.

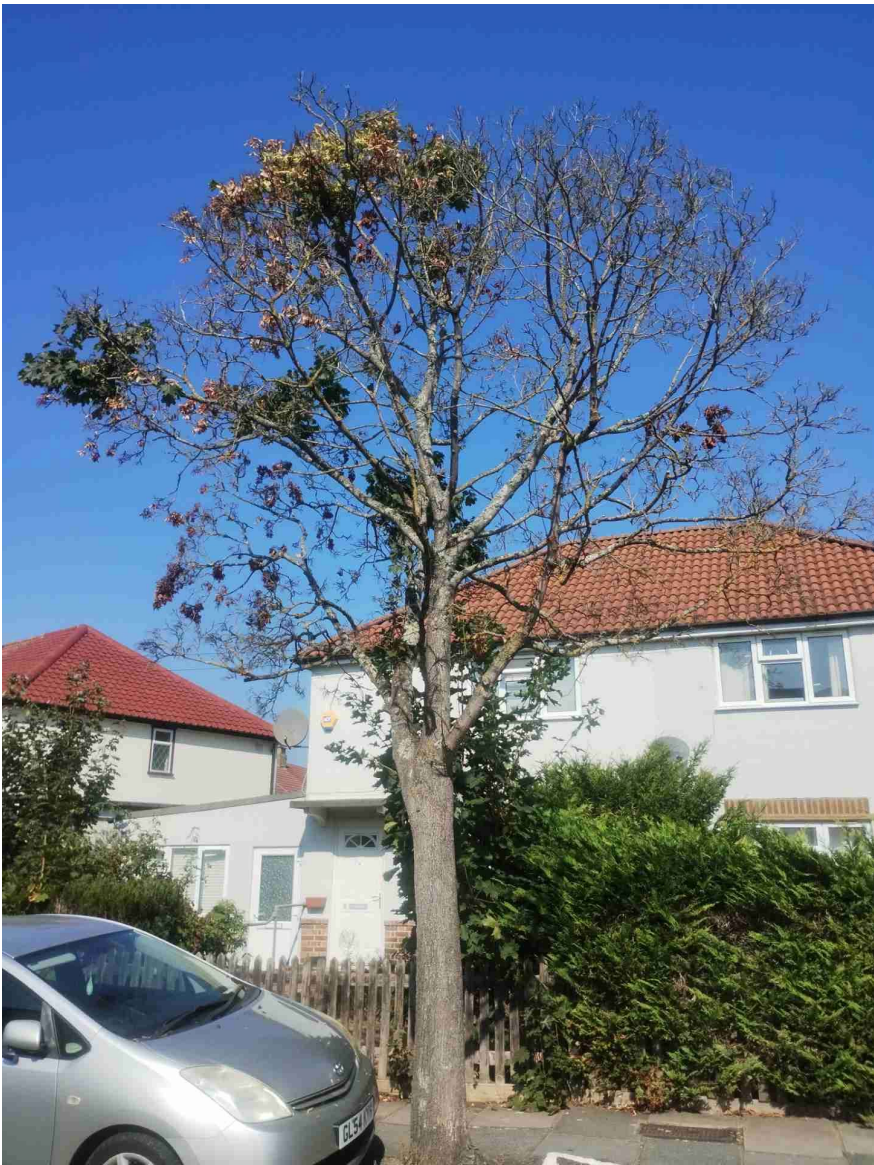
| Inspection findings | The tree is in moribund condition with 80% of the crown being dead. Tree is no longer suitable for retention. Removal is required to facilitate replanting. |

**Images shows moribund tree in street scene**

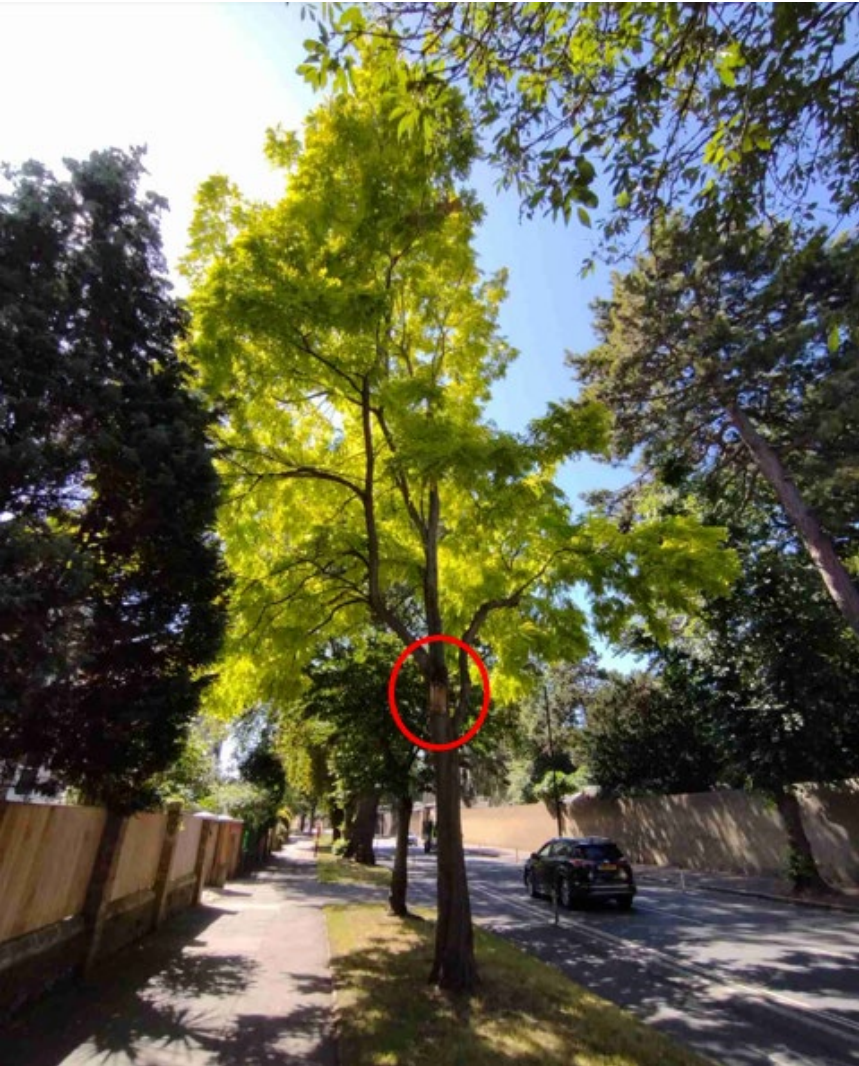
| Inspection findings | The tree has had primary stem failure in crown due to a wide mouth union on the main trunk. This has now left a tree with an unacceptable structural weakness at the point of failure at base of crown. The tree is no longer suitable for retention and is being removed to manage risk, prevent further natural failure and to facilitate replanting. |

Image shows tree in street scene with cavity circle in red

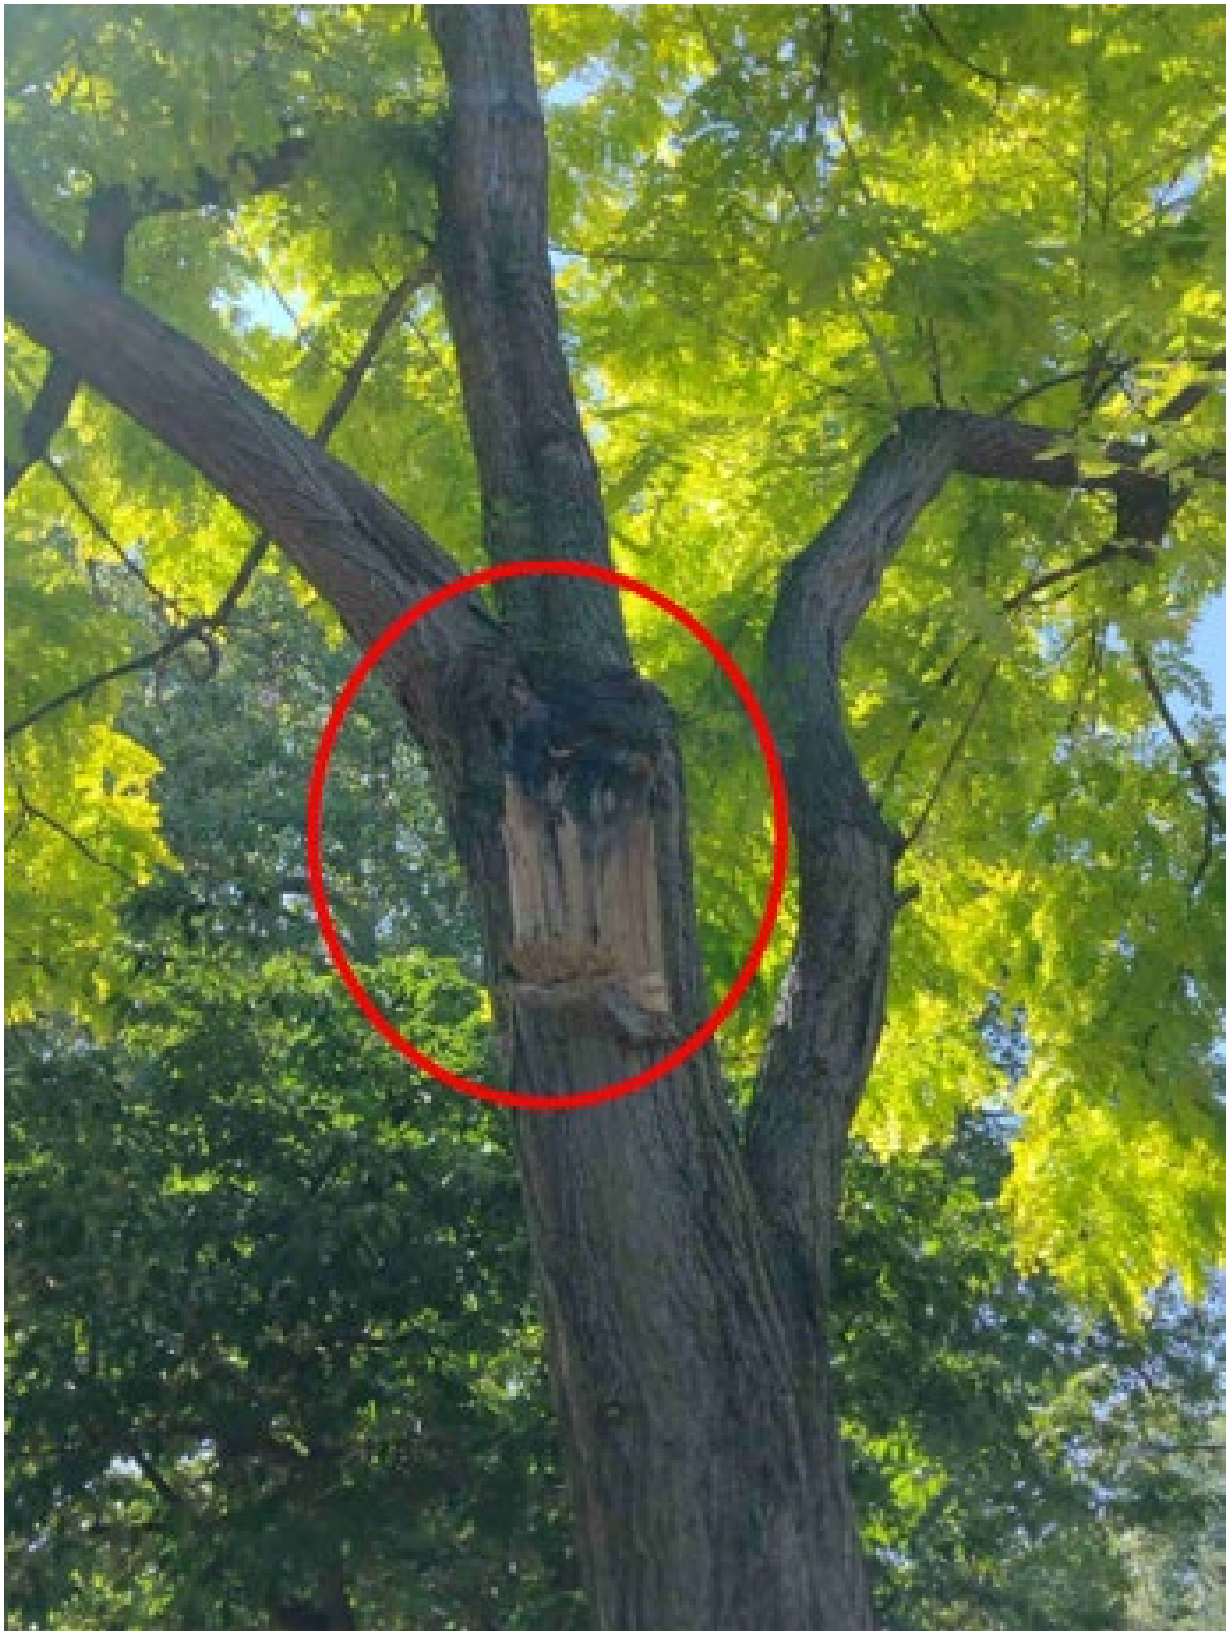
*Image shows cavity at base of major union*

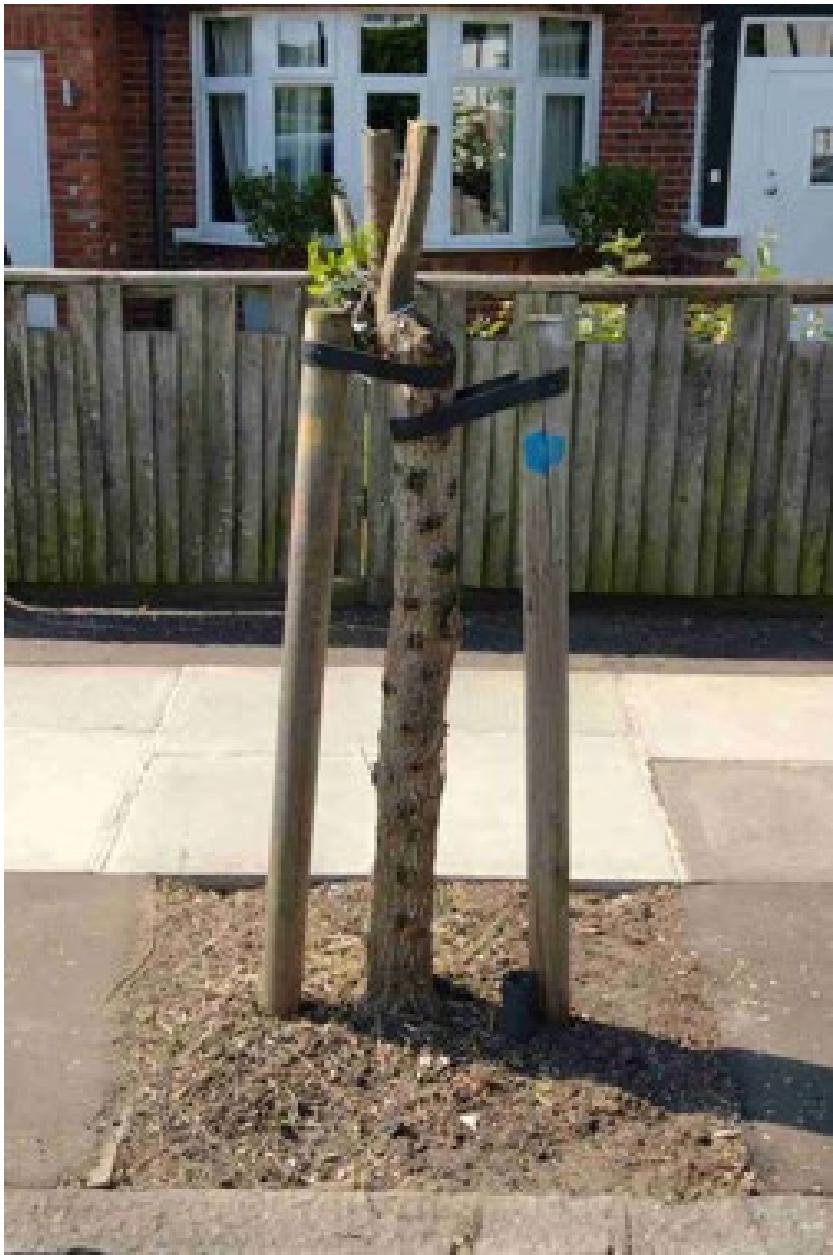
| Inspection findings | This tree has been vandalised with the crown being cut at the top of main stem/trunk. This will prevent the tree from forming a useful specimen. Removal is required to facilitate replanting |

Image shows vandalised tree with central leader missing

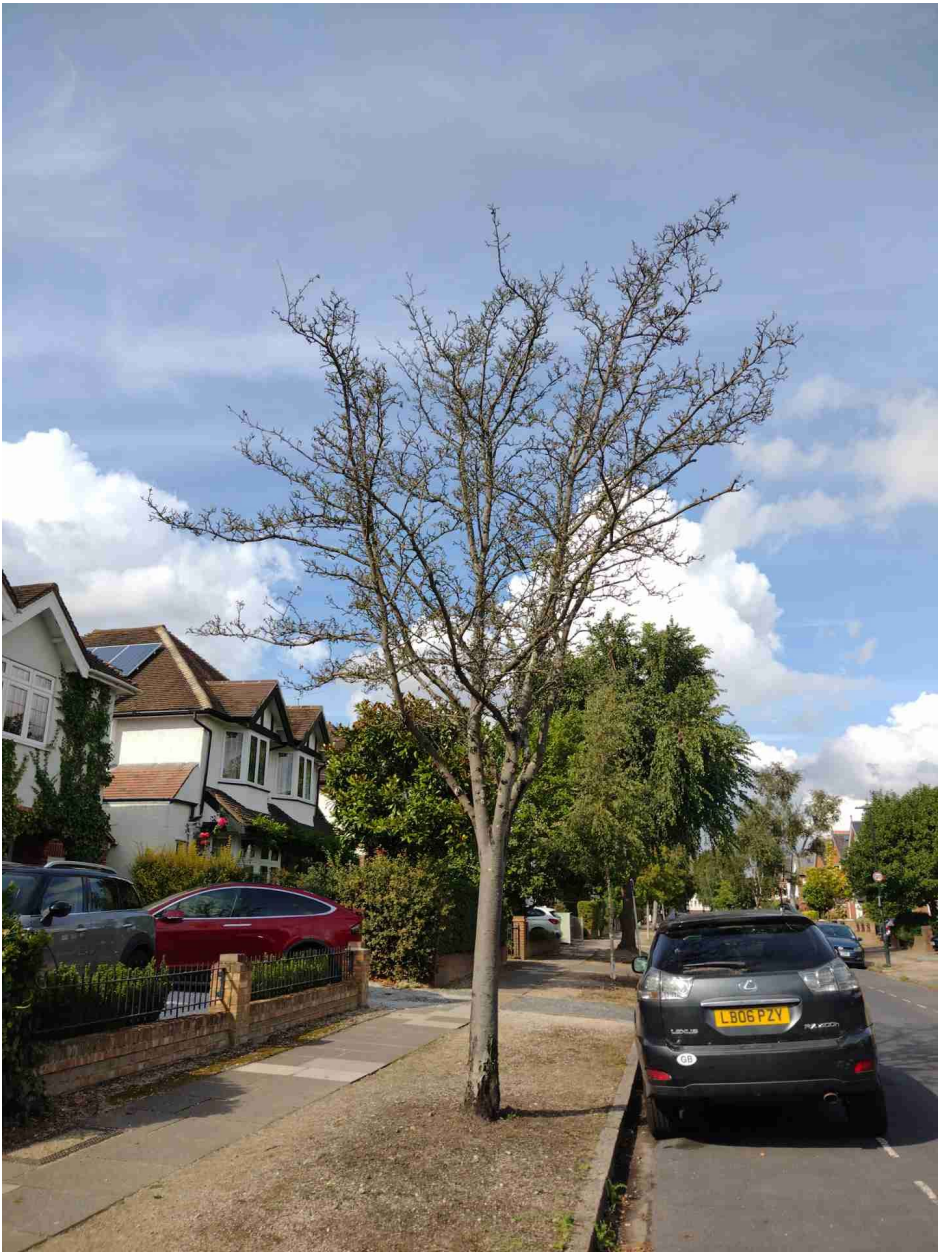
| Inspection findings | This tree is dead, removal is required to prevent natural failure and facilitate replanting. |

Image shows dead tree in street scene.

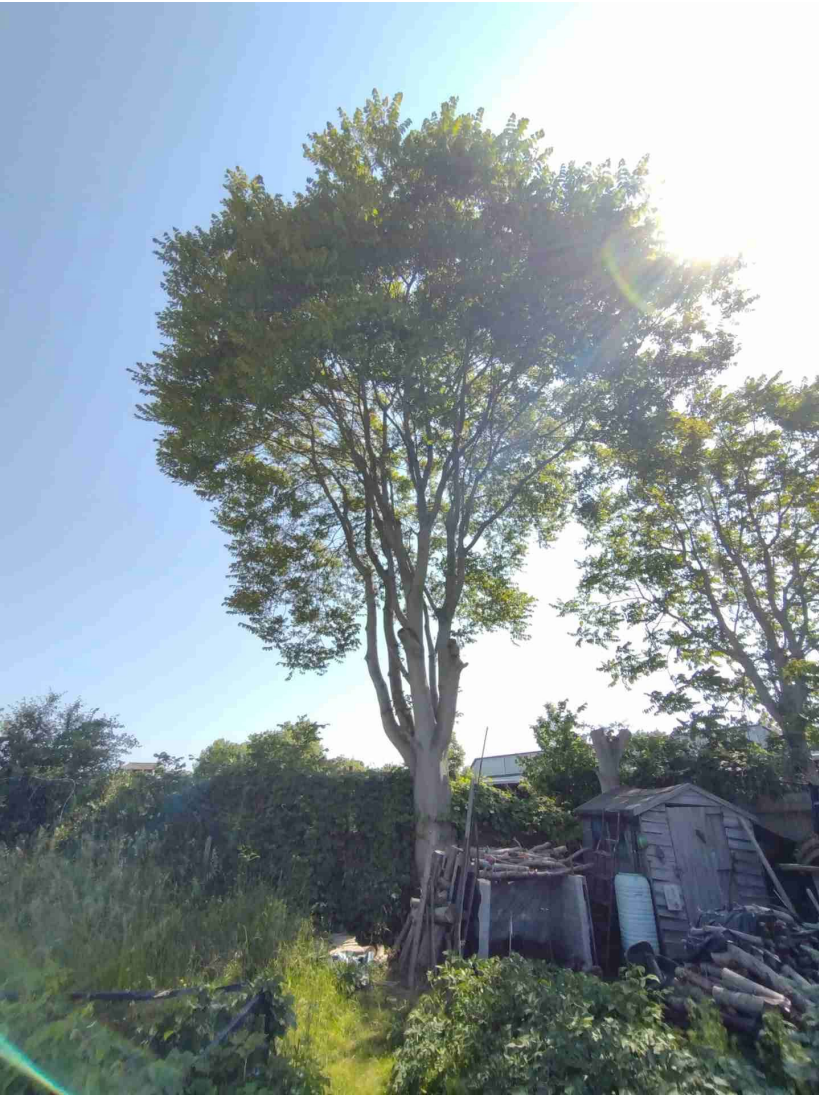
| Inspection findings | This is an inappropriate species for this location and is causing suckering issues in the allotment plots. Removal is required to prevent further suckering and facilitate replanting with an appropriate species. |

Image shows tree in allotments scene
