# October 2023 - Reactive Tree Works Programme

## Introduction

Dated 16.10.2023

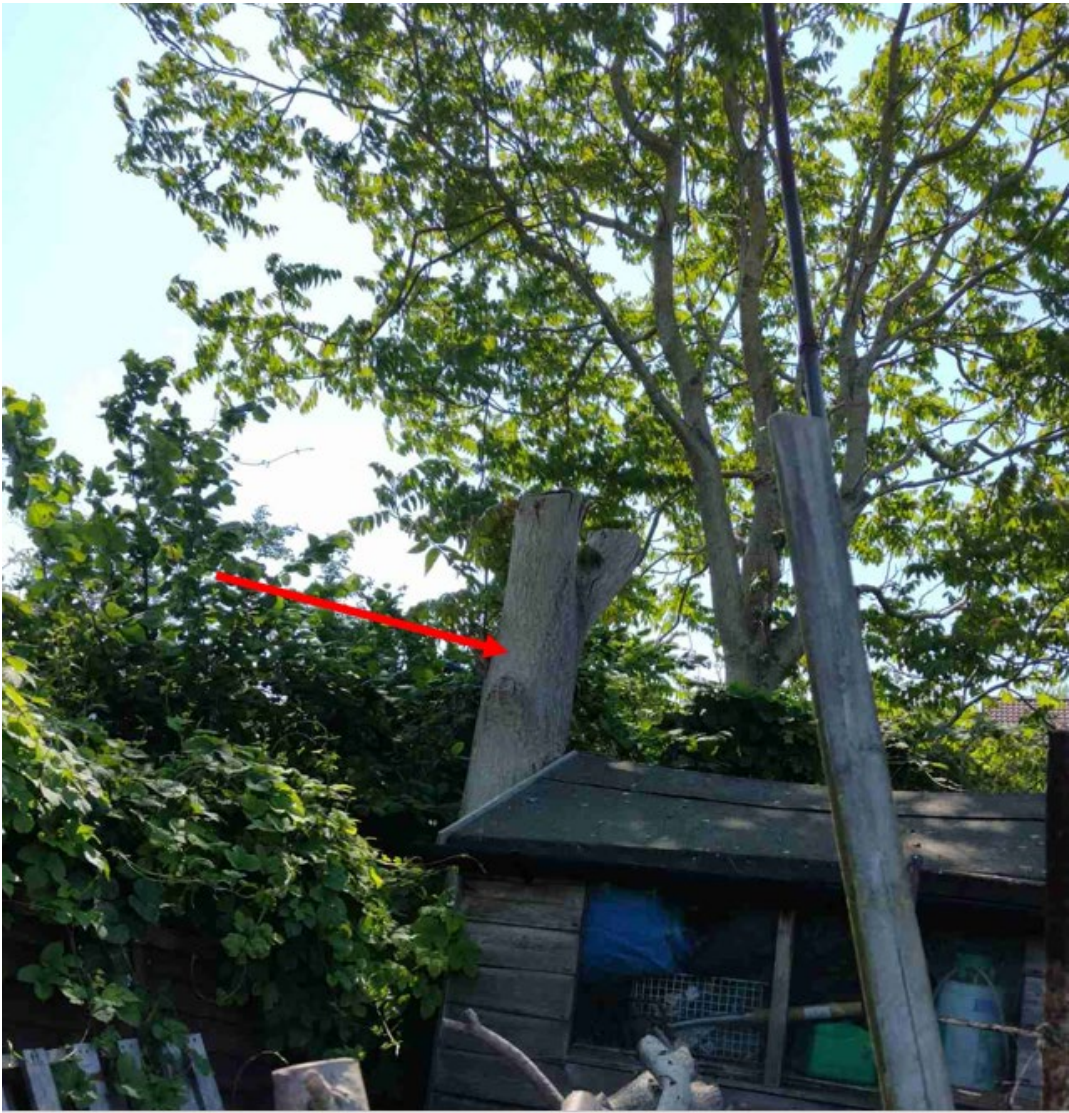
| Inspection findings | The tree stem/trunk is dead, removal is required to manage risk and prevent natural failure. |

Image shows dead tree trunk in allotment scene

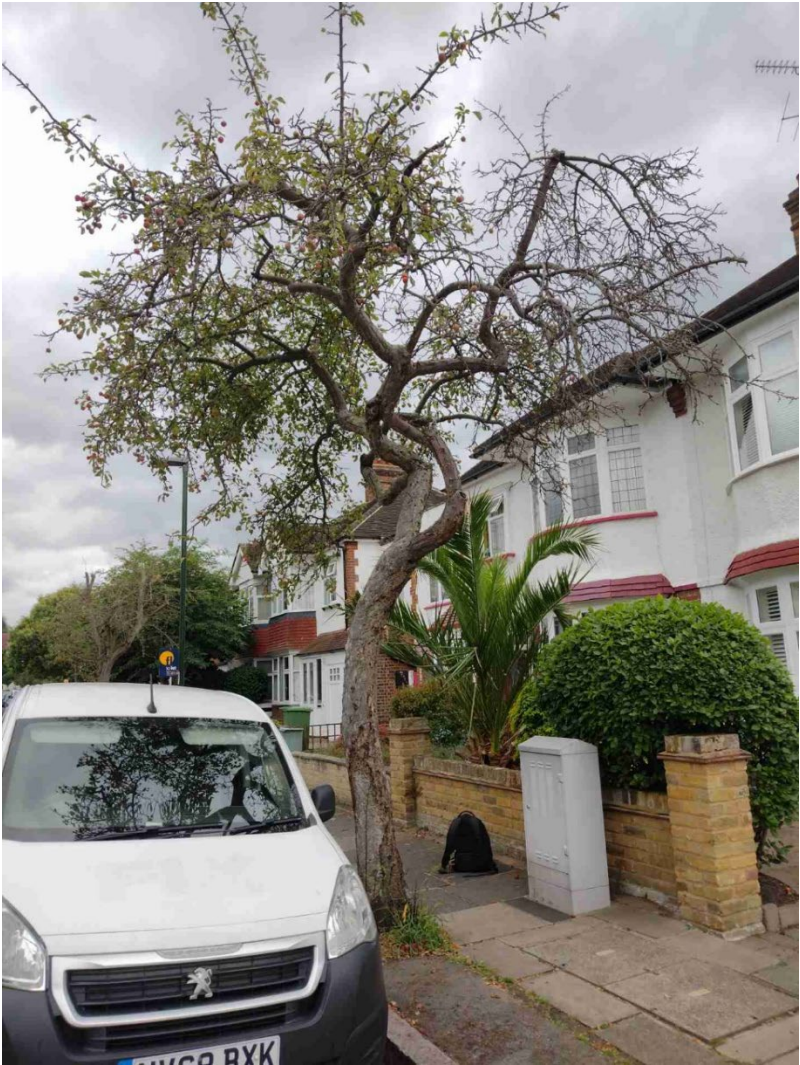
| Inspection findings | This tree is in moribund condition with 50% of the crown being dead. Necrosis and an unacceptable amount of decay is present on the main stem of this tree; the decline of the trees vascular system correlates with dieback within the crown. Removal is required to prevent natural failure and to facilitate replanting. |

Image shows moribund tree in street scene

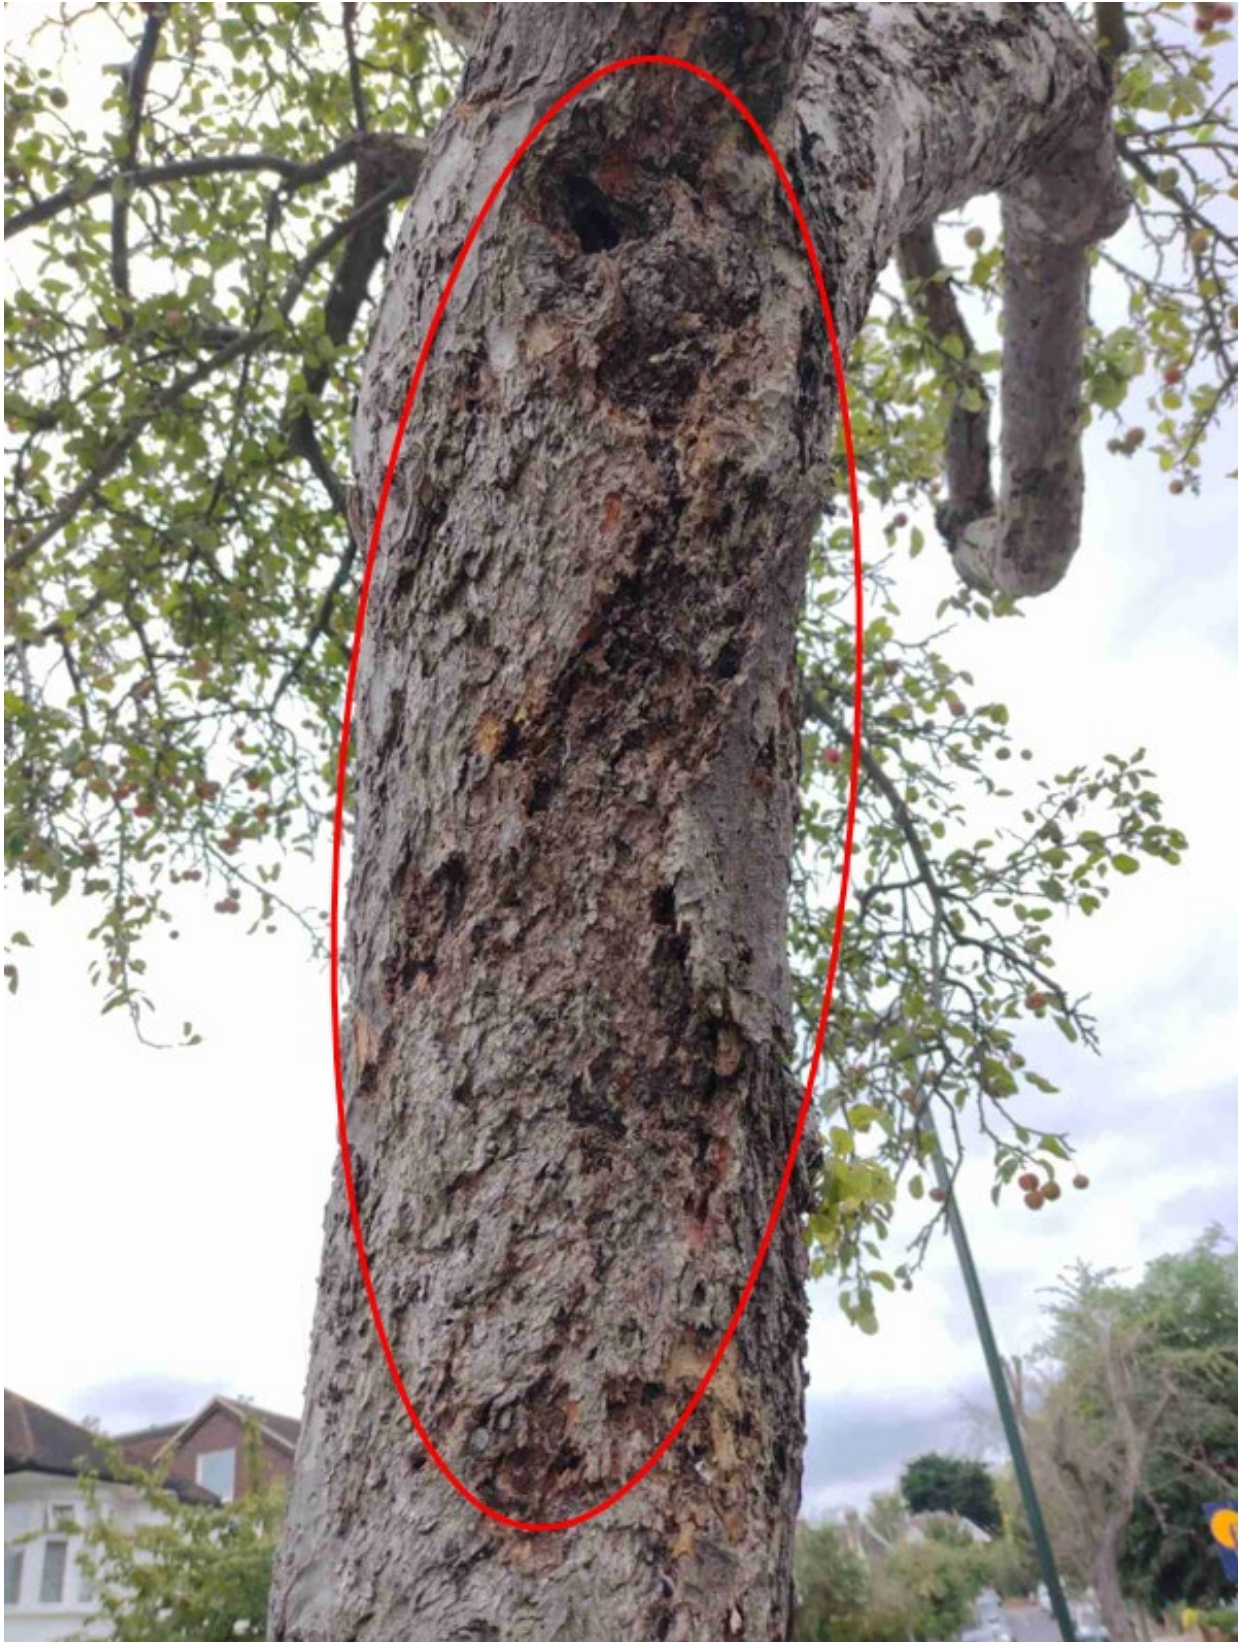
***Image shows area of bark necrosis and decay on stem circled in red***

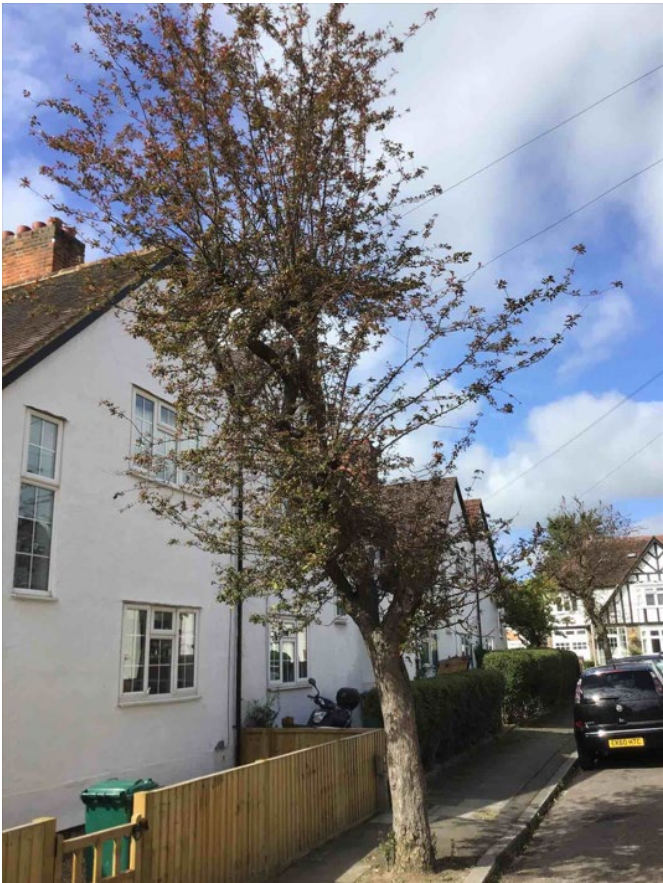
| Inspection findings | A fungal fruiting body of the species Shaggy Polypore ( <i>Inonotus hispidus</i> ) is present on the main stem or trunk, this fungus causes a simultaneous white rot which can cause snapping of tree parts in this species. This tree has also sustained substantial vehicle damage to primary branches in the crown which has caused vascular dysfunction and led to the development of decay pathogens. It is in a state of physiological decline and contains weak branches that are liable to collapse. This tree is no longer suitable for retention and should be removed to prevent natural failure. |

Image shows tree in street scene

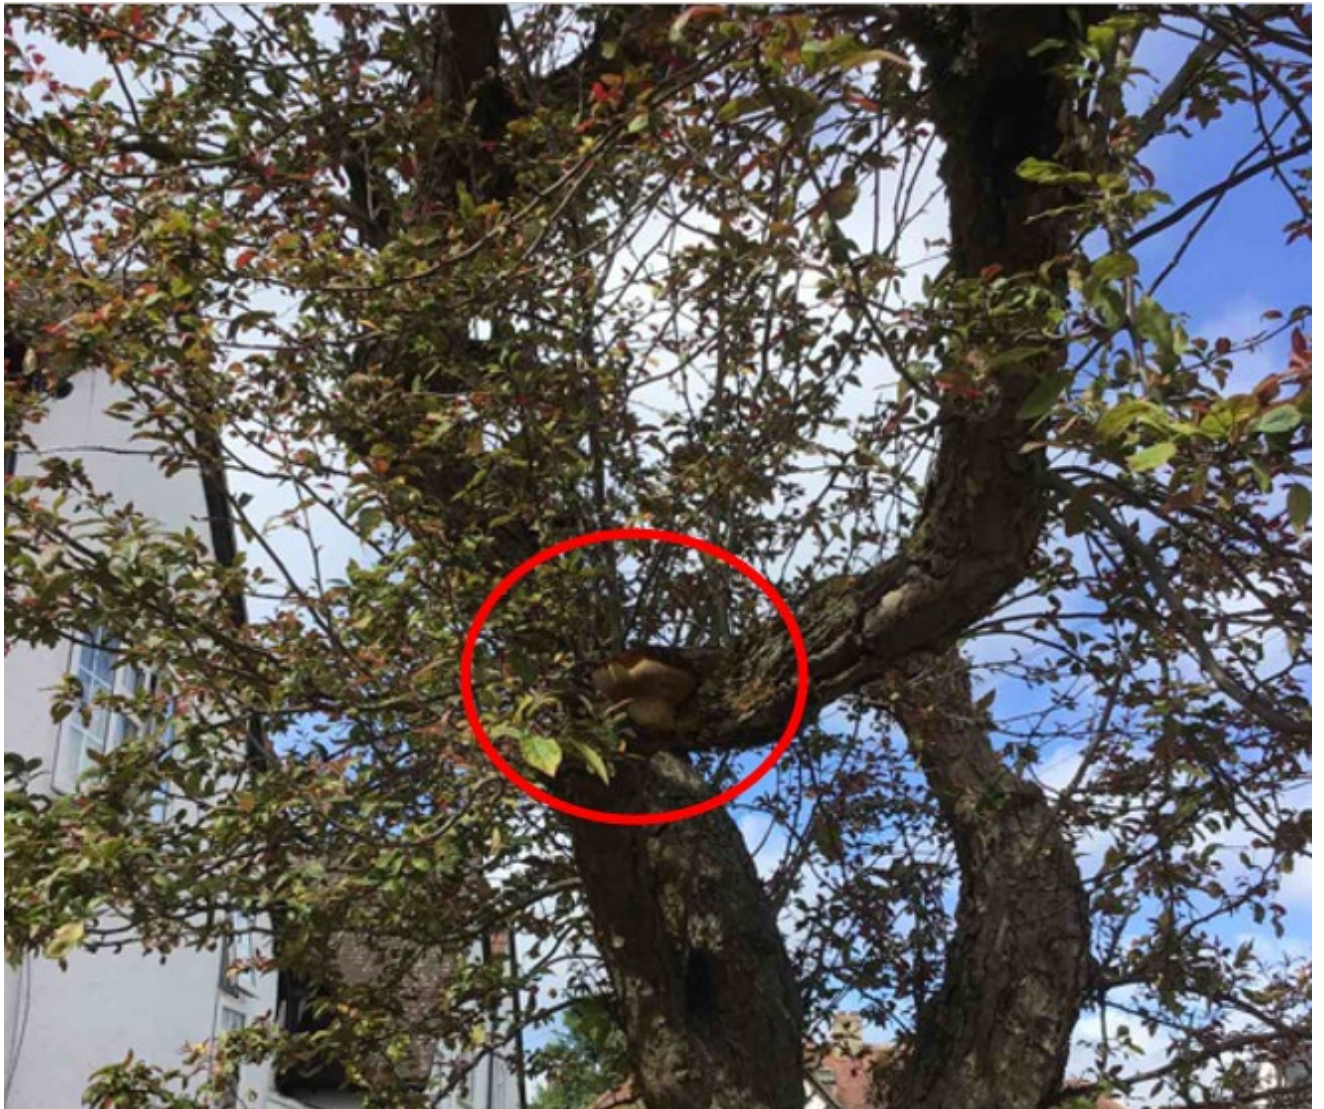
***Image shows tree with fruiting body circled***

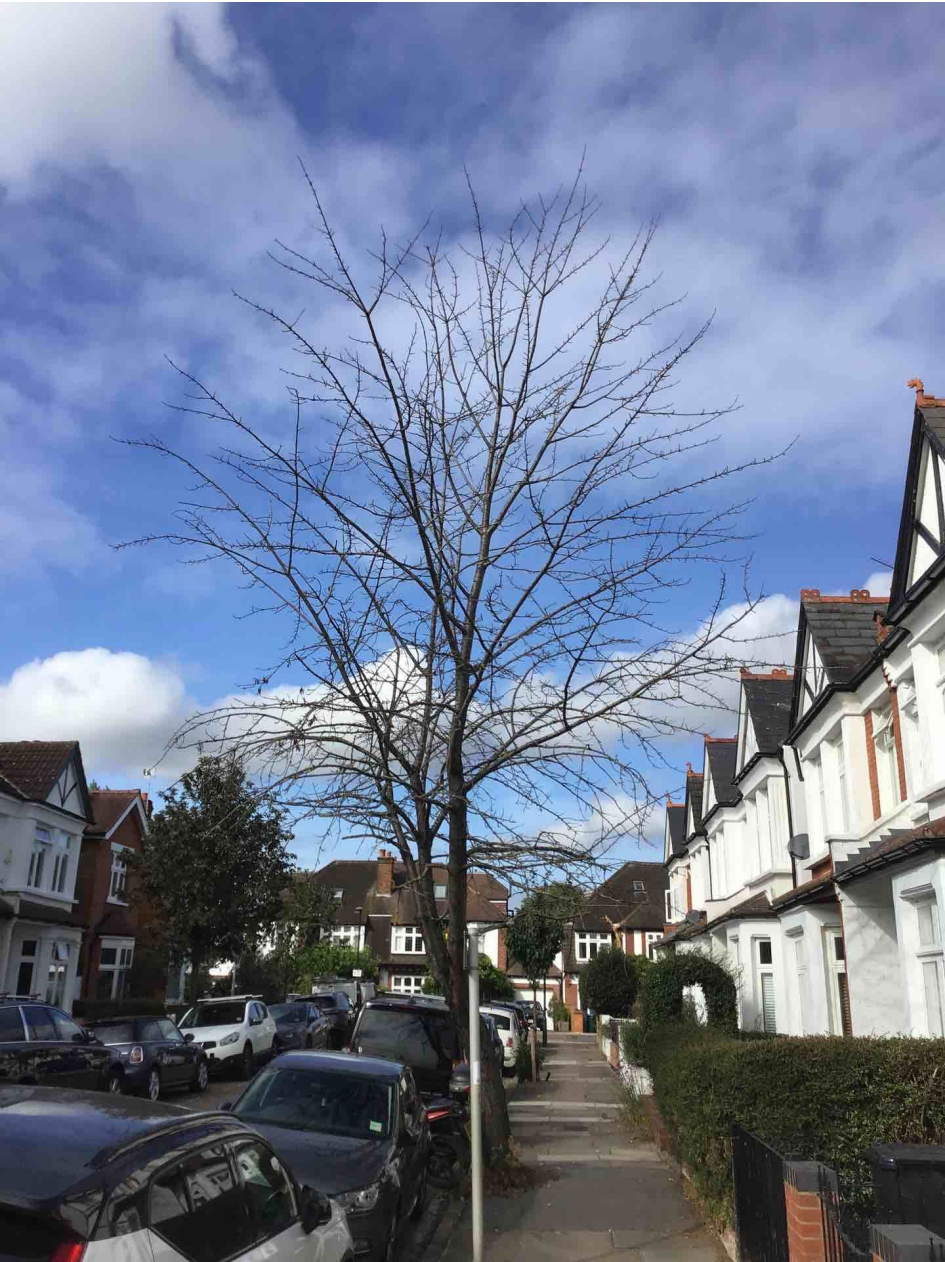
| Inspection findings | The tree is dead, removal is required to prevent natural failure and to facilitate replanting. |

Image shows dead tree in street scene

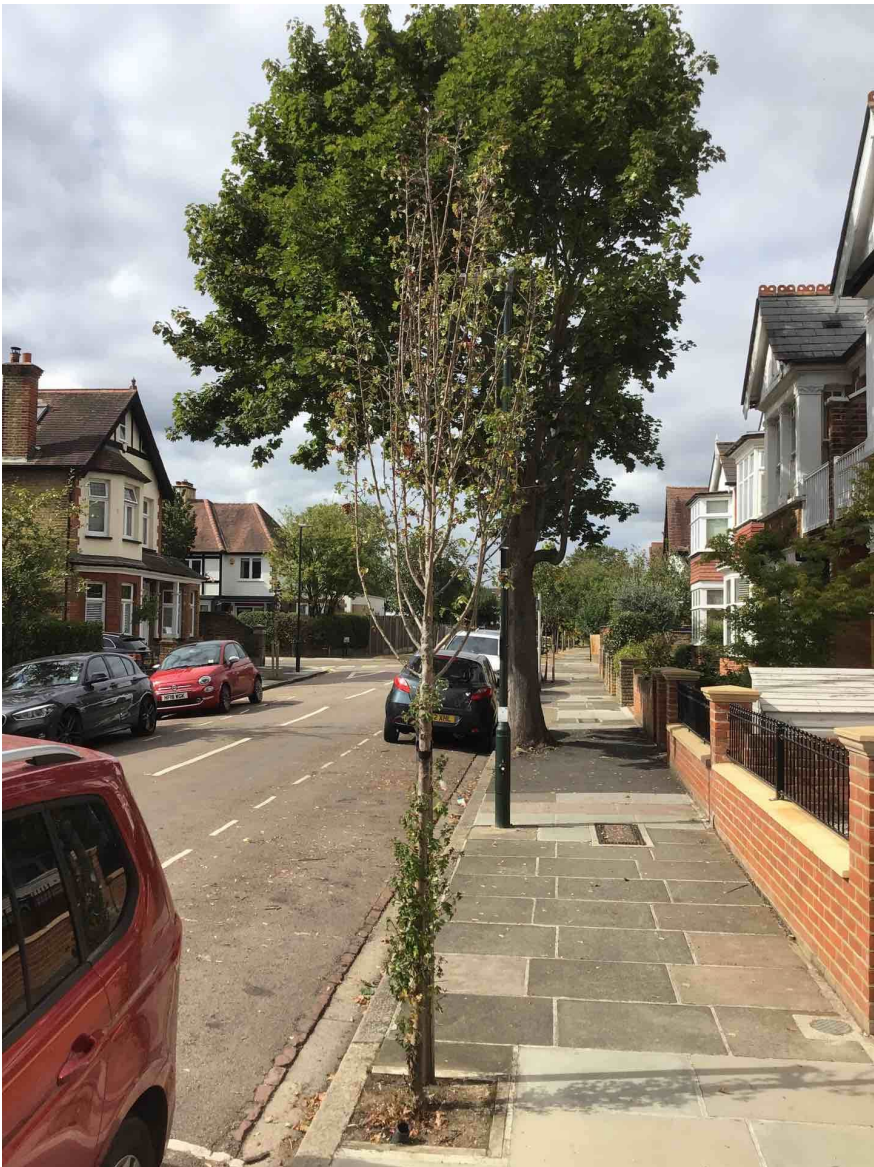
| Inspection findings | This tree is in moribund condition with approximately 70% of the crown being dead. Removal is required to facilitate replanting. |

Image shows moribund tree in street scene

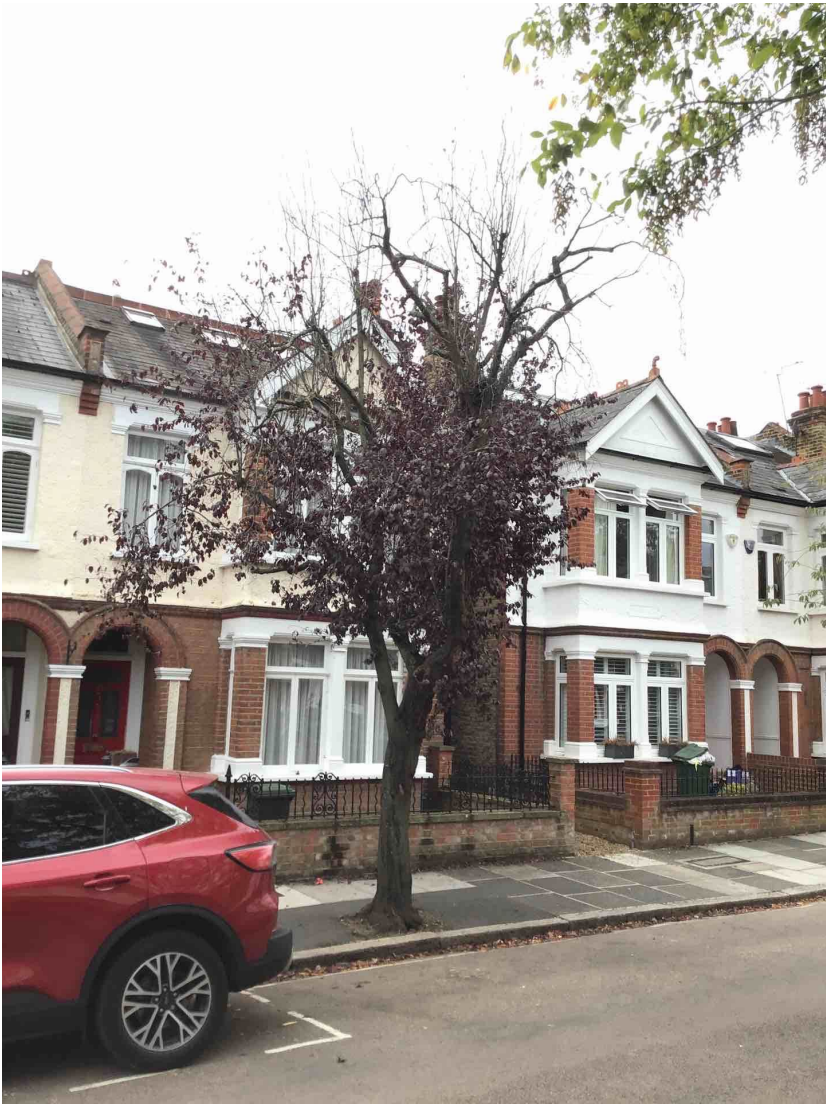
| Inspection findings | This tree has a cavity at ground level on the roadside of the stem with an unacceptable amount of decay in centre of the stem. The tree is in moribund condition with approximately 60% of the crown is dead which corresponds with the decay at base of the stem. Removal is required to prevent natural failure and to facilitate replanting. |

Image shows moribund tree in street scene

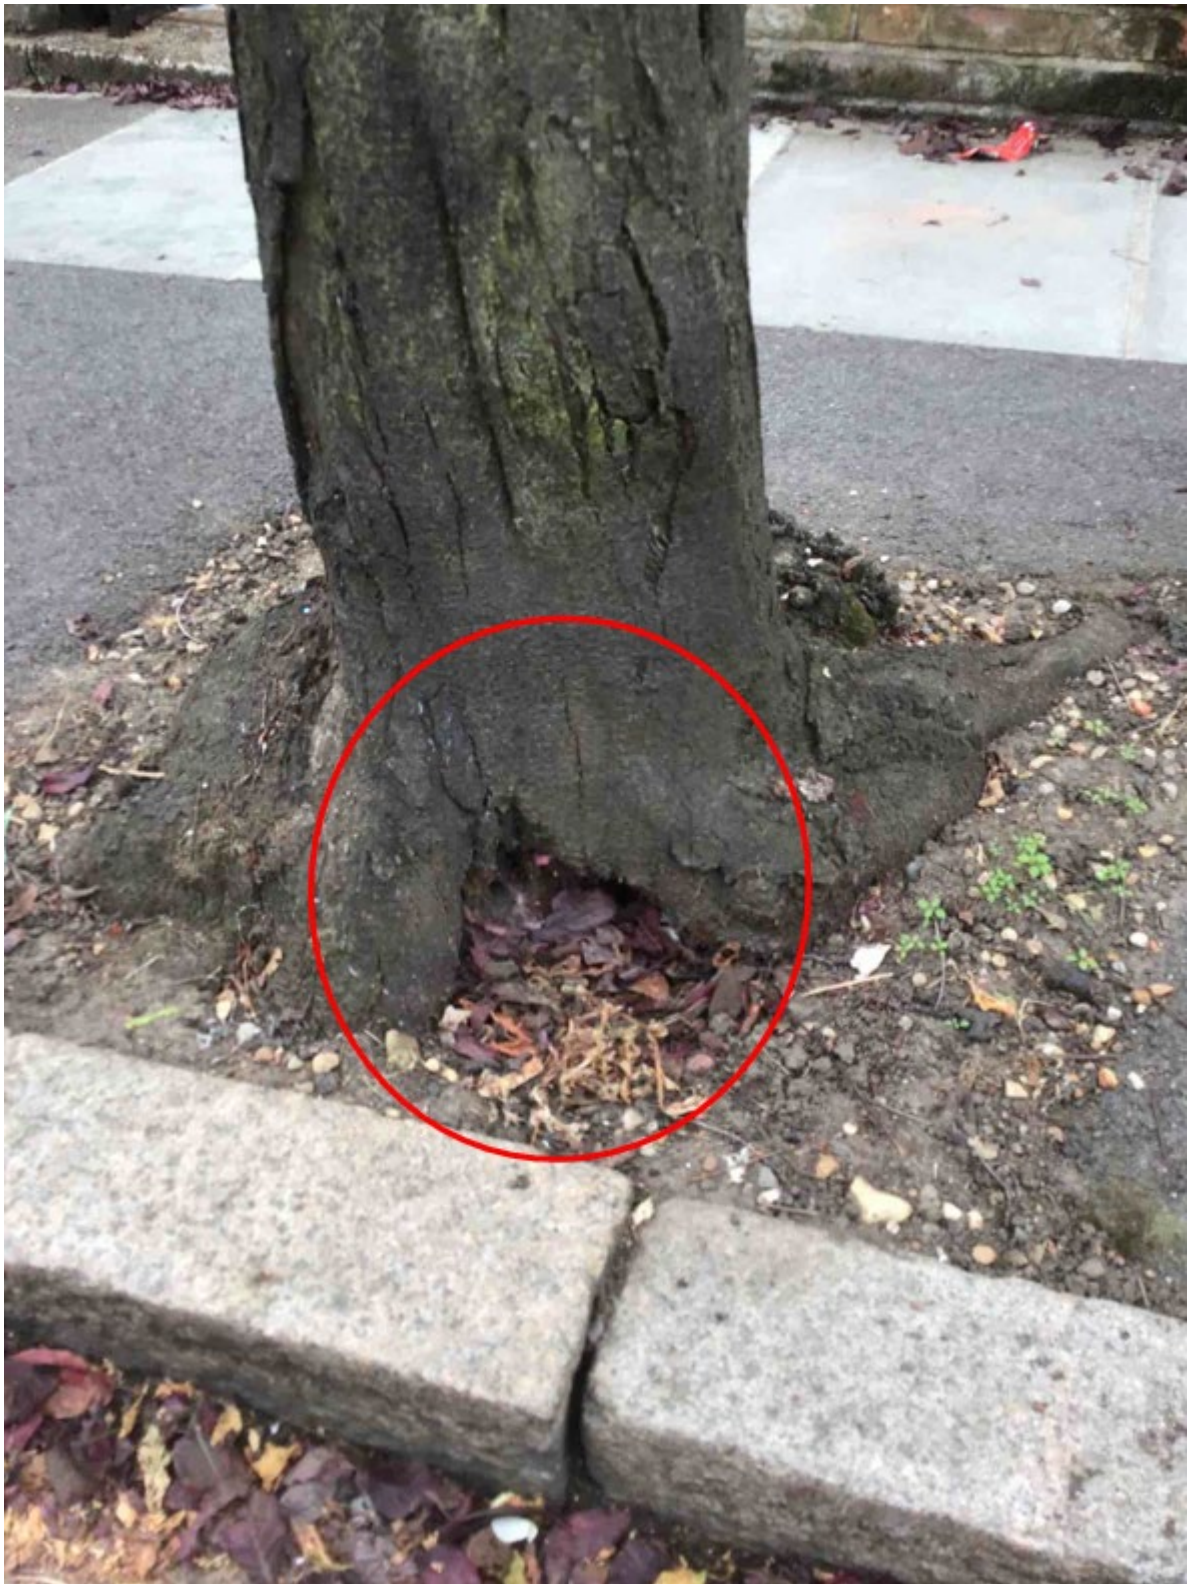
***Image shows cavity at base of tree circled in red***

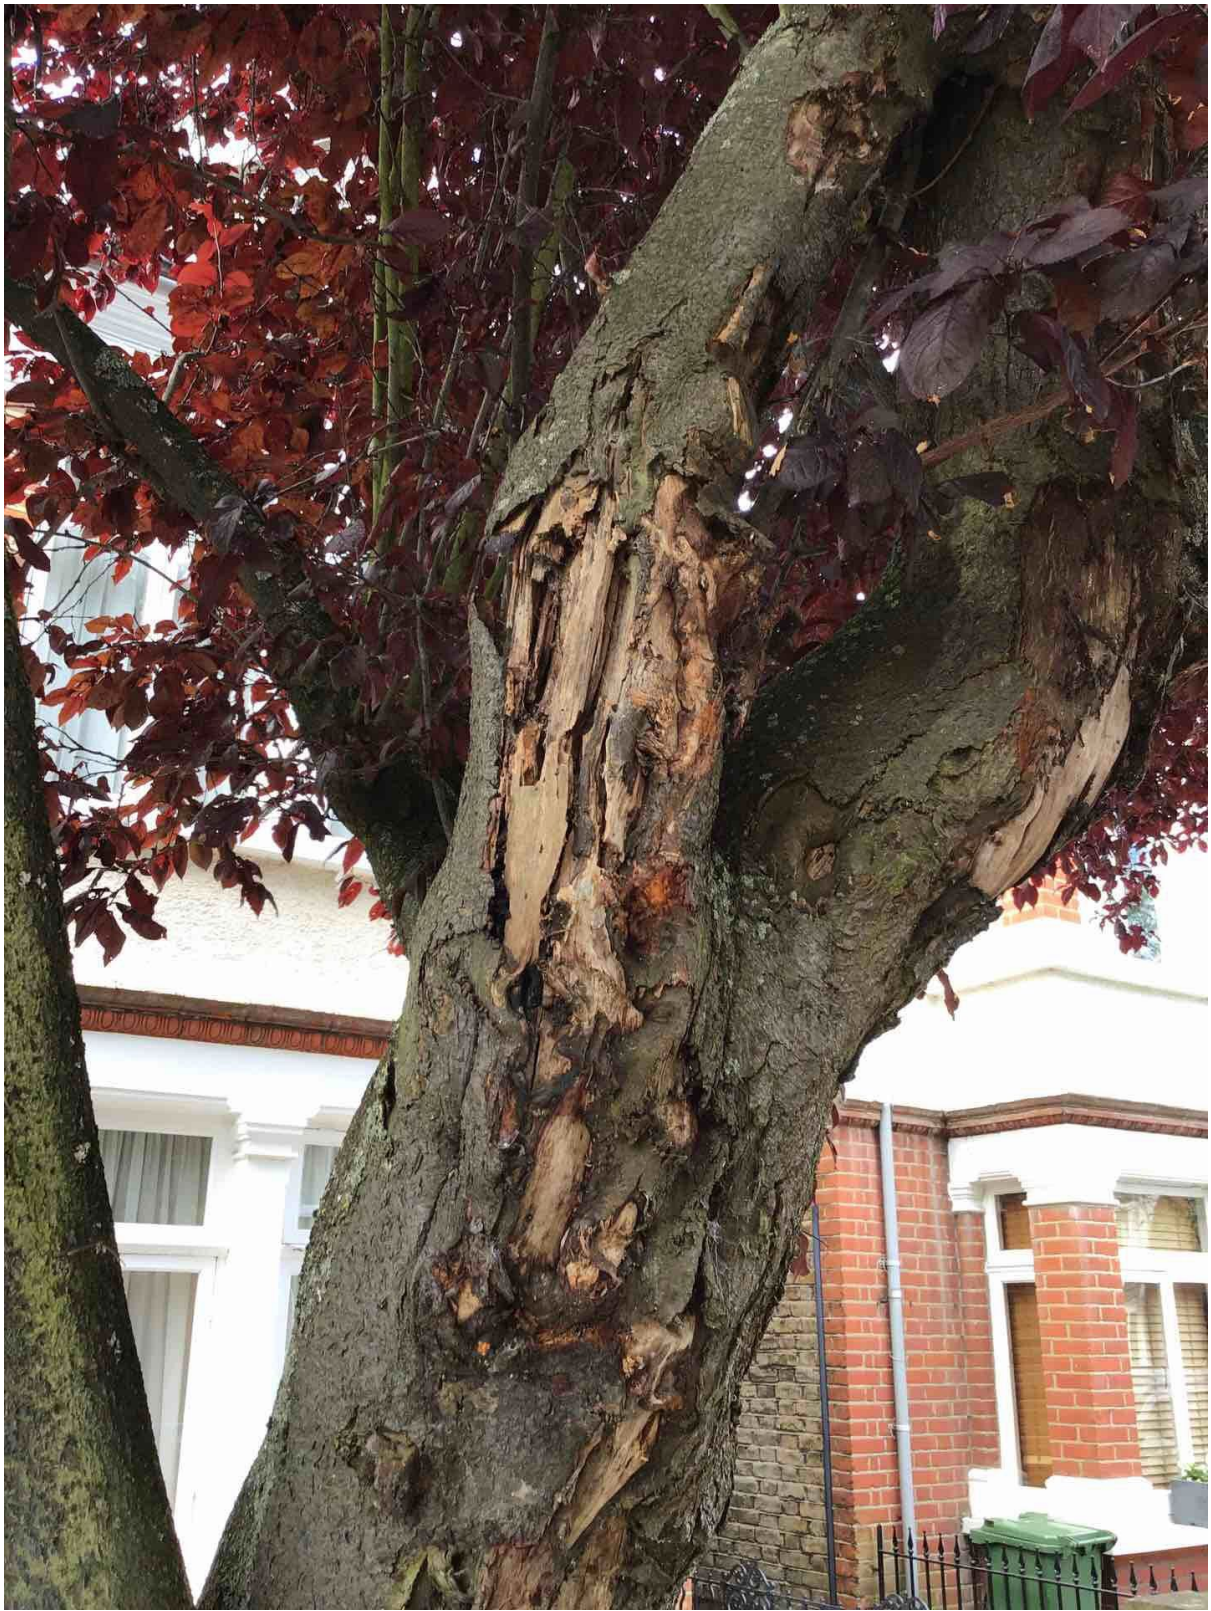
*Image shows damage to stem from vehicle strike.*

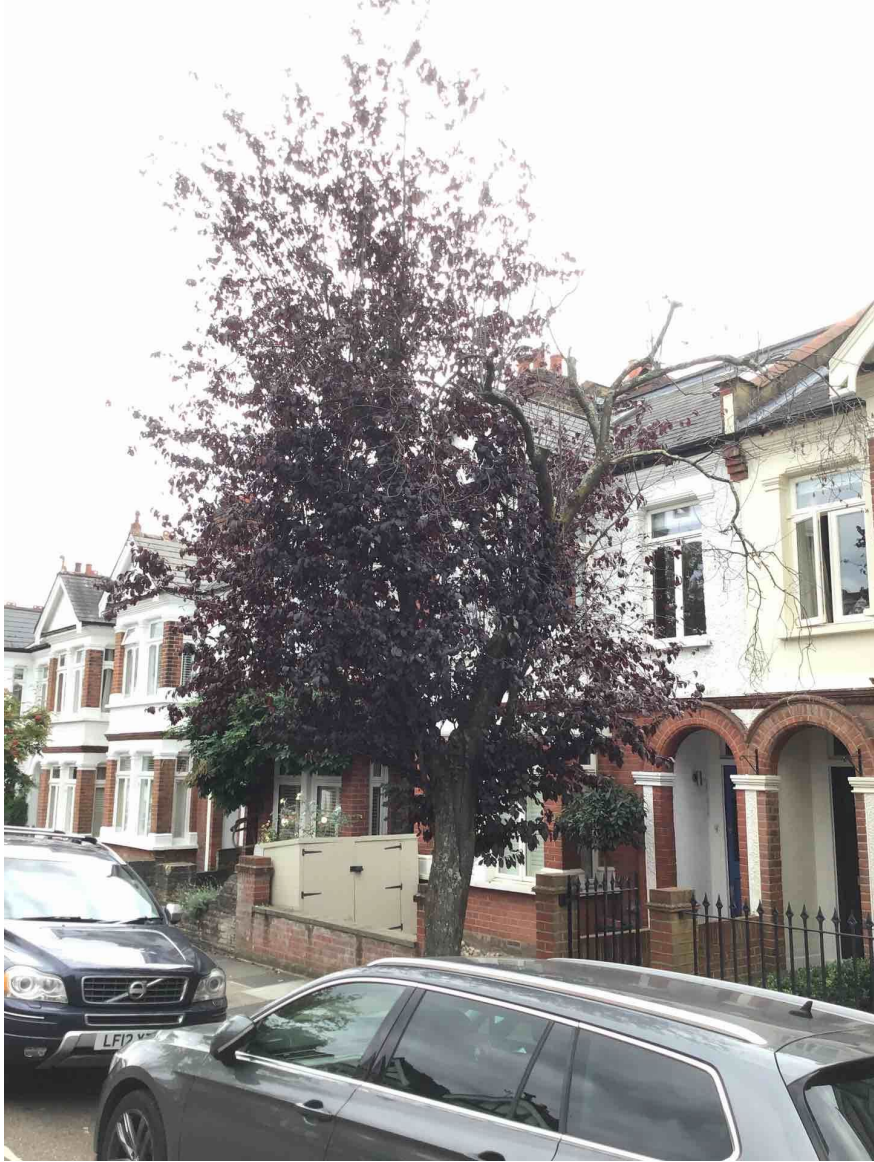
| Inspection findings | Fungal fruiting bodies of the cushion fungus ( <i>Phellinus pomaceus</i> ) are present on the main stem of this tree. This fungus causes a crumbly white rot that commonly causes this species of tree to snap. Approximately 50% of the crown is dead which corresponds with the decay at the base of the stem. Removal is required to prevent natural failure and to facilitate replanting. |

Image shows moribund tree in street scene

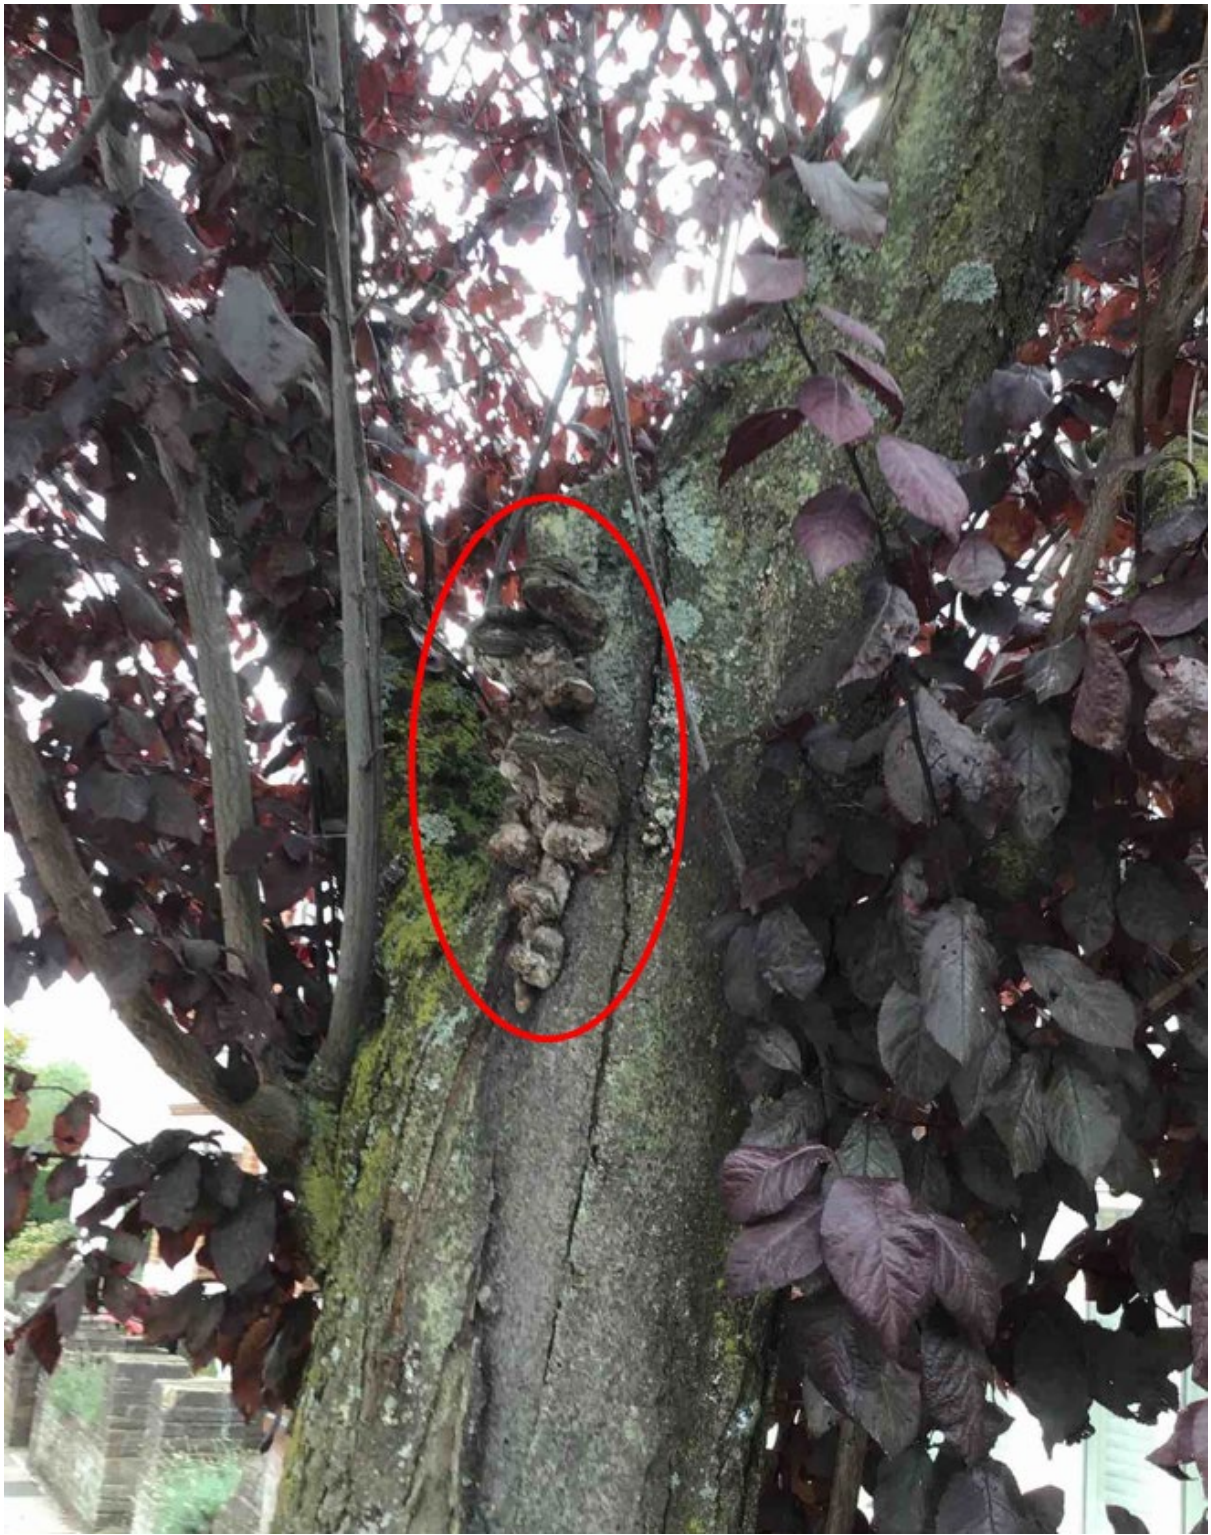
*Image shows fungal fruiting bodies circled in red*

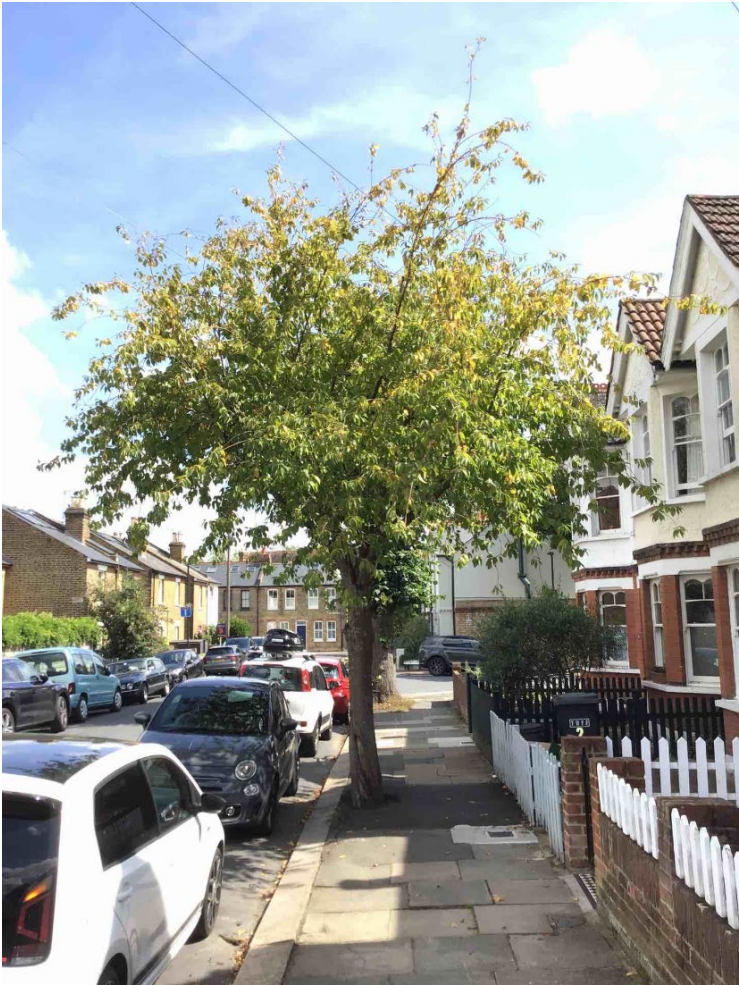
| Inspection findings | Fungal fruiting bodies of the wood decay fungus <i>Laetiporus sulphureus</i> are present at the base of this tree. This fungus causes a brown rot which can rapidly reduce wood strength and cause whole tree failure through brittle fracture. Investigation with probe revealed an unacceptable amount of decay around fruiting bodies. Removal is required to prevent natural failure and facilitate replanting. |

Image shows tree in street scene

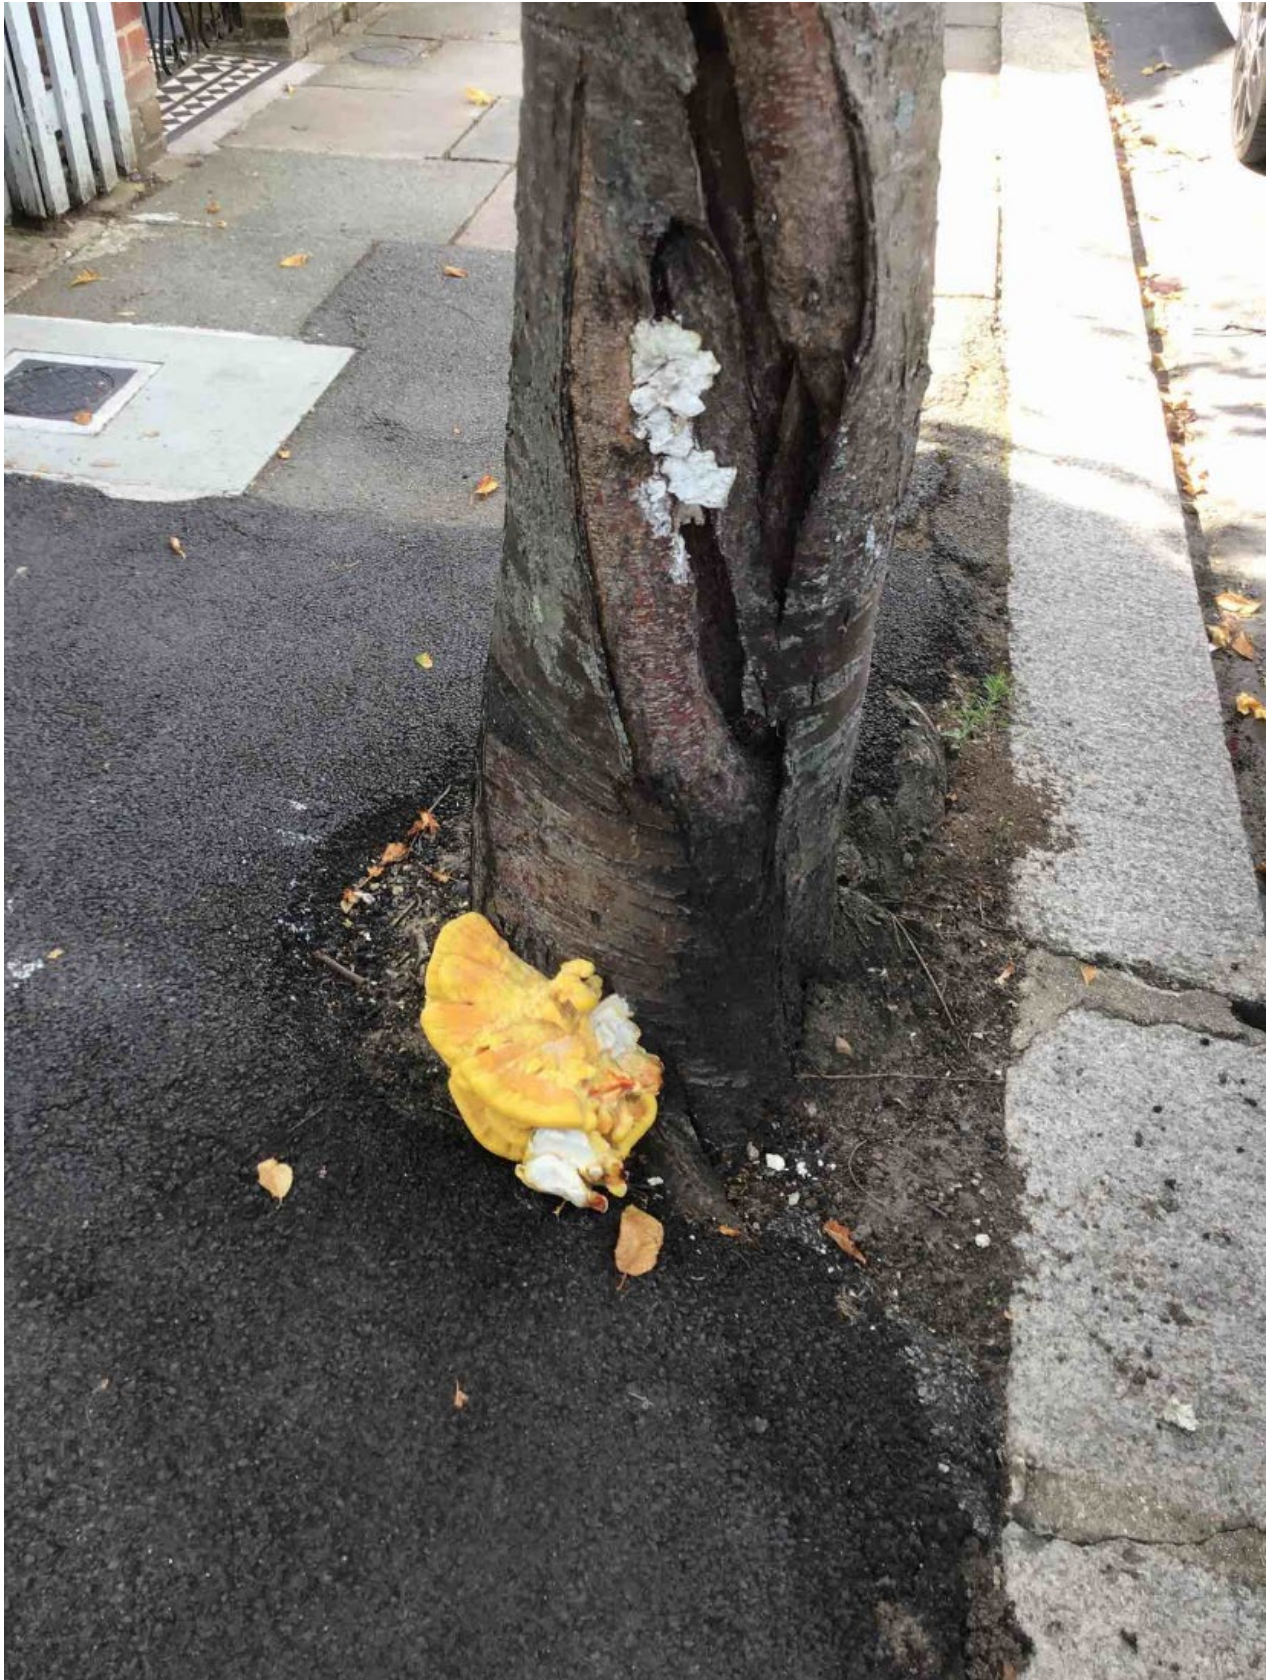
***Image shows fungal brackets at the base of the trunk.***

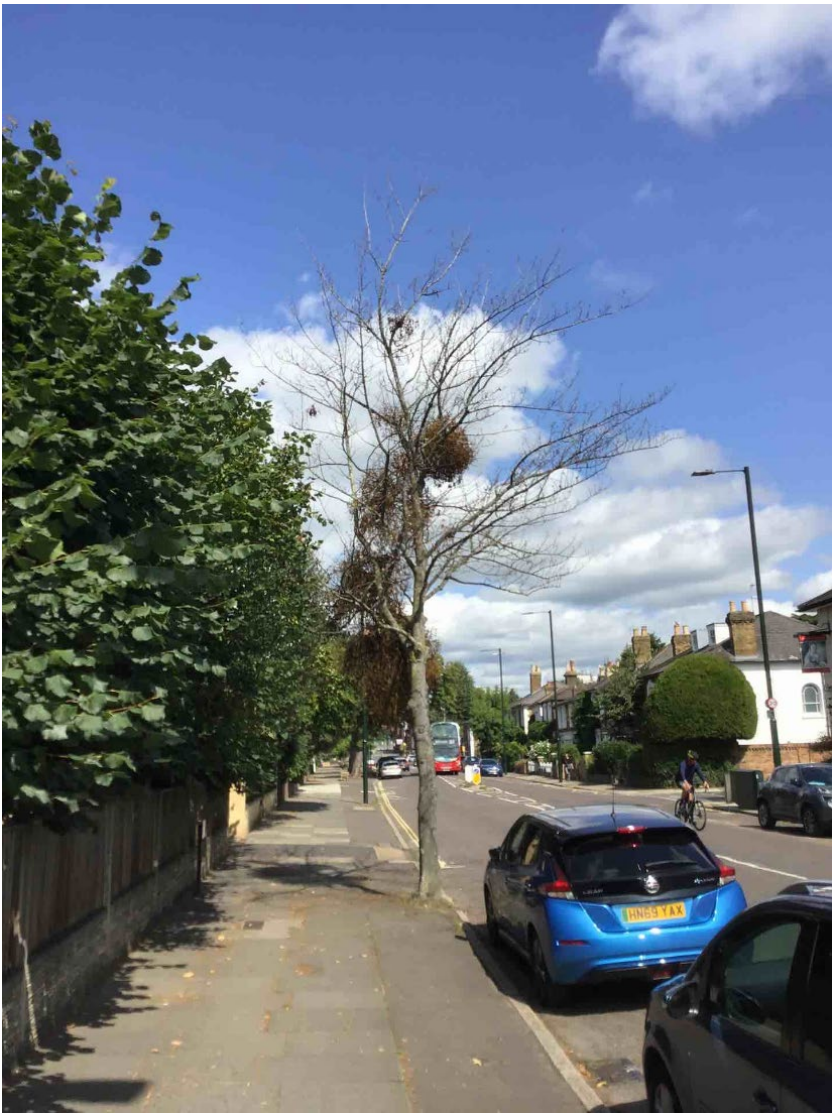
| Inspection findings | This tree is dead; removal is required to prevent natural failure and facilitate replanting |

Image shows dead tree in street scene

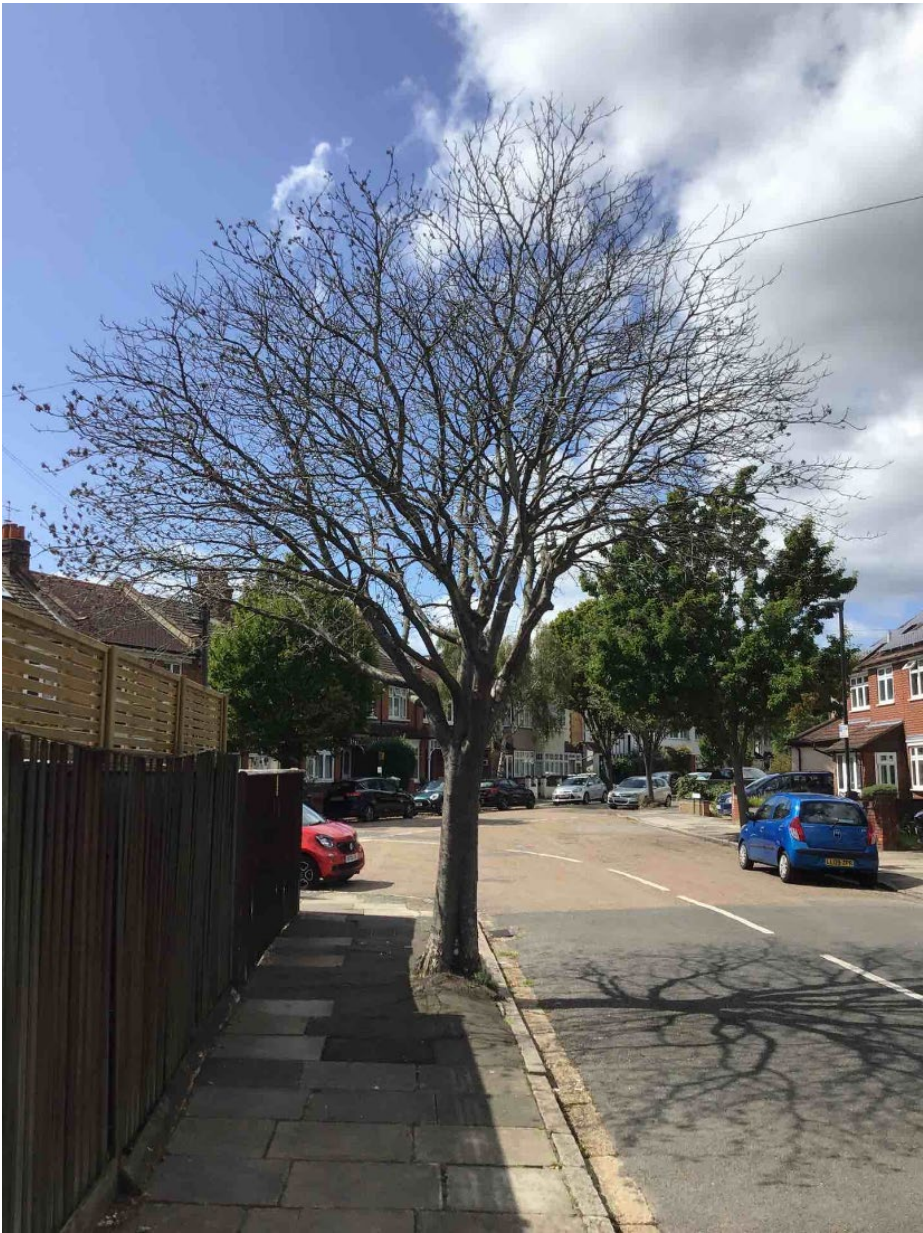
| Inspection findings | This tree is dead; removal is required to prevent natural failure and facilitate replanting |

Image shows dead tree in street scene

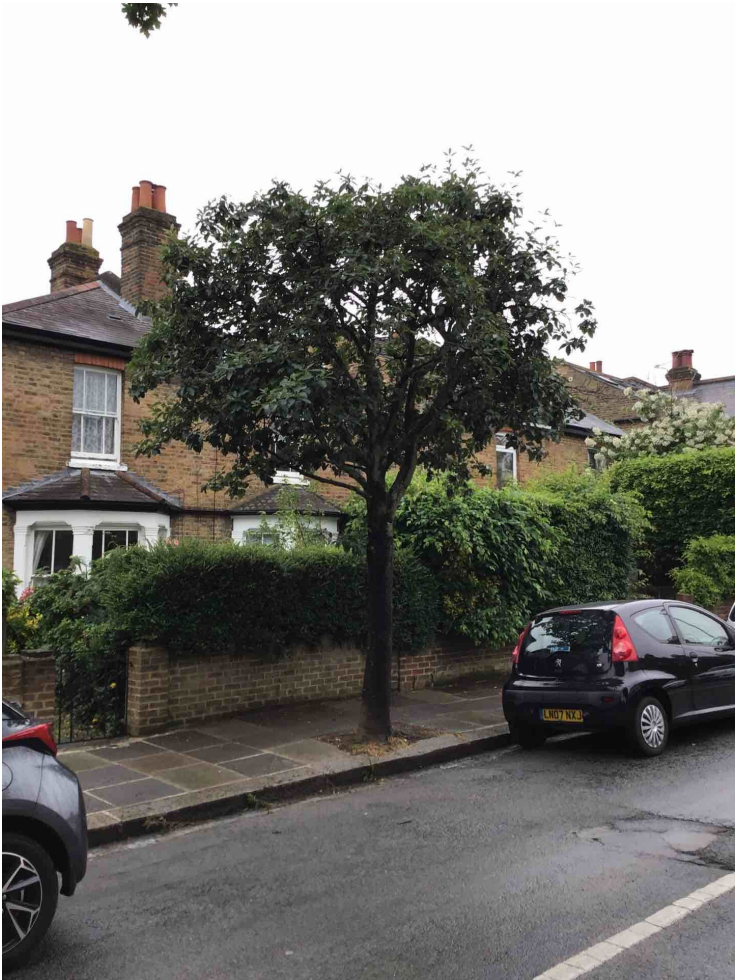
| Inspection findings | Fungal fruiting bodies of the species Shaggy Polypore ( <i>Inonotus hispidus</i> ) are present on the main stem, this fungus causes a simultaneous white rot which can cause snapping of tree parts in this species. This tree is in a state of physiological decline and contains weak branches that are liable to collapse which correlates with the presence of this pathogen. Removal is required to prevent natural failure and facilitate replanting |

Image shows tree in street scene
