# October 2023 - Reactive Tree Works Programme

## Introduction

Dated 16.10.2023

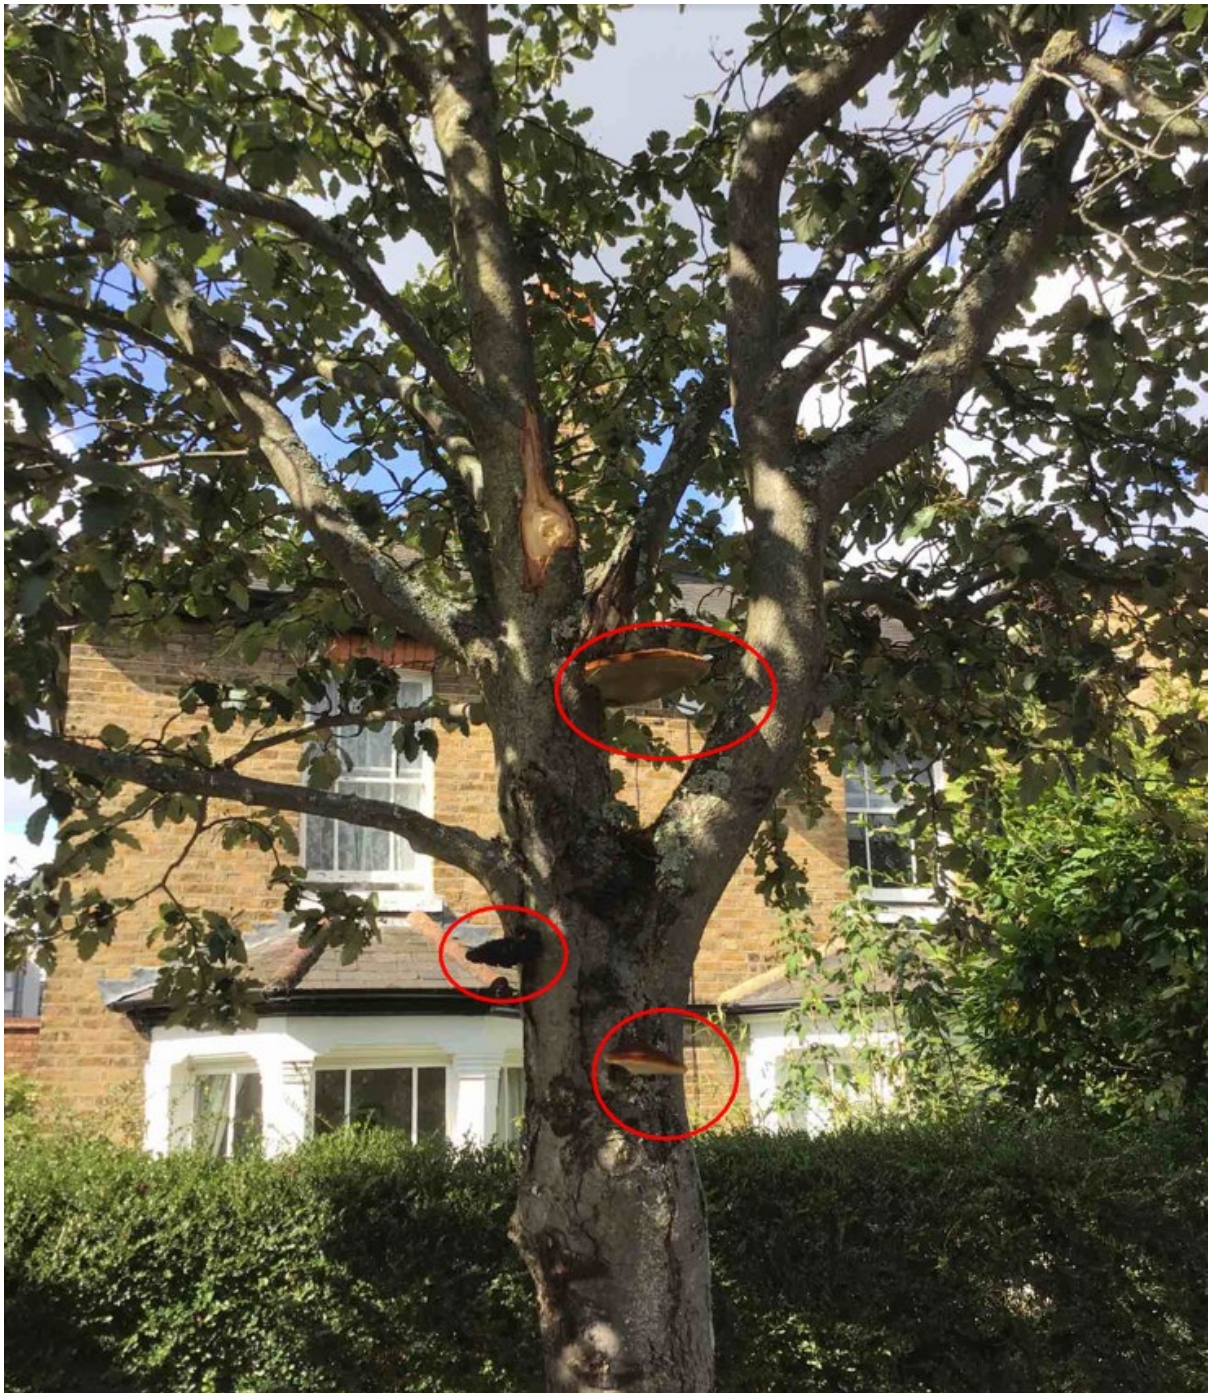
***Image shows fungal fruiting bodies circled in red.***

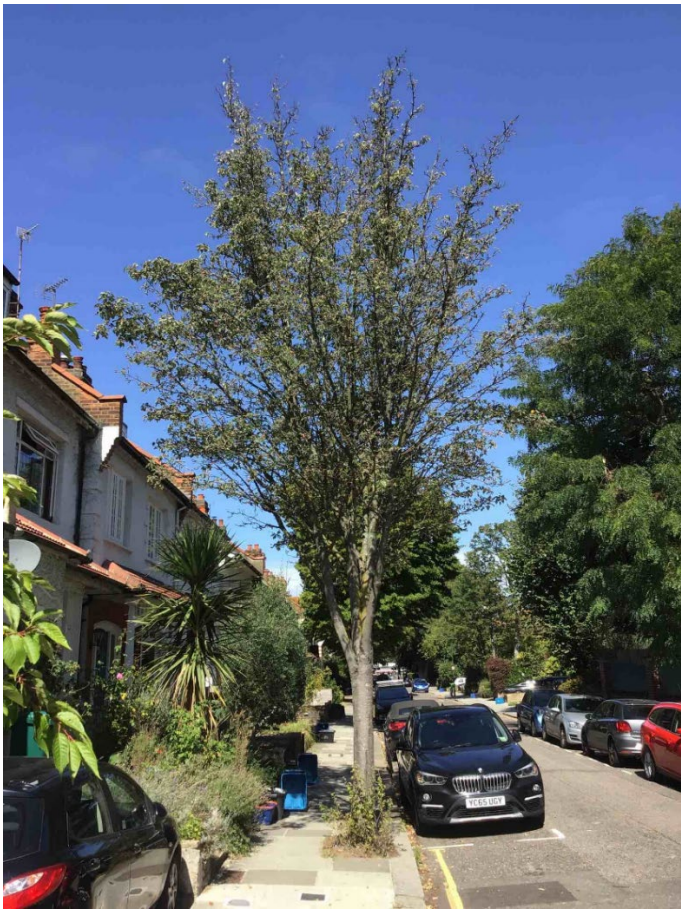
| Inspection findings | A fungal fruiting body of the decay pathogen <i>Ganoderma</i> sp. is present at the stem base. Colonisation by this fungus causes a white rot of the stem and root system that can cause entire trees to collapse through fracture or windthrow. This tree is in a state of physiological decline with sparse foliage which correlates with the pathogen present at the base of the stem. This tree is no longer suitable for retention and removal is required to prevent natural failure and facilitate replanting. |

Image shows tree in street scene

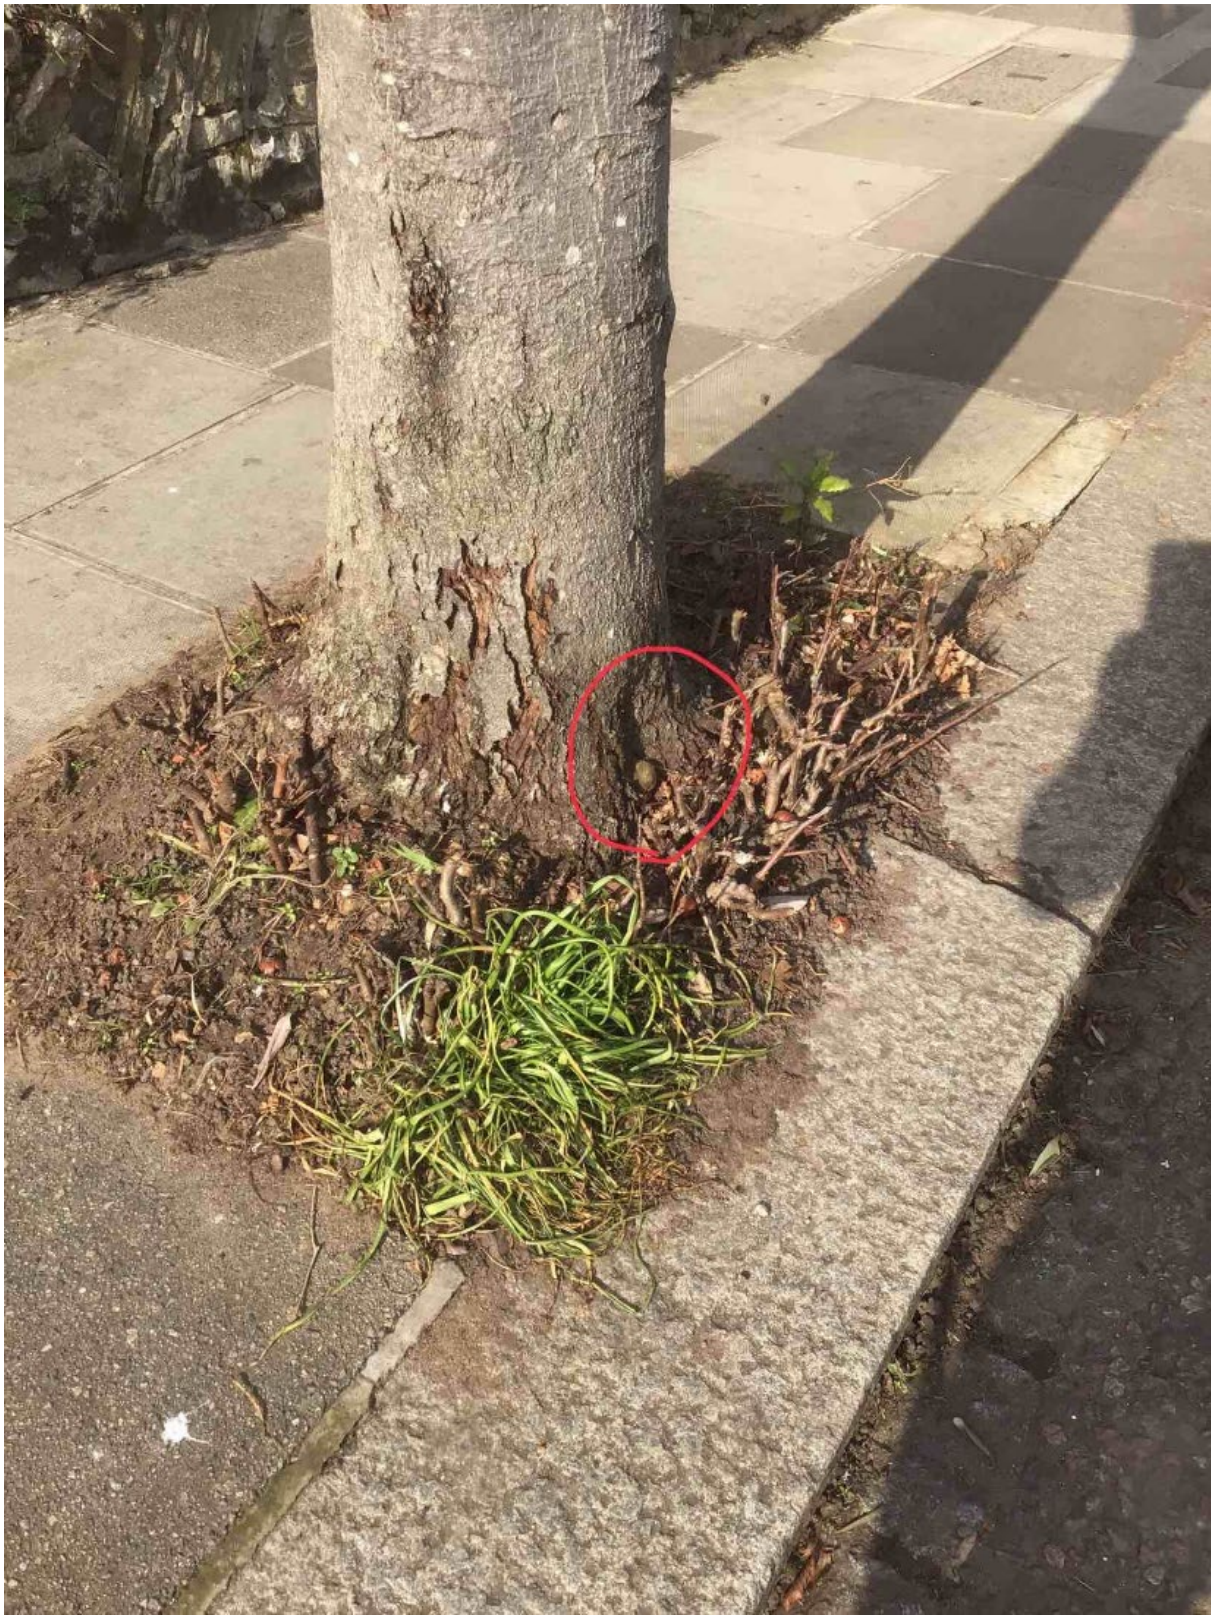
***Image shows fungal fruiting body circled in red***

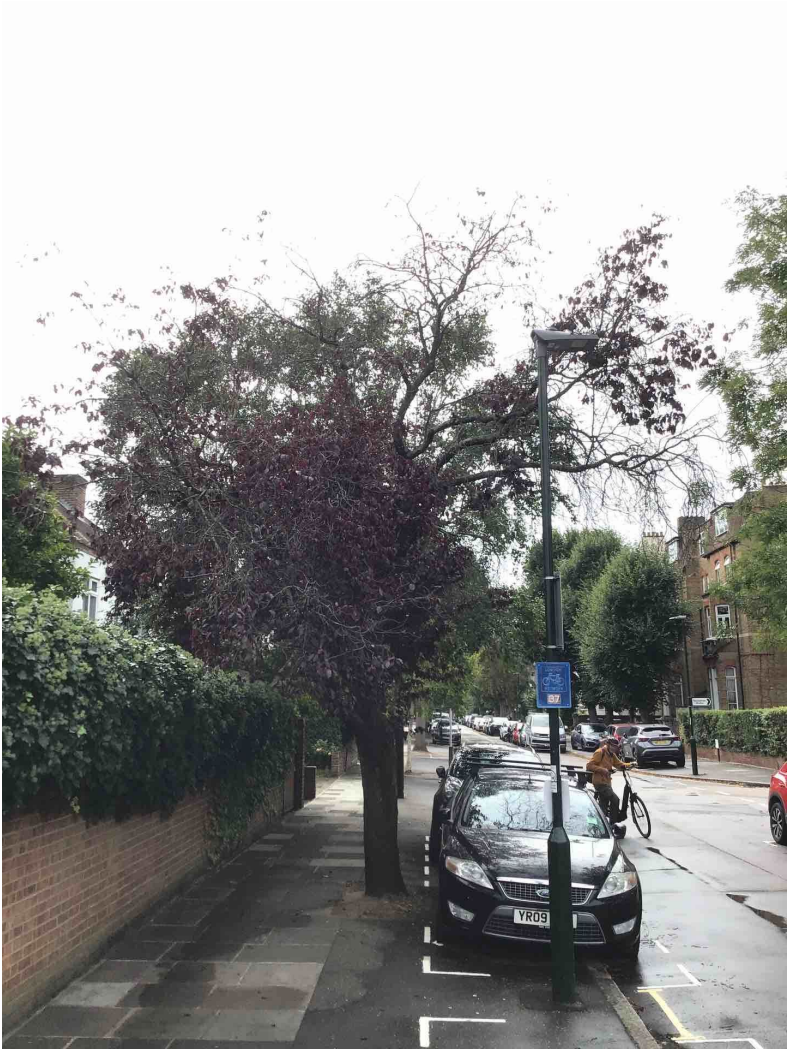
| Inspection findings | Fruiting bodies of the decay fungus Turkey Tail ( <i>Tramates versicolor</i> ) are prolific on the trunk of this tree. This fungus causes a selective white rot of the wood and when prolific is indicative of wider physiological dysfunction. This tree is in a state of physiological decline with over 50% of the crown having died which correlates with the pathogen on the trunk. Removal is required to prevent natural failure and facilitate replanting. |

Image shows moribund tree in street scene

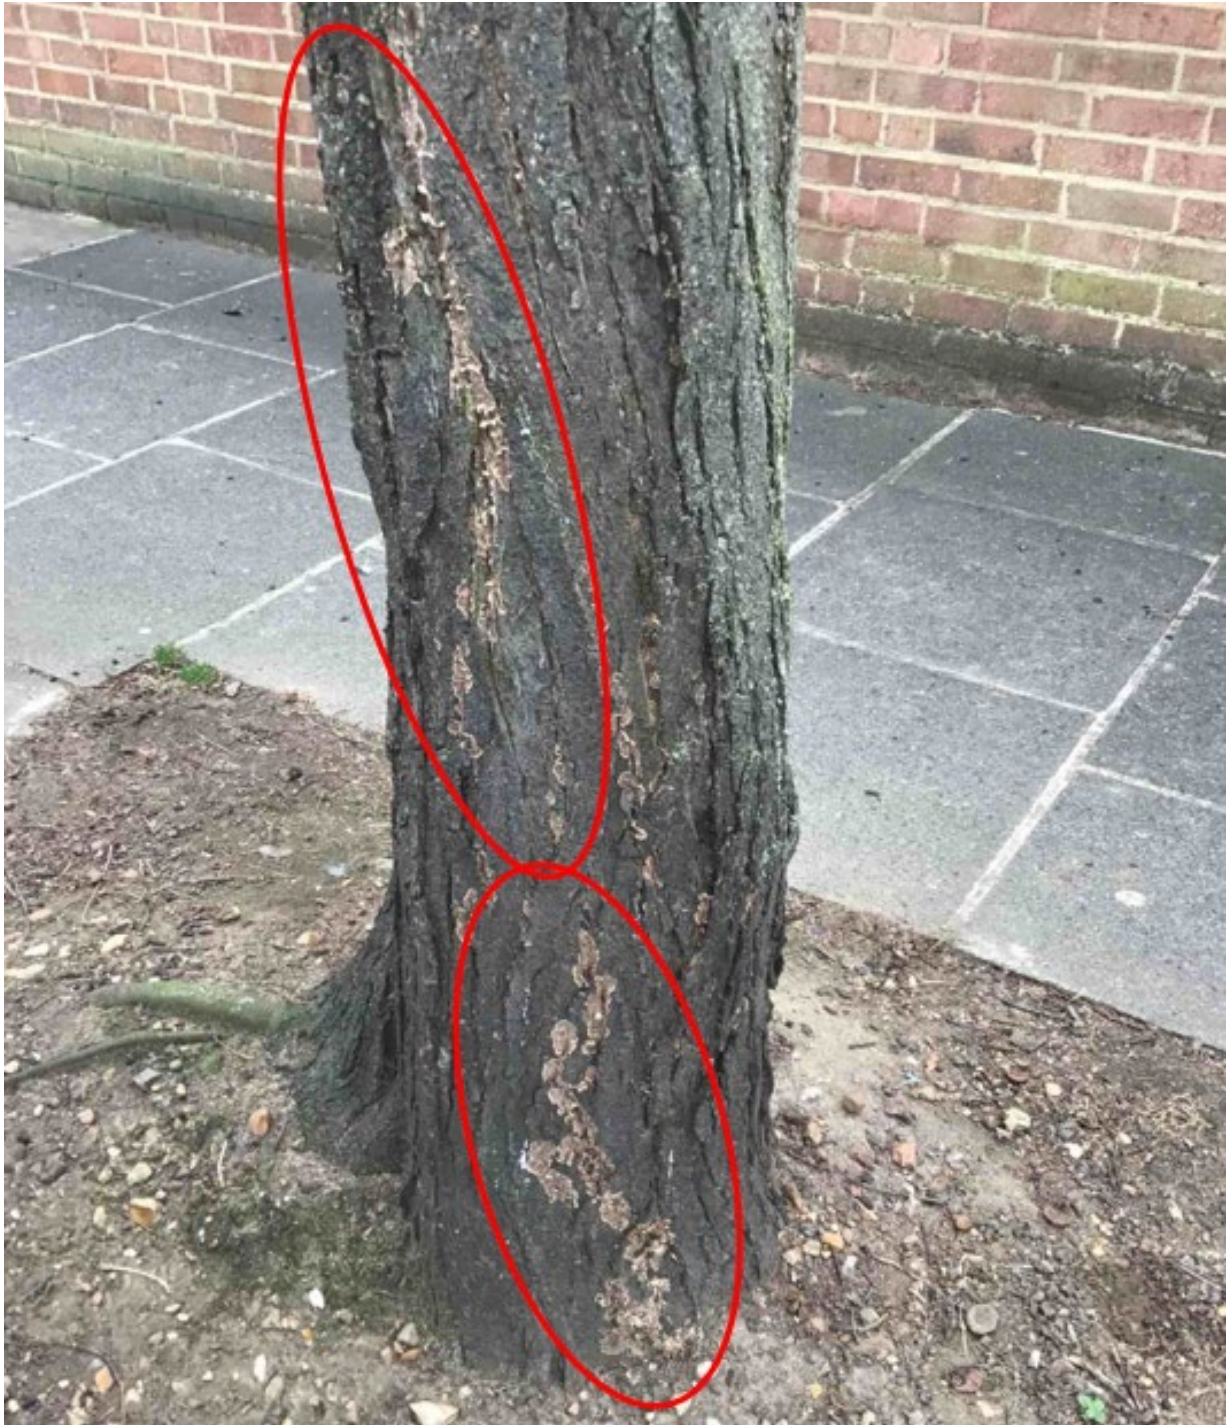
***Image shows fruiting bodies on stem of tree circled in red***

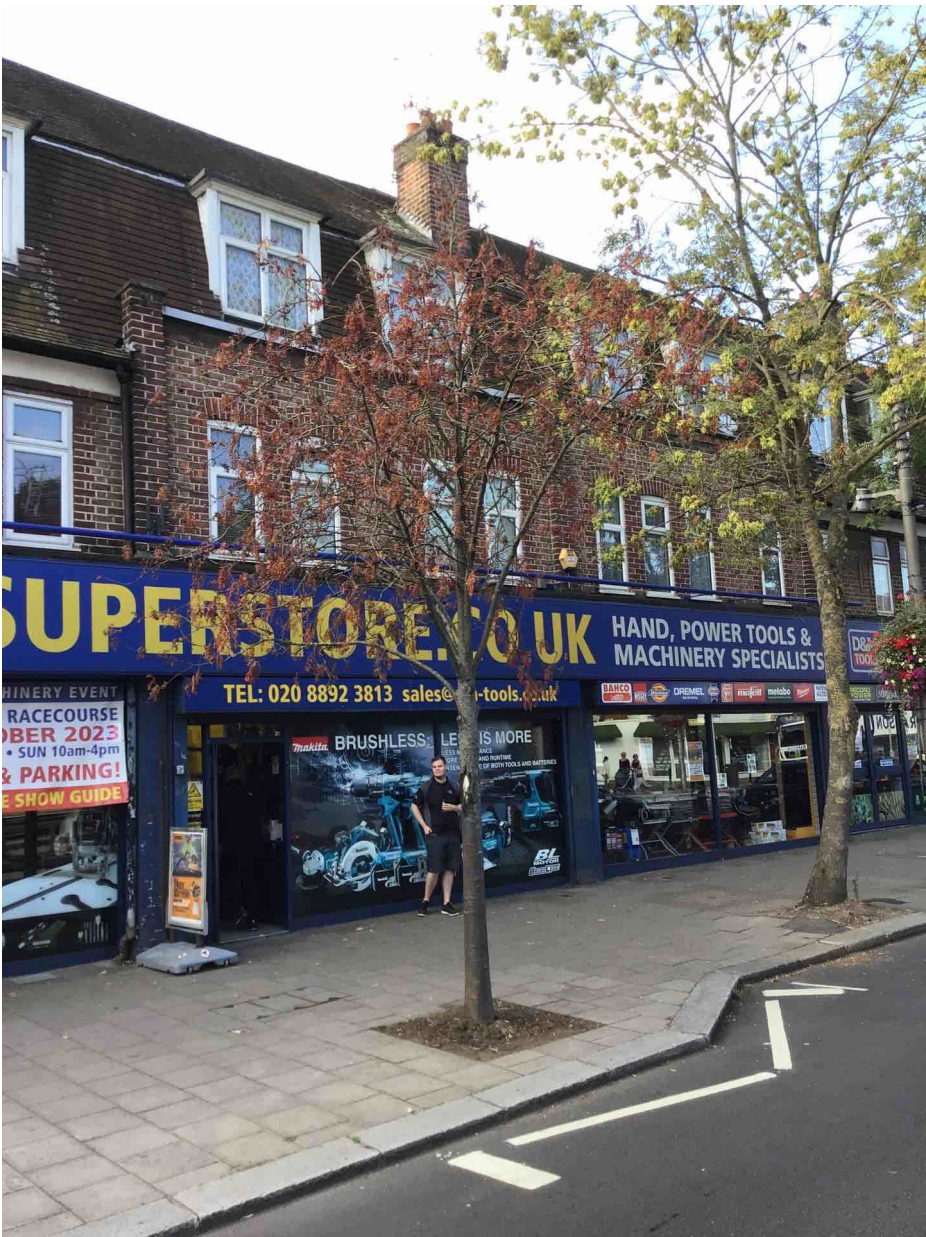
| Inspection findings | This tree dead and is no longer suitable for retention. Removal is required to prevent natural failure and facilitate replanting. |

Image shows dead tree in street scene

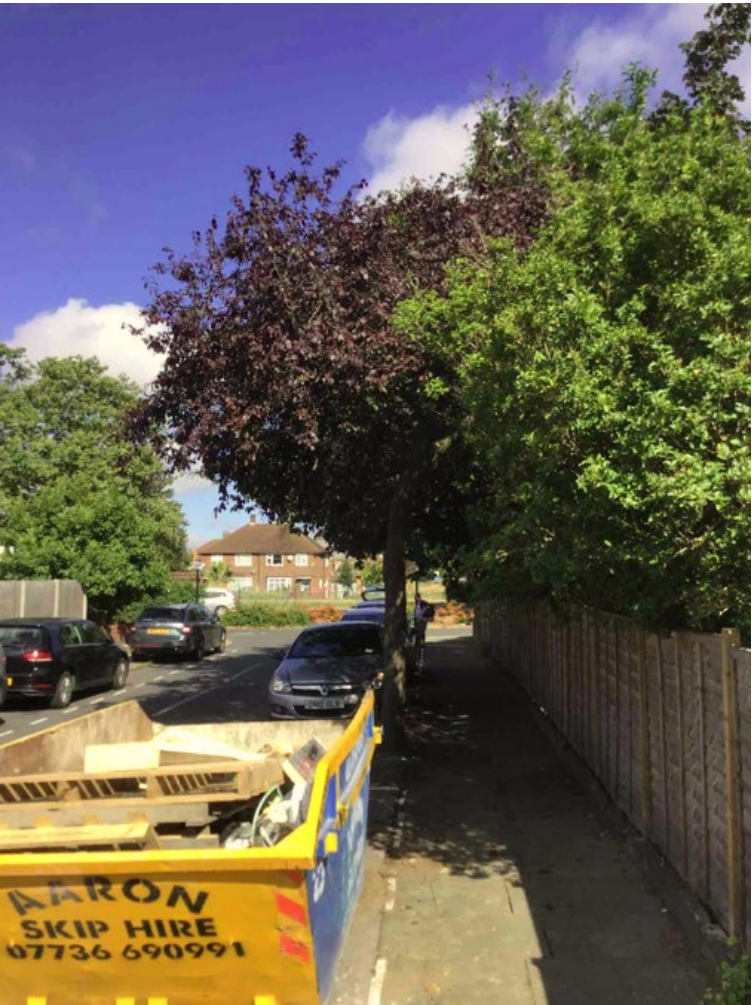
| Inspection findings | Fungal fruiting bodies of the wood decay fungus <i>Laetiporus sulphureus</i> are present on the trunk of this tree. This fungus causes a brown rot which can rapidly reduce wood strength and cause branch or whole tree failure through brittle fracture. The tree presents an unacceptable risk of failure and removal is required to prevent natural failure and facilitate replanting. |

Image shows tree in street scene

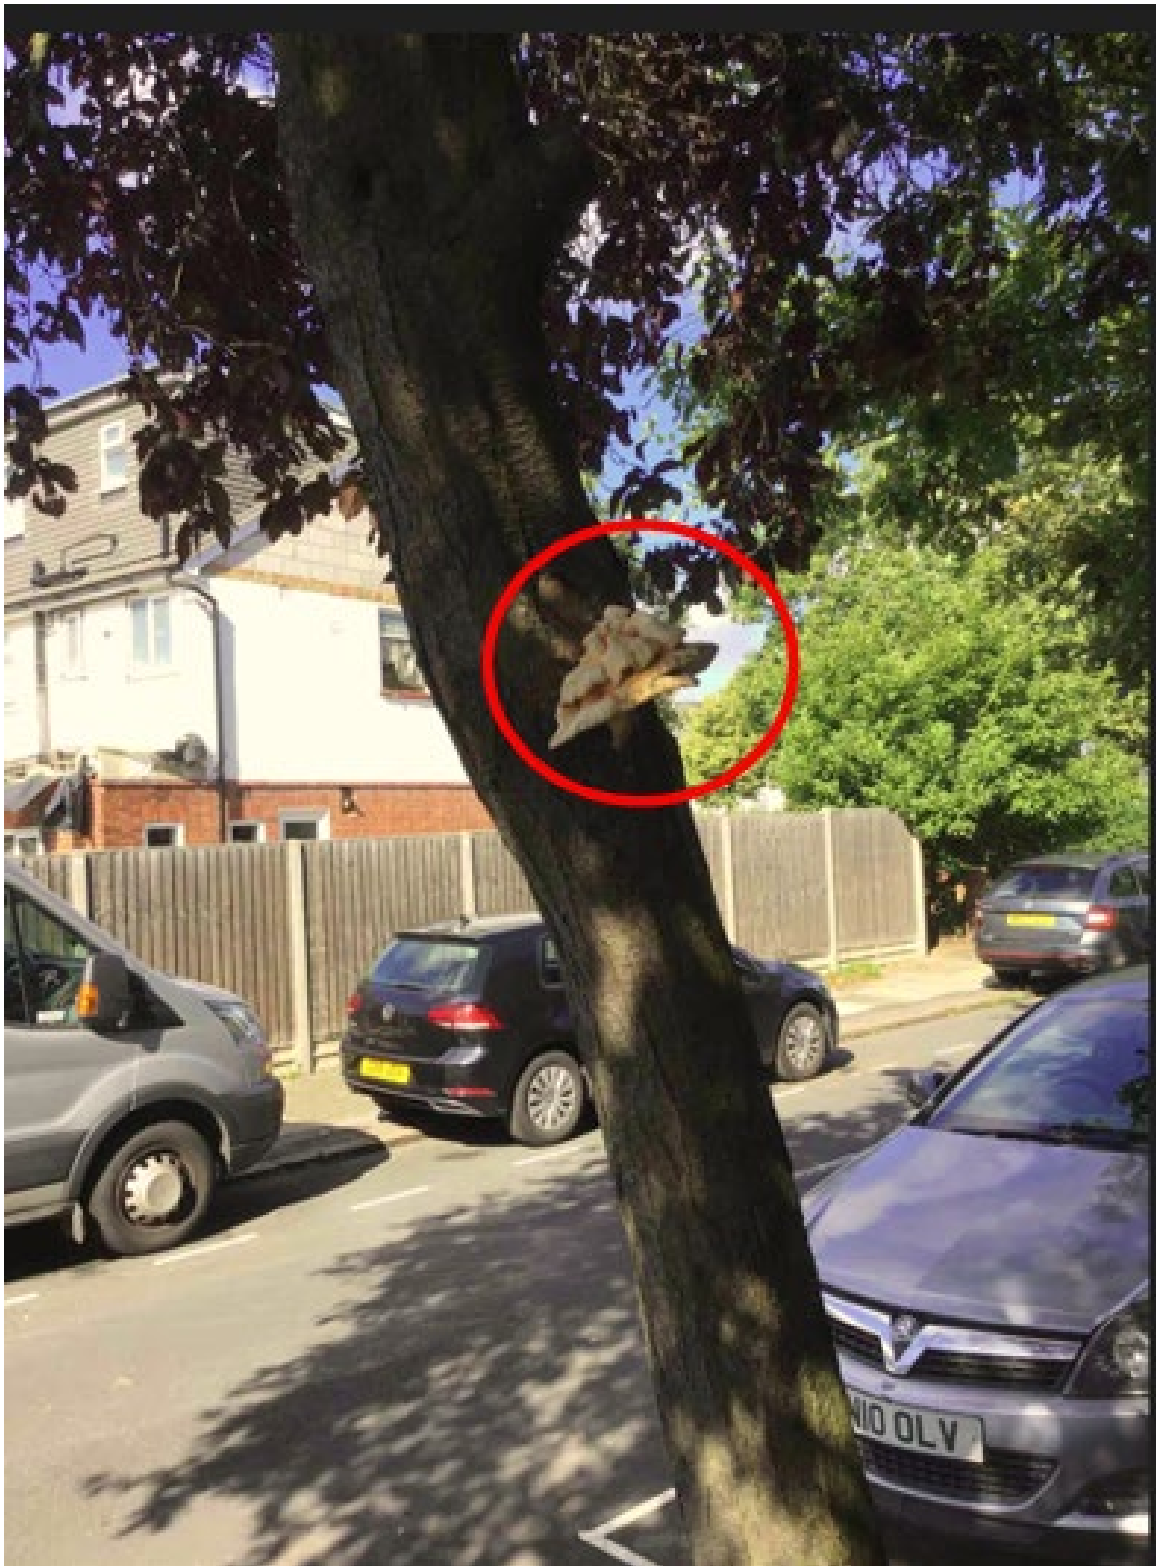
*Images showing tree with fungal fruiting body on stem circled in red*

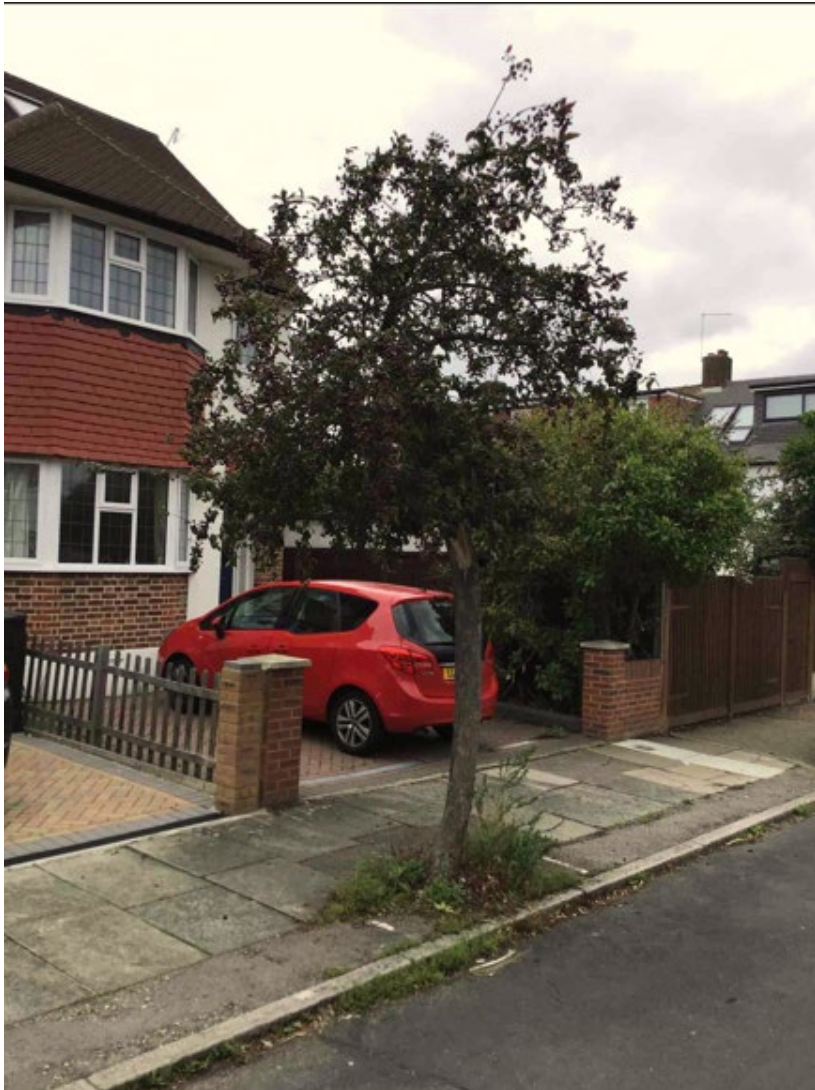
| Inspection findings | A fungal fruiting body of the species Shaggy Polypore ( <i>Inonotus hispidus</i> ) is present on the main stem or trunk. This fungus causes a simultaneous white rot which can cause snapping of tree parts in this species. The proximity of the fungus to the major cavity makes the risk of failure unacceptable. Removal is required to prevent natural failure and facilitate replanting. |

Image shows tree in street scene

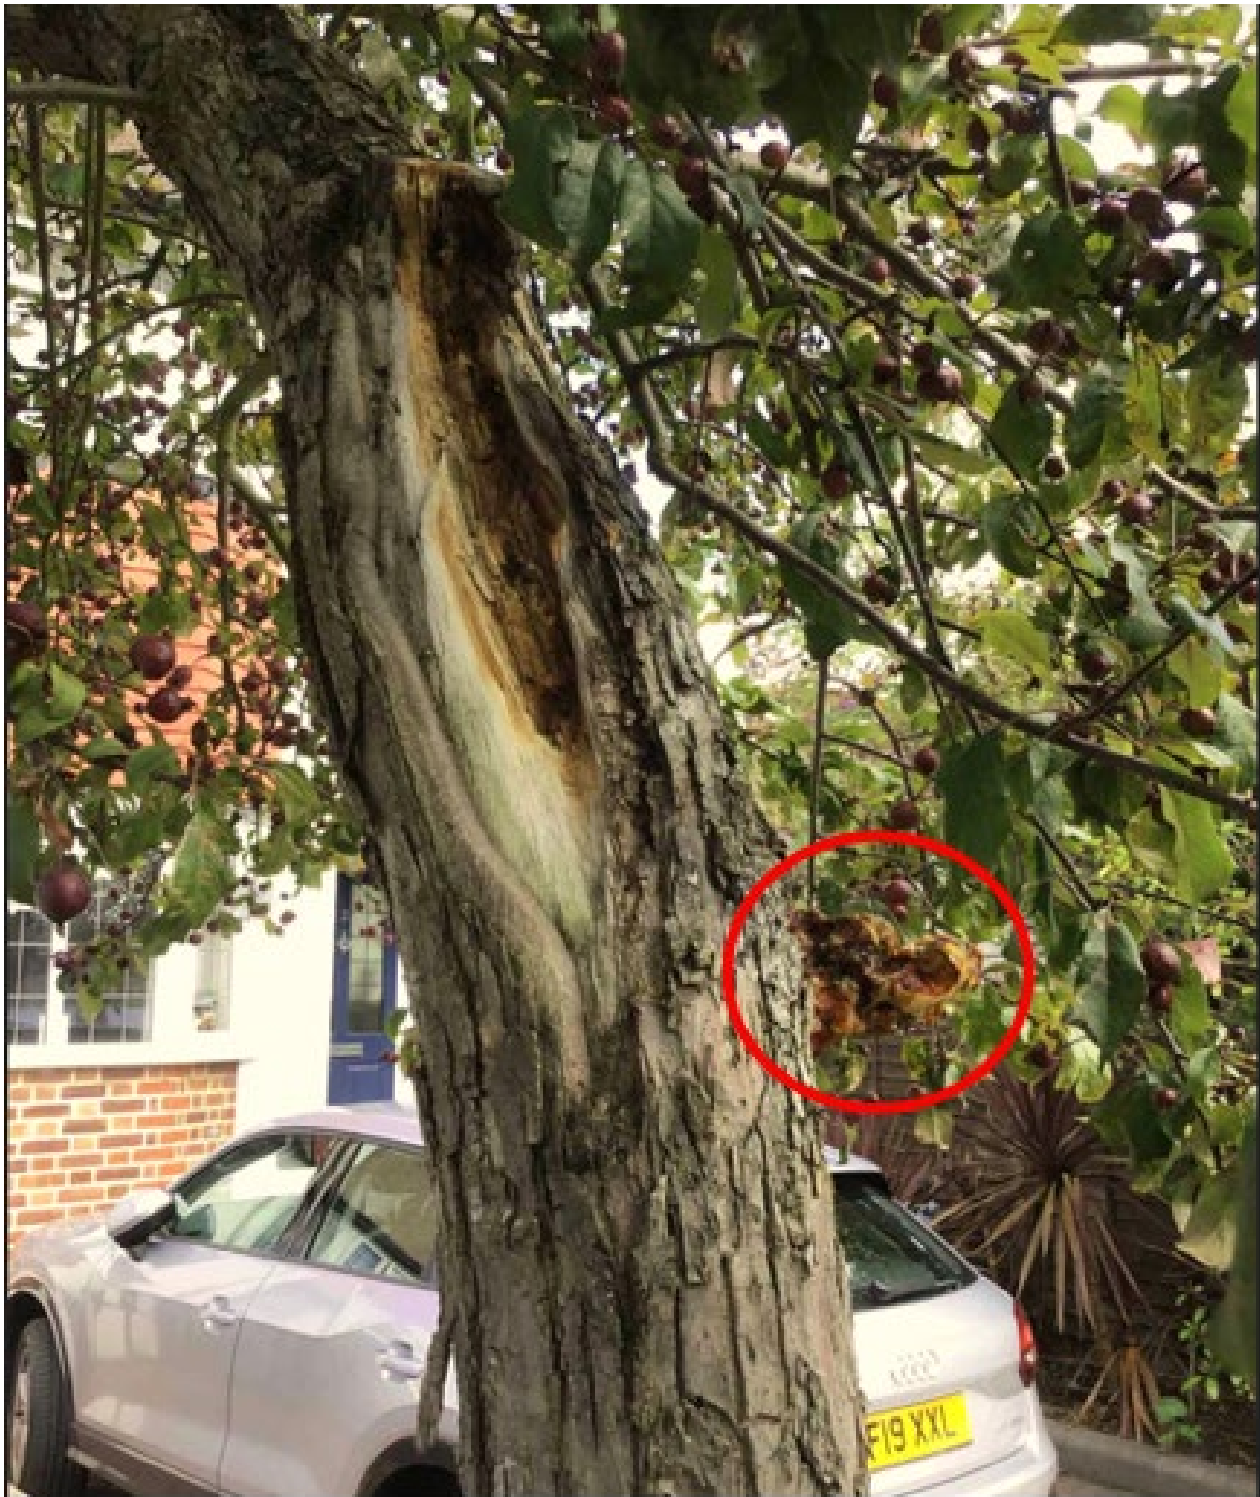
*Images shows bark wound with fungal fruiting body below it marked with red circle*

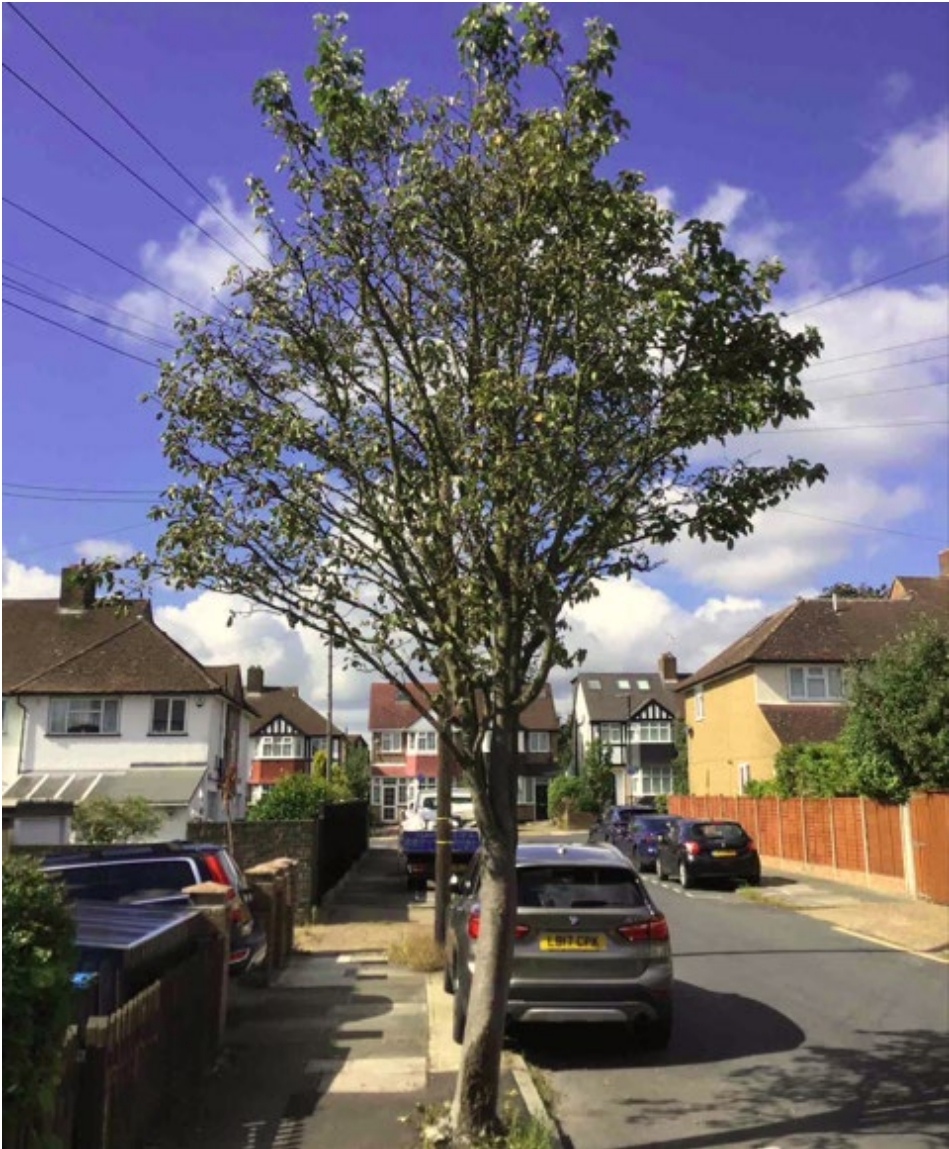
| Inspection findings | The tree has extensive basal decay and a fungal fruiting body of the decay pathogen <i>Ganoderma</i> sp. is present at the stem base. Colonisation by this fungus causes a white rot of the stem and root system that can cause entire trees to collapse through fracture or windthrow. Removal is required to prevent natural failure and facilitate replanting. |

Image shows tree in street scene

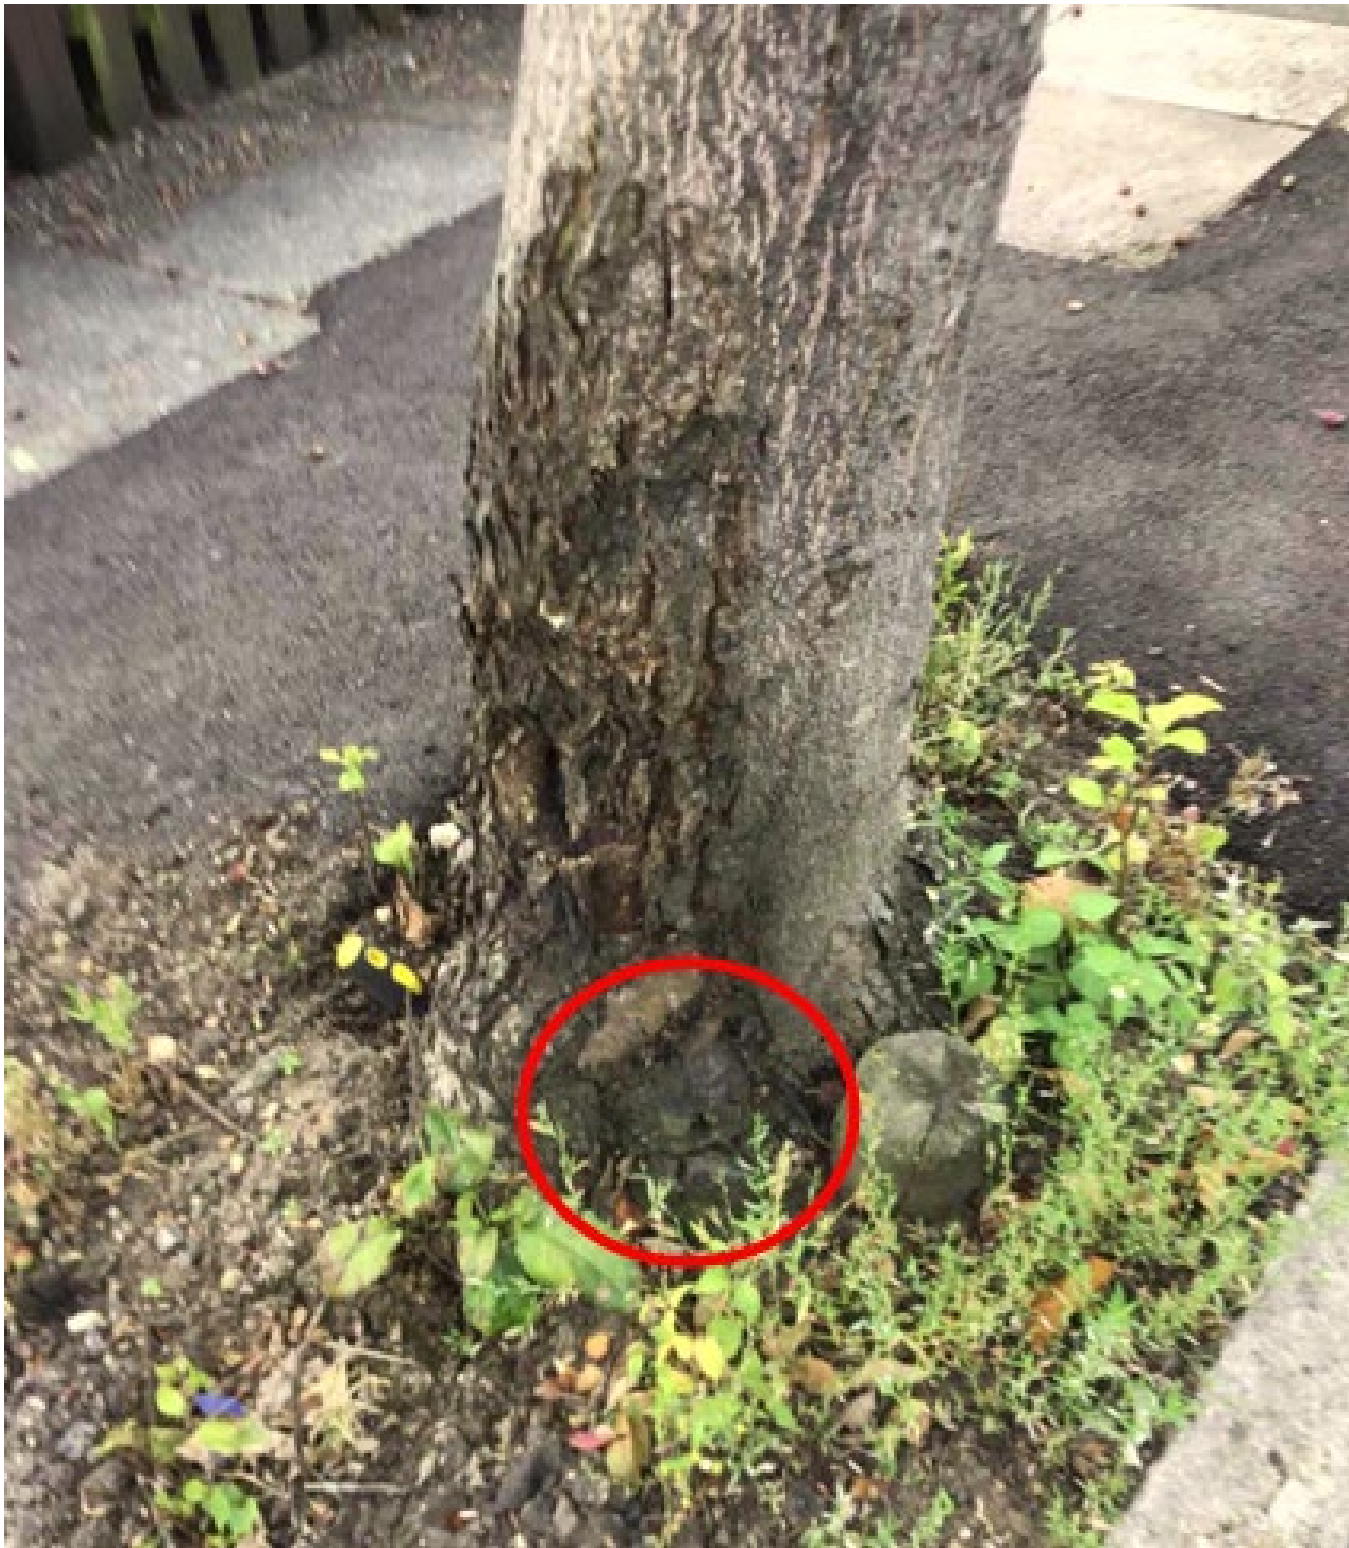
*Images shows base wound with Ganoderma bracket marked with red circle*

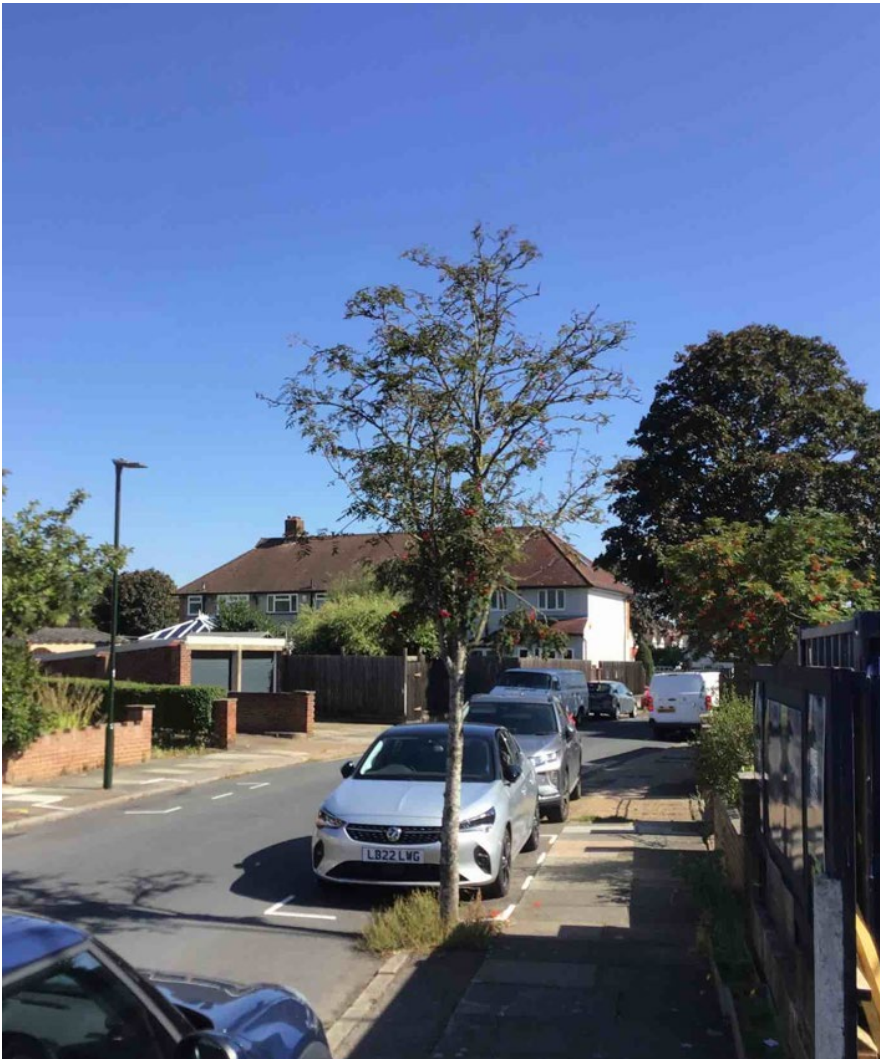
| Inspection findings | A fungal fruiting body of the species Shaggy Polypore ( <i>Inonotus hispidus</i> ) is present on the main stem or trunk, this fungus causes a simultaneous white rot which can cause snapping of tree parts in this species. This tree is in a state of physiological decline with over 60% of the crown having died which correlates with the pathogen on the trunk. Removal is required to prevent natural failure and facilitate replanting. |

Image shows moribund tree in street scene

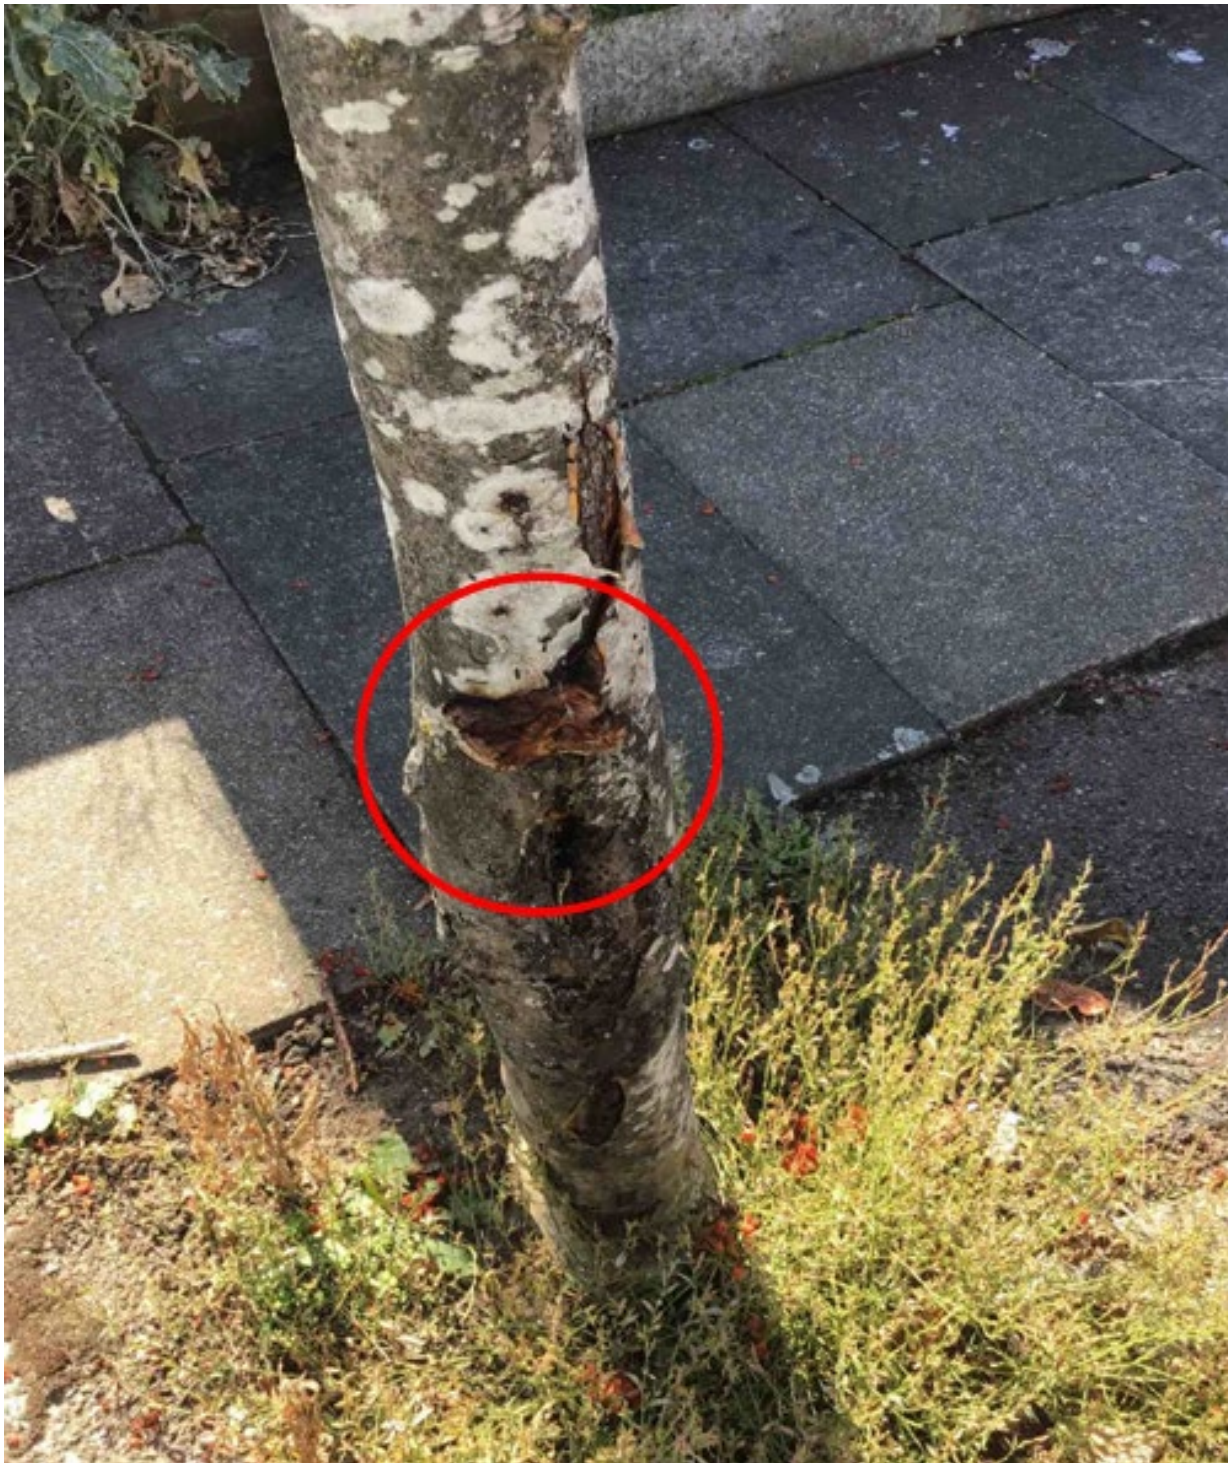
***Image shows wound on trunk of tree with fungal fruiting body circled in red***

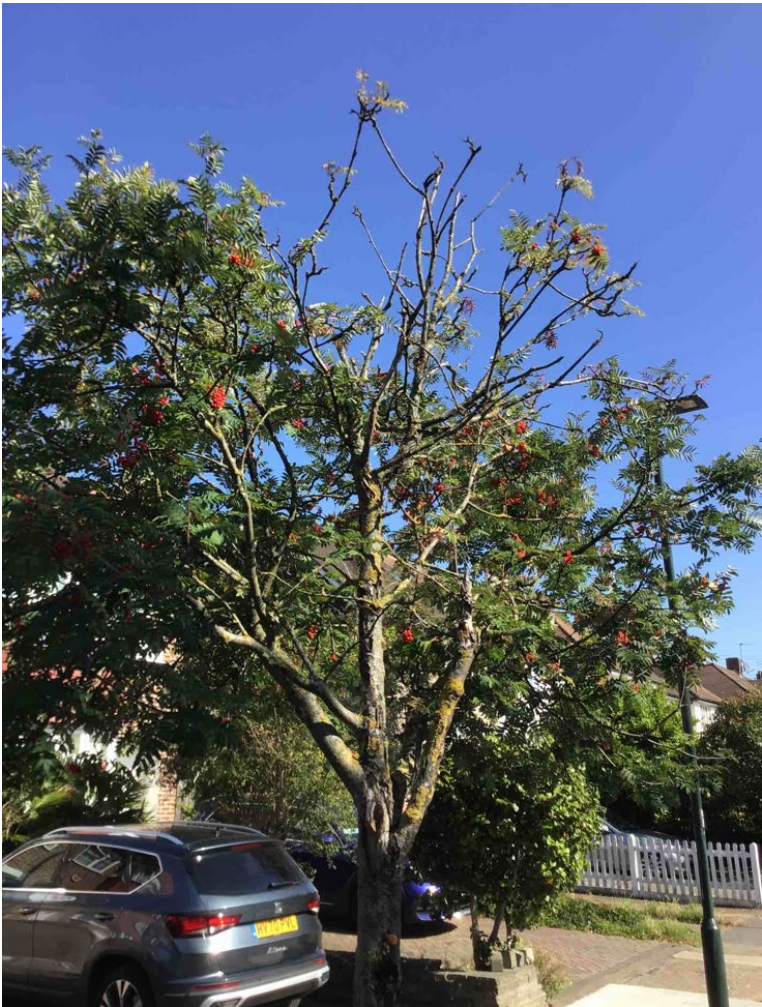
| Inspection findings | A fungal fruiting body of the species Shaggy Polypore ( <i>Inonotus hispidus</i> ) is present on the main stem or trunk, this fungus causes a simultaneous white rot which can cause snapping of tree parts in this species. This tree is in a state of physiological decline with over 70% of the crown having died which correlates with the pathogen on the trunk. Removal is required to prevent natural failure and facilitate replanting. |

Image shows moribund tree in street scene

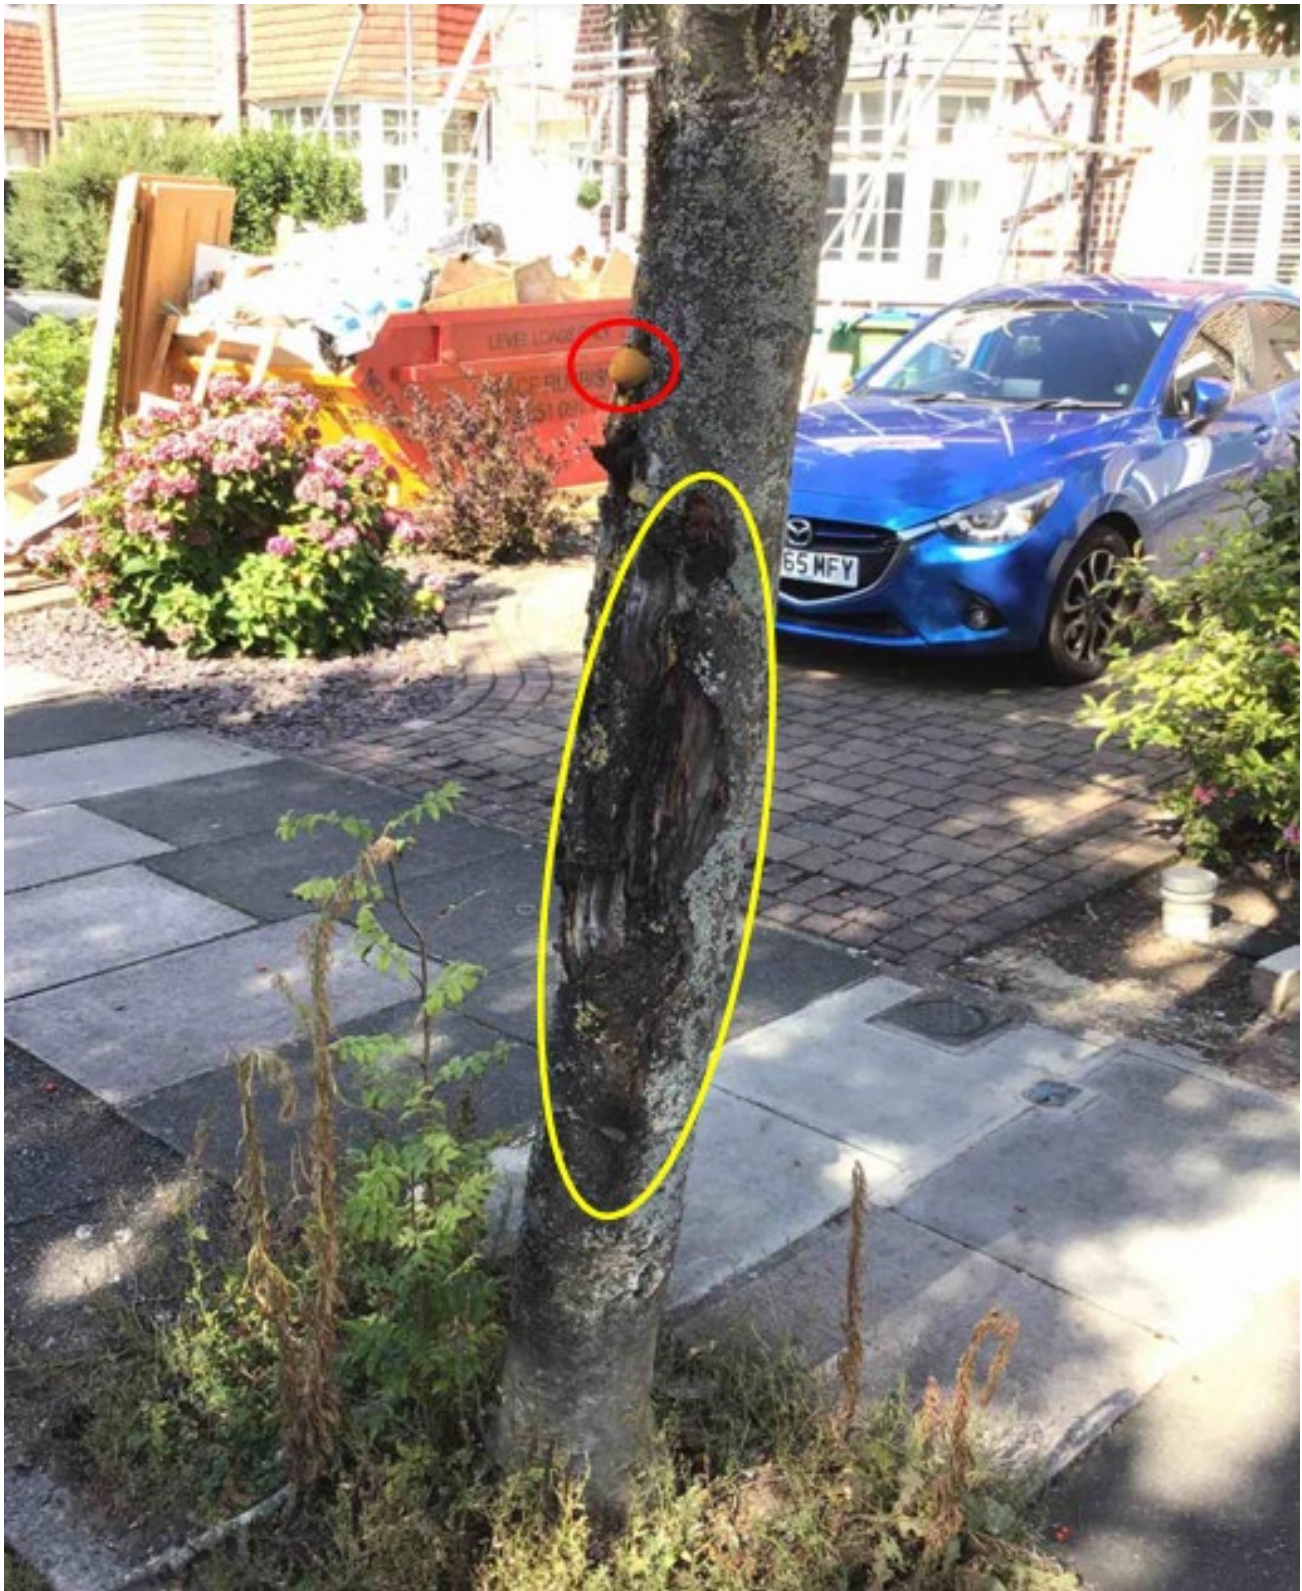
***Image shows trunk of tree with cavities circled in yellow and fruiting body circled in red***
