# October 2023 - Reactive Tree Works Programme

## Introduction

Dated 16.10.2023

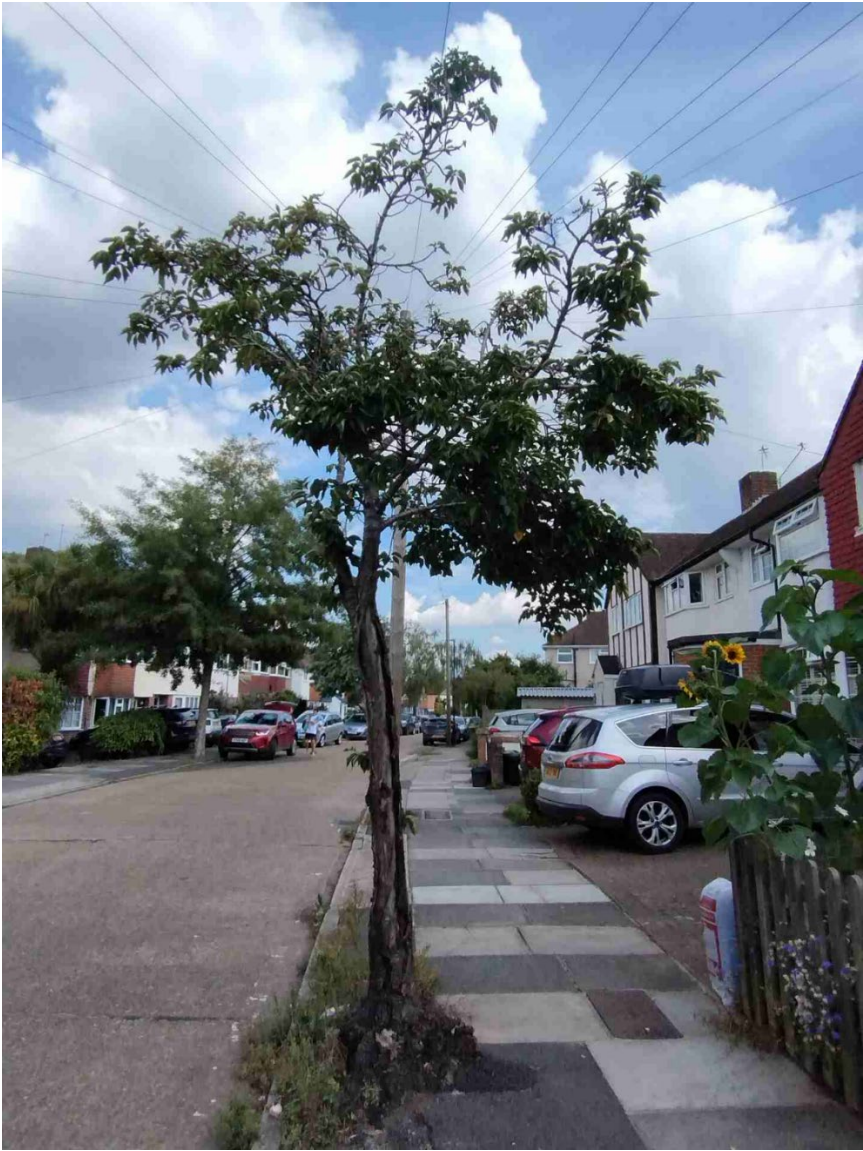
| Inspection findings | Cankering and bark necrosis is present on the stem of this tree indicating dysfunction of the vascular system. The tree presents an unacceptable risk and removal is required to prevent natural failure and facilitate replanting. |

Image shows tree in street scene

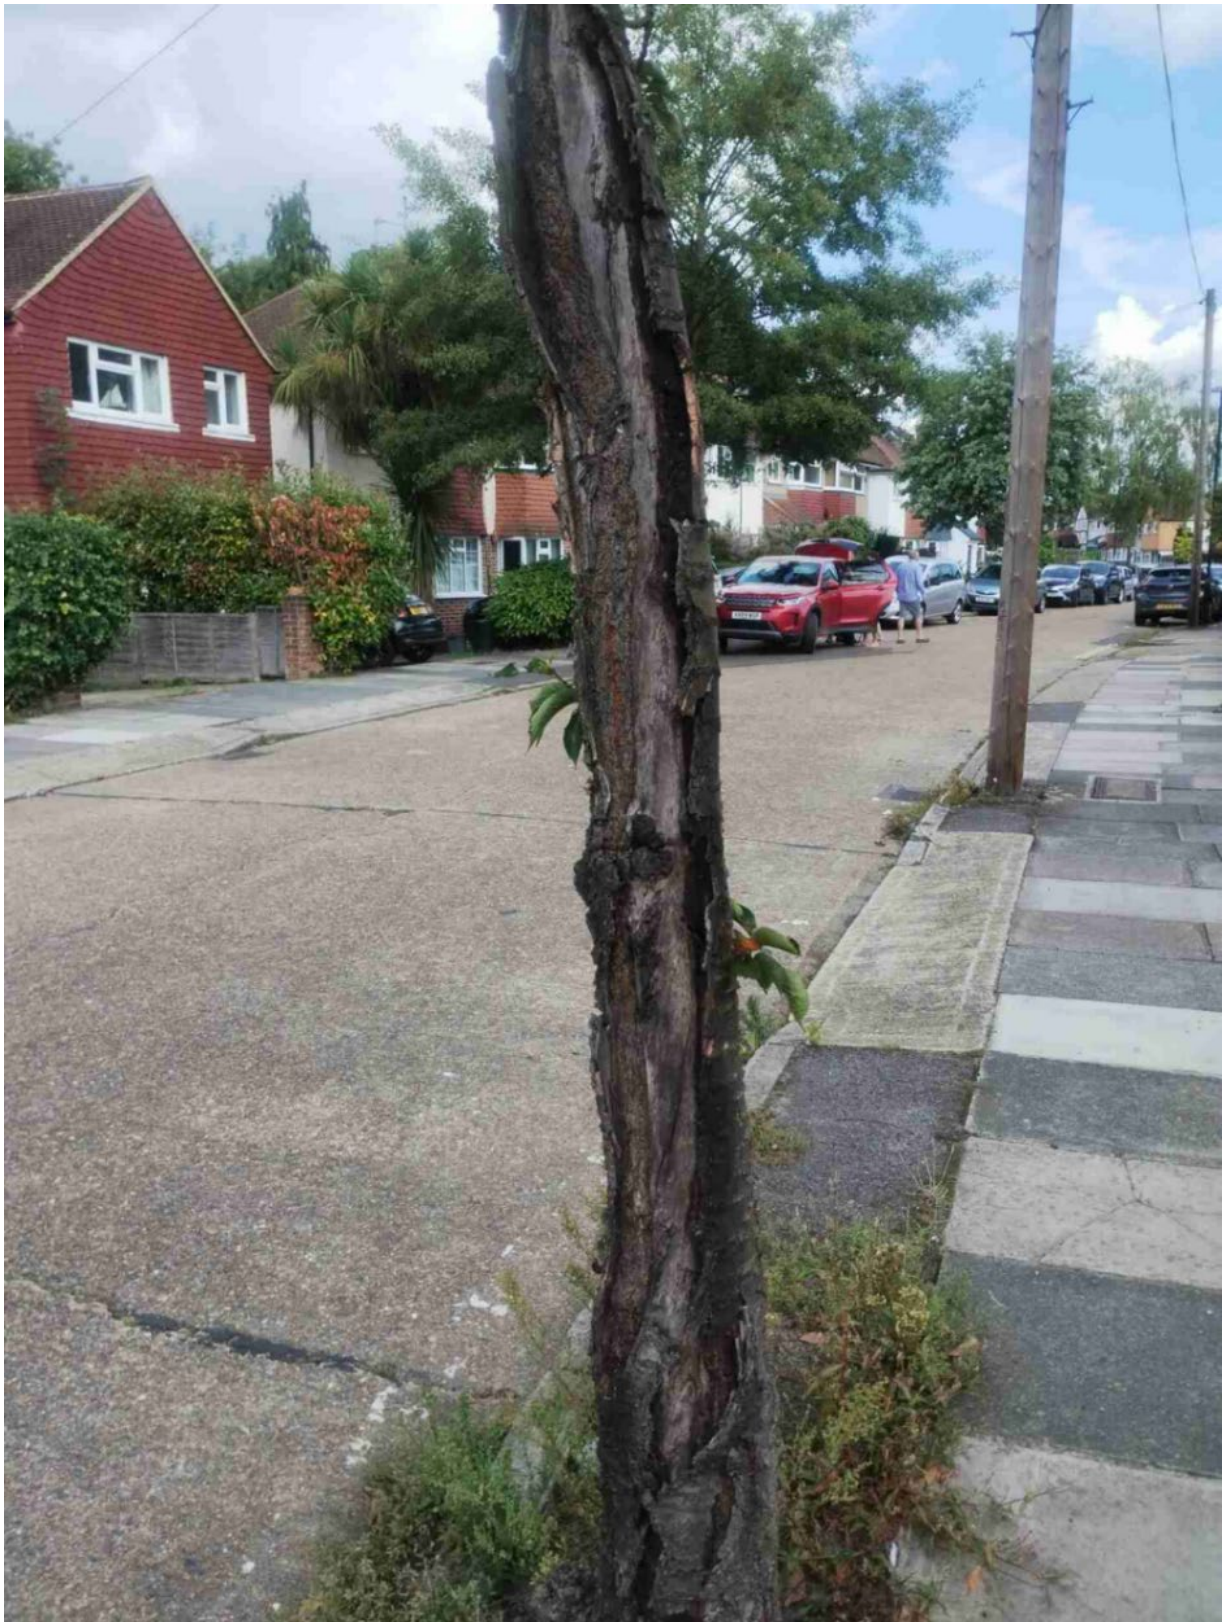
***Image shows cankering and bark necrosis on stem.***

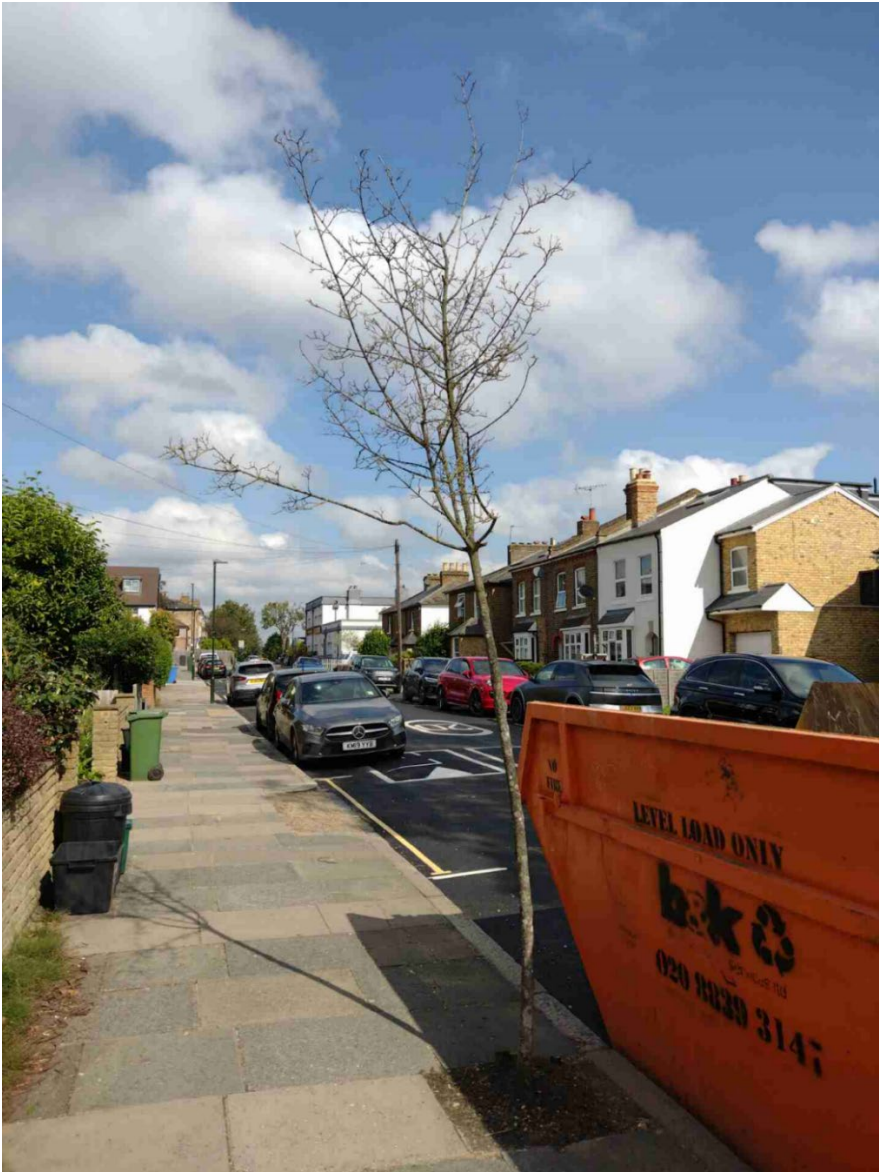
| Inspection findings | This tree is dead; removal is required to prevent natural failure and facilitate replanting |

Image shows dead tree in street scene.

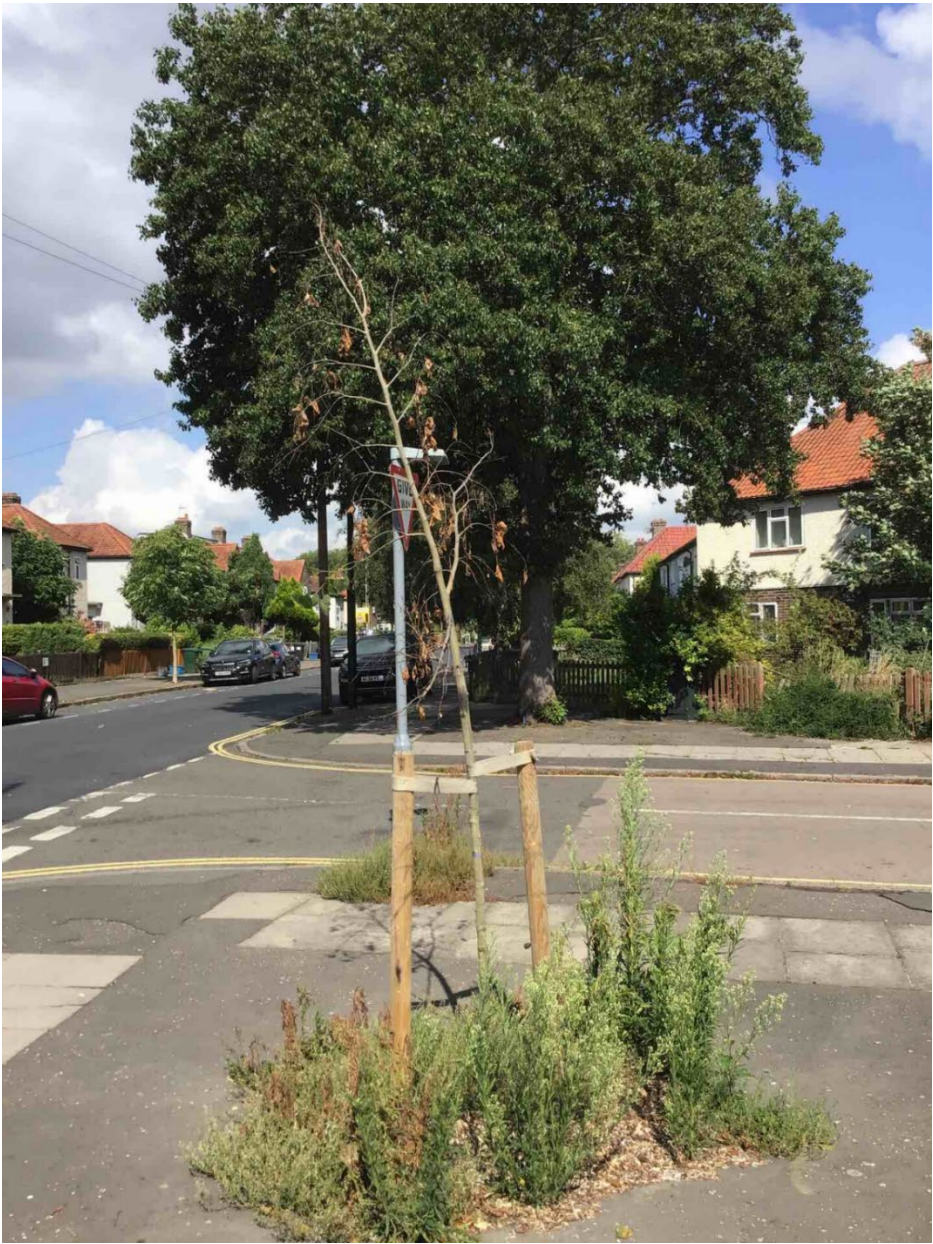
| Inspection findings | This tree is dead; removal is required to prevent natural failure and facilitate replanting |

Image shows dead tree in street scene

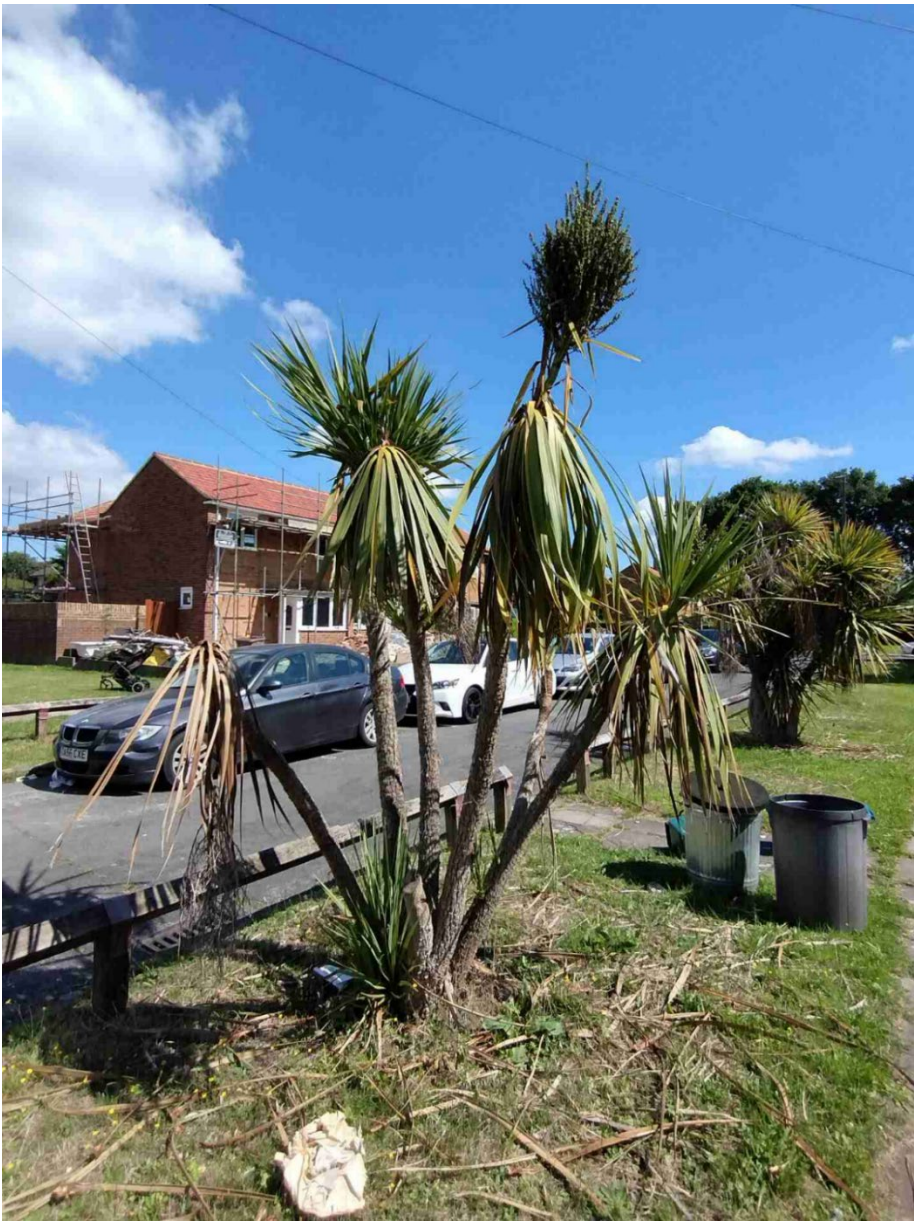
| Inspection findings | Tree is moribund; removal is required to prevent natural failure and facilitate replanting required to prevent natural failure and facilitate replanting. |

Image shows moribund tree in street scene

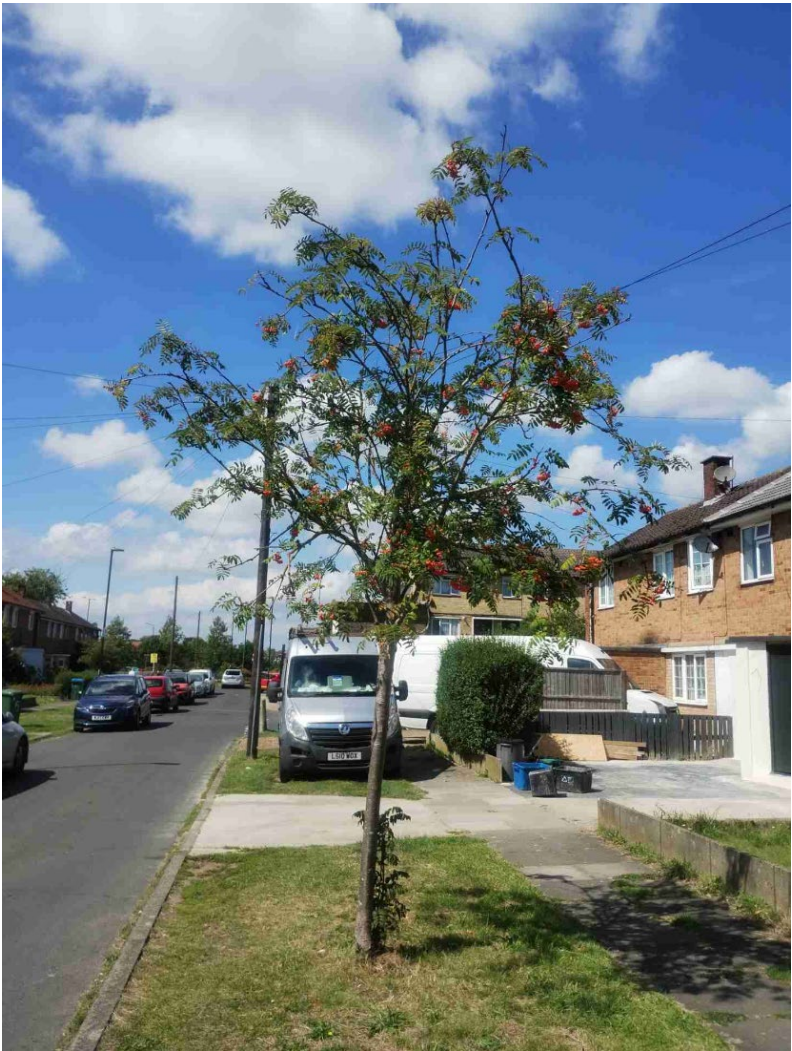
| Inspection findings | Cankering and bark necrosis is present on the stem of this tree indicating dysfunction of the vascular system. The tree presents an unacceptable risk and removal is required prevent natural failure and facilitate replanting. |

Image shows tree in street scene

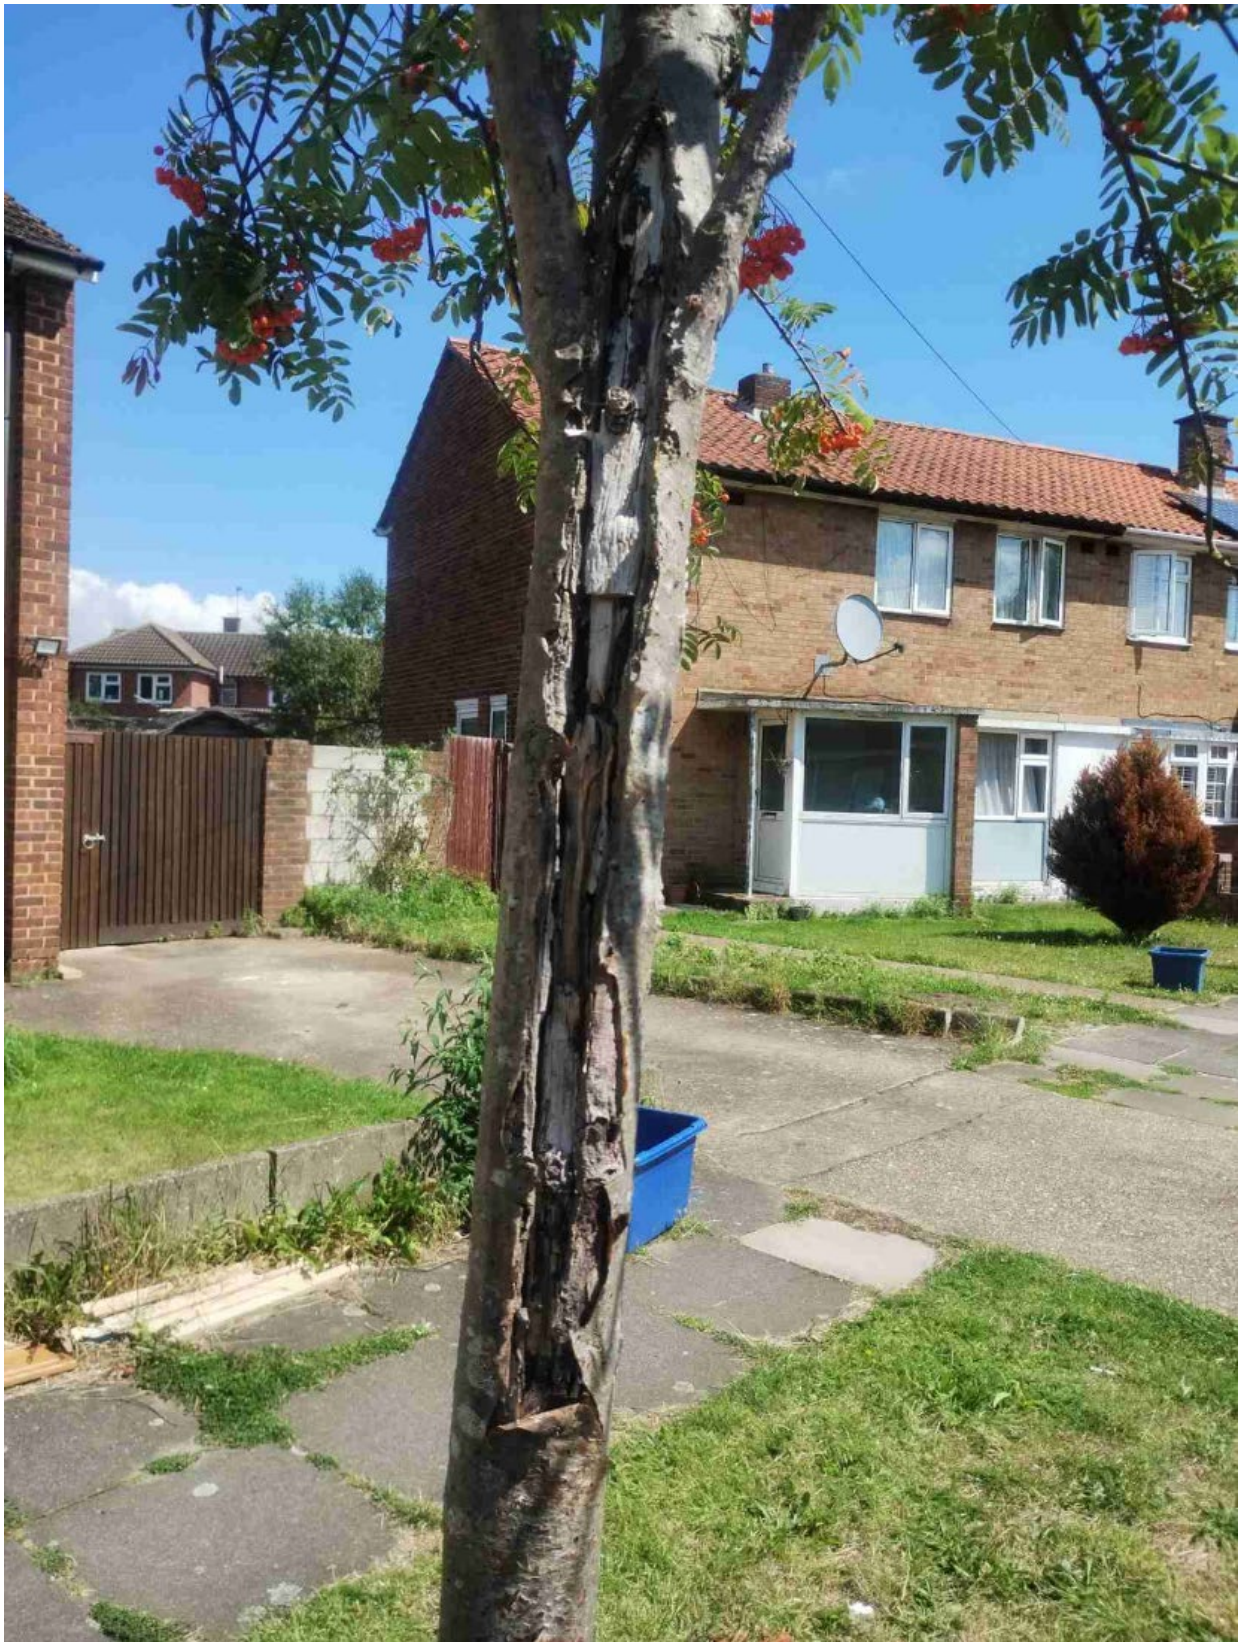
*Image shows canker and bark necrosis on stem of tree*

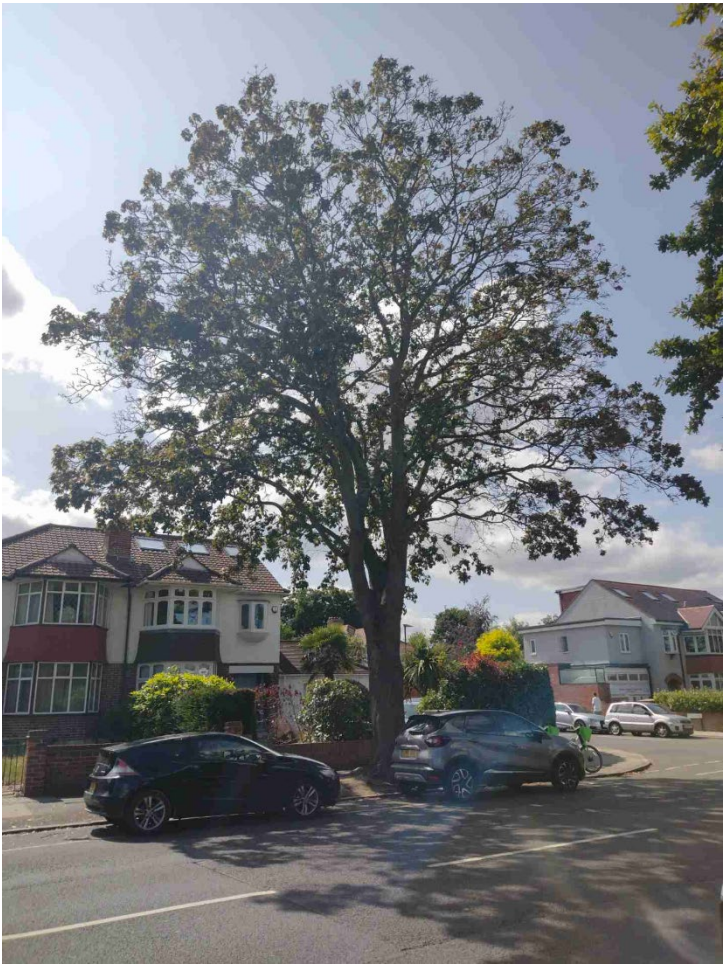
| Inspection findings | A fungal fruiting body of the decay pathogen <i>Ganoderma</i> sp. is present at the stem base. Colonisation by this fungus causes a white rot of the stem and root system that can cause entire trees to collapse through fracture or windthrow. Sparse crown is indicative of root dysfunction/decay. The tree presents an unacceptable risk and removal is required to prevent natural failure and facilitate replanting. |

Image shows tree in street scene

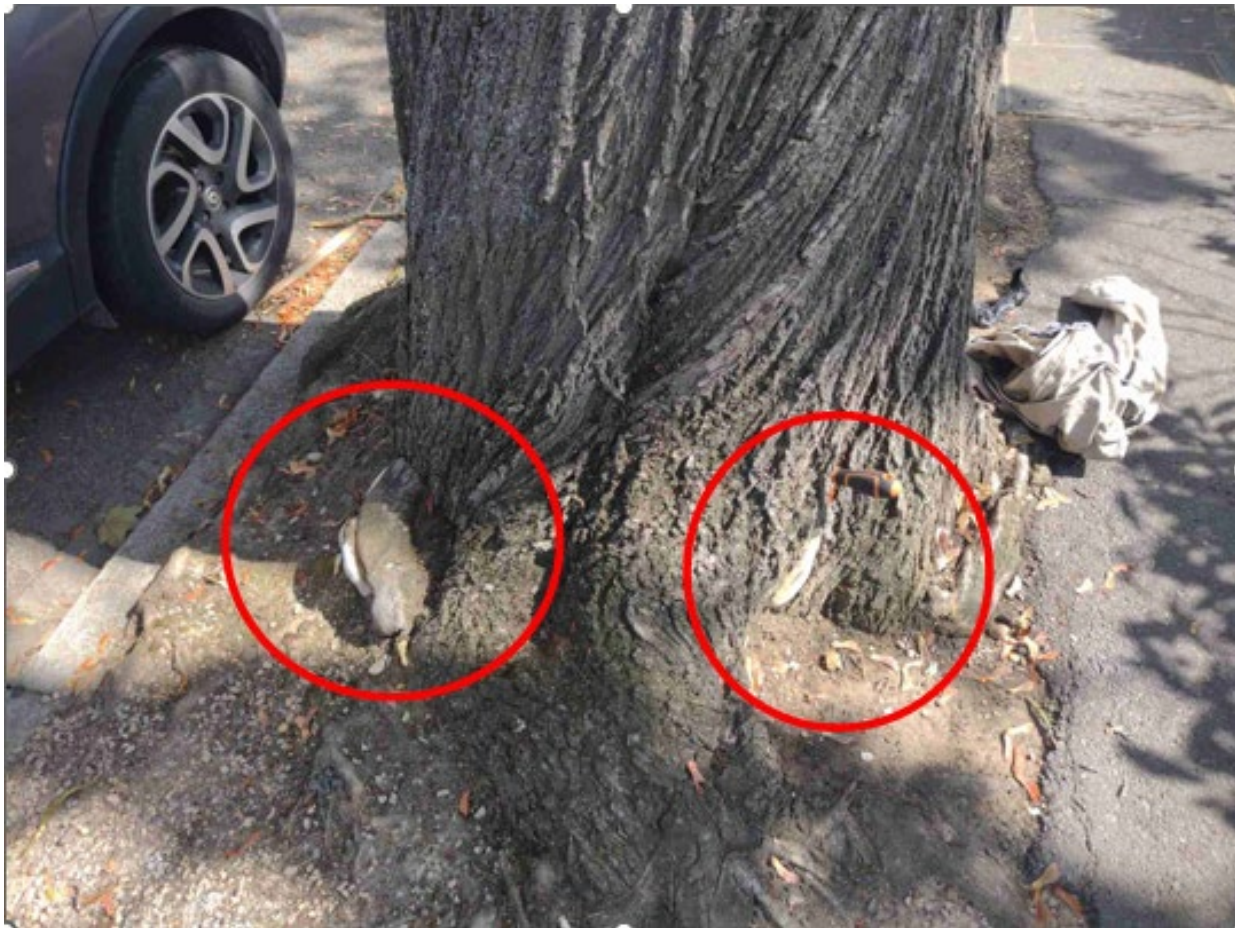
***Image shows fungal brackets circled in red***

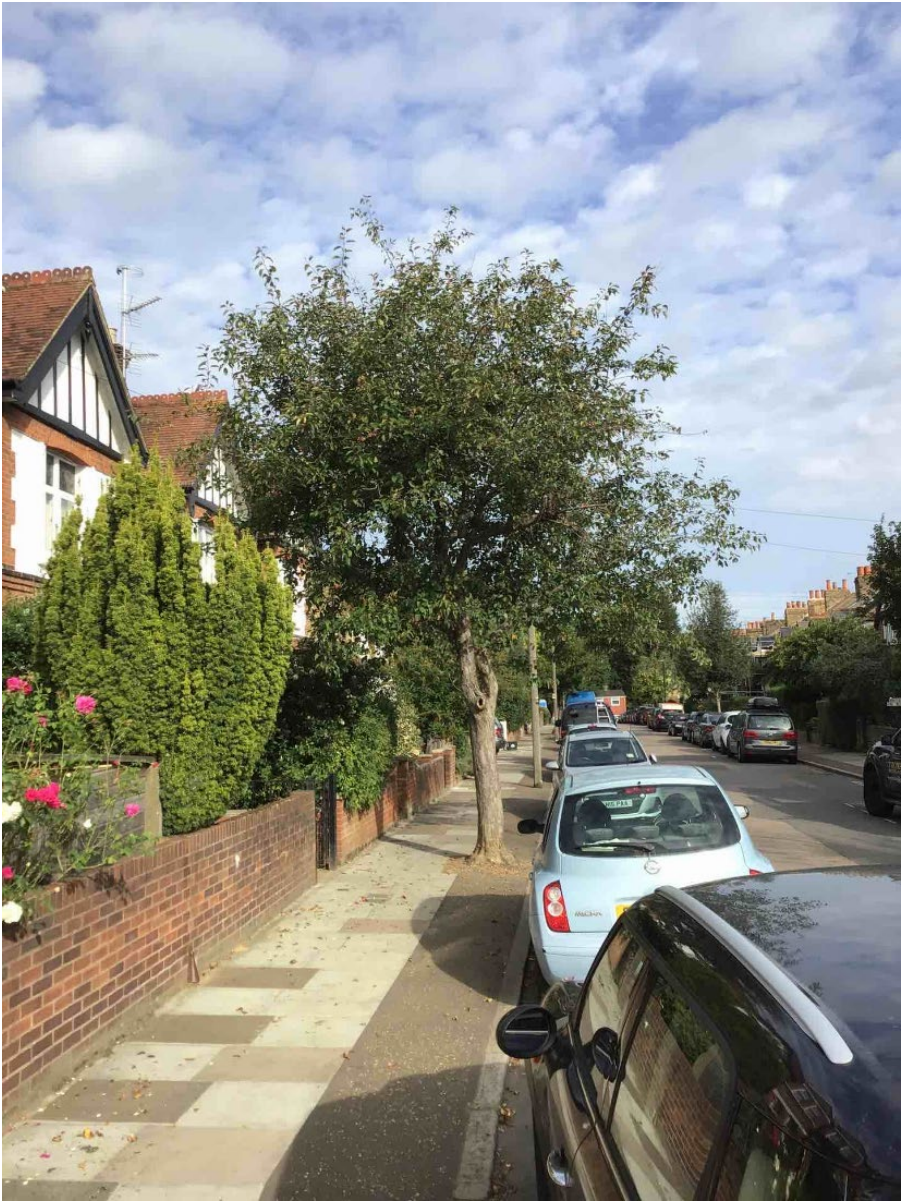
| Inspection findings | Large cavity with an unacceptable amount of decay is present in the main stem/trunk of tree. The tree presents an unacceptable risk and removal is required to prevent natural failure and facilitate replanting. |

Image shows tree in street scene

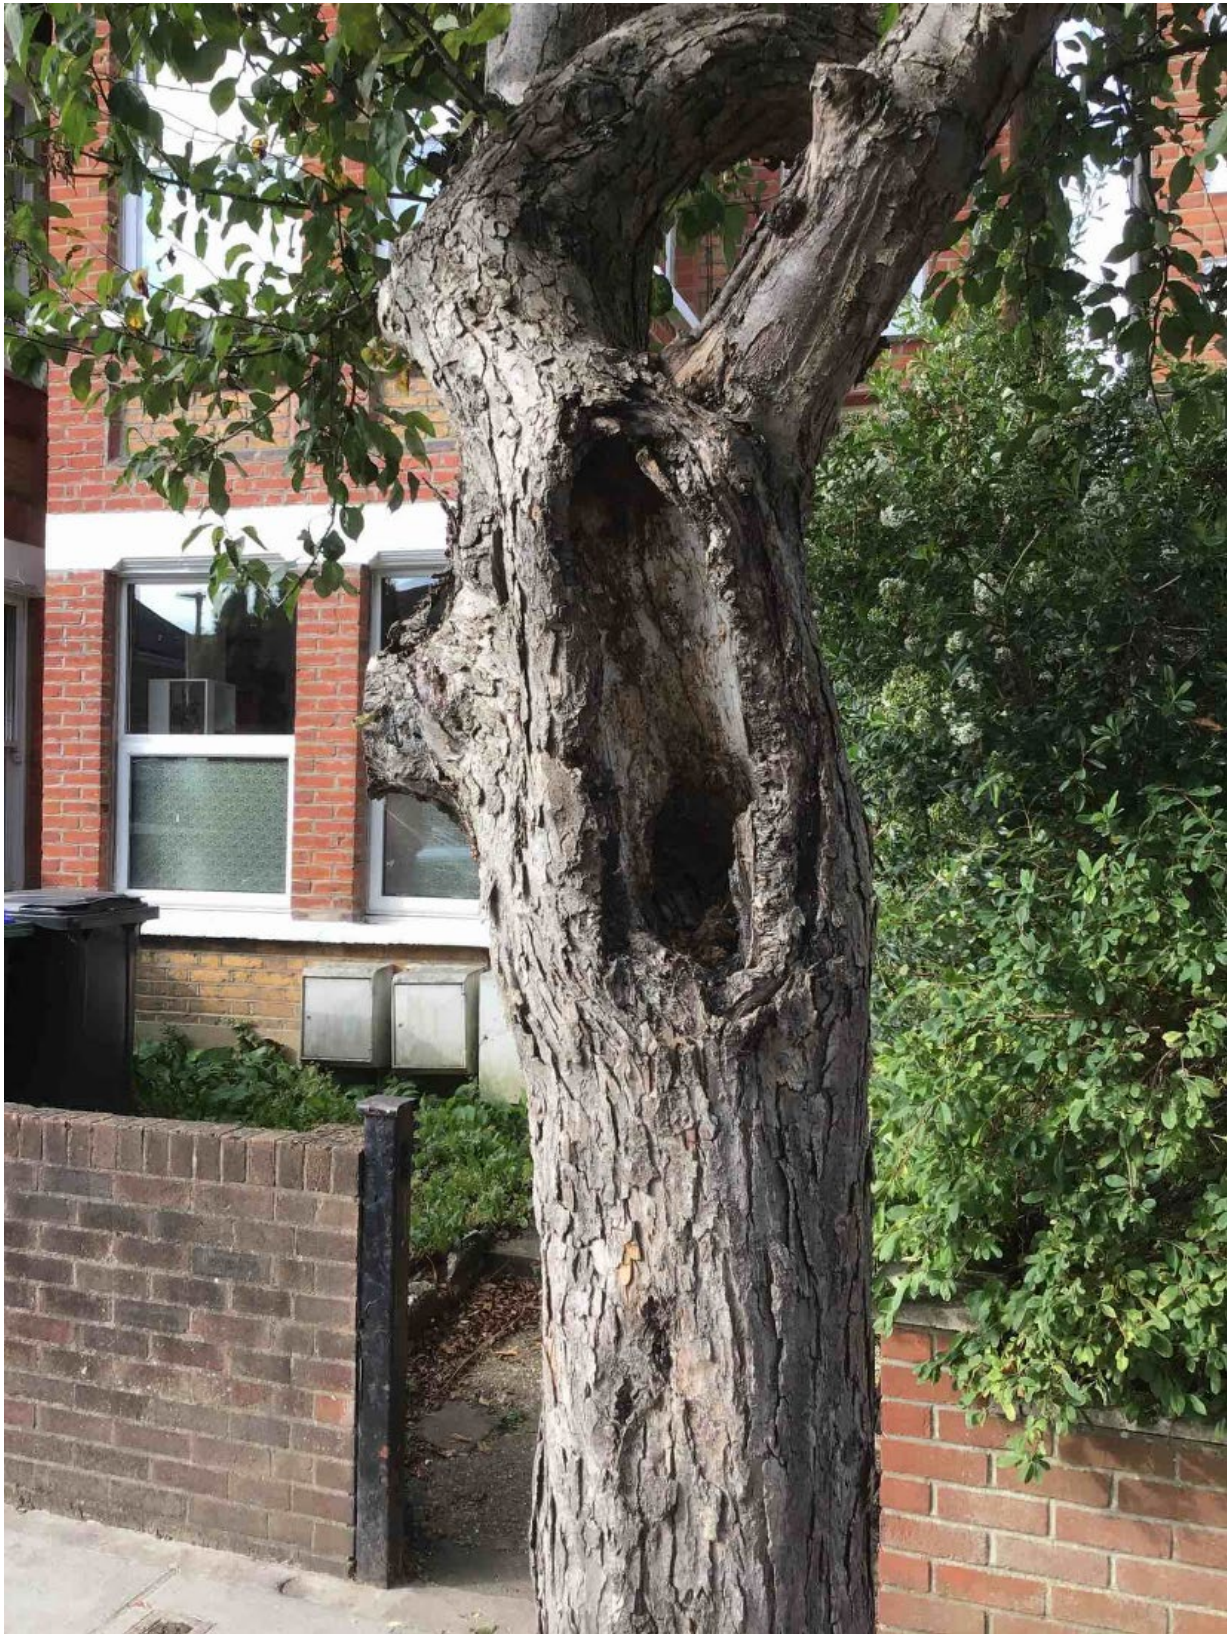
*Image shows large cavity at base of major union.*

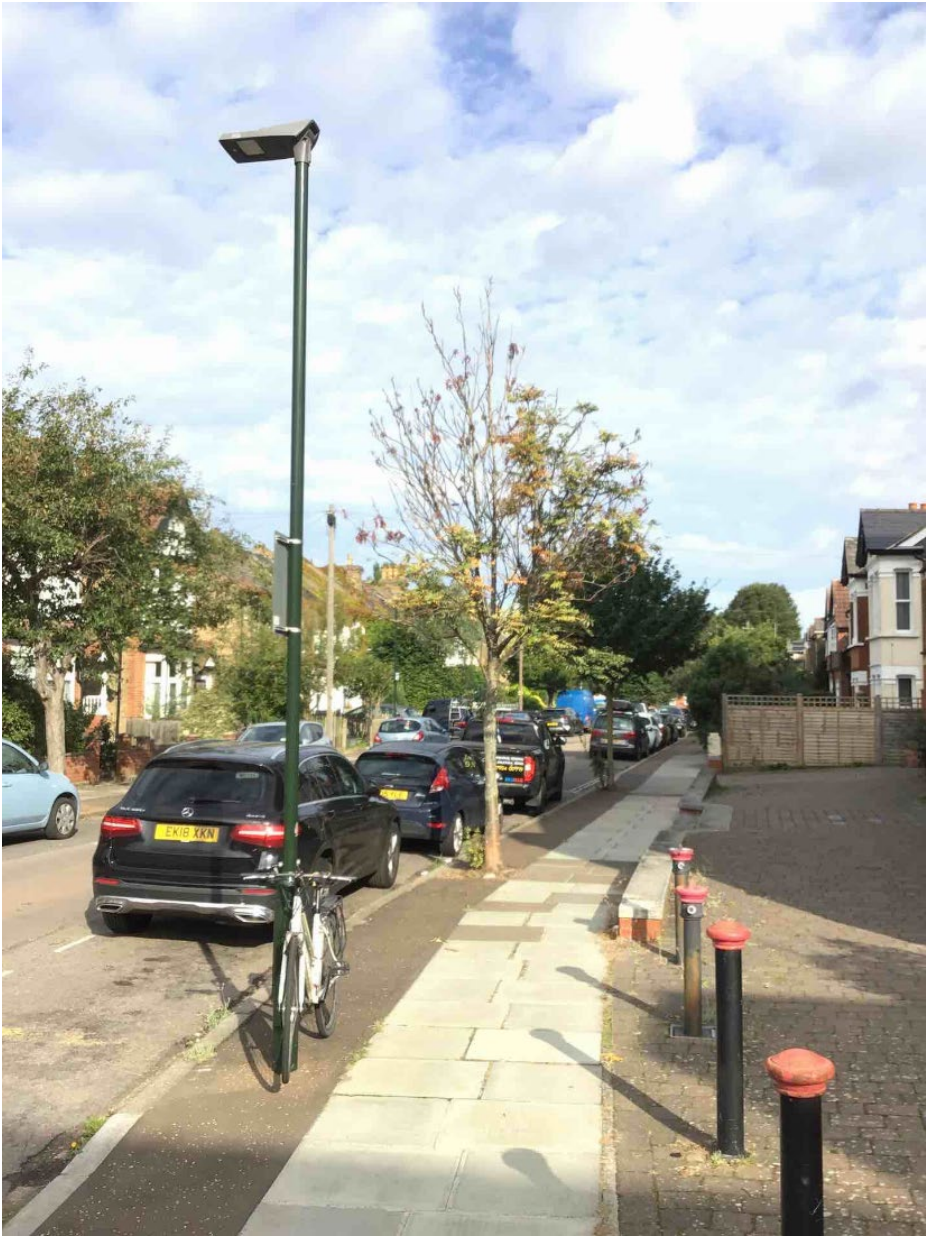
| Inspection findings | The crown of this tree is in moribund condition with over 80% of crown being dead. Removal is required to facilitate replanting. |

Image shows moribund tree in street scene

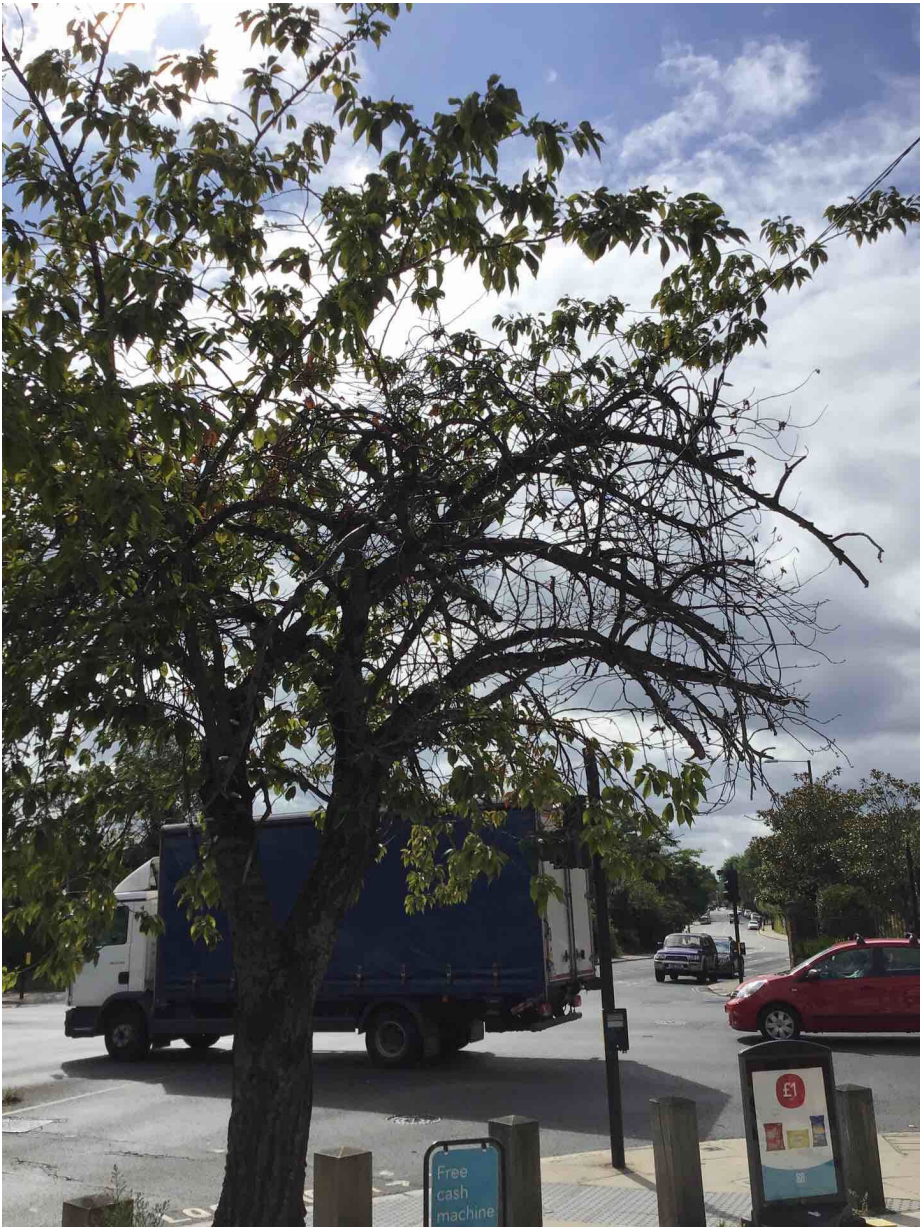
Image shows moribund tree in street scene.

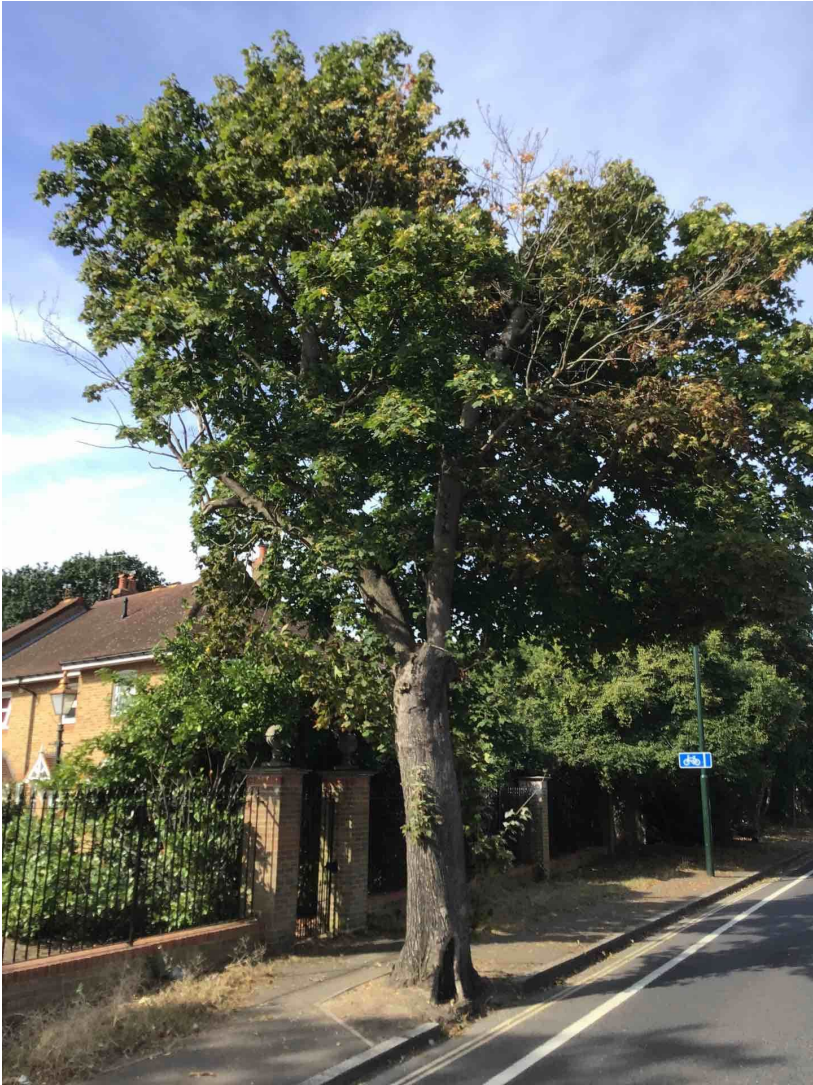
| Inspection findings | A cavity indicating root and lower stem decay is present at the base of this tree. An unacceptable amount of decay is present in cavity which correlates with the dieback in the crown indicative of root dysfunction. Removal is required to prevent failure and facilitate replanting. |

Image shows tree in street scene

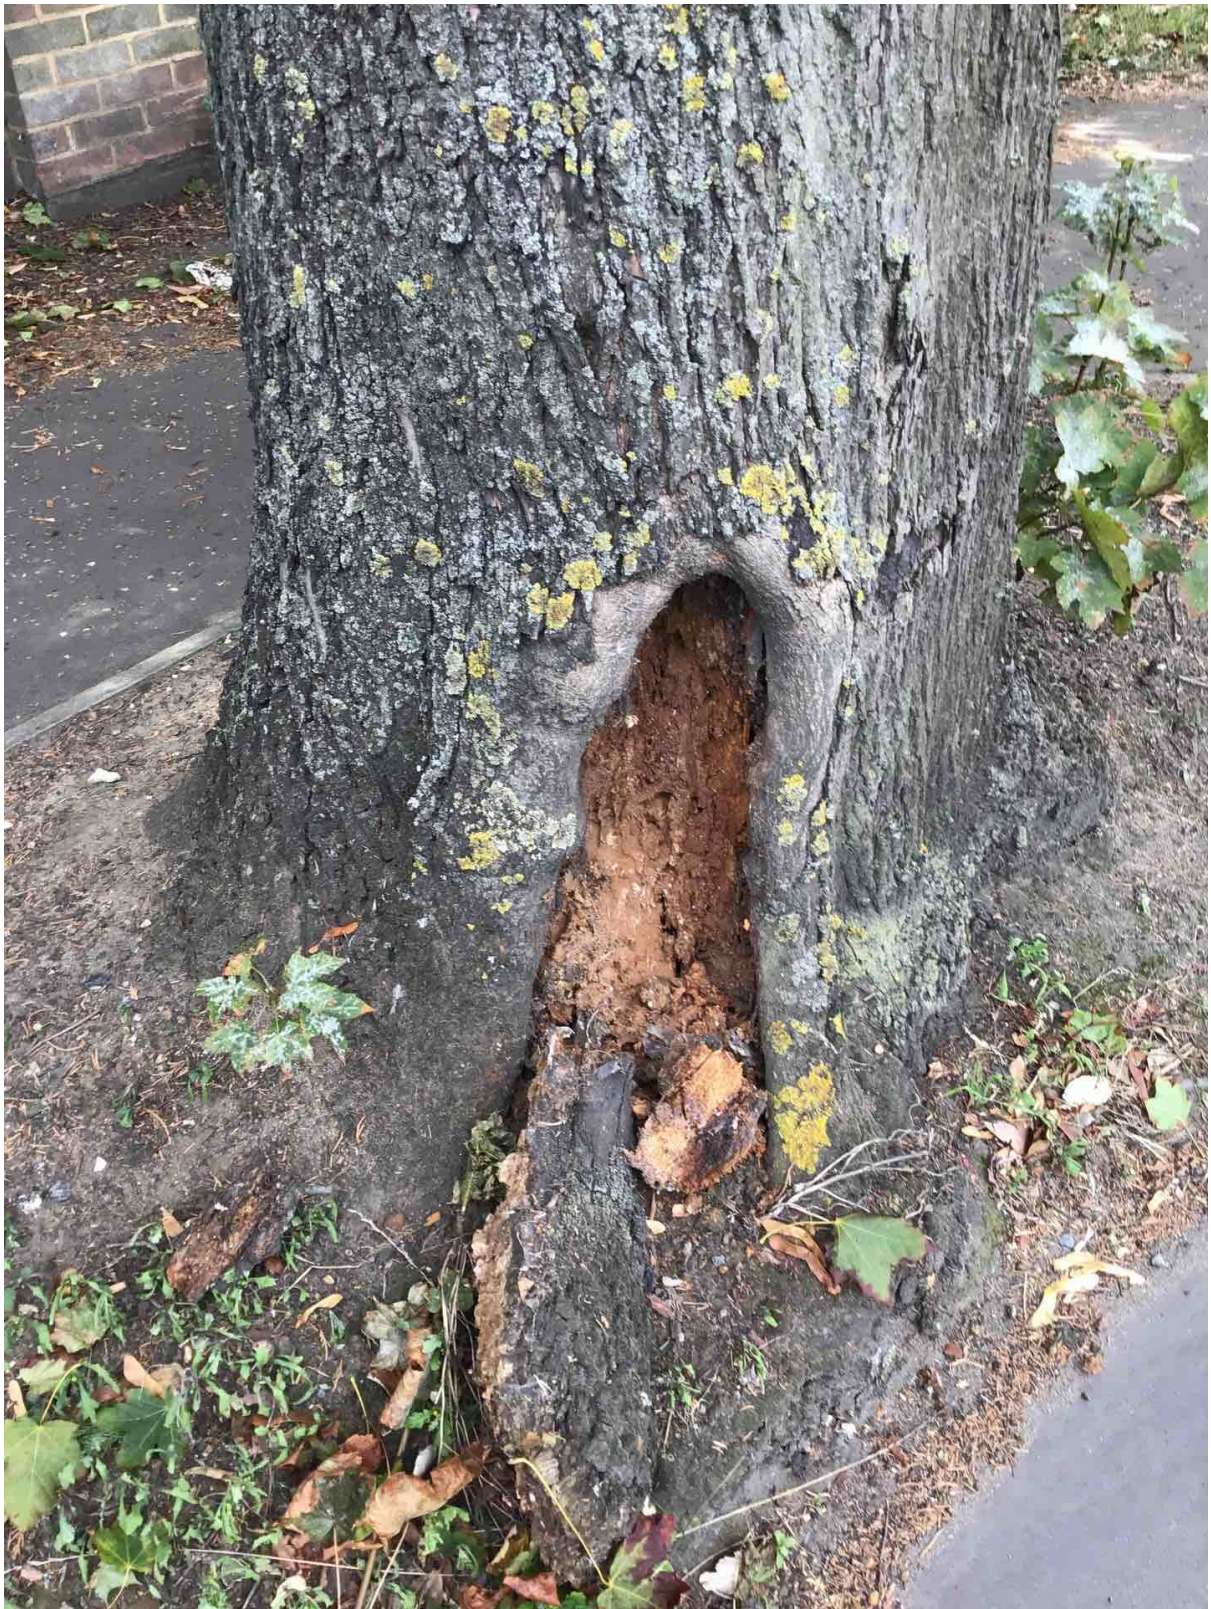
***Image shows cavity at the base of the stem***
