November 2023 - Reactive Tree Works Programme

Introduction

Dated 21.11.2023

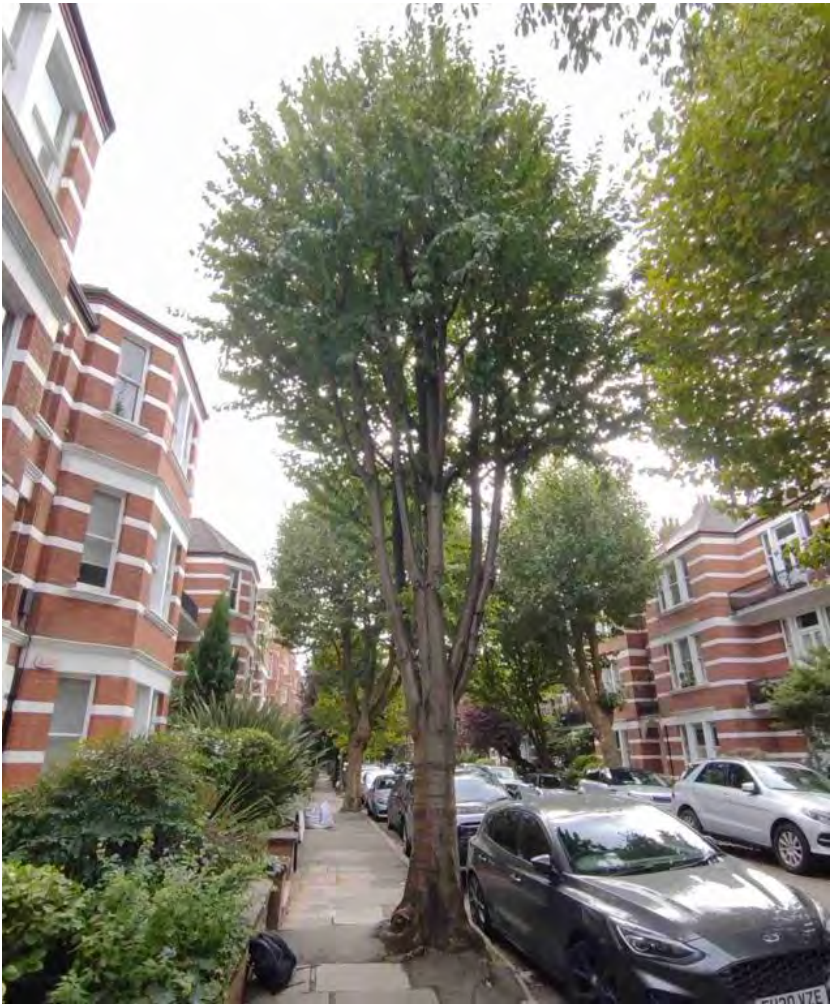
Ward	Barnes
Road	Riverview Gardens
Location	Outside entrance of 25-30 Riverview Gardens
Species	Hybrid Cherry (<i>Prunus x schmittii</i>)
Height	12.0m
Physiological Condition	Poor
Structural Condition	Poor
Inspection findings	A fungal fruiting body of the decay pathogen <i>Ganoderma</i> sp. is present at the stem base. Colonisation by this fungus causes a white rot of the stem and root system that can cause entire trees to collapse through fracture or windthrow. A resonance test revealed an unacceptable degree of decay in the trunk of this tree, removal is required to prevent natural failure and facilitate replanting.

Image shows tree in street scene.

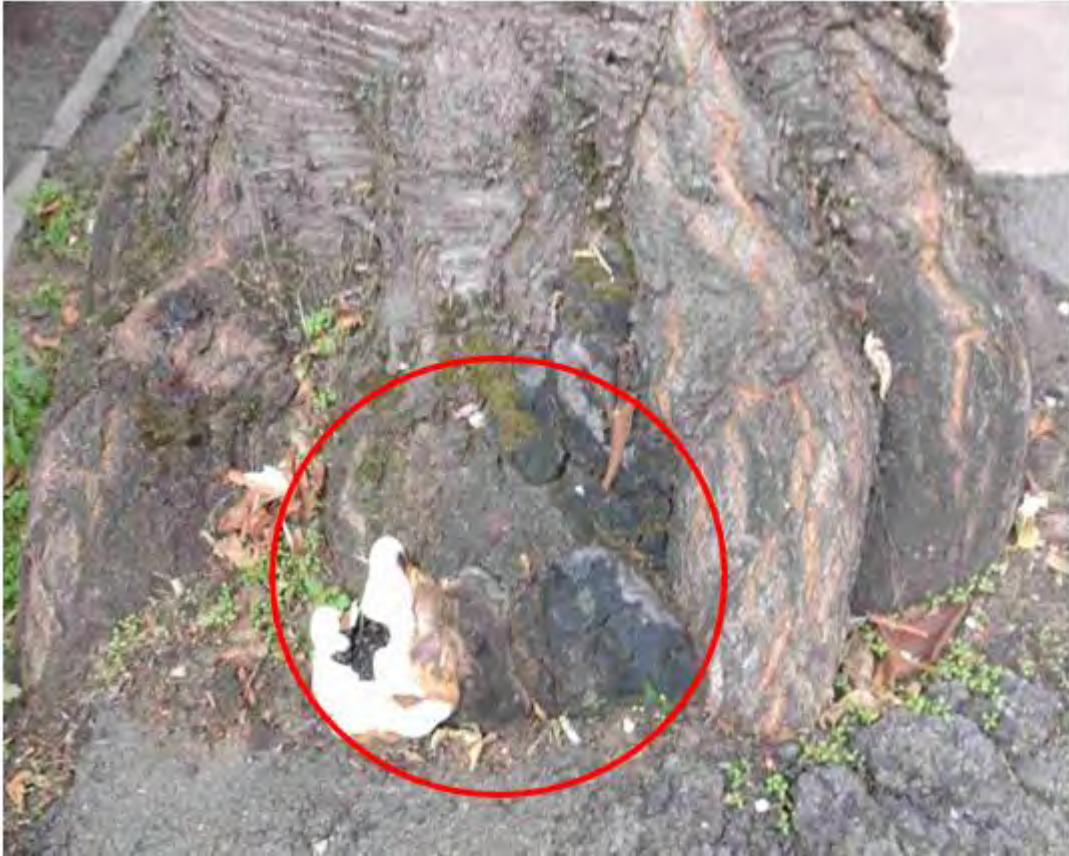
Image shows base of tree with fruiting body circled.

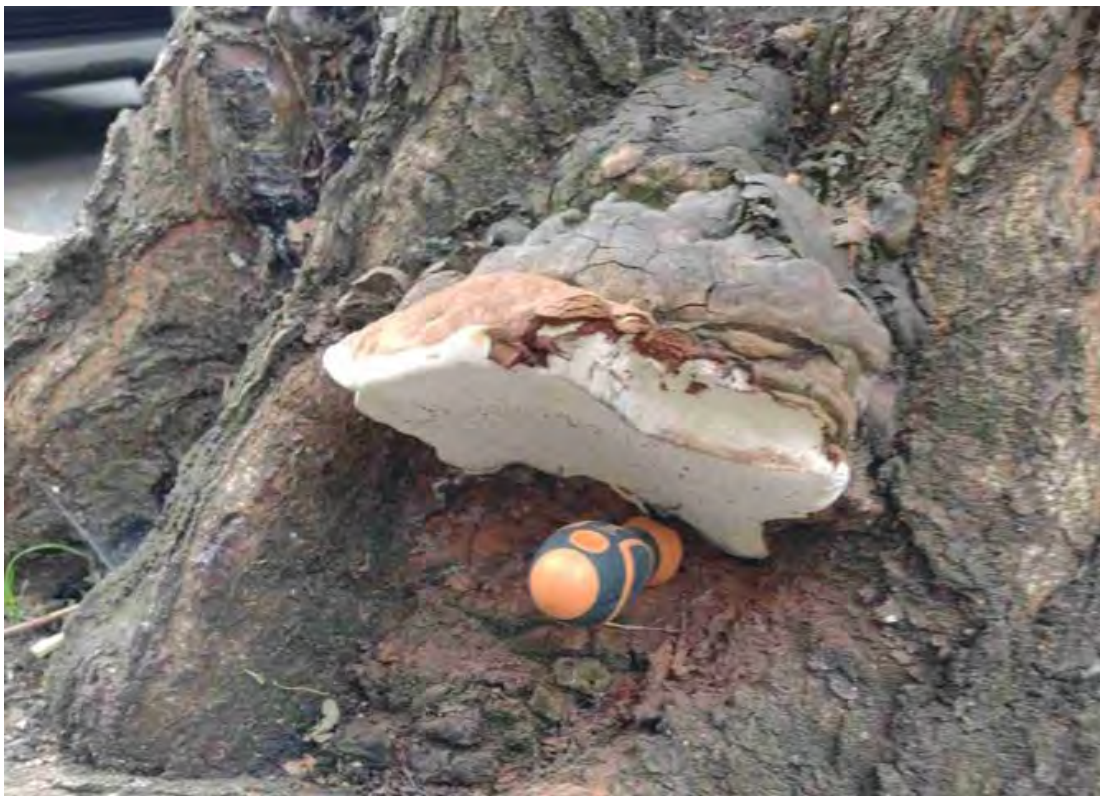
Image shows base of stem with fruiting body and probe below highlighting decay.

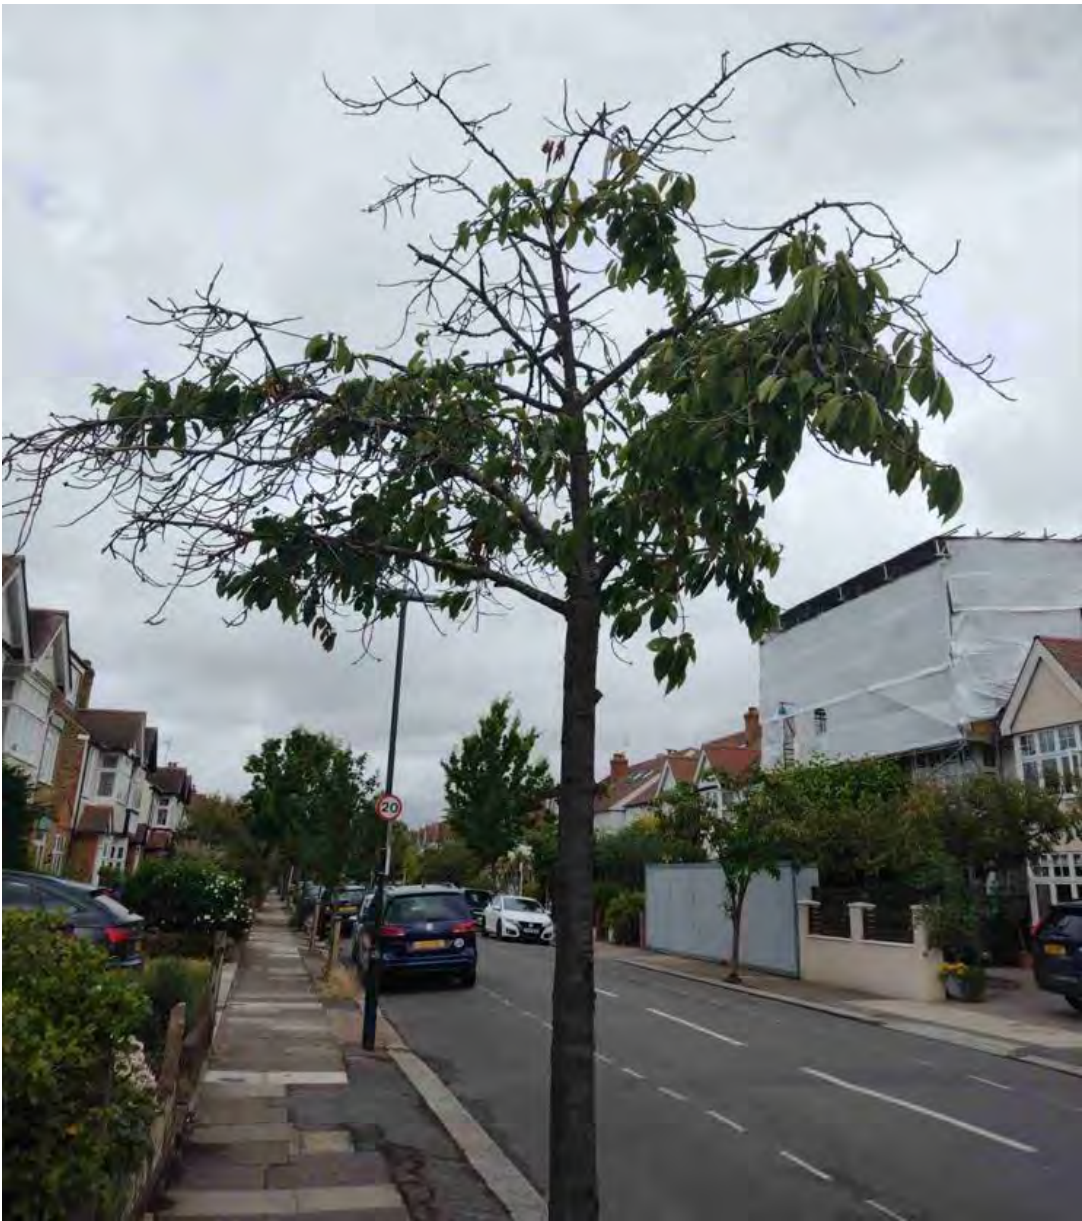
Ward	Barnes
Road	Gerard Road
Location	Outside 44/46
Species	Wild Cherry (<i>Prunus avium</i>)
Height	5.5m
Physiological Condition	Poor
Structural Condition	Fair
Inspection findings	This tree is moribund; removal is required to prevent natural failure and facilitate replanting

Image shows tree in moribund condition

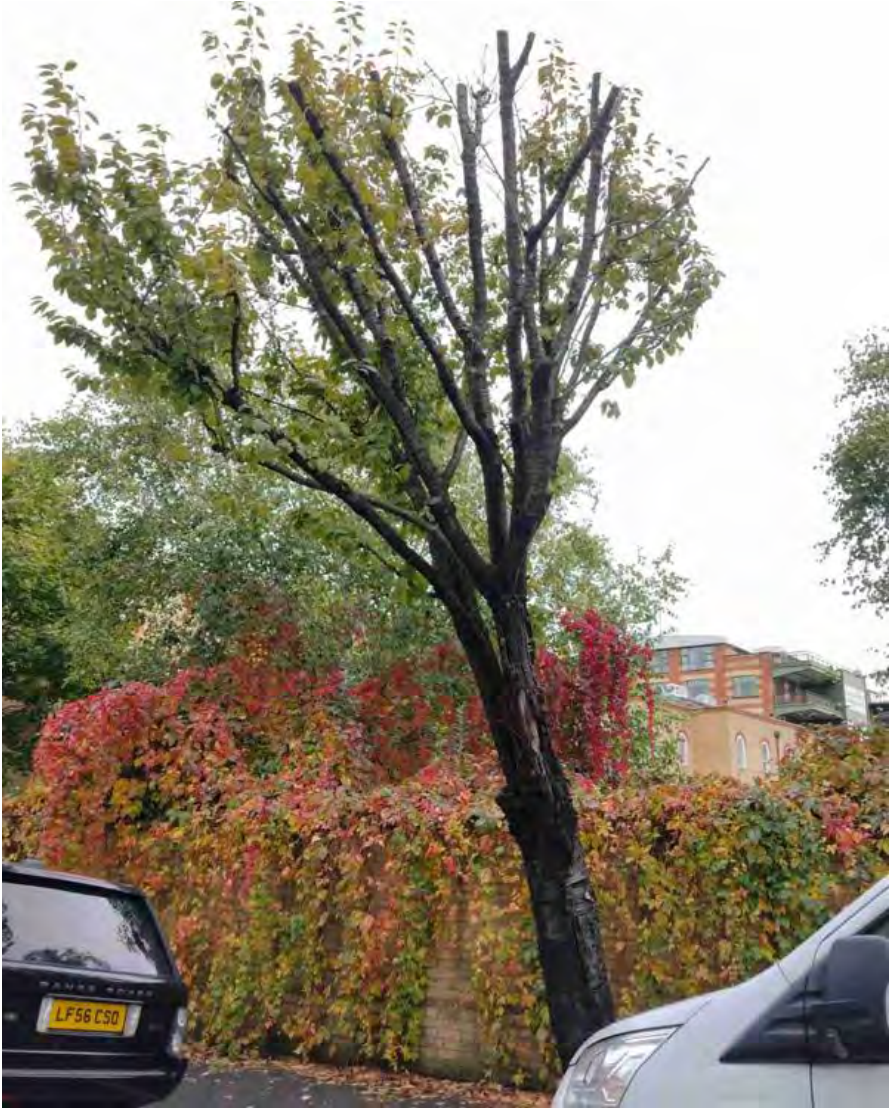
Ward	Barnes
Road	Riverview Gardens
Location	On opposite side of road to side of 46 building
Species	Hybrid Cherry (<i>Prunus x schmittii</i>)
Height	11.0m
Physiological Condition	Fair
Structural Condition	Poor
Inspection findings	A fungal fruiting body of the decay pathogen <i>Ganoderma</i> sp. is present at the stem base. Colonisation by this fungus causes a white rot of the stem and root system that can cause entire trees to collapse through fracture or windthrow. Investigation with a probe revealed an unacceptable amount of decay. Removal is required to prevent natural failure and facilitate replanting.

Image shows tree in street scene with lean

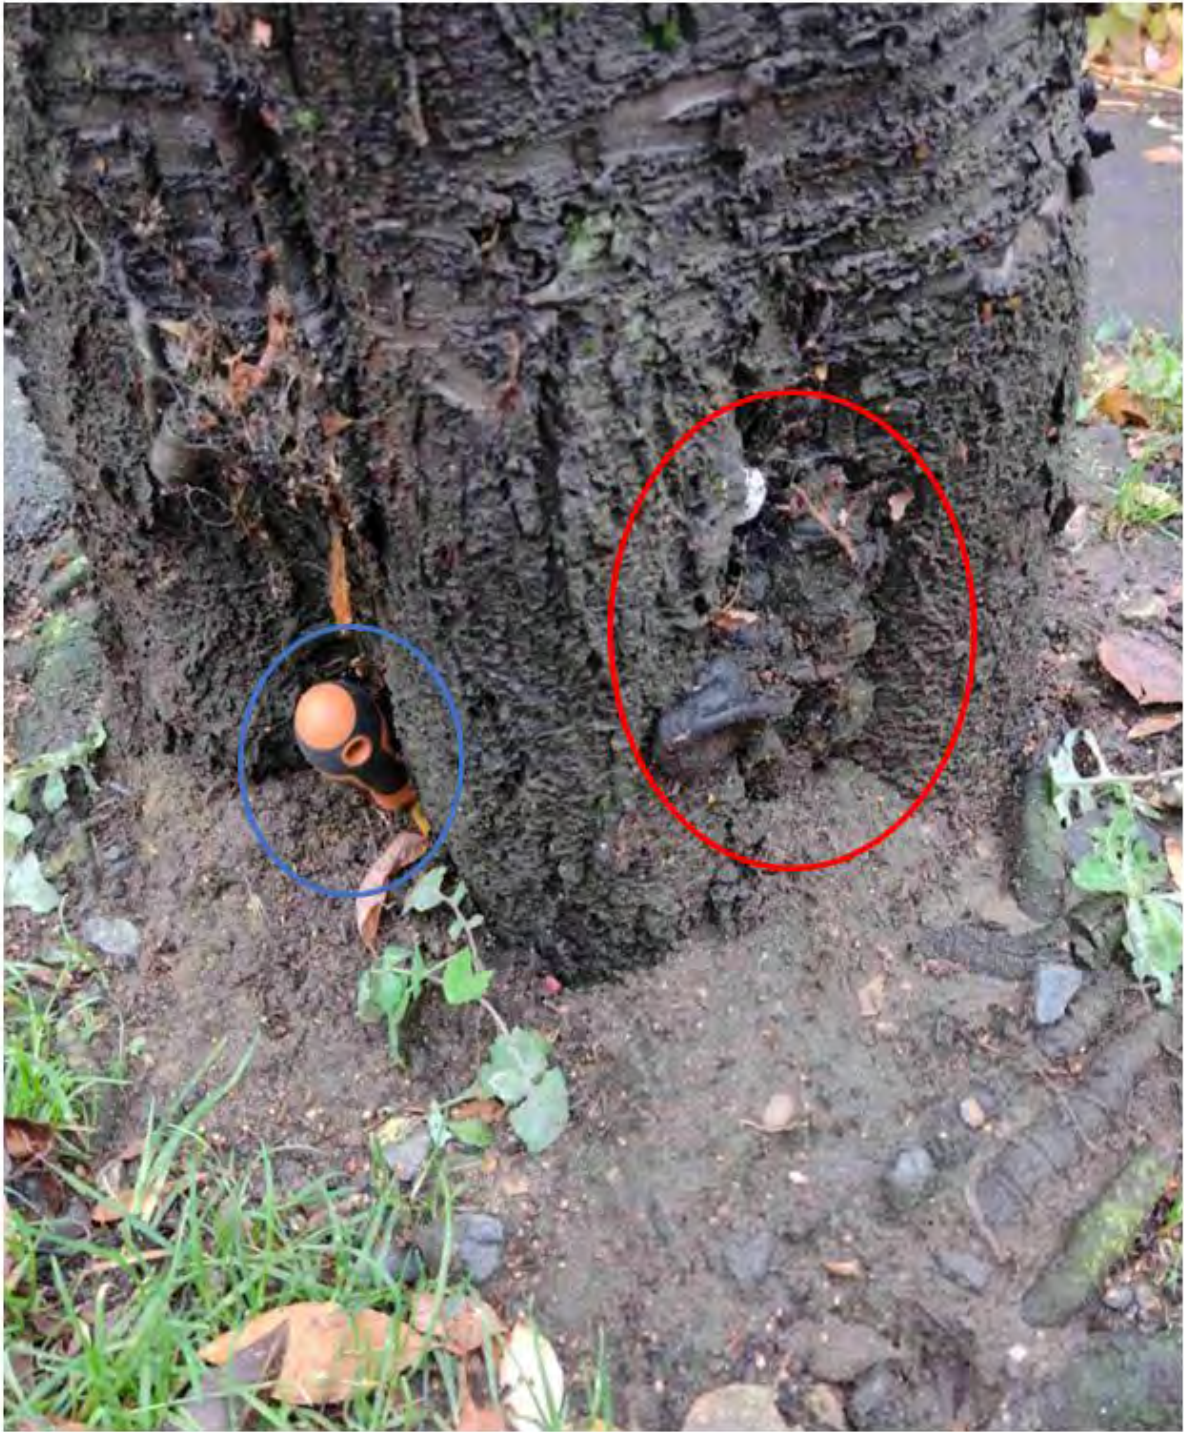
Image shows Ganoderma circle in red and probe circled in blue highlighting decay in stem.

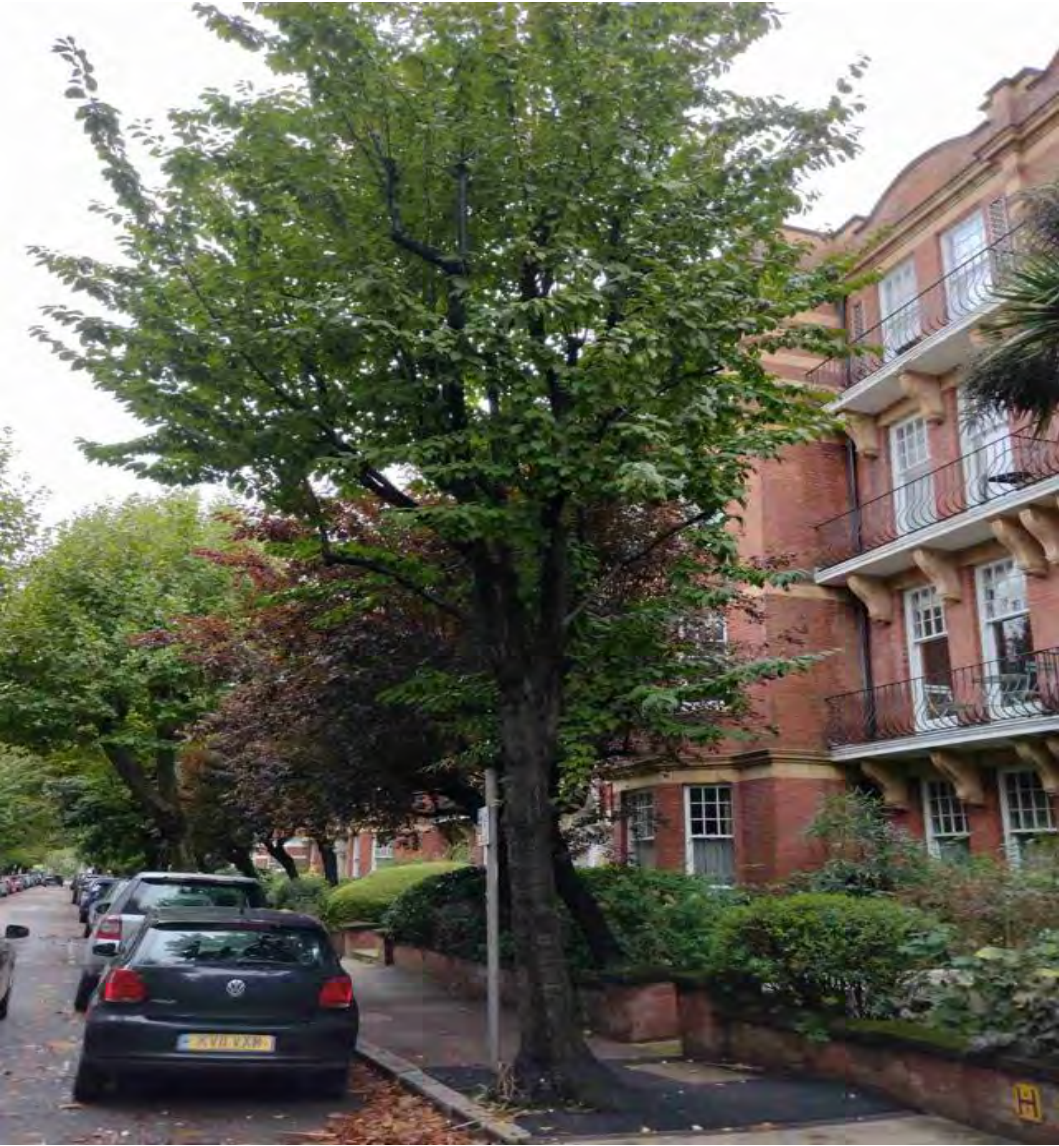
Ward	Barnes
Road	Riverview Gardens
Location	Opposite entrance to 86-89 Riverview Gardens.
Species	Hybrid Cherry (<i>Prunus x schmittii</i>)
Height	9.5m
Physiological Condition	Fair
Structural Condition	Poor
Inspection findings	A fungal fruiting body of the decay pathogen <i>Ganoderma</i> sp. is present at the stem base. Colonisation by this fungus causes a white rot of the stem and root system that can cause entire trees to collapse through fracture or windthrow. Investigation revealed an unacceptable amount of decay. Removal is required to prevent natural failure and facilitate replanting.

Image shows tree in street scene

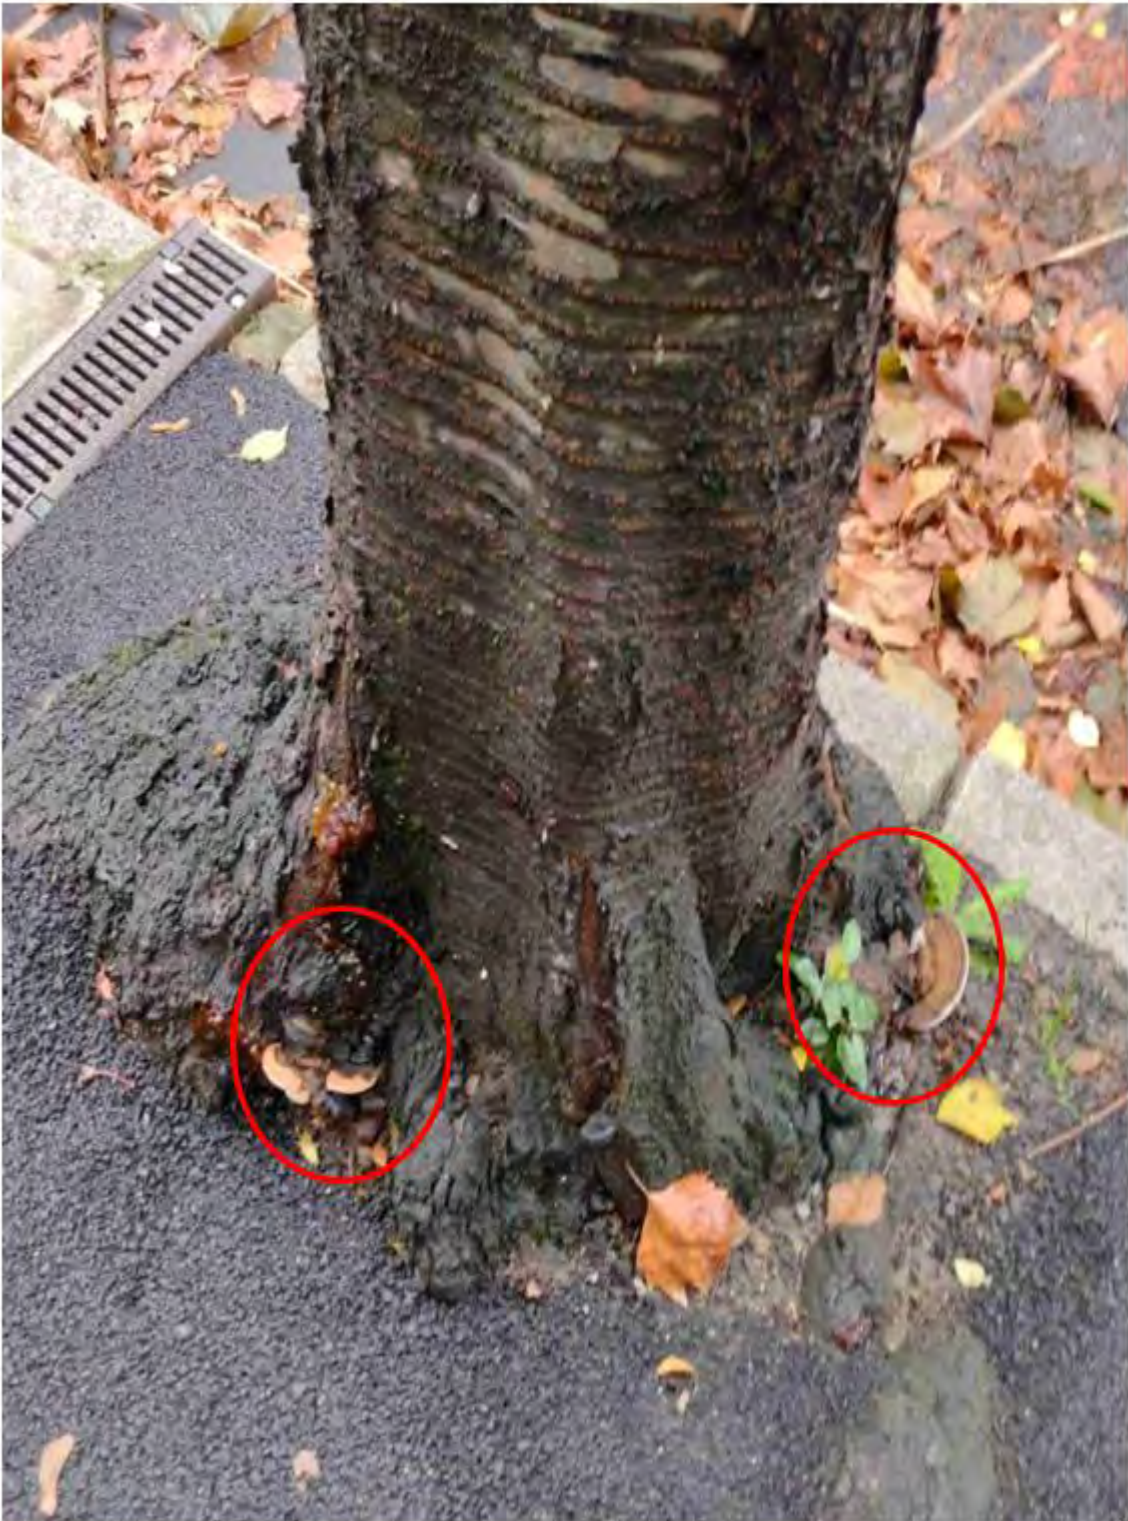
Image shows fruiting bodies circled at base of stem.

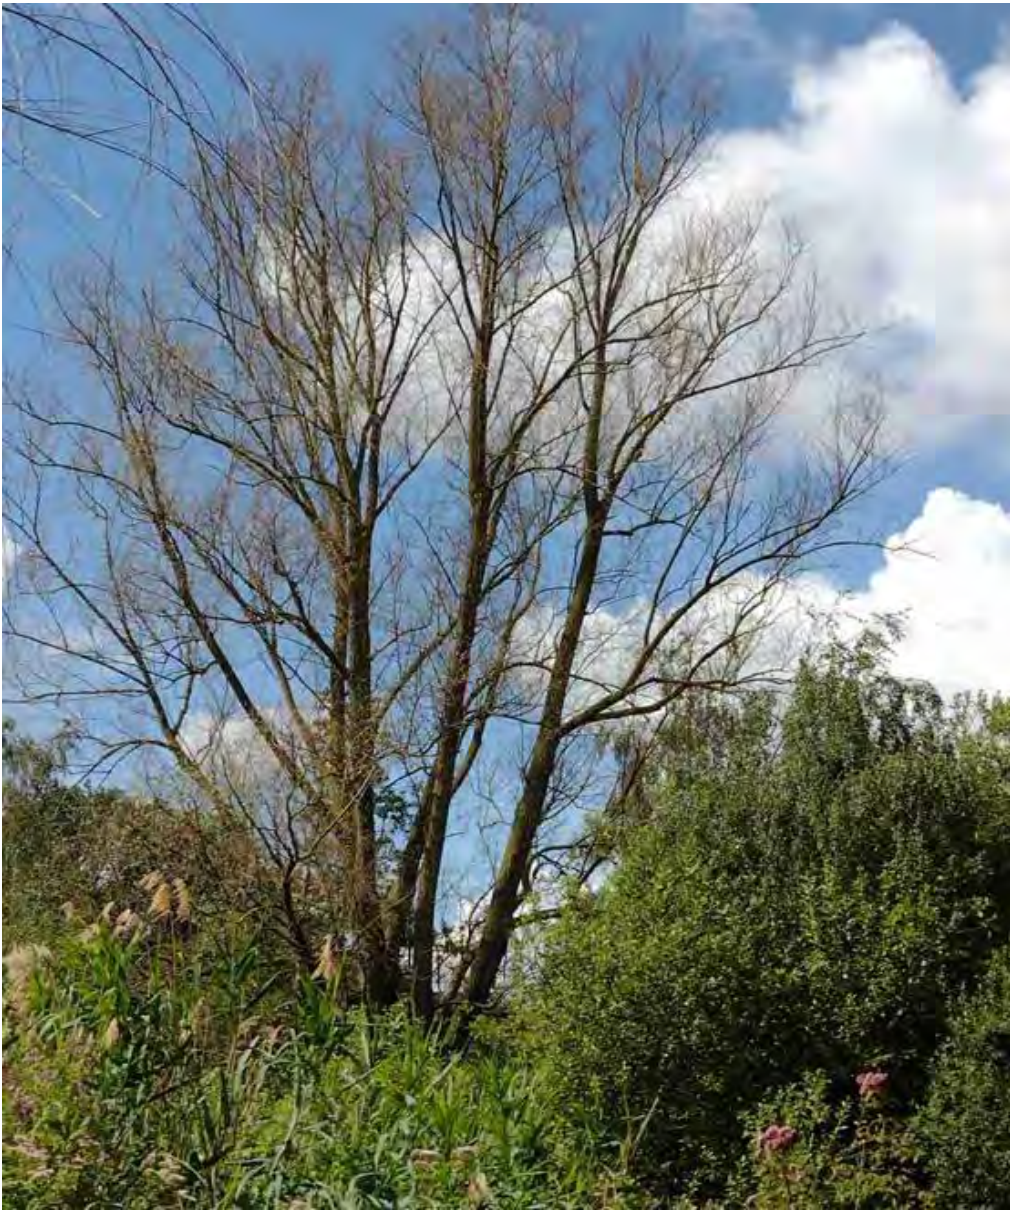
Ward	Barnes
Road	Church Road
Location	Barnes Green - on island in pond What3Words- ///laptop.hope.smart
Species	Willow (Salix sp.)
Height	16.0m
Physiological Condition	Dead
Structural Condition	Dead
Inspection findings	This tree is dead; removal is required to prevent natural failure and facilitate replanting

Image shows dead tree in park scene.

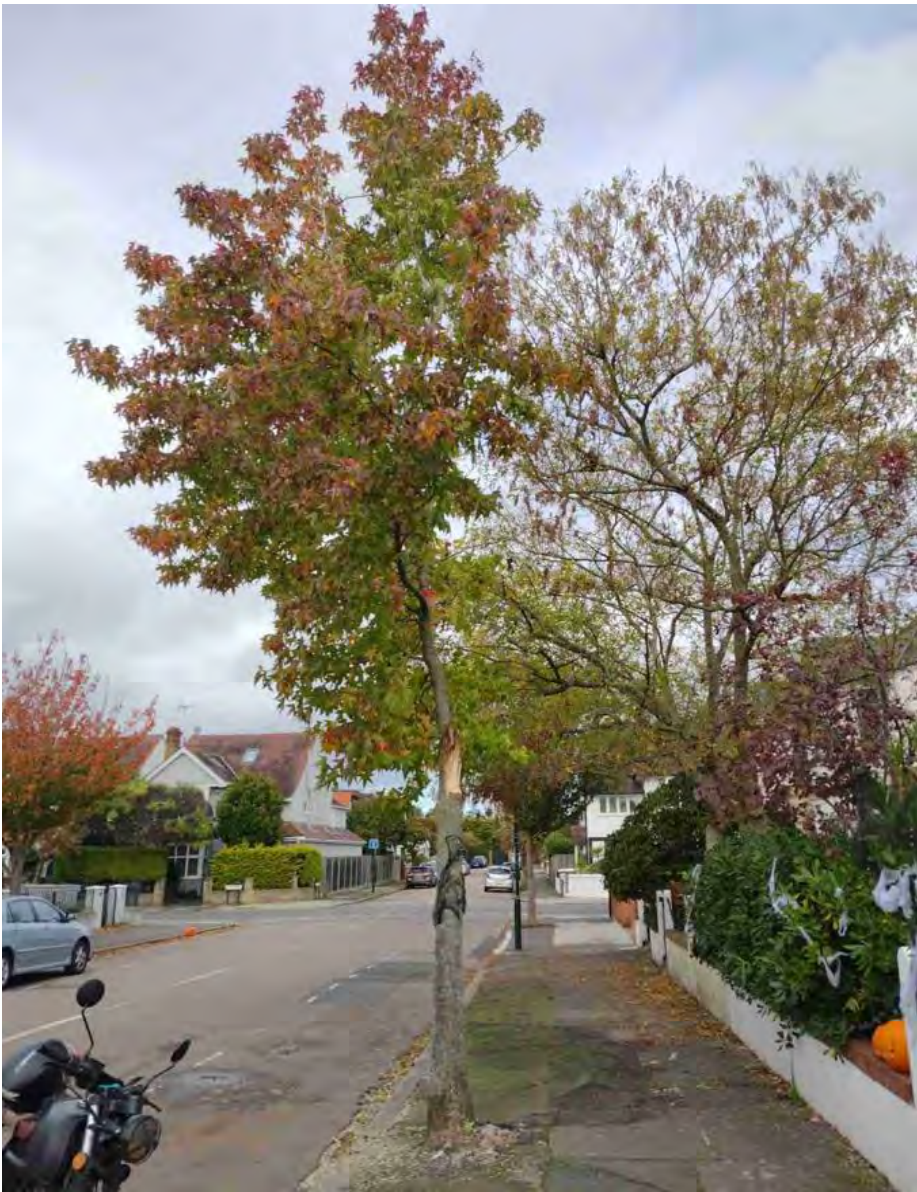
Ward	Barnes
Road	Lowther Road
Location	Outside 70
Species	American Sweetgum (<i>Liquidambar styraciflua</i>)
Height	8.5m
Physiological Condition	Good
Structural Condition	Poor
Inspection findings	This tree has failed at primary union, with remaining stem now presenting an unacceptable level of risk of failure. Removal is required to prevent further failure and facilitate replanting.

Image shows tree in street scene

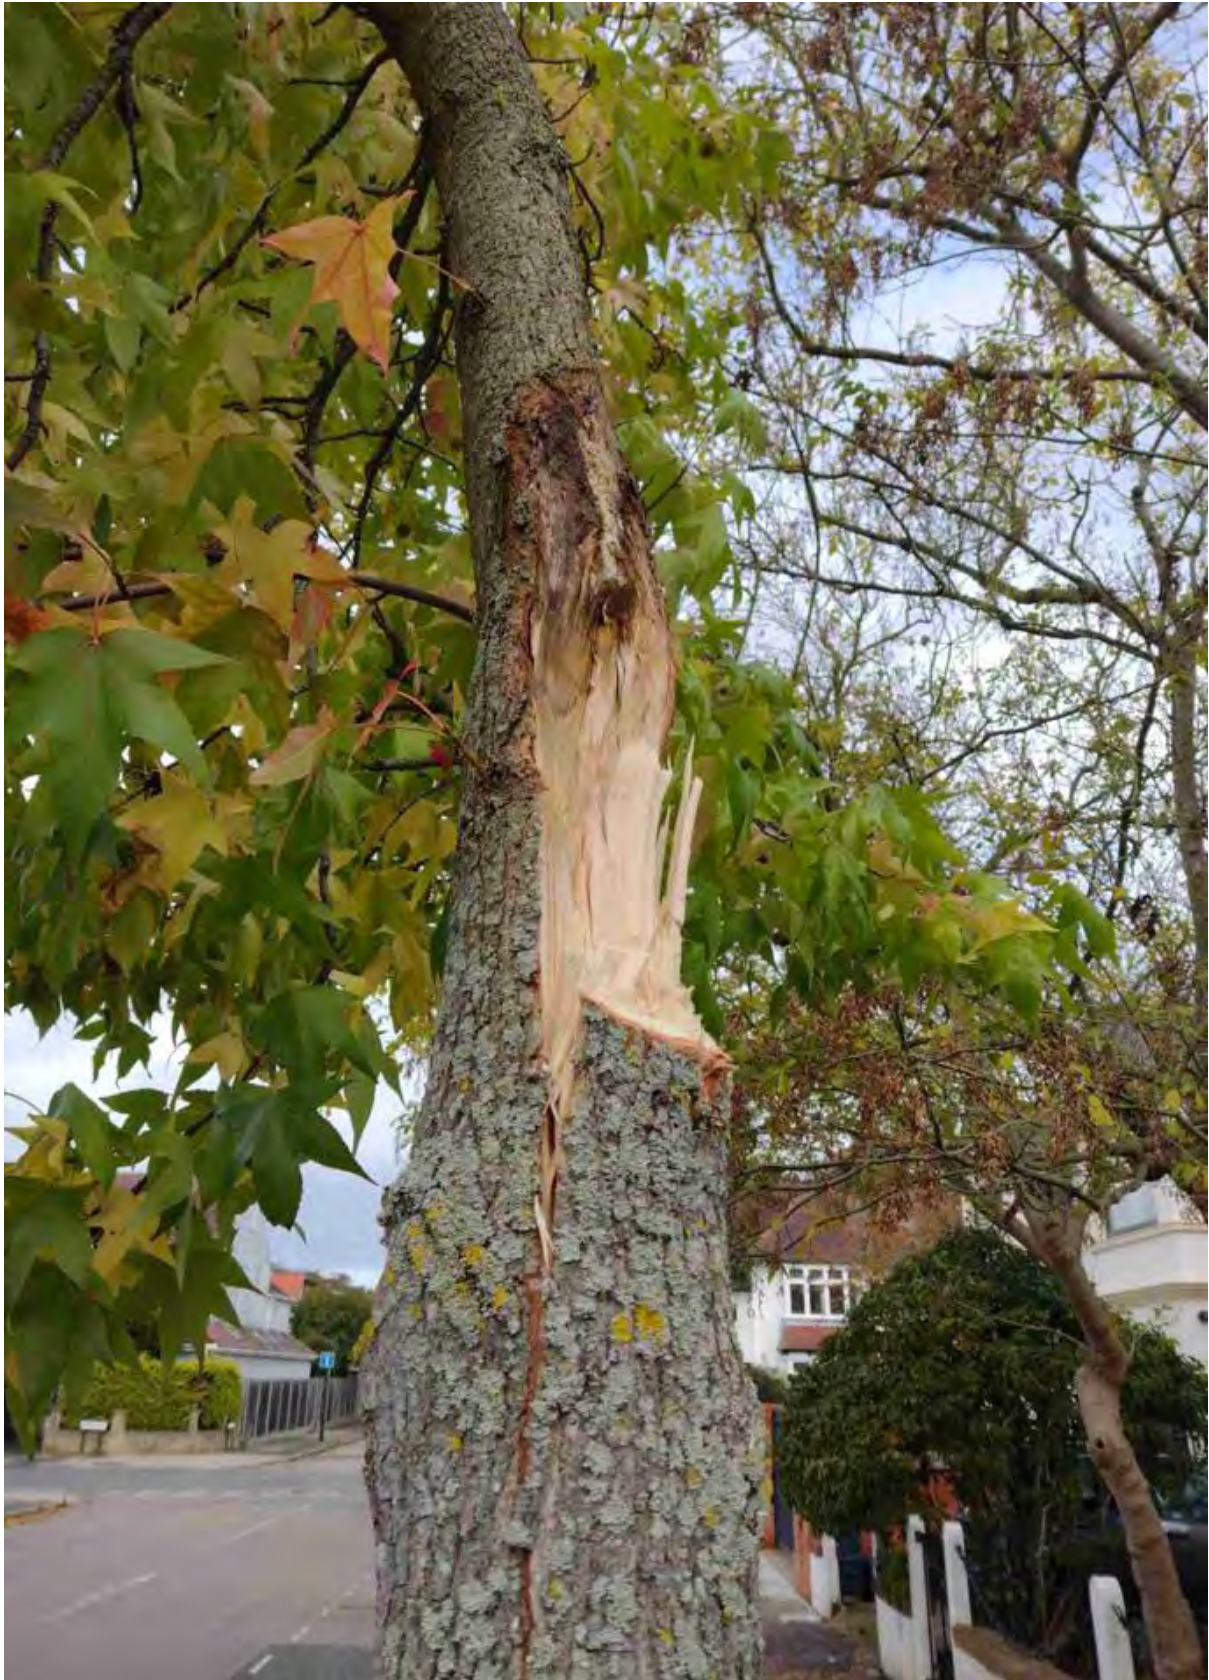
Image shows fracture wound on stem after primary union failed.

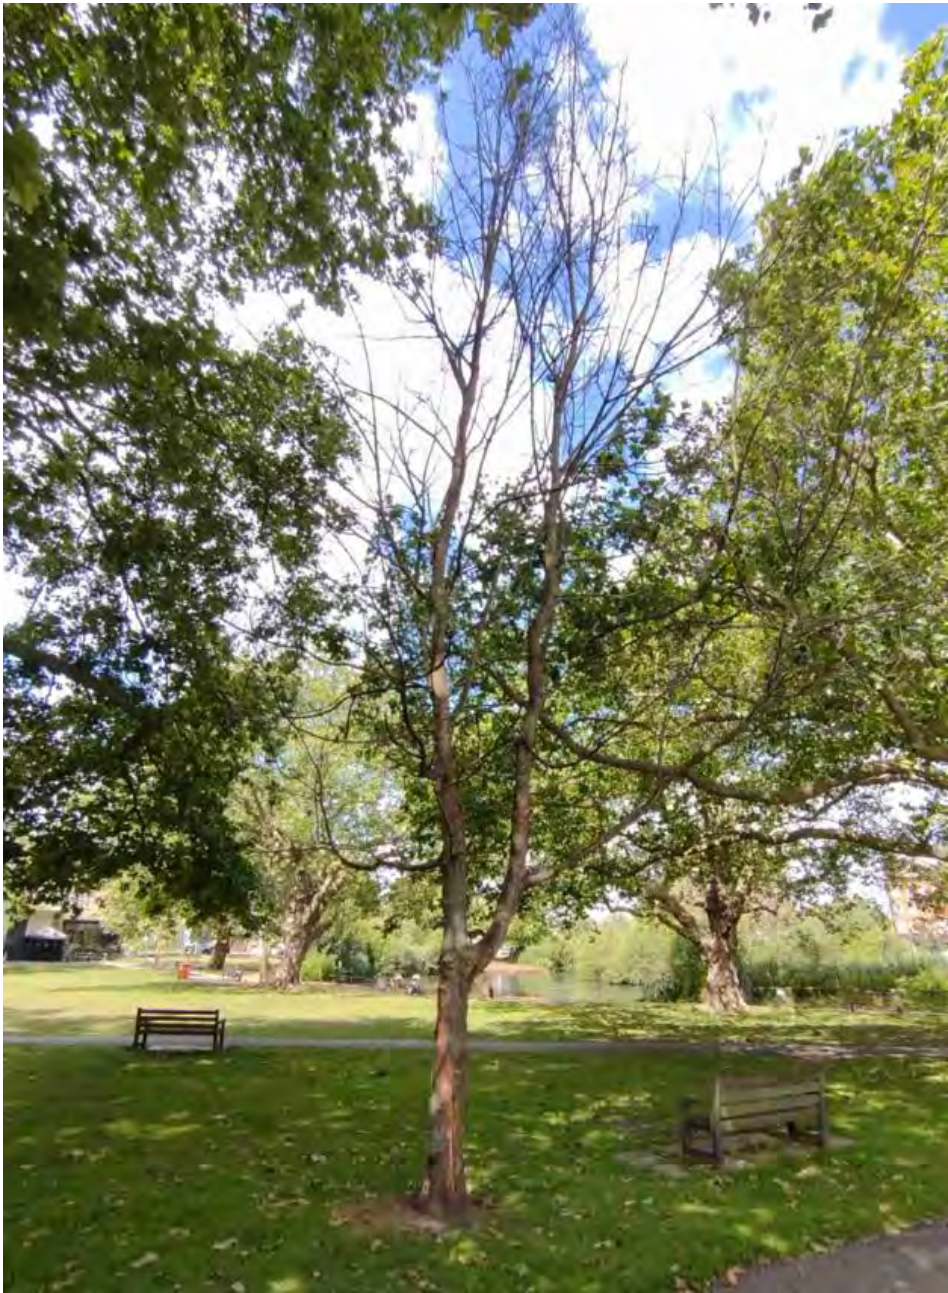
Ward	Barnes
Road	Church Road
Location	Opposite 30 The Crescent – What3Words- ///shapes.pushed.school
Species	Norway Maple (<i>Acer platanoides</i>)
Height	12.5m
Physiological Condition	Dead
Structural Condition	Dead
Inspection findings	This tree is dead; removal is required to prevent natural failure and facilitate replanting

Image shows dead tree in park scene

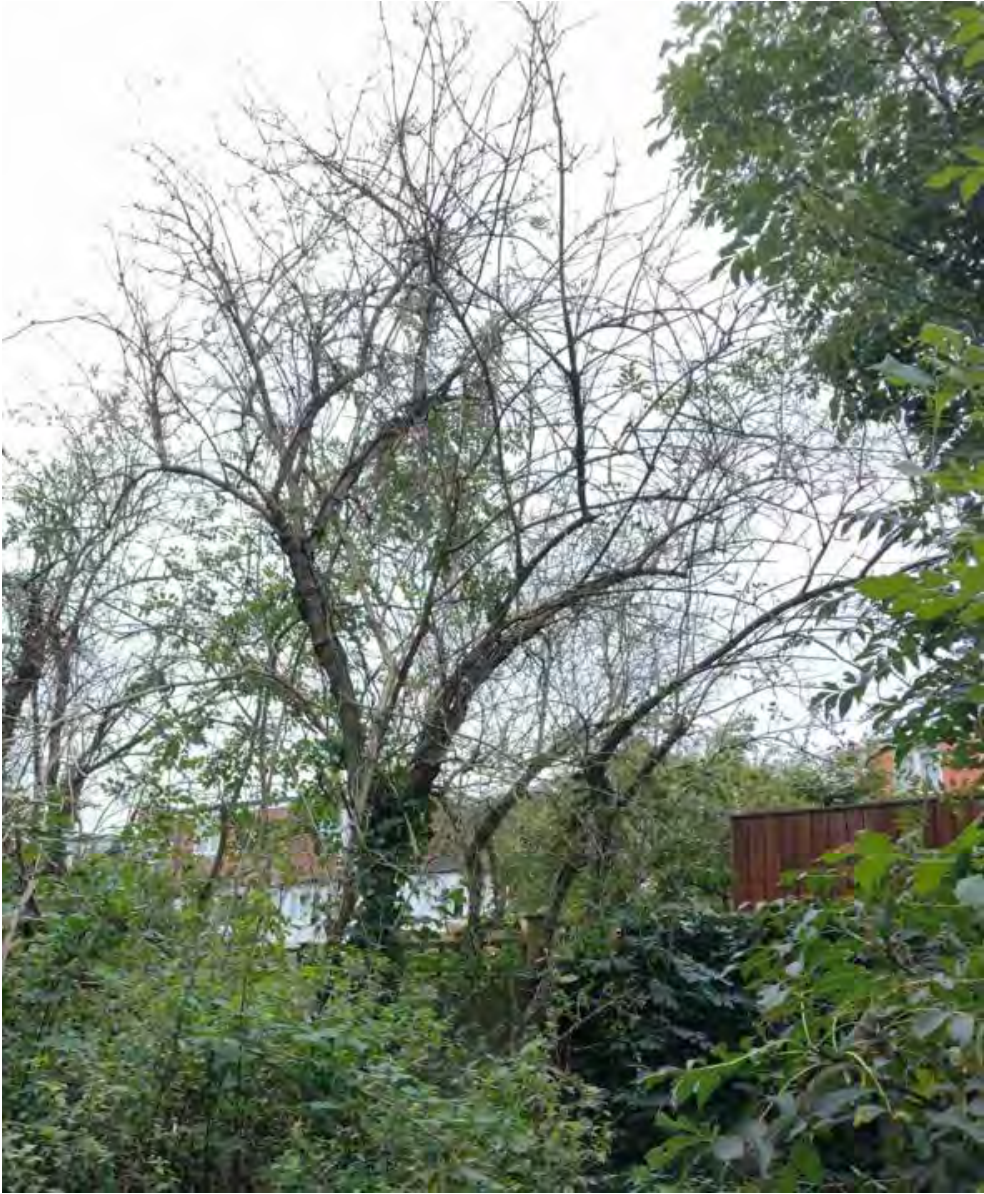
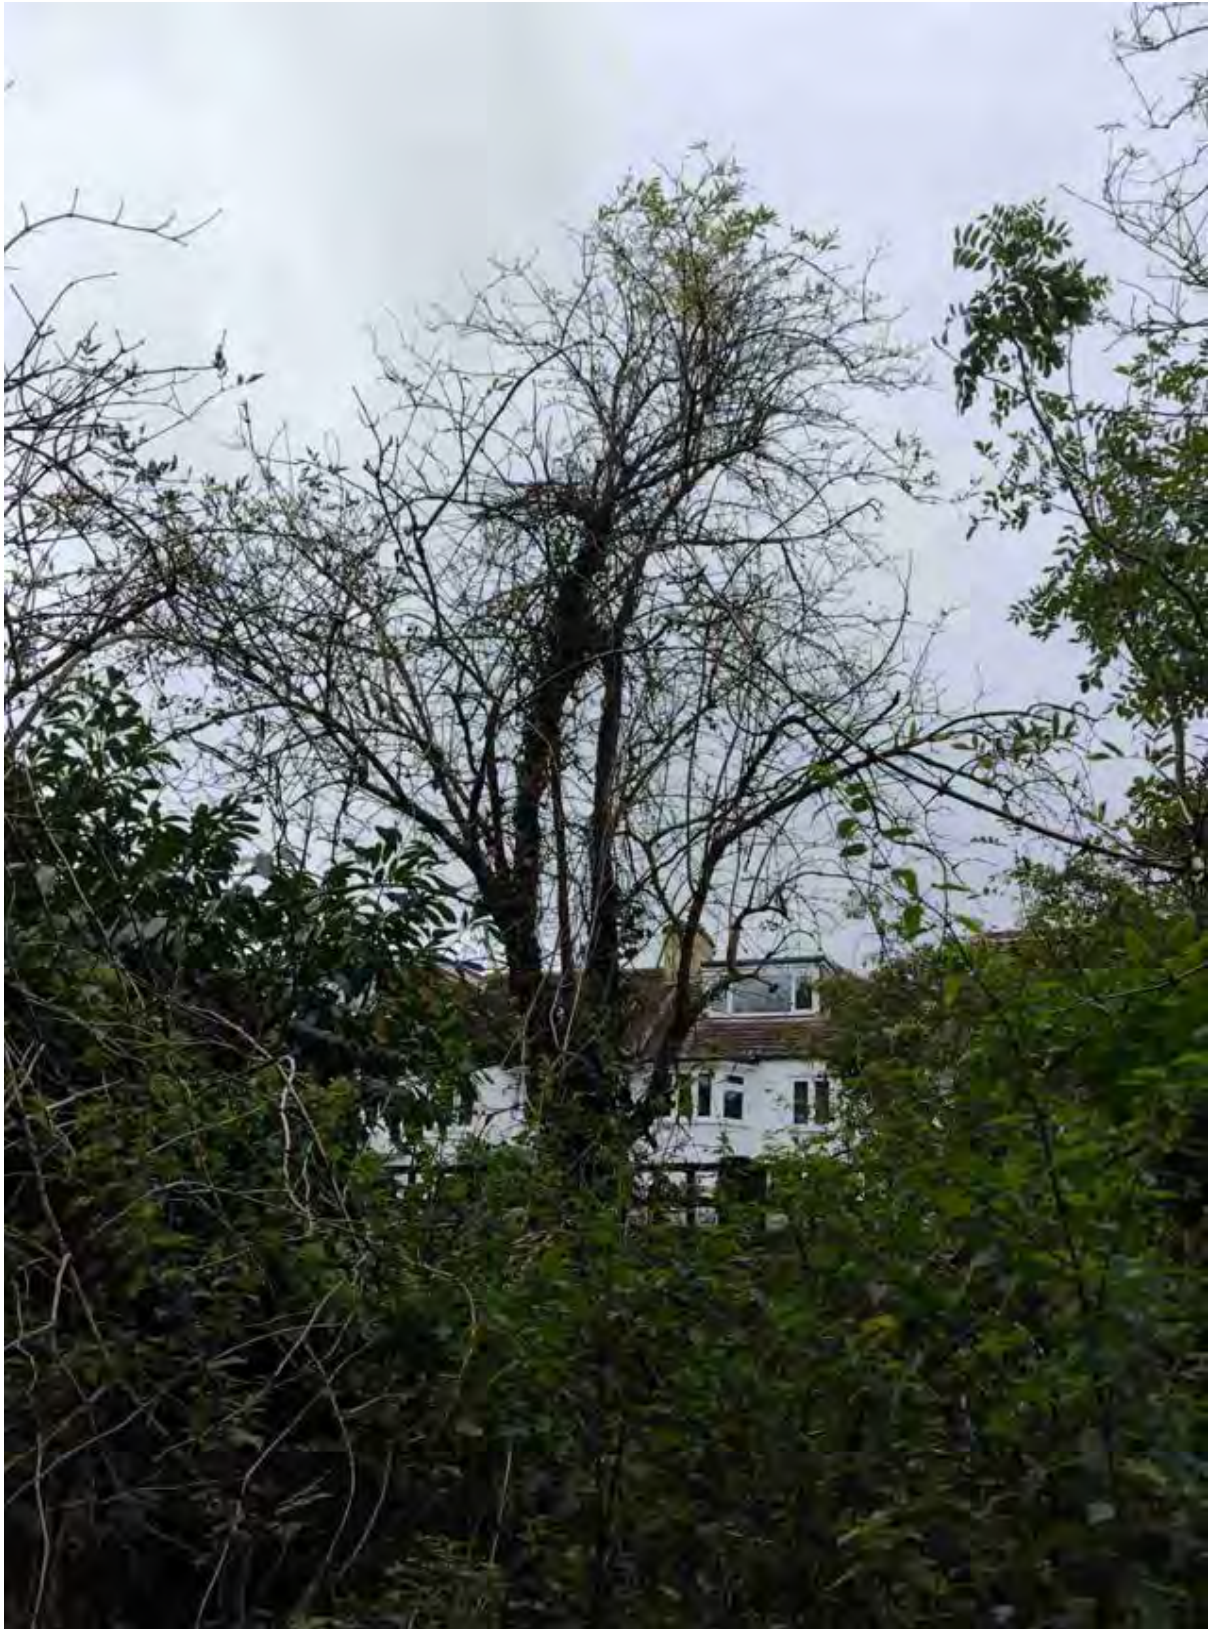
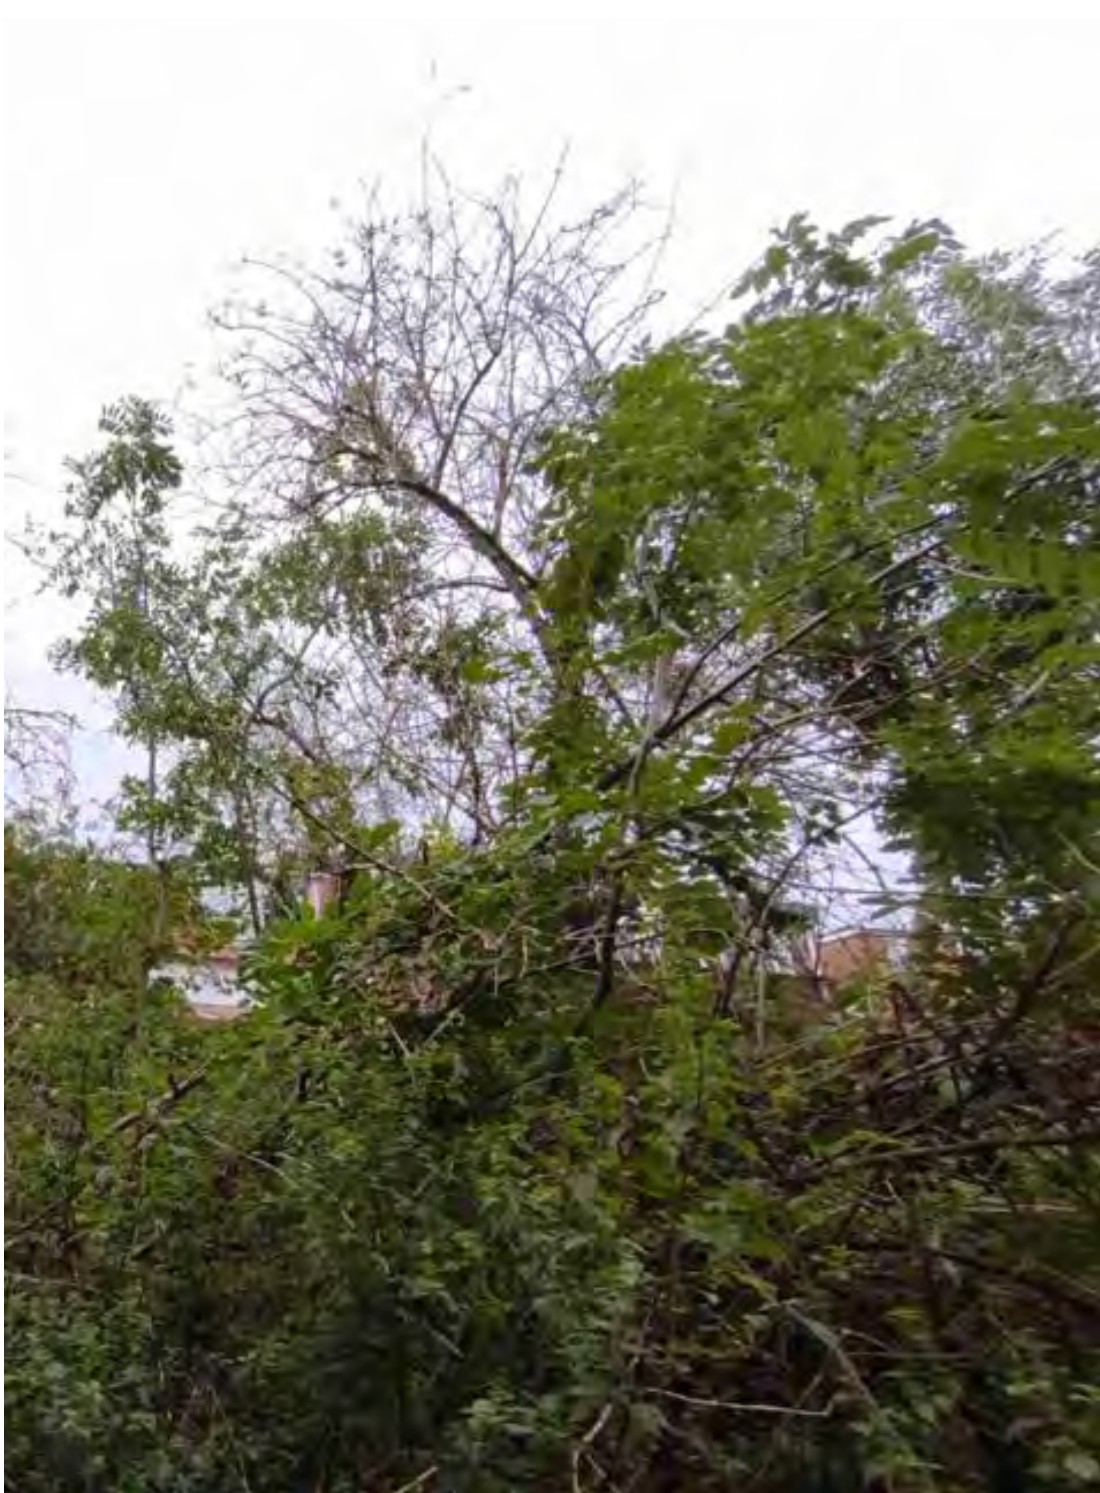
Ward	East Sheen
Road	Enmore Gardens
Location	Palewell Common - What3Words/// ankle.verse.unrealistic Behind 29 Enmore Garden's fence line.
Species	Group of 3 x Elderberry (<i>Sambucus nigra</i>)
Height	Between 4.0m and 6.0m
Physiological Condition	Poor
Structural Condition	Poor
Inspection findings	These trees are moribund; removal is required to prevent natural failure and manage risk.

Image 1 shows moribund tree in allotment scene.

Image 2 shows moribund tree in allotment scene.

Image 3 shows moribund tree in allotment scene.

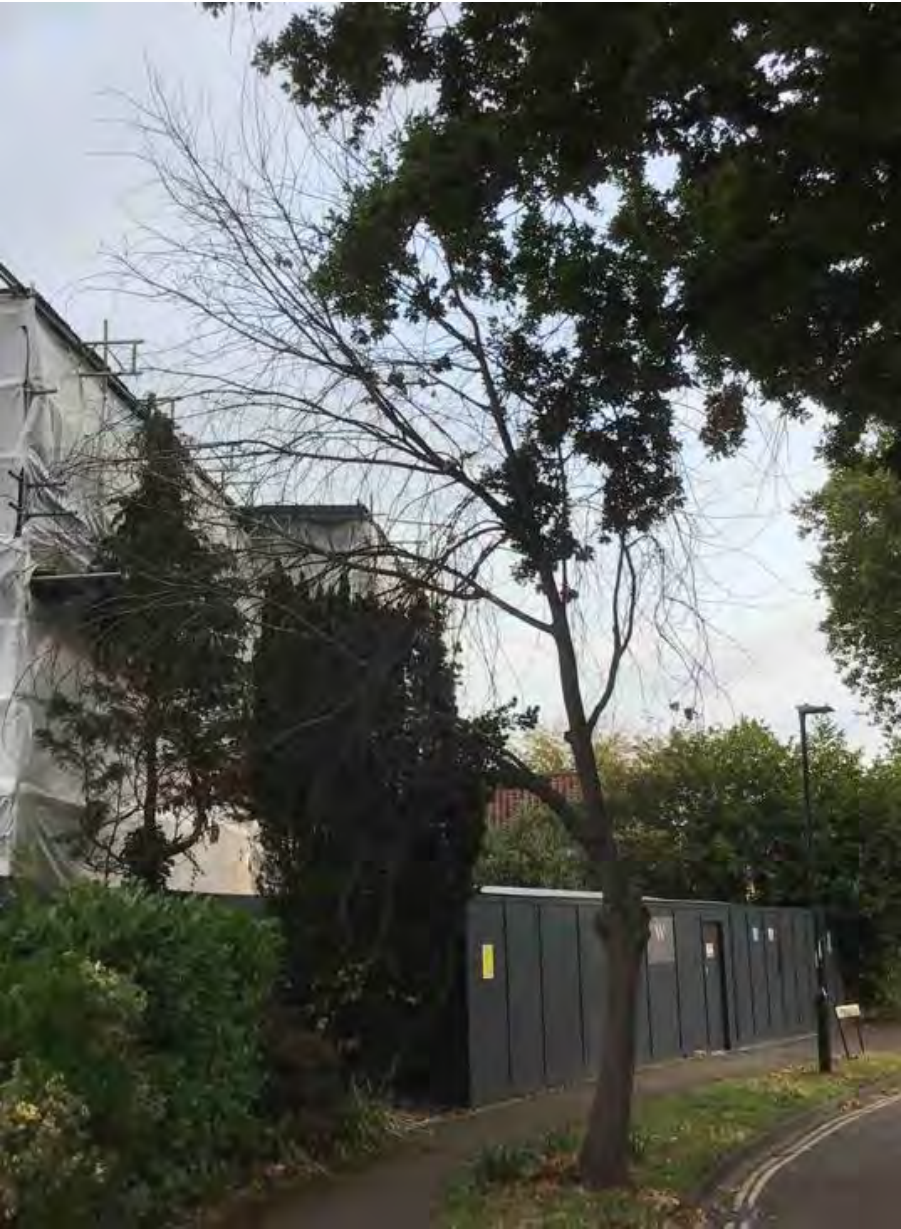
Ward	Ham, Petersham and Richmond Riverside
Road	Ashfield Close
Location	Outside 4
Species	Bird Cherry (<i>Prunus padus</i>)
Height	9.0m
Physiological Condition	Dead
Structural Condition	Dead
Inspection findings	This tree is dead; removal is required to prevent natural failure and facilitate replanting

Image shows dead tree in street scene

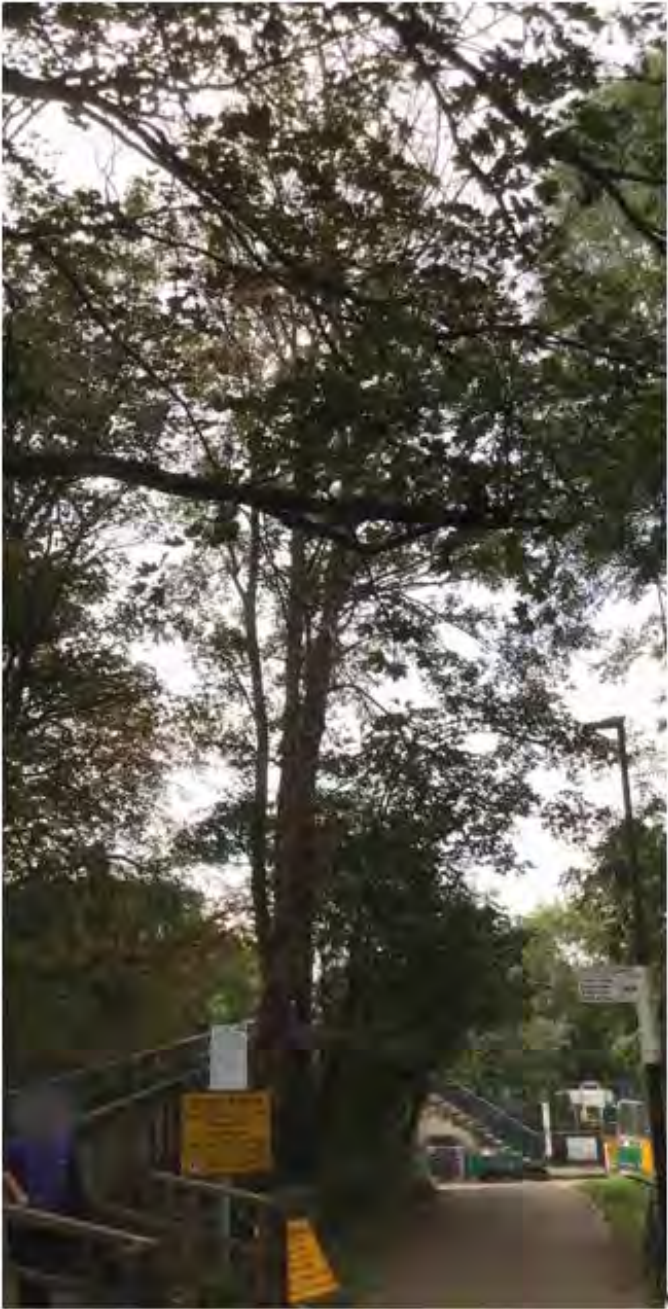
Ward	Ham, Petersham and Richmond Riverside
Road	Riverside Drive
Location	Thames Towpath- ///What3Words- stews.dates.petal
Species	Sycamore (<i>Acer platanoides</i>)
Height	21.0m
Physiological Condition	Dead
Structural Condition	Dead
Inspection findings	This tree is dead; removal is required to prevent natural failure and manage risk.

Image shows dead tree in street scene.
