November 2023 - Reactive Tree Works Programme

Introduction

Dated 21.11.2023

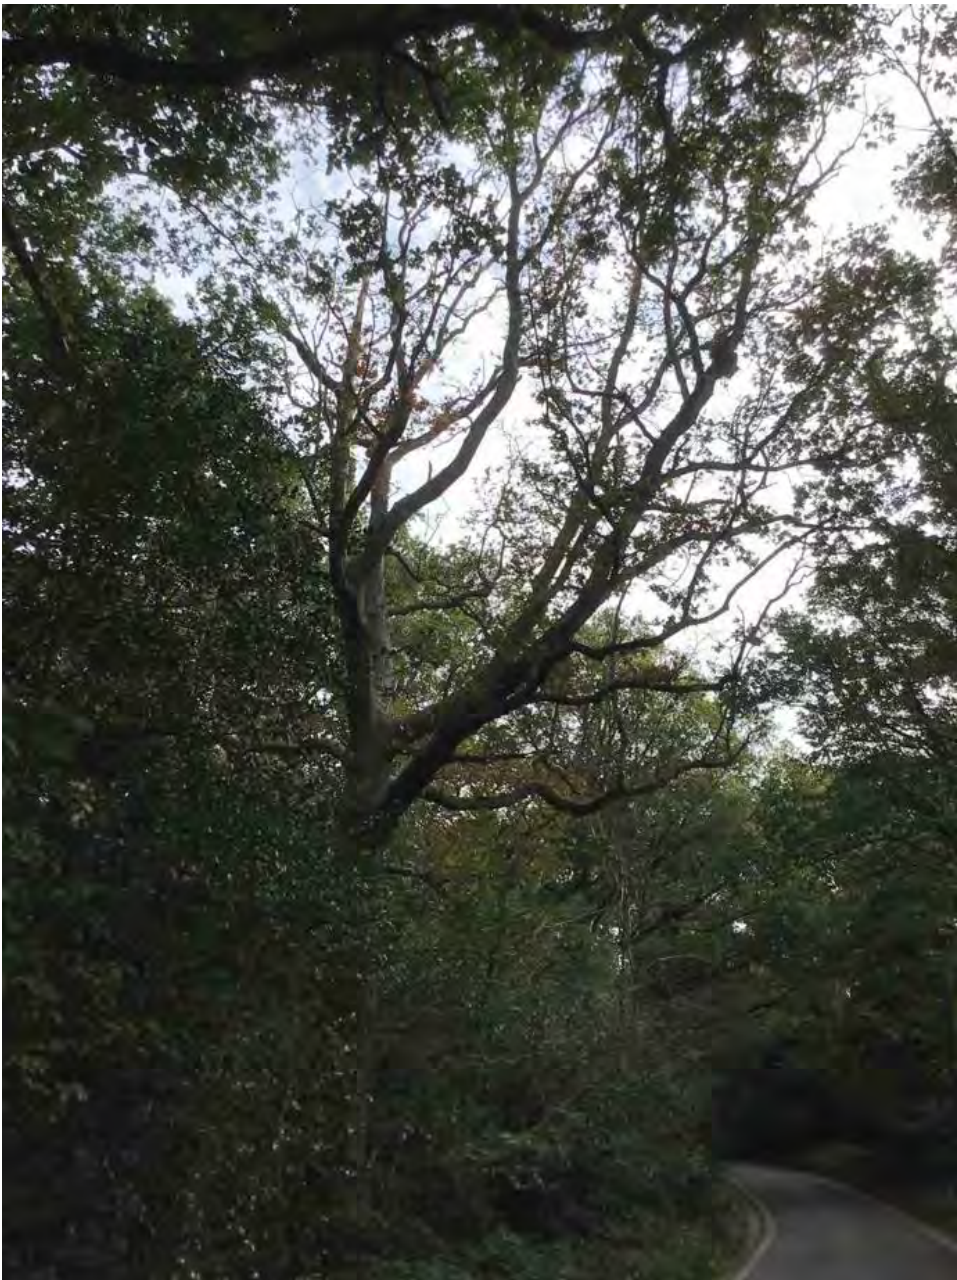
Ward	Ham, Petersham and Richmond Riverside
Road	Upper Ham Road
Location	Ham Common Woods- ///What3Words- tools.firmly.support
Species	Common Oak (<i>Quercus robur</i>)
Height	22.0m
Physiological Condition	Poor
Structural Condition	Poor
Inspection findings	This tree is in a state of physiological decline and contains weak branches that are liable to collapse. Removal is required to prevent natural failure and manage risk.

Image shows tree with extensive canopy loss

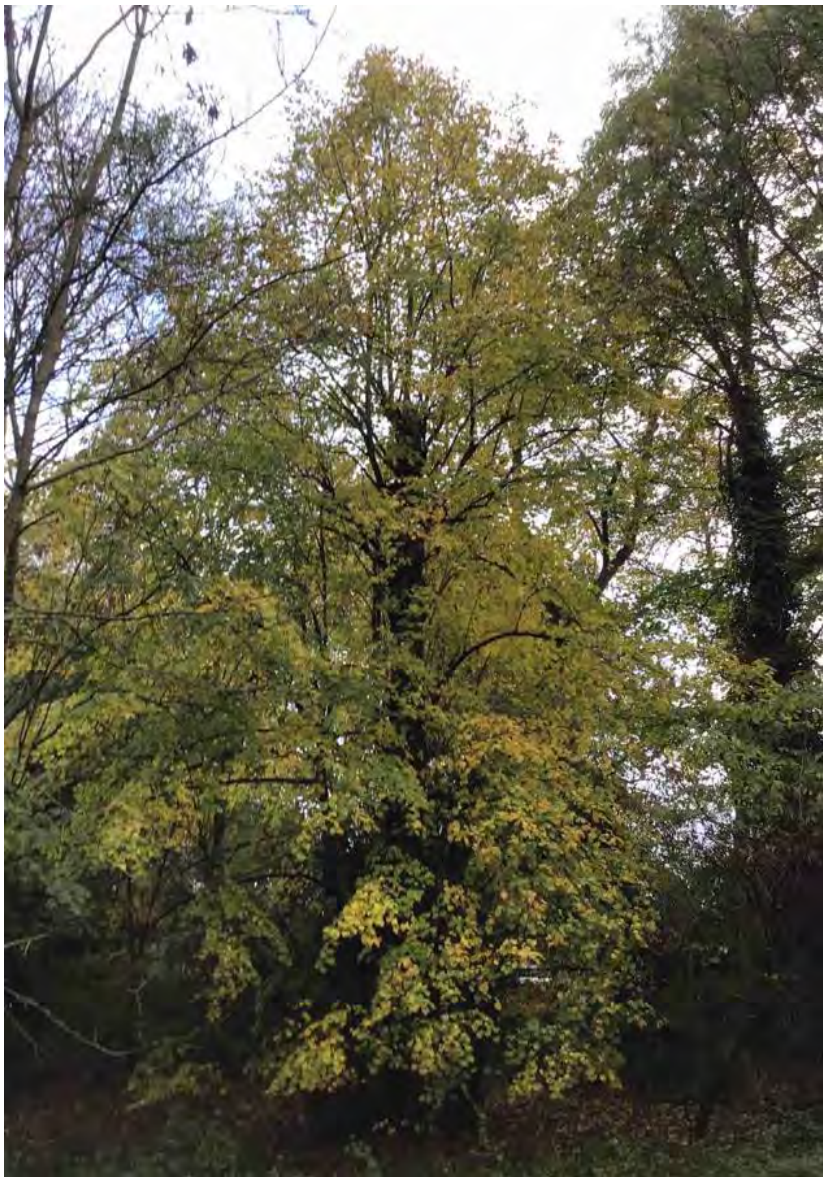
Ward	Ham, Petersham and Richmond Riverside
Road	River Lane
Location	Petersham Lodge Woods- ///limit.rested.hurt
Species	Lime Tree (<i>Tilia sp.</i>)
Height	21.0m
Physiological Condition	Poor
Structural Condition	Poor
Inspection findings	This tree is in a state of physiological decline, with an unacceptable amount of decay at the base and weak branches that are liable to collapse. Removal is required to prevent natural failure and manage risk.

Images show tree in woodland scene.

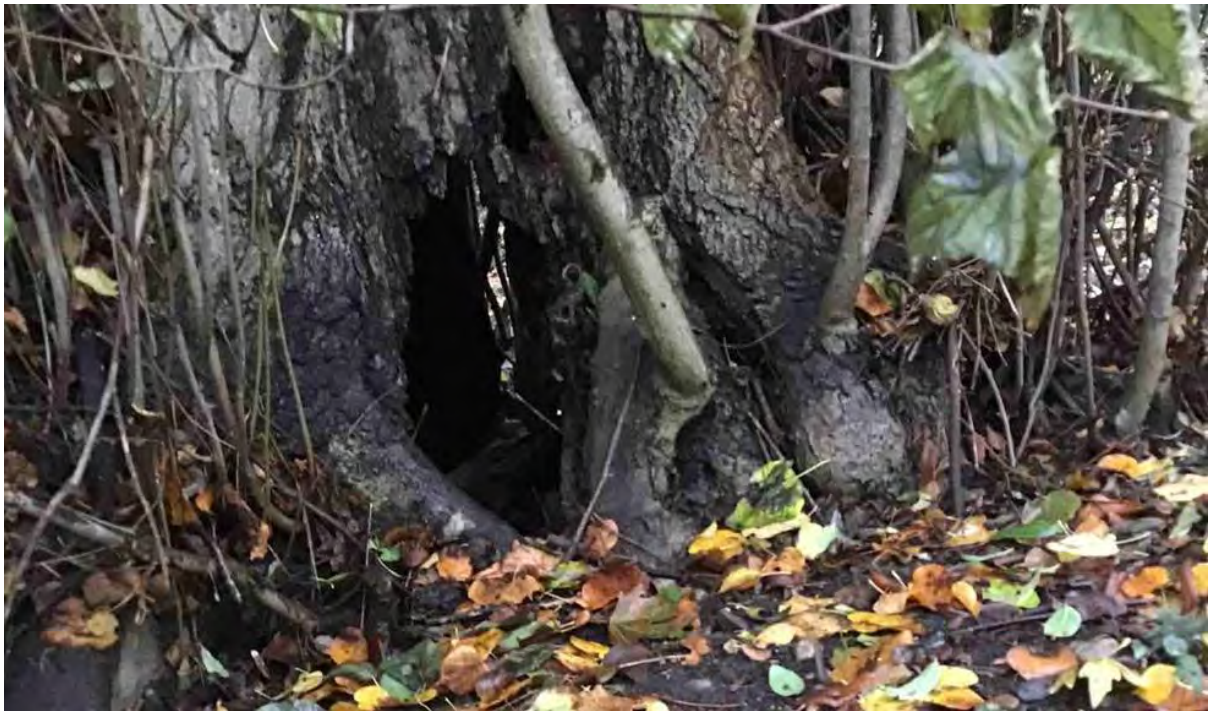
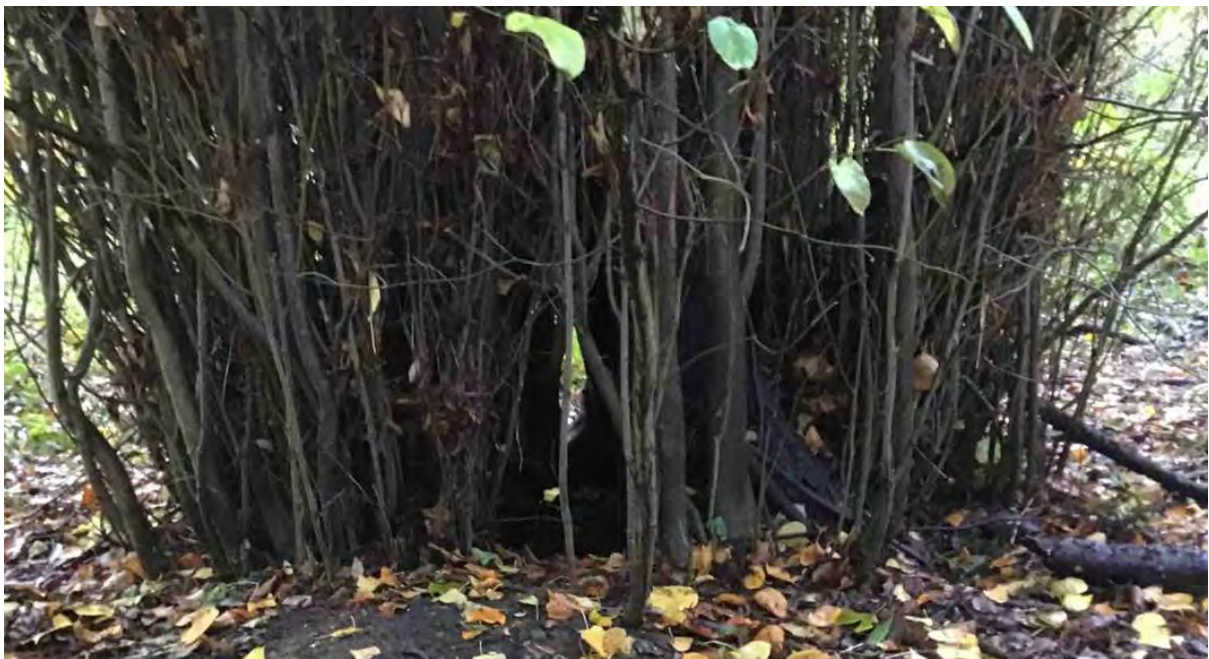
Images show decay in base of stem.

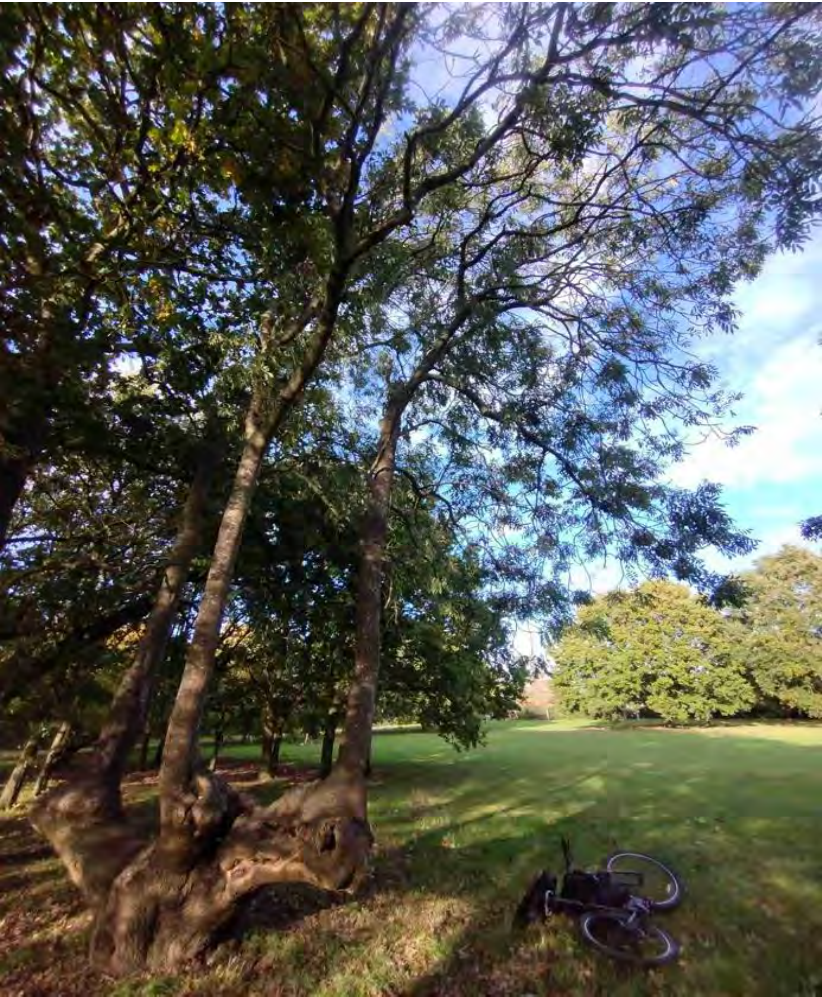
Ward	Hampton North
Road	Buckingham Road
Location	Hampton Common- ///What3Words- chip.shark.blaze
Species	Common Ash (<i>Fraxinus excelsior</i>)
Height	10.0m
Physiological Condition	Fair
Structural Condition	Poor
Inspection findings	A fungal fruiting body of the species Shaggy Polypore (<i>Inonotus hispidus</i>) is present on the main stem or trunk. This fungus causes a simultaneous white rot which can cause snapping of tree parts in this species. There is an unacceptable amount of decay at the base of the three stems on this tree. The tree will be coppiced to 1m by removing the three main stems to prevent failure and retain the high habitat value of the base allowing the tree to regrow from the stump. This is traditional management for this species.

Image shows tree in park scene

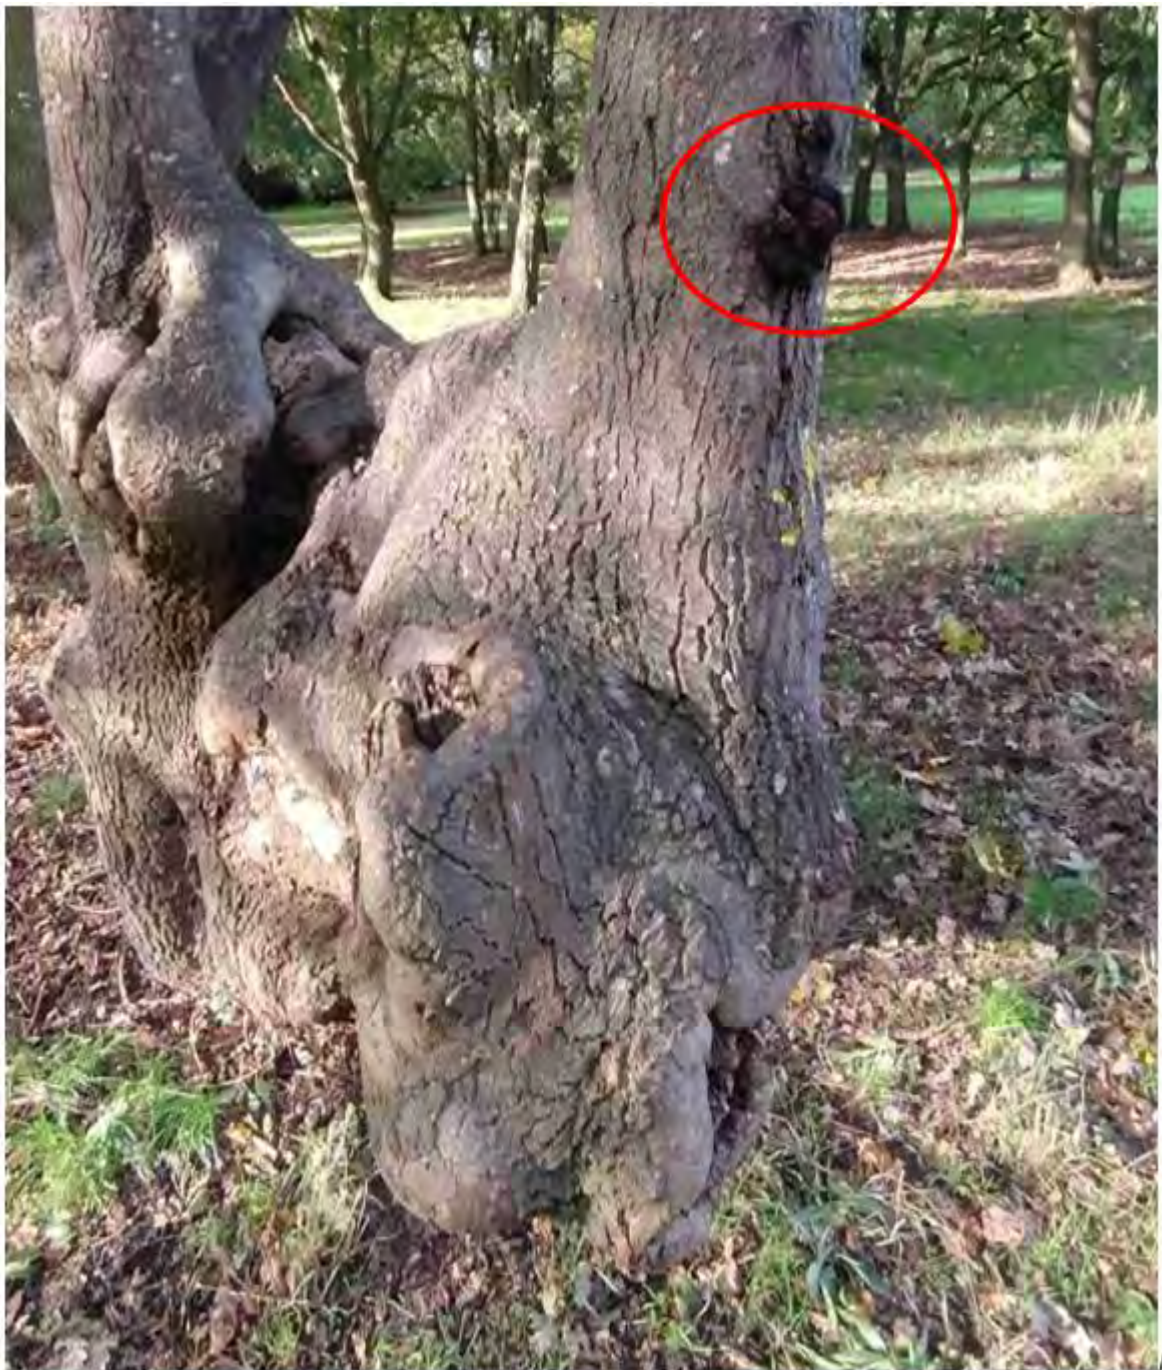
Image shows fruiting bodies circled.

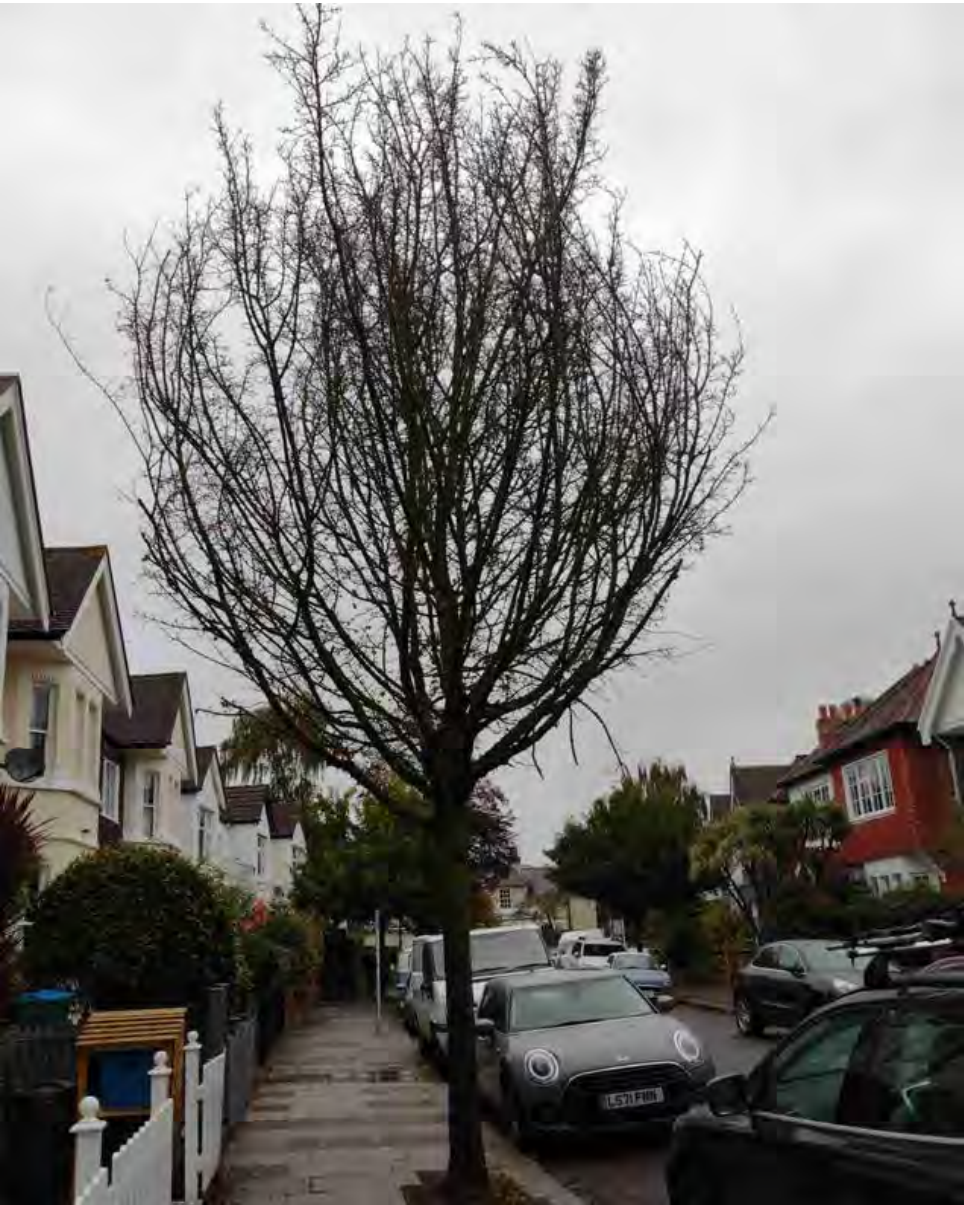
Ward	Kew
Road	Burlington Avenue
Location	Outside 14/16
Species	Field Maple (<i>Acer campestre</i>)
Height	9.0m
Physiological Condition	Dead
Structural Condition	Dead
Inspection findings	This tree is dead; removal is required to prevent natural failure and facilitate replanting

Image shows dead tree in street scene.

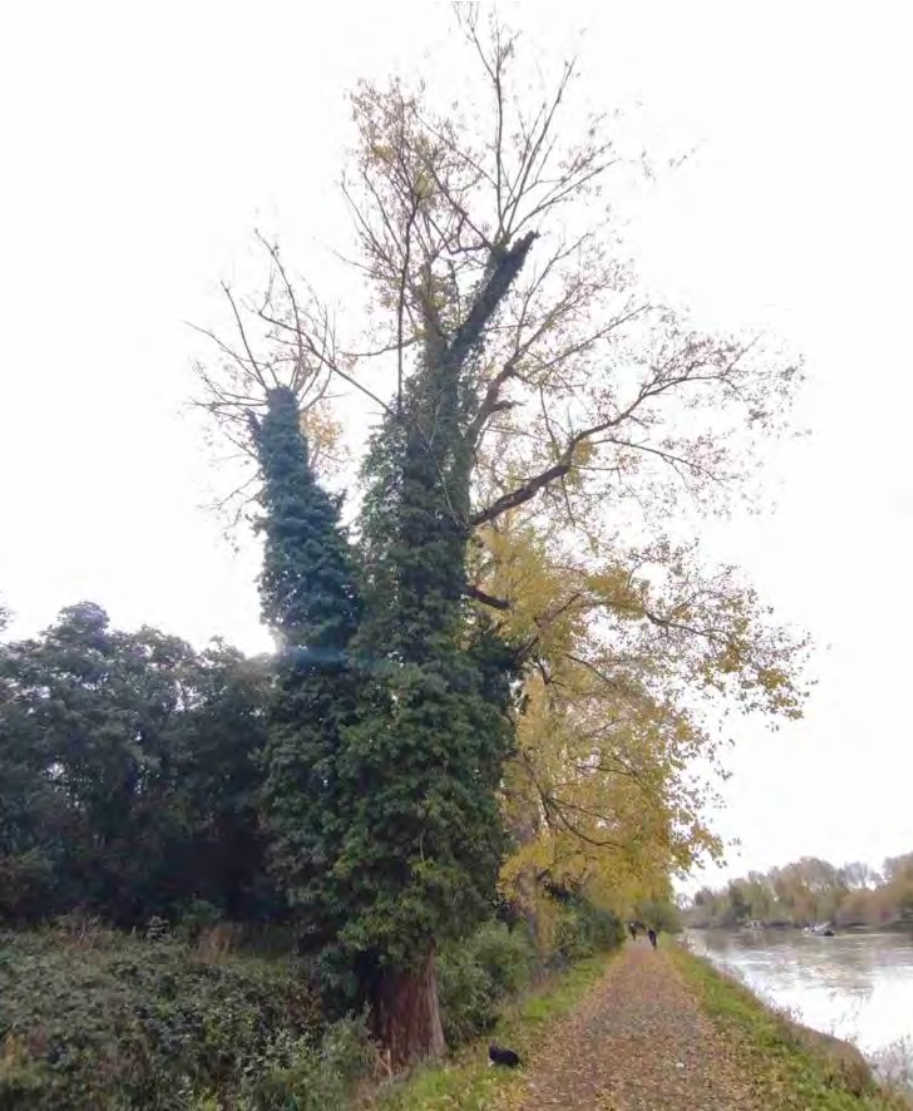
Ward	Kew
Road	UNFP - Queens Cottage Grounds to Kew Bdg
Location	Thames Towpath- risk.bridge.ample
Species	Black Poplar (<i>Populus nigra</i>)
Height	27.0m
Physiological Condition	Fair
Structural Condition	Poor
Inspection findings	A fungal fruiting body of the decay pathogen <i>Ganoderma</i> sp. is present at the stem base. Colonisation by this fungus causes a white rot of the stem and root system that can cause entire trees to collapse through fracture or windthrow. A resonance test revealed an unacceptable degree of decay in the trunk of this tree; this decay correlates with crown dieback and decline. Removal is required to prevent natural failure and manage risk.

Image shows tree in Towpath scene showing crown in decline.

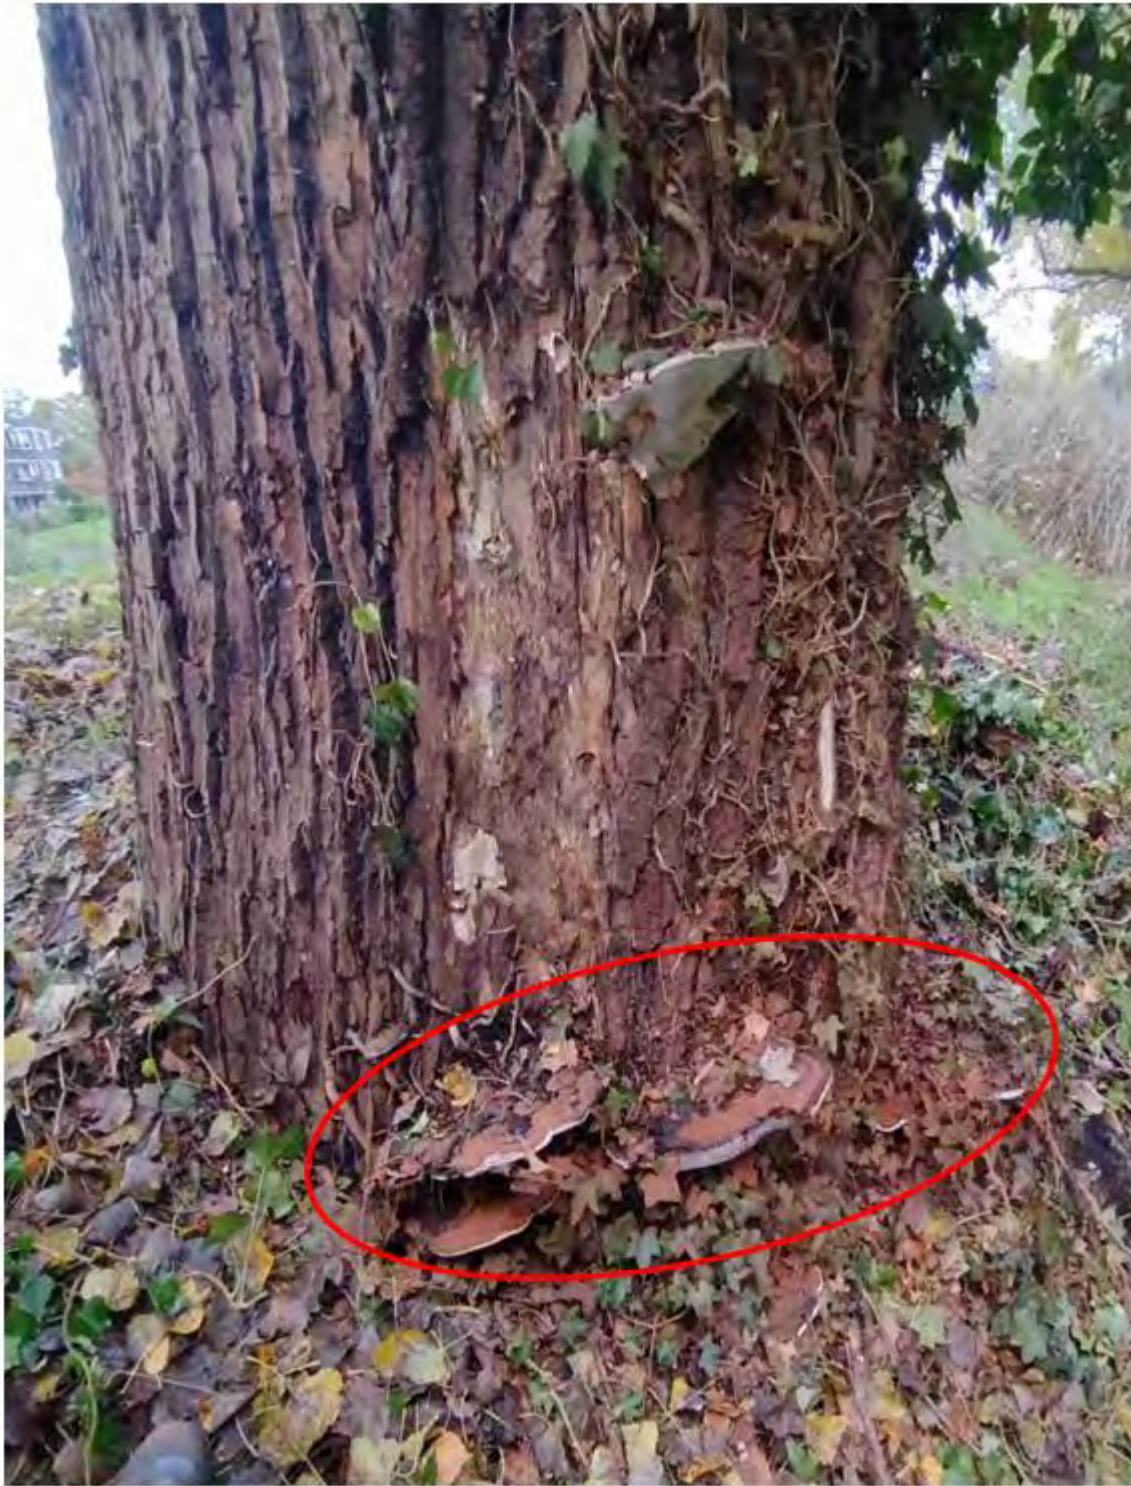
Image shows fruiting bodies circled at base of stem.

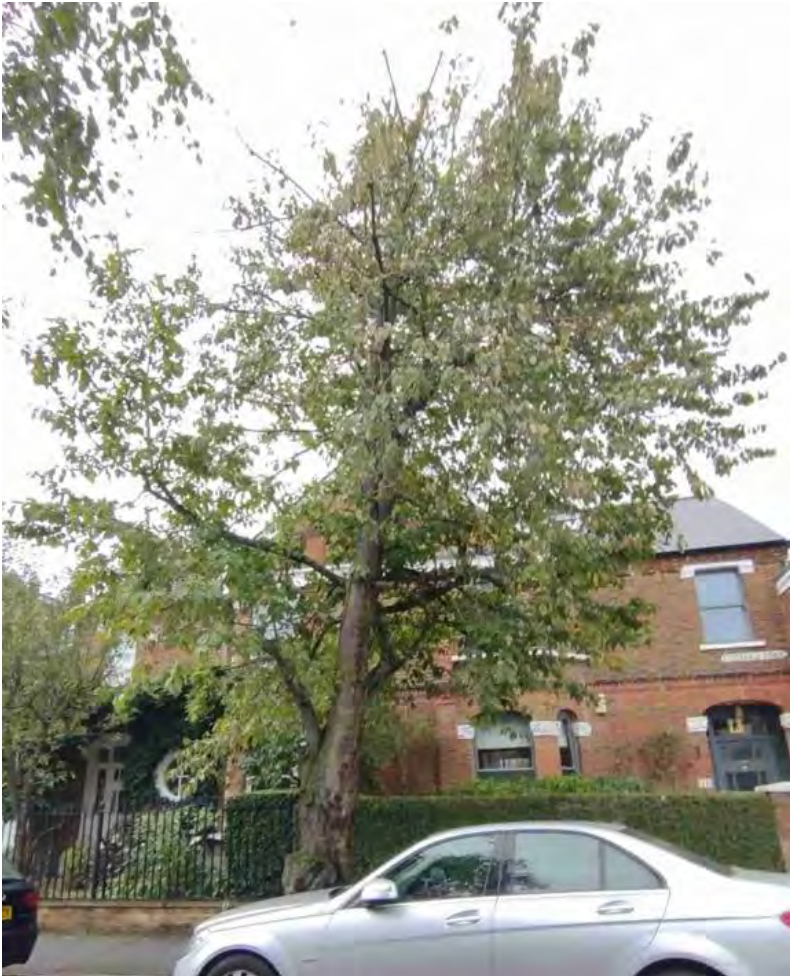
Ward	Mortlake and Barnes Common
Road	Fitzgerald Avenue
Location	Outside 11/13
Species	Wild Cherry (<i>Prunus avium</i>)
Height	11.0m
Physiological Condition	Good
Structural Condition	Poor
Inspection findings	A fungal fruiting body of the decay pathogen <i>Ganoderma</i> sp. is present at the stem base. Colonisation by this fungus causes a white rot of the stem and root system that can cause entire trees to collapse through fracture or windthrow. Investigation with a probe revealed an unacceptable amount of decay. Removal is required to prevent natural failure and facilitate replanting.

Image shows tree in street scene

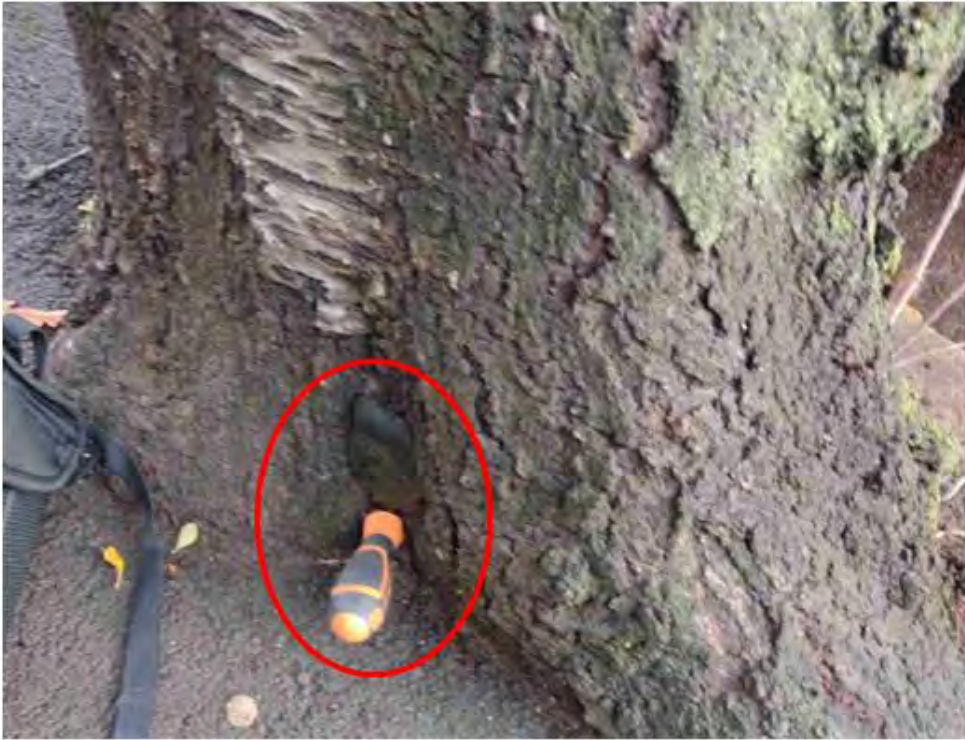
Image shows fruiting body with probe showing decay circled.

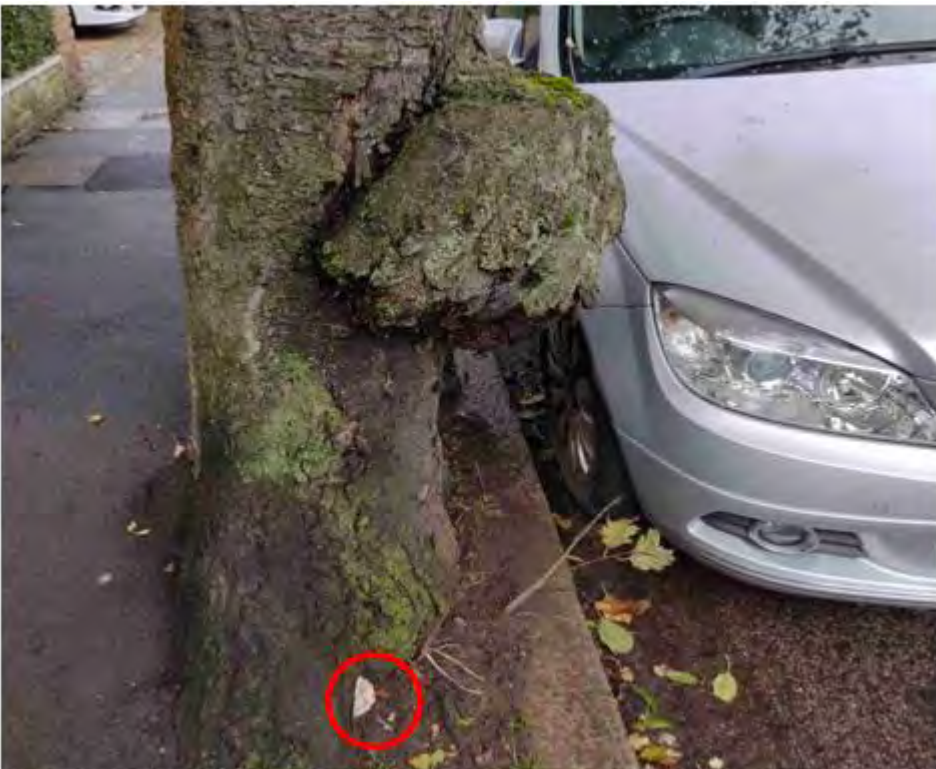
Image shows fruiting body circled and large canker.

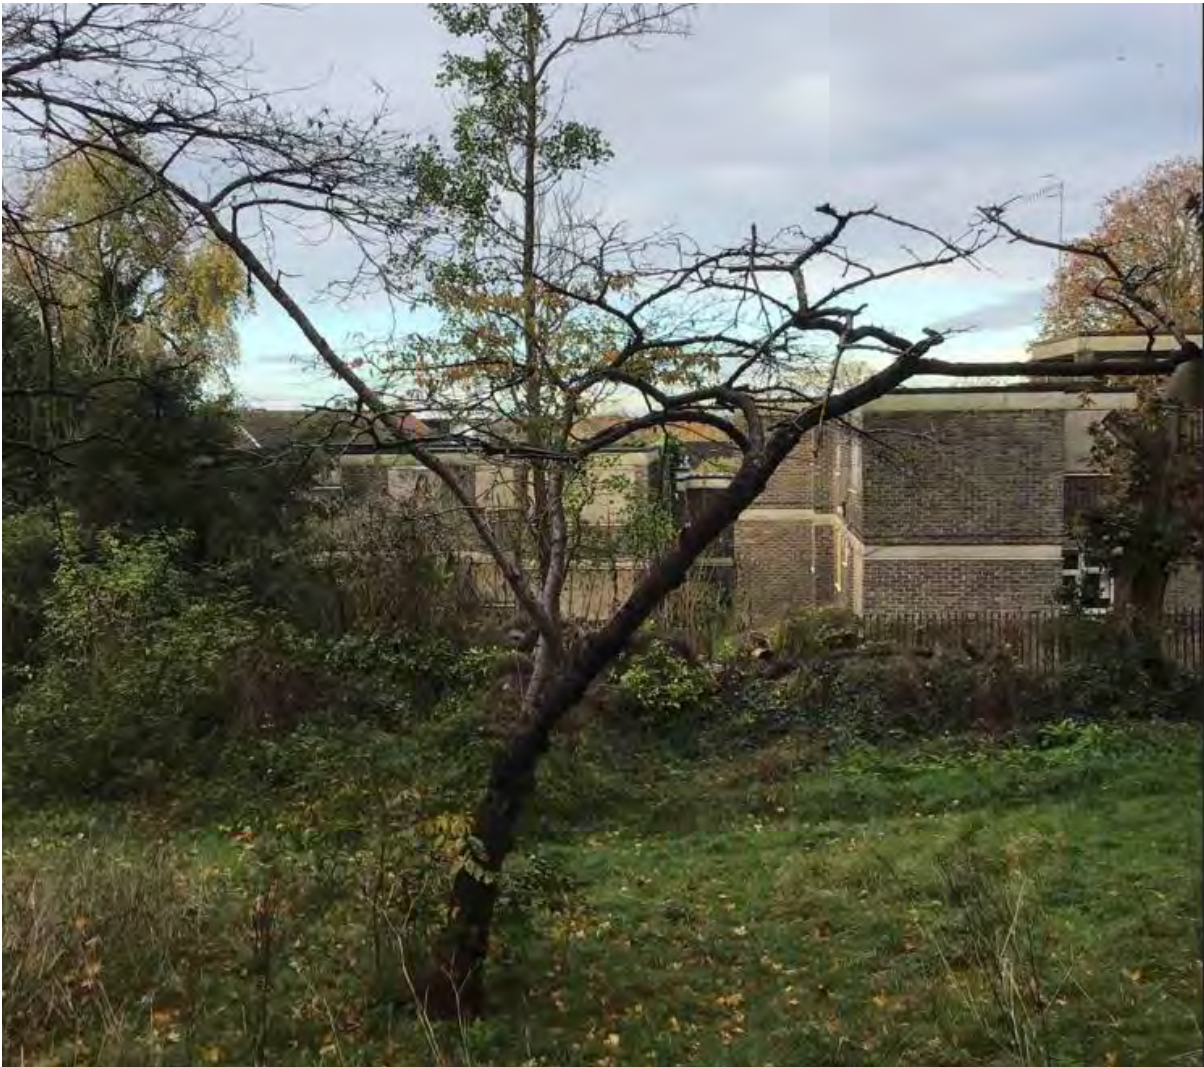
Ward	South Richmond
Road	Petersham Road
Location	Terrace Gardens- ///alarm.mice.foods
Species	Cherry (<i>Prunus sp.</i>)
Height	6.0m
Physiological Condition	Poor
Structural Condition	Poor
Inspection findings	This tree is moribund; removal is required to prevent natural failure and facilitate replanting

Image shows moribund tree in park scene.

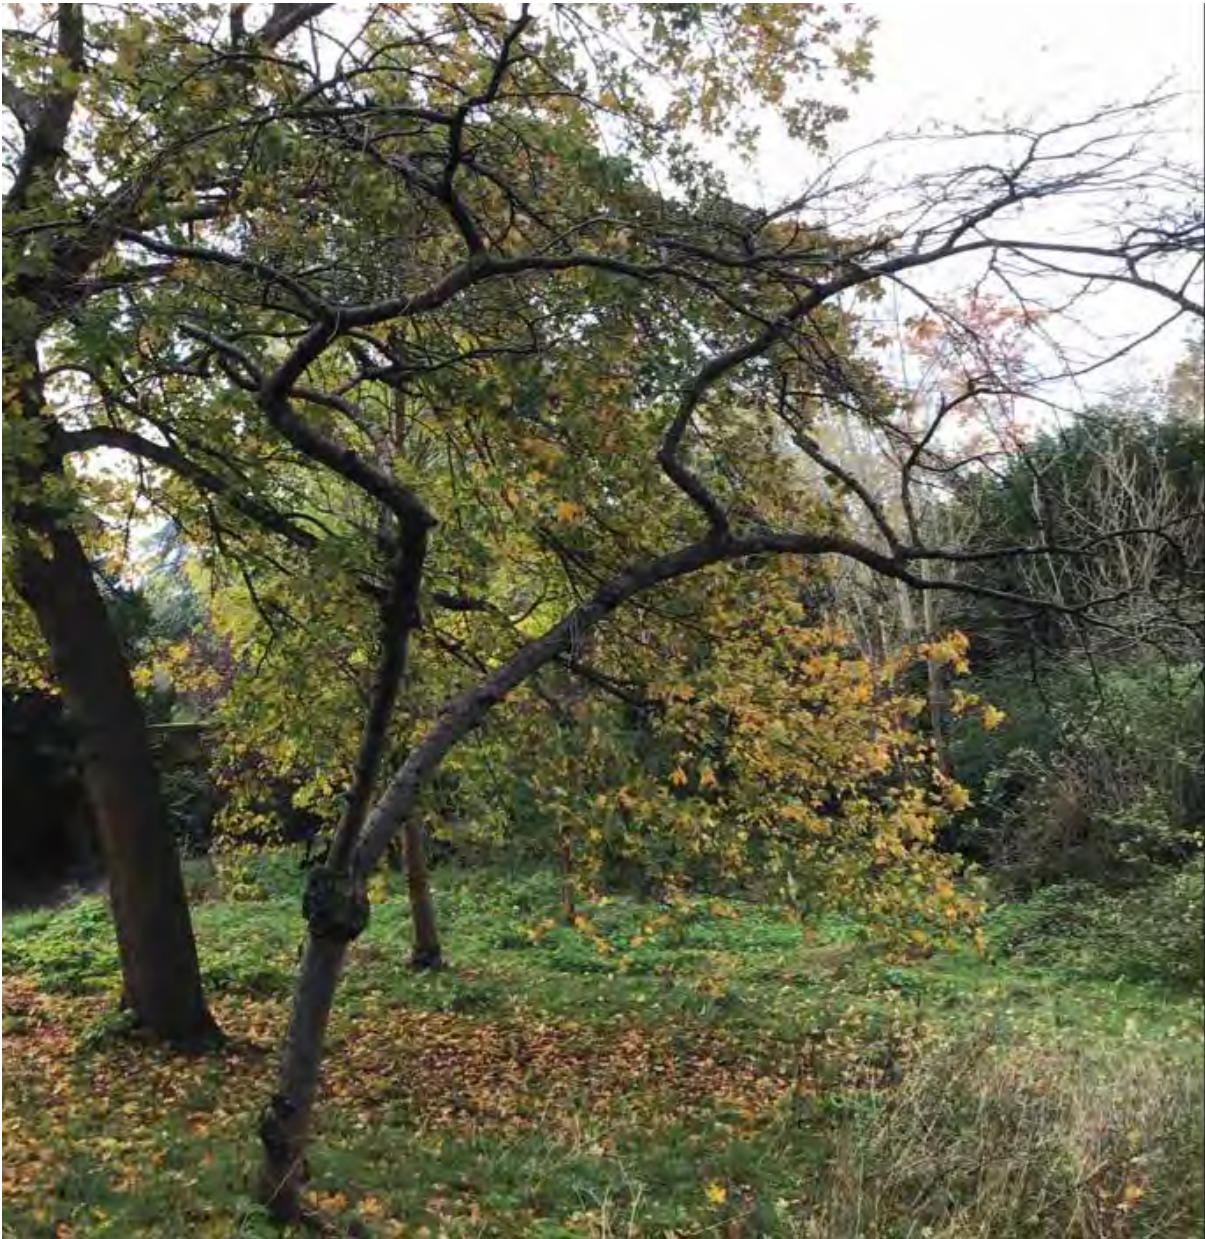
Ward	South Richmond
Road	Petersham Road
Location	Terrace Gardens- ///cattle.flap.discrepancy
Species	Cherry (<i>Prunus</i> sp.)
Height	6.0m
Physiological Condition	Dead
Structural Condition	Dead
Inspection findings	This tree is dead; removal is required to prevent natural failure and facilitate replanting

Image shows dead tree in park scene.

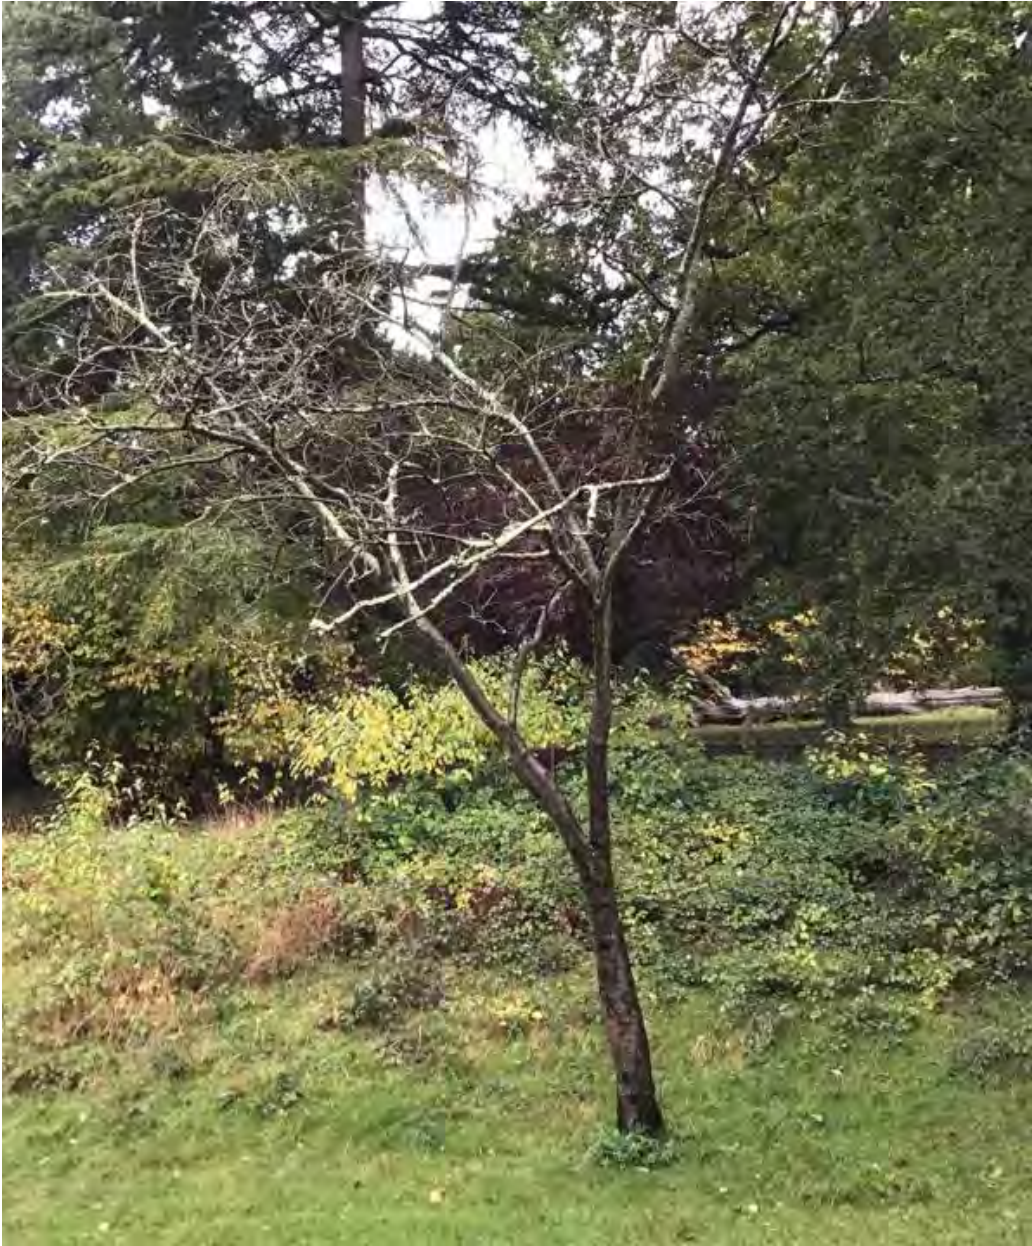
Ward	South Richmond
Road	Petersham Road
Location	Terrace Gardens- ///gladiators.curving.serves
Species	Cherry (<i>Prunus</i> sp.)
Height	7.0m
Physiological Condition	Dead
Structural Condition	Dead
Inspection findings	This tree is dead; removal is required to prevent natural failure and facilitate replanting

Image shows dead tree in park scene.

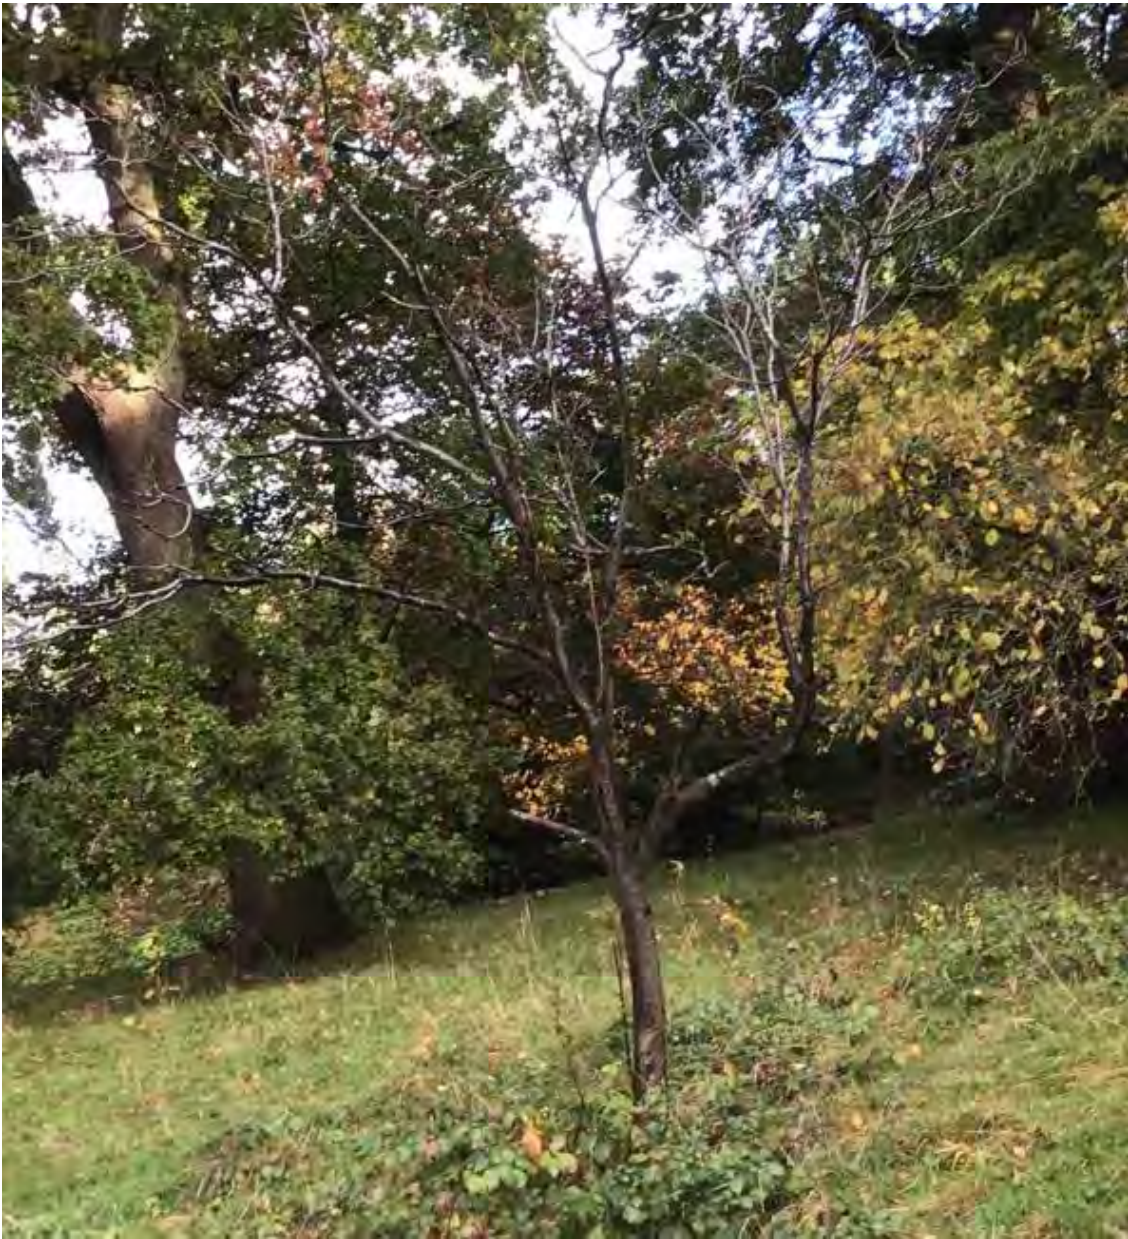
Ward	South Richmond
Road	Petersham Road
Location	Terrace Gardens- ///gladiators.curving.serves
Species	Rowan (<i>Sorbus aucuparia</i>)
Height	4.0m
Physiological Condition	Dead
Structural Condition	Dead
Inspection findings	This tree is dead; removal is required to prevent natural failure and facilitate replanting

Image shows dead tree in park scene.

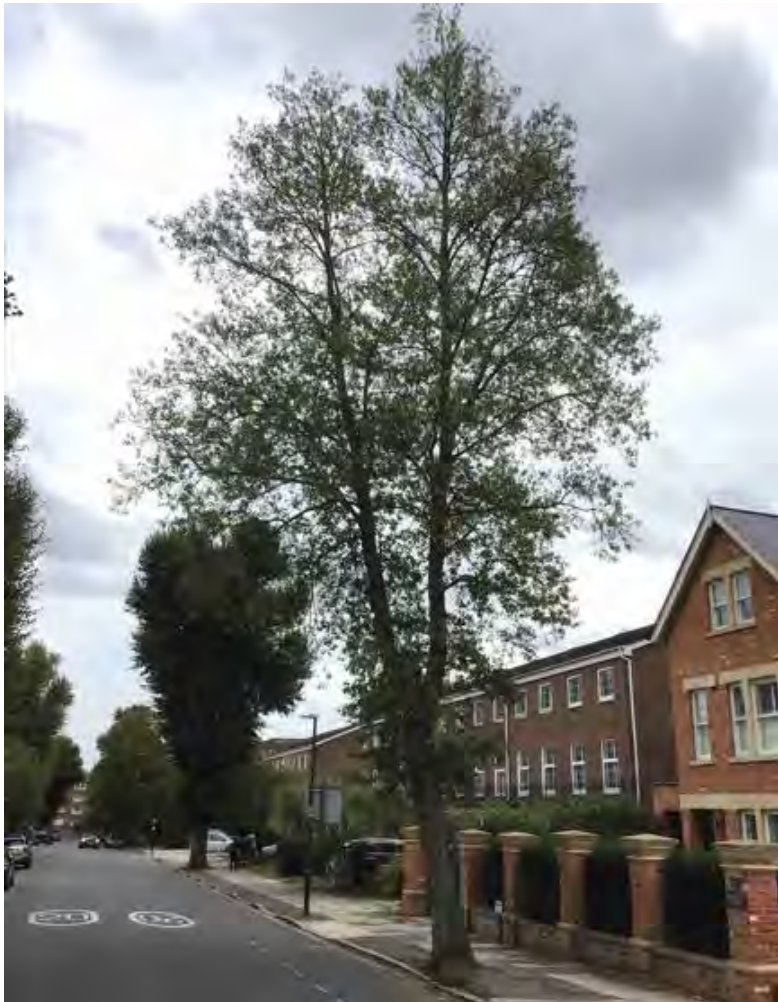
Ward	South Twickenham
Road	Waldegrave Park
Location	Outside 46A
Species	Italian Alder (<i>Alnus cordata</i>)
Height	20.5m
Physiological Condition	Poor
Structural Condition	Fair
Inspection findings	This tree has bark discolouration that indicates the presence of pathogen <i>Phytophthora</i> sp. This causes rotting of the roots of hosts which can cause entire trees to fail. Removal is required to prevent natural failure and facilitate replanting

Image shows tree on street scene with canopy die back evident.

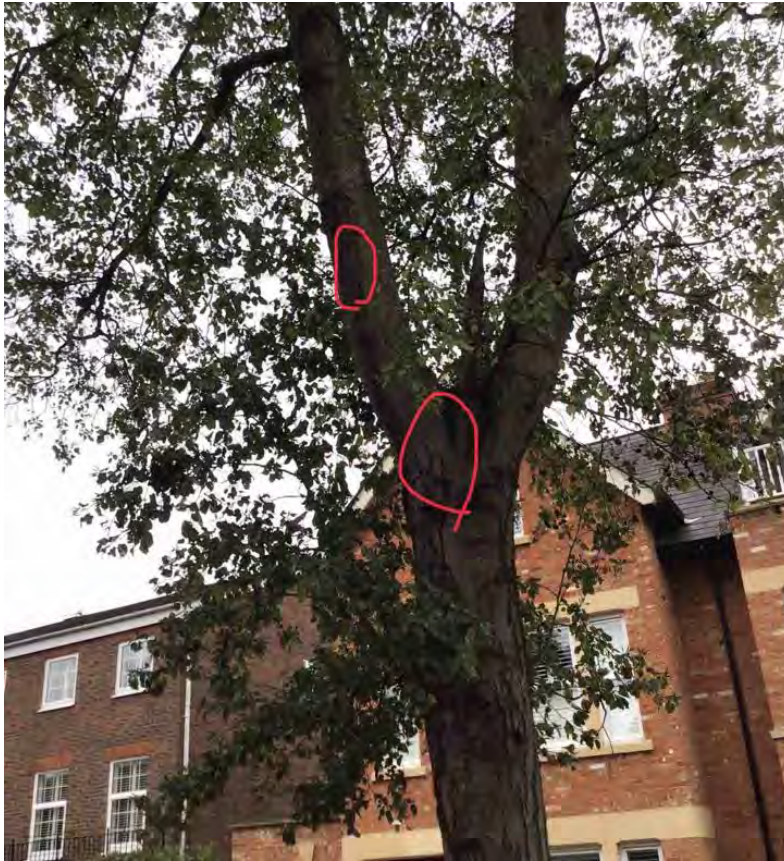
Image shows areas of bleeding bark circled in red associated with Phytophthora.

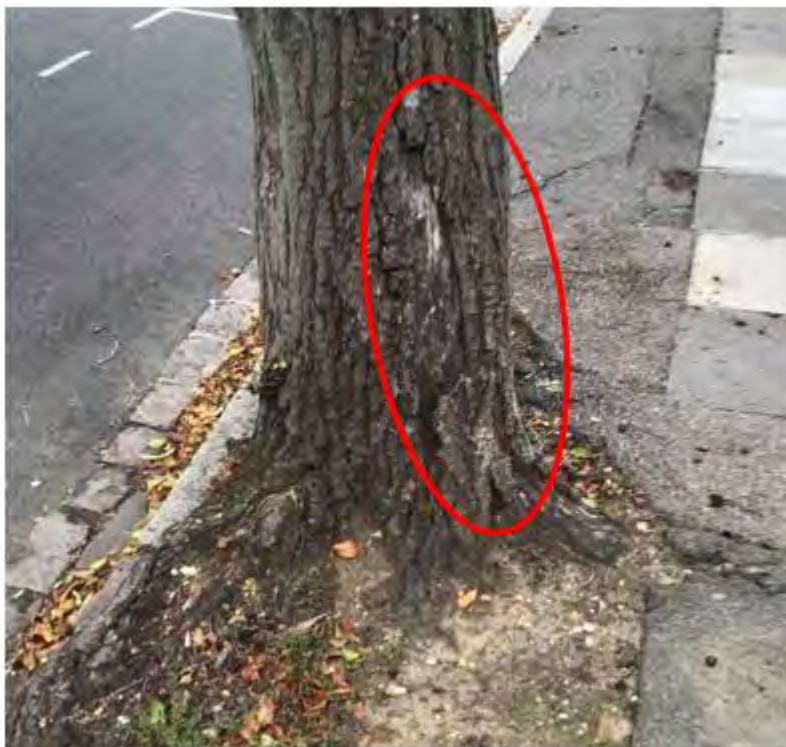
Image shows areas of delaminated bark circled in red at base of stem

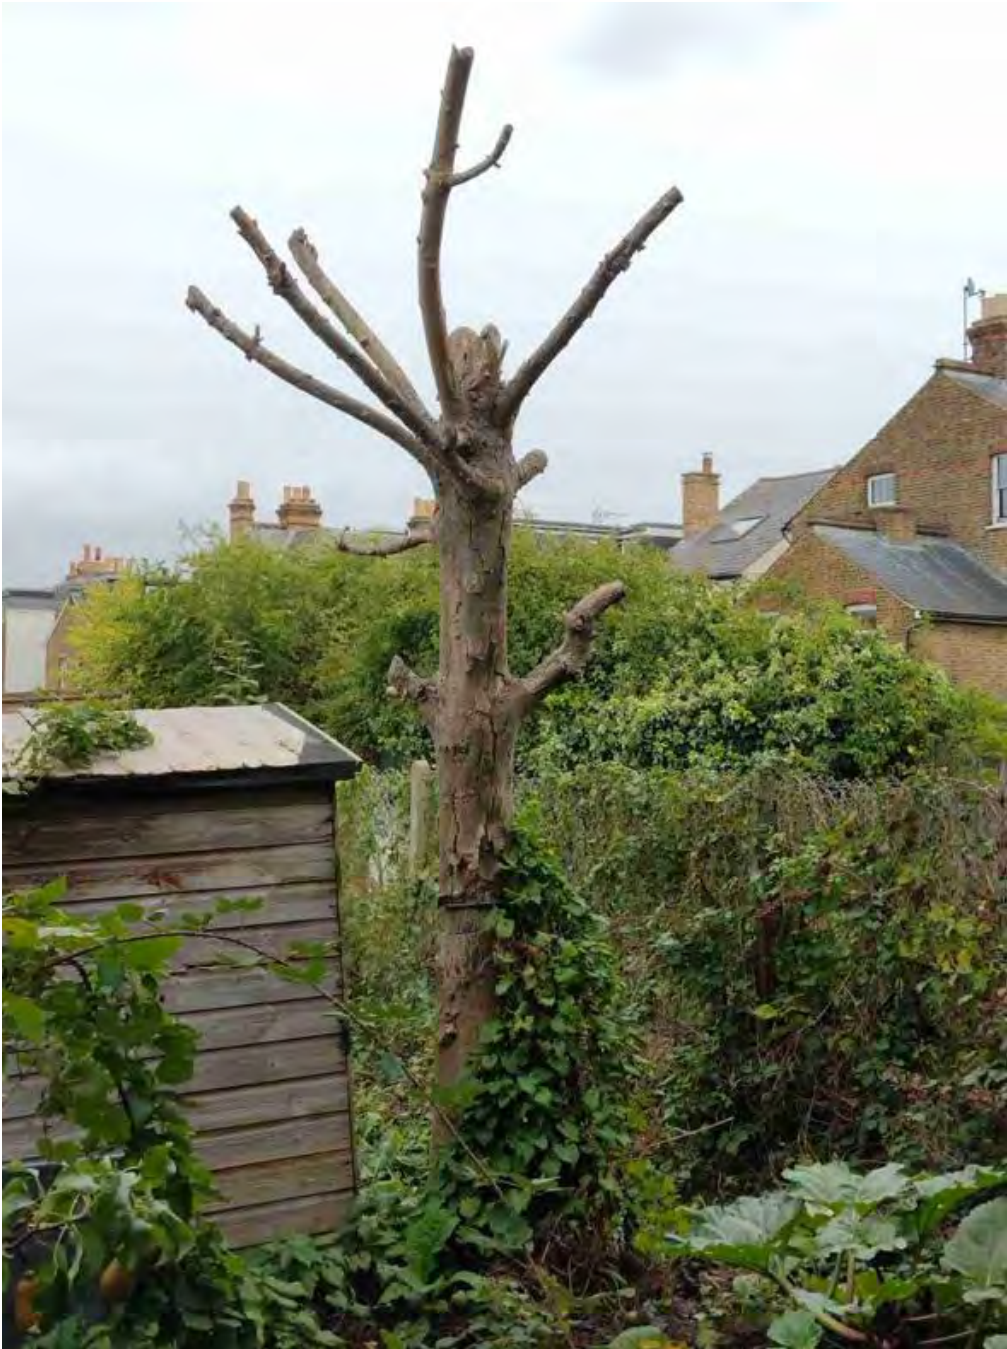
Ward	South Twickenham
Road	Heath Gardens
Location	Heath garden allotments What3Words-///verbs.aura.kept
Species	Common Ash (<i>Fraxinus excelsior</i>)
Height	3.0m
Physiological Condition	Dead
Structural Condition	Dead
Inspection findings	This tree is dead; removal is required to prevent natural failure.

Image shows dead tree in allotment scene
