November 2023 - Reactive Tree Works Programme

Introduction

Dated 21.11.2023

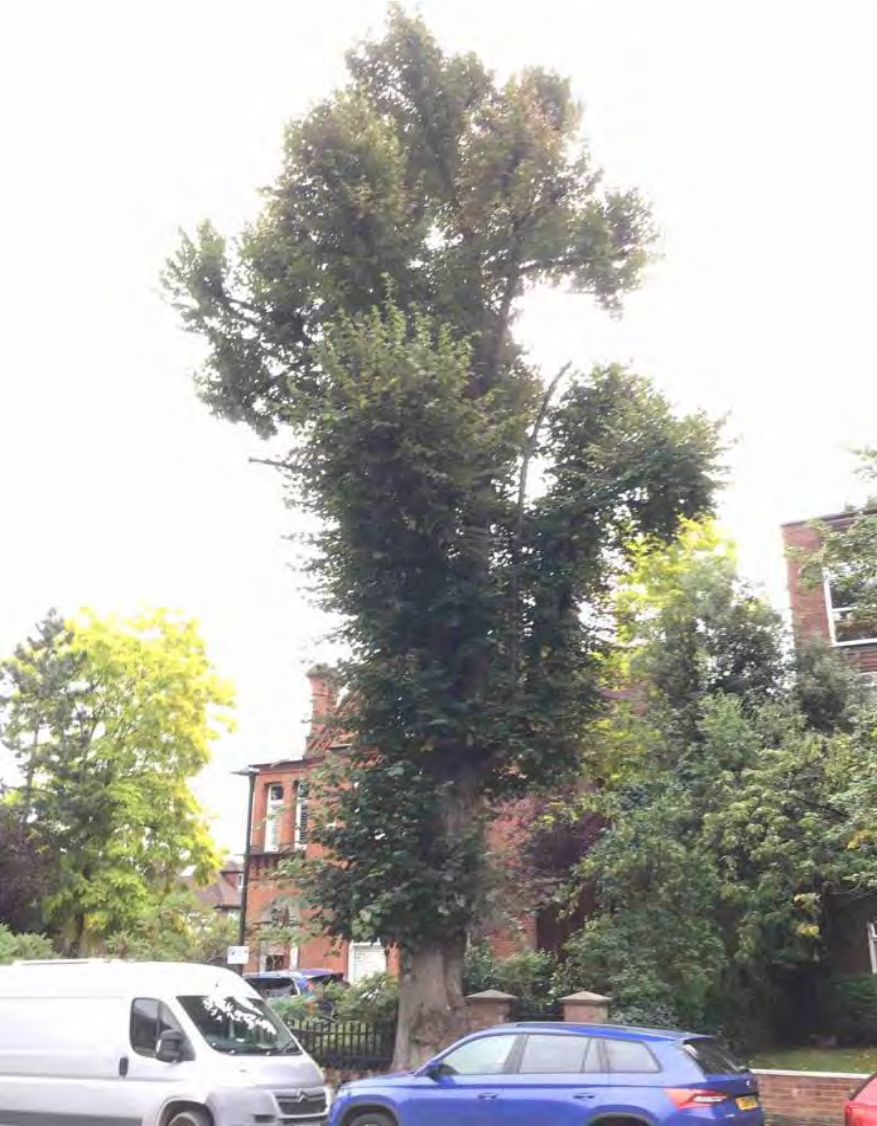
Ward	South Twickenham
Road	Waldegrave Park
Location	Outside 66
Species	Common Lime (<i>Tilia x europaea</i>)
Height	21.0m
Physiological Condition	Fair
Structural Condition	Poor
Inspection findings	A fungal fruiting body of the decay pathogen <i>Ganoderma</i> sp. is present at the stem base. Colonisation by this fungus causes a white rot of the stem and root system that can cause entire trees to collapse through fracture or windthrow. Investigation with a probe revealed an unacceptable amount of decay around fruiting body. Removal is required to prevent natural failure and facilitate replanting.

Image shows tree in street scene

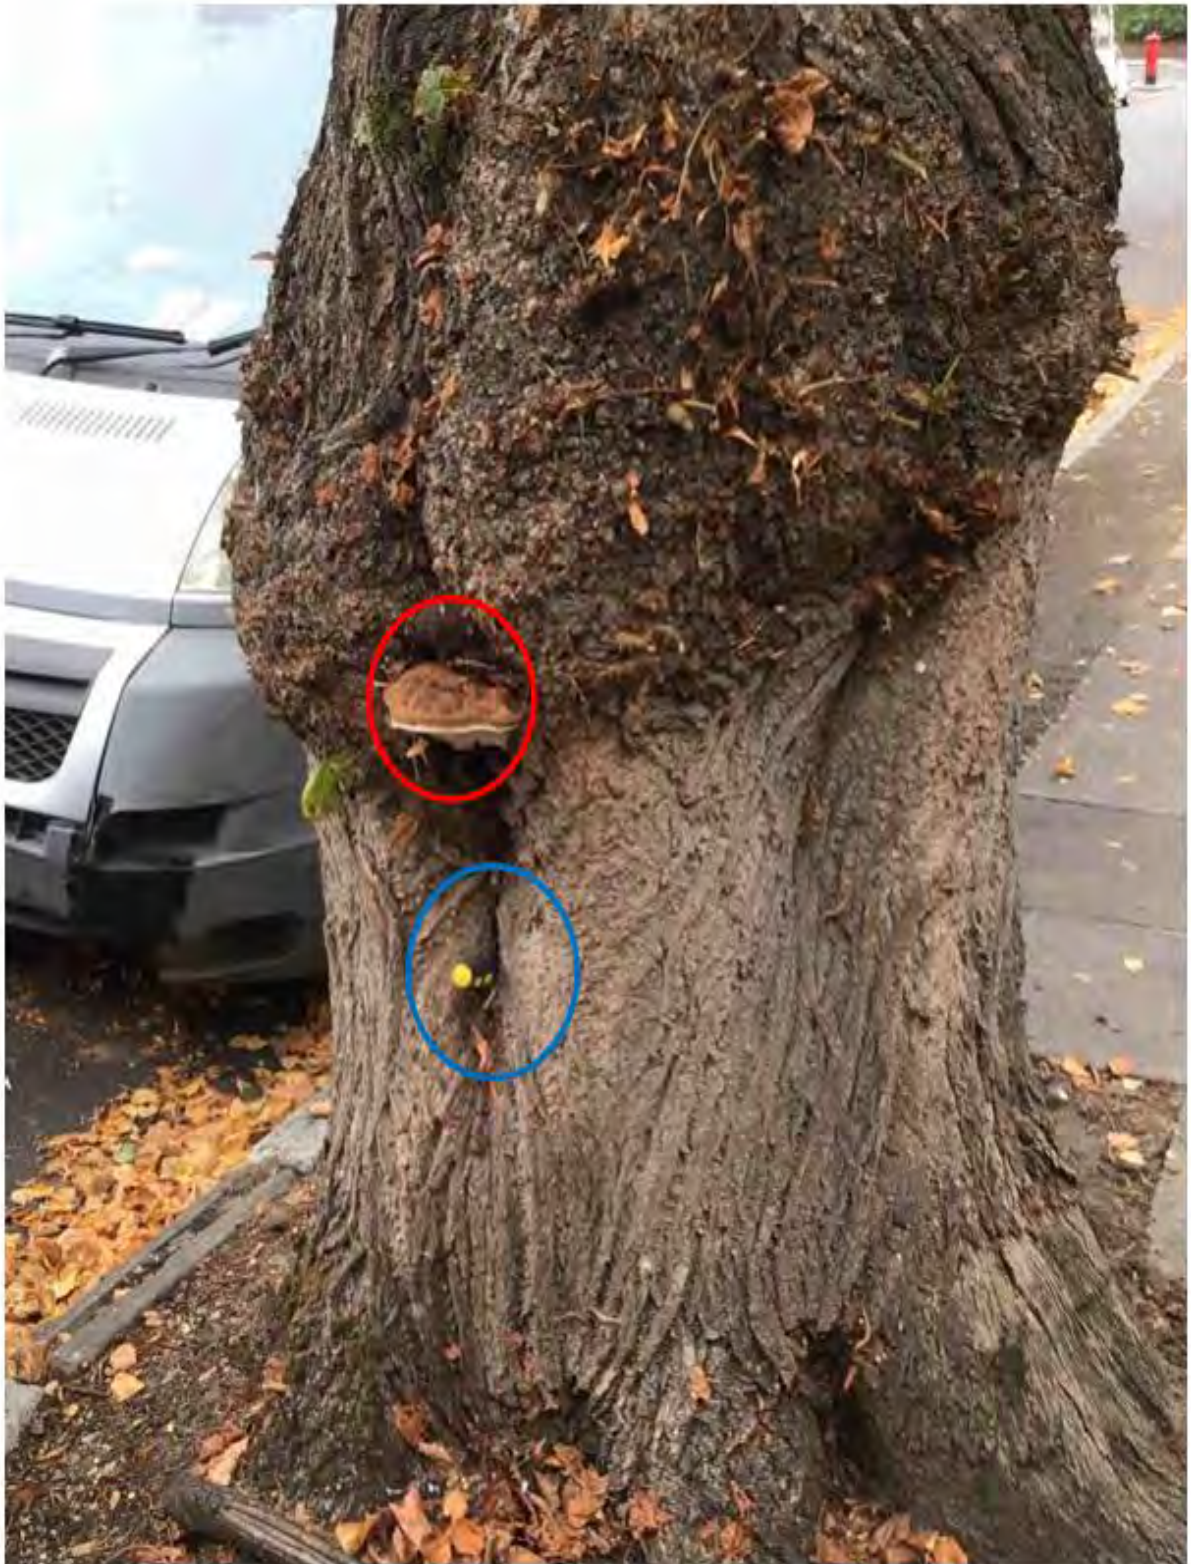
Image shows Ganoderma circle in red and probe circled in blue highlighting decay in stem.

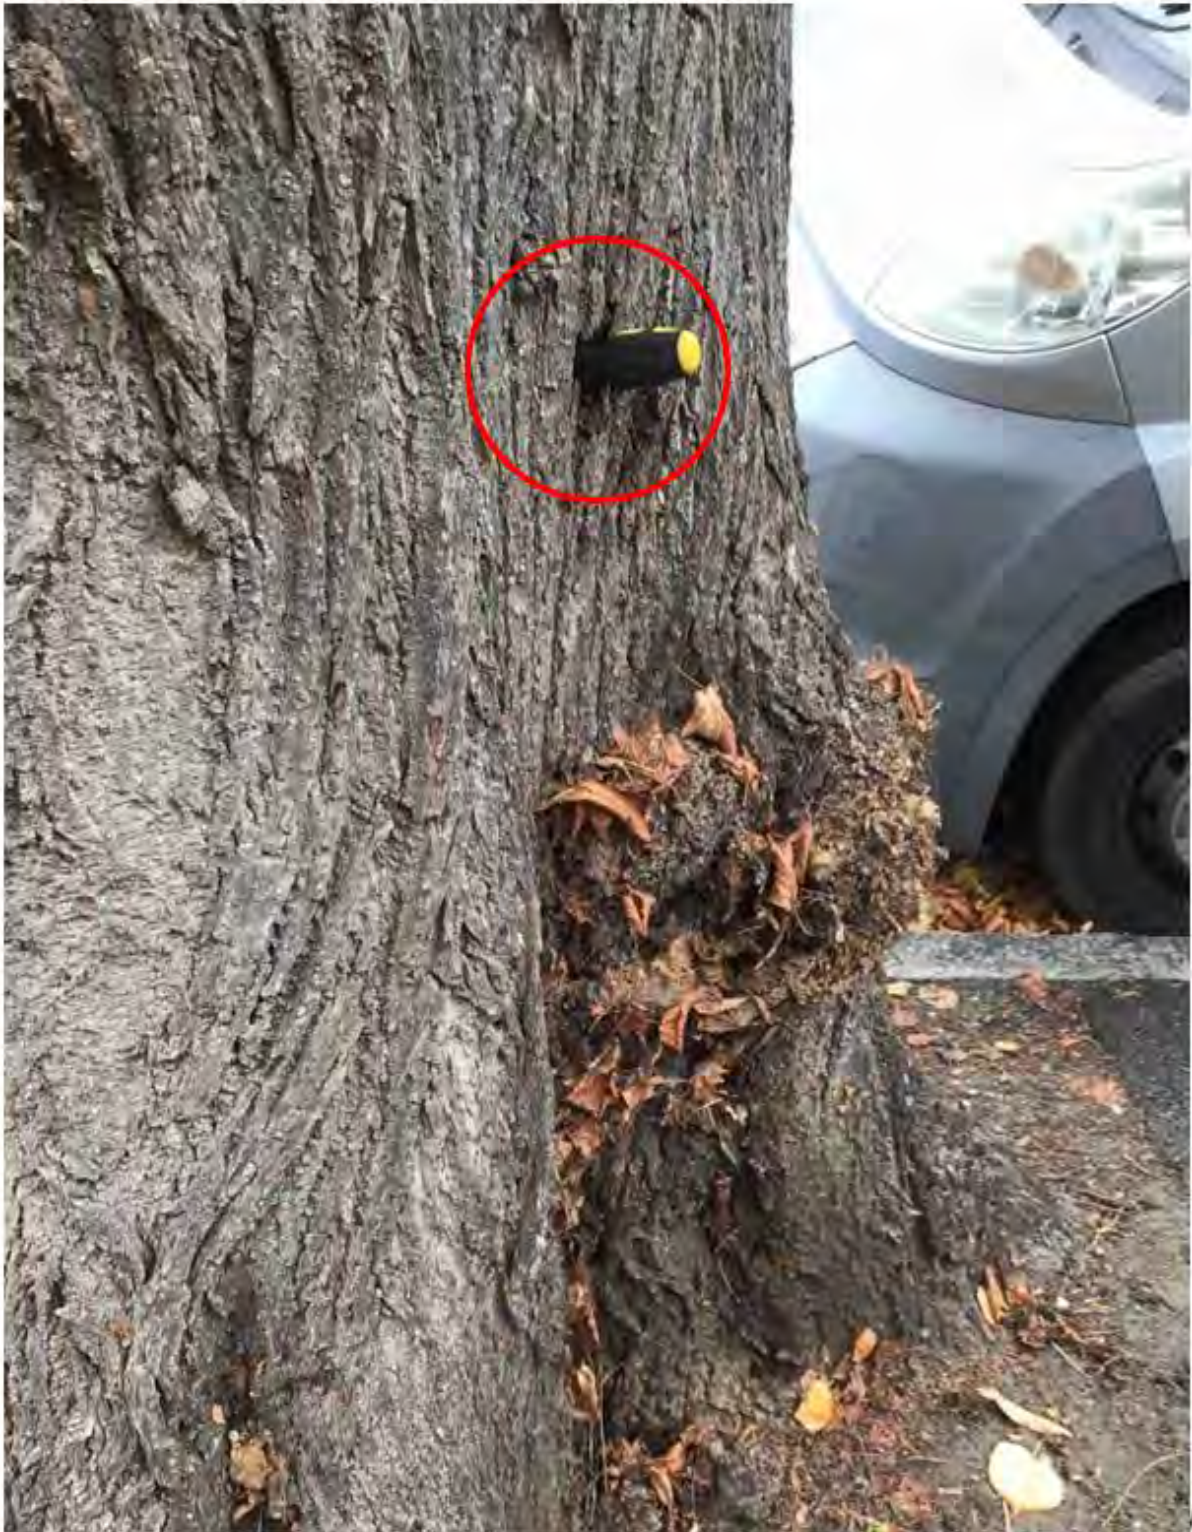
Image shows probe circle in red highlighting decay in stem

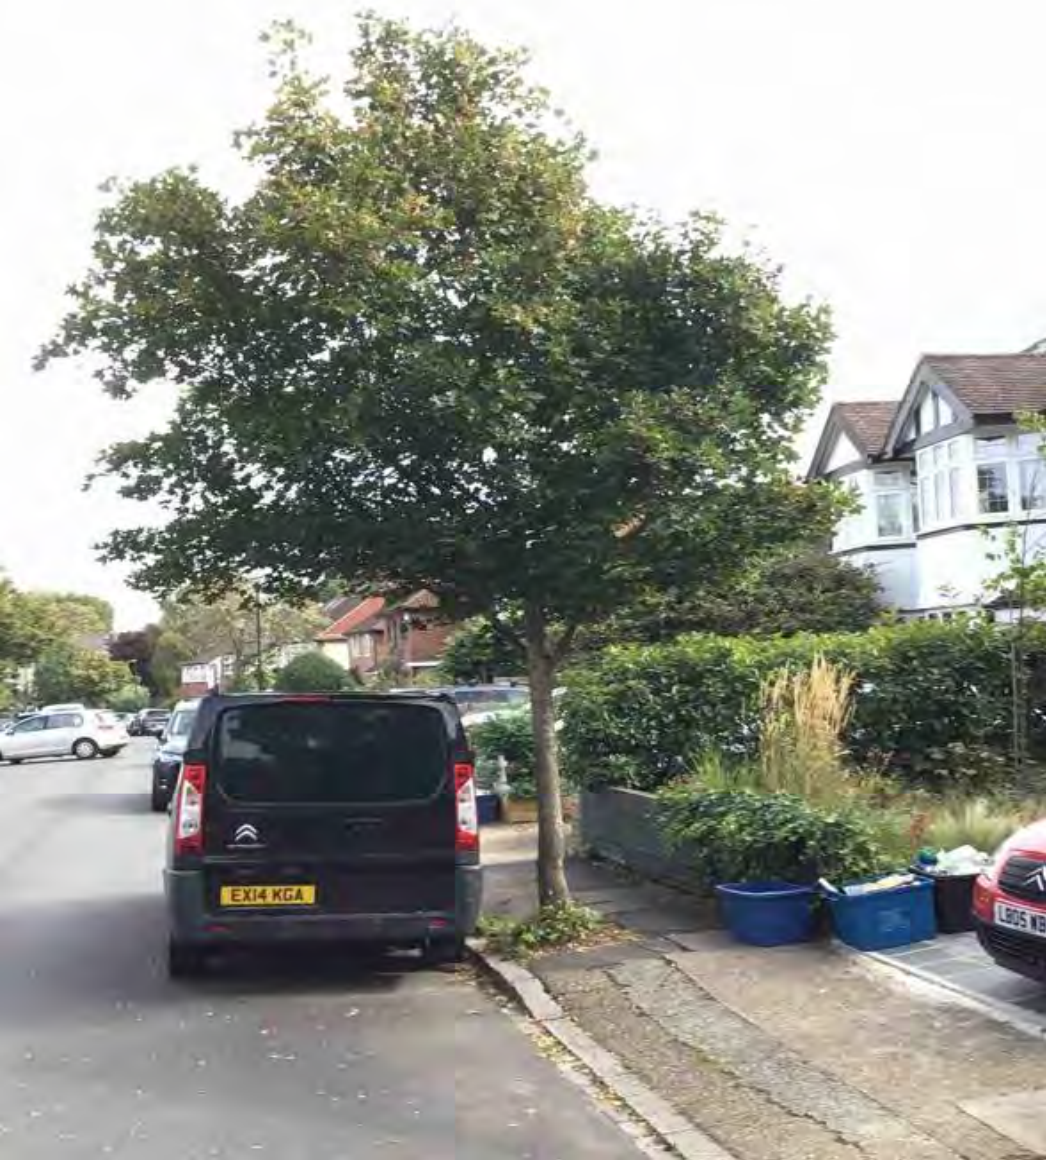
Ward	South Twickenham
Road	Clive Road
Location	Outside 25
Species	Field maple (<i>Acer campestre</i>)
Height	6.5m
Physiological Condition	Fair
Structural Condition	Poor
Inspection findings	Tree is moving in such a way that indicates that the structure of root system is compromised presenting unacceptable risk of failure. Removal is required to prevent natural failure and facilitate replanting.

Image shows tree in street scene

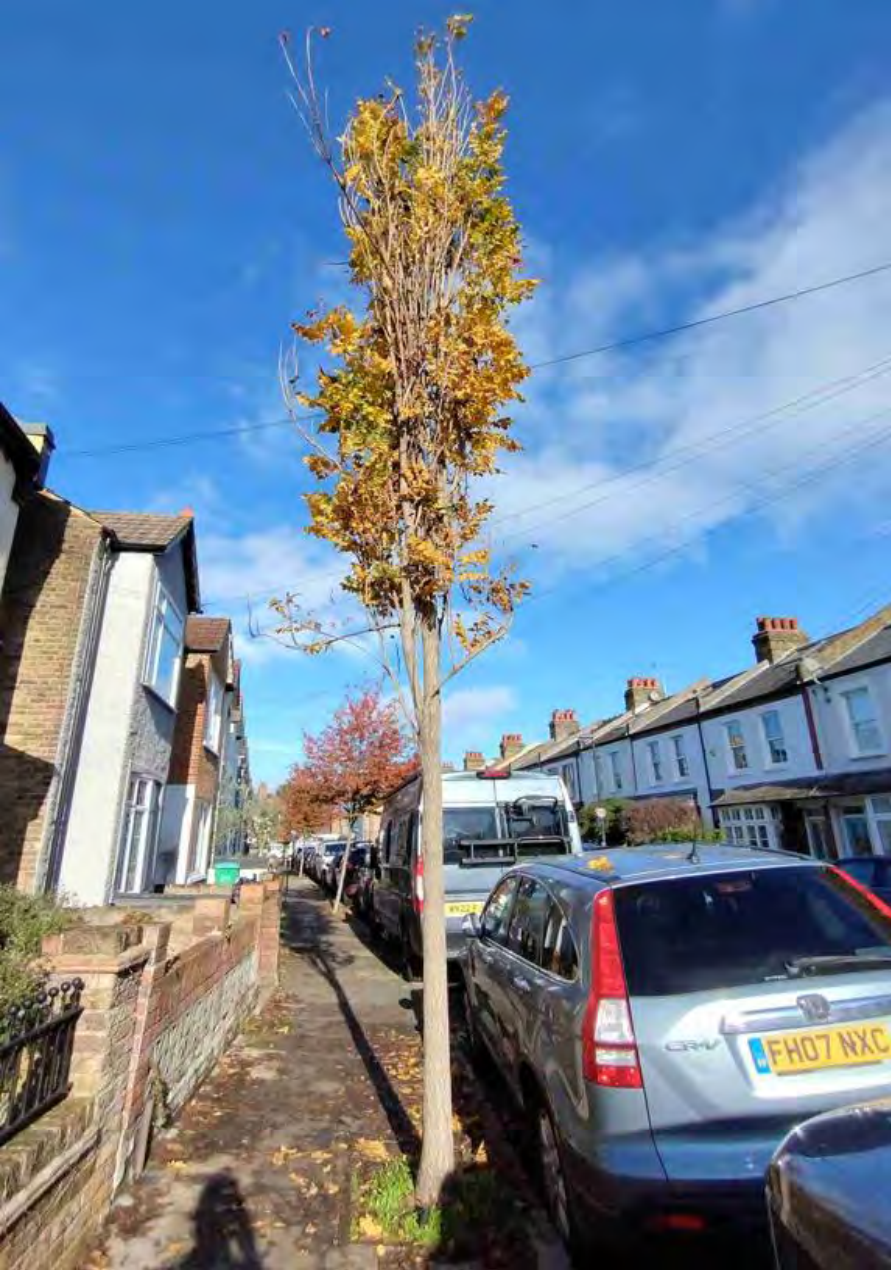
Ward	South Twickenham
Road	Heath Gardens
Location	Outside 25/27
Species	Golden Rain-tree (<i>Koelreuteria paniculata Fastigiata</i>)
Height	7.0m
Physiological Condition	Poor
Structural Condition	Fair
Inspection findings	This tree is moribund; removal is required to prevent natural failure and facilitate replanting

Image shows moribund tree in street scene.

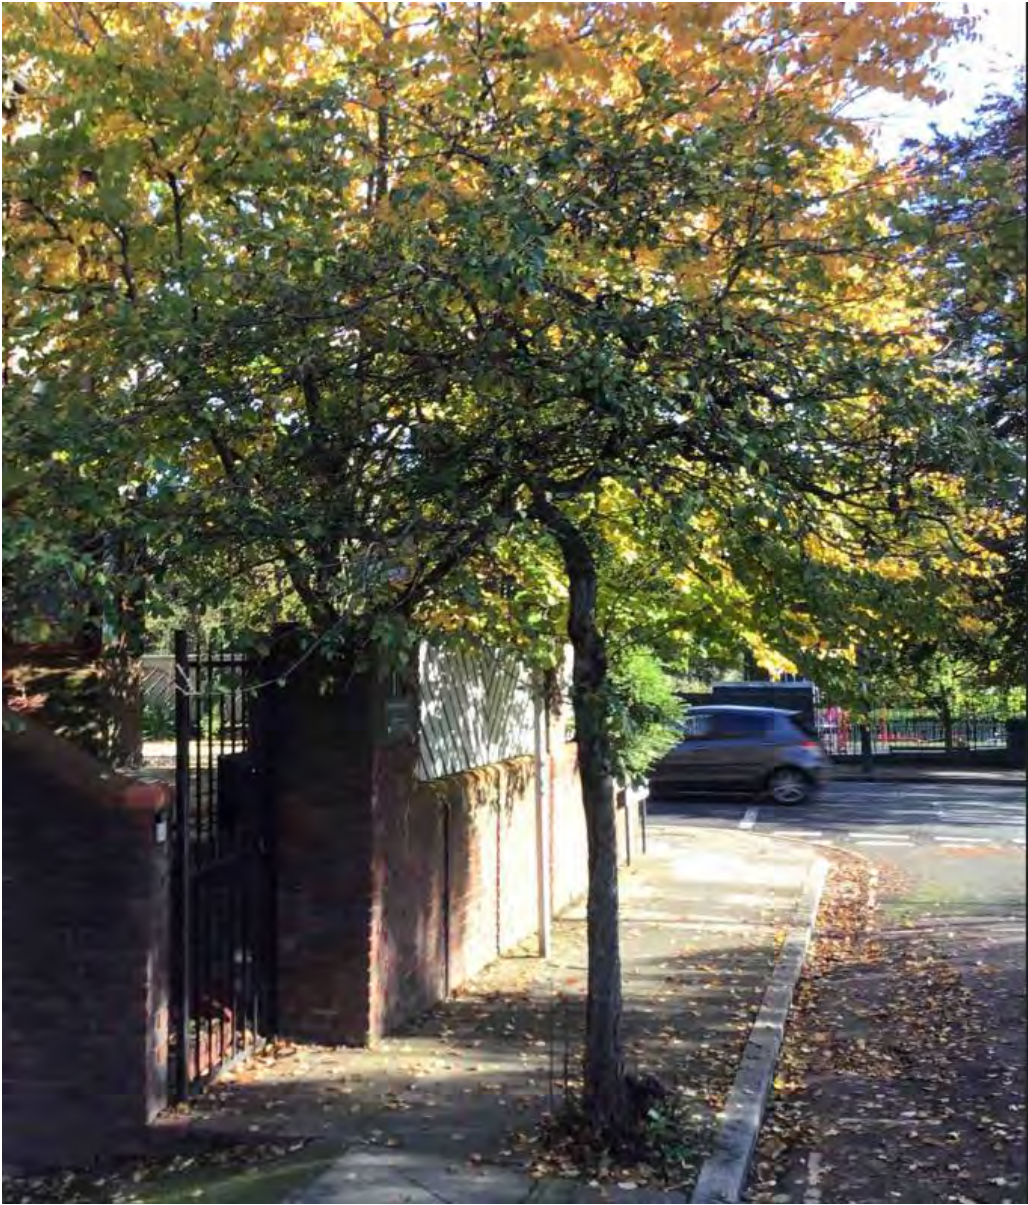
Ward	South Twickenham
Road	Riverview Gardens
Location	Adjacent to 100 Cross Deep main building
Species	Apple tree (<i>Malus sp.</i>)
Height	5.5m
Physiological Condition	Fair
Structural Condition	Poor
Inspection findings	Tree is moving in such a way that indicates that the structure of root system is compromised presenting increased risk of failure. Removal is required to prevent natural failure and facilitate replanting.

Image shows tree in street scene

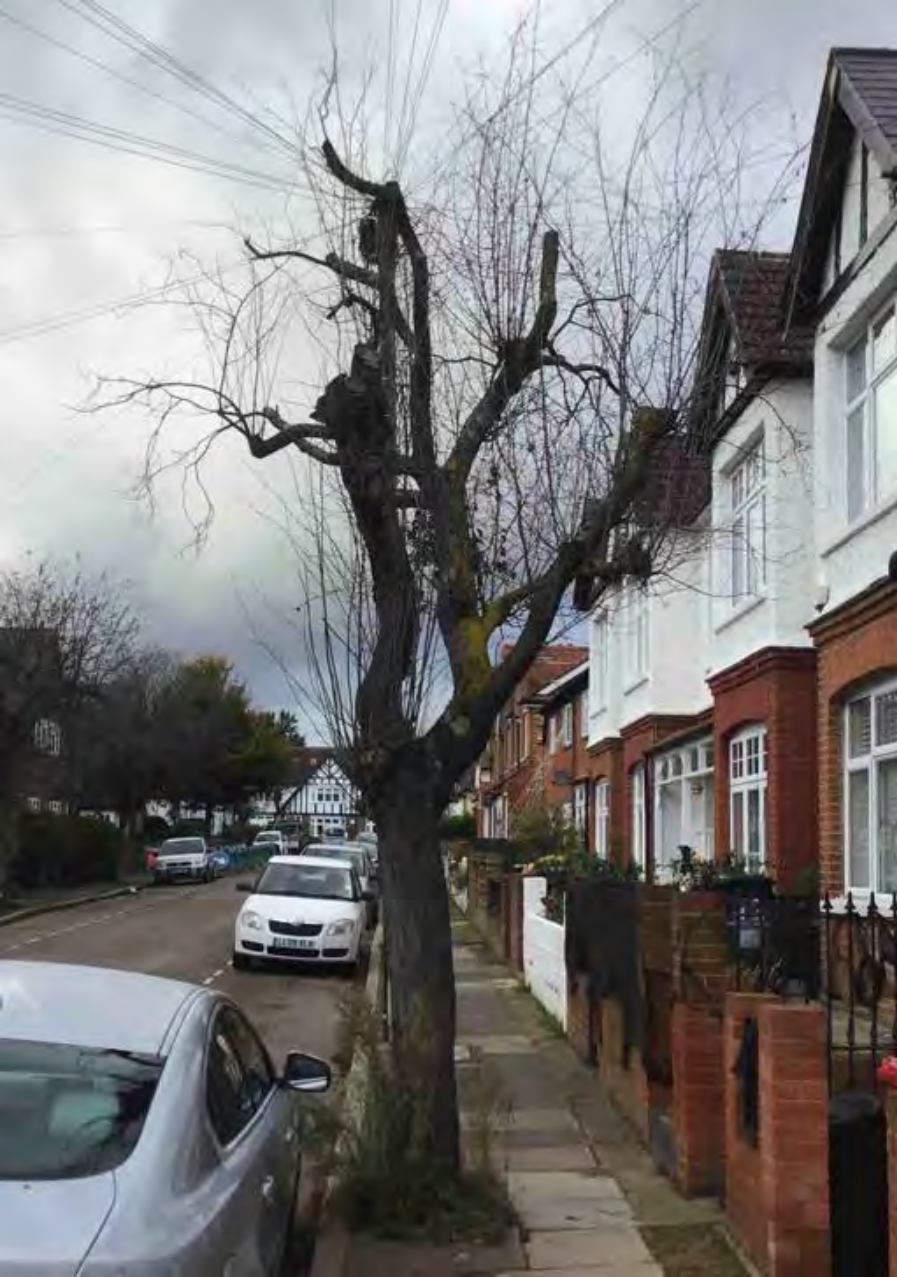
Ward	South Twickenham
Road	Riverview Gardens
Location	Outside 10/12
Species	Cherry Plum (<i>Prunus cerasifera</i>)
Height	8.5m
Physiological Condition	Poor
Structural Condition	Poor
Inspection findings	This tree is moribund; removal is required to prevent natural failure and facilitate replanting

Image shows moribund tree in street scene.

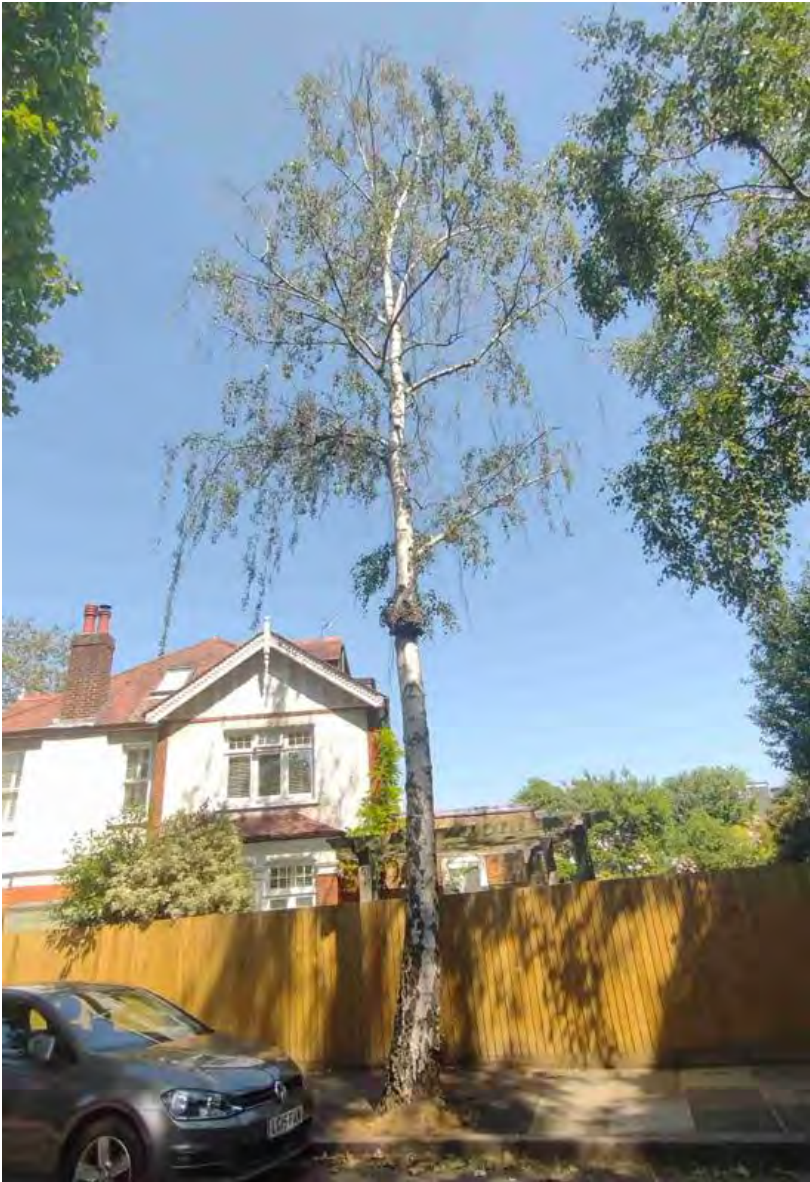
Ward	St Margarets and North Twickenham
Road	Sidney Road
Location	Opposite 62/64
Species	Silver Birch (<i>Betula pendula</i>)
Height	17.0m
Physiological Condition	Poor
Structural Condition	Poor
Inspection findings	This tree is moribund; removal is required to prevent natural failure and facilitate replanting

Image shows tree in street scene in moribund state

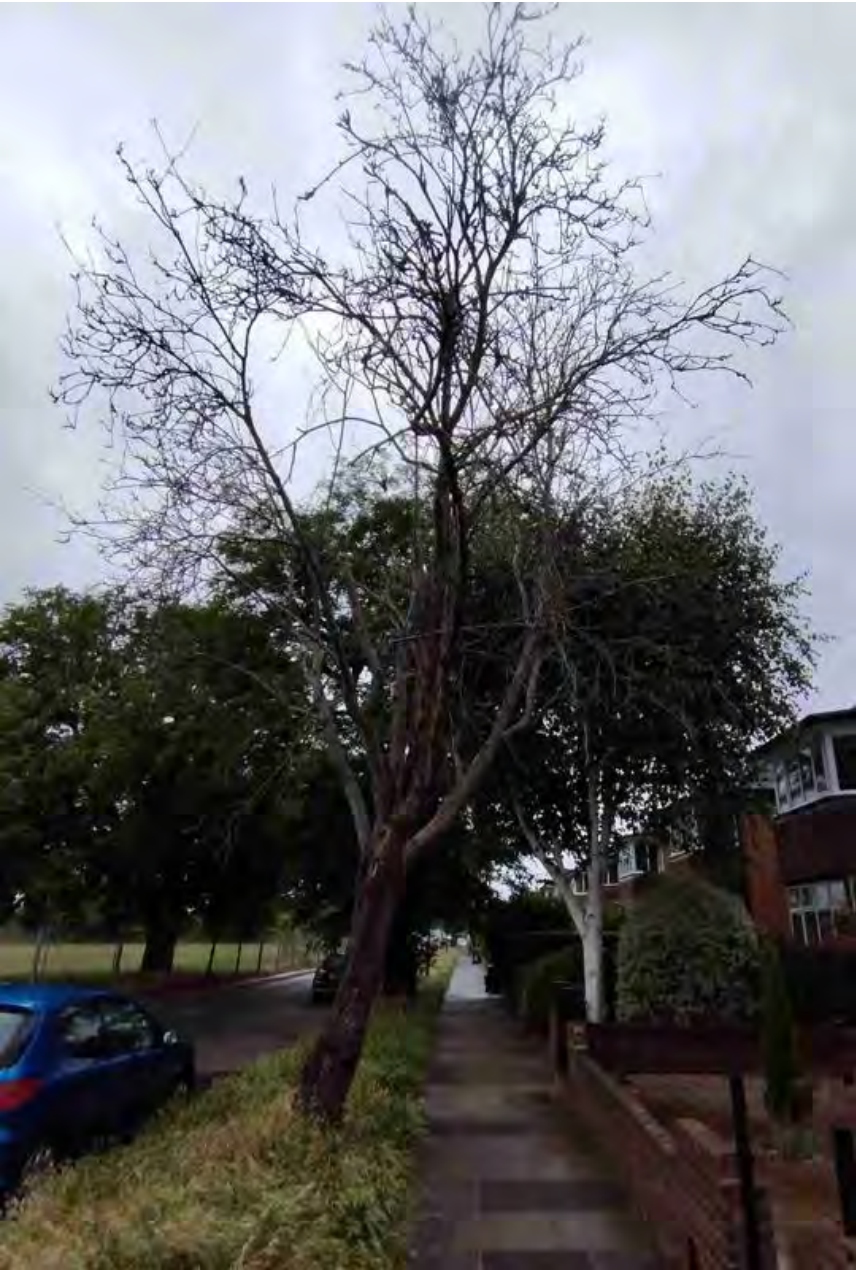
Ward	St Margarets and North Twickenham
Road	Craneford Way
Location	Outside 82/84
Species	Swedish Whitebeam (<i>Sorbus intermedia</i>)
Height	10.0m
Physiological Condition	Dead
Structural Condition	Dead
Inspection findings	This tree is dead. Removal is required to prevent natural failure and facilitate replanting

Image shows dead tree in street scene

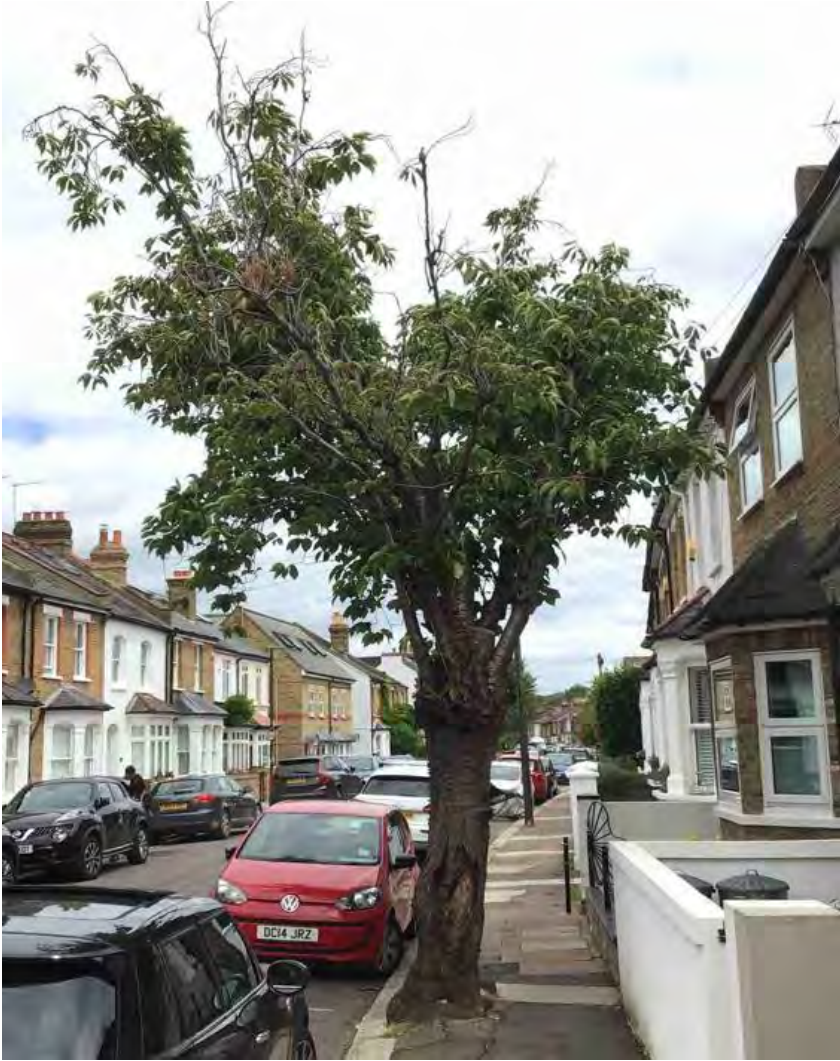
Ward	St Margarets and North Twickenham
Road	Haliburton Road
Location	Outside 86/88
Species	Cherry (<i>Prunus sp.</i>)
Height	8.0m
Physiological Condition	Poor
Structural Condition	Poor
Inspection findings	A fungal fruiting body of the decay pathogen <i>Ganoderma</i> sp. is present at the stem base. Colonisation by this fungus causes a white rot of the stem and root system that can cause entire trees to collapse through fracture or windthrow. Tree is declining with dieback present in crown and this correlates with the pathogen present on lower stem. Removal is required to prevent natural failure and facilitate replanting

Image shows tree in street scene.

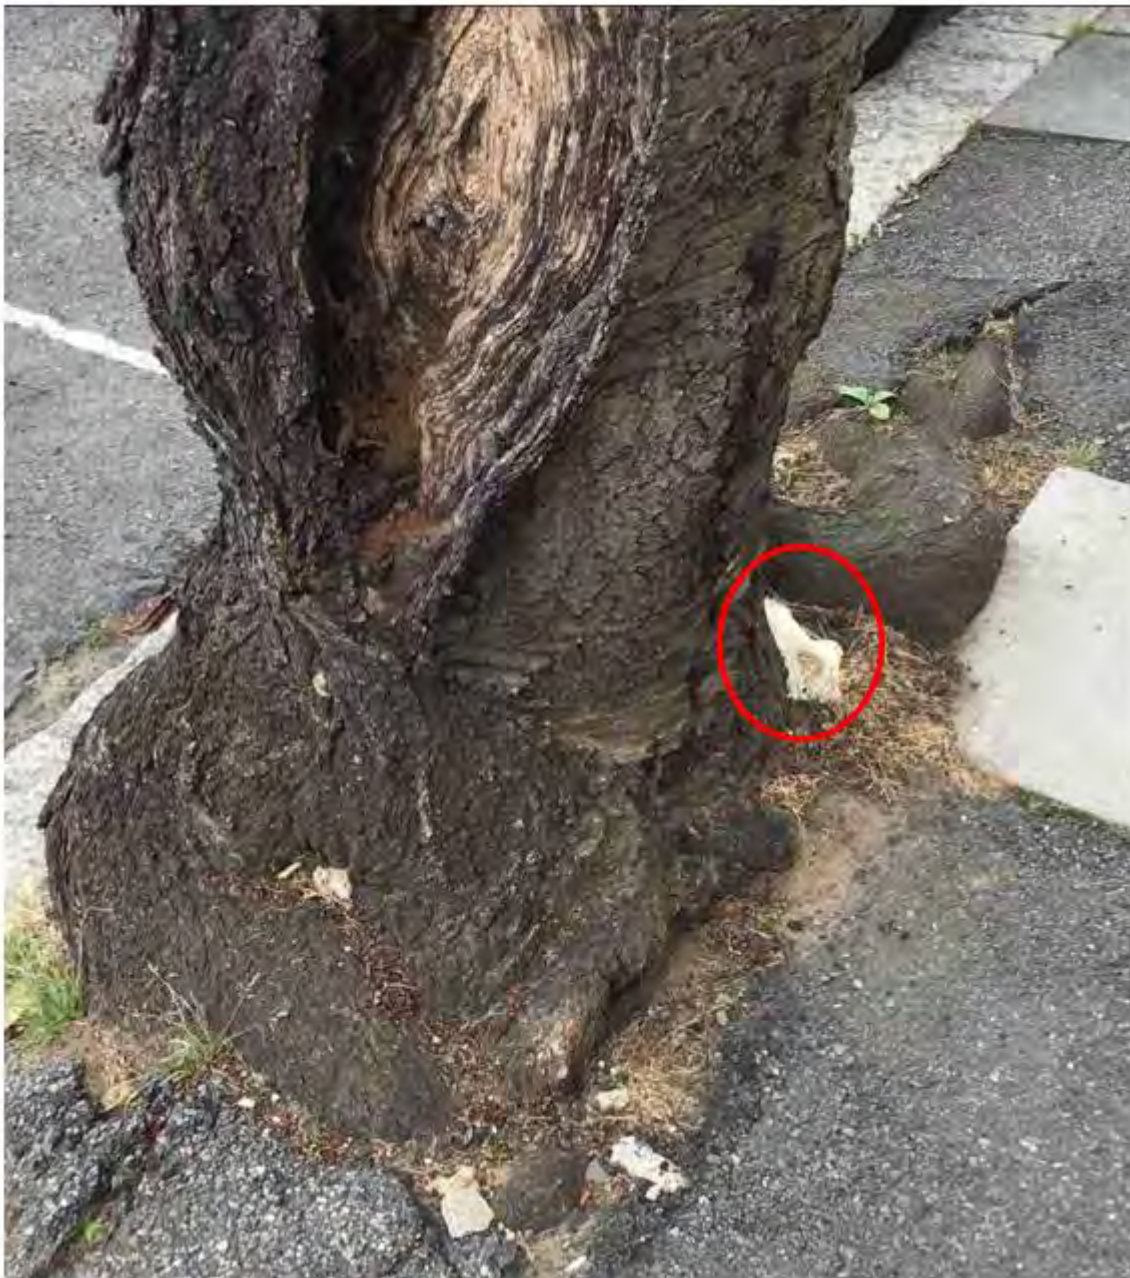
Images shows fruiting fungal bodies at base of stem circled.

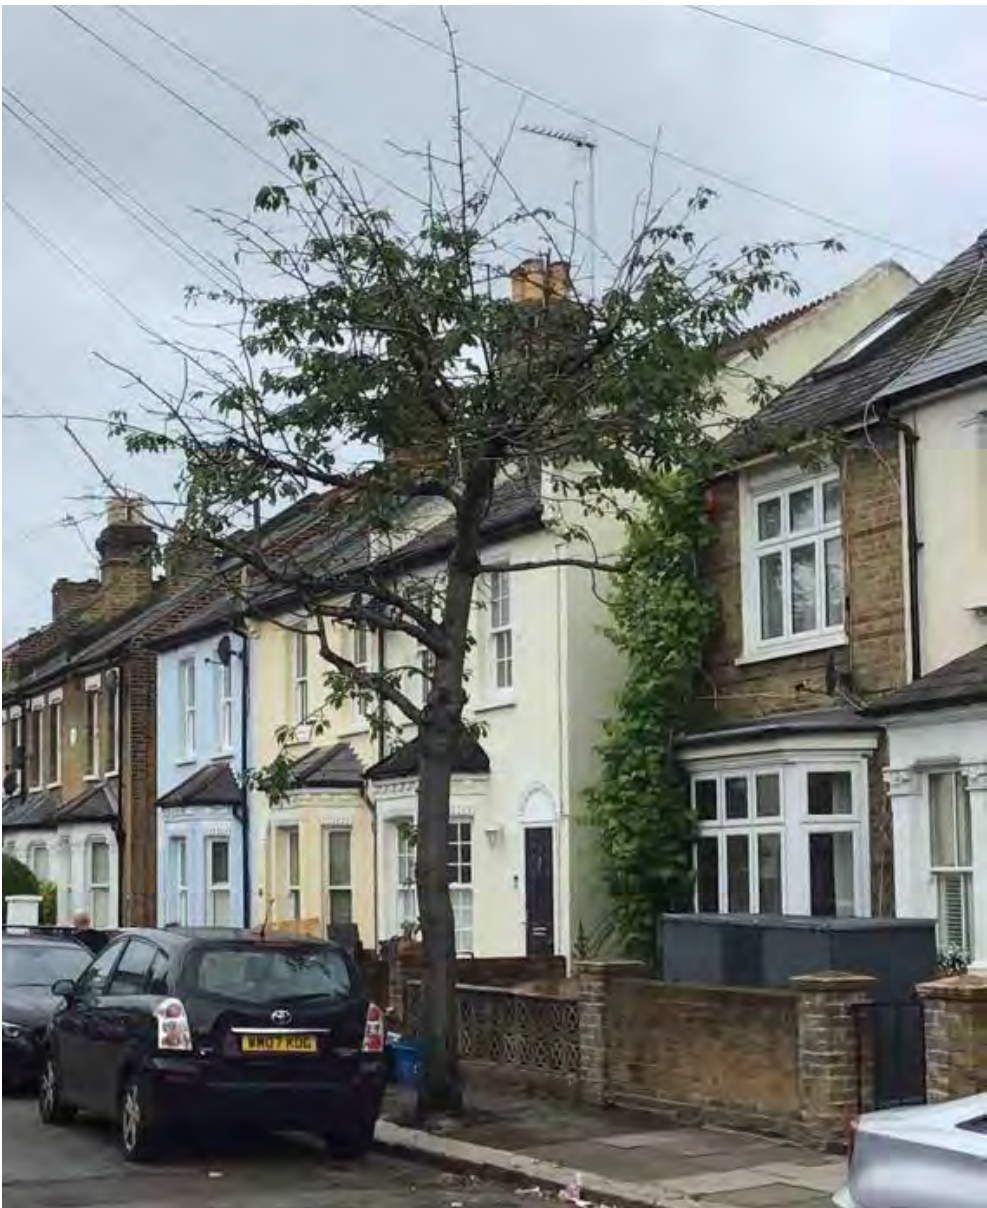
Ward	St Margarets and North Twickenham
Road	Haliburton Road
Location	Outside 86/88
Species	Cherry (<i>Prunus sp.</i>)
Height	8.0m
Physiological Condition	Poor
Structural Condition	Poor
Inspection findings	This tree is moribund; Investigation with a probe revealed decay at base and this correlates with crown dieback and decline. Removal is required to prevent natural failure and facilitate replanting

Image shows tree in street scene in moribund state.

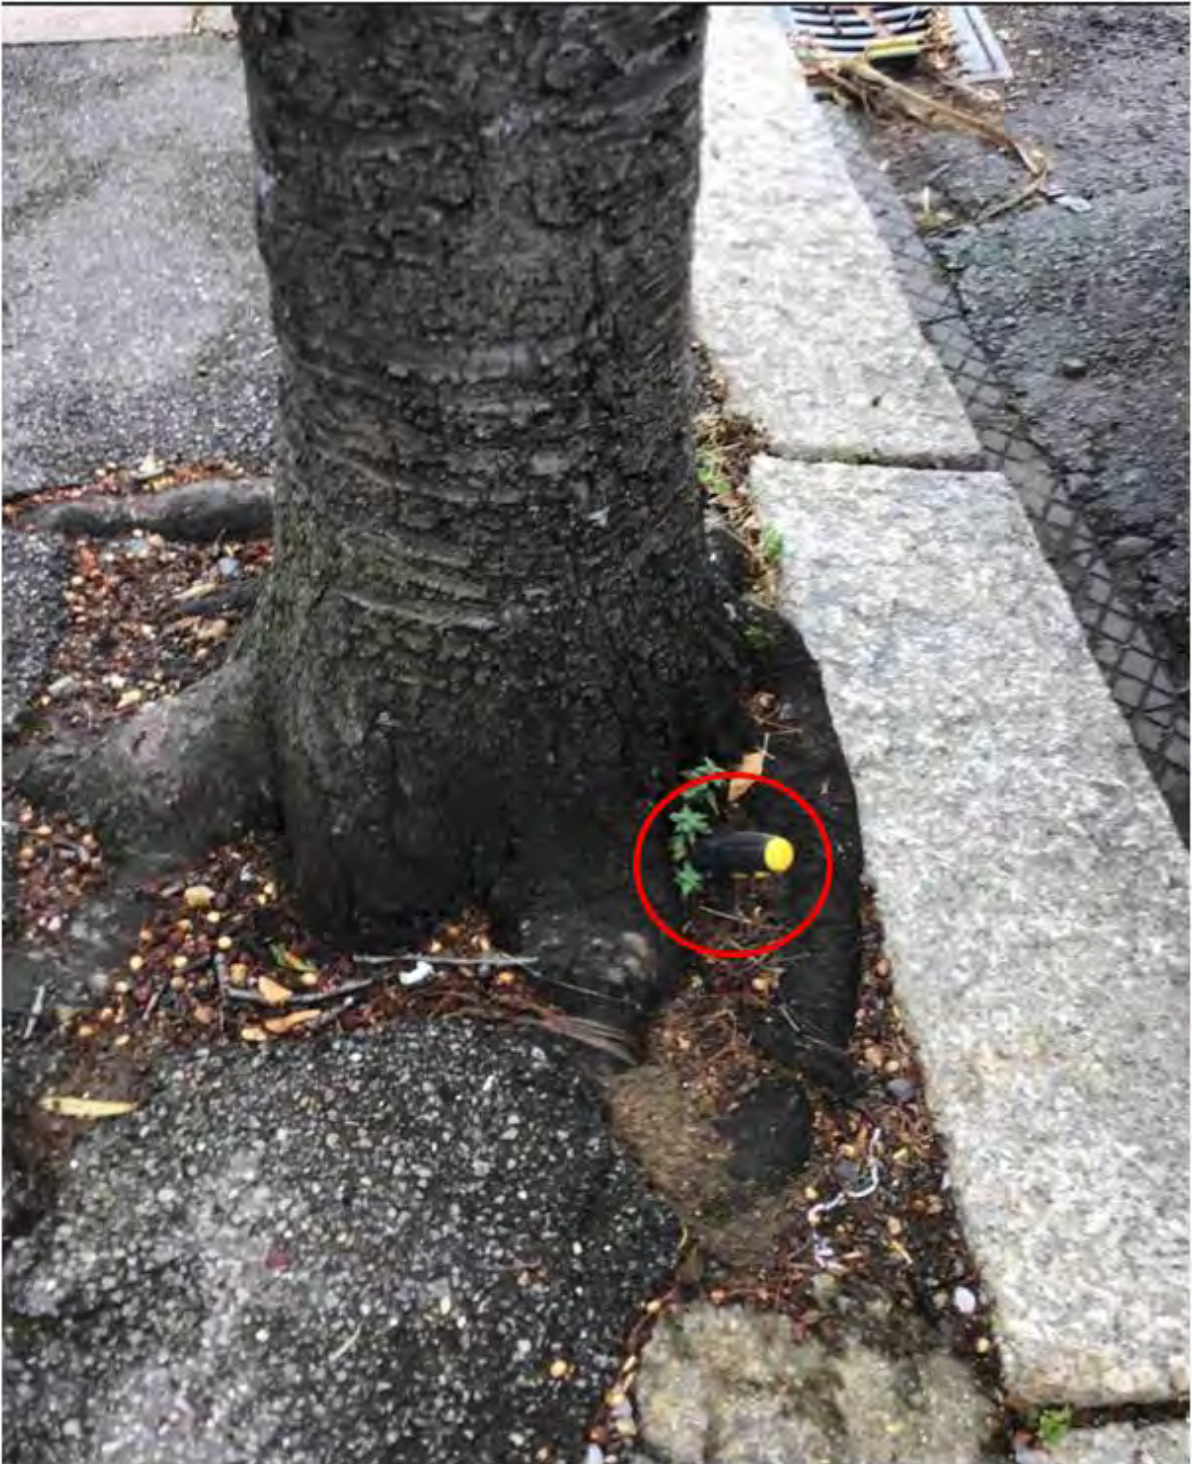
Image shows probe highlighting decay at base of stem circled.

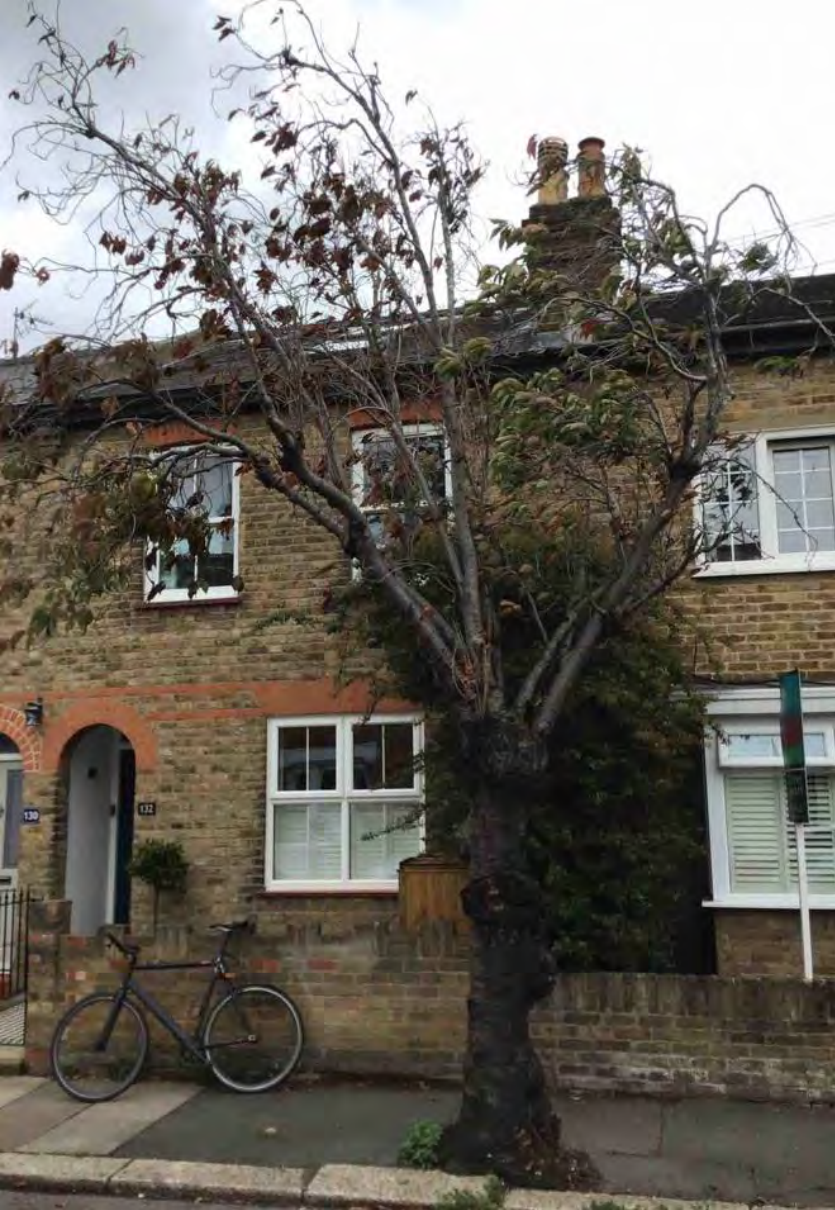
Ward	St Margarets and North Twickenham
Road	Haliburton Road
Location	Outside 132/134
Species	Cherry (<i>Prunus sp.</i>)
Height	6.0m
Physiological Condition	Poor
Structural Condition	Poor
Inspection findings	This tree is moribund. Removal is required to prevent natural failure and facilitate replanting

Image shows tree in street scene in moribund state

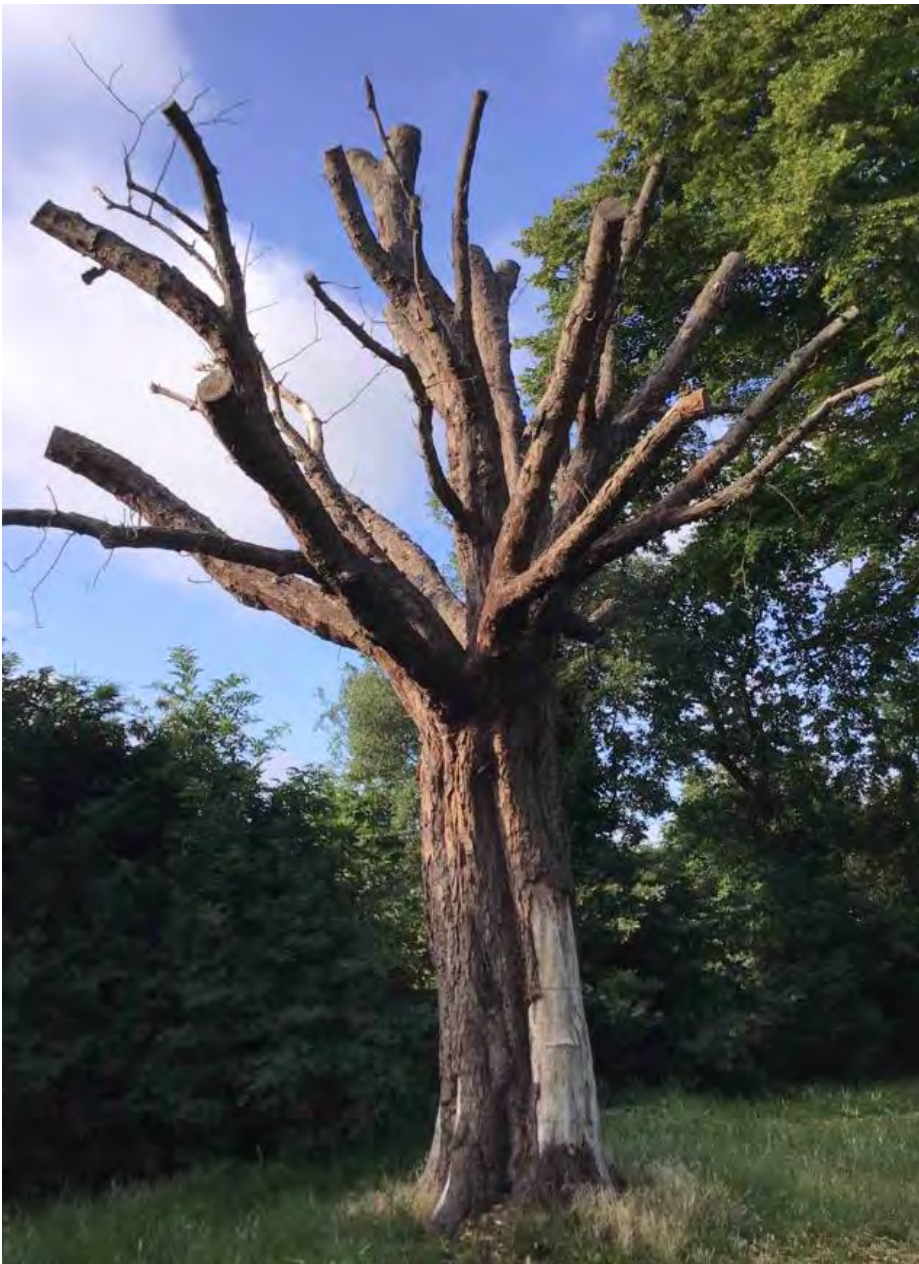
Ward	St Margarets and North Twickenham
Road	Moor Mead Road
Location	Moormead Park- ///What3Words- game.crush.leans
Species	Horse Chestnut (<i>Aesculus hippocastanum</i>)
Height	7.0m
Physiological Condition	Dead
Structural Condition	Dead
Inspection findings	This tree is dead. Removal is required to prevent natural failure and manage risk. Stump will be left as a 4 meter high monolith for ecology purposes.

Image shows dead tree in park scene.

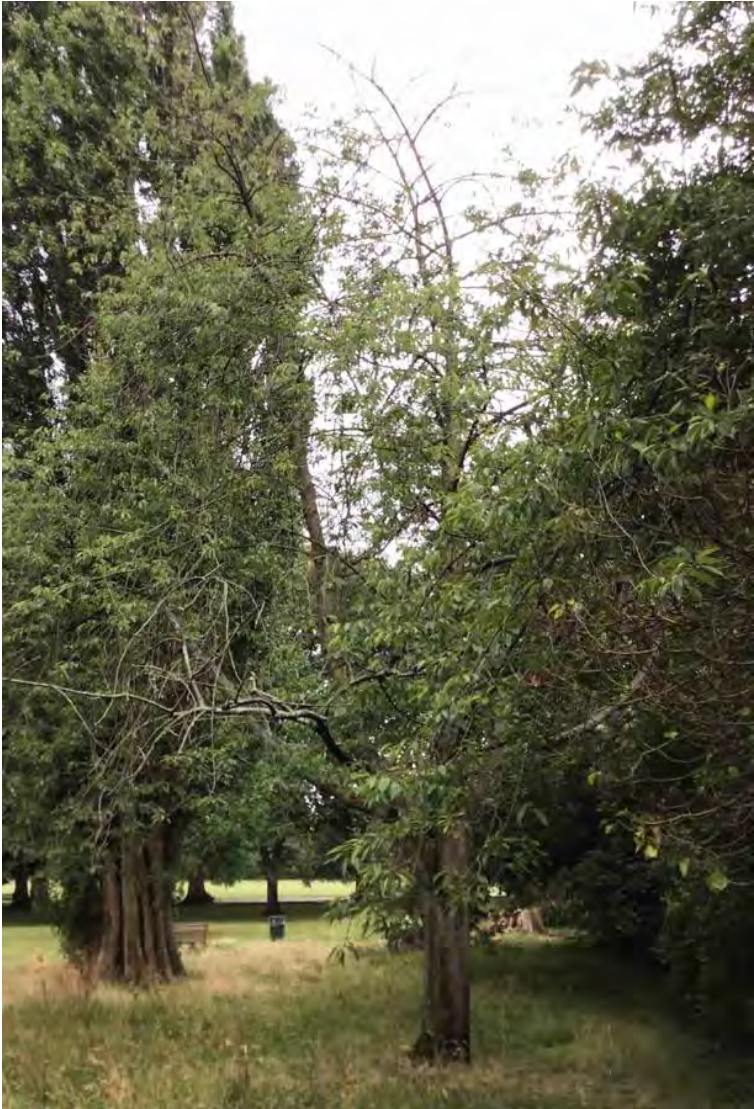
Ward	St Margarets and North Twickenham
Road	Moor Mead Road
Location	Moormead Park- ///What3Words- healer.blur.battle
Species	Wild Cherry (<i>Prunus avium</i>)
Height	14,5m
Physiological Condition	Poor
Structural Condition	Poor
Inspection findings	A fungal fruiting body of the decay pathogen <i>Ganoderma</i> sp. is present at the stem base. Colonisation by this fungus causes a white rot of the stem and root system that can cause entire trees to collapse through fracture or windthrow. A resonance test revealed an unacceptable degree of decay in the trunk of this tree, removal is required to prevent natural failure and manage risk.

Image shows tree in park scene with sparse canopy indicating poor vitality.

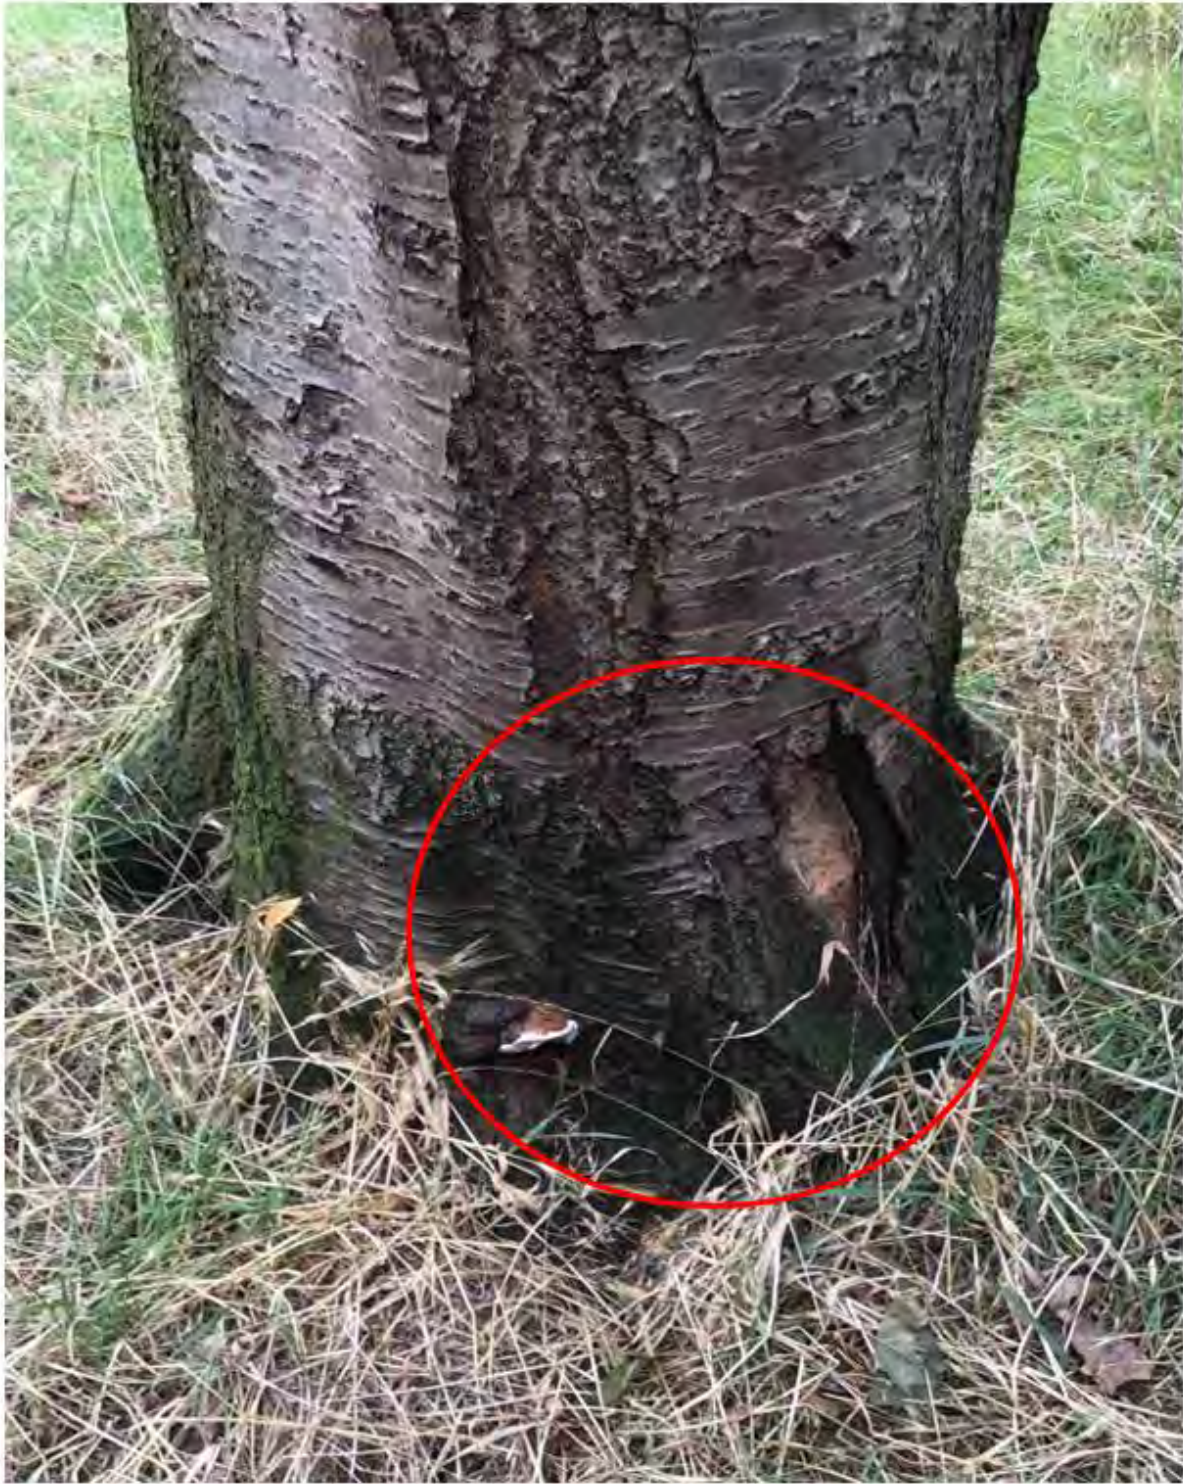
Images shows fruiting fungal bodies at base of stem circled.
