November 2023 - Reactive Tree Works Programme

Introduction

Dated 21.11.2023

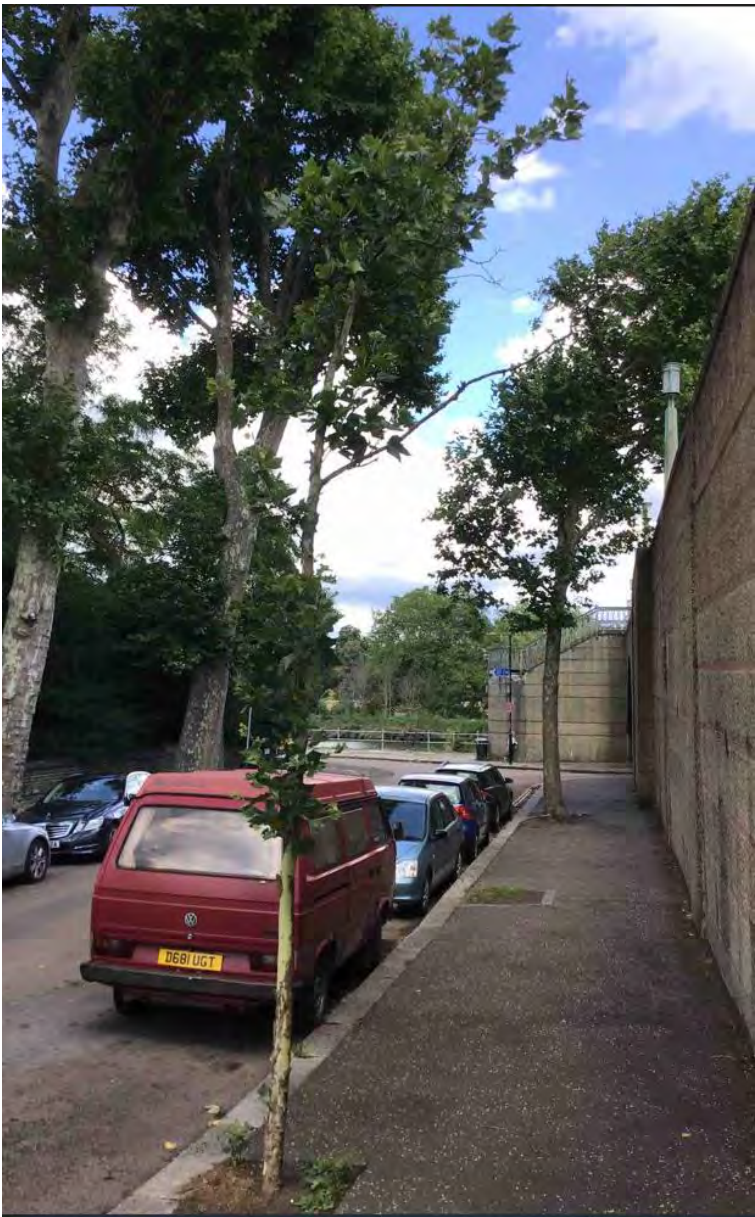
Ward	St Margarets and North Twickenham
Road	The Avenue
Location	///What3Words- paints.linked.tummy
Species	London plane (<i>Platanus x hispanica</i>)
Height	7.0m
Physiological Condition	Fair
Structural Condition	Poor
Inspection findings	This tree has an unacceptable amount of damage to the stem and this correlates with crown dieback and decline. Removal is required to prevent natural failure and facilitate replanting

Image shows tree in street scene

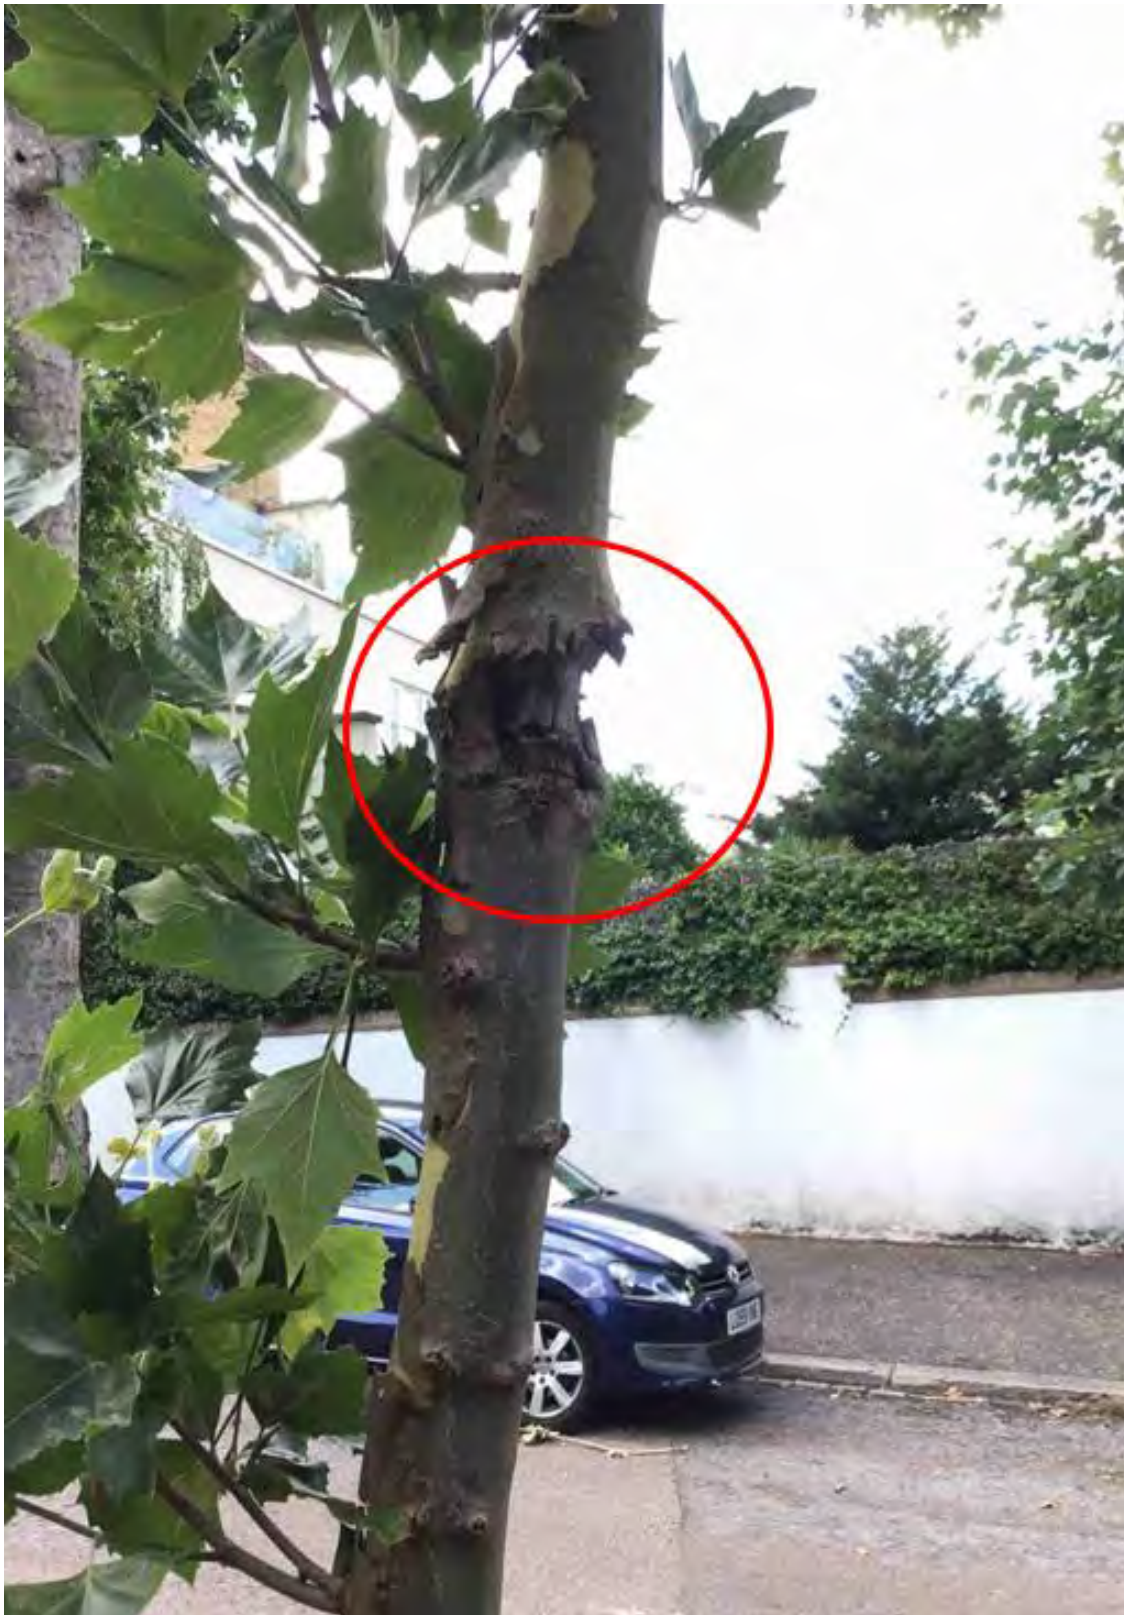
Image shows damage to stem circled.

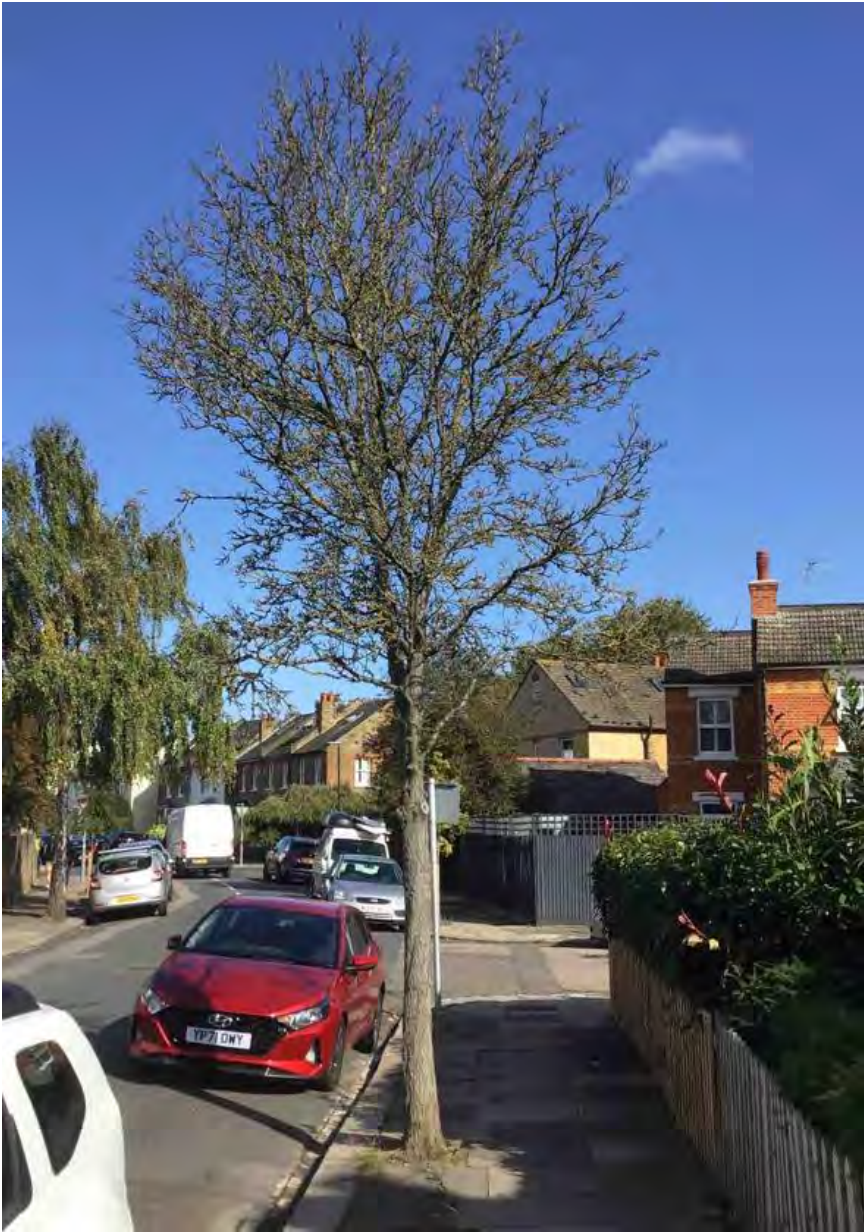
Ward	Teddington
Road	Bushy Park Road
Location	Opposite 86-88
Species	Ornamental Pear (<i>Pyrus Chanticleer</i>)
Height	8.0m
Physiological Condition	Dead
Structural Condition	Dead
Inspection findings	This tree is dead; removal is required to prevent natural failure and facilitate replanting

Image shows dead tree in street scene

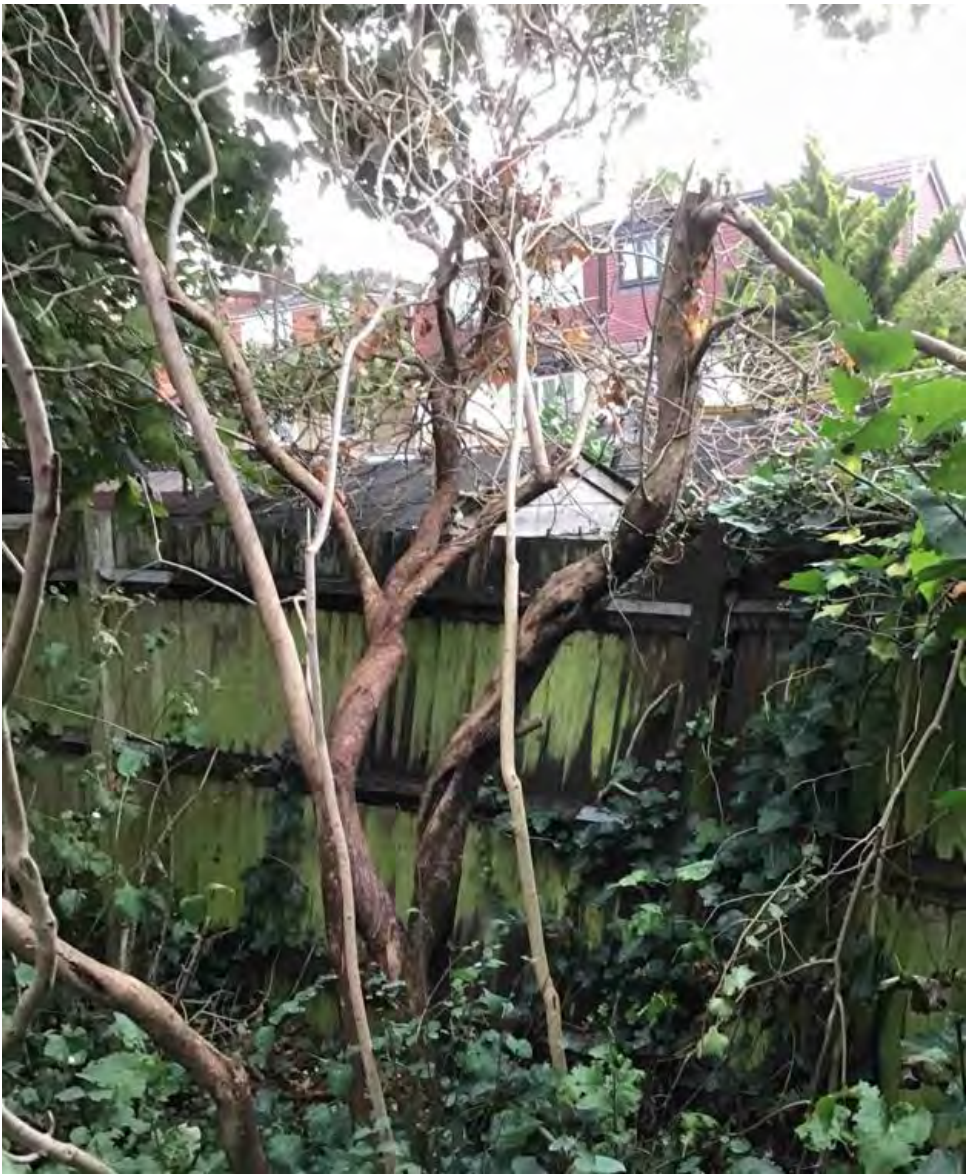
Ward	Teddington
Road	High Street
Location	Teddington Library- ///What3Words- yarn.merit.palace
Species	Common Lilac (<i>Syringa vulgaris</i>)
Height	6.0m
Physiological Condition	Dead
Structural Condition	Dead
Inspection findings	This tree is dead; removal is required to prevent natural failure and facilitate replanting

Image shows dead tree.

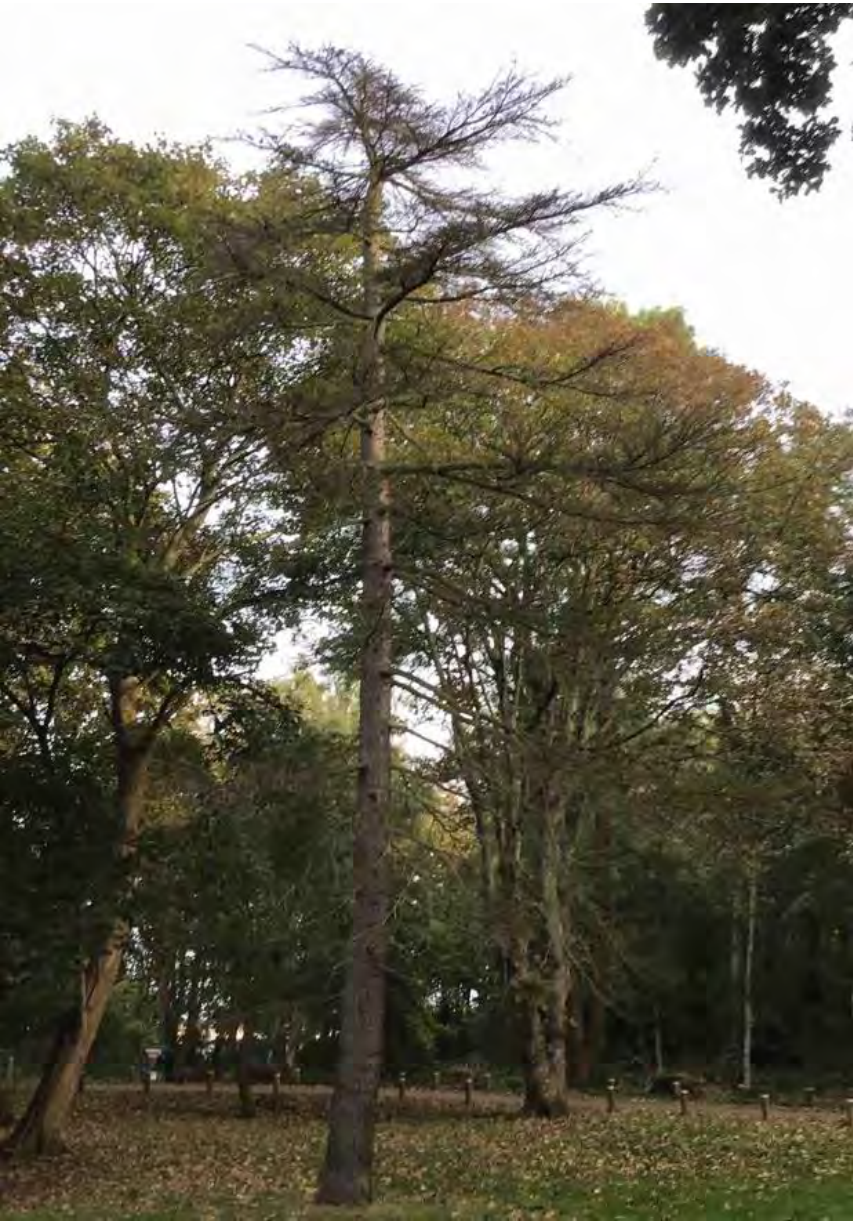
Ward	Twickenham Riverside
Road	Riverside
Location	Orleans House Gallery Gardens- ///What3Word-tribune.brand.belt
Species	Cedar (<i>Cedrus sp.</i>)
Height	16.0m
Physiological Condition	Dead
Structural Condition	Dead
Inspection findings	This tree is dead; removal is required to prevent natural failure and facilitate replanting

Image shows dead tree in park scene.

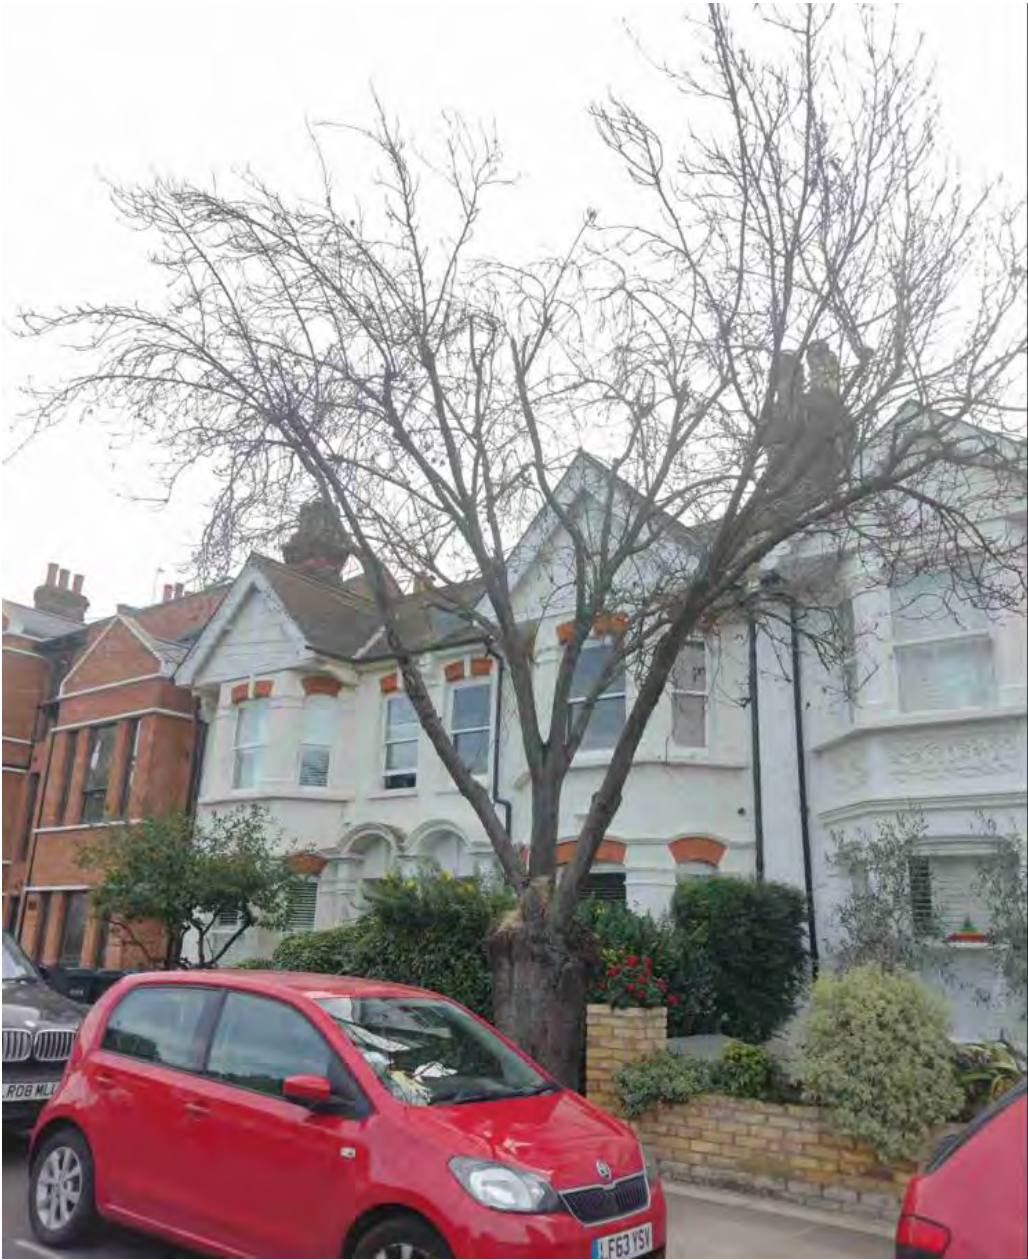
Ward	Twickenham Riverside
Road	Amyand Park Road
Location	Outside 182/184
Species	Wild Cherry (<i>Prunus avium</i>)
Height	8.0m
Physiological Condition	Dead
Structural Condition	Dead
Inspection findings	This tree is dead; removal is required to prevent natural failure and facilitate replanting

Image shows dead tree in street scene.

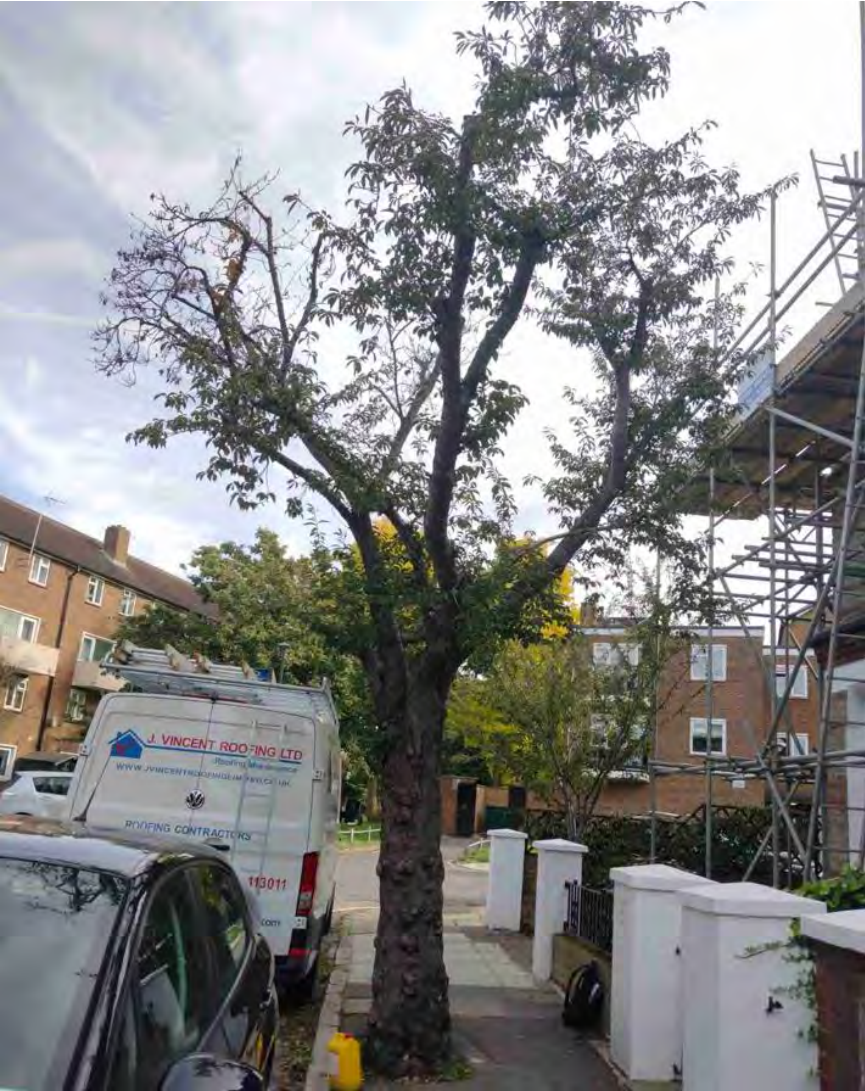
Ward	Twickenham Riverside
Road	Haggard Road
Location	Outside 51
Species	Wild Cherry (<i>Prunus avium</i>)
Height	6.0m
Physiological Condition	Poor
Structural Condition	Poor
Inspection findings	A fungal fruiting body of the decay pathogen <i>Ganoderma</i> sp. is present at the stem base. Colonisation by this fungus causes a white rot of the stem and root system that can cause entire trees to collapse through fracture or windthrow. Tree is declining with significant dieback present in crown and this correlates with the pathogen present on lower stem. Removal is required to prevent natural failure and facilitate replanting.

Images shows tree in street scene.

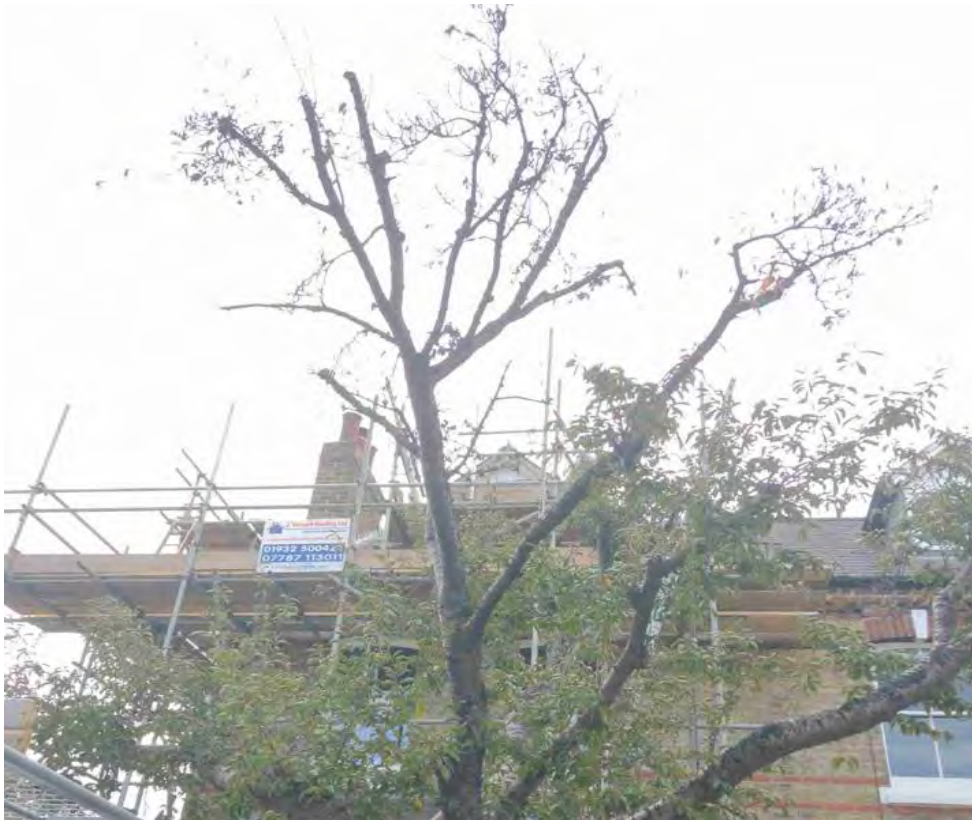
Images shows tree declining with significant dieback.

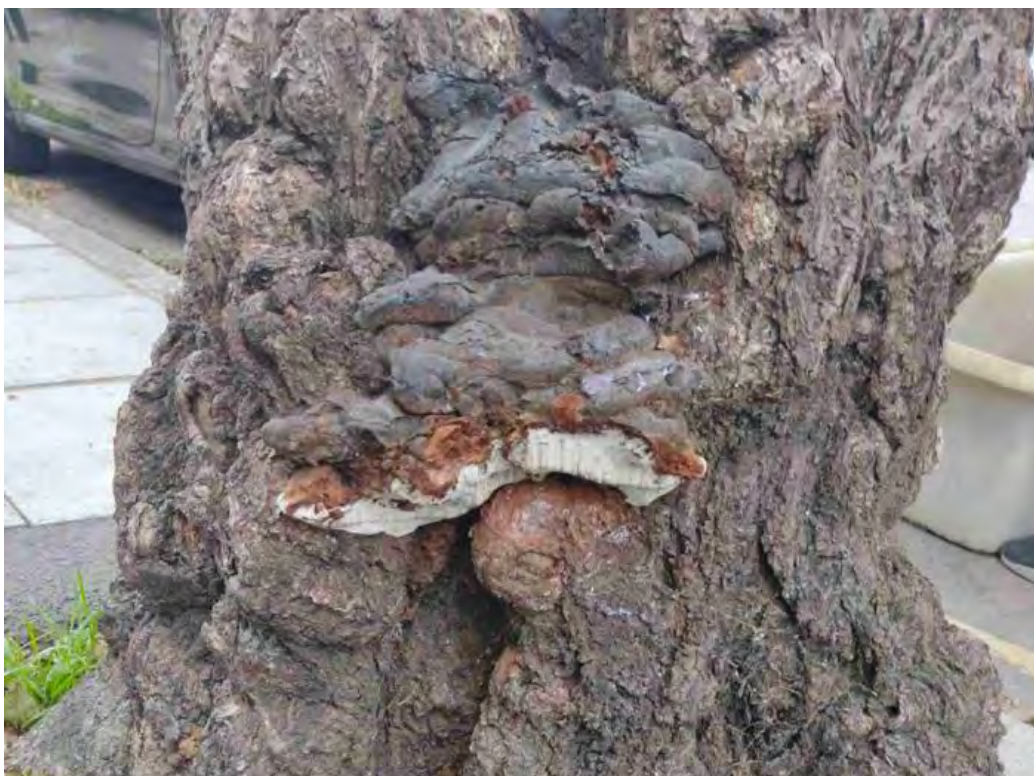
Images shows fruiting fungal bodies at base of stem

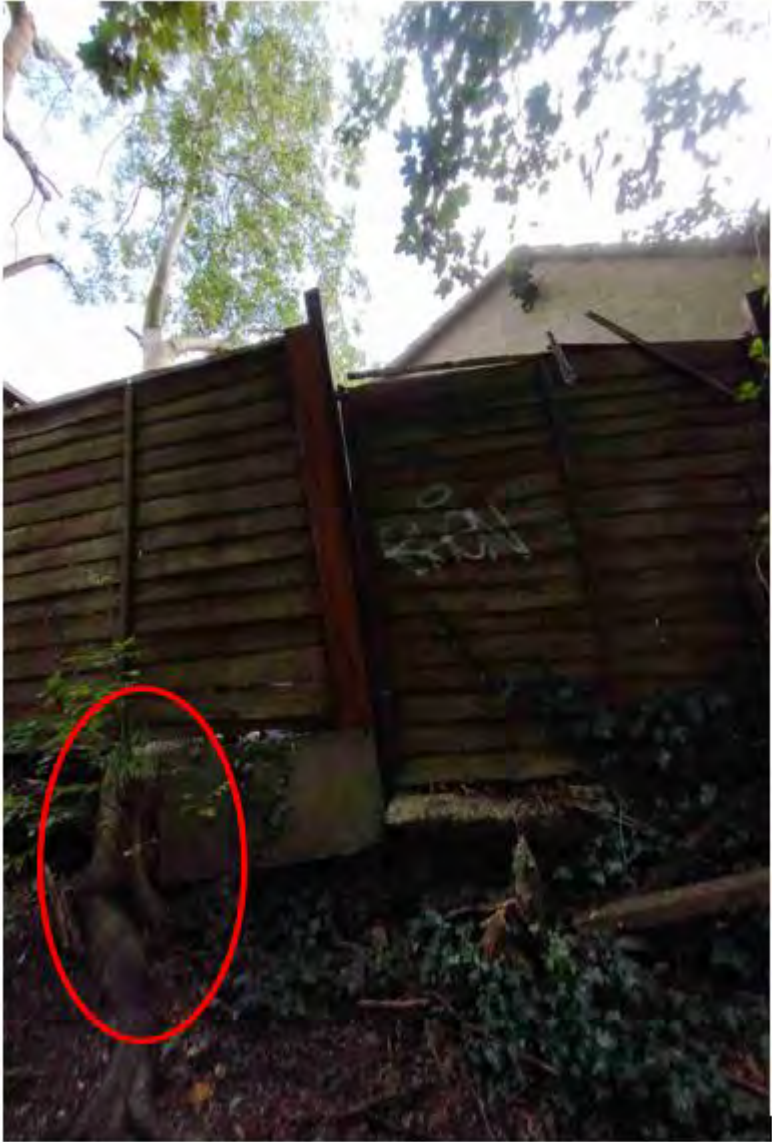
Ward	West Twickenham
Road	Mill Road
Location	Crane Park- What3Words ///submit.odds.wasp
Species	Common Ash (<i>Fraxinus excelsior</i>)
Height	14.0m
Physiological Condition	Fair
Structural Condition	Fair
Inspection findings	Tree is growing in an unsuitable location and causing damage to a fence

Images show tree in woodland context with base of stem damaging fence circled

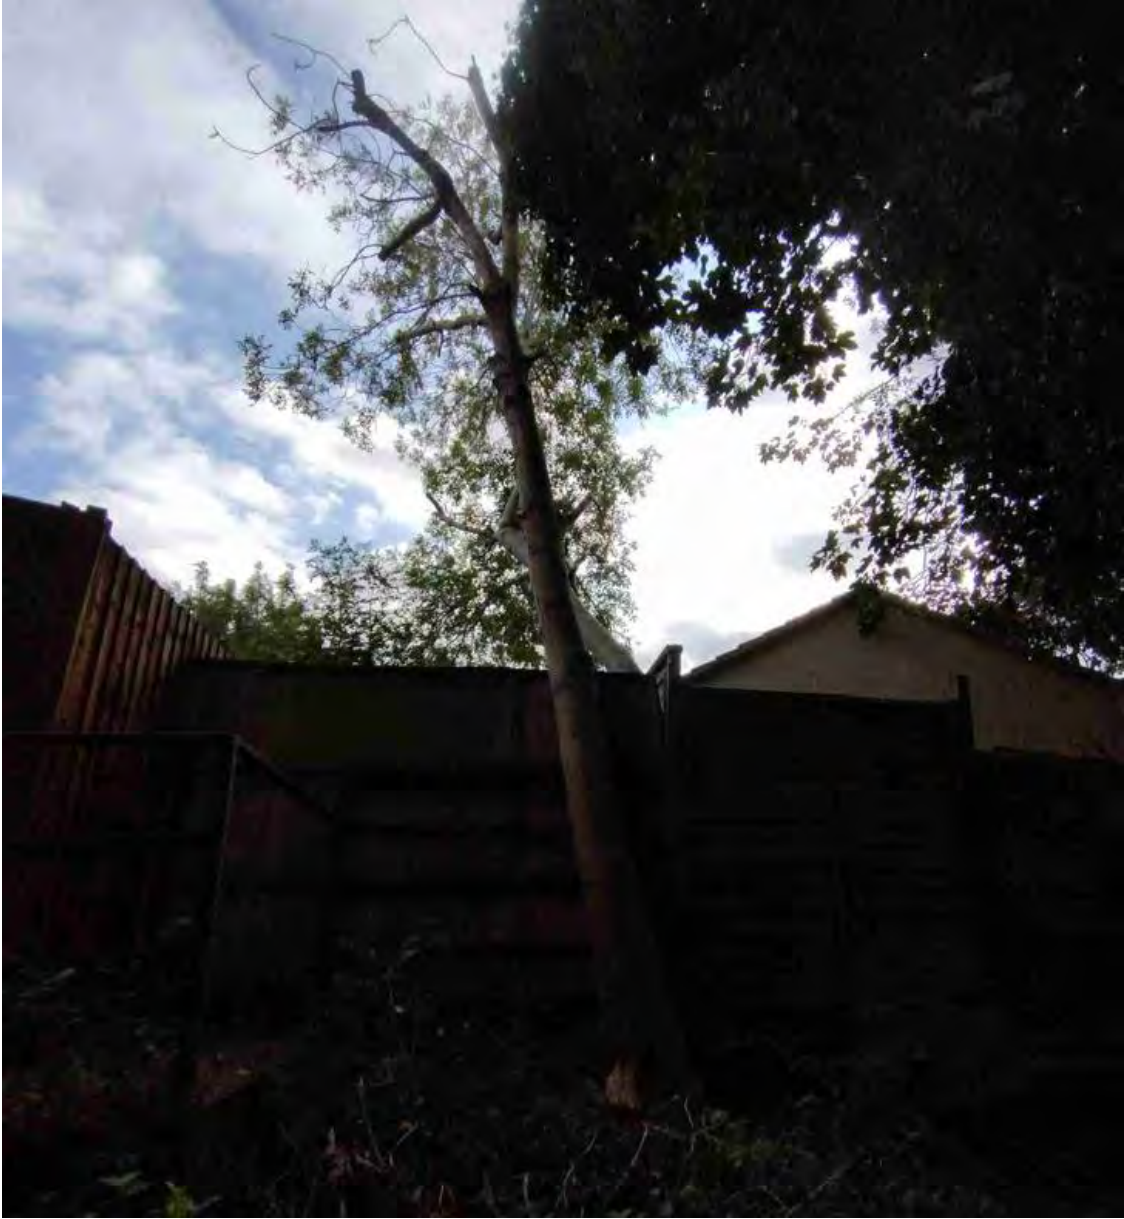
Ward	West Twickenham
Road	Mill Road
Location	Craine Park- What3Words ///void.train.those
Species	Common Ash (<i>Fraxinus excelsior</i>)
Height	9.0m
Physiological Condition	Fair
Structural Condition	Fair
Inspection findings	This tree is growing in an unsuitable location and causing damage to a fence

Images shows tree in park scene.

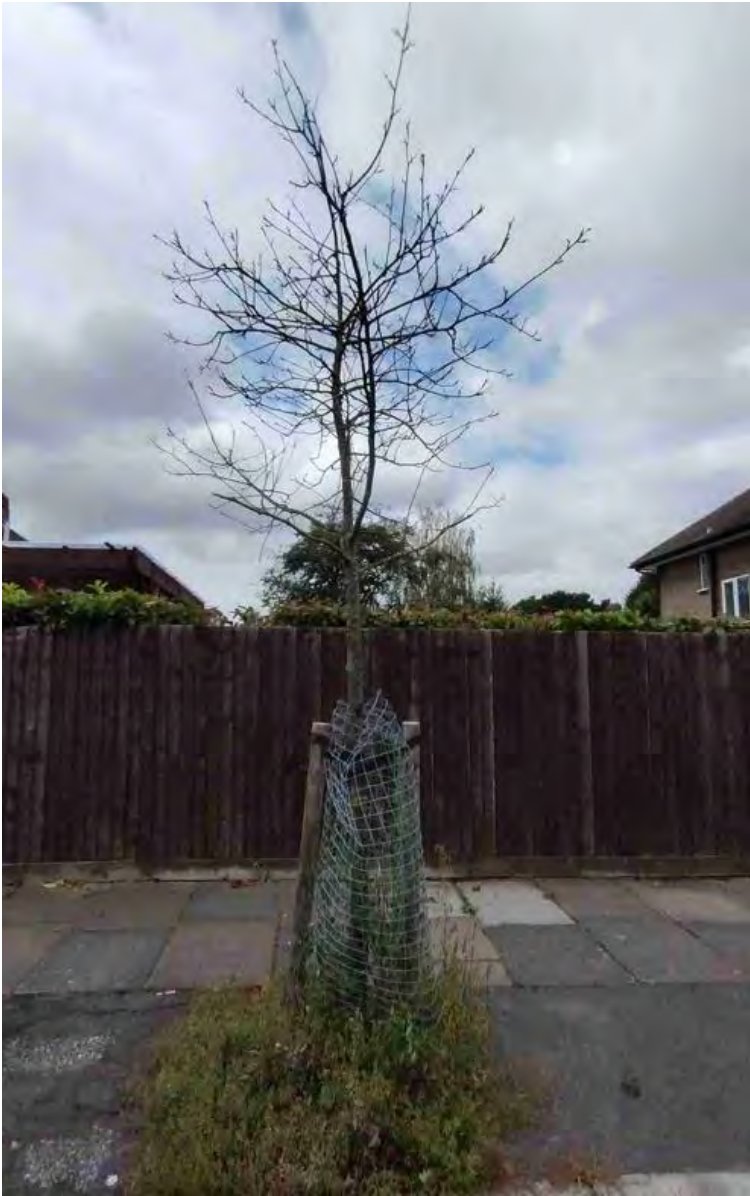
Ward	Whitton
Road	Grasmere Avenue
Location	Opposite 65/67
Species	Swedish Whitebeam (<i>Sorbus intermedia</i>)
Height	3.0m
Physiological Condition	Dead
Structural Condition	Dead
Inspection findings	This tree is dead; removal is required to prevent natural failure and facilitate replanting

Images shows dead tree in street scene.
