## December 2024 - Reactive Tree Works Programme

### Introduction

Dated 16.12.2024

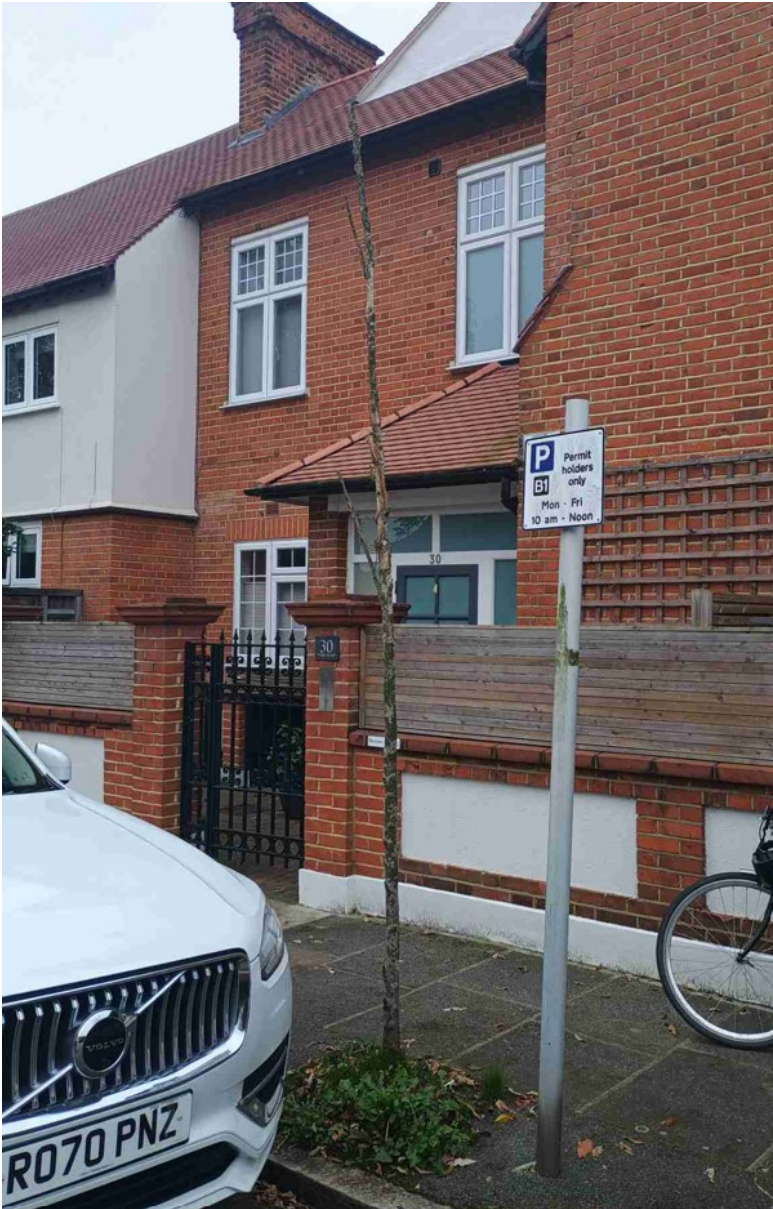
Ward	Barnes
Road	Suffolk Road
Location	Adjacent 30 Ferry Road main building
Species	Hornbeam ( <i>Carpinus betulus</i> )
Height	4.0m
Physiological Condition	Dead
Structural Condition	Dead
Inspection findings/reason for exemption	This tree is dead; removal is required to prevent natural failure, manage risk, and facilitate replanting

Image shows dead tree in street scene

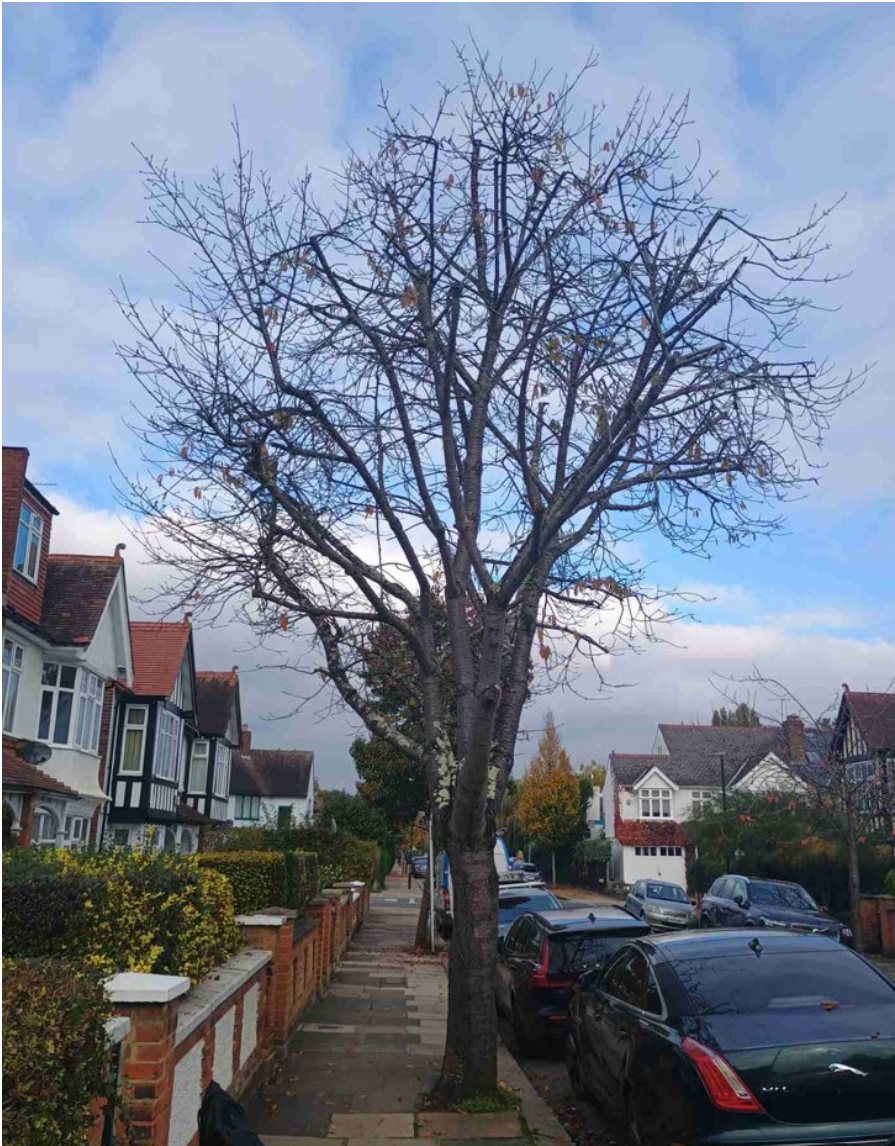
<b>Ward</b>	Barnes
<b>Road</b>	Madrid Road
<b>Location</b>	Outside 95
<b>Species</b>	Cherry ( <i>Prunus sp.</i> )
<b>Height</b>	8.0m
<b>Physiological Condition</b>	Poor
<b>Structural Condition</b>	Poor
<b>Inspection findings/reason for exemption</b>	Fungal fruiting bodies of the decay fungi <i>Armillaria sp.</i> are present at the base of this tree. Colonisation by this fungus causes a white rot of the roots and butt that can cause entire tree failure. Crown dieback could correlate with the parasite present. Removal is required to prevent natural failure, manage risk, and facilitate replanting

**Image shows tree in street scene**

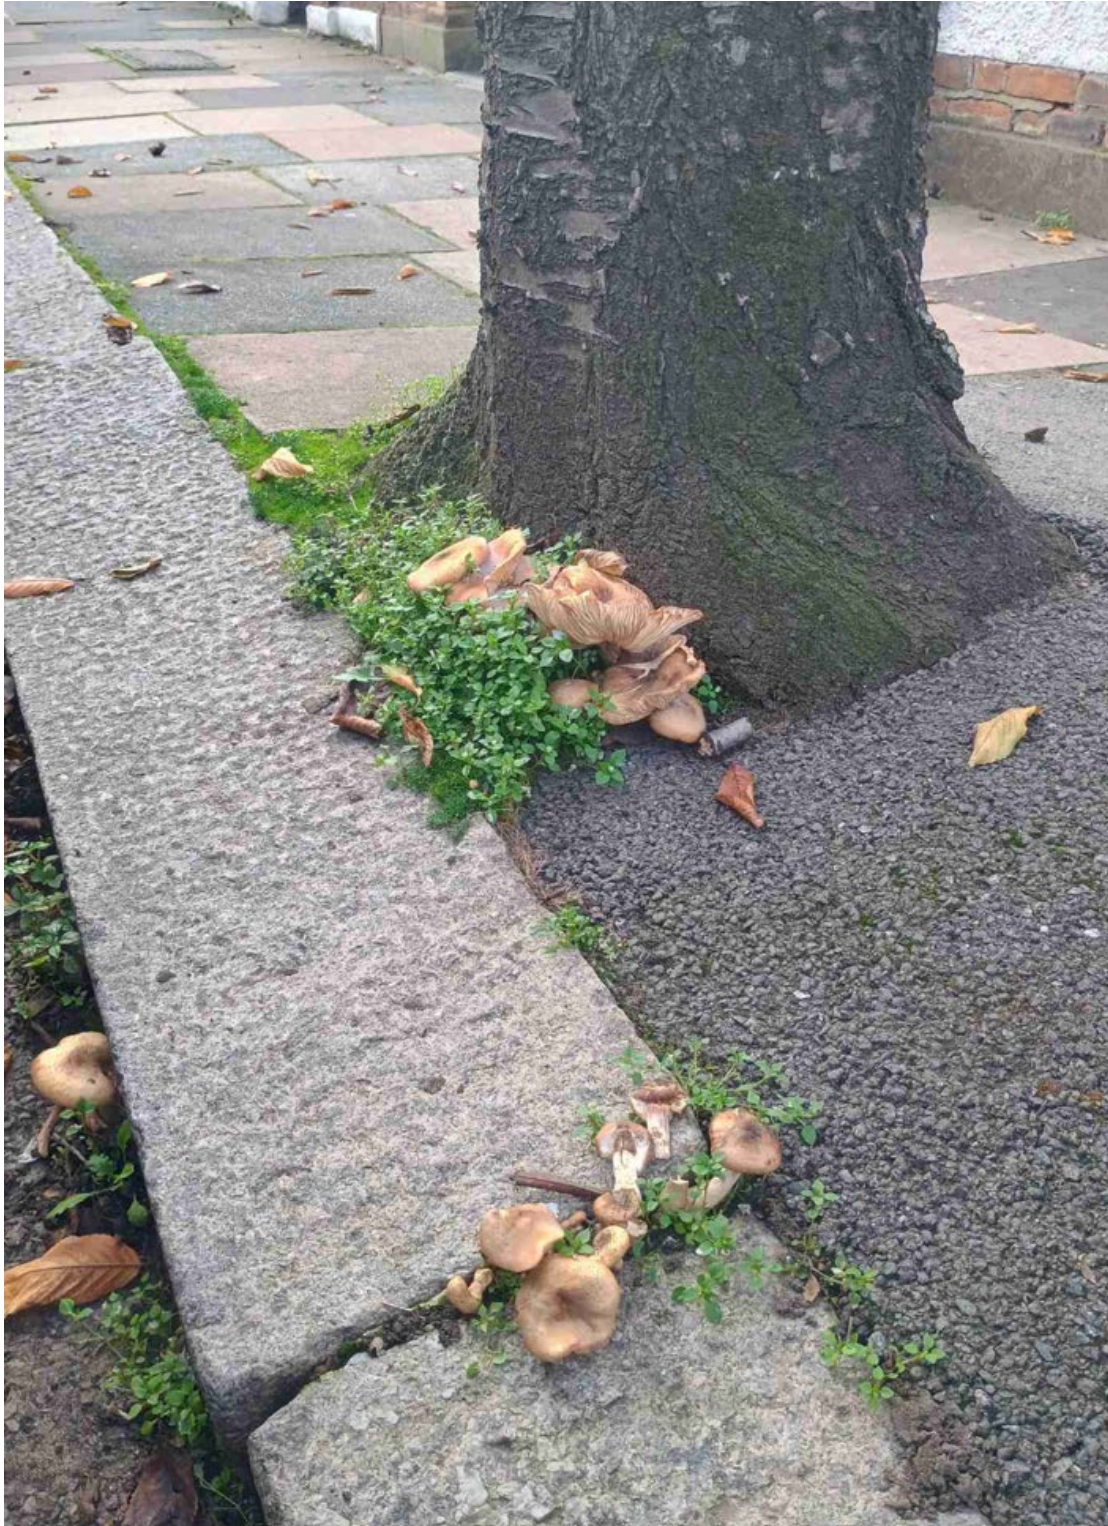
**Image shows fruiting body circled at base of trunk.**

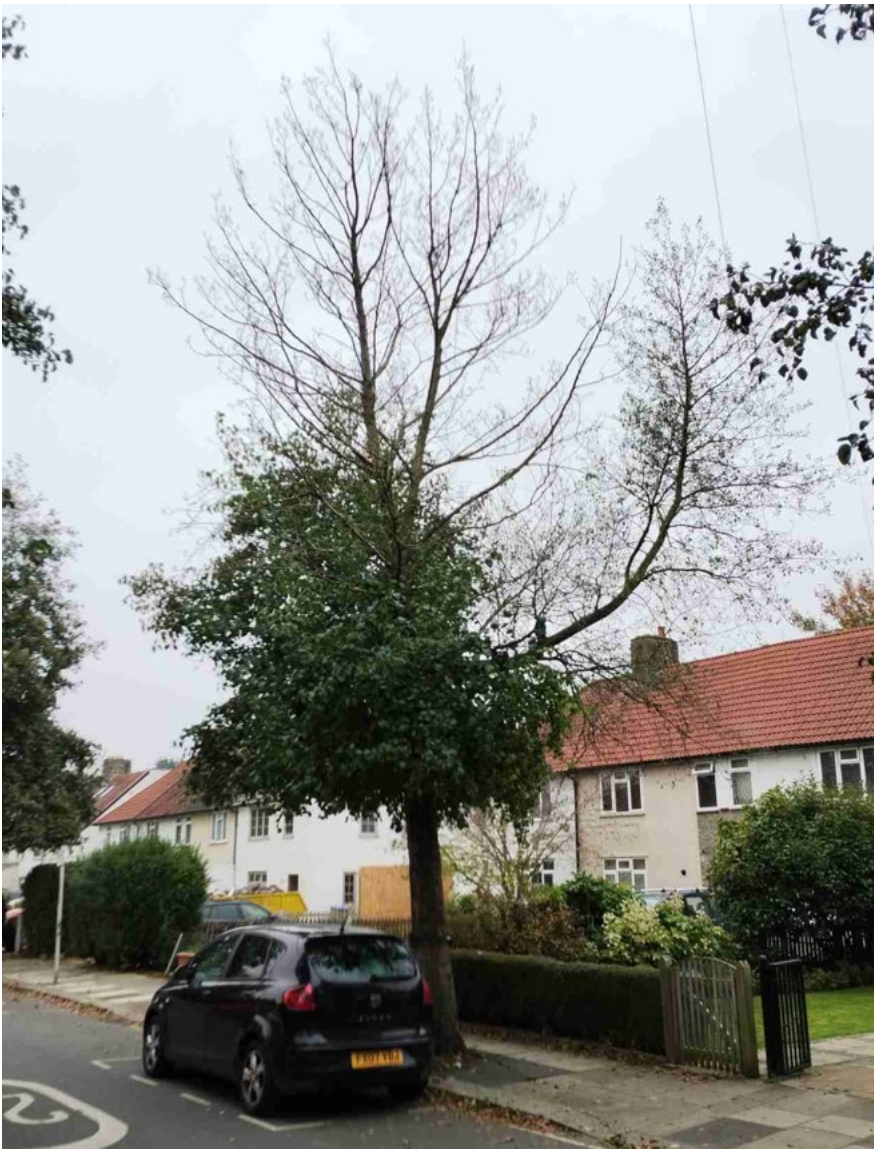
<b>Ward</b>	Barnes
<b>Road</b>	Barnes Avenue
<b>Location</b>	Outside 41
<b>Species</b>	Italian Alder ( <i>Alnus cordata</i> )
<b>Height</b>	12.5m
<b>Physiological Condition</b>	Poor
<b>Structural Condition</b>	Poor
<b>Inspection findings/reason for exemption</b>	This tree is moribund with over 70% of the crown being dead. Removal is required to prevent natural failure, manage risk, and facilitate replanting

**Image shows moribund tree in street scene.**

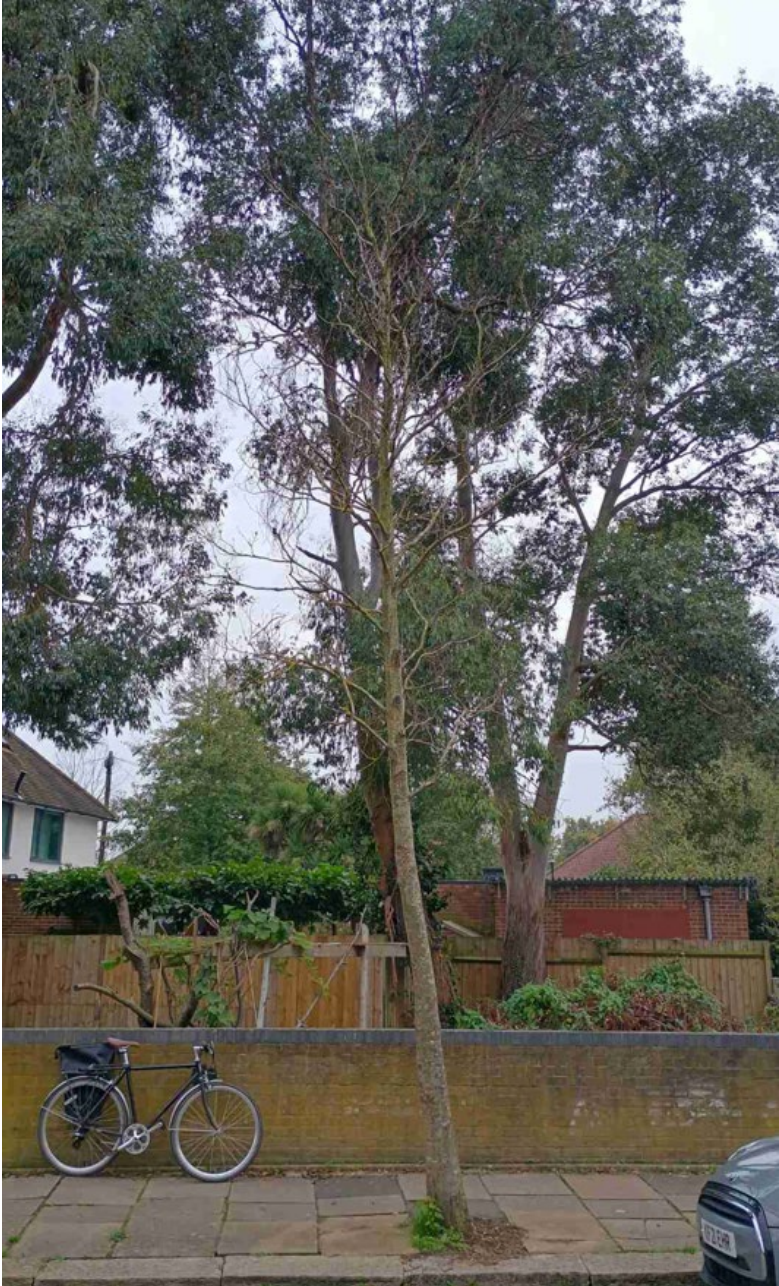
<b>Ward</b>	Barnes
<b>Road</b>	Stillingfleet Road
<b>Location</b>	Outside 4 front garden
<b>Species</b>	Common Alder ( <i>Alnus glutinosa</i> )
<b>Height</b>	7.0m
<b>Physiological Condition</b>	Dead
<b>Structural Condition</b>	Dead
<b>Inspection findings/reason for exemption</b>	This tree is dead; removal is required to prevent natural failure and facilitate replanting

**Image shows dead tree in street scene.**

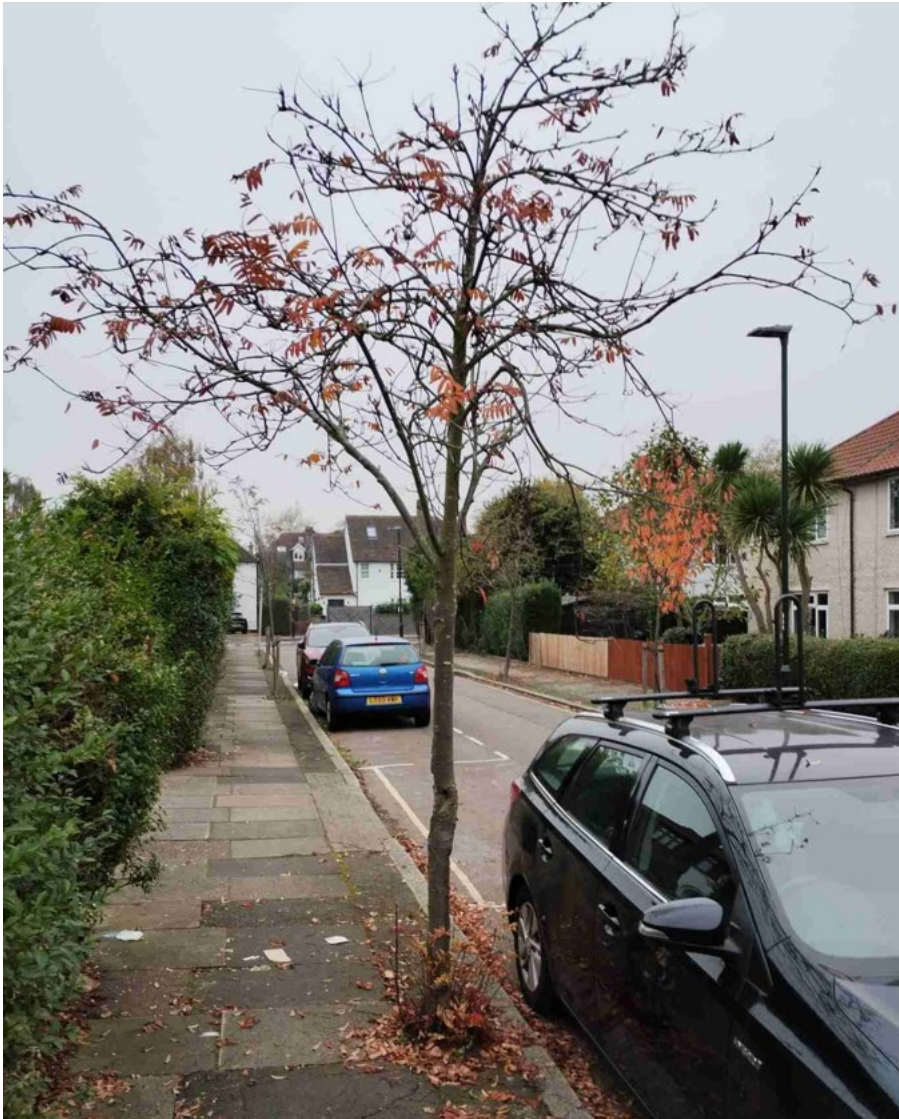
<b>Ward</b>	Barnes
<b>Road</b>	Everdon Road
<b>Location</b>	Outside 19
<b>Species</b>	Rowan ( <i>Sorbus aucuparia</i> )
<b>Height</b>	4.5m
<b>Physiological Condition</b>	Fair
<b>Structural Condition</b>	Poor
<b>Inspection findings/reason for exemption</b>	This tree has Substantial wounding on the main trunk. This feature has caused a weak point to the trunk which is liable to fail as the tree grows. Removal is required to prevent natural failure, manage risk, and manage risk.

**Image shows tree in street scene.**

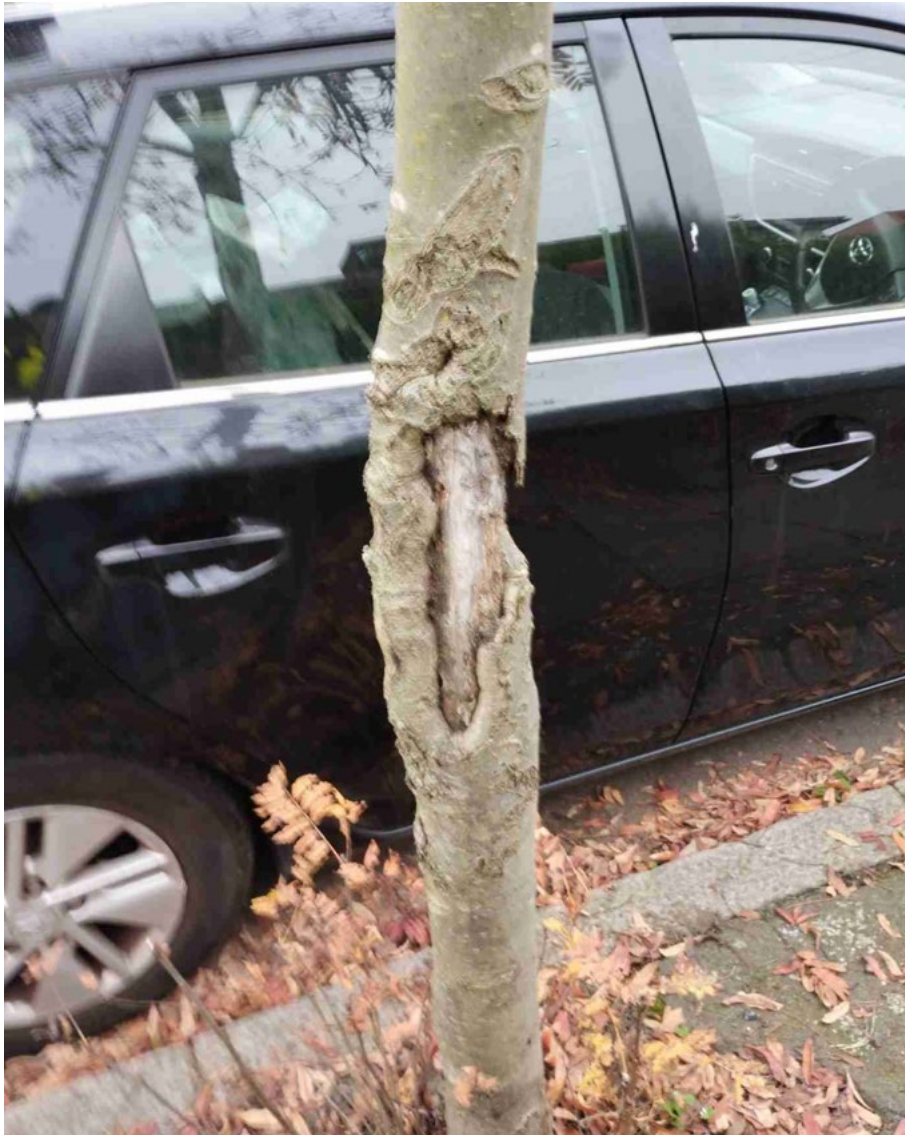
**Image shows wounding on trunk.**

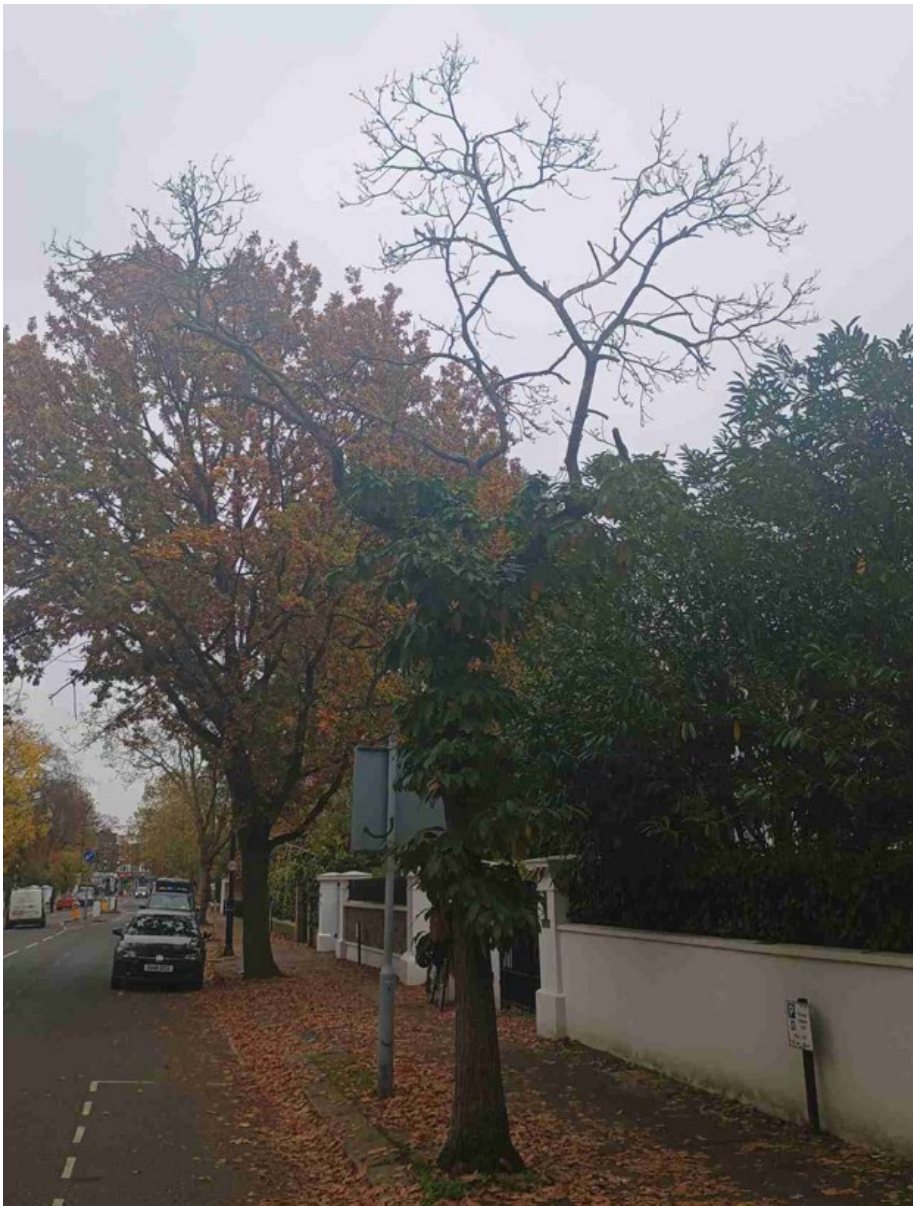
<b>Ward</b>	Barnes
<b>Road</b>	Lonsdale Road
<b>Location</b>	Outside 25
<b>Species</b>	Sweet Chestnut ( <i>Castanea sativa</i> )
<b>Height</b>	8.0m
<b>Physiological Condition</b>	Poor
<b>Structural Condition</b>	Fair
<b>Inspection findings/reason for exemption</b>	This tree is moribund with over 80% of the crown being dead. Removal is required to prevent natural failure, manage risk, and facilitate replanting

**Image shows moribund tree in street scene.**

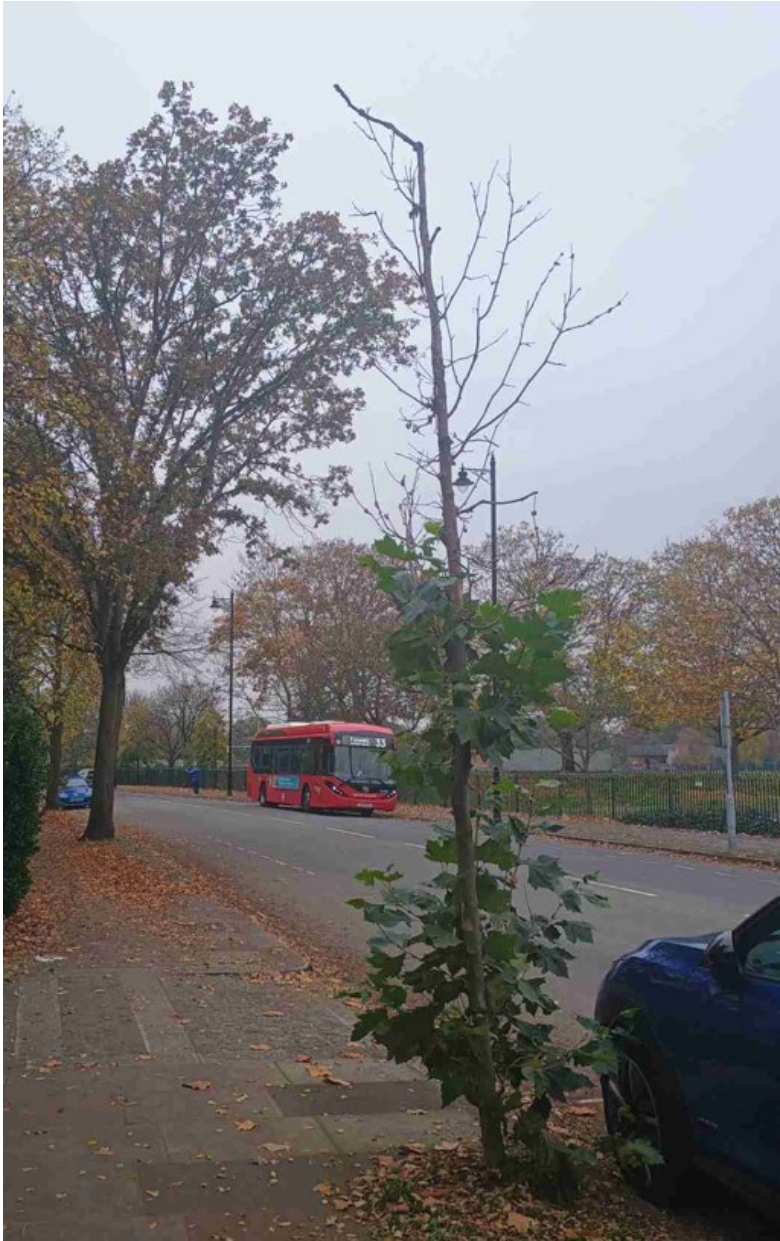
<b>Ward</b>	Barnes
<b>Road</b>	Lonsdale Road
<b>Location</b>	Outside 19
<b>Species</b>	London Plane ( <i>Platanus x hispanica</i> )
<b>Height</b>	4.5m
<b>Physiological Condition</b>	Fair
<b>Structural Condition</b>	Poor
<b>Inspection findings/reason for exemption</b>	This tree is moribund with over 80% of the crown being dead. Removal is required to prevent natural failure, manage risk, and facilitate replanting

**Image shows moribund tree in street scene.**

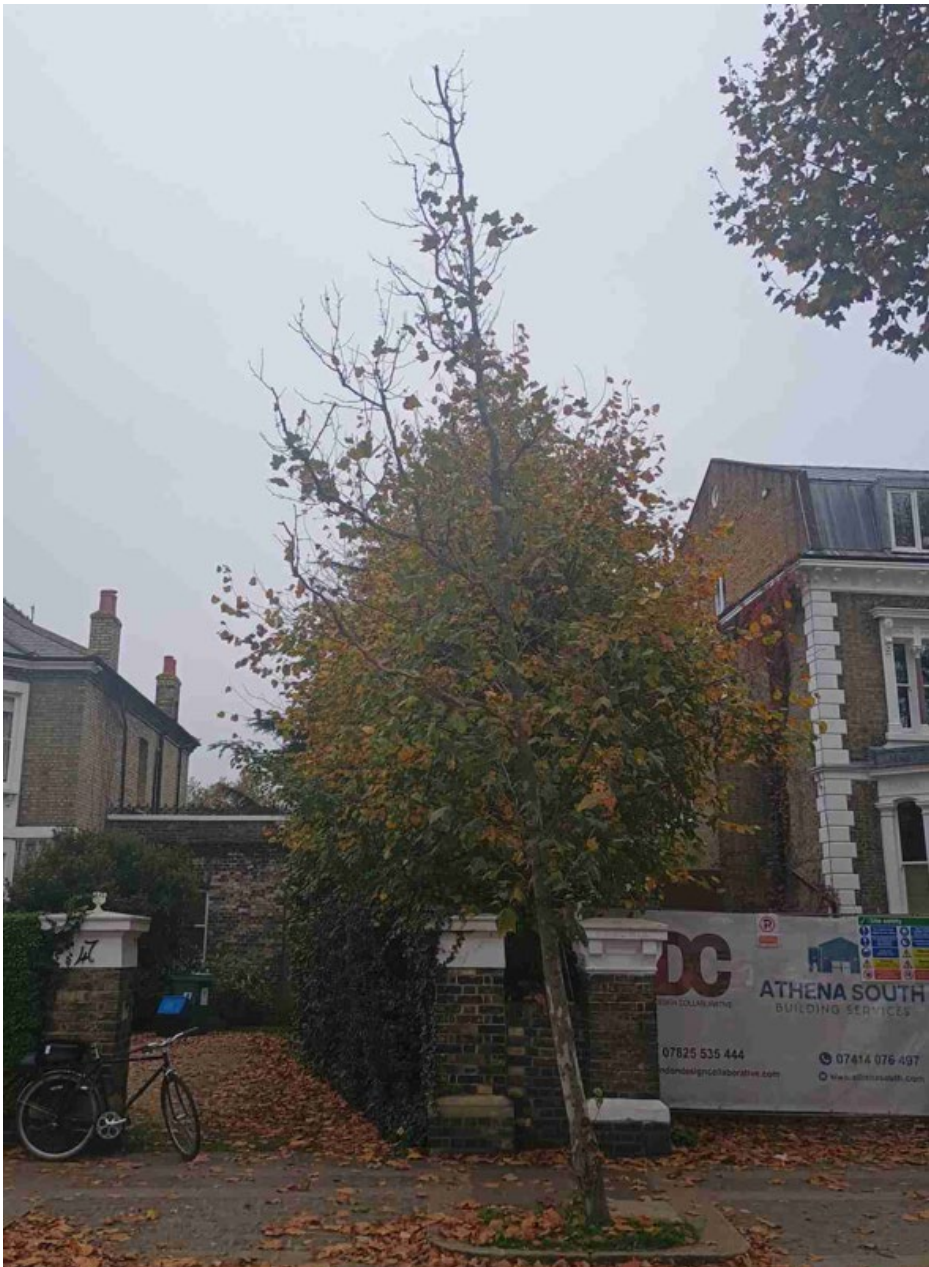
<b>Ward</b>	Barnes
<b>Road</b>	Lonsdale Road
<b>Location</b>	Outside 47/49b
<b>Species</b>	London Plane ( <i>Platanus x hispanica</i> )
<b>Height</b>	9.5m
<b>Physiological Condition</b>	Poor
<b>Structural Condition</b>	Fair
<b>Inspection findings/reason for exemption</b>	This tree is moribund with over 70% of the crown being dead. Removal is required to prevent natural failure, manage risk, and facilitate replanting

**Image shows moribund tree in street scene.**

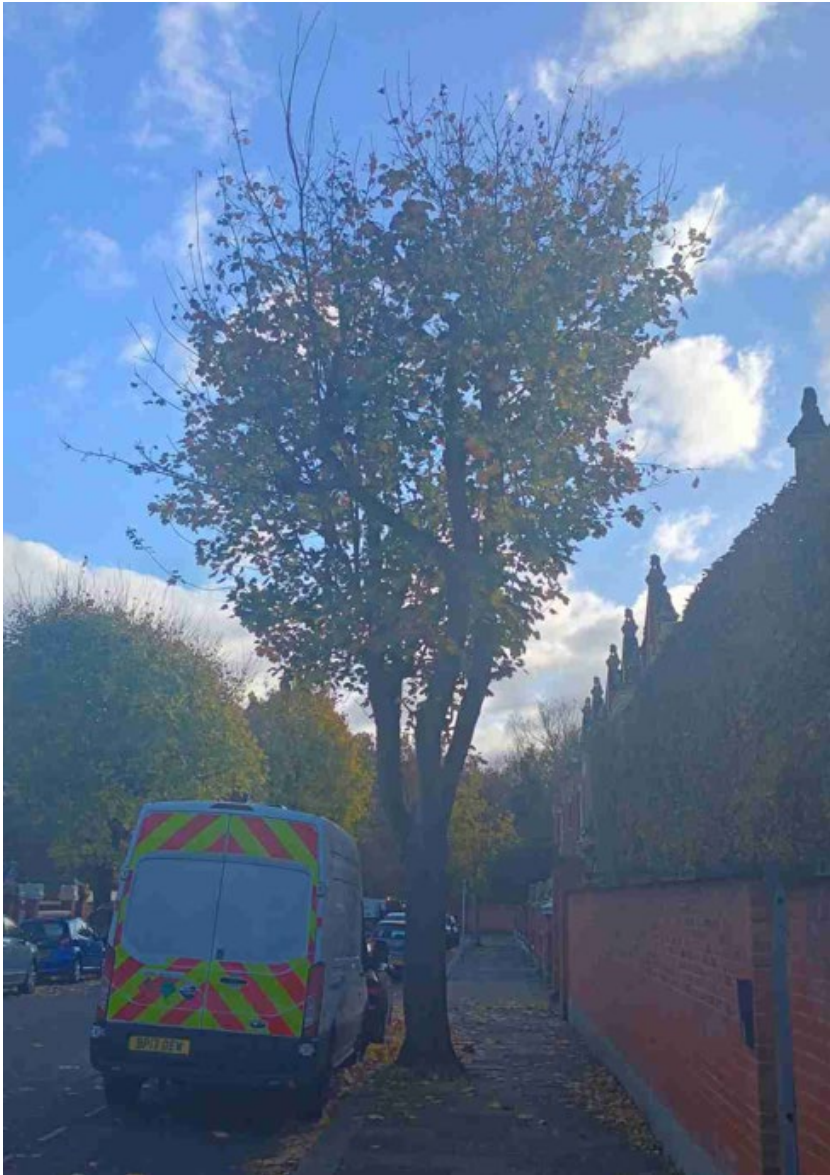
<b>Ward</b>	Barnes
<b>Road</b>	Glebe Road
<b>Location</b>	Opposite 51
<b>Species</b>	Norway Maples ( <i>Acer platanoides</i> )
<b>Height</b>	13.0m
<b>Physiological Condition</b>	Fair
<b>Structural Condition</b>	Poor
<b>Inspection findings/reason for exemption</b>	This tree has a cavity at the base of trunk. Investigation with a probe revealed an unacceptable degree of decay inside the cavity. Removal is required to prevent natural failure, manage risk, and facilitate replanting.

**Image shows tree in street scene.**

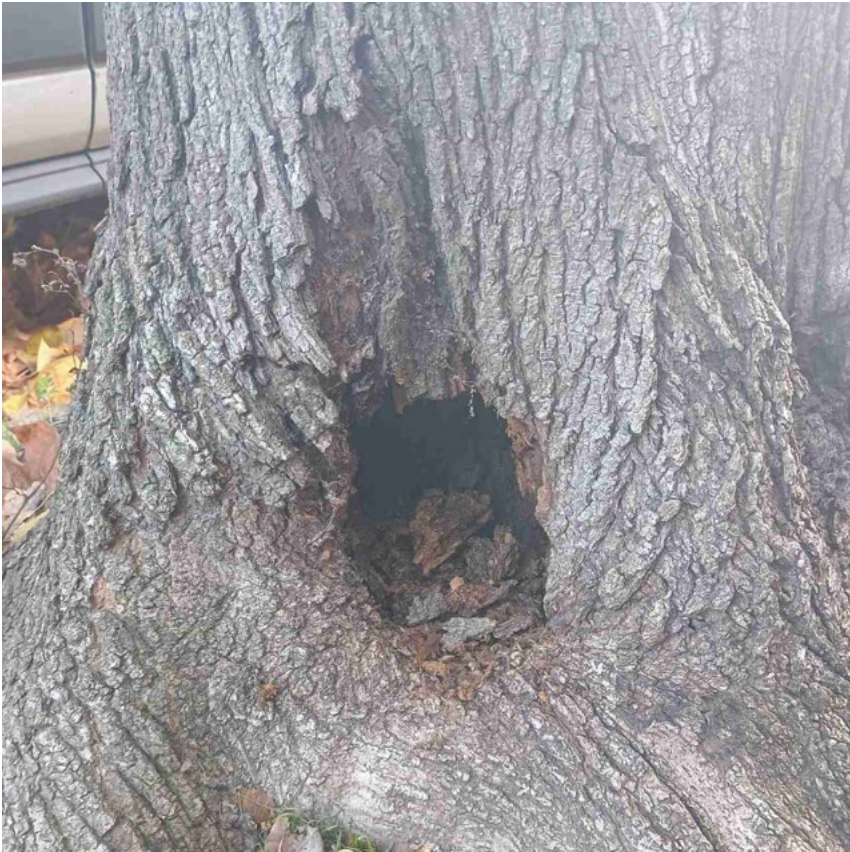
***Image shows cavity at base of stem.***

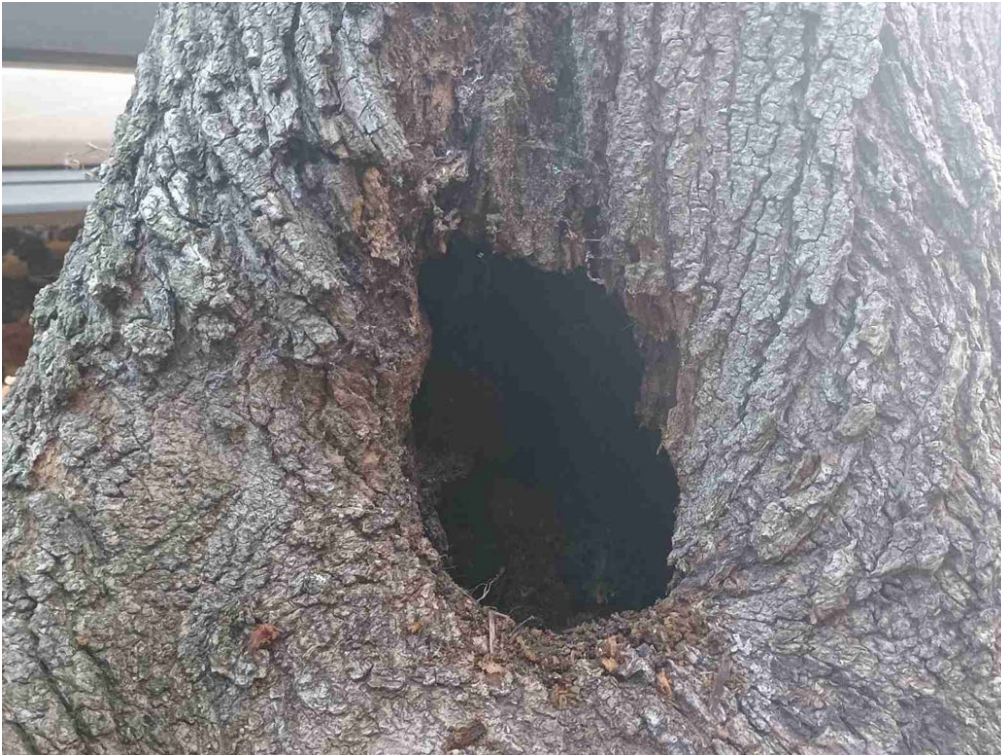
***Image shows close up of cavity at base of stem.***

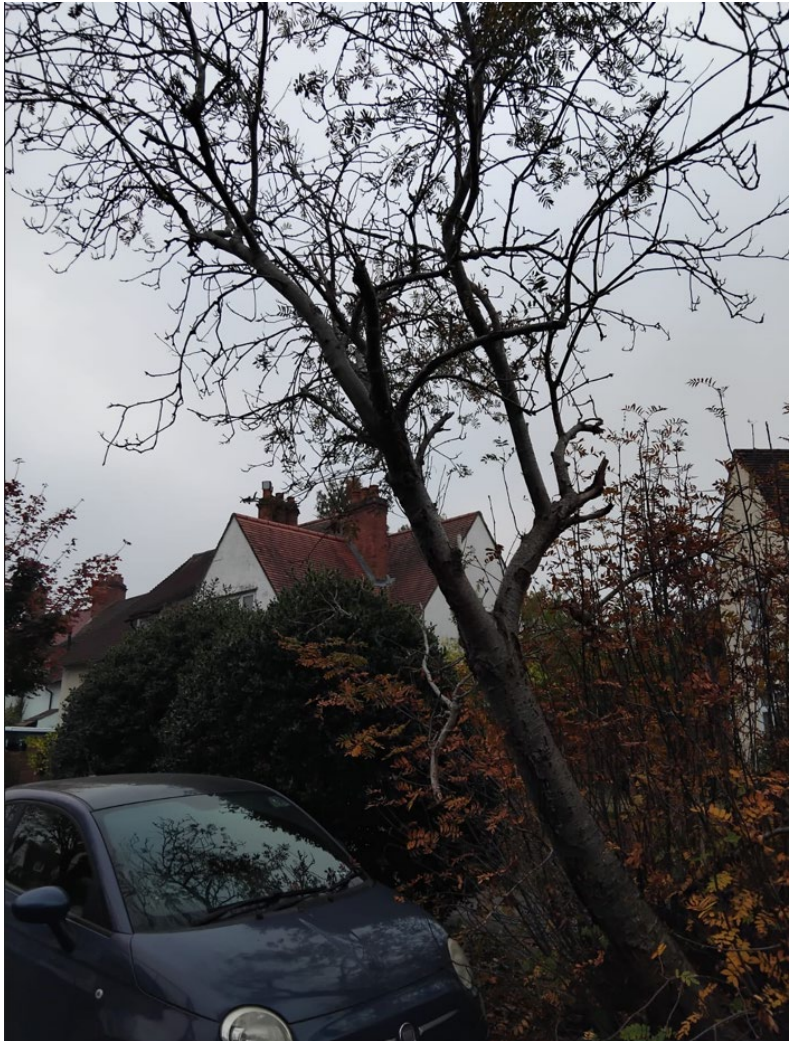
<b>Ward</b>	Fulwell and Hampton Hill
<b>Road</b>	Mays Road
<b>Location</b>	Outside 17 driveway
<b>Species</b>	Rowan ( <i>Sorbus aucuparia</i> )
<b>Height</b>	6.0m
<b>Physiological Condition</b>	Poor
<b>Structural Condition</b>	Poor
<b>Inspection findings/reason for exemption</b>	A fungal fruiting body of the decay fungi <i>Ganoderma</i> sp. is present at the stem base. Colonisation by this fungus causes a white rot of the stem and root system that can cause entire trees to collapse through fracture or windthrow. Crown dieback indicates that the tree is under considerable physiological stress and likely advanced decay of the supporting root system. Removal is required to prevent natural failure and manage risk.

***Image shows tree in street scene.***

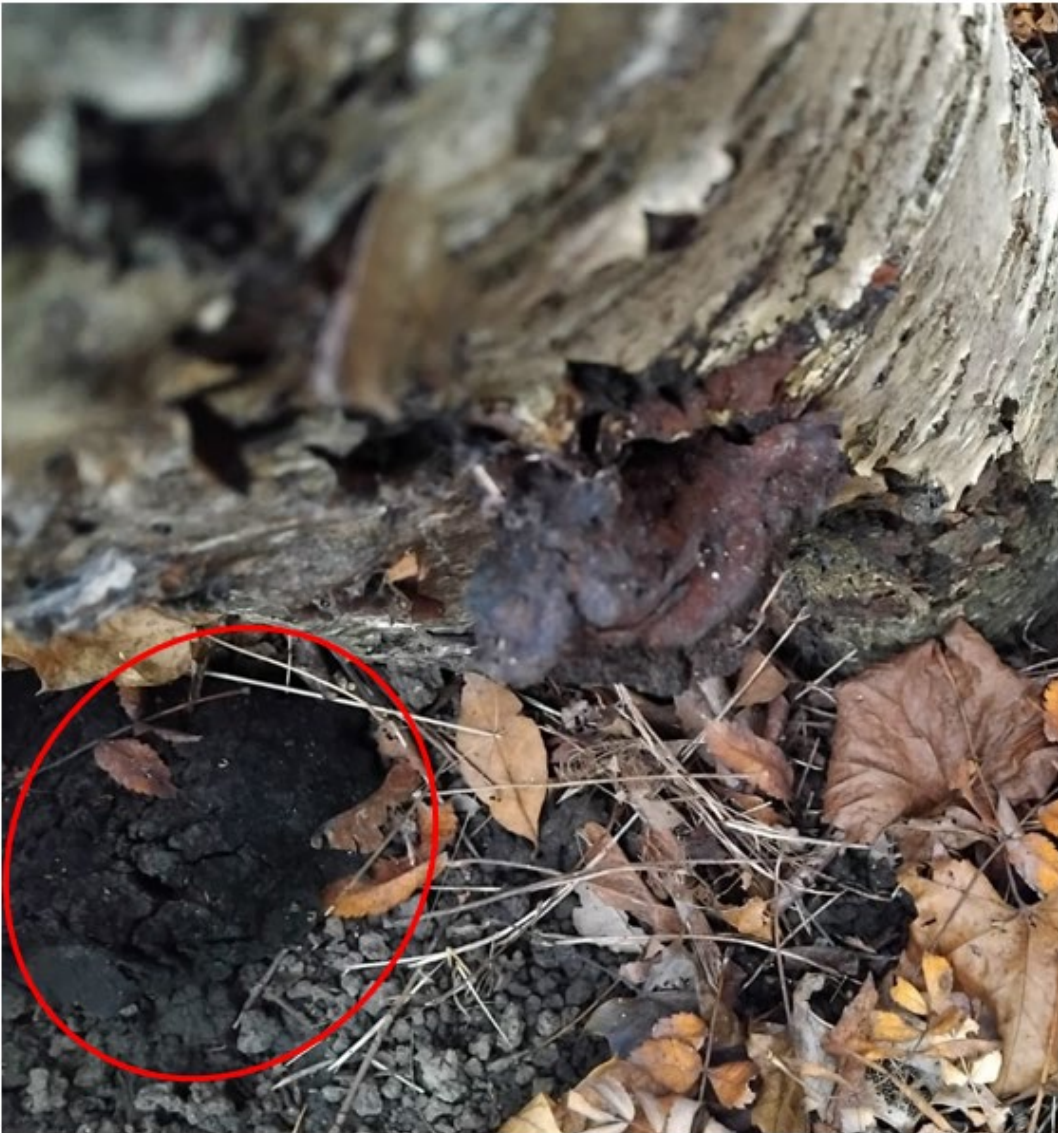
***Image shows fruiting body circled.***

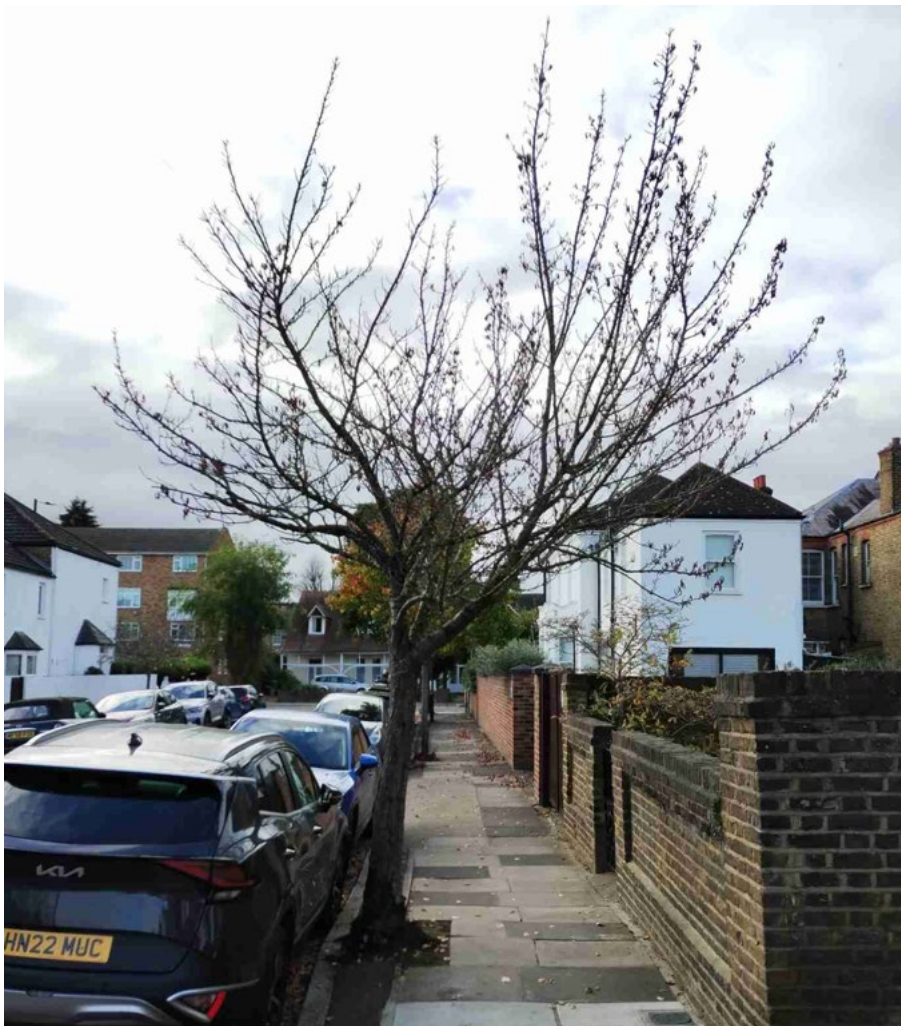
<b>Ward</b>	Hampton Wick and South Teddington
<b>Road</b>	St Winifreds Road
<b>Location</b>	Outside 1A
<b>Species</b>	Cherry ( <i>Prunus sp.</i> )
<b>Height</b>	6.5m
<b>Physiological Condition</b>	Poor
<b>Structural Condition</b>	Poor
<b>Inspection findings/reason for exemption</b>	Fungal fruiting bodies of the decay fungi <i>Armillaria</i> sp. are present at the base of this tree. Colonisation by this fungus causes a white rot of the roots and butt that can cause entire tree failure. Crown dieback could correlate with the parasite present. Removal is required to prevent natural failure, manage risk, and facilitate replanting

**Image shows tree in street scene.**

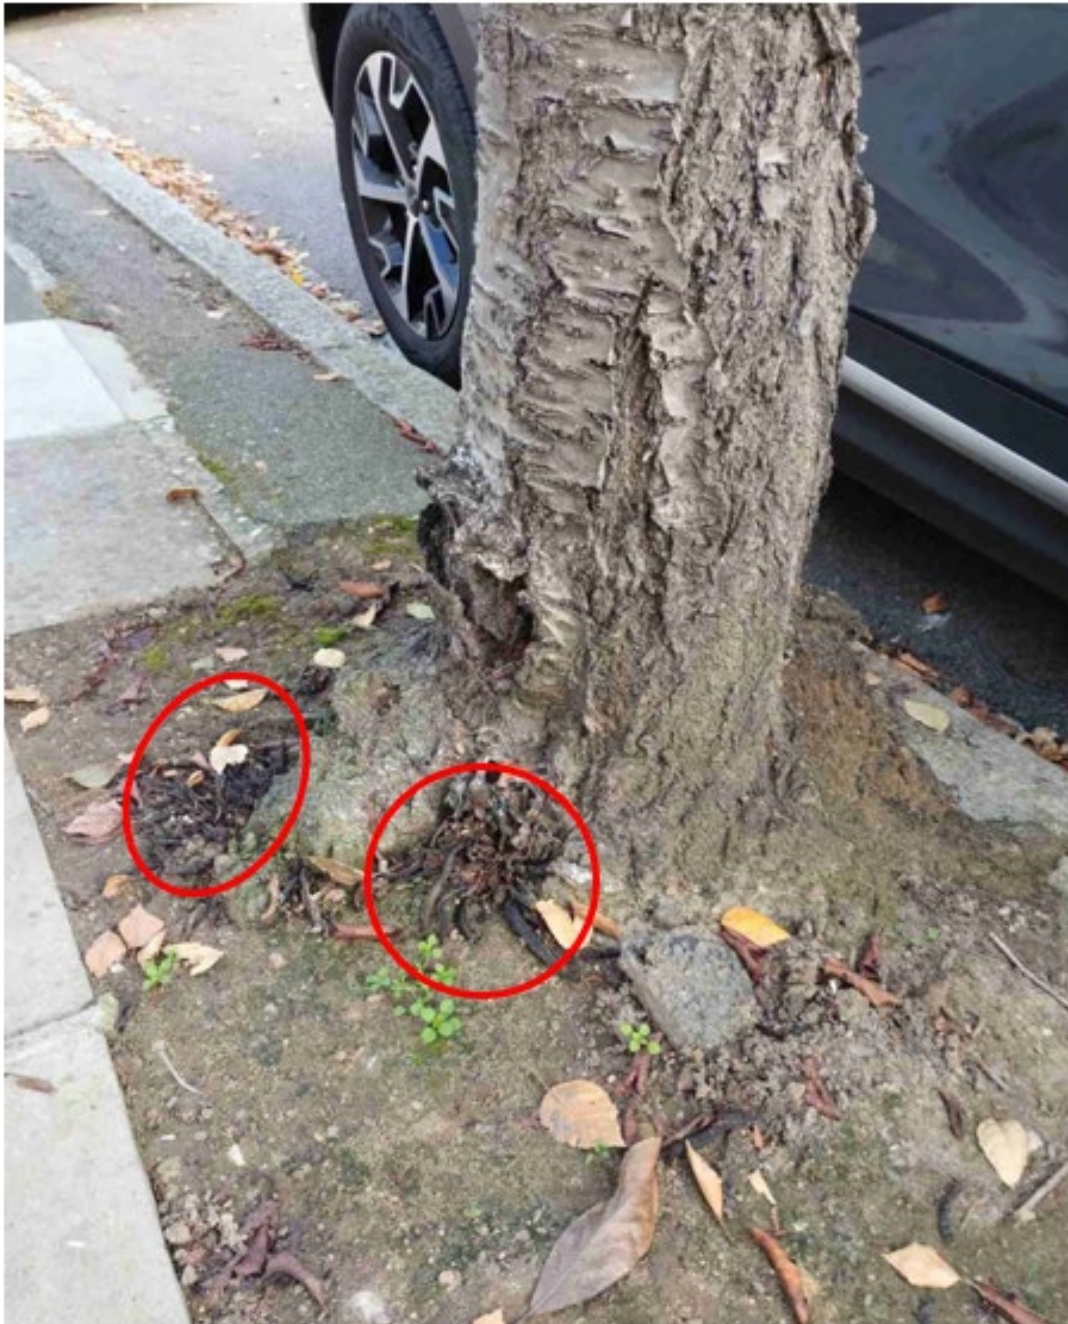
***Image shows fungal fruiting bodies circled at base of tree.***

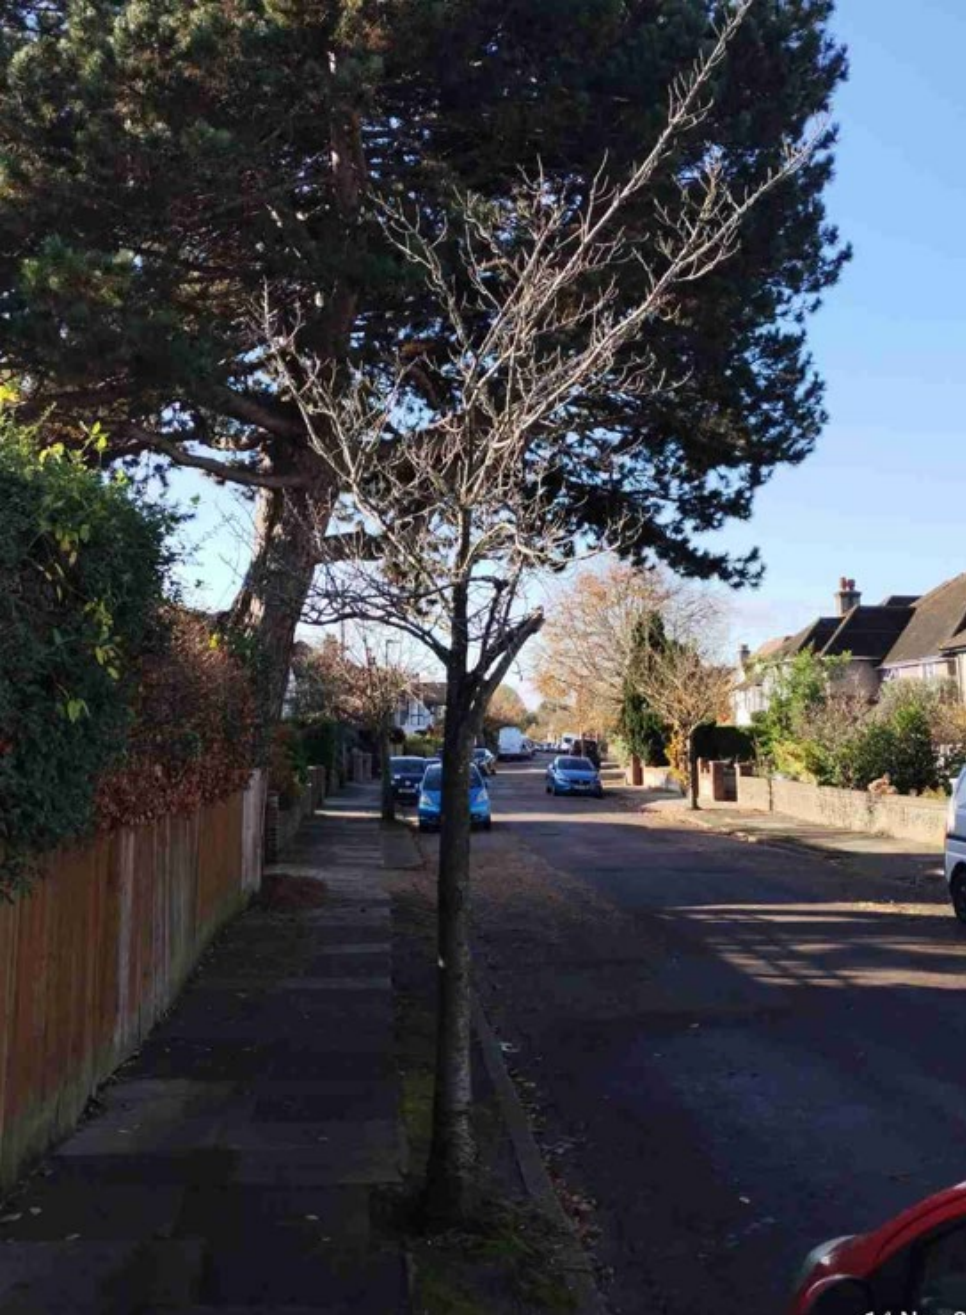
<b>Ward</b>	Hampton Wick and South Teddington
<b>Road</b>	St Winifreds Road
<b>Location</b>	Adjacent to 78 Broom Road rear garden
<b>Species</b>	Wild Cherry ( <i>Prunus avium</i> )
<b>Height</b>	4.5m
<b>Physiological Condition</b>	Dead
<b>Structural Condition</b>	Dead
<b>Inspection findings/reason for exemption</b>	This tree is dead; removal is required to prevent natural failure, manage risk, and facilitate replanting

Image shows dead tree in street scene.

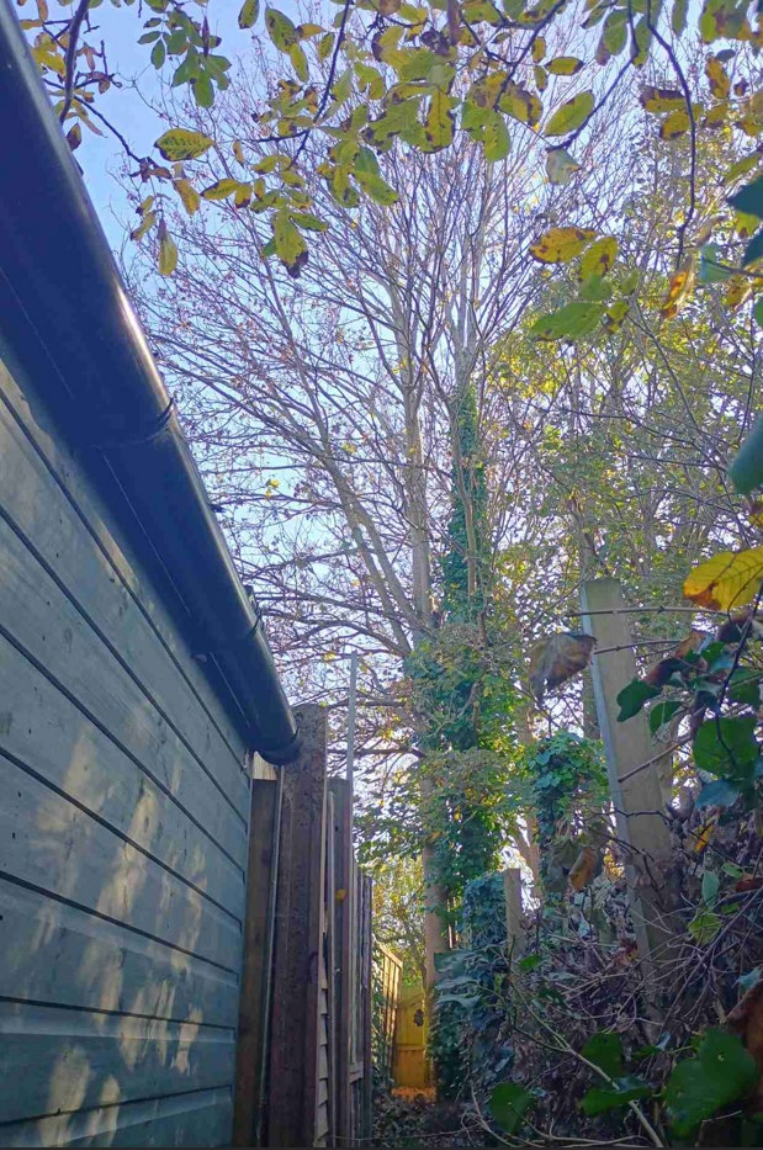
<b>Ward</b>	Hampton Wick and South Teddington
<b>Road</b>	School House Lane
<b>Location</b>	In alleyway between open space and to the rear of houses- ///buns.roof.broke
<b>Species</b>	Sycamore ( <i>Acer pseudoplatanus</i> )
<b>Height</b>	12.0m
<b>Physiological Condition</b>	Good
<b>Structural Condition</b>	Good
<b>Inspection findings/reason for exemption</b>	This tree is causing an unreasonable obstruction to a passage with a designated right of way, which the council is obligated to keep clear. The only viable solution in this situation is to remove the tree to restore unobstructed access to the path.

Image shows tree in park scene.
