## December 2024 - Reactive Tree Works Programme

### Introduction

Dated 16.12.2024

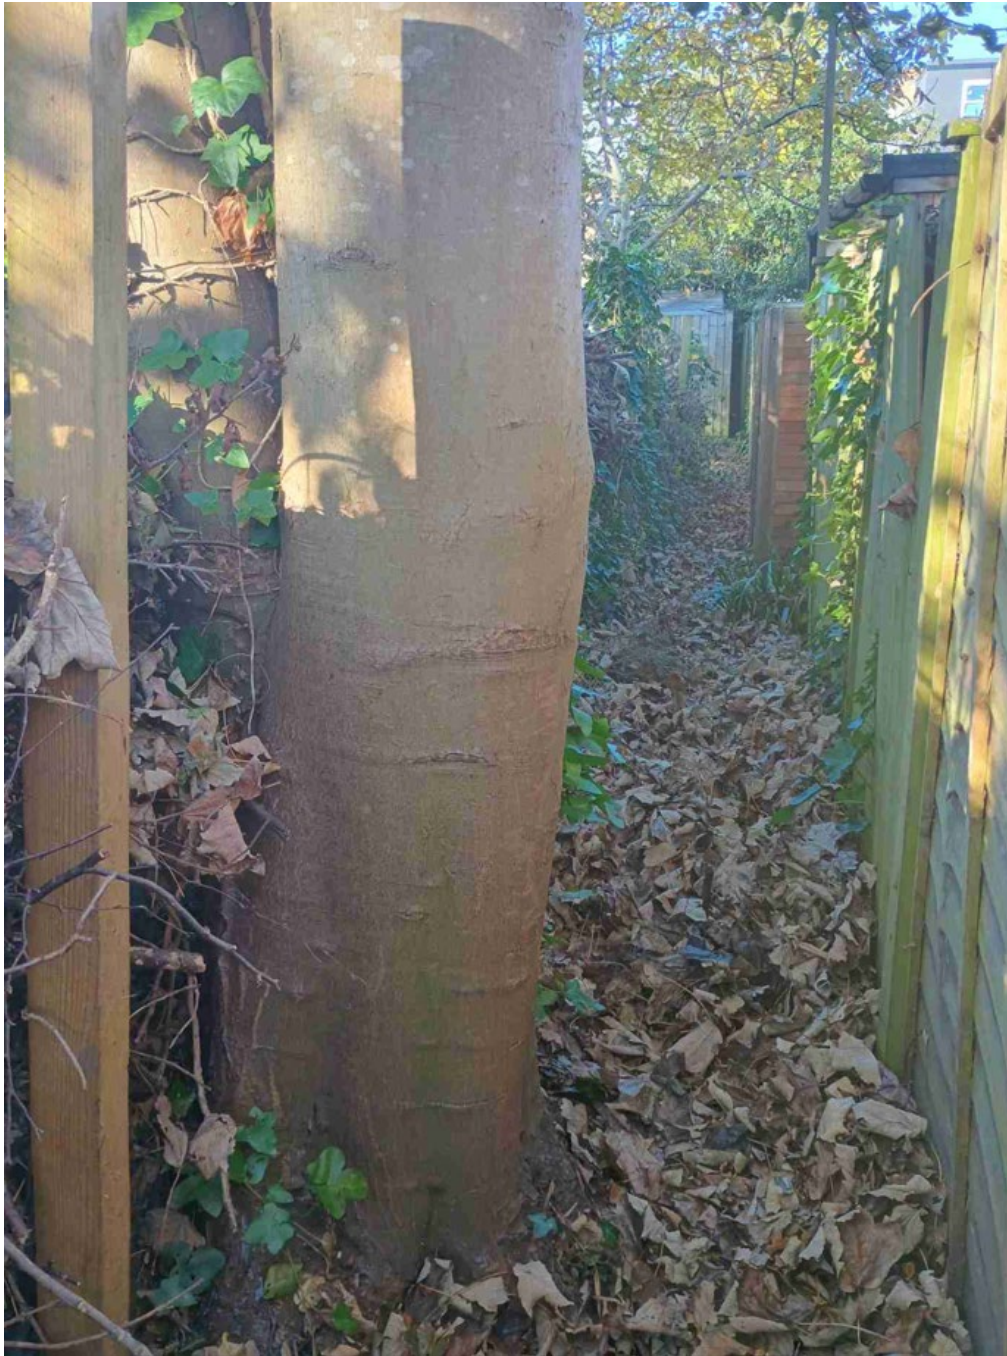
***Image shows trunk blocking right of way.***

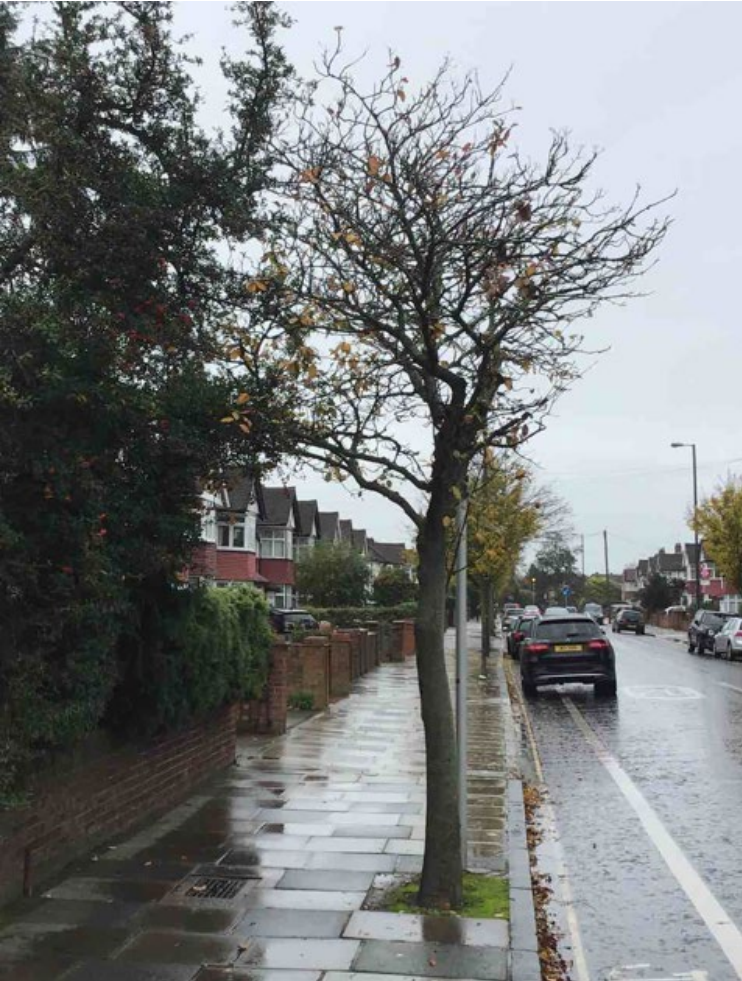
Ward	Heathfield
Road	Percy Road
Location	Outside 147-149
Species	Whitebeam ( <i>Sorbus aria</i> )
Height	15.0m
Physiological Condition	Poor
Structural Condition	Poor
Inspection findings/reason for exemption	A fungal fruiting body of the species Shaggy Polypore ( <i>Inonotus hispidus</i> ) is present on main stem in crown, this fungus causes a simultaneous white rot which can cause snapping of tree parts in this particular species. Removal is required to prevent natural failure, manage risk, and facilitate replanting

Image shows tree in street scene.

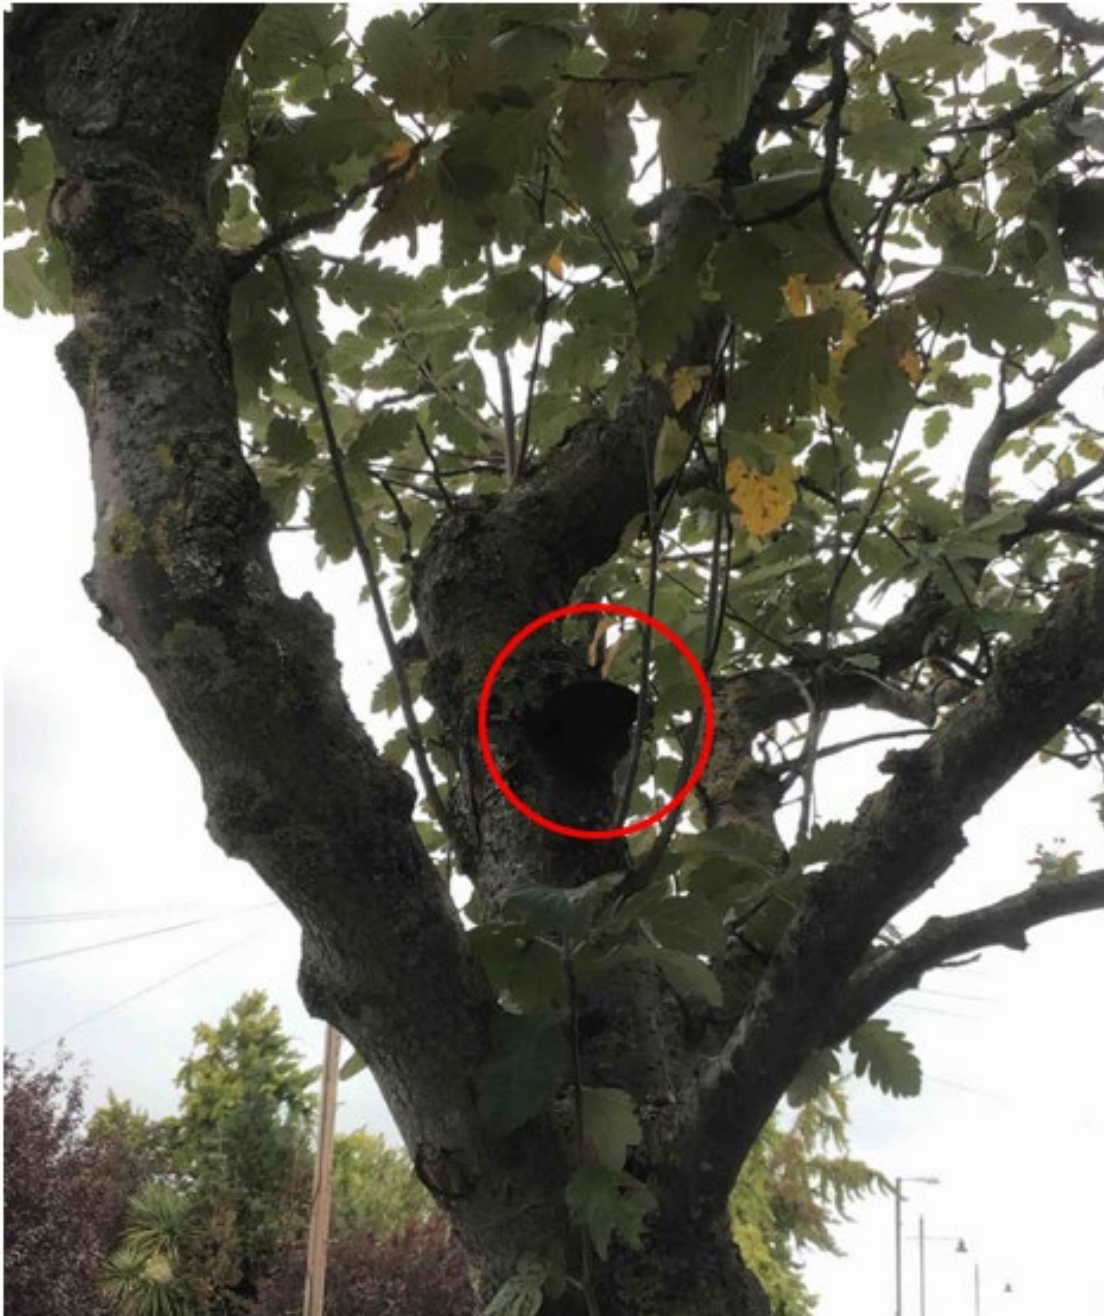
***Image shows fungal fruiting body circled.***

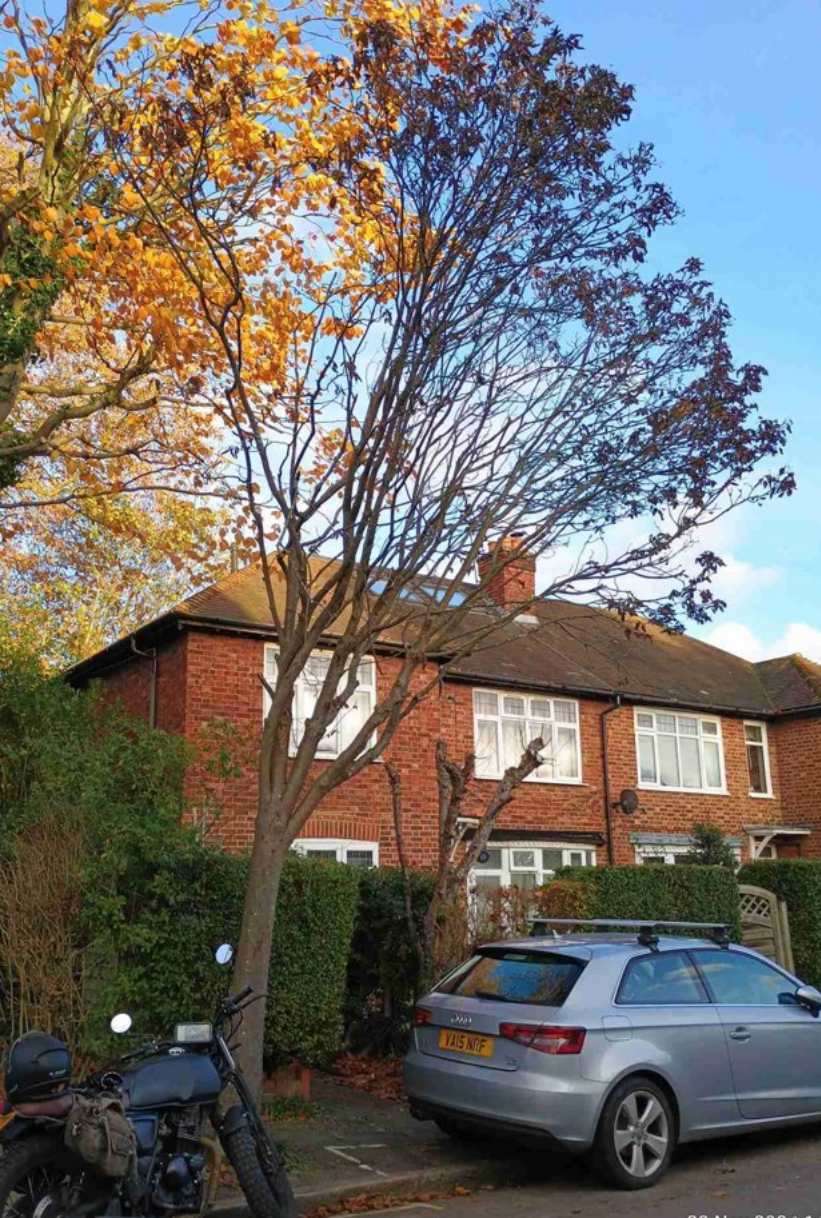
Ward	Kew
Road	Courtlands Avenue
Location	Outside 29
Species	Whitebeam ( <i>Sorbus x thuringiaca</i> )
Height	7.5m
Physiological Condition	Dead
Structural Condition	Dead
Inspection findings/reason for exemption	This tree is dead; removal is required to prevent natural failure, manage risk, and facilitate replanting

**Image shows dead tree in street scene.**

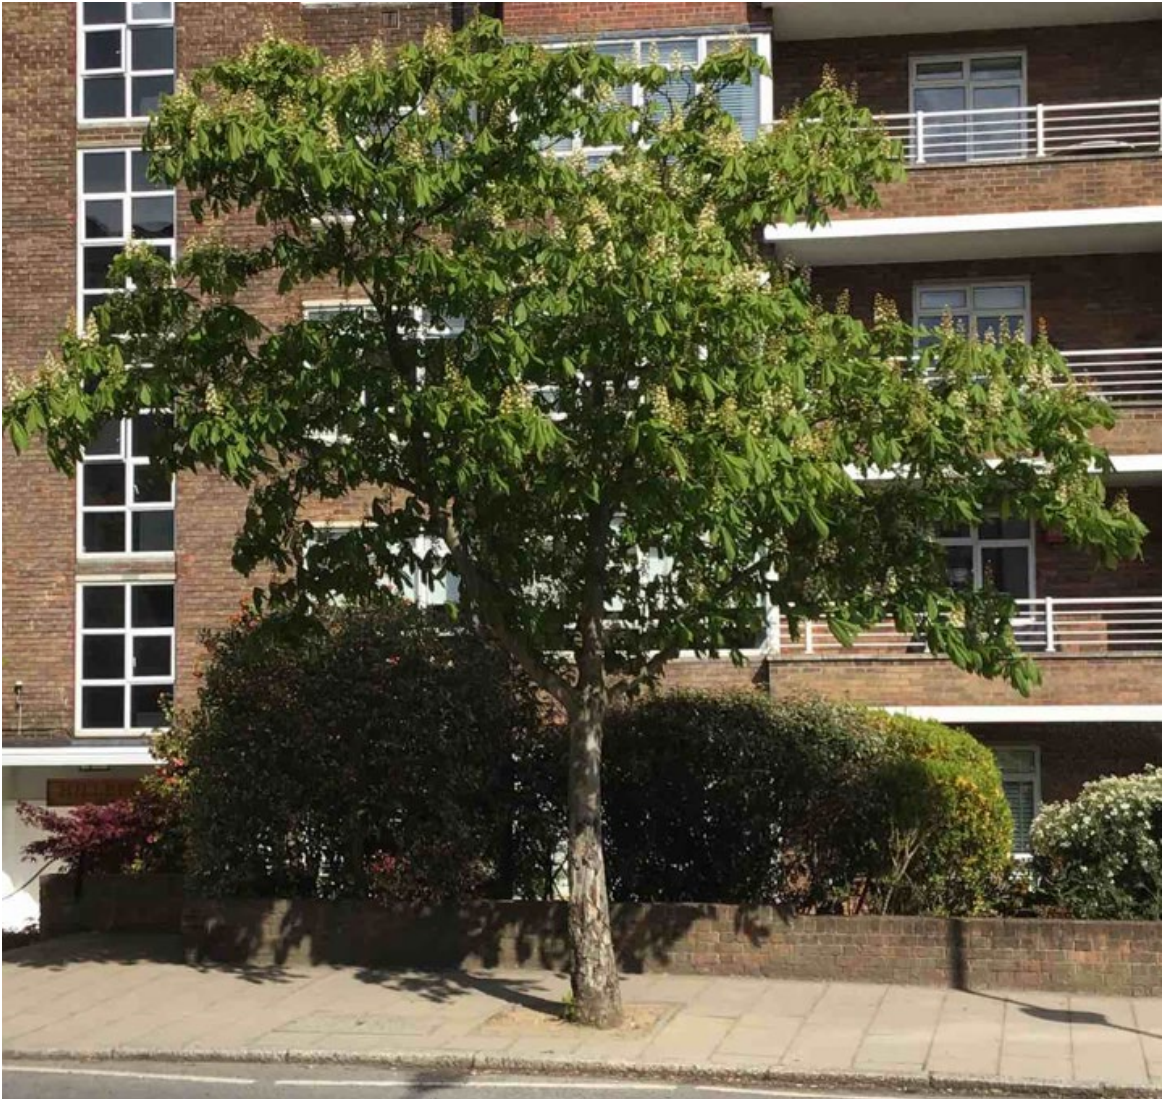
<b>Ward</b>	South Richmond
<b>Road</b>	Friars Stile Road
<b>Location</b>	Opposite Terrace Lane
<b>Species</b>	Horse Chestnut ( <i>Aesculus hippocastanum</i> )
<b>Height</b>	7.0m
<b>Physiological Condition</b>	Fair
<b>Structural Condition</b>	Poor
<b>Inspection findings/reason for exemption</b>	This is a retrospective notice of this tree being felled, as our contractor noted an unacceptable amount of bark necrosis and stem decay which would lead to dysfunction of the vascular system, and which would course the tree to decline and stem failure. Removal was required to prevent natural failure, manage risk, and facilitate replanting.

**Image shows tree in street scene.**

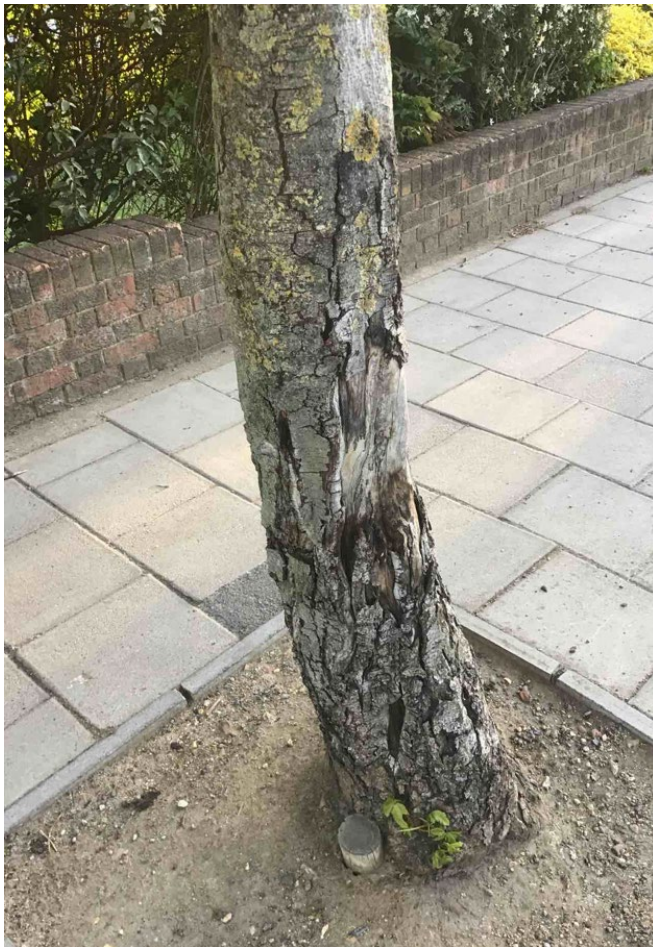
**Image shows bleeding bark cankering with associated necroses on trunk.**

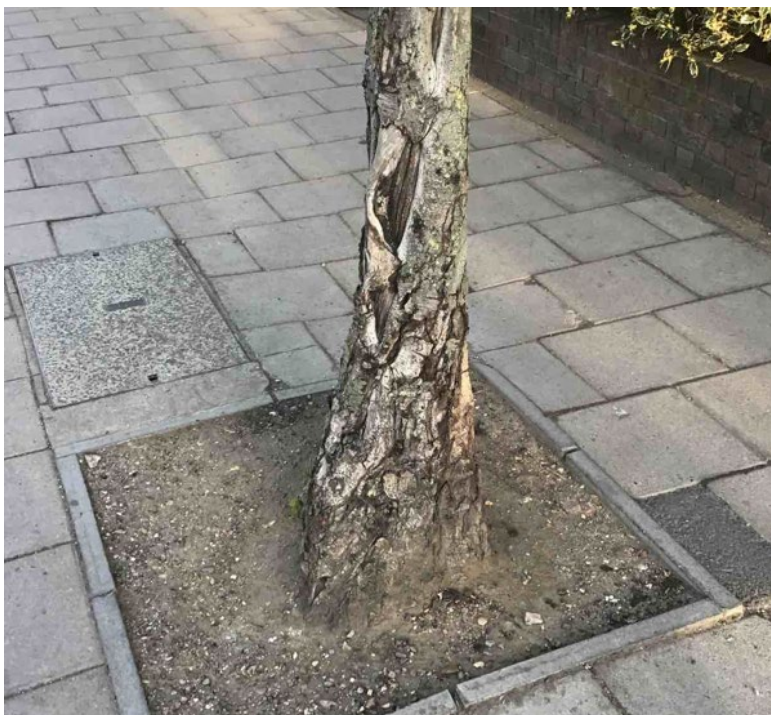
**Image shows bleeding bark cankering with associated necroses on trunk.**

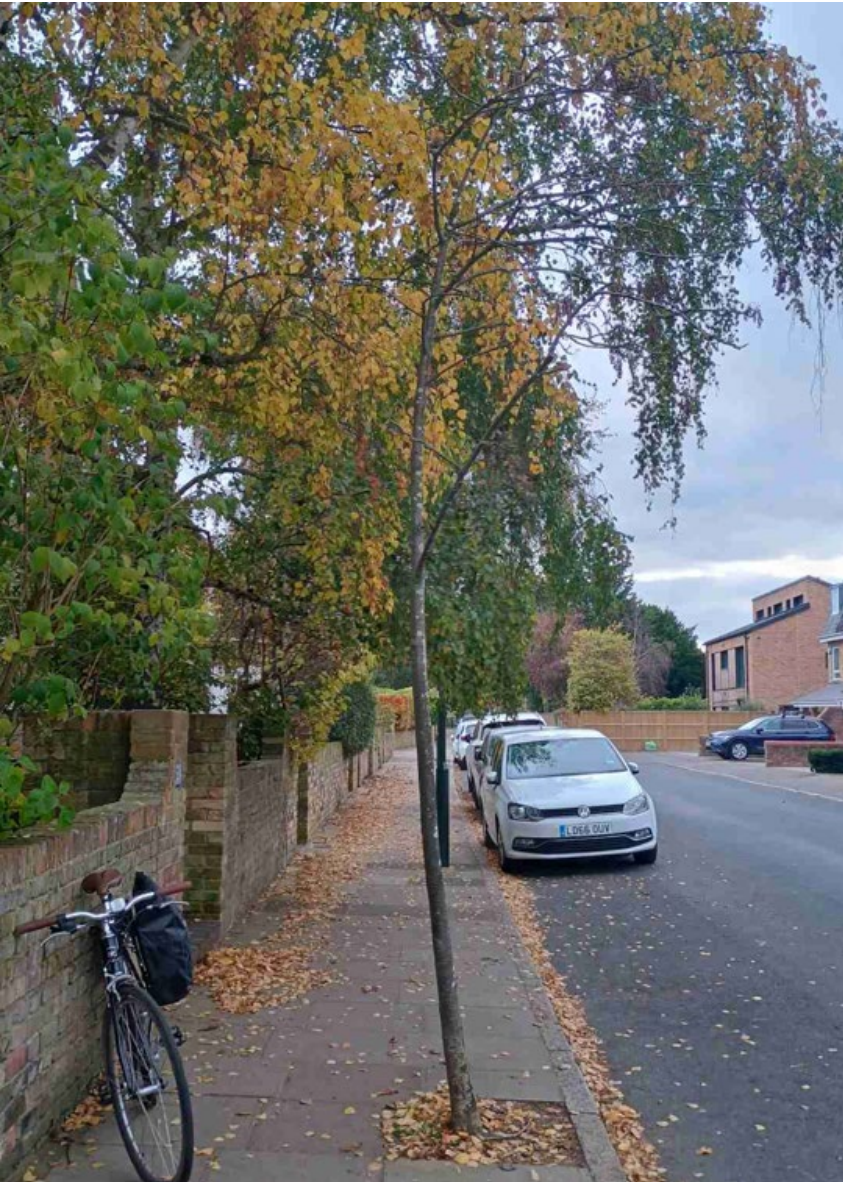
Ward	South Twickenham
Road	Popes Avenue
Location	Outside 59
Species	Rowan ( <i>Sorbus aucuparia</i> )
Height	5.0m
Physiological Condition	Dead
Structural Condition	Dead
Inspection findings/reason for exemption	This tree is dead; removal is required to prevent natural failure, manage risk, and facilitate replanting

**Image shows dead tree in street scene.**
