# May 2025 - Reactive Tree Works Programme

A survey of trees in Barnes and East Sheen wards have been undertaken; this is being conducted by specialist arboricultural officers as part of the scheduled 4 yearly detailed inspection regime that has been devised for all Council highway and parks trees.

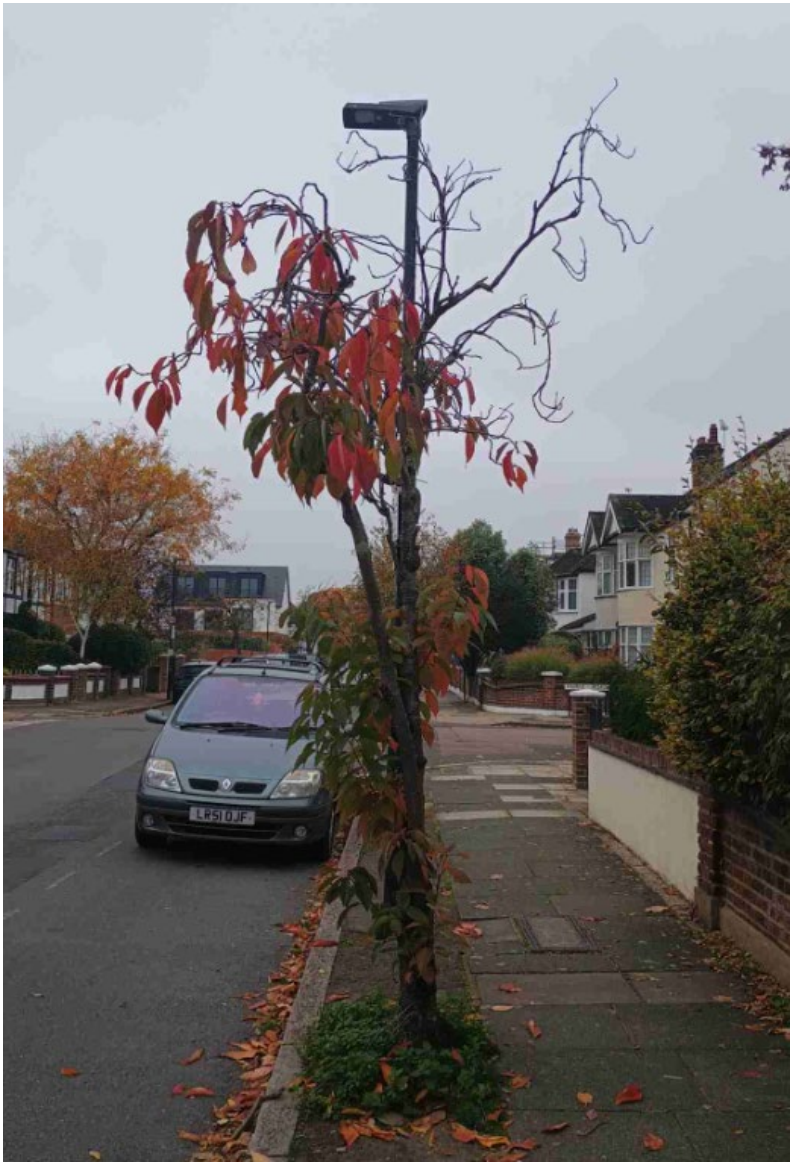
Ward	Barnes
Road	Suffolk Road
Location	Outside 28
Species	Winter flowing cherry ( <i>Prunus x subhirtella</i> )
Height	3.5m
Physiological Condition	Poor
Structural Condition	Fair
Inspection findings/reason for exemption	This tree is moribund with over fifty percent of the crown being dead. Removal is required to prevent natural failure, manage risk and facilitate replanting.

Image shows moribund tree in street scene.

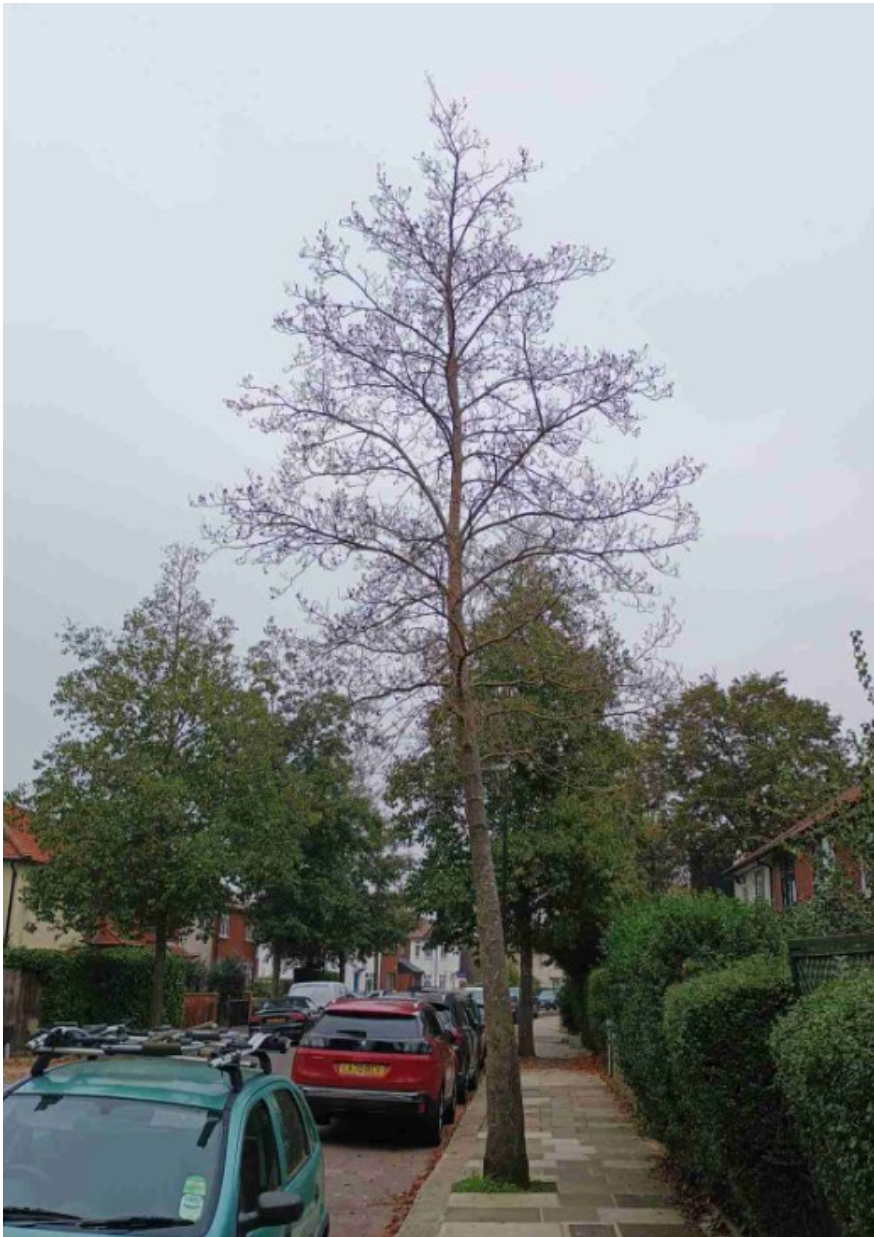
Ward	Barnes
Road	Bracken Gardens
Location	Outside 29
Species	Common alder ( <i>Alnus glutinosa</i> )
Height	12.0m
Physiological Condition	Dead
Structural Condition	Poor
Inspection findings/reason for exemption	This tree is dead; removal is required to prevent natural failure, manage risk, and facilitate replanting.

Image shows dead tree in street scene.

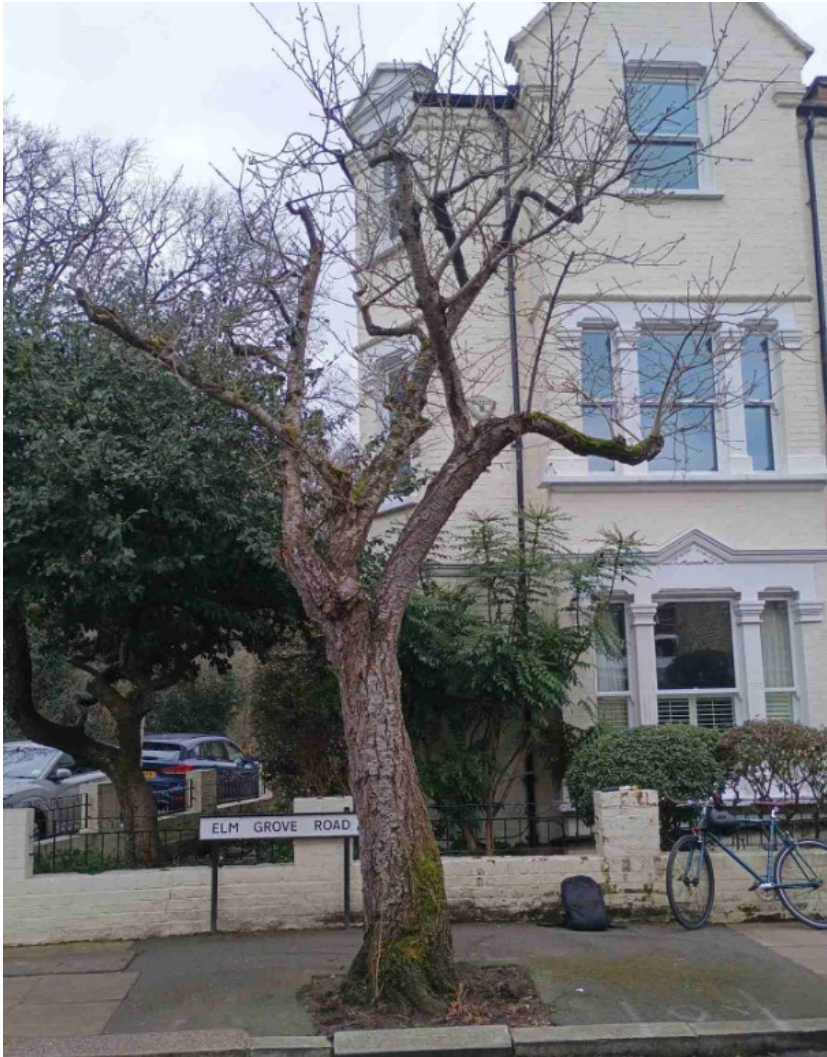
Ward	Barnes
Road	Elm Grove Road
Location	Adjacent to 10a Ranelagh Avenue
Species	Wild cherry ( <i>Prunus avium</i> )
Height	7.5m
Physiological Condition	Fair
Structural Condition	Poor
Inspection findings/reason for exemption	A fungal fruiting body of the decay fungus <i>Ganoderma sp.</i> is present at the base of the trunk. Colonization by this fungus causes a white rot of the stem and root system, which can lead to the entire tree collapsing through fracture or windthrow. A resonance test with a sounding hammer has revealed an unacceptable degree of decay spreading from the base of the stem up to a cavity at the base of the crown on a historic pruning wound. Removal is required to prevent natural failure, manage risk and facilitate replanting.

Image shows tree in street scene.

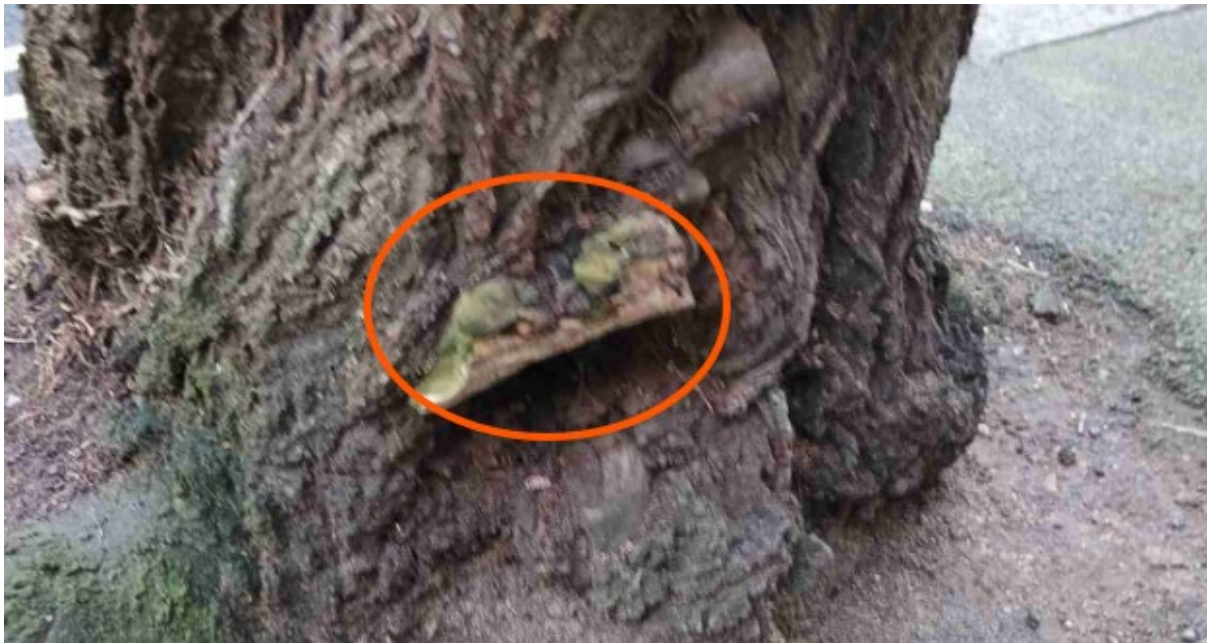
***Image shows fruiting body circled.***

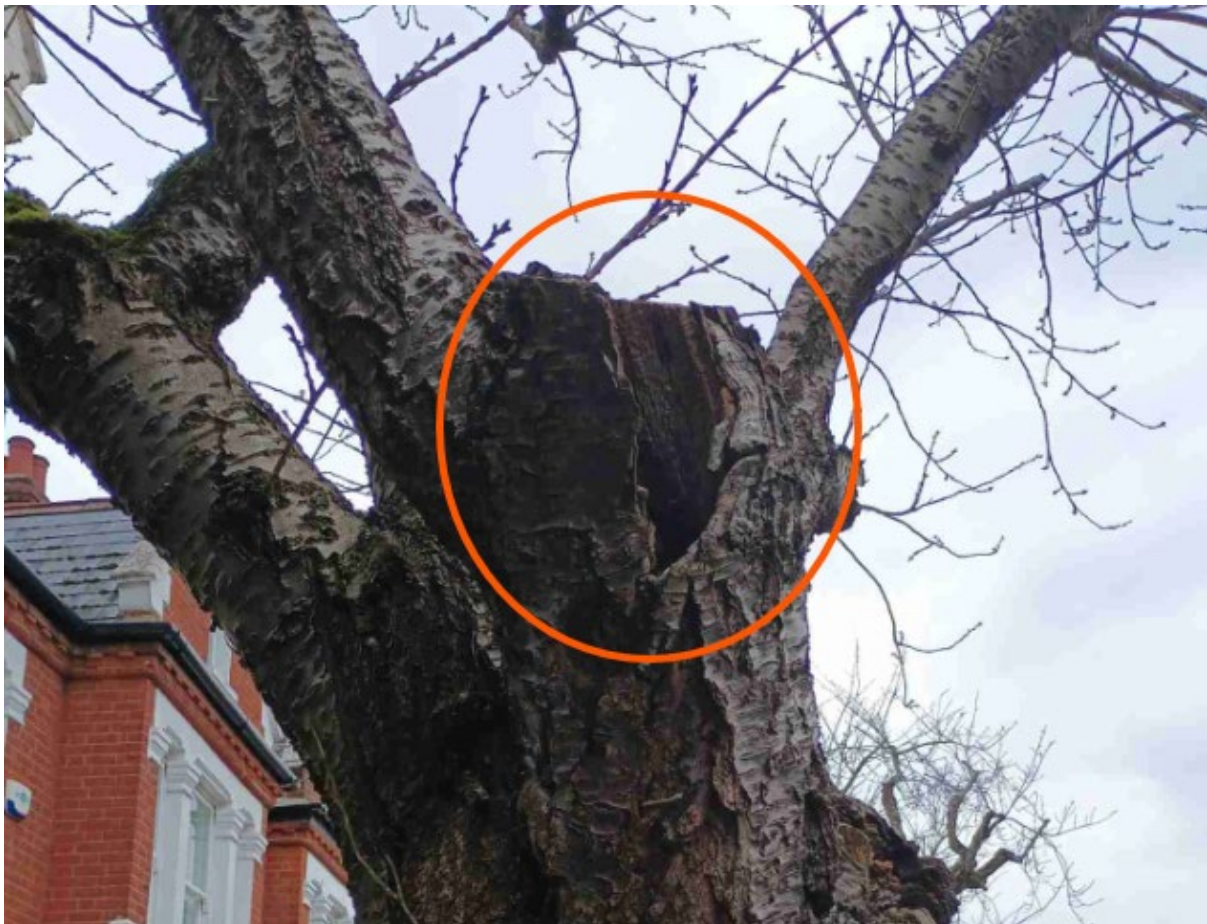
***Image shows cavity on pruning wound circled.***

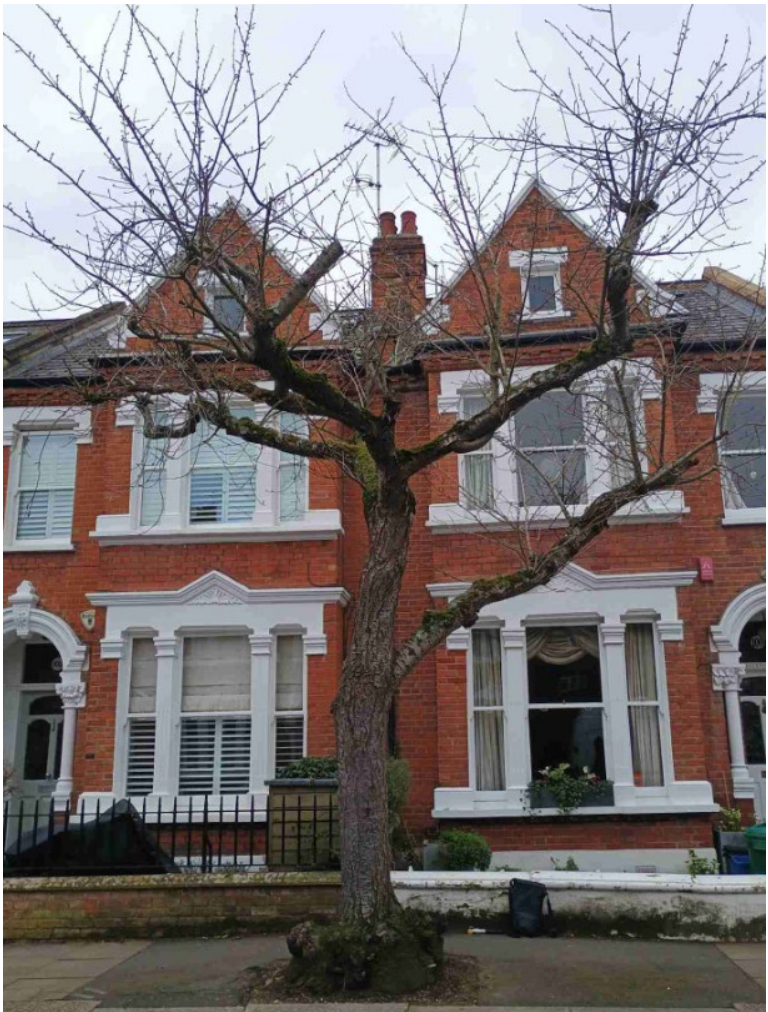
Ward	Barnes
Road	Elm Grove Road
Location	Outside 100-102
Species	Wild cherry ( <i>Prunus avium</i> )
Height	7.5m
Physiological Condition	Poor
Structural Condition	Poor
Inspection findings/reason for exemption	A fungal fruiting body of the decay fungi <i>Ganoderma sp.</i> is present at the base of the trunk. Colonization by this fungus causes a white rot of the stem and root system, which can lead to the collapse of entire trees through fracture or windthrow. The presence of <i>Phellinus pomaceus</i> (Cushion fungus) in the crown can cause extensive decay, contributing to the snapping of affected parts. This decay is a crumbly white rot found on the underside of branches. This correlates with the pathogens at the base of the trunk in the tree's decline. Removal is required to prevent natural failure, manage risk, and facilitate replanting

Image shows in street scene.

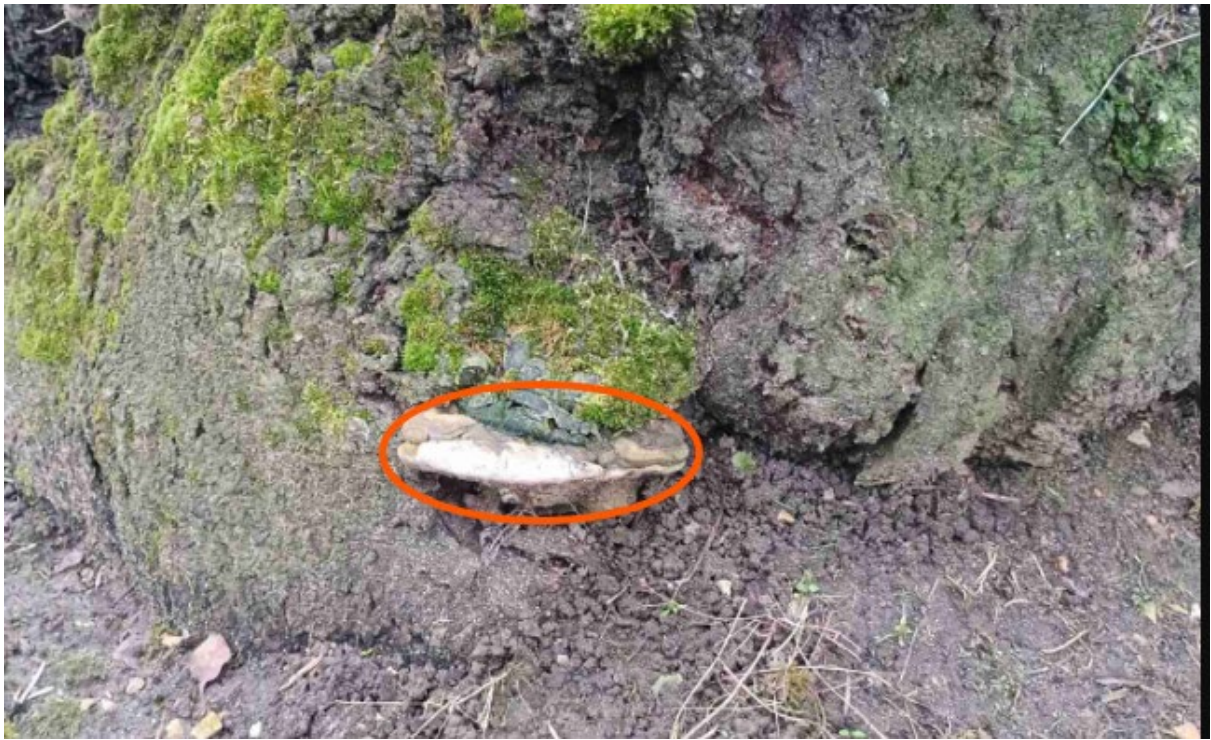
*Image shows fruiting body circled at base of trunk.*

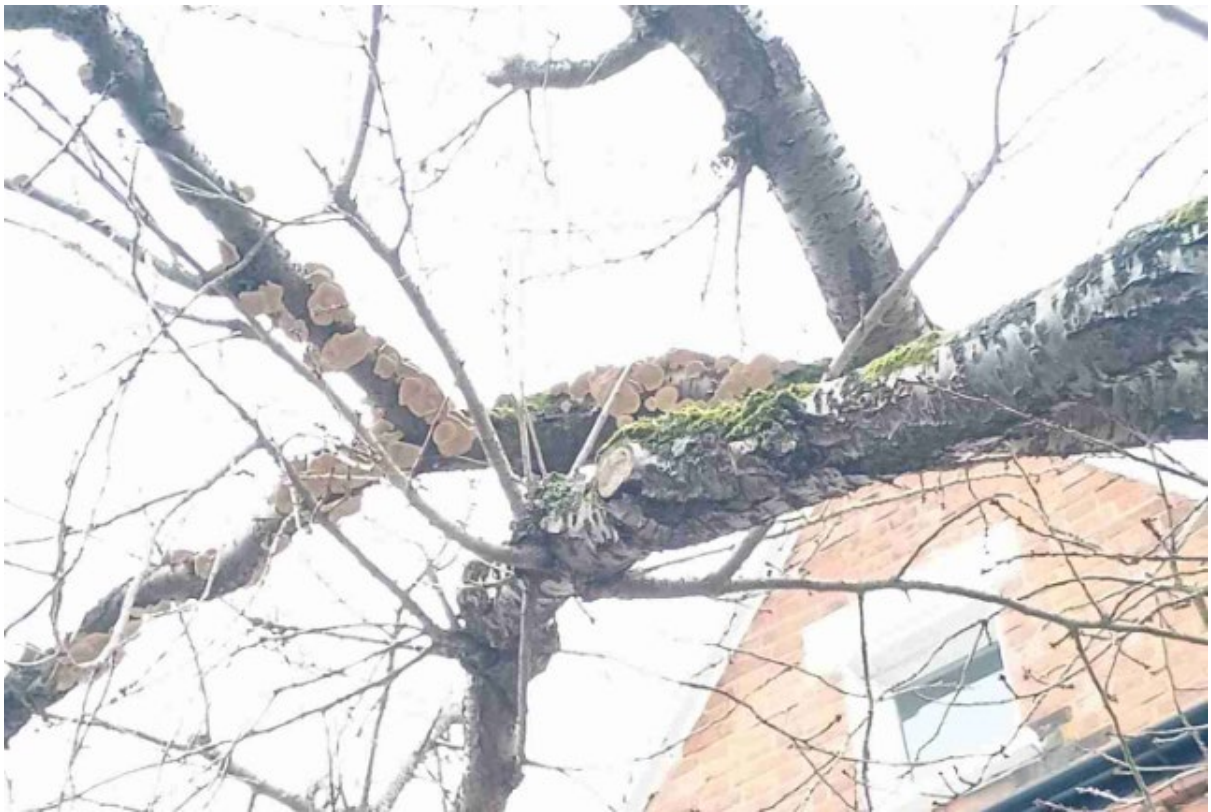
*Image shows fruiting body on underside of branches in crown.*

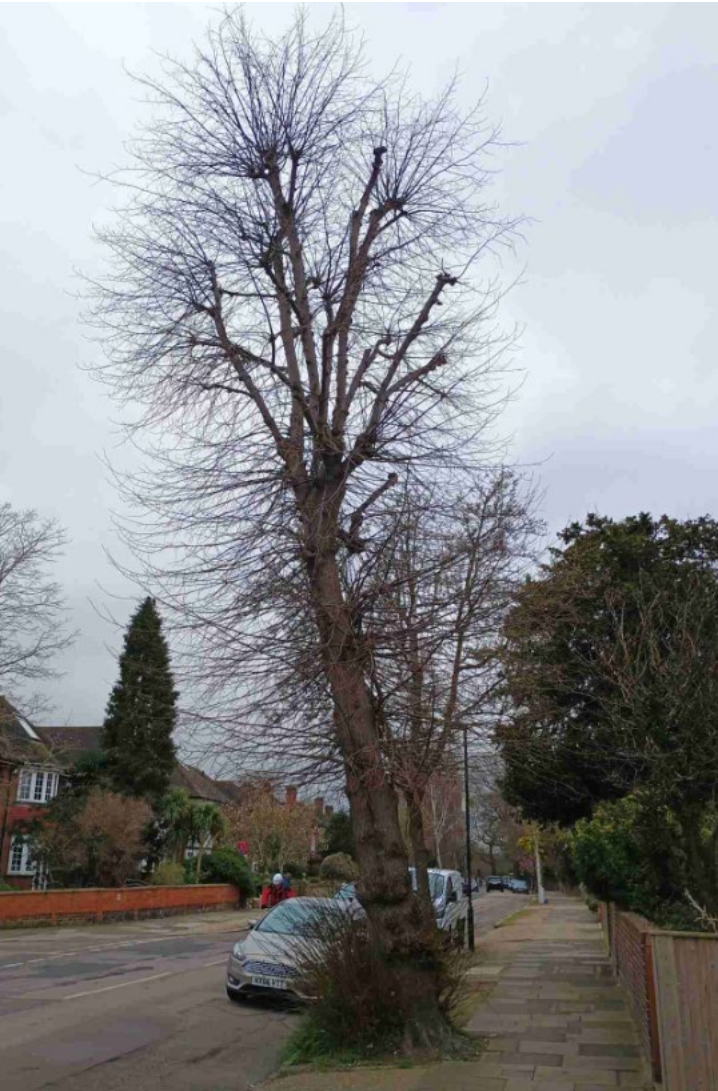
Ward	East Sheen
Road	Sheen Lane
Location	Outside 246
Species	Common lime ( <i>Tilia x europaea</i> )
Height	16.0m
Physiological Condition	Fair
Structural Condition	Poor
Inspection findings/reason for exemption	Investigation of this tree with a probe and resonance testing with a sounding hammer has revealed an unacceptable degree of decay beyond the visible cavities at the base of the trunk. Removal is required to prevent natural failure, manage risk, and facilitate replanting.

Image shows in street scene.

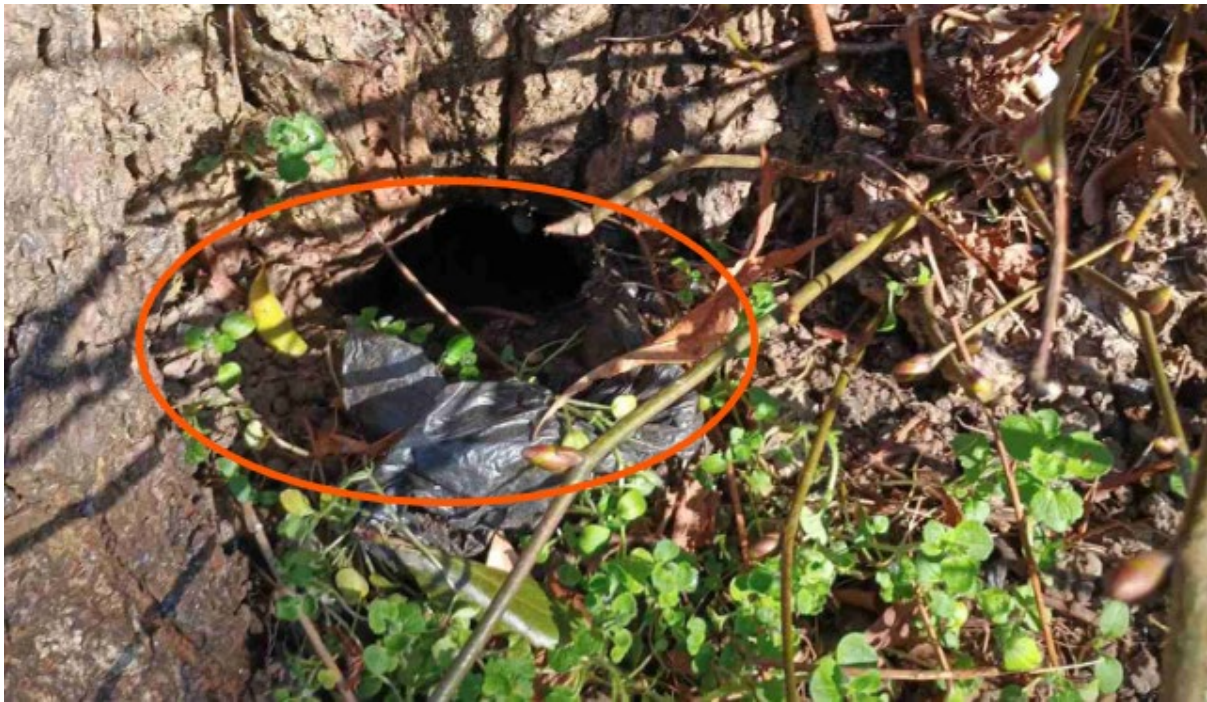
**Image shows cavity at base of trunk circled.**

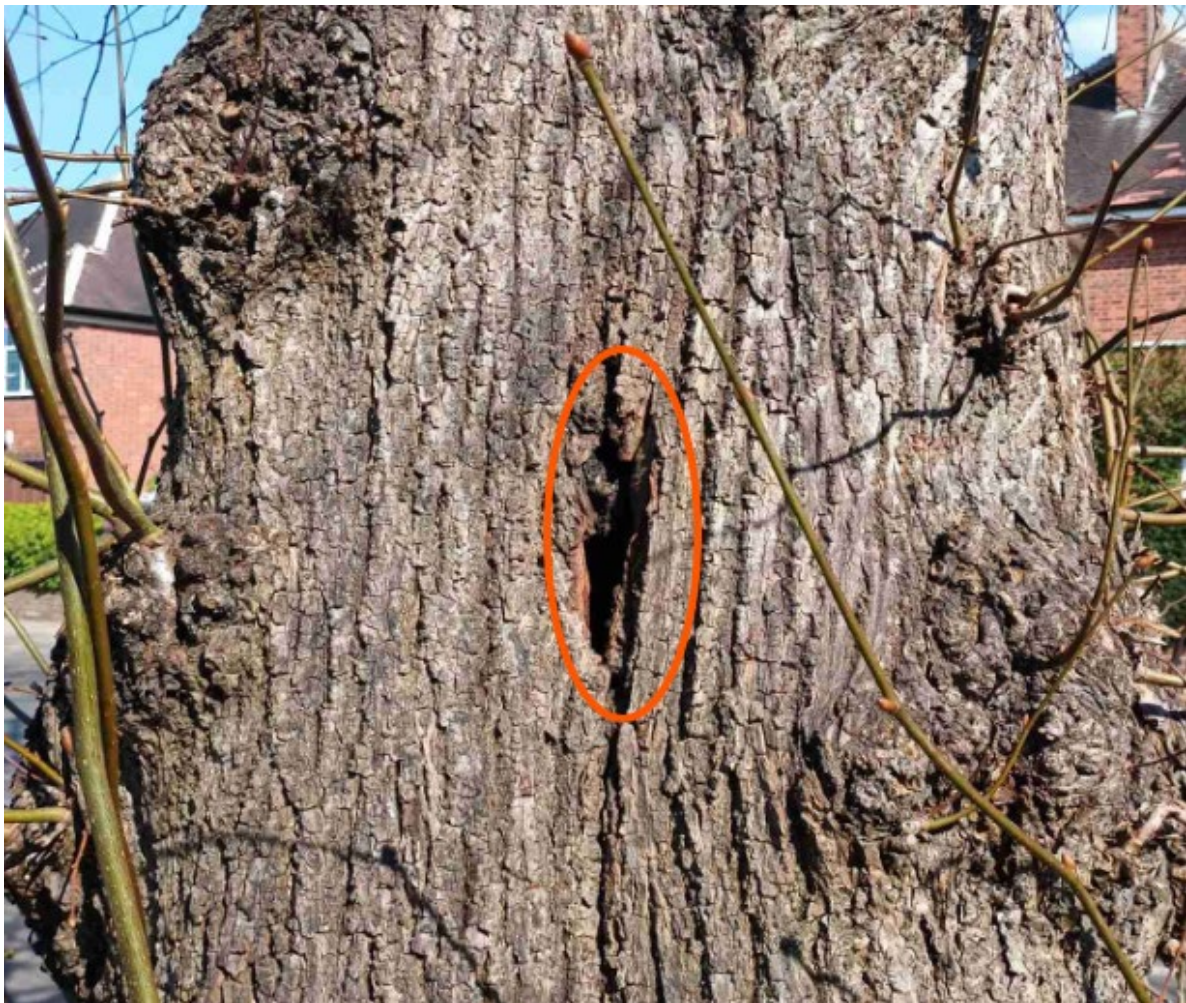
**Image shows cavity on trunk circled.**

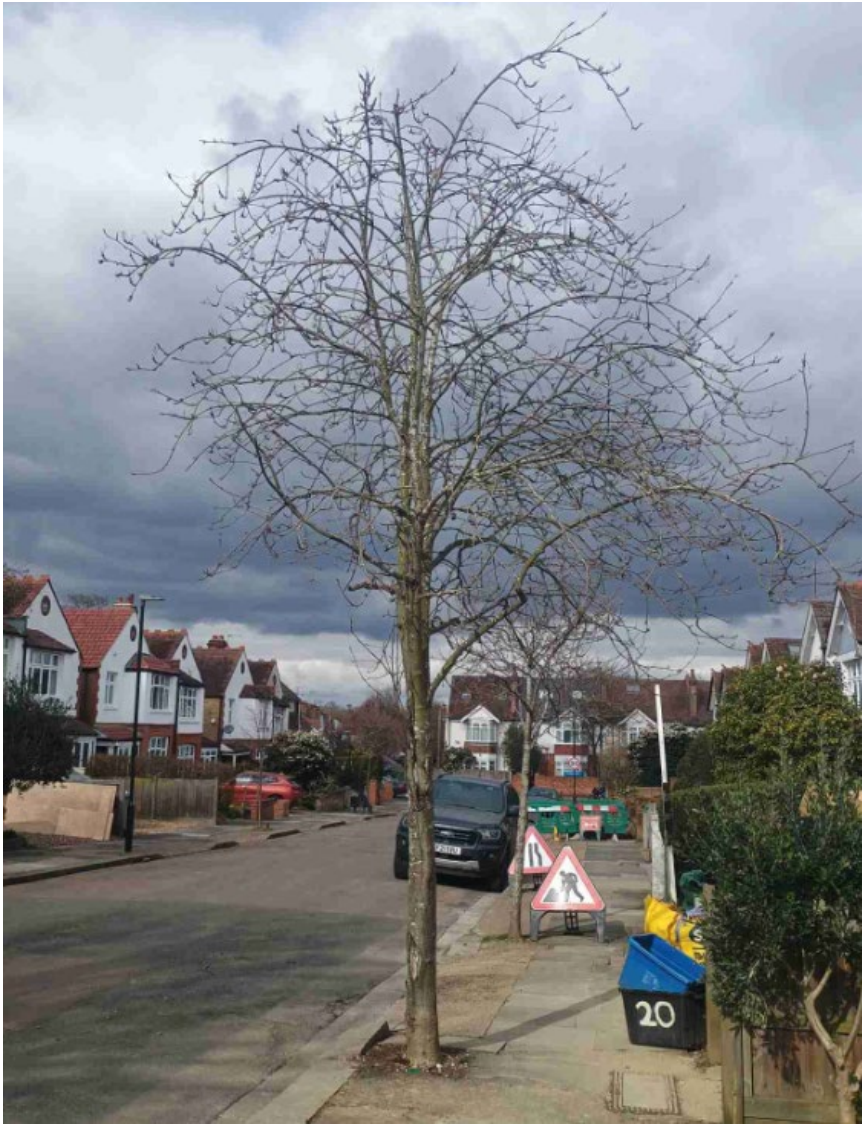
Ward	East Sheen
Road	Deanhill Road
Location	Outside 20/22
Species	Rowan ( <i>Sorbus aucuparia</i> )
Height	8.0m
Physiological Condition	Fair
Structural Condition	Poor
Inspection findings/reason for exemption	A fungal fruiting body of the species Shaggy Polypore ( <i>Inonotus hispidus</i> ) is present on the bifurcated main stem adjacent to wounding caused by vehicle strike, this fungus causes a simultaneous white rot which can cause snapping of tree parts in this species. Removal is required to prevent natural failure, manage risk, and facilitate replanting

Images show tree in street scene.

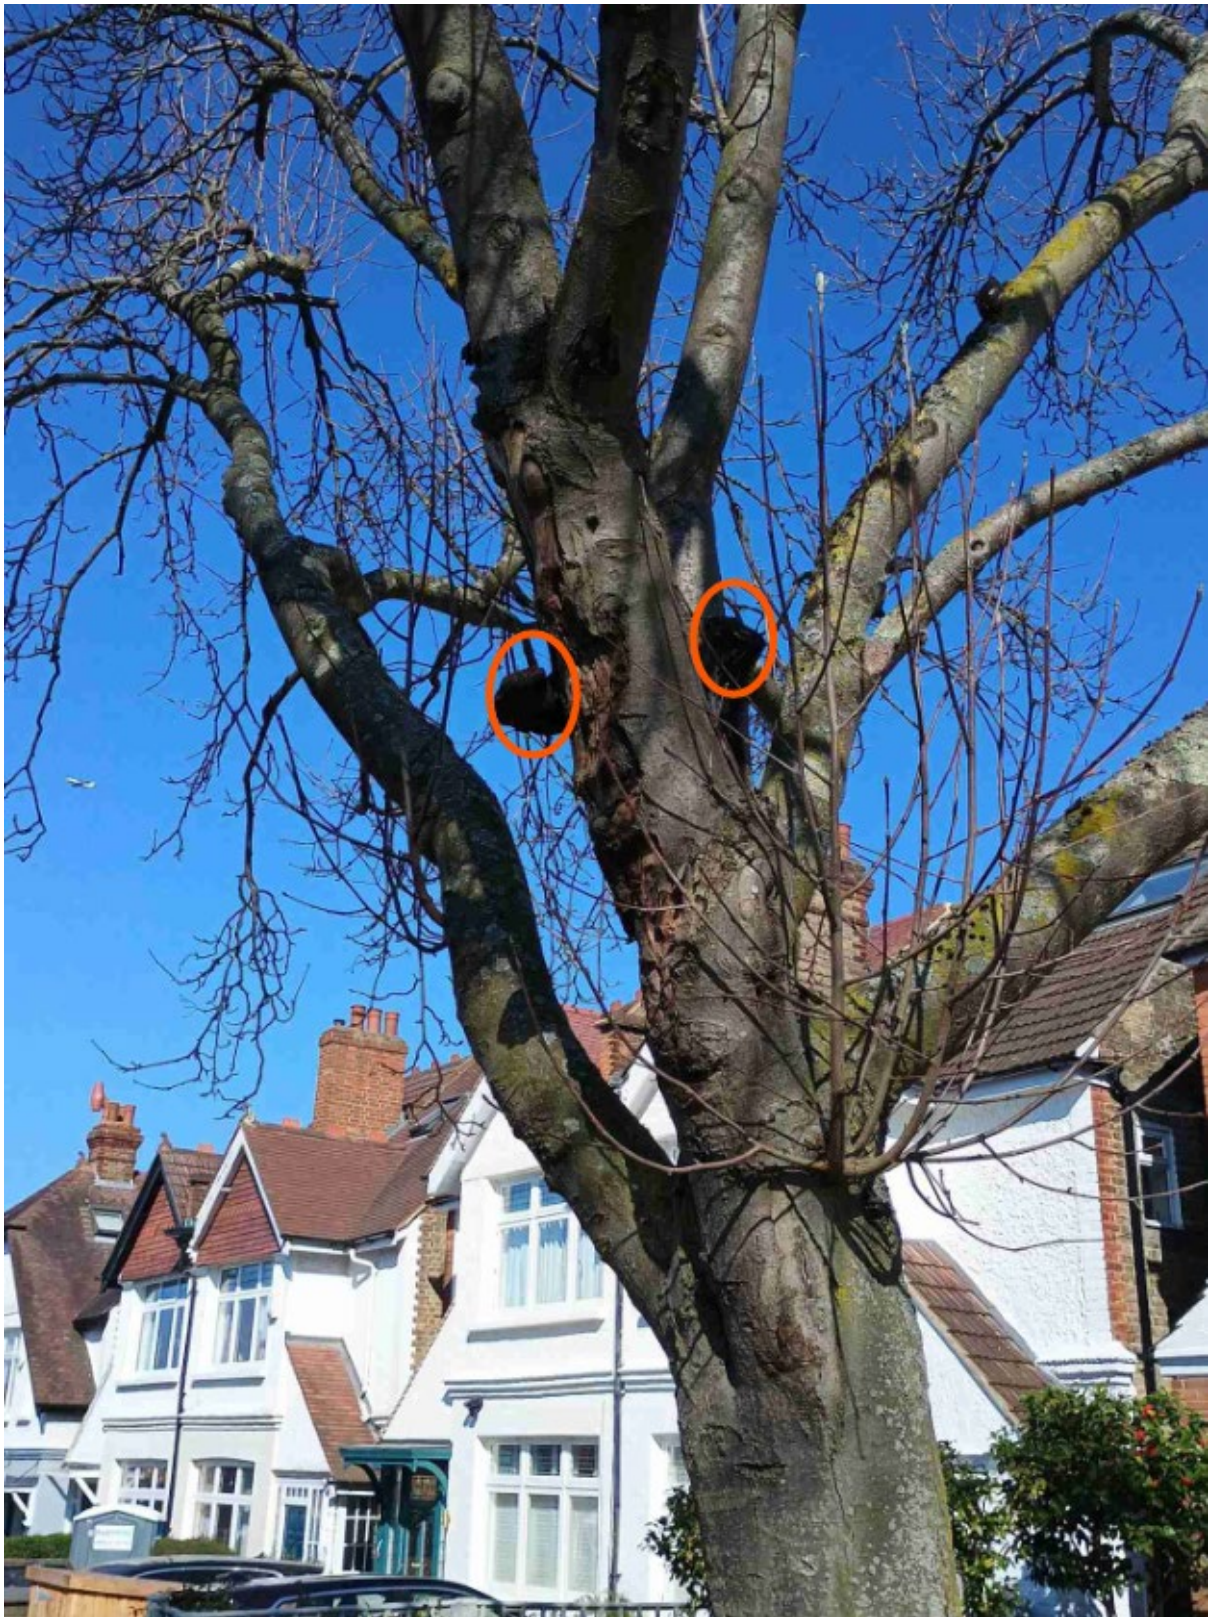
***Images show fungal fruiting bodies on stems circled.***

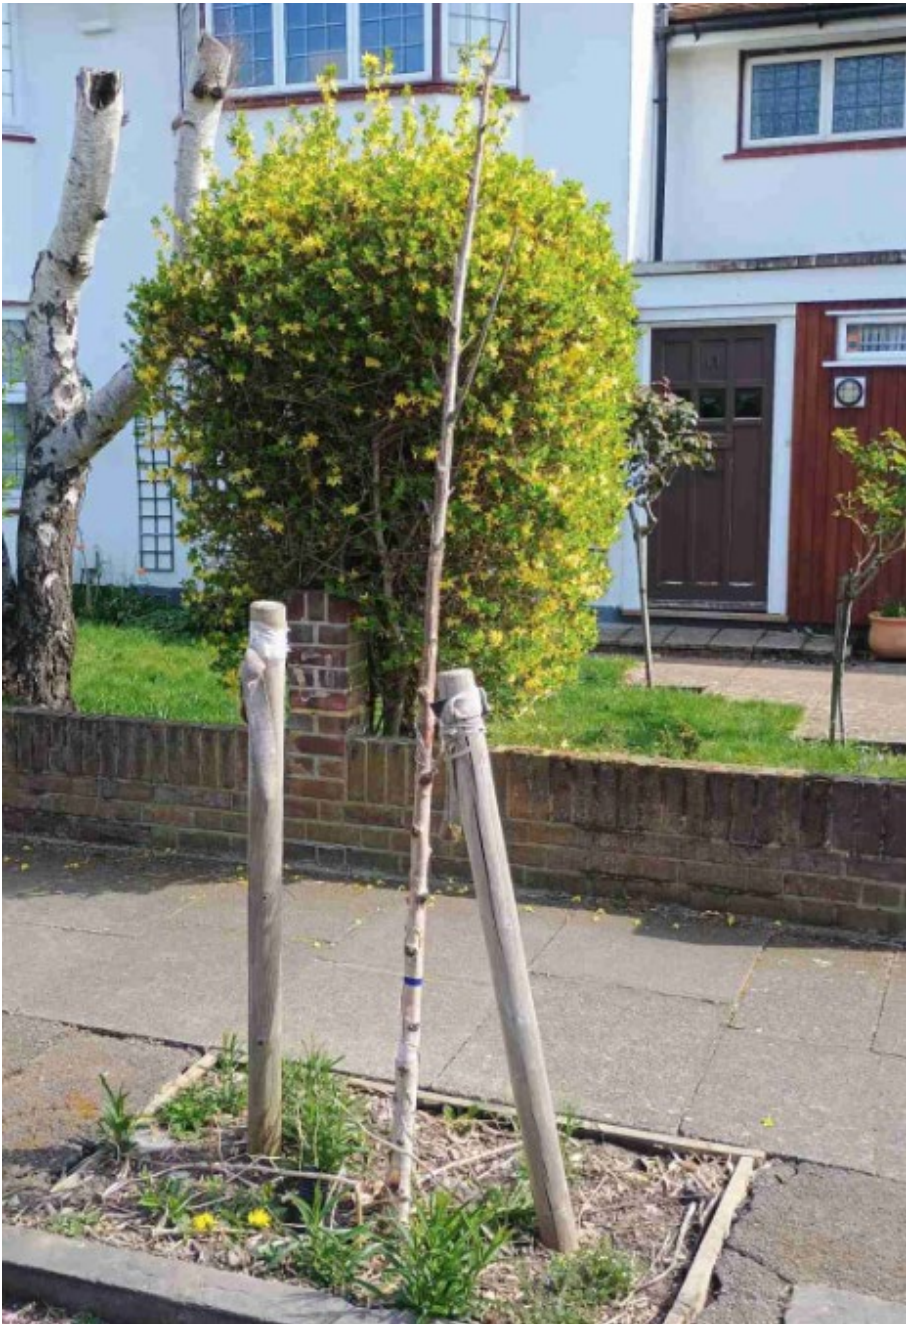
Ward	East Sheen
Road	Shottfield Avenue
Location	Outside 13
Species	Chinese red birch ( <i>Betula albo-sinensis</i> )
Height	3.0m
Physiological Condition	Dead
Structural Condition	Dead
Inspection findings/reason for exemption	This tree is dead; removal is required to prevent natural failure, manage risk, and facilitate replanting.

Image shows dead tree in street scene.

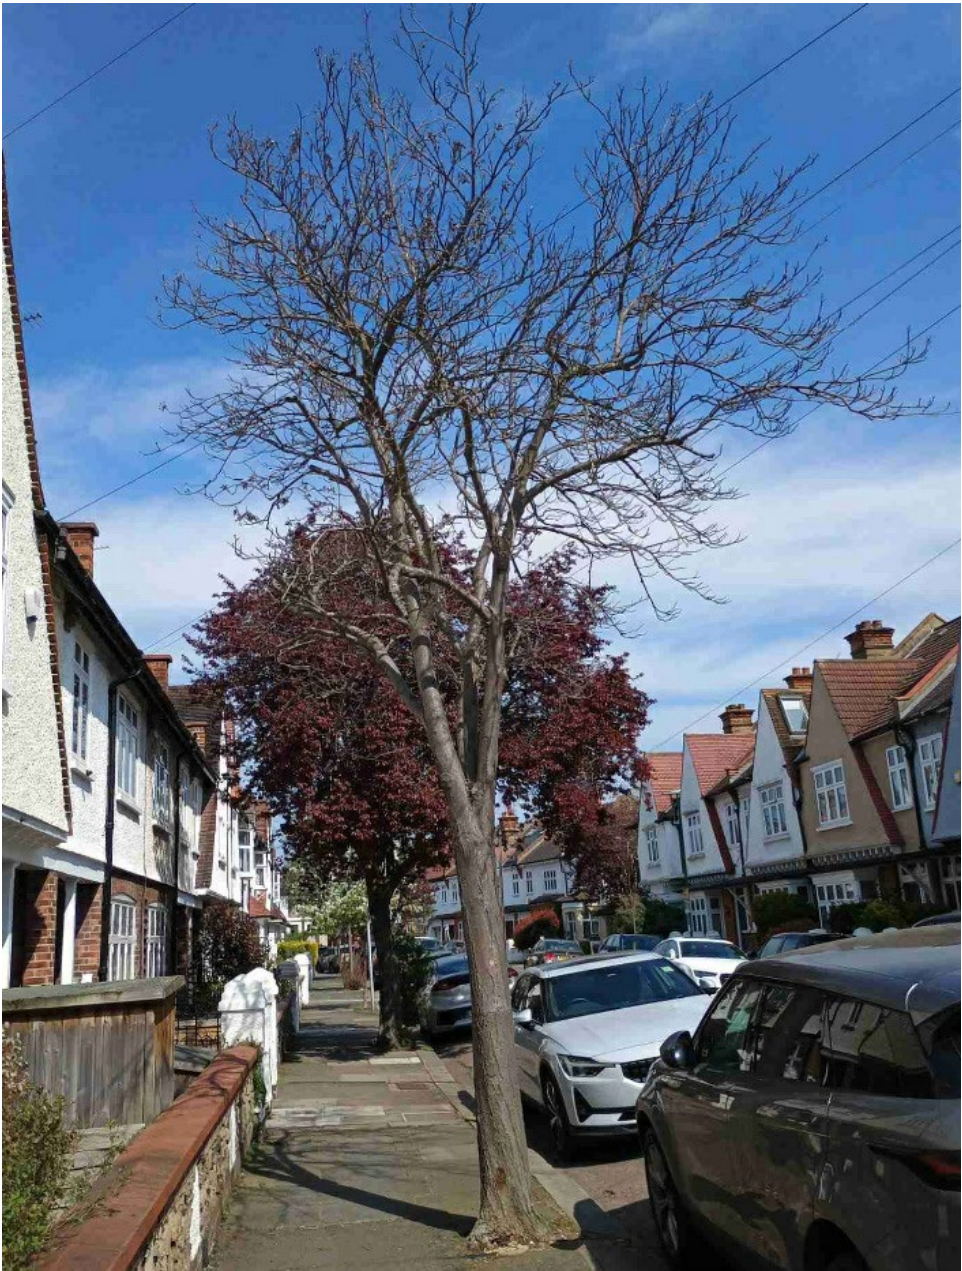
Ward	East Sheen
Road	Glendower Road
Location	Outside 5/7
Species	Whitebeam ( <i>Sorbus aria</i> )
Height	7.5m
Physiological Condition	Dead
Structural Condition	Dead
Inspection findings/reason for exemption	This tree is dead; removal is required to prevent natural failure, manage risk, and facilitate replanting.

Image shows dead tree in street scene.

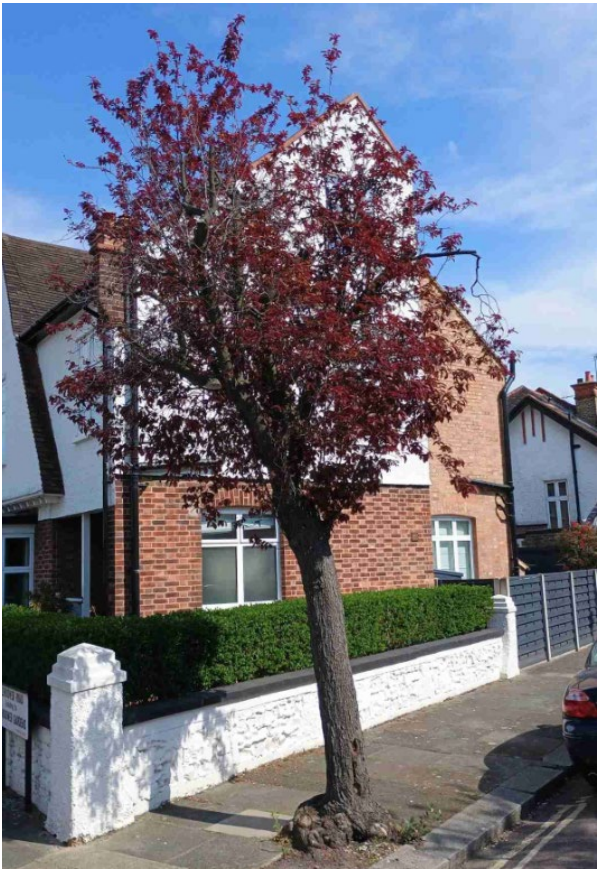
Ward	East Sheen
Road	Vernon Road.
Location	Adjacent to 2 Glendower Road
Species	Cherry plum ( <i>Prunus cerasifera</i> )
Height	7.0m
Physiological Condition	Fair
Structural Condition	Poor
Inspection findings/reason for exemption	A fungal fruiting body of the decay fungi <i>Ganoderma sp.</i> is present at the base of the trunk. Colonization by this fungus causes a white rot of the stem and root system, which can lead to the collapse of entire trees through fracture or windthrow. There are also cavities on the lower trunk. Investigation with a probe and a resonance test with a sounding hammer has revealed an unacceptable degree of decay beyond the visible cavities at the base of the trunk. This correlates with the pathogens at the base of the trunk. Removal is required to prevent natural failure, manage risk, and facilitate replanting.

Images show tree in street scene.

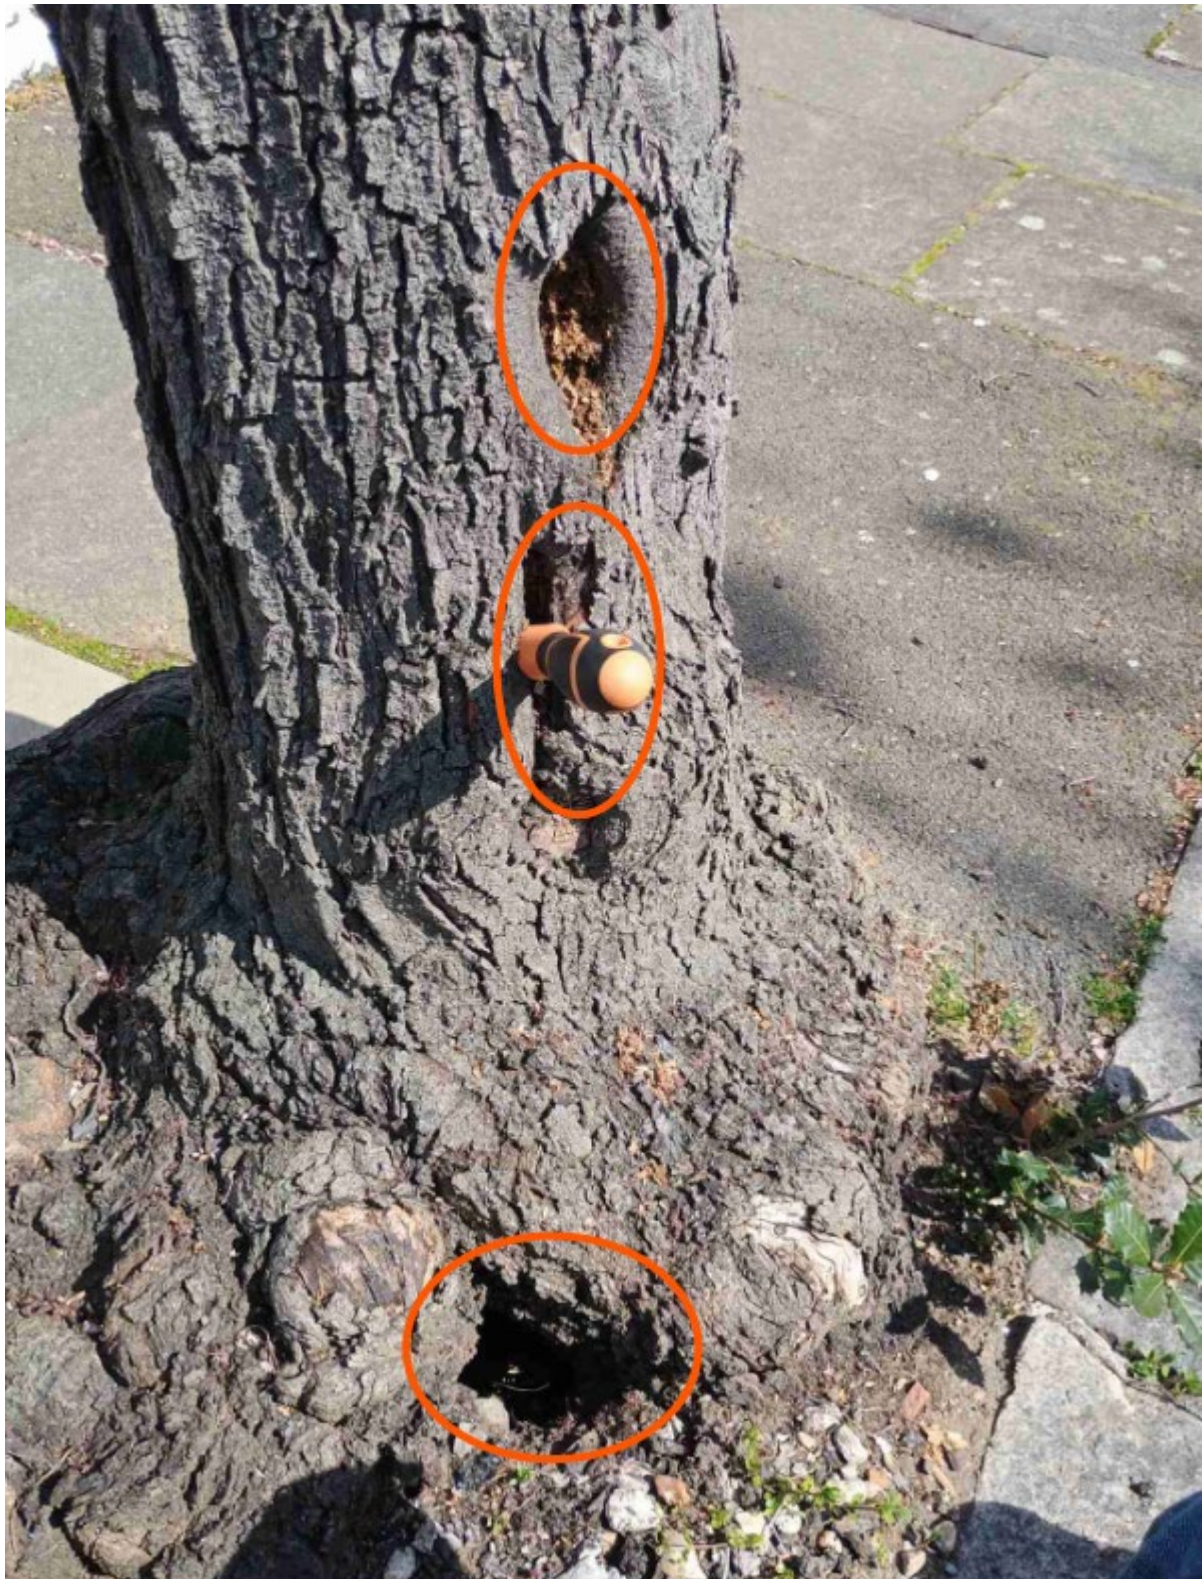
***Images show cavities circled on trunk.***

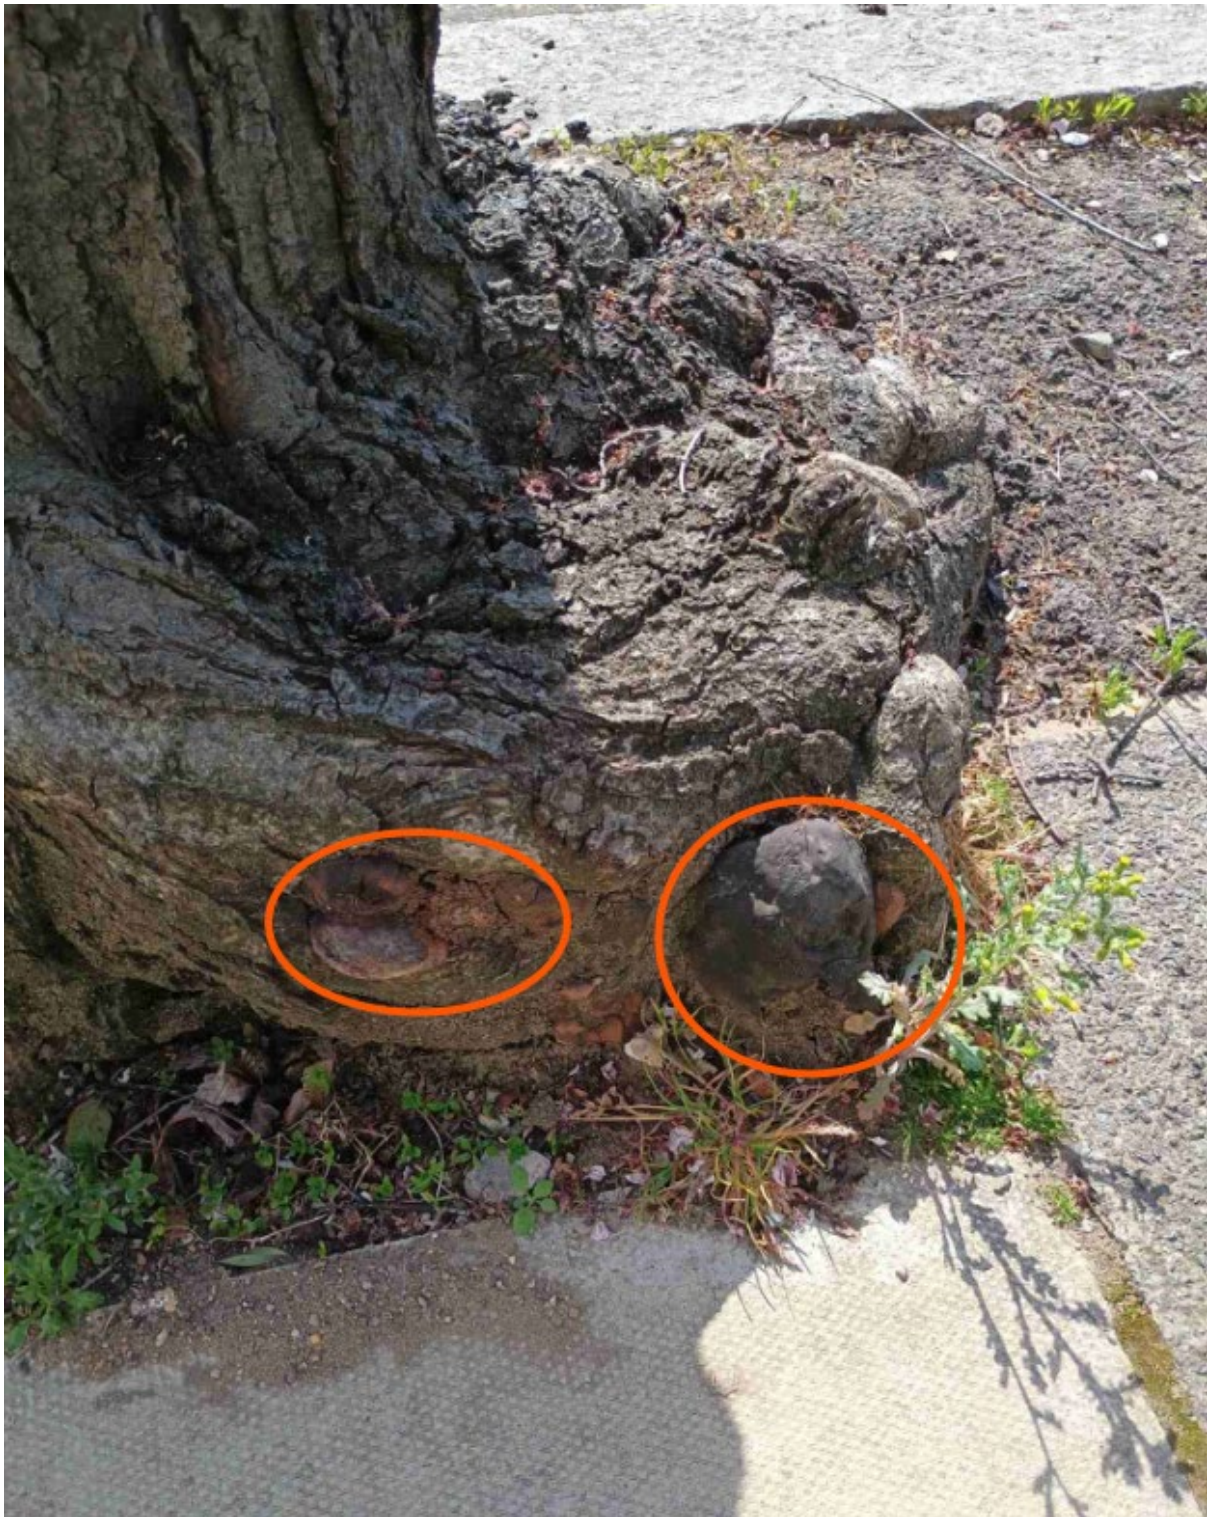
***Image shows fruiting bodies circled on trunk.***

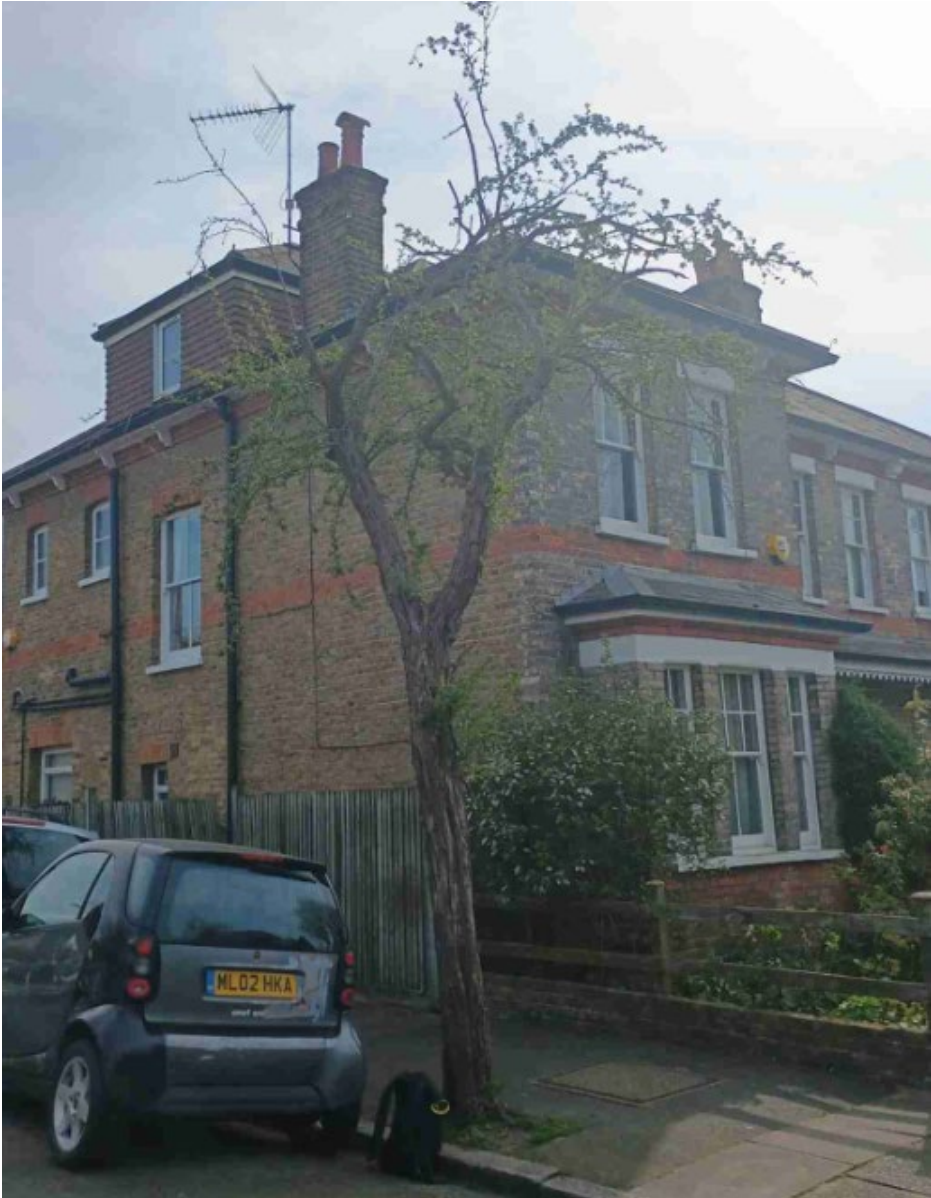
Ward	East Sheen
Road	Leinster Avenue
Location	Adjacent to 1 Ormonde Road front edge of building
Species	Hawthorn ( <i>Crataegus monogyna</i> )
Height	7.5m
Physiological Condition	Fair
Structural Condition	Poor
Inspection findings/reason for exemption	Investigation with a probe and a resonance test with a sounding hammer has revealed an unacceptable amount of decay beyond the visible cavities at the base of the trunk. Removal is required to prevent natural failure, manage risk, and facilitate replanting.

Image shows tree in street scene.
