# May 2025 - Reactive Tree Works Programme

A survey of trees in Barnes and East Sheen wards have been undertaken; this is being conducted by specialist arboricultural officers as part of the scheduled 4 yearly detailed inspection regime that has been devised for all Council highway and parks trees.

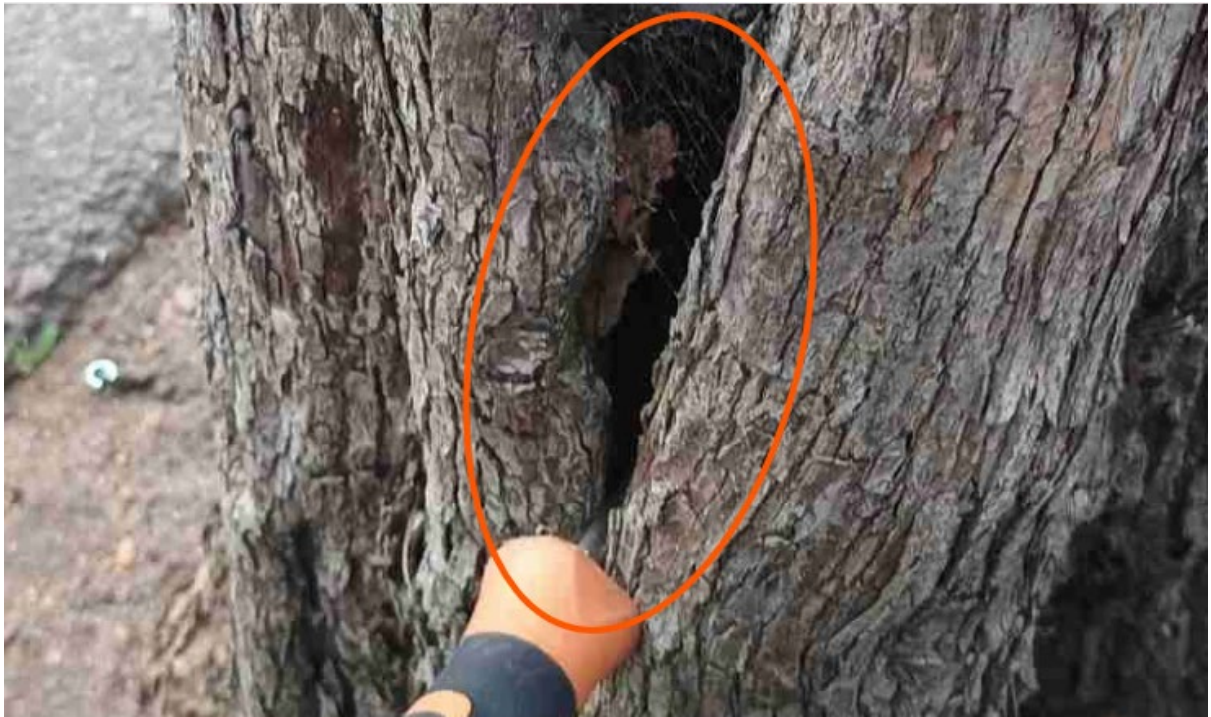
***Image show cavity circled on trunk.***

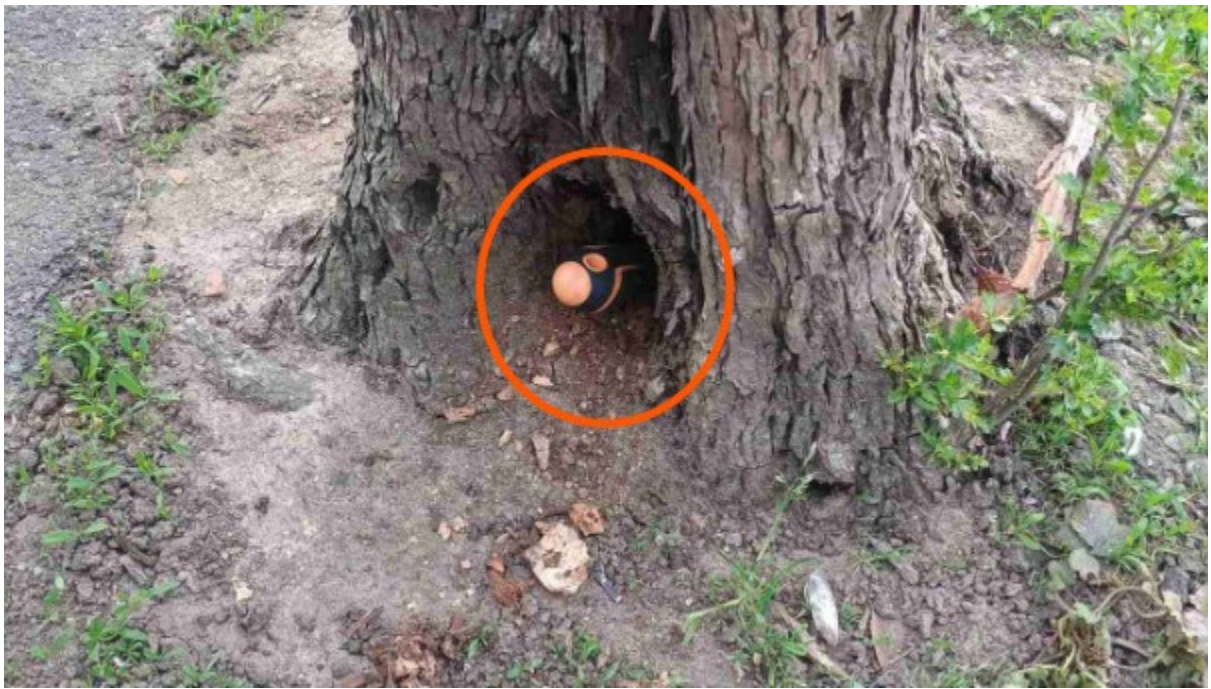
***Image show cavity circled on trunk.***

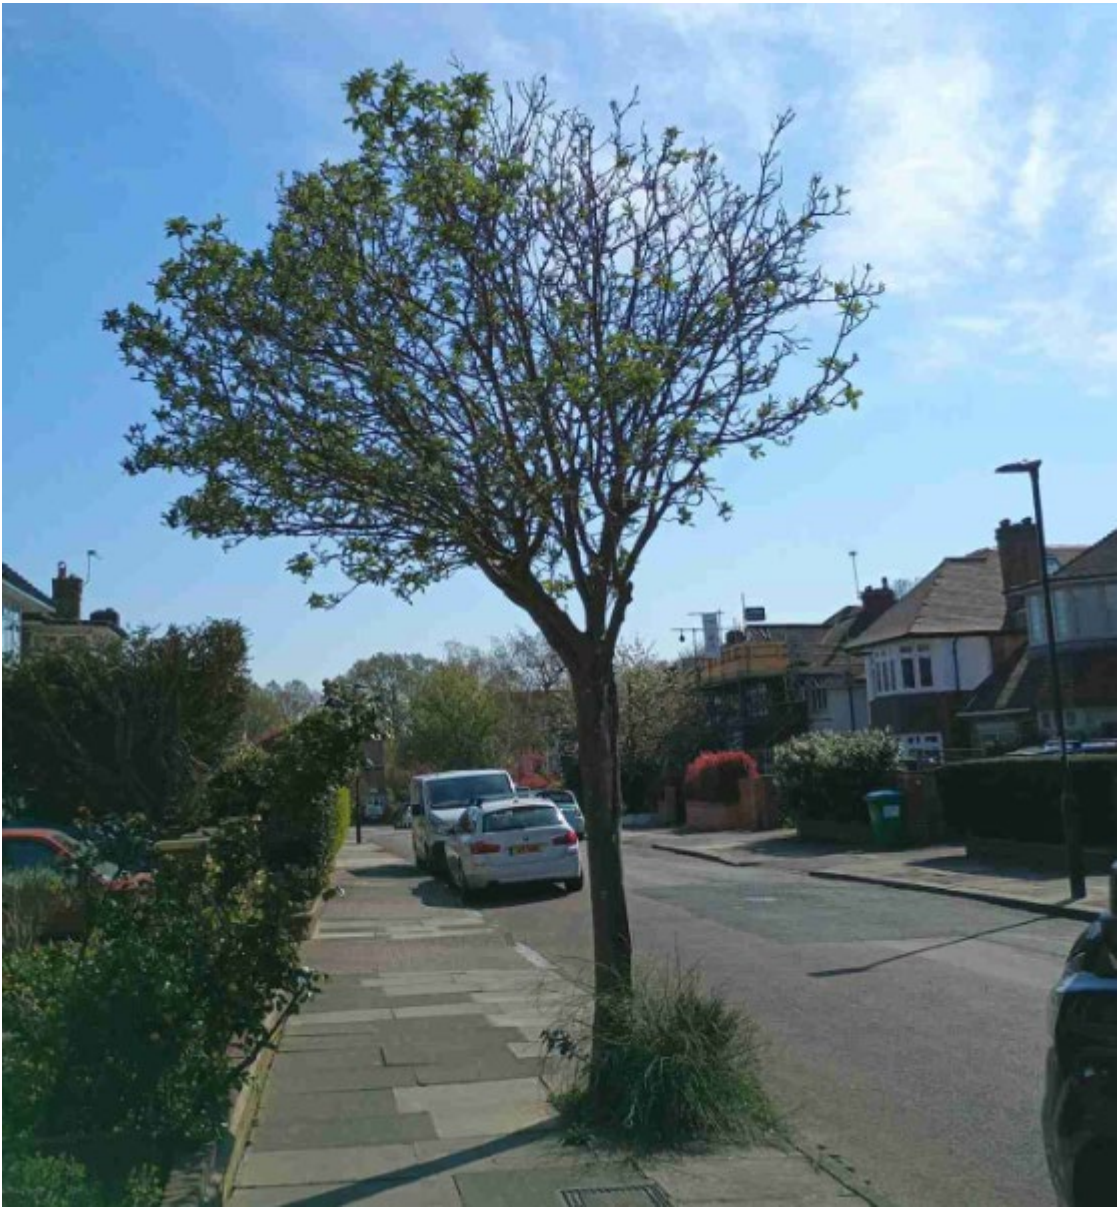
Ward	East Sheen
Road	Stonehill Road
Location	Outside 33
Species	Swedish whitebeam ( <i>Sorbus x intermedia</i> )
Height	5.0m
Physiological Condition	Poor
Structural Condition	Poor
Inspection findings/reason for exemption	This tree is moribund; removal is required to prevent natural failure, manage risk, and facilitate replanting

Image shows moribund tree in street scene.

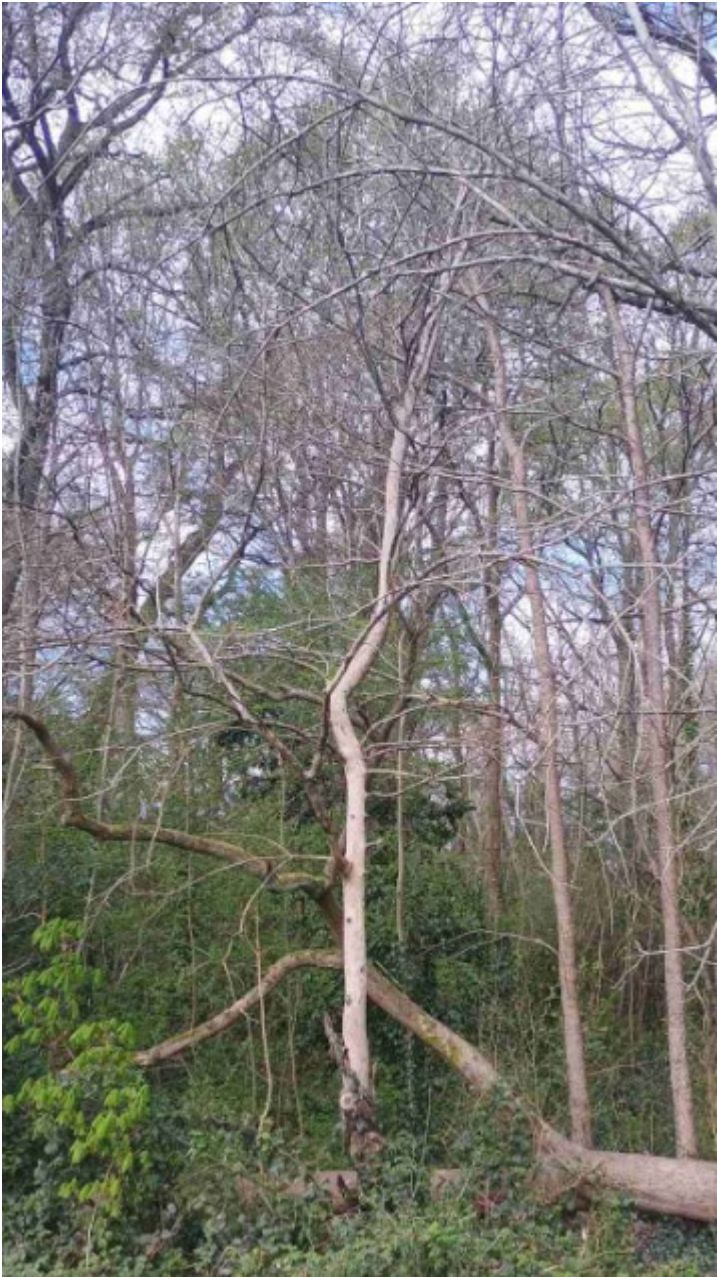
Ward	East Sheen
Road	Palewell Common Drive
Location	Palewell Common- ///middle.dine.brush
Species	Sycamore ( <i>Acer pseudoplatanus</i> )
Height	8.0m
Physiological Condition	Dead
Structural Condition	Dead
Inspection findings/reason for exemption	This tree is dead; removal is required to prevent natural failure and manage risk. Stump is to be left as a 1.5m monolith for ecological reasons.

Image shows dead tree in park scene.

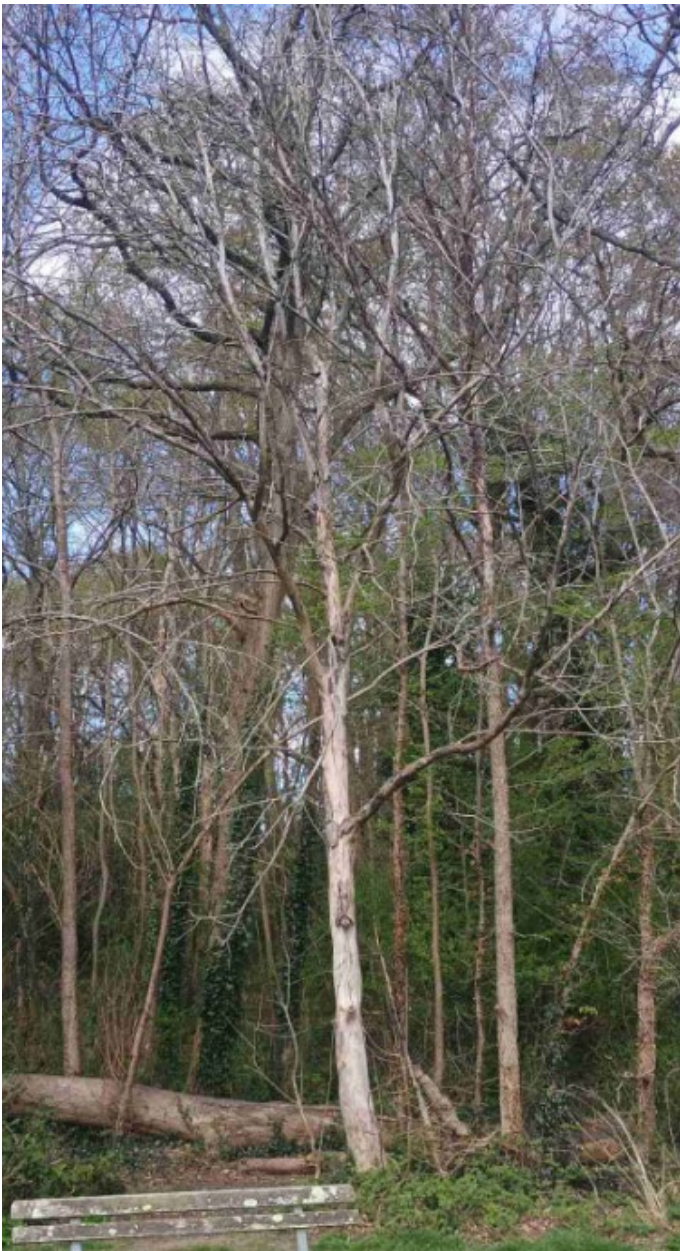
Ward	East Sheen
Road	Palewell Common Drive
Location	Palewell Common- ///stream.cable.tribes
Species	Sycamore ( <i>Acer pseudoplatanus</i> )
Height	8.0m
Physiological Condition	Dead
Structural Condition	Dead
Inspection findings/reason for exemption	This tree is dead; removal is required to prevent natural failure and manage risk. Stump is to be left as a 1.5m monolith for ecological reasons.

Image shows dead tree in park scene.

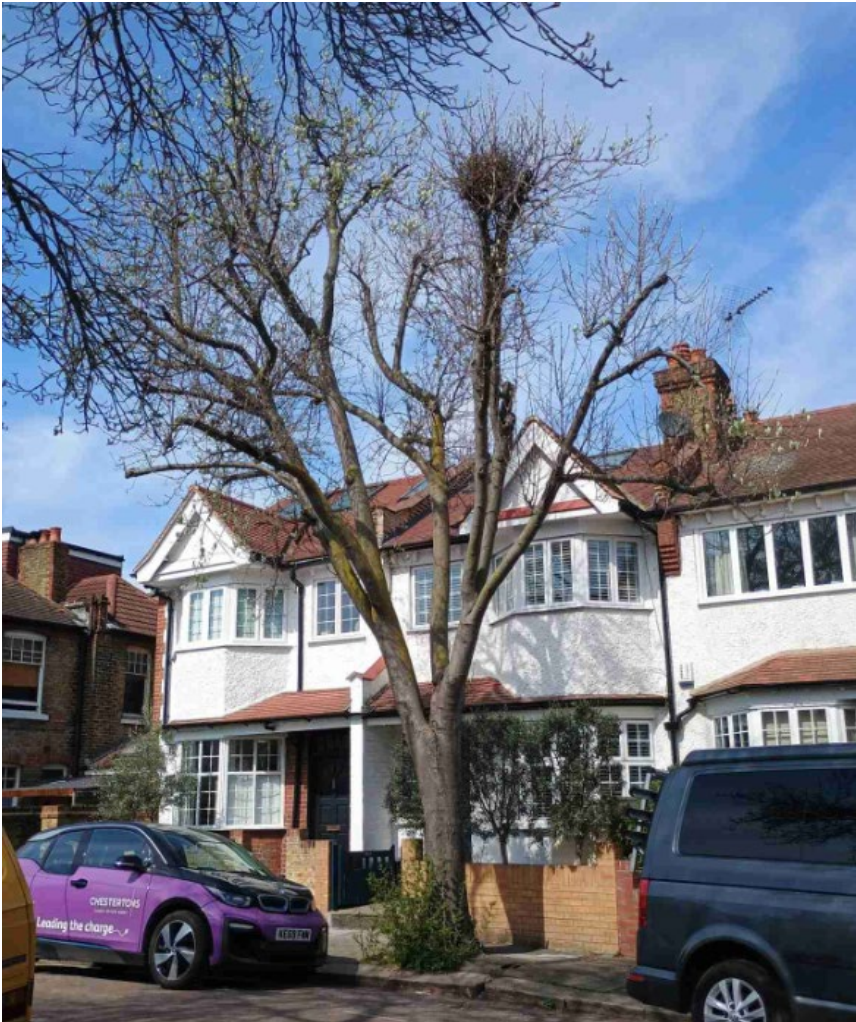
Ward	East Sheen
Road	Milton Road
Location	Outside 3
Species	Whitebeam ( <i>Sorbus aria</i> )
Height	10.5m
Physiological Condition	Fair
Structural Condition	Poor
Inspection findings/reason for exemption	A fungal fruiting body of the species Shaggy Polypore ( <i>Inonotus hispidus</i> ) is present on branches throughout the crown, this fungus causes a simultaneous white rot which can cause snapping of tree parts in this particular species. Removal is required to prevent natural failure, manage risk, and facilitate replanting

Image shows tree in street scene.

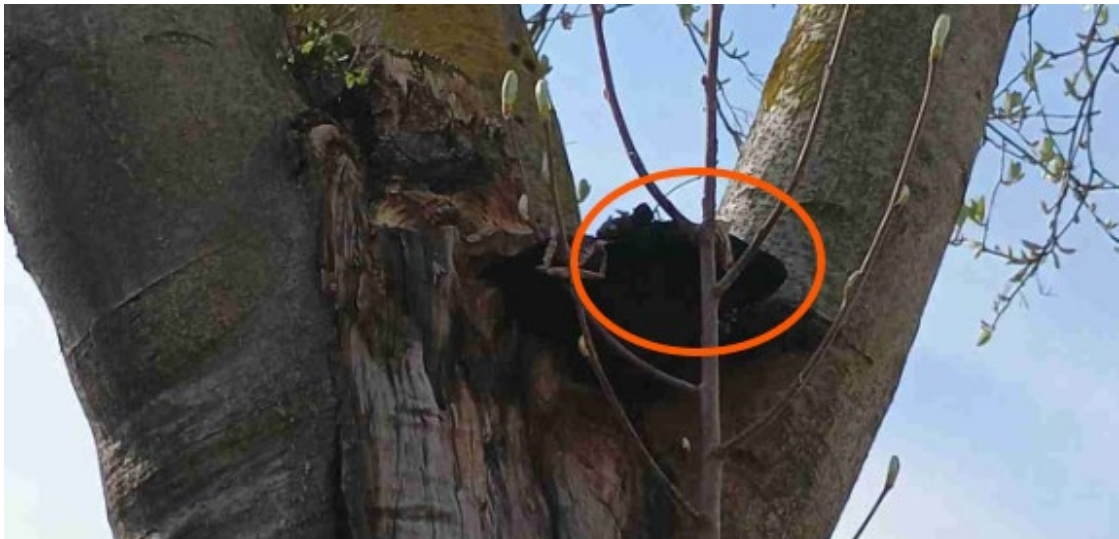
***Image shows fruiting body circled on trunk.***

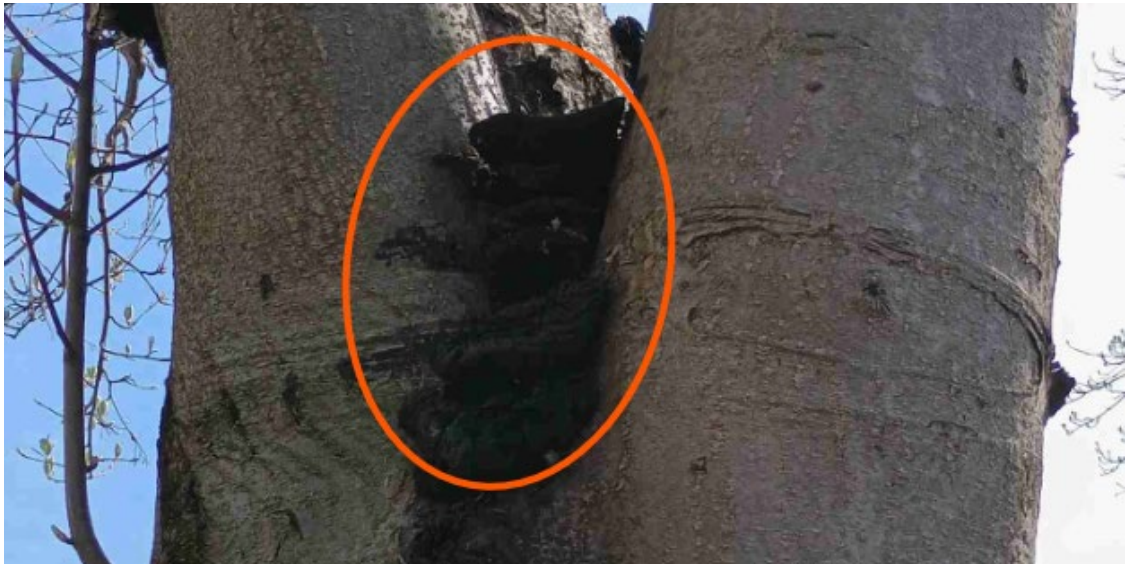
***Image shows fruiting bodies circled on trunk.***

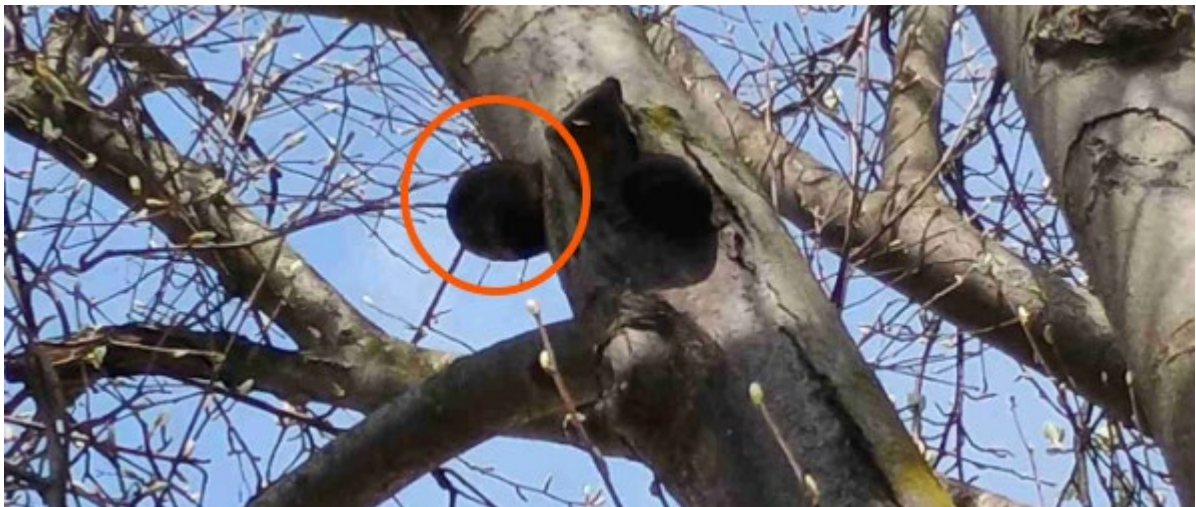
***Image shows fruiting body circled on trunk.***

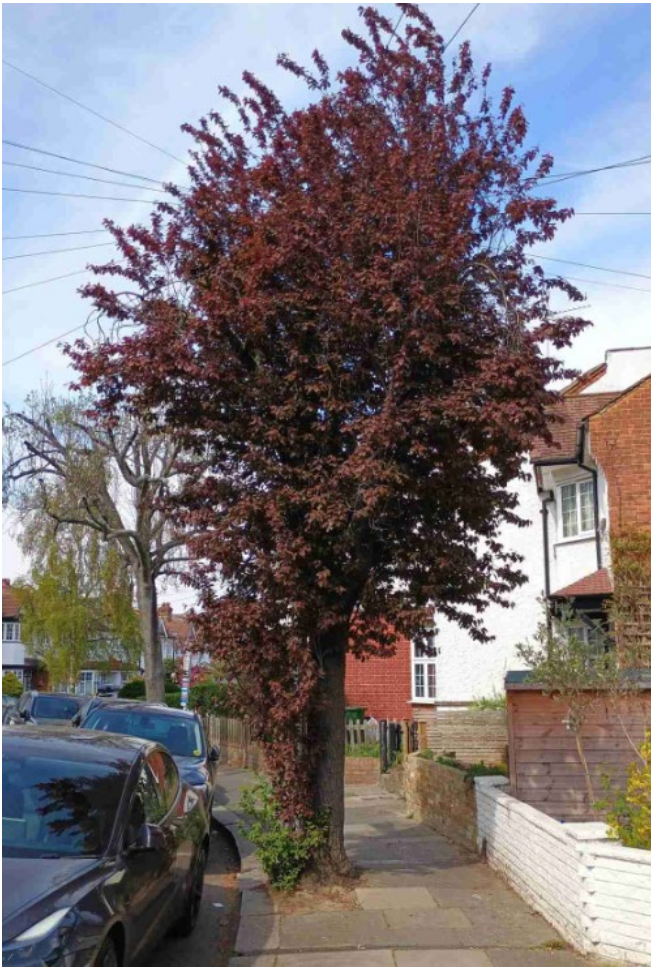
Ward	East Sheen
Road	Milton Road
Location	Outside 85
Species	Cherry plum ( <i>Prunus cerasifera</i> )
Height	7.5m
Physiological Condition	Fair
Structural Condition	Poor
Inspection findings/reason for exemption	A fungal fruiting body of the decay fungus <i>Ganoderma sp.</i> was present at the base of the trunk in 2020. Colonization by this fungus causes a white rot of the stem and root system, which can lead to entire trees collapsing through fracture or windthrow. During a recent inspection, an unacceptable amount of decay was noted in the lower stem and root system, correlating with the presence of this pathogen. Removal is required to prevent natural failure, manage risk, and facilitate replanting.

Image shows tree in street scene.

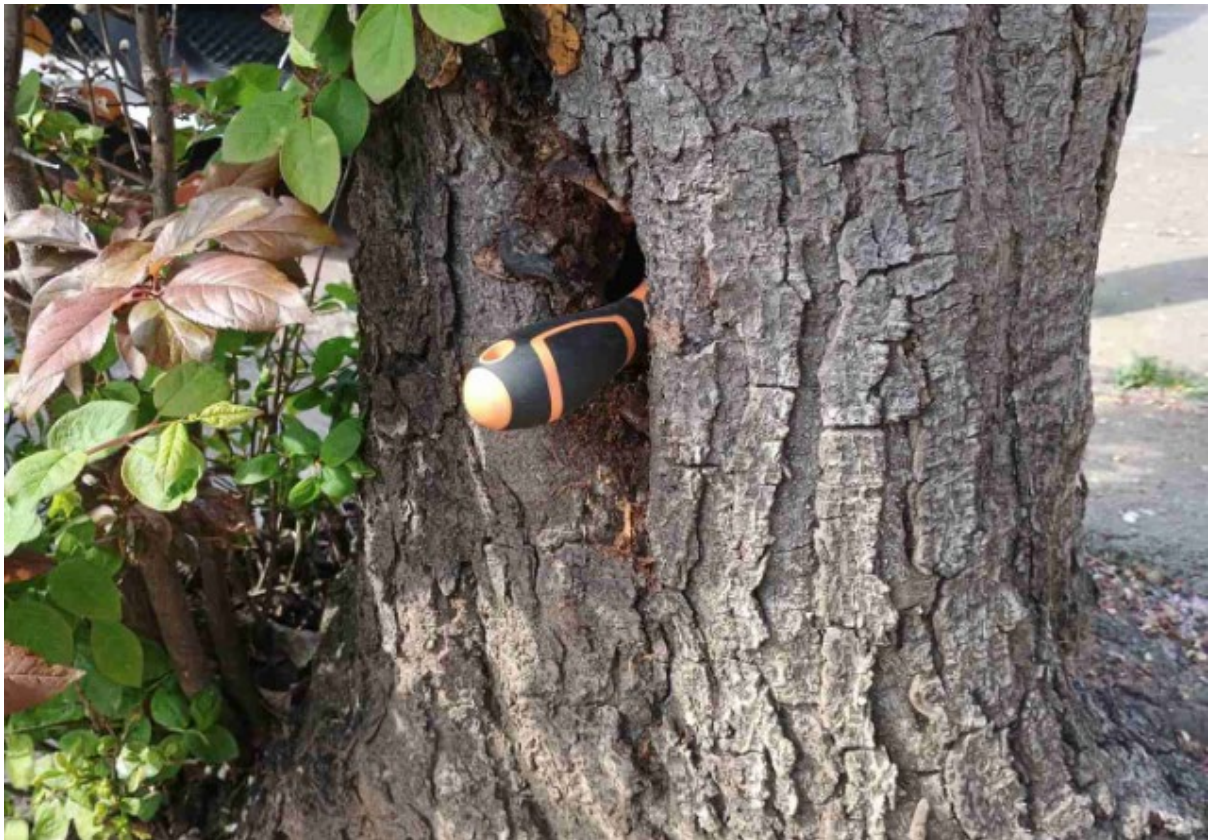
*Image shows cavity circled on trunk.*

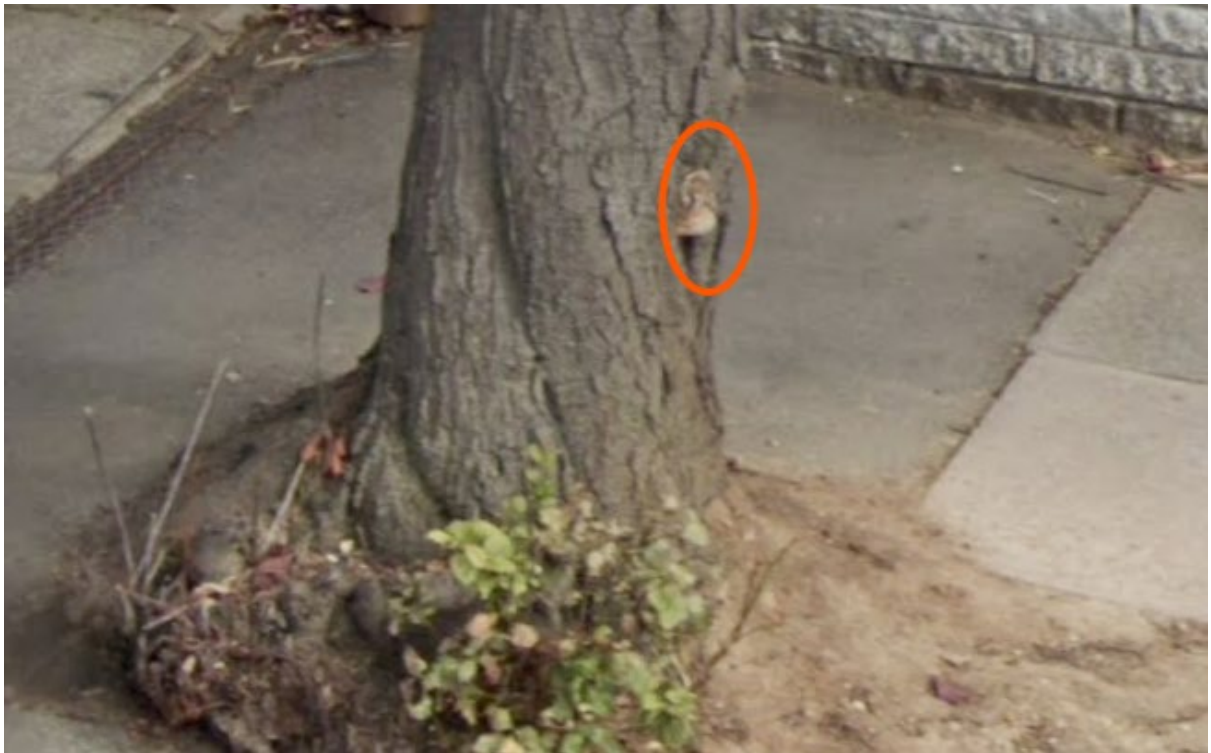
*Image from a previous inspection shows fruiting body circled on trunk.*

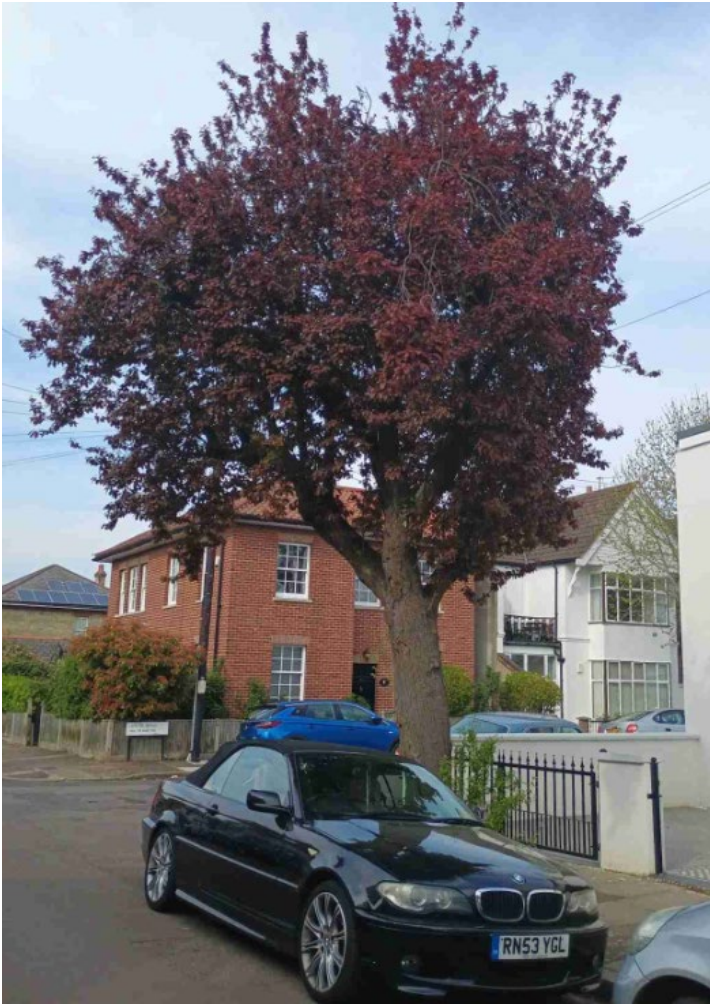
Ward	East Sheen
Road	Leinster Avenue
Location	Outside 17
Species	Cherry plum ( <i>Prunus cerasifera</i> )
Height	8.5m
Physiological Condition	Fair
Structural Condition	Poor
Inspection findings/reason for exemption	A fungal fruiting body of the decay fungi <i>Ganoderma sp.</i> is present at the base of the trunk. Colonization by this fungus causes a white rot of the stem and root system, which can lead to the collapse of entire trees through fracture or windthrow. The presence of <i>Phellinus pomaceus</i> (Cushion fungus) can cause extensive decay, contributing to the snapping of affected parts. This decay is a crumbly white rot found on the underside of branches. This correlates with the pathogens at the base of the trunk in the tree's decline. Removal is required to prevent natural failure, manage risk, and facilitate replanting

Image shows tree in street scene.

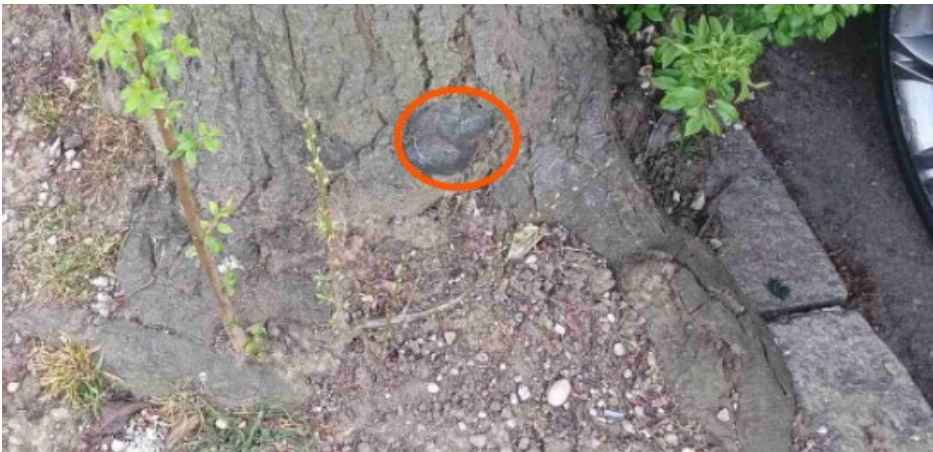
***Image shows fruiting body circled on trunk.***

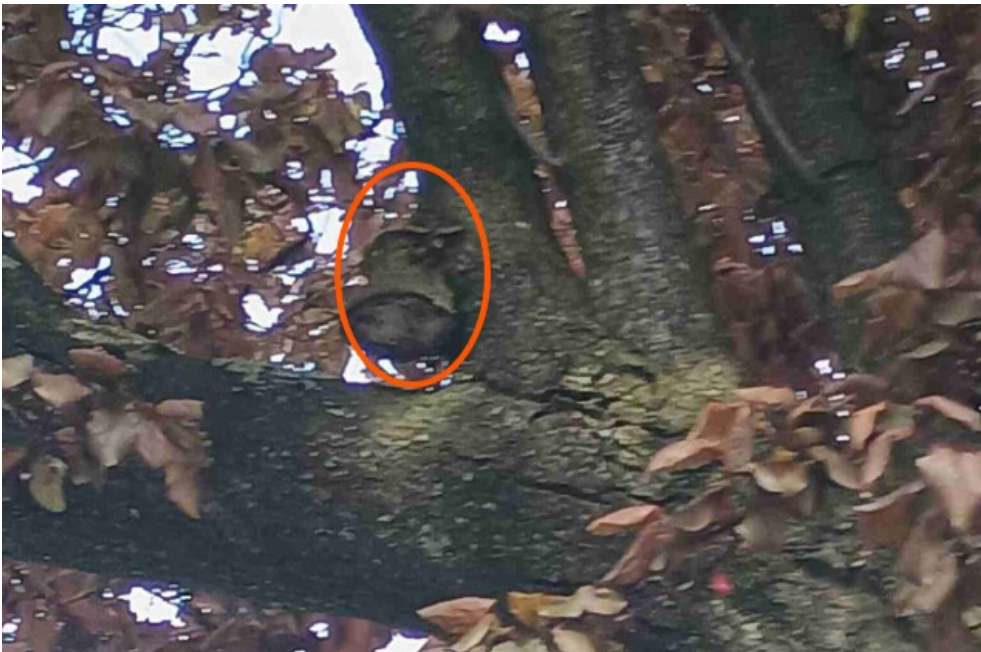
***Image shows fruiting body circled on trunk.***

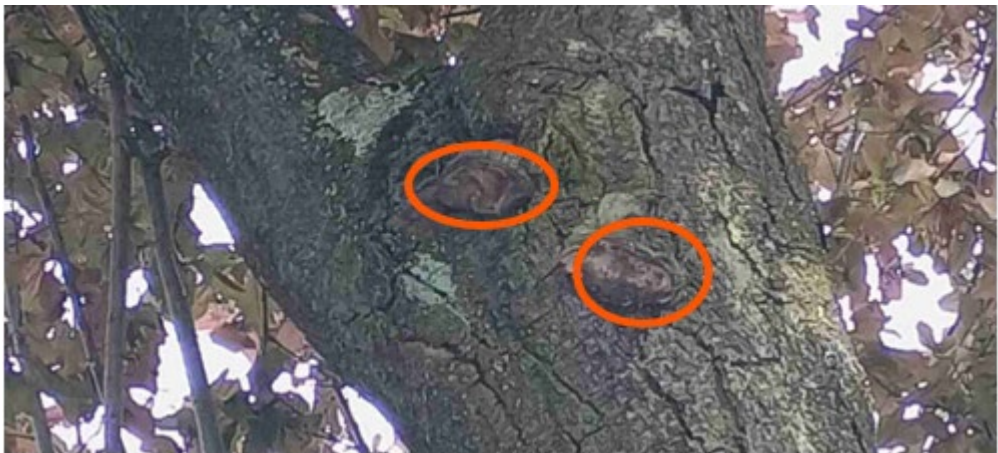
***Image shows fruiting bodies circled on trunk.***

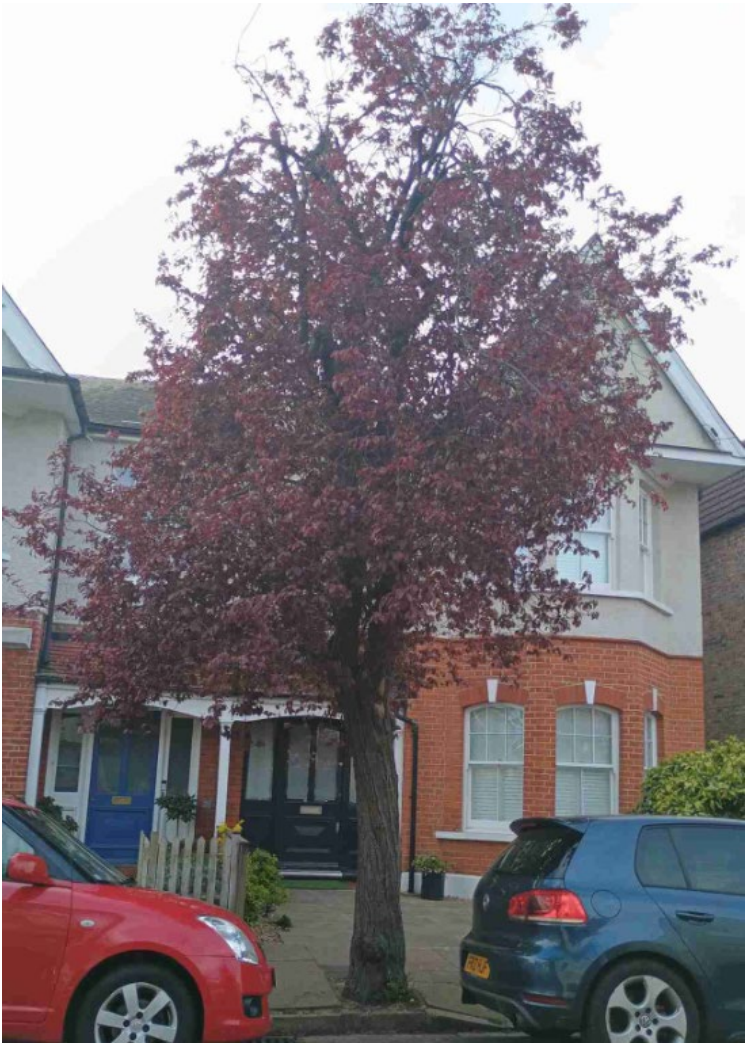
Ward	East Sheen
Road	Leinster Avenue
Location	Outside 22
Species	Cherry plum ( <i>Prunus cerasifera</i> )
Height	8.5m
Physiological Condition	Fair
Structural Condition	Poor
Inspection findings/reason for exemption	A fungal fruiting body of the decay fungus <i>Phellinus pomaceus</i> (Cushion fungus) is present on the main trunk below an historic branch failure wound. This fungus causes a crumbly white rot which can lead failure of affected parts. Removal is required to prevent natural failure, manage risk, and facilitate replanting

Image shows tree in street scene.

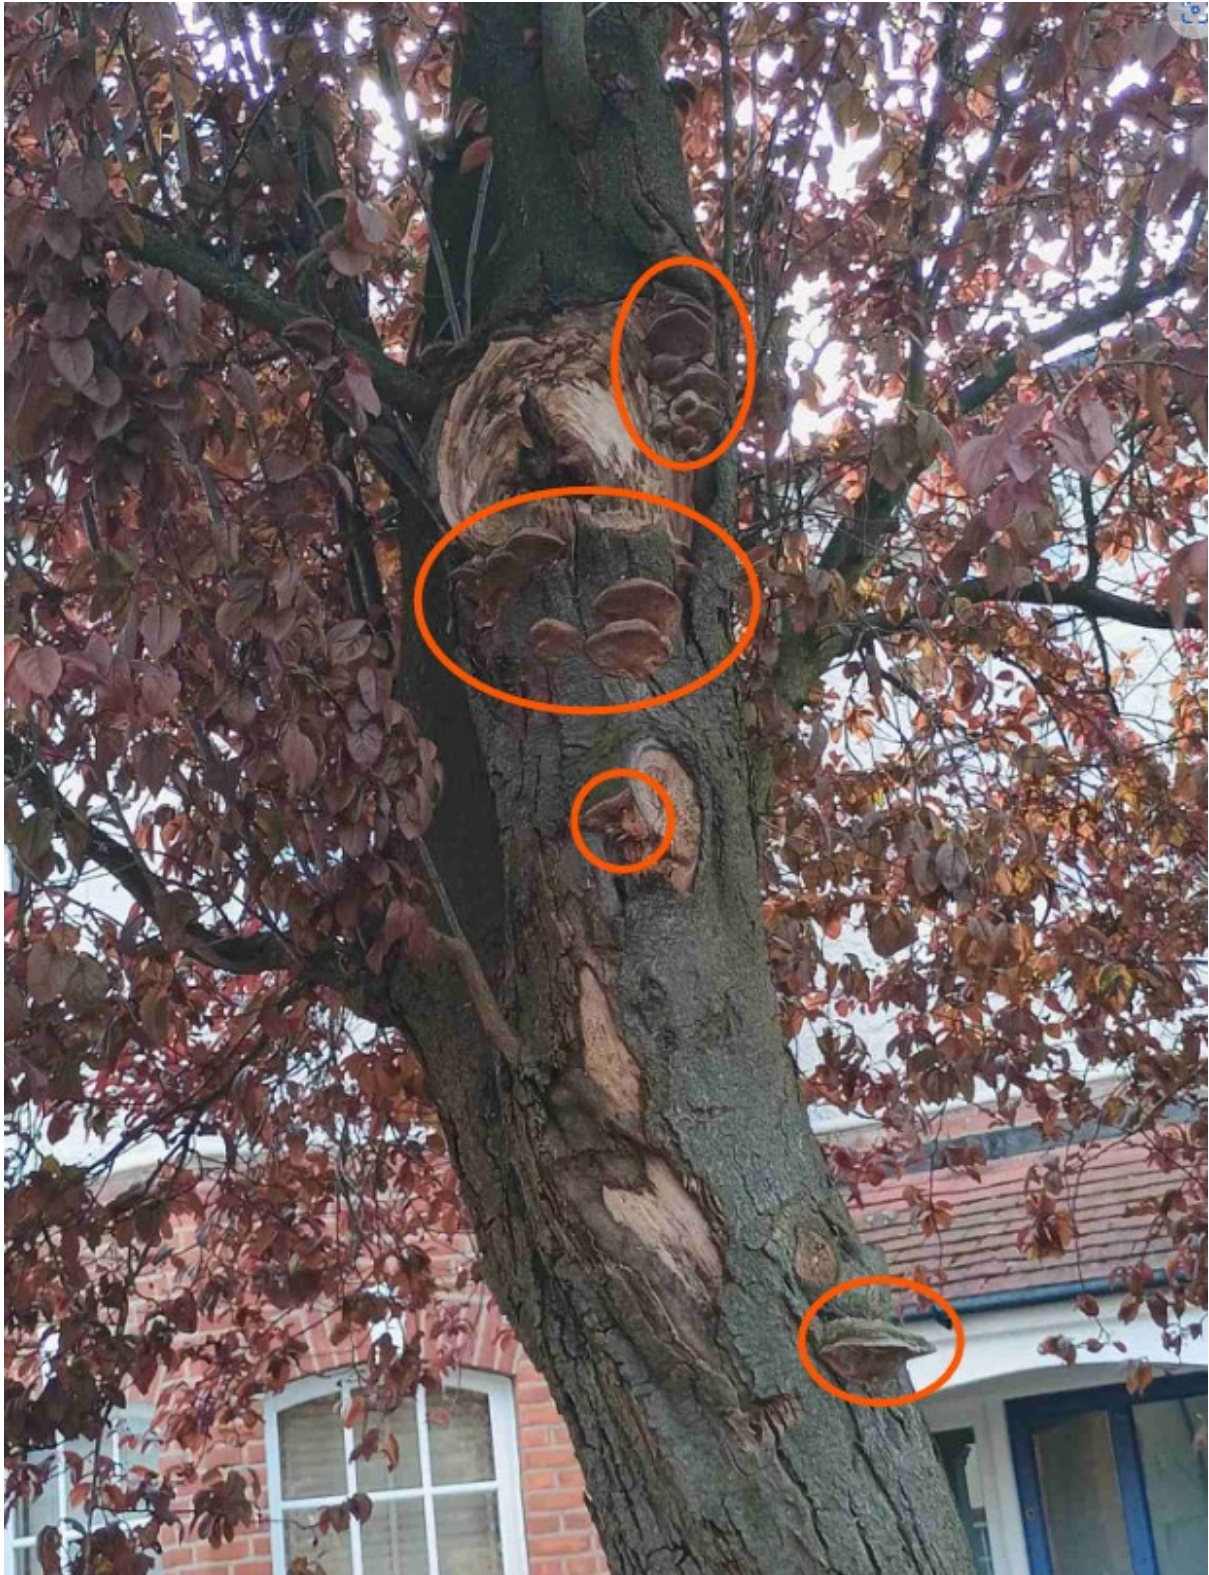
***Image shows fruiting bodies circled on trunk.***

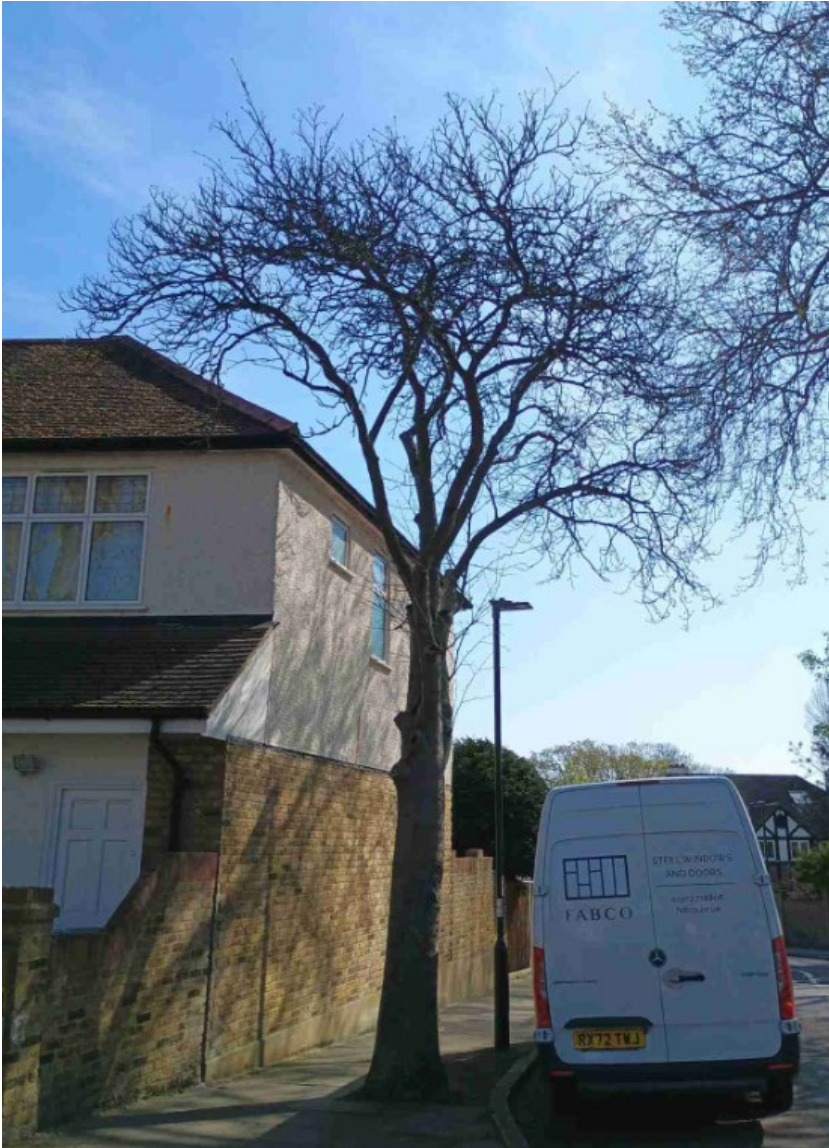
Ward	East Sheen
Road	Hertford Avenue
Location	Adjacent to 40 Park Drive
Species	Swedish whitebeam ( <i>Sorbus x intermedia</i> )
Height	12.0m
Physiological Condition	Fair
Structural Condition	Poor
Inspection findings/reason for exemption	A fungal fruiting body of the species Shaggy Polypore ( <i>Inonotus hispidus</i> ) is present on branches throughout the crown; this fungus causes a simultaneous white rot which can cause snapping of tree parts in this species. Removal is required to prevent natural failure, manage risk, and facilitate replanting

Image shows tree in street scene.

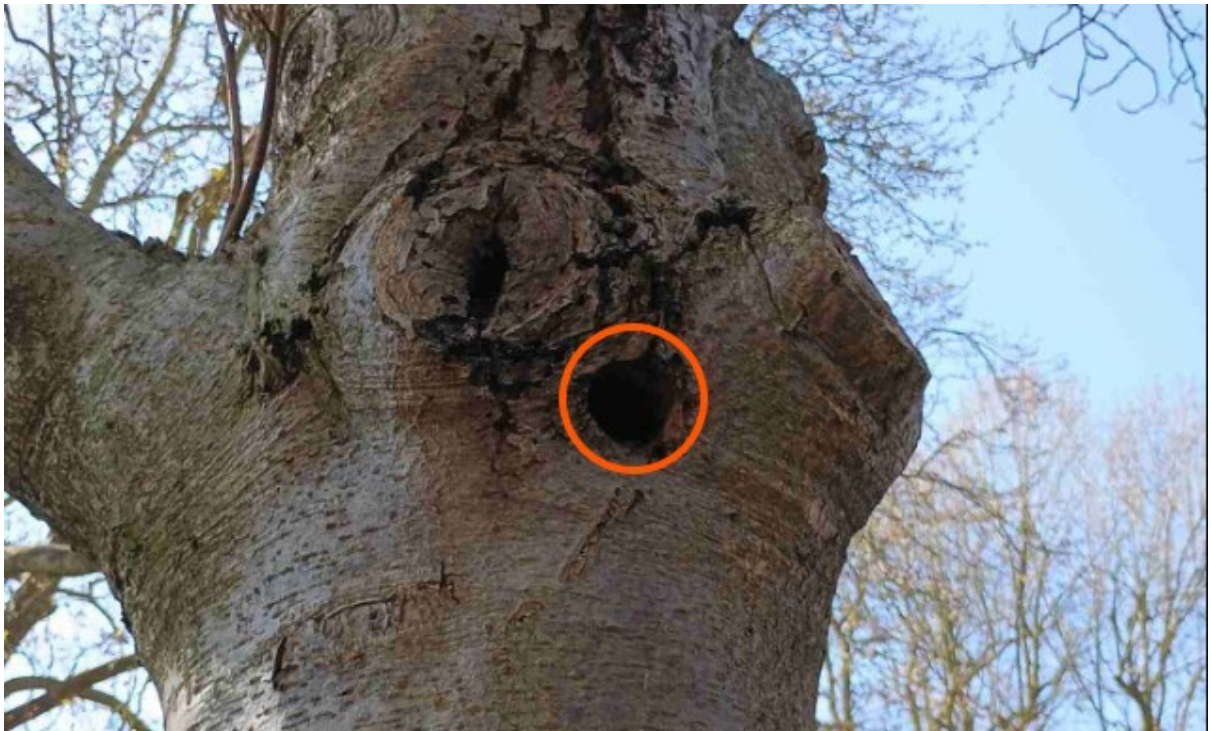
***Image shows fruiting body circled on trunk.***

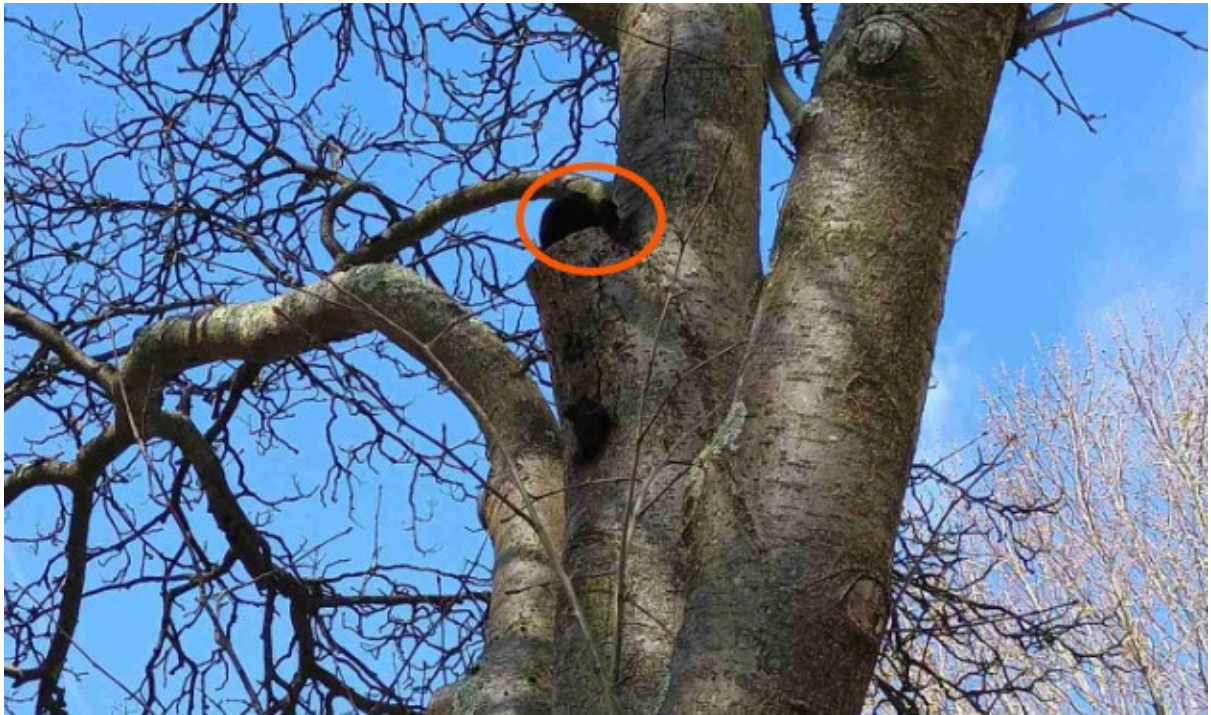
***Image shows fruiting body circled on crown.***

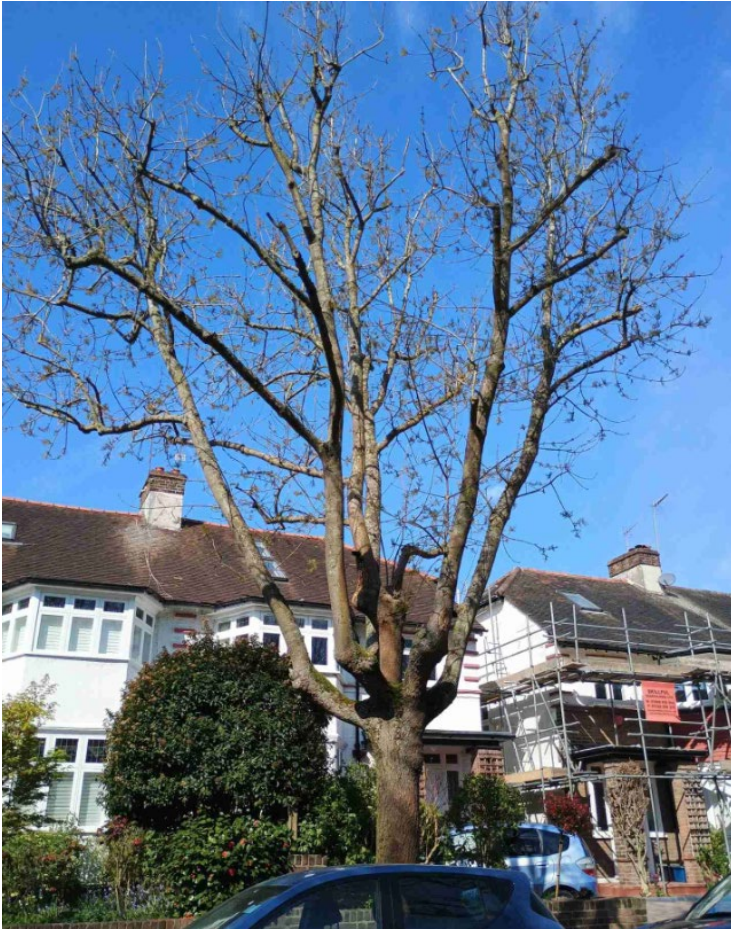
Ward	East Sheen
Road	Park Drive
Location	Outside 13/15
Species	Common ash ( <i>Fraxinus excelsior</i> )
Height	15.0m
Physiological Condition	Fair
Structural Condition	Poor
Inspection findings/reason for exemption	A fungal fruiting body of the species Shaggy Polypore ( <i>Inonotus hispidus</i> ) is present on branches throughout the crown; this fungus causes a simultaneous white rot which can cause snapping of tree parts in this species. Removal is required to prevent natural failure, manage risk, and facilitate replanting

Image shows tree in street scene.

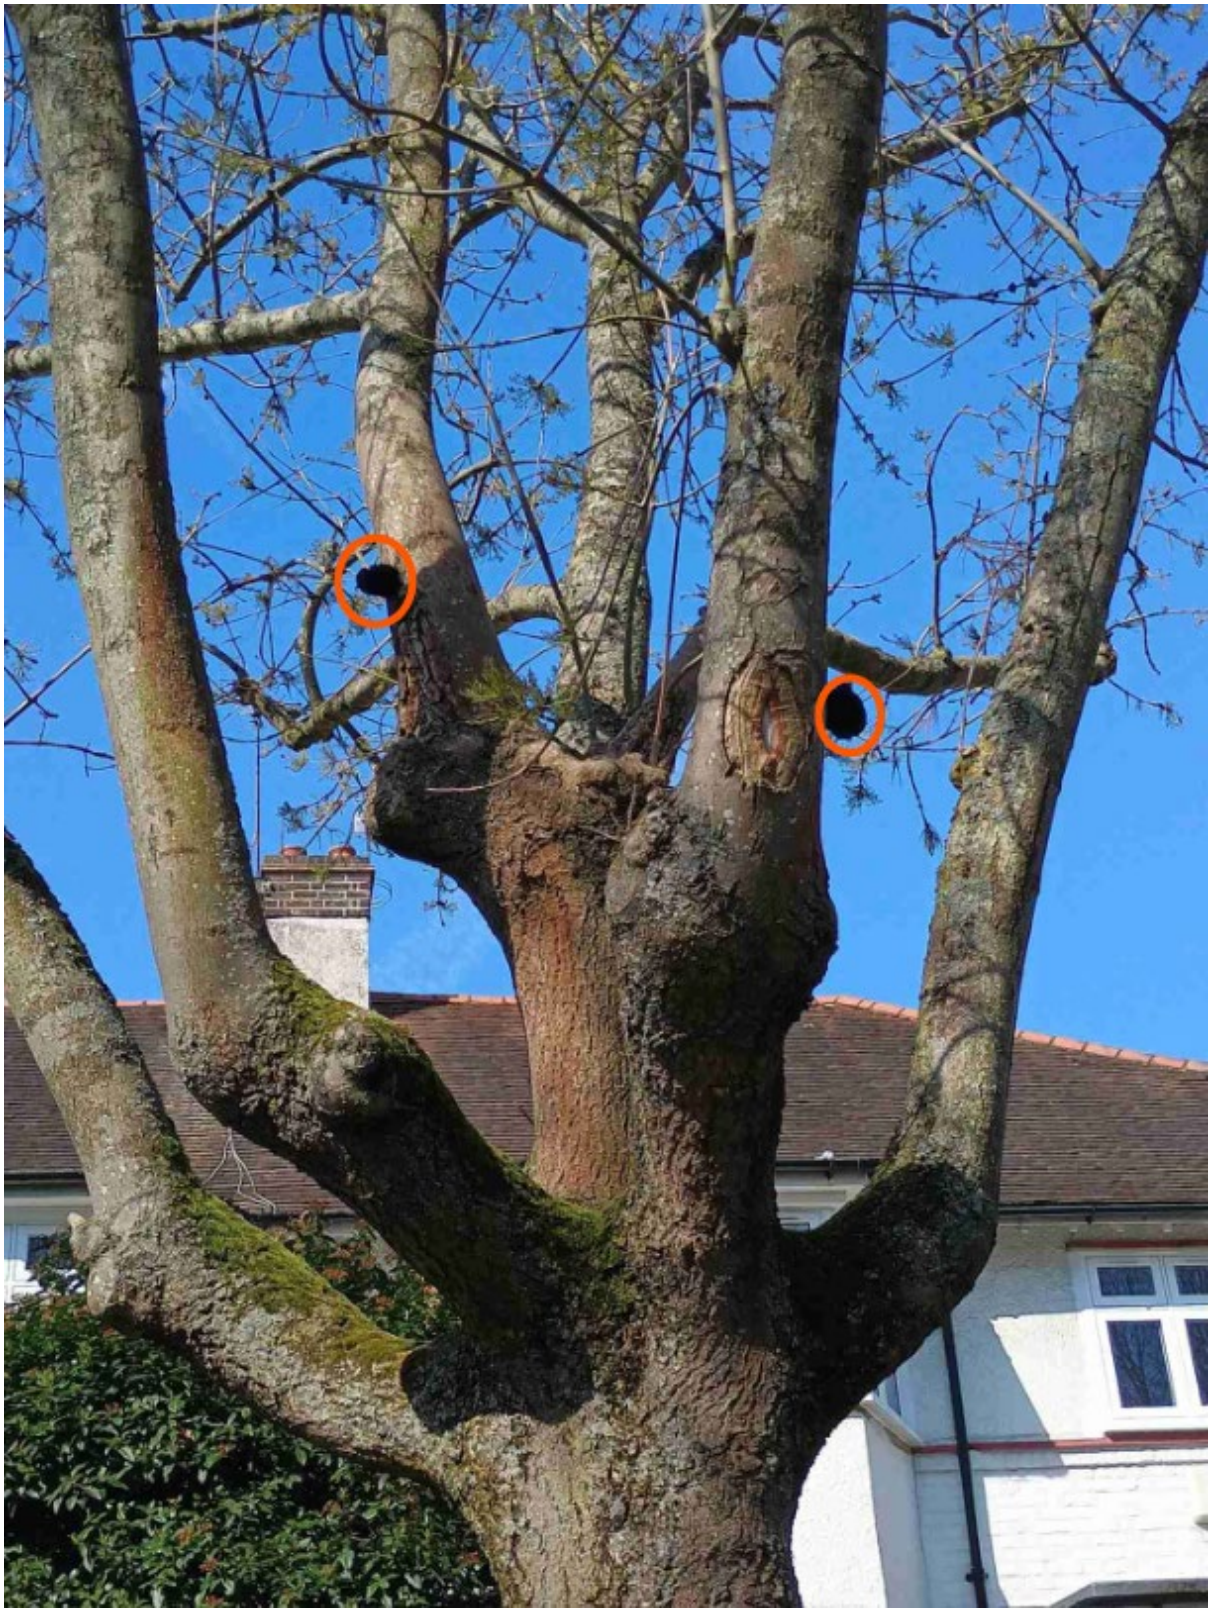
***Image shows fruiting bodies circled on crown.***
