# May 2025 - Reactive Tree Works Programme

A survey of trees in Barnes and East Sheen wards have been undertaken; this is being conducted by specialist arboricultural officers as part of the scheduled 4 yearly detailed inspection regime that has been devised for all Council highway and parks trees.

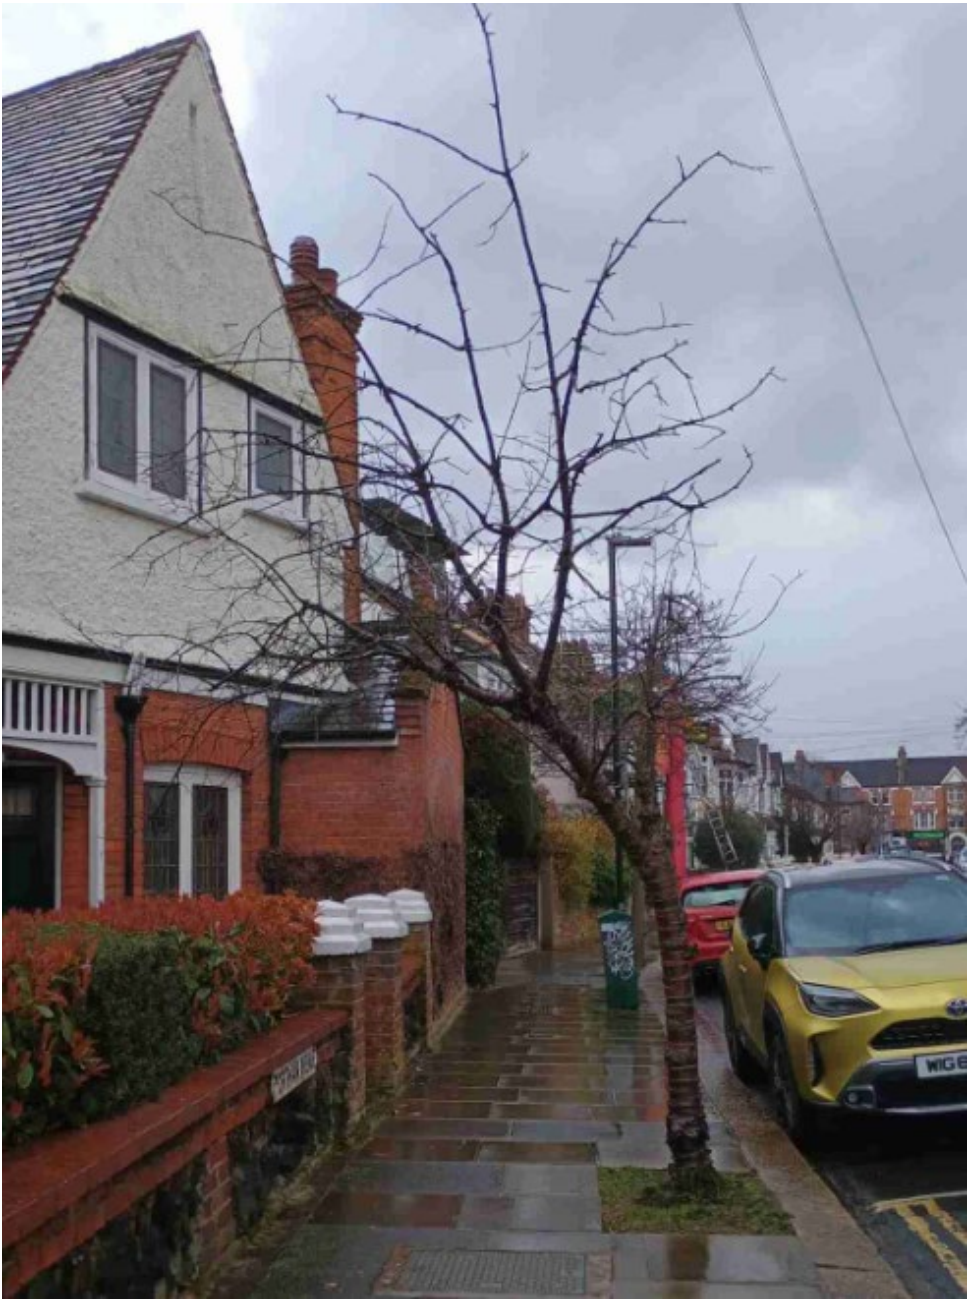
Ward	East Sheen
Road	Portman Avenue
Location	Outside 51
Species	Birchbark cherry ( <i>Prunus serrula</i> )
Height	4.5m
Physiological Condition	Dead
Structural Condition	Dead
Inspection findings/reason for exemption	This tree is dead; removal is required to prevent natural failure, manage risk, and facilitate replanting

Image shows dead tree in street scene.

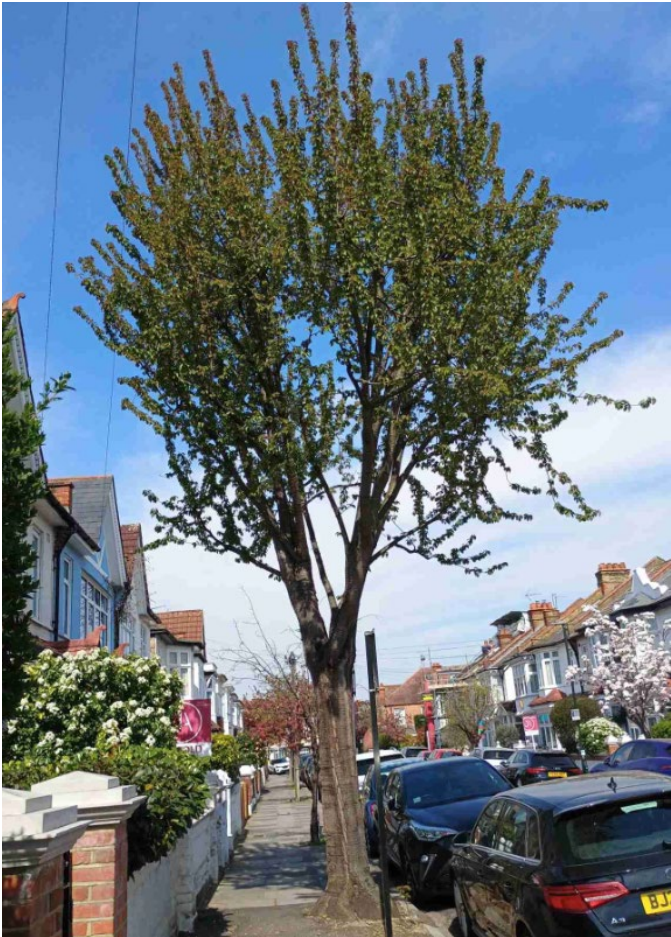
Ward	East Sheen
Road	Portman Avenue
Location	Outside 11/13
Species	Schmitt's cherry ( <i>Prunus x schmittii</i> )
Height	10.0m
Physiological Condition	Fair
Structural Condition	Poor
Inspection findings/reason for exemption	<p>A fungal fruiting body of the decay fungi <i>Ganoderma sp.</i> is present at the base of the trunk. Colonization by this fungus causes a white rot of the stem and root system, which can lead to the collapse of entire trees through fracture or windthrow. The presence of <i>Phellinus pomaceus</i> (Cushion fungus) can cause extensive decay, contributing to the snapping of affected parts. This decay is a crumbly white rot found on the underside of branches. Removal is required to prevent natural failure, manage risk, and facilitate replanting</p>

Image shows tree in street scene.

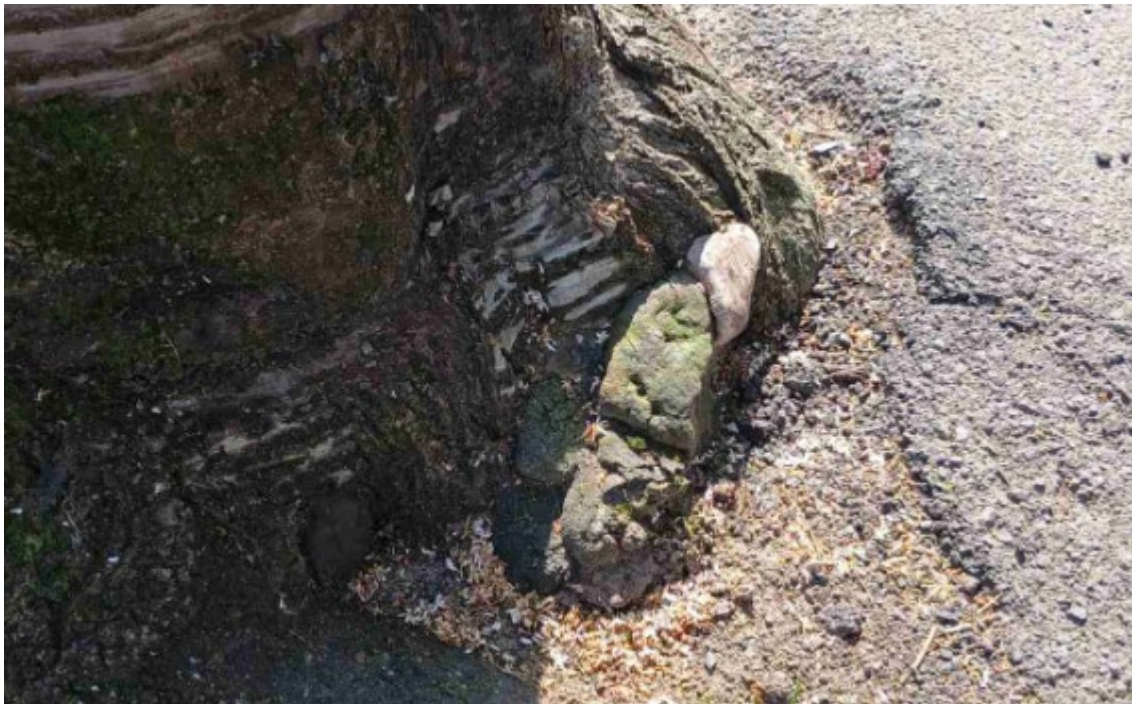
*Image shows fruiting body circled on base of trunk.*

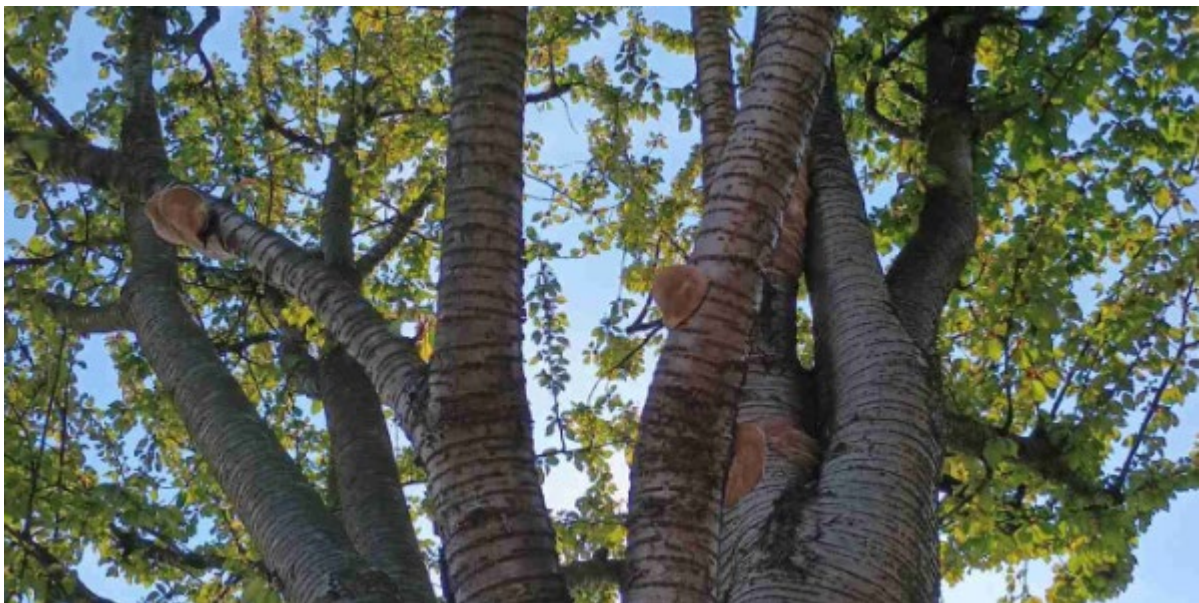
*Image shows fruiting bodies circled on crown.*

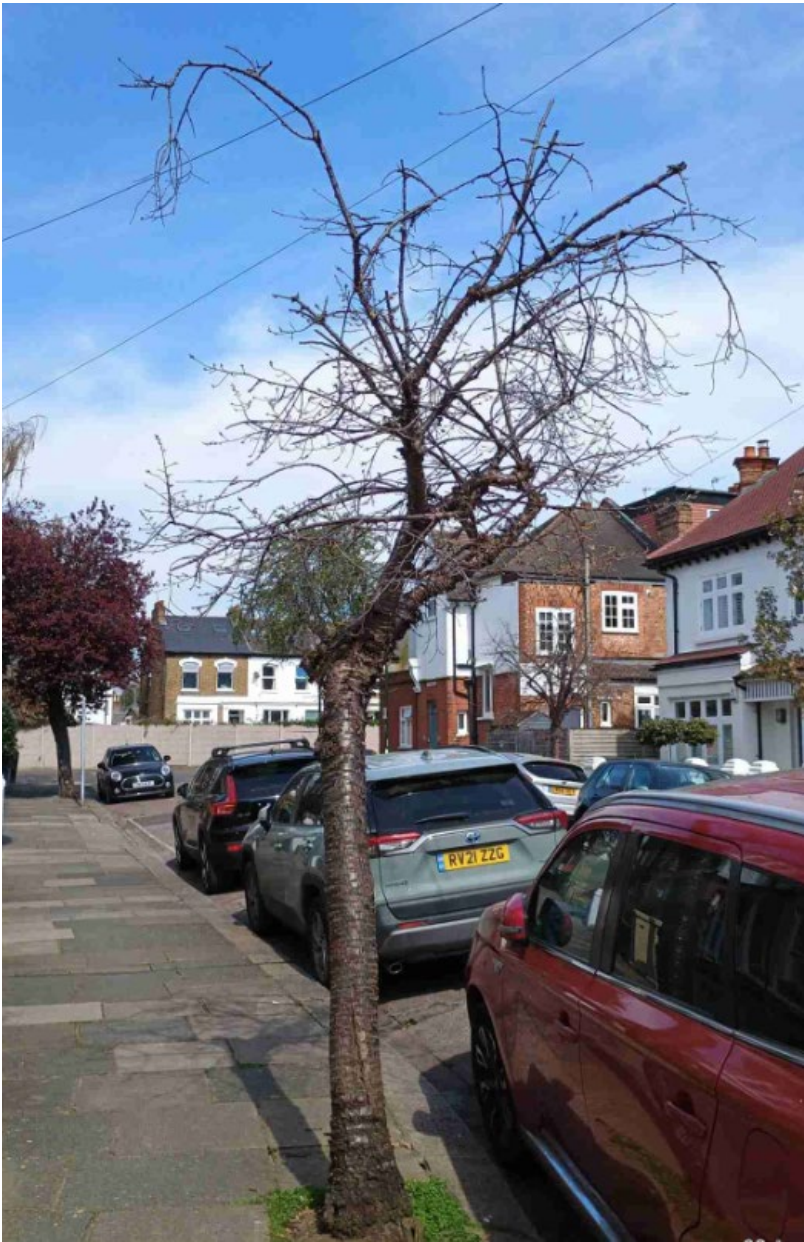
Ward	East Sheen
Road	Glendower Road
Location	Outside 51
Species	Birchbark cherry ( <i>Prunus serrula</i> )
Height	3.5m
Physiological Condition	Poor
Structural Condition	Fair
Inspection findings/reason for exemption	This tree is moribund; removal is required to prevent natural failure, manage risk, and facilitate replanting

Image shows moribund tree in street scene.

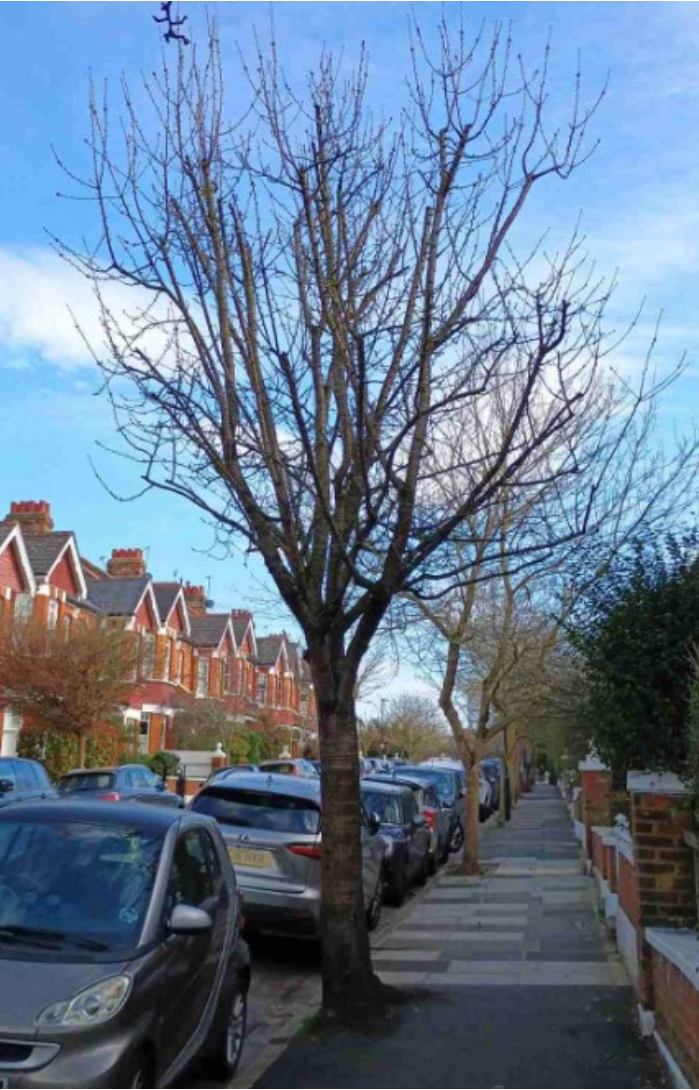
Ward	East Sheen
Road	Palmerston Road
Location	Outside 19/21
Species	Schmitt's cherry ( <i>Prunus x schmittii</i> )
Height	8.0m
Physiological Condition	Fair
Structural Condition	Poor
Inspection findings/reason for exemption	A fungal fruiting body of the decay fungus <i>Ganoderma sp.</i> is present at the base of the trunk. Colonization by this fungus causes a white rot of the stem and root system, which can lead to the entire tree collapsing through fracture or windthrow. A resonance test with a sounding hammer has revealed an unacceptable degree of decay at base of the trunk. Removal is required to prevent natural failure, manage risk and facilitate replanting.

Image shows tree in street scene.

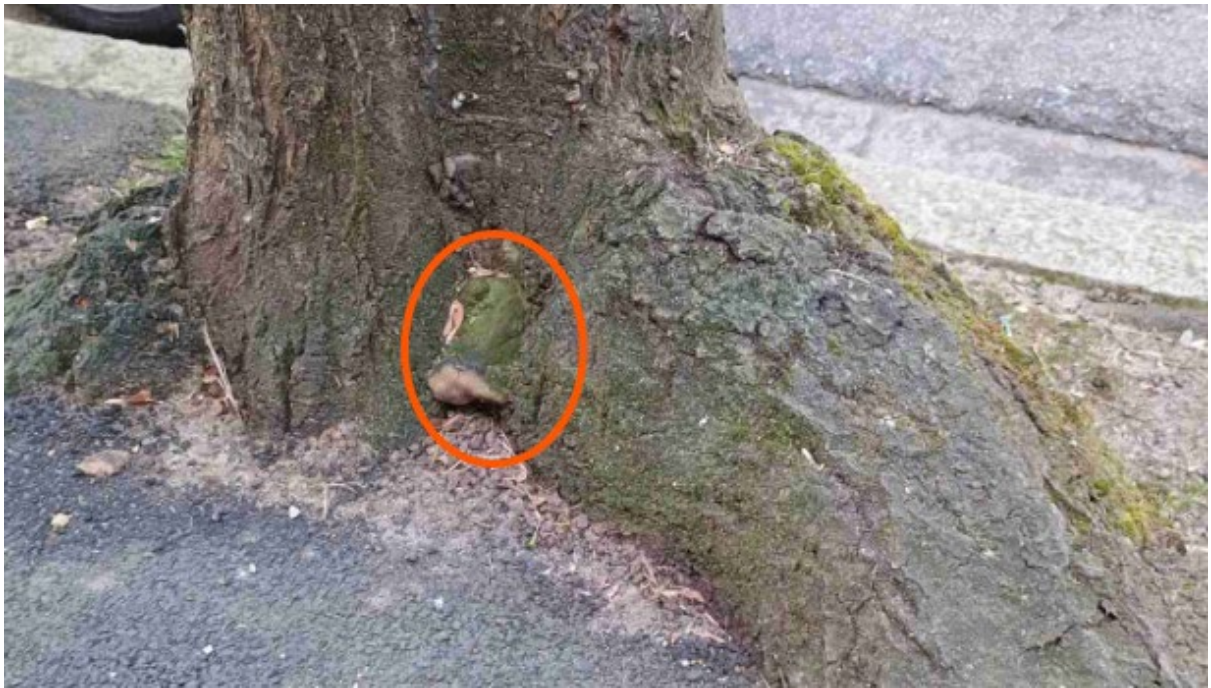
***Image shows fungal fruiting body circled.***

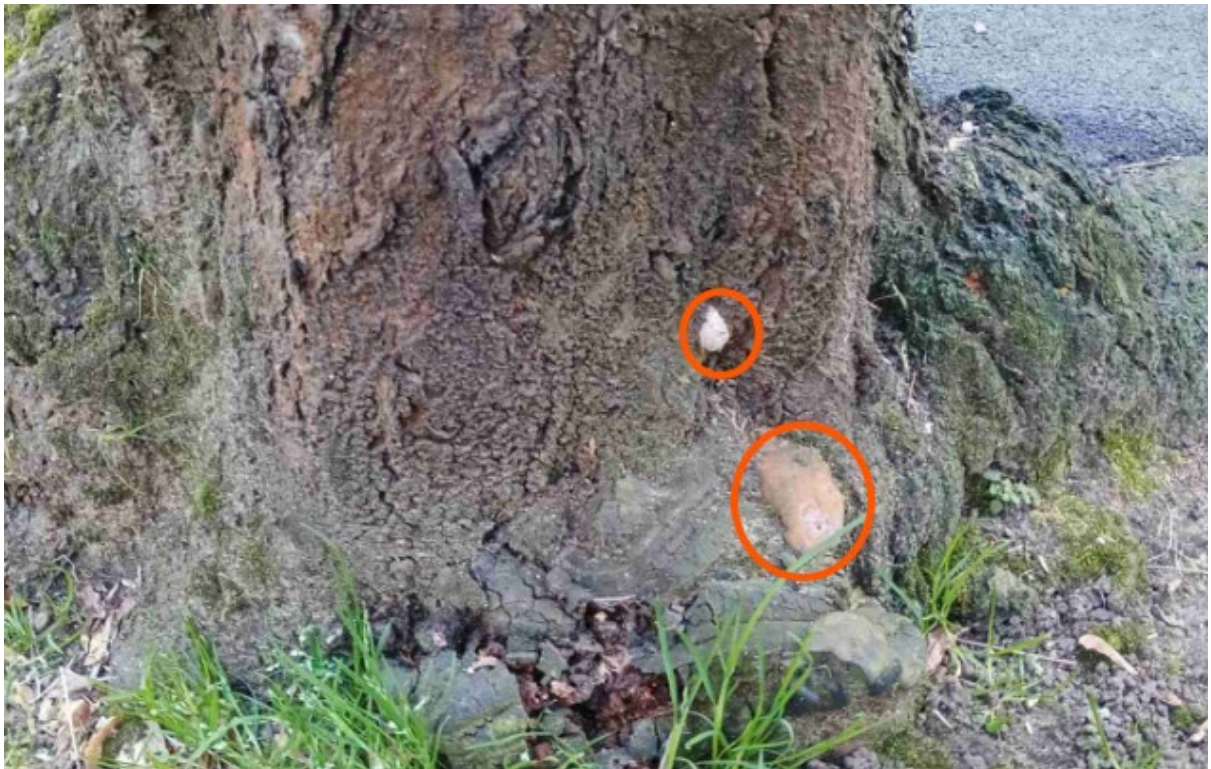
***Image shows fungal fruiting bodies circled.***

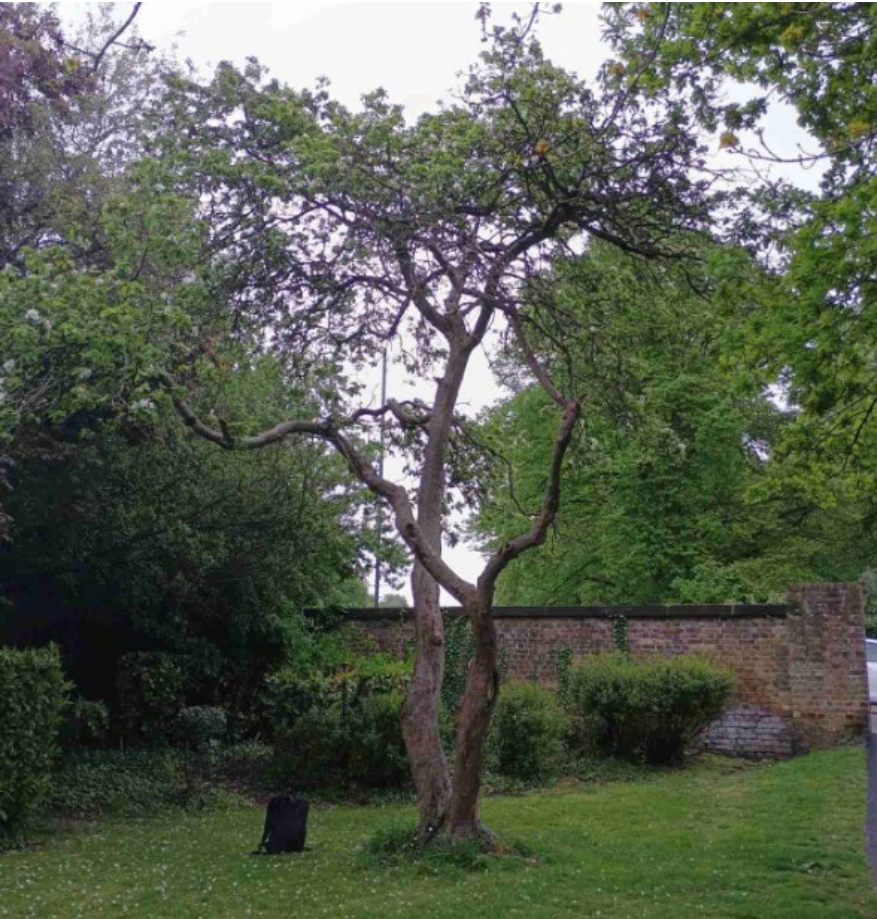
Ward	Fulwell and Hampton Hill
Road	Uxbridge Road
Location	Pantile Bridge Open Space- ///signal.hero.called
Species	Apple ( <i>Malus</i> sp.)
Height	5.5m
Physiological Condition	Poor
Structural Condition	Poor
Inspection findings/reason for exemption	An investigation using a probe and a resonance test with a sounding hammer has revealed significant decay beyond the visible cavities at the base of the trunk. The observed crown and trunk dieback correlates to the deterioration of the tree's structural and supporting root system. Removal is required to prevent natural failure, manage risk, and facilitate replanting.

Image shows tree in park scene.

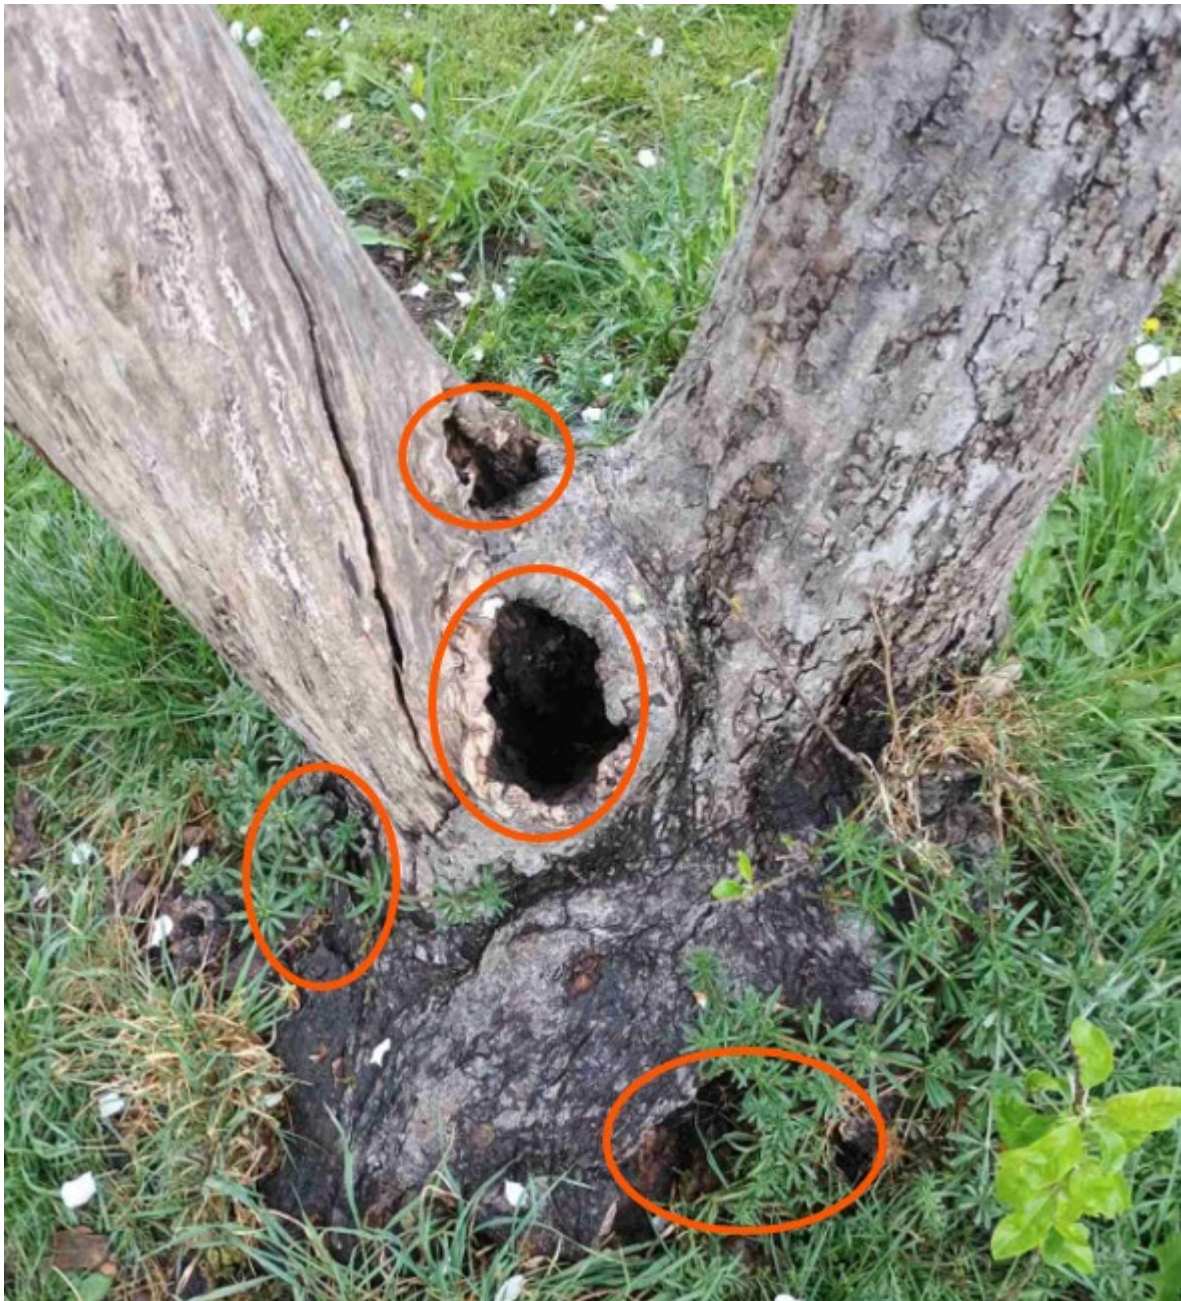
***Image shows cavities at base of trunk circled.***

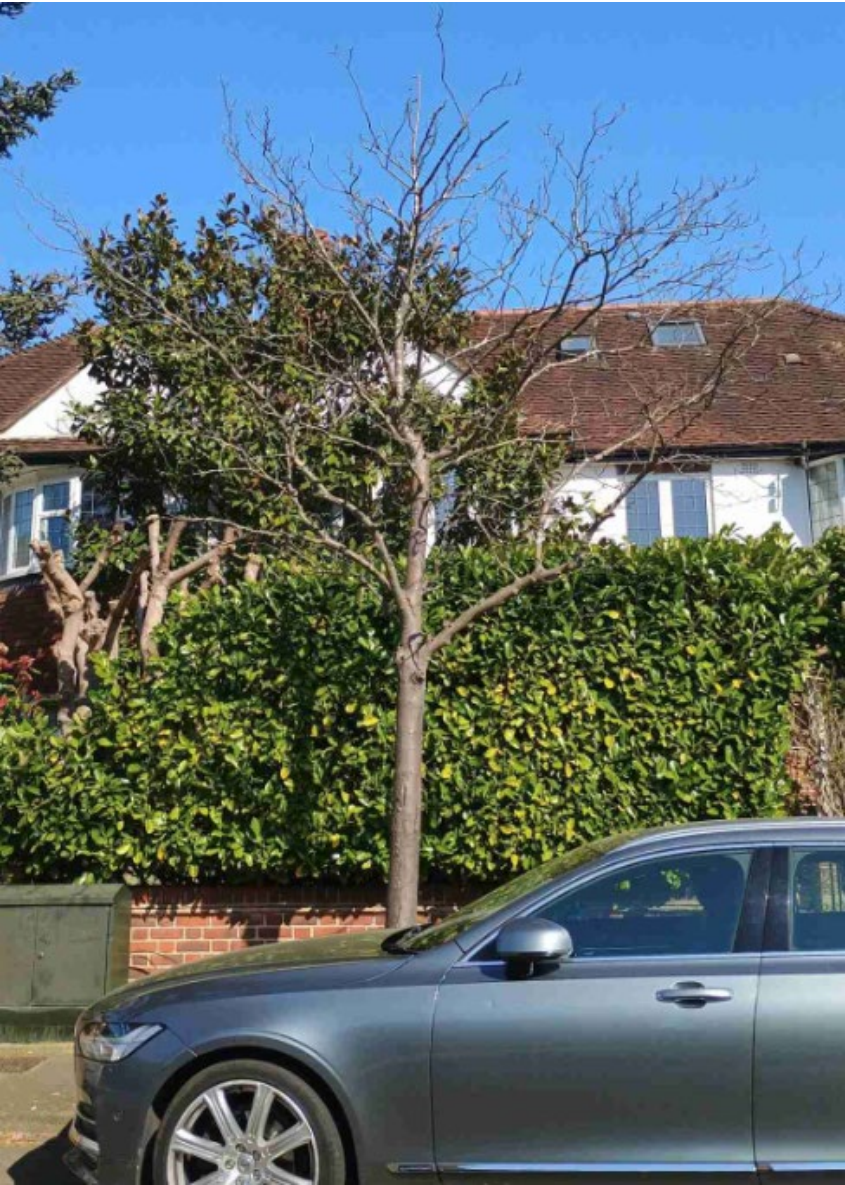
Ward	Ham, Petersham and Richmond Riverside
Road	Arlington Road
Location	Outside 7
Species	Swedish whitebeam ( <i>Sorbus x intermedia</i> )
Height	6.0m
Physiological Condition	Dead
Structural Condition	Dead
Inspection findings/reason for exemption	This tree is dead; removal is required to prevent natural failure and manage risk, and facilitate replanting

Image shows dead tree in street scene.

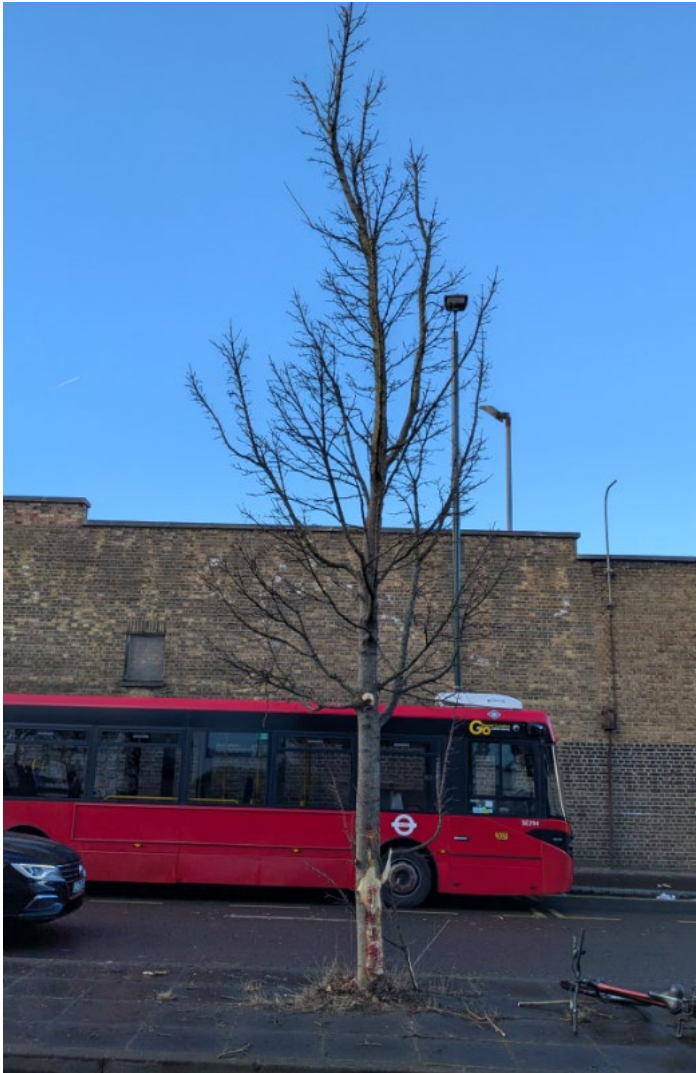
Ward	Mortlake and Barnes Common
Road	Mortlake High Street
Location	Opposite 40 on traffic island
Species	Norway maple ( <i>Acer platanoides</i> )
Height	8.0m
Physiological Condition	Good
Structural Condition	Poor
Inspection findings/reason for exemption	This tree has sustained vehicle damage on the lower stem. This extensive wounding has damaged the tree's vascular system and is irreparable. The lifted paving stone at the base of the tree indicates root damage and structural instability. Removal is required to prevent natural failure, manage risk, and facilitate replanting.

Image shows tree in street scene with trunk damaged caused by vehicle strike.

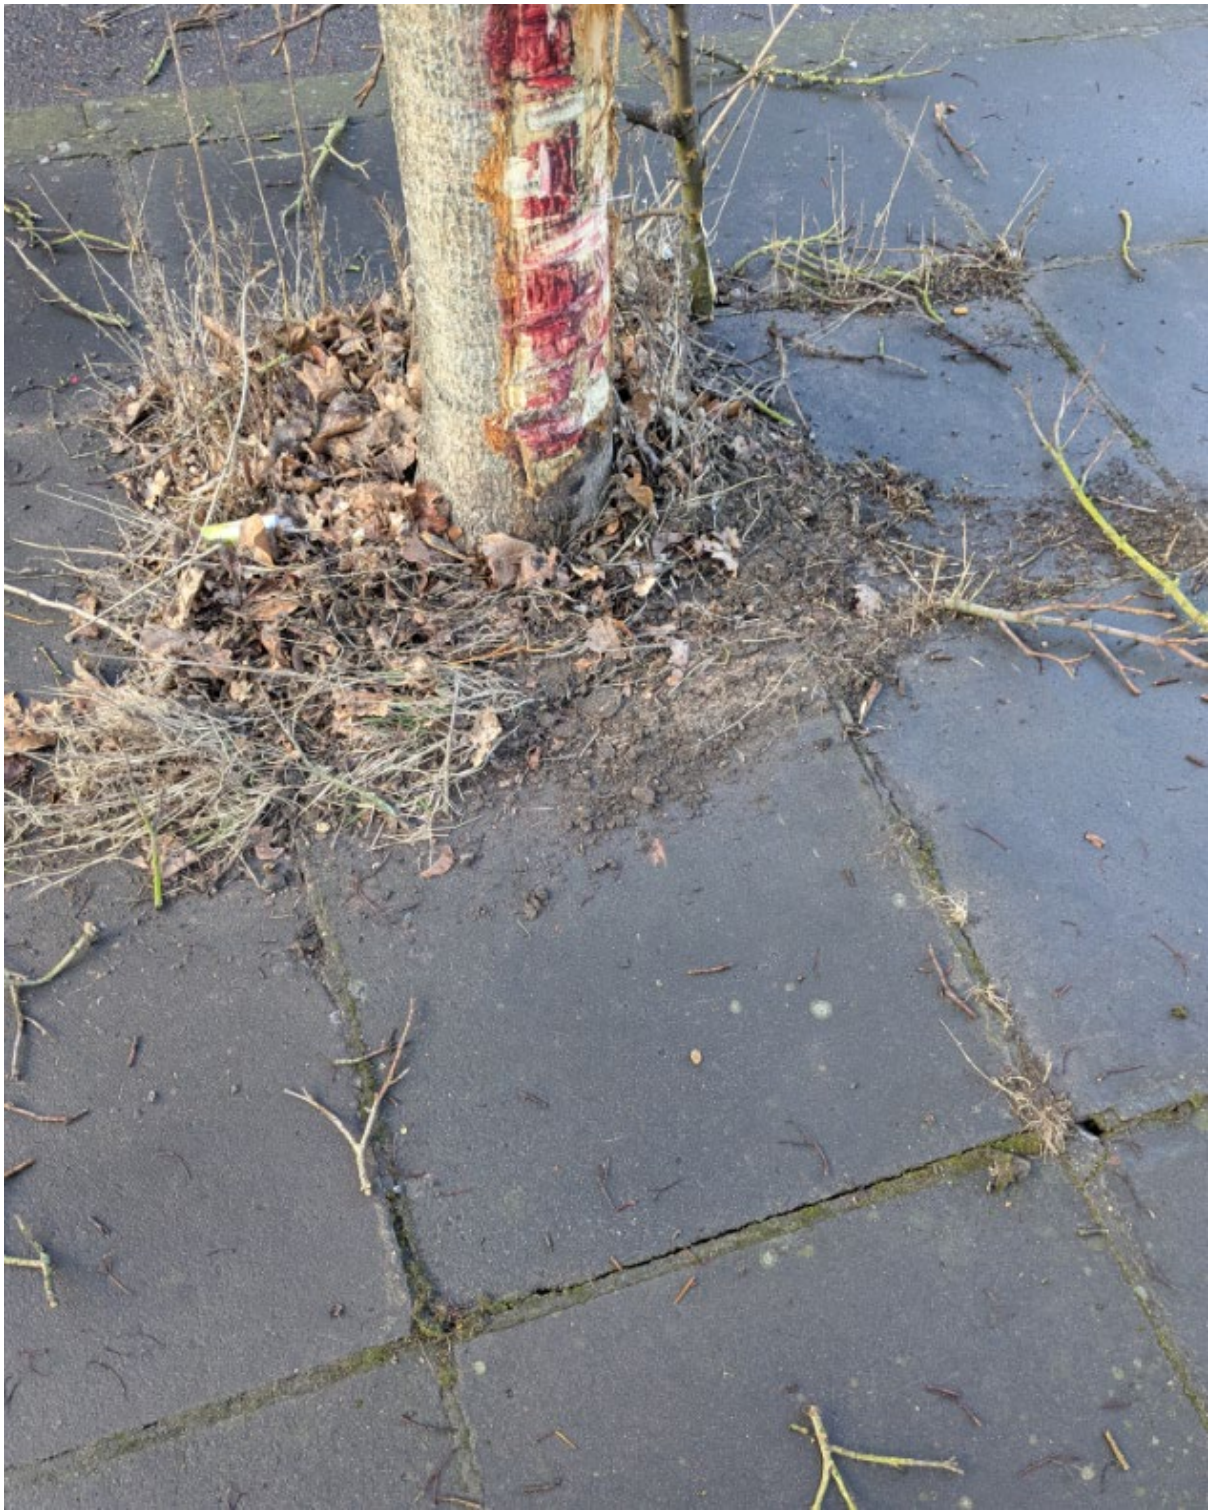
***Image shows trunk damaged caused by vehicle strike lifted paving slab.***

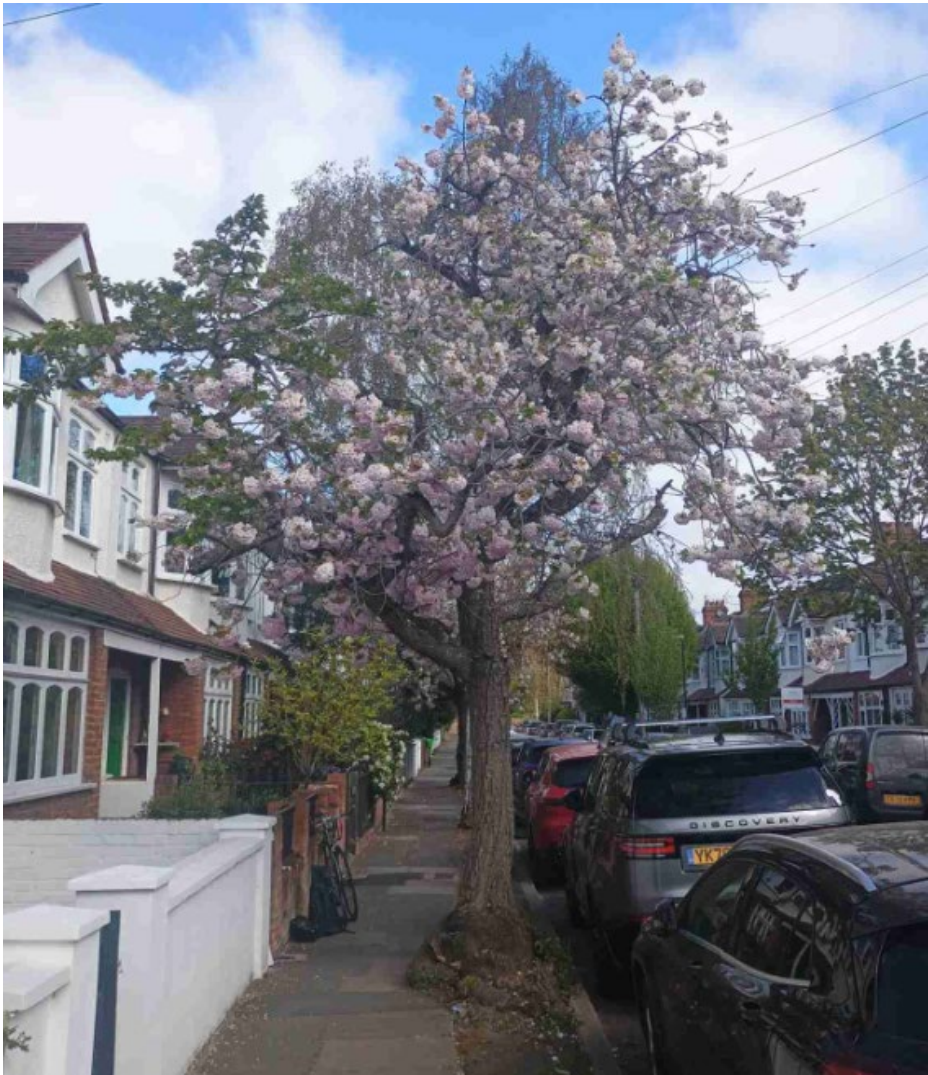
Ward	Mortlake and Barnes Common
Road	Ripley Gardens
Location	Outside 3/5
Species	Wild cherry ( <i>Prunus avium</i> )
Height	8.0m
Physiological Condition	Fair
Structural Condition	Poor
Inspection findings/reason for exemption	A fungal fruiting body of the decay fungus <i>Ganoderma sp.</i> is present at the base of the trunk. Colonization by this fungus causes a white rot of the stem and root system, which can lead to the entire tree collapsing through fracture or windthrow. A resonance test with a sounding hammer has revealed an unacceptable amount of decay at base of trunk around pathogens. Removal is required to prevent natural failure, manage risk and facilitate replanting.

Image shows tree in street scene.

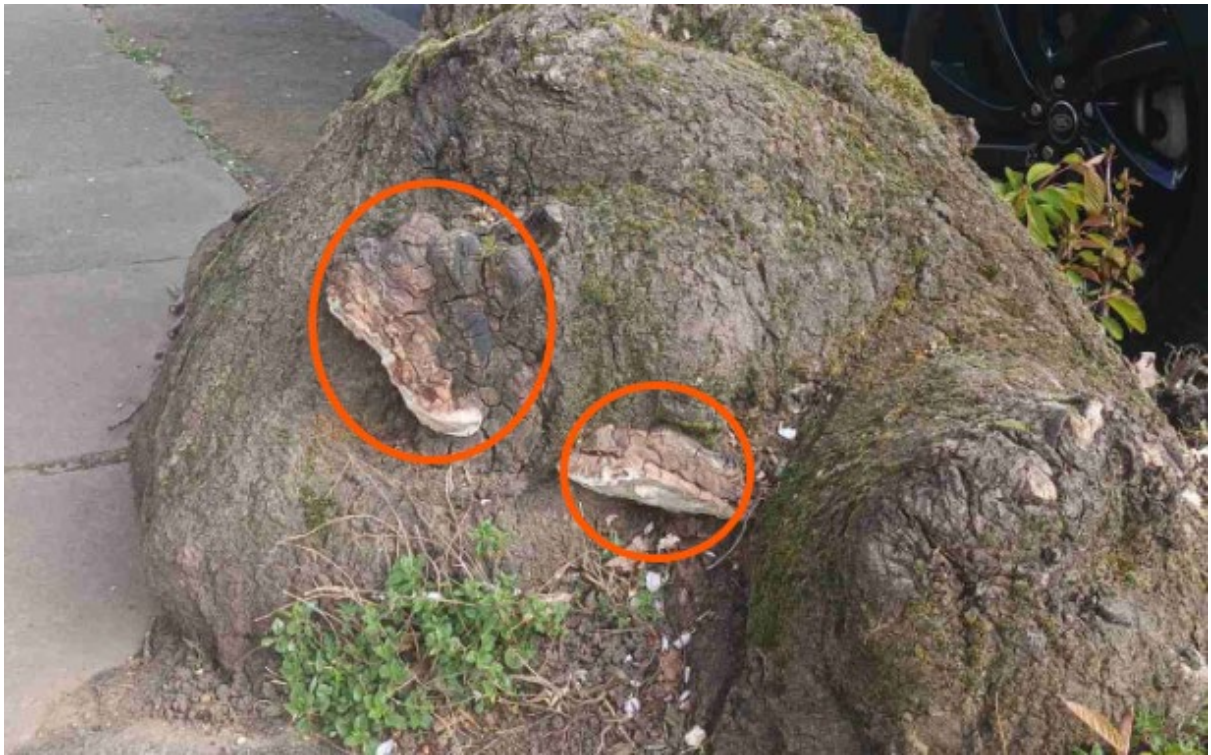
*Image shows fungal fruiting bodies circled.*

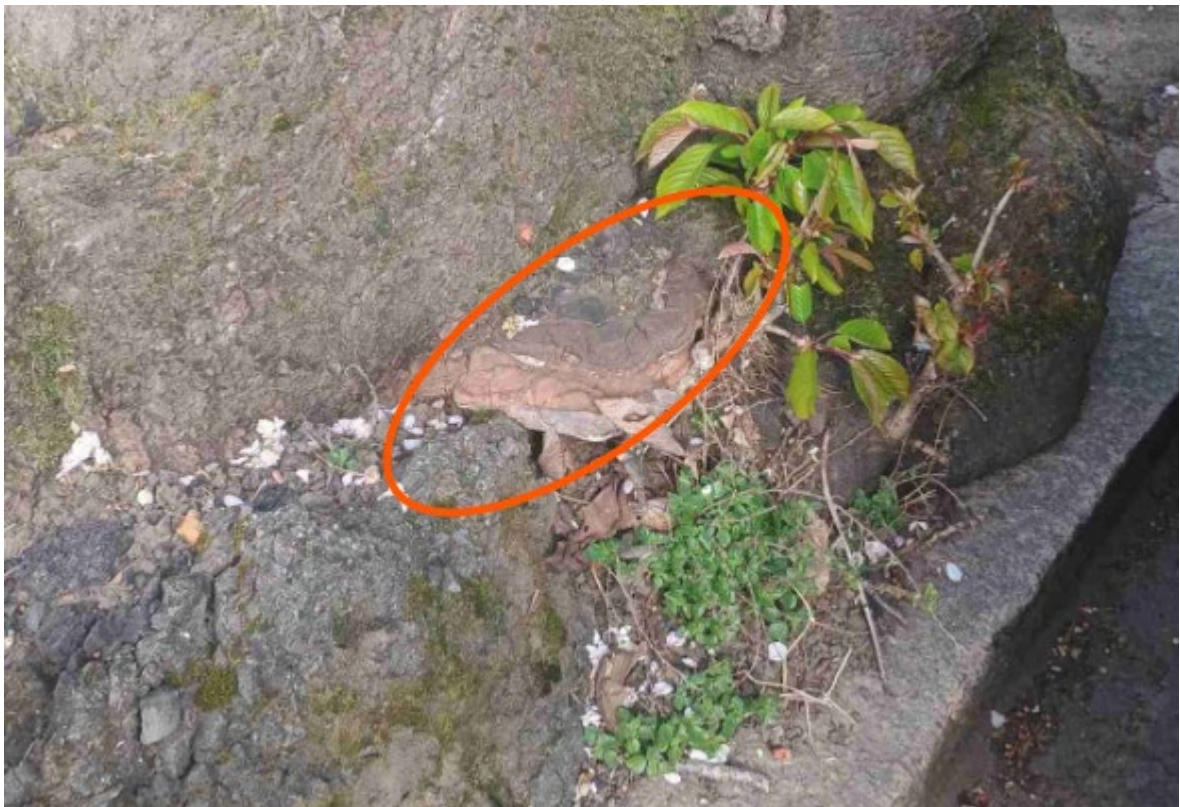
*Image shows fungal fruiting body circled.*

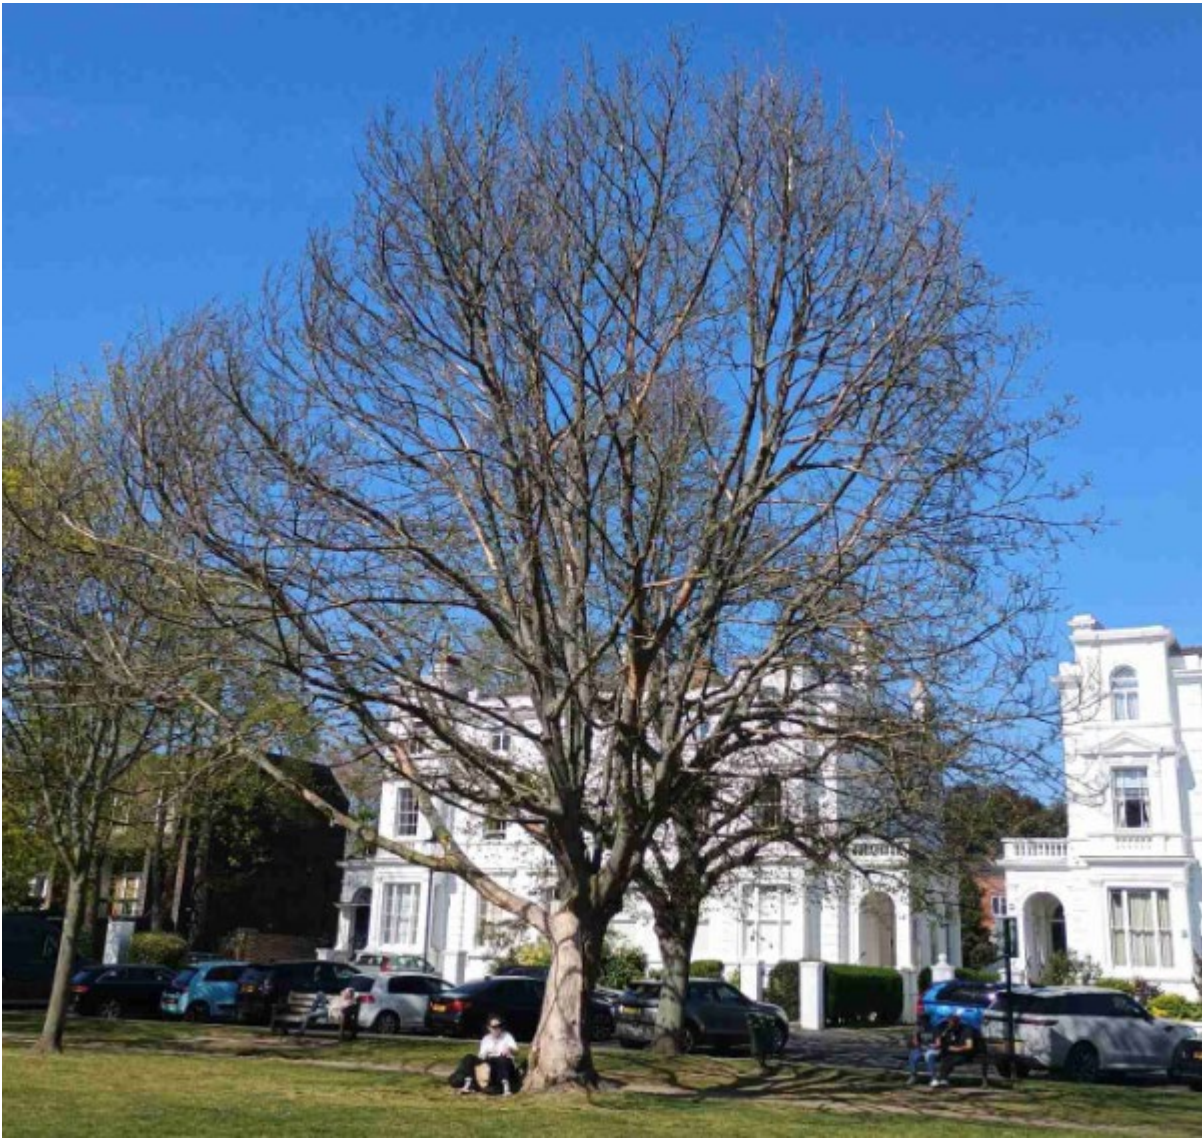
Ward	South Richmond
Road	The Green
Location	Richmond Green- ///polite.usual.traps
Species	Norway maple ( <i>Acer platanoides</i> )
Height	16.5m
Physiological Condition	Dead
Structural Condition	Dead
Inspection findings/reason for exemption	This tree is dead; removal is required to prevent natural failure, manage risk, and facilitate replanting

Image shows dead tree in park scene.

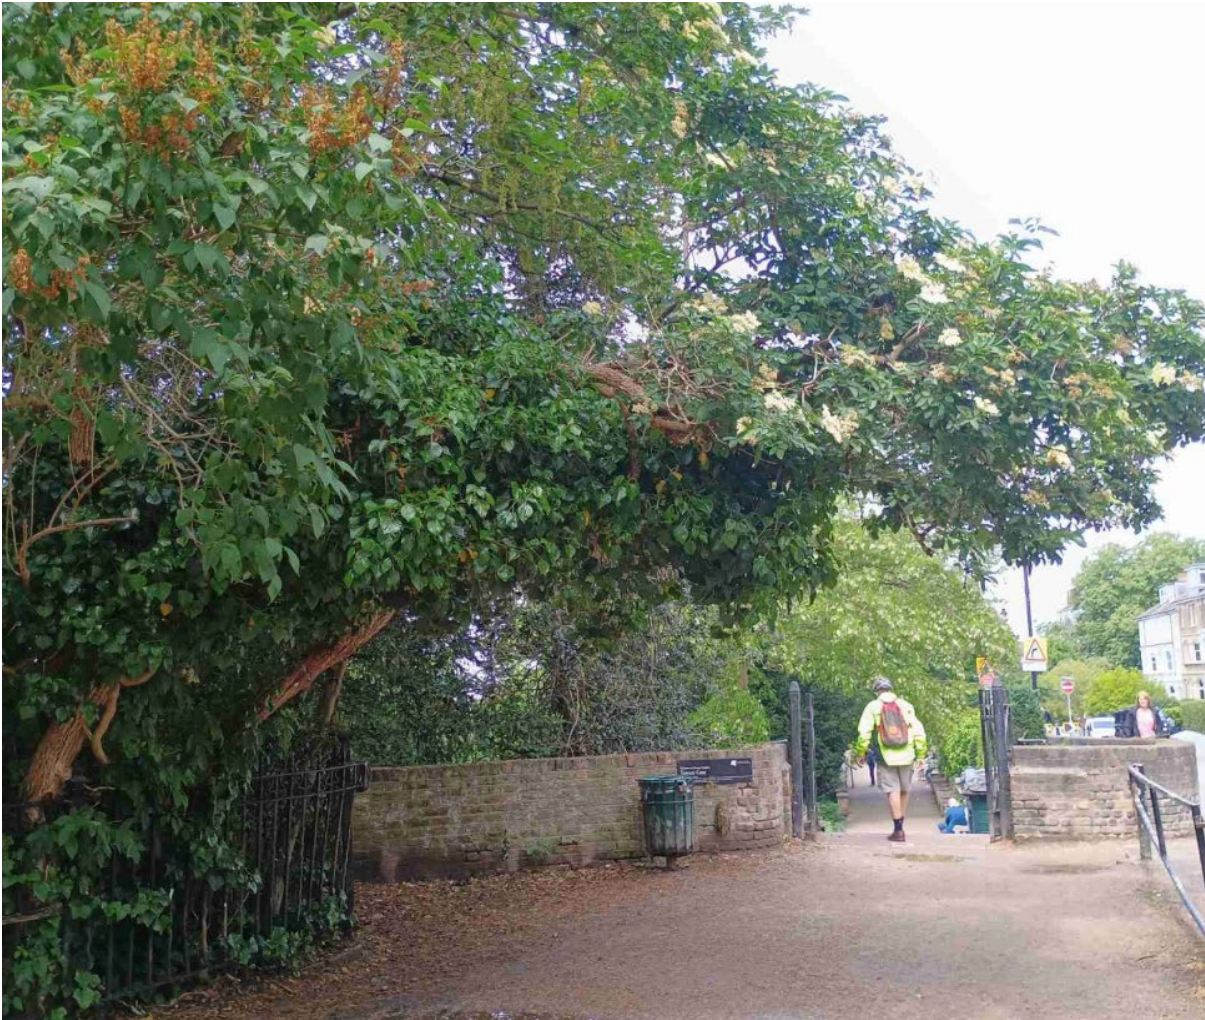
Ward	South Richmond
Road	Petersham Road
Location	Terrace Gardens- ///lonely.toast.tape
Species	Elderflower ( <i>Sambucus nigra</i> )
Height	5.5m
Physiological Condition	Fair
Structural Condition	Poor
Inspection findings/reason for exemption	The tree is exhibiting a significant lean towards the boundary fence of the park, resulting in an unacceptable amount of damage and decay to the main stem, compromising its structural integrity. Removal is required to prevent natural failure, manage risk, and facilitate replanting

Image shows tree in park scene.

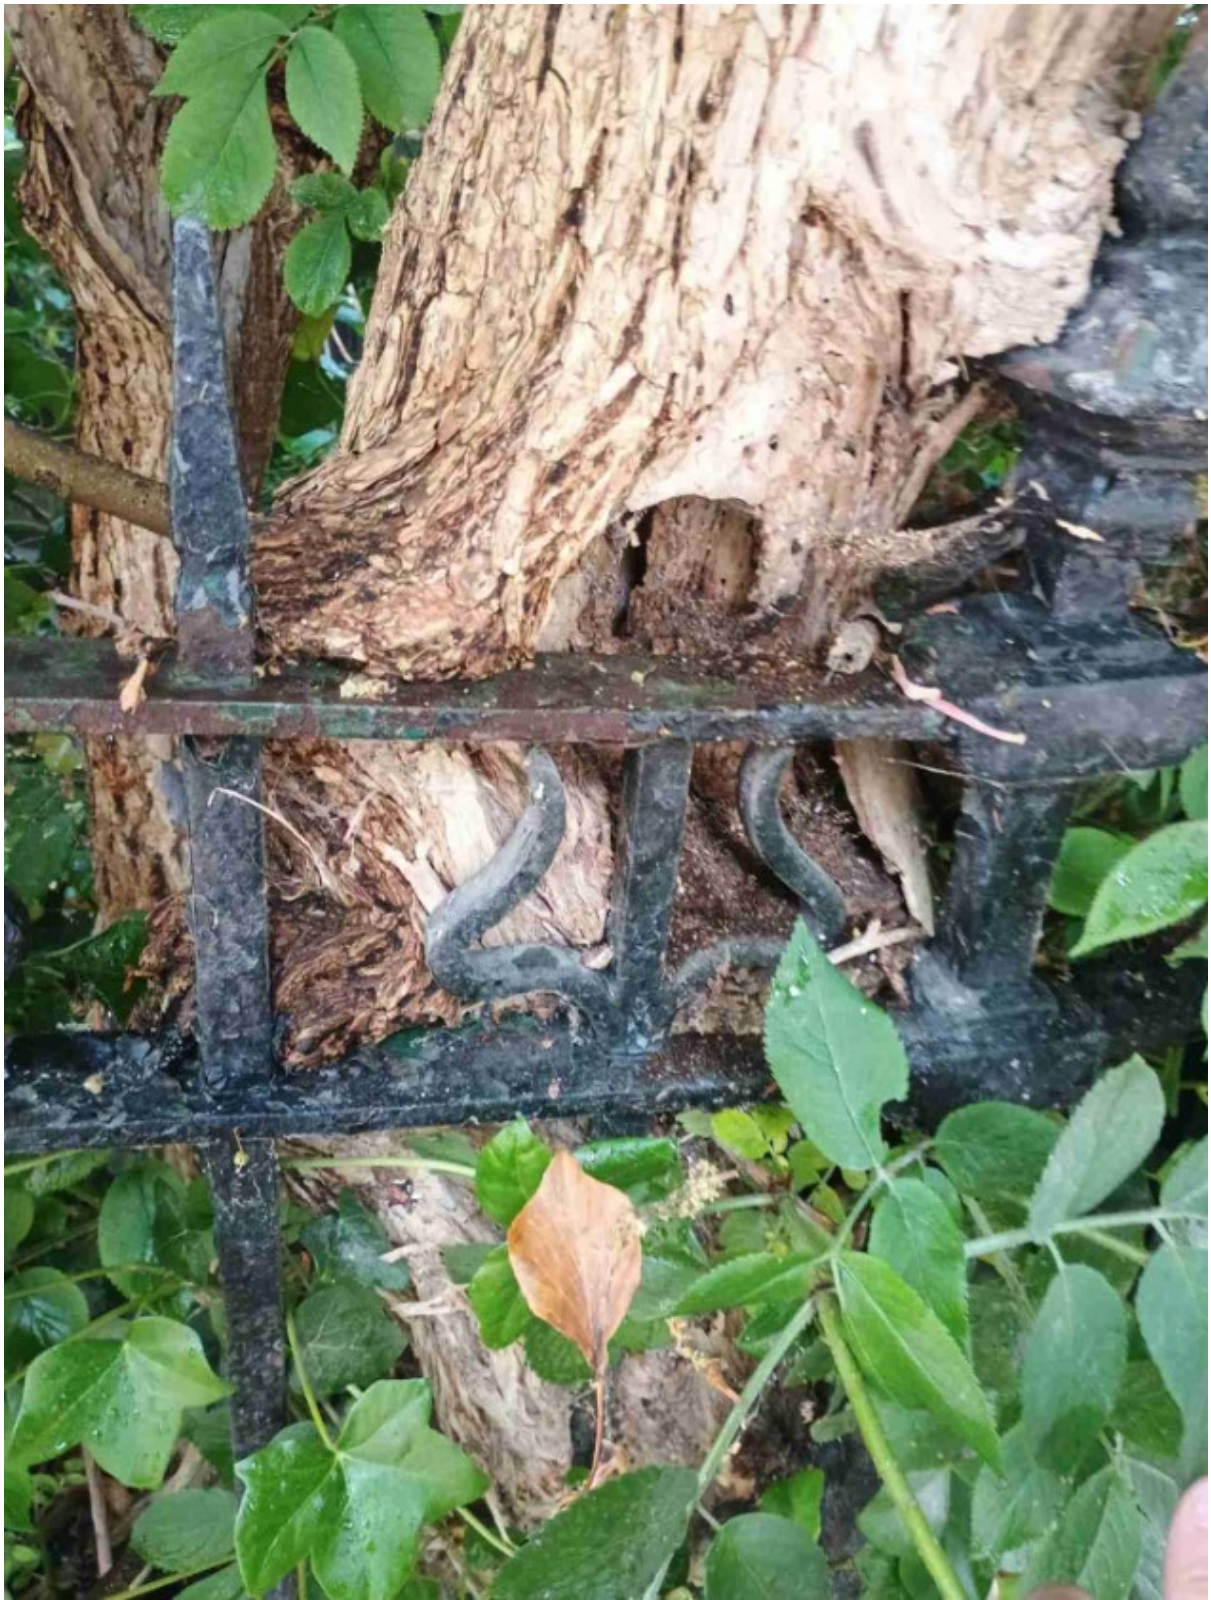
***Image shows damaged trunk on fence.***

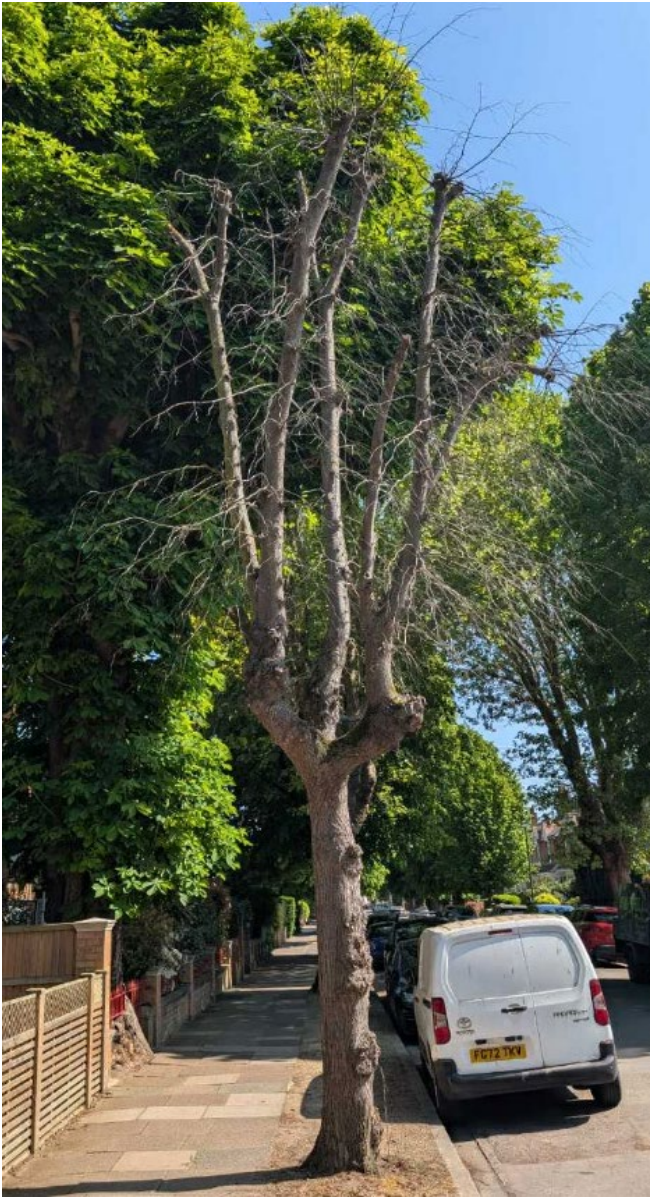
Ward	South Twickenham
Road	Walpole Road
Location	Opposite 3
Species	Common lime ( <i>Tilia x europaea</i> )
Height	9.5m
Physiological Condition	Dead
Structural Condition	Dead
Inspection findings/reason for exemption	This tree is dead; removal is required to prevent natural failure, manage risk, and facilitate replanting

Image shows dead tree in street scene.
