# May 2025 - Reactive Tree Works Programme

A survey of trees in Barnes and East Sheen wards have been undertaken; this is being conducted by specialist arboricultural officers as part of the scheduled 4 yearly detailed inspection regime that has been devised for all Council highway and parks trees.

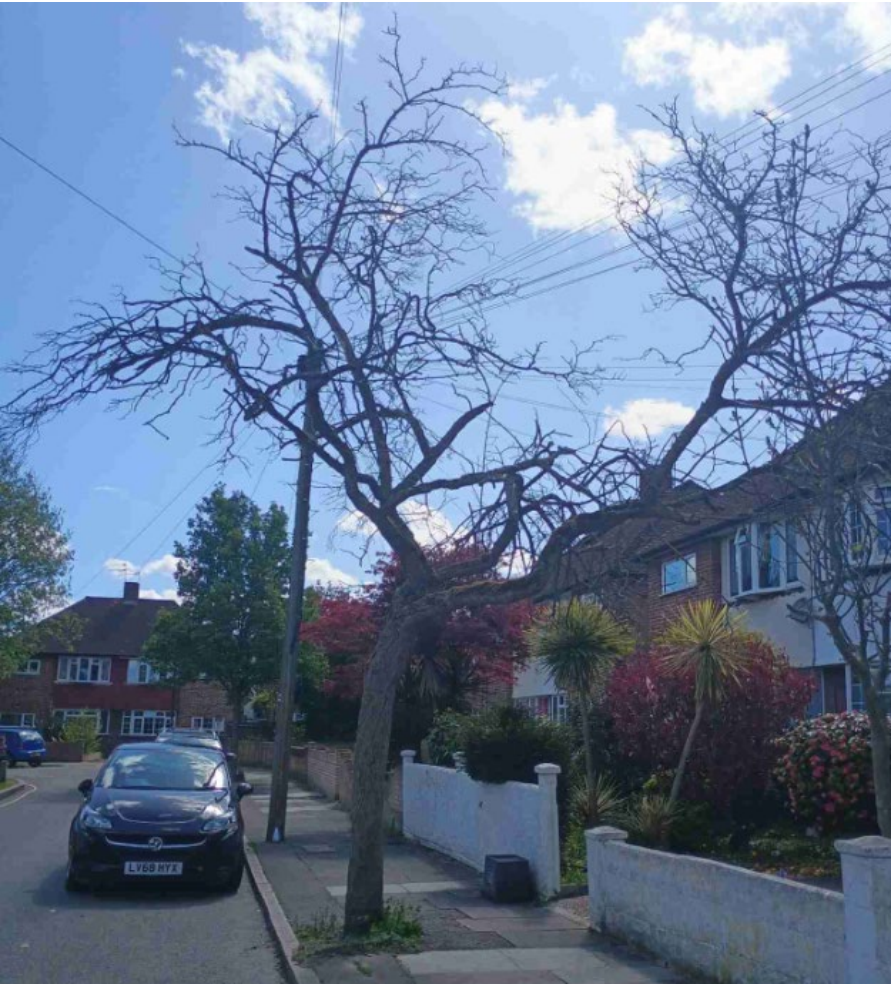
Ward	Whitton
Road	Bramley Close
Location	Adjacent to 137-139 Constance Road
Species	Hawthorn ( <i>Betula sp.</i> )
Height	3.0m
Physiological Condition	Dead
Structural Condition	Dead
Inspection findings/reason for exemption	This tree is dead; removal is required to prevent natural failure, manage risk, and facilitate replanting

Image shows dead tree in street scene.

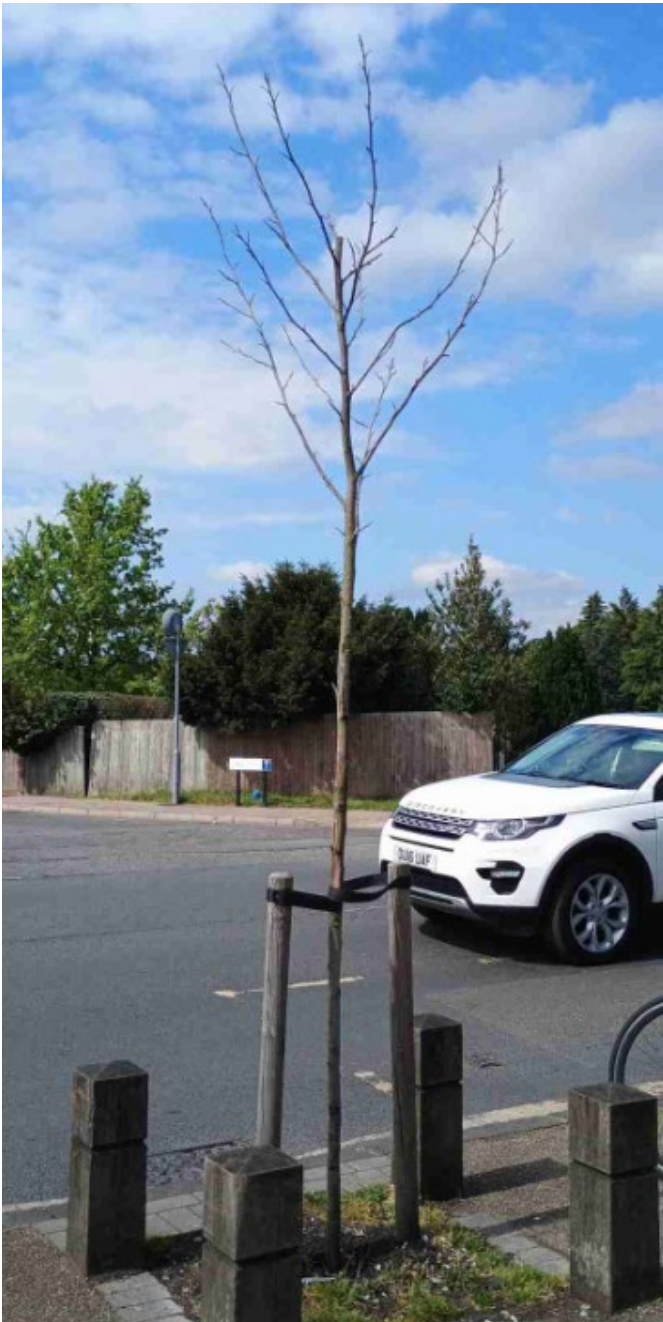
Ward	Whitton
Road	Hanworth Road
Location	Outside 668
Species	American sweetgum ( <i>Liquidambar styraciflua</i> )
Height	4.0m
Physiological Condition	Dead
Structural Condition	Dead
Inspection findings/reason for exemption	This tree is dead; removal is required to prevent natural failure, manage risk, and facilitate replanting

Image shows dead tree in street scene.
