September 2023 - Reactive Tree Works Programme

The following pages provide the locations of each tree that is to be removed, in addition photographs and descriptions of the inspection findings have been provided.

Dated 18.9.2023

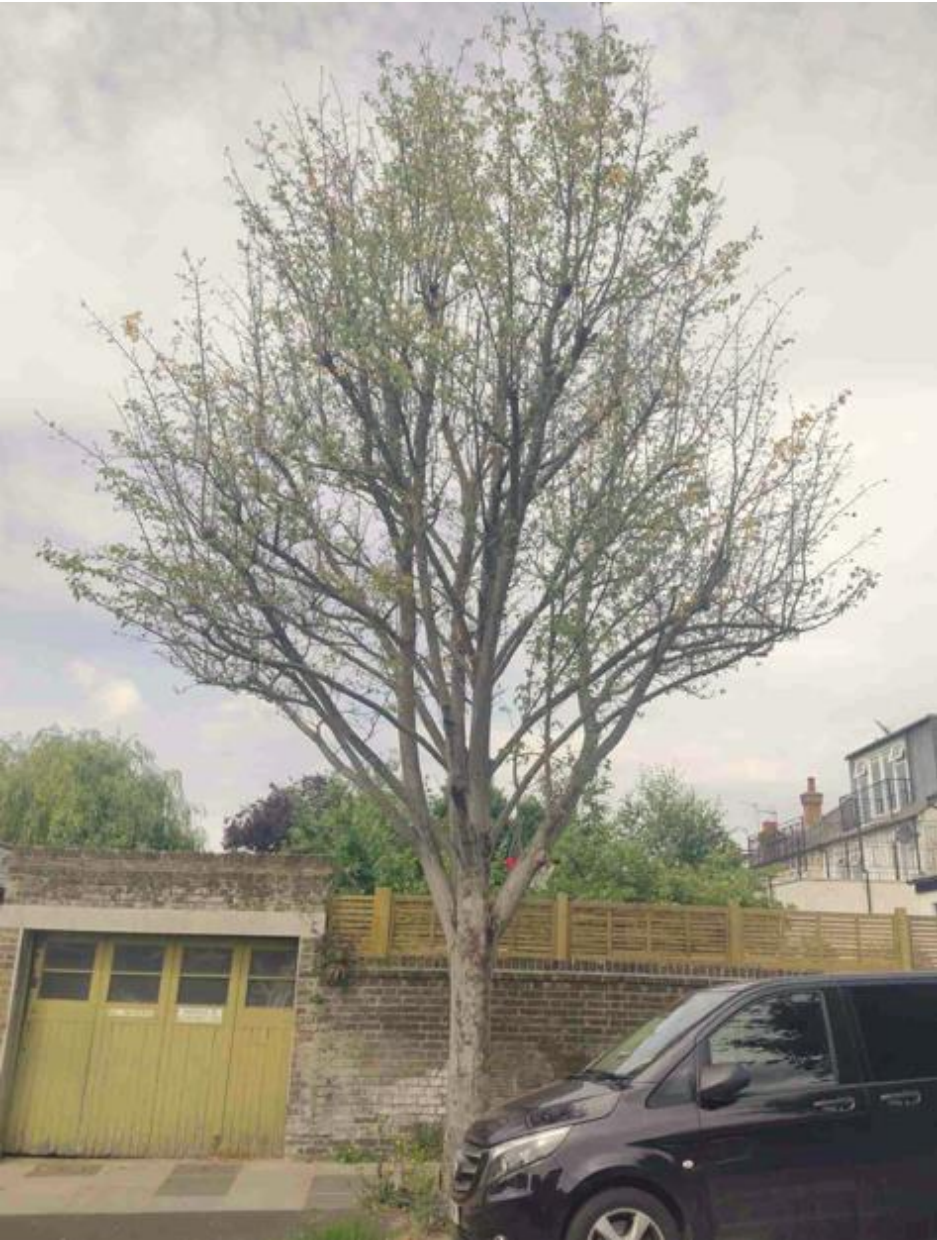
Ward	Barnes
Road	Bracken Gardens
Location	Adjacent to 44 Church Road
Species	Crab Apple (<i>Malus tschonoskii</i>)
Height	11.0m
Physiological Condition	Poor
Structural Condition	Fair
Inspection findings	This tree is in a state of physiological decline and contains weak branches that are liable to collapse. Removal is required to prevent natural failure and manage risk.

Image shows tree in street scene with sparse crown and small leaves indicating poor vitality

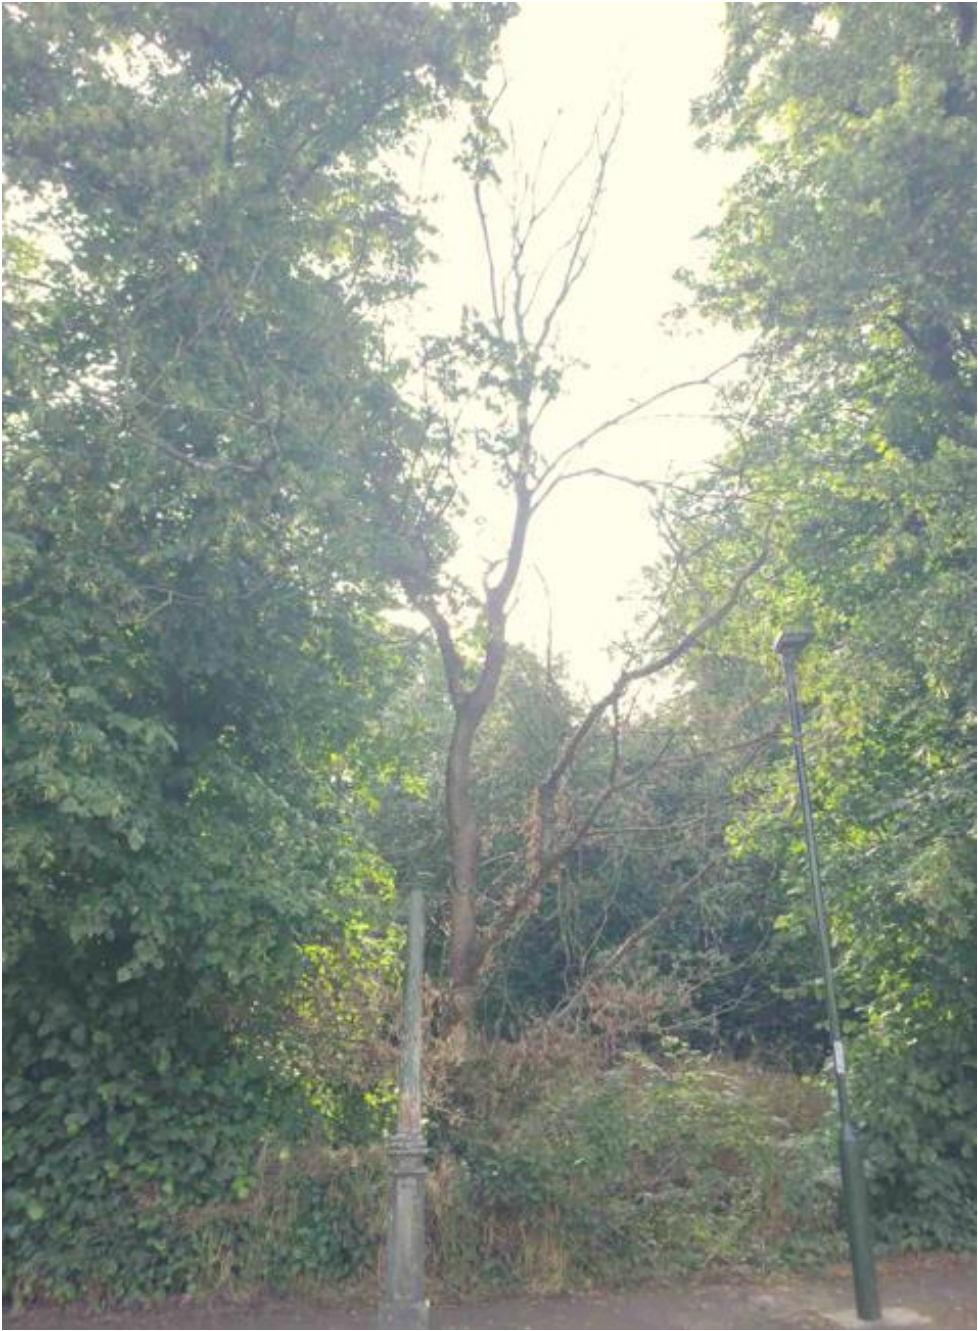
Ward	Barnes
Road	Vine Road
Location	Barnes common - Next to lamp post 015 vine road.
Species	Elm (<i>Ulmus sp.</i>)
Height	12.0m
Physiological Condition	Dead
Structural Condition	Dead
Inspection findings	This tree is dead and requires removal to prevent natural failure.

Image shows dead tree in woodland scene

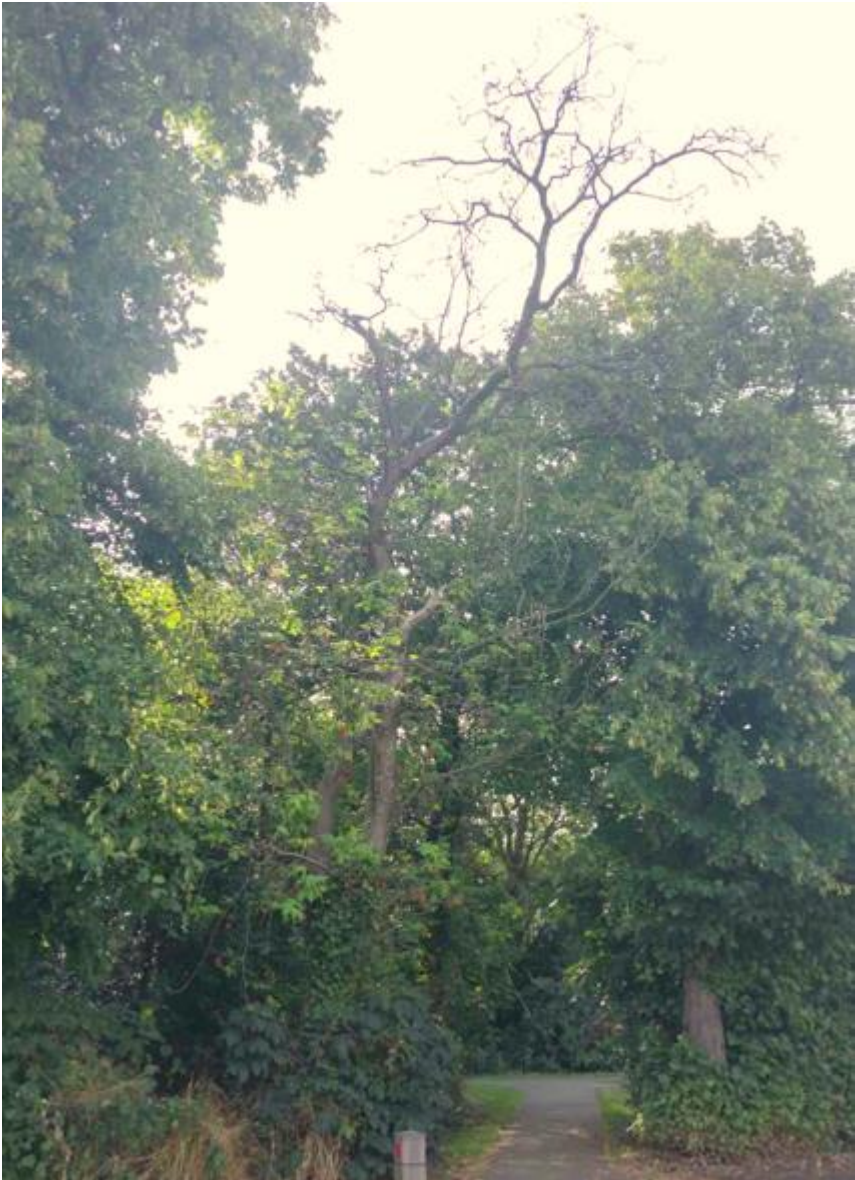
Ward	Barnes
Road	Vine Road
Location	Barnes common - opposite 3 vine road
Species	Horse Chestnut (<i>Aesculus hippocastanum</i>)
Height	12.0m
Physiological Condition	Dead
Structural Condition	Dead
Inspection findings	This tree is dead and requires removal to prevent natural failure

Image shows dead tree in woodland scene

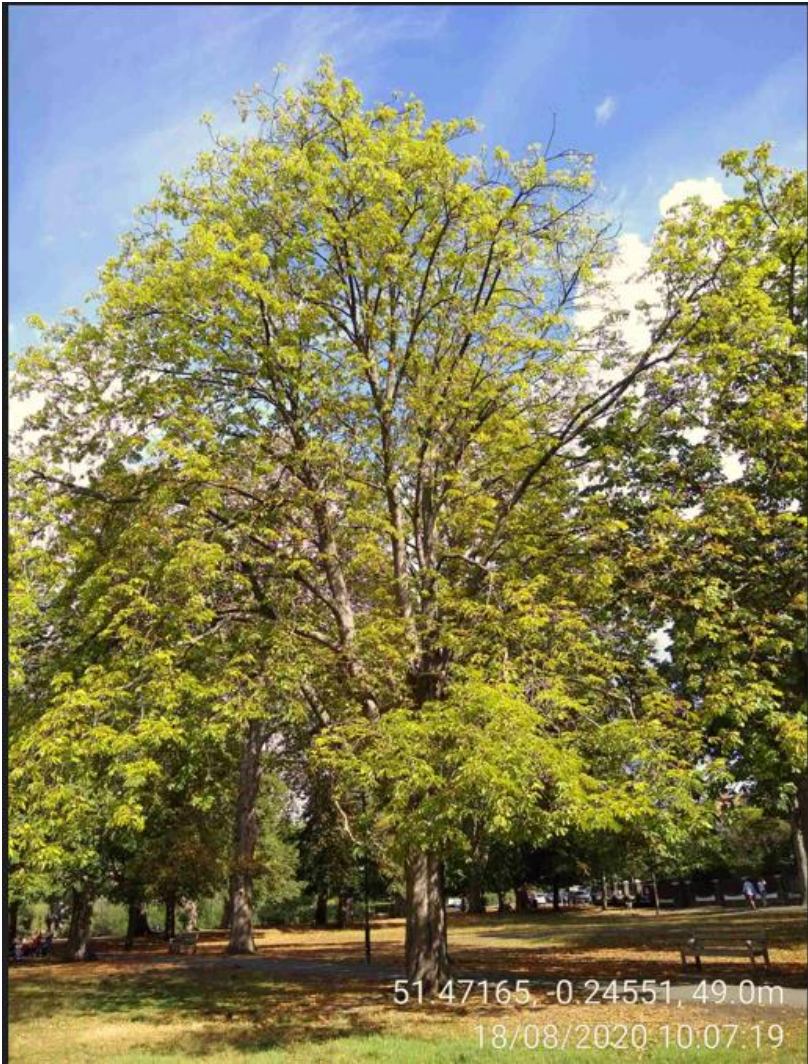
Ward	Barnes
Road	Church Road
Location	Barnes Green- ///What3Word- gently.spice.awards
Species	Horse Chestnut (<i>Aesculus hippocastanum</i>)
Height	23.0m
Physiological Condition	Poor
Structural Condition	Poor
Inspection findings	A fungal fruiting body of the decay pathogen <i>Ganoderma</i> sp. is present at the stem base. Colonisation by this fungus causes a white rot of the stem and root system that can cause entire trees to collapse through fracture or windthrow. A detailed investigation of this tree using sonic tomography revealed an unacceptable degree of decay, removal is required to prevent natural failure and manage risk.

Image shows dead tree in park scene with sparse crown indicating poor vitality

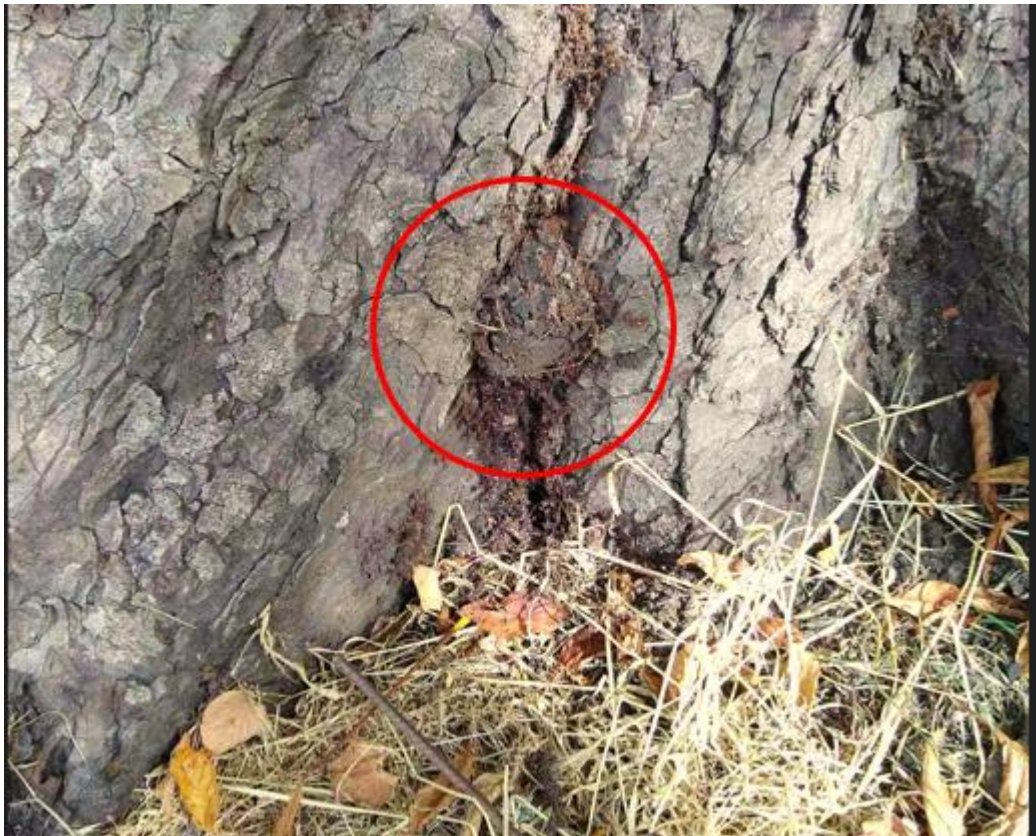
Image shows fruiting body (circled) at base of tree

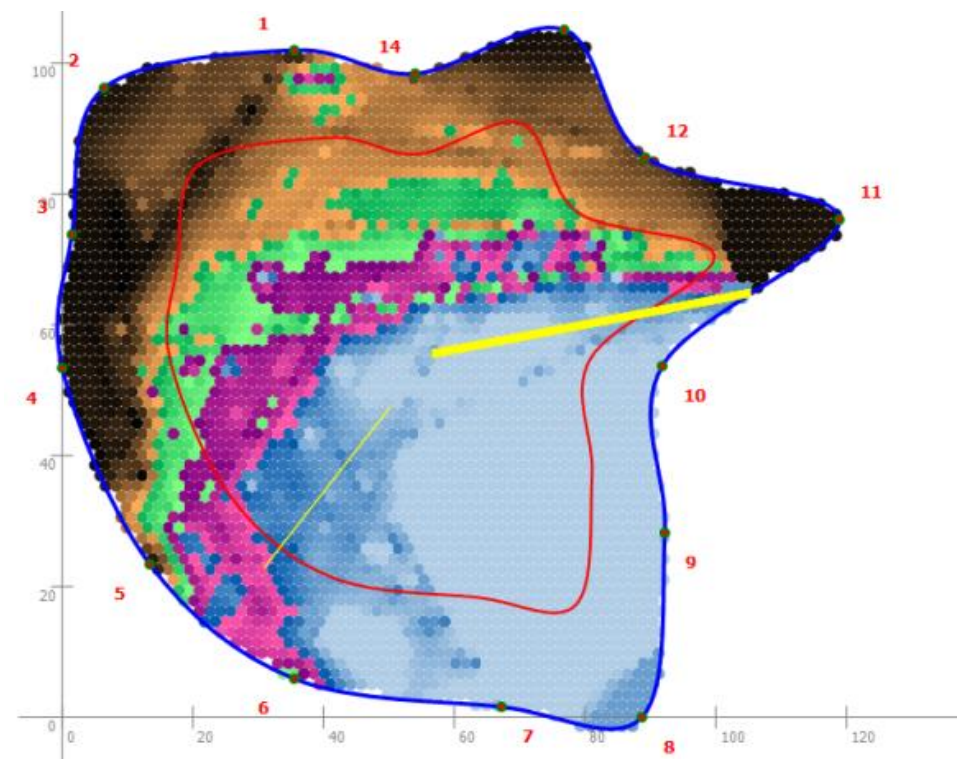
Image shows results from decay detection investigation at the base of the tree – green, blue and purple indicate decayed wood

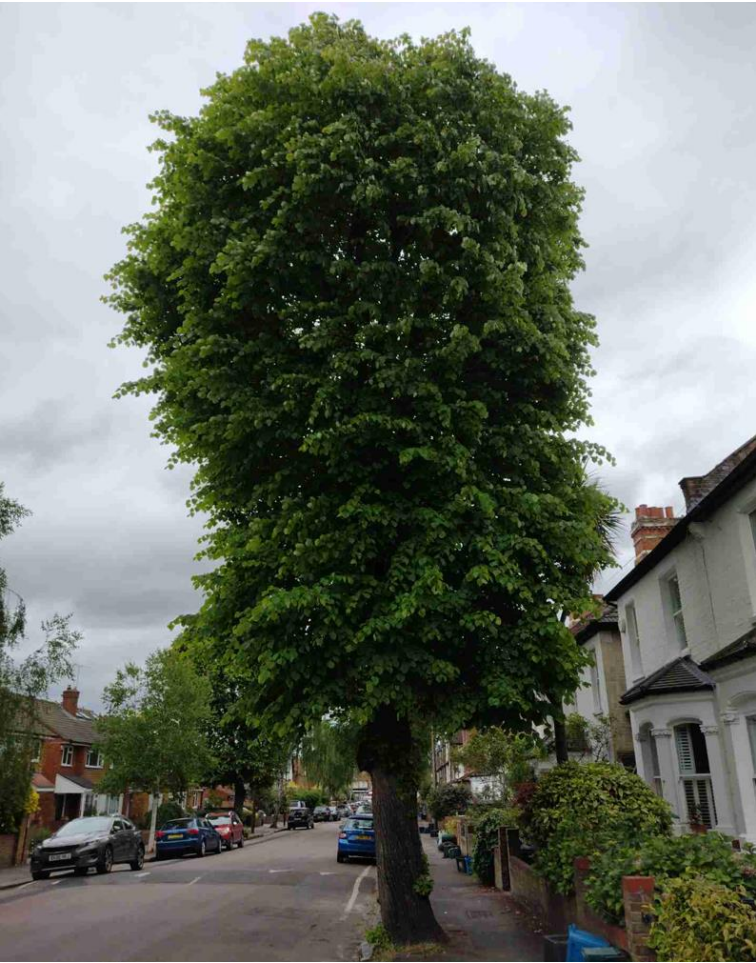
Ward	Fulwell and Hampton Hill
Road	Princes Road
Location	Outside 43
Species	Lime (<i>Tilia</i> sp.)
Height	14.5m
Physiological Condition	Good
Structural Condition	Poor
Inspection findings	A fungal fruiting body of the decay pathogen <i>Ganoderma</i> sp. is present at the stem base. Colonisation by this fungus causes a white rot of the stem and root system that can cause entire trees to collapse through fracture or windthrow. A detailed investigation of this tree using sonic tomography revealed an unacceptable degree of decay, removal is required to prevent natural failure and manage risk.

Image shows tree with apparently healthy canopy

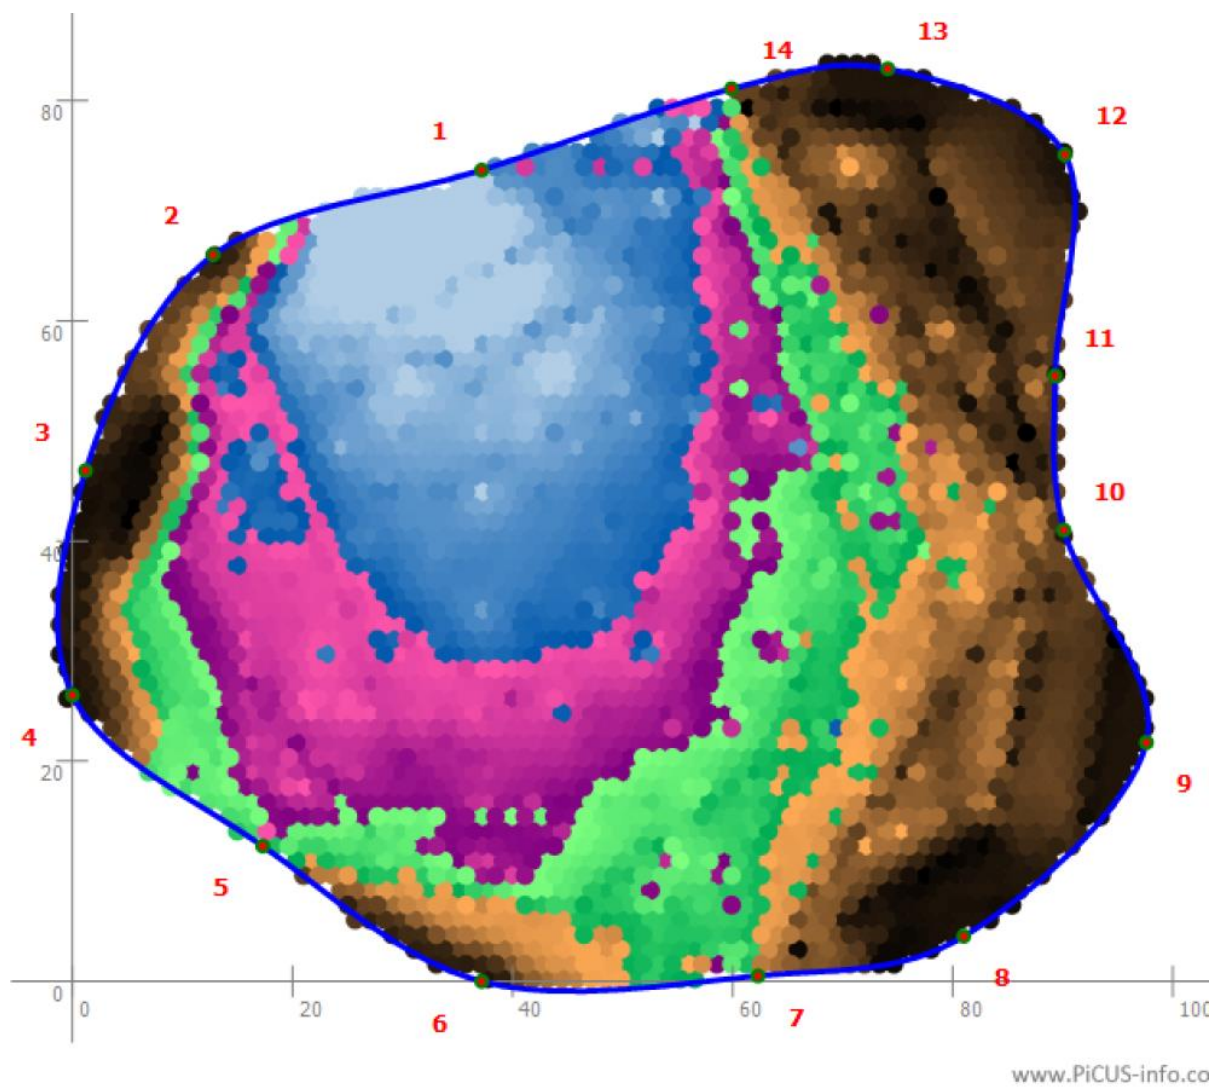
Image shows results from decay detection investigation at the base of the tree – green, blue and purple indicate decayed wood

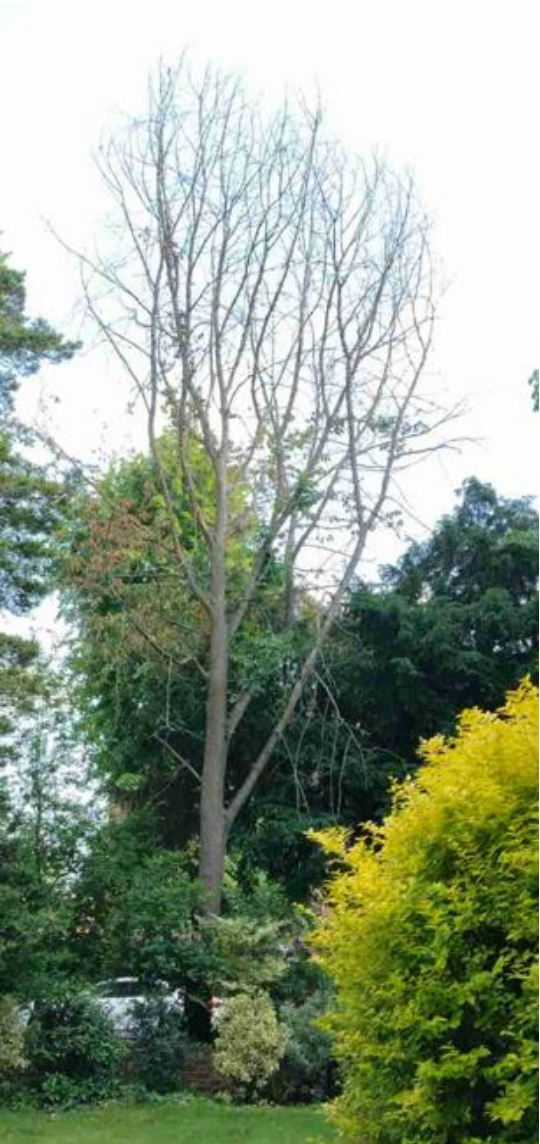
Ward	Hampton Wick
Road	Cromwell Road
Location	On Grass area adjacent to Faircroft Court- ///What3words-ozone.claps.glass
Species	Elm (<i>Ulmus sp.</i>)
Height	18.0m
Physiological Condition	Dead
Structural Condition	Dead
Inspection findings	These trees have died of Dutch Elm Disease (<i>Ophiostoma novo-ulmi</i>) and removal is required to prevent natural failure and facilitate replanting.

Image shows dead tree

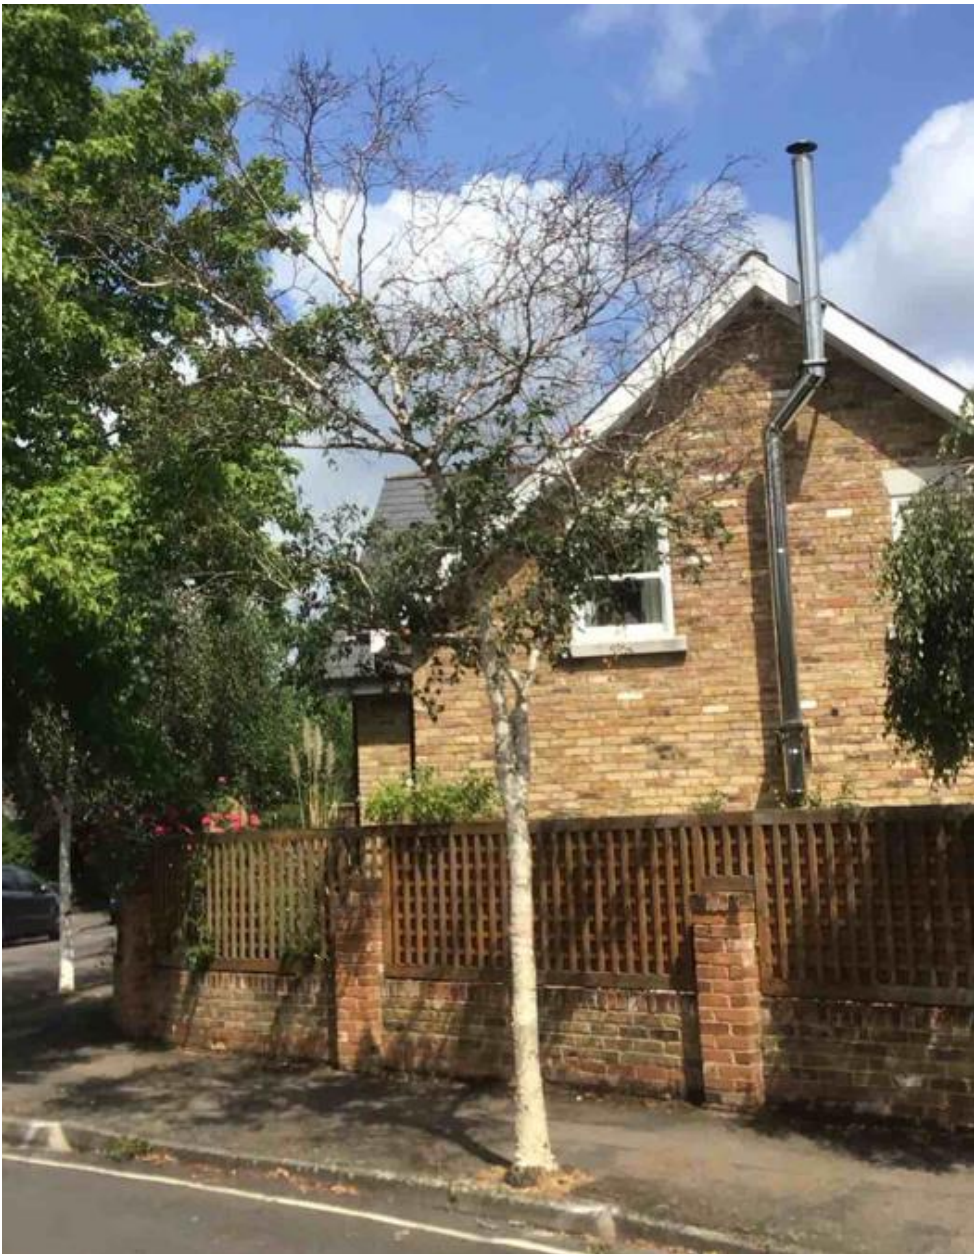
Ward	Hampton Wick
Road	Glamorgan Road
Location	Adjacent to 2H & opposite 1 rear gate
Species	Birch (<i>Betula sp.</i>)
Height	6.0m
Physiological Condition	Poor
Structural Condition	Fair
Inspection findings	This tree is in a state of physiological decline and contains weak branches that are liable to collapse. Removal is required to prevent natural failure and facilitate replanting

Image shows tree in moribund condition

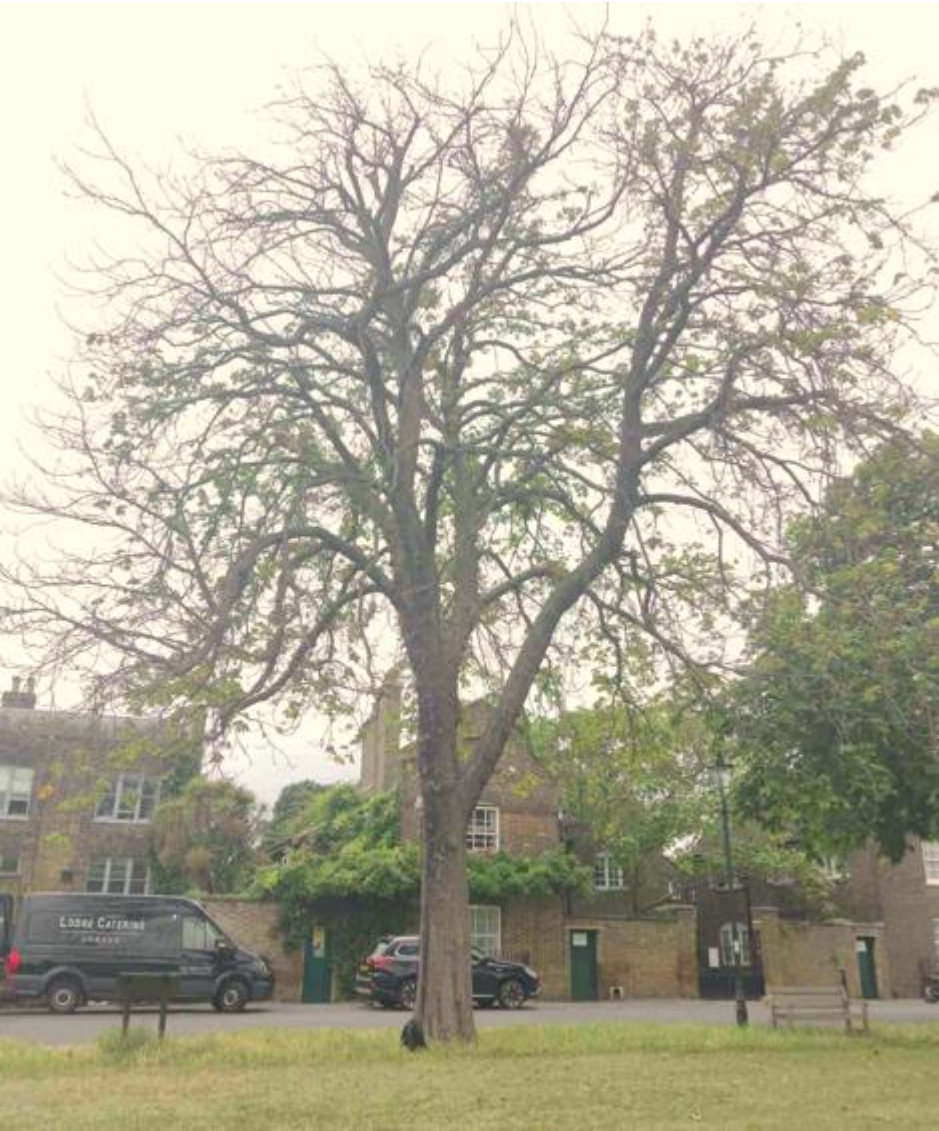
Ward	Kew
Road	Kew Road
Location	Kew Green Open space- What3Words- grain.vibe.entry
Species	Horse Chestnut (<i>Aesculus hippocastanum</i>)
Height	17.5m
Physiological Condition	Poor
Structural Condition	Fair
Inspection findings	Tree crown is displaying advanced symptoms of physiological decline with over 80% of crown being dead. Removal is required to prevent natural failure and facilitate replanting.

Image shows tree in street scene showing crown in a state of decline

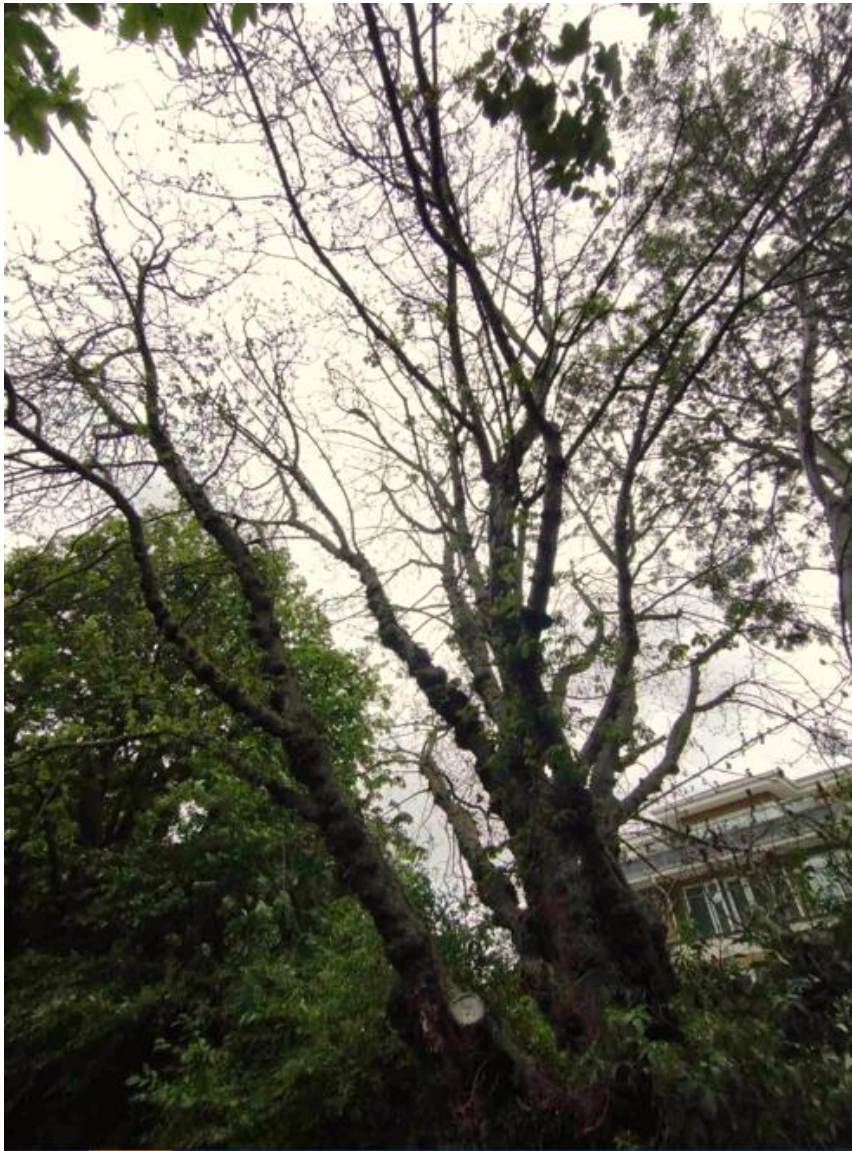
Ward	Kew
Road	UNFP - Riverside to Chiswick Bridge
Location	Thames Towpath
Species	Cherry (<i>Prunus sp.</i>)
Height	16.0m
Physiological Condition	Poor
Structural Condition	Fair
Inspection findings	Tree crown is displaying advanced symptoms of physiological decline with over 90% of crown being dead. Removal is required to prevent natural failure. Trunk is to be left as a 2m high monolith for ecological purposes.

Image shows tree in street scene showing crown in a state of decline

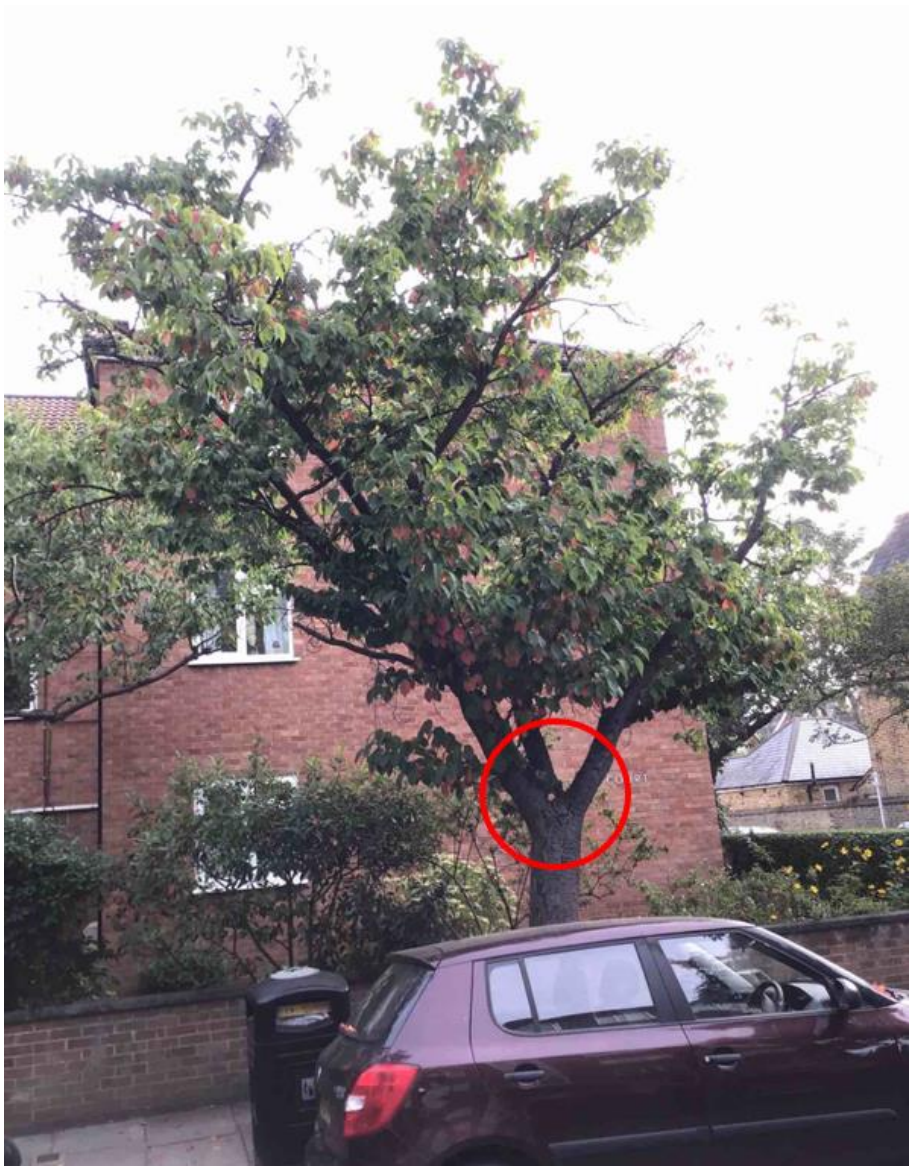
Ward	Kew
Road	Lichfield Road
Location	Opposite 25-32 Garden Court
Species	Cherry (<i>Prunus sp.</i>)
Height	6.5m
Physiological Condition	Fair
Structural Condition	Poor
Inspection findings	Fungal fruiting bodies of the wood decay fungus <i>Laetiporus sulphureus</i> are present on the trunk of this tree. This fungus causes a brown rot which can rapidly reduce wood strength and cause branch or whole tree failure through brittle fracture. Tree is declining, significant deadwood and dieback is present and this correlates with the pathogen present. Removal is required to manage risk.

Image shows tree with *Laetiporus* fruiting body circled and crown dieback in upper right of image

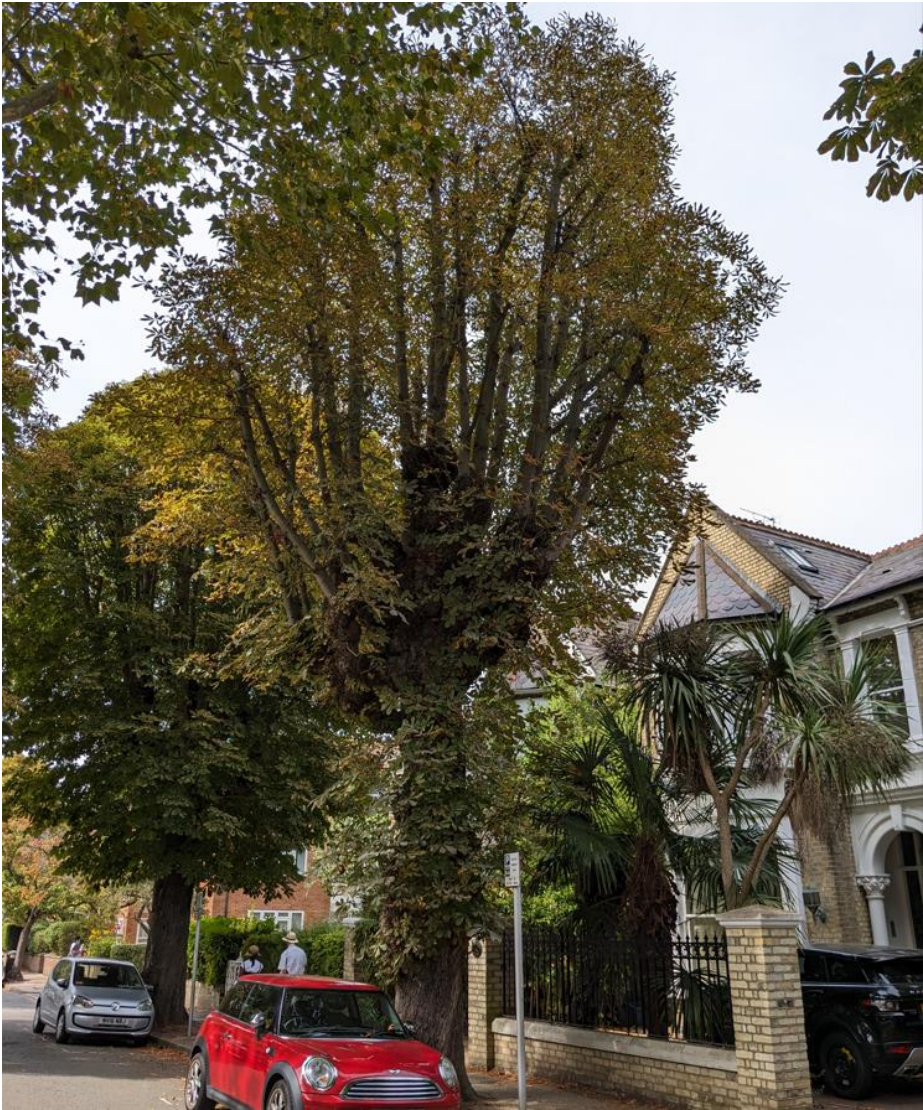
Ward	Kew
Road	Lichfield Road
Location	Outside 2
Species	Horse Chestnut (<i>Aesculus hippocastanum</i>)
Height	14.5m
Physiological Condition	Poor
Structural Condition	Poor
Inspection findings	A fungal fruiting body of the decay pathogen <i>Ganoderma</i> sp. is present at the stem base. Colonisation by this fungus causes a white rot of the stem and root system that can cause entire trees to collapse through fracture or windthrow. A resonance test revealed an unacceptable degree of decay in the trunk of this tree, removal is required to prevent natural failure and manage risk.

Image shows tree in street scene with sparse crown and small leaves indicating poor vitality

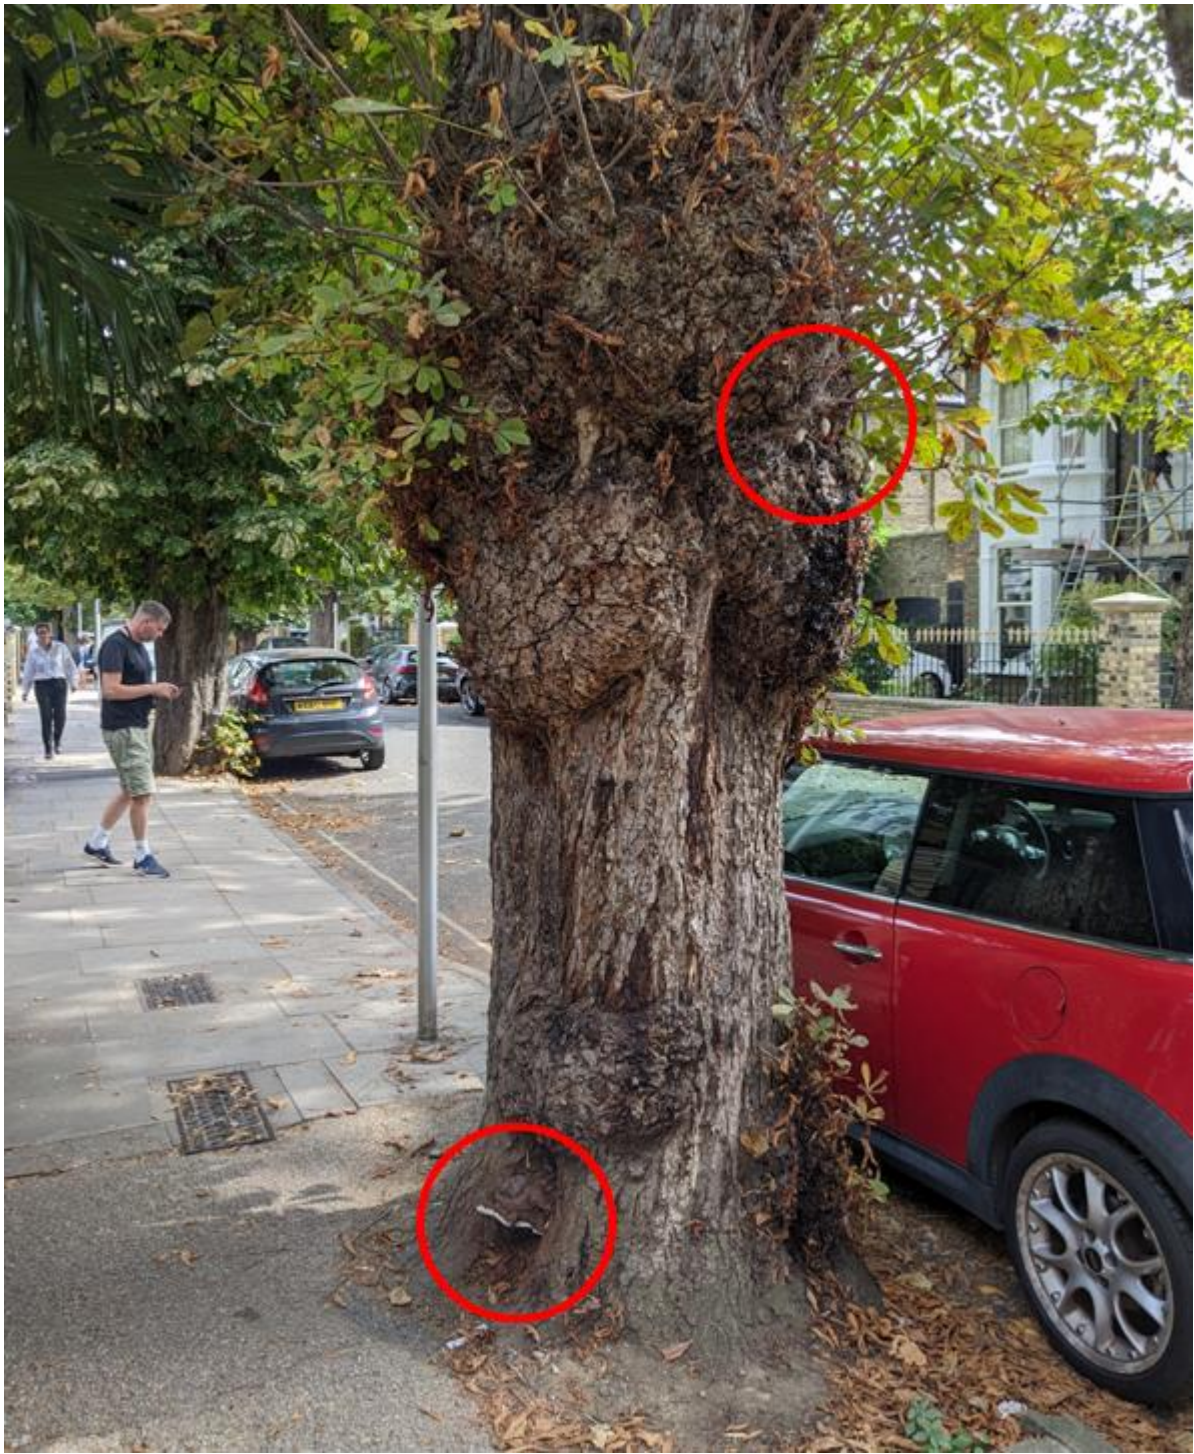
Image shows tree stem with location of Ganoderma fruiting bodies circled

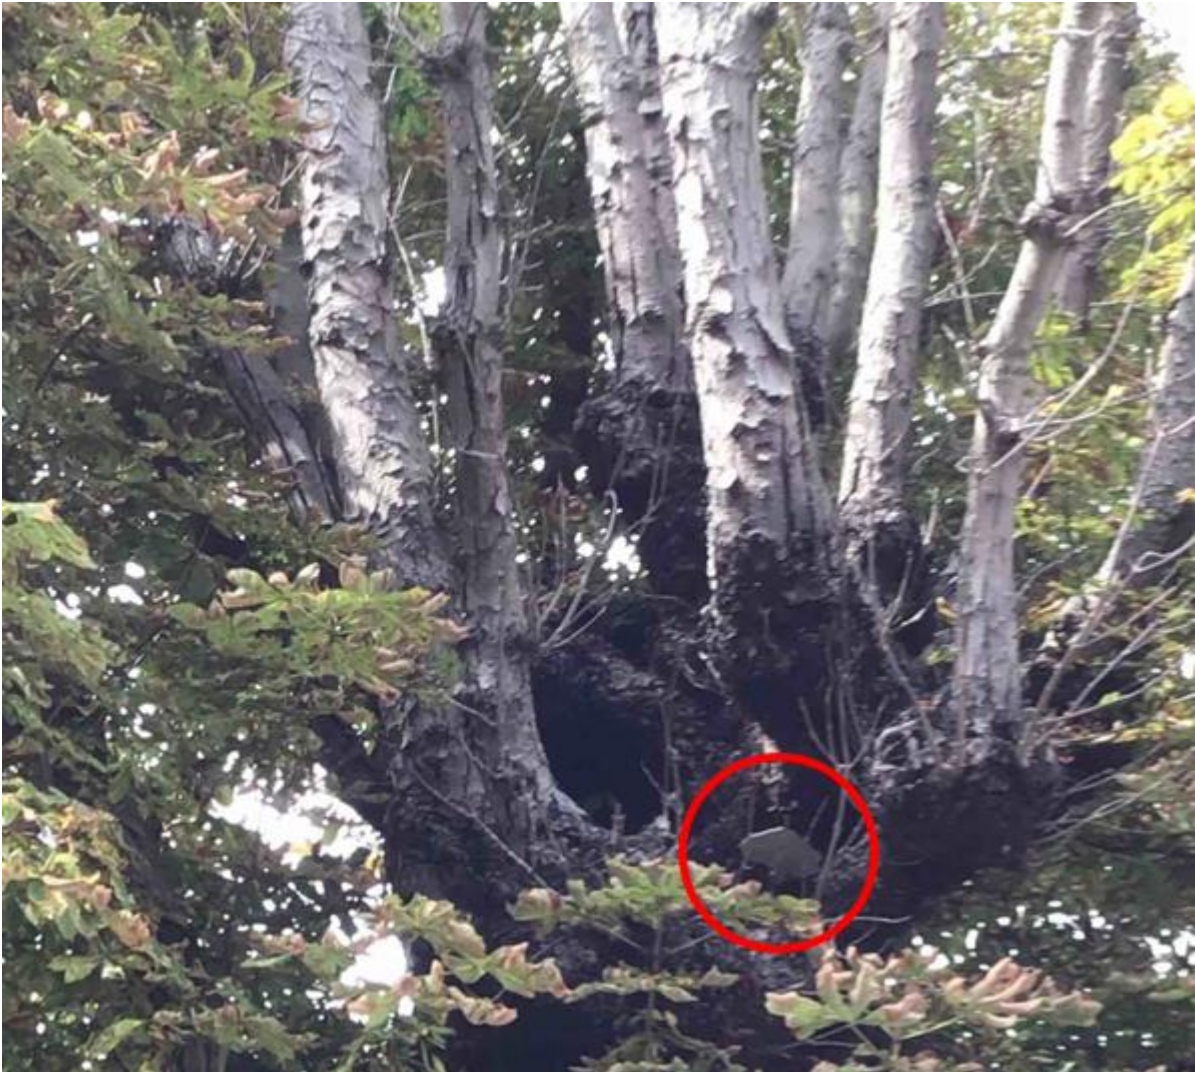
Ward	Kew
Road	Lichfield Road
Location	Outside 17
Species	Horse Chestnut (<i>Aesculus hippocastanum</i>)
Height	14.5m
Physiological Condition	Poor
Structural Condition	Poor
Inspection findings	Fungal fruiting bodies of the decay pathogen <i>Ganoderma</i> sp. are present in the crown of this tree. Colonisation by this fungus causes a white rot of the stem and root system that can cause failure of entire tree parts. The crown is declining, significant deadwood and dieback is present and this correlates with the pathogen present. Removal is required to mitigate the risk of failure.

Image shows crown break of the tree with fungal fruiting body circled in red and dead branches present

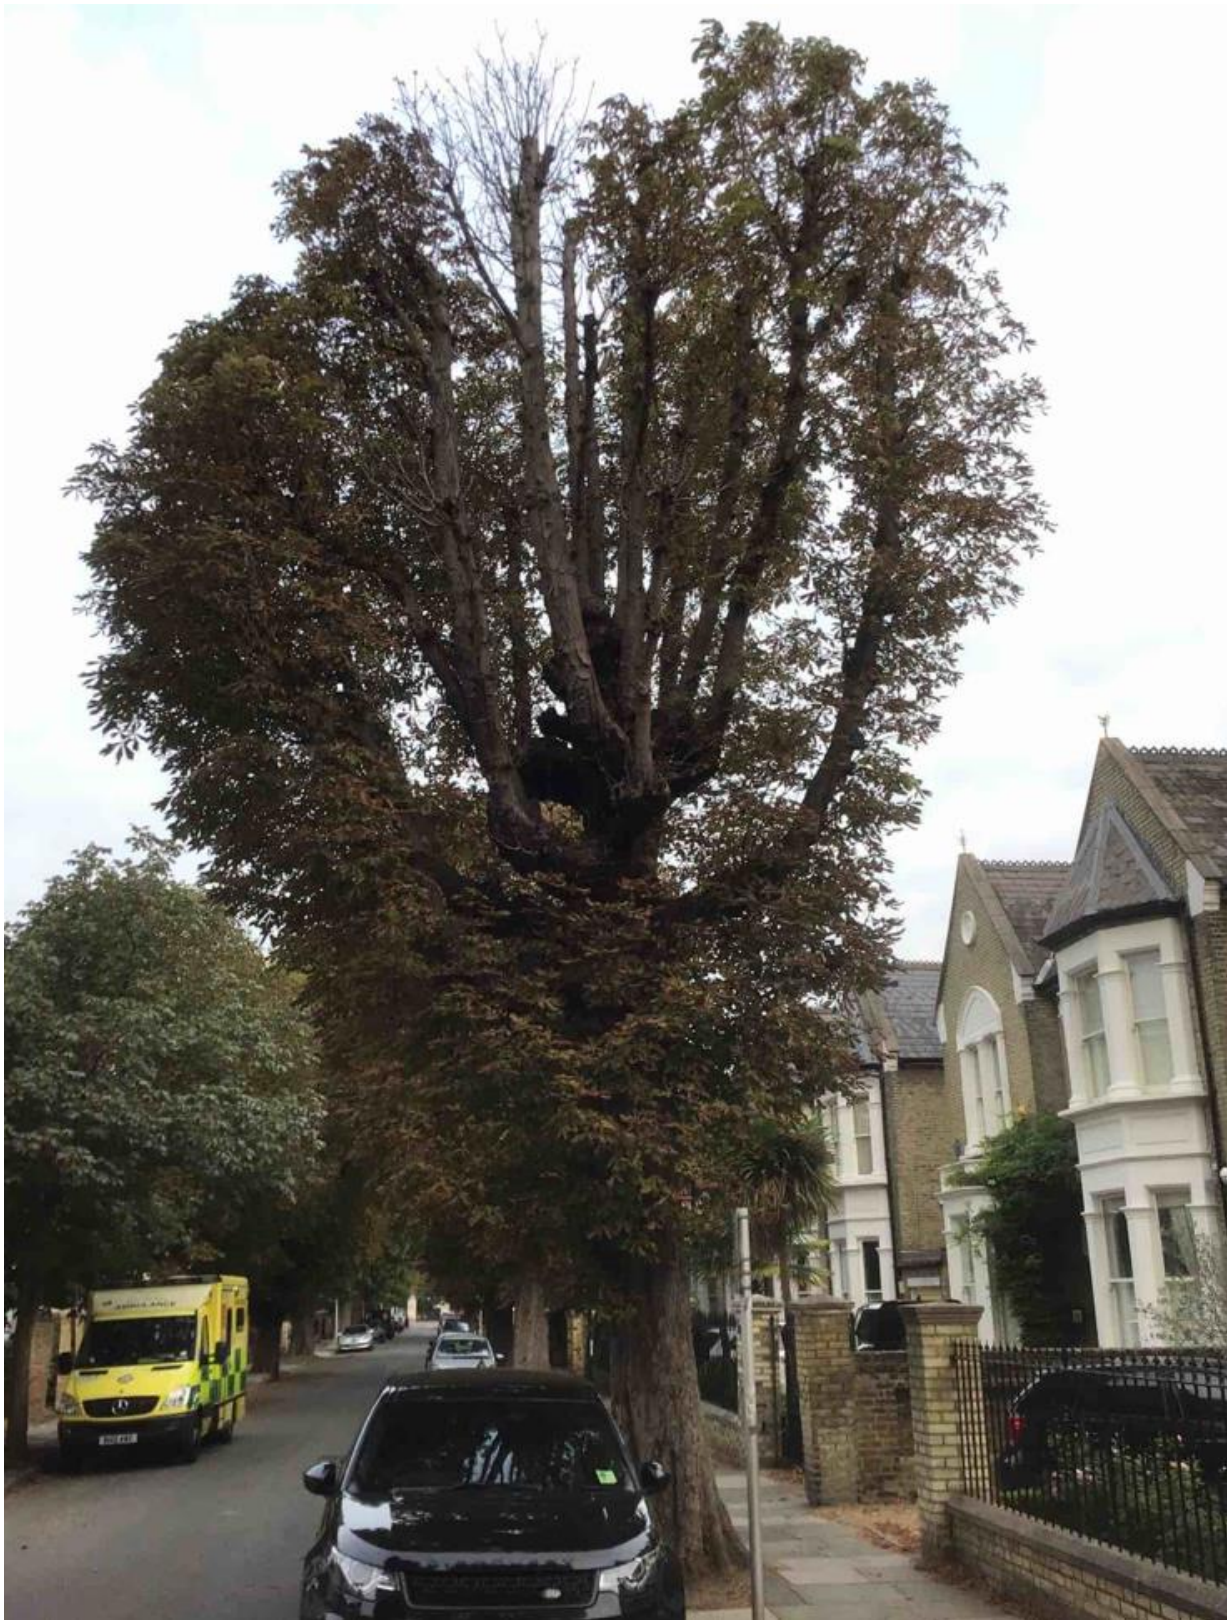
Image shows tree in street scene with canopy dieback evident

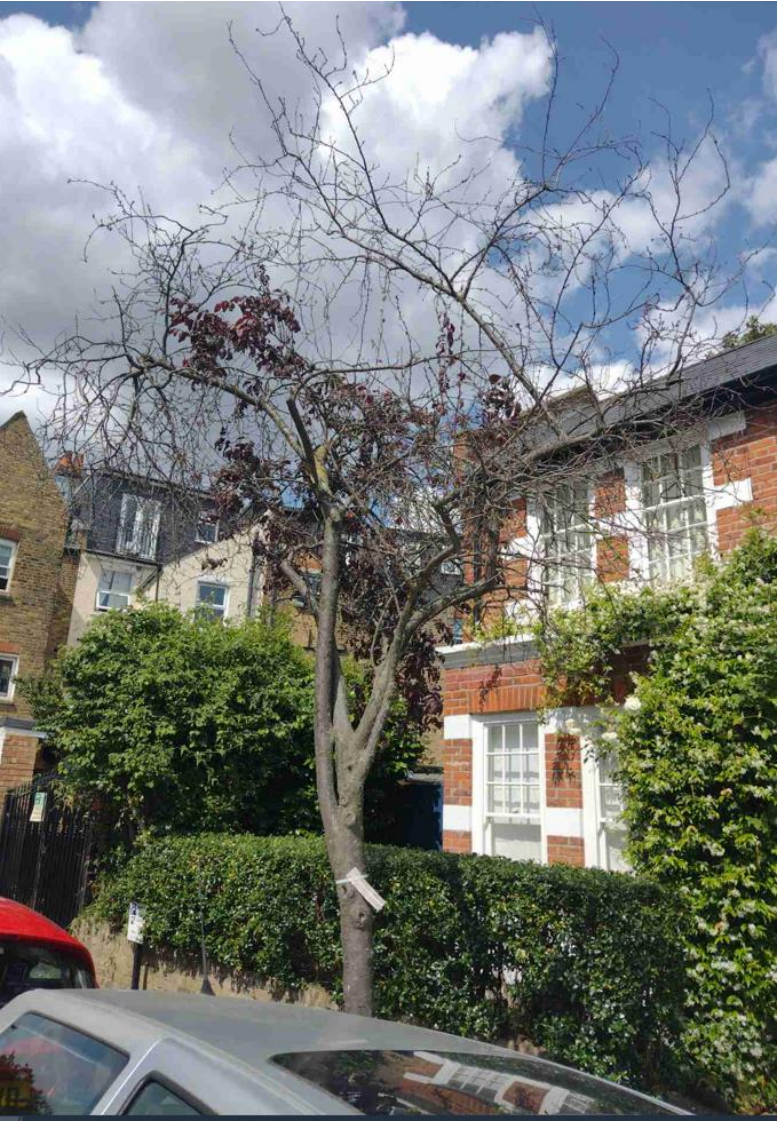
Ward	Mortlake and Barnes Common
Road	First Avenue
Location	Outside 1
Species	Cherry Plum (<i>Prunus cerasifera</i>)
Height	6.0m
Physiological Condition	Poor
Structural Condition	Poor
Inspection findings	Tree crown is displaying advanced symptoms of physiological decline with over 90% of crown being dead. Removal is required to prevent natural failure and facilitate replanting.

Image shows tree in street scene showing crown in poor condition

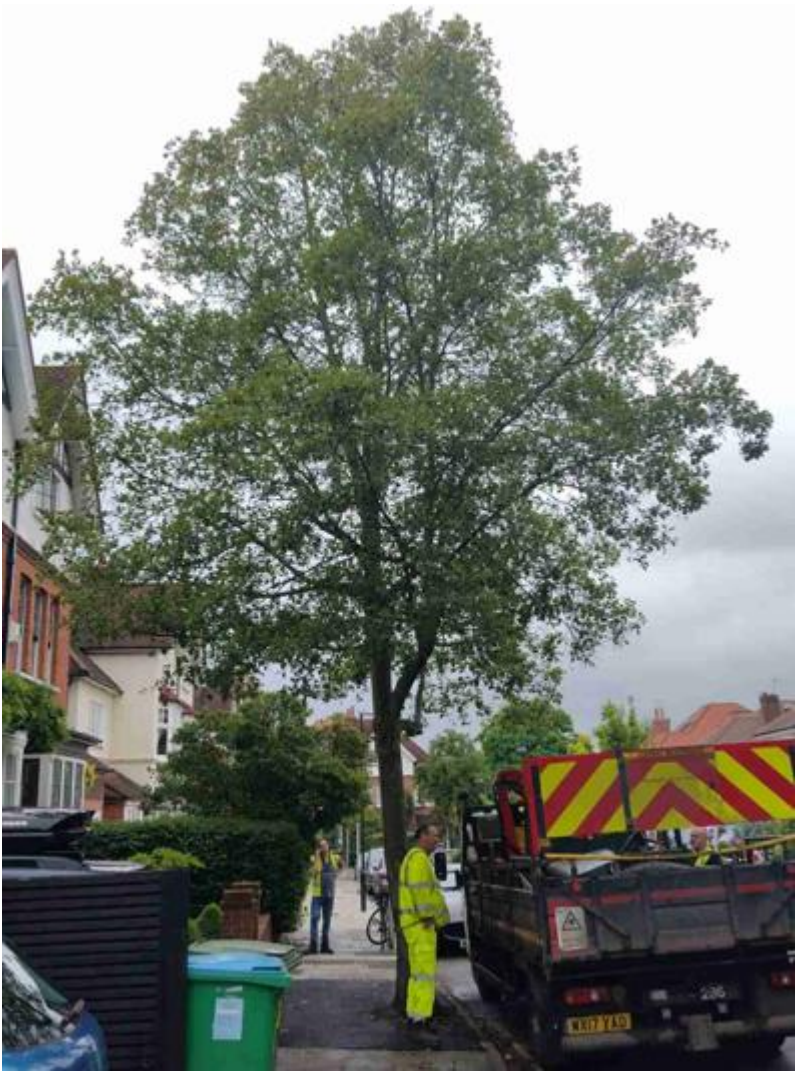
Ward	South Richmond
Road	Denbigh Gardens
Location	Outside 6
Species	Gray Alder (<i>Alnus incana</i>)
Height	11.0M
Physiological Condition	Fair
Structural Condition	Poor
Inspection findings	This tree has bark discolouration that indicates the presence of pathogen <i>Phytophthora</i> sp. which causes rotting of the roots of hosts which can cause entire trees to fail. Removal is required to prevent natural failure and manage risk.

Image shows tree in street scene
