September 2023 - Reactive Tree Works Programme

The following pages provide the locations of each tree that is to be removed, in addition photographs and descriptions of the inspection findings have been provided.

Dated 18.9.2023

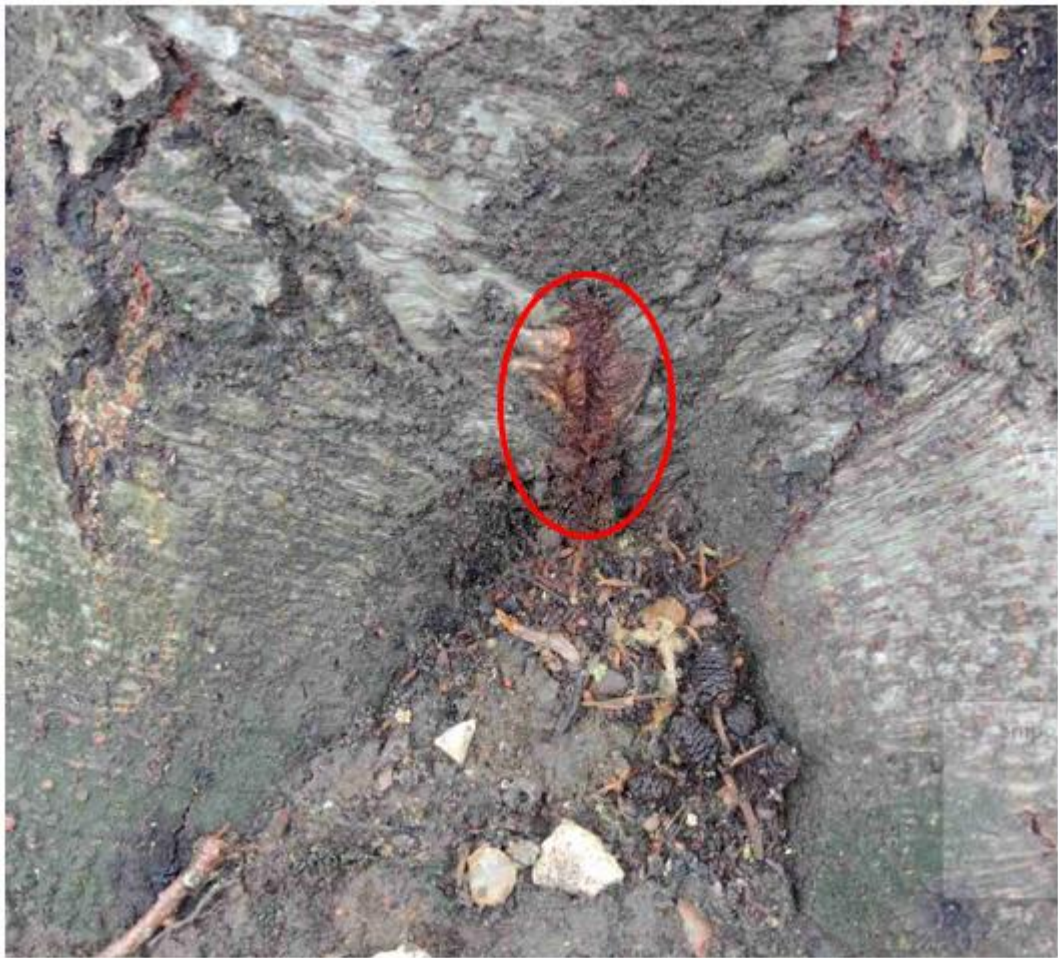
Image shows bleeding bark circled which is associated with the pathogen *Phytophthora*

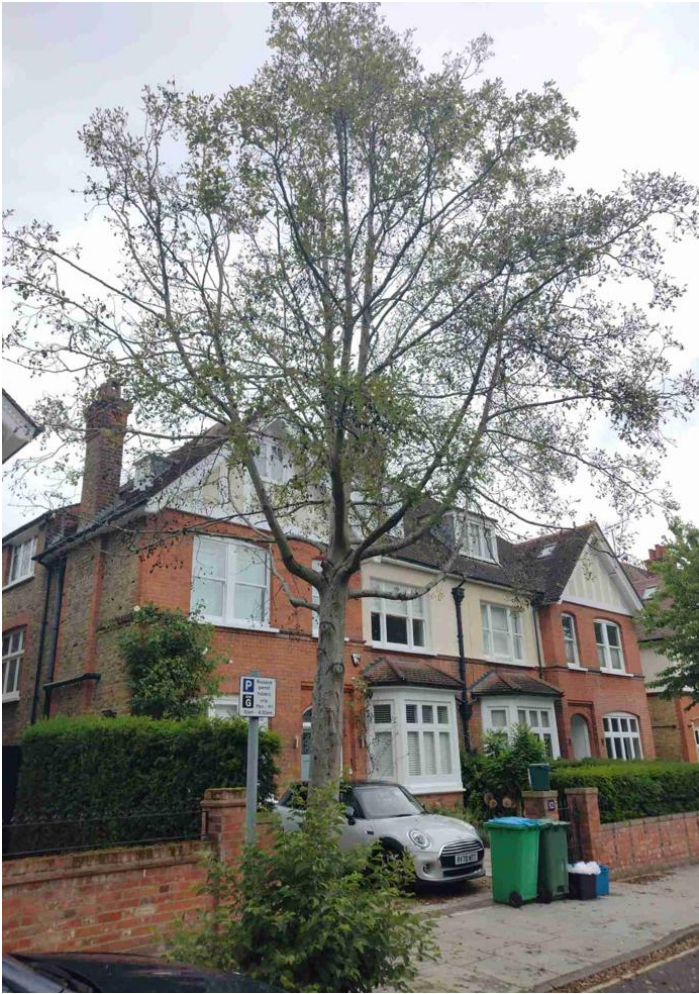
Ward	South Richmond
Road	Denbigh Gardens
Location	Outside 12/14
Species	Gray Alder (<i>Alnus incana</i>)
Height	10.0m
Physiological Condition	Poor
Structural Condition	Fair
Inspection findings	This tree has bark discolouration that indicates the presence of pathogen <i>Phytophthora</i> sp. This causes rotting of the roots of hosts and can cause entire trees to fail. Removal is required to prevent natural failure and manage risk.

Image shows tree in street scene with declining crown

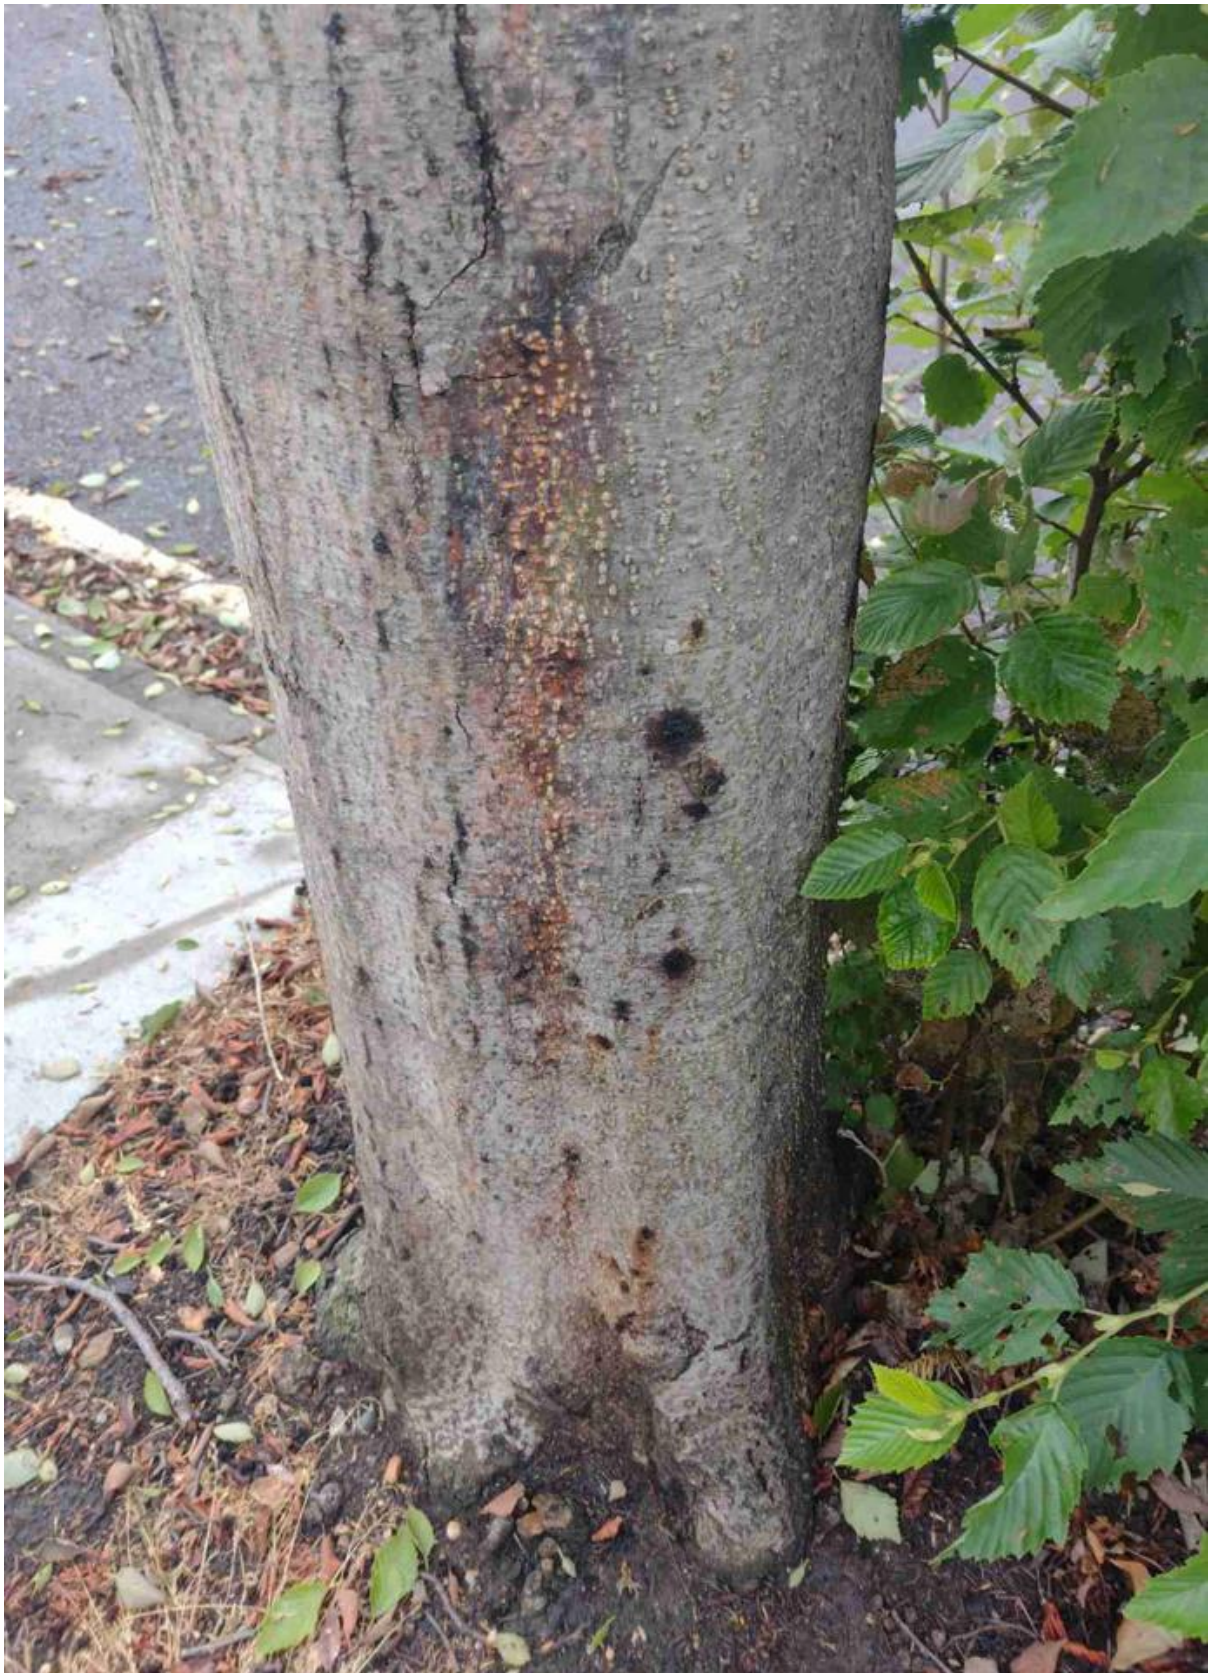
Image shows *Phytophthora* spots and discolouration on lower stem

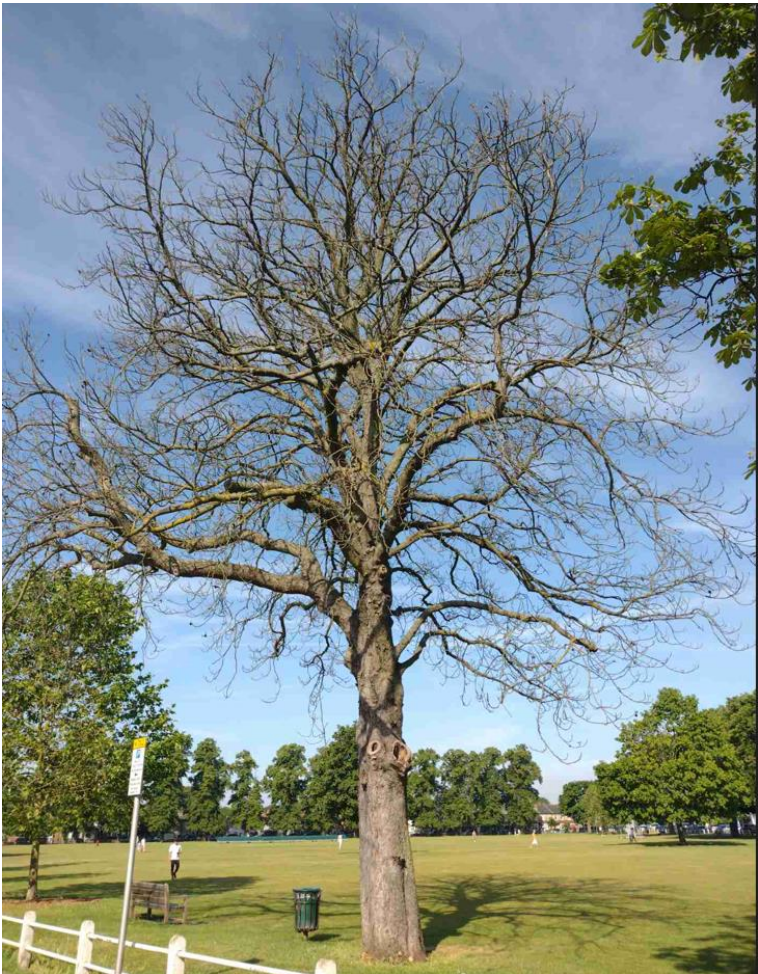
Ward	South Twickenham
Road	The Green
Location	Opposite 29 & Gifford Lodge. /// <w3w-void.prop.ladder< td=""></w3w-void.prop.ladder<>
Species	Horse Chestnut (<i>Aesculus hippocastanum</i>)
Height	18.5m
Physiological Condition	Dead
Structural Condition	Dead
Inspection findings	This tree is dead with fungal fruiting bodies around the base of stem visually consistent with the decay fungus Giant Ash Bracket (<i>Perenniporia fraxinea</i>) are present around the base of this tree. This fungus causes a simultaneous white rot of the wood and can cause catastrophic failure of entire trees and branches and could have contributed to the death of this tree. Removal is required to facilitate replanting and prevent natural failure.

Image shows dead tree.

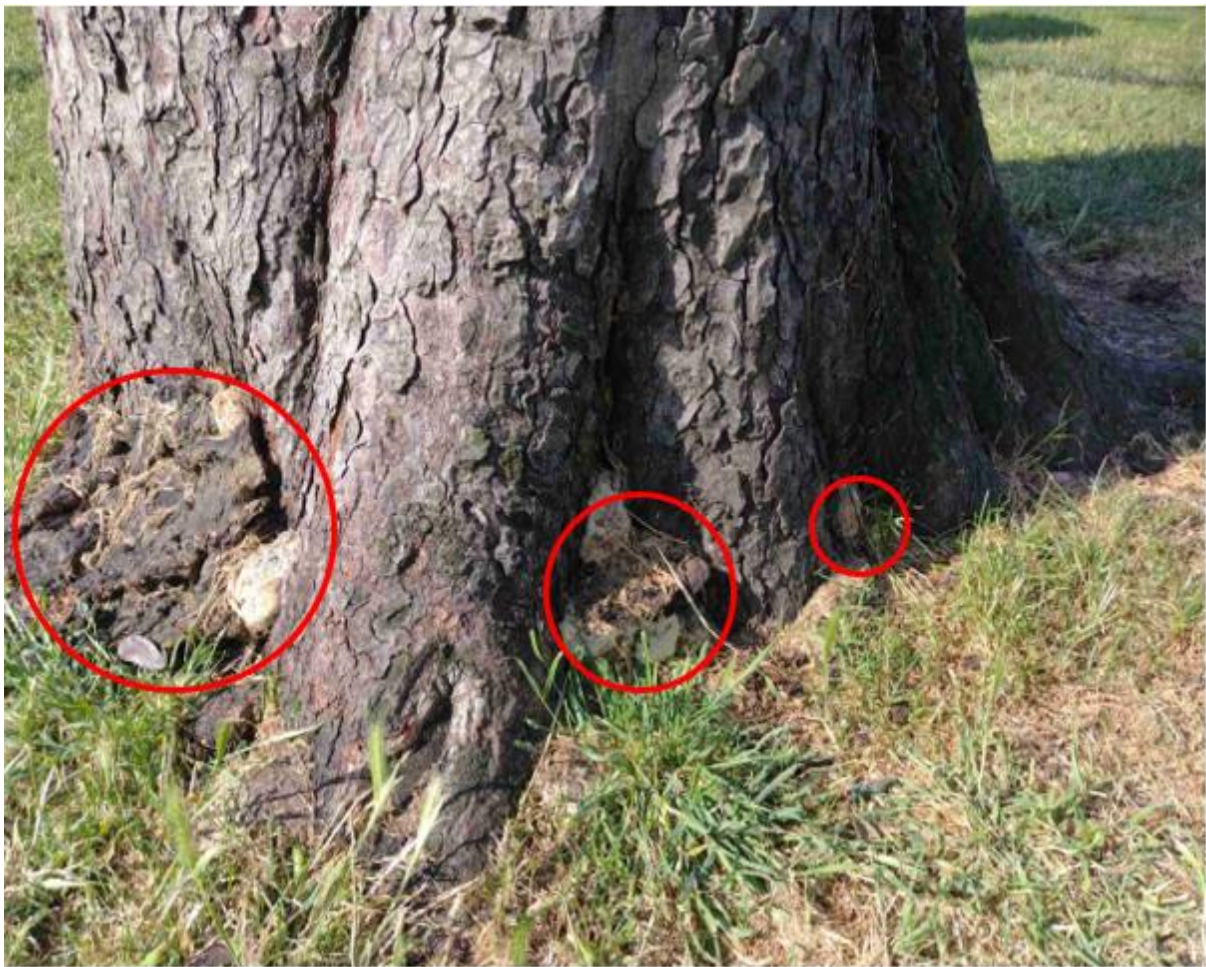
Image shows tree with location of fungal fruiting bodies circled

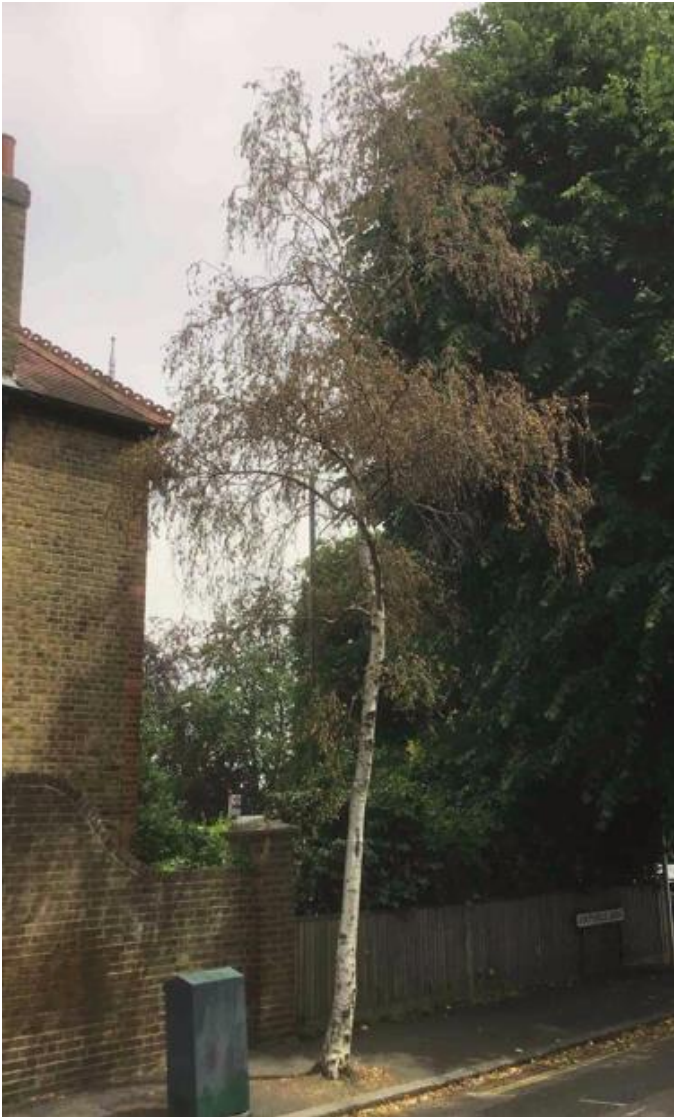
Ward	South Twickenham
Road	Southfield Gardens
Location	Adjacent to 241 Waldegrave Road front edge of building, Opposite Lamppost 001
Species	Birch (<i>Betula sp.</i>)
Height	9.5m
Physiological Condition	Dead
Structural Condition	Dead
Inspection findings	This tree is dead and requires removal to facilitate replanting and prevent natural failure.

Image shows dead tree in street scene.

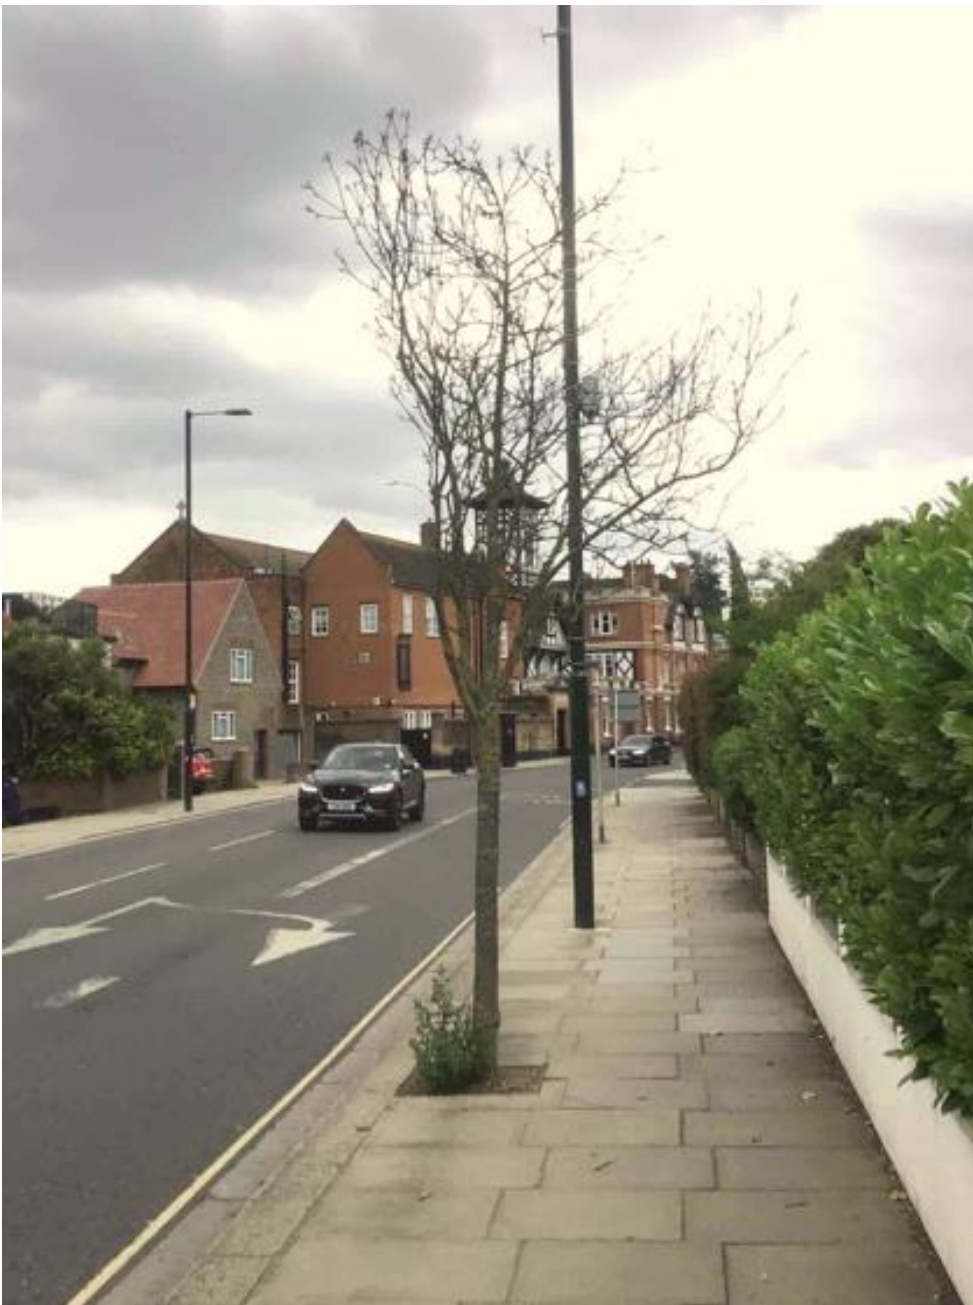
Ward	South Twickenham
Road	Cross Deep
Location	Outside 36
Species	Rowan (<i>Sorbus aucuparia</i>)
Height	5.5m
Physiological Condition	Dead
Structural Condition	Dead
Inspection findings	This tree is dead and requires removal to facilitate replanting and prevent natural failure.

Image shows dead tree in street scene.

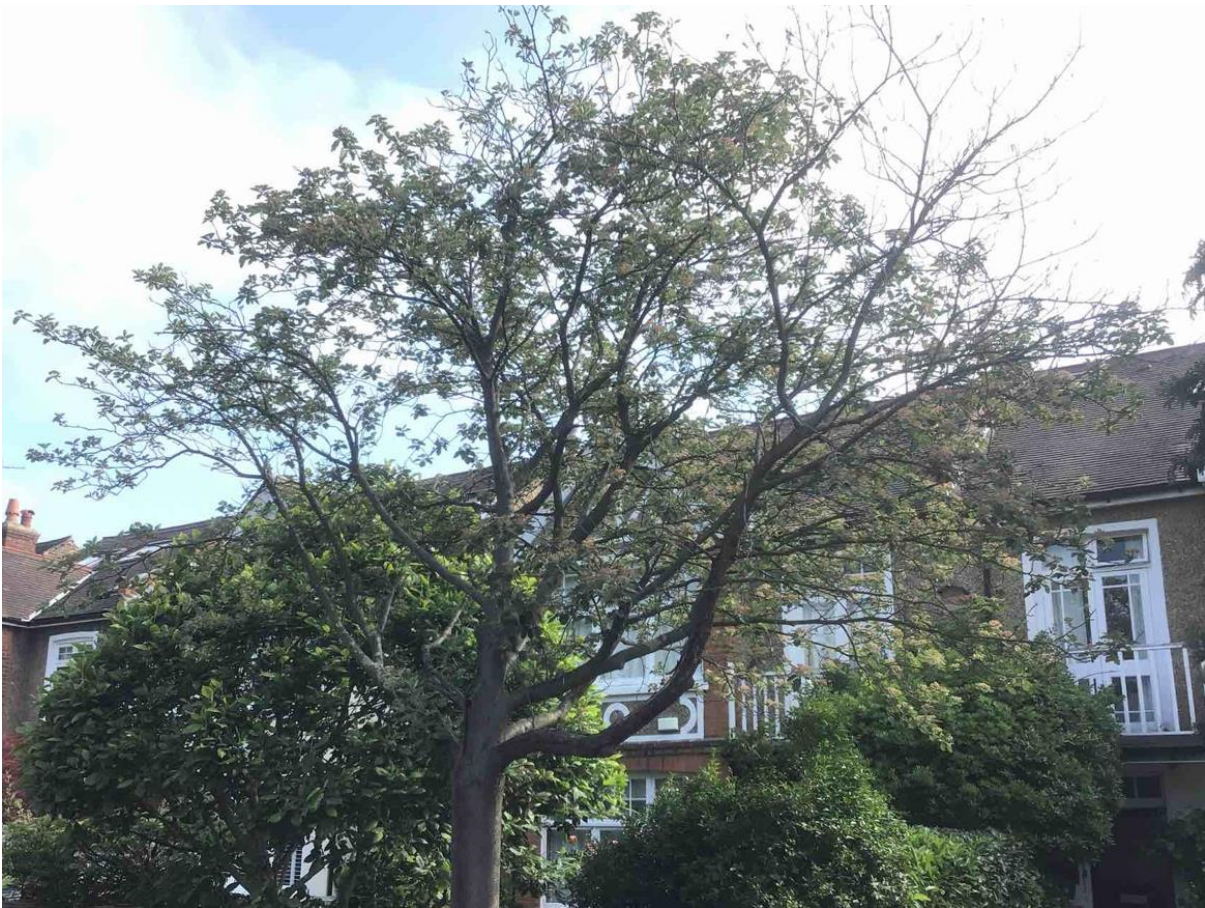
Ward	St Margarets and North Twickenham
Road	Cassilis Road
Location	Outside 11/13
Species	Swedish Whitebeam (<i>Sorbus intermedia</i>)
Height	7.5m
Physiological Condition	Poor
Structural Condition	Poor
Inspection findings	A fungal fruiting body of the species Shaggy Polypore (<i>Inonotus hispidus</i>) is present on the main stem or trunk by a cavity with necrosis spreading down the stem, this fungus causes a simultaneous white rot which can cause snapping of tree parts in this species. The crown of tree is declining, where significant deadwood and dieback is present and this correlates with the pathogen present on the stem. This tree requires removal to facilitate replanting and prevent natural failure.

Image shows tree with canopy die back evident.

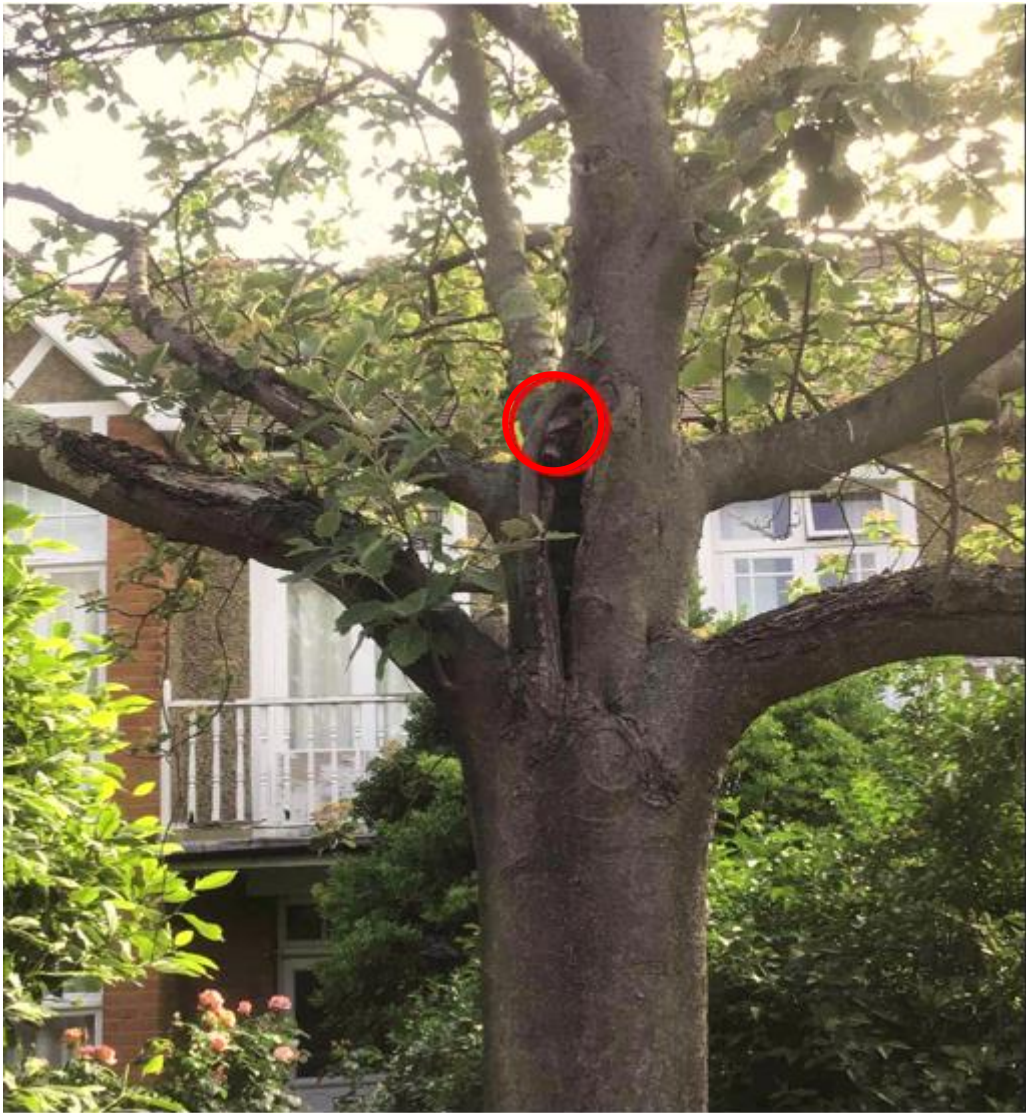
Image shows fruiting body circled on cavity on main stem.

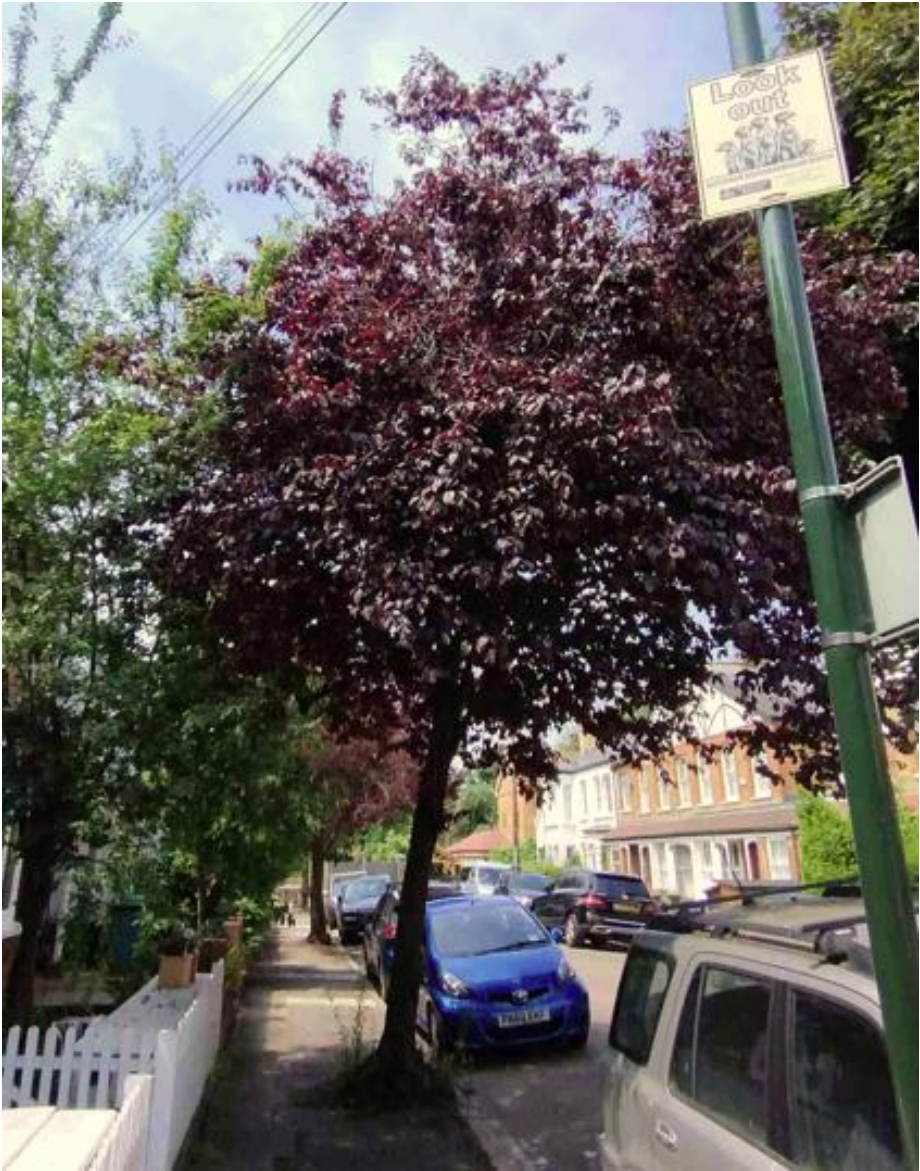
Ward	St Margarets and North Twickenham
Road	Orchard Road
Location	Outside 37/39
Species	Cherry Plum (<i>Prunus cerasifera</i>)
Height	8.0m
Physiological Condition	Fair
Structural Condition	Poor
Inspection findings	A fungal fruiting body of the decay pathogen <i>Ganoderma</i> sp. is present at the stem base. Colonisation by this fungus causes a white rot of the stem and root system that can cause entire trees to collapse through fracture or windthrow. Significant cracking is also present at the base of this tree. There is an unacceptable degree of decay in the trunk of this tree, removal is required to prevent natural failure and manage risk.

Image shows tree in street scene

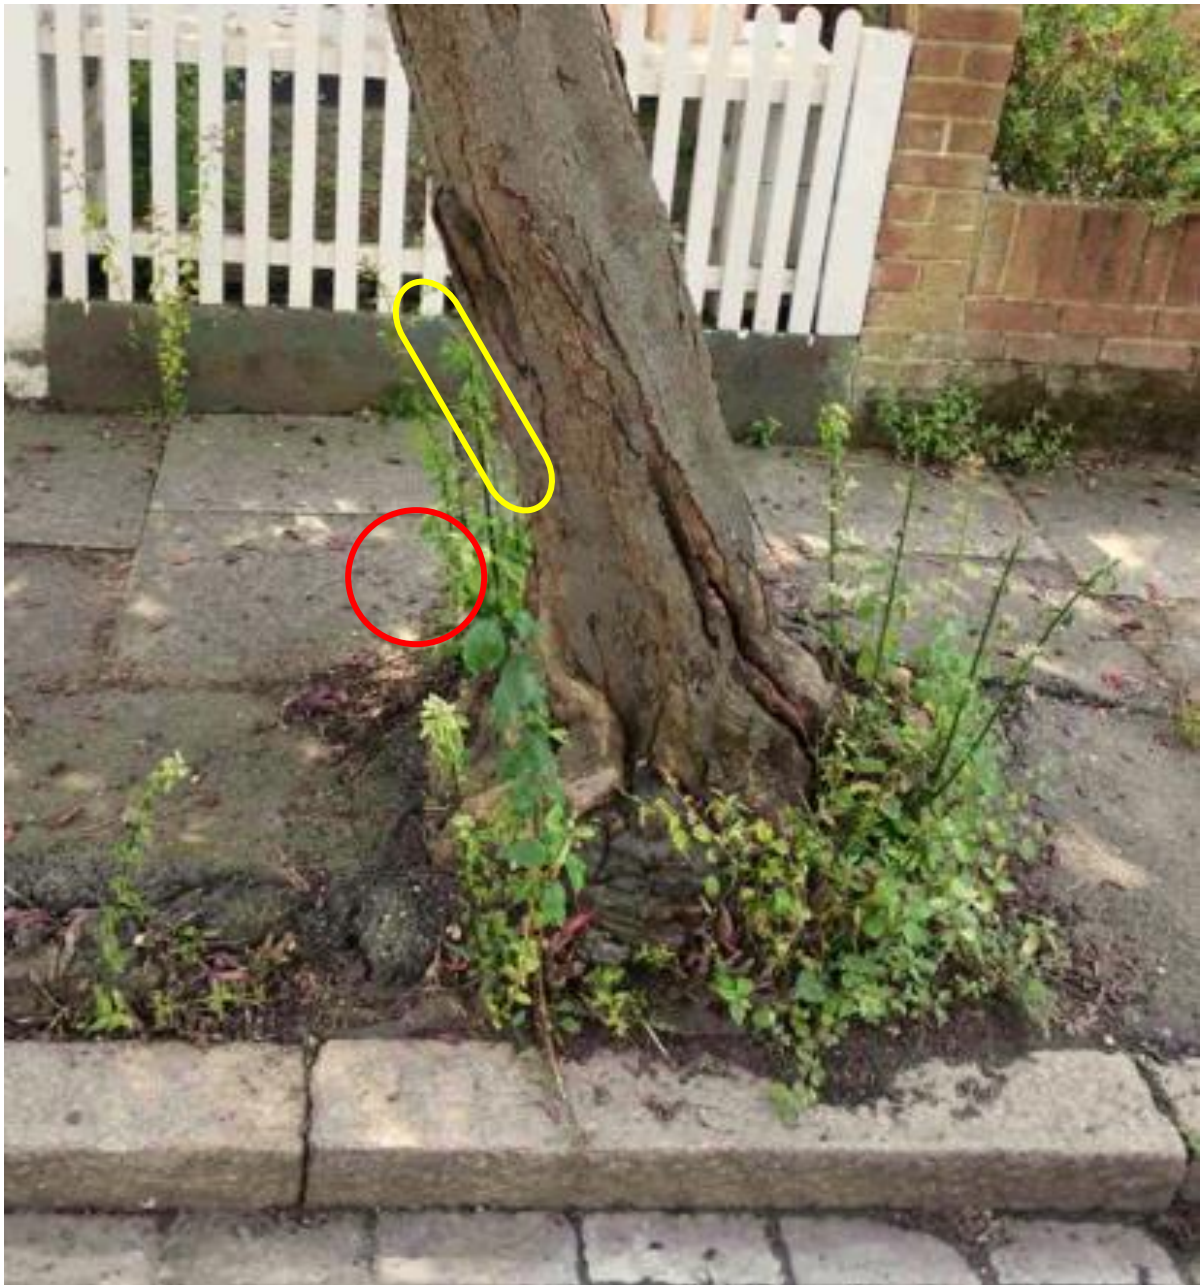
Image shows fruiting body circled in red and cracking to stem circled in yellow

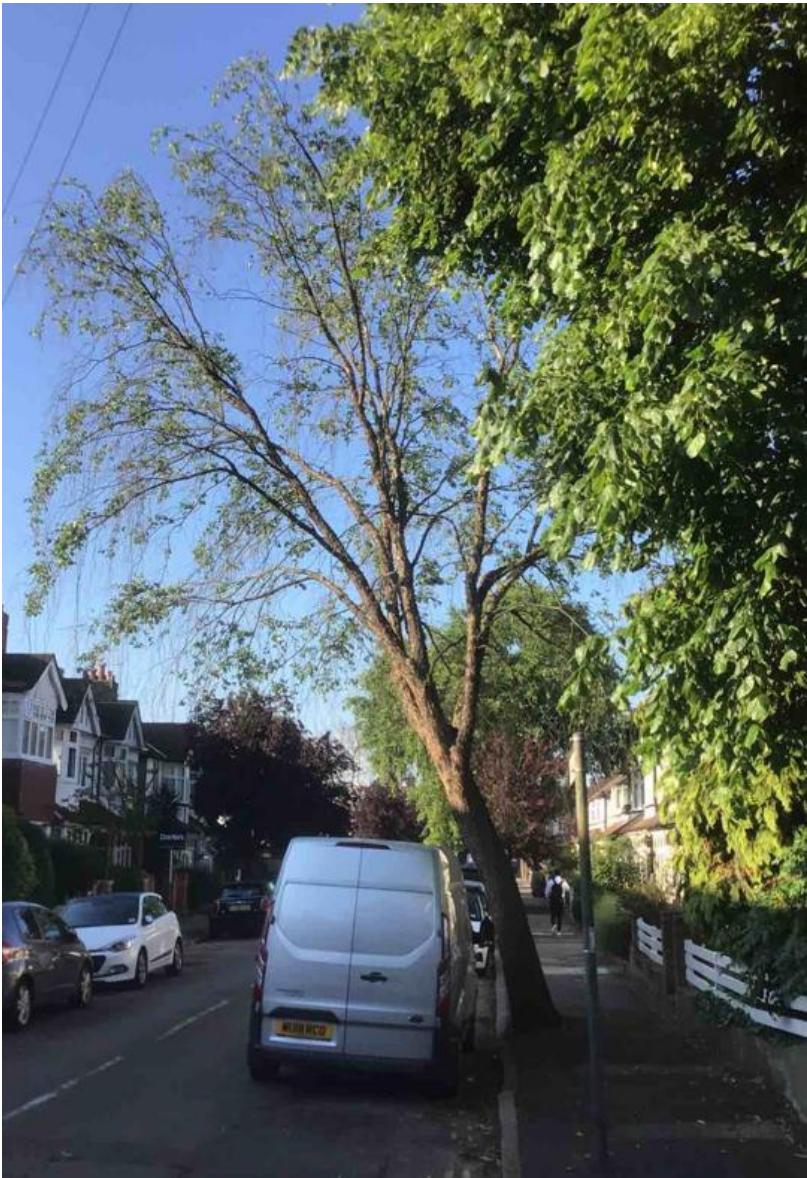
Ward	St Margarets and North Twickenham
Road	Kilmorey Gardens
Location	Outside 1
Species	Black birch (<i>Betula nigra</i>)
Height	12.5m
Physiological Condition	Poor
Structural Condition	Poor
Inspection findings	Stem lean towards road has increased from 10 degrees measured in 2019 to 15 degrees in 2023 inspection with crown showing over 70% foliage dieback correlates with the degradation of the trees structural or supporting root system. Removal is required to prevent natural failure and manage risk.

Image shows tree in street scene with sparse foliage in crown indicating poor vitality

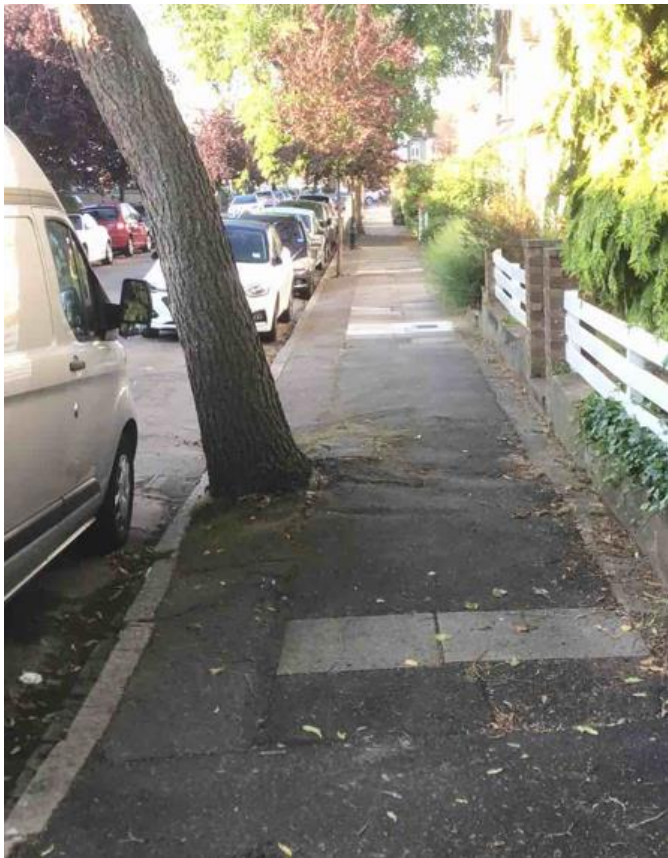
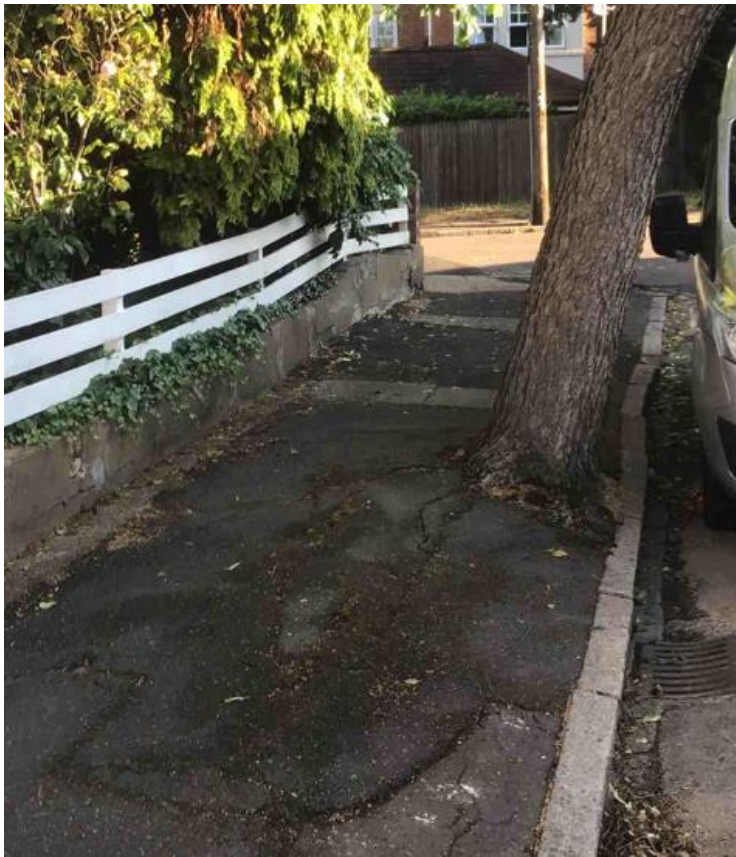
Images above shows pavement disruption with root heave caused by leaning stem

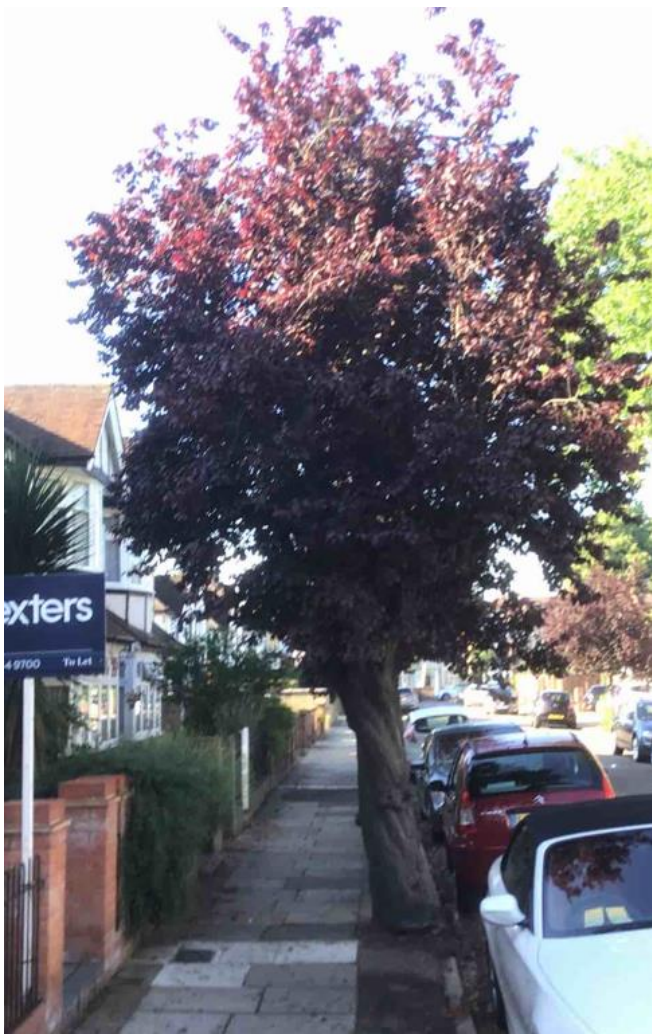
Ward	St Margarets and North Twickenham
Road	Kilmorey Gardens
Location	Outside 16
Species	Cherry Plum (<i>Prunus cerasifera</i>)
Height	8.0m
Physiological Condition	Fair
Structural Condition	Poor
Inspection findings	Fungal fruiting bodies of the decay pathogen <i>Ganoderma</i> sp. are present around the stem base. Colonisation by this fungus causes a white rot of the stem and root system that can cause entire trees to collapse through fracture or windthrow. Investigation with a probe revealed decay in roadside of lower stem with a resonance test has revealed an area of extensive decay beyond the visible cavities. Removal is required to prevent natural failure and manage risk

Image shows tree in street scene

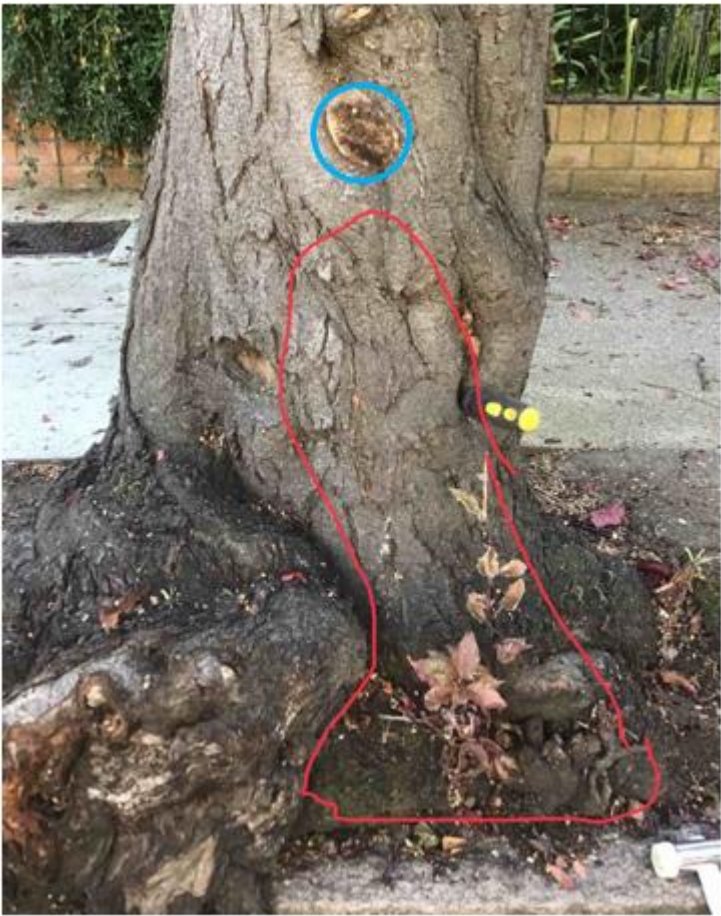
Image shows stem with location internal decay highlighted in red with fungal fruiting body circled in blue.

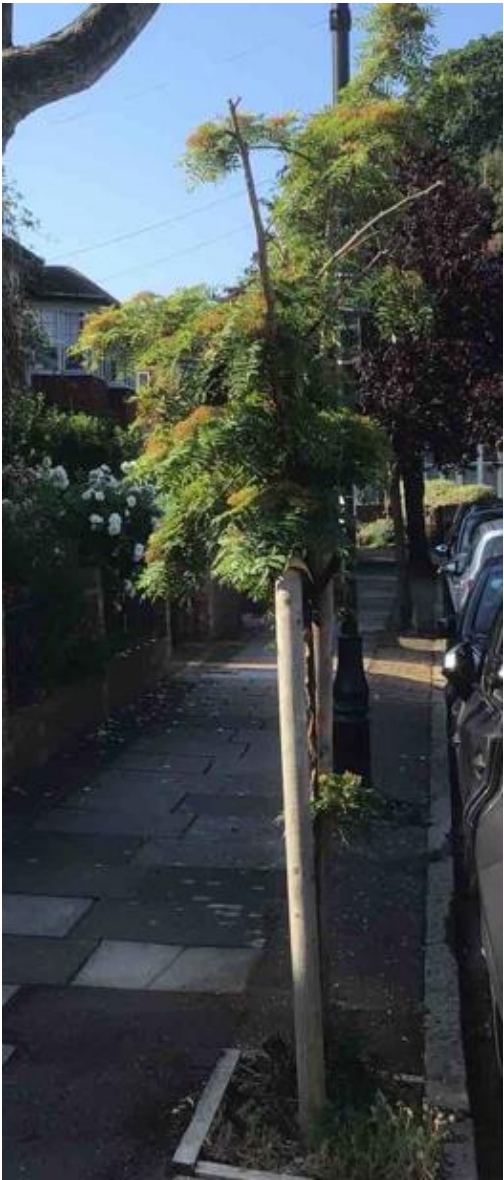
Ward	St Margarets and North Twickenham
Road	Kilmorey Gardens
Location	Outside 30
Species	Swedish Whitebeam (<i>Sorbus intermedia</i>)
Height	3.5m
Physiological Condition	Poor
Structural Condition	Poor
Inspection findings	This tree is in a state of physiological decline with bark necrosis is present on the stem causing dysfunction of the vascular system. Tree crown is displaying symptoms of physiological decline with over 50% of crown dead. Removal is required to prevent natural failure and facilitate replanting

Image shows tree in street scene and poor condition of crown

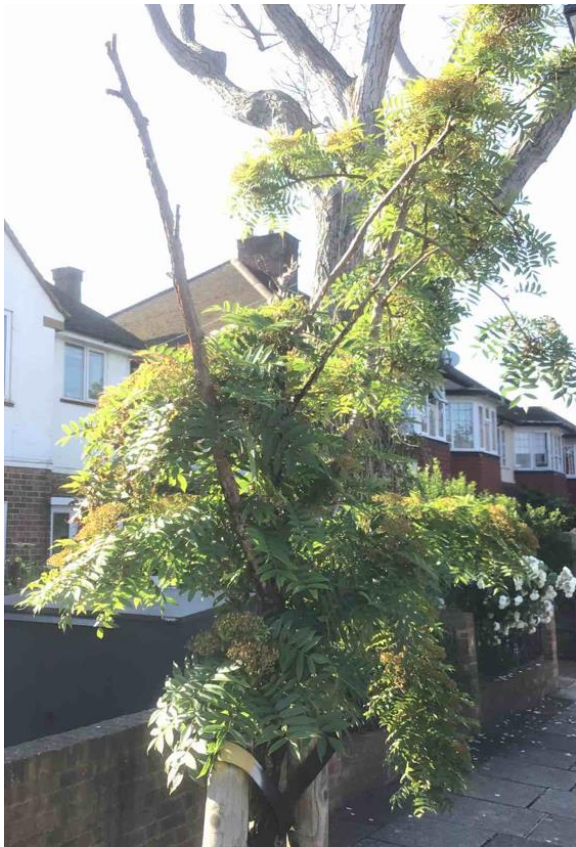
Image shows tree in street scene

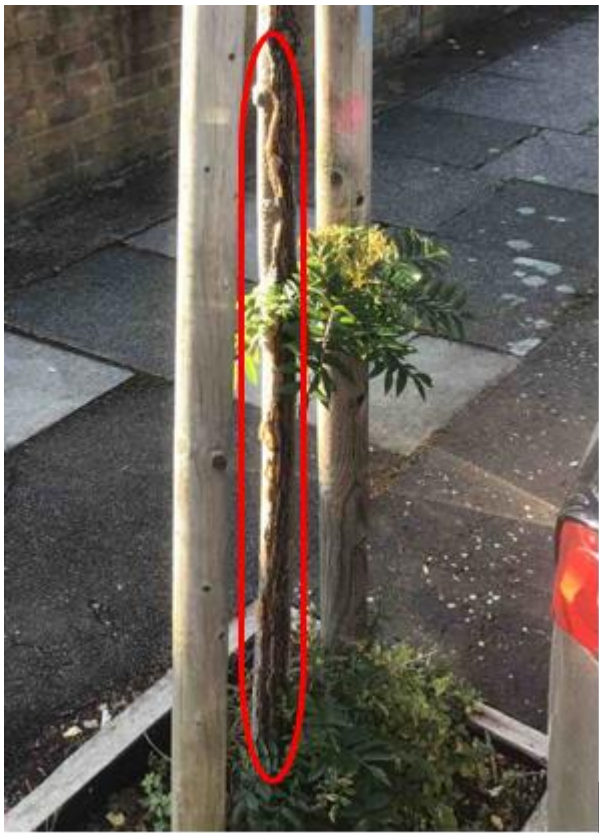
Image shows bark necrosis on the stem circled.

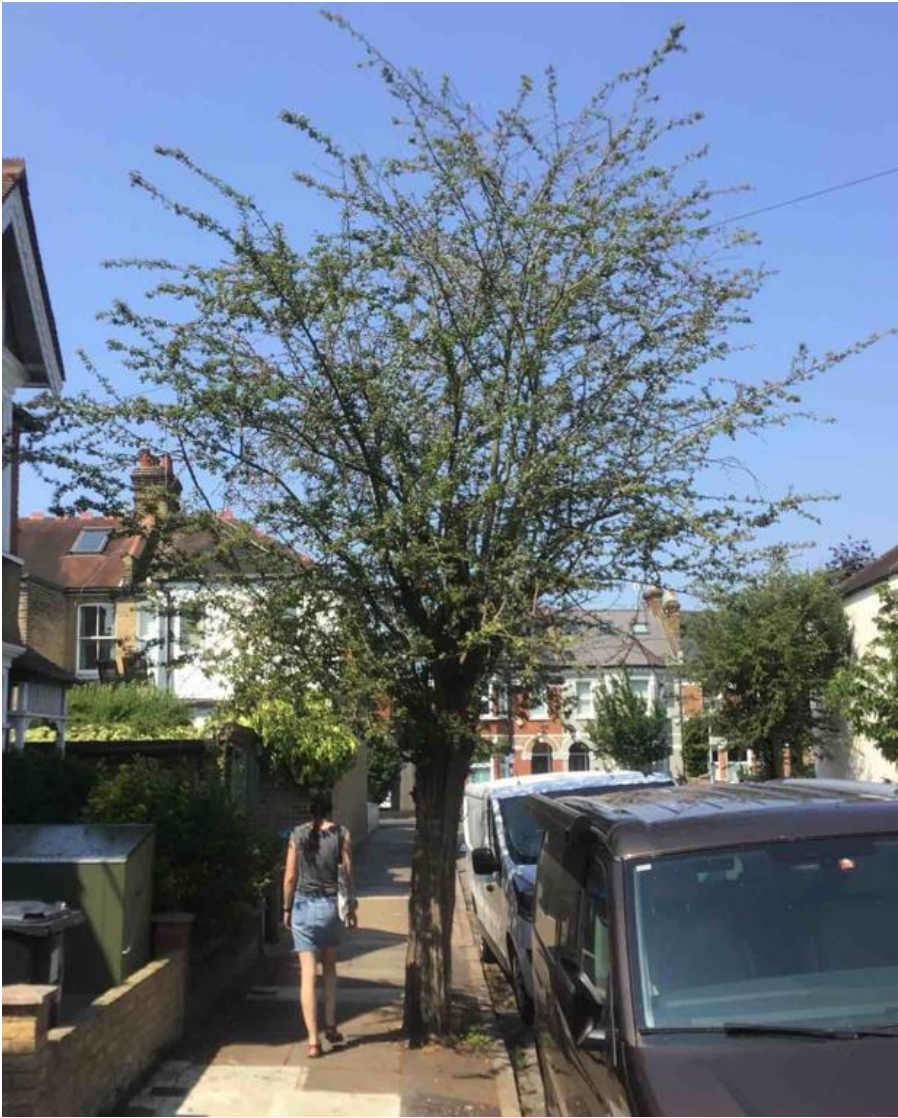
Ward	St Margarets and North Twickenham
Road	Kilmorey Gardens
Location	Outside 52/54
Species	Hawthorn (<i>Crataegus monogyna</i>)
Height	3.5m
Physiological Condition	Poor
Structural Condition	Poor
Inspection findings	This tree is in a state of physiological decline with over 70% of foliage being dead and fruiting bodies with visual similarities of the decay fungus Turkey Tail (<i>Trametes versicolor</i>). This is prolific on the trunk of this tree. This fungus causes a selective white rot of the wood and when prolific is indicative of wider physiological dysfunction. Removal is required to prevent natural failure and facilitate replanting

Image shows tree in street scene with declining crown

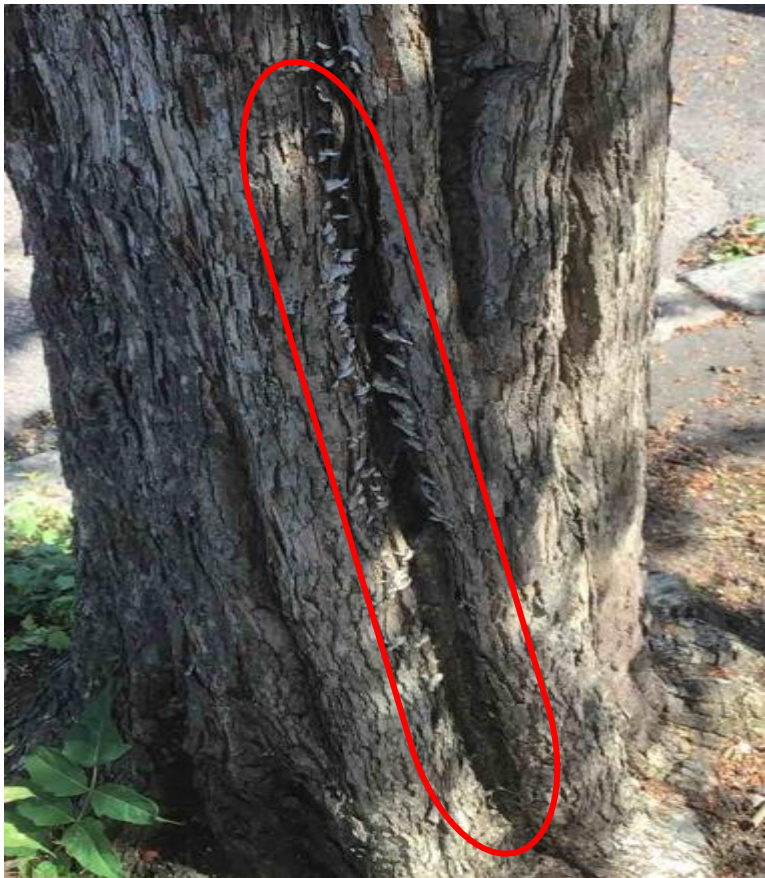
Image shows an example of fungal fruiting body circled with is covering stem.

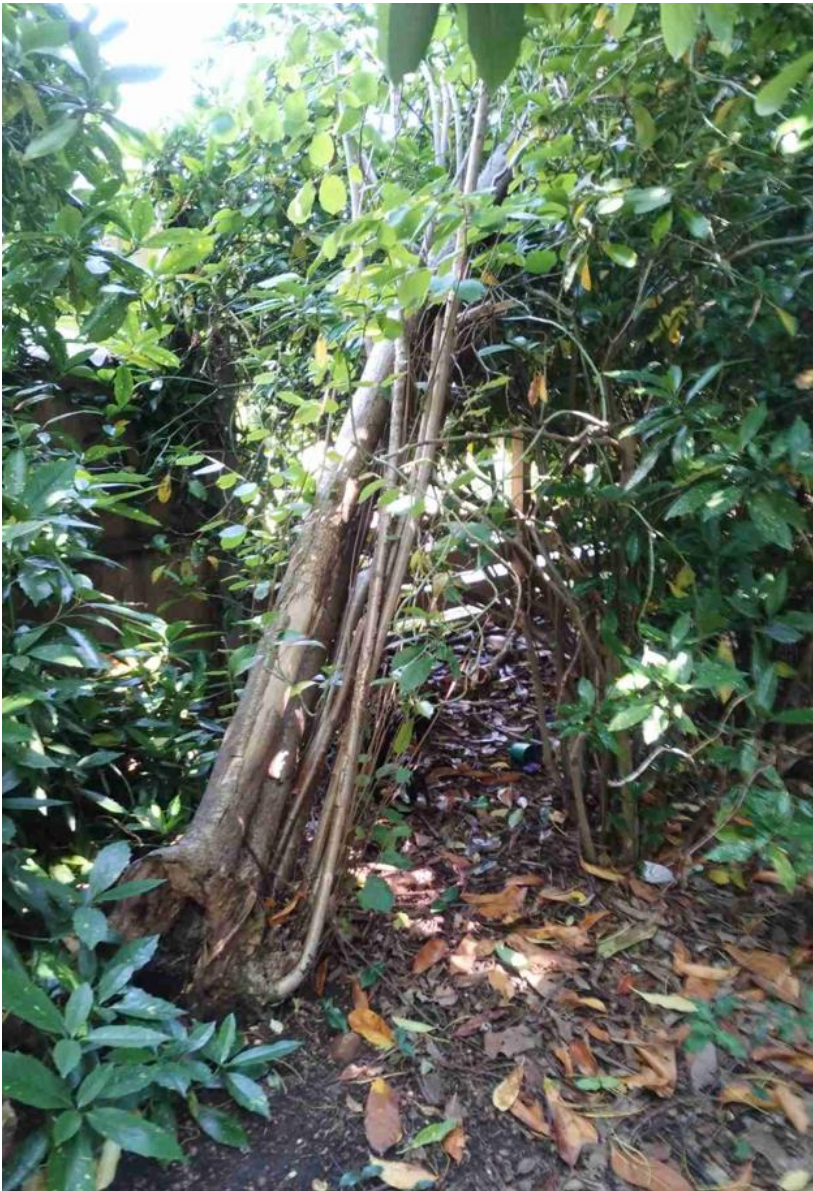
Ward	St Margarets and North Twickenham
Road	Normanhurst Drive
Location	Whatthreewords-///image.marble.port
Species	Hazel (<i>Corylus avellana</i>)
Height	5.0m
Physiological Condition	Good
Structural Condition	Poor
Inspection findings	This tree has part failed at base of stem and is now leaning on adjacent shrubs. This is due to roots with extensively decayed. This tree requires removal to facilitate replanting and prevent natural failure.

Image shows part failed tree
