September 2023 - Reactive Tree Works Programme

The following pages provide the locations of each tree that is to be removed, in addition photographs and descriptions of the inspection findings have been provided.

Dated 18.9.2023

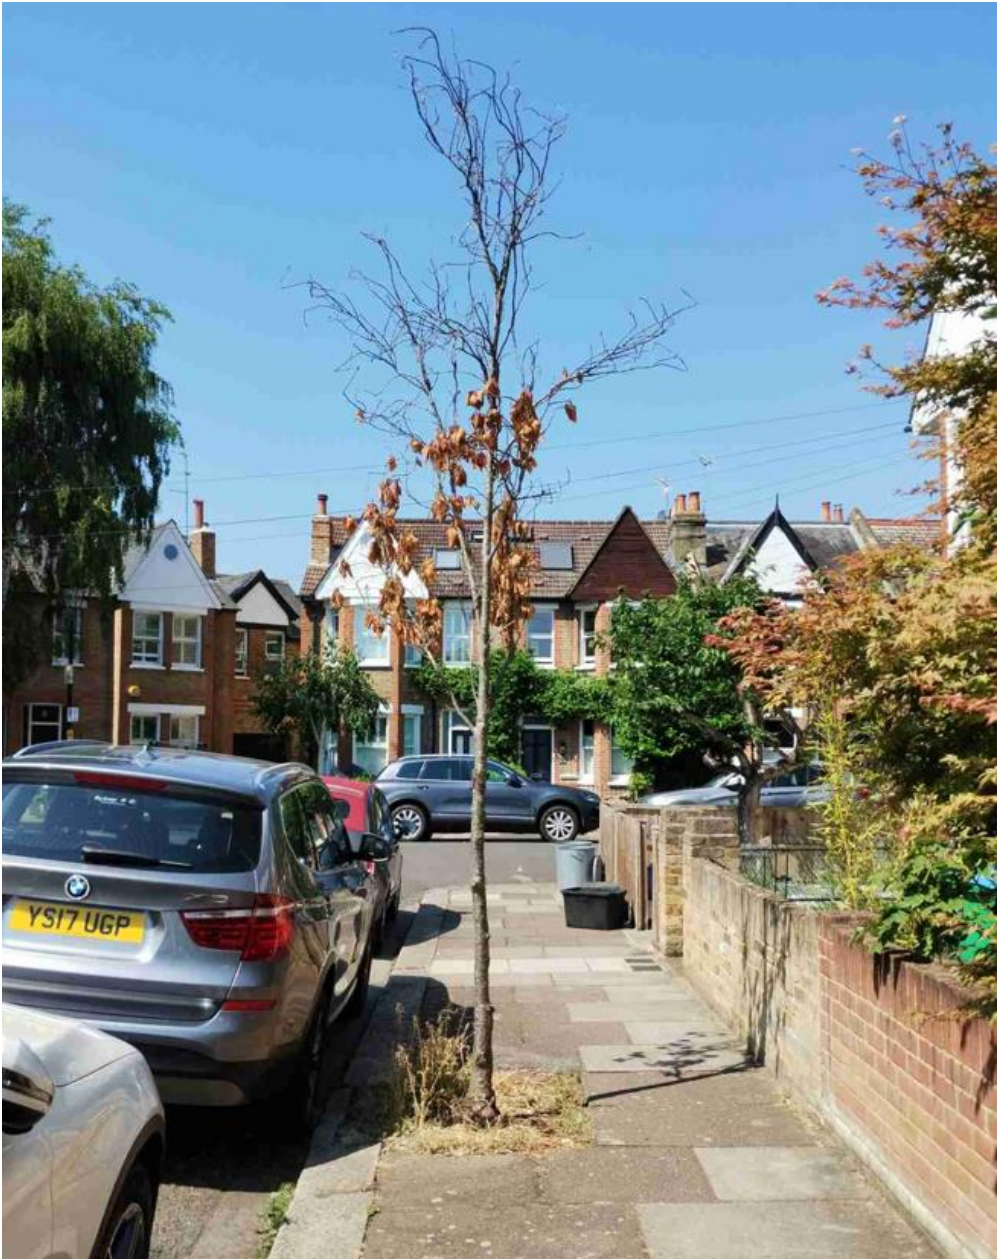
Ward	St Margarets and North Twickenham
Road	Ailsa Avenue
Location	Outside 56/58
Species	Cherry (<i>Prunus</i> sp.)
Height	4.0m
Physiological Condition	Dead
Structural Condition	Dead
Inspection findings	These trees have died, and removal is required to prevent natural failure and facilitate replanting.

Image shows dead tree in street scene

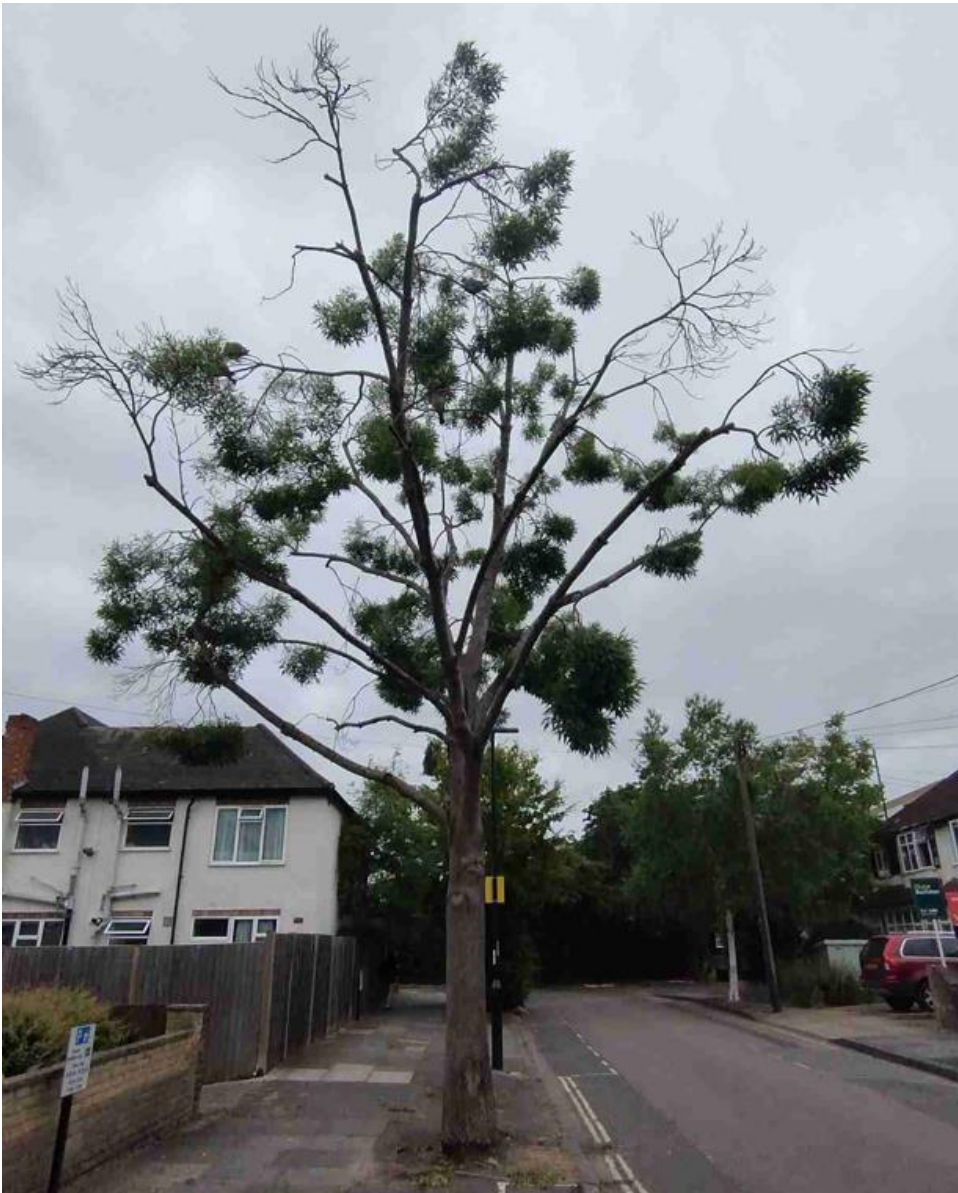
Ward	St Margarets and North Twickenham
Road	Tayben Avenue
Location	Outside 5
Species	Raywood Ash (<i>Fraxinus angustifolia</i> 'Raywood')
Height	4.0m
Physiological Condition	Poor
Structural Condition	Fair
Inspection findings	Tree crown is displaying advanced symptoms of physiological decline associated with Ash Die Back (<i>Hymenoscyphus fraxineus</i>). This is serious fungal disease of the European Ash, characterized by the progressive decline of the tree's branches and will eventually lead to the death of the tree.

Image shows tree in street scene with advanced symptoms of Ash Die Back

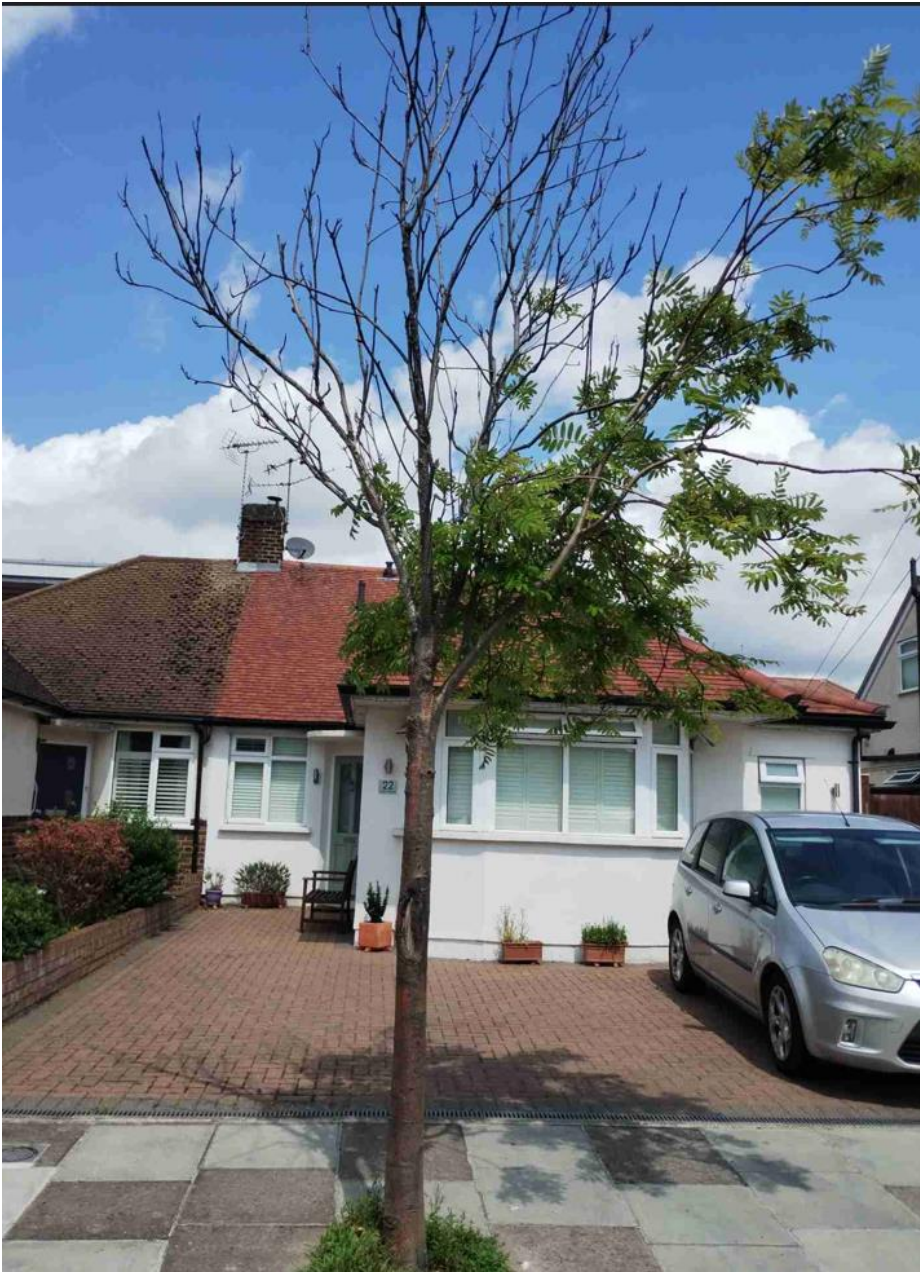
Ward	St Margarets and North Twickenham
Road	Lime Grove
Location	Outside 22
Species	Rowan (<i>Sorbus aucuparia</i>)
Height	5.5m
Physiological Condition	Poor
Structural Condition	Poor
Inspection findings	Tree crown is displaying advanced symptoms of physiological decline with over 60% of crown being dead. Removal is required to prevent natural failure and facilitate replanting.

Image shows tree in street scene showing crown in a state of decline

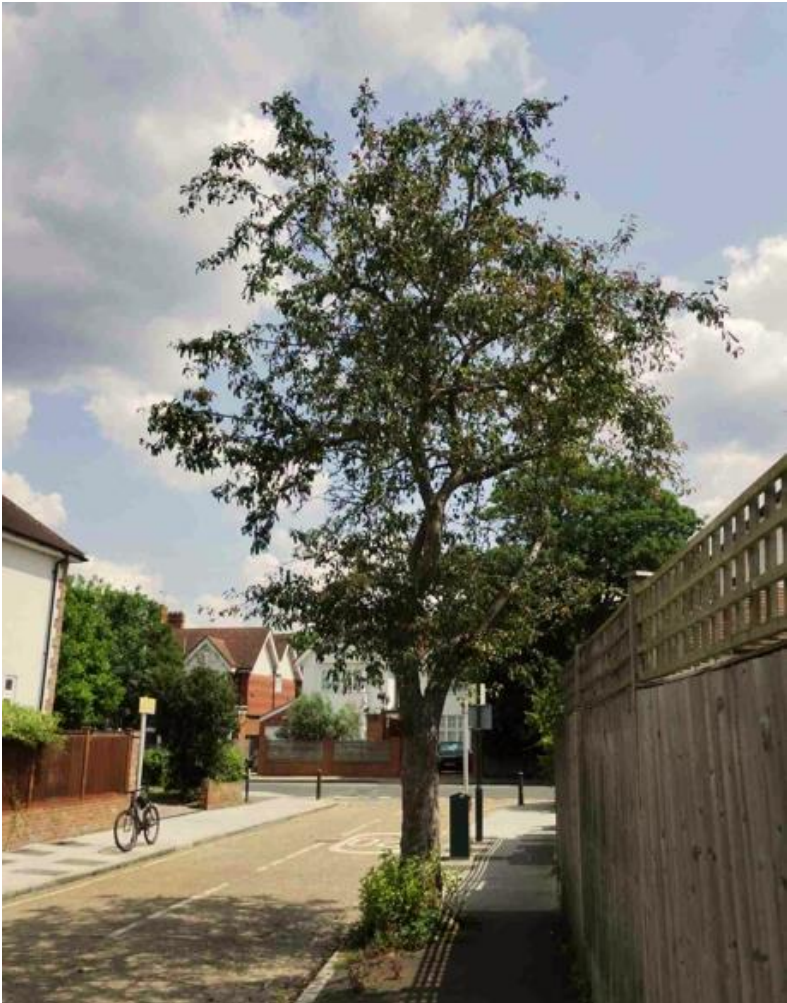
Ward	St Margarets and North Twickenham
Road	Lime Grove
Location	Side of 189 Whitton Road
Species	Apple (<i>Malus Sp.</i>)
Height	5.5m
Physiological Condition	Fair
Structural Condition	Poor
Inspection findings	Fungal fruiting bodies of the decay pathogen <i>Ganoderma</i> sp. are present at the stem base. Colonisation by this fungus causes a white rot of the stem and root system that can cause entire trees to collapse through fracture or windthrow. The tree is declining; significant deadwood and dieback are present and this correlates with the pathogen present. Removal is required to prevent natural failure and facilitate replanting.

Image shows tree in street scene with apparently healthy canopy

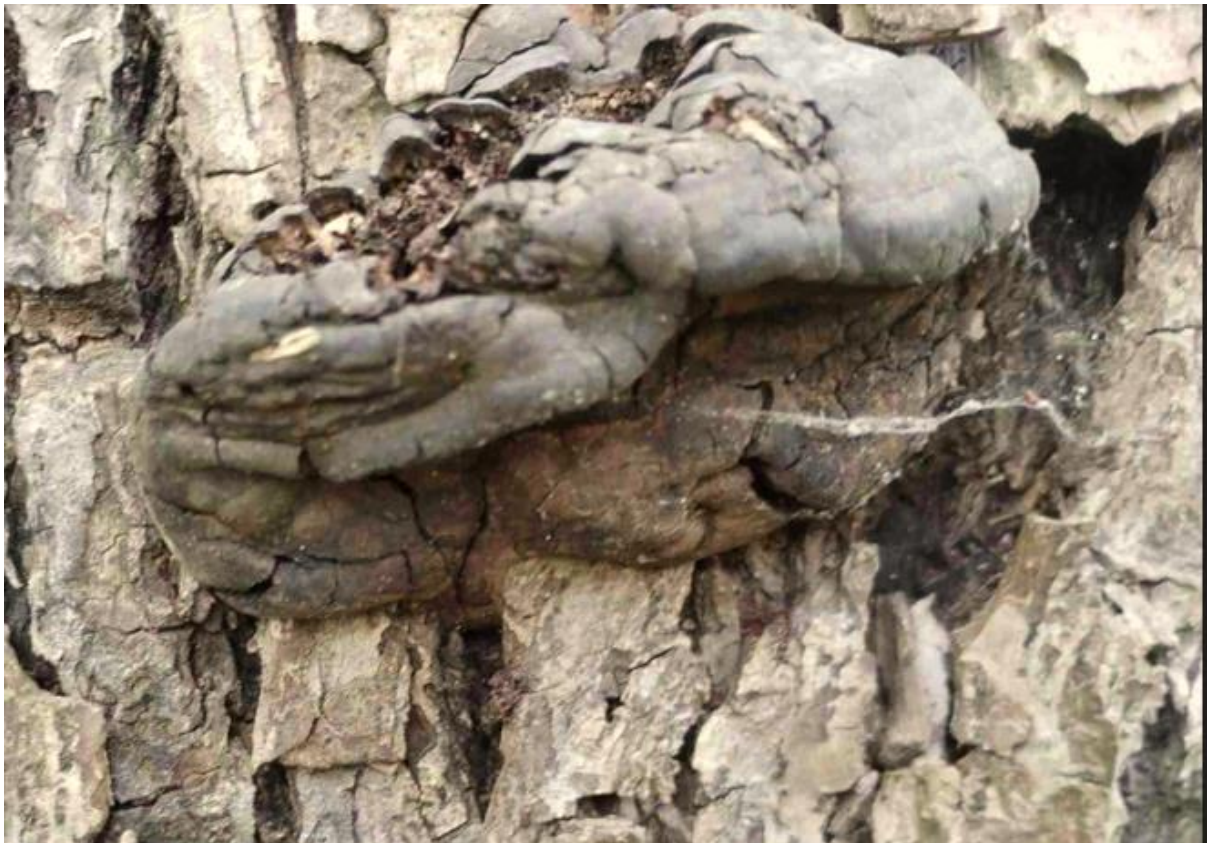
Image shows stem with of fungal fruiting body.

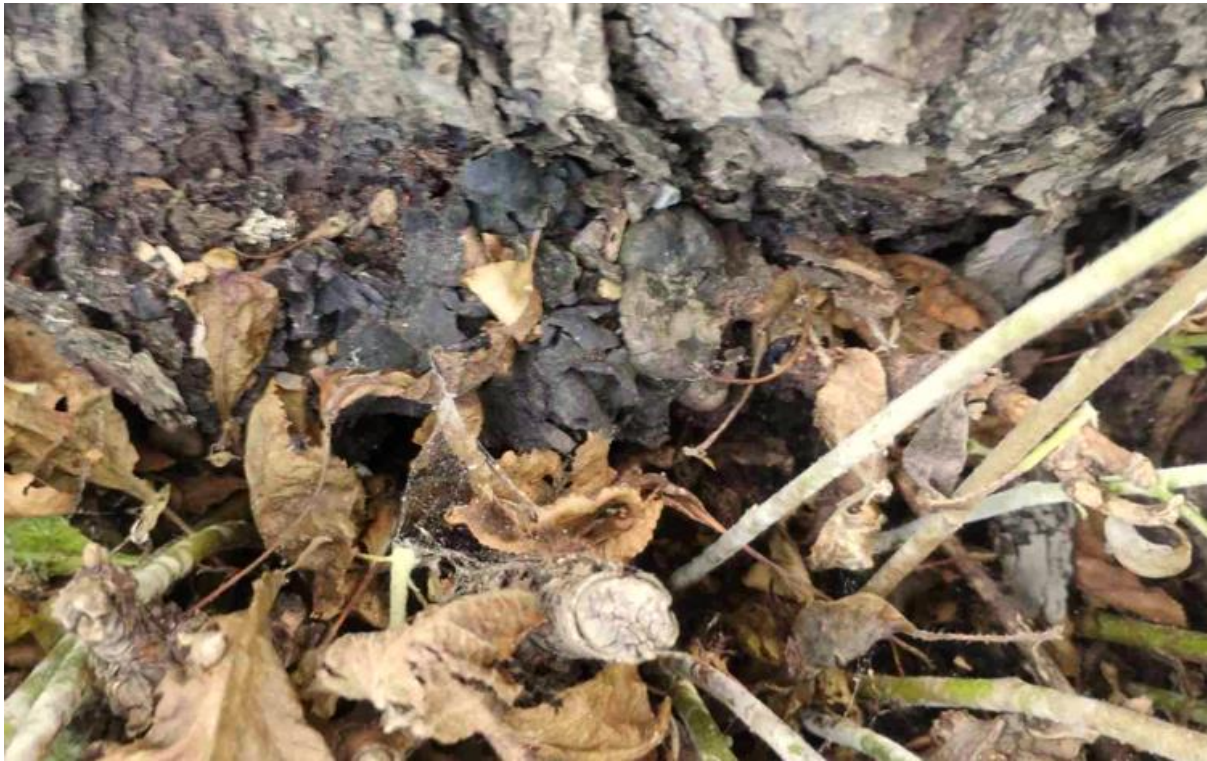
Image shows stem with of fungal fruiting body.

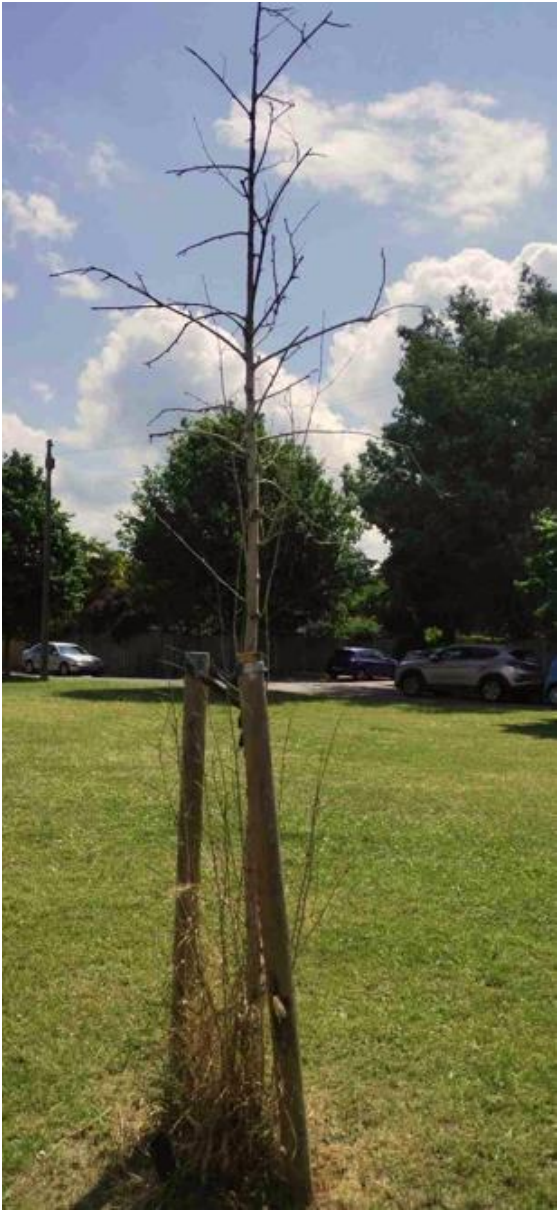
Ward	St Margarets and North Twickenham
Road	Court Close
Location	Opposite 13
Species	Birch (<i>Betula sp.</i>)
Height	4.5m
Physiological Condition	Dead
Structural Condition	Dead
Inspection findings	This tree has died, removal is required to prevent natural failure and facilitate replanting.

Images shows dead tree

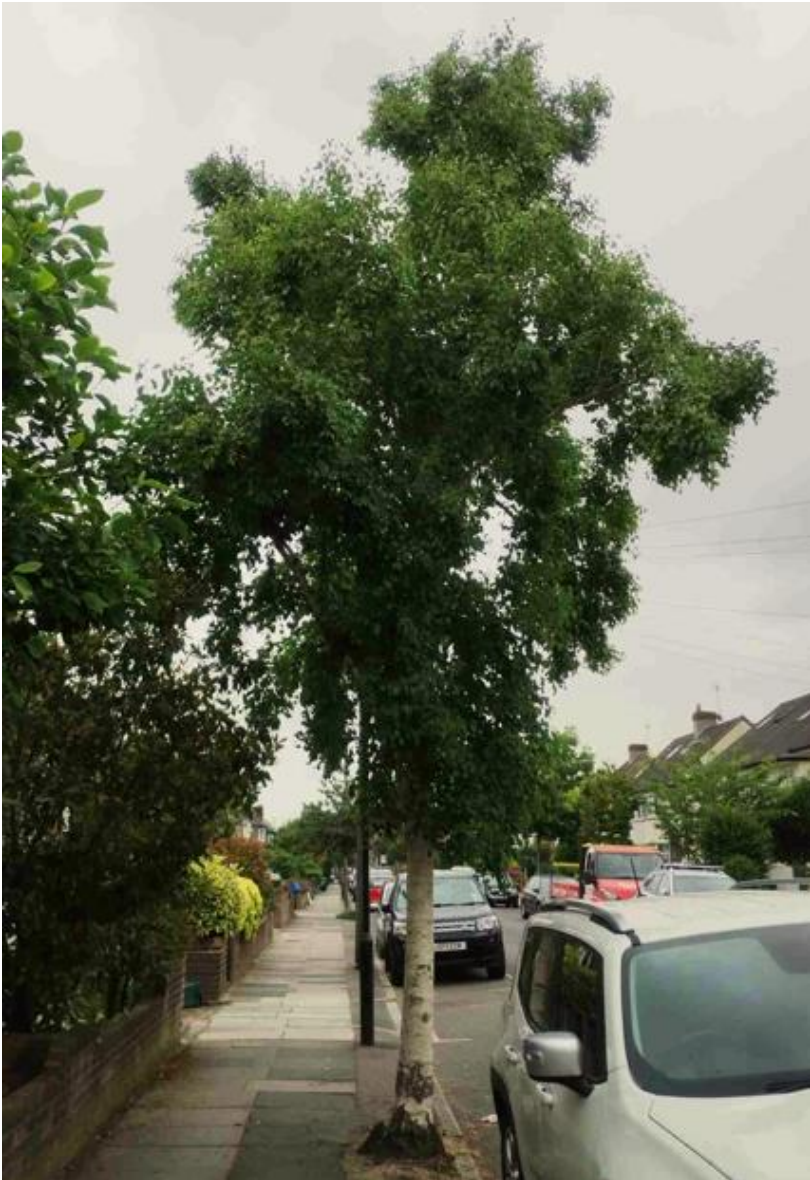
Ward	St Margarets and North Twickenham
Road	Court Way
Location	Outside 42/44
Species	Birch (<i>Betula sp.</i>)
Height	8.0m
Physiological Condition	Fair
Structural Condition	Poor
Inspection findings	There is a large cavity at base of the stem of this tree. Investigation with a probe revealed an unacceptable degree of decay present. Removal is required to prevent natural failure and facilitate replanting.

Image shows tree in street scene.

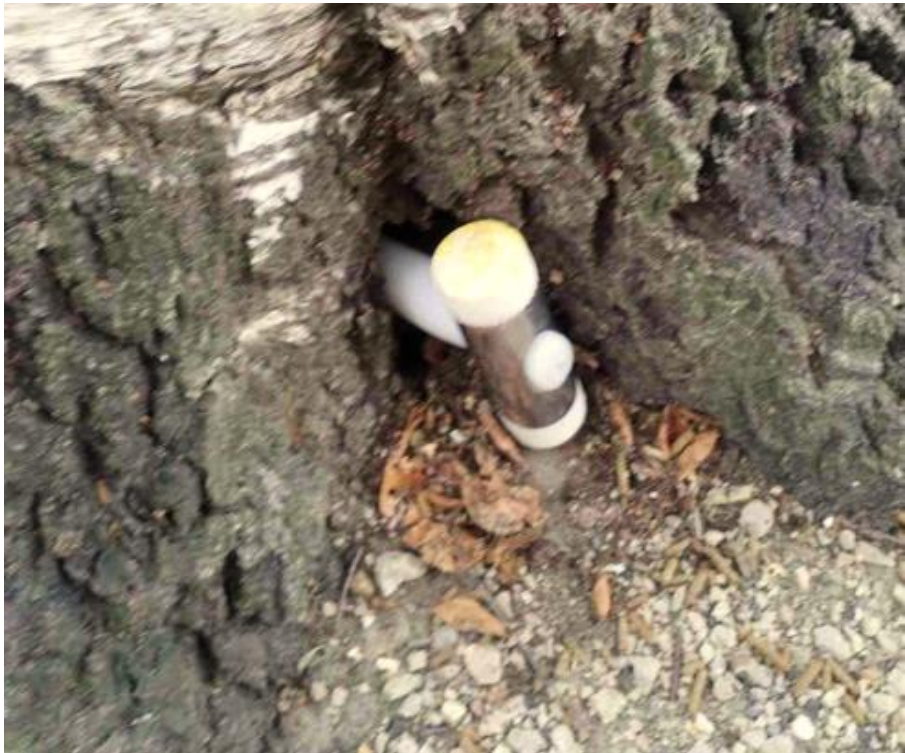
Image shows Cavity viewed from East side at base of tree.

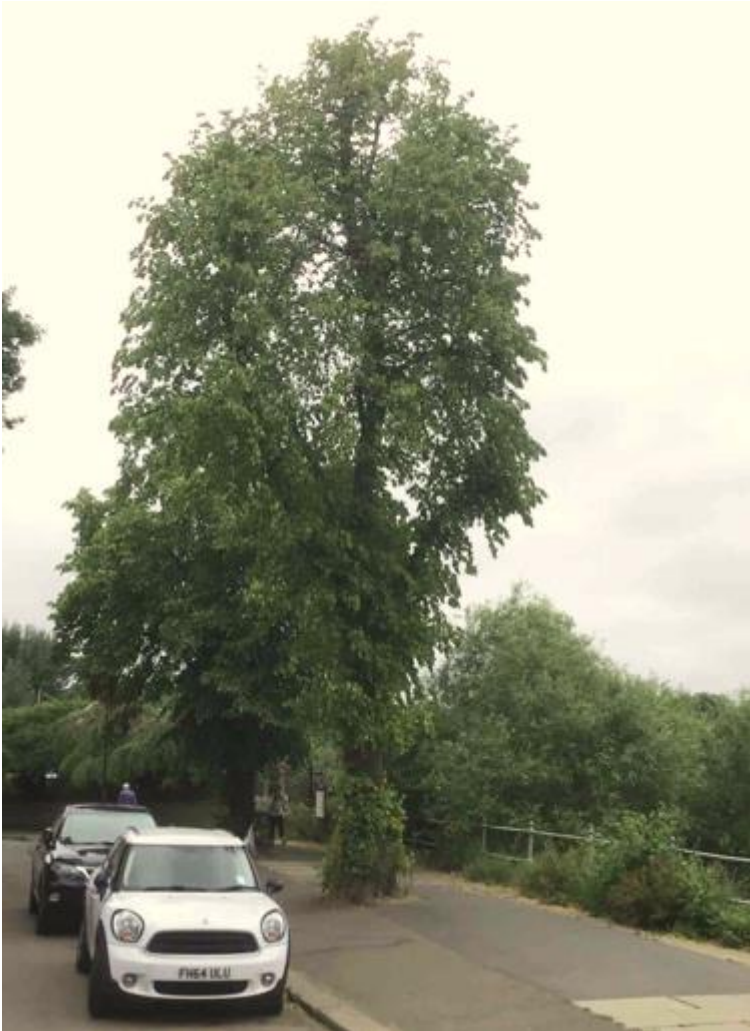
Ward	St Margarets and North Twickenham
Road	Ranelagh Drive
Location	///What3Words- trace.powers.envy
Species	Lime (<i>Tilia sp.</i>)
Height	8.0m
Physiological Condition	Fair
Structural Condition	Poor
Inspection findings	A fungal fruiting body of the decay pathogen <i>Ganoderma</i> sp. is present at the stem base. Colonisation by this fungus causes a white rot of the stem and root system that can cause entire trees to collapse through fracture or windthrow. Investigation with a probe revealed extensive decay and removal is required to prevent natural failure and facilitate replanting.

Image shows tree in street scene.

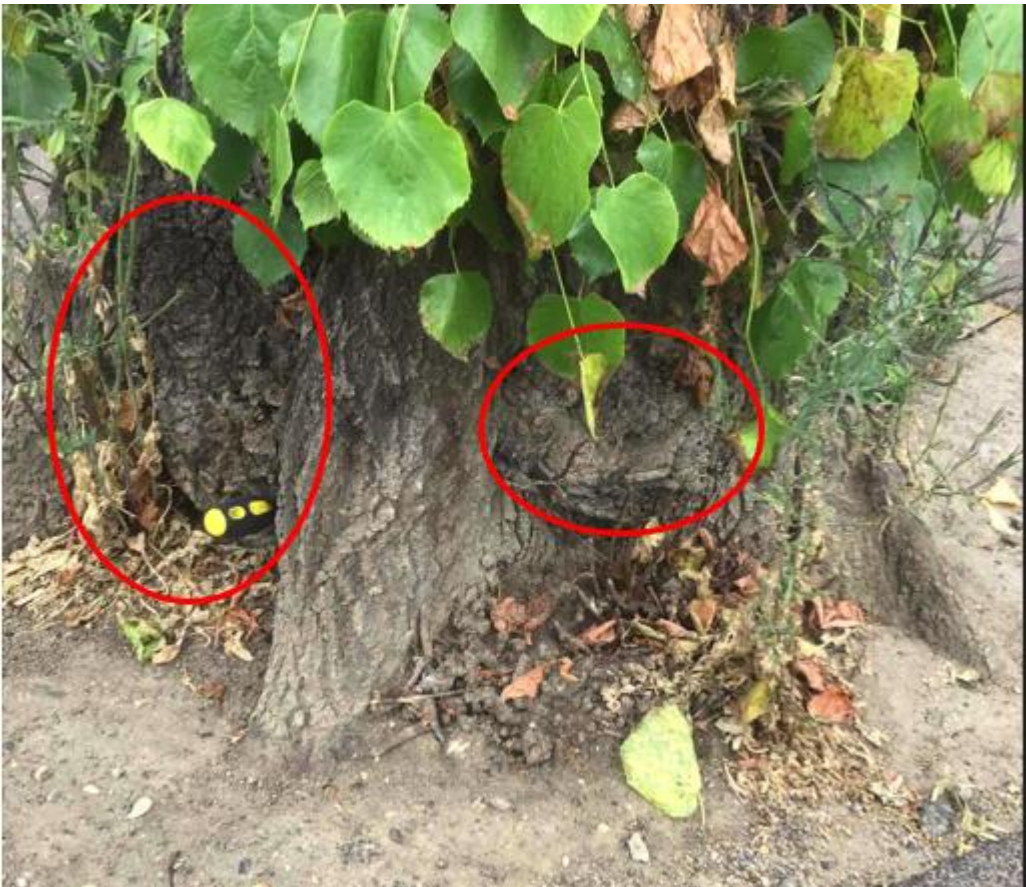
Image shows probe inserted to full extent, highlighting decay in stem (circled left) and fungal fruiting body (circled right)

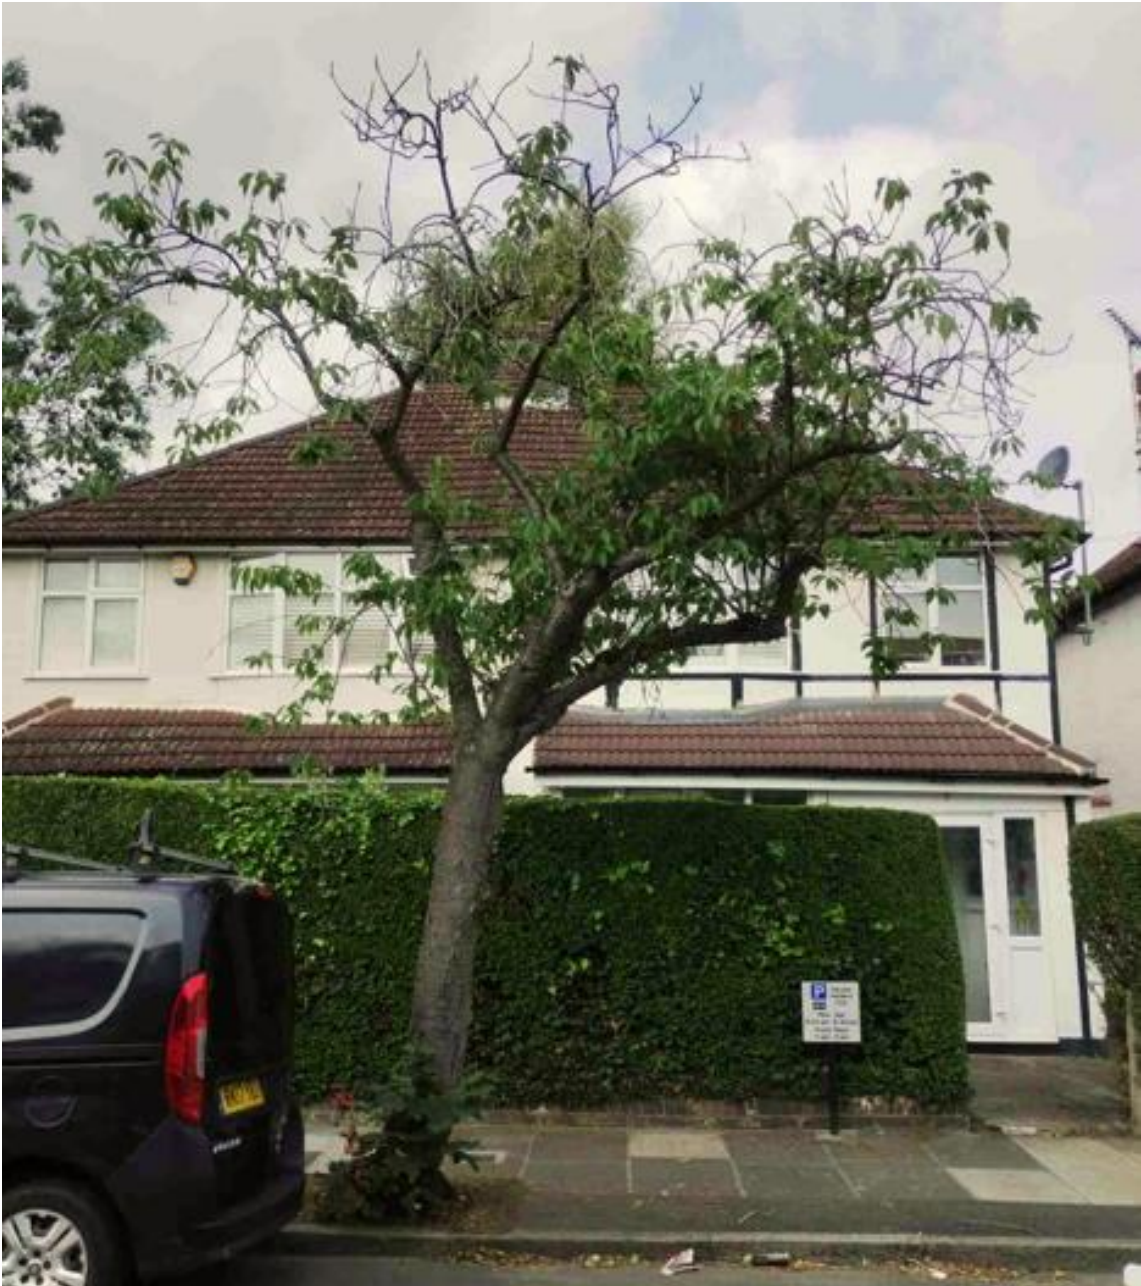
Ward	St Margarets and North Twickenham
Road	Palmerston Road
Location	Outside 1/5
Species	Cherry (<i>Prunus sp.</i>)
Height	6.0m
Physiological Condition	Poor
Structural Condition	Fair
Inspection findings	Tree crown is displaying advanced symptoms of physiological decline with over 60% of crown being dead. Removal is required to prevent natural failure and facilitate replanting.

Image shows tree in street scene with canopy dieback evident.

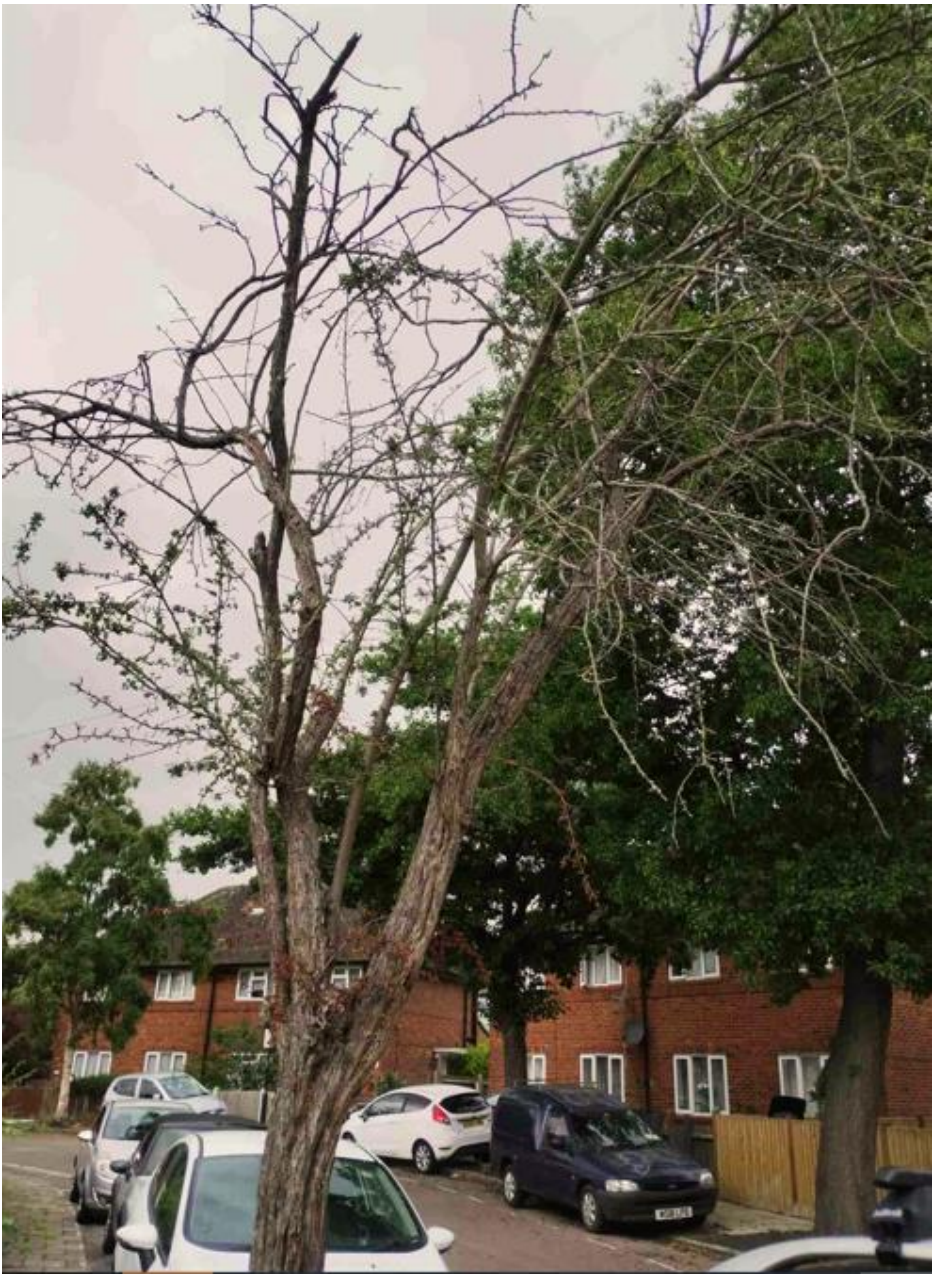
Ward	St Margarets and North Twickenham
Road	Marlow Crescent
Location	Opposite 39/41
Species	Hawthorn (<i>Crataegus monogyna</i>)
Height	7.0m
Physiological Condition	Poor
Structural Condition	Fair
Inspection findings	Tree crown is displaying advanced symptoms of physiological decline with over 90% of crown being dead. Removal is required to prevent natural failure and facilitate replanting.

Image shows tree in street scene with extensive canopy dieback present

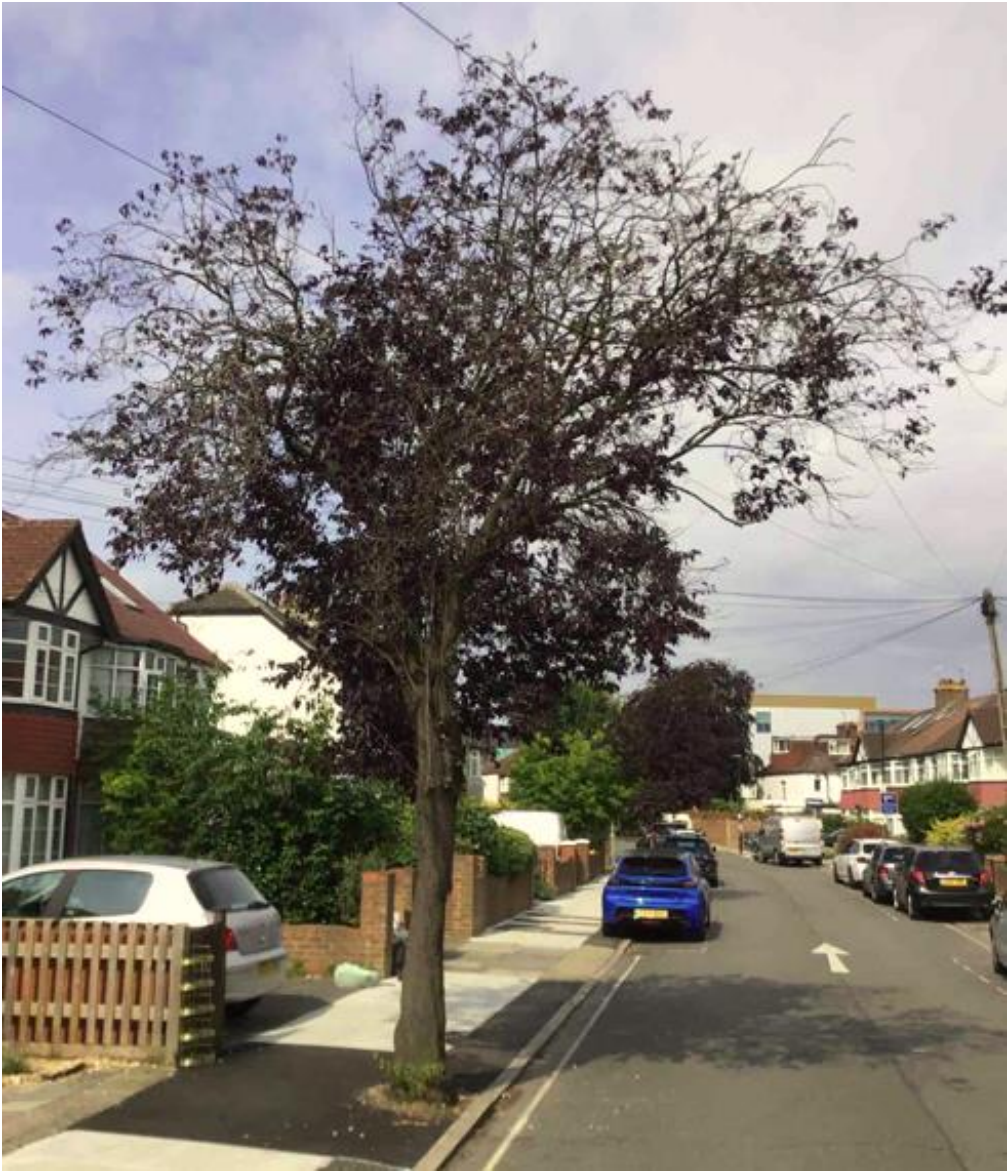
Ward	St Margarets and North Twickenham
Road	Heathfield North
Location	Outside 77/79
Species	Cherry Plum (<i>Prunus cerasifera</i>)
Height	7.5m
Physiological Condition	Poor
Structural Condition	Poor
Inspection findings	Fungal fruiting bodies of the wood decay fungus <i>Laetiporus sulphureus</i> are present on the trunk of this tree. This fungus causes a brown rot which can rapidly reduce wood strength and cause branch or whole tree failure through brittle fracture. The crown dieback could correlate with the degradation of the trees structural. Removal is required to prevent natural failure and facilitate replanting.

Image shows tree in street scene with canopy dieback present.

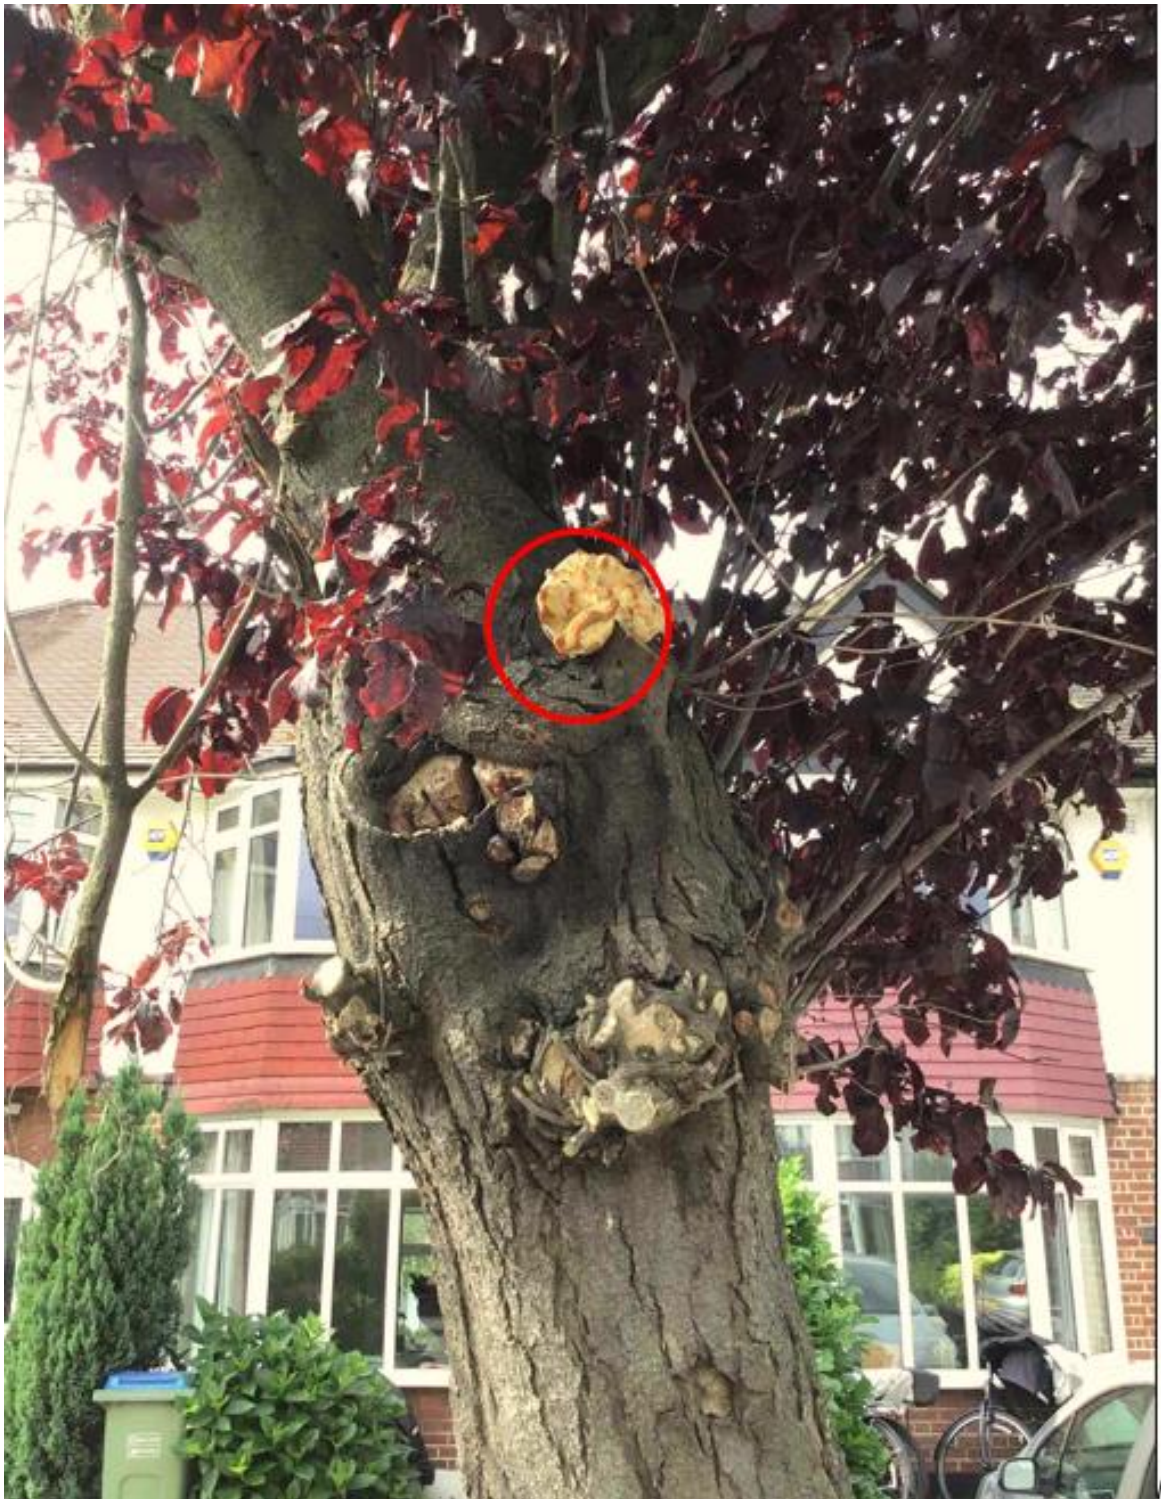
Image shows fruiting body on main stem circled

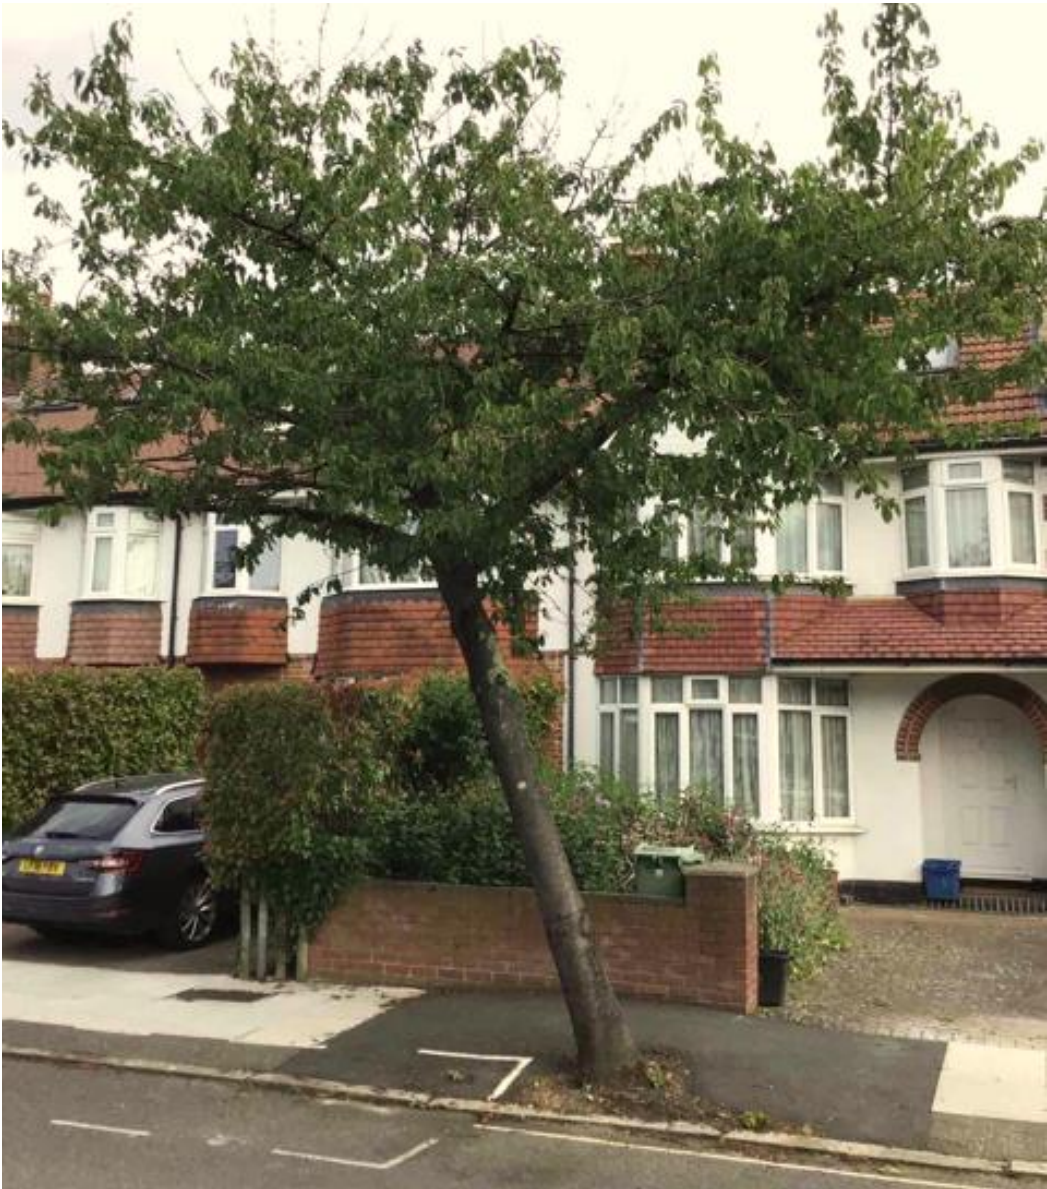
Ward	St Margarets and North Twickenham
Road	Heathfield North
Location	Outside 60
Species	Cherry (<i>Prunus sp.</i>)
Height	7.0m
Physiological Condition	Poor
Structural Condition	Poor
Inspection findings	Stem lean towards East has increased from 15 degrees measured in 2019 to 20 degrees in 2023 inspection and visible heave to the pavement indicates degradation of the trees structural. Removal is required to prevent natural failure and manage risk.

Image shows tree in street scene.

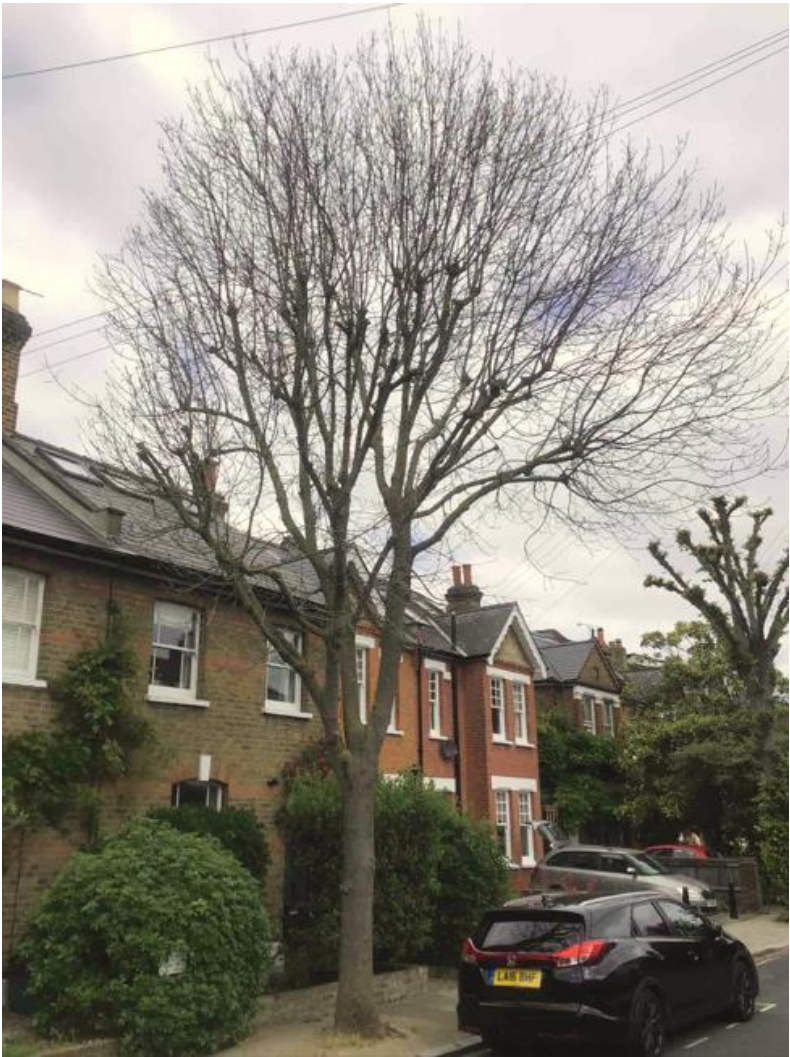
Ward	Teddington
Road	Teddington Park
Location	Outside 13/15
Species	Common Ash (<i>Fraxinus excelsior</i>)
Height	12.5m
Physiological Condition	Dead
Structural Condition	Dead
Inspection findings	This tree has died, likely caused by Ash Dieback (<i>Hymenoscyphus fraxineus</i>). This is serious fungal disease of the European Ash, characterized by the progressive decline of the tree's branches and will eventually lead to the death of the tree. This tree requires removal to facilitate replanting and prevent natural failure.

Image shows dead tree in street scene.

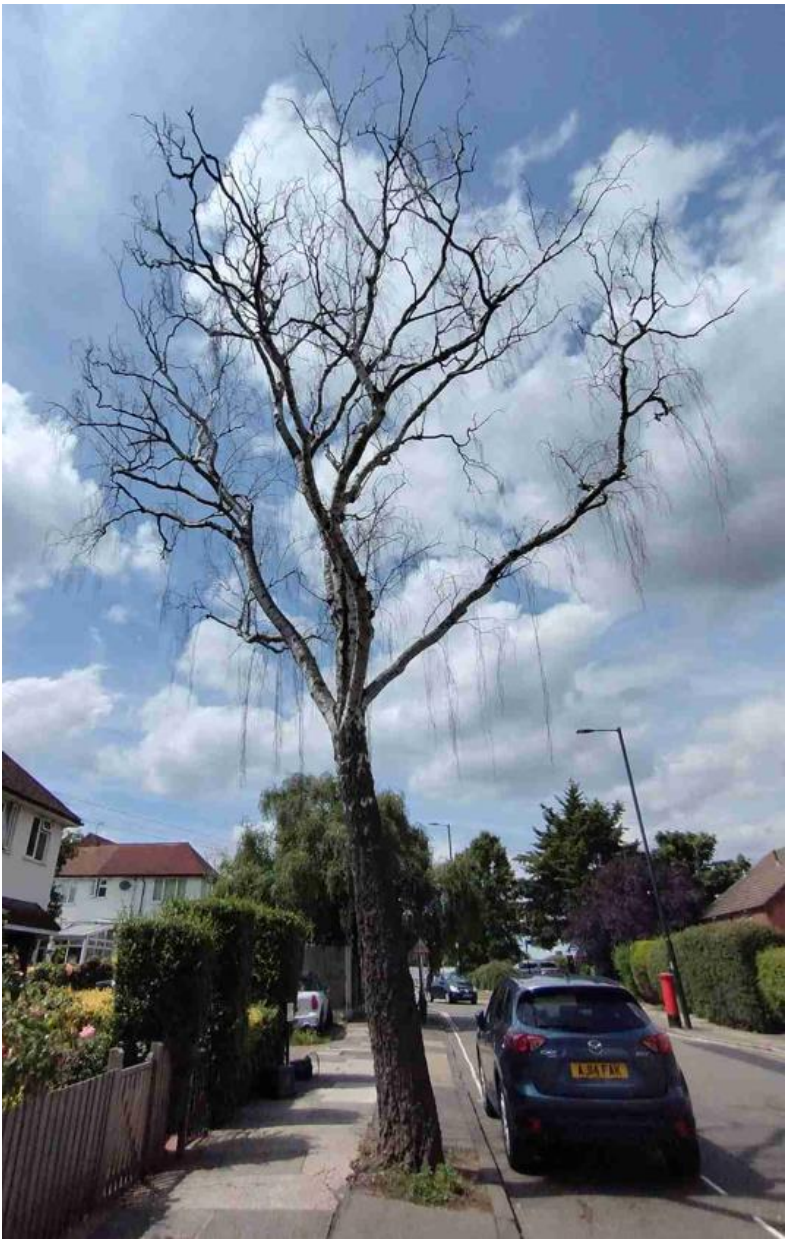
Ward	West Twickenham
Road	Meadway
Location	Outside 111/113
Species	Silver Birch (<i>Betula pendula</i>)
Height	14.5m
Physiological Condition	Dead
Structural Condition	Poor
Inspection findings	This tree is dead and requires removal to facilitate replanting and prevent natural failure.

Image shows dead tree in street scene

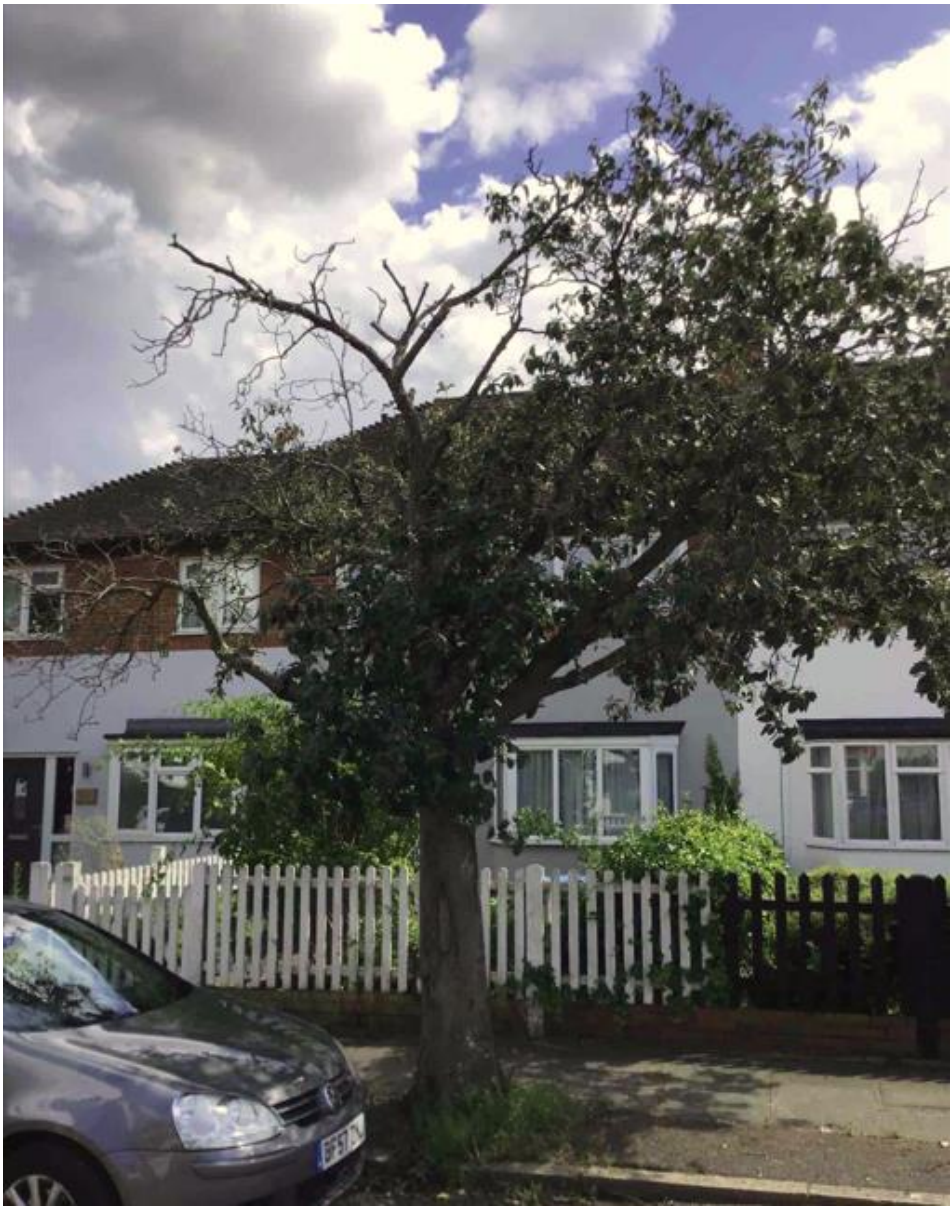
Ward	West Twickenham
Road	Rivermeads Avenue
Location	Outside 31
Species	Whitebeam (<i>Sorbus aria</i>)
Height	5.5m
Physiological Condition	Poor
Structural Condition	Poor
Inspection findings	Roots and lower stem decay is present at the base of this tree. Crown dieback correlates with the degradation of the trees lower stem and root system. This tree requires removal to facilitate replanting and prevent natural failure.

Image shows tree with extensive canopy loss and deadwood

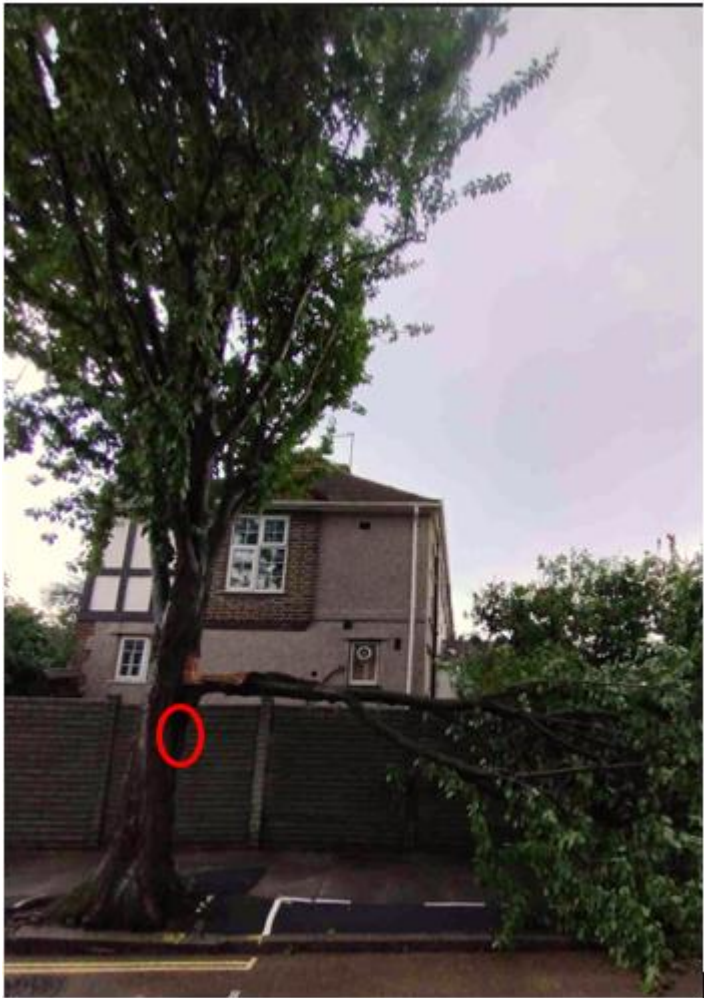
Ward	West Twickenham
Road	Fulwell Park Avenue
Location	Opposite 147
Species	Cherry (<i>Prunus</i> sp.)
Height	10.5m
Physiological Condition	Fair
Structural Condition	Poor
Inspection findings	A major stem failed on this tree. Aa inspection of the tree revealed a fungal fruiting body of the decay pathogen <i>Ganoderma</i> sp. on the main stem below the failure. Colonisation by this fungus causes a white rot of the stem and root system that can cause entire trees to collapse through fracture or windthrow. Removal is required to prevent further failure and facilitate replanting.

Image shows tree in street scene with failed branch with fungal fruiting body circled.
