September 2023 - Reactive Tree Works Programme

The following pages provide the locations of each tree that is to be removed, in addition photographs and descriptions of the inspection findings have been provided.

Dated 18.9.2023

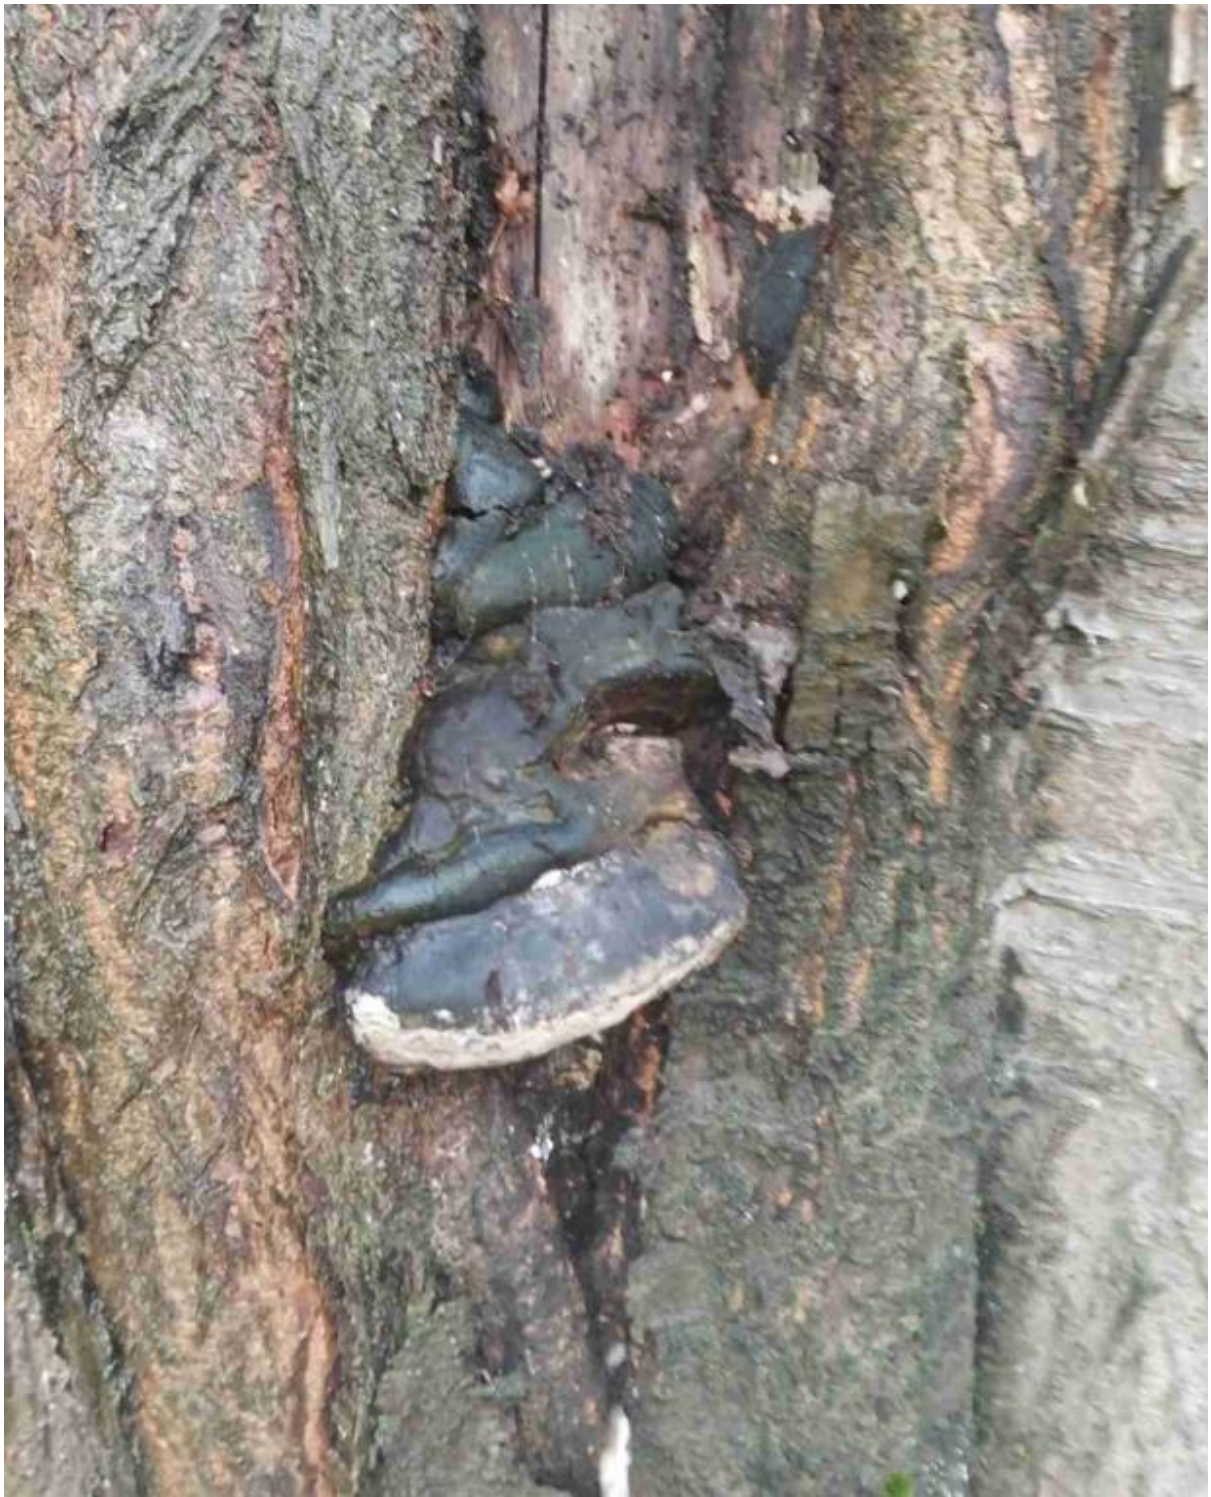
Image shows fruiting body on main stem.

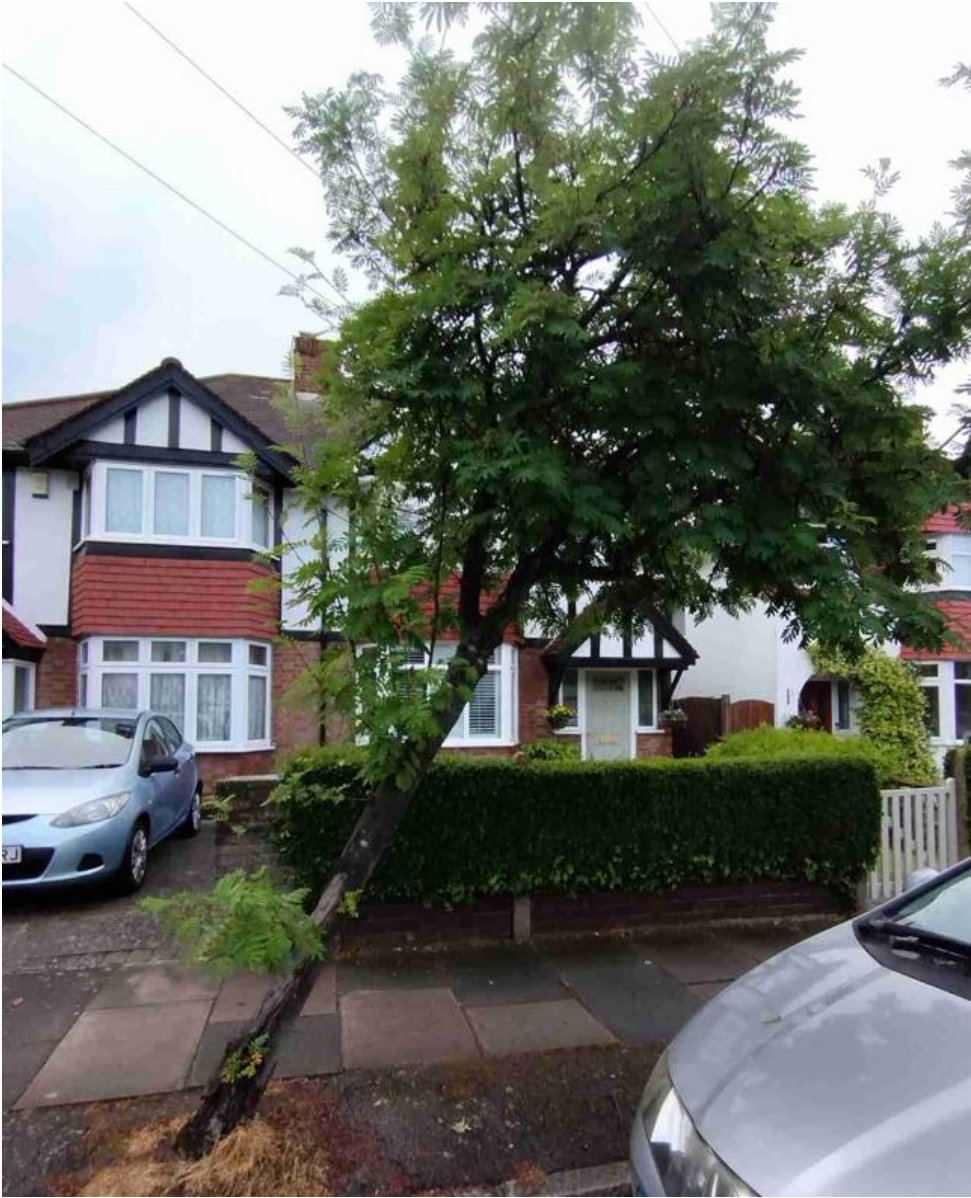
Ward	West Twickenham
Road	Rivermeads Avenue
Location	Outside 20/22
Species	Rowan (<i>Sorbus aucuparia</i>)
Height	4.0m
Physiological Condition	Good
Structural Condition	Poor
Inspection findings	This tree has sustained historic vehicle damage on the lower stem; this extensive wounding has caused necrosis which has led to decay causing the stem to part fail. Removal is required to prevent further failure and facilitate replanting.

Image shows tree in street scene

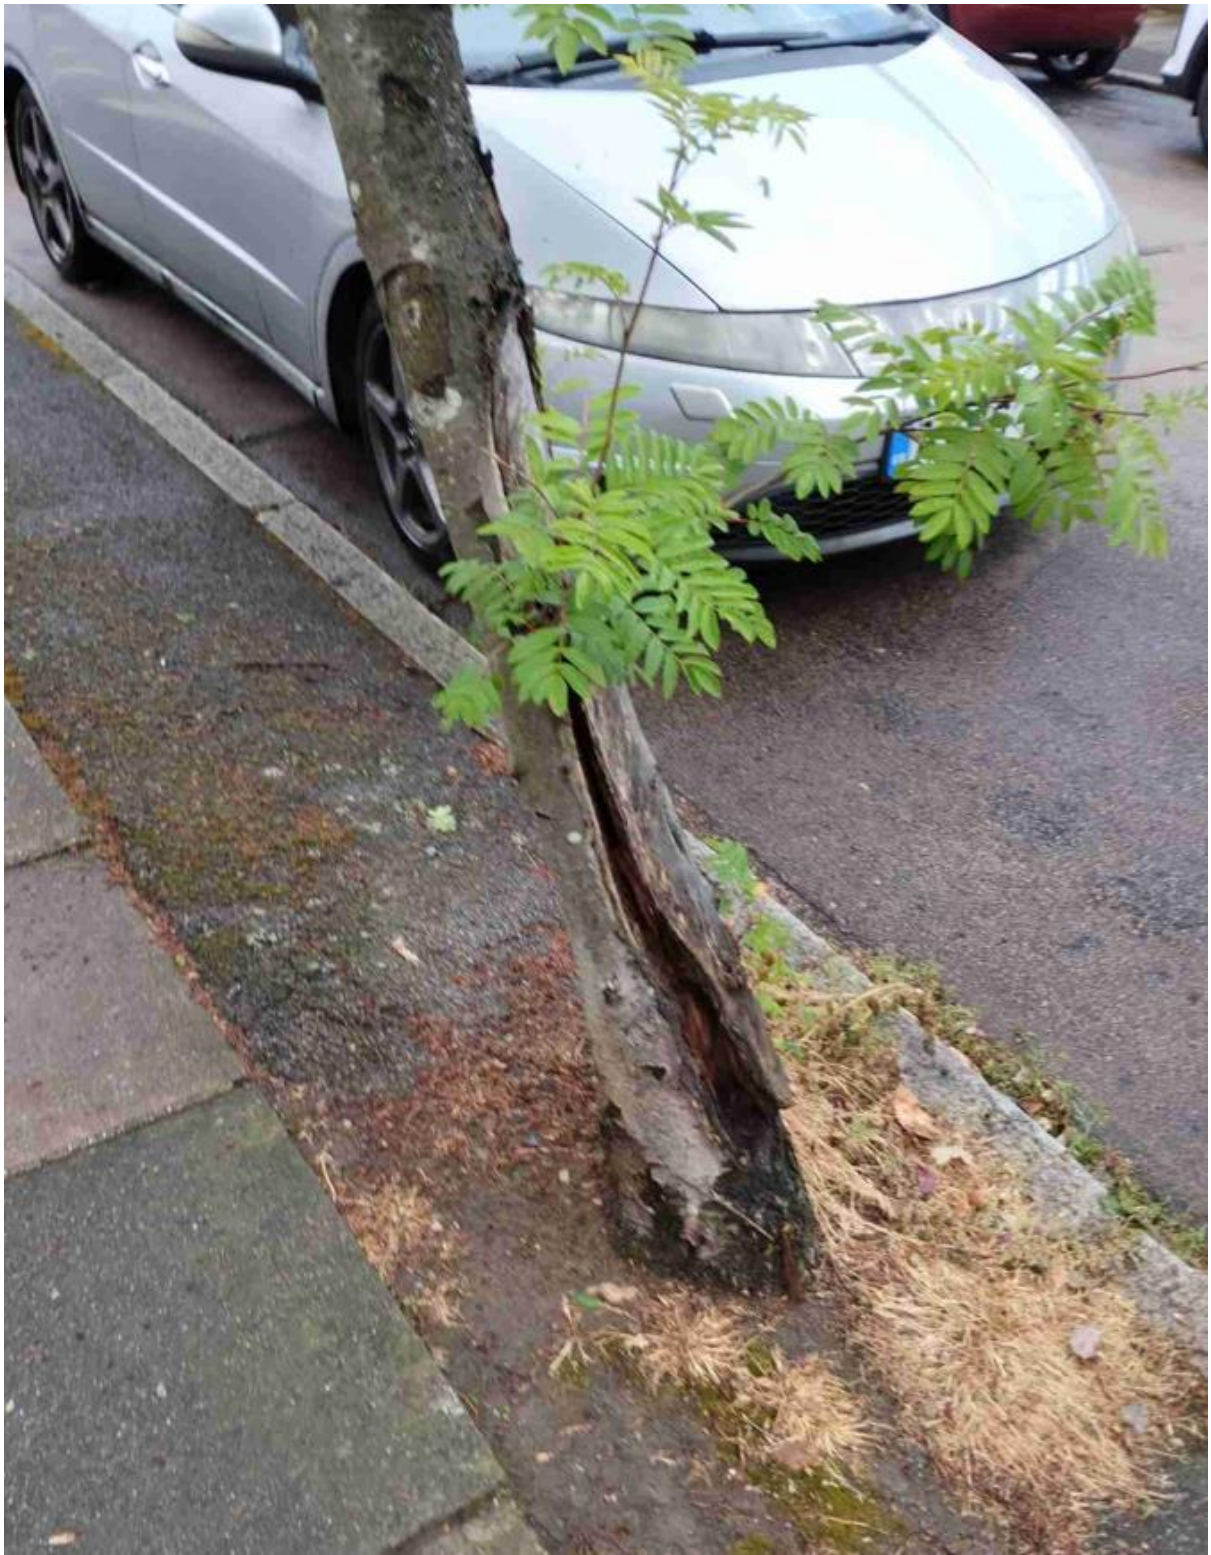
Image shows stem damage with decay, which has led to stem failure.

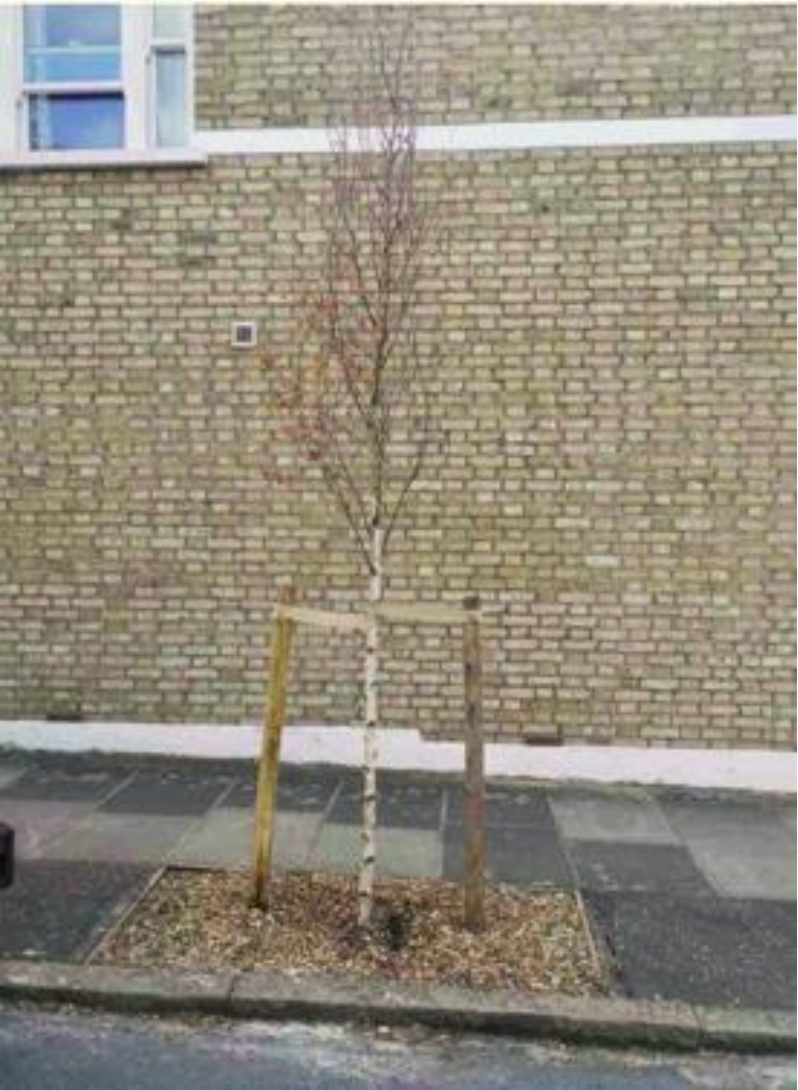
Ward	Whitton
Road	Camellia Place
Location	Opposite 62
Species	Birch (<i>Betula sp.</i>)
Height	2.0m
Physiological Condition	Dead
Structural Condition	Dead
Inspection findings	This newly planted tree is dead due to suspected poisoning. Purple plastic coving drill hole where poison was injected into stem. Removal is required to facilitate replanting of tree

Images shows dead tree

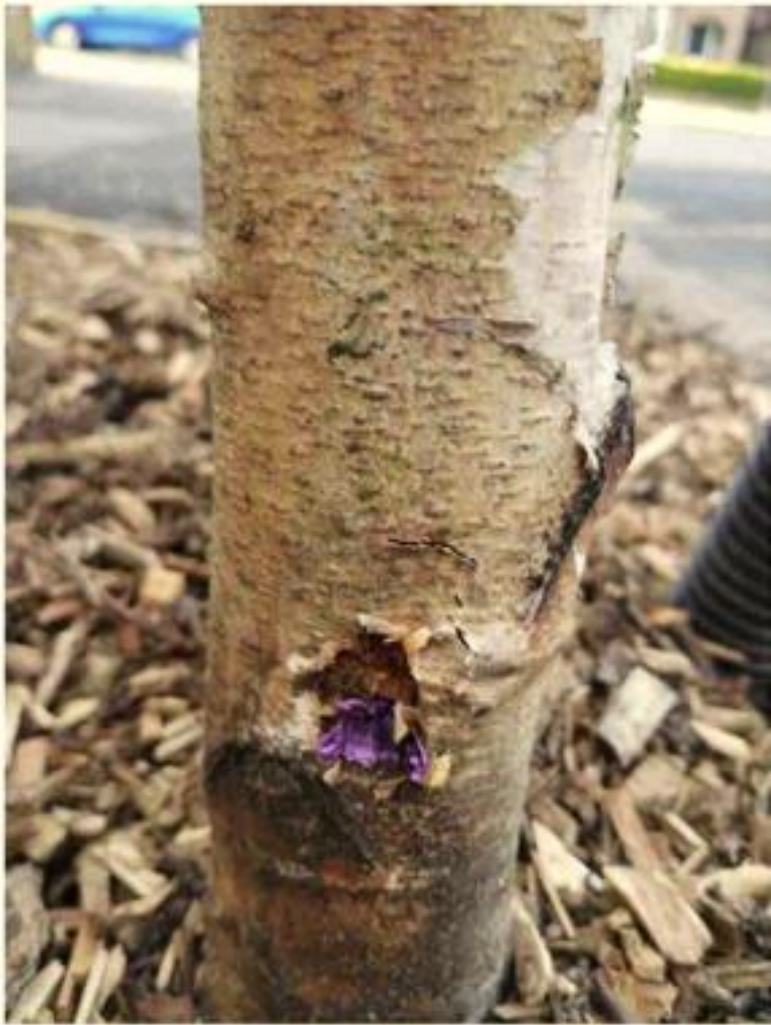
Images shows purple plastic covering hole in stem where poison suspected to be injected

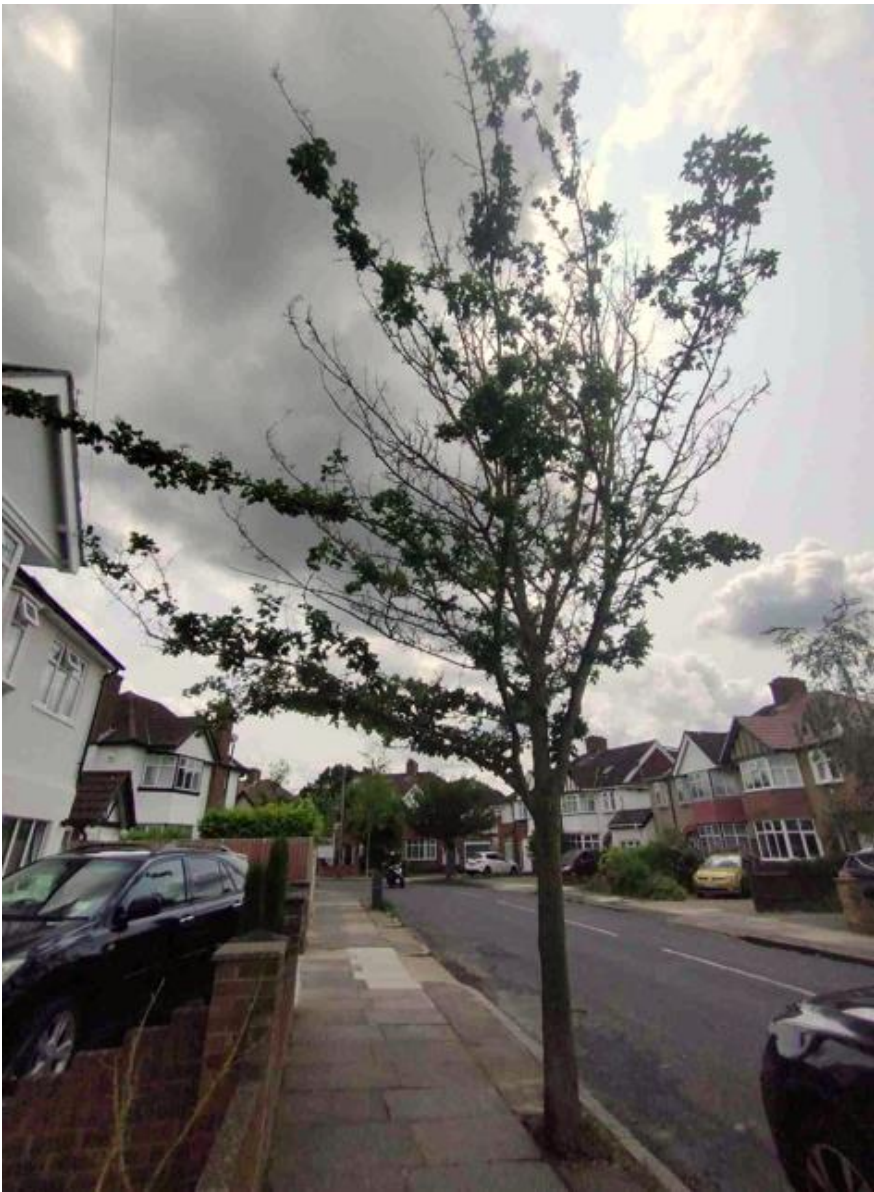
Ward	Whitton
Road	Constance Road
Location	Outside 54/56
Species	Field Maple (<i>Acer campestre</i>)
Height	8.5m
Physiological Condition	Poor
Structural Condition	Good
Inspection findings	Tree crown is displaying advanced symptoms of physiological decline with over 50% of crown being dead. Removal is required to prevent natural failure and facilitate replanting.

Image shows tree in street scene showing crown in a state of decline

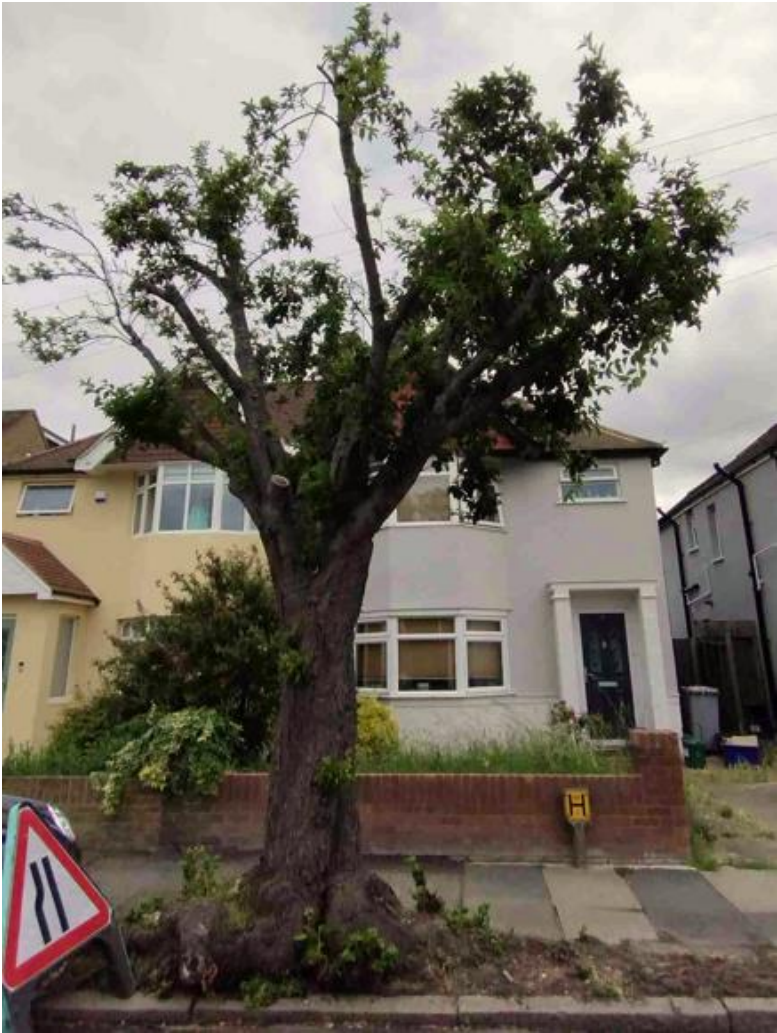
Ward	Whitton
Road	Whitton Way
Location	Outside 5o
Species	Cherry (<i>Prunus avium</i>)
Height	8.5m
Physiological Condition	Fair
Structural Condition	Poor
Inspection findings	A fungal fruiting body of the decay pathogen <i>Ganoderma</i> sp. is present at the stem base. Colonisation by this fungus causes a white rot of the stem and root system that can cause entire trees to collapse through fracture or windthrow. A resonance test has indicated root and lower stem or trunk decay; this decay correlates with crown dieback and decline. Removal is required to prevent natural failure and facilitate replanting.

Image shows tree in street scene in poor condition

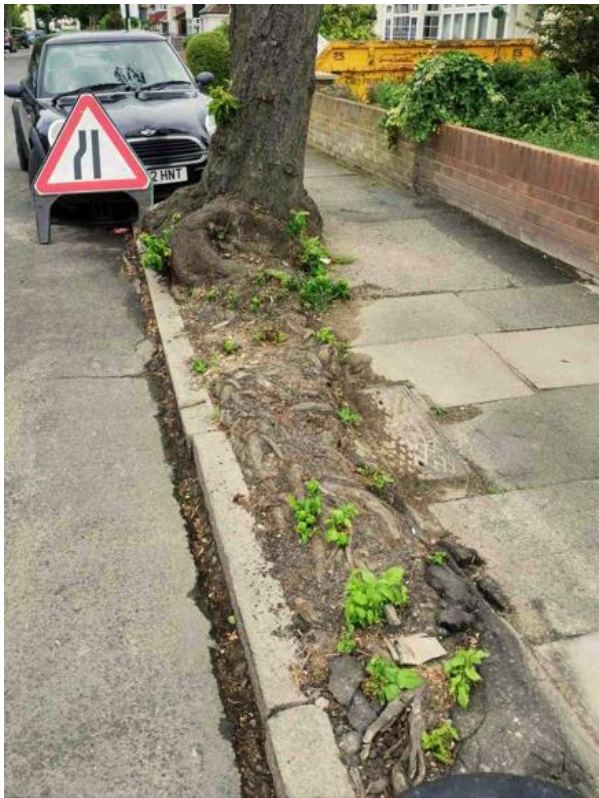
Image shows exposed damaged roots.

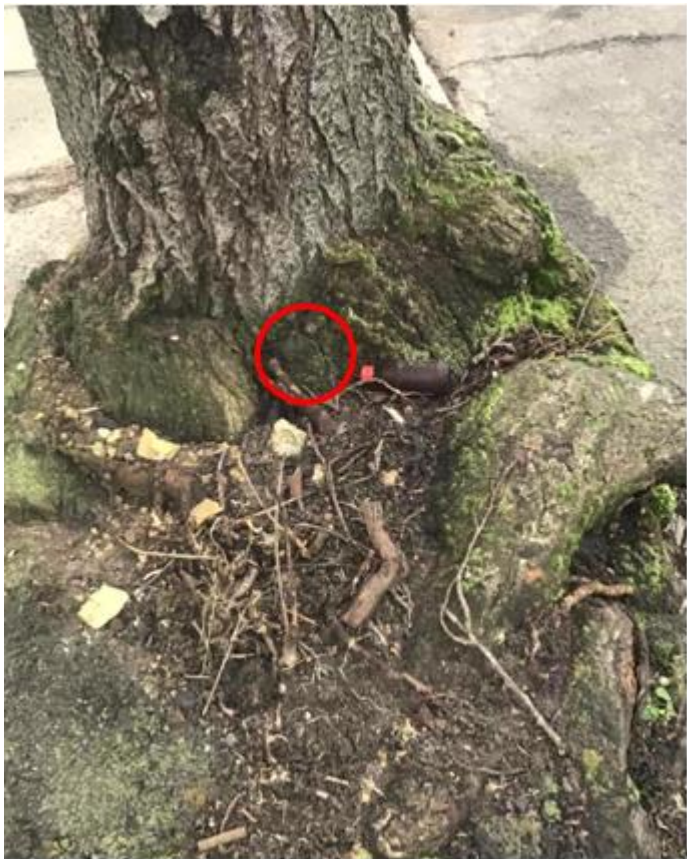
Image shows base of stem with location of fungal fruiting body circled.
