March 2024 - Reactive Tree Works Programme

Introduction

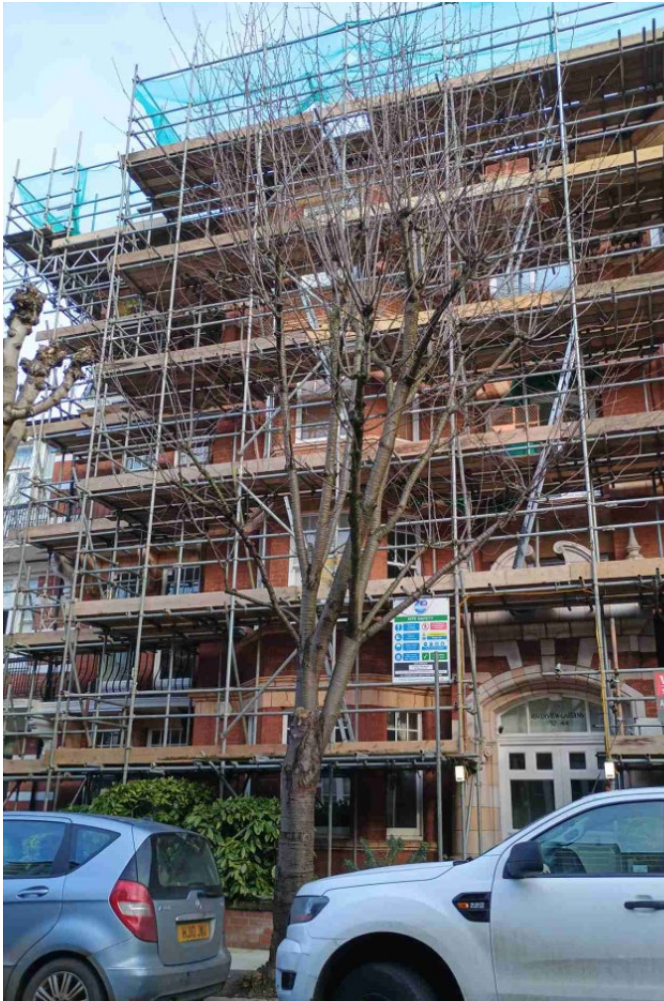
Image shows tree in street scene

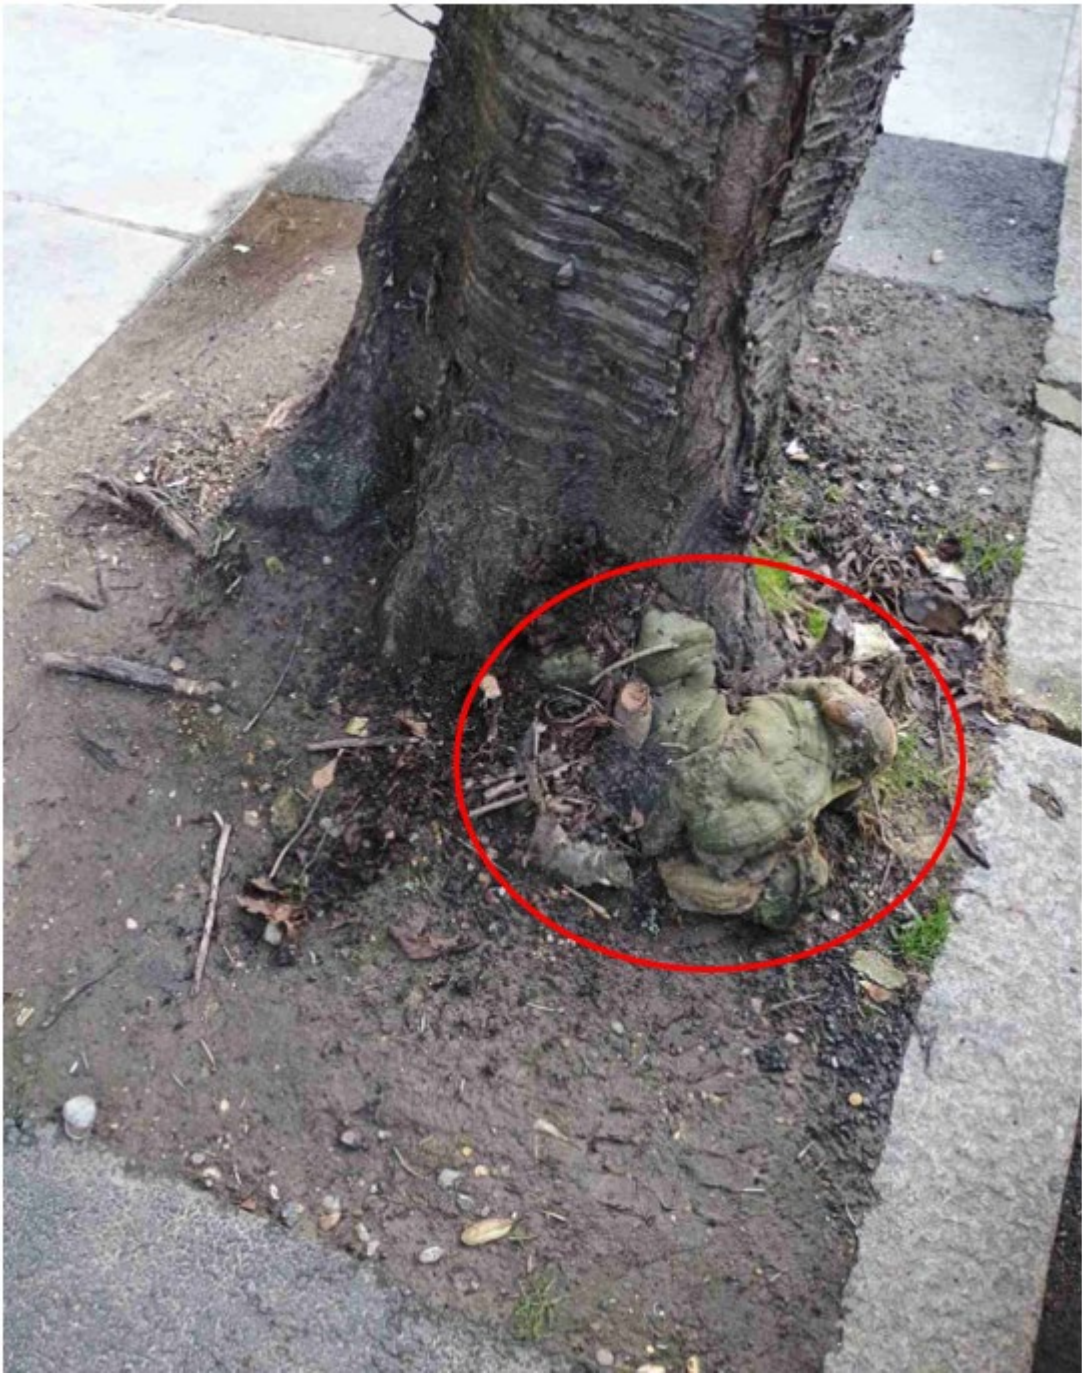
Ward	Barnes
Road	Riverview Gardens
Location	Outside 37-44 Riverview Gardens.
Species	Schmitt's cherry (<i>Prunus x schmittii</i>)
Height	10.5m
Physiological Condition	Fair
Structural Condition	Poor
Inspection findings/reason for exemption	A fungal fruiting body of the decay fungi <i>Ganoderma sp.</i> is present at the base of the trunk. Colonisation by this fungus causes a white rot of the stem and root system that can cause entire trees to collapse through fracture or windthrow. A resonance test revealed an unacceptable degree of decay in the trunk of this tree. Removal is required to prevent natural failure, manage risk, and facilitate replanting.

Image shows fungal fruiting bodies circled.

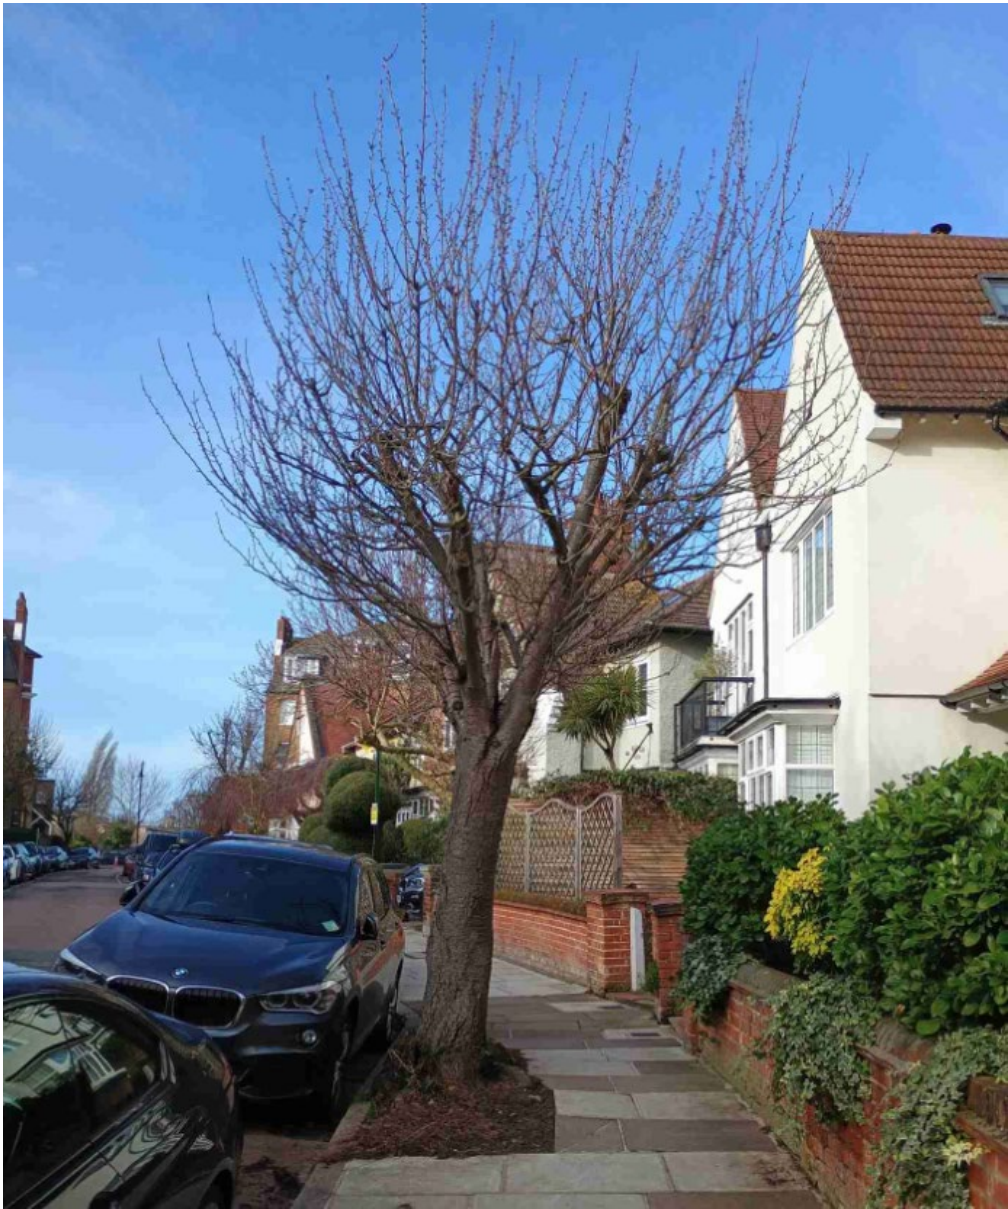
Image shows tree in street scene.

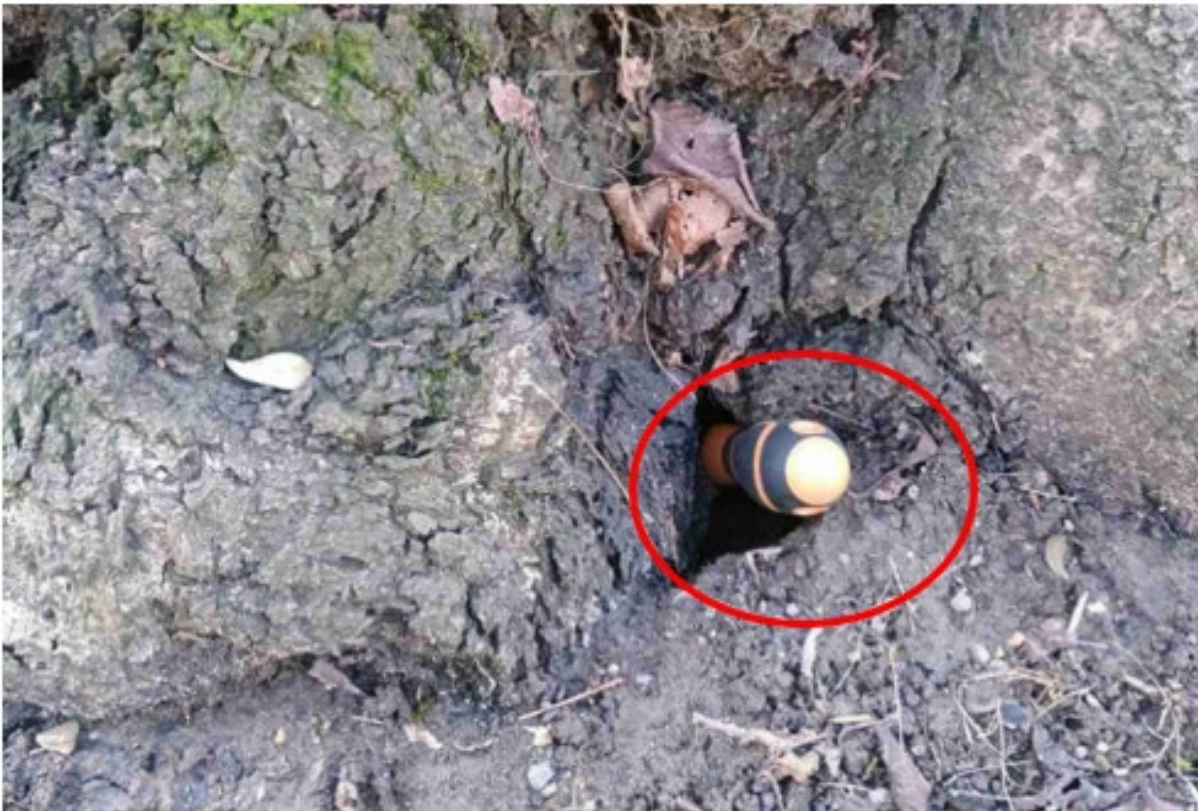
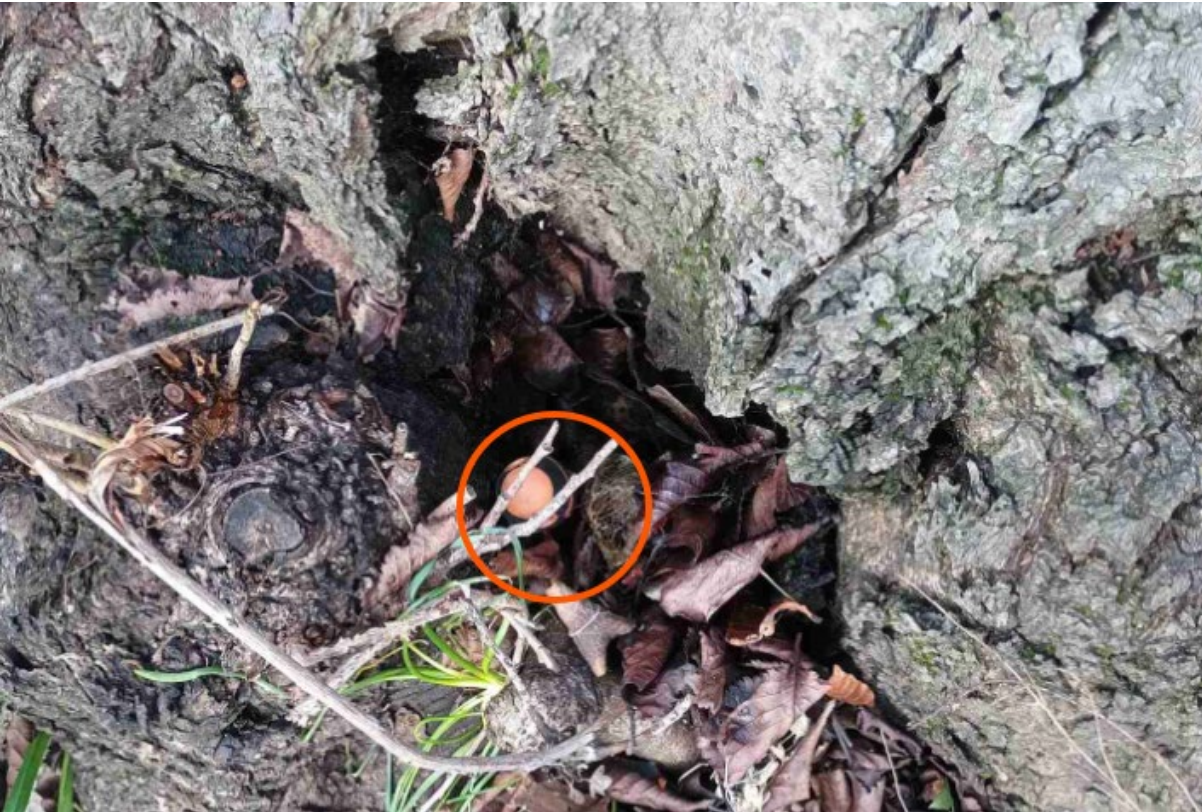
Ward	Barnes
Road	Clavering Avenue
Location	Outside 18
Species	Schmitt's cherry (<i>Prunus x schmittii</i>)
Height	7.0m
Physiological Condition	Good
Structural Condition	Poor
Inspection findings/reason for exemption	Investigation with a probe and a resonance test with a sounding hammer has revealed an unacceptable amount of decay beyond the visible cavities at the base of the trunk. Removal is required to prevent natural failure, manage risk, and facilitate replanting.

Image shows probe in cavity at base of trunk circled.

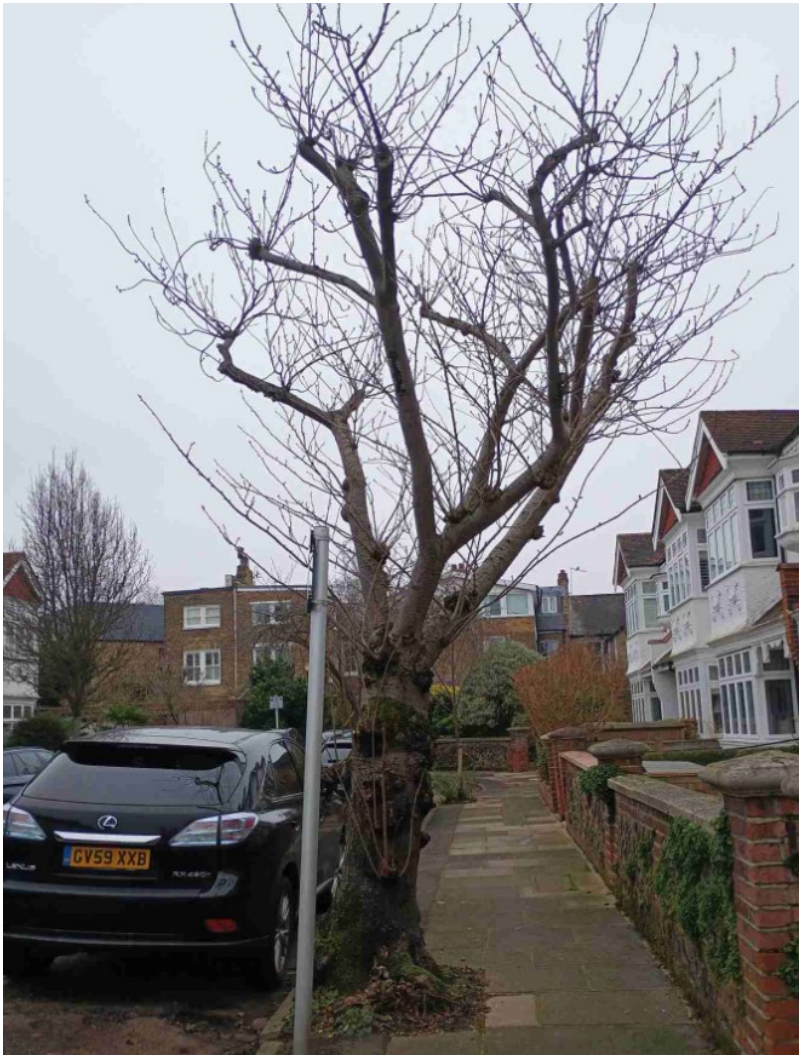
Image shows tree in street scene and near complete die back of crown

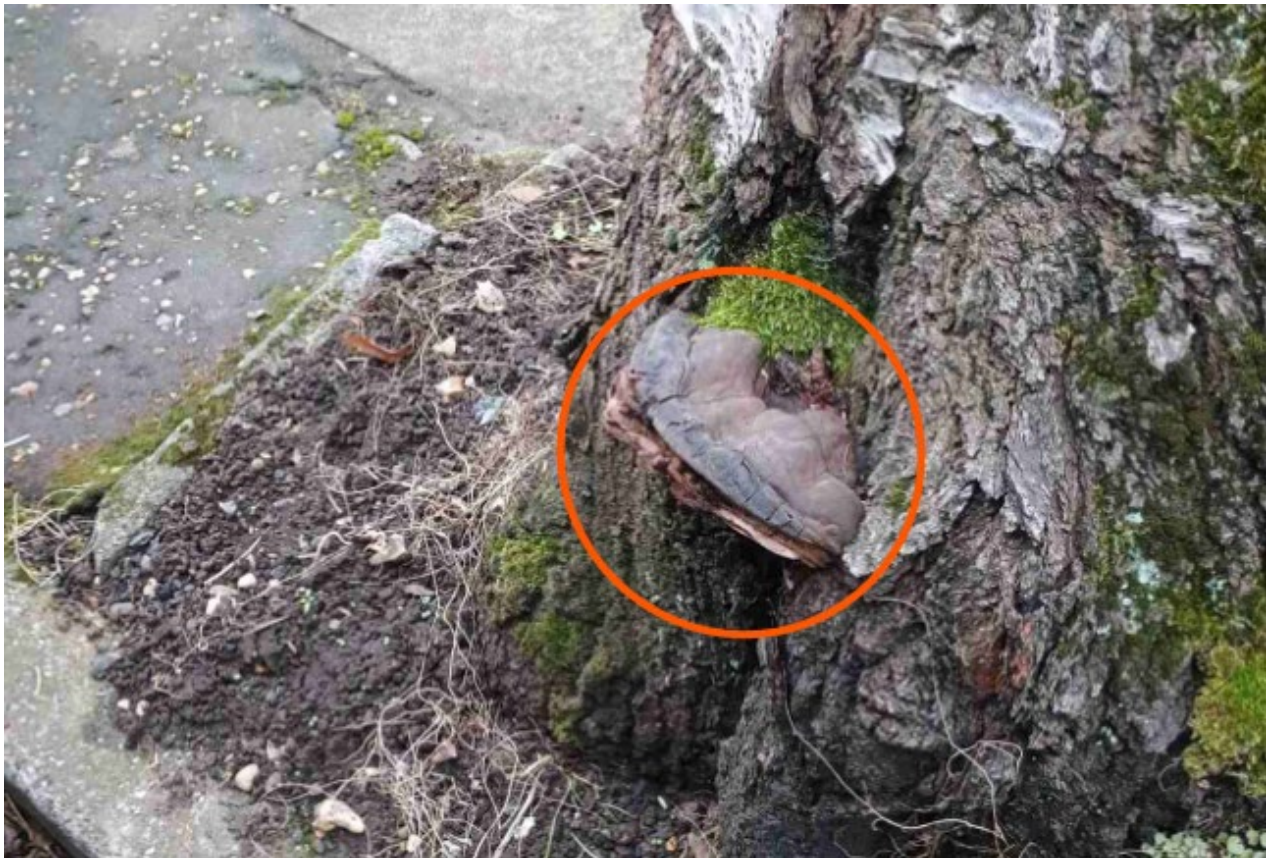
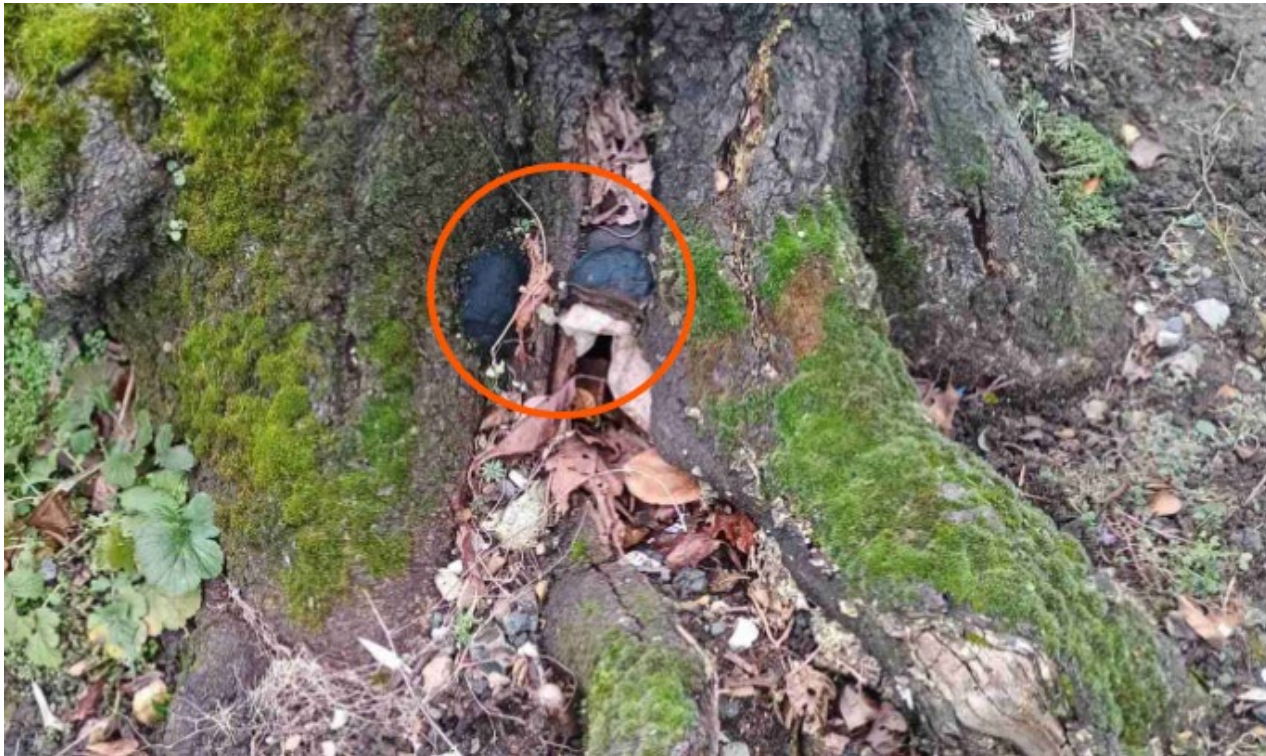
Ward	Barnes
Road	Bracken Gardens
Location	Outside 12A
Species	Wild Cherry (<i>Prunus avium</i>)
Height	7.5m
Physiological Condition	Fair
Structural Condition	Poor
Inspection findings/reason for exemption	A fungal fruiting body of the decay fungi <i>Ganoderma sp.</i> is present at the base of the trunk. Colonisation by this fungus causes a white rot of the stem and root system that can cause entire trees to collapse through fracture or windthrow. A resonance test revealed an unacceptable degree of decay in the trunk of this tree. Removal is required to prevent natural failure, manage risk, and facilitate replanting.

Image shows fungal fruiting bodies circled.

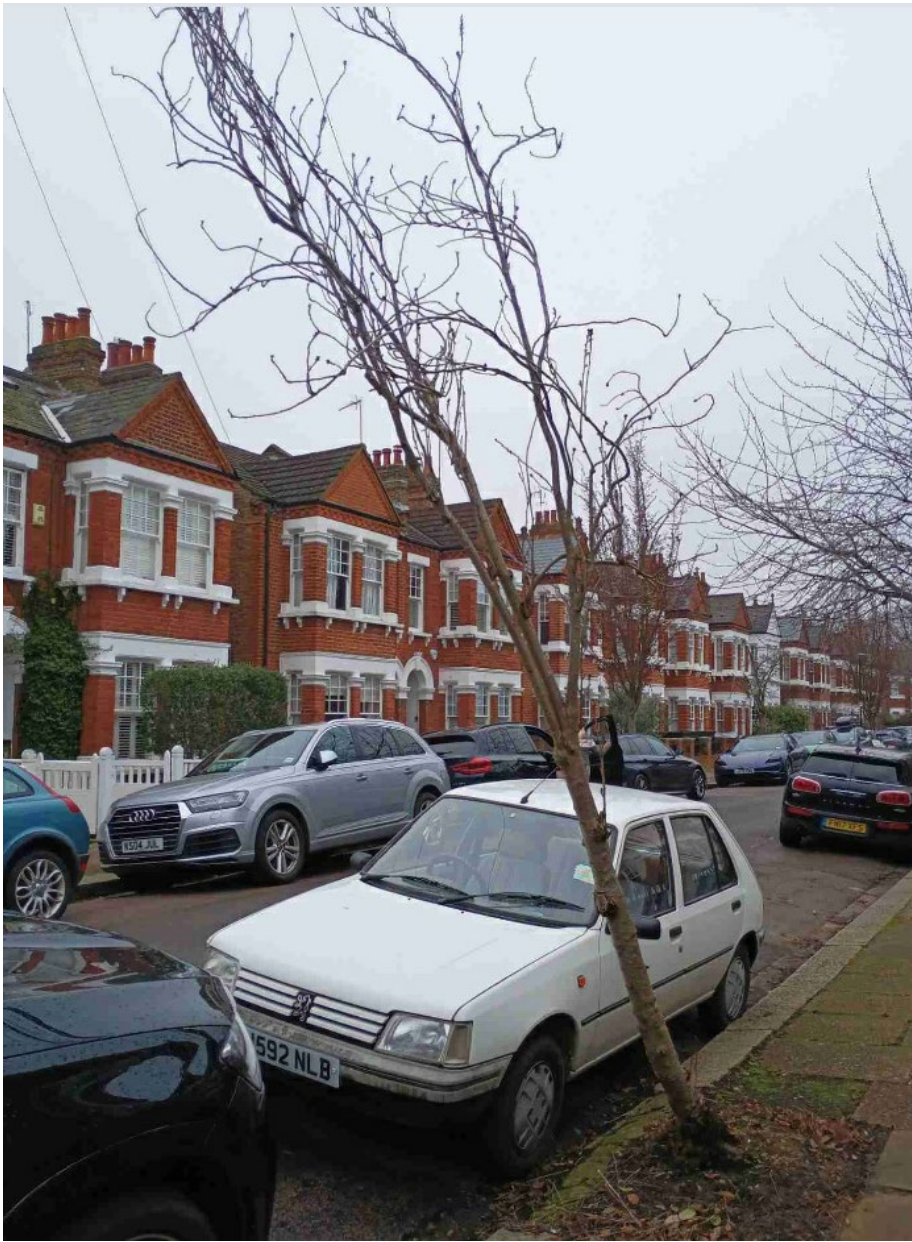
Ward	Barnes
Road	Rectory Road
Location	Outside 48
Species	Wild Cherry (<i>Prunus avium</i>)
Height	5.0m
Physiological Condition	Fair
Structural Condition	Poor
Inspection findings/reason for exemption	This tree has a progressive lean, and the trunk is moving in such a way that indicates that the root structure is compromised presenting increased risk of failure. Removal is required to prevent natural failure, manage risk, and facilitate replanting.

Image shows leaning tree in street scene.

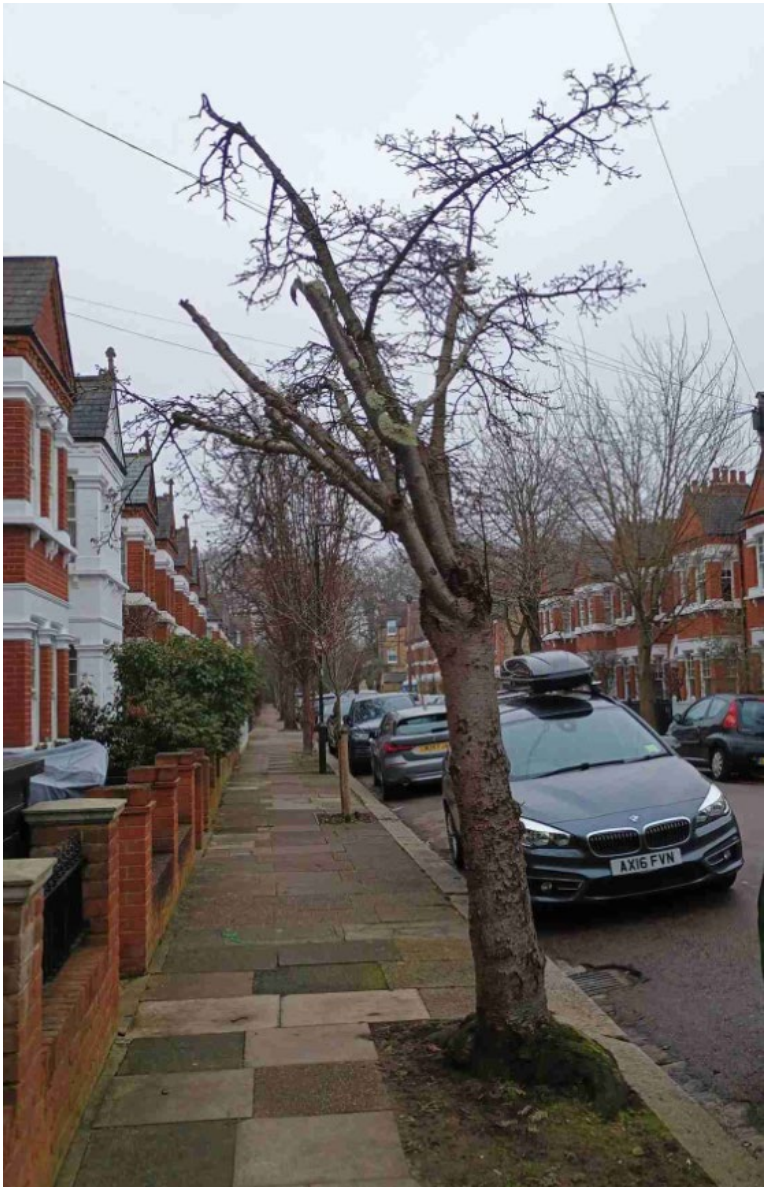
Ward	Barnes
Road	Rectory Road
Location	Outside 36
Species	Wild Cherry (<i>Prunus avium</i>)
Height	4.0m
Physiological Condition	Poor
Structural Condition	Poor
Inspection findings/reason for exemption	This tree is moribund with up to 50% of the crown having died off. Removal is required to prevent natural failure, manage risk, and facilitate replanting.

Image shows moribund tree in street scene.

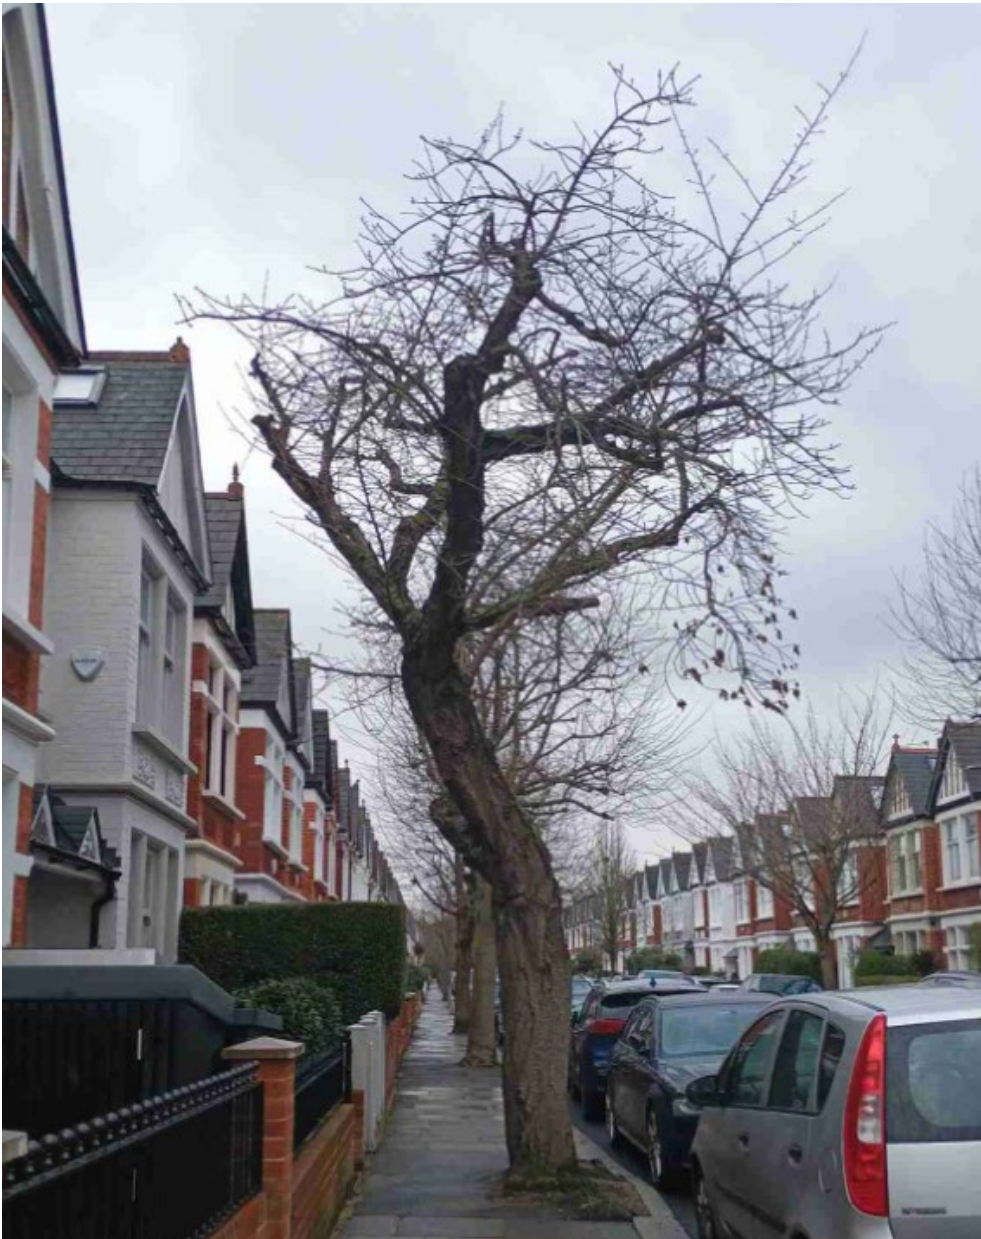
Image shows tree in street scene

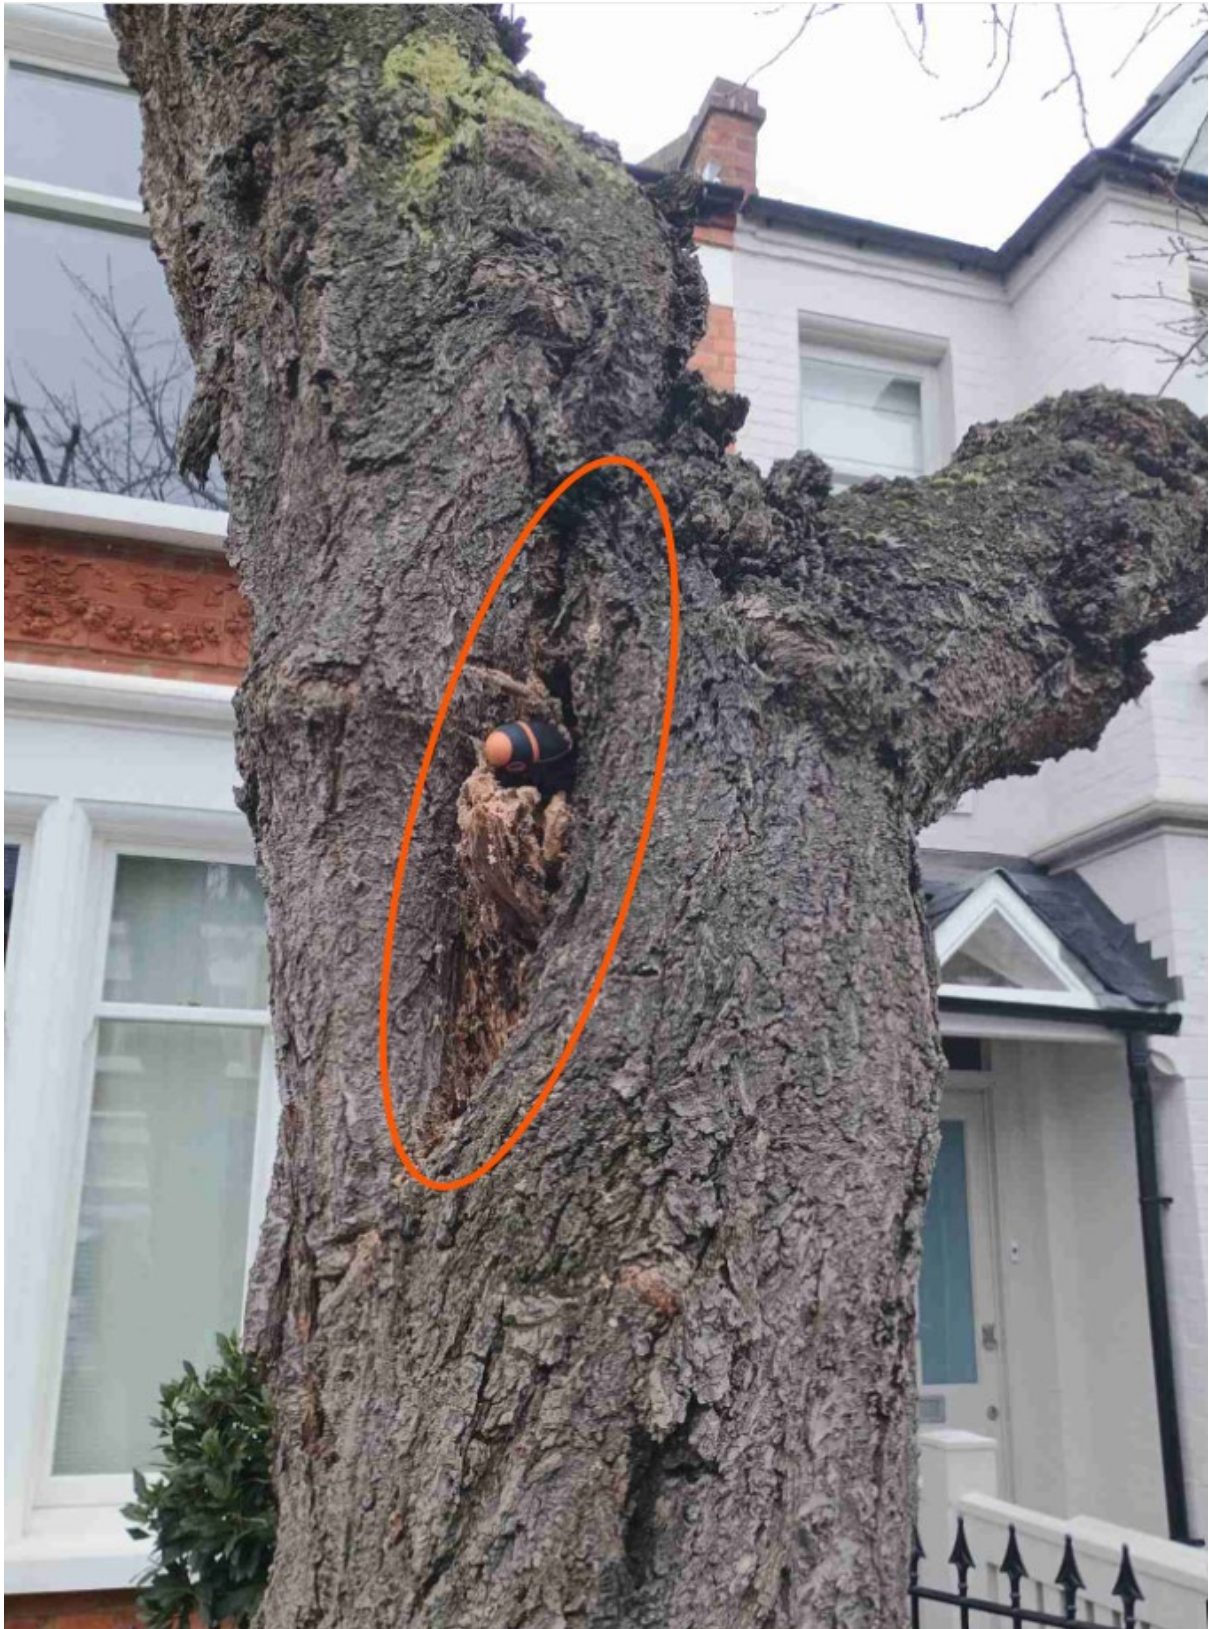
Road	Elm Grove Road
Location	Outside 17
Species	Wild Cherry (<i>Prunus avium</i>)
Height	7.5m
Physiological Condition	Fait
Structural Condition	Poor
Inspection findings/reason for exemption	Investigation with a probe and a resonance test with a sounding hammer has revealed an unacceptable amount of decay beyond the visible cavity on the trunk. Removal is required to prevent natural failure, manage risk, and facilitate replanting.

Image shows cavity with probe on trunk circled.

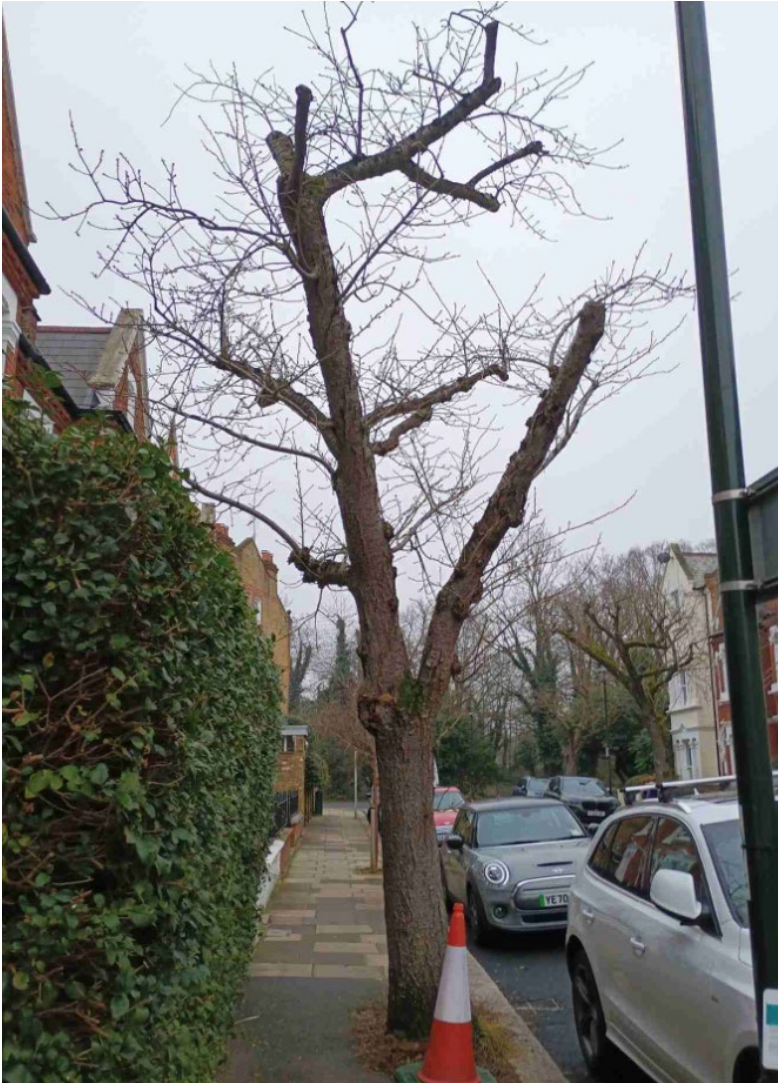
Image shows tree in street scene.

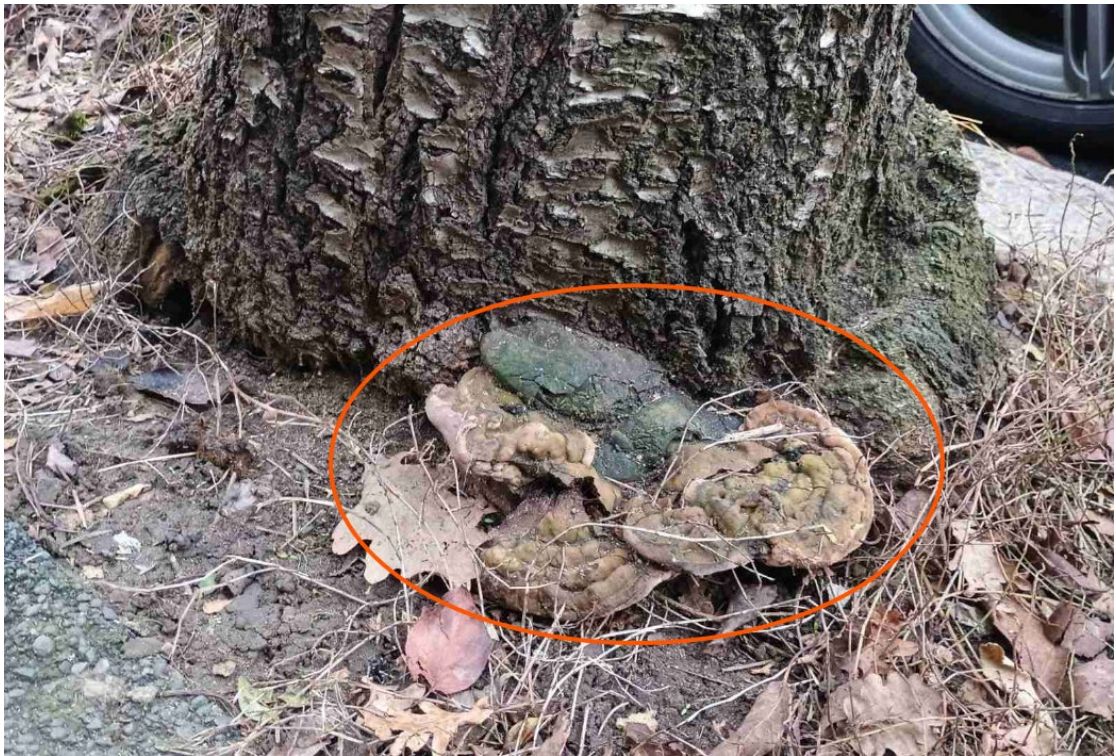
Ward	Barnes
Road	Elm Grove Road
Location	Outside 103/105
Species	Wild Cherry (<i>Prunus avium</i>)
Height	7.0m
Physiological Condition	Fair
Structural Condition	Poor
Inspection findings/reason for exemption	A fungal fruiting body of the decay fungi <i>Ganoderma sp.</i> is present at the base of the trunk. Colonisation by this fungus causes a white rot of the stem and root system that can cause entire trees to collapse through fracture or windthrow. A resonance test revealed an unacceptable degree of decay at the base of the trunk and also around the cavity at the first union of this tree. Removal is required to prevent natural failure, manage risk, and facilitate replanting.

Image shows base of trunk with fruiting body circled

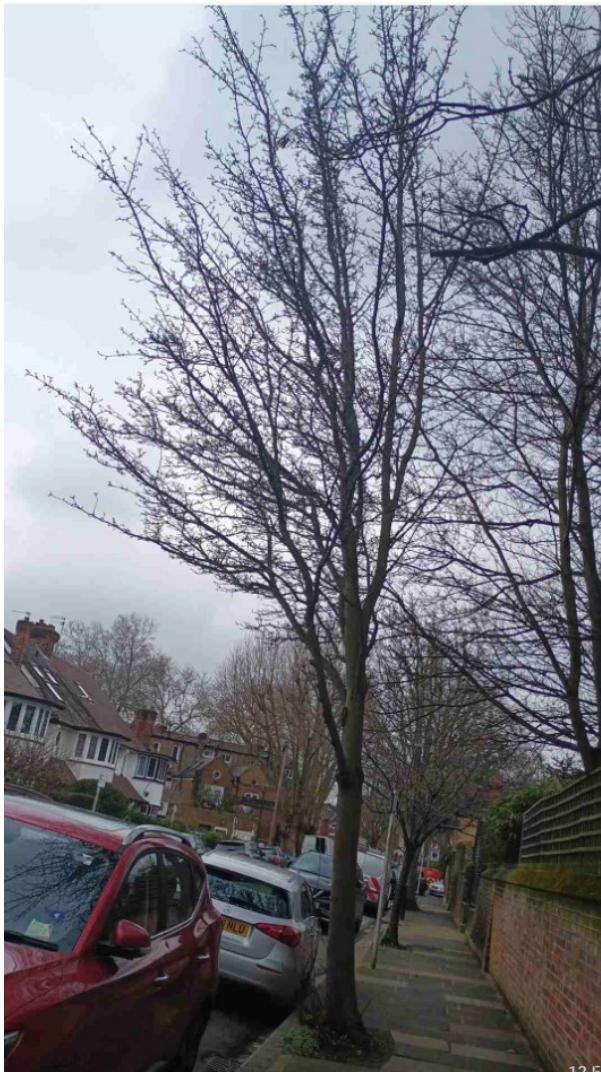
Image shows tree in street scene.

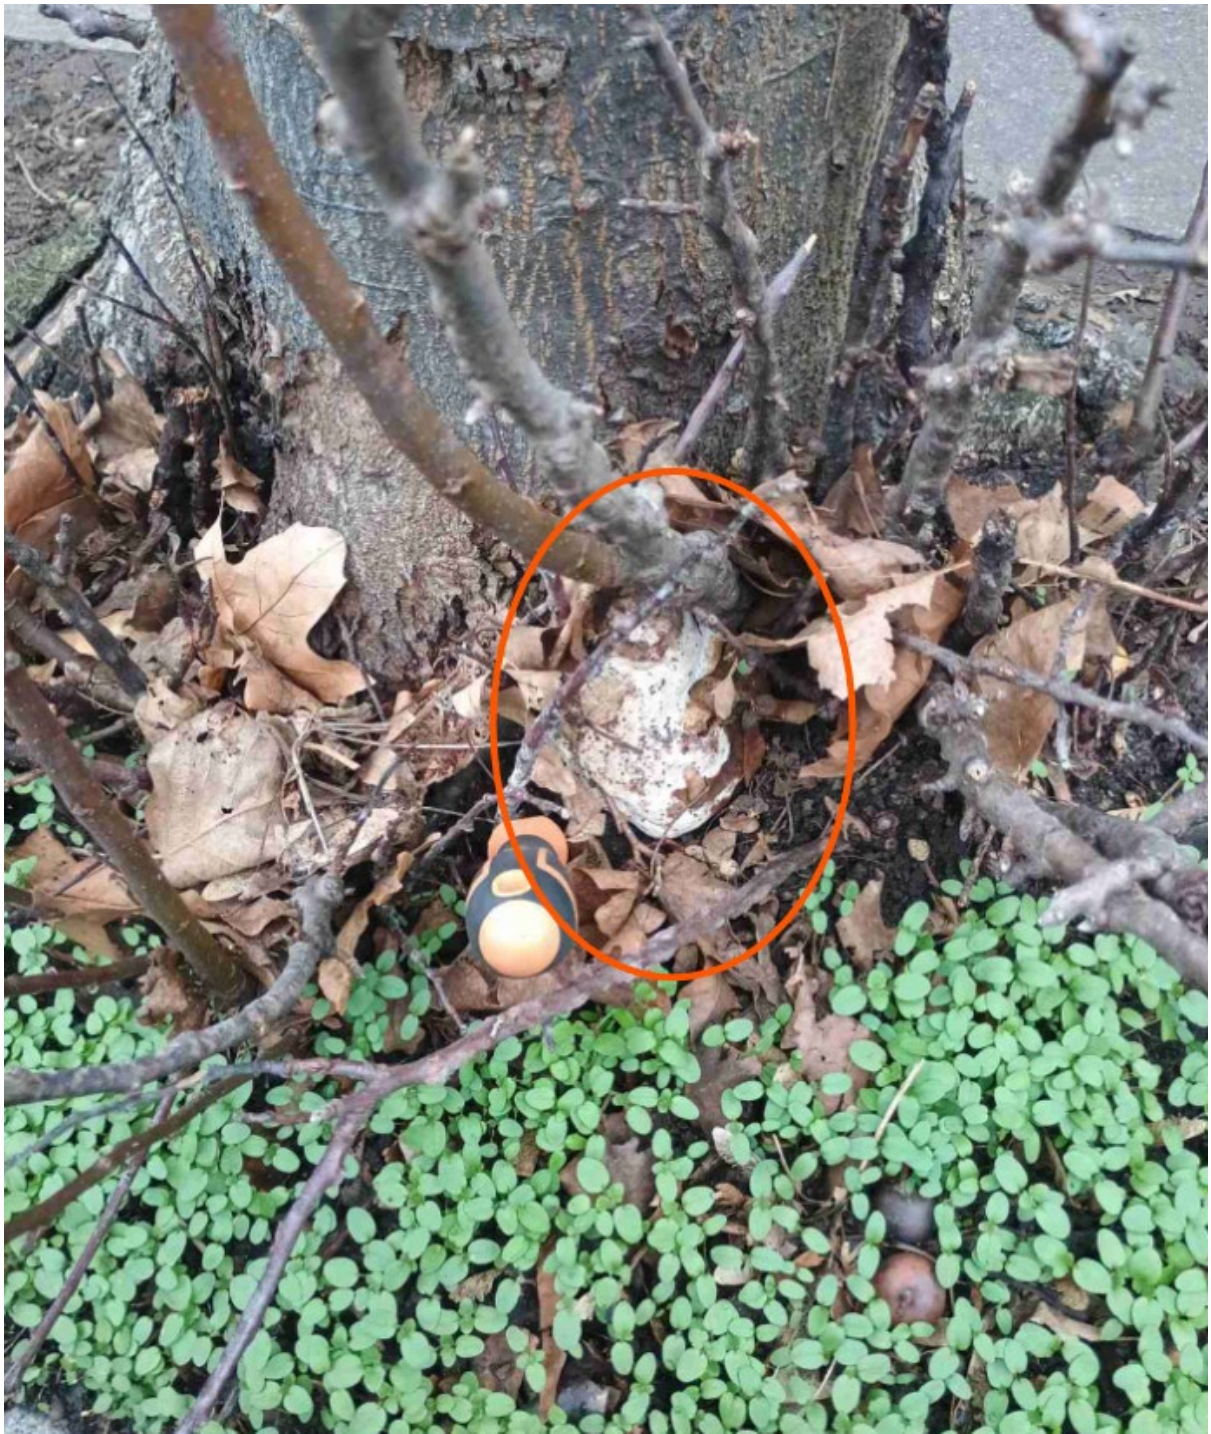
Ward	Barnes
Road	Grange Road
Location	Opposite 12/14
Species	Chonosuki crab apple (<i>Malus tschonoskii</i>)
Height	9.5m
Physiological Condition	Good
Structural Condition	Poor
Inspection findings/reason for exemption	<p>A fungal fruiting body of the decay fungi <i>Ganoderma sp.</i> is present at the base of the trunk. Colonisation by this fungus causes a white rot of the stem and root system that can cause entire trees to collapse through fracture or windthrow.</p> <p>Investigation with a probe and a resonance test revealed an unacceptable degree of decay in the base of the trunk by the fruiting body. Removal is required to prevent natural failure, manage risk, and facilitate replanting.</p>

Image shows base of trunk with fruiting body circled

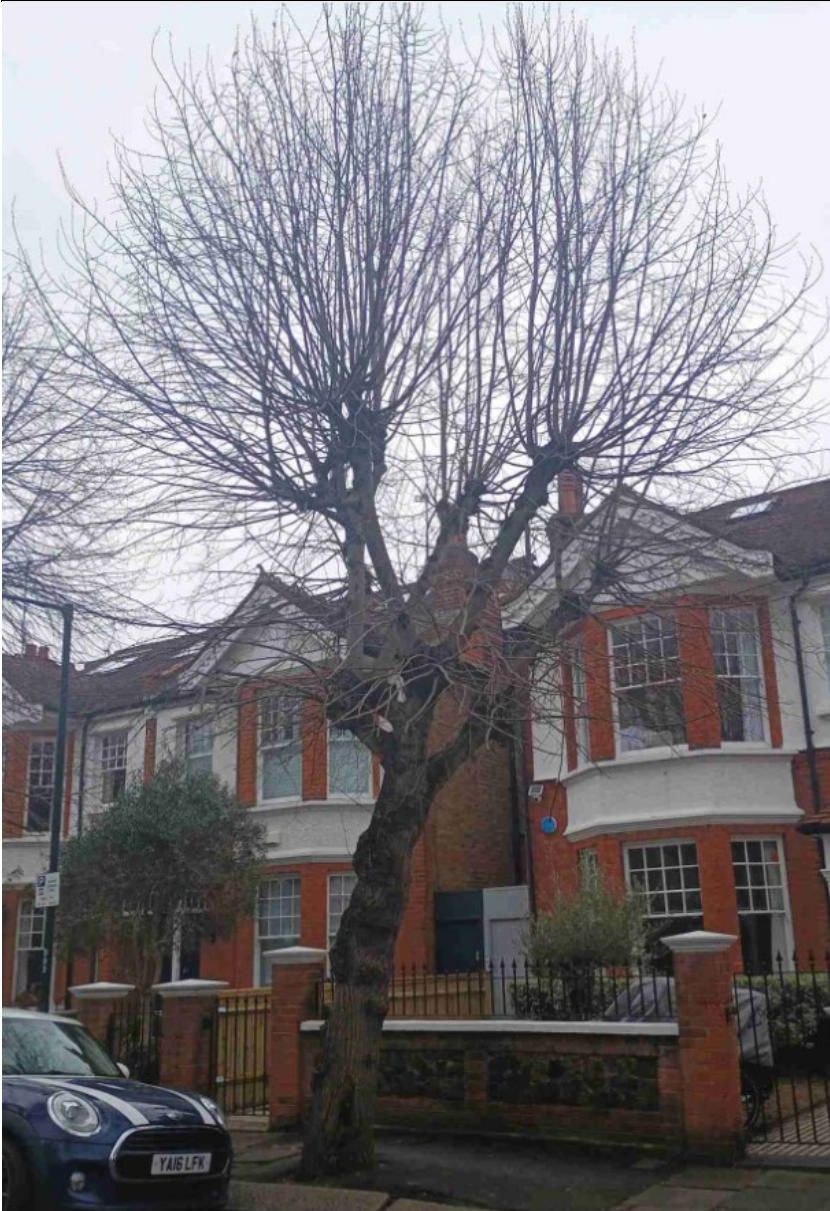
Image shows tree in street scene.

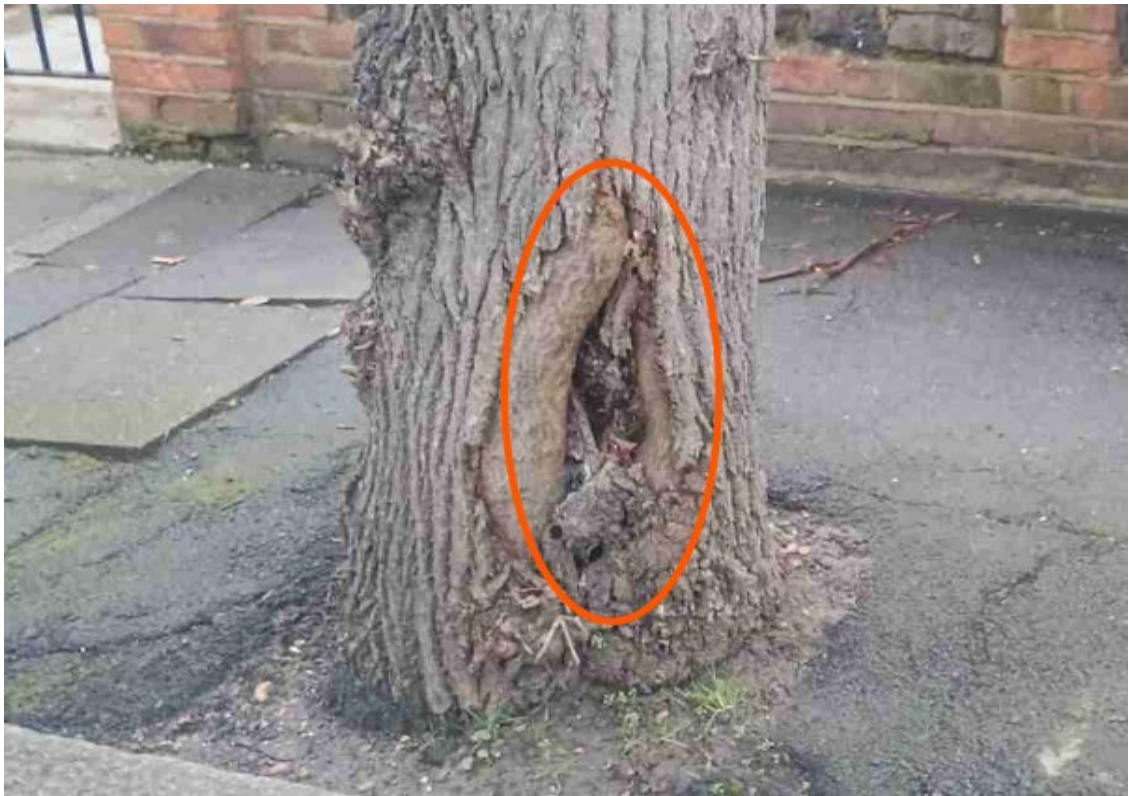
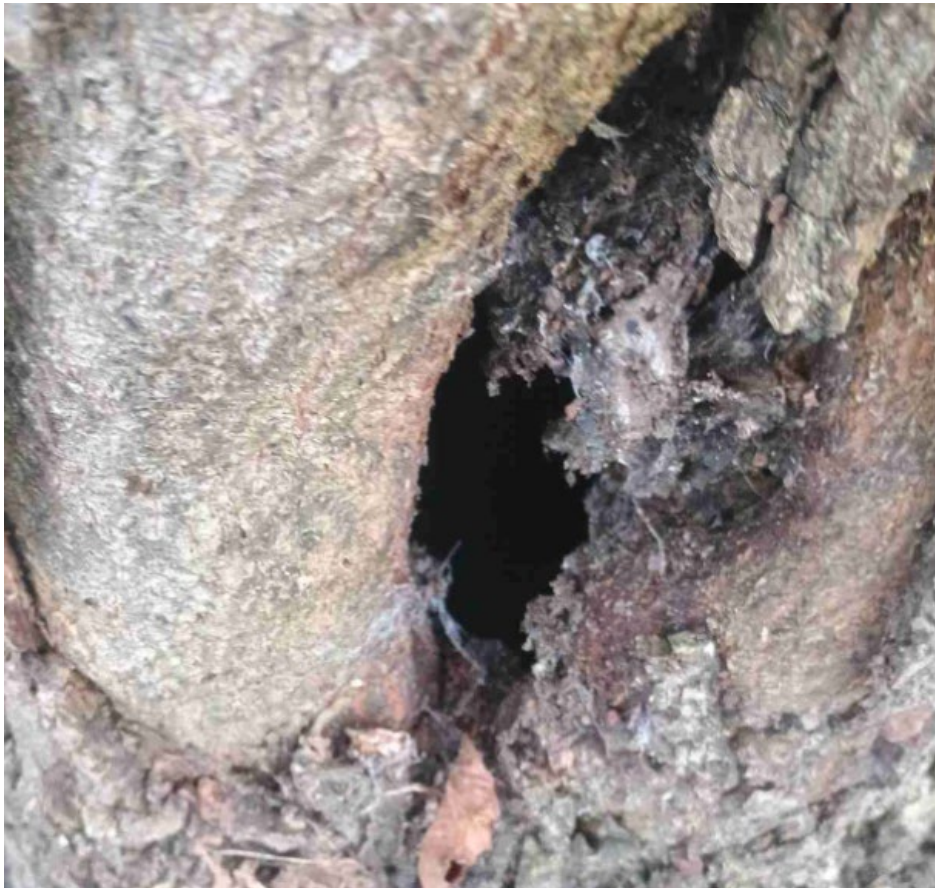
Ward	Barnes
Road	Melville Road
Location	Outside 19
Species	Common lime (<i>Tilia x europaea</i>)
Height	9.0m
Physiological Condition	Good
Structural Condition	Poor
Inspection findings/reason for exemption	Investigation with a probe and a resonance test with a sounding hammer has revealed an unacceptable amount of decay beyond the visible cavities at the base of the trunk. Removal is required to prevent natural failure, manage risk, and facilitate replanting.

Image shows cavity at base of trunk circled

Image shows hollowing to trunk inside cavity.

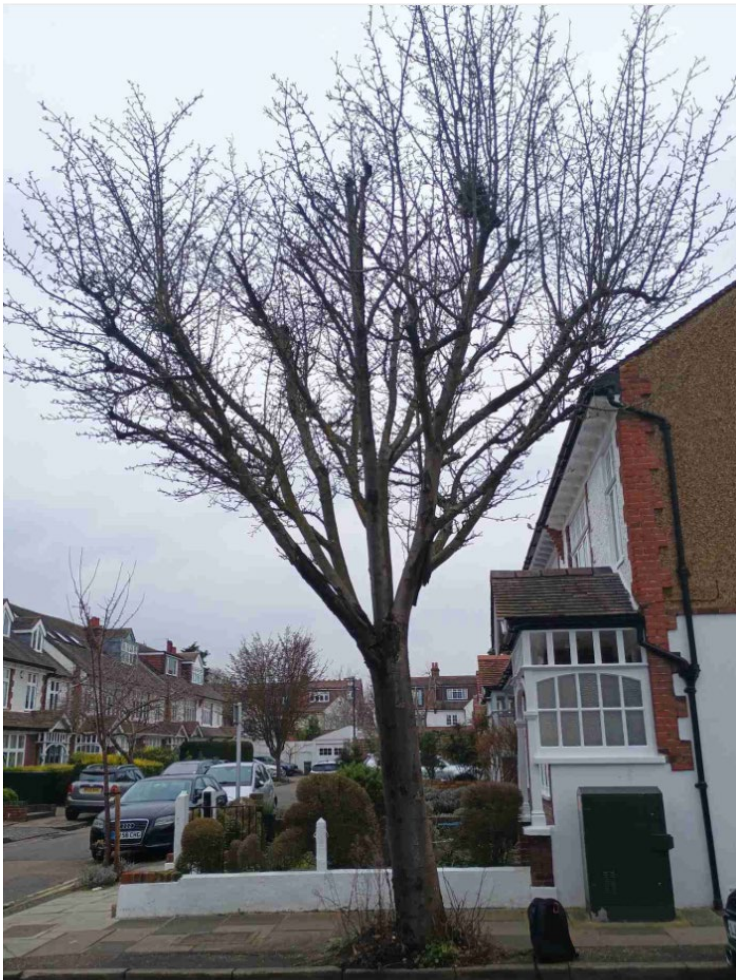
Image shows tree in street scene.
