March 2024 - Reactive Tree Works Programme

Introduction

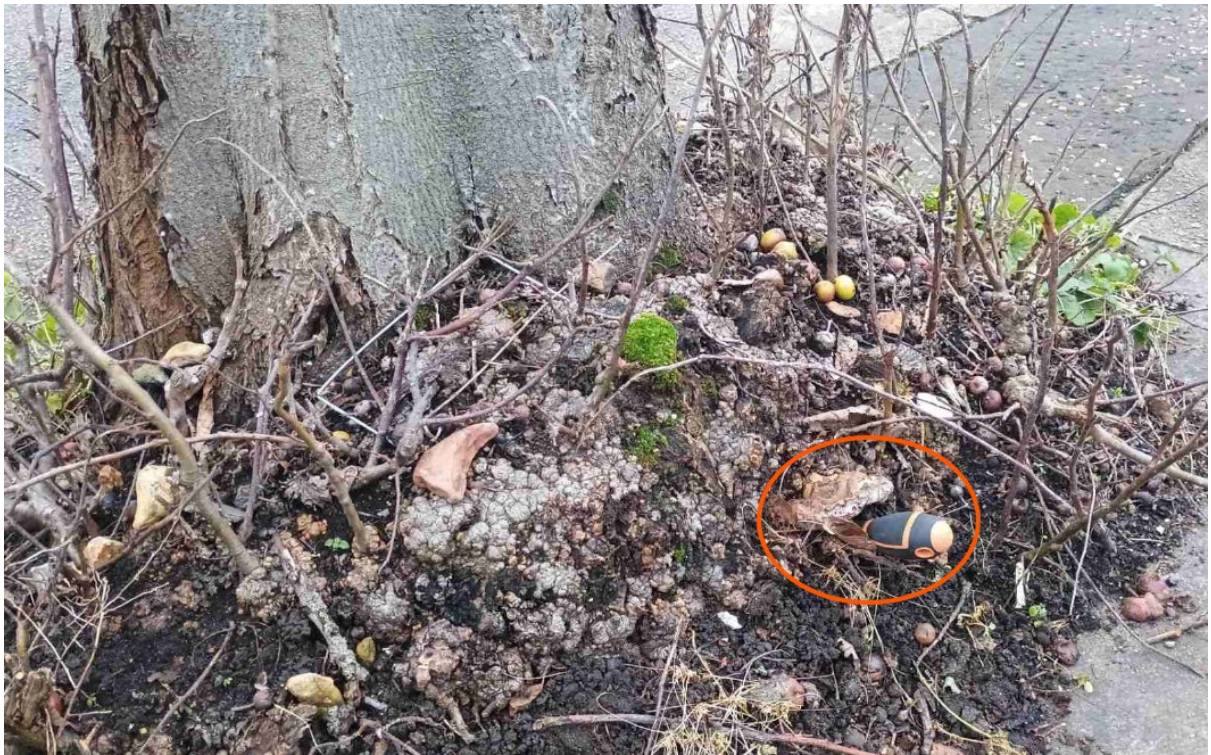
Ward	Barnes
Road	Bracken Gardens
Location	Adjacent to 34 front gardens
Species	Chonosuki crab apple (Malus tschonoskii)
Height	9m
Physiological Condition	Good
Structural Condition	Poor
Inspection findings/reason for exemption	A fungal fruiting body of the decay fungi Ganoderma sp. is present at the base of the trunk. Colonisation by this fungus causes a white rot of the stem and root system that can cause entire trees to collapse through fracture or windthrow. Investigation with a probe and a resonance test revealed an unacceptable degree of decay in the base of the trunk by the fruiting body. There is also cavities and bark delamination on the trunk by the first union. Removal is required to prevent natural failure, manage risk, and facilitate replanting.

Image shows base of trunk with probe and fruiting body circled

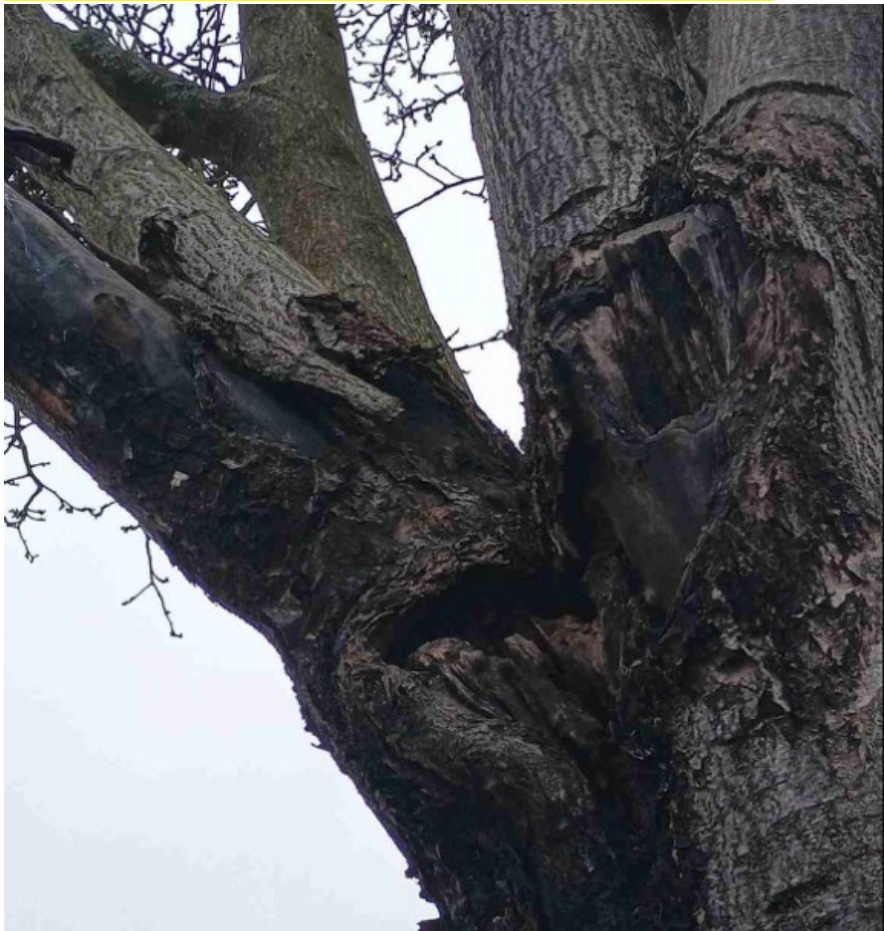
Image shows cavities and bark delamination of trunk by first union.

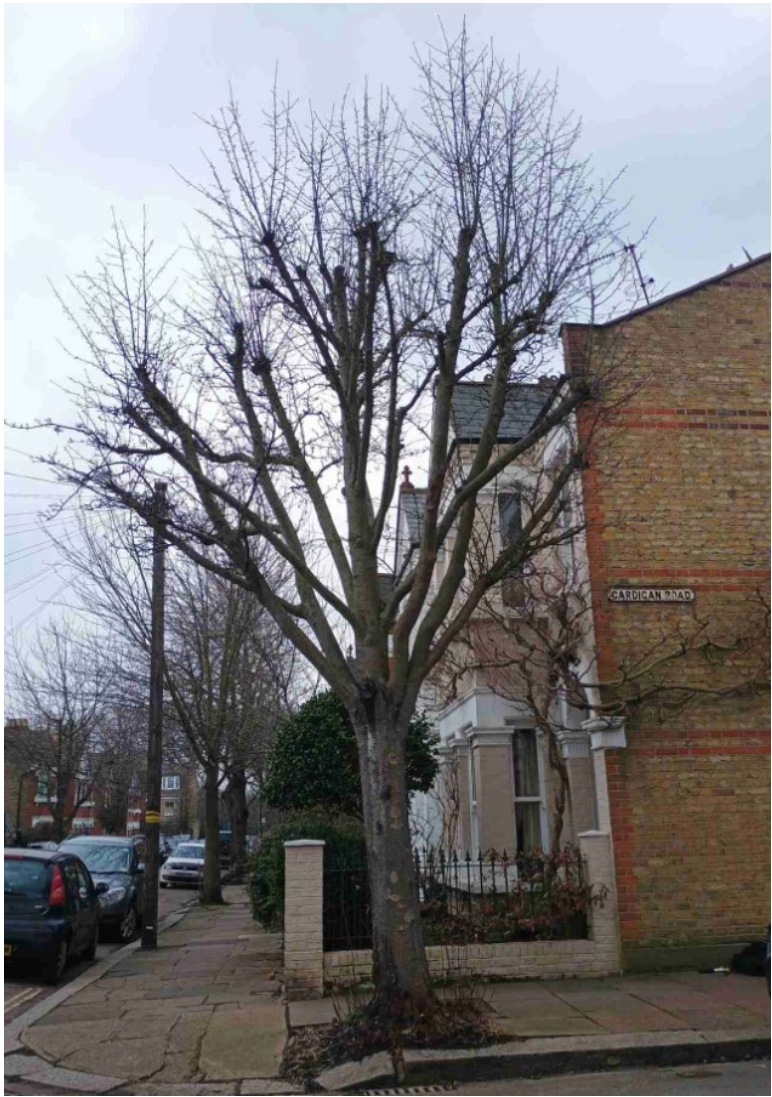
Image shows tree in street scene.

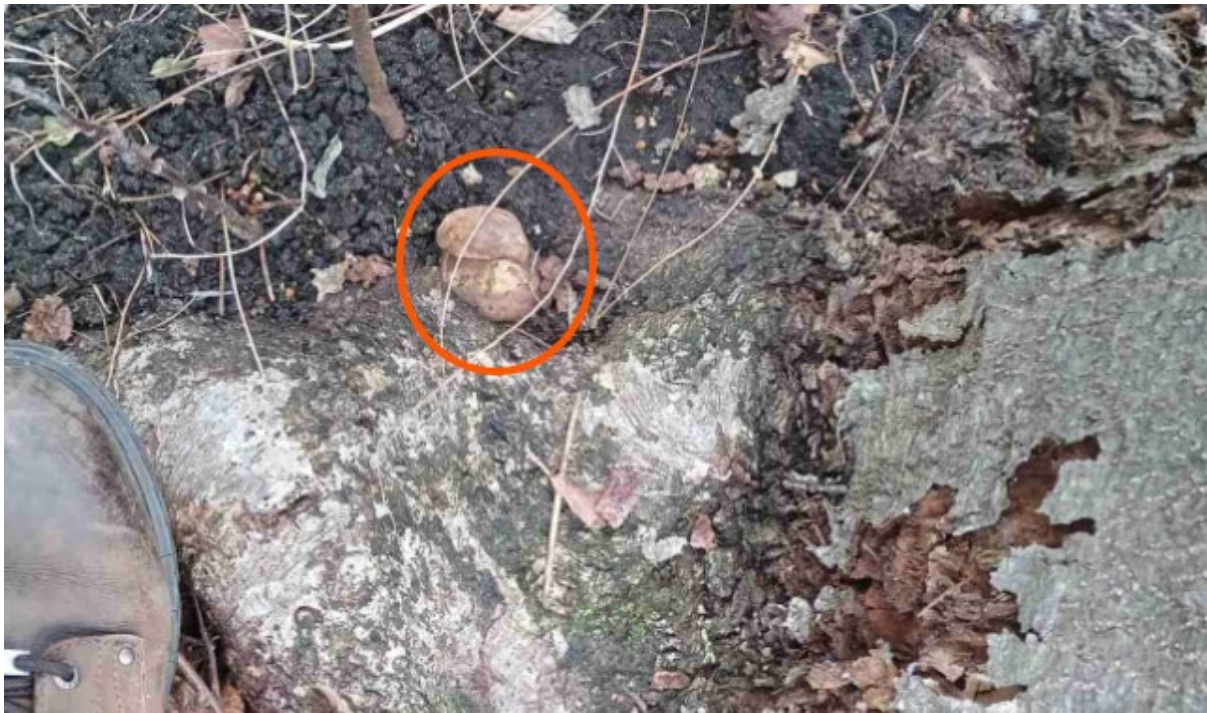
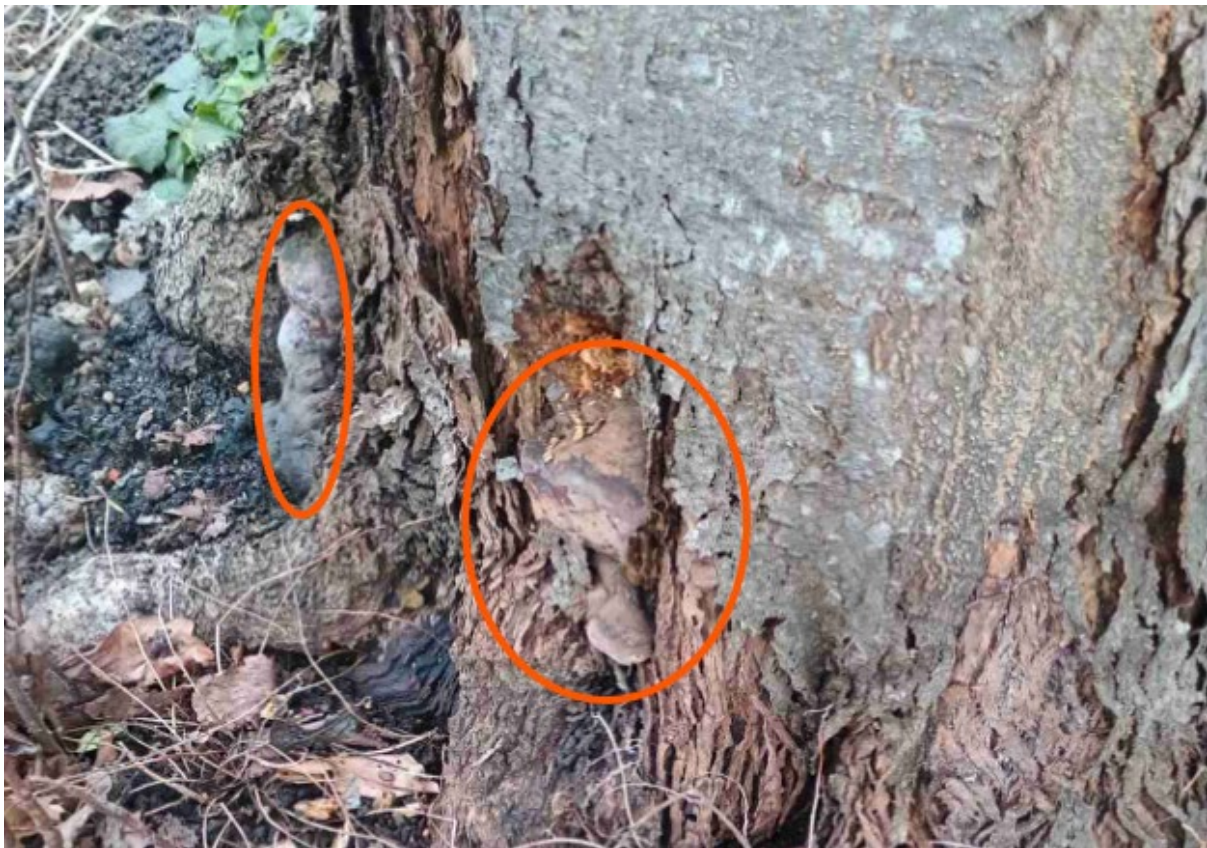
Ward	Barnes
Road	Cardigan Road
Location	Adjacent to 27 Rectory Road front of building
Species	Chonosuki crab apple (<i>Malus tschonoskii</i>)
Height	10.0m
Physiological Condition	Fair
Structural Condition	Poor
Inspection findings/reason for exemption	<p>A fungal fruiting body of the decay fungi <i>Ganoderma sp.</i> is present at the base of the trunk. Colonisation by this fungus causes a white rot of the stem and root system that can cause entire trees to collapse through fracture or windthrow.</p> <p>Investigation with a probe revealed an unacceptable degree of decay in the base of the trunk by the fruiting body. Removal is required to prevent natural failure, manage risk, and facilitate replanting.</p>

Image shows base of trunk with fruiting body circled

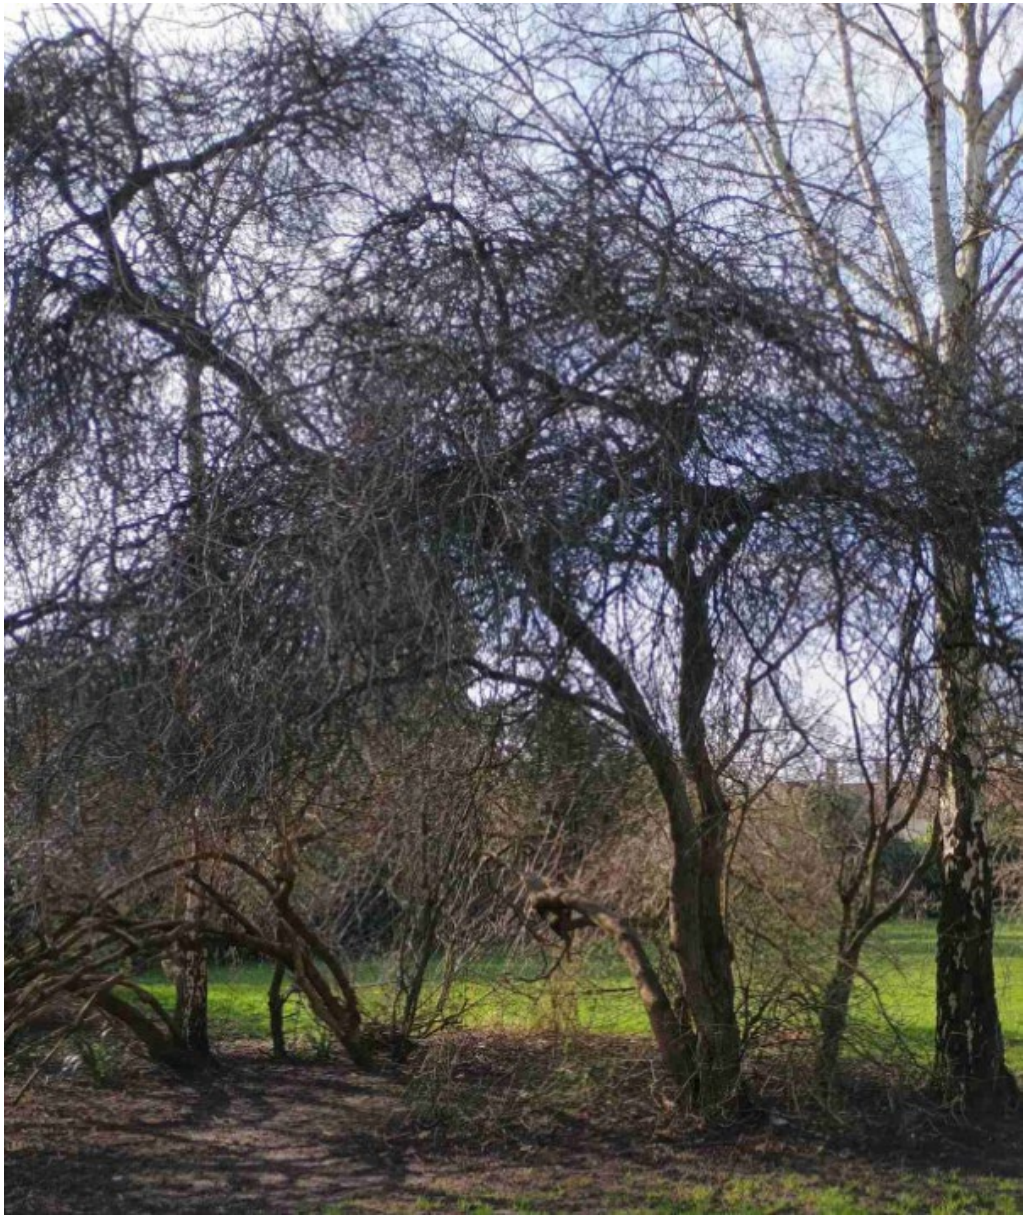
Image shows tree in park scene.

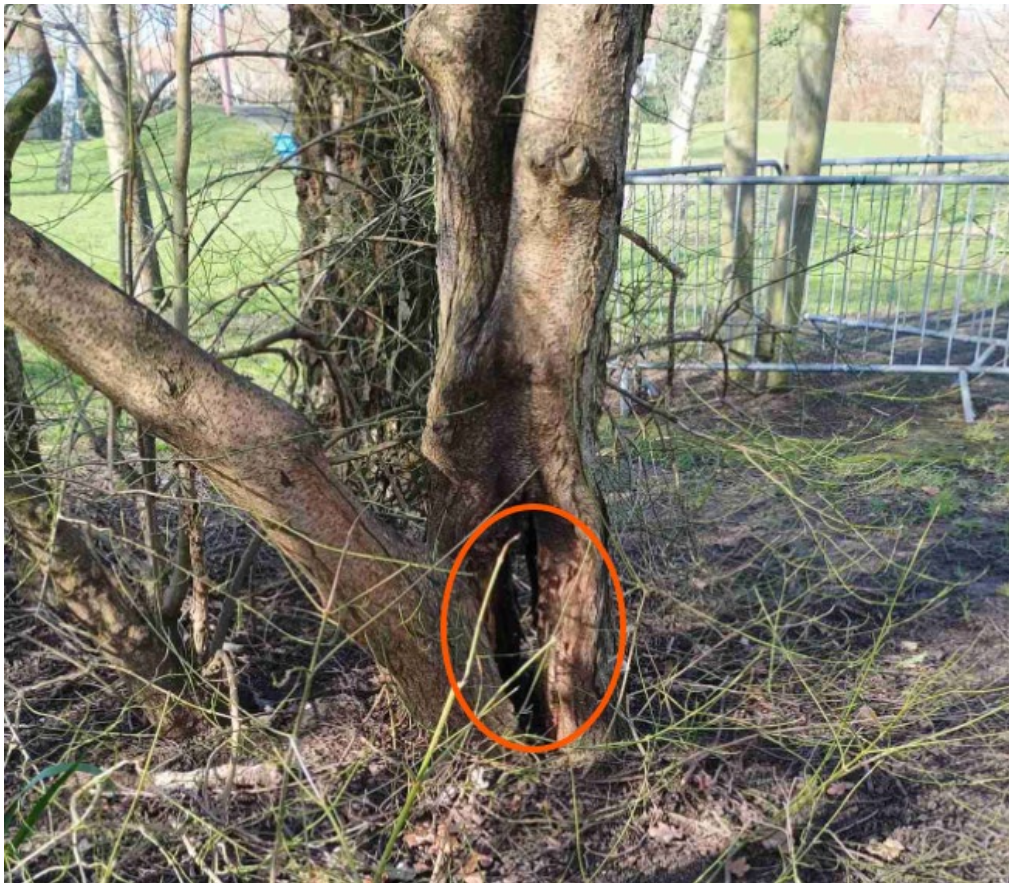
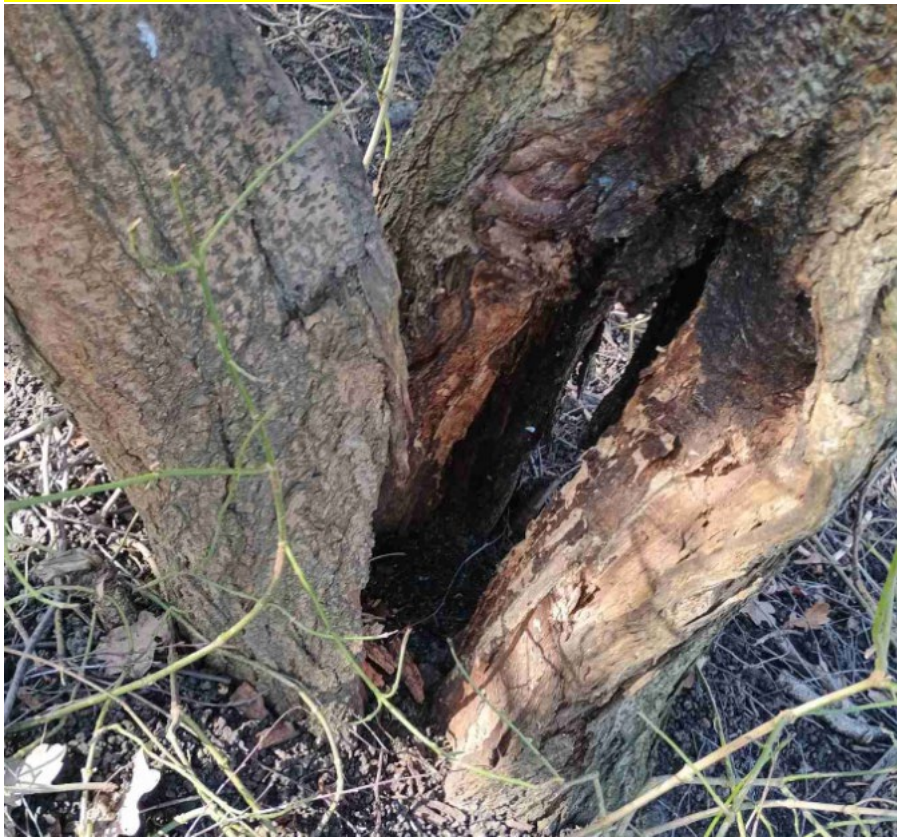
Ward	Barnes
Road	Barnes Avenue
Location	Castelnau Recreational ground ///slows.extend.oddly
Species	Cherry plum (<i>Prunus cerasifera</i>)
Height	6.5m
Physiological Condition	fair
Structural Condition	Poor
Inspection findings/reason for exemption	There is an unacceptable amount of decay at the base of this tree which has led to stem failure. Removal is required to prevent further natural failure, manage risk, and facilitate replanting.

Image shows decay at the base of the trunk circled

Image shows decay and failed union at the base of the trunk.

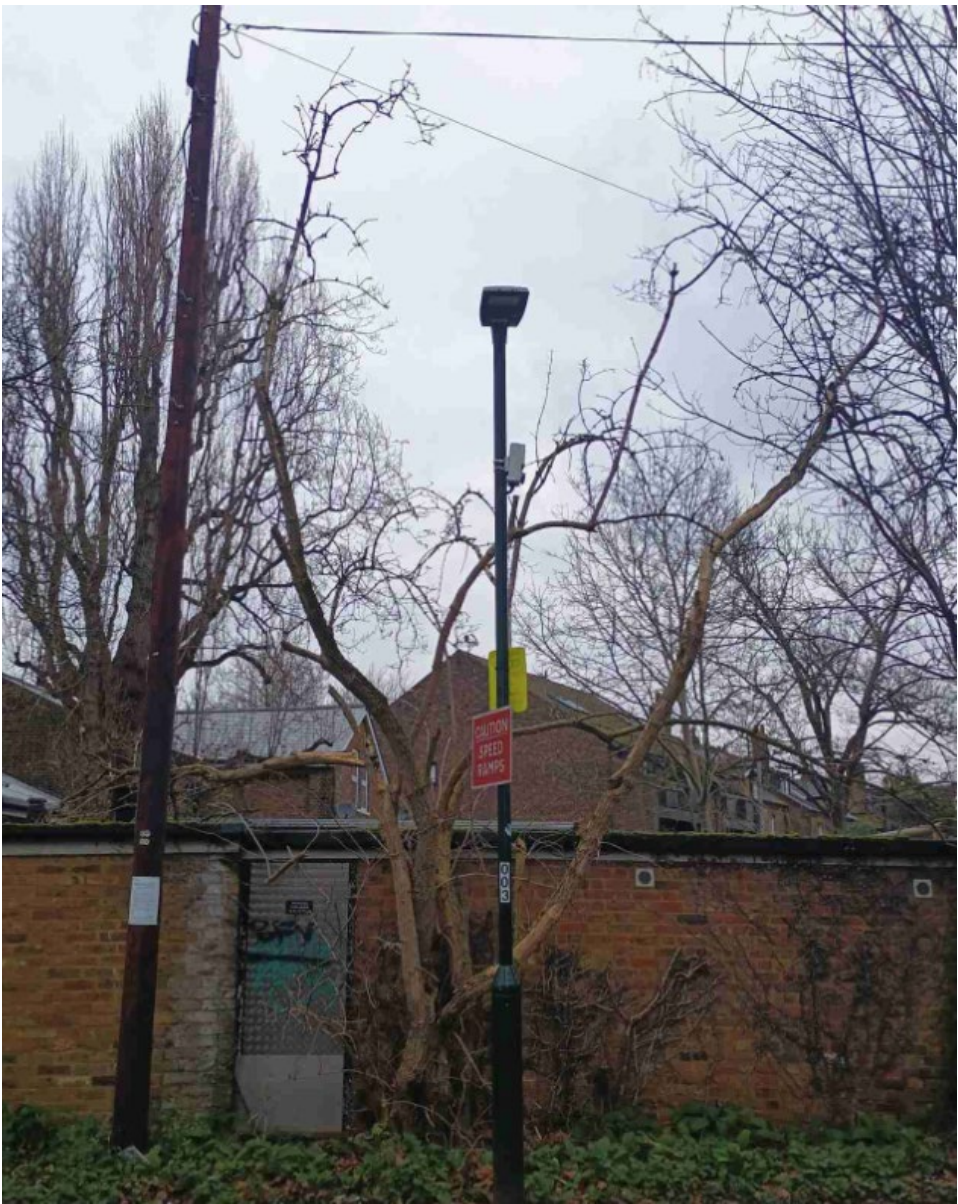
Ward	Barnes
Road	Queen Elizabeth Walk
Location	Queen Elizabeth Walk- ///nest.lofts.fantastic
Species	Elderberry (<i>Sambucus nigra</i>)
Height	7.0m
Physiological Condition	Poor
Structural Condition	Poor
Inspection findings/reason for exemption	This tree is moribund with an unacceptable amount of decay at the base of this tree which has led to stem failures. Removal is required to prevent further natural failure, manage risk, and facilitate replanting.

Image shows moribund tree in street scene.

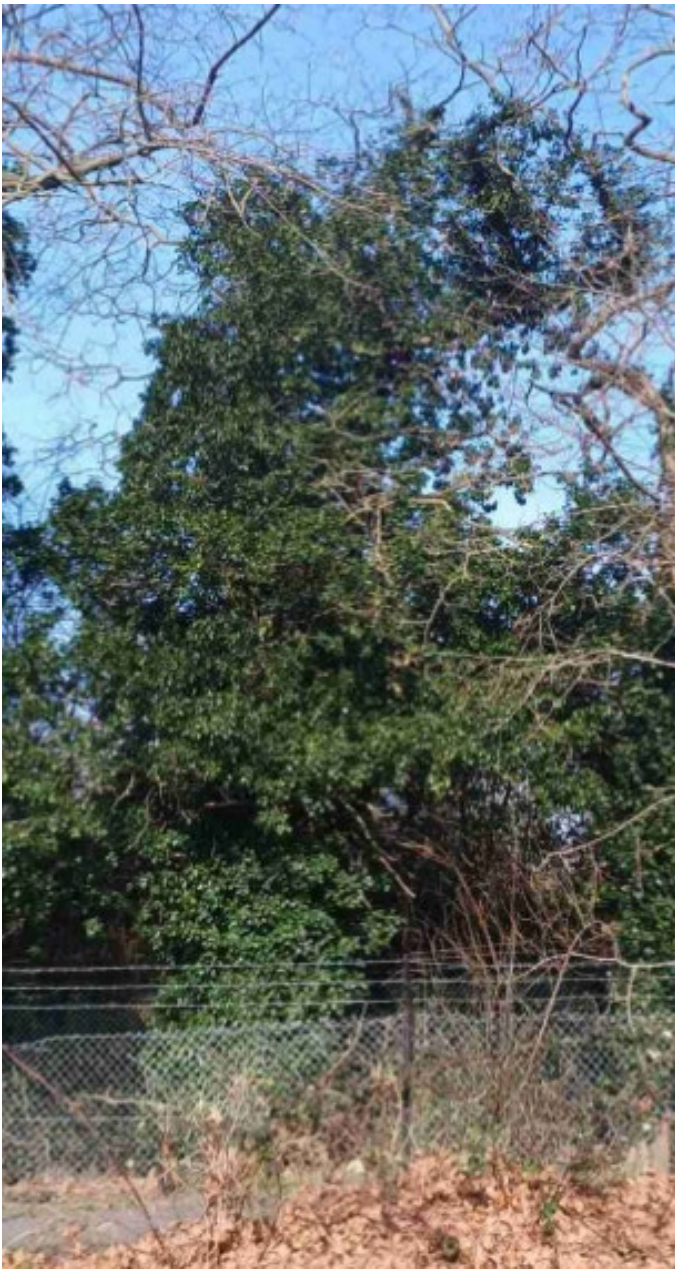
Ward	Barnes
Road	Queen Elizabeth Walk
Location	Queen Elizabeth Walk- ///pasta.wallet.pets
Species	Black locust (<i>Robinia pseudoacacia</i>)
Height	15.0m
Physiological Condition	Poor
Structural Condition	Poor
Inspection findings/reason for exemption	This tree is moribund; removal is required to prevent natural failure and manage risk. The stump will be left at 1.5m high for ecological purposes.

Image shows moribund tree in street scene.

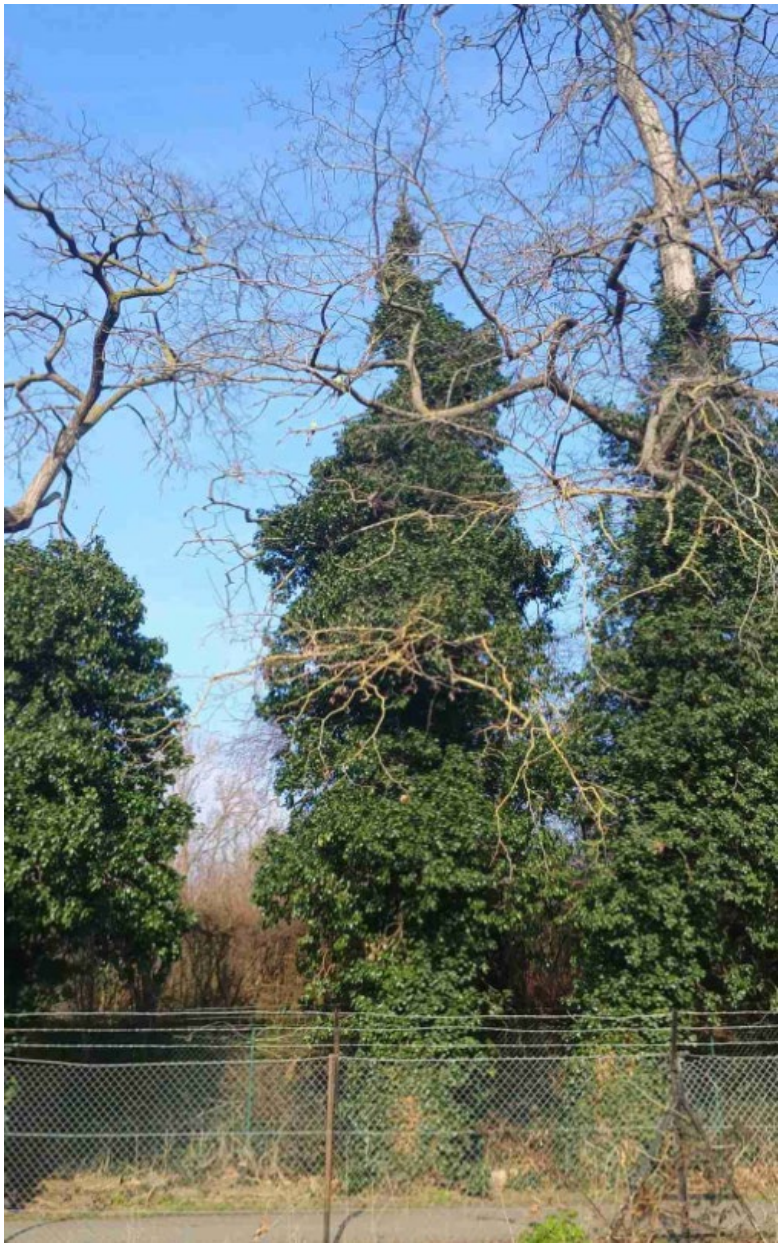
Ward	Barnes
Road	Queen Elizabeth Walk
Location	Queen Elizabeth Walk- ///tender.garden.lively
Species	Black locust (<i>Robinia pseudoacacia</i>)
Height	16.0m
Physiological Condition	Poor
Structural Condition	Poor
Inspection findings/reason for exemption	This tree is moribund; removal is required to prevent natural failure and manage risk. The stump will be left at 1.5m high for ecological purposes.

Image shows moribund tree in street scene.

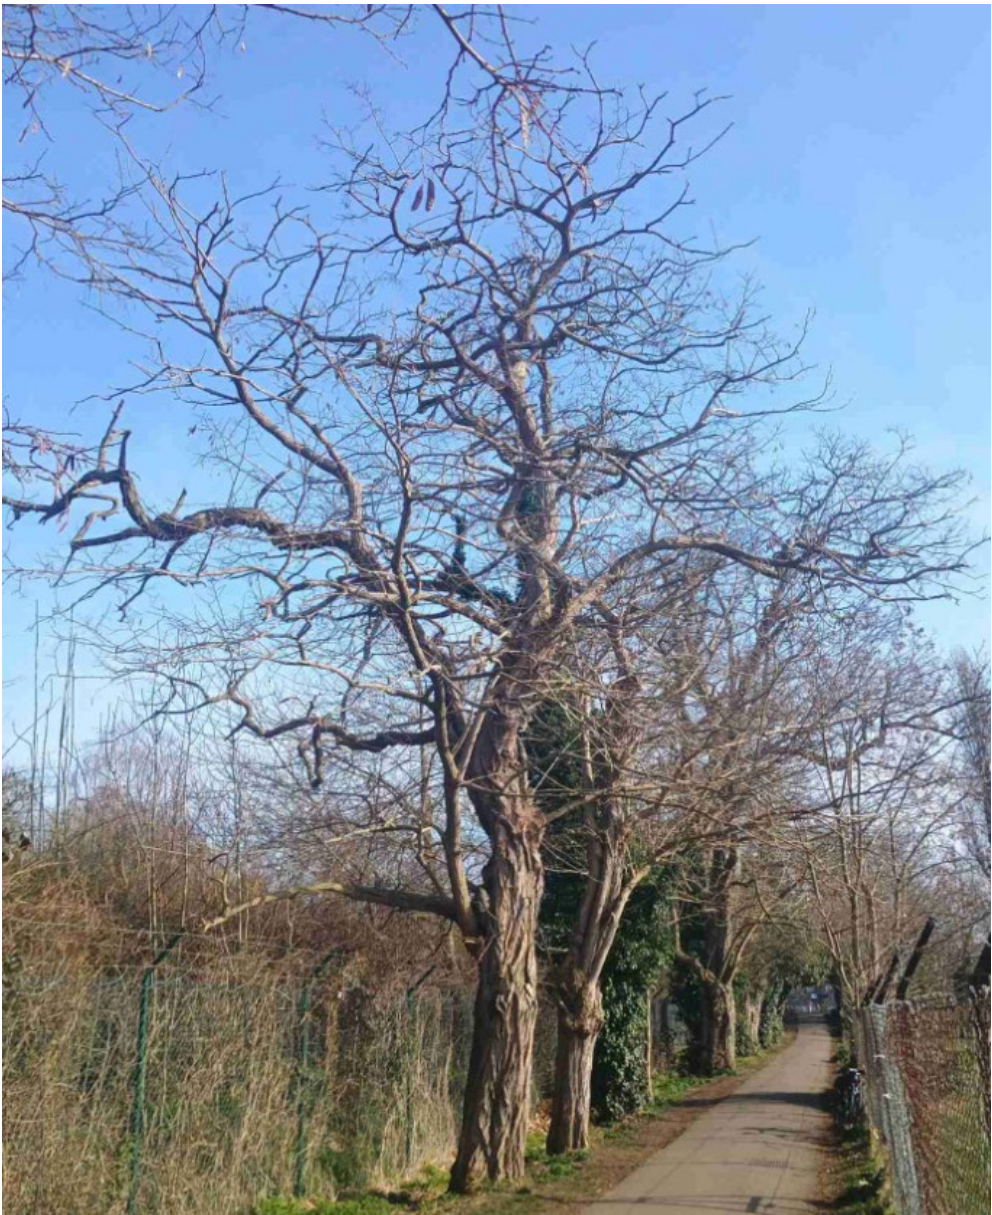
Ward	Barnes
Road	Queen Elizabeth Walk
Location	Queen Elizabeth Walk- ///stand.eager.ranks
Species	Black locust (<i>Robinia pseudoacacia</i>)
Height	16.0m
Physiological Condition	Poor
Structural Condition	Poor
Inspection findings/reason for exemption	This tree is moribund; removal is required to prevent natural failure and manage risk. The stump will be left at 1.5m high for ecological purposes.

Image shows moribund tree in street scene

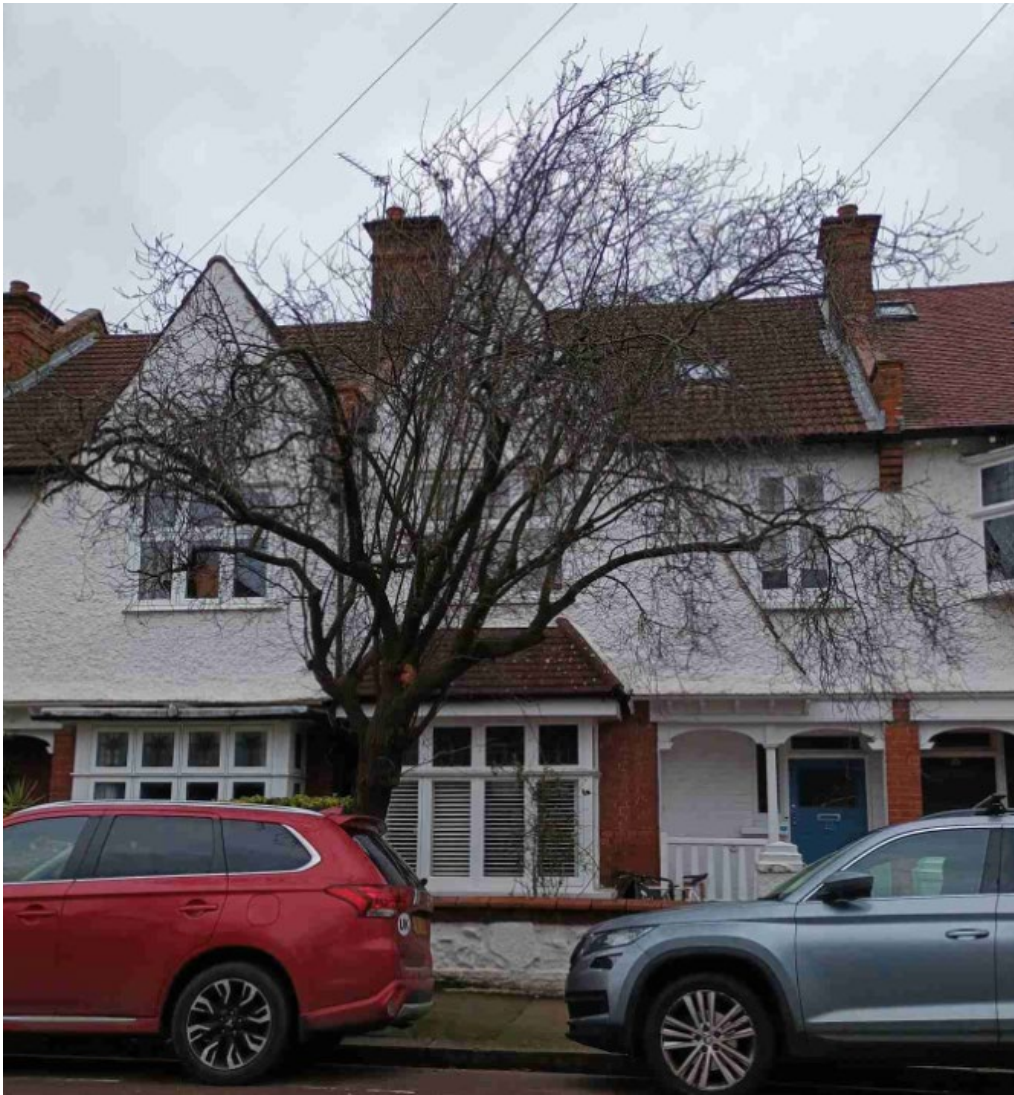
Image shows tree in street scene.

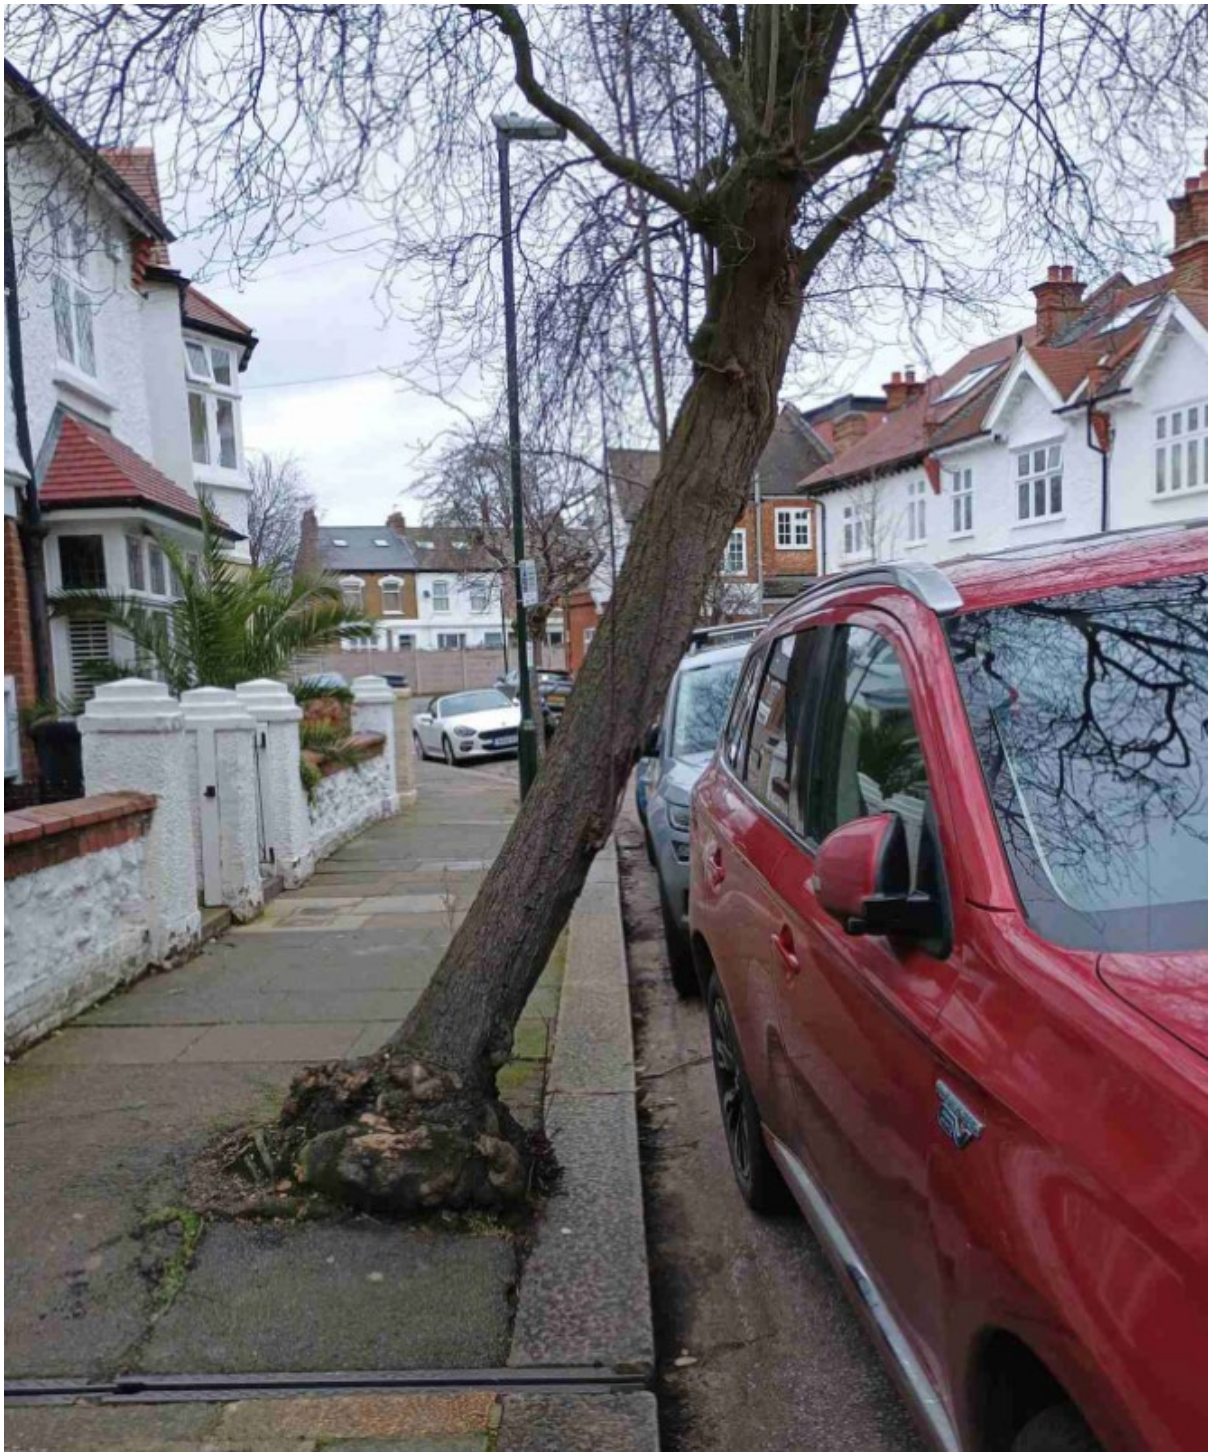
Ward	East Sheen
Road	Glendower Road
Location	Outside 23
Species	Cherry plum (<i>Prunus cerasifera</i>)
Height	8.0m
Physiological Condition	Fair
Structural Condition	Poor
Inspection findings/reason for exemption	The trunk of this tree has shown an increased lean since the last inspection, indicating compromised root structure. Removal is required to prevent natural failure, manage risk, and facilitate replanting

Image shows lean on trunk.

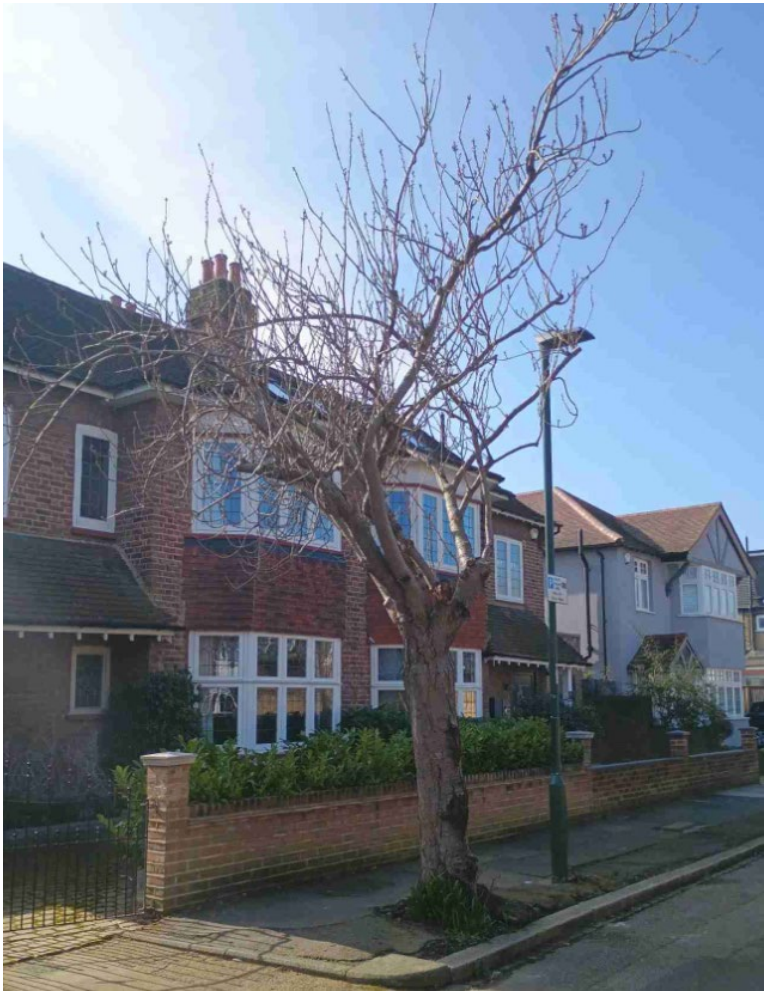
Images show tree in street scene.

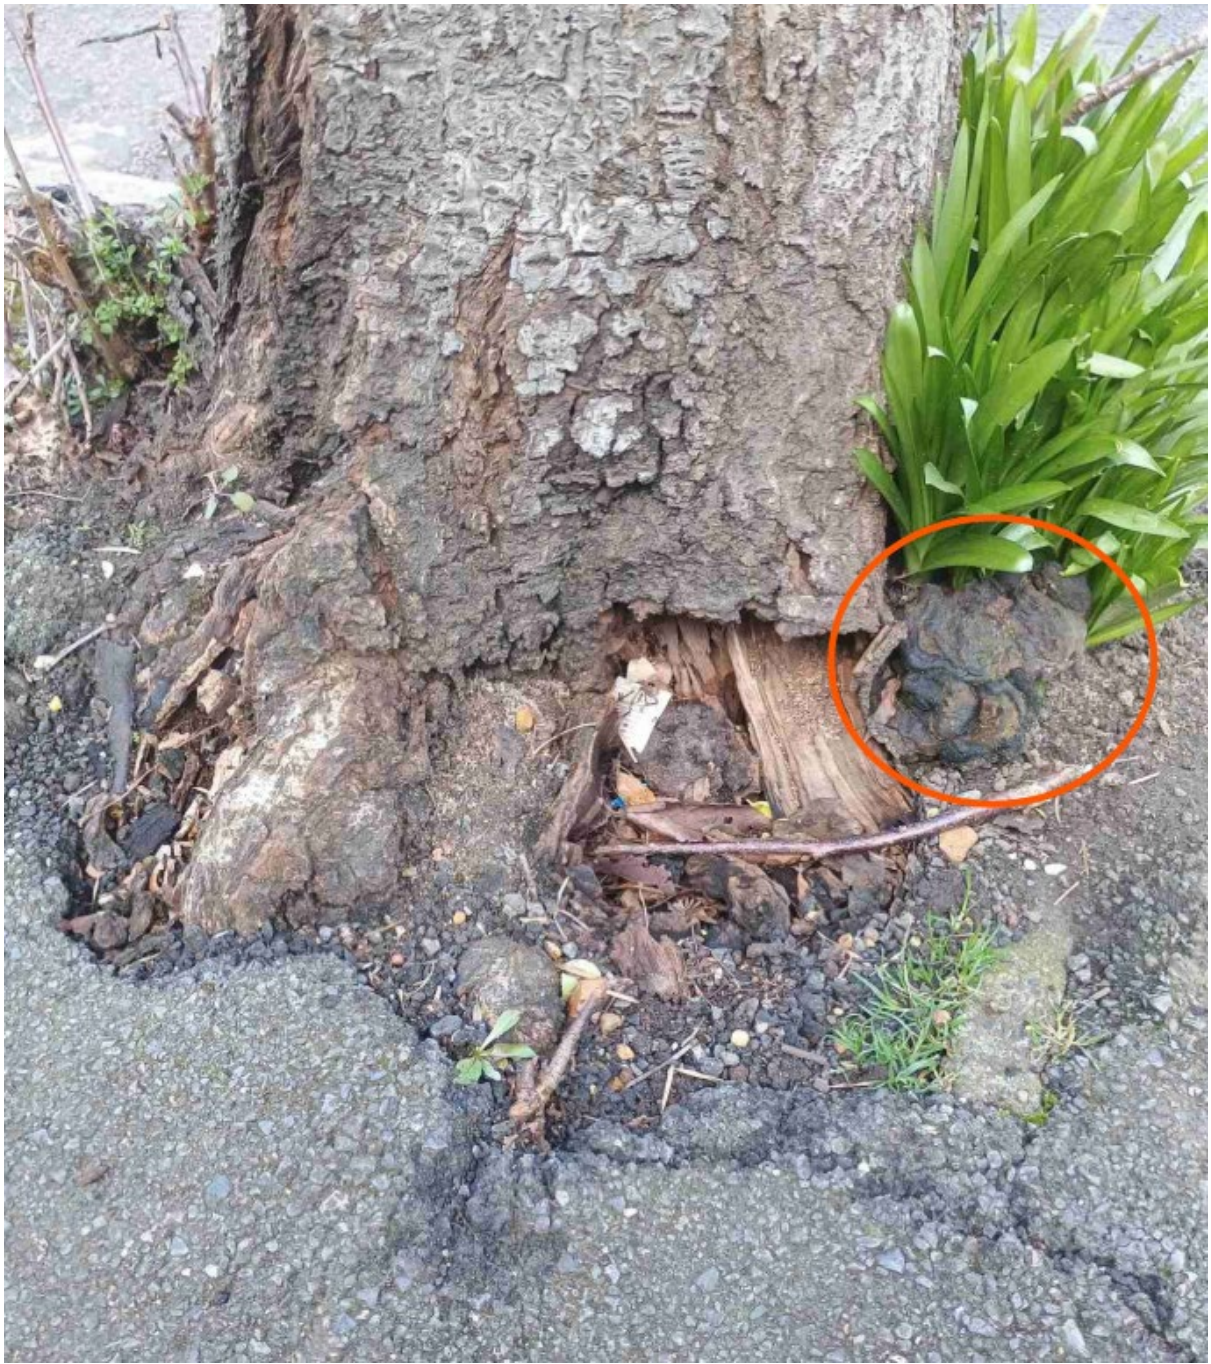
Ward	East Sheen
Road	Parkfield Avenue
Location	Outside 23
Species	Wild cherry (<i>Prunus avium</i>)
Height	6.0m
Physiological Condition	Fair
Structural Condition	Poor
Inspection findings/reason for exemption	<p>A fungal fruiting body of the decay fungi <i>Ganoderma sp.</i> is present at the base of the trunk. Colonisation by this fungus causes a white rot of the stem and root system that can cause entire trees to collapse through fracture or windthrow.</p> <p>Investigation with a probe revealed an unacceptable degree of decay in the base of the trunk by the fruiting body. Removal is required to prevent natural failure, manage risk, and facilitate replanting.</p>

Images show fruiting body circled.

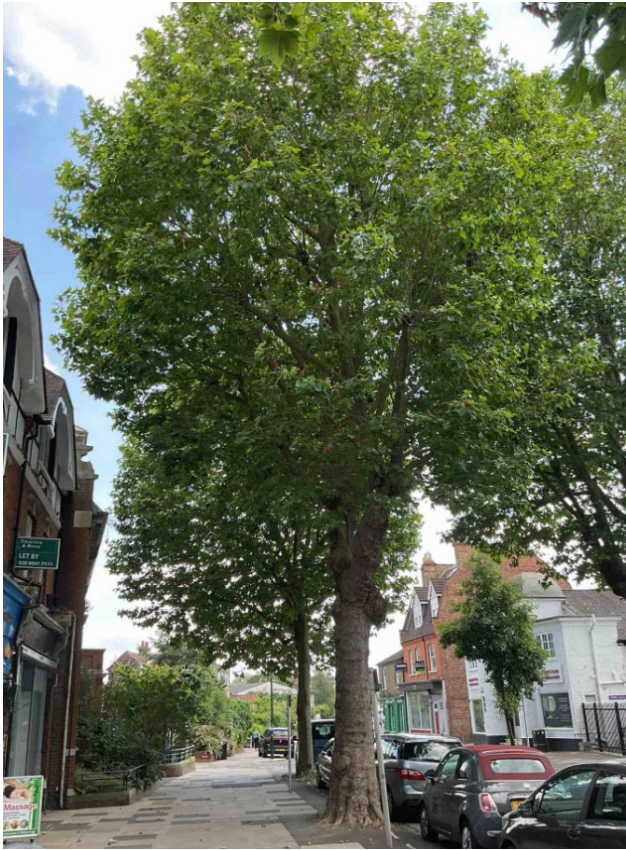
Images show tree in street scene.

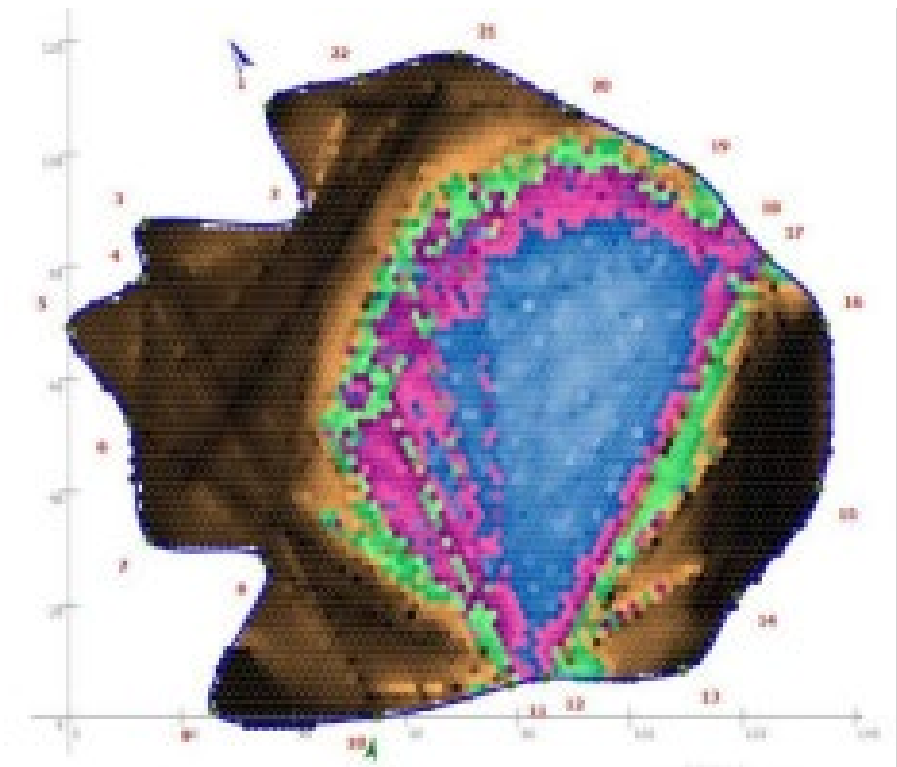
Ward	Hampton
Road	Station Road
Location	Outside 70/72
Species	London plane (<i>Platanus x hispanica</i>)
Height	18.0m
Physiological Condition	Fair
Structural Condition	Poor
Inspection findings/reason for exemption	A fungal fruiting body of the decay fungi <i>Ganoderma sp.</i> is present in the lower trunk of this tree. Colonization by this fungus causes white rot in the stem and root system, potentially leading to the tree's collapse through fracture or windthrow. A detailed investigation using sonic tomography revealed an unacceptable amount of decay, indicated by the light-coloured areas in the cross-section image of the stem below, spreading to the sound wood shown as darker-coloured areas. Removal is necessary to prevent natural failure, manage risk, and facilitate replanting.

Image shows detailed inspection of trunk taken at 10 cm from ground level. Blue area indicates decayed wood.

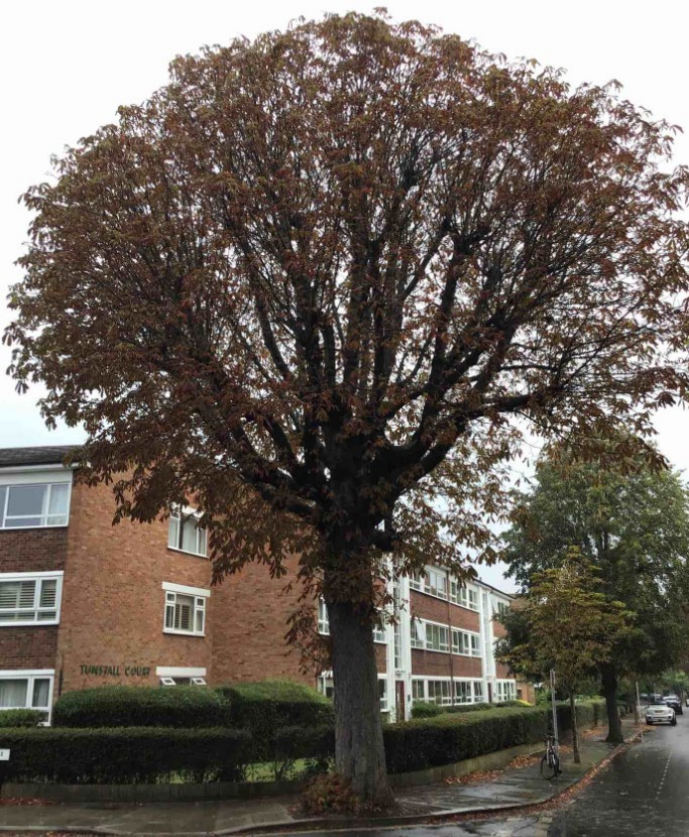
Image shows tree in street scene.

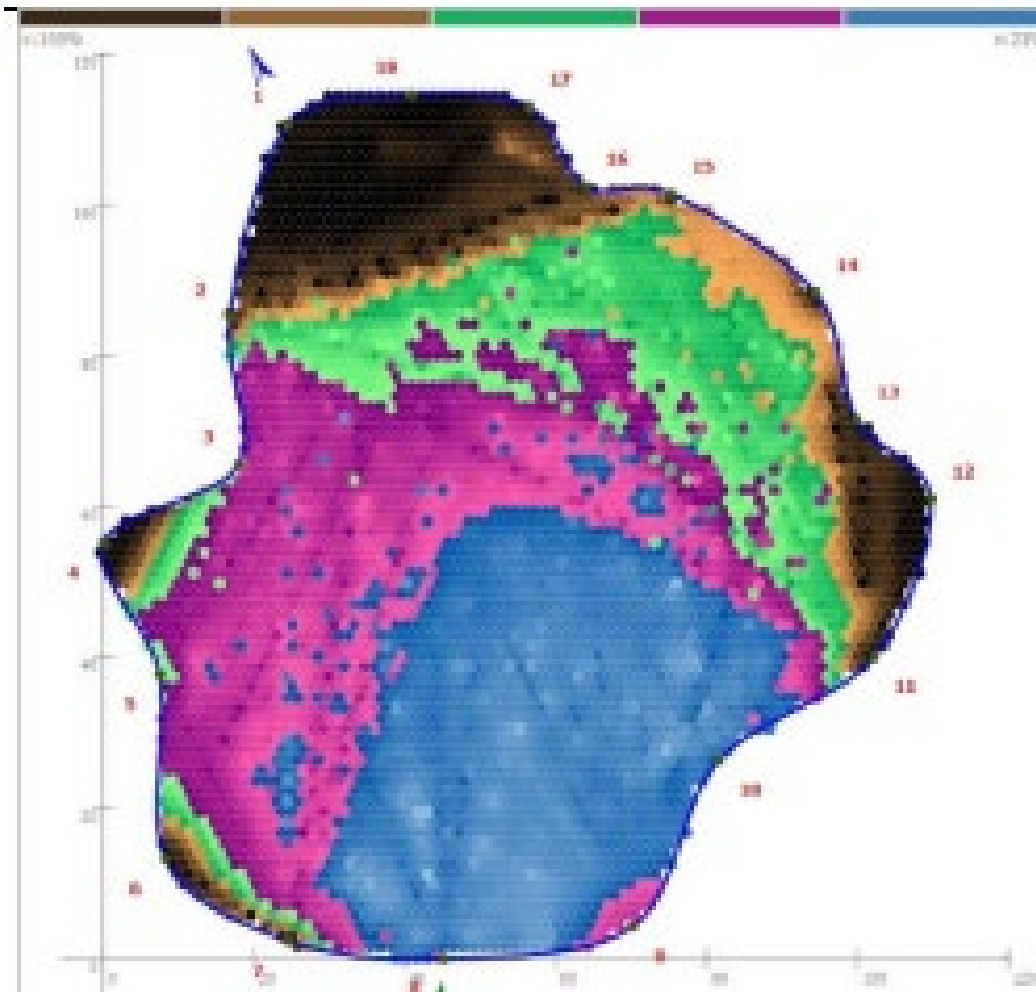
Ward	Kew
Road	Ennerdale Road
Location	On the Junction of Hatherley Road Opposite 31
Species	Horse chestnut (<i>Aesculus hippocastanum</i>)
Height	15.0m
Physiological Condition	Fair
Structural Condition	Poor
Inspection findings/reason for exemption	A fungal fruiting body of the decay fungi <i>Ganoderma sp.</i> is present in the lower trunk of this tree. Colonization by this fungus causes white rot in the stem and root system, potentially leading to the tree's collapse through fracture or windthrow. A detailed investigation using sonic tomography revealed an unacceptable amount of decay, indicated by the light-coloured areas in the cross-section image of the stem below, spreading to the sound wood shown as darker-coloured areas. Removal is necessary to prevent natural failure, manage risk, and facilitate replanting.

Image shows fungal fruiting body circled.

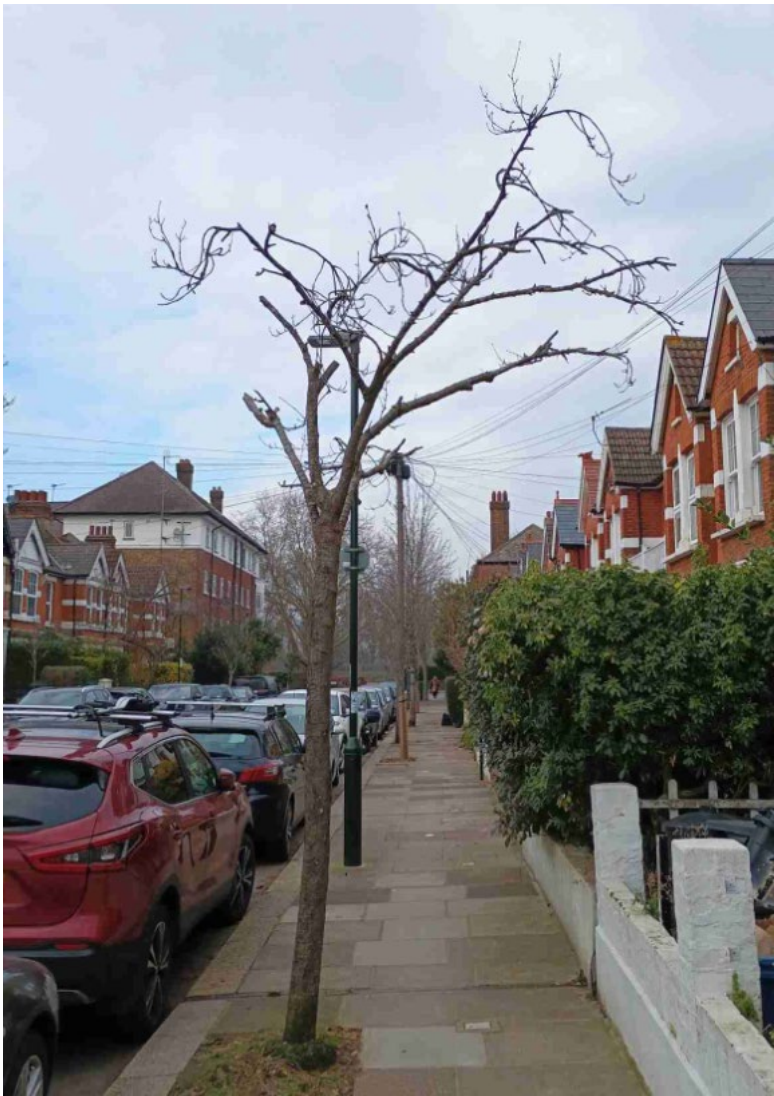
Ward	Mortlake and Barnes Common
Road	Avondale Road
Location	Outside 41
Species	Cherry (<i>Prunus sp.</i>)
Height	4.0m
Physiological Condition	Dead
Structural Condition	Dead
Inspection findings/reason for exemption	This tree is dead; removal is required to prevent natural failure, manage risk, and facilitate replanting

Image shows dead tree in street scene.
