March 2024 - Reactive Tree Works Programme

Introduction

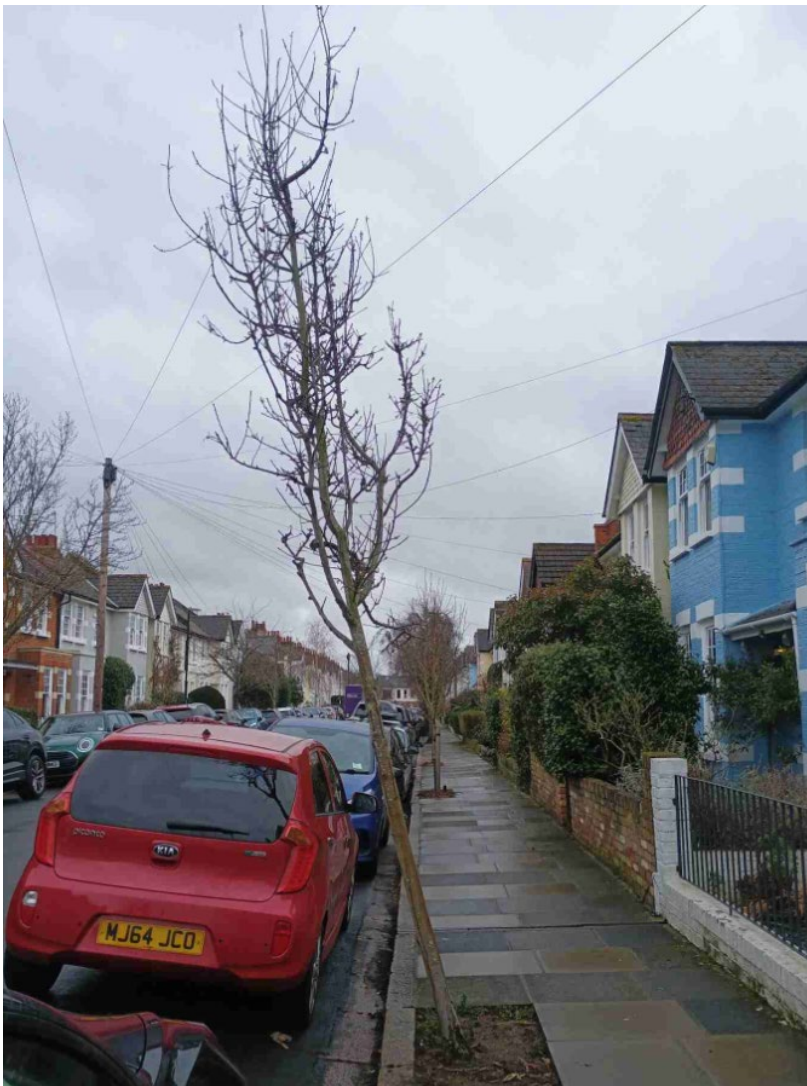
Ward	Mortlake and Barnes Common
Road	First Avenue
Location	Outside 4
Species	Field maple (<i>Acer campestre</i>)
Height	5.0m
Physiological Condition	Fair
Structural Condition	Poor
Inspection findings/reason for exemption	This tree is moving in such a way that indicates that the structure of the roots has been compromised. Removal is required to prevent natural failure, manage risk, and facilitate replanting

Image shows tree in street scene.

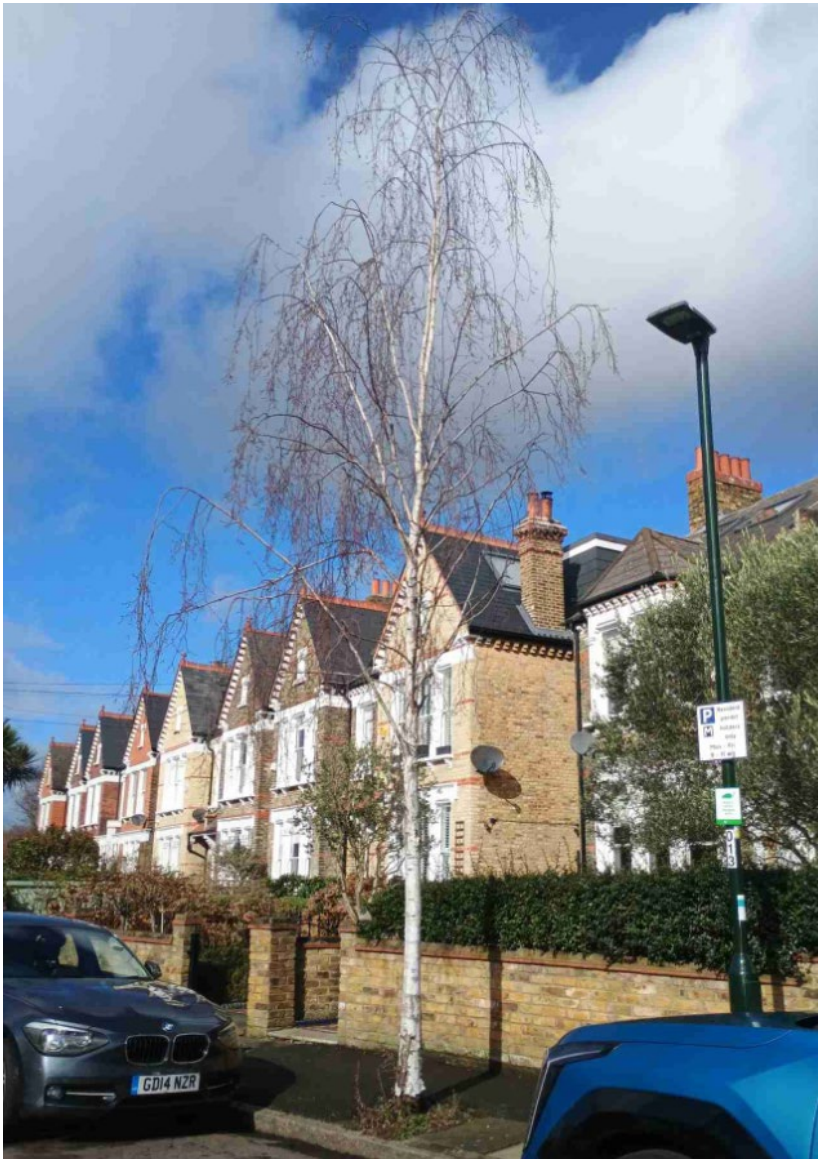
Image shows tree in street scene.

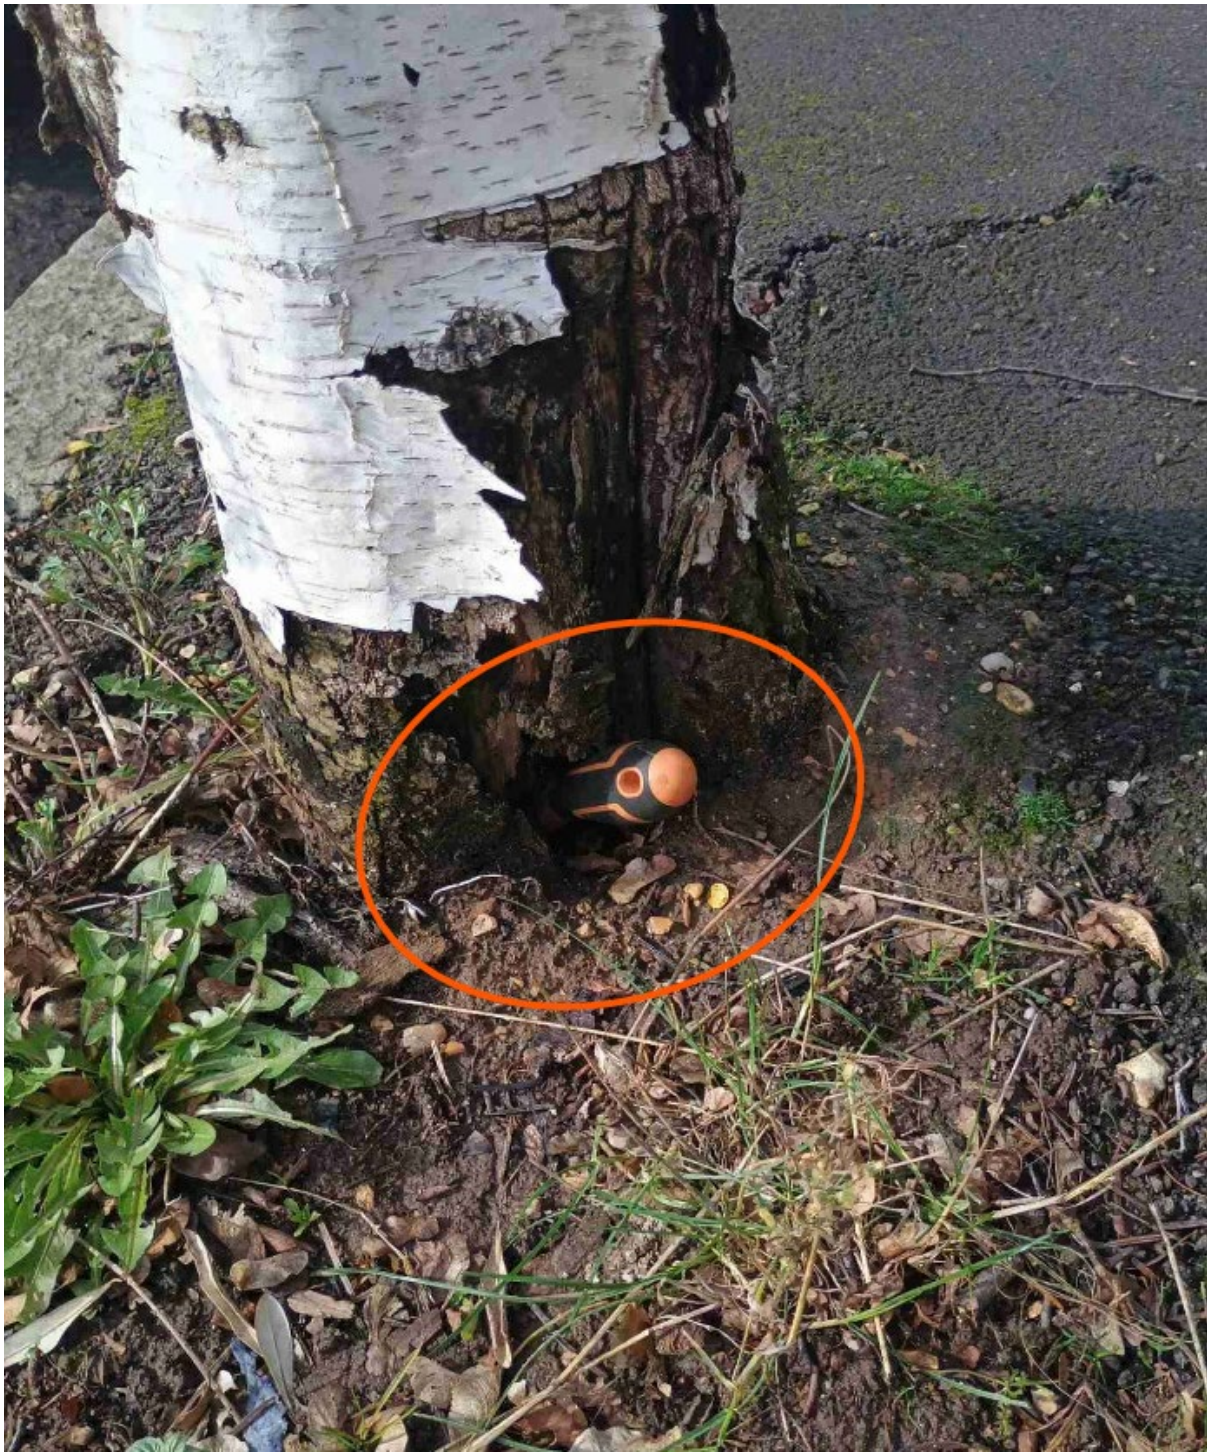
Ward	Mortlake and Barnes Common
Road	Elm Bank Gardens
Location	Outside 23
Species	Downy birch (<i>Betula pubescens</i>)
Height	10.0m
Physiological Condition	Good
Structural Condition	Poor
Inspection findings/reason for exemption	Investigation with a probe and a resonance test with a sounding hammer has revealed an unacceptable amount of decay beyond the visible cavities at the base of the trunk. Removal is required to prevent natural failure, manage risk, and facilitate replanting.

Image shows cavity with probe on trunk circled

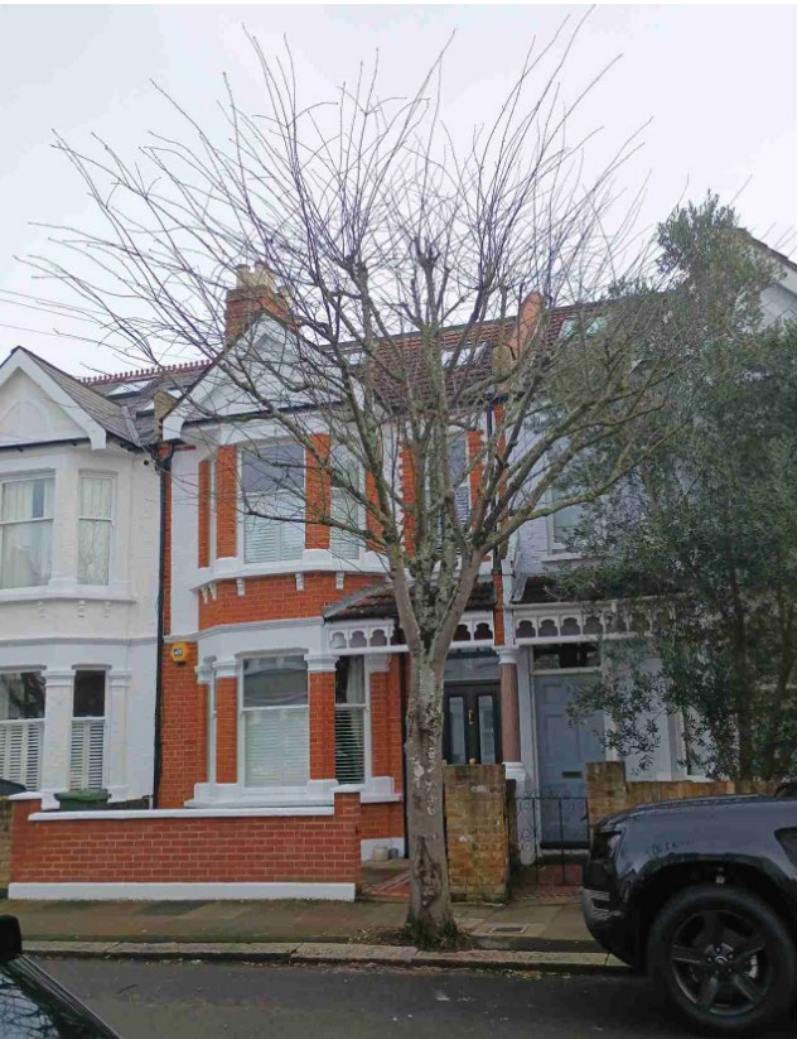
Image shows tree in street scene.

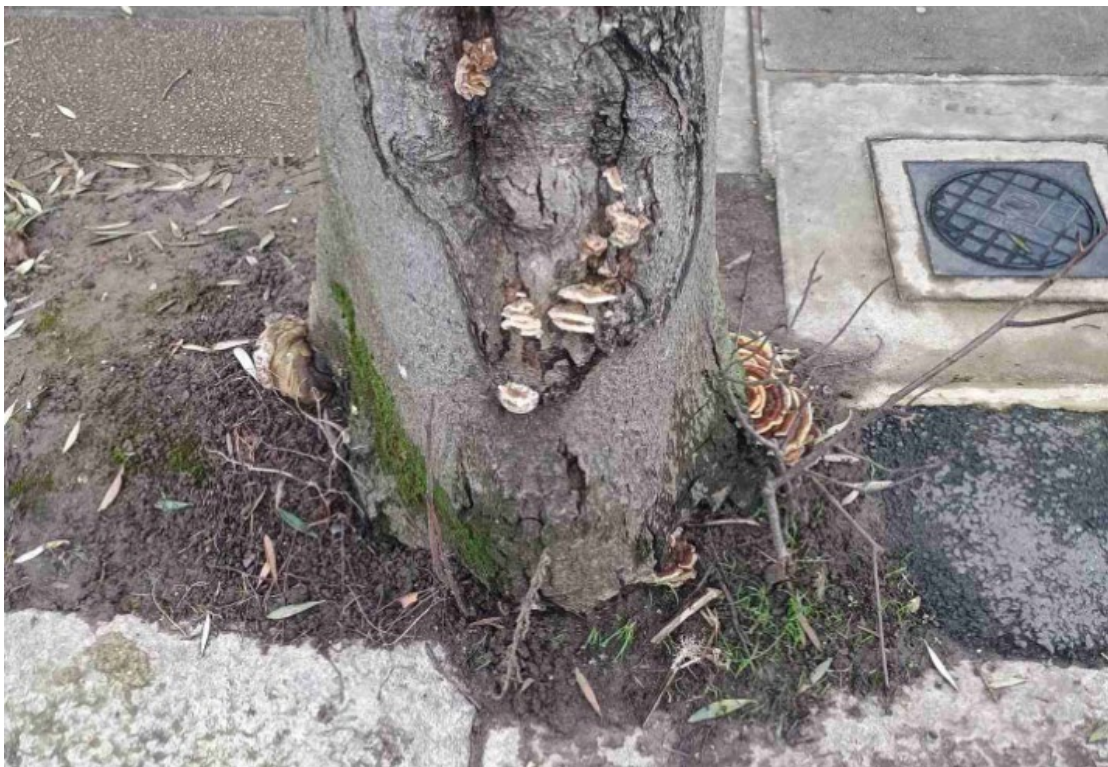
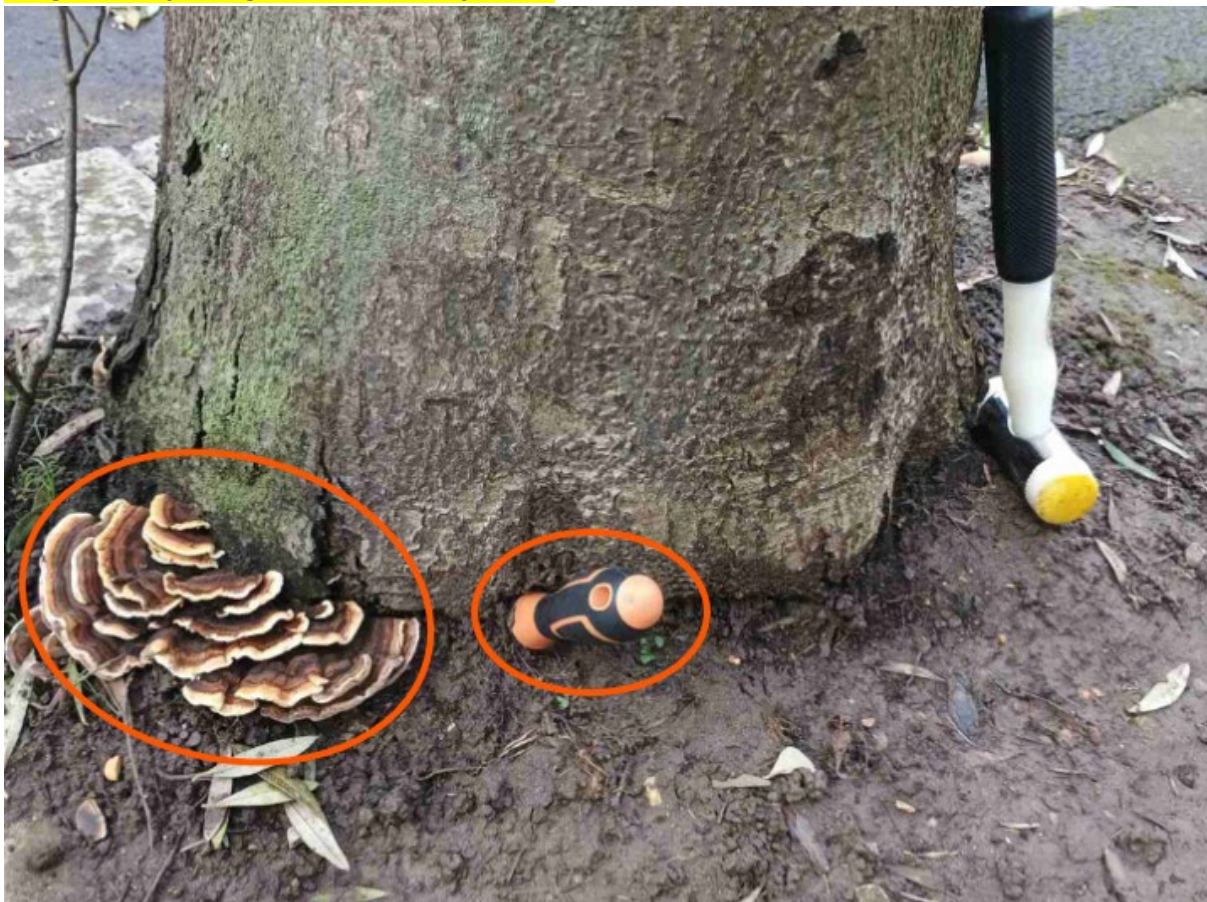
Ward	Mortlake and Barnes Common
Road	Grosvenor Avenue
Location	Outside 4
Species	Bird cherry (<i>Prunus padus</i>)
Height	7.0m
Physiological Condition	Fair
Structural Condition	Poor
Inspection findings/reasons for exemption	Fruiting bodies of the decay fungus <i>Trametes versicolor</i> are prolific on the trunk of this tree. This fungus causes a selective white rot of the wood, and its abundance often indicates broader physiological dysfunction. An investigation using a probe revealed an unacceptable degree of decay, correlating with the presence of the pathogen at the base of the trunk. Removal is necessary to prevent natural failure, manage risk, and facilitate replanting https://northernwoodlands.org/articles/article/turkey_tail_fungus_trametes_versicolor .

Image shows fruiting bodies at base of trunk.

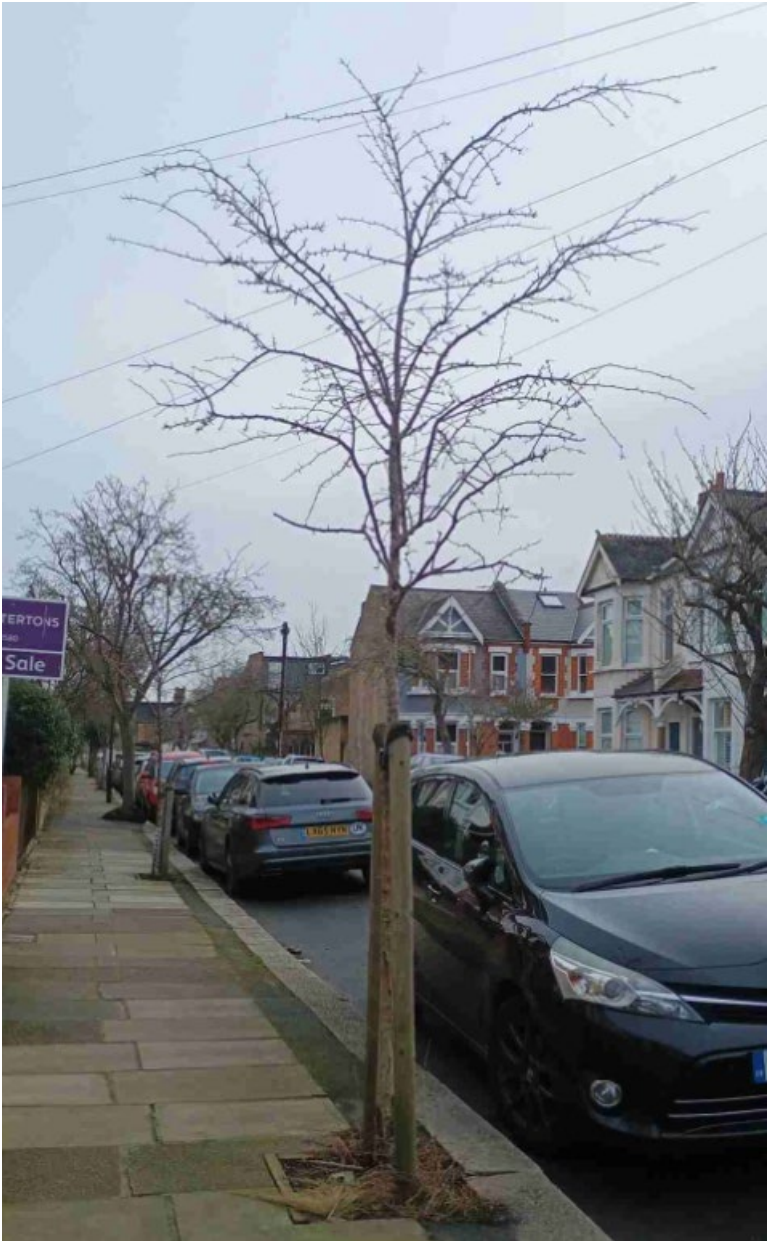
Ward	Mortlake and Barnes Common
Road	Grosvenor Avenue
Location	Outside 49/51
Species	Hawthorn (<i>Crataegus monogyna</i>)
Height	4.0m
Physiological Condition	Dead
Structural Condition	Dead
Inspection findings/reason for exemption	This tree is dead; removal is required to prevent natural failure, manage risk, and facilitate replanting

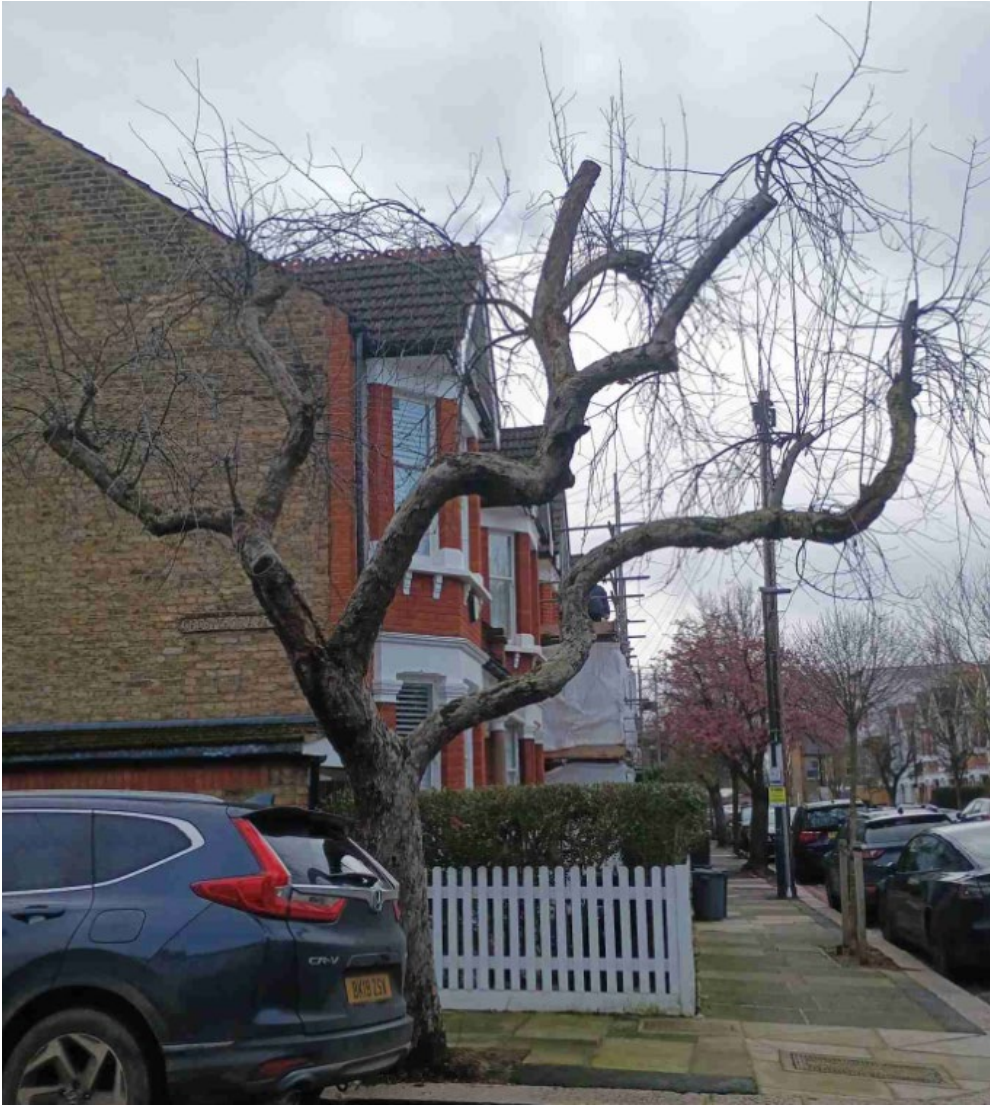
Image shows tree in street scene.

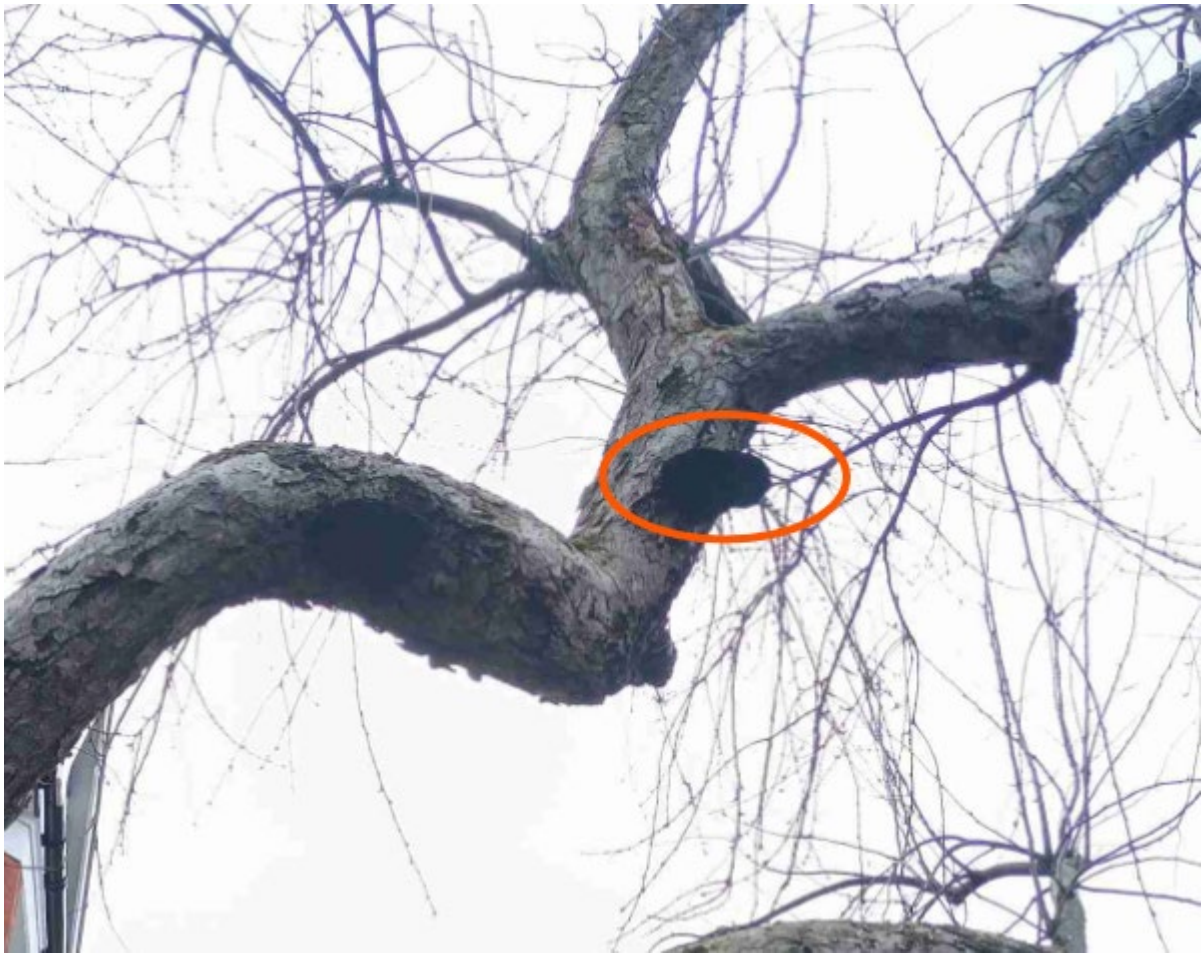
Ward	Mortlake and Barnes Common
Road	Grosvenor Avenue
Location	Opposite 89
Species	Crab apple (<i>Malus sylvestris</i>)
Height	7.5m
Physiological Condition	Poor
Structural Condition	Poor
Inspection findings/reason for exemption	A fungal fruiting body of the species <i>Inonotus hispidus</i> is present on the main stems in the crown, this fungus causes a simultaneous white rot which can cause snapping of tree parts in this species. Removal is required to prevent natural failure, manage risk, and facilitate replanting

Image shows fruiting body circled.

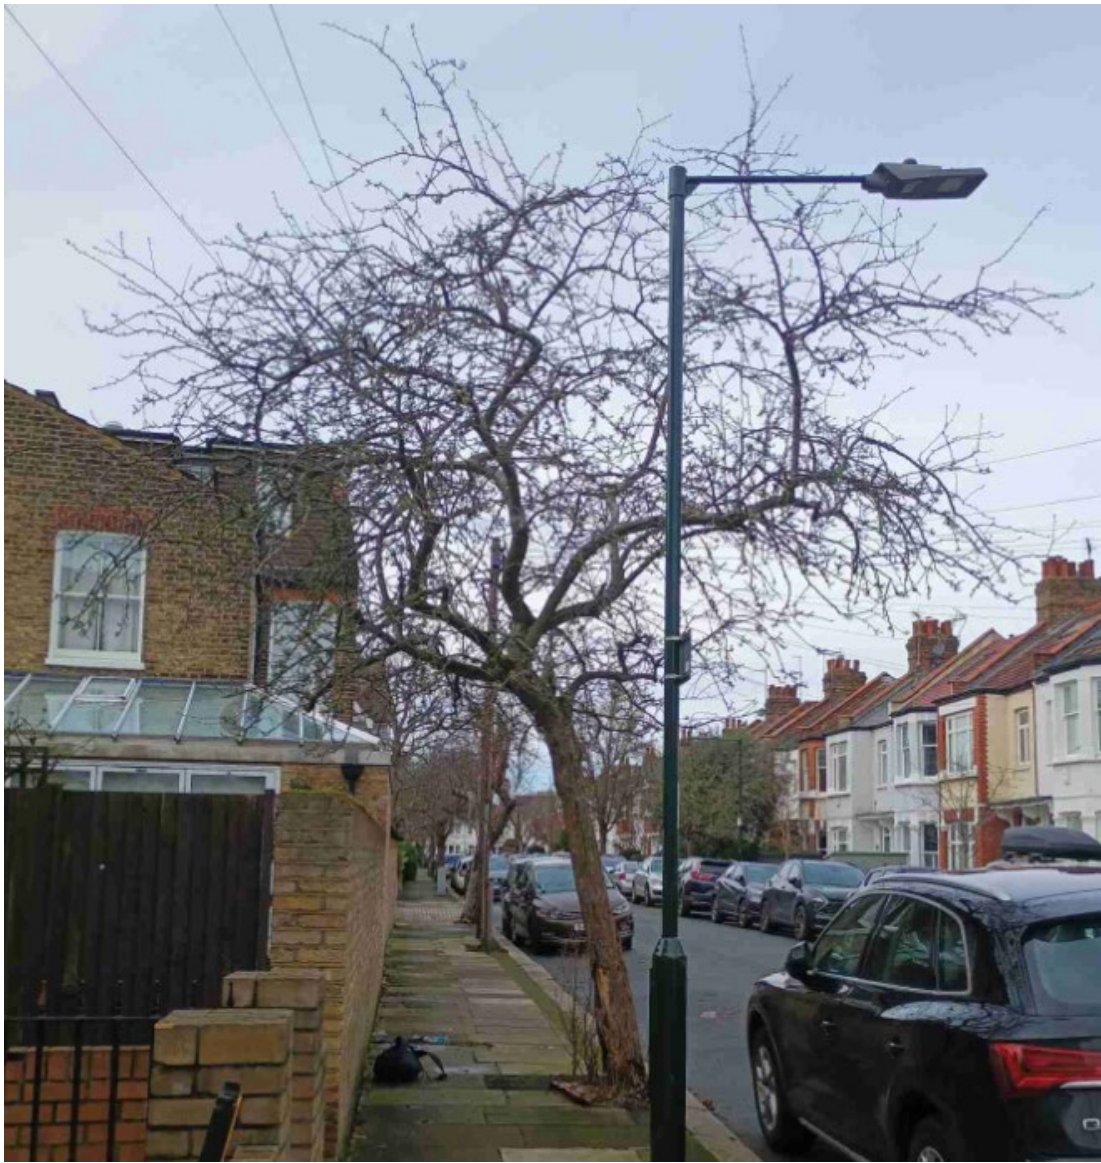
Ward	Mortlake and Barnes Common
Road	Grosvenor Avenue
Location	Opposite 99
Species	Crab apple (<i>Malus sylvestris</i>)
Height	7.0m
Physiological Condition	Poor
Structural Condition	Poor
Inspection findings/reason for exemption	This tree is dead; removal is required to prevent natural failure, manage risk, and facilitate replanting.

Image shows dead tree in street scene.

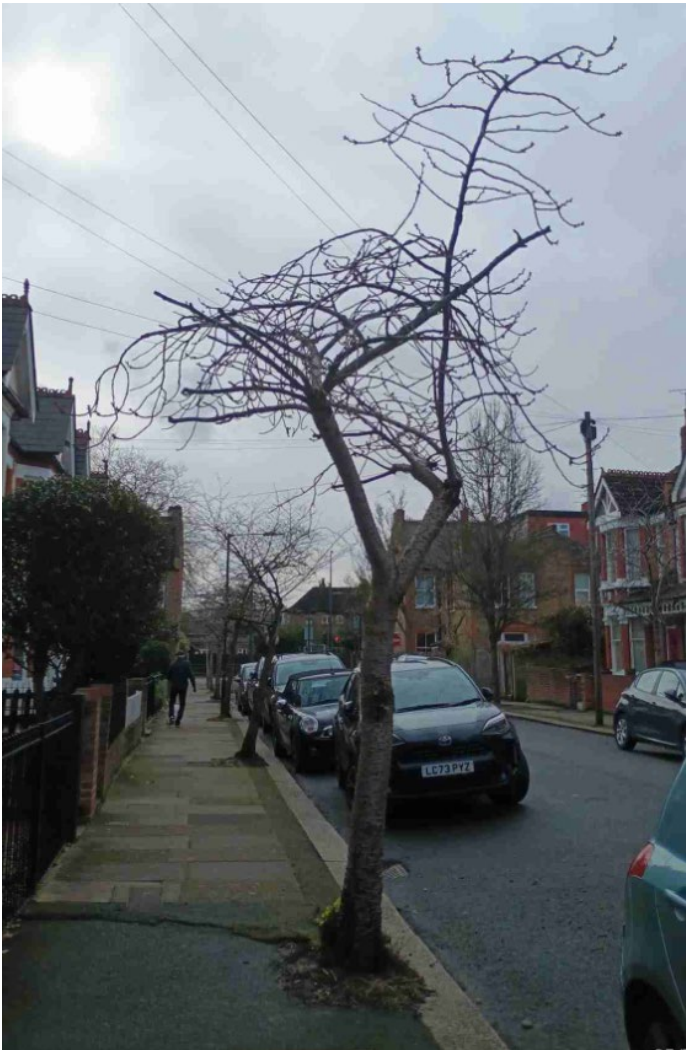
Image shows tree in street scene.

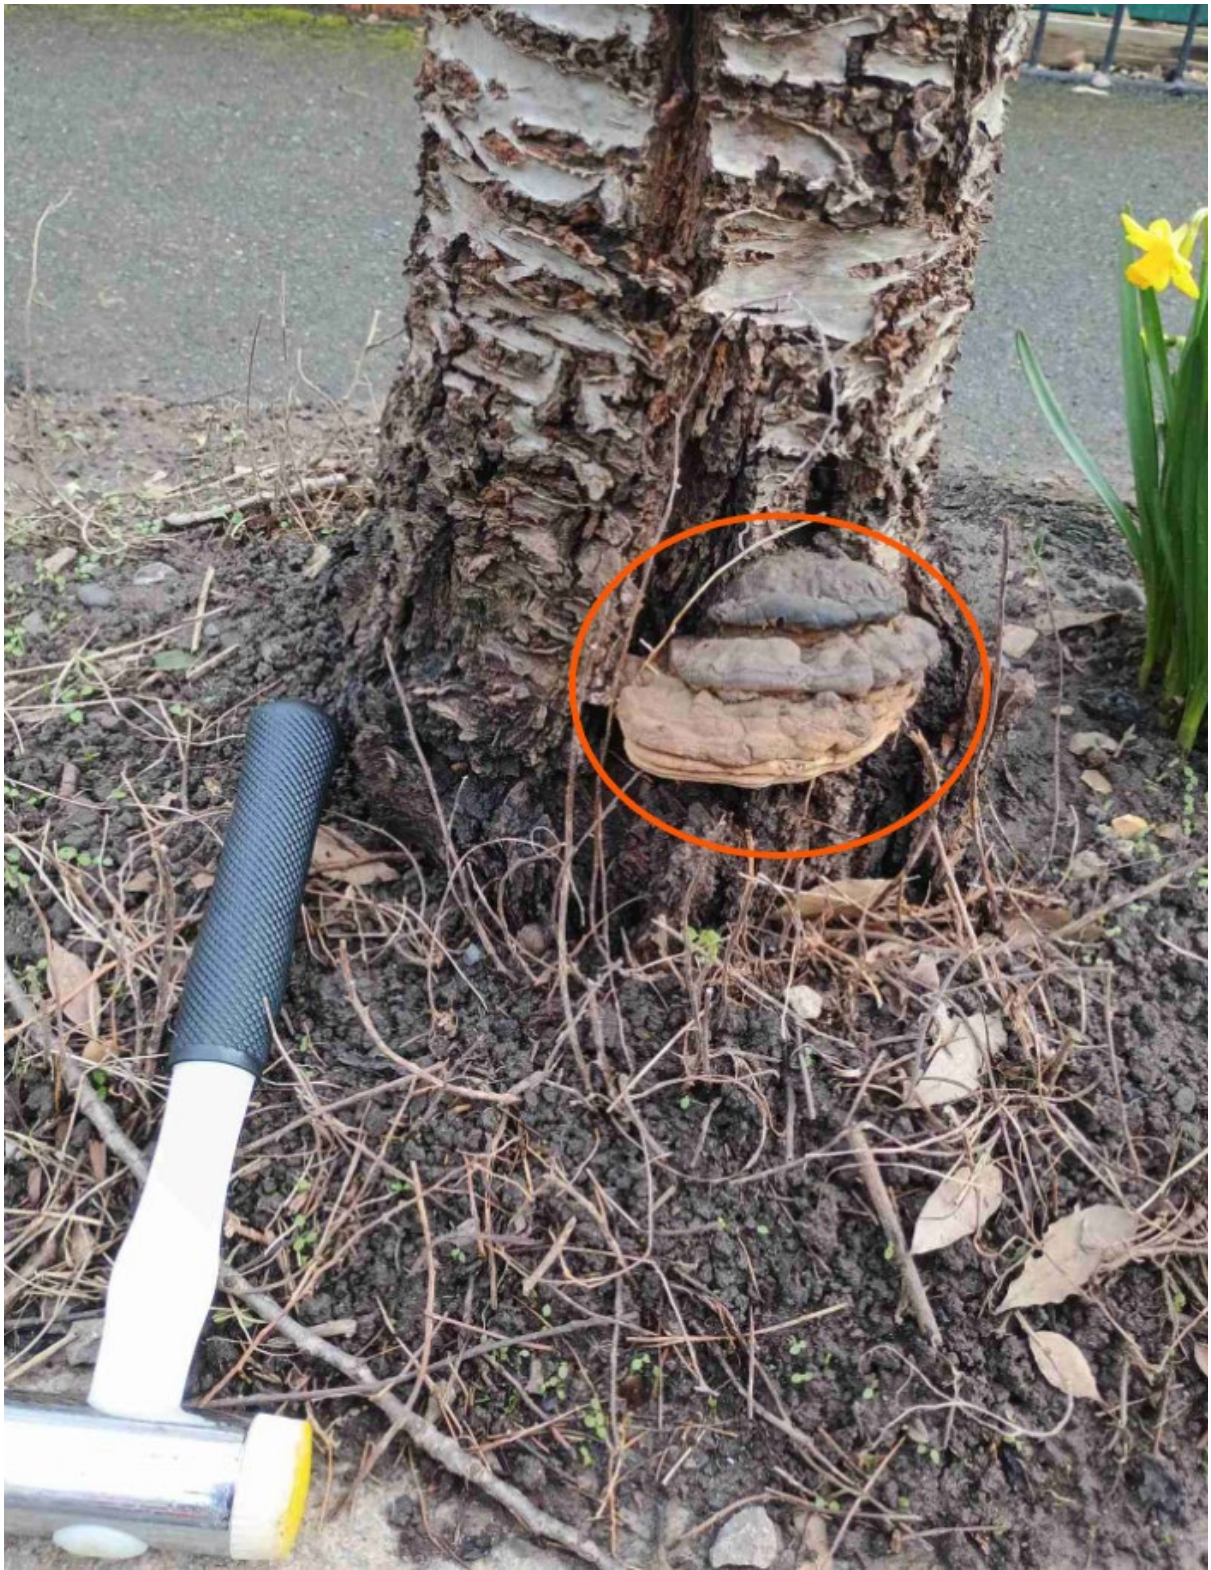
Ward	Mortlake and Barnes Common
Road	Grosvenor Garden
Location	Outside 12/14
Species	Cherry (<i>Prunus sp.</i>)
Height	4.0m
Physiological Condition	Fair
Structural Condition	Poor
Inspection findings/reason for exemption	A fungal fruiting body of the decay fungi <i>Ganoderma sp.</i> is present at the base of the trunk. Colonisation by this fungus causes a white rot of the stem and root system that can cause entire trees to collapse through fracture or windthrow. A resonance test revealed an unacceptable degree of decay in the trunk of this tree. Removal is required to prevent natural failure, manage risk, and facilitate replanting.

Image shows fruiting body circled.

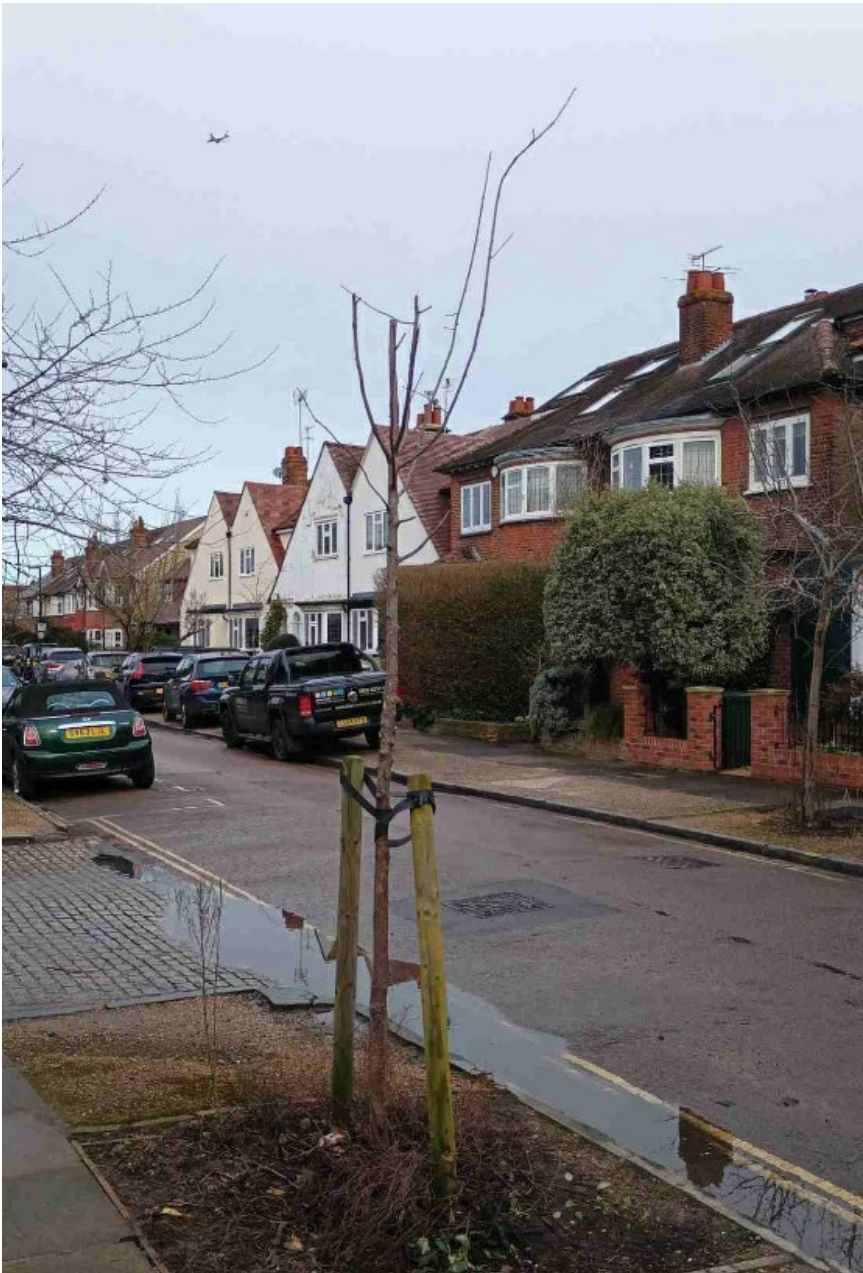
Ward	Mortlake and Barnes Common
Road	Westwood Road
Location	Outside 11
Species	Bird cherry (<i>Prunus padus</i>)
Height	5.0m
Physiological Condition	Dead
Structural Condition	Dead
Inspection findings/reason for exemption	This tree is dead; removal is required to prevent natural failure, manage risk, and facilitate replanting

Image shows dead tree in street scene.

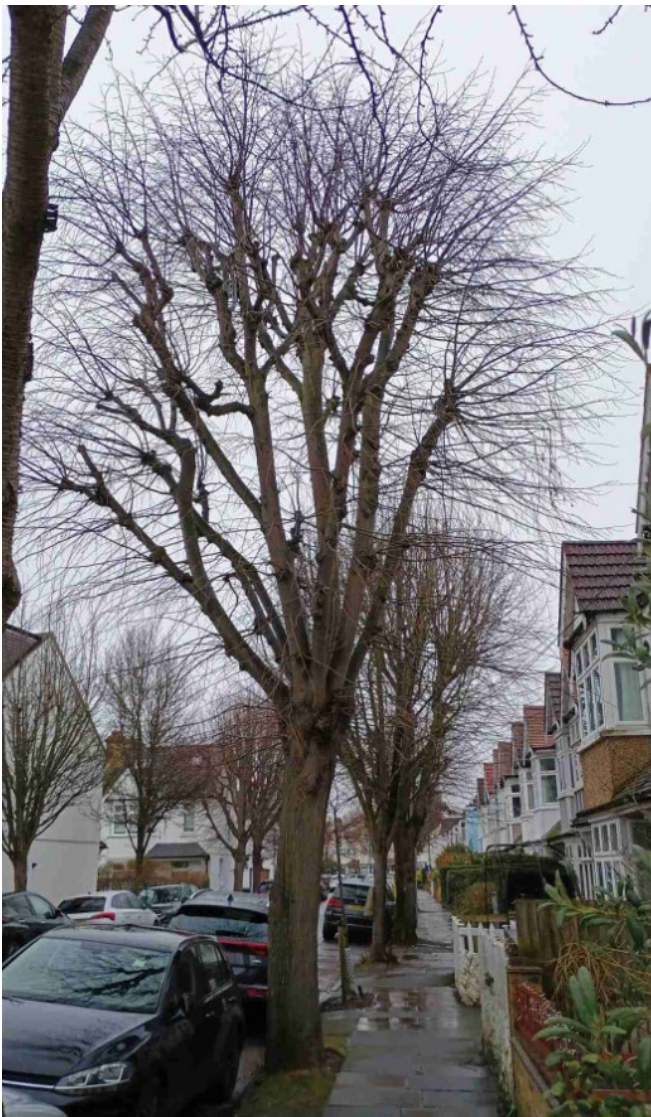
Image shows tree in street scene.

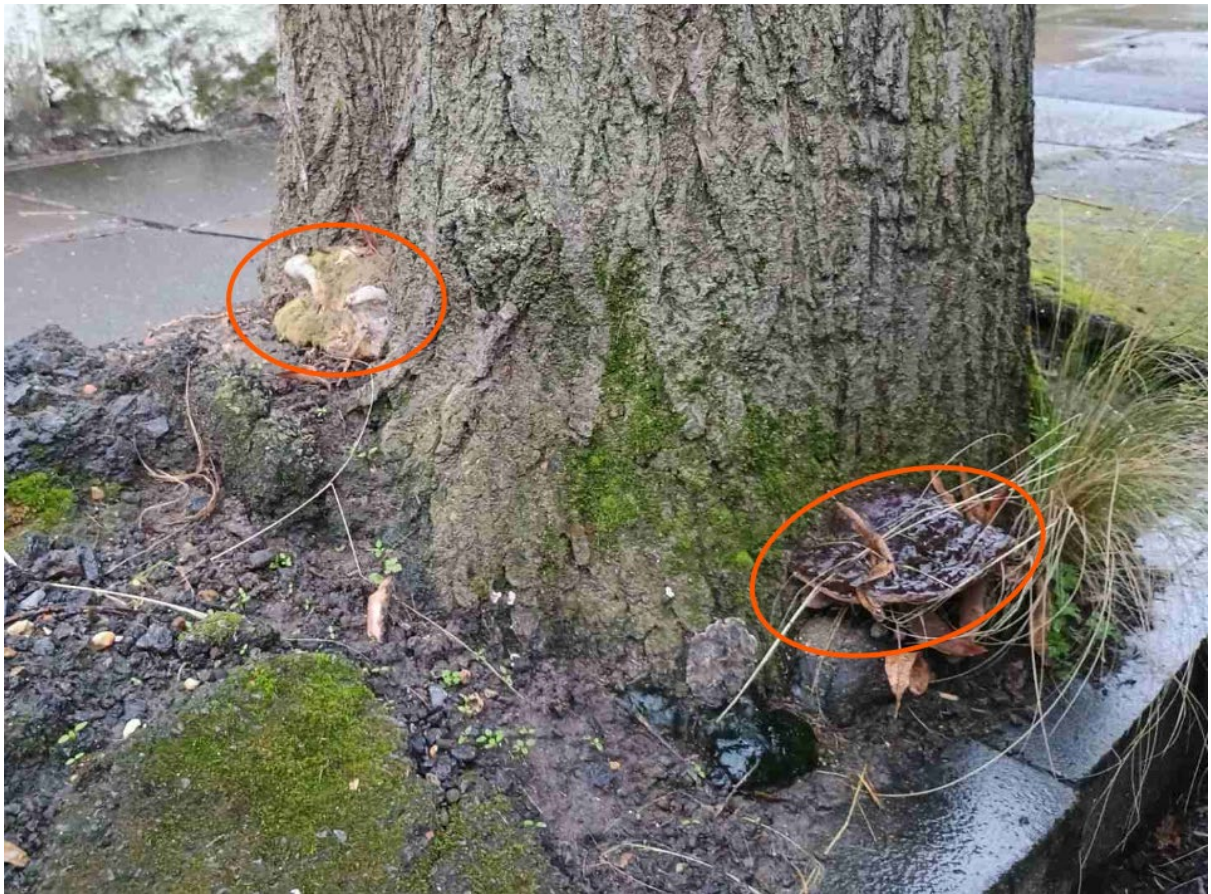
Ward	Mortlake and Barnes Common
Road	Treen Avenue
Location	Outside 8
Species	Common Lime (<i>Tilia x europaea</i>)
Height	11.0m
Physiological Condition	Dead
Structural Condition	Dead
Inspection findings/reason for exemption	A fungal fruiting body of the decay fungi <i>Ganoderma sp.</i> is present at the base of the trunk. Colonisation by this fungus causes a white rot of the stem and root system that can cause entire trees to collapse through fracture or windthrow. A resonance test revealed an unacceptable degree of decay in the trunk of this tree. Removal is required to prevent natural failure, manage risk, and facilitate replanting.

Image shows fruiting bodies circled.

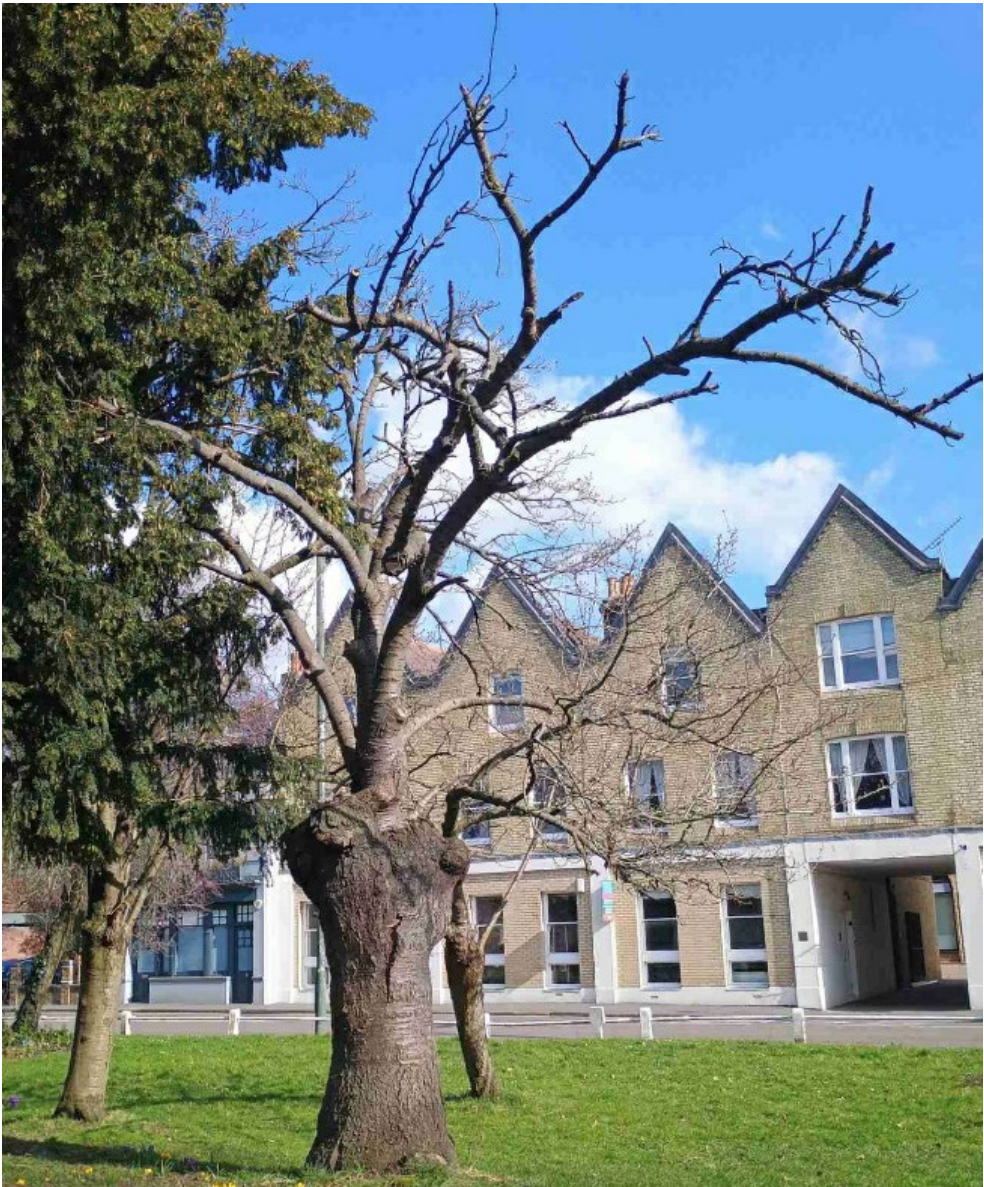
Ward	Mortlake and Barnes Common
Road	Sheen Lane
Location	Mortlake Green ///cheeks.slurs.model
Species	Prunus 'Kanzan' (<i>Prunus Kanzan</i>)
Height	5.0m
Physiological Condition	Dead
Structural Condition	Dead
Inspection findings/reason for exemption	This tree is dead; removal is required to prevent natural failure, manage risk, and facilitate replanting

Image shows dead tree in street scene.

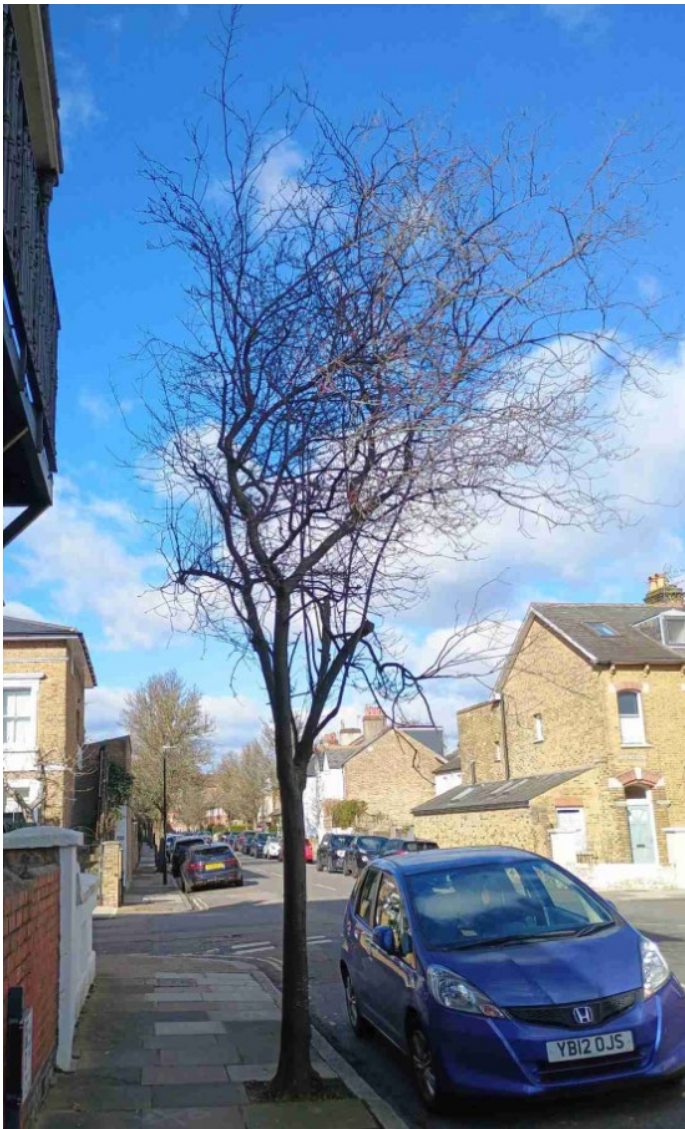
Image shows tree in street scene.

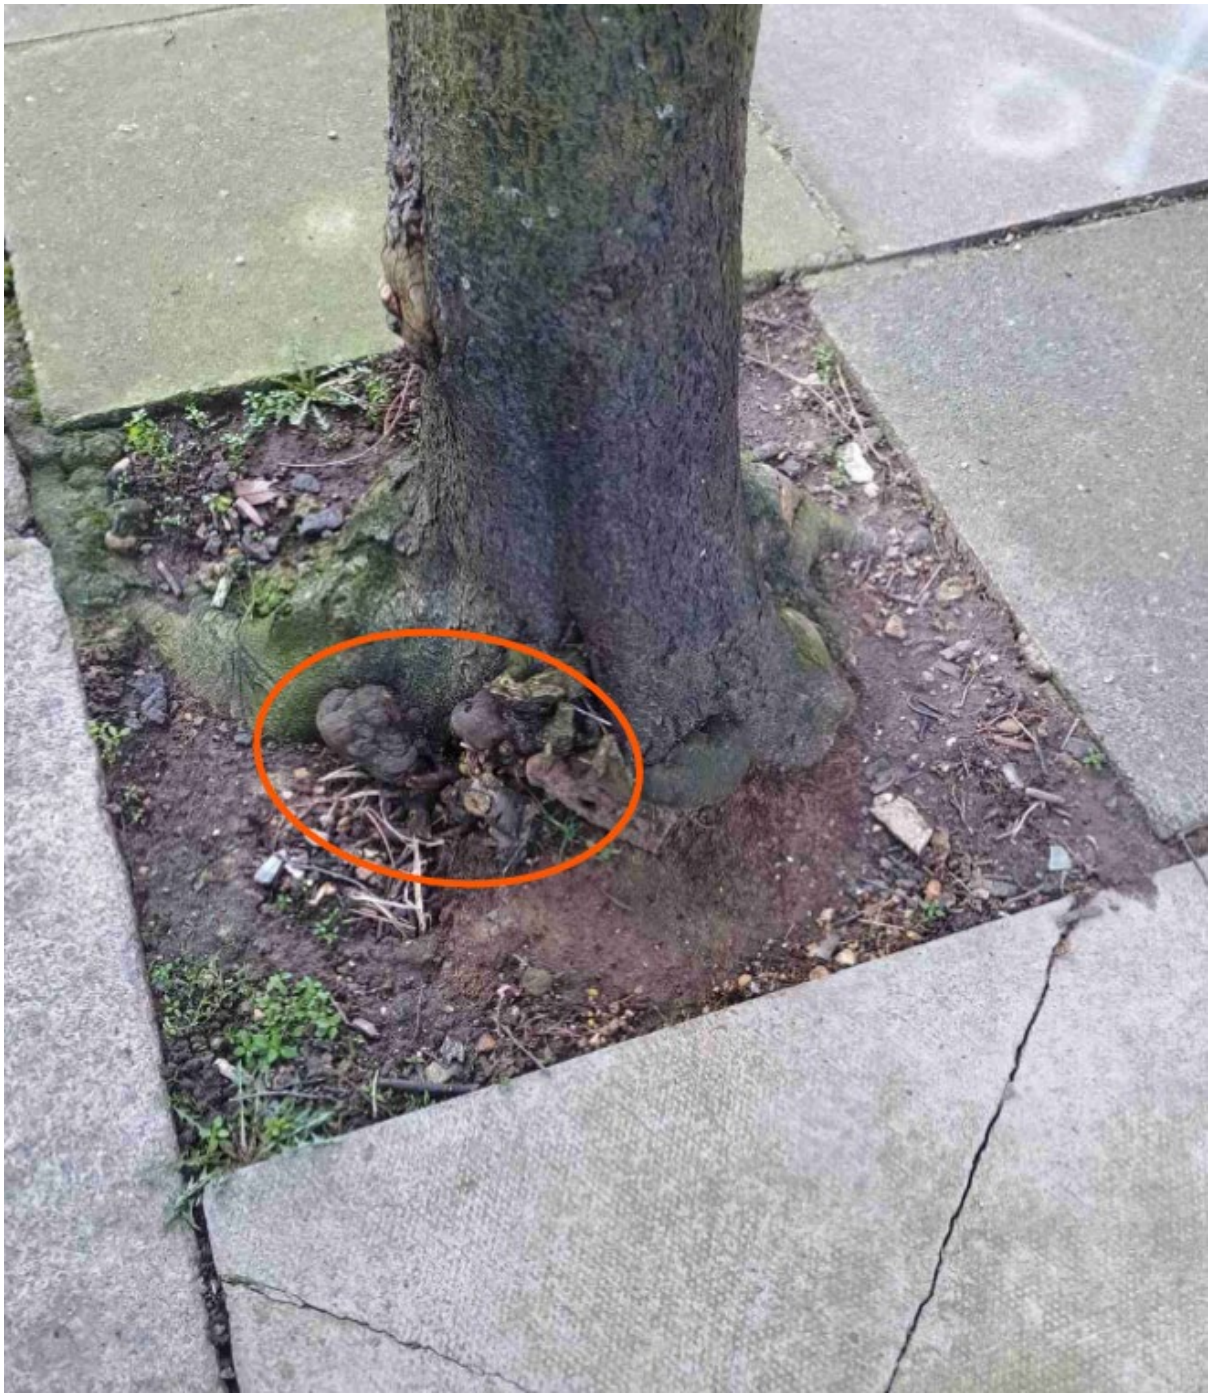
Ward	Mortlake and Barnes Common
Road	Cambridge Road
Location	Adjacent to 26 Cleveland Road
Species	Plum cherry (<i>Prunus cerasifera</i>)
Height	7.0m
Physiological Condition	Good
Structural Condition	Poor
Inspection findings/reason for exemption	A fungal fruiting body of the decay fungi <i>Ganoderma sp.</i> is present at the base of the trunk. Colonisation by this fungus causes a white rot of the stem and root system that can cause entire trees to collapse through fracture or windthrow. A resonance test revealed an unacceptable degree of decay in the trunk of this tree. Removal is required to prevent natural failure, manage risk, and facilitate replanting.

Image shows fruiting body circled.

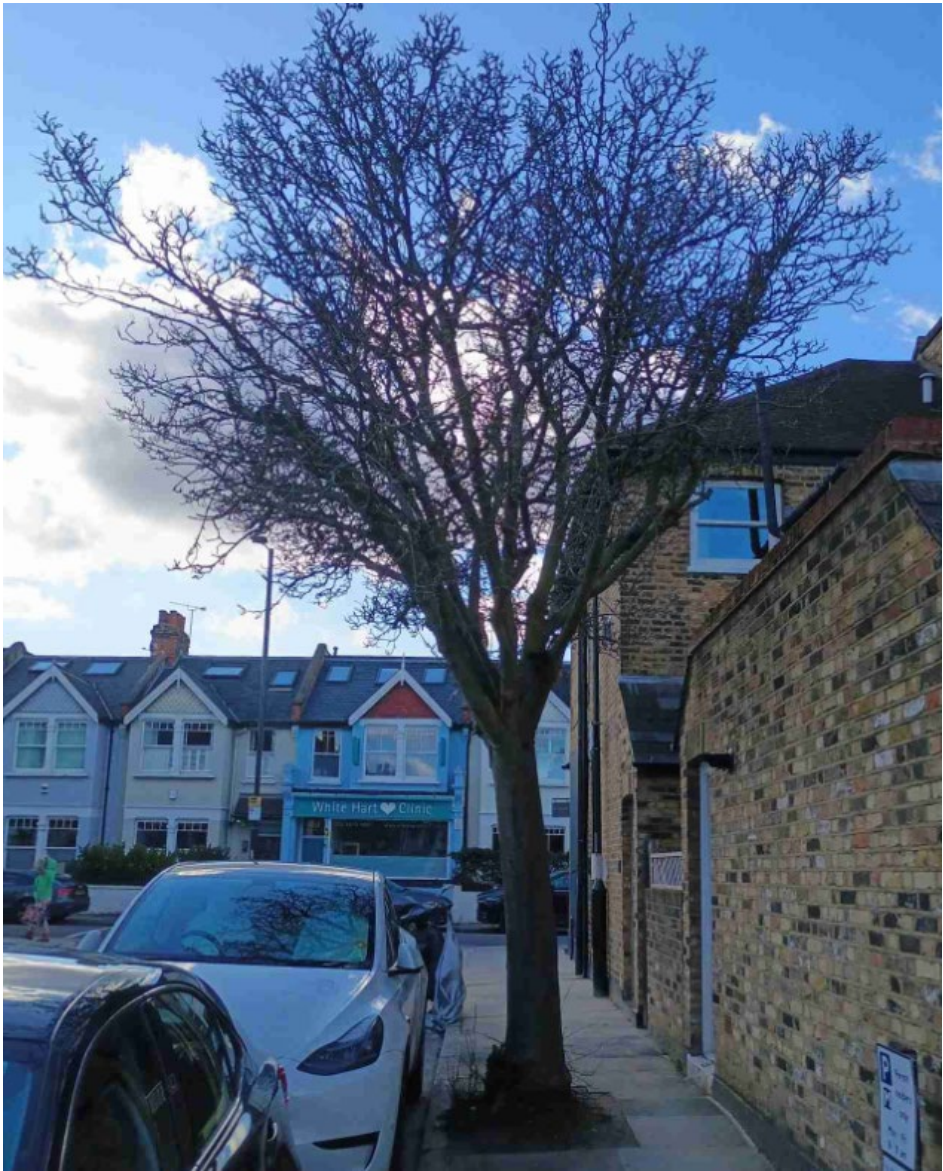
Image shows tree in street scene.
