March 2024 - Reactive Tree Works Programme

Introduction

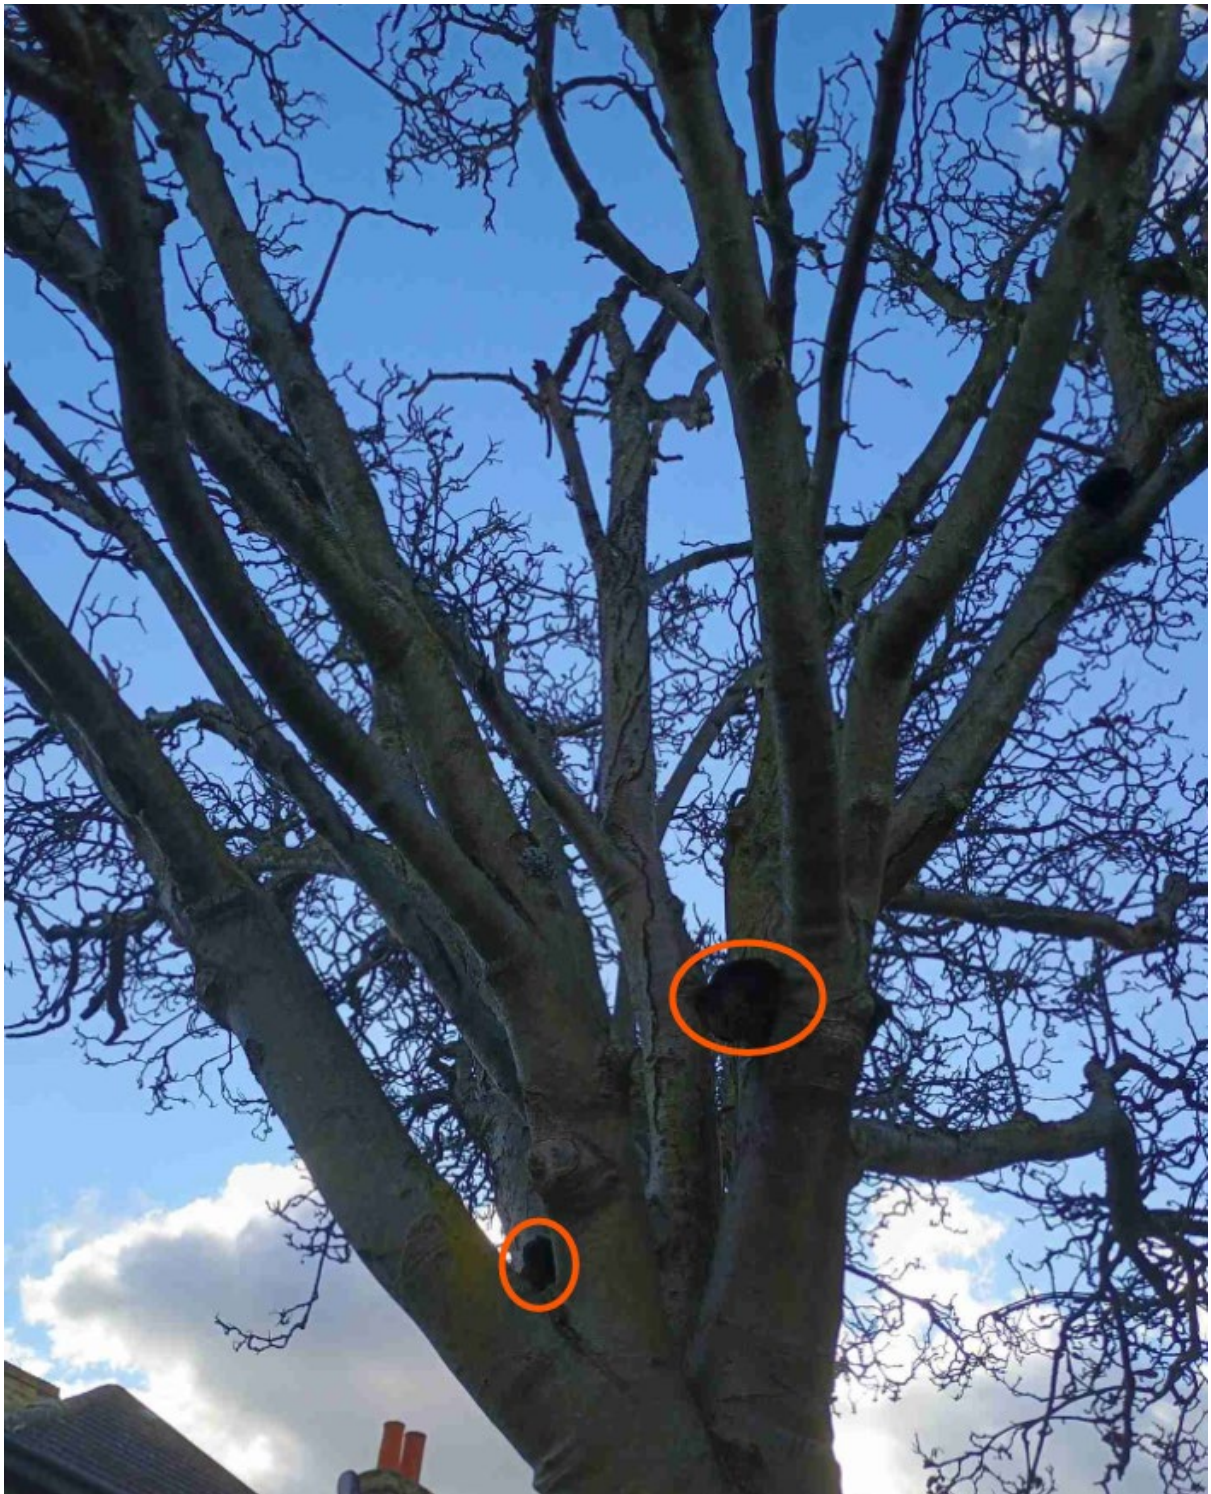
Ward	Mortlake and Barnes Common
Road	Charles Street
Location	Outside 1B
Species	Swedish whitebeam (<i>Sorbus x intermedia</i>)
Height	6.5m
Physiological Condition	Poor
Structural Condition	Poor
Inspection findings/reason for exemption	A fungal fruiting body of the species <i>Inonotus hispidus</i> is present on the main stems in the crown, this fungus causes a simultaneous white rot which can cause snapping of tree parts in this species. Crown dieback correlates with the pathogen present. Removal is required to prevent natural failure, manage risk, and facilitate replanting

Image shows fruiting bodies circled and crown dieback in upper crown.

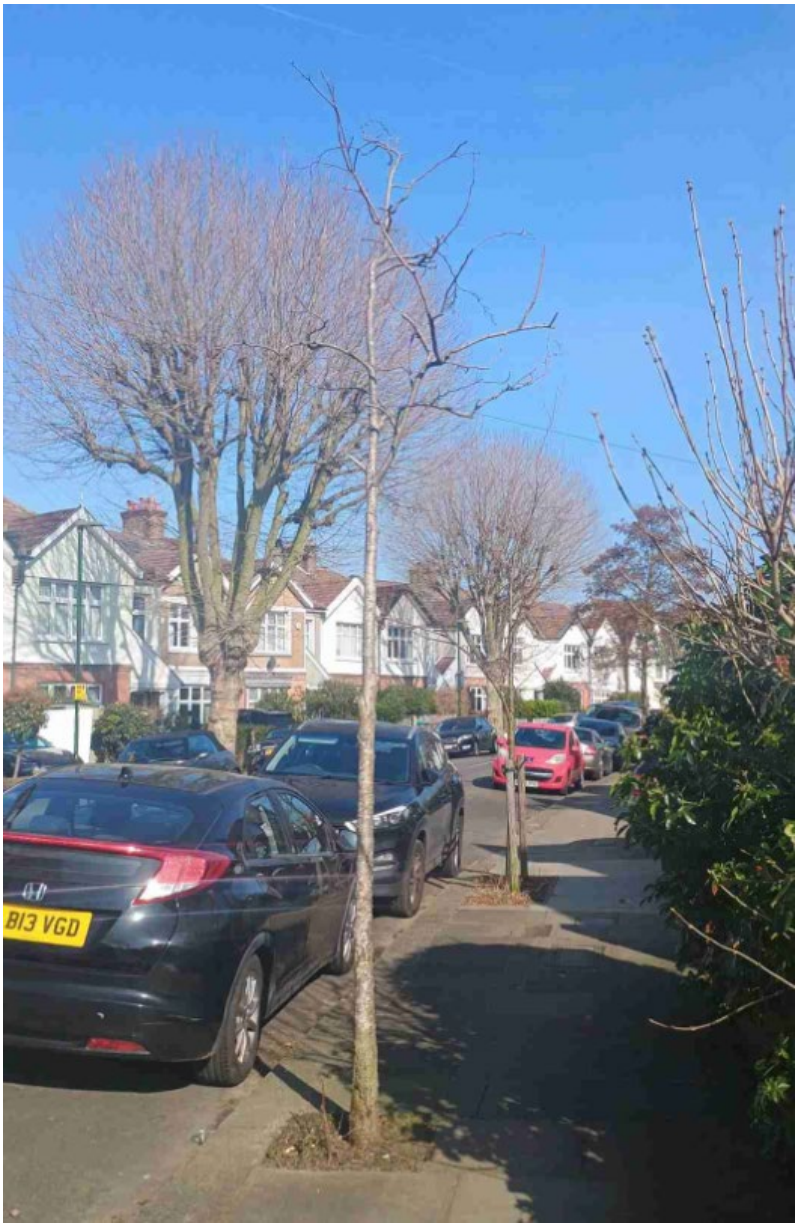
Ward	North Richmond
Road	St Leonards Road
Location	Outside 97
Species	Italian alder (<i>Alnus cordata</i>)
Height	5.0m
Physiological Condition	Dead
Structural Condition	Dead
Inspection findings/reason for exemption	This tree is dead; removal is required to prevent natural failure, manage risk, and facilitate replanting

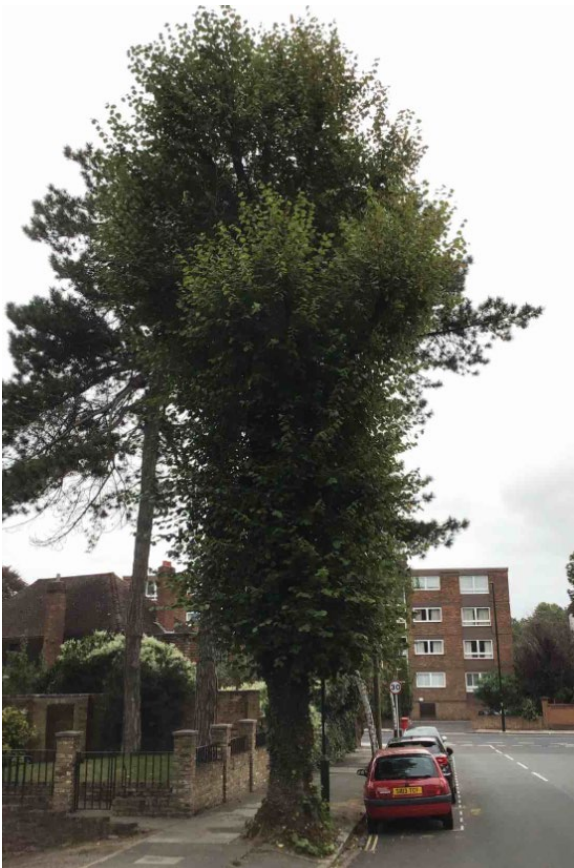
Image shows tree in street scene.

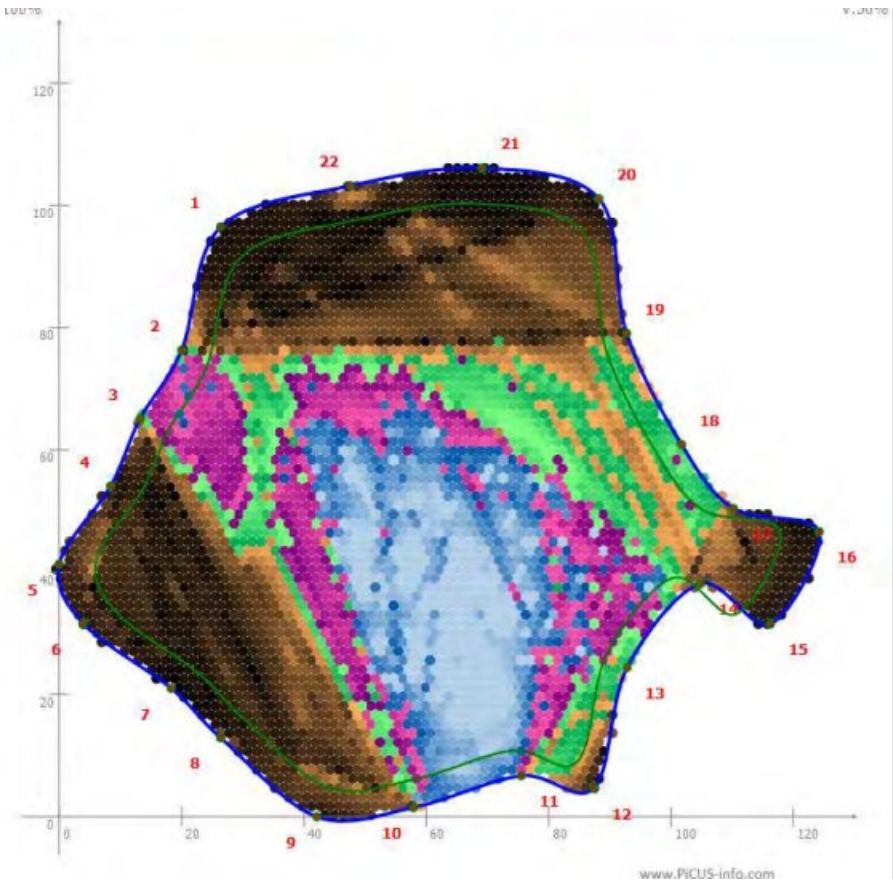
Ward	South Twickenham
Road	Waldegrave Park
Location	Outside 89
Species	Common Lime (<i>Tilia x europaea</i>)
Height	16.0m
Physiological Condition	Fair
Structural Condition	Poor
Inspection findings/reason for exemption	A fungal fruiting body of the decay fungi <i>Ganoderma sp.</i> is present in the lower trunk of this tree. Colonization by this fungus causes white rot in the stem and root system, potentially leading to the tree's collapse through fracture or windthrow. A detailed investigation using sonic tomography revealed an unacceptable amount of decay, indicated by the light-coloured areas in the cross-section image of the stem below, spreading to the sound wood shown as darker-coloured areas. Removal is necessary to prevent natural failure, manage risk, and facilitate replanting

Image shows detailed inspection of trunk taken at 28cm from ground level. Blue area indicates decayed wood

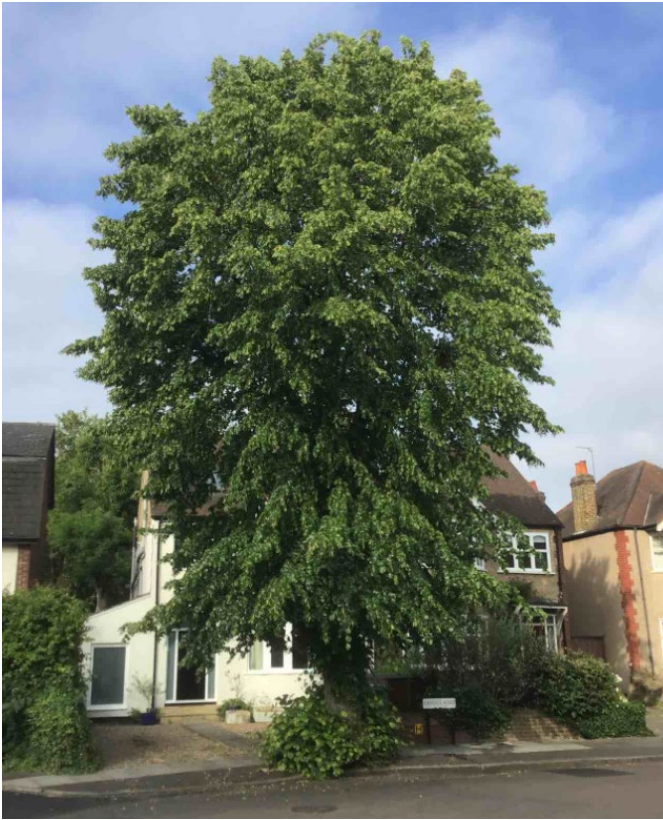
Image shows in street scene

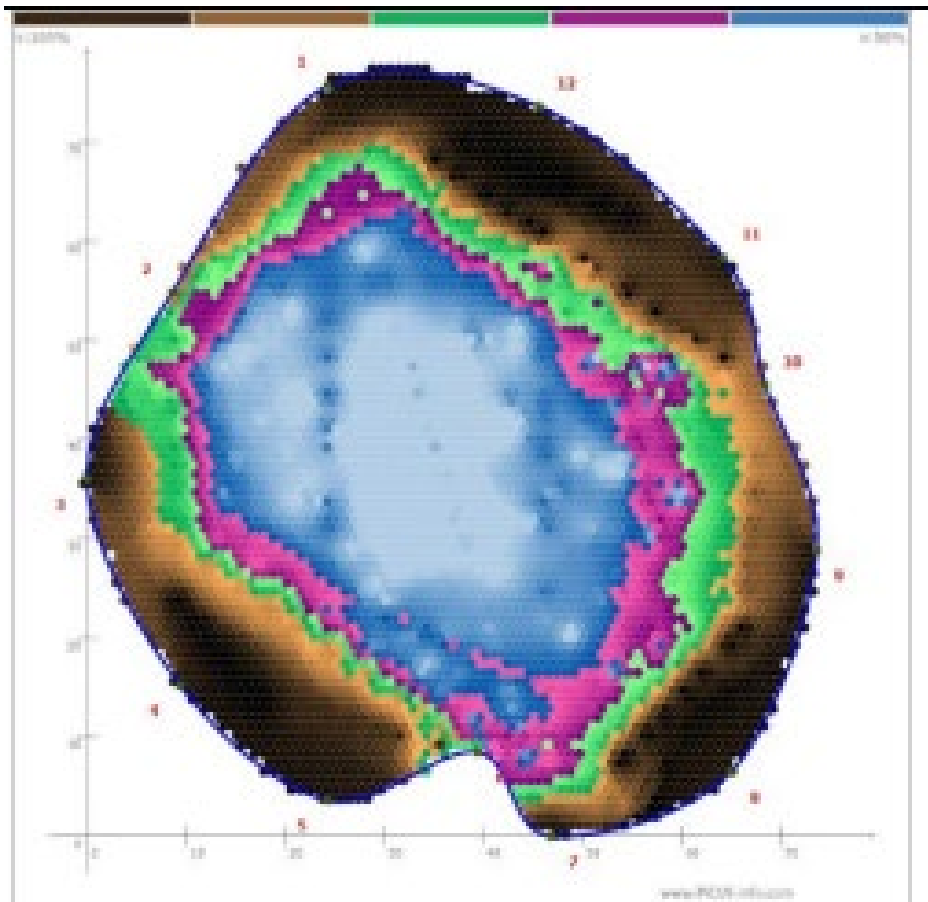
Ward	St Margarets and North Twickenham
Road	Cassilis Road
Location	Outside 2
Species	Common lime (<i>Tilia x europaea</i>)
Height	15.0m
Physiological Condition	Fair
Structural Condition	Poor
Inspection findings/reason for exemption	A fungal fruiting body of the decay fungi <i>Ganoderma sp.</i> is present in the lower trunk of this tree. Colonization by this fungus causes white rot in the stem and root system, potentially leading to the tree's collapse through fracture or windthrow. A detailed investigation using sonic tomography revealed an unacceptable amount of decay, indicated by the light-coloured areas in the cross-section image of the stem below, spreading to the sound wood shown as darker-coloured areas. Removal is necessary to prevent natural failure, manage risk, and facilitate replanting

Image shows detailed inspection of trunk taken at 2m from ground level. Blue area indicates decayed wood.

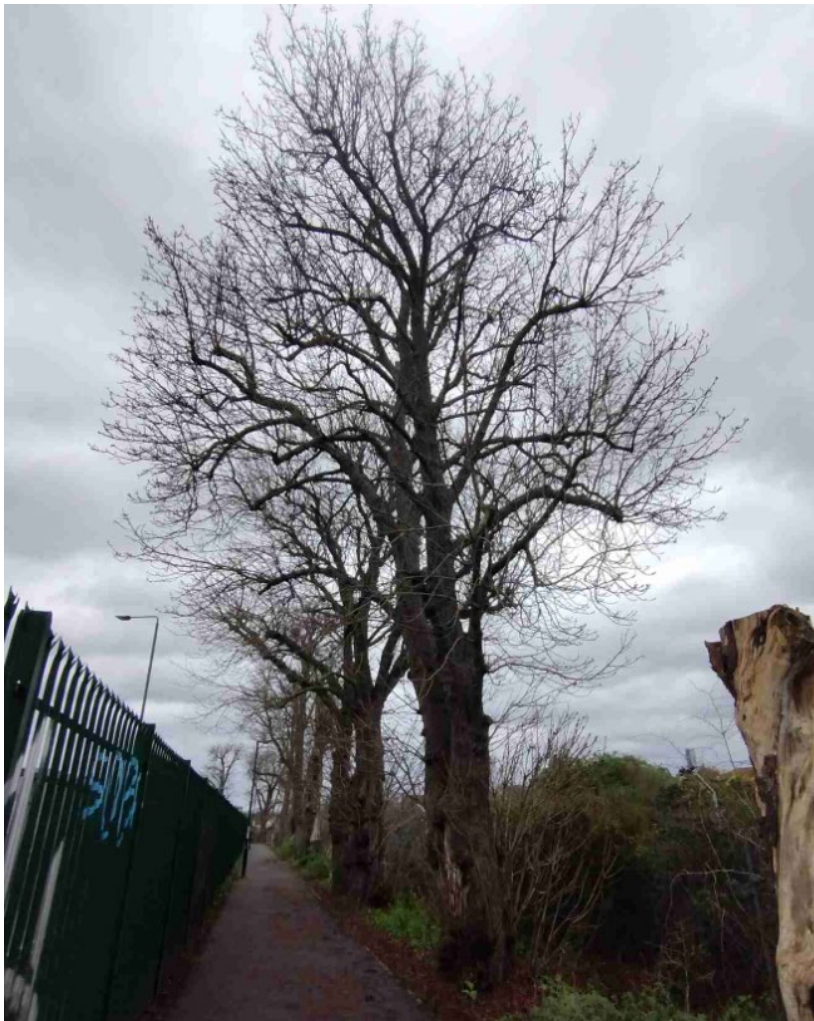
Image shows tree in street scene.

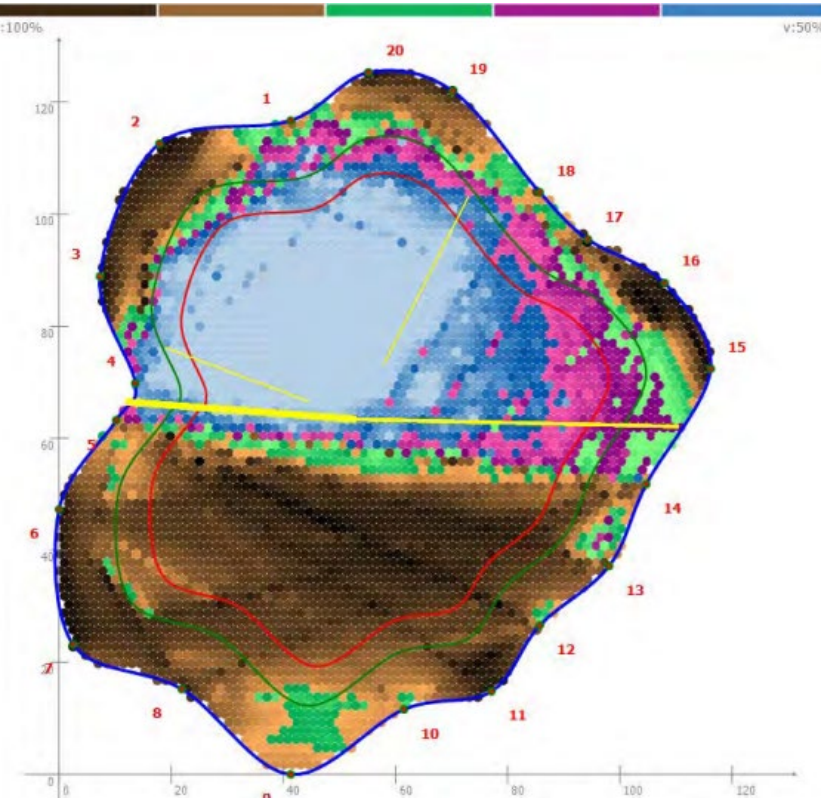
Ward	St Margarets and North Twickenham
Road	Craneford way
Location	Craneford way- ///amuse.lime.both
Species	Horse Chestnut (<i>Aesculus hippocastanum</i>)
Height	18.0m
Physiological Condition	Fair
Structural Condition	Poor
Inspection findings/reason for exemption	This tree has a large area of bark damage at the base of the trunk. Investigation with a probe and a resonance test with a sounding hammer revealed decay beyond the visible wound at the base of the trunk. A detailed investigation was conducted on the trunk of this tree using sonic tomography. The results of the detailed inspection identify significant decay, as shown in the light-coloured areas in the image of the cross-section of the stem below, spreading to the sound wood shown as darker-coloured areas. Removal is required to prevent natural failure, manage risk, and facilitate replanting.

Image shows detailed inspection of trunk taken at 15cm from ground level. Blue area indicates decayed wood

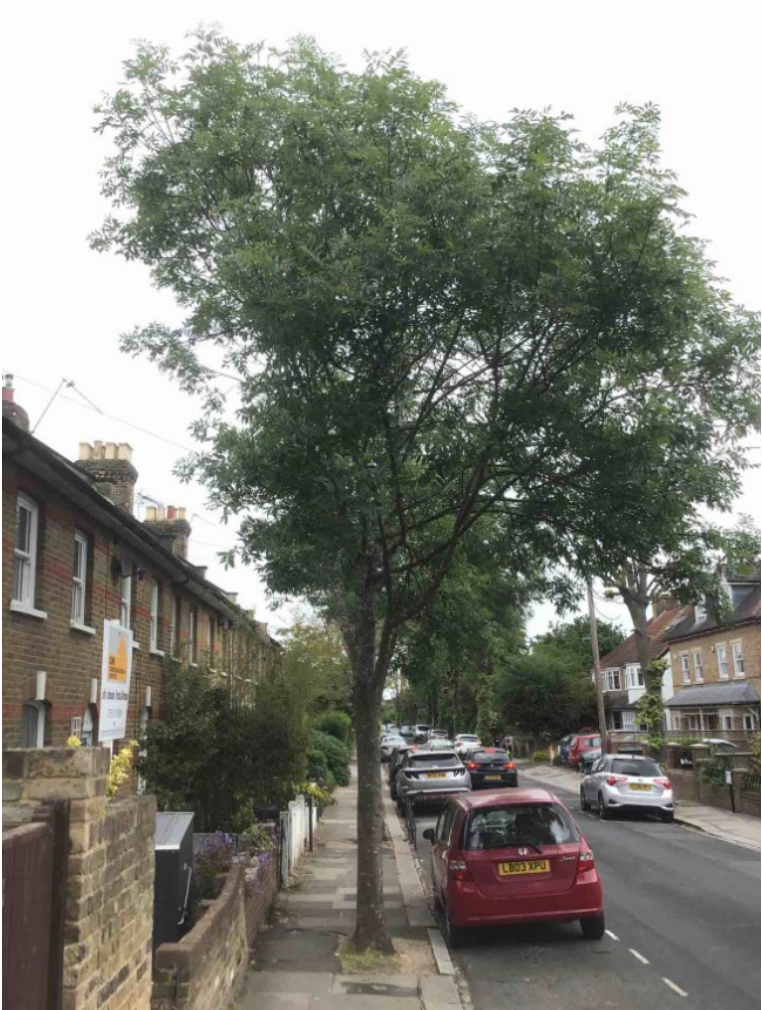
Image shows tree in in street scene.

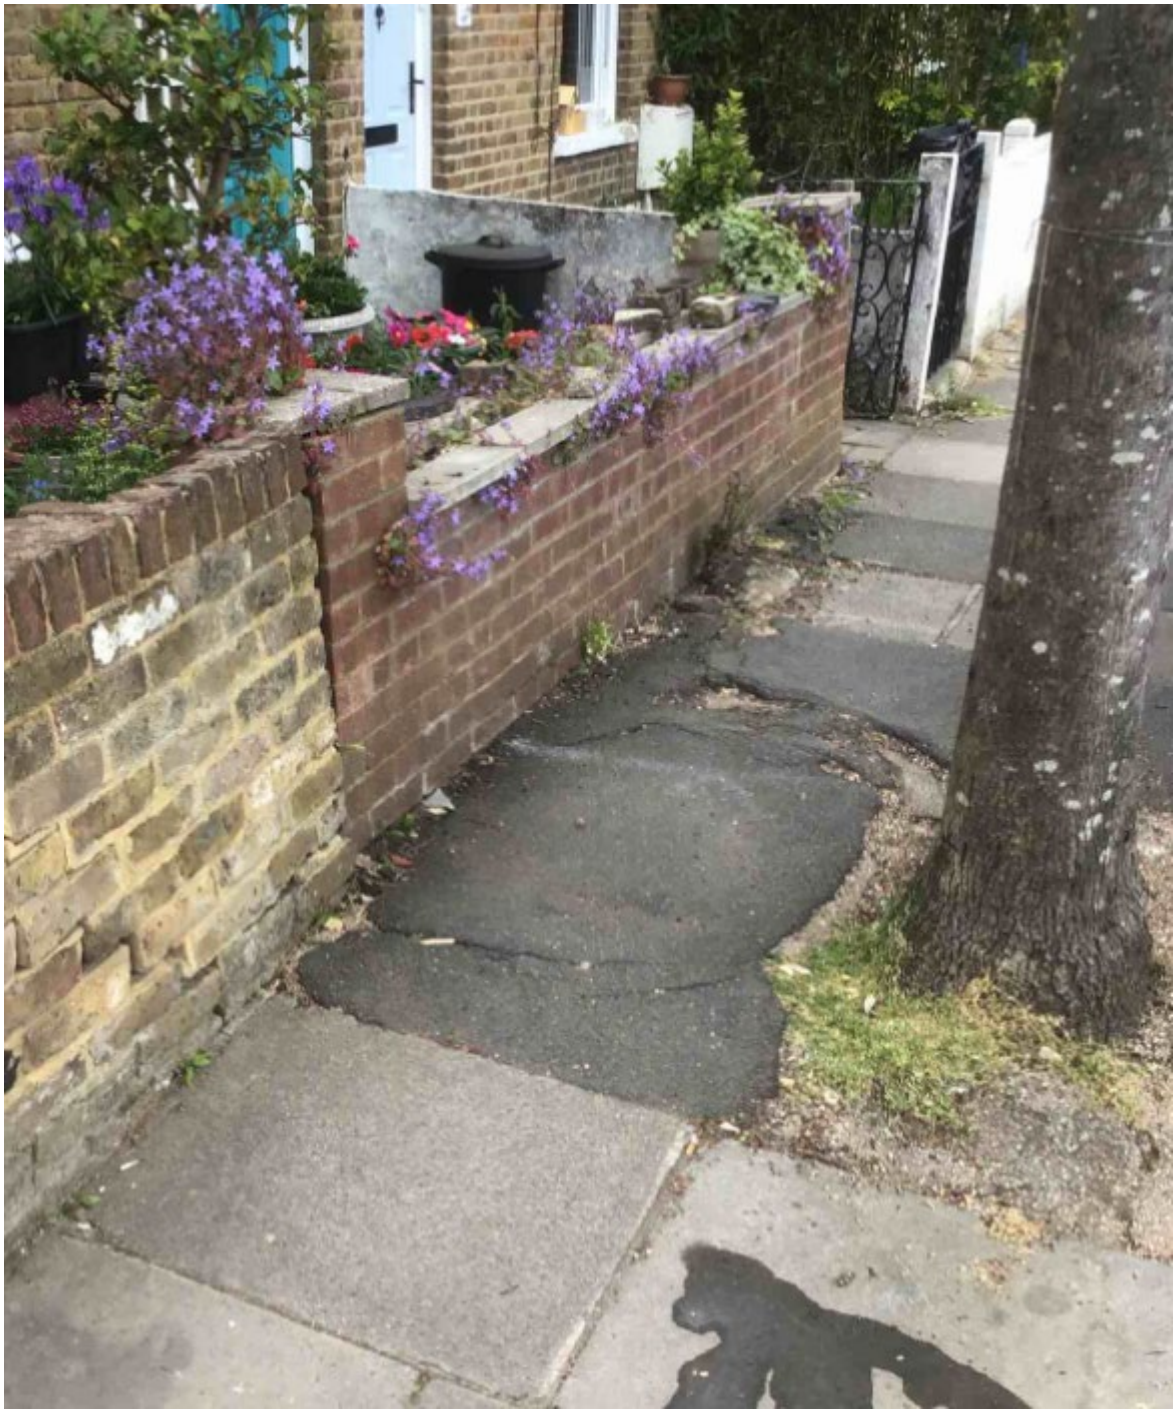
Ward	Teddington
Road	Teddington Park
Location	Outside 1-3
Species	Manna ash (<i>Fraxinus ornus</i>)
Height	9.0m
Physiological Condition	Good
Structural Condition	Good
Inspection findings/reason for exemption	Tree has raised and damaged roots causing trip hazards and an unacceptable obstruction to the pavement making an impasse for prams & wheelchairs to safely pass. With no engineering solution available to resolve this issue, we are unable to meet our duties under the Equality Act 2010. For this reason, removal is required to manage risk and facilitate replanting. Removal is required to prevent natural failure and facilitate replanting.

Image shows damaged narrow pavement due to tree
