# June 2023 – Reactive Tree Works Programme

## Introduction

Dated 16.6.2023

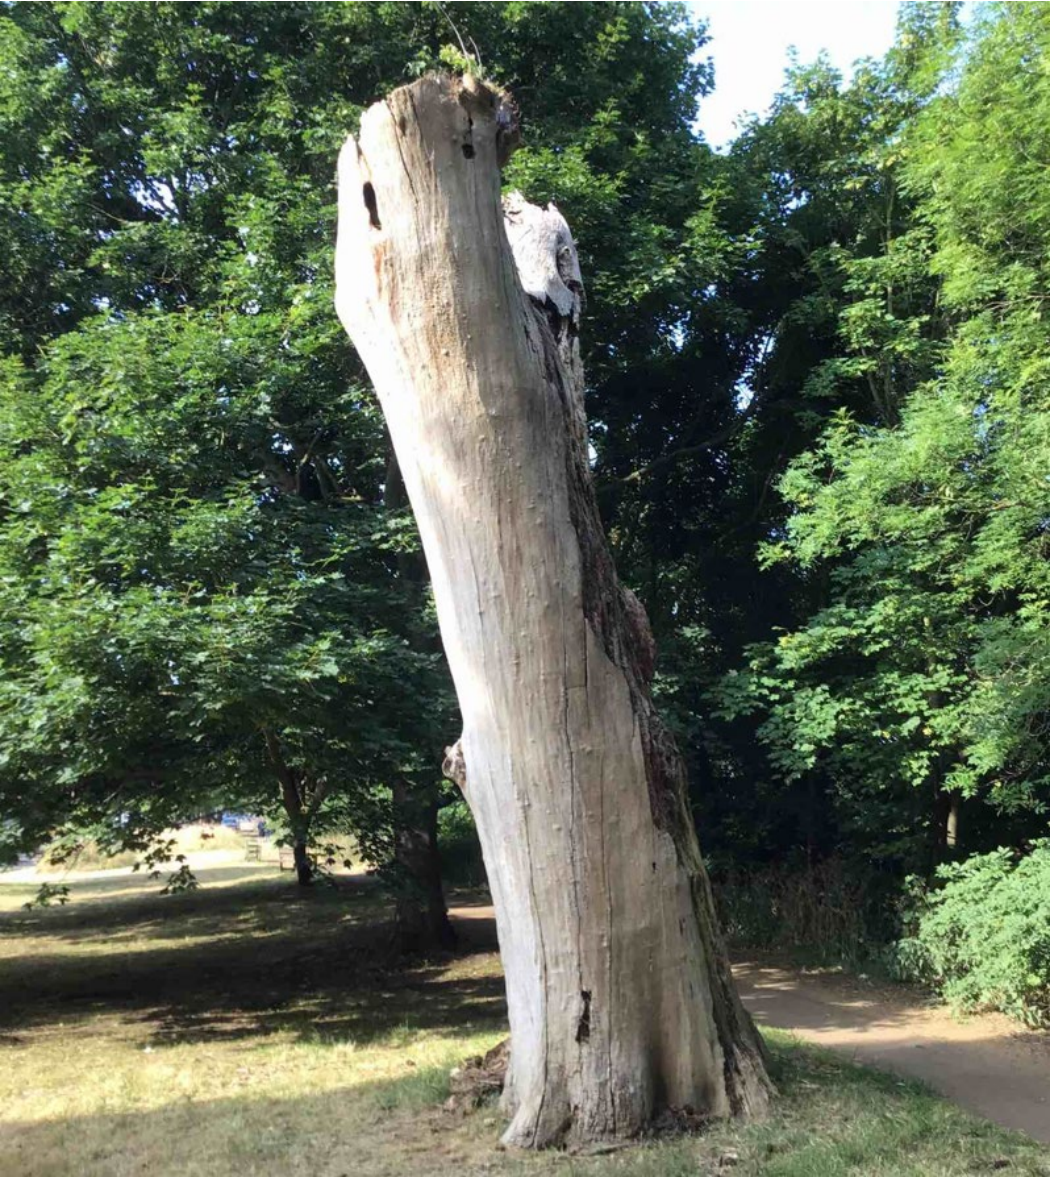
| Inspection findings | This tree was retained as a monolith for its habit value. However, it has now decayed to an unacceptable degree and removal is required to prevent natural failure. |

Image shows tree in street scene

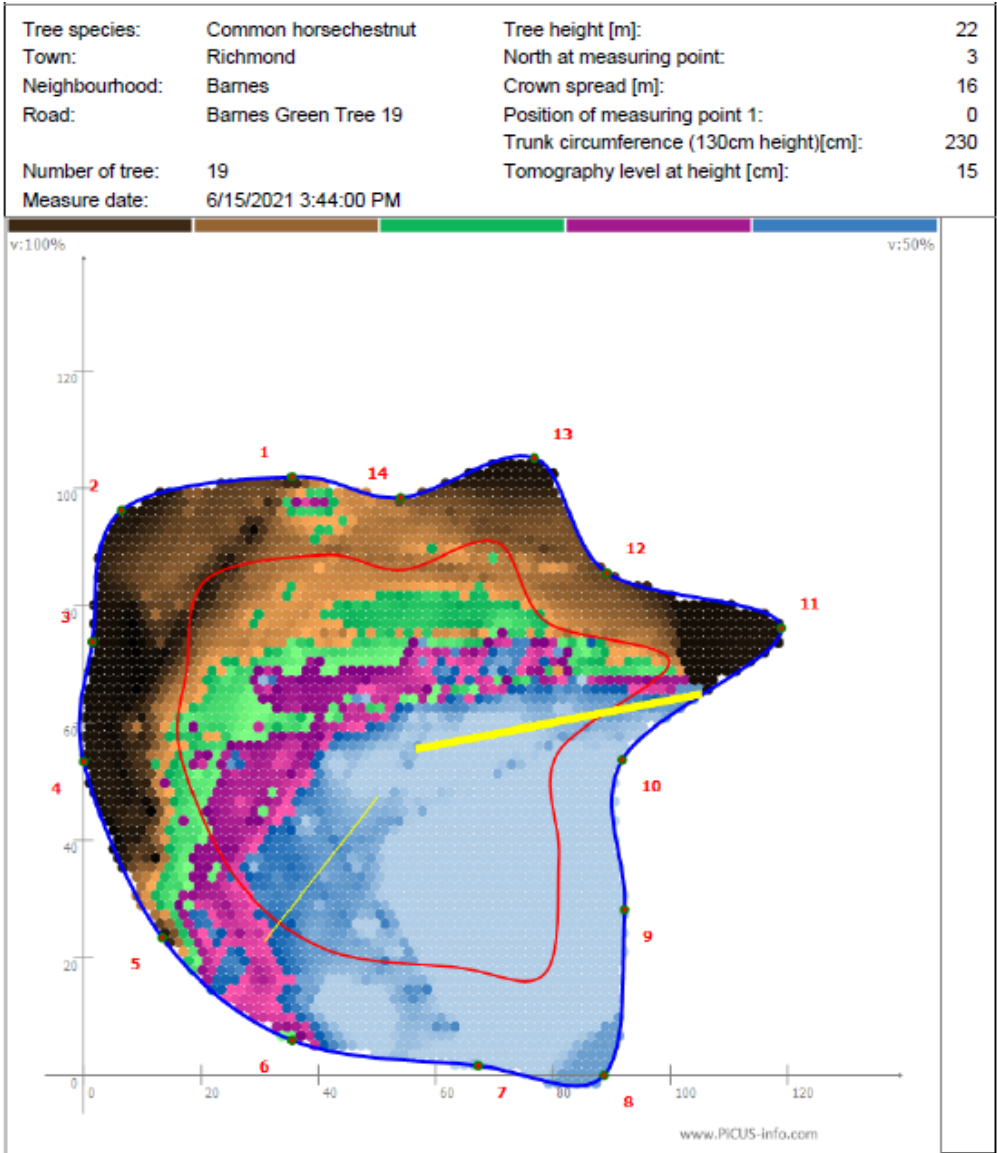
| Inspection findings | A fungal fruiting body of the decay pathogen <i>Ganoderma</i> sp. is present at the stem base. Colonisation by this fungus causes a white rot of the stem and root system that can cause entire trees to collapse through fracture or windthrow. A detailed investigation of this tree using sonic tomography revealed an unacceptable degree of decay, removal is required to prevent natural failure and manage risk. |

Image shows tomogram with blue and purple indicating extensive decay.

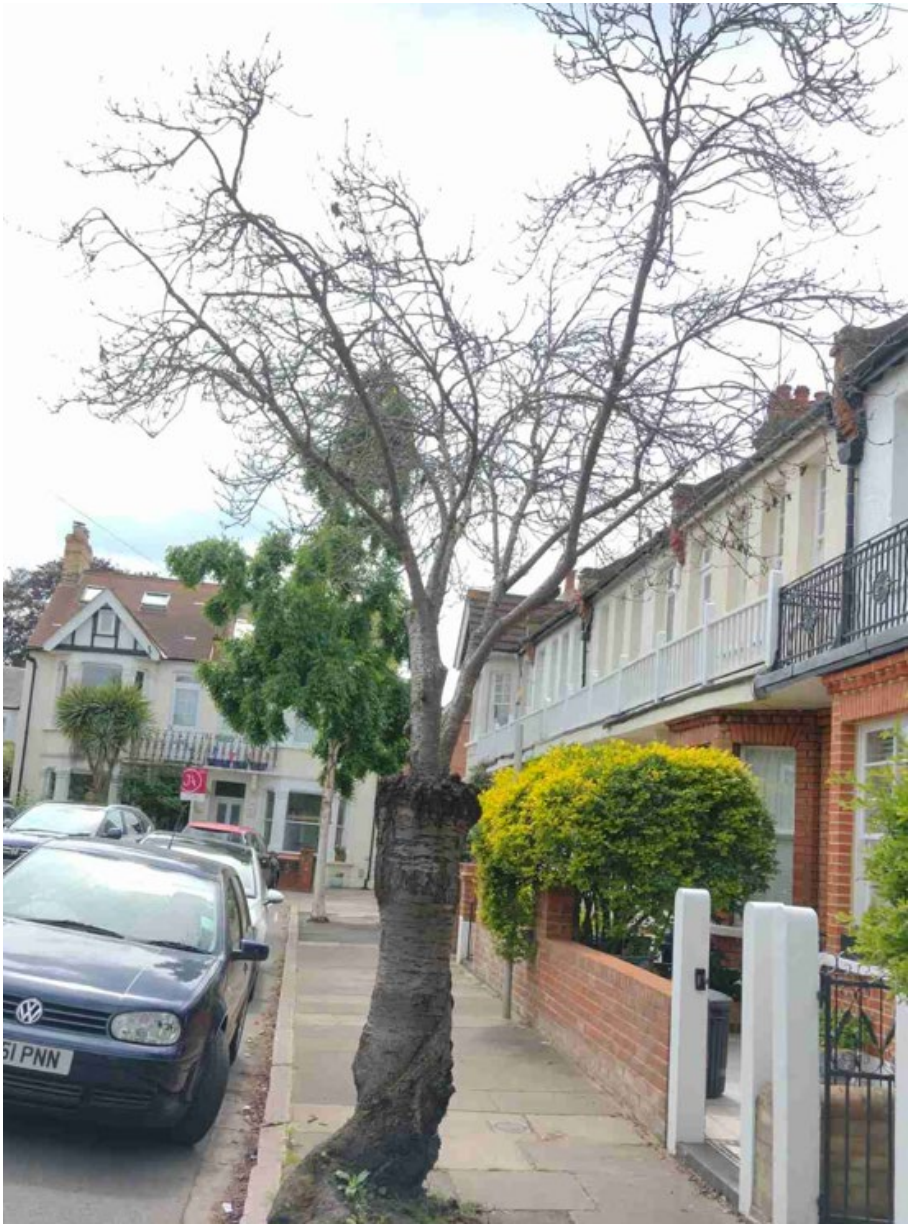
| Inspection findings | This tree is dead; removal is required to prevent natural failure and facilitate replanting |

Images shows dead tree

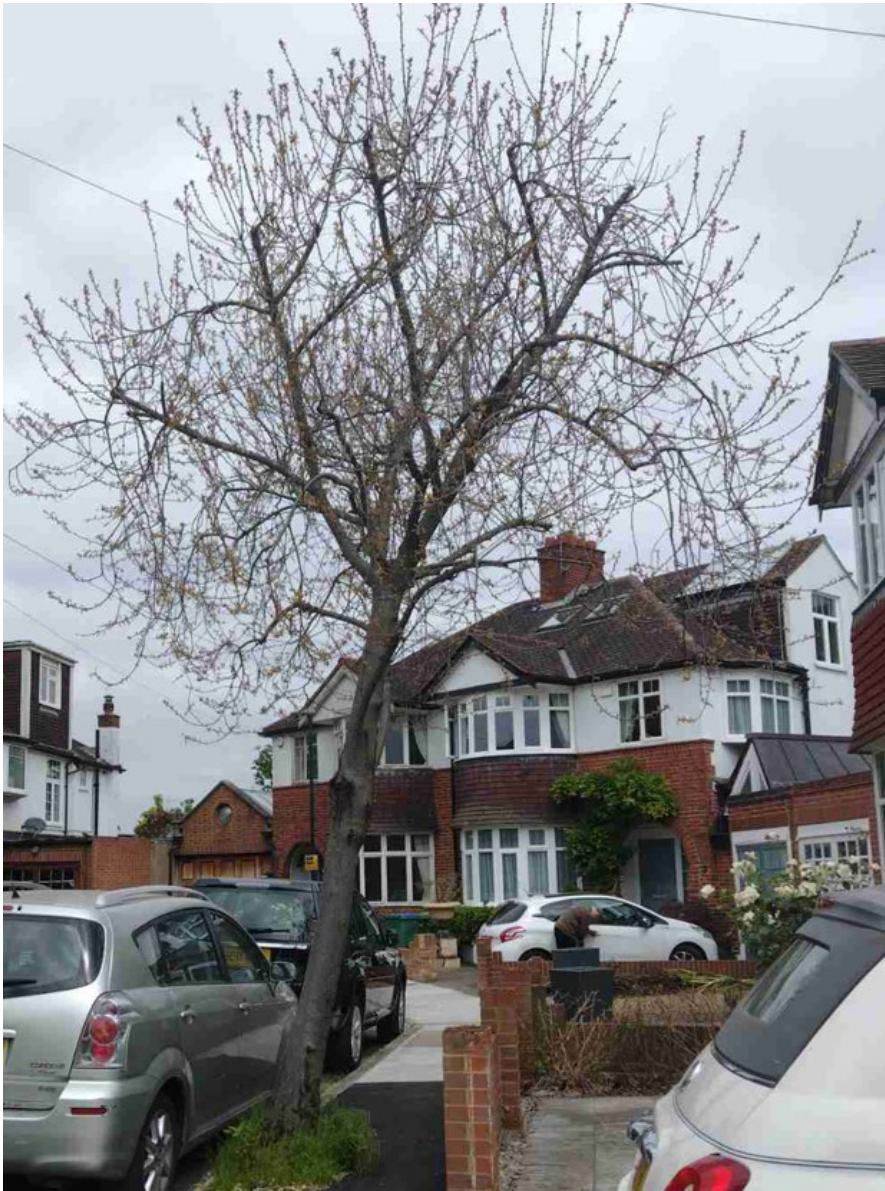
| Inspection findings | This tree is in a state of physiological decline and contains weak branches that are liable to collapse. Removal is required to prevent natural failure and facilitate replanting |

Images show tree in a state of physiological decline

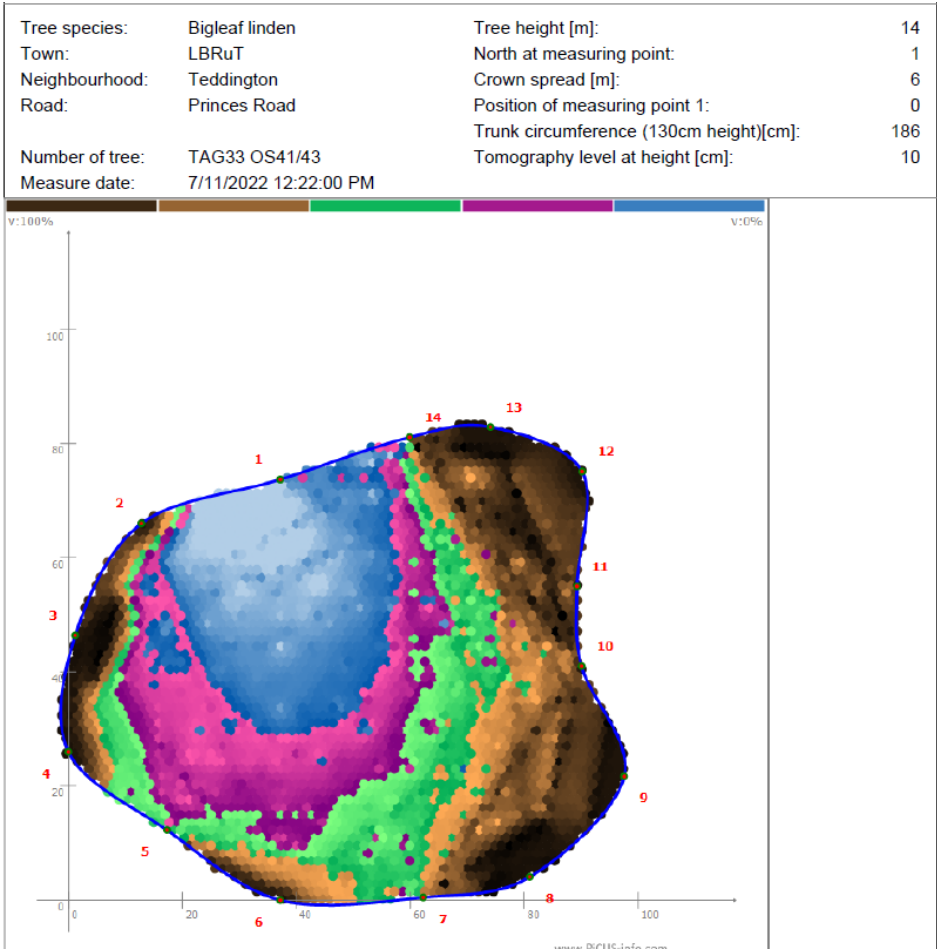
| Inspection findings | A fungal fruiting body of the decay pathogen <i>Ganoderma</i> sp. is present at the stem base. Colonisation by this fungus causes a white rot of the stem and root system that can cause entire trees to collapse through fracture or windthrow. A detailed investigation of this tree using sonic tomography revealed an unacceptable degree of decay, removal is required to prevent natural failure and manage risk. |

Image shows tomogram with blue and purple indicating extensive decay.

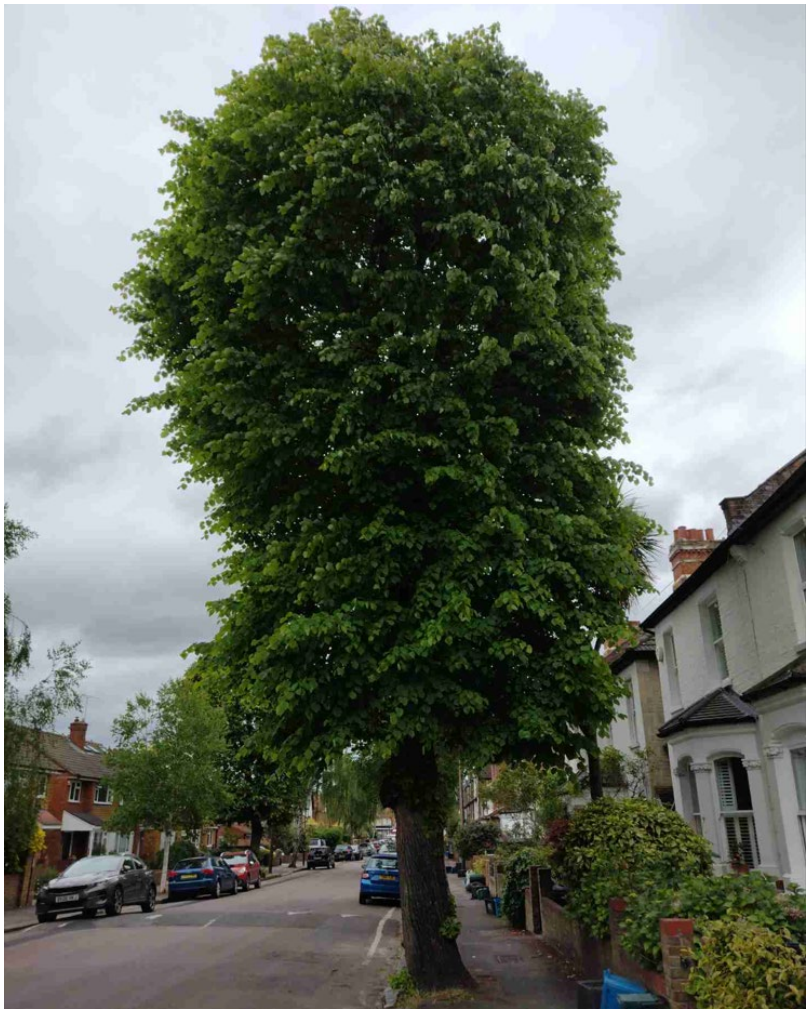
Image shows tree in street scene

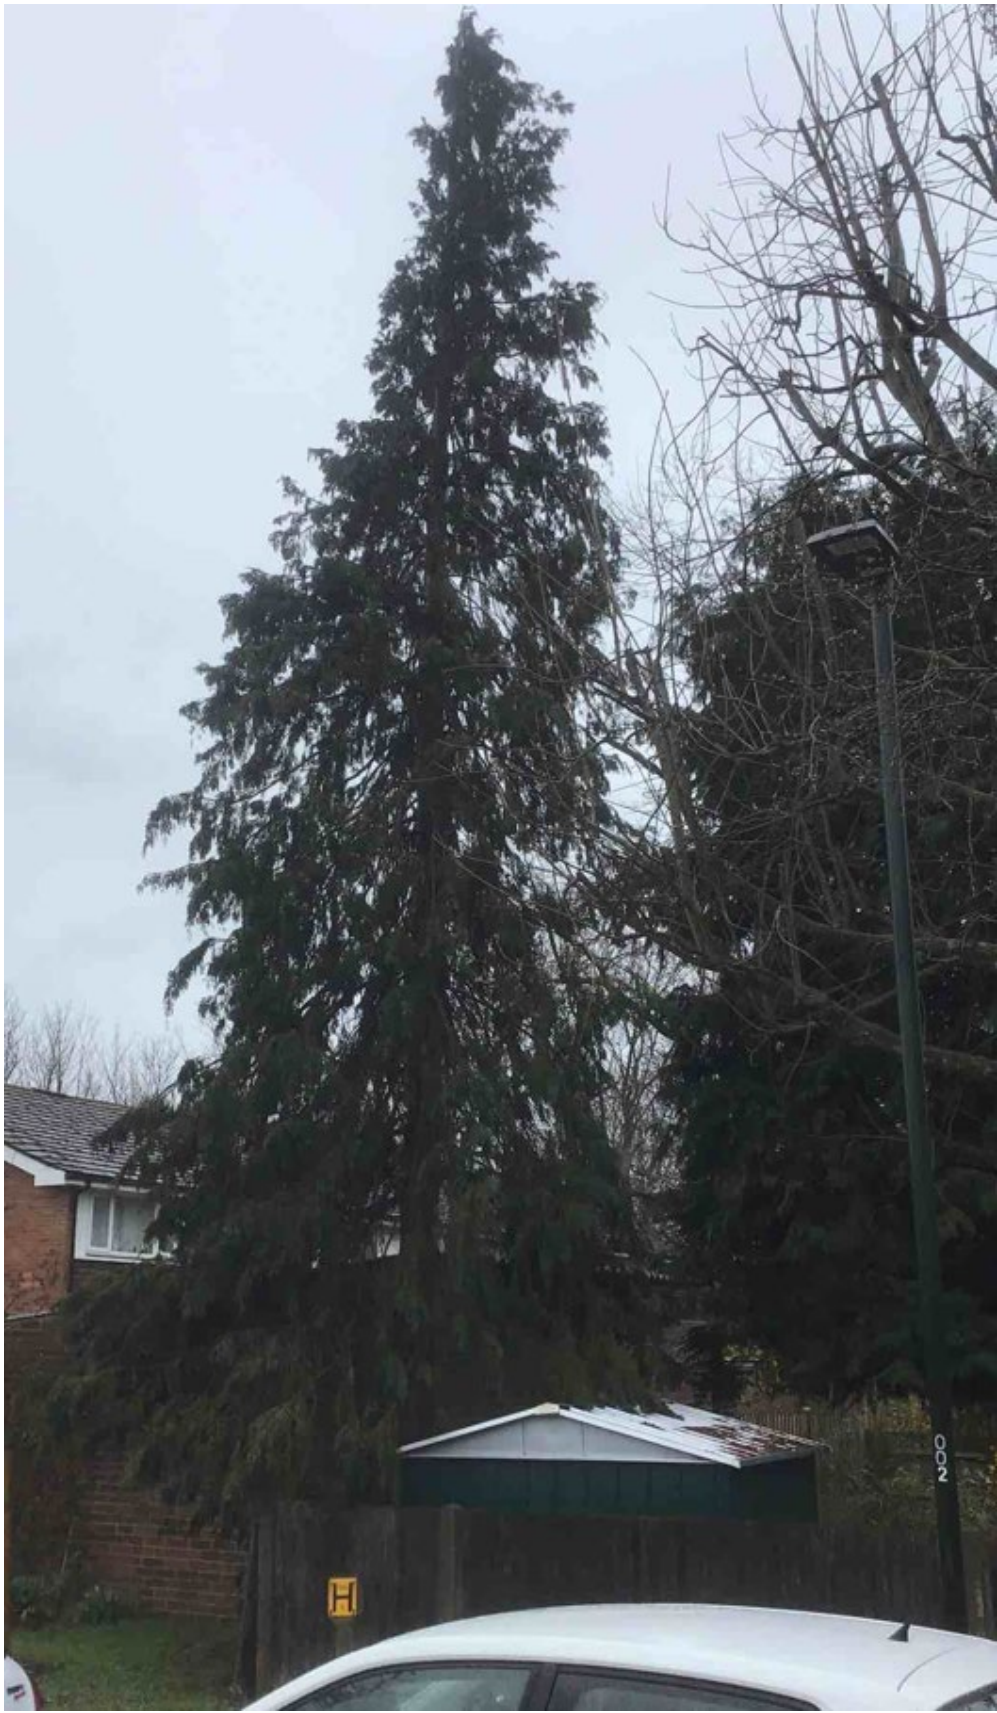
| Inspection findings | Tree growing in unsuitable location and has damaged boundary fence and outbuilding to privately owned garden |

***Image shows tree in context with location to privately owned fence and outbuilding***

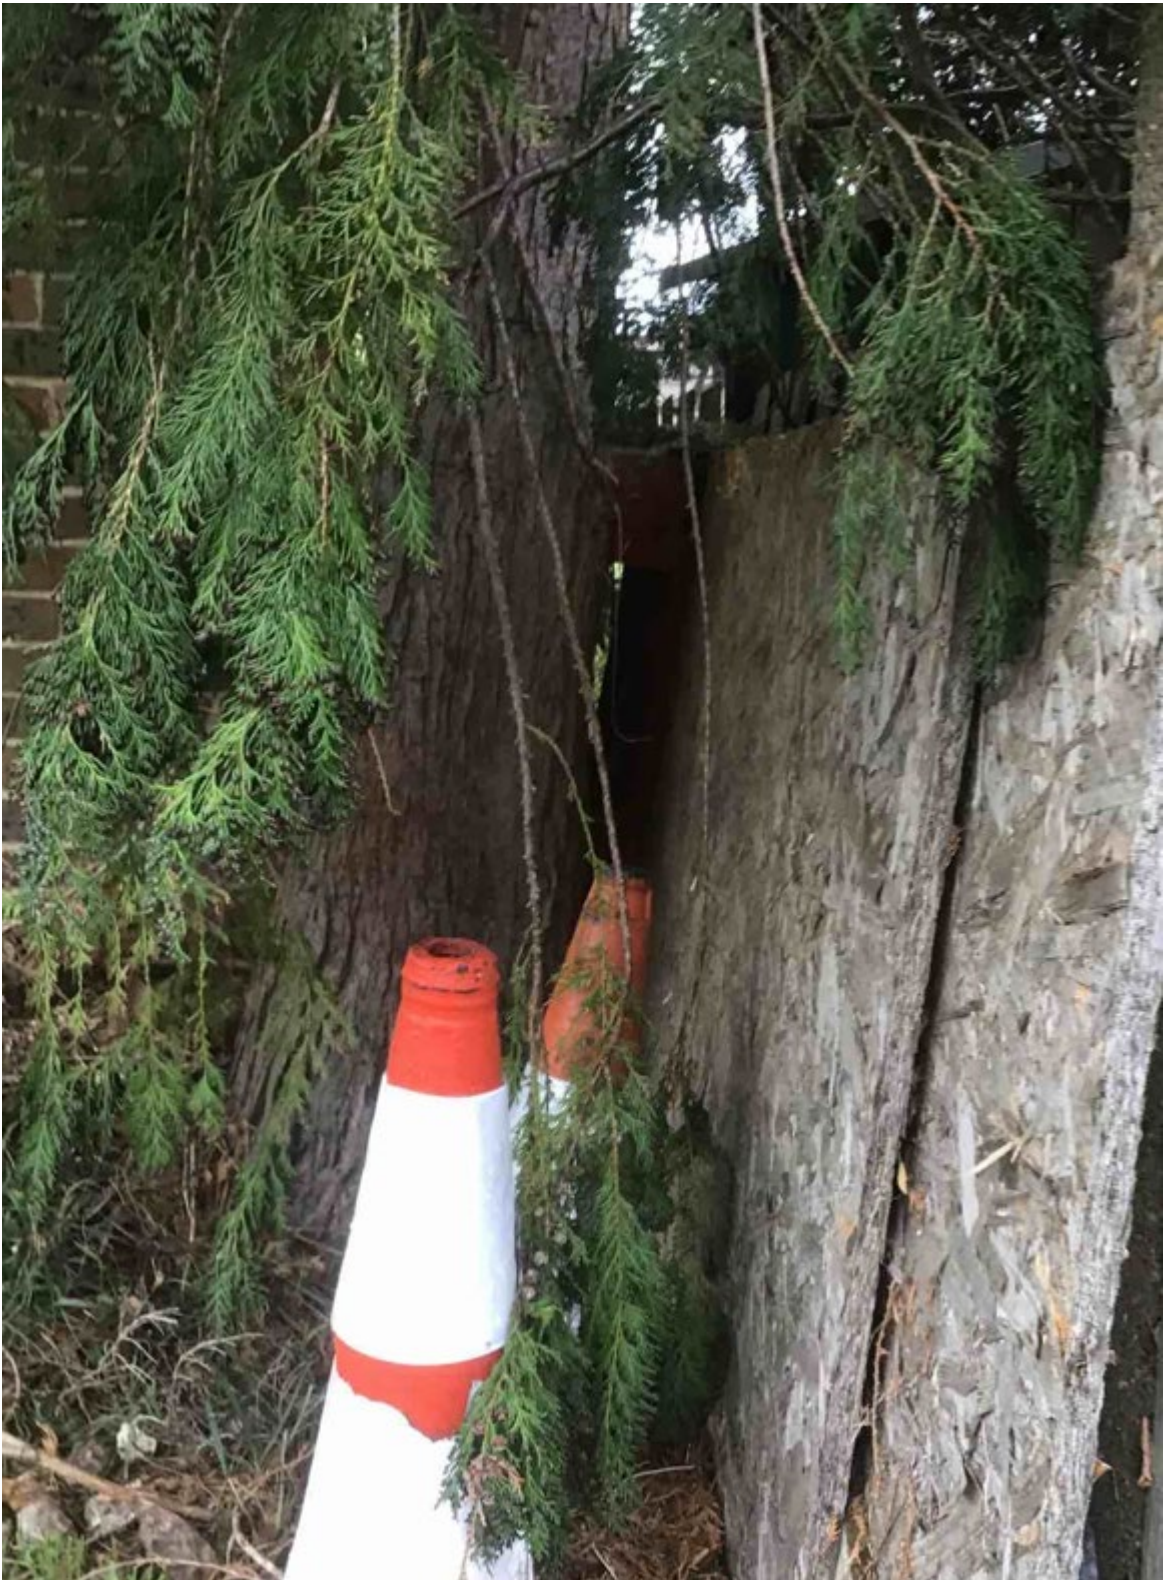
**Image shows Trunk in unsuitable location**

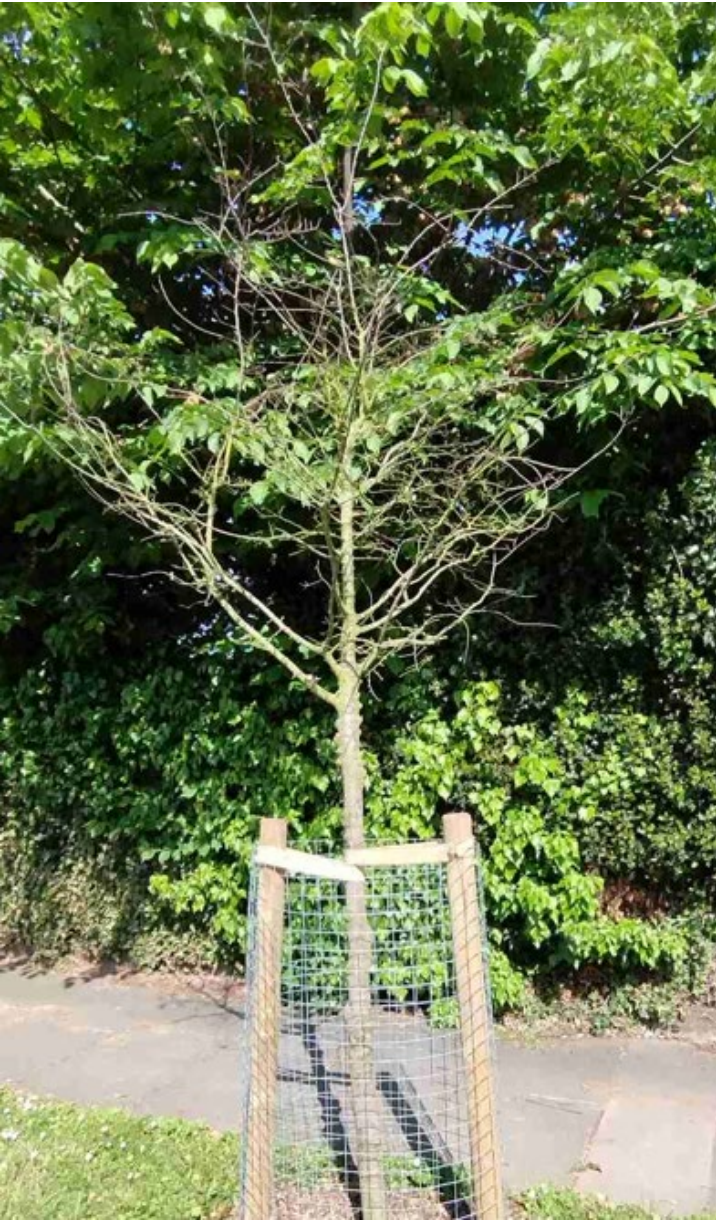
| Inspection findings | This tree is dead and requires removal to facilitate replanting and prevent natural failure |

Image shows dead tree

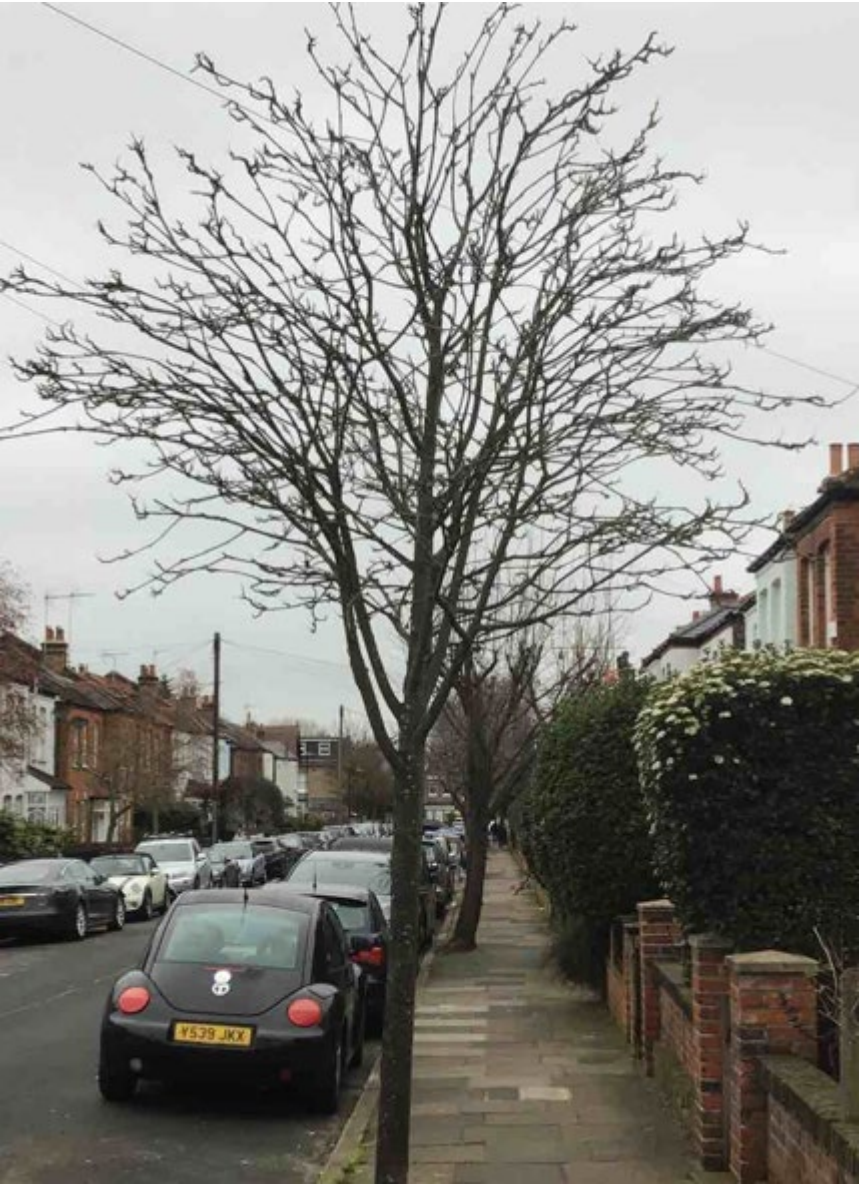
| Inspection findings | This tree is dead; removal is required to prevent natural failure and facilitate replanting |

Image shows dead tree

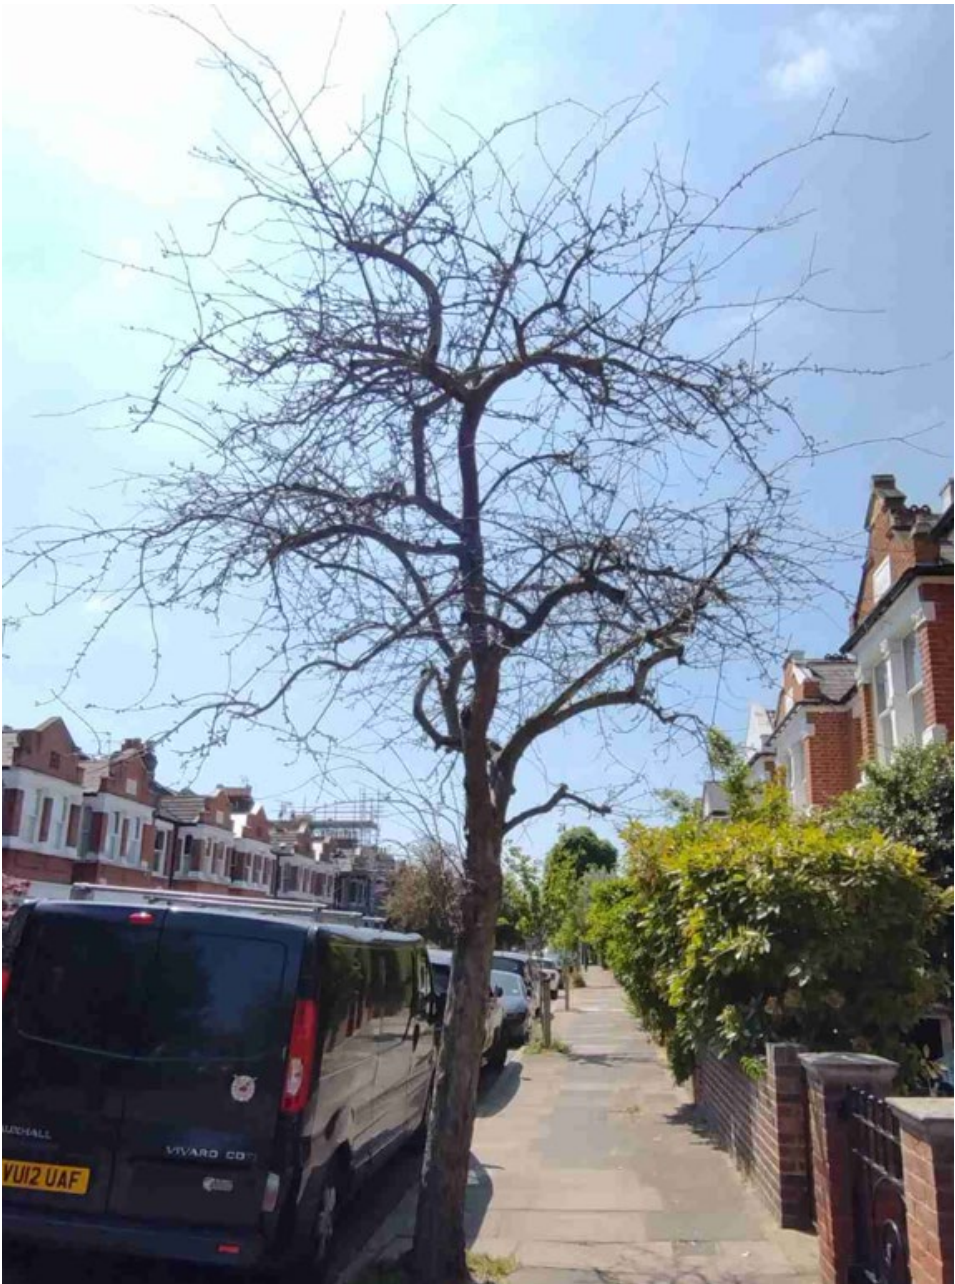
| Inspection findings | This tree is dead; removal is required to prevent natural failure and facilitate replanting |

Image shows dead tree

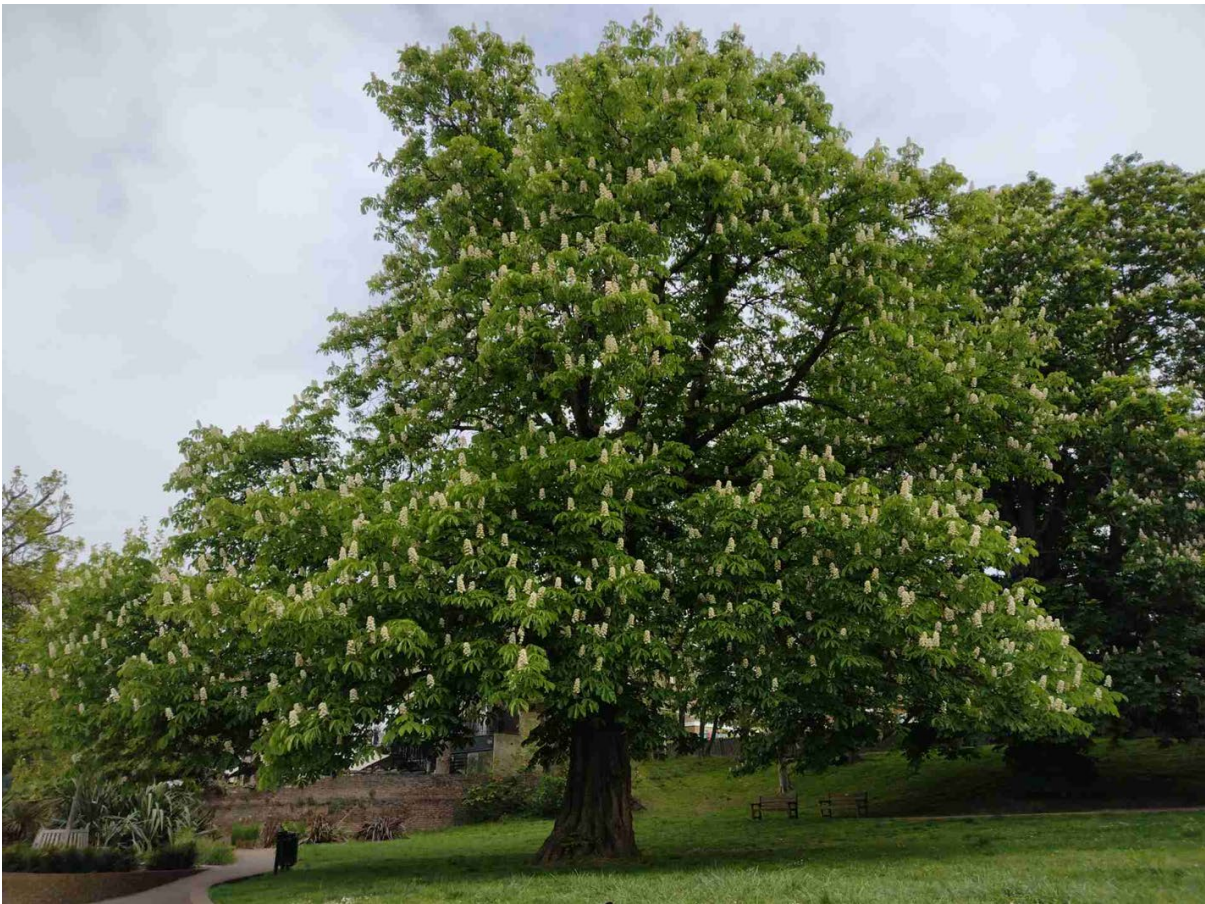
Image shows tree in park

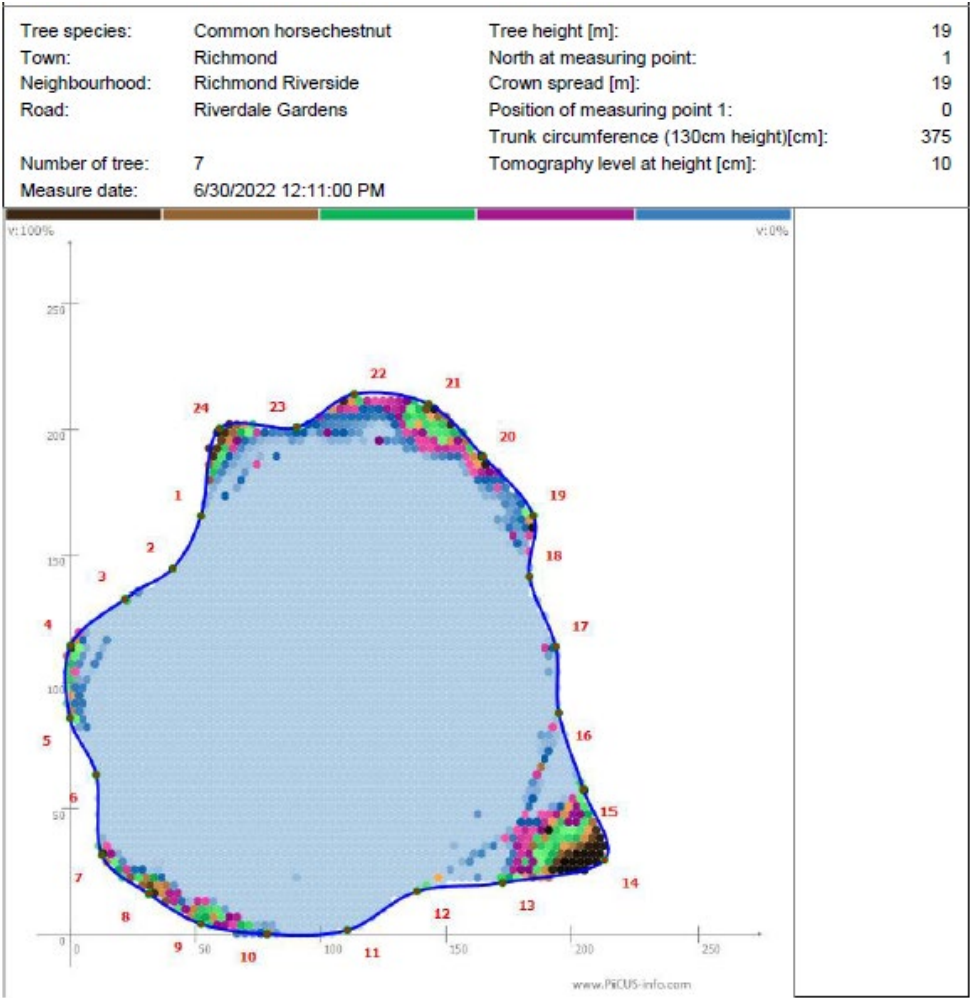
| Inspection findings | A cavity indicating root and lower stem decay is present at the base of this tree. Crown dieback could correlate with the degradation of the trees structural or supporting root system. A detailed investigation of this tree using sonic tomography revealed an unacceptable degree of decay, removal is required to prevent natural failure and manage risk. |

**Image shows tomogram with blue indicating area of decay**

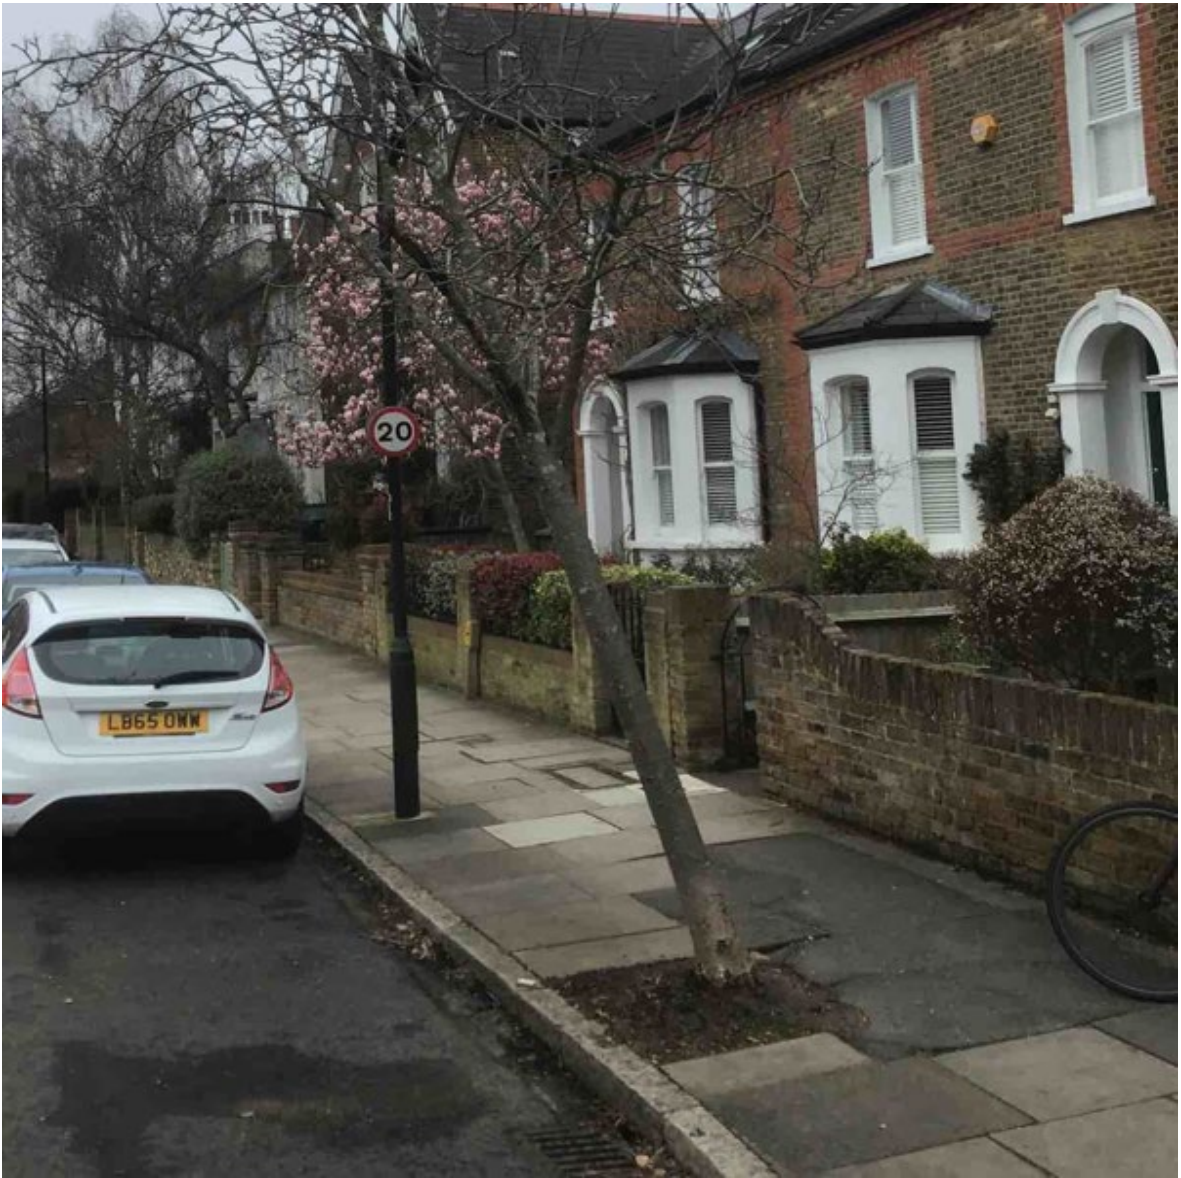
| Inspection findings | Tree roots failure: tree is moving in such a way that indicates that the structure is compromised presenting increased risk of failure |

Image shows tree in street scene with signs of movement around base of trunk

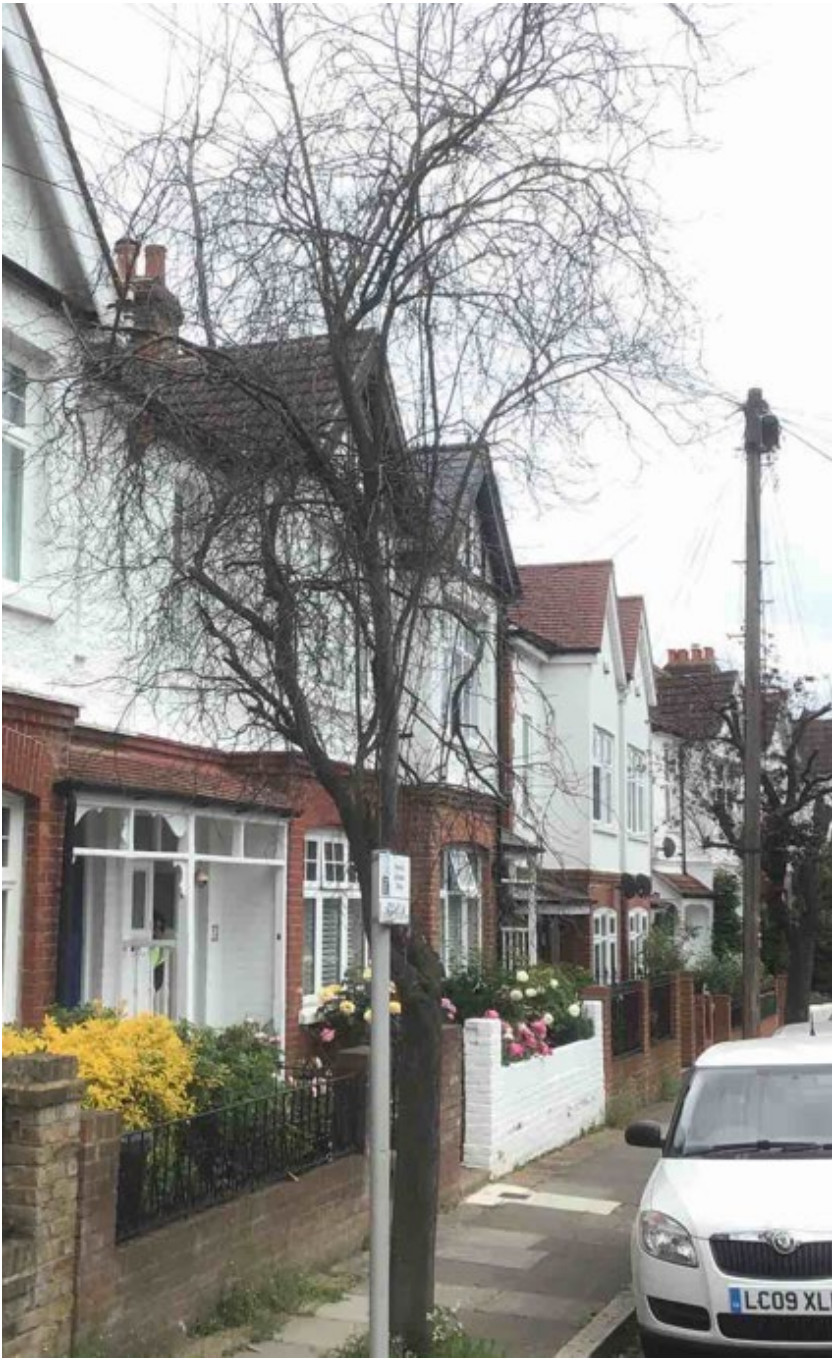
| Inspection findings | This tree is dead and requires removal to facilitate replanting and prevent natural failure |

Image shows dead tree

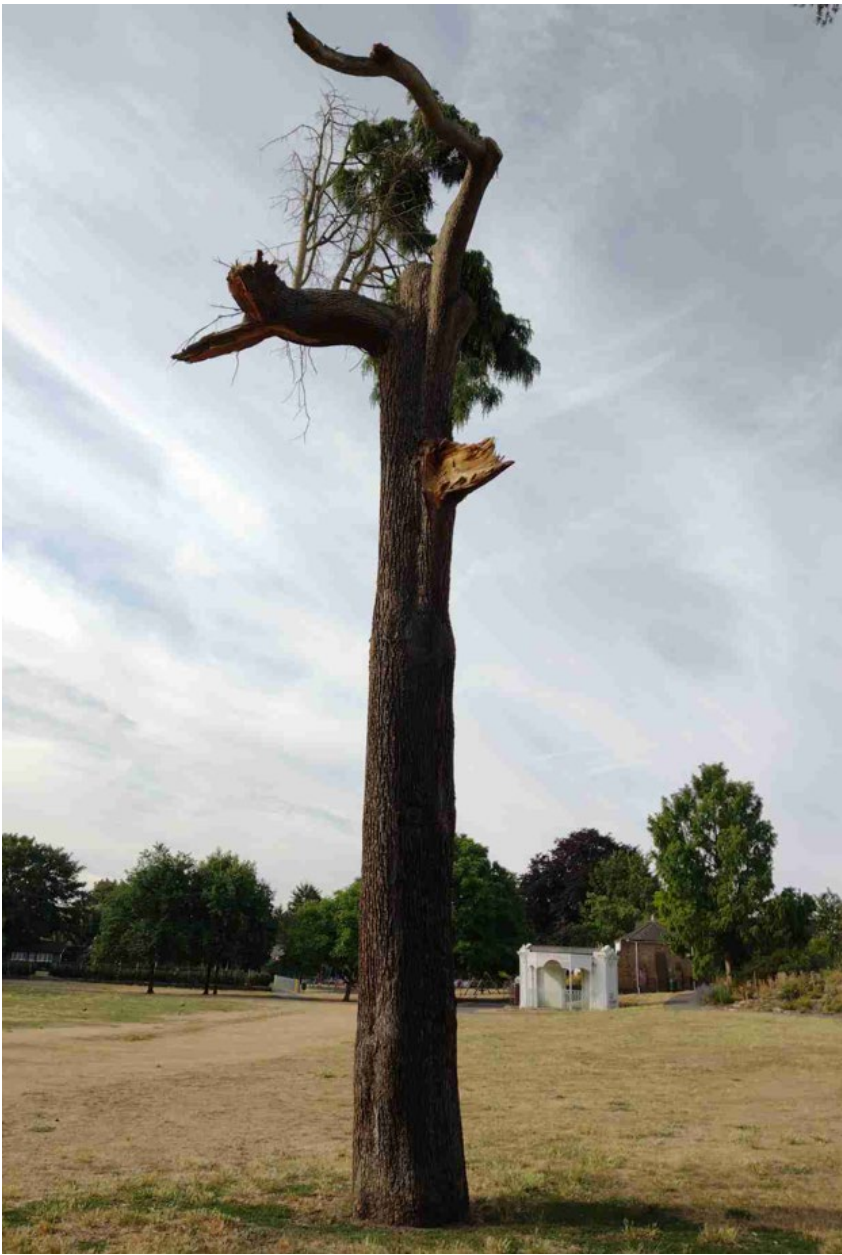
| Inspection findings | Crown of tree has previously failed in storms with no viable canopy remaining. The tree will be reduced to approximately 3.5m from ground level. |

Image shows tree in park setting with destroyed crown

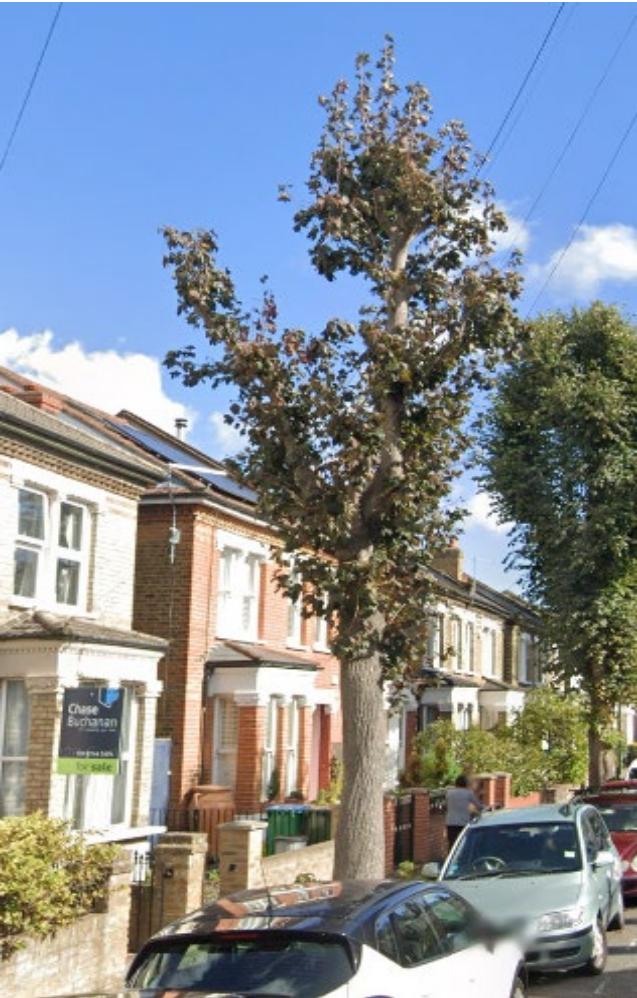
| Inspection findings | A fungal fruiting body of the species Shaggy Polypore ( <i>Inonotus hispidus</i> ) is present on the main stem or trunk, this fungus causes a simultaneous white rot which can cause snapping of tree parts in this particular species. Inonotus fruiting bodies on ground from base of stem indicate stem dysfunction. A probe and resonance test supports root and lower stem or trunk decay; this decay correlates with crown decline. |

Image shows tree decline to crown

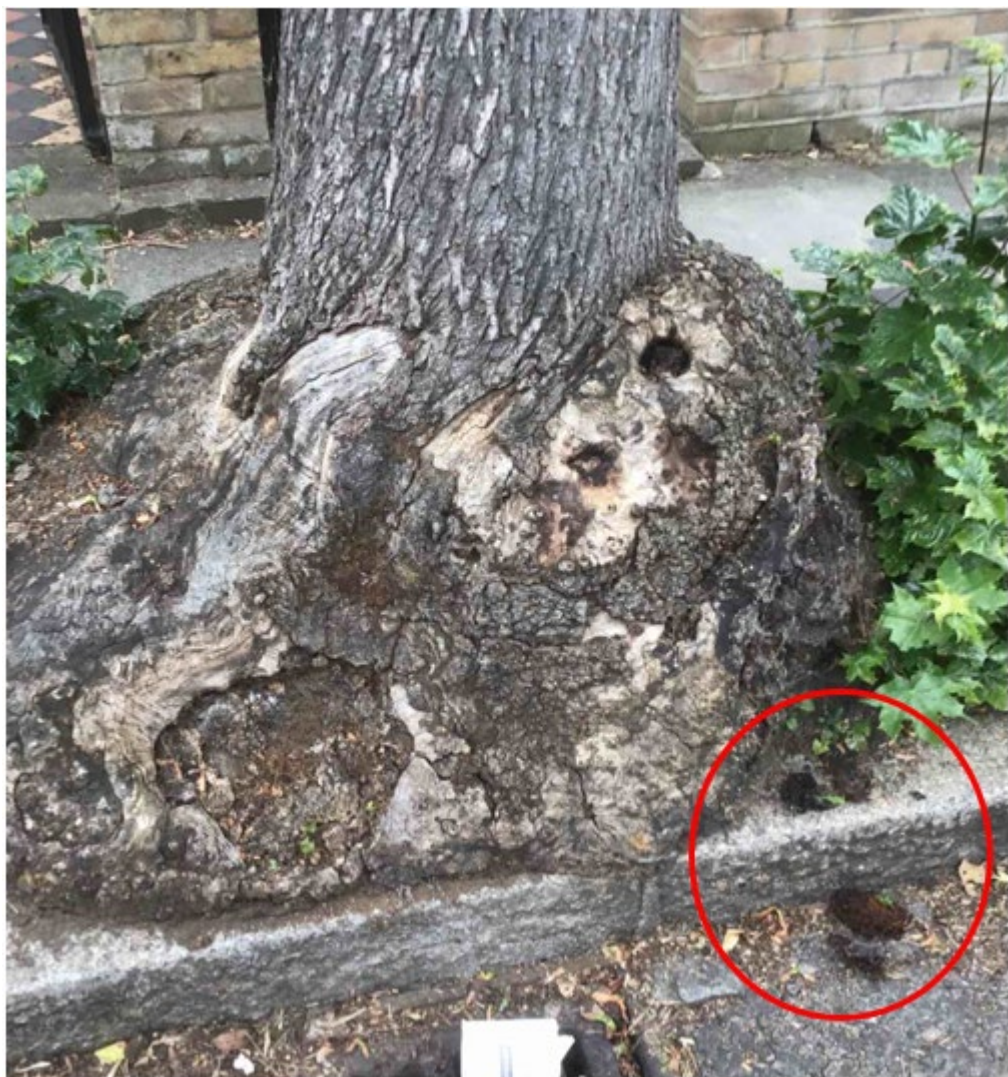
*Image shows base of with extensive decay and Inonotus fruiting body circled at base of trunk*

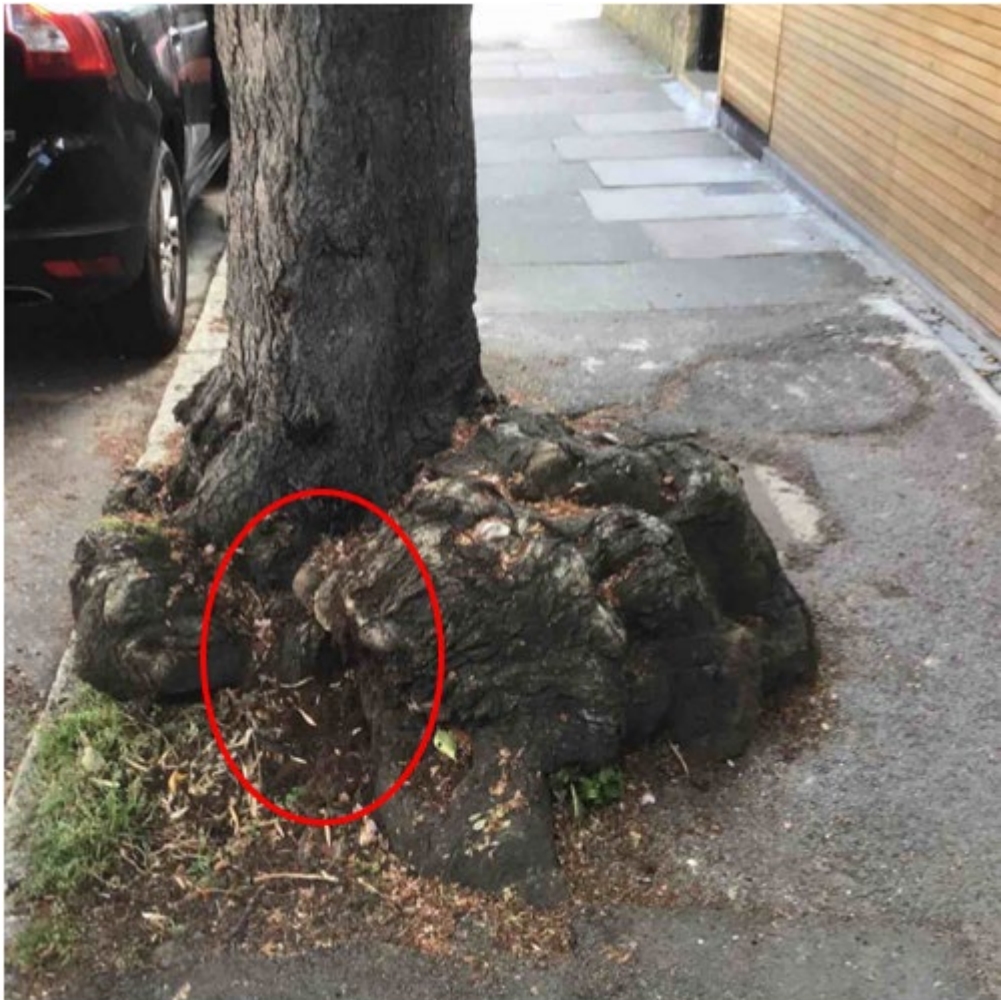
| Inspection findings | A fungal fruiting body of the decay pathogen <i>Ganoderma</i> sp. is present at the stem base. Colonisation by this fungus causes a white rot of the stem and root system that can cause entire trees to collapse through fracture or windthrow. Multiple cavities and <i>Ganoderma</i> brackets on lower stem indicating root and lower stem decay is present at the base of this tree. A resonance test revealed an unacceptable degree of decay in the lower trunk of this tree, removal is required to prevent natural failure and manage risk. |

Image shows tree with location of fungal fruiting body and decay circled
